# **Report on Damage to the Site of Babylon, Iraq**

**John Malcolm Russell, Ph.D.**

**Cultural Heritage Center  
Bureau of Educational and Cultural Affairs  
Department of State**

**April 2010**

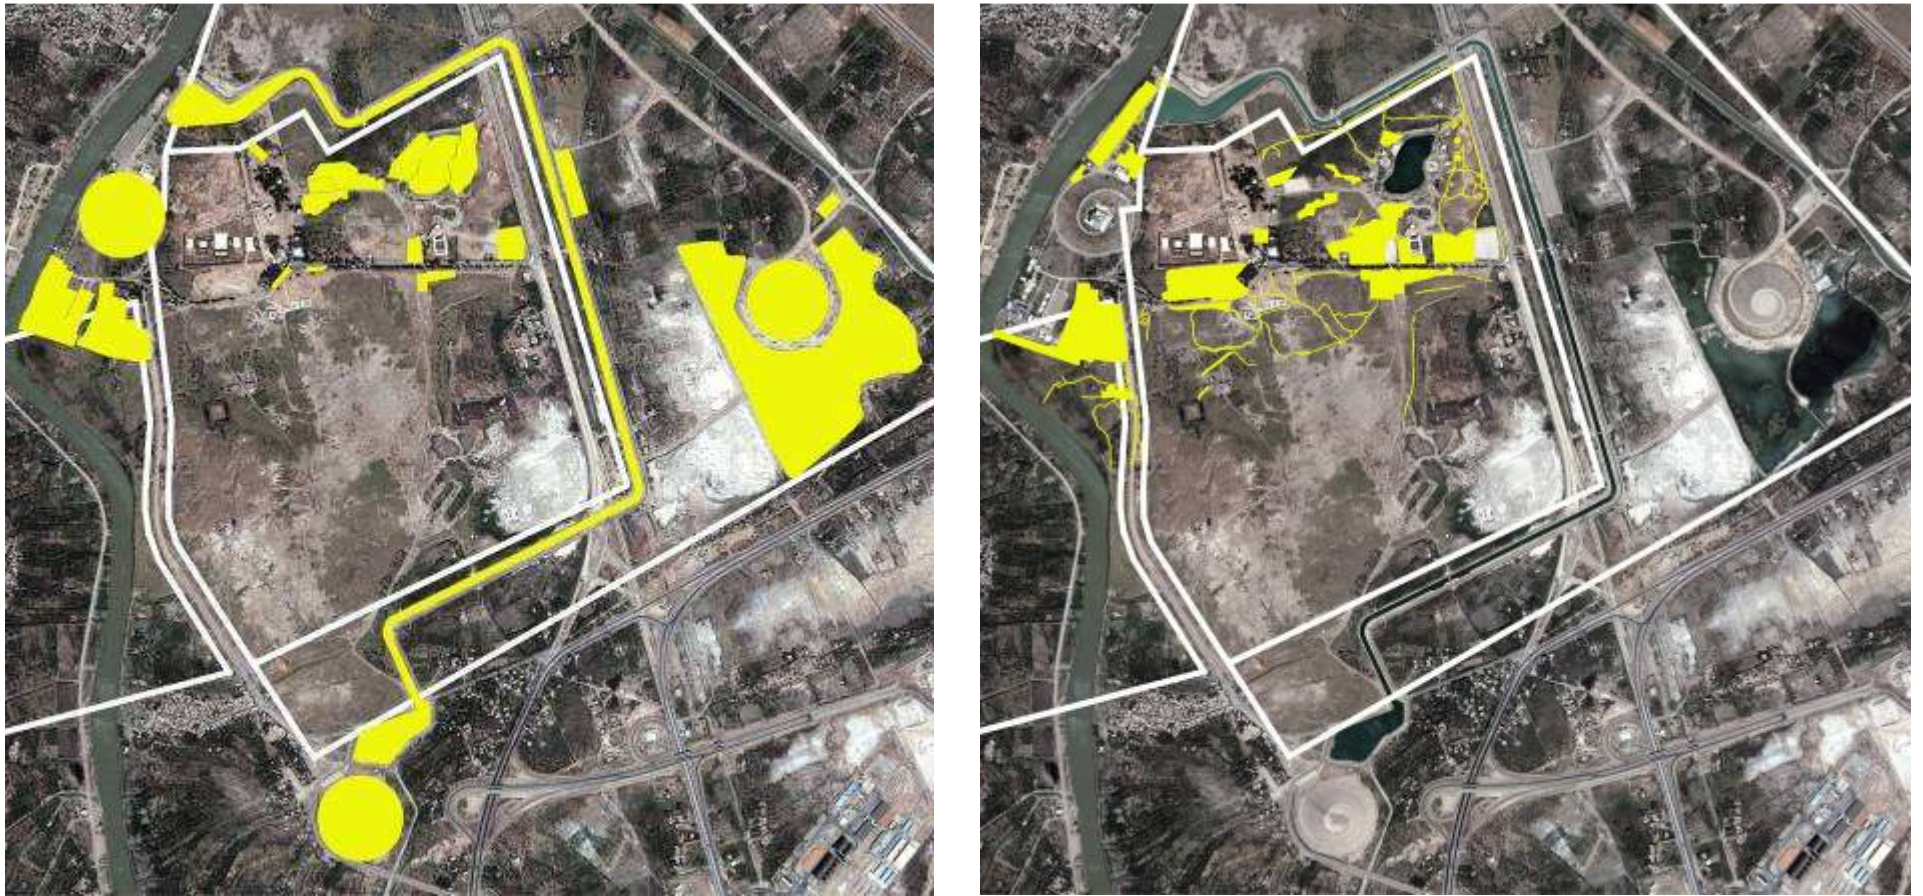
Map 2: Comparison of alterations to Babylon by Saddam (left) and Camp Babylon (right) shown in yellow, with line of ancient city wall in white, Russell composite.

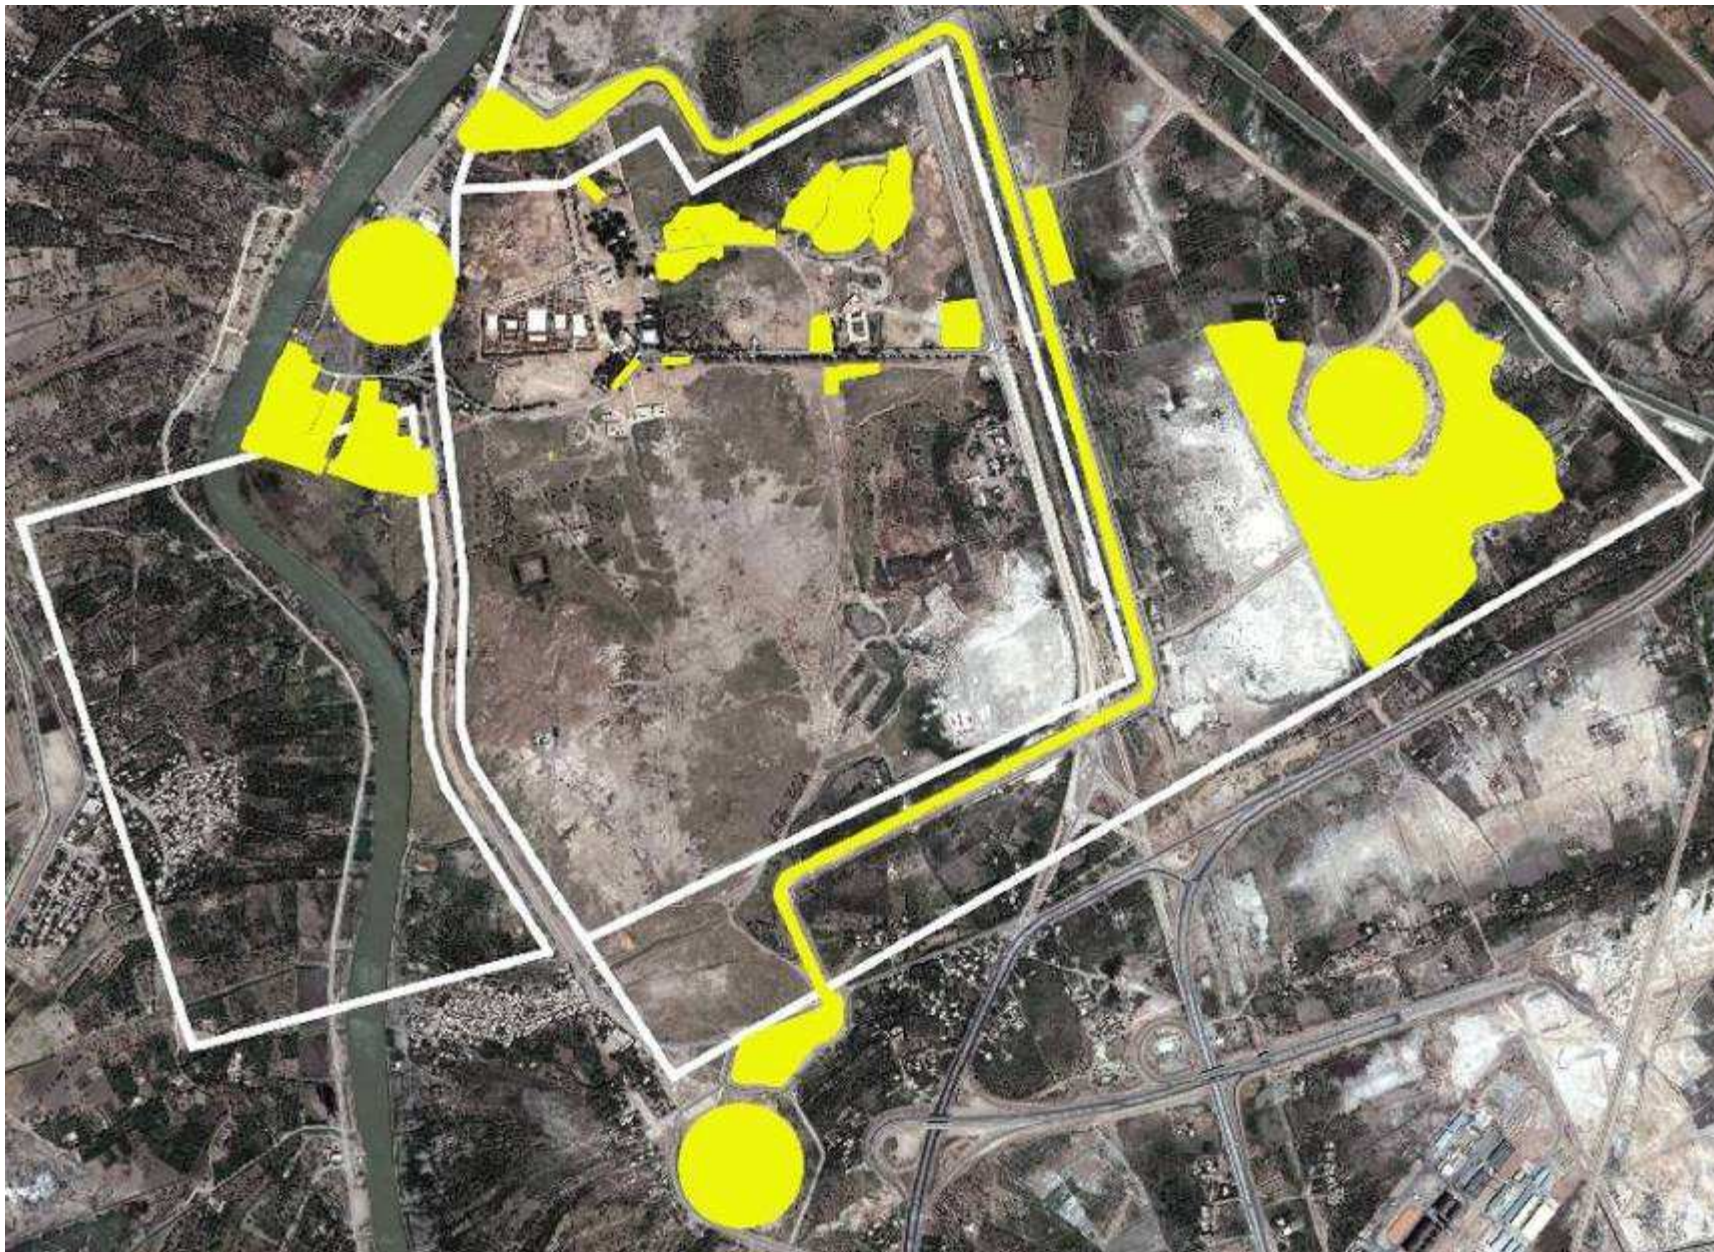
Map 3: Major Saddam alterations to Babylon (yellow) in relation to the city walls (white), 5 July 2002, Russell composite.

The alterations to the Babylon site during the period of Saddam are roughly quantified in Map 3 and Table 1. The magnitude of Saddam's alterations is astounding, impacting a total surface area of at least 969,192 m<sup>2</sup> (96.9 hectares or 239.5 acres), nearly a full square kilometer, comprising more than 10% of the site's total area. In terms of the area measure most familiar to US readers, this is equivalent to an area of 181 US football fields.

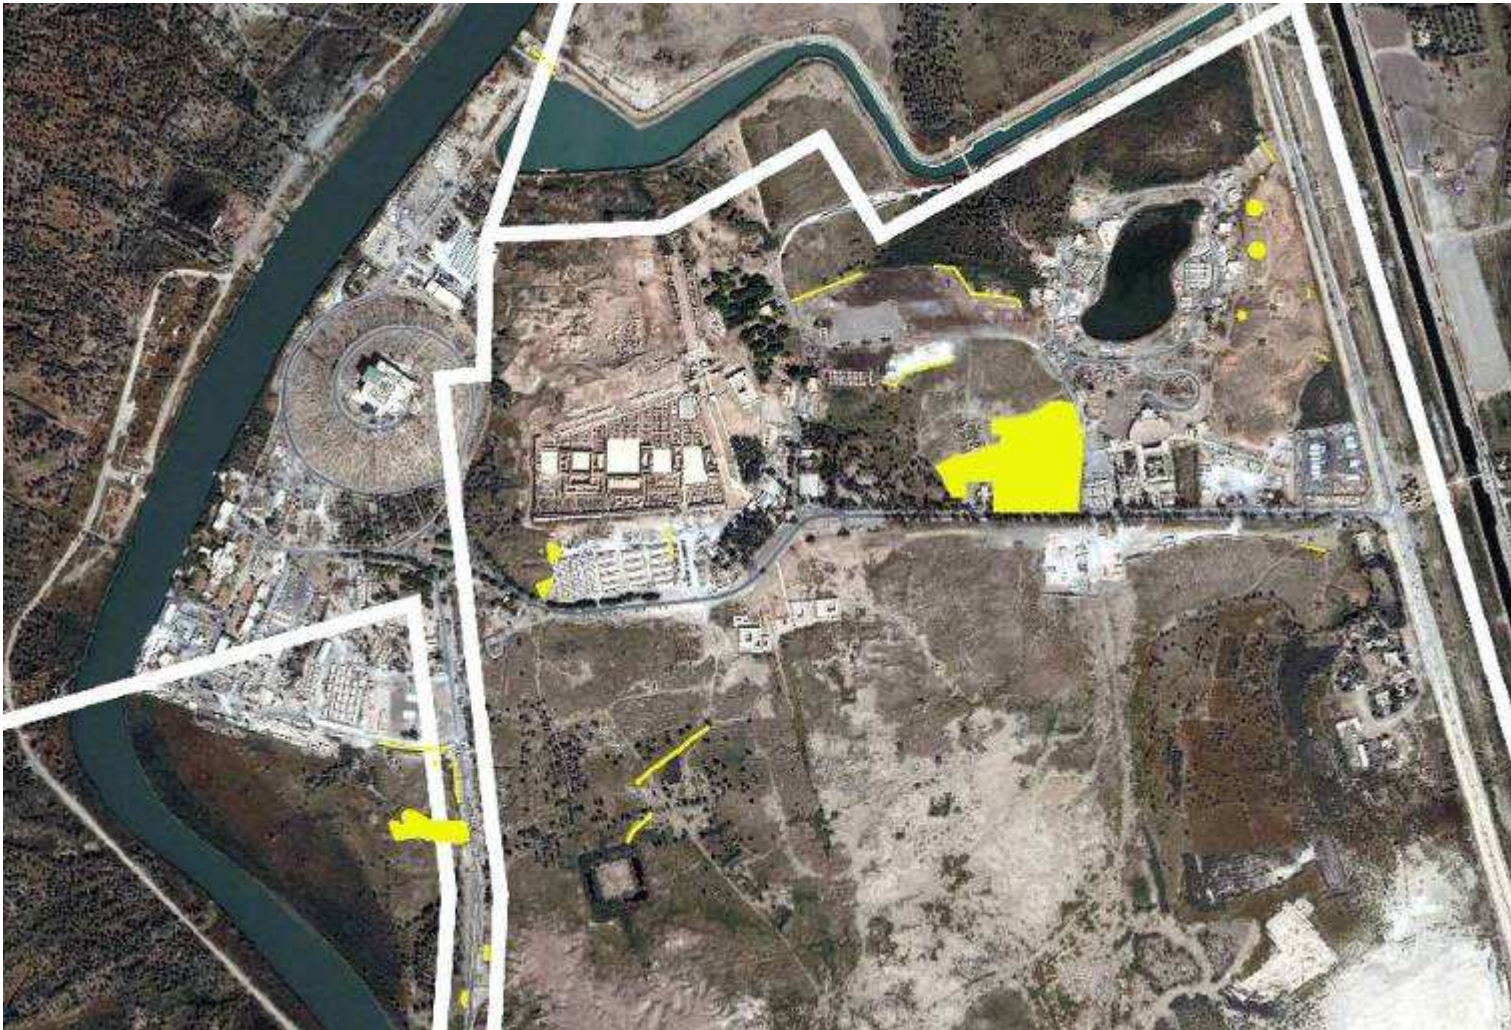
Map 4: Location of cuts, trenches, and pits (yellow) at Camp Babylon in relation to city walls (white), 8 October 2004, Russell composite.

The most archaeologically invasive activity at Camp Babylon was digging: cutting and flattening mounds, and digging trenches and pits. The most serious such impacts were the flattening of archaeological mounds throughout the KBR yard, four large cuts into the Homera mound, and two long trenches through the temple enclosure to the north of the ziggurat. These and numerous smaller interventions are documented in the Appendices. The total area of Babylon impacted by Coalition digging activities was roughly 30,000 m<sup>2</sup> (about 7.4 acres). This can be expressed in familiar units as destruction of an area equal to five and a half US football fields, but it is more compelling to think of this in terms of what digging means at an archaeological site.

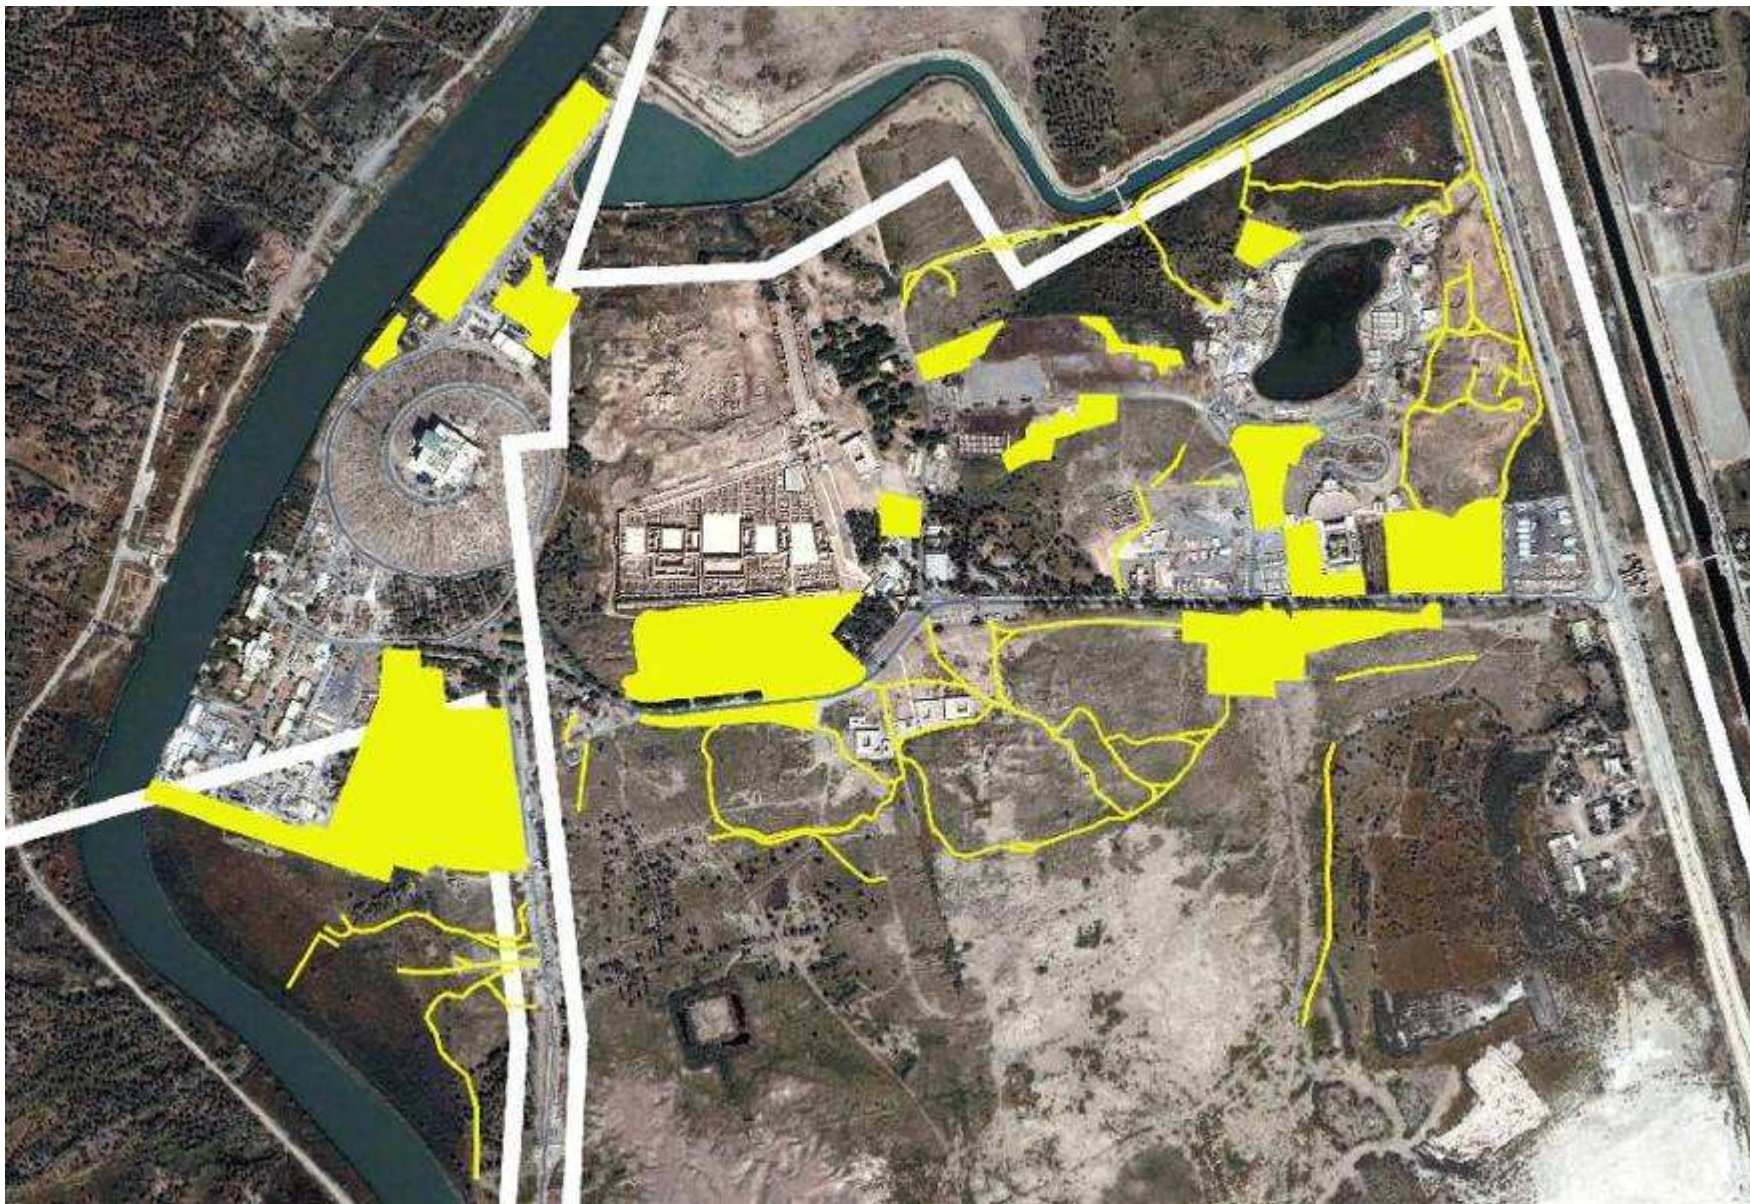
Map 5: Location of utility/parking areas and roads (yellow) at Camp Babylon in relation to city walls (white), 8 October 2004, Russell composite.

The construction of new utility/parking areas and roads was by far the most widespread type of damage at Camp Babylon, covering a known total area of about 224,000 m<sup>2</sup> (more than 55 acres), distributed throughout the site. To use the most familiar US measure of area, this is equivalent to 42 US football fields.

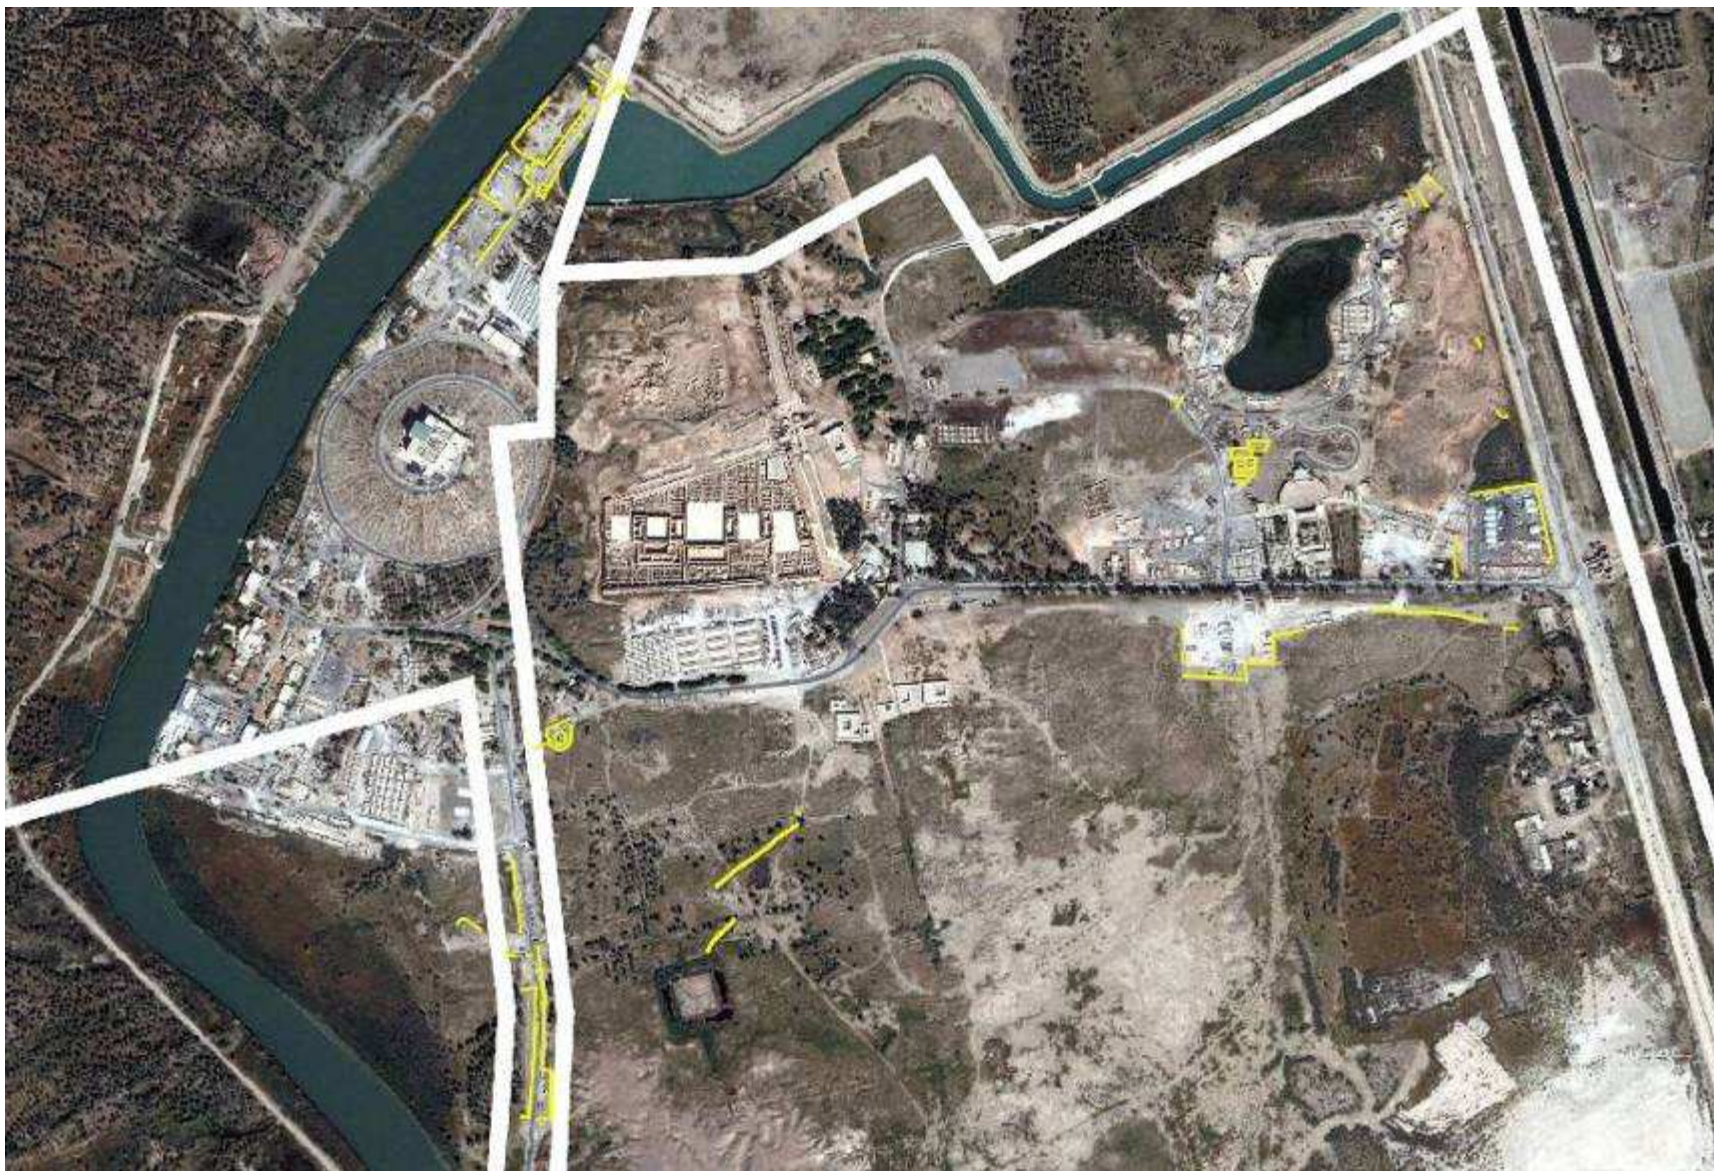
Map 6: Location of berms and HESCO barriers (yellow) at Camp Babylon in relation to city walls (white), 8 October 2004, Russell composite.

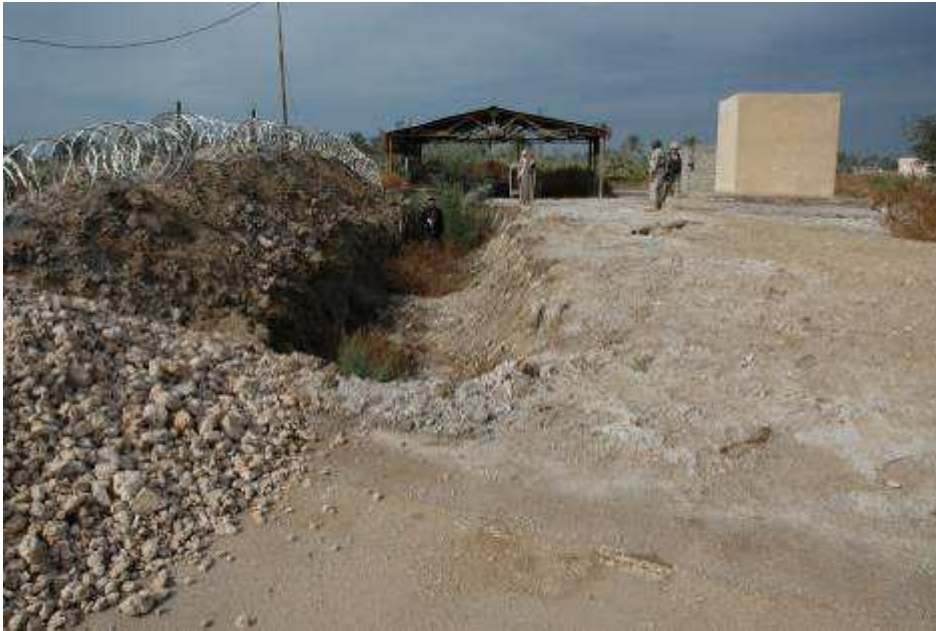
Euphrates North, north gate, 5th trench and adjacent berm, Iraqi final report 26

In Camp Babylon, defensive trenches and berms were usually paired, so that the trench serves as the outer obstacle, backed by the berm formed from the trench fill, as shown at left above. When the fortification is abandoned, the berm can be pushed back into the trench, leaving little visible surface disturbance. In the case of an archaeological site such as Babylon, however, the archaeological stratigraphy of the trench has nevertheless been destroyed, so it is important that the location of any such filled trenches be recorded.

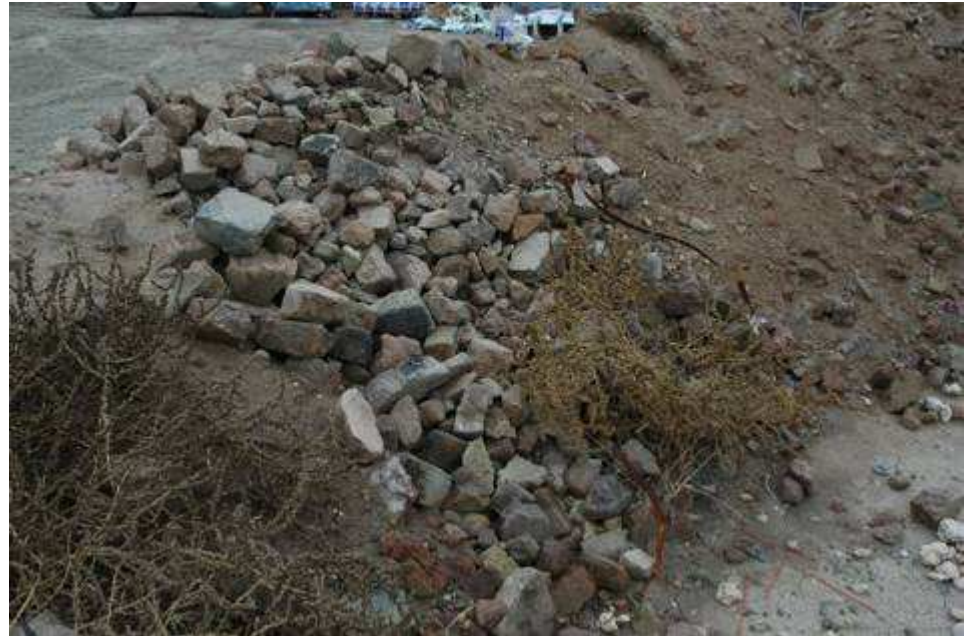
Euphrates North, artifact-filled earth evidently brought from another location for a berm between Lots 5 and 6, Polish report p. 6

The earth used to form berms appears sometimes to have been brought from a different location, rather than being excavated from directly adjacent to the berm. In Lot 6 in the Euphrates North area, shown at right above, the earth in the berm was filled with artifacts, even though the surrounding terrain appears to be clean alluvial soil from the former riverbed.

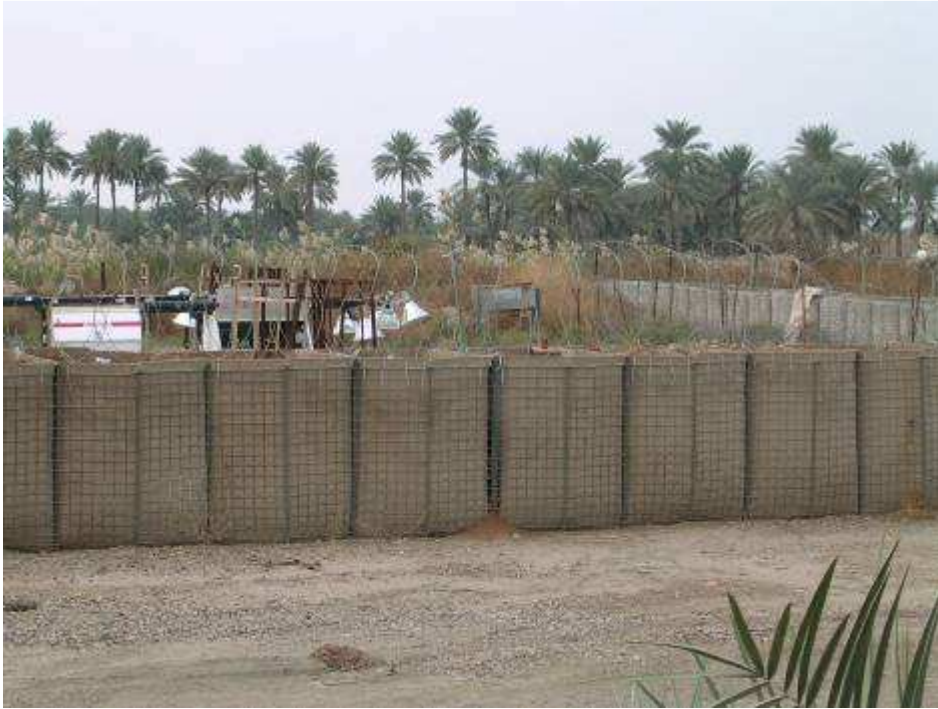
Euphrates North, Lot 6, HESCO barriers along east and north sides, Curtis photo 7625 (photo © John Curtis)

Lot 6, HESCO barriers along east and north sides, Curtis photo 7625 (photo © John Curtis)

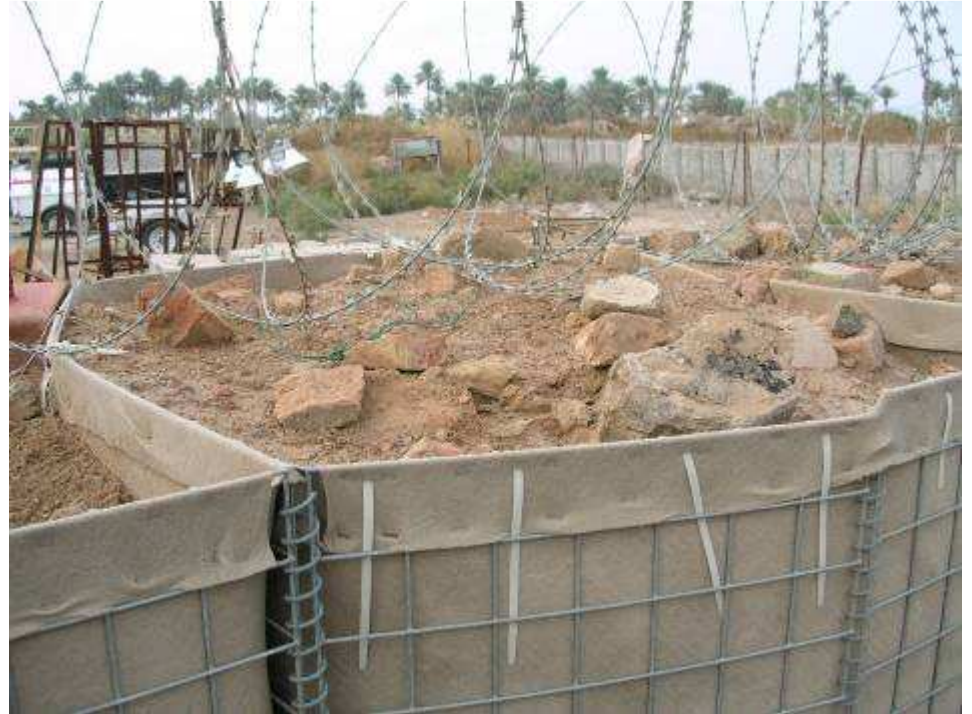
Euphrates North, Lot 6, artifact-filled earth in HESCO barrier along east side, Curtis photo 7624 (photo © John Curtis)

As with berms, the earth used to fill HESCO barriers at Babylon seems sometimes to have been brought from a different location, rather than being excavated from directly adjacent to the barrier. In Lot 6 in the Euphrates North area, shown above, the earth in the HESCO barrier was filled with artifacts, even though the surrounding terrain appears to be clean alluvial soil from the former riverbed.

Lot 6, HESCO barrier along east side, Curtis photo 7624 (photo © John Curtis)

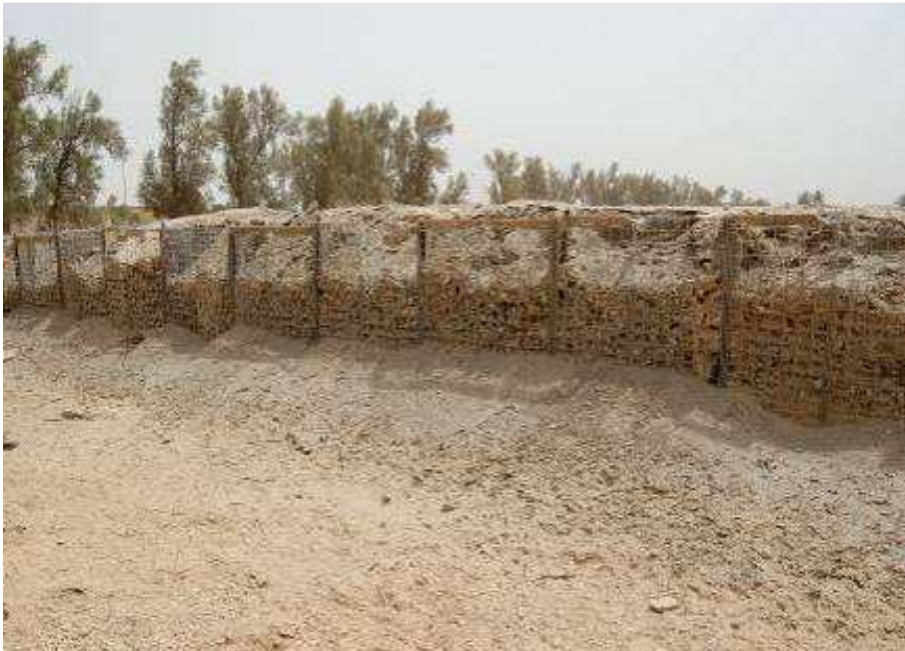
HESCO containers maintain a constant thickness of earth protection from top to bottom, and therefore use earth more efficiently than berms, but they introduce the additional intrusive materials of fabric and steel mesh. The fabric eventually degrades when exposed to the environment, but the steel mesh has an anti-corrosion coating and may be expected to endure for quite some time. When Camp Babylon was abandoned, many HESCO barriers were left in place, where they are now deteriorating, with their contents spilling out onto the adjacent soil, as seen below.

Merkes, Landing Zone 3, deteriorating HESCO containers, July 2008, Russell photo 195 (photo © John Russell)

HESCO, 17 July 2008 (Russell photo 195)

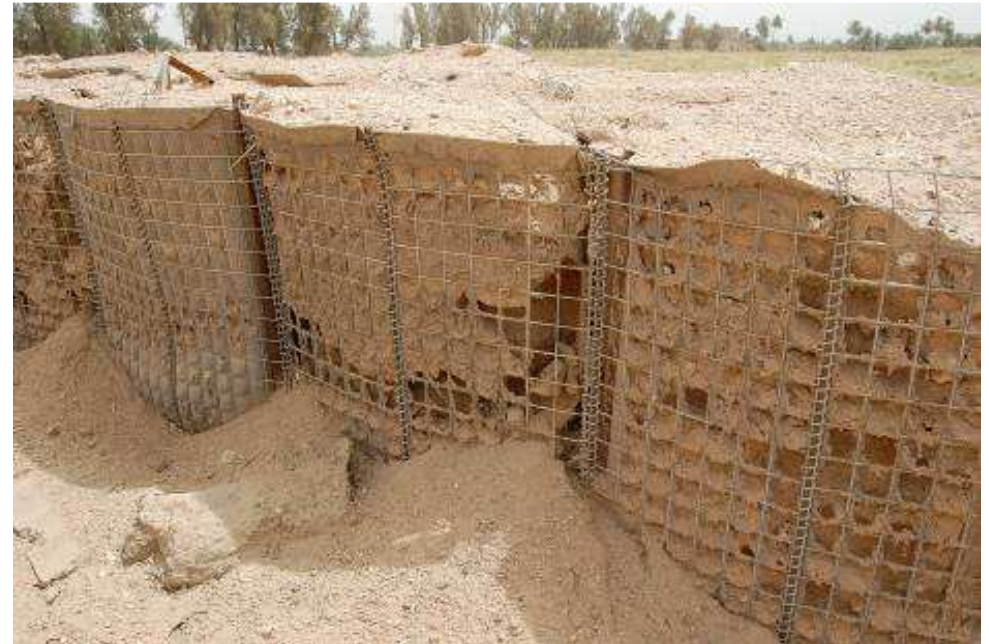
Merkes, Landing Zone 3, deteriorating HESCO containers, July 2008, Russell photo 196 (photo © John Russell)

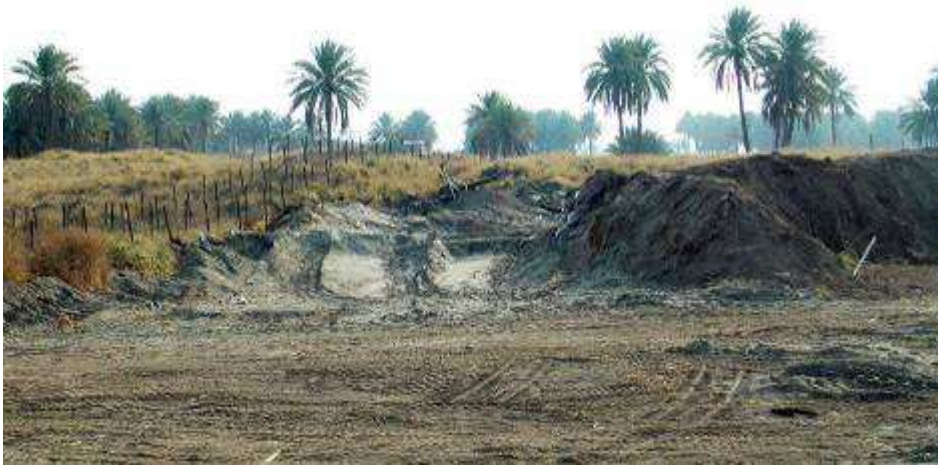
In other cases, the HESCO containers were dumped out, leaving new mounds of earth on the surface, as seen at left below, or they were pushed aside in a mangled mixture of earth, steel mesh, and fabric, as illustrated below at right.

Ka-Dingir-Ra, ammunition storage facility, berm (right) surrounded by dumped fill from HESCO bags (center), Curtis photo 7615 (photo © John Curtis)

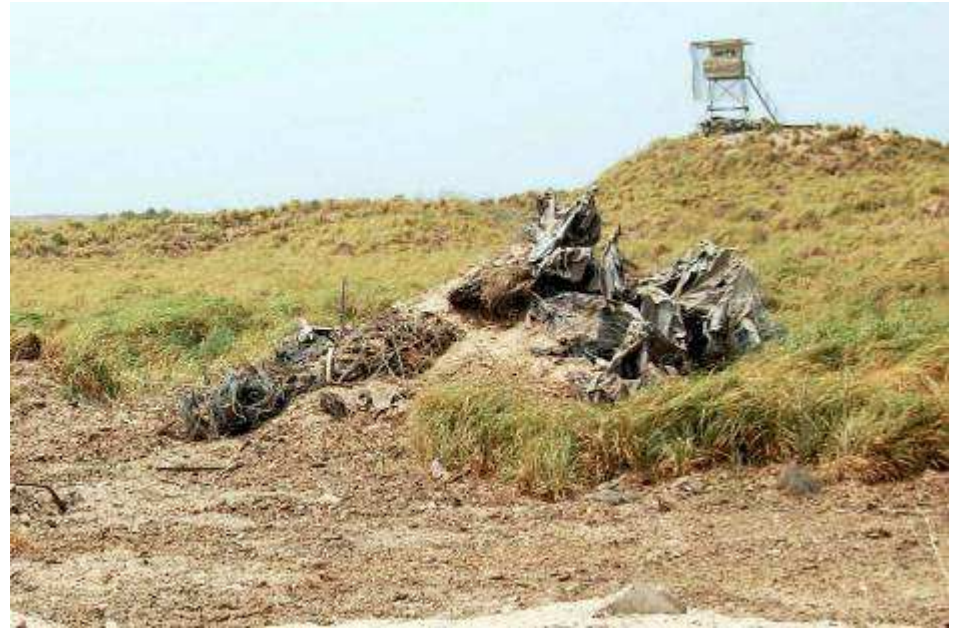
Merkes, Landing Zone 3, debris from demolished HESCO containers, July 2008, Russell photo 201 (photo © John Russell)

bulldozed HESCO, 17 July 2008 (Russell photo 201)

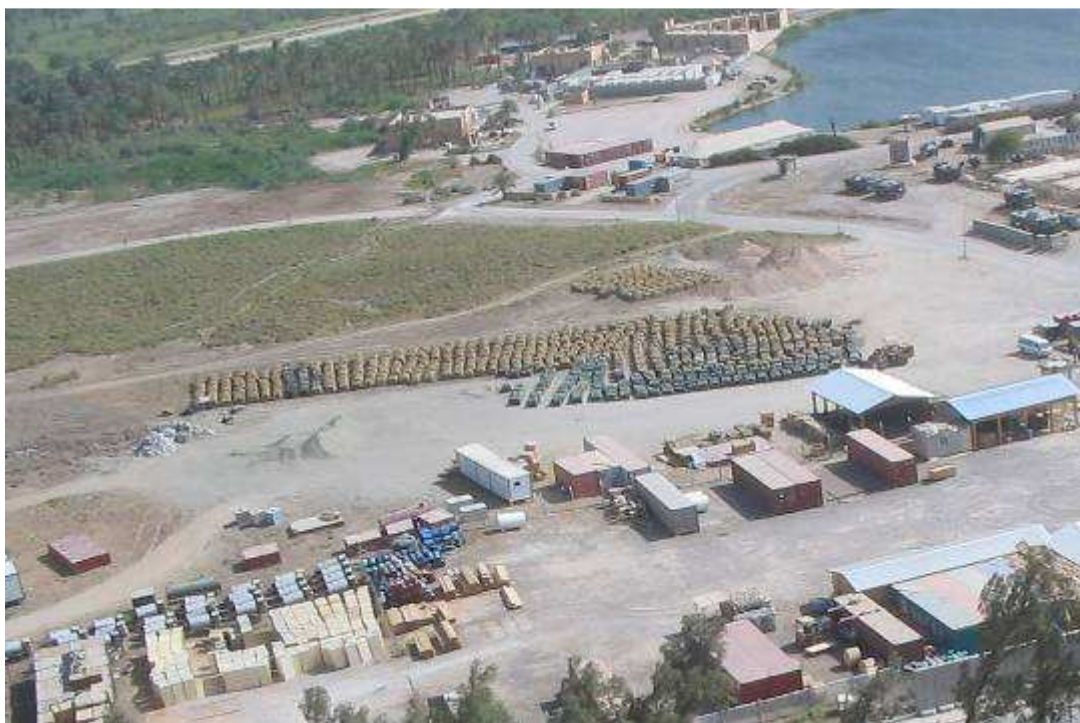
Sandbags were used by the tens of thousands at Camp Babylon. At the time of John Russell's visits to Babylon in late May and early June 2004, more than 40,000 sandbags were stacked on pallets in the KBR yard (Newtown area) ready for use, with extensive piles of earth nearby to fill further sandbags. According to subsequent satellite imagery, all of the sandbags and filler earth eventually disappeared, presumably distributed as needed throughout the site. Sandbags are not particularly durable. Over time, birds pull the fabric apart for nesting material, leaving behind a pile of earth.

Newtown, sandbags on pallets in KBR yard, 8 June 2004, Russell photo 124\_2436 (photo © John Russell)

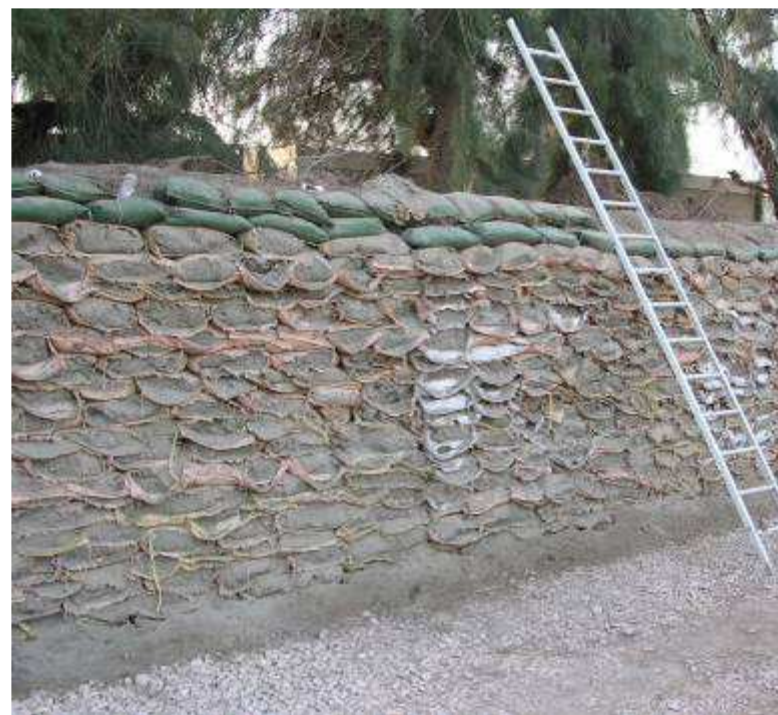
Newtown, sandbags deteriorating, December 2004, Curtis photo 7577 (photo © John Curtis)

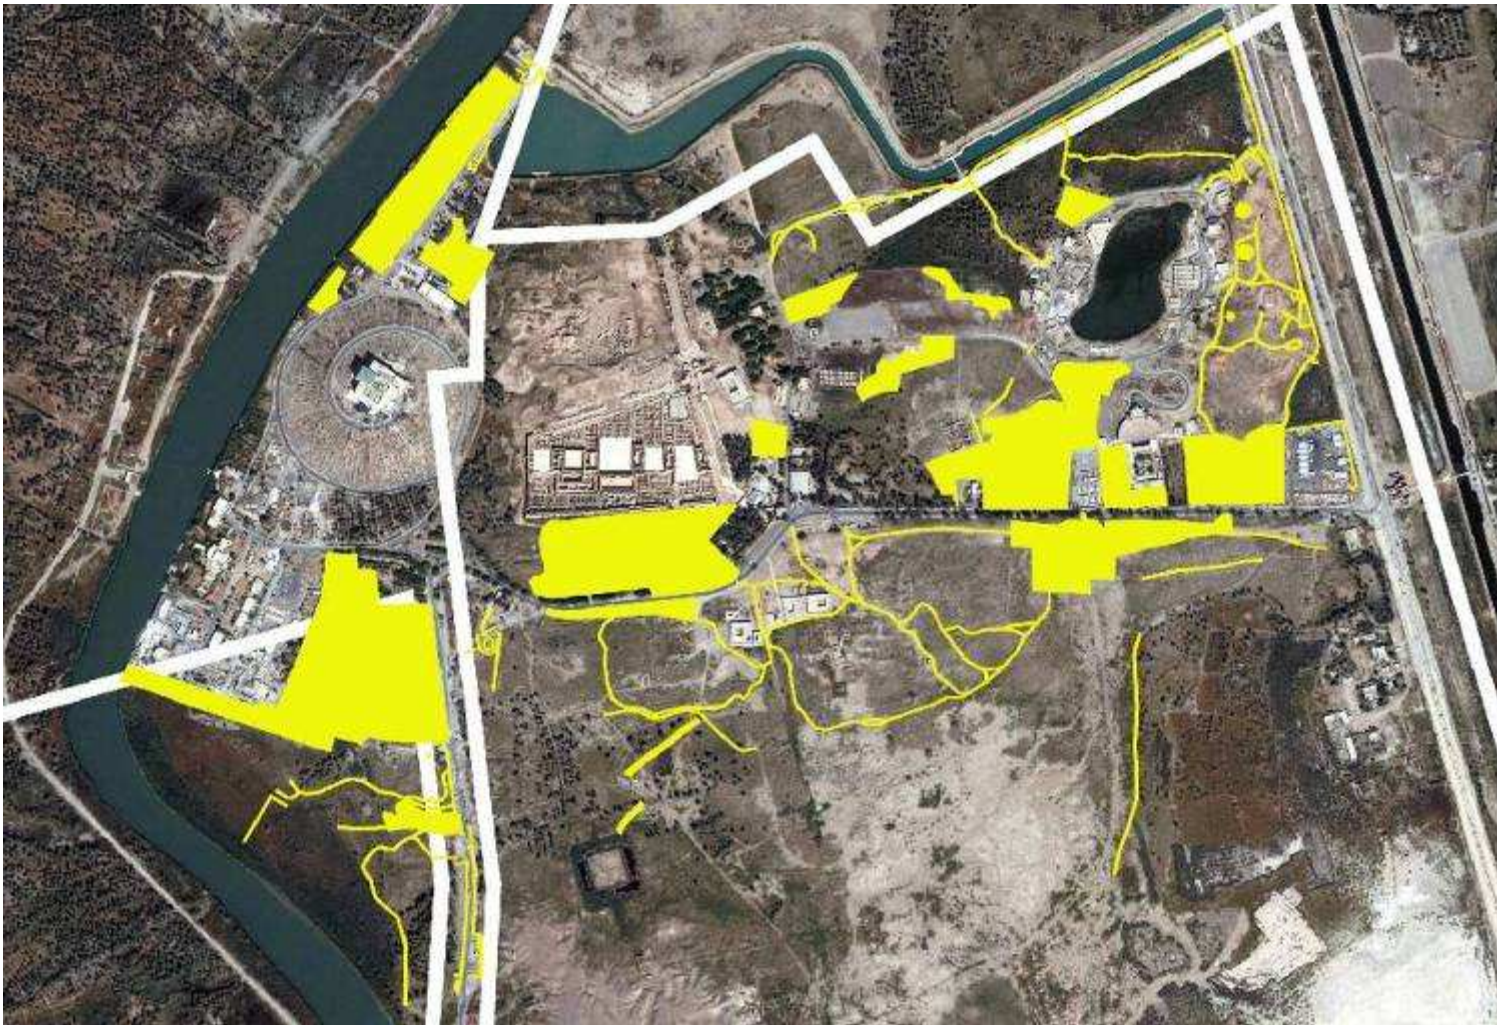
Map 7: Location of all Coalition impacts (yellow) at Camp Babylon in relation to city walls (white), 8 October 2004, Russell composite.

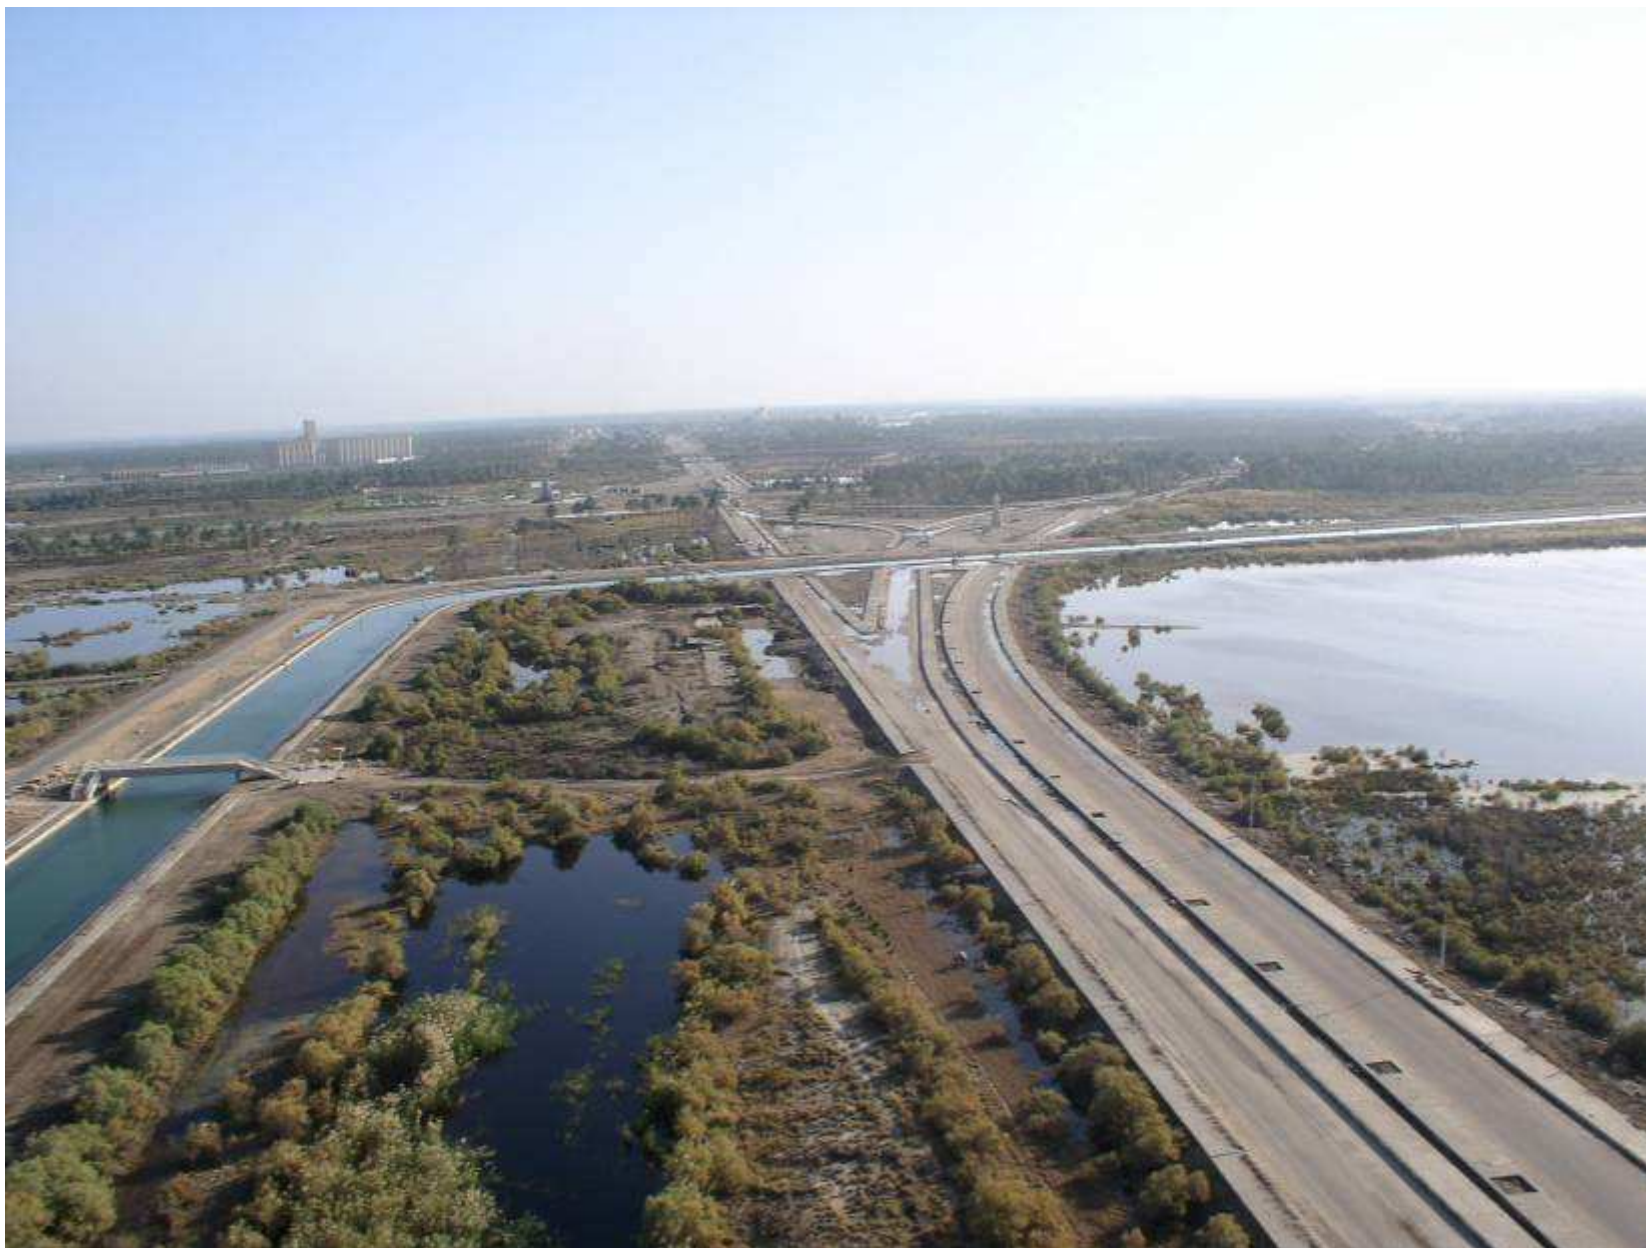
**"Al-Hawliyah moat or canal.** It surrounds the city of Babylon on the east and partially on the north and south. Its length is 4.5 km and its width is 15 m. The trench is lined on the bottom and sides with cement. This trench is crossed from the north by the main street that links the city of Babylon with the outer perimeter" (Iraqi final report p. 3 and fig. 3).

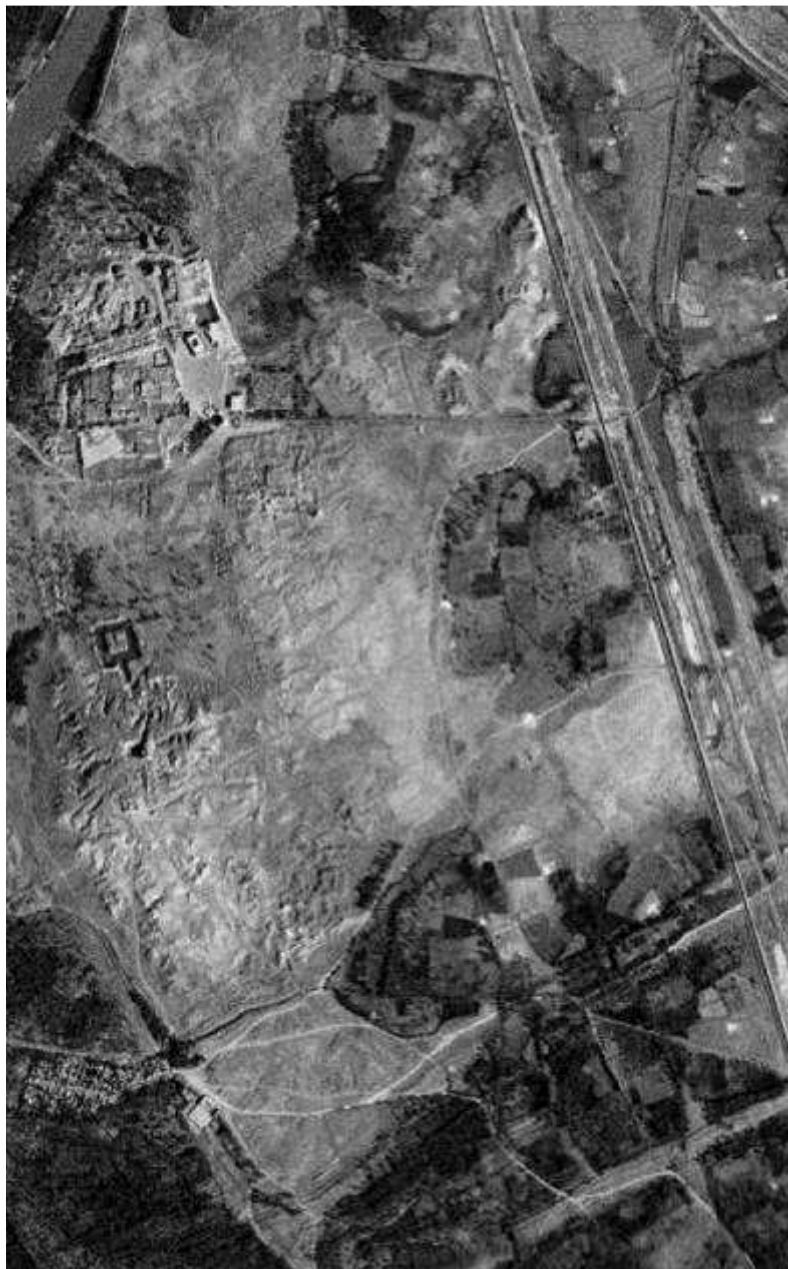
Before building canal, 13 October 1965, Russell composite
