# **Report on Damage to the Site of Babylon, Iraq**

**John Malcolm Russell, Ph.D.**

**Cultural Heritage Center  
Bureau of Educational and Cultural Affairs  
Department of State**

**April 2010**

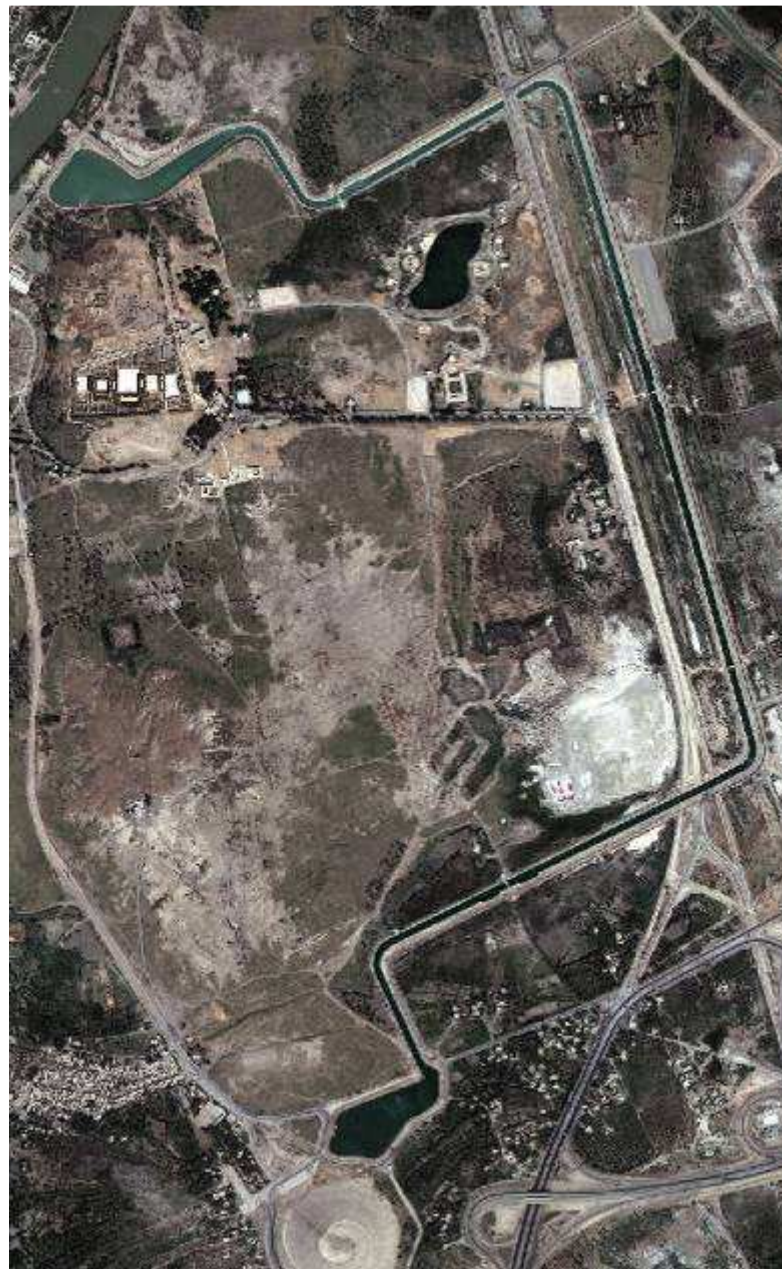
Canal, 5 July 2002, Russell composite

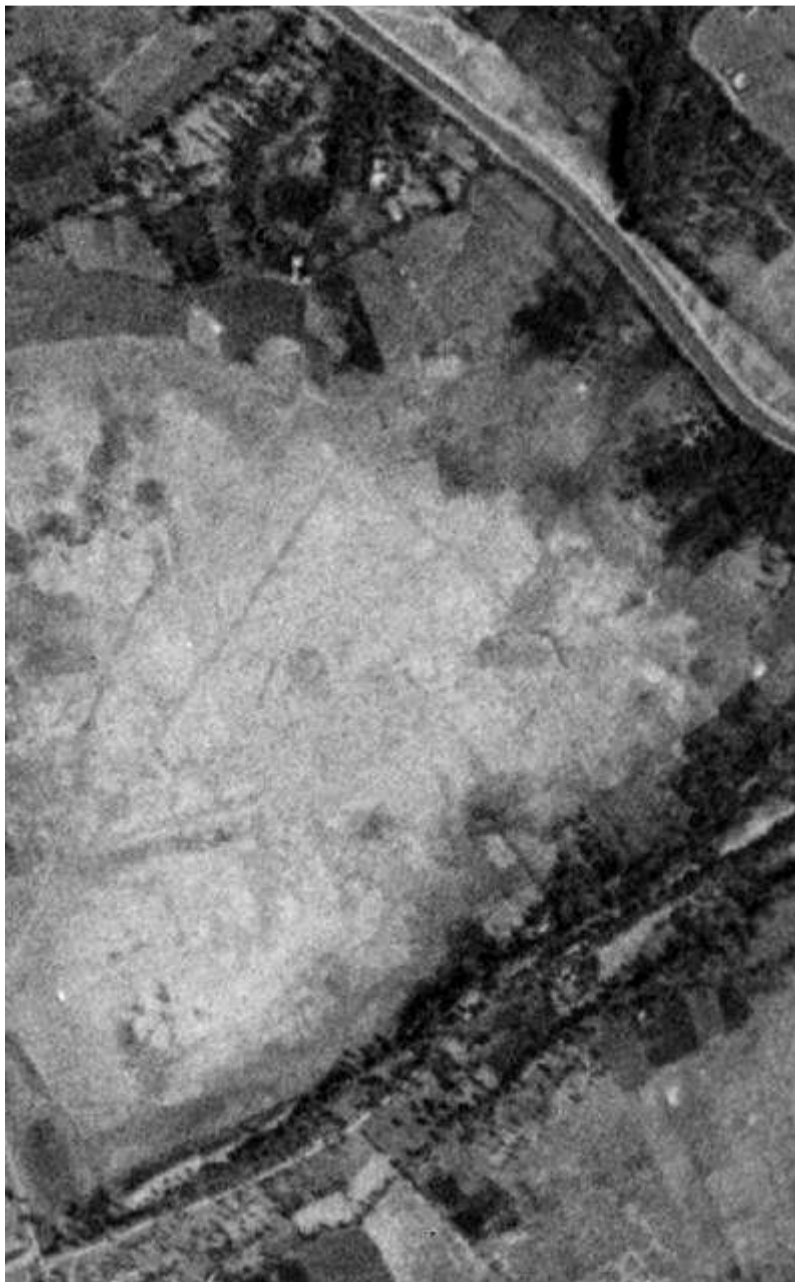
**"Lake No. 1:** Called Nissan Lake, it is located in the southeast part of the city between the inner and outer walls. With an area of 116 dunams [29 ha, 71.65 acres], it is the largest of the lakes" (Iraqi final report p. 3 and fig. 4).

Before Lake No. 1 was built, 1965, Russell composite

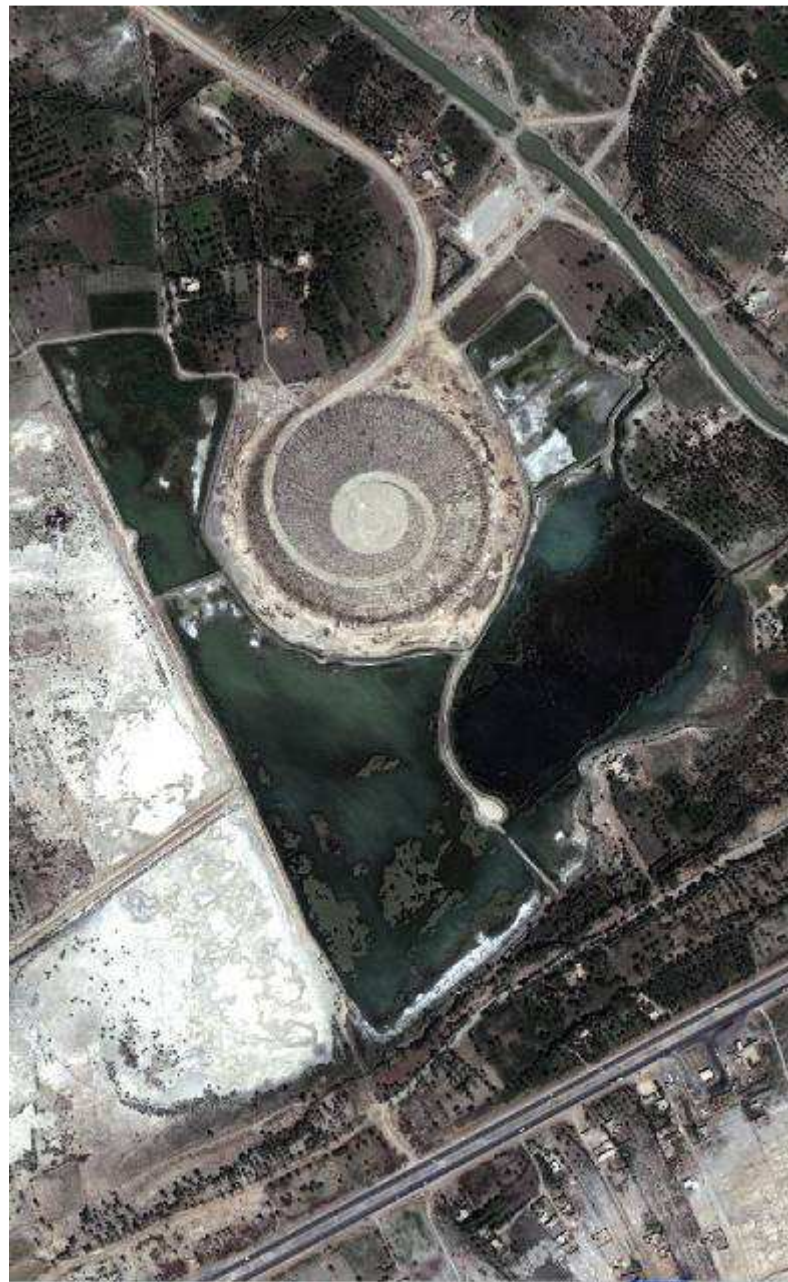
Lake No. 1, 2002, Russell composite

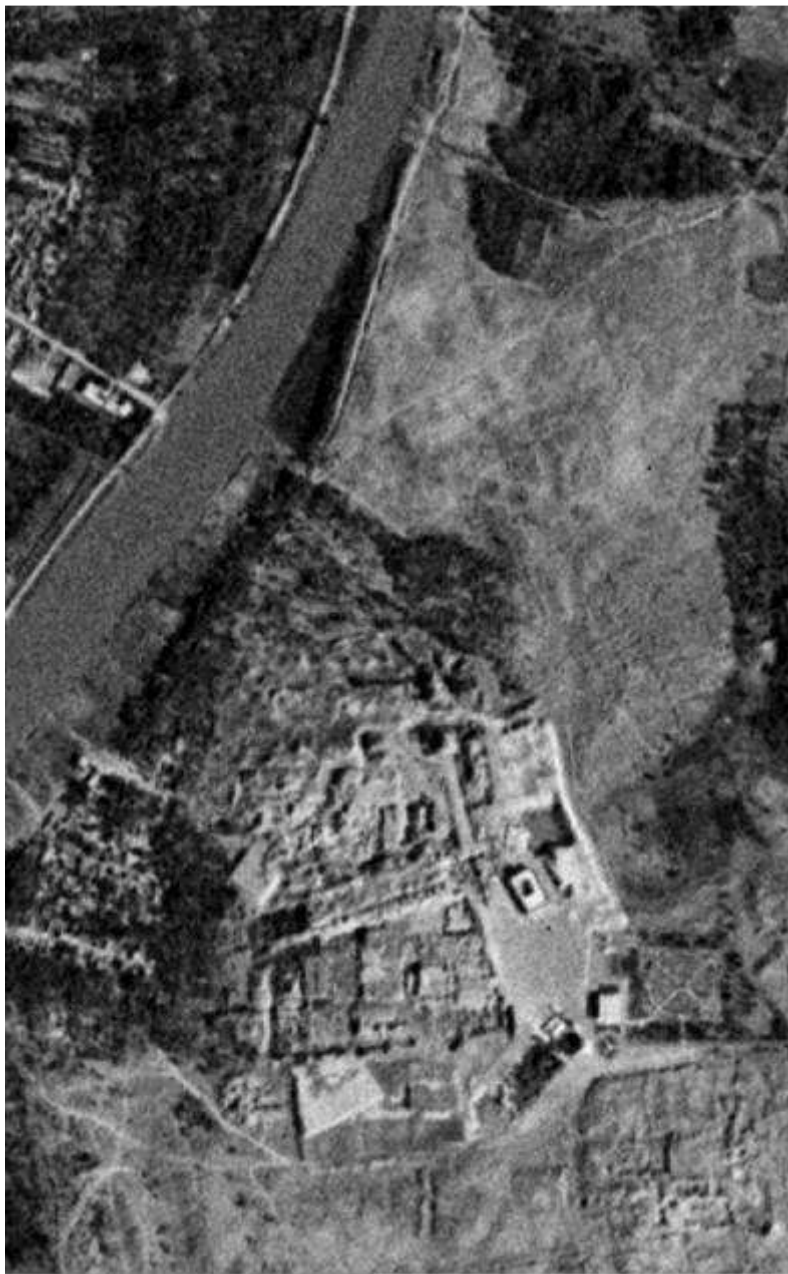
**"Lake No. 2:** Called Saddam Lake, it is located in the northern part of the city and has an area of 16 dunams [4 ha, 9.9 acres]" (Iraqi final report p. 3 and fig. 5).

Before Lake No. 2 was built, 1965, Russell composite

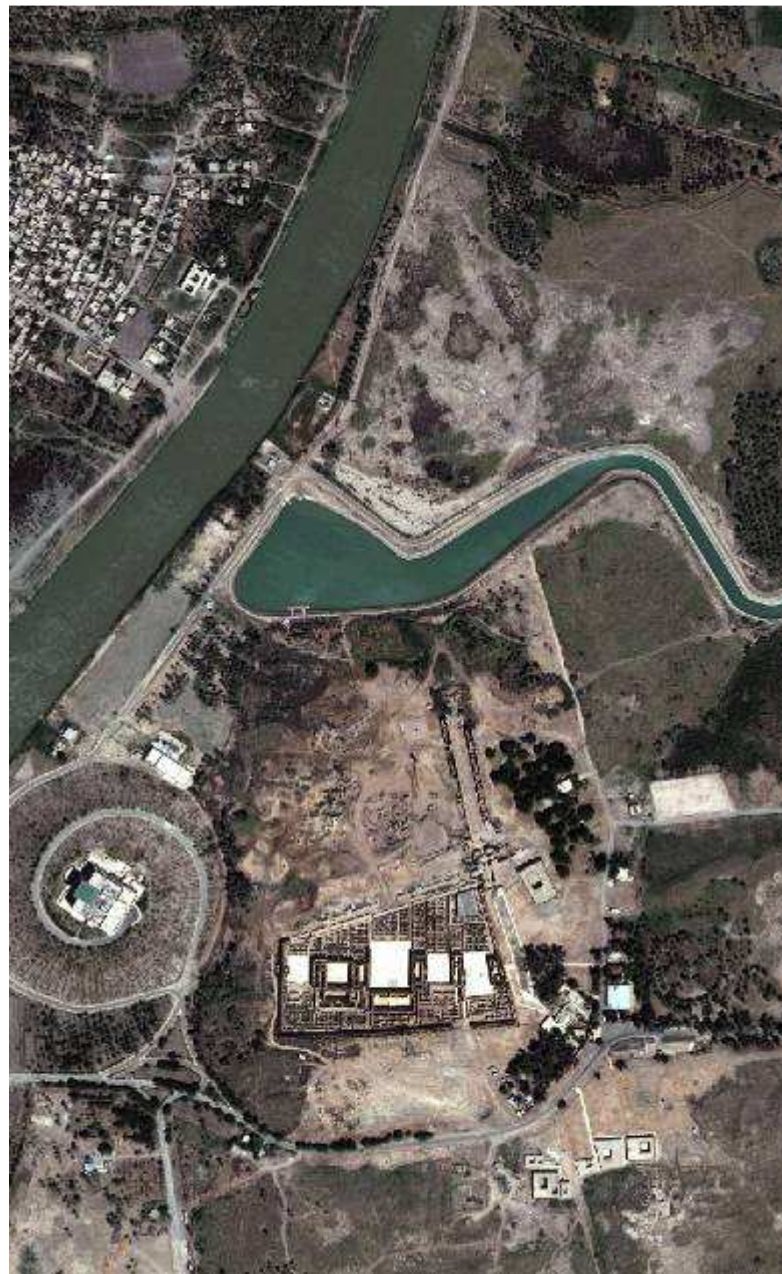
Lake No. 2, 2002, Russell composite

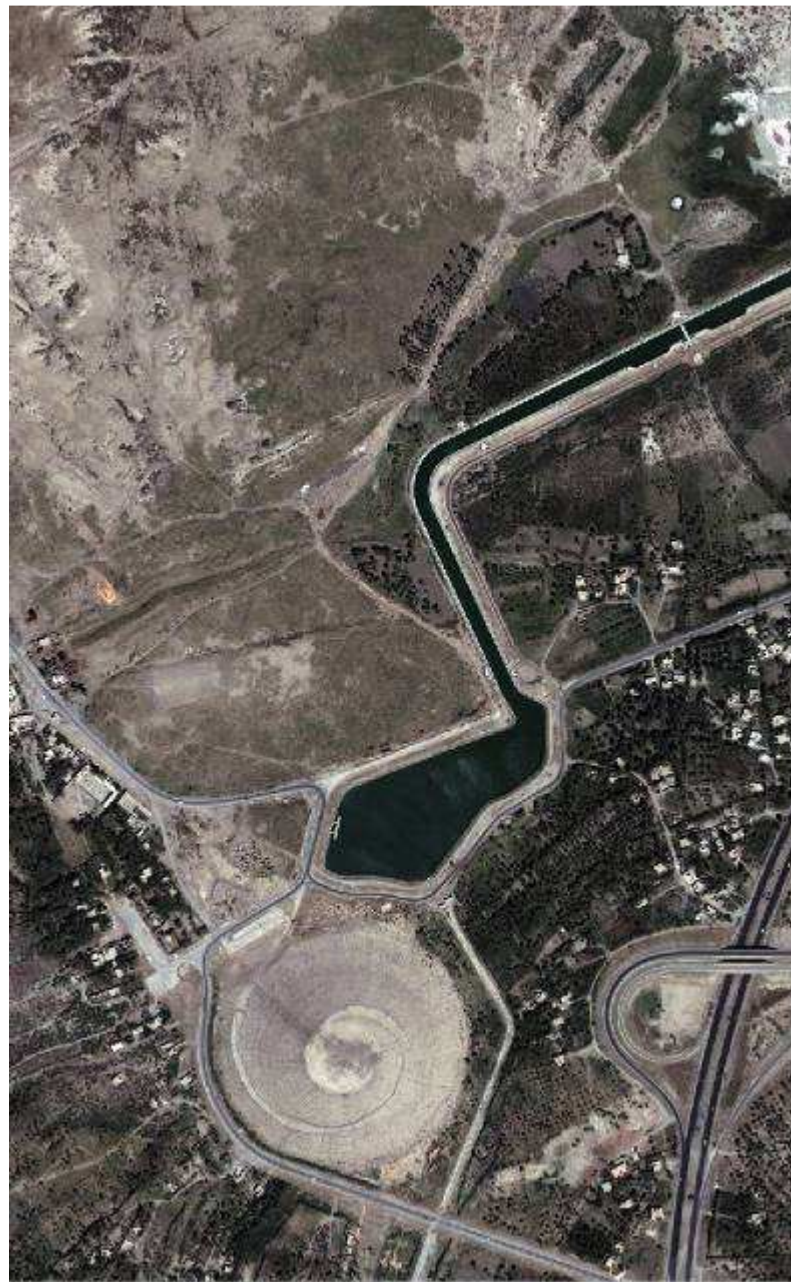
**"Lake No. 3:** Called Tammuz Lake, it is located on the south of and within the buffer zone of the city, near the village of al-Jumjumah. It has an area of 17 dunams [4.25 ha, 10.5 acres]" (Iraqi final report p. 3 and fig. 6).

Lake No. 3, 2002, Russell composite

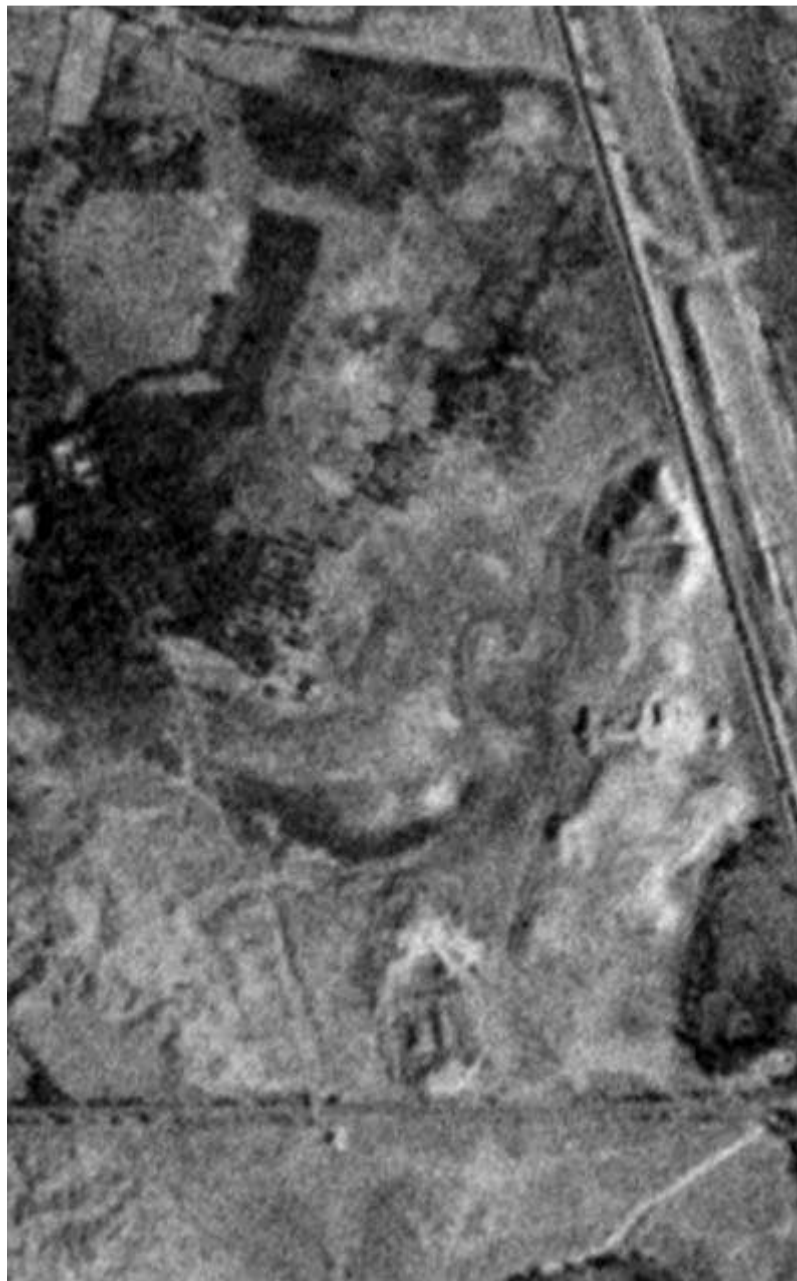
**"Lake No. 4:** Located in the northeast part of the city, inside the inner wall north of the Greek Theater, it has an area of 10 dunams [2.5 ha, 6.2 acres]" (Iraqi final report p. 3 and fig. 7).

Before Lake No. 4 was built, 1965, Russell composite

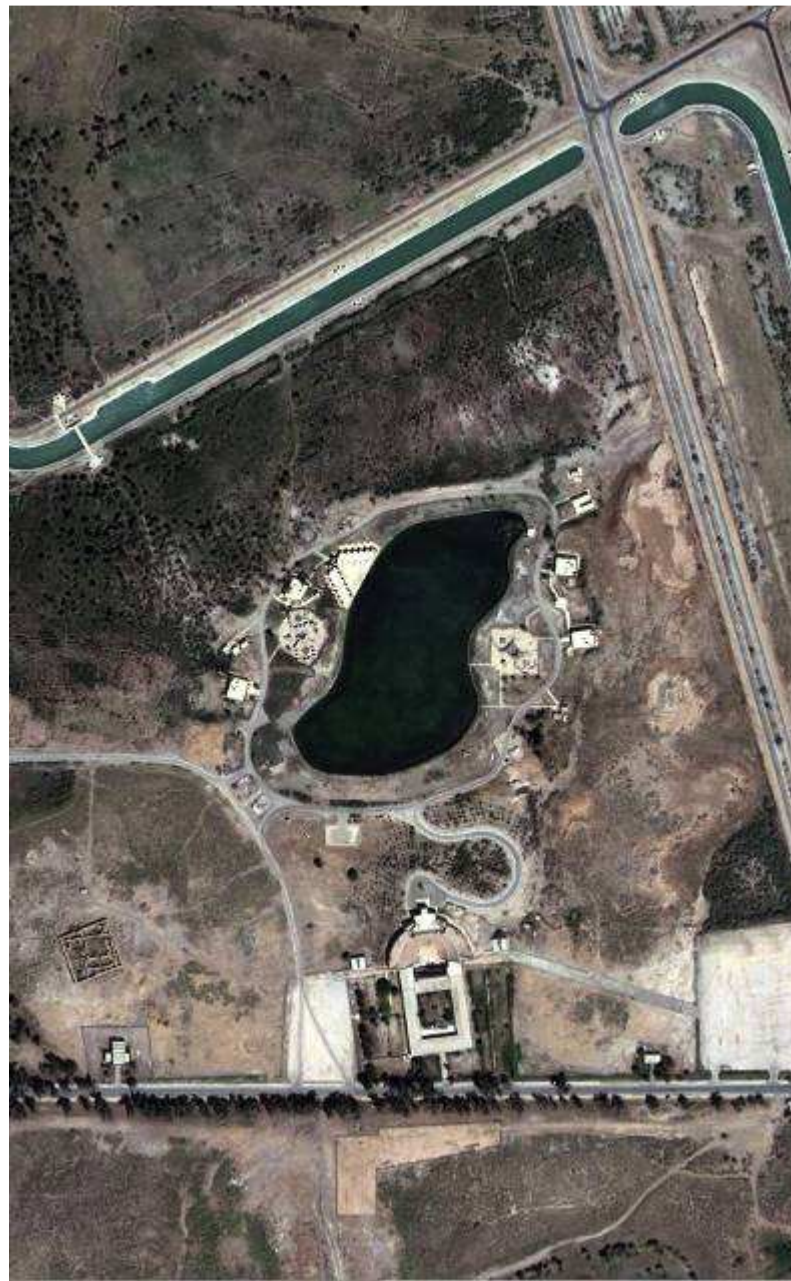
Lake No. 4, 2002, Russell composite

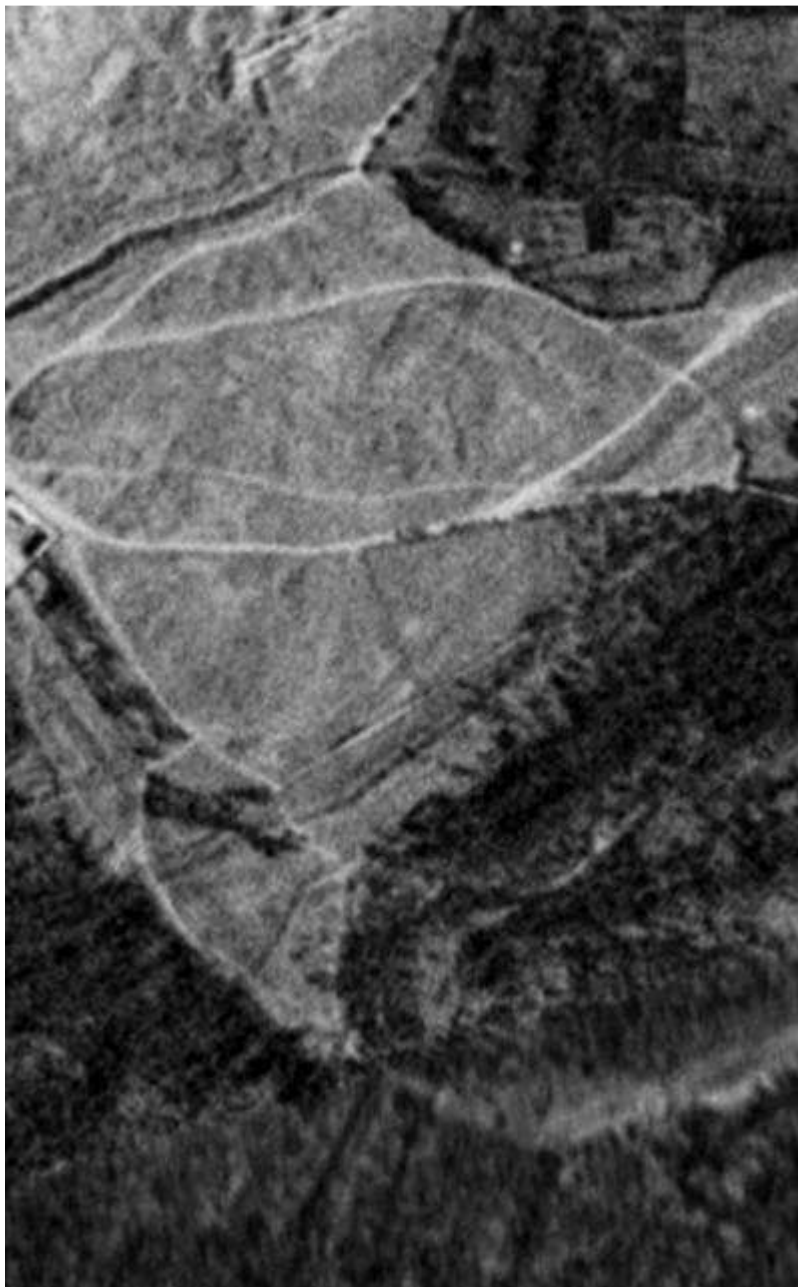
**"Mt. Tammuz:** It is in the south of the city, within its sacred precincts" (Iraqi final report p. 3 and fig. 8).

Before Mt. Tammuz was built, 1965, Russell composite

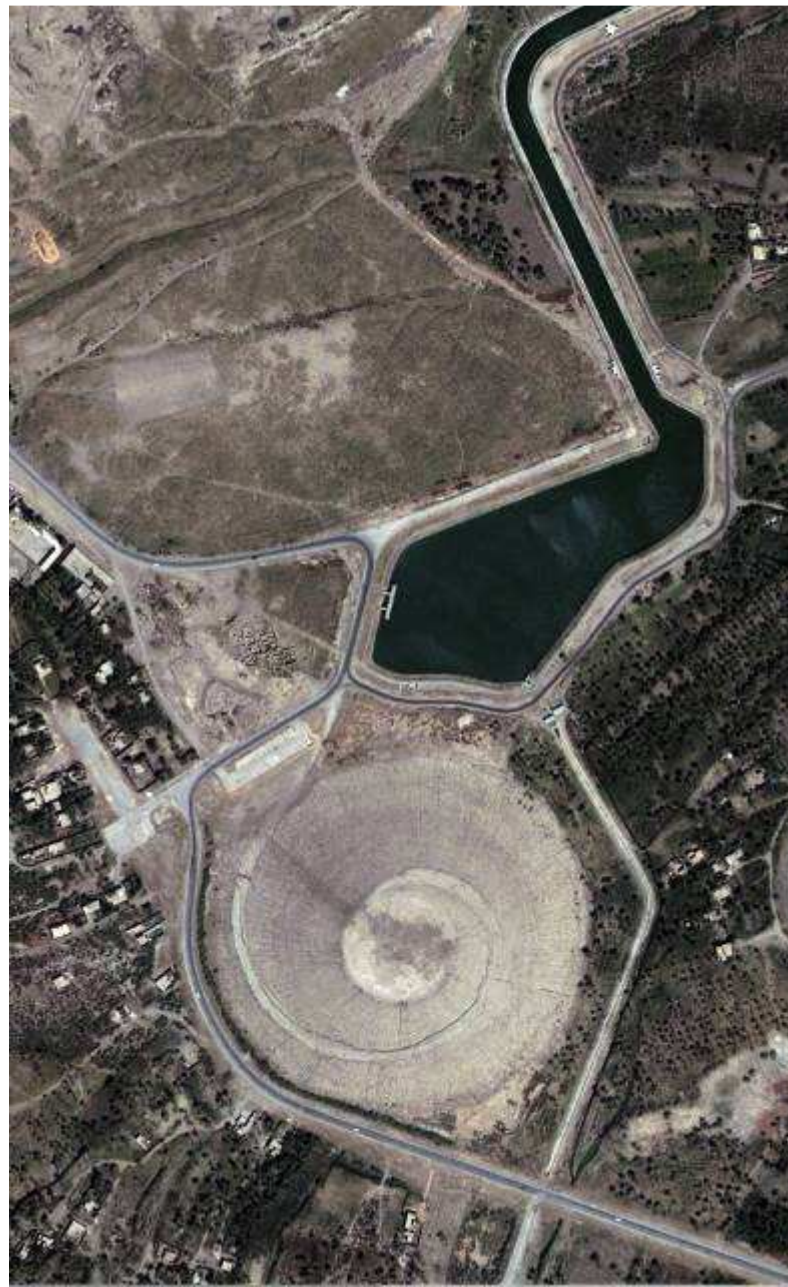
Mt. Tammuz, 2002, Russell composite

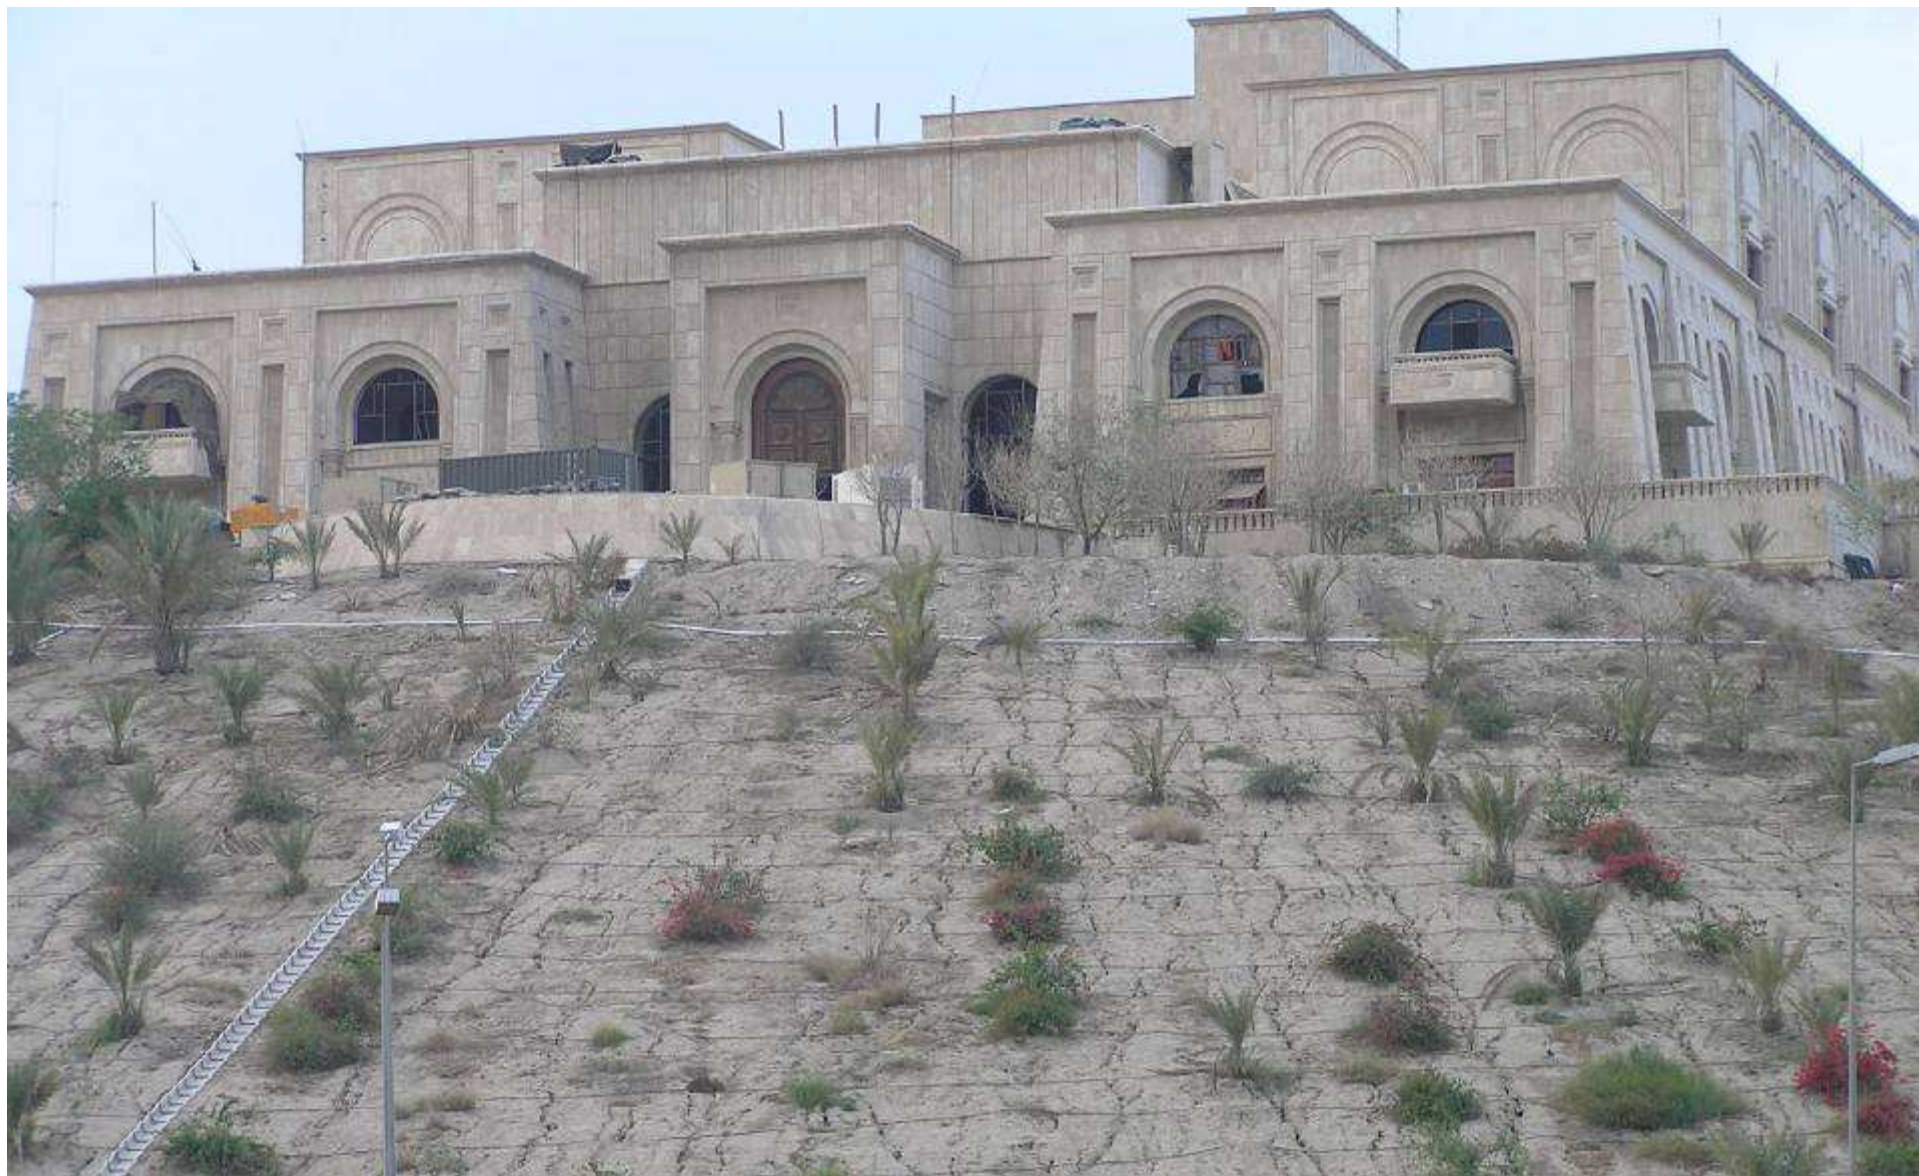
Mt. Saddam, Iraqi final report fig. 10

**"Mt. Saddam:** It is north of the city, overlooking the Euphrates River from the east. One of the presidential palaces was built on it" (Iraqi final report p. 3 and fig. 10).

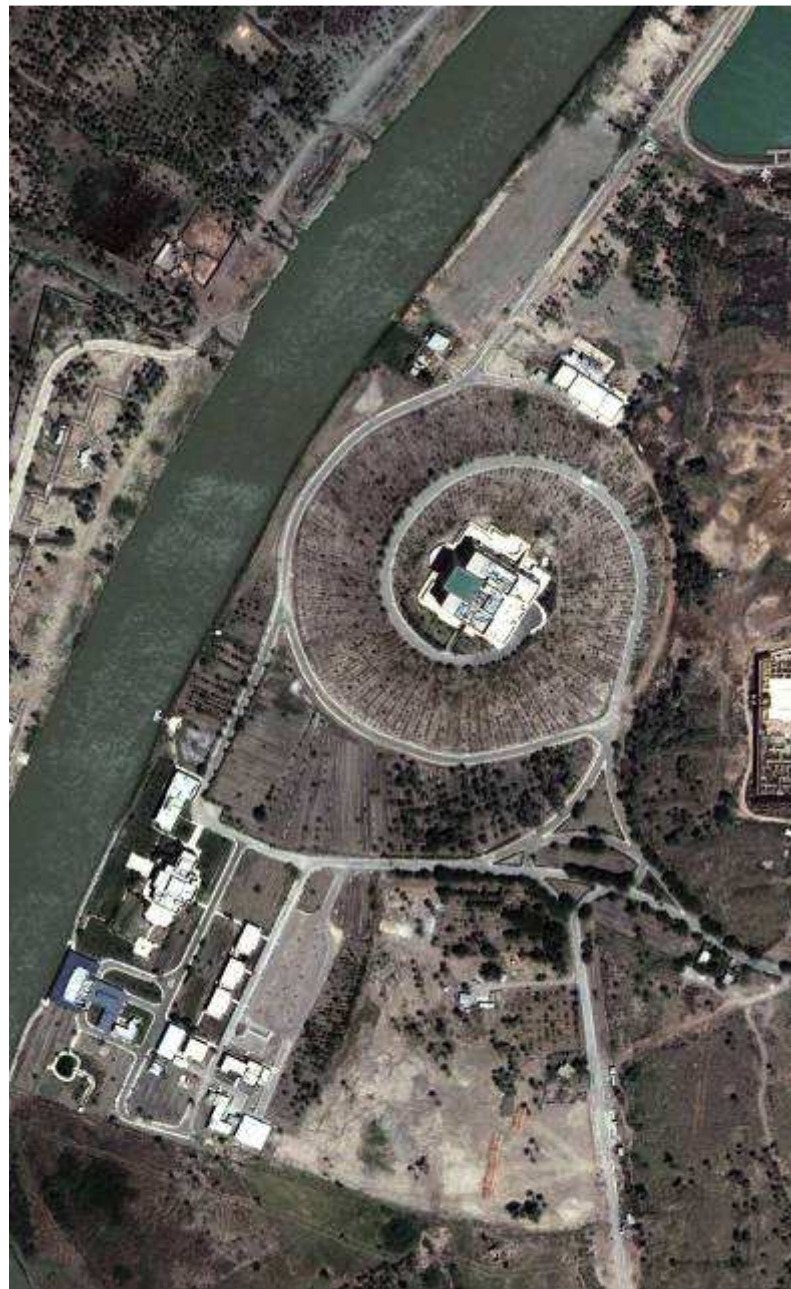
Mt. Saddam, 2002, Russell composite

**Russell comment:** Although Mt. Saddam is said to have been built in the old bed of the Euphrates, on the site of the modern village of Kuwayrish, in fact it also covers a large part of the western bastion of the Neo-Babylonian palace.

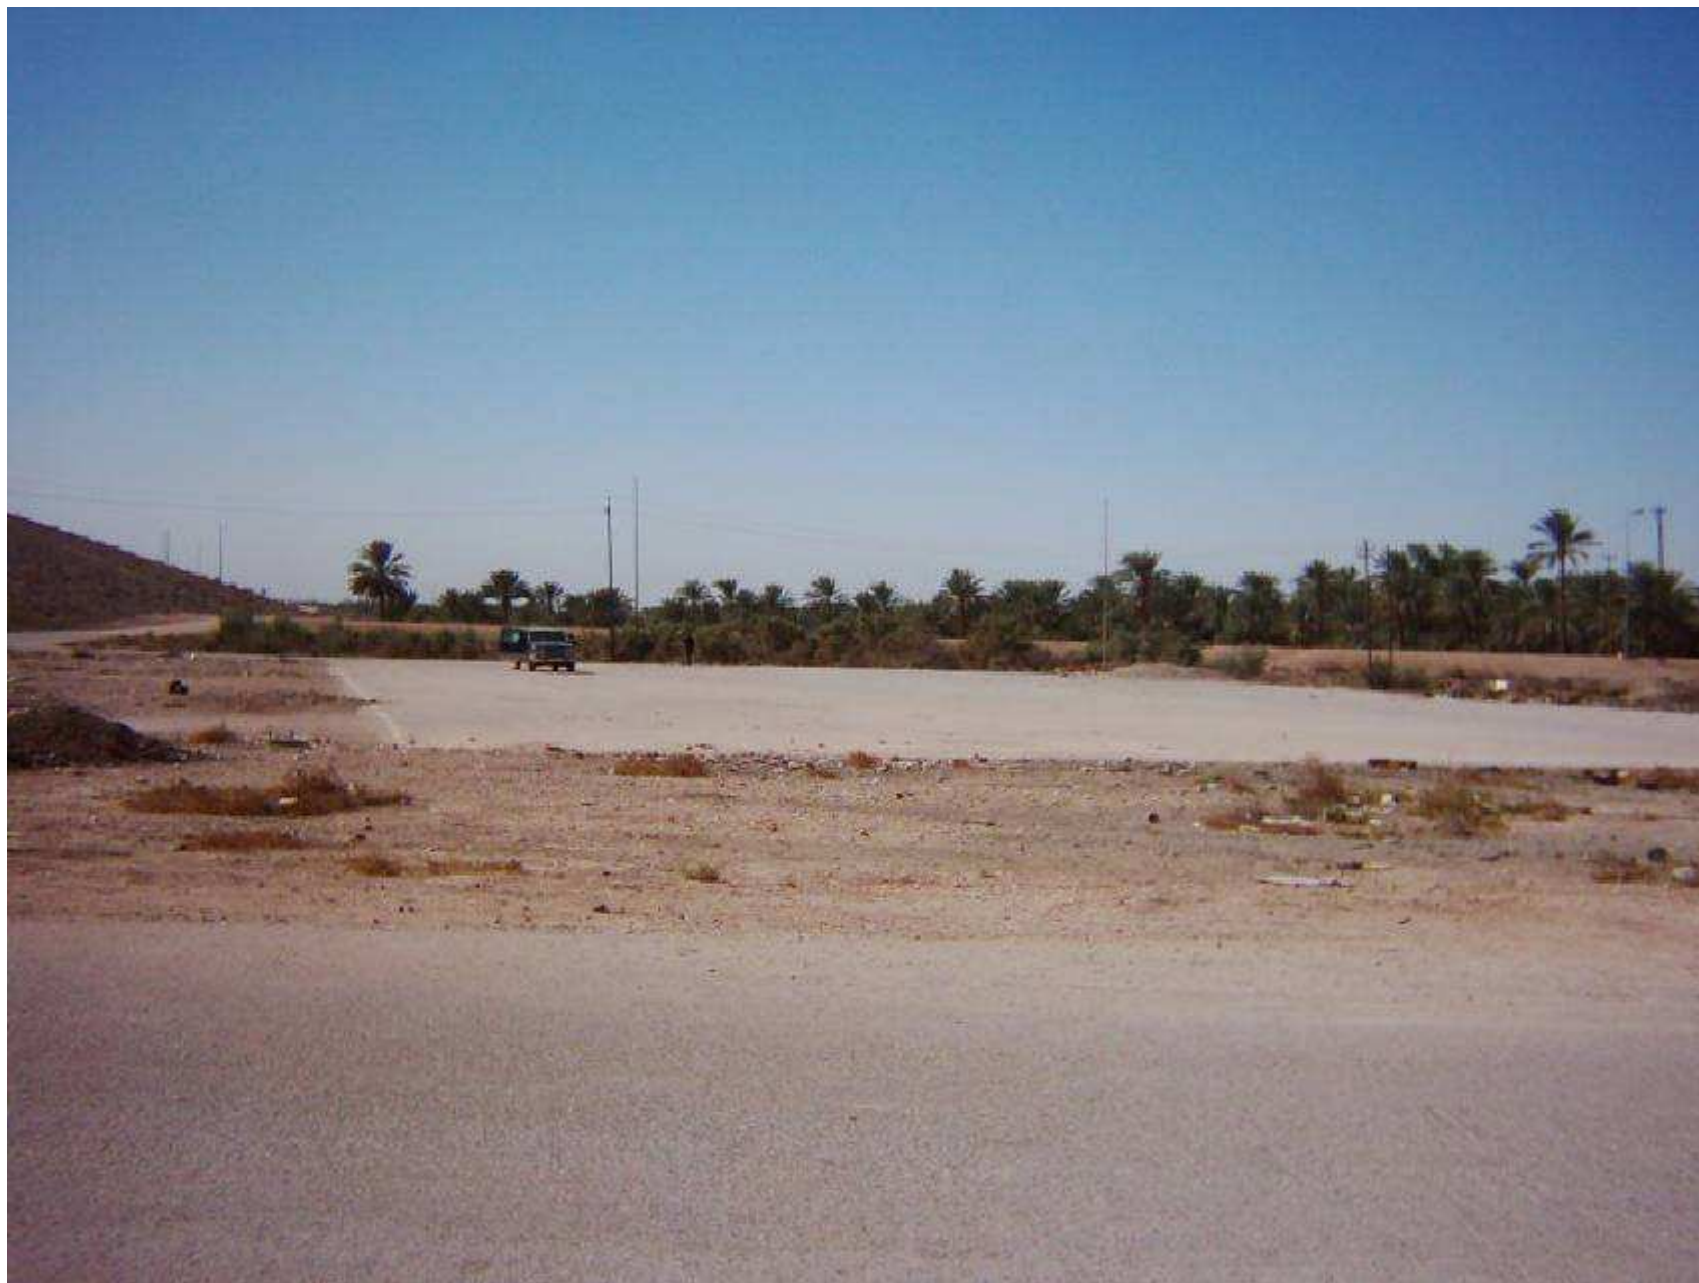
**"1<sup>st</sup> lot:** Southeast of the city, it has an area of 58 x 116 m, a part of which (26 x 16) is unpaved" (Iraqi final report p. 3 and fig. 11).

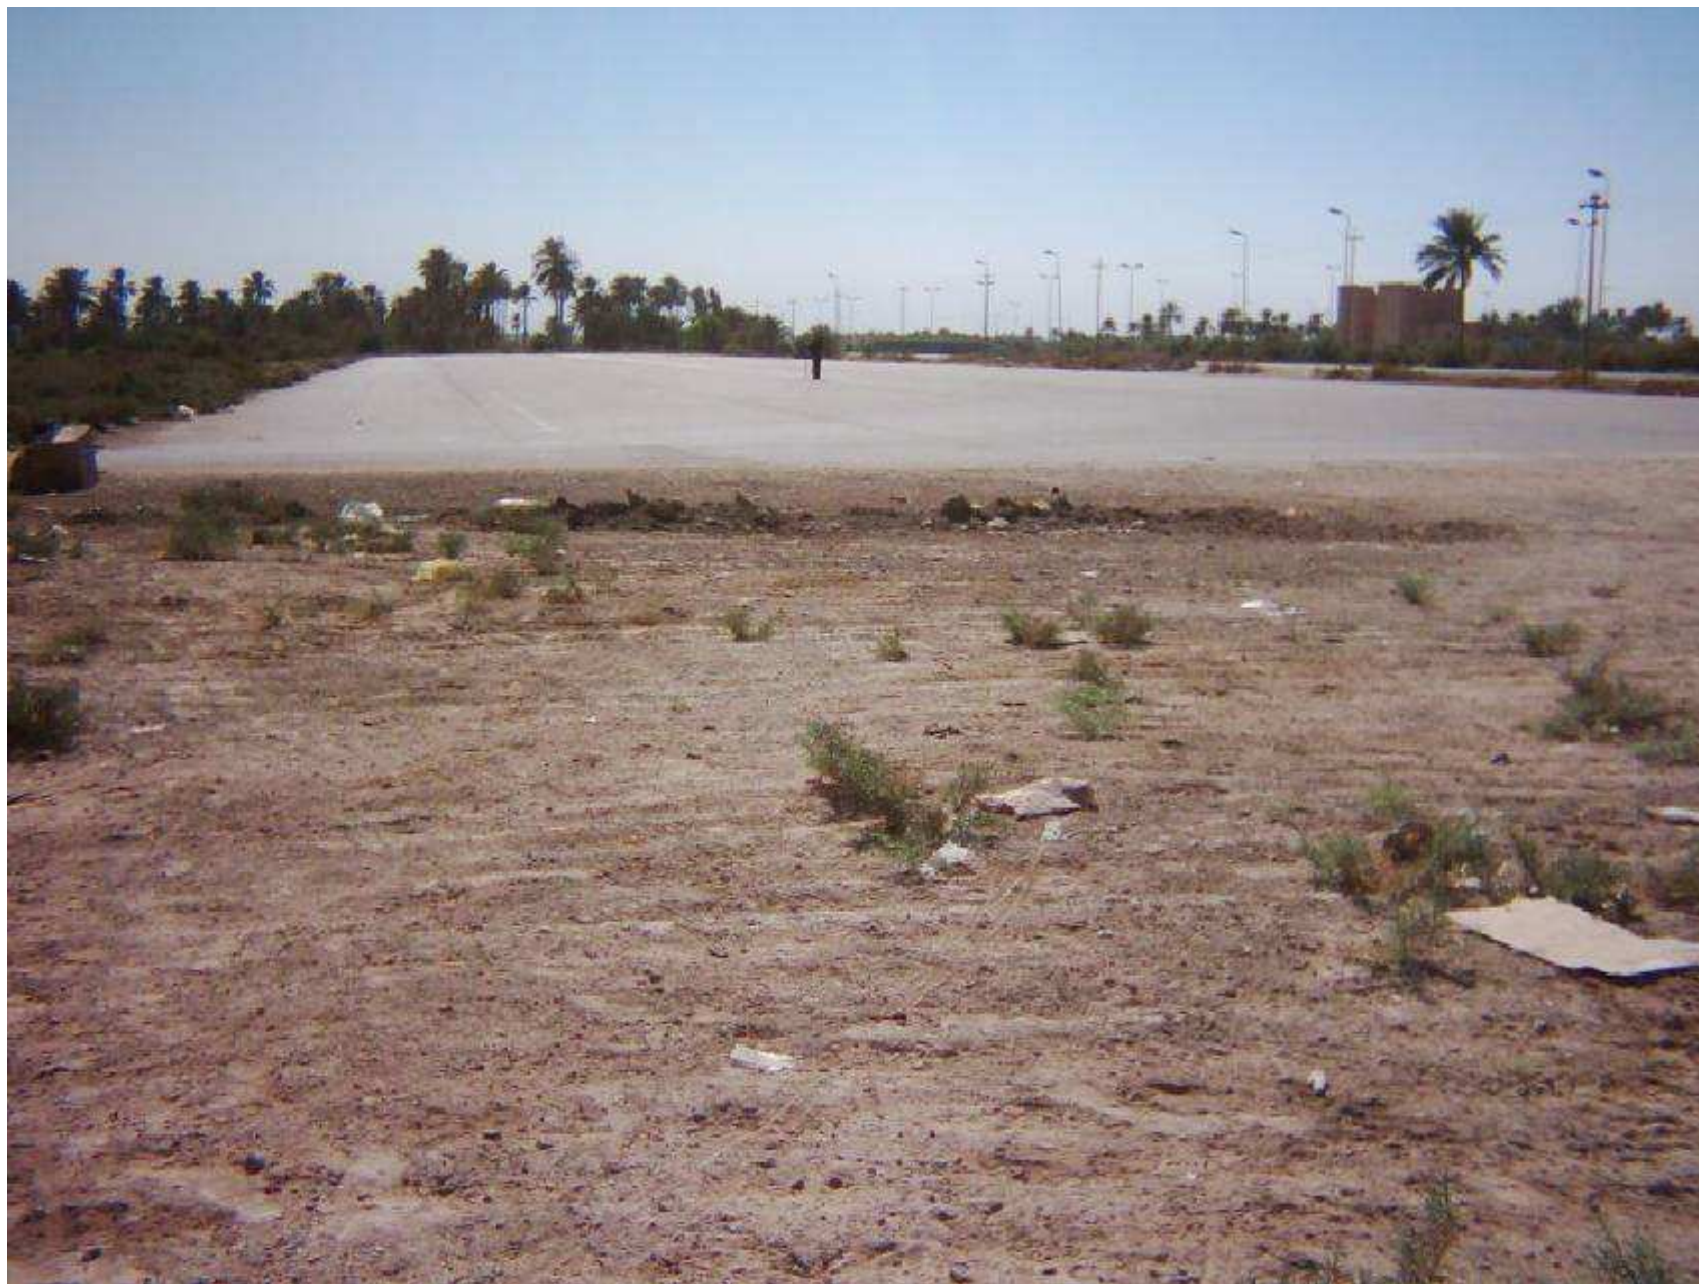
**"2<sup>nd</sup> lot:** Alongside the eastern part of the inner wall on the east and the moat, it has an area of 260 x 271 m" (Iraqi final report p. 3 and fig. 12).

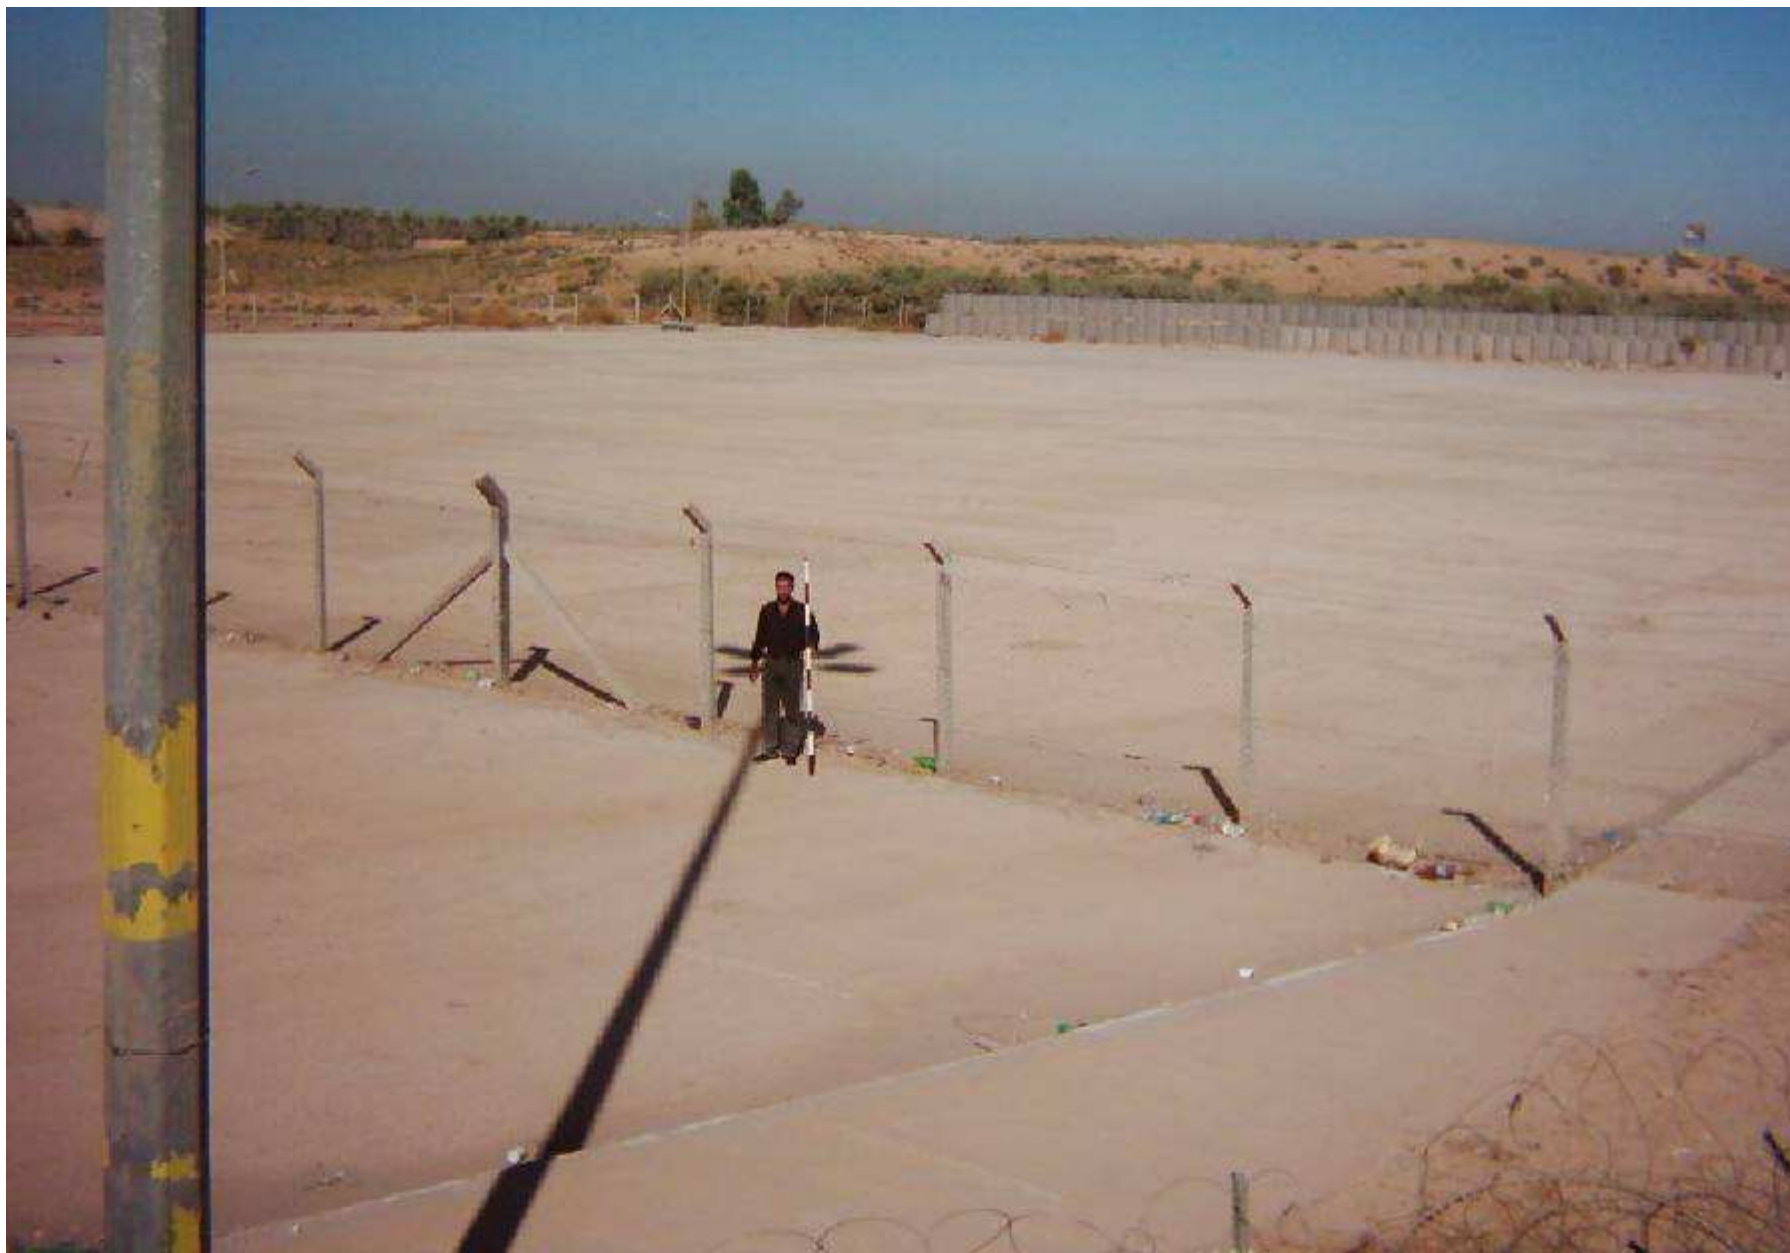
**"3<sup>rd</sup> lot:** Located opposite the interior side of Marduk Gate, at the start of the street leading to the archeological city, it has an area of 100 x 126 m" (Iraqi final report p. 3 and fig. 13).

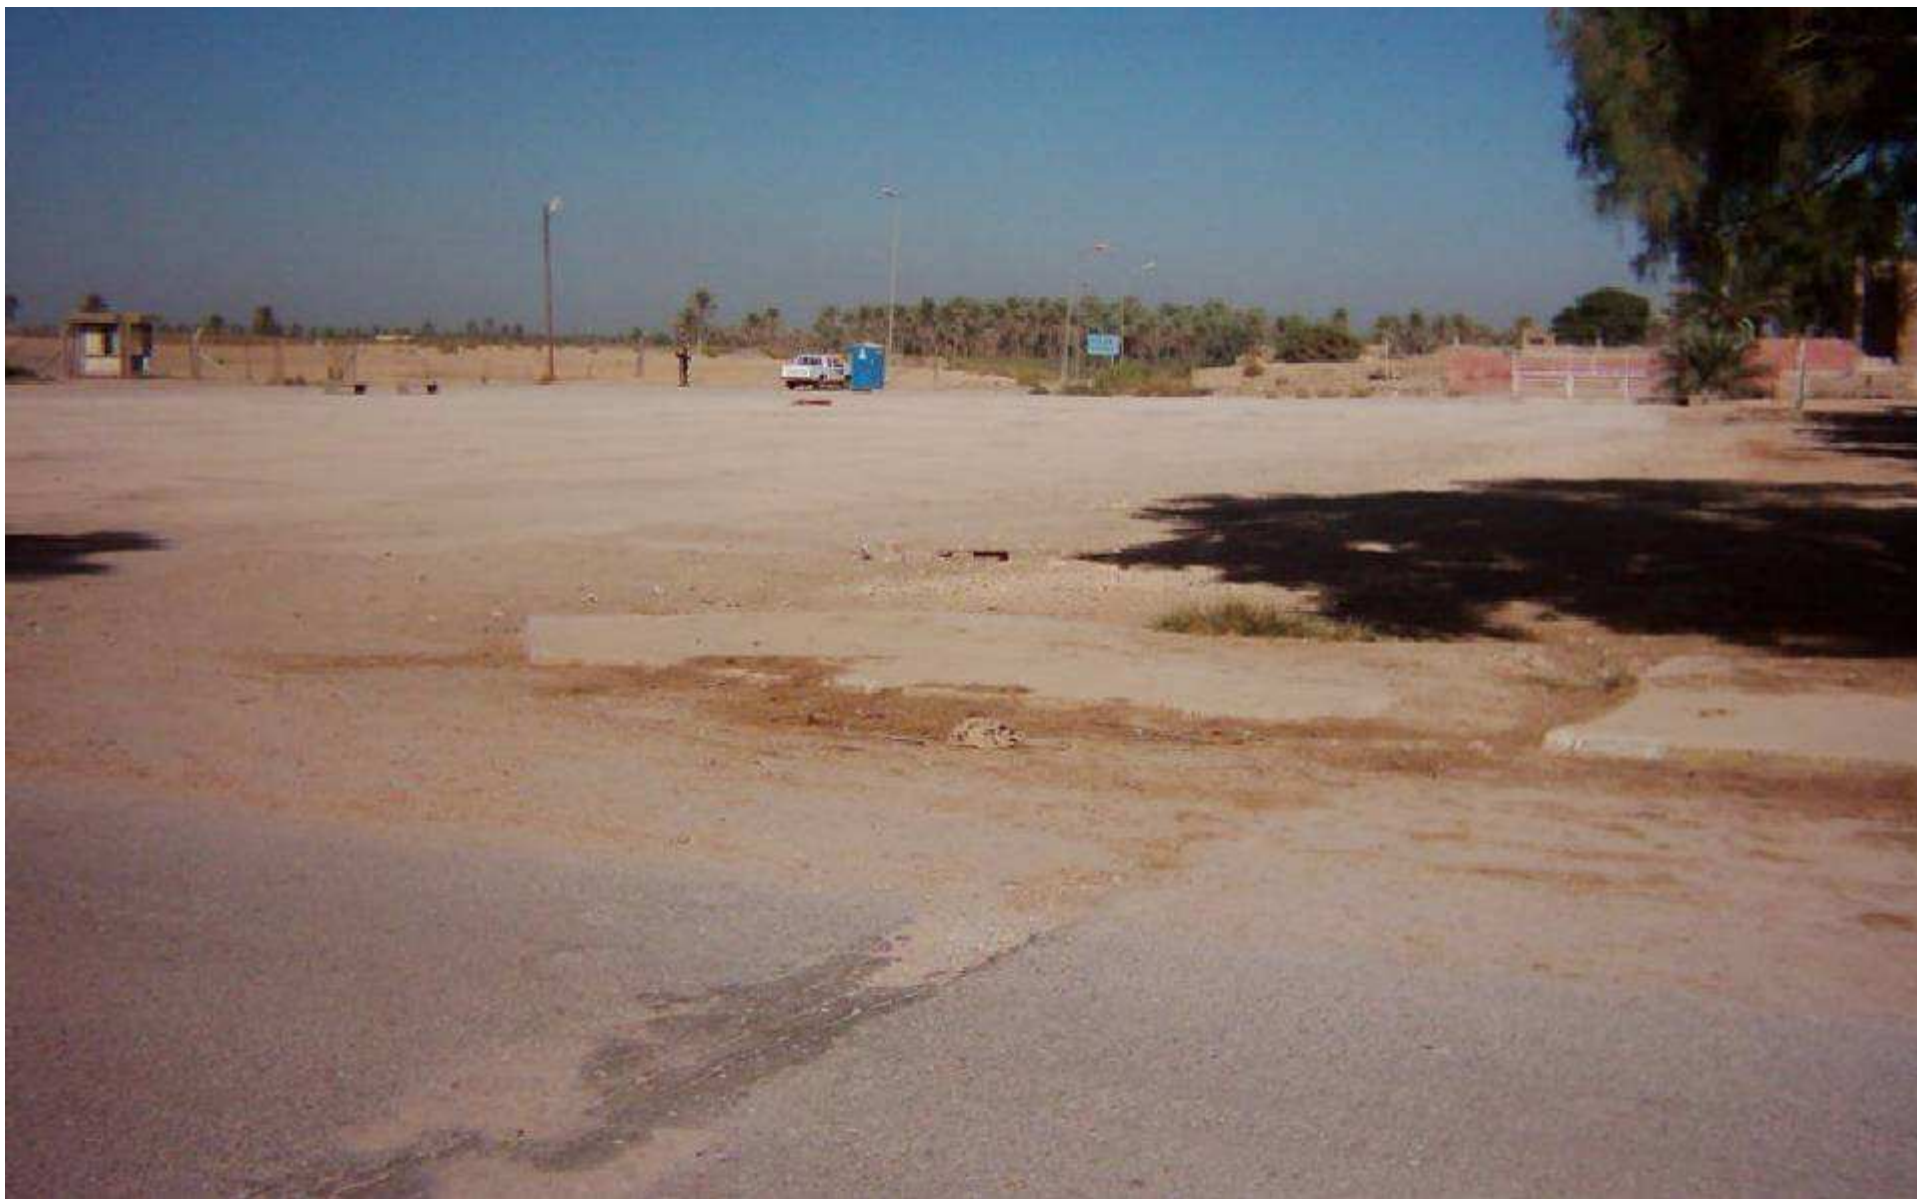
"4<sup>th</sup> lot: West of the theater, it has an area of 53 x 98 m" (Iraqi final report p. 4 and fig. 14).
