# **Report on Damage to the Site of Babylon, Iraq**

**John Malcolm Russell, Ph.D.**

**Cultural Heritage Center  
Bureau of Educational and Cultural Affairs  
Department of State**

**April 2010**

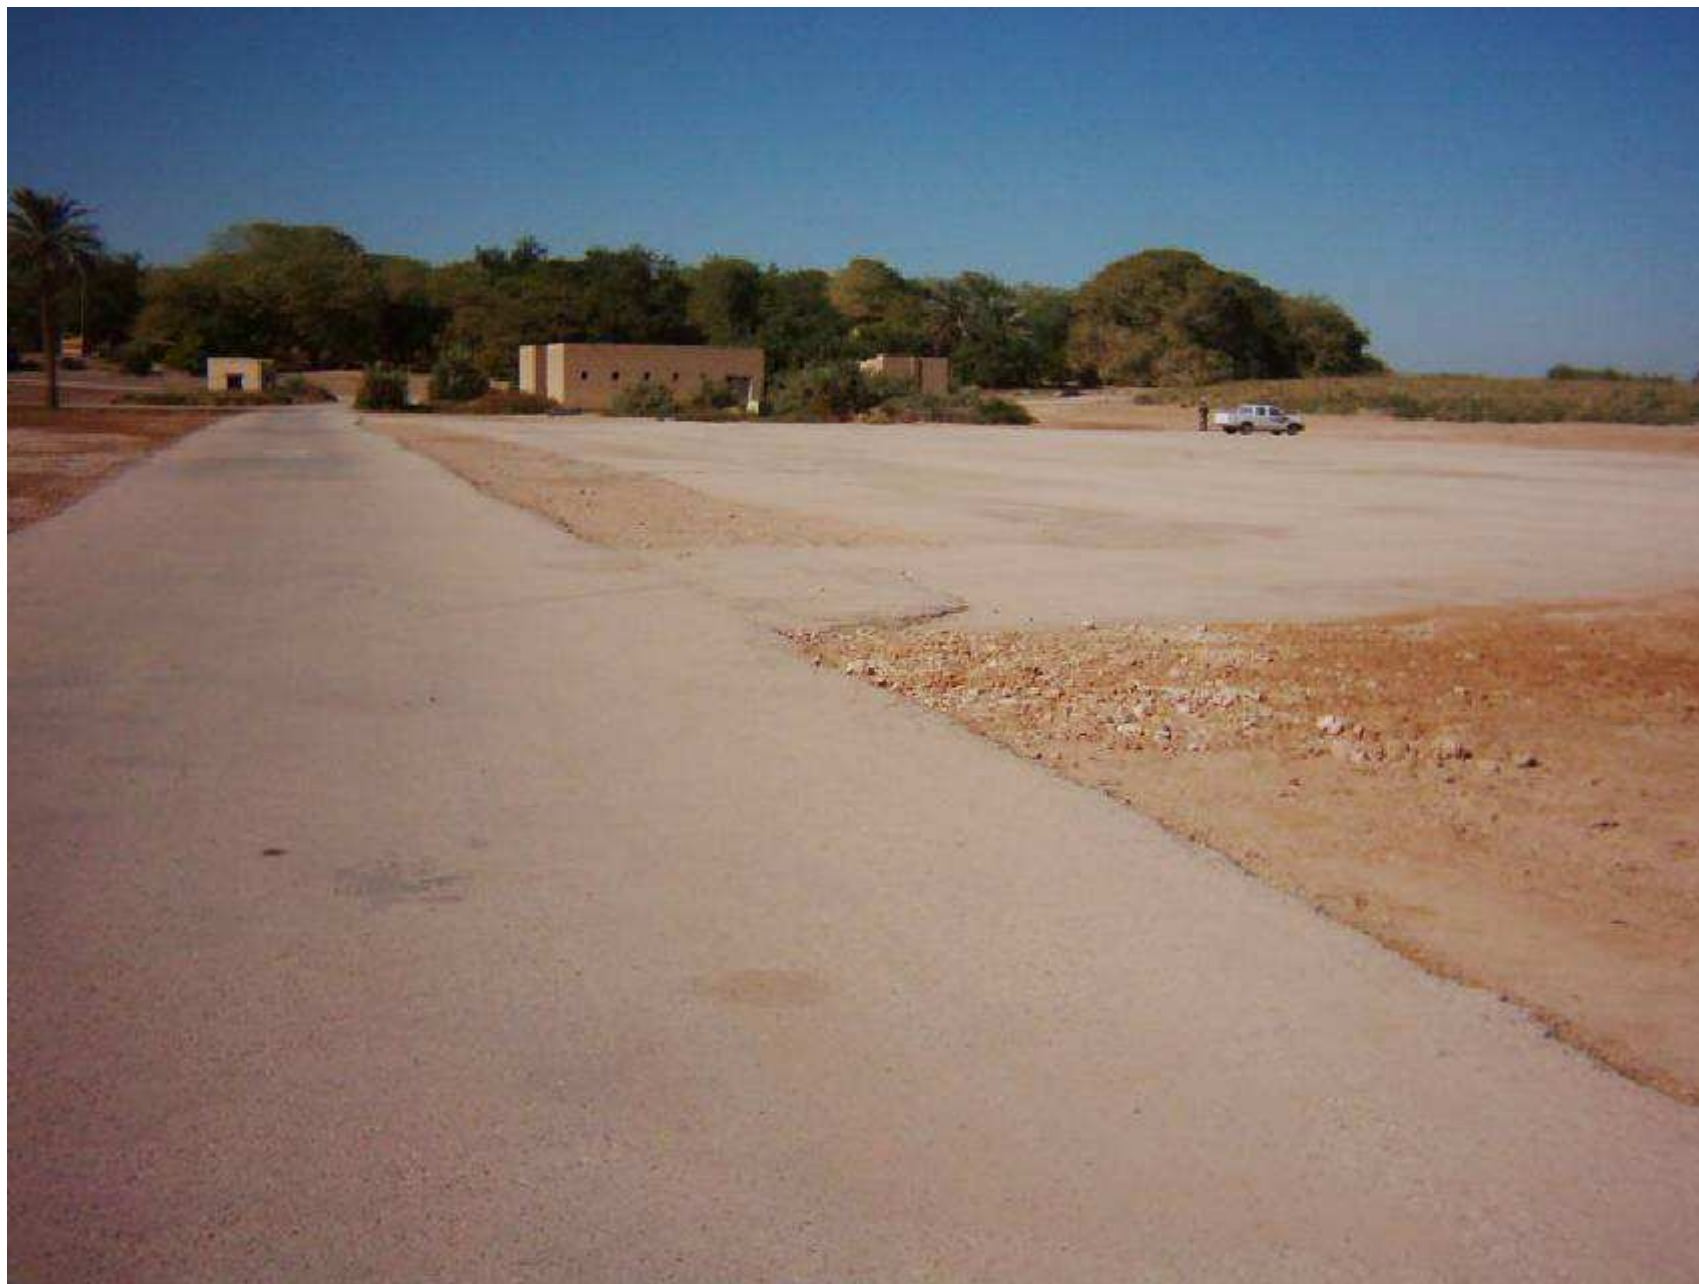
**"5<sup>th</sup> lot:** North of the Babylonian House (area of the airfield built by the MF), it has an area of 98 x 54 m" (Iraqi final report p. 4 and fig. 15).

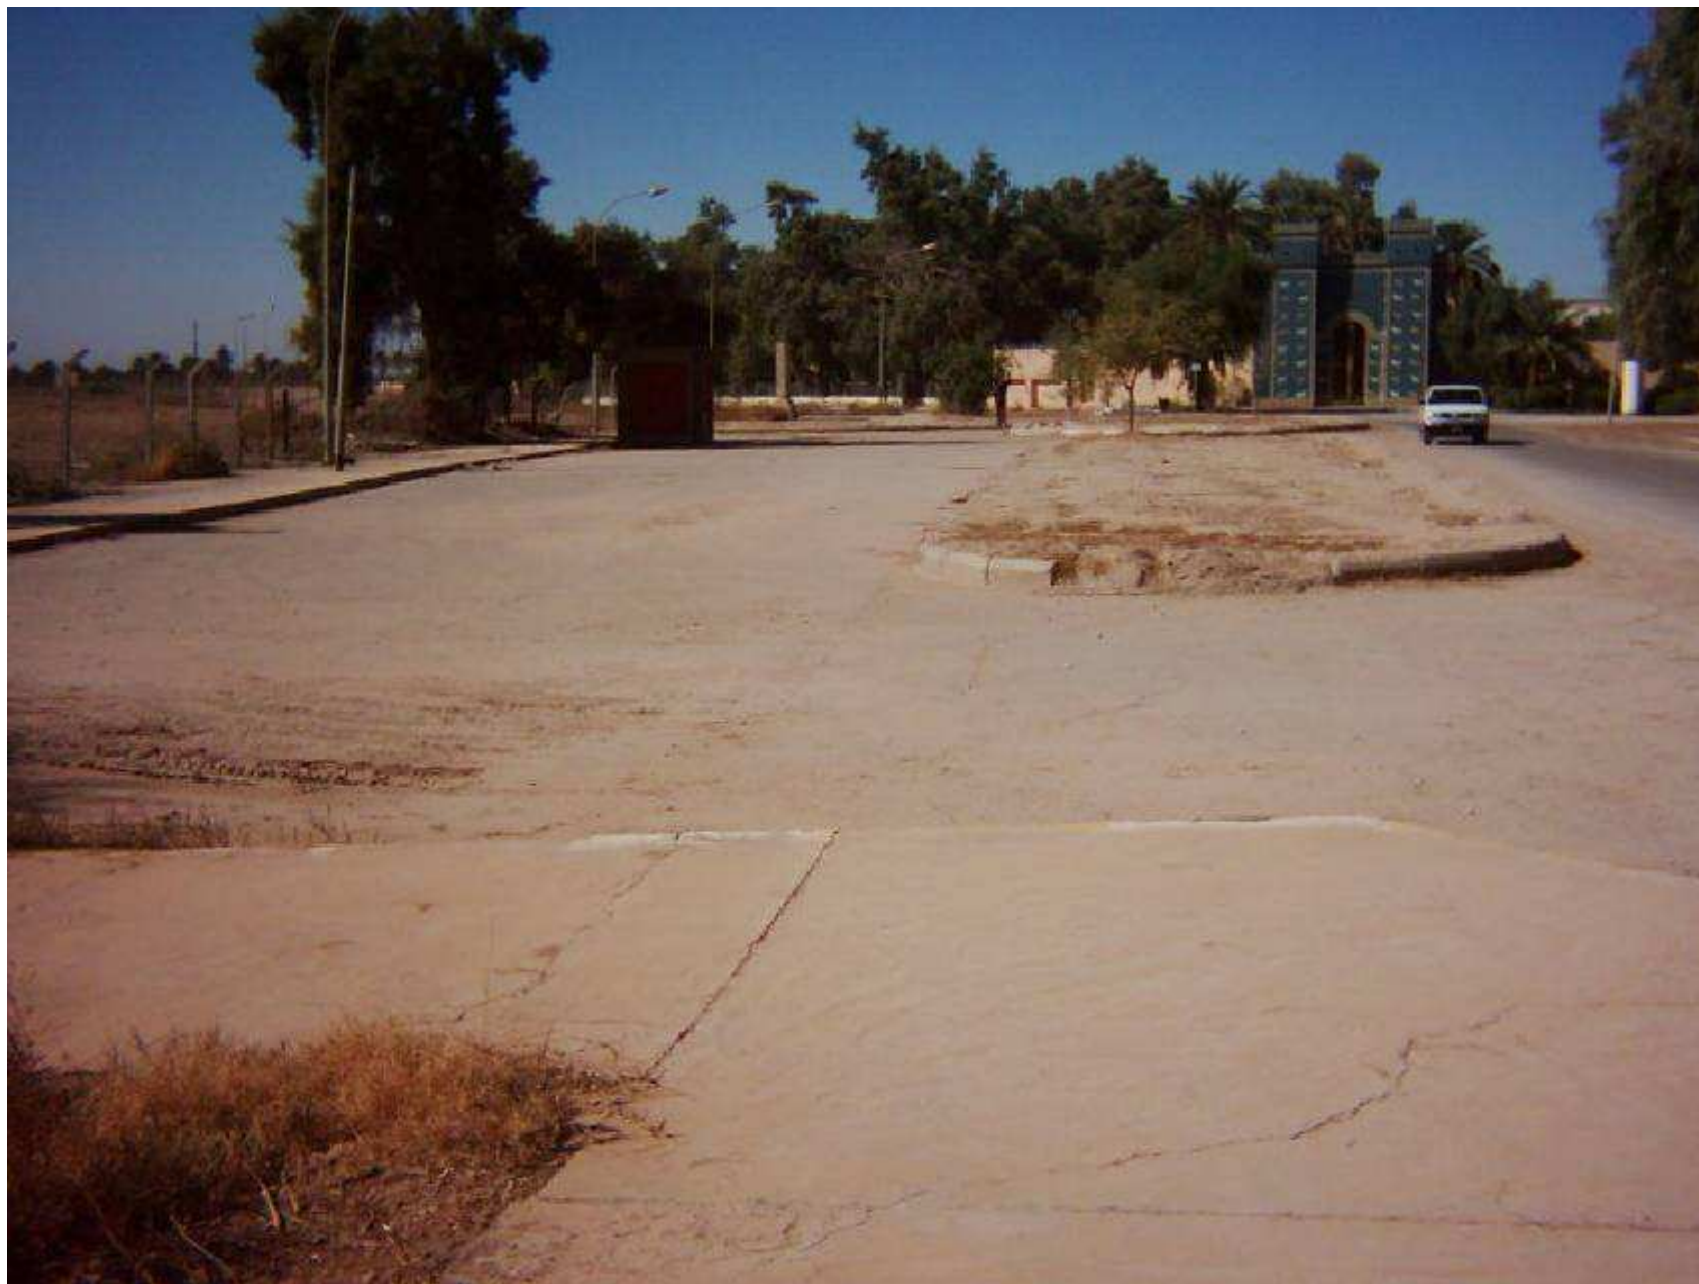
**"6<sup>th</sup> lot:** Across from the rest house north of the Ishtar Temple, it has an area of 18 x 67 m" (Iraqi final report p. 4 and fig. 16).

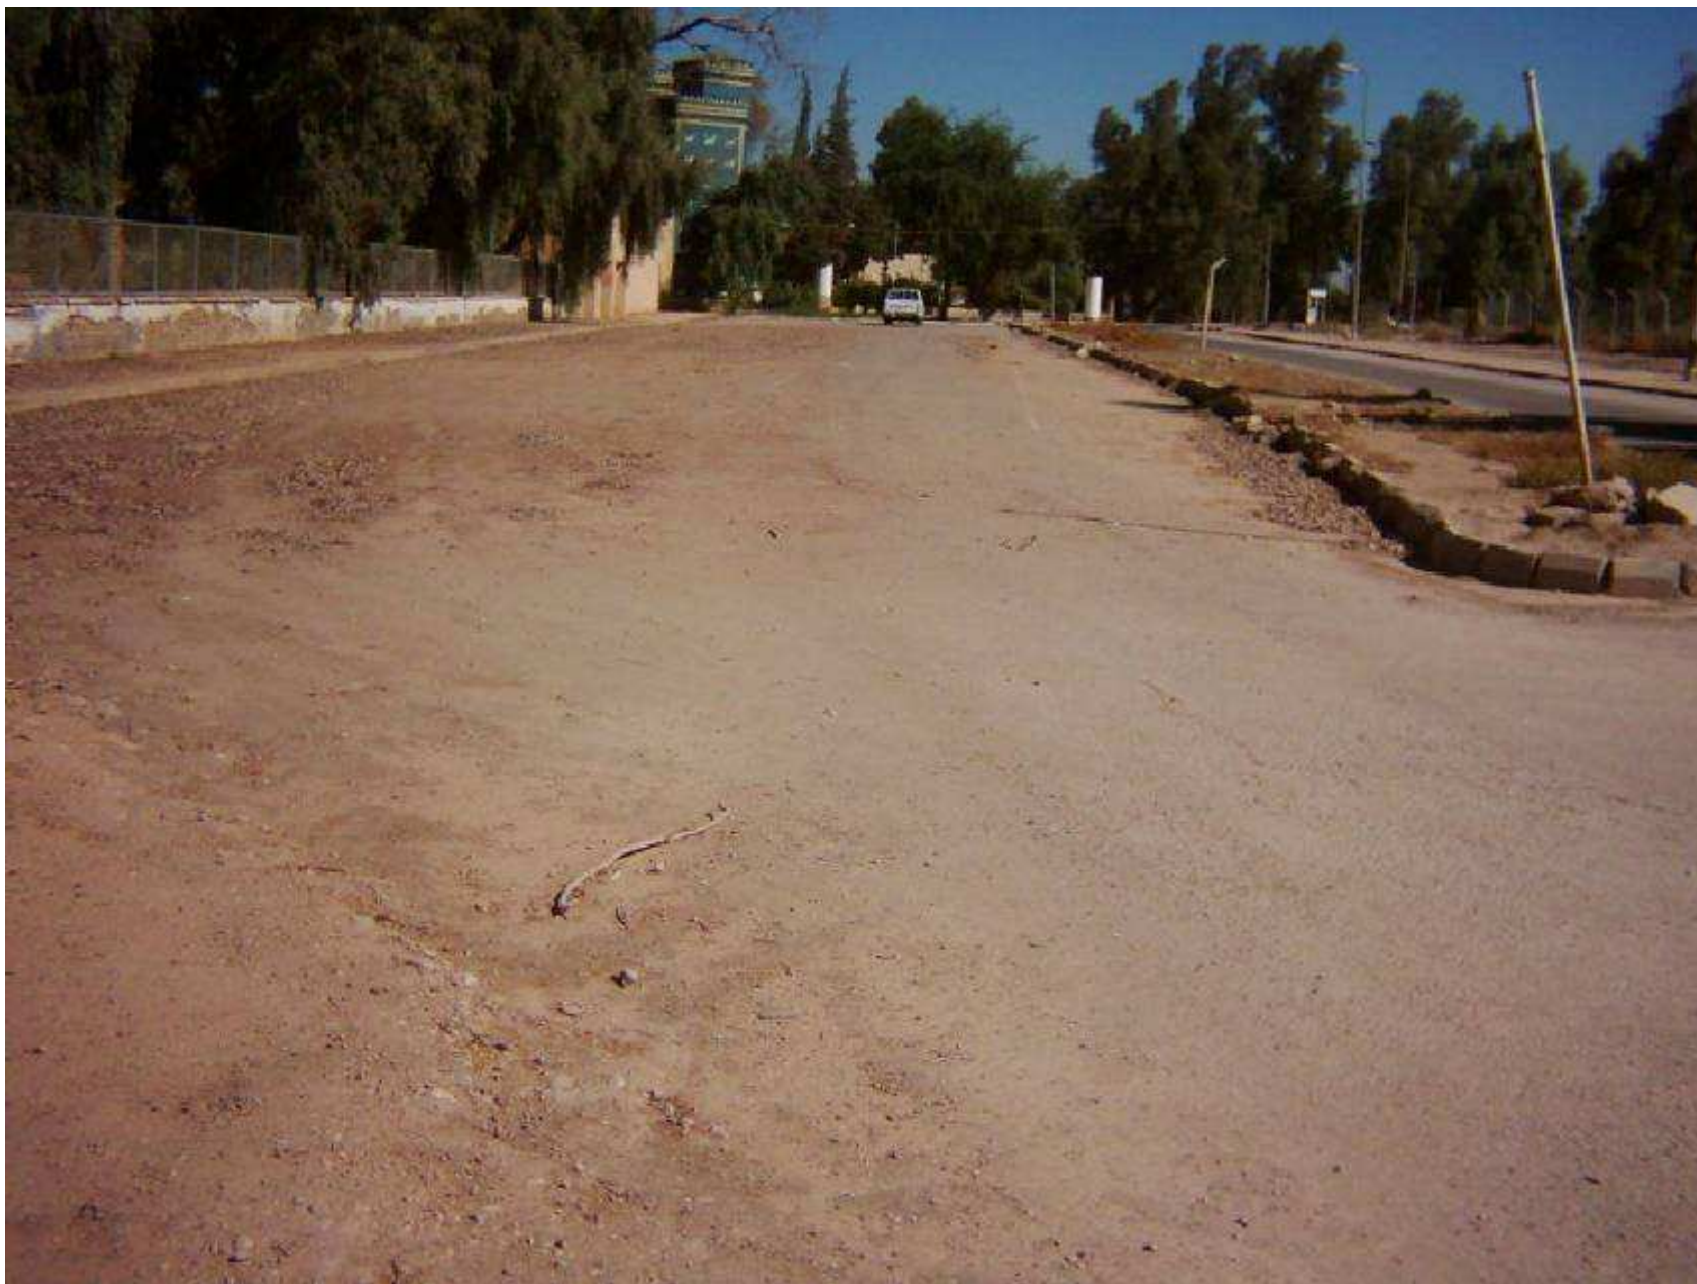
**"7<sup>th</sup> lot:** Alongside the road leading to the presidential palace on the north, near the new Ishtar Gate, it has an area of 16 x 100 m" (Iraqi final report p. 4 and fig. 17).

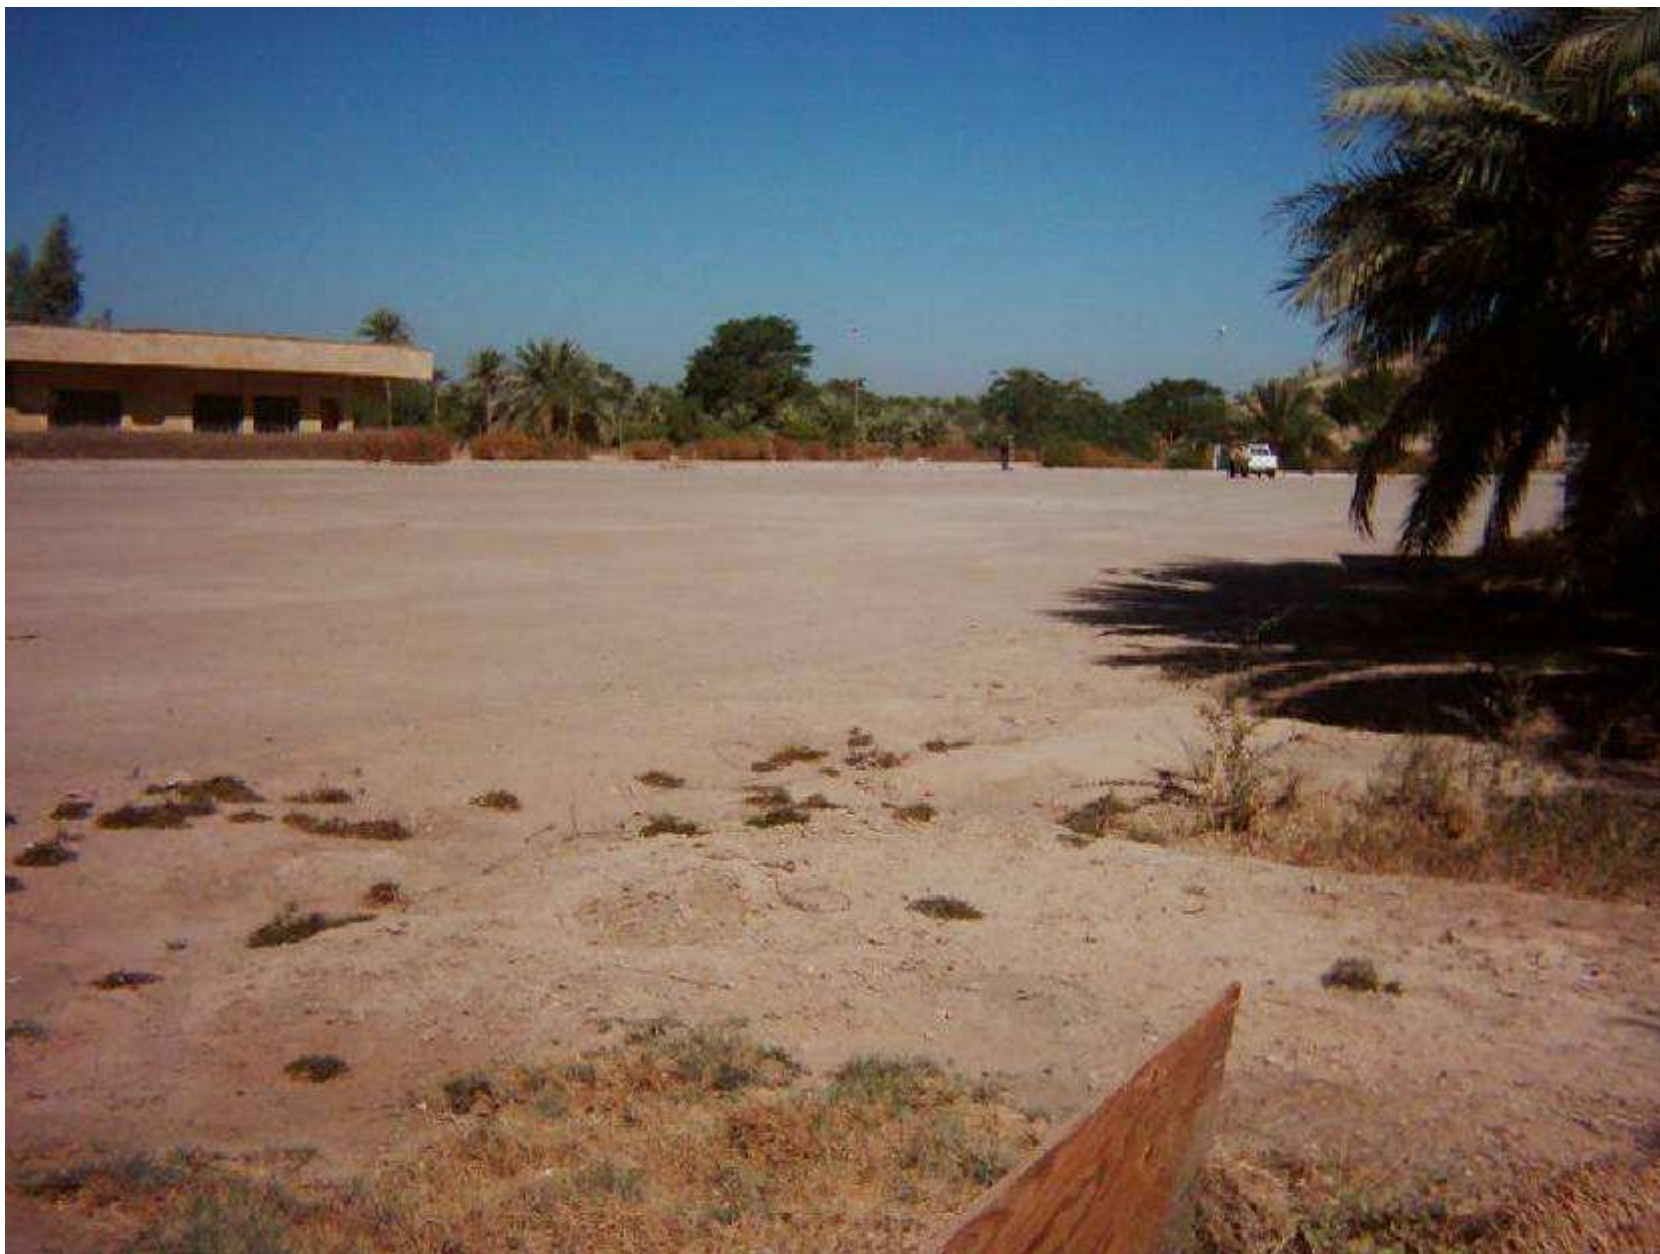
**"8<sup>th</sup> lot:** It is located south of the presidential palace, across from three modern buildings. Its area is 52 x 127 m" (Iraqi final report p. 4 and fig. 18).

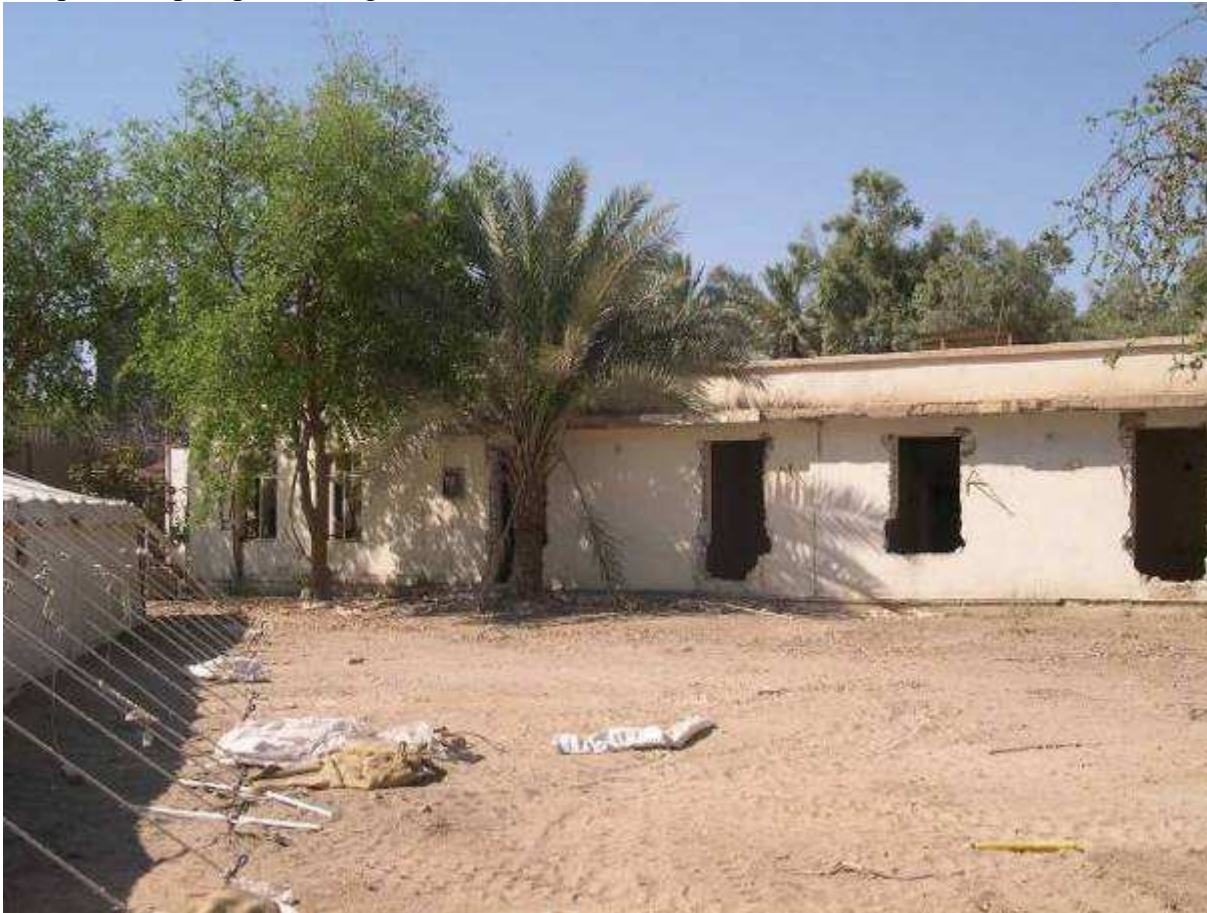
Iraqi final report fig. 19

"In addition, the Nebuchadnezzar Museum, Hammurabi Museum, the Studies Headquarters, office, and rest house were built in the center of the city" (Iraqi final report p. 4 and fig. 19).

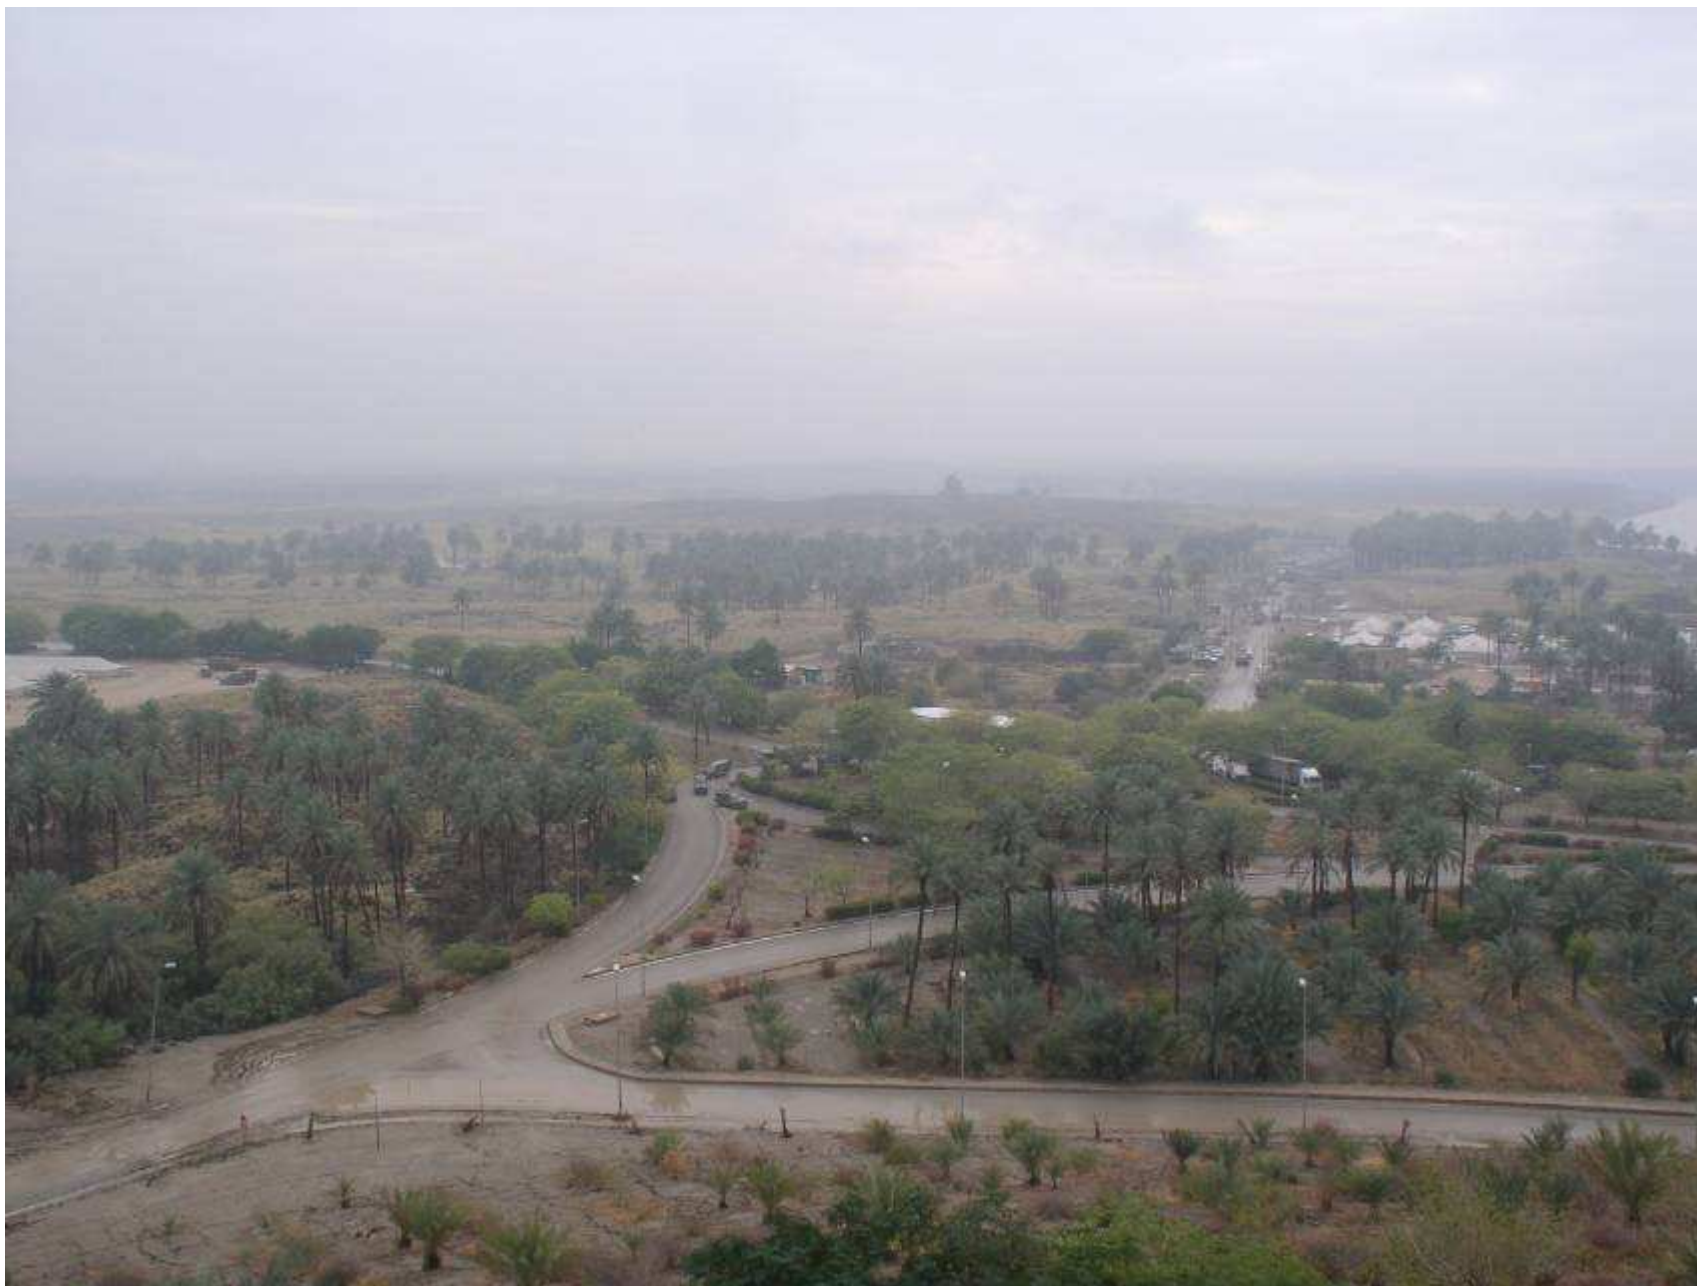
**"Parks scattered throughout the city.** These include the so-called "Pavilions Park" located in the center of the city, near the inner wall and near the Temple of Nanmakh, in addition to parks located in the area of the presidential palace" (Iraqi final report p. 4 and fig. 20).

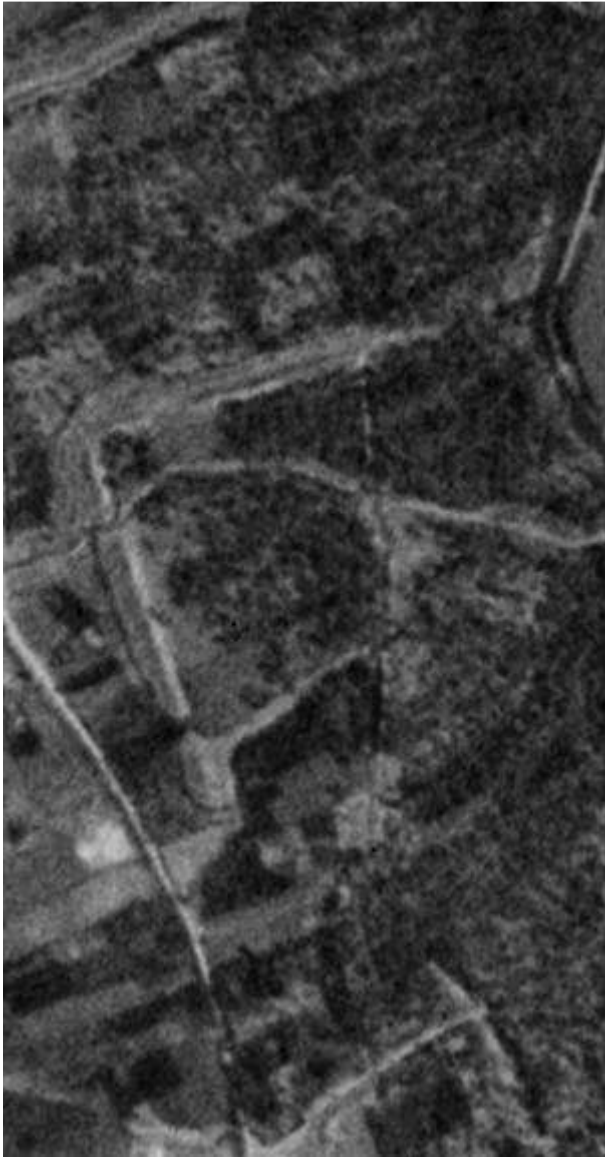
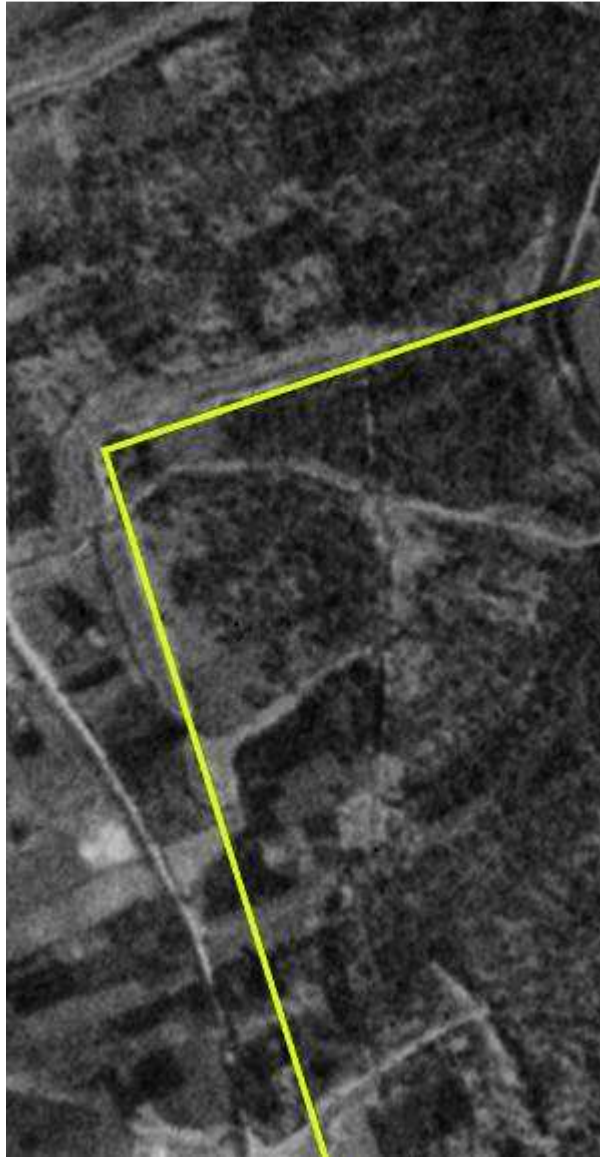
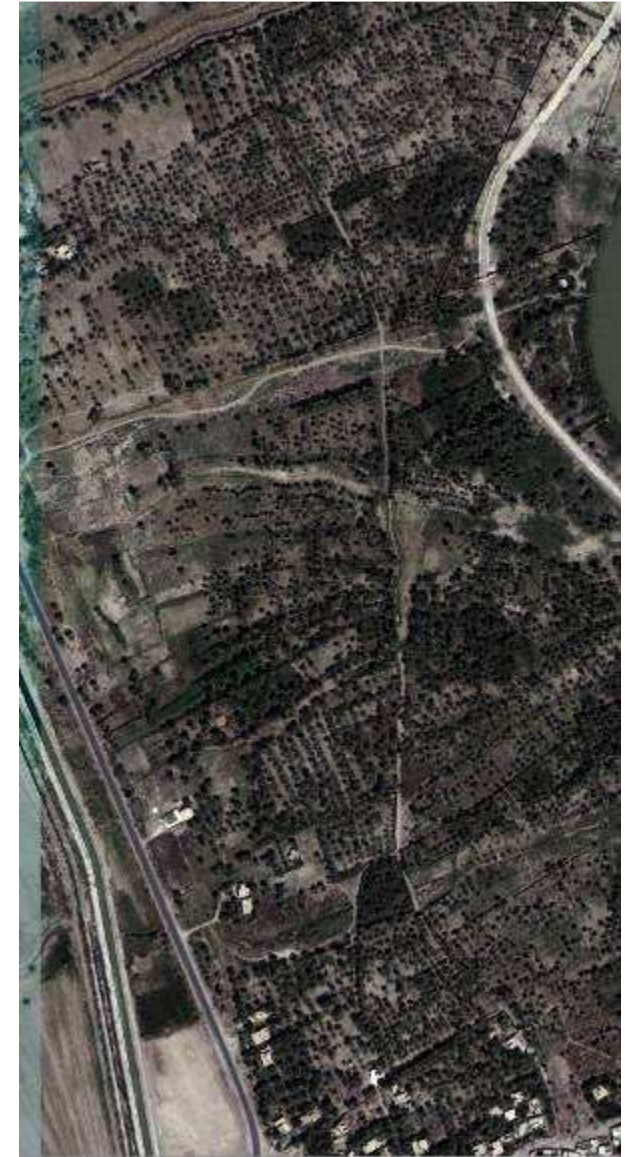
Western wall, NW corner, 1965

Western wall, NW corner, 2002

**Russell comment:** It is difficult to determine the state of preservation of the NW corner of the western part of the city wall from the satellite images. Traces of its course are still visible in the 2002 image.

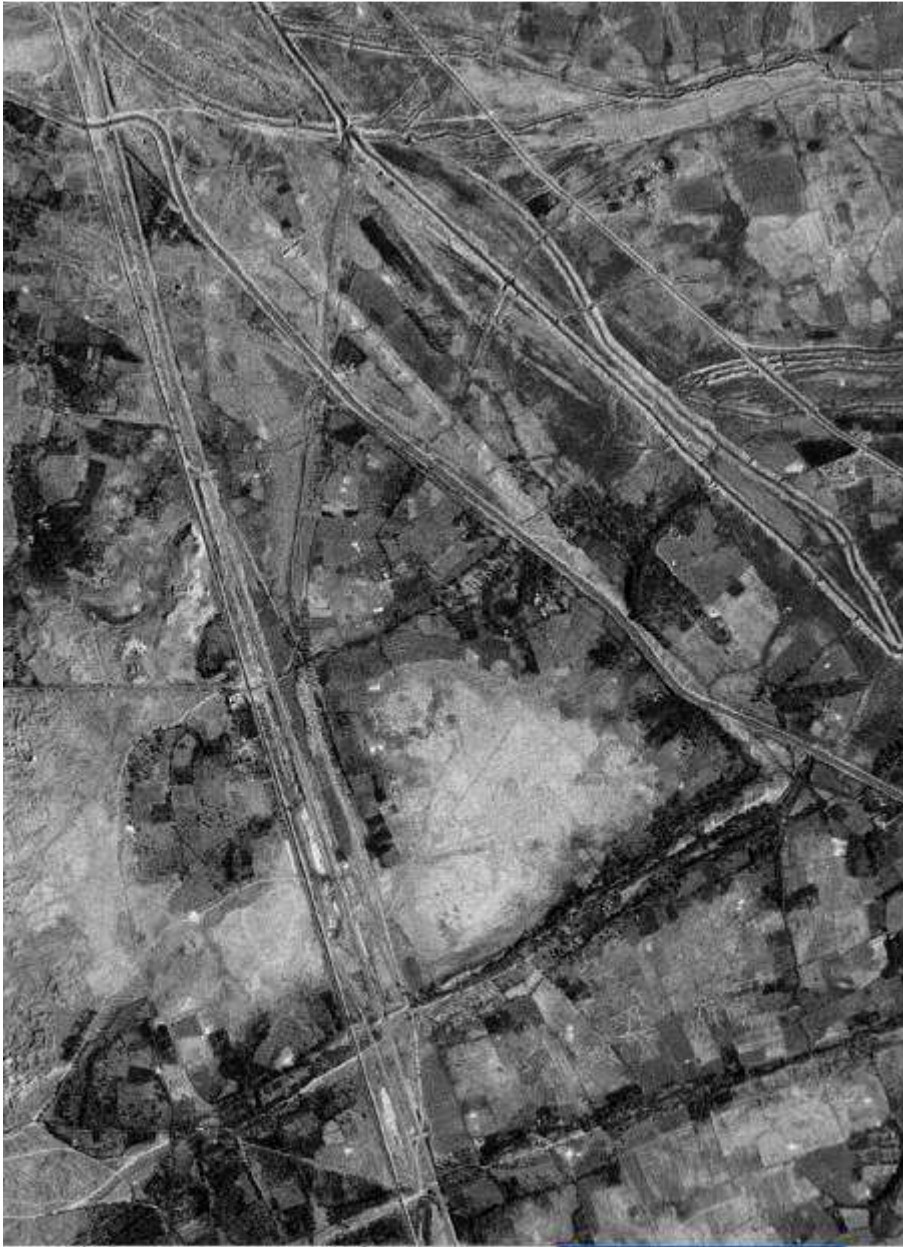
Eastern outer wall, 1965, Russell composite

**Russell comment:** The eastern outer wall appears to have been relatively untouched by development, apart from being cut by a canal near its eastern corner sometime prior to 1965.

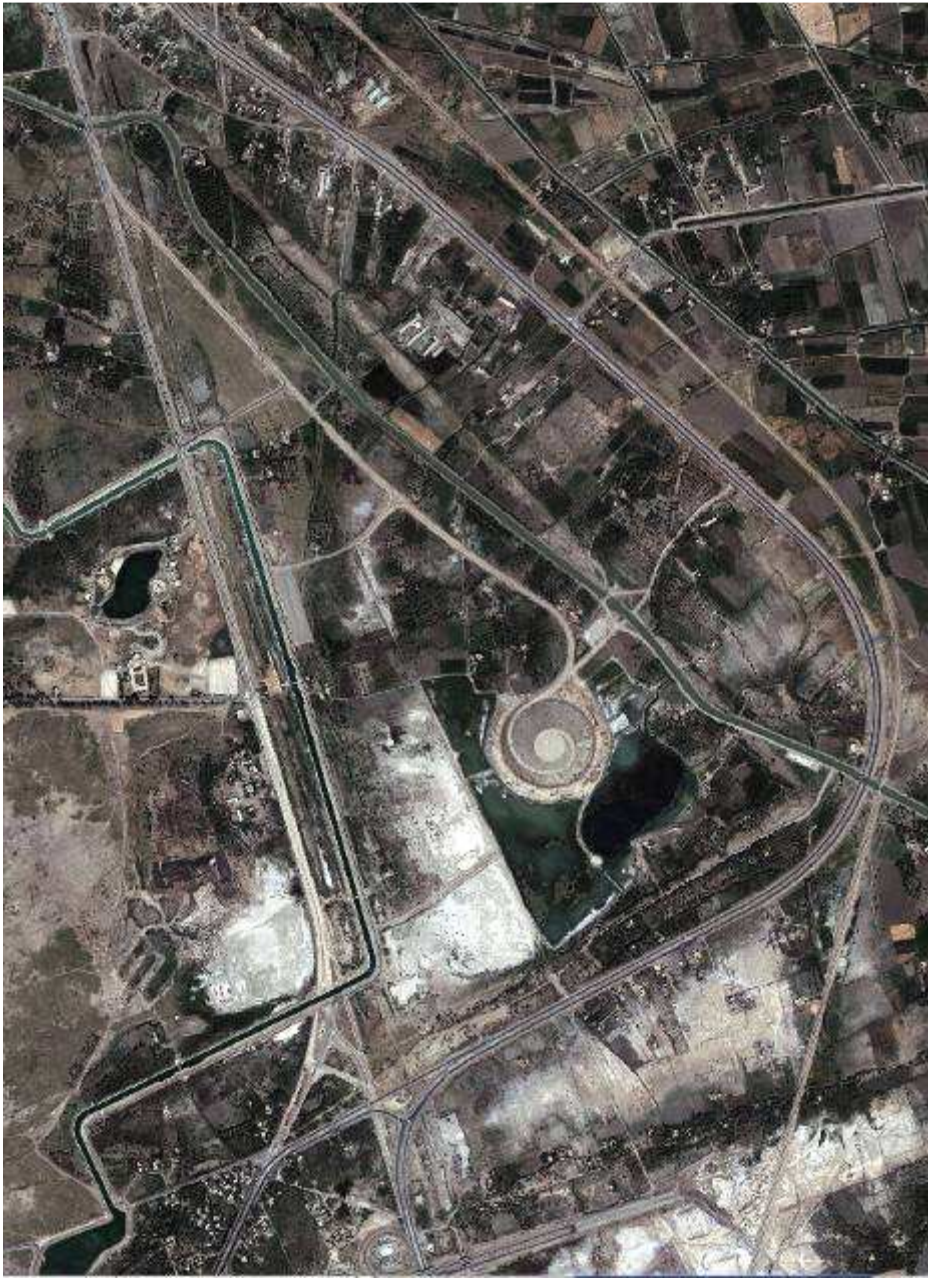
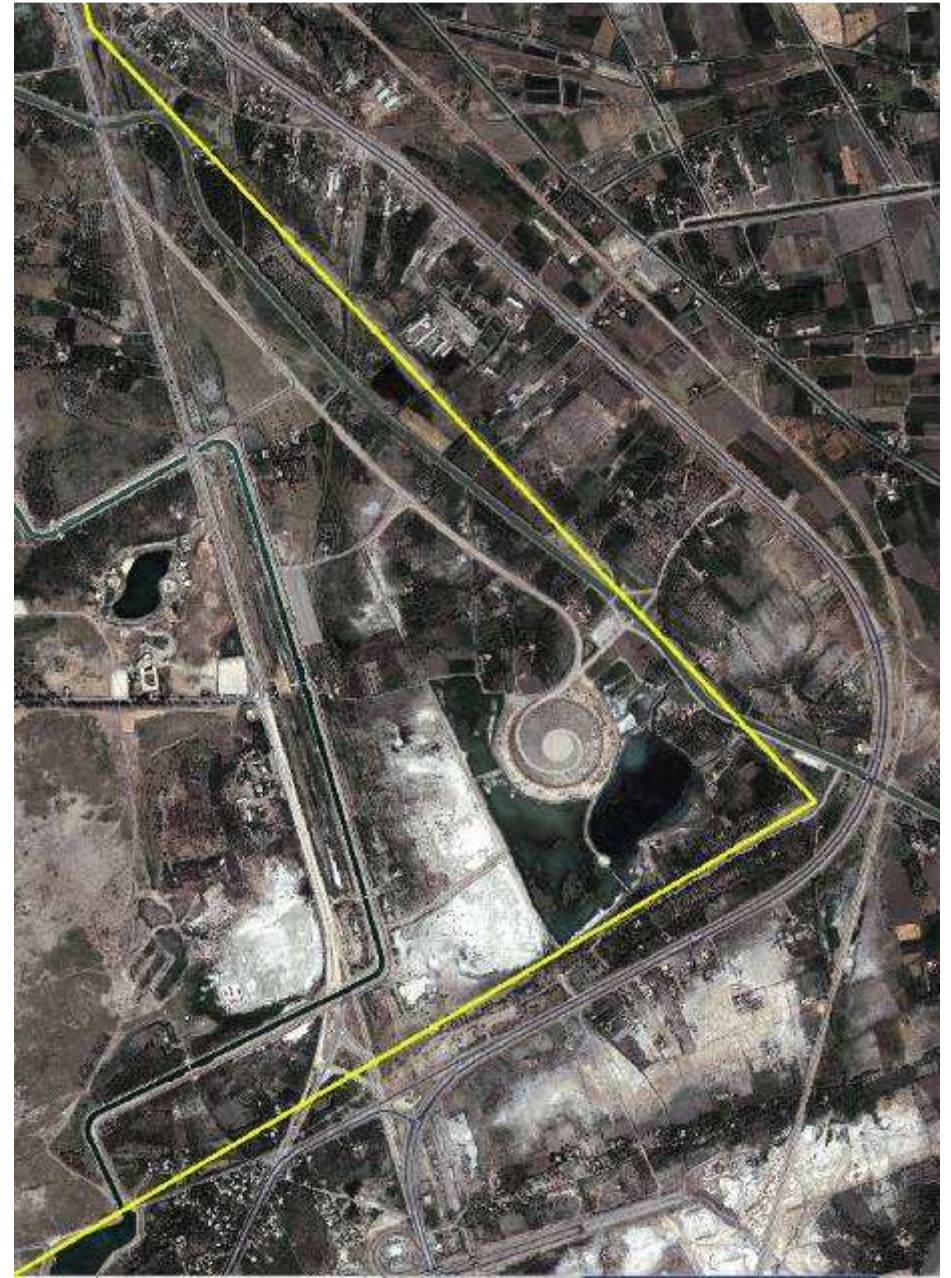
Eastern outer wall, 2002, Russell composite

**Russell comment:** More recent construction largely avoided the eastern outer wall.

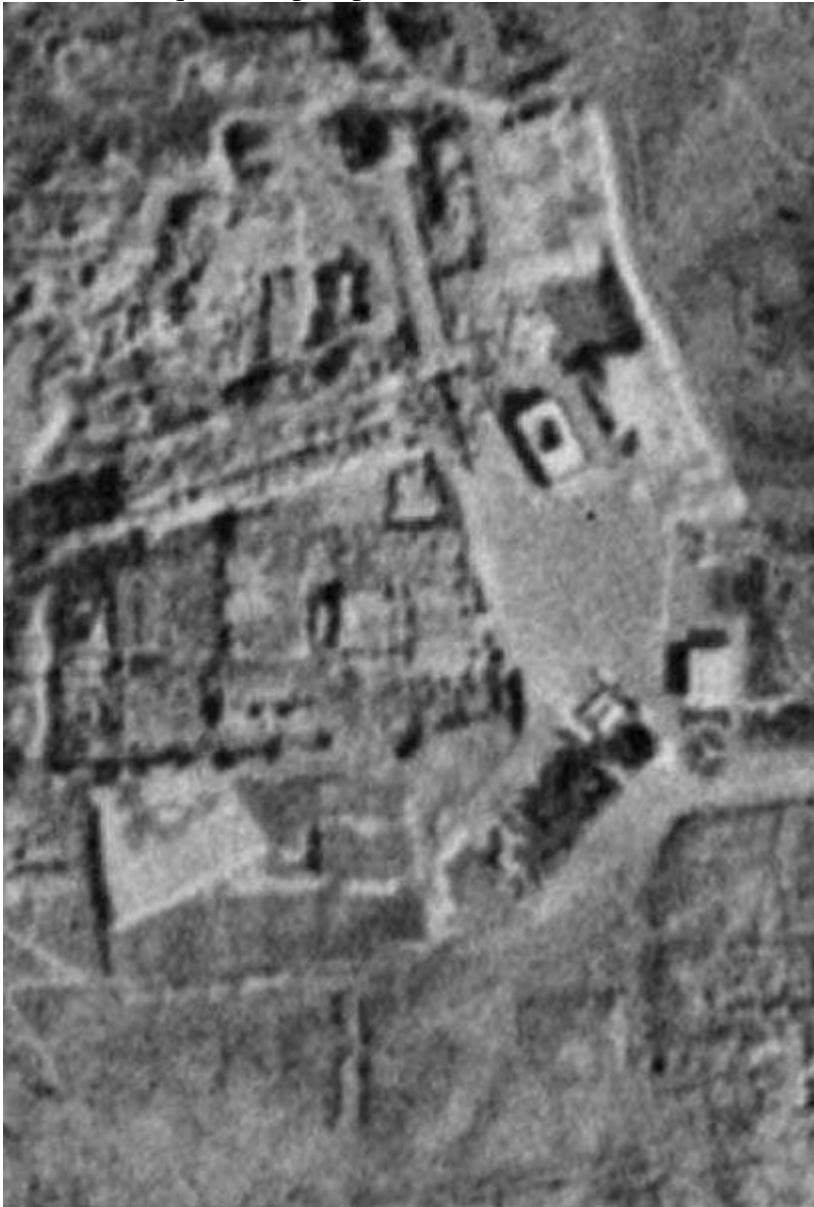
**"Unscientific preservation.** Additions and modifications have been made to numerous archeological structures in the city, particularly the Southern Palace, the northern portion of Processional Way, several temples, the eastern portion of the inner wall, the Babylonian houses, and the Greek Theater" (Iraqi final report p. 5).

Southern Palace and temples, before reconstruction, 1965

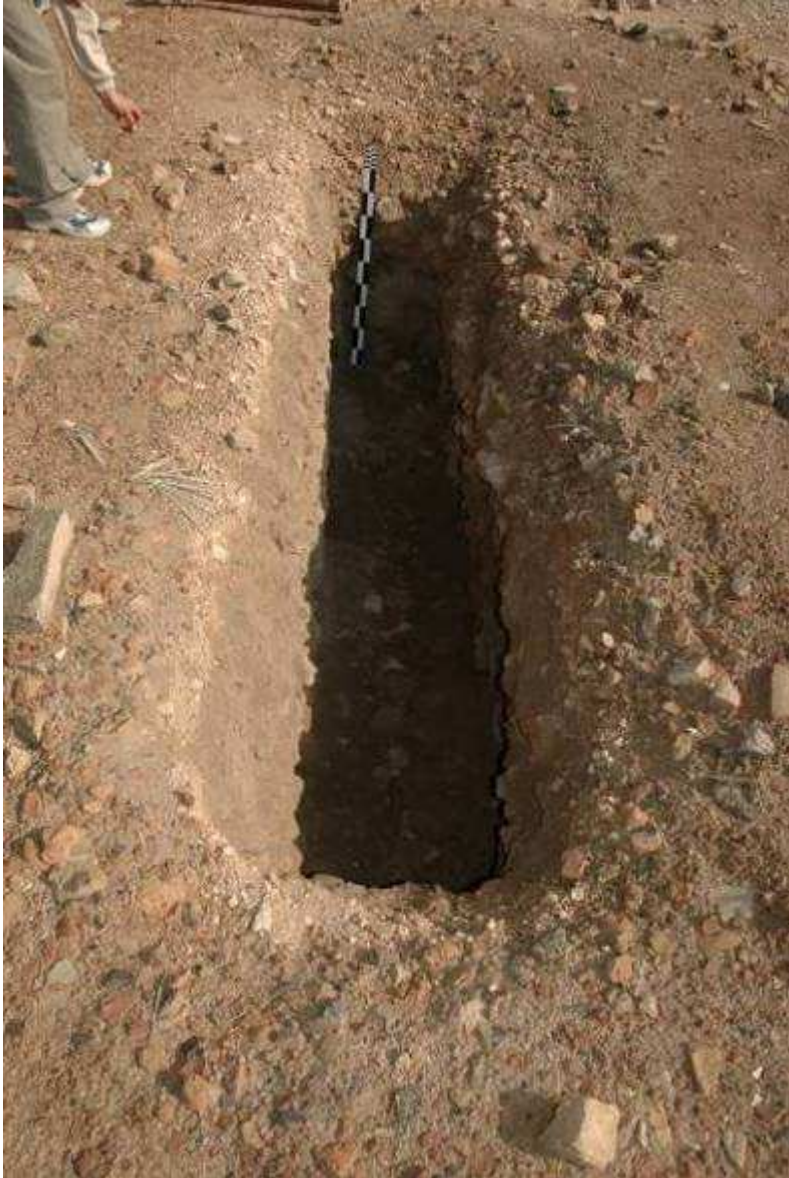
**"Excavation works.** These consist of a series of defensive trenches dug prior to the recent war in 2003 in scattered areas of the city near the presidential palace, the Southern Palace, and the Greek theater. The square footages of the trenches are approximately the same" (Iraqi final report p. 5 and fig. 21).

**Russell comment:** Dozens of firing positions were dug prior to April 2003, evidently to protect Saddam's palace. The Iraqi final report gives only the above information about them, so they are discussed in detail below on the basis of the satellite imagery.

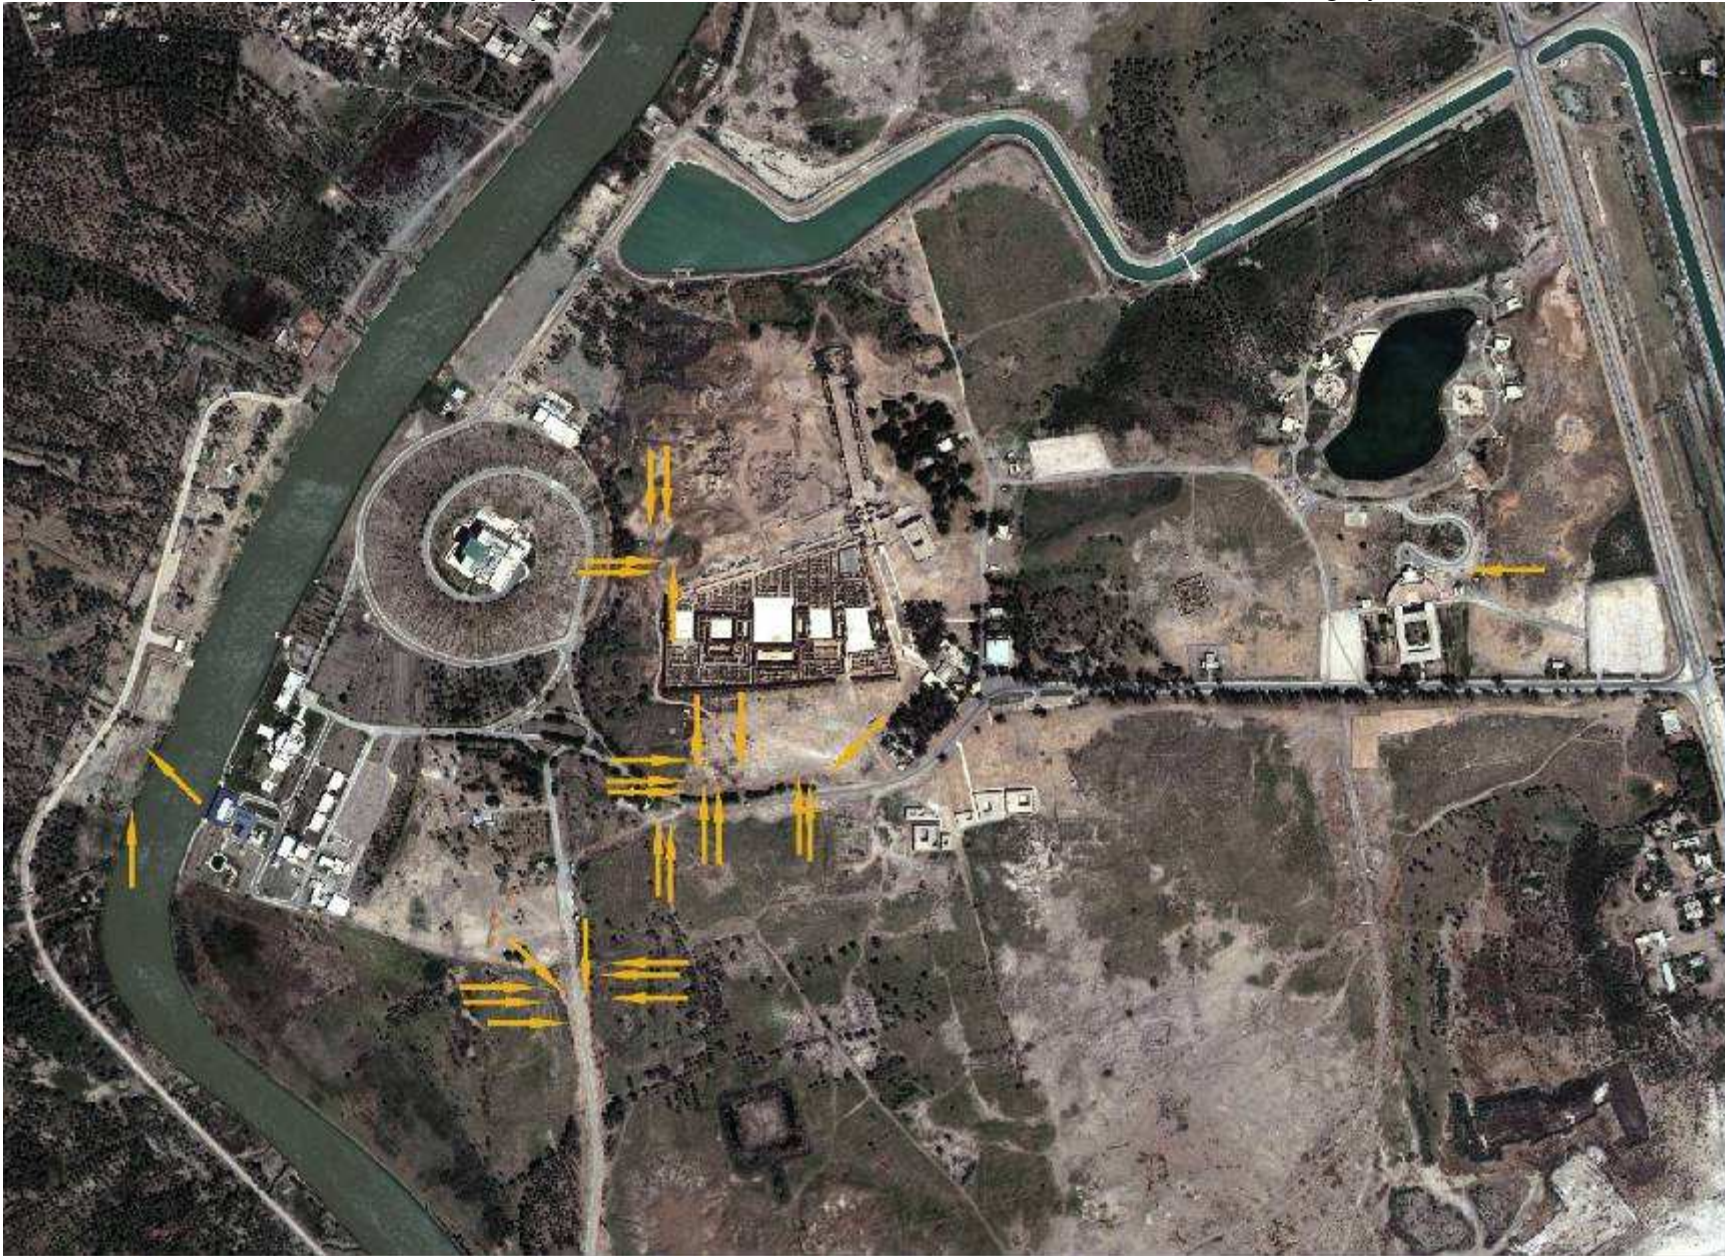
Firing positions in place by 5 July 2002, Russell composite
