# **Report on Damage to the Site of Babylon, Iraq**

**John Malcolm Russell, Ph.D.**

**Cultural Heritage Center  
Bureau of Educational and Cultural Affairs  
Department of State**

**April 2010**

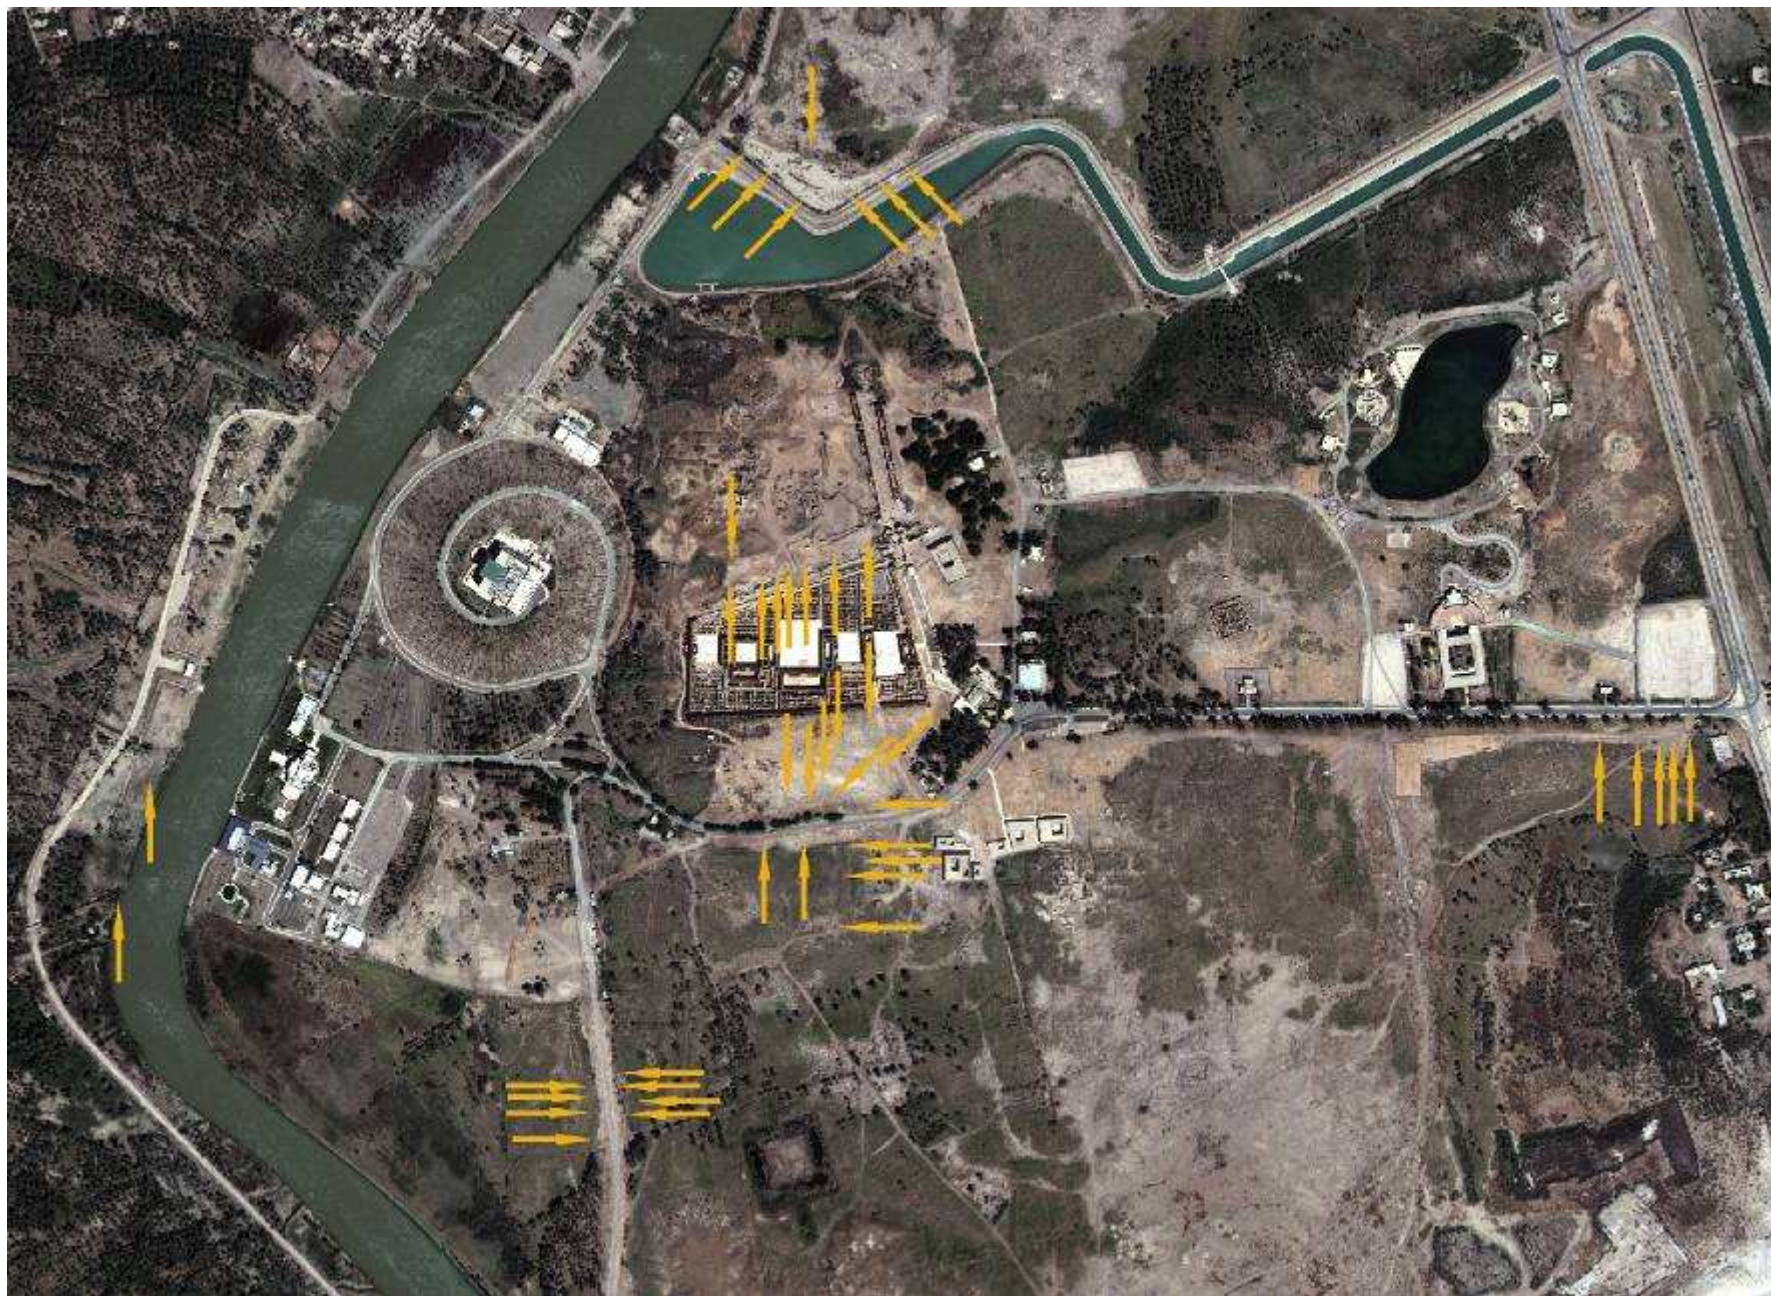
Firing positions dug between July 2002 and 1 April 2003, Russell composite

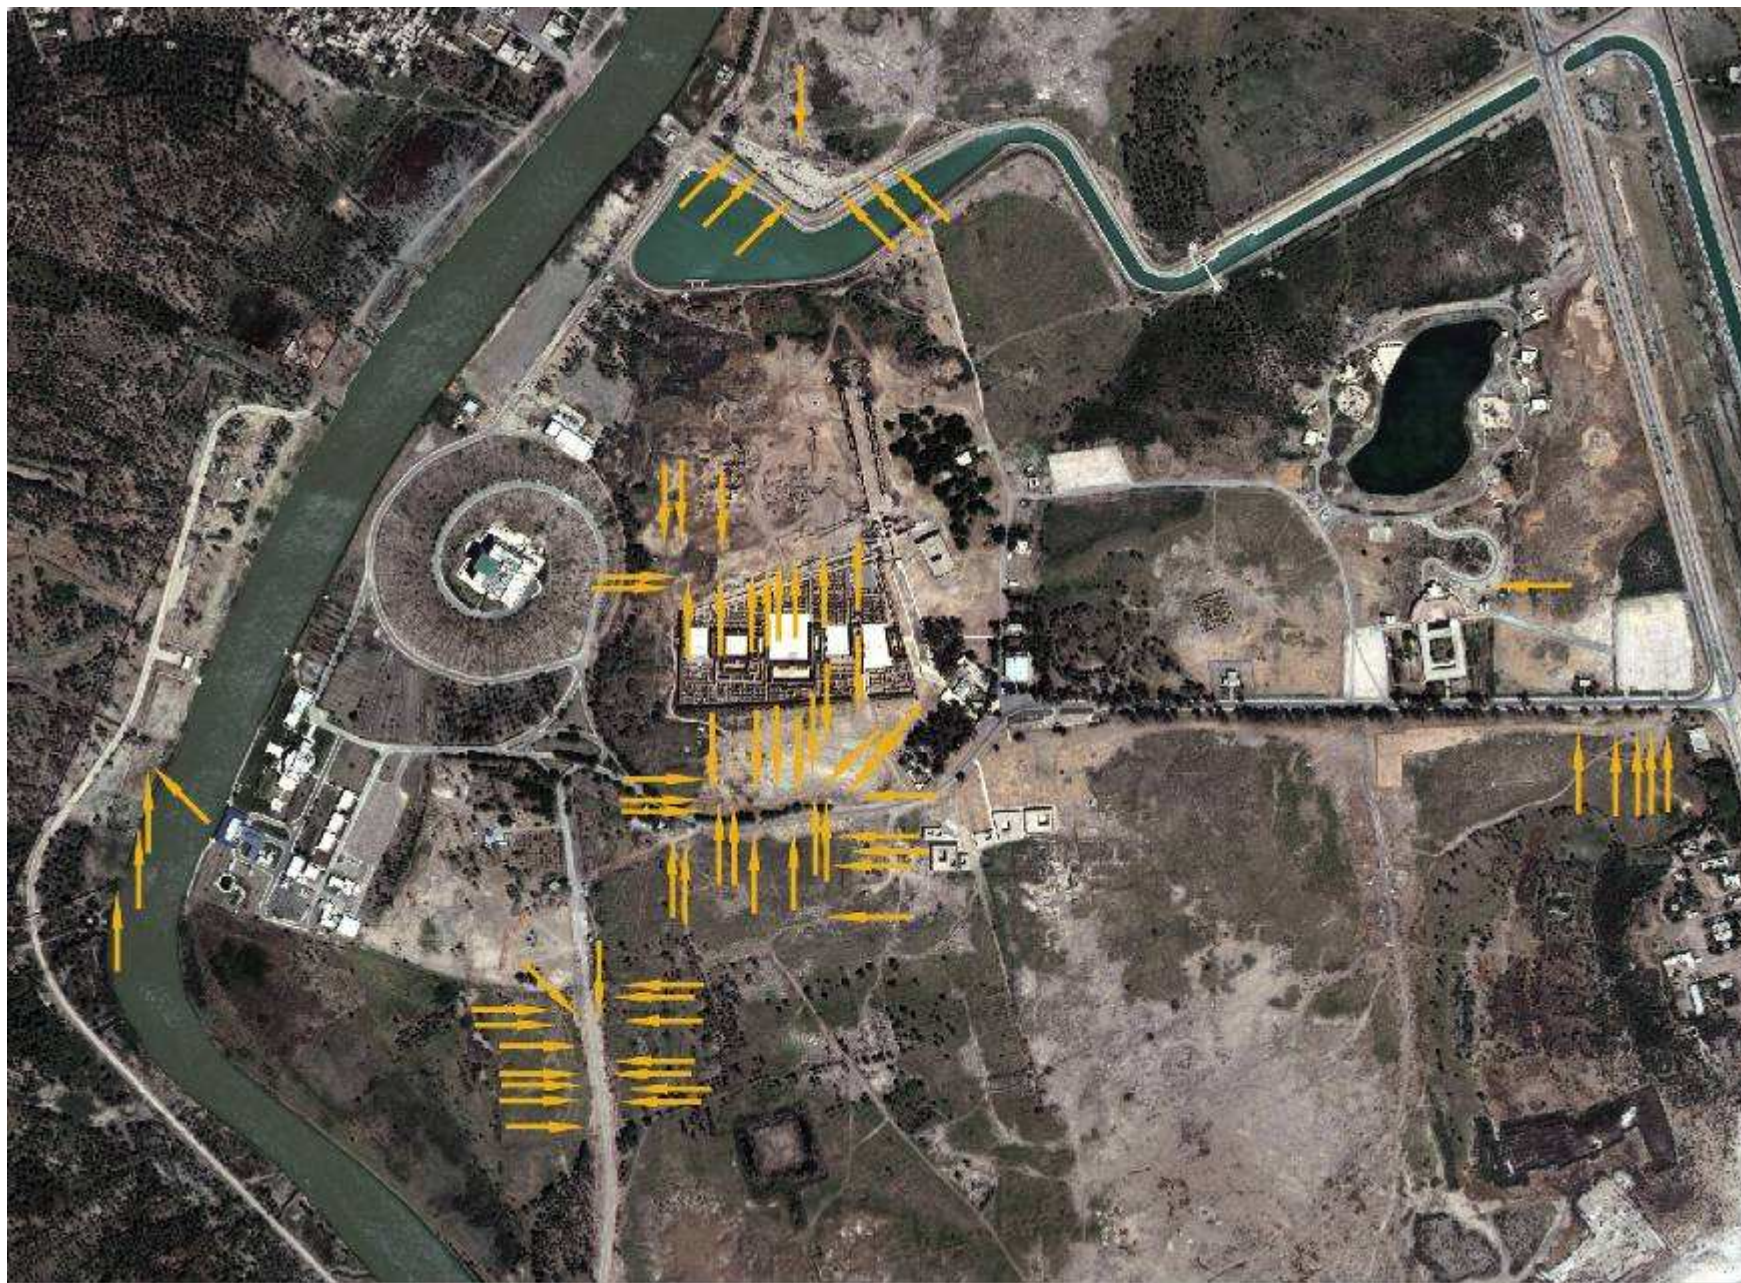
All firing positions as of 1 April 2003, Russell composite

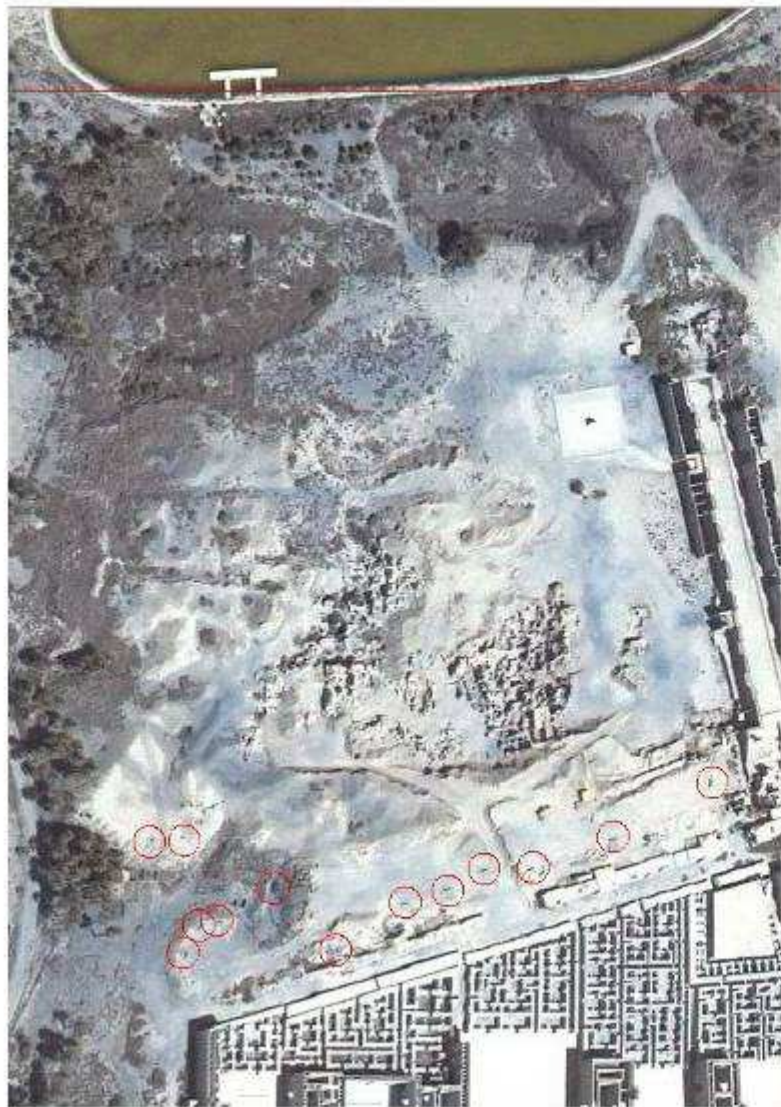
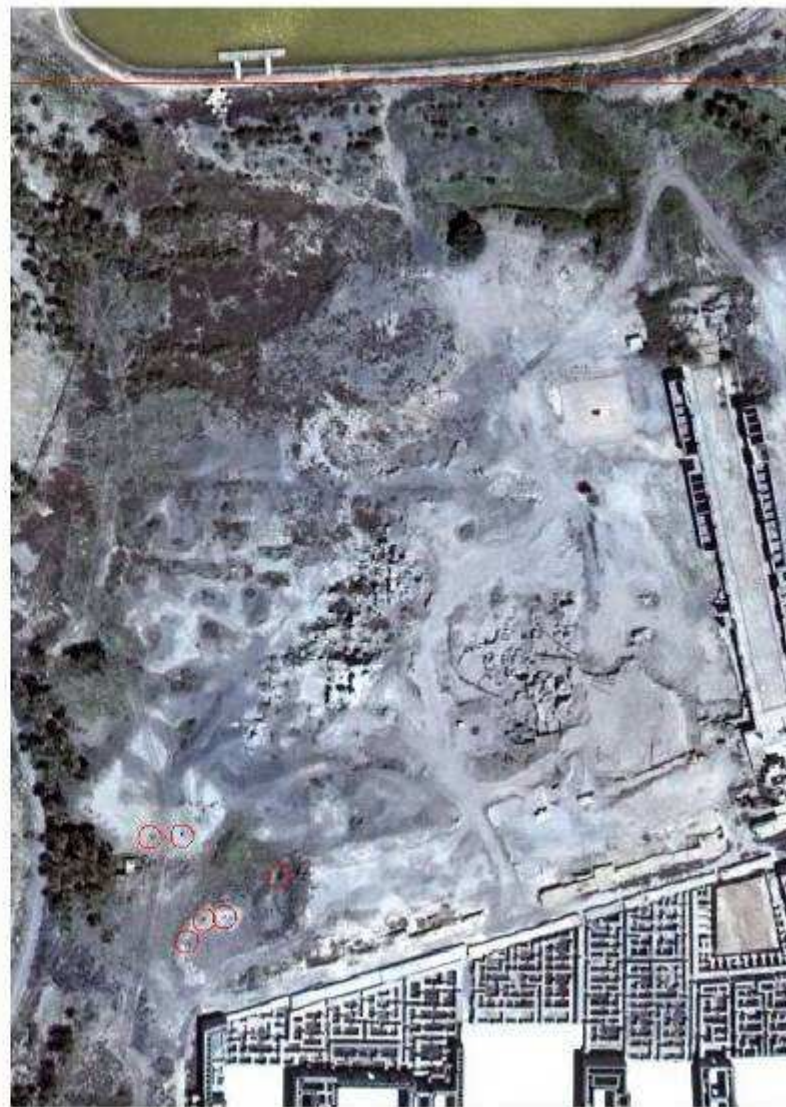
Firing positions 8, 9, 10, 12, 13 are already on the July 2002 image. Firing positions 1-7, 11 first appear on the April 1, 2003 map (image 1 April 2003, Russell composite).

**Stone report:** Firing positions 8-13 are visible in the February 2002 imagery (Fig. 4).

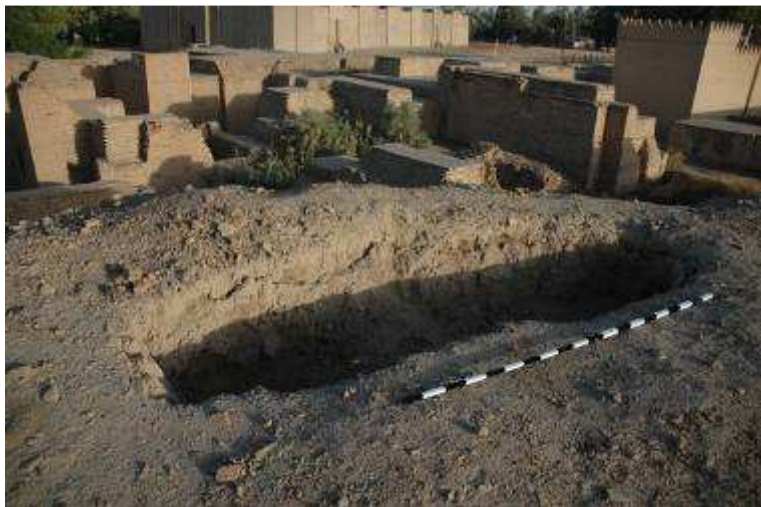
There are 13 firing positions located between the Southern Palace reconstruction and the Northern (or Principal) Palace shown in the pictures below [above], Polish report p. 8 (photo © Ministry of Culture and National Heritage, Republic of Poland)

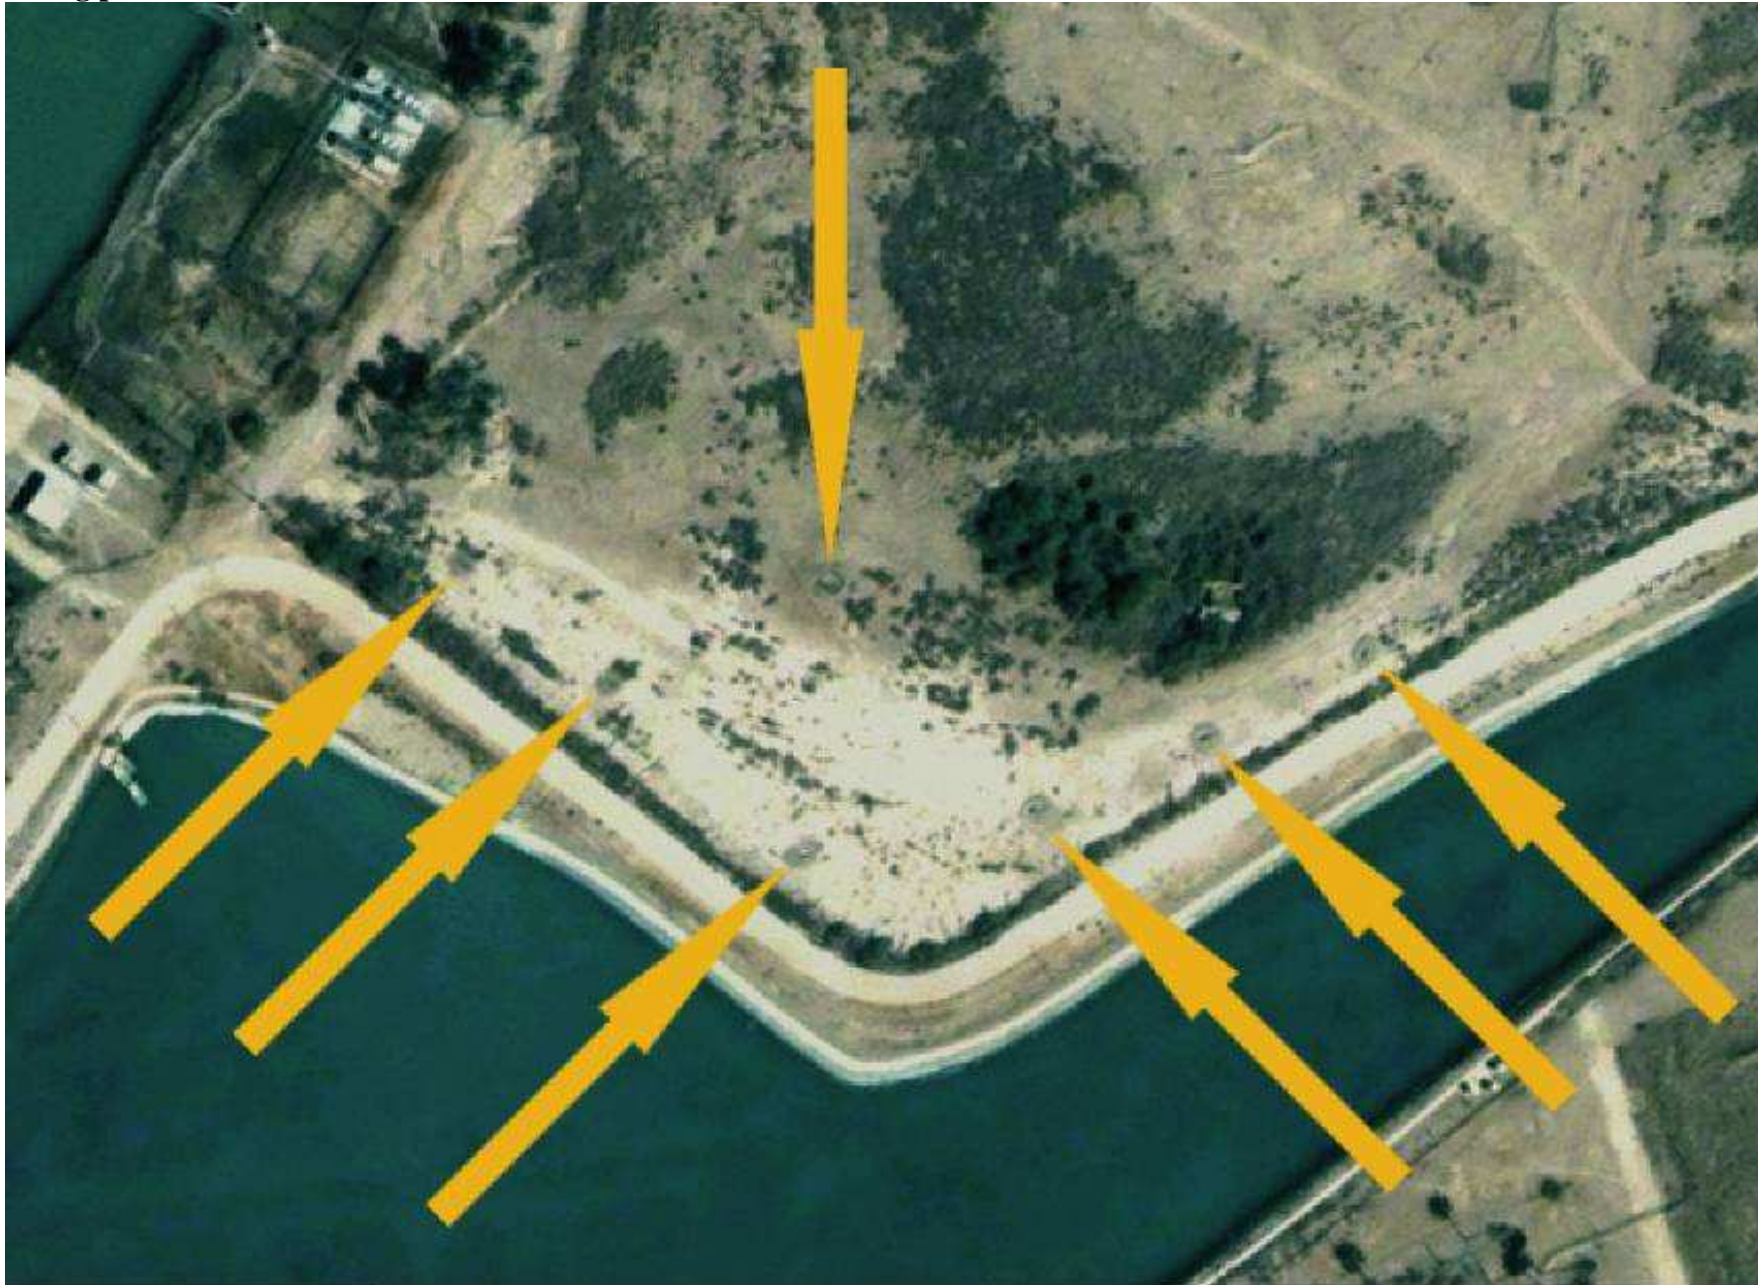
Firing positions north of the canal, all dug between July 2002 and 1 April 2003 (image 1 April 2003, Russell composite)

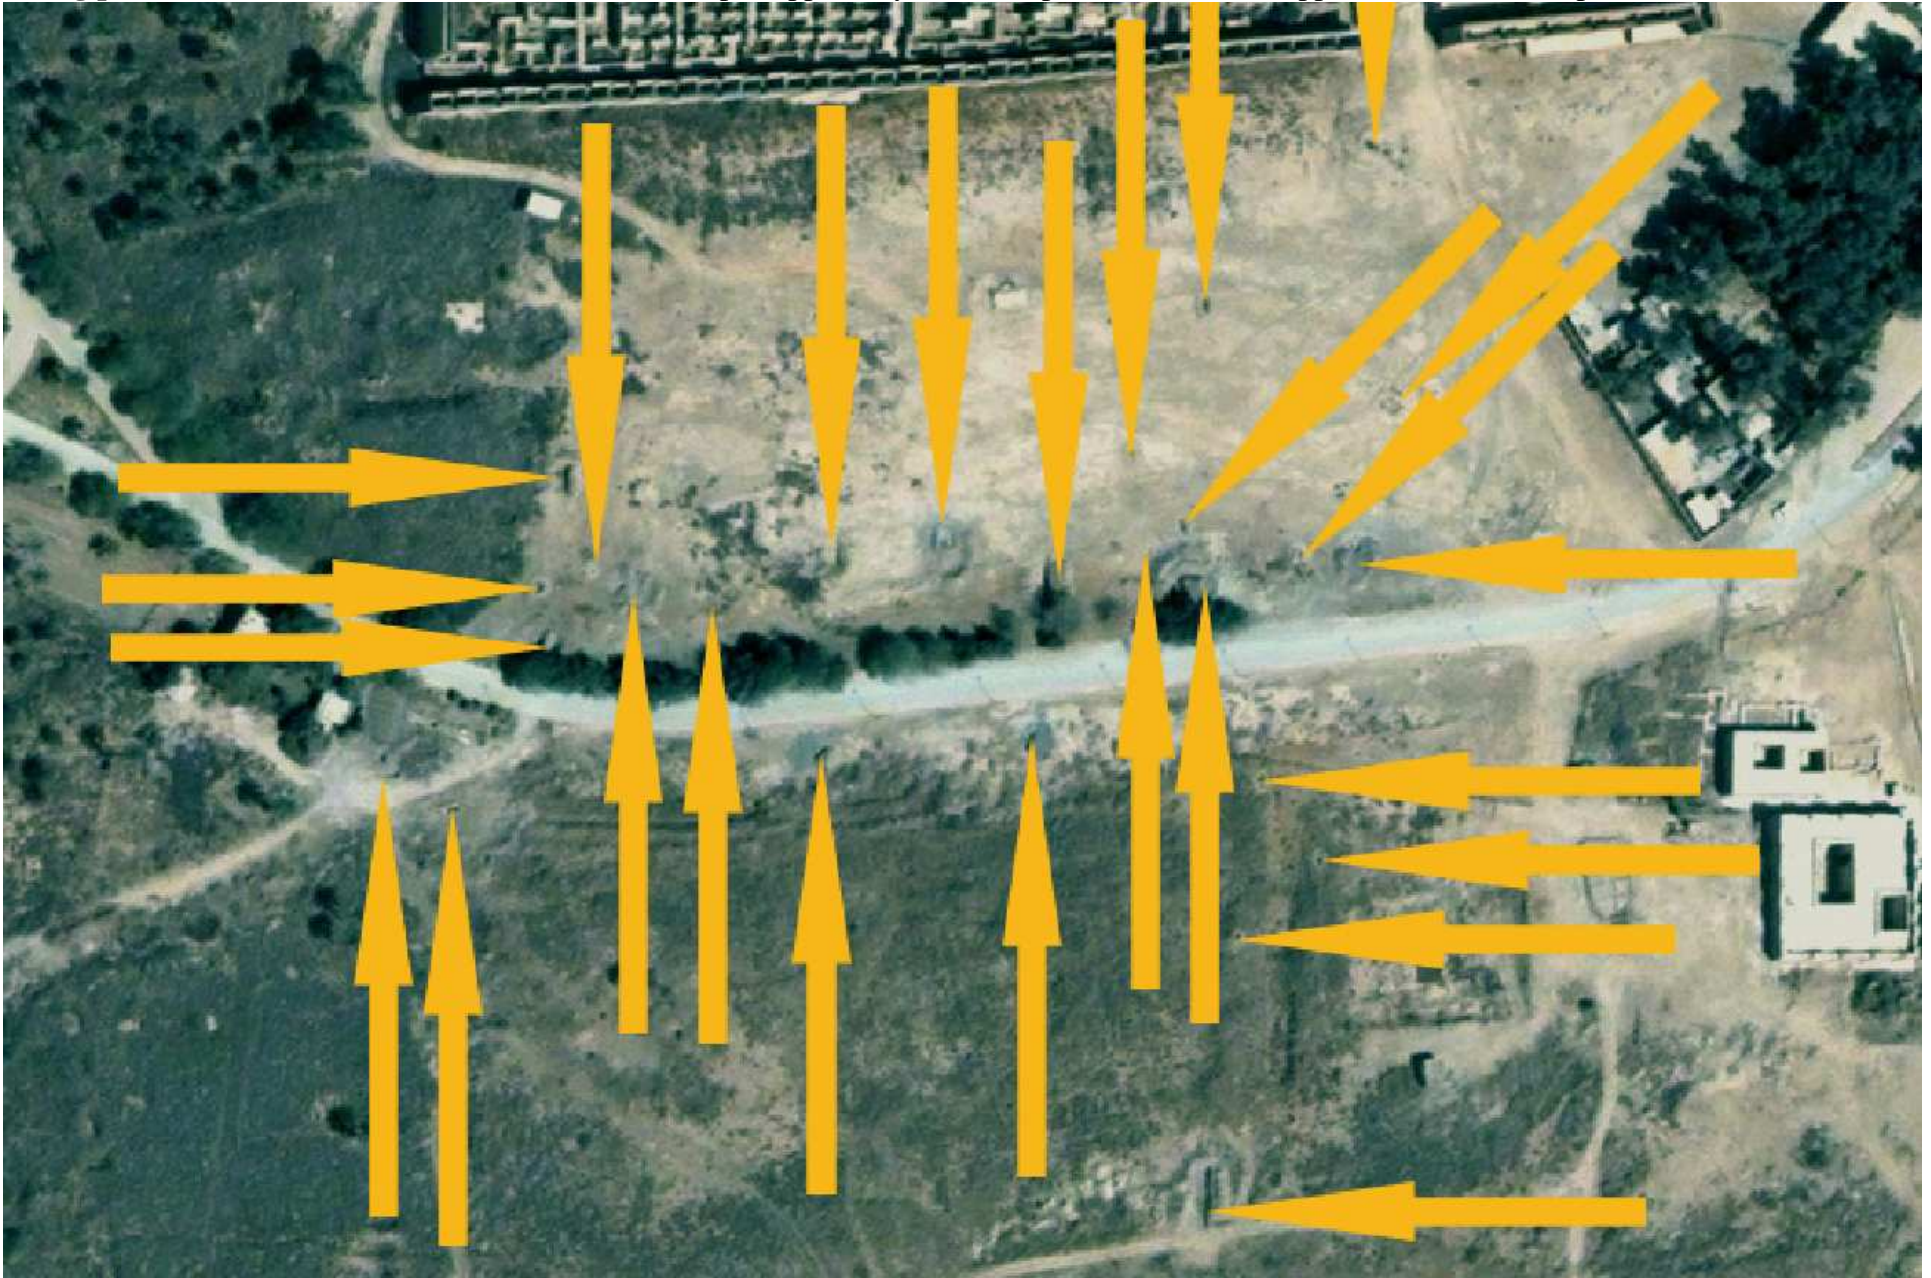
**Firing positions south of the Southern Palace:** These pits apparently served to protect the eastern approach to Saddam's palace.

26 firing pits can be seen in the satellite images in the area south of the Southern Palace (image 1 April 2003, Russell composite).

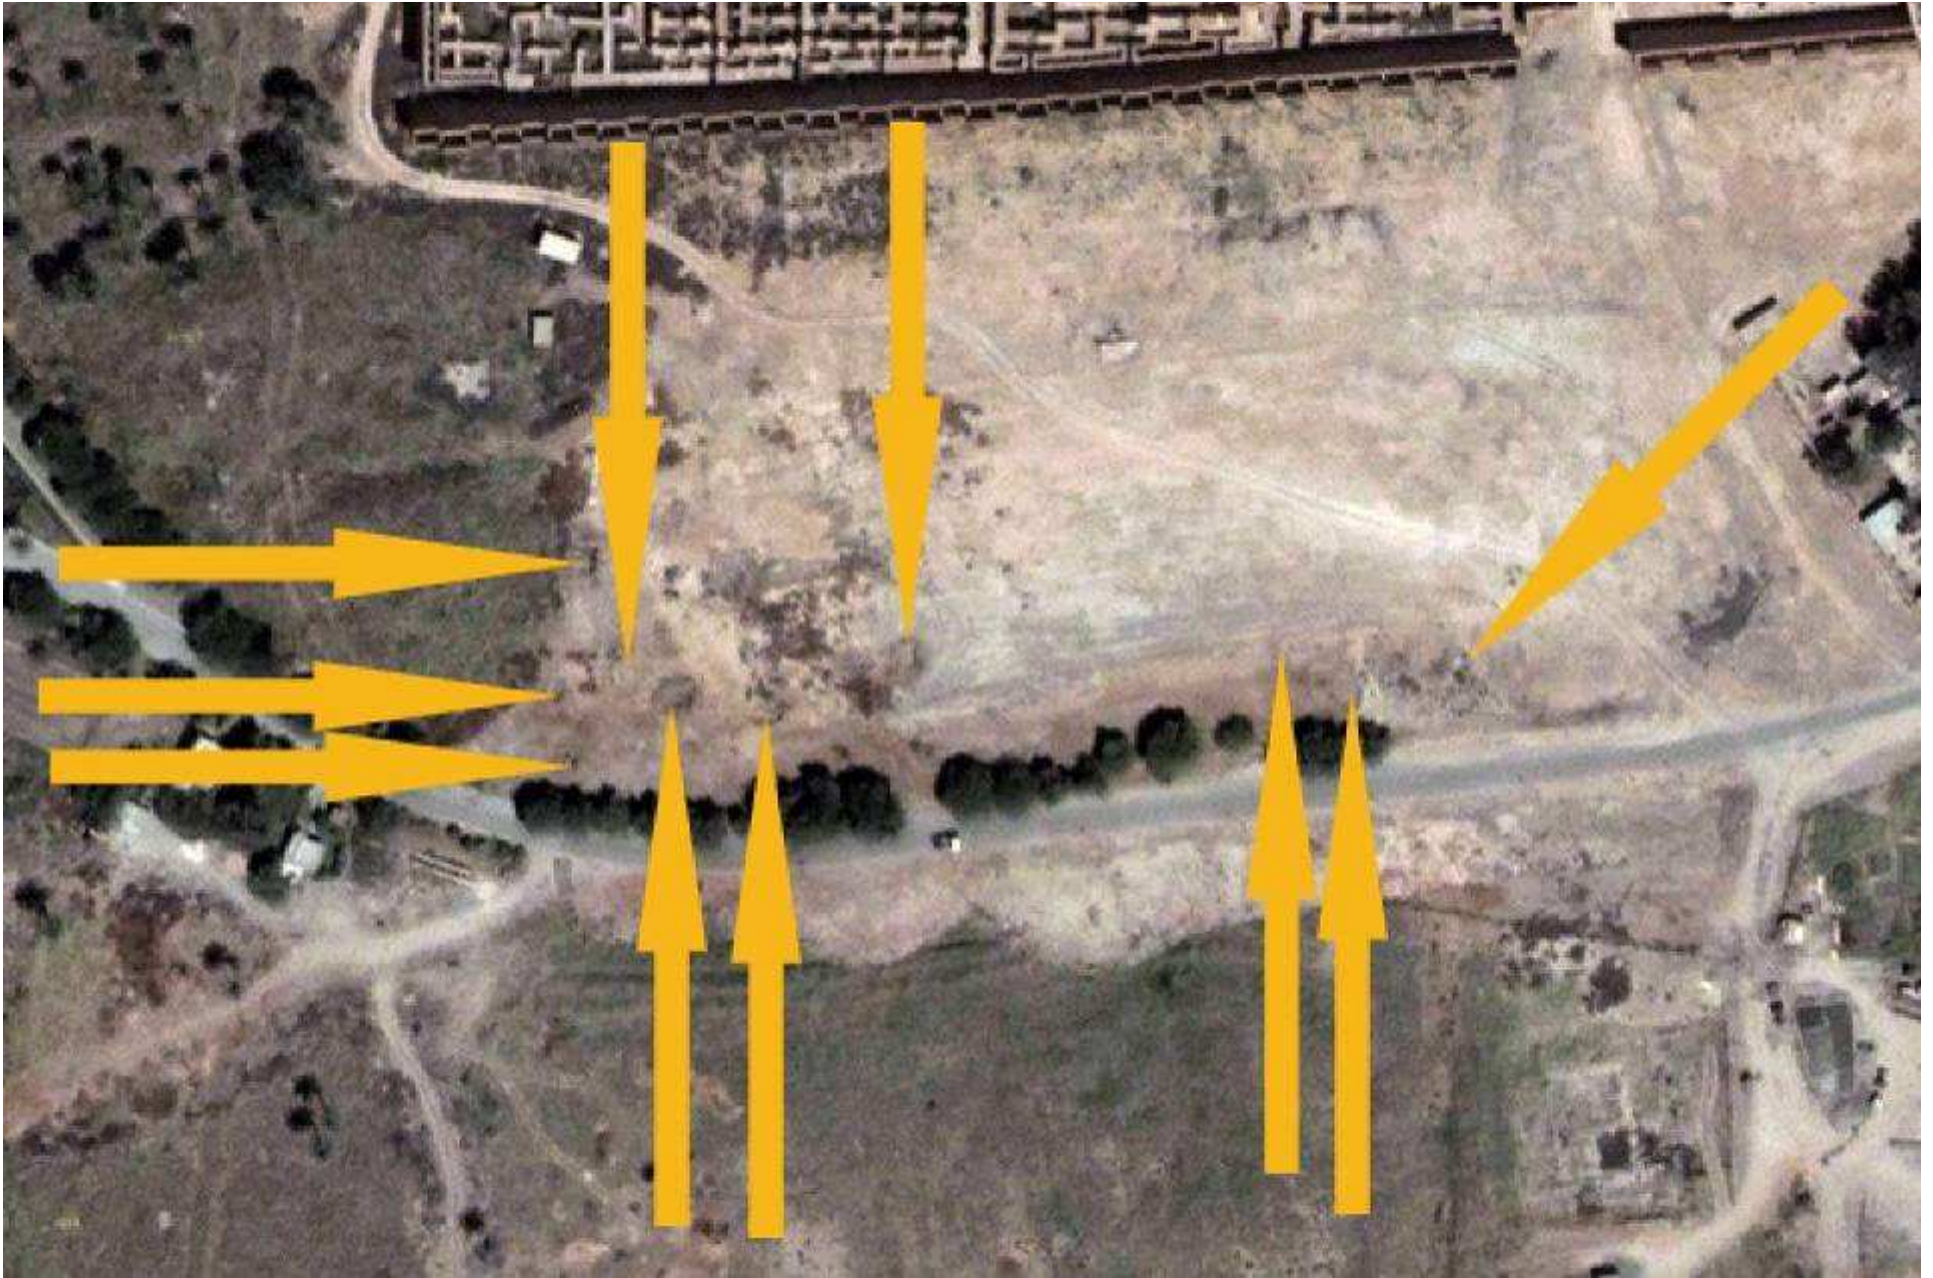
10 firing positions to the north of the road are already visible in the image of 5 July 2002, Russell composite image

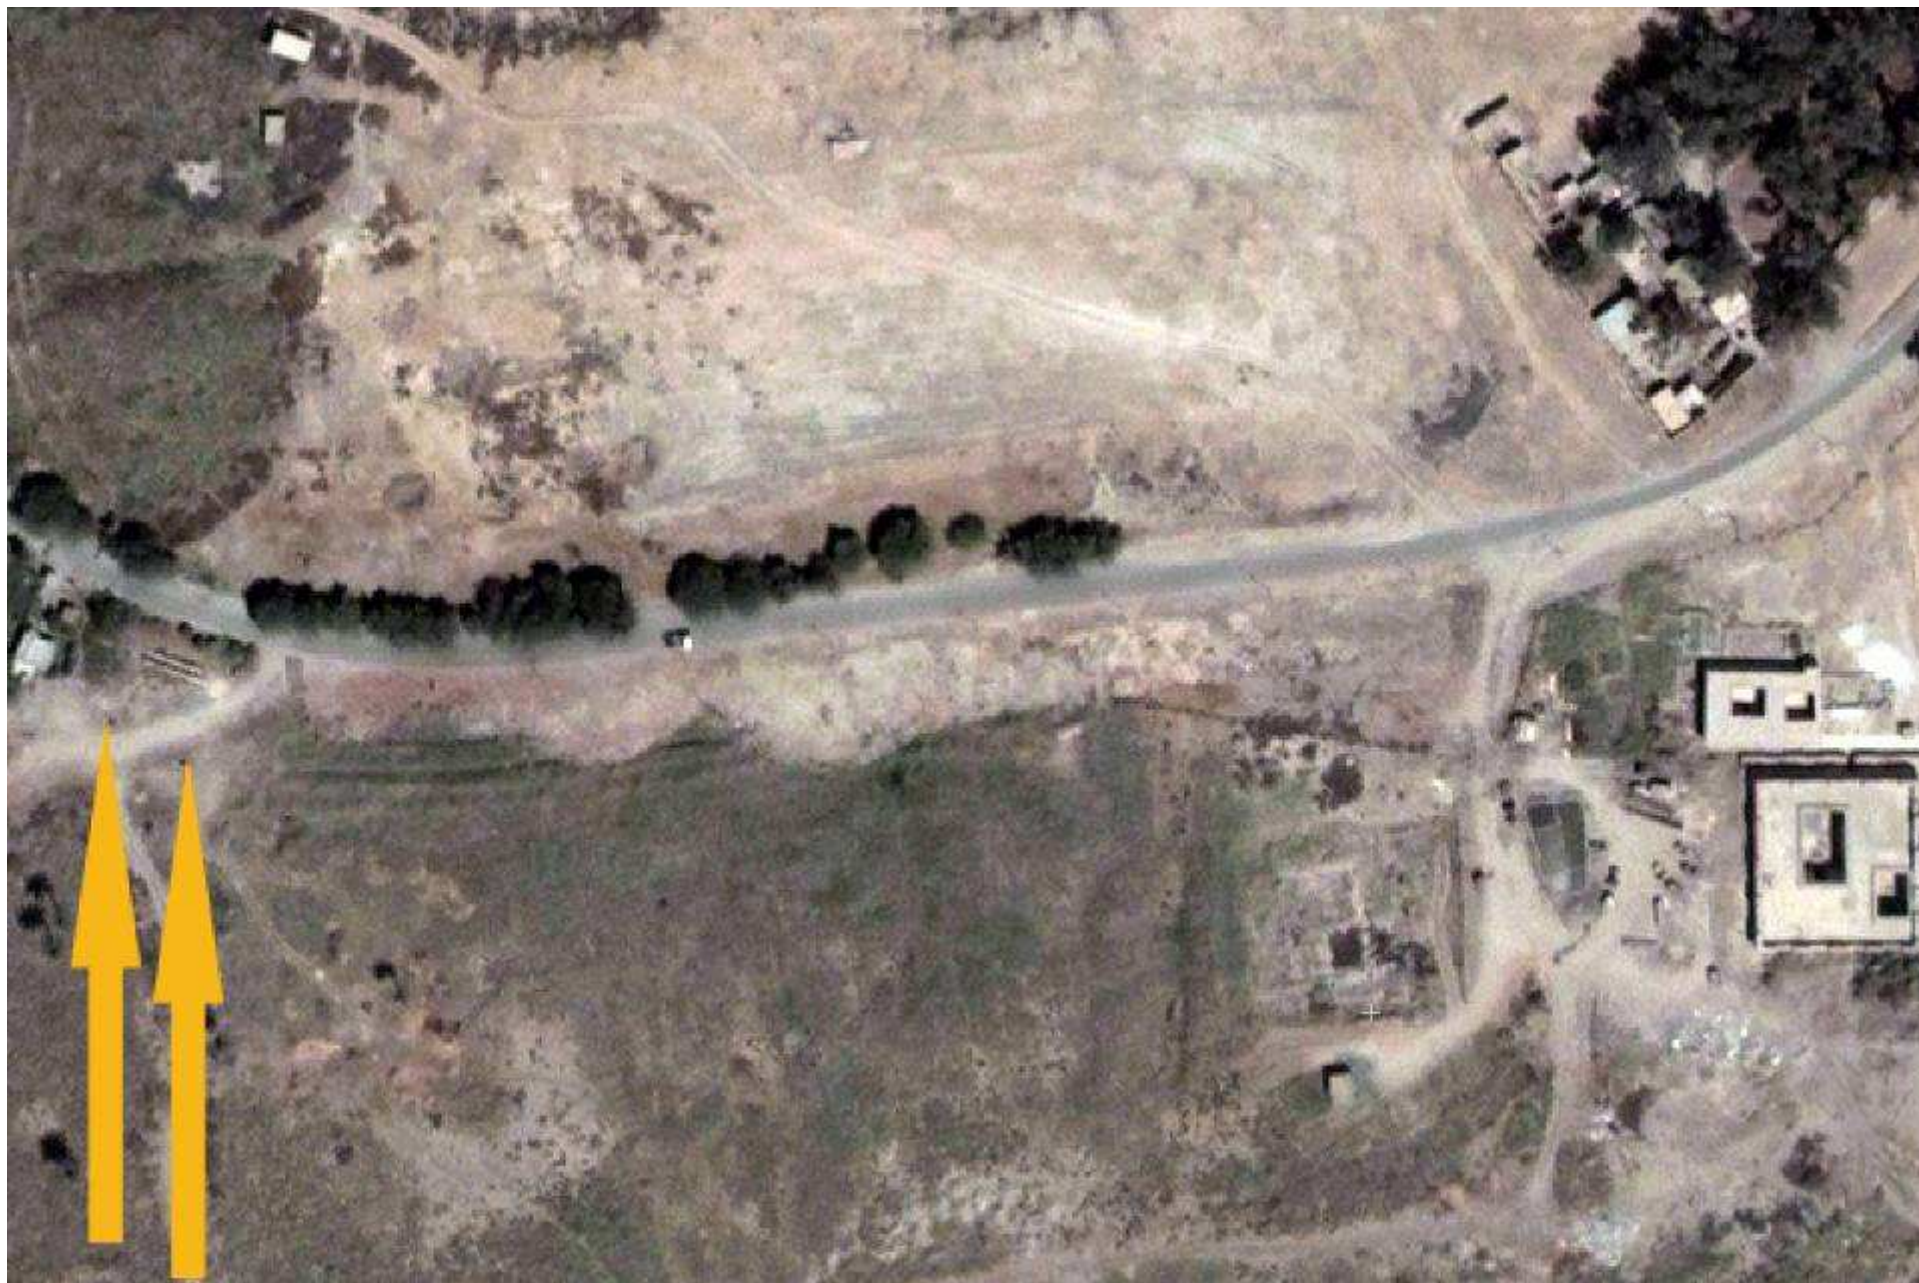
2 firing positions to the south of the road are already visible in the image of 5 July 2002, Russell composite image

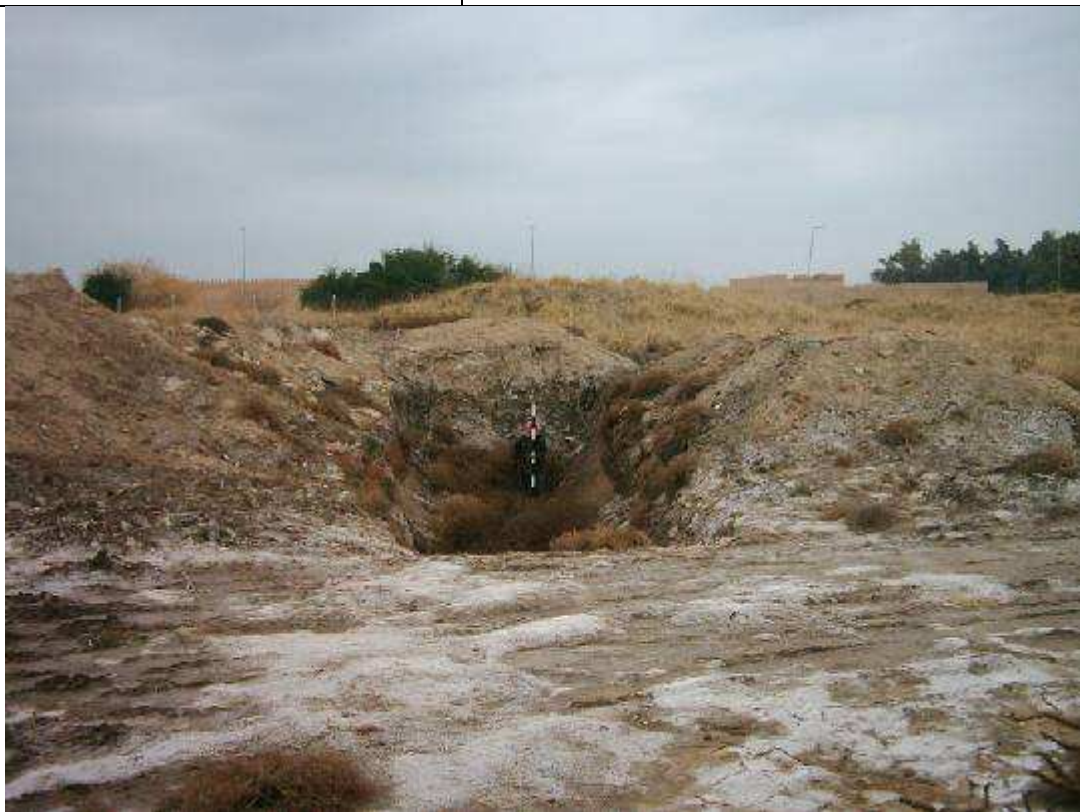
Trench 9, Iraqi final report fig. 36

Iraqi preliminary report	Iraqi final report	Curtis report	Polish report
<p>The third trench is located south of the second trench, to the west of the Nabu-sha-Hare Temple, near the</p> <p>[A adds: according to the report, has a length of 25 m. However, we could not gain access to it because it is surrounded by barbed wire. This trench is near an]</p> <p>area of excavations conducted by the Babel Archaeological Restoration Mission in 1982.</p>	<p>9. Ninth trench: This trench is located approximately 50 m north of the seventh trench, southwest of the Nabu-sha-Hare Temple, near the area of the excavations conducted by the Babylon Archeological Restoration Project in 1982. It has a length of 15 m, a width of 3 m, and a depth of 2 m. This trench is surrounded by dirt that has been removed from it. The dirt contains various archeological fragments, including pottery, baked bricks, and bone. The salient pieces include a glass pottery vessel, part of which is missing. The vessel was found in the western part of the trench (see Photo 36).</p>	<p>We were not able to see the third trench (Trench C in the <i>Polish Report</i>, figs. on pp. 53, 58-59) as it is inside the wire surrounding the camp.</p>	<p>5) Trench 'C': South from the boundary of the camp on the level of Tent City #1, is located a trench about 15 meters long, 3 meters wide, and 2 meters deep. Its depth reaches around 2 meters. On the piles of dirt around the trench are scattered numerous fragments of ceramic. In taking the photographic documentation an olive lamp was found. Fragments of bricks can be found as well.</p>

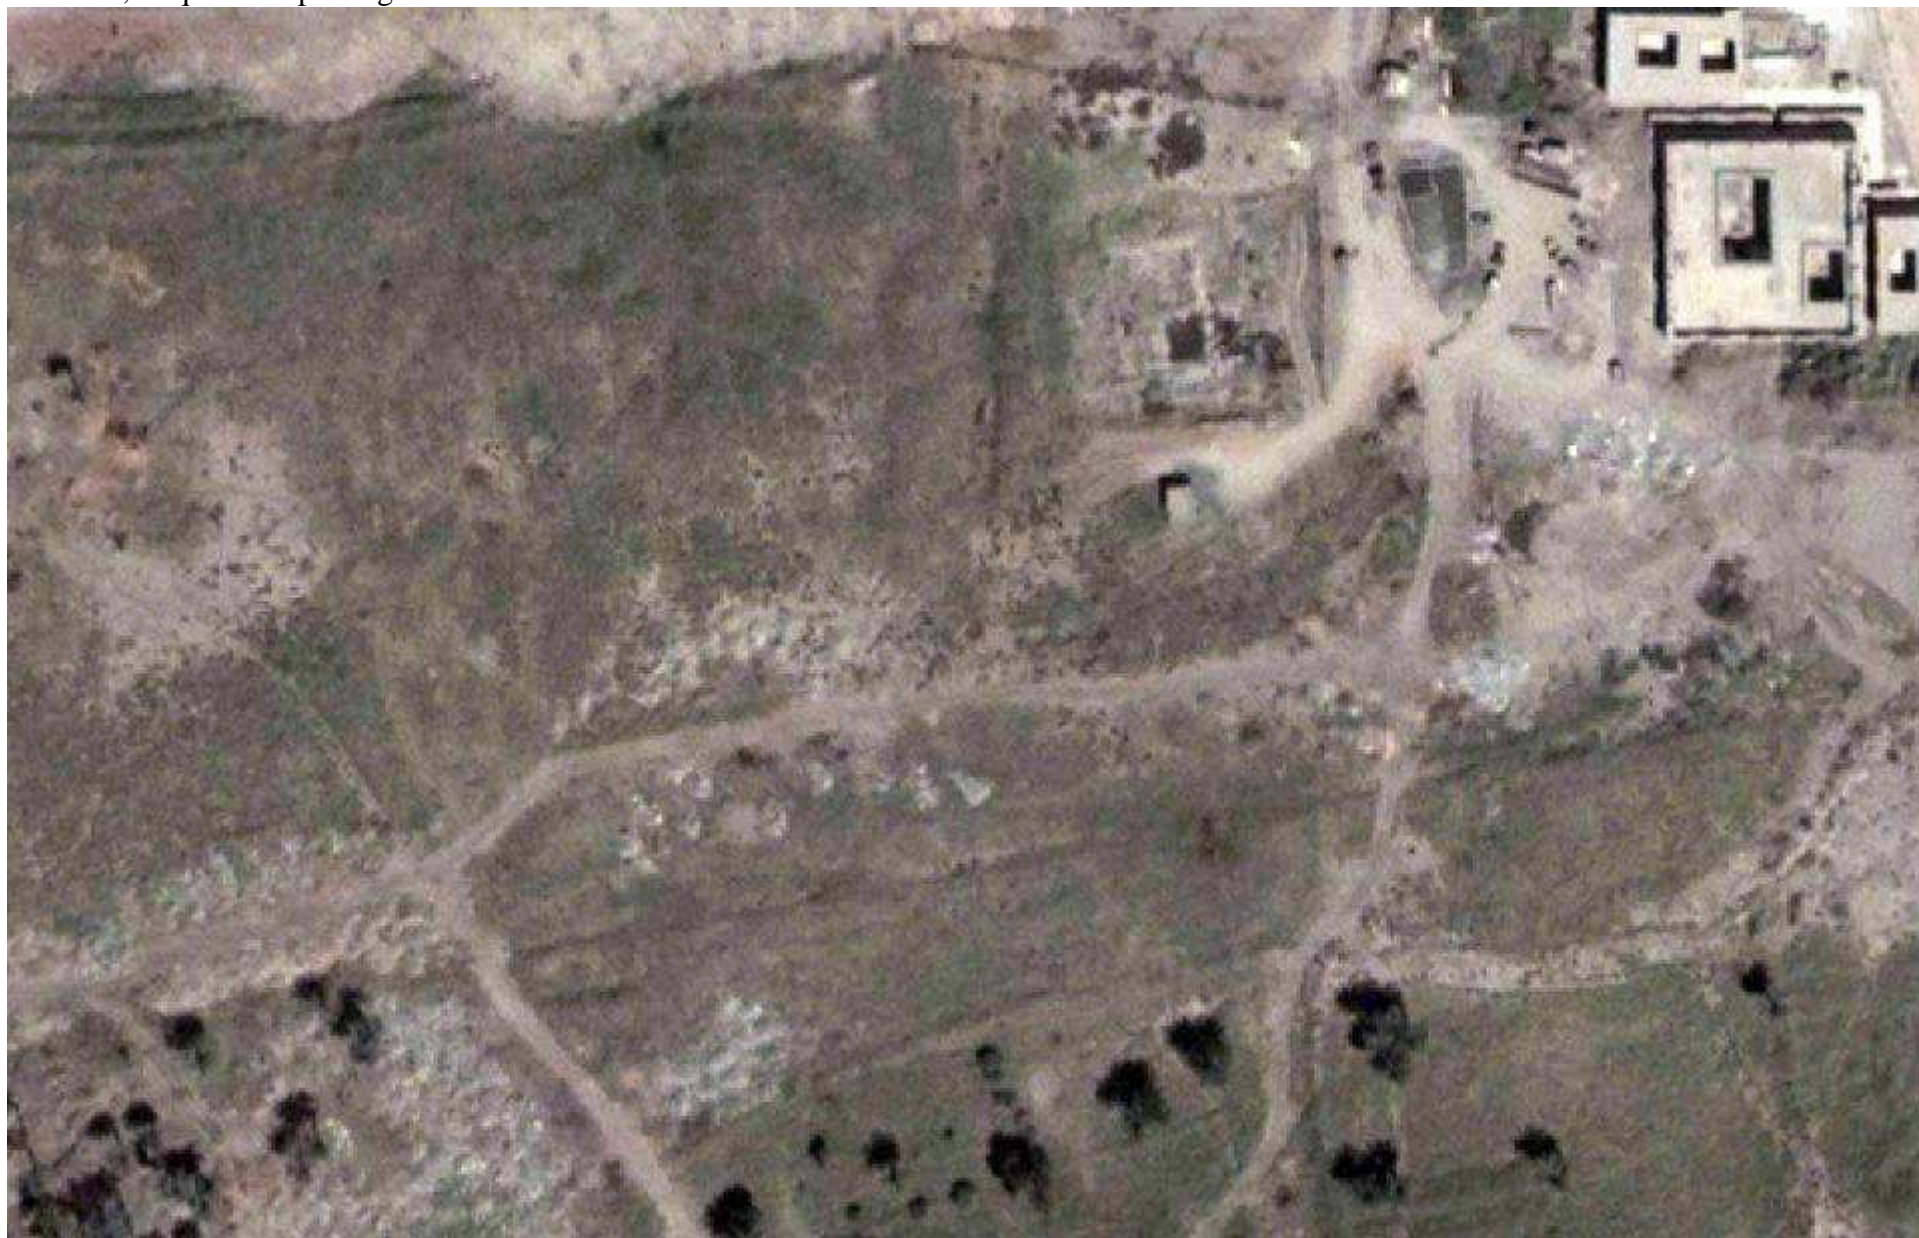
View before Trench 9 was dug, July 2002, Russell composite

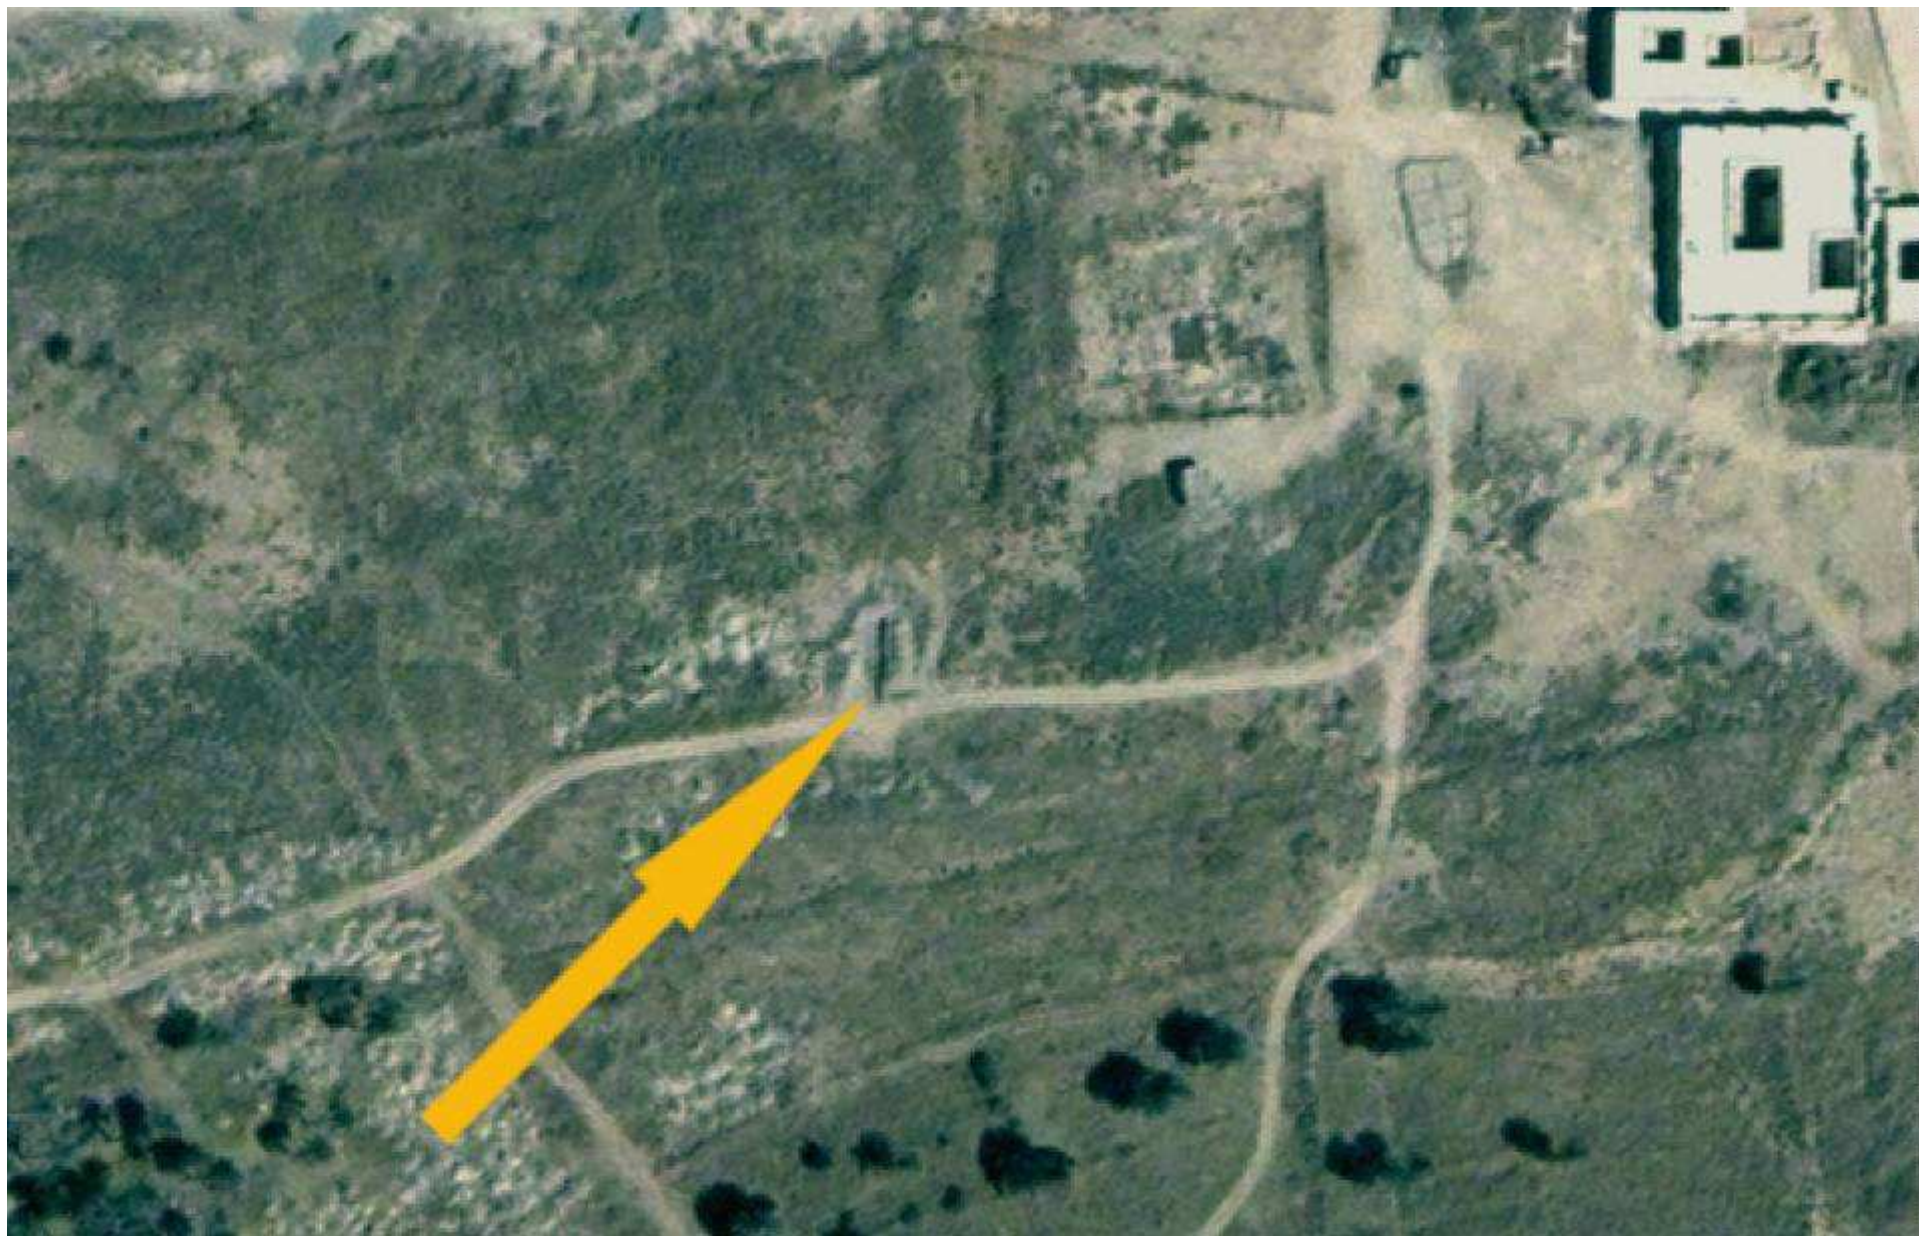
Trench 9 was dug between July 2002 and 1 April 2003, before Coalition forces arrived at Babylon. (image 1 April 2003, Russell composite).
