# **Report on Damage to the Site of Babylon, Iraq**

**John Malcolm Russell, Ph.D.**

**Cultural Heritage Center  
Bureau of Educational and Cultural Affairs  
Department of State**

**April 2010**

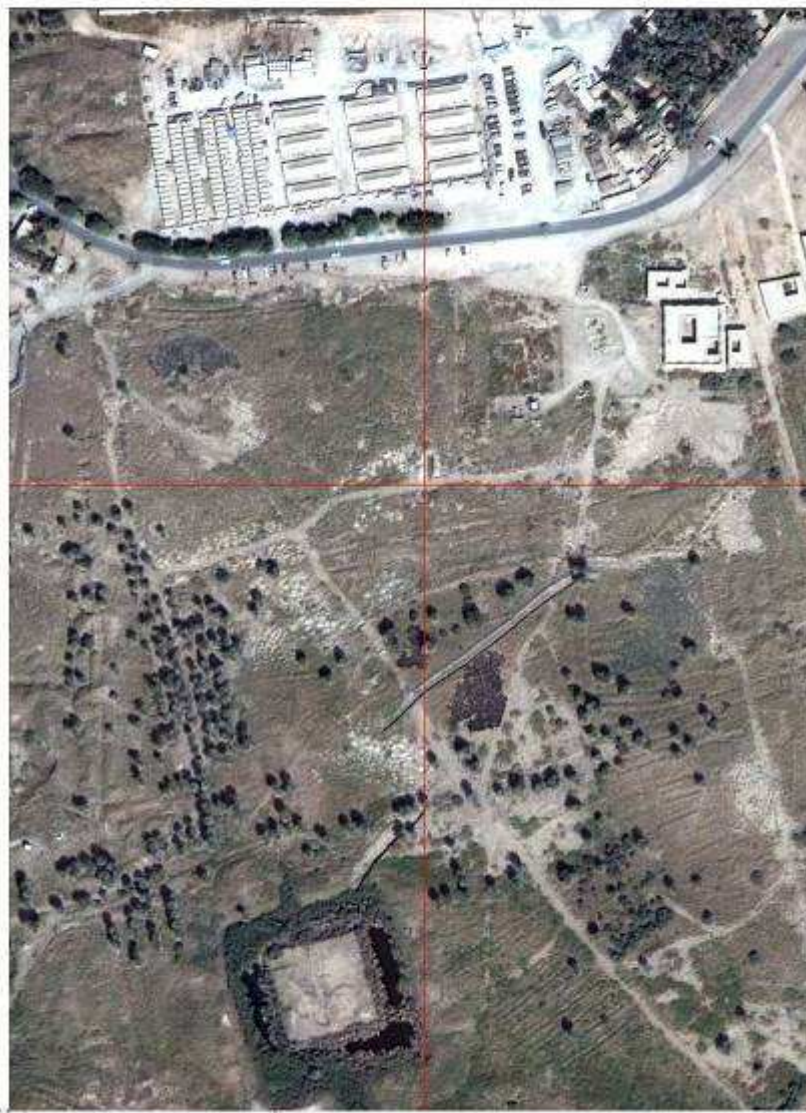
**Stone report:** The third cut (Fig 33) was already in existence before the war.

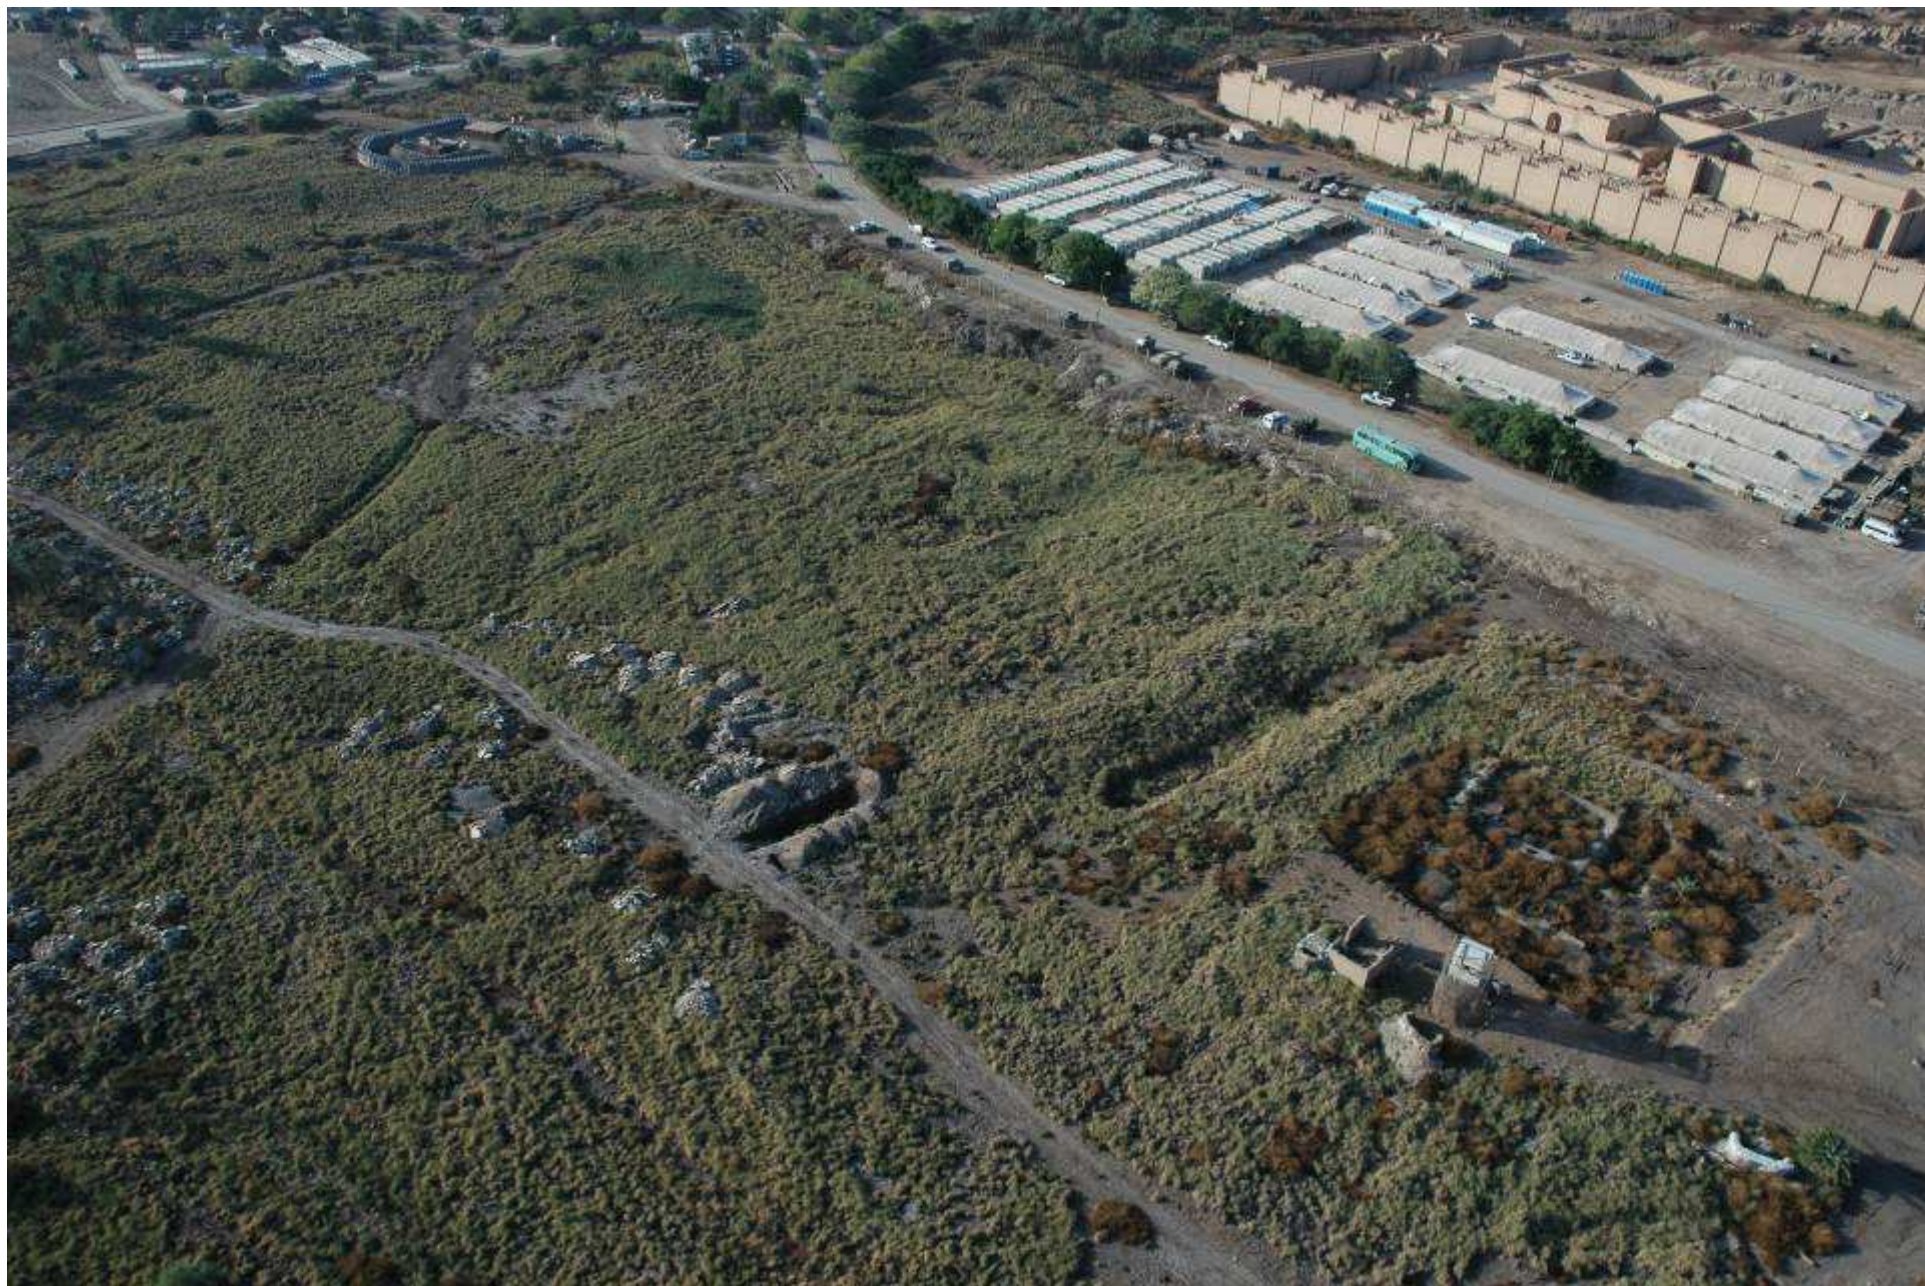
Trench 9 (center), Polish photo 30 (photo © Ministry of Culture and National Heritage, Republic of Poland)

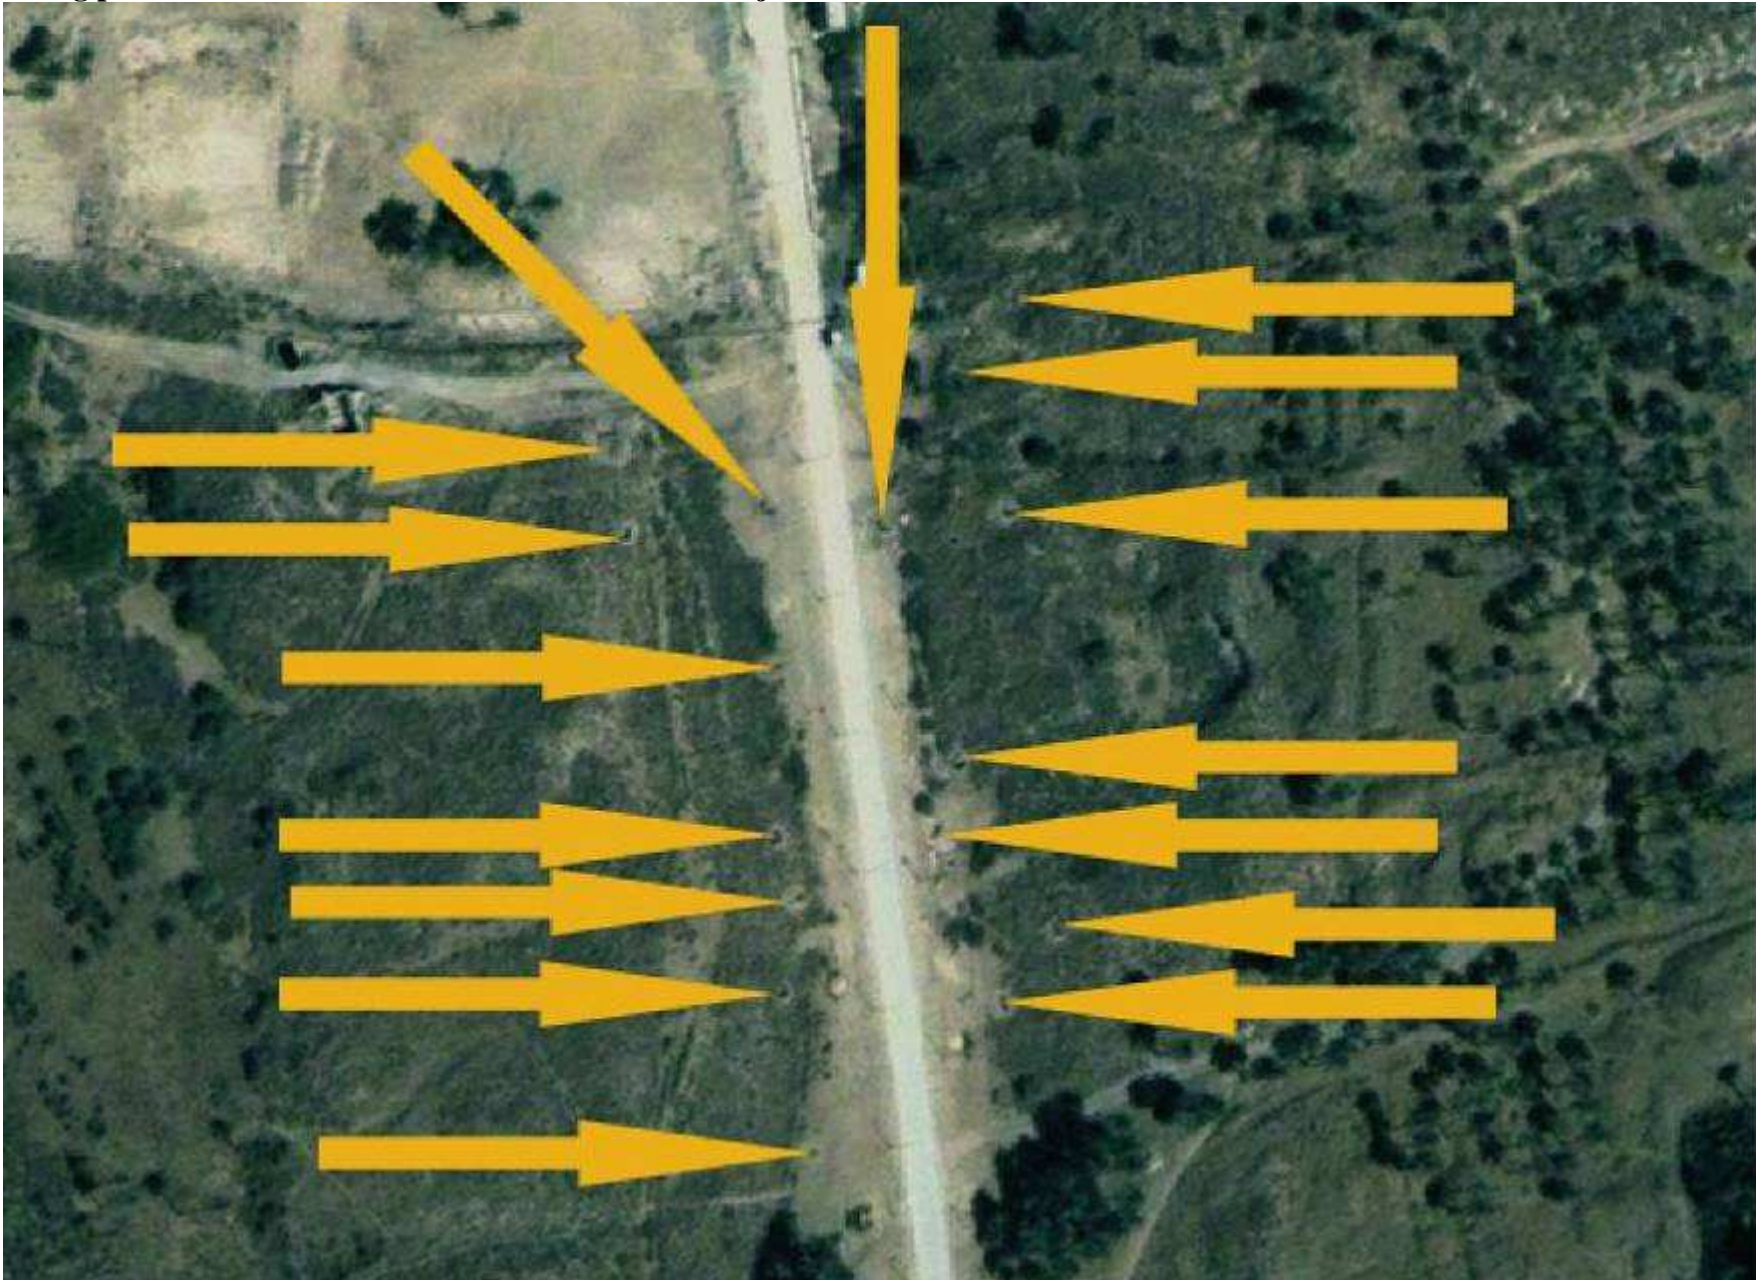
The 8 to the north were dug by 5 July 2002, and the remaining 8 by 1 April 2003 (image 1 April 2003, Russell composite).

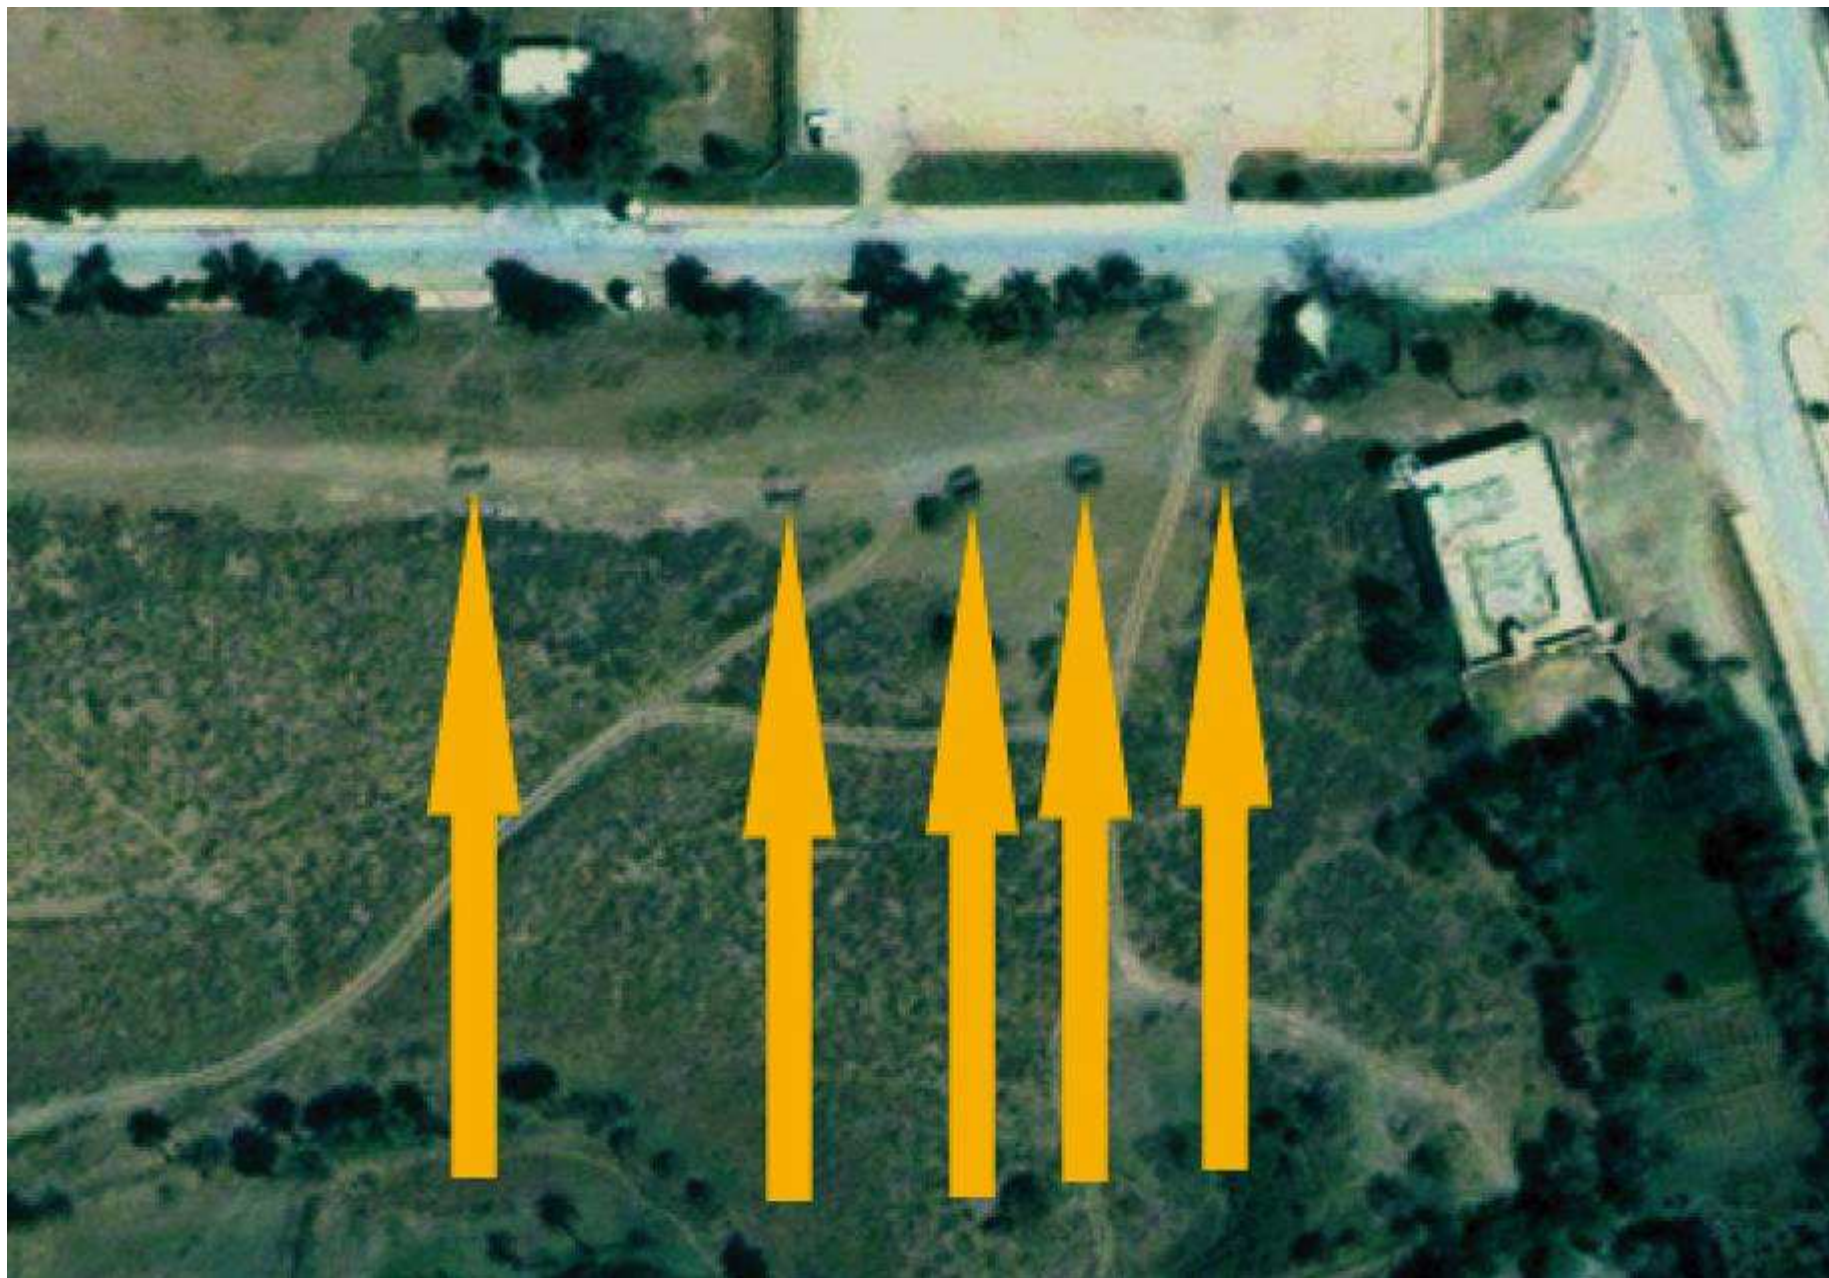
South of the road, five new firing positions visible, 1 April 2003, Russell composite

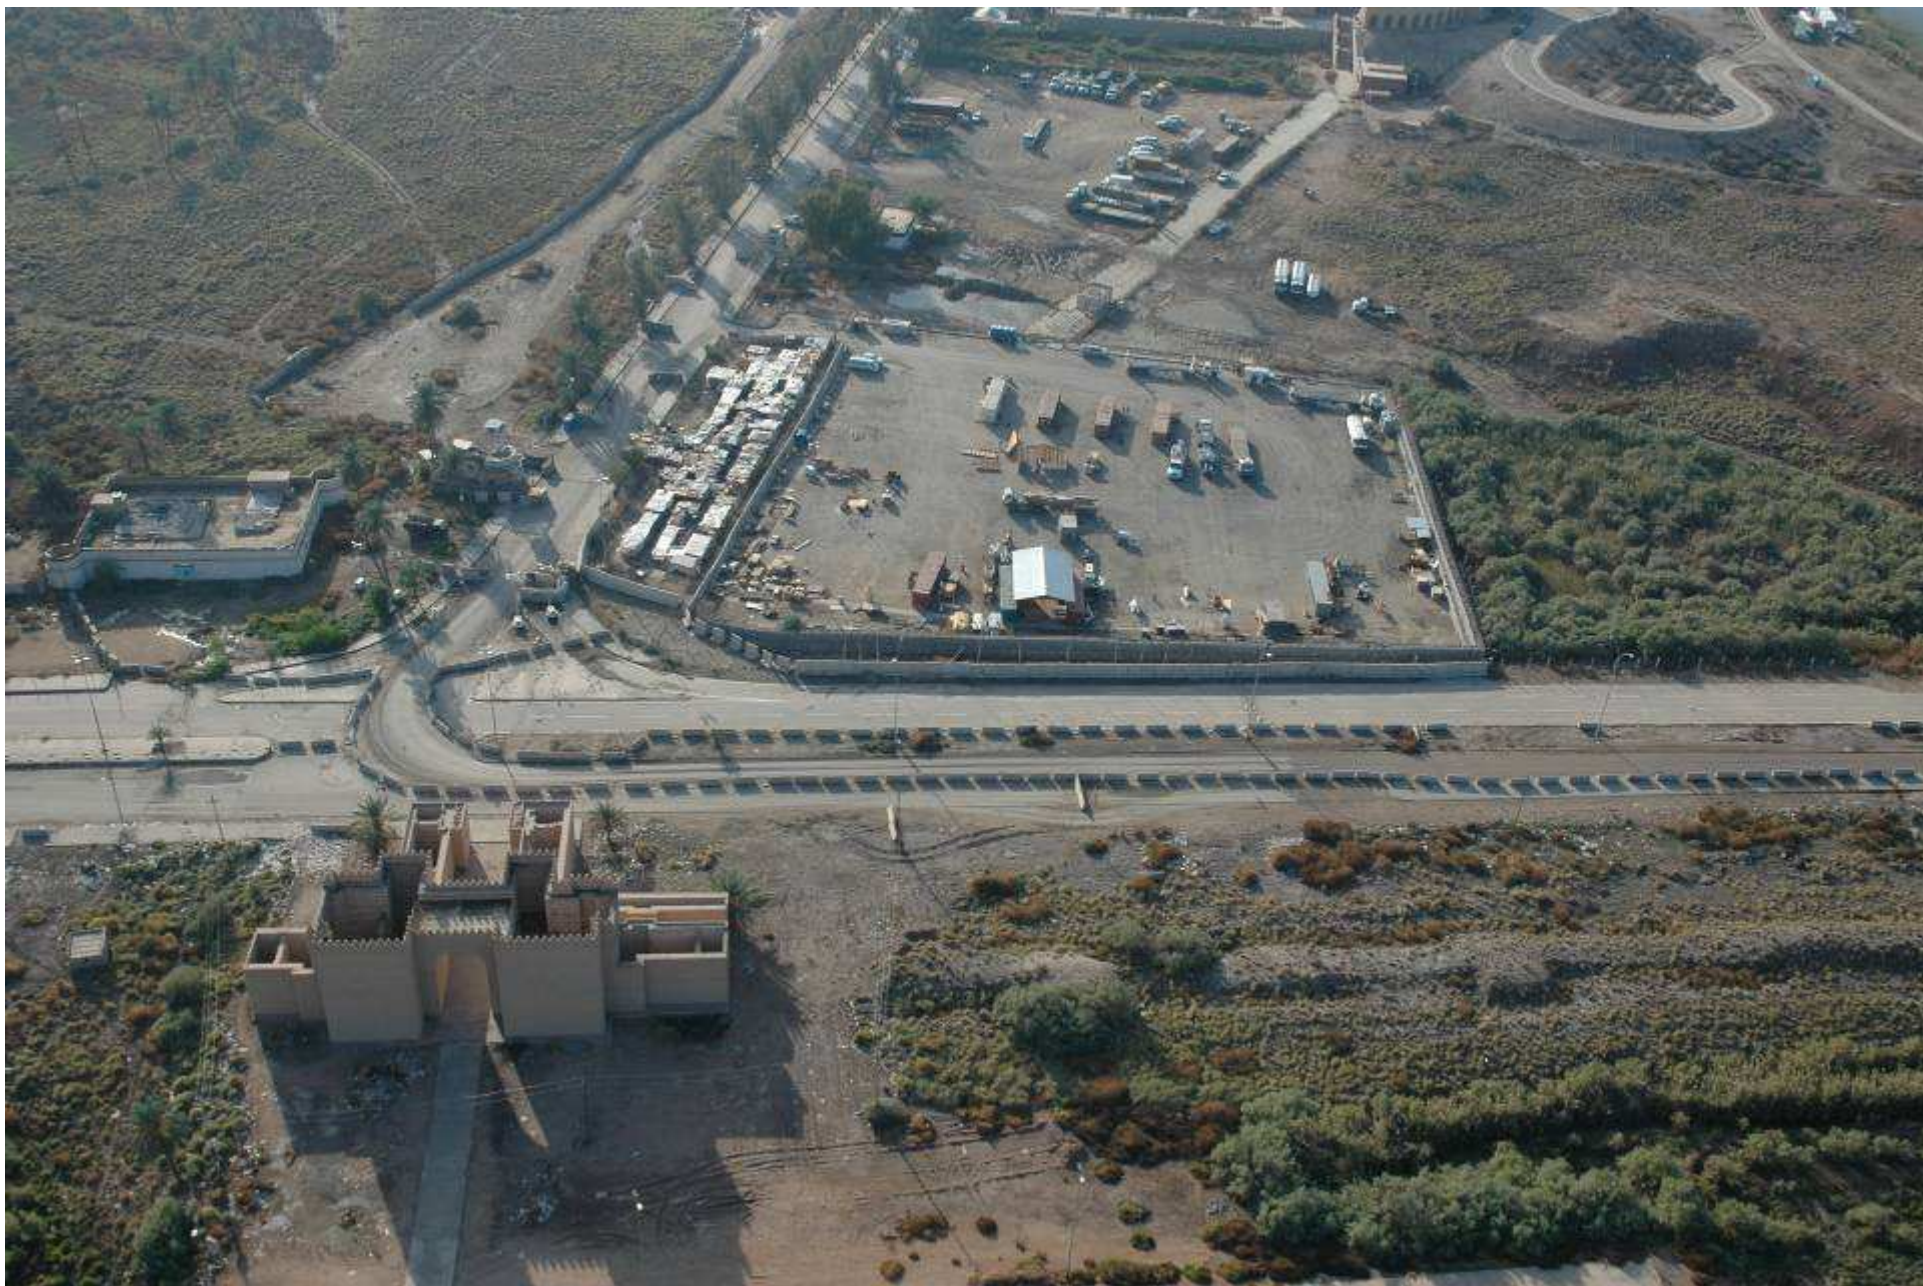
South of the road, firing positions, now overgrown, visible in road at upper left center, Polish photo 14 (photo © Ministry of Culture and National Heritage, Republic of Poland)

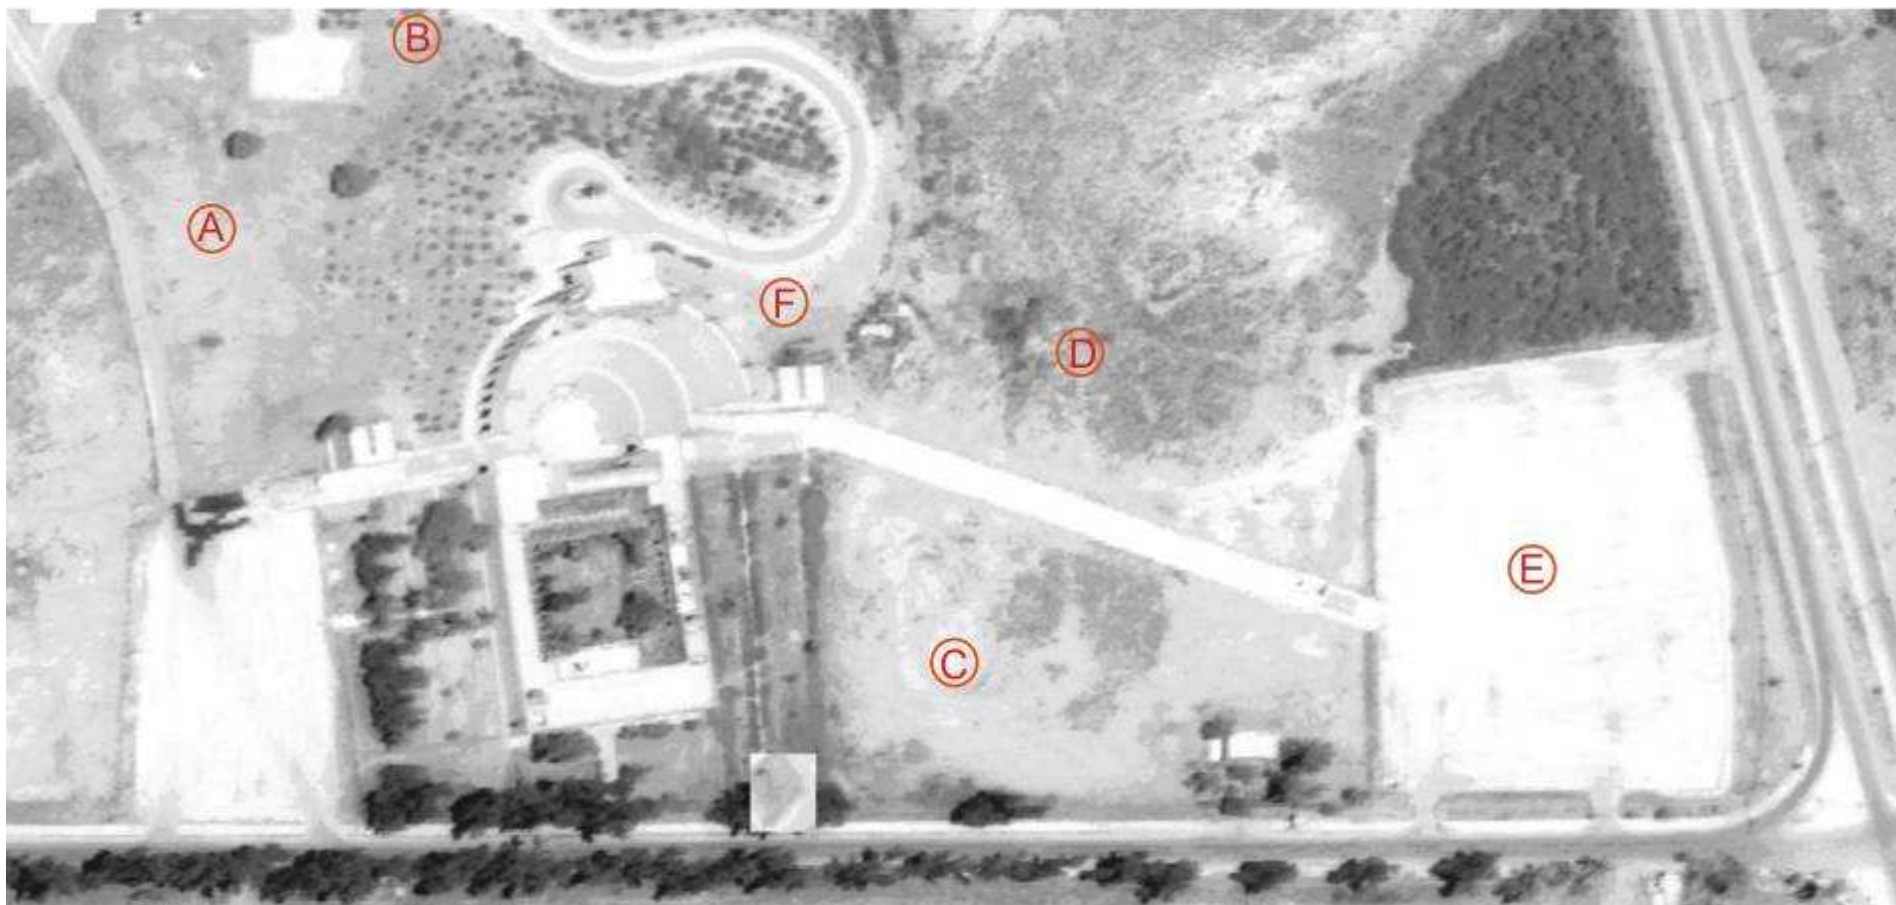
Polish report p. 34 (photo © Ministry of Culture and National Heritage, Republic of Poland)

**Polish report:** 5) On the slopes of the Amphitheatre are firing position. On the picture at the beginning [below] it is annotated by the letter “F”.

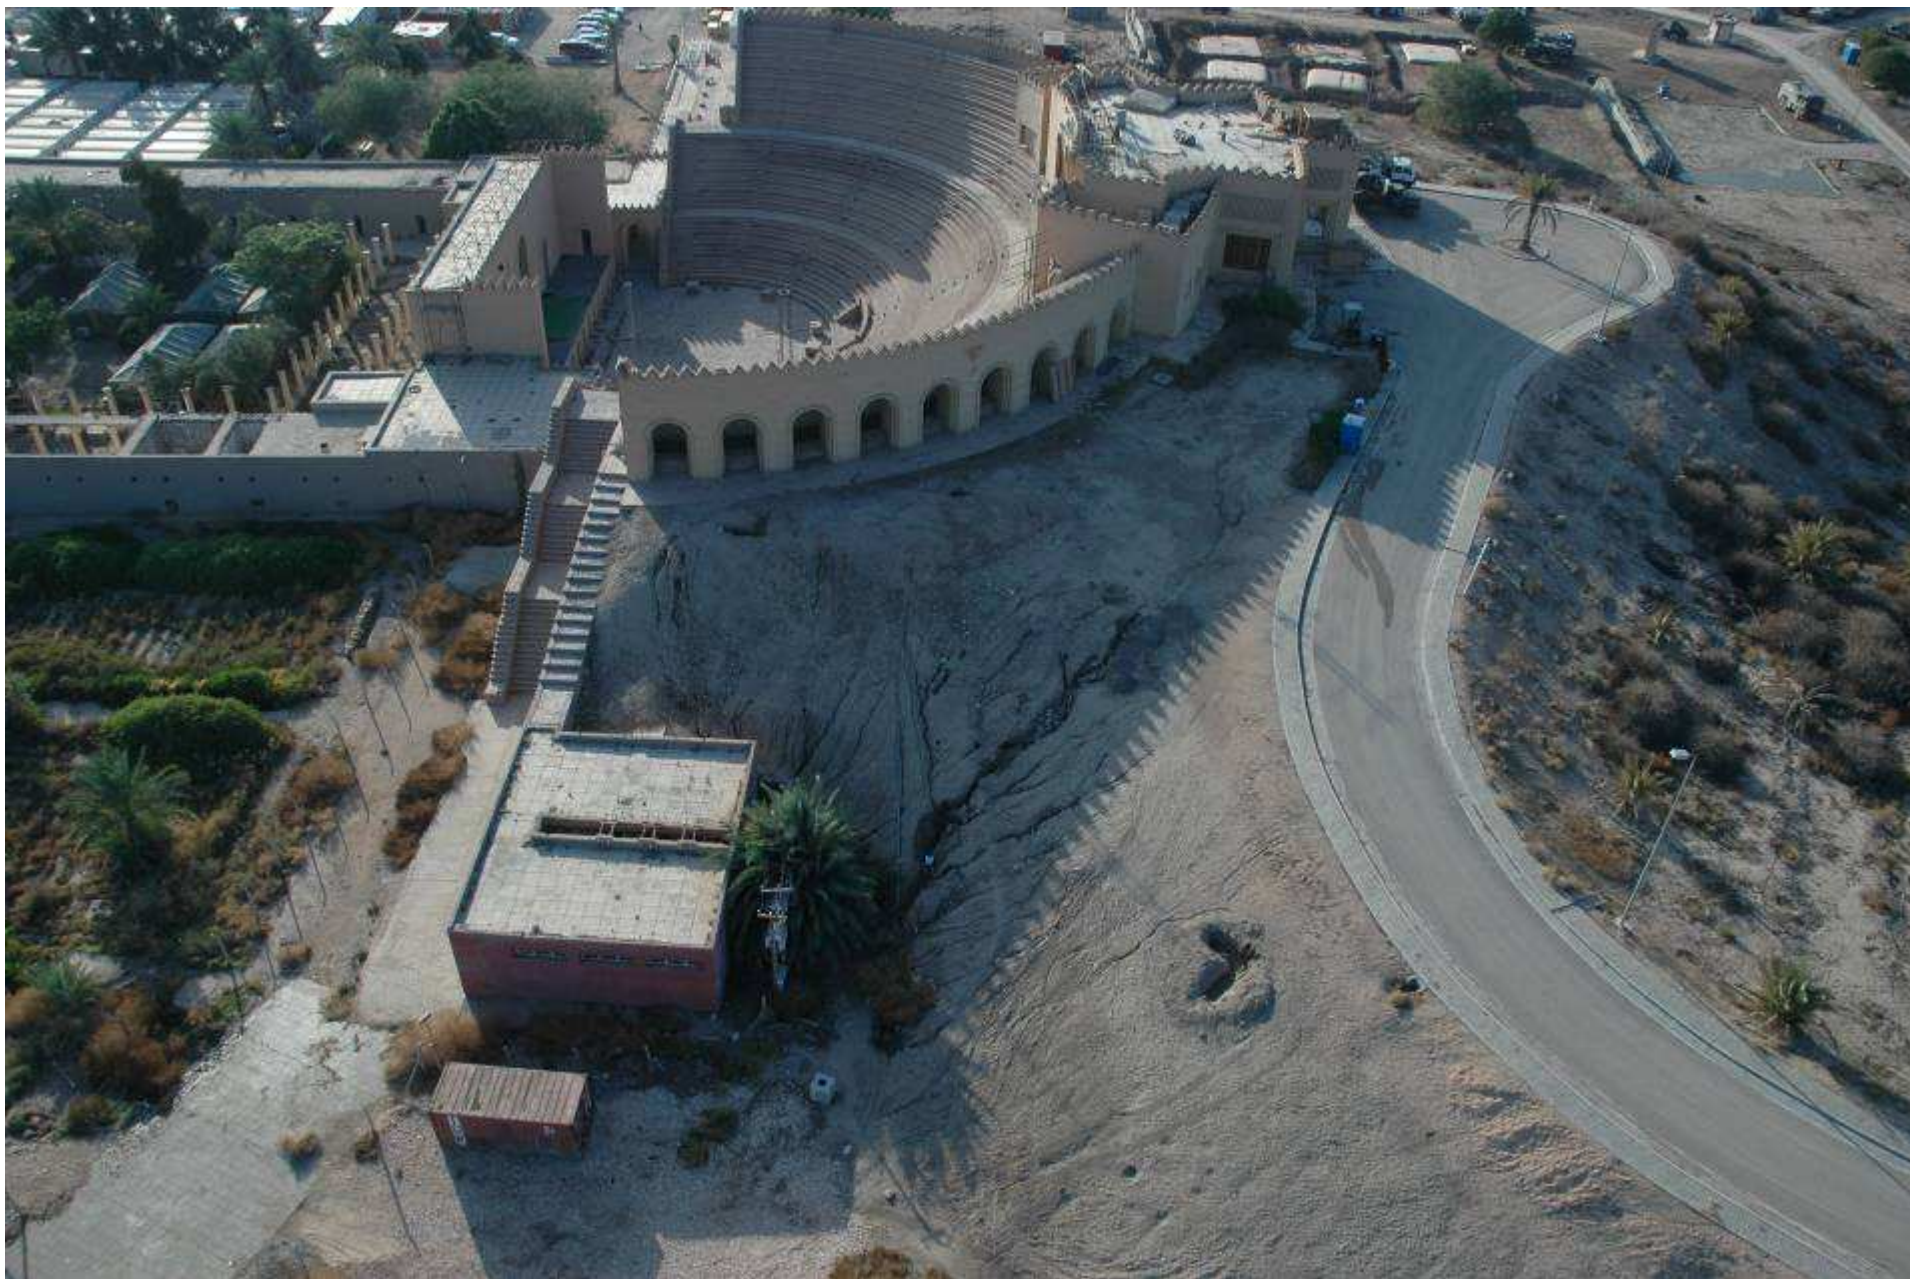
View of embankment beside theatre, with firing position visible, Polish photo 84 (photo © Ministry of Culture and National Heritage, Republic of Poland)

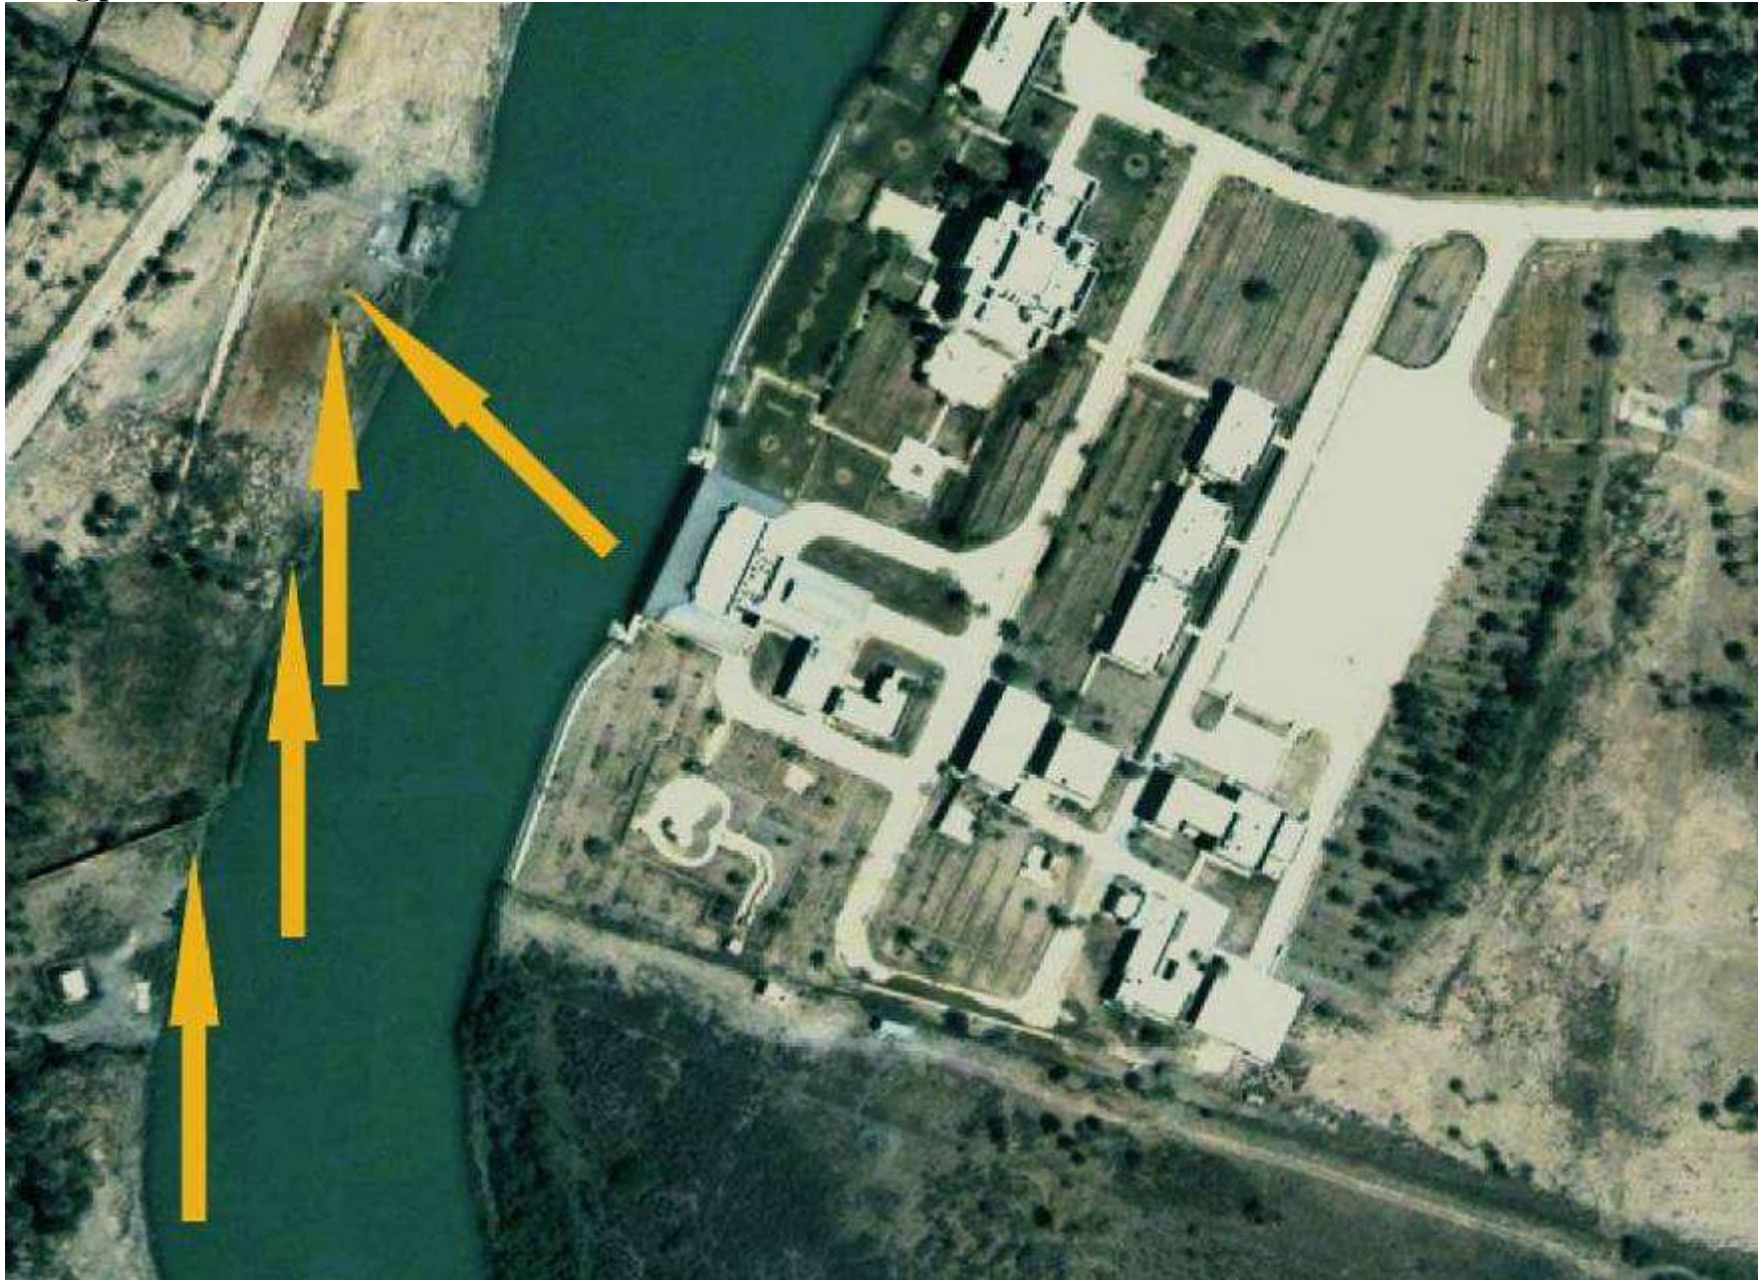
Counting from the north, the 1st and 3rd were dug by 5 July 2002, and the 2nd and 4th by 1 April 2003 (image 1 April 2003, Russell composite).

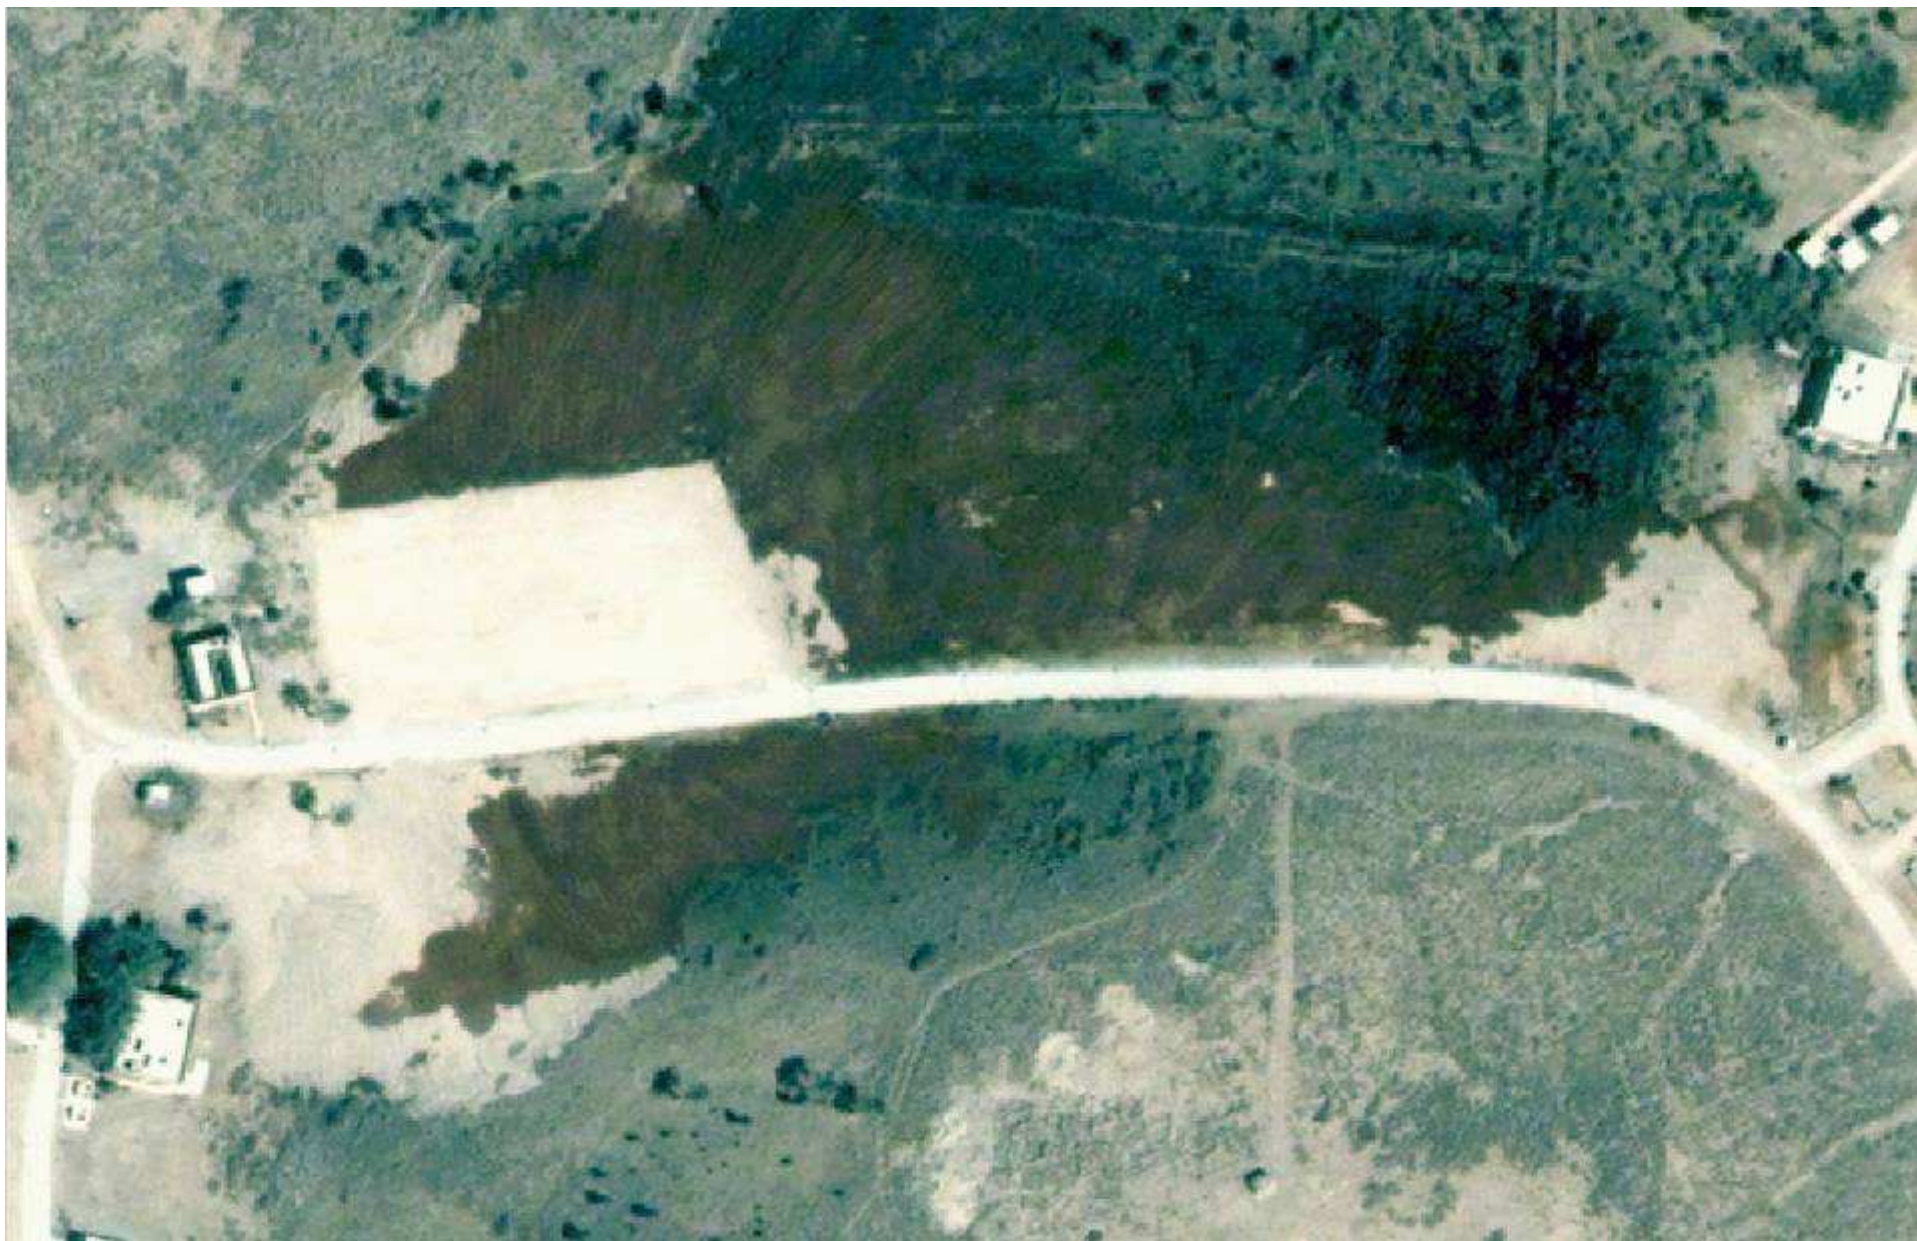
After construction of Landing Zone, prior to founding of Camp Babylon. Surface north and south of road has been bulldozed, graveled and oiled, 1 April 2003, Russell composite

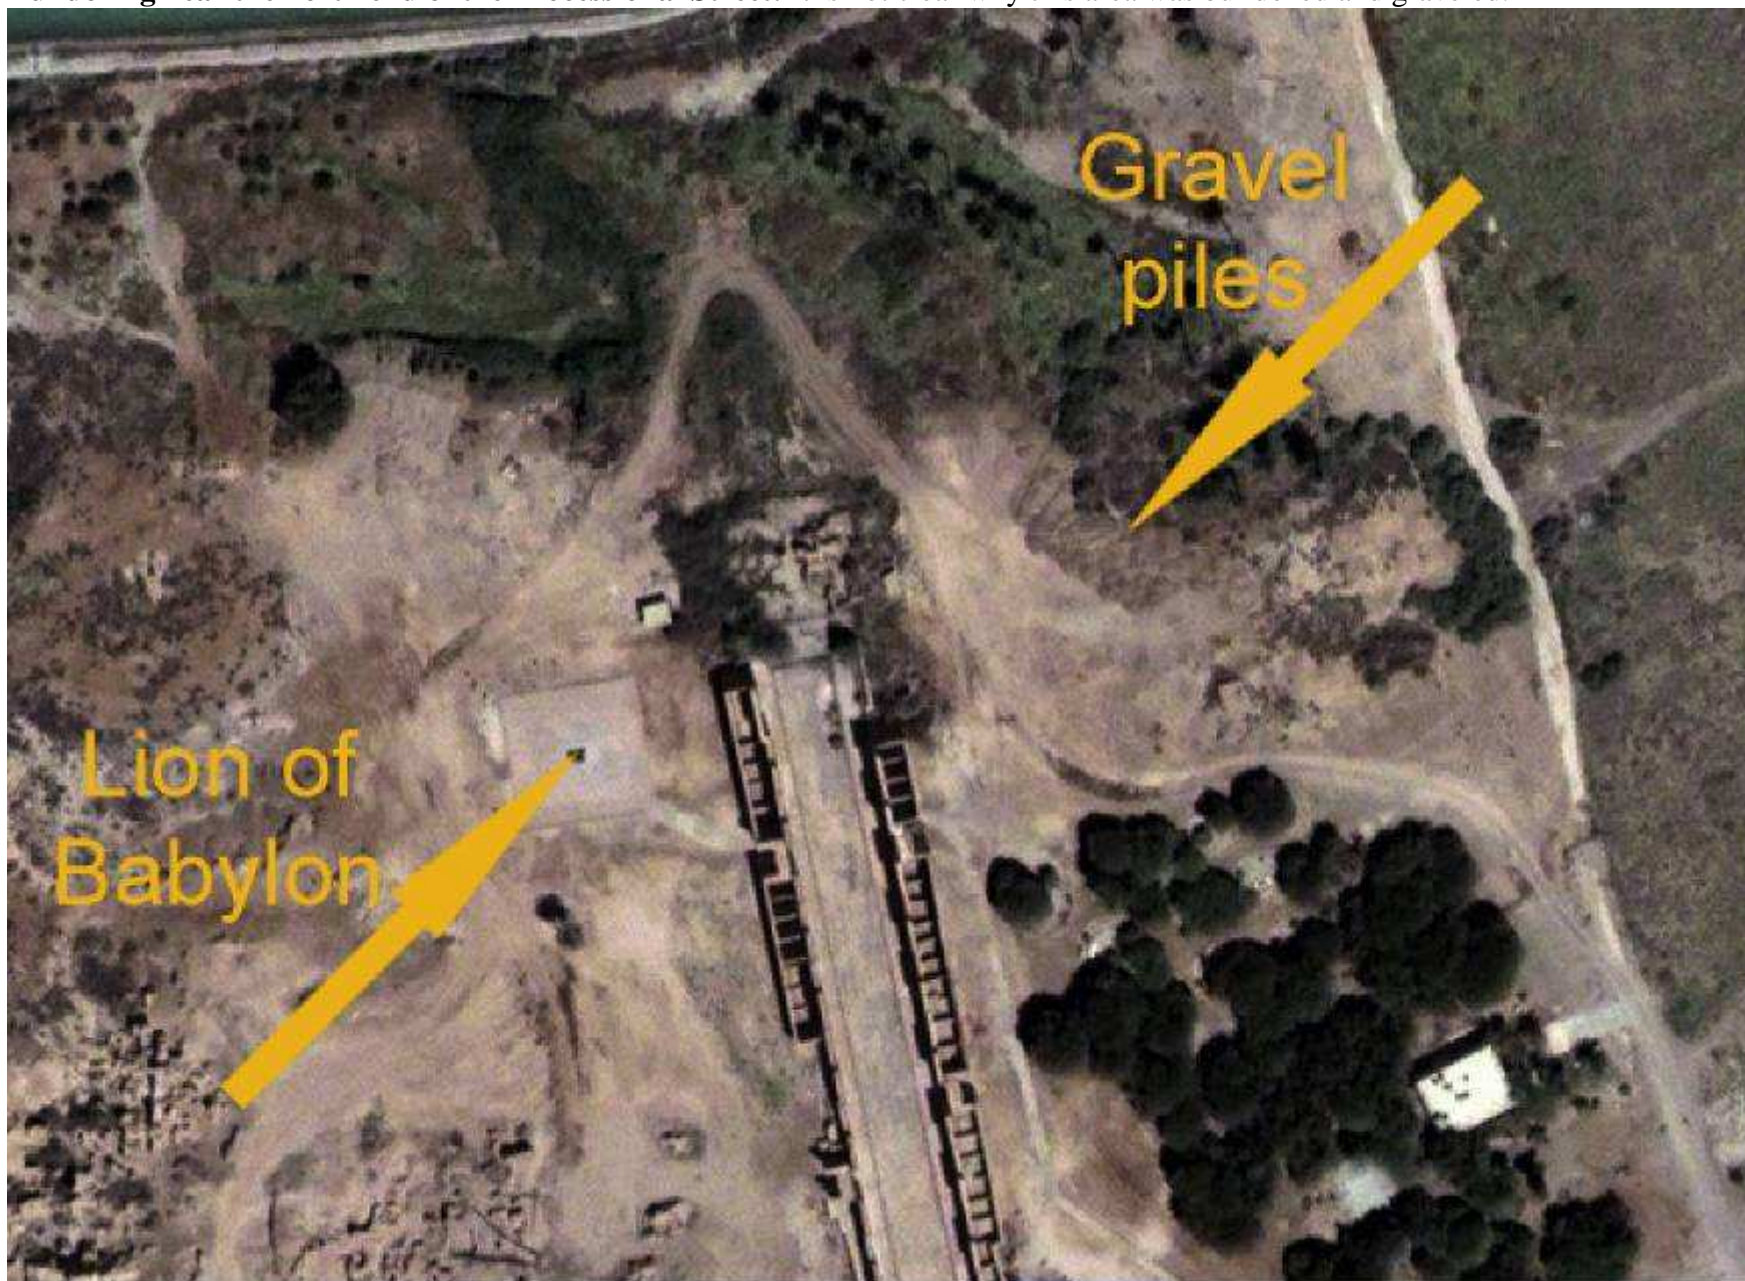
**Bulldozing near the north end of the Processional Street:** It is not clear why this area was bulldozed and graveled.

View prior to Coalition occupation, with piles of gravel, 5 July 2002, Russell composite
