# **Report on Damage to the Site of Babylon, Iraq**

**John Malcolm Russell, Ph.D.**

**Cultural Heritage Center  
Bureau of Educational and Cultural Affairs  
Department of State**

**April 2010**

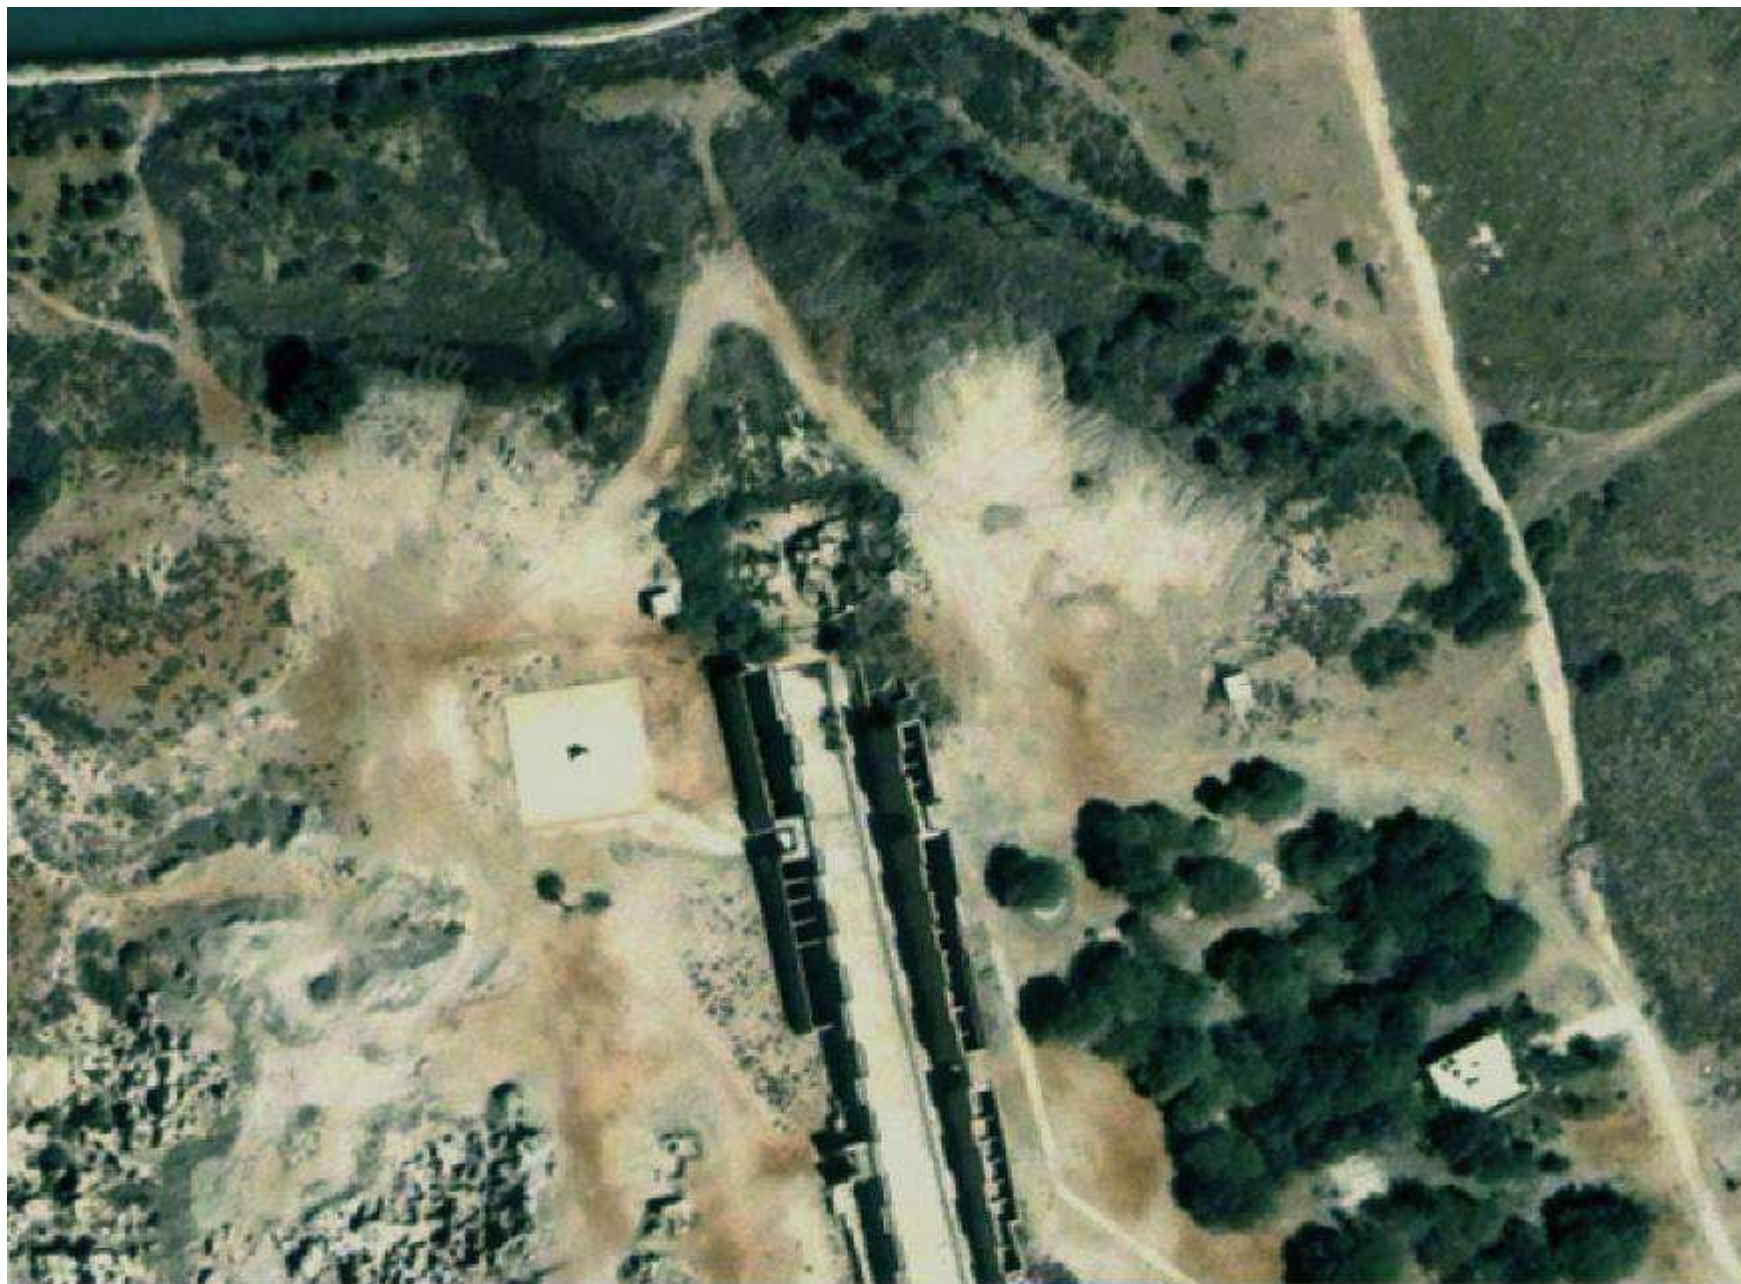
Gravel has been bulldozed to the north and east, enlarging the lot, 1 April 2003, Russell composite

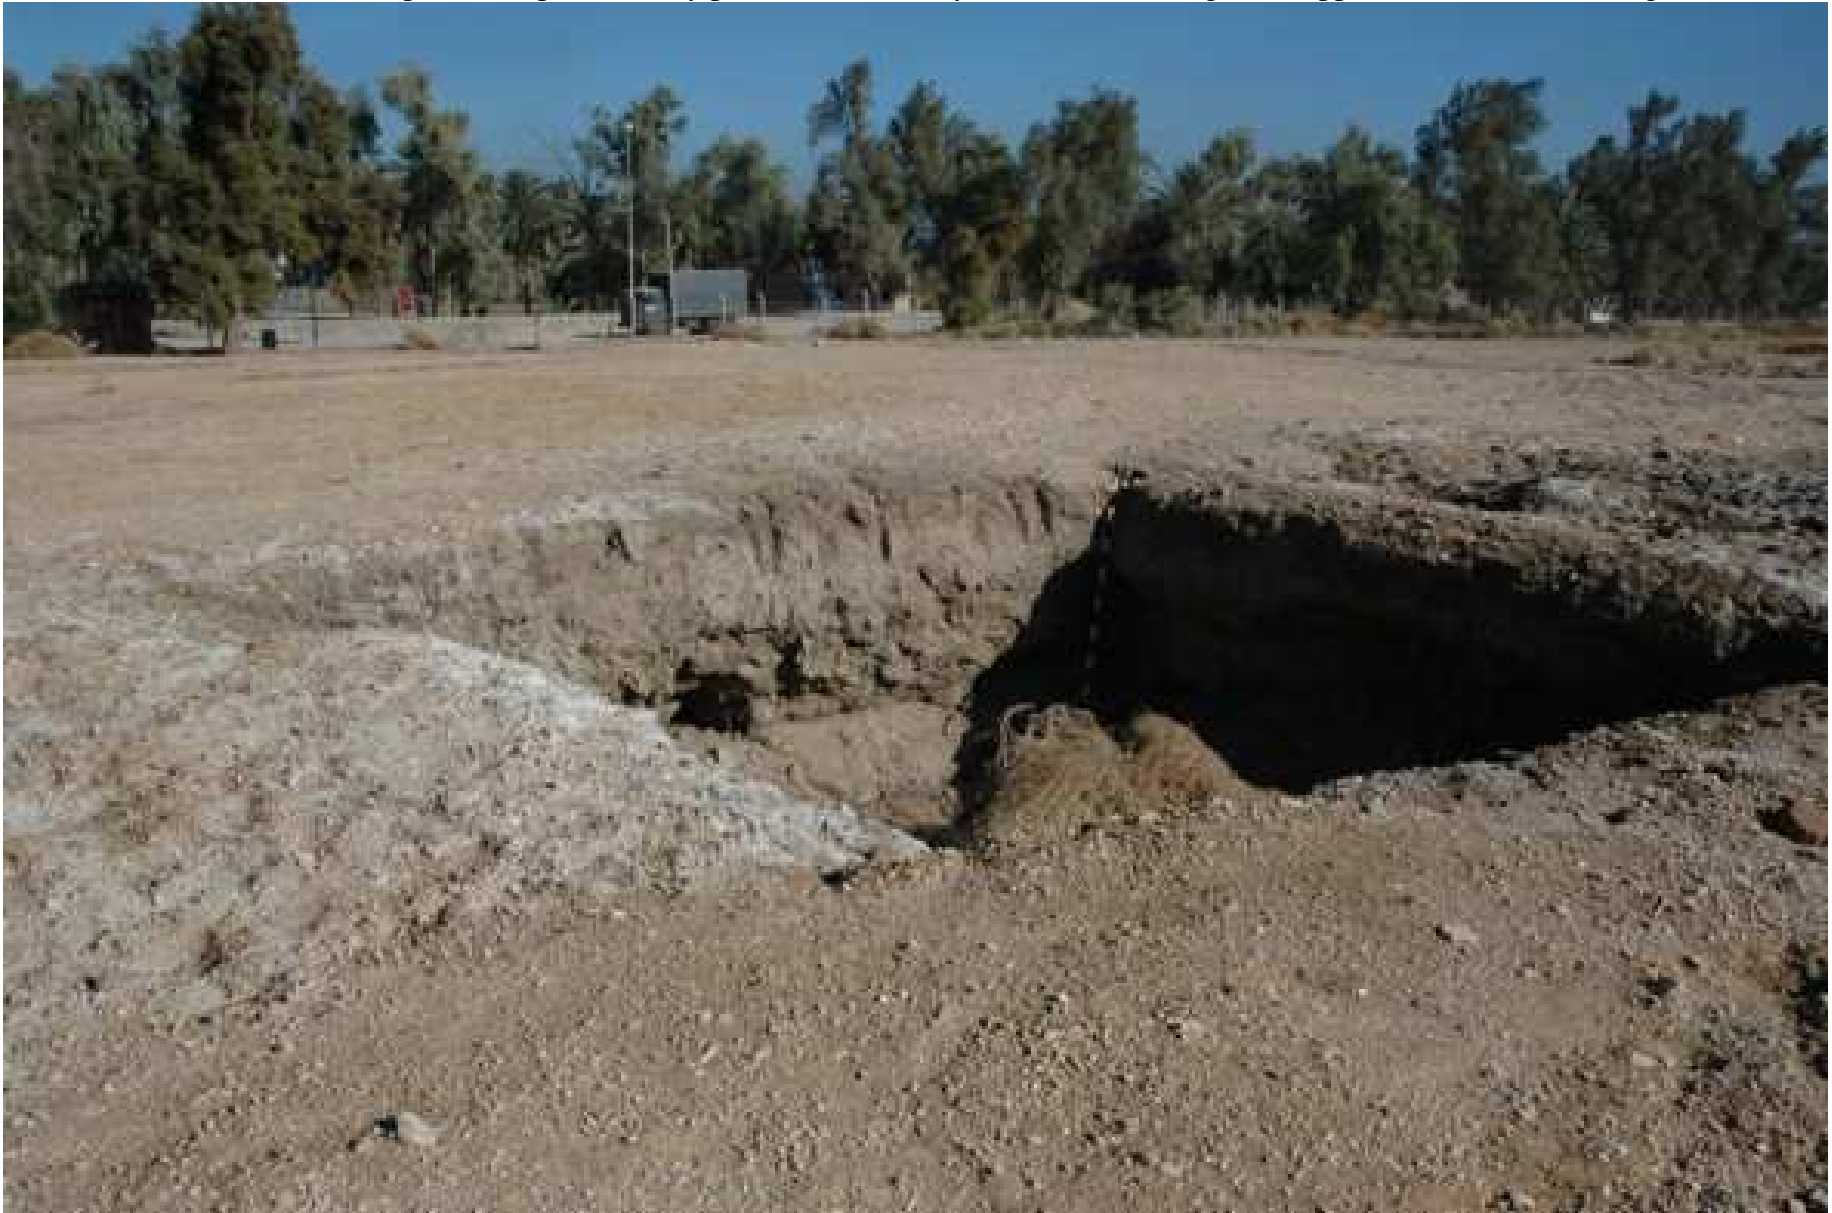
**Russell comment:** As Stone reports, this pit is already present in the 5 July 2002 satellite image, and appears to be an archaeological trench.

**Polish report:** "On the "Reconstructions" area, in the northern direction from the reconstructed Ishtar Temple, is located a hole about 4 meters by 4 meters and 2.5 meters deep" (Polish report pp. 23-24, photo © Ministry of Culture and National Heritage, Republic of Poland).

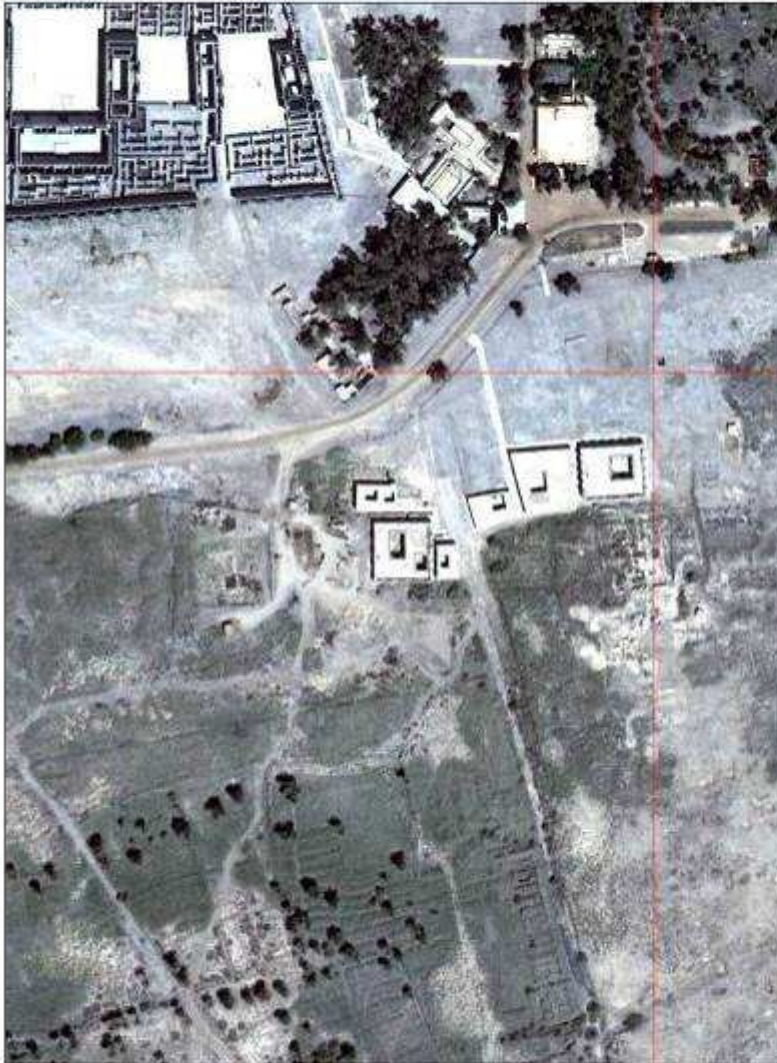
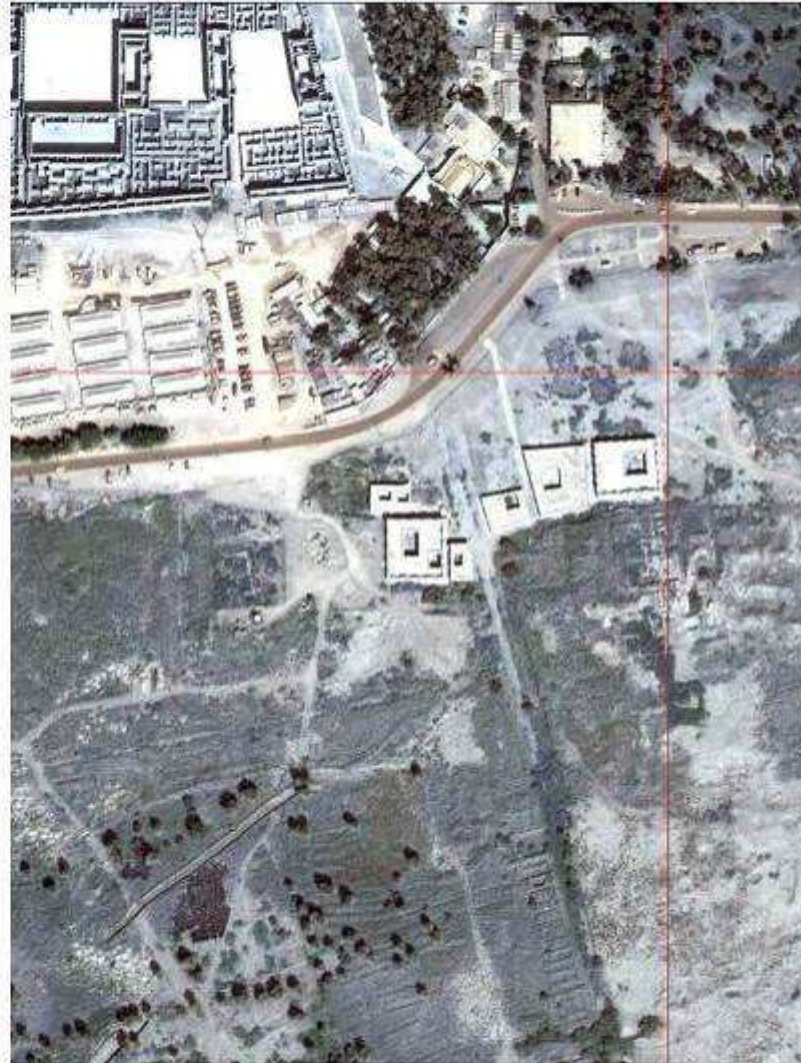
**Stone report:** The square hole mentioned in the Polish report was also present before the war—indeed it was already present in 2002 (Fig. 13). Its orientation and size suggests that it was the result of archaeological research.

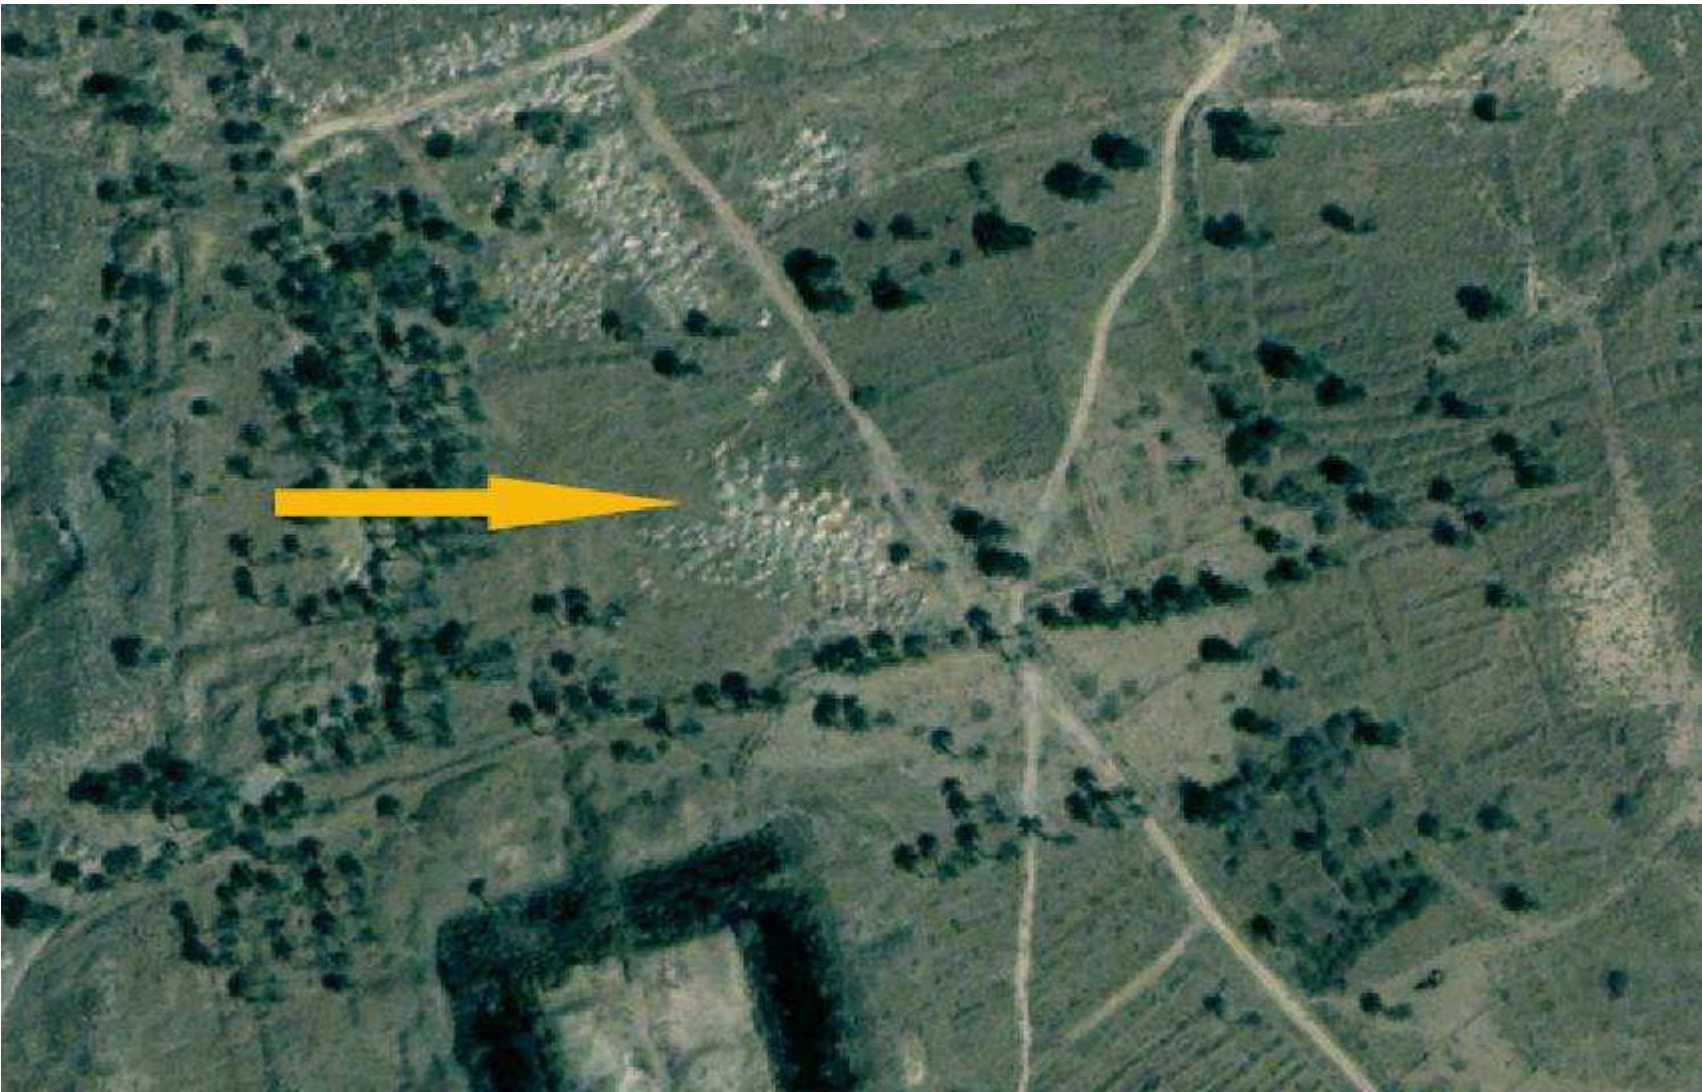
Polish report	Stone report
6) Debris dump: In between the ditches described above (A and B) is a debris dump. The dump has been used to dispose of pieces of bricks, concrete slabs, stones and sand.	The debris field noted by the Polish report appears to have already been present at the time of the war.

1 April 2003, showing debris field already present, Russell composite

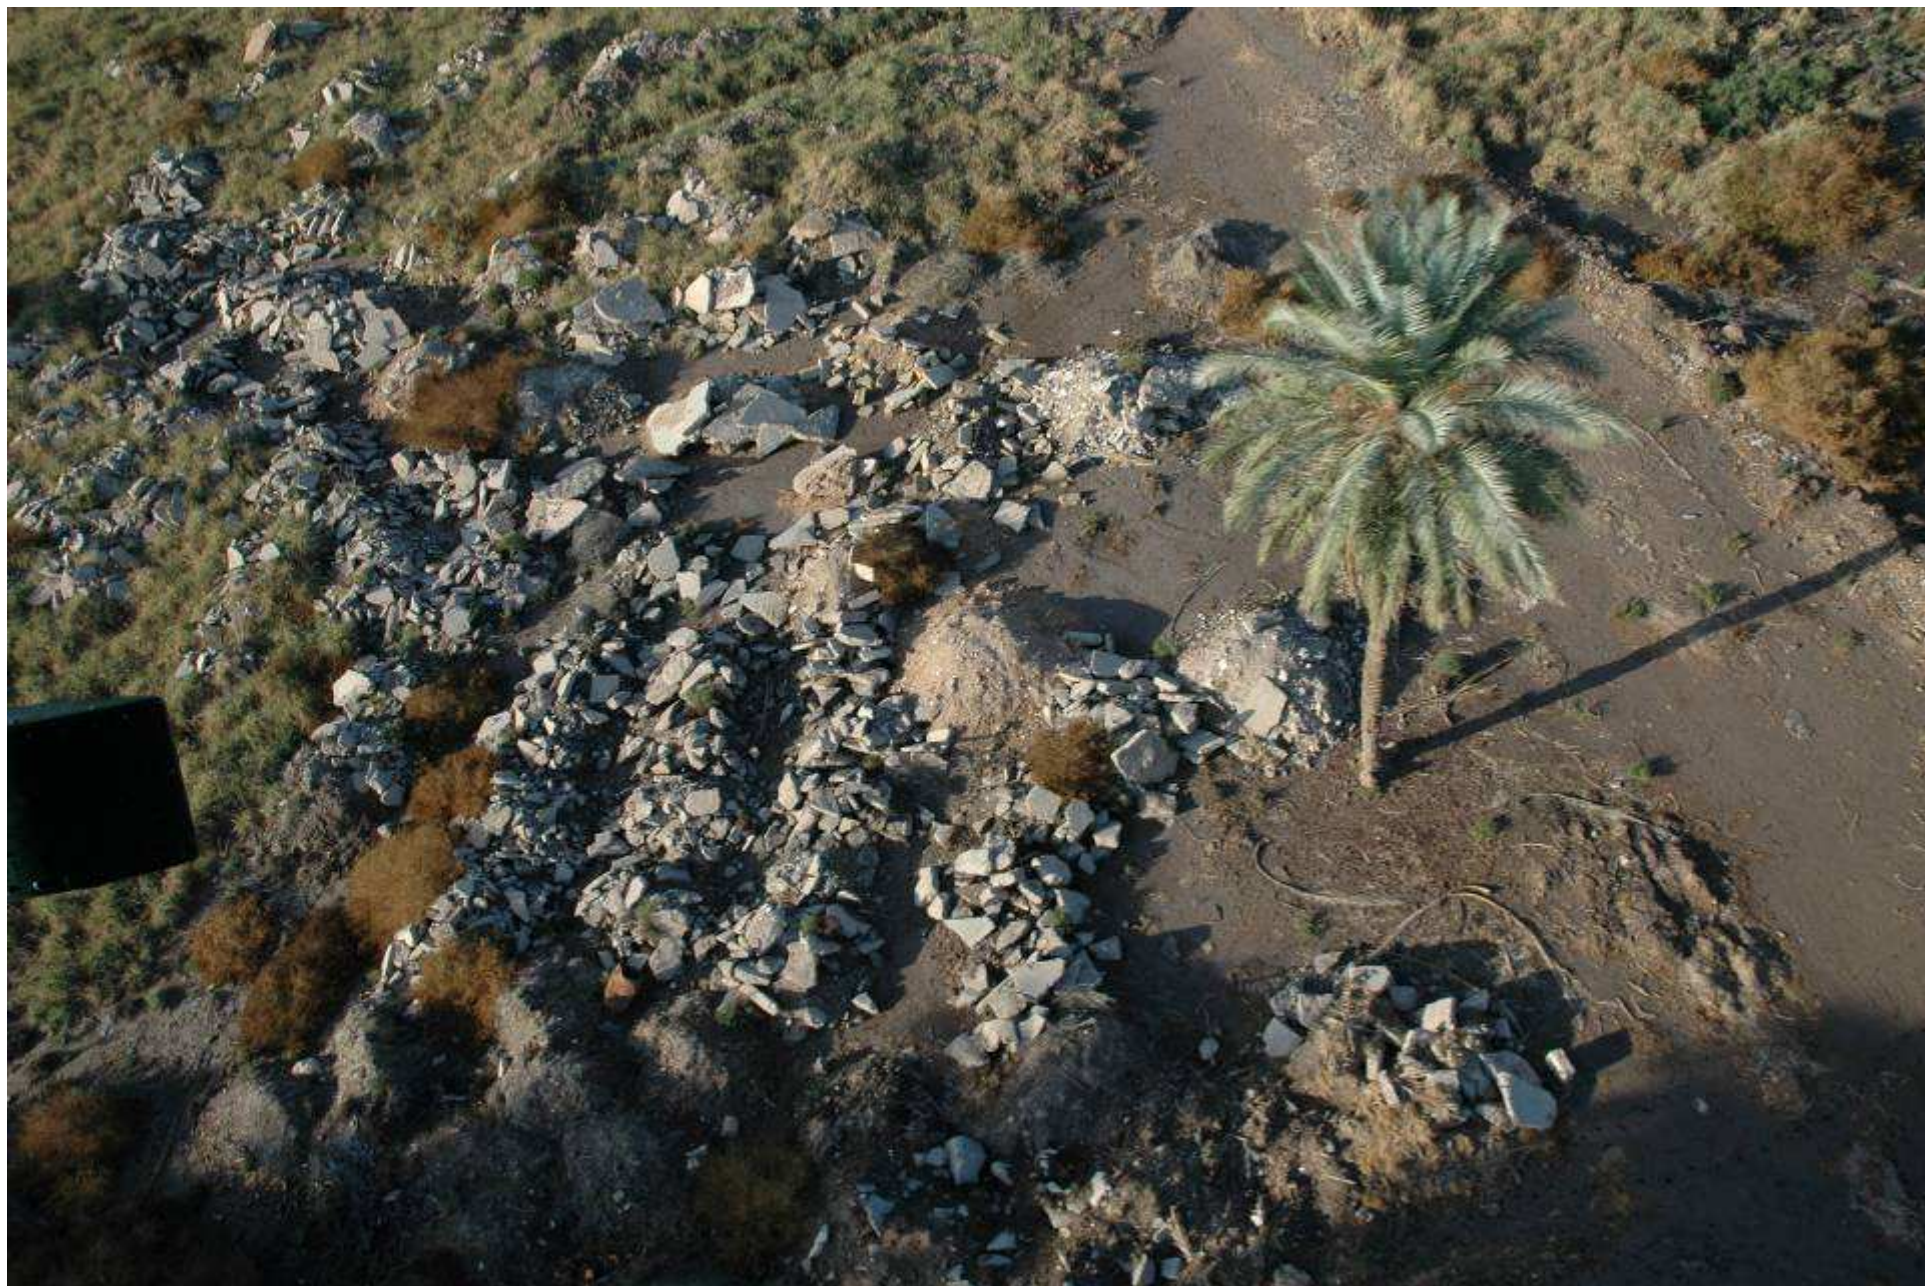
Debris field, Polish photo 111 (photo © Ministry of Culture and National Heritage, Republic of Poland)

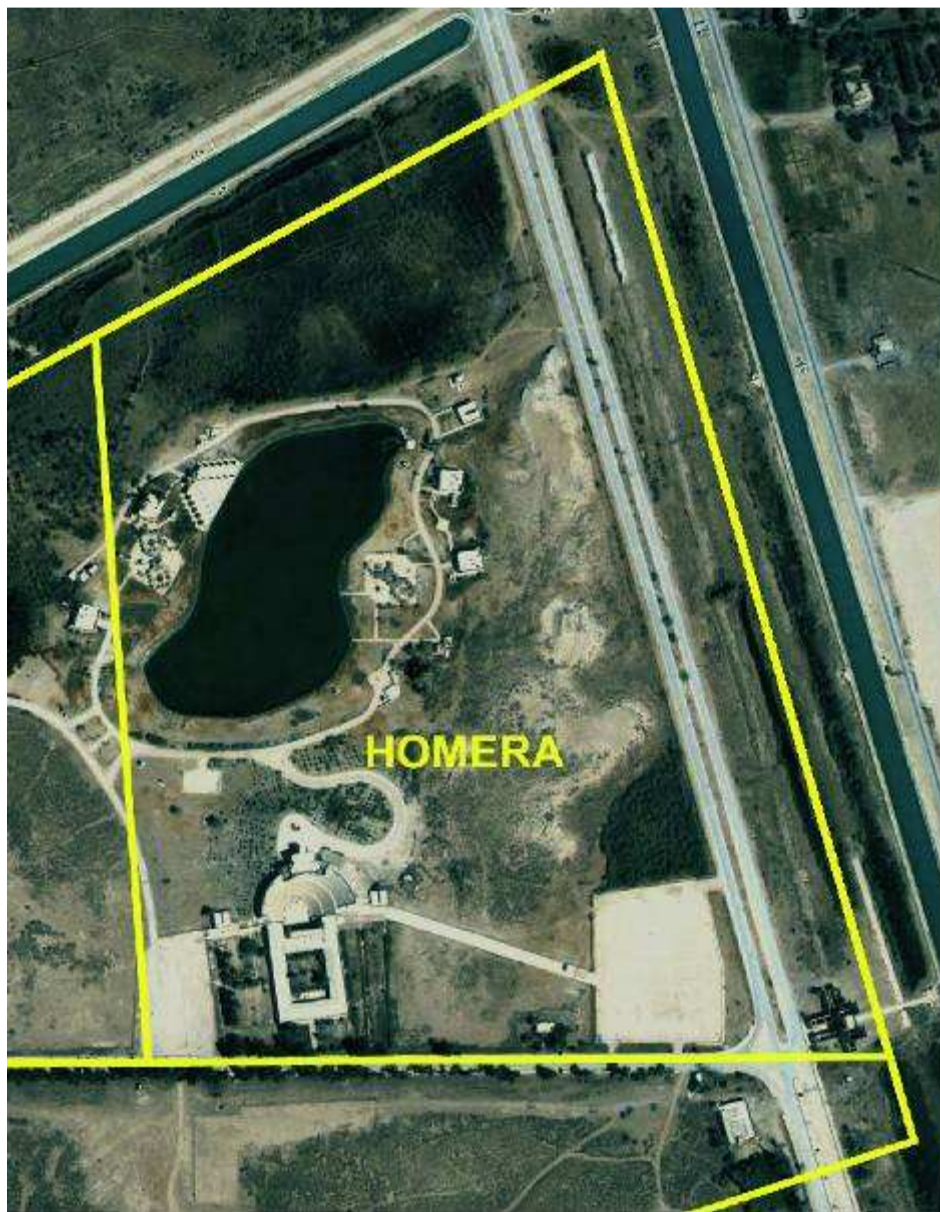
Homera area, 1 April 2003, Russell composite.

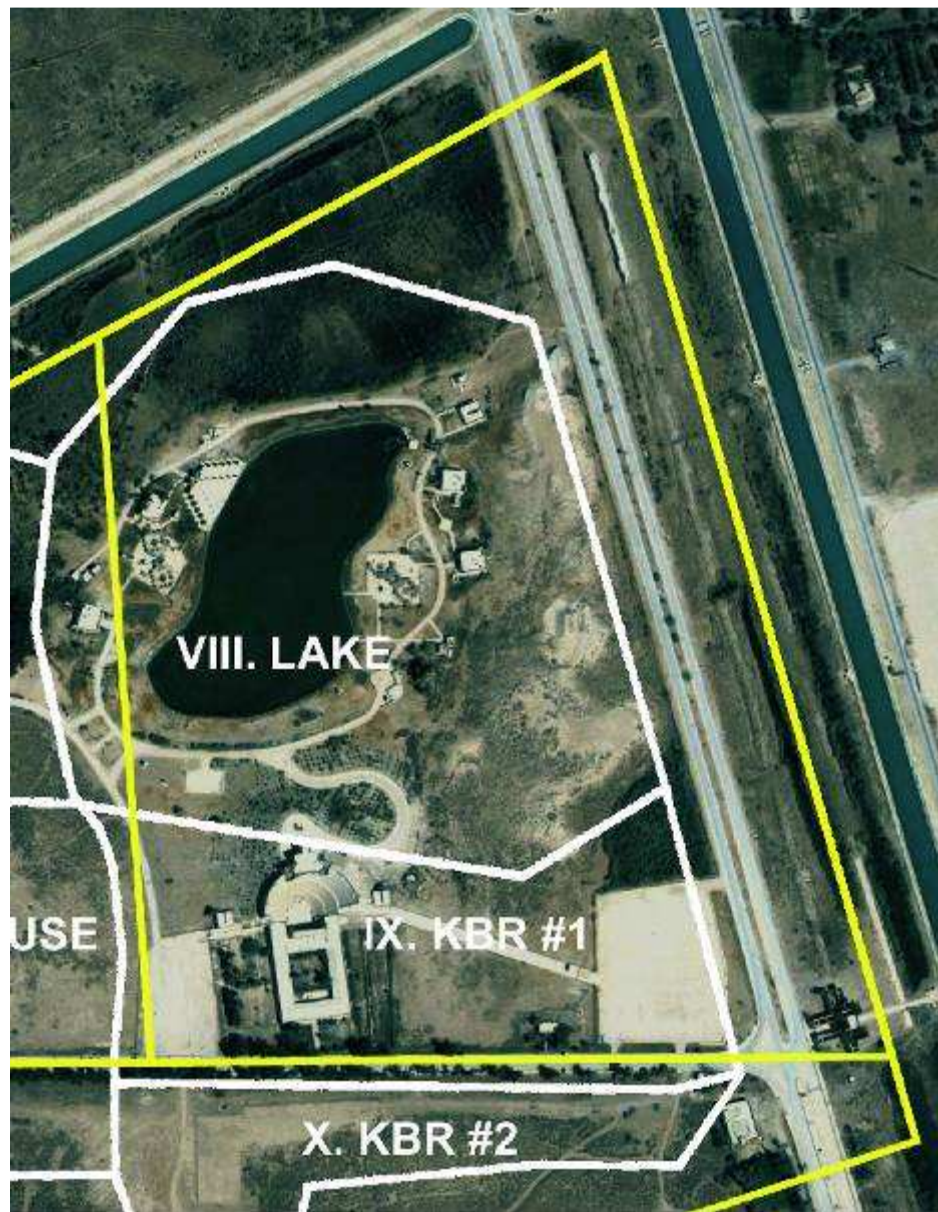
Homera area correlated with Polish areas VIII and IX, Russell composite.

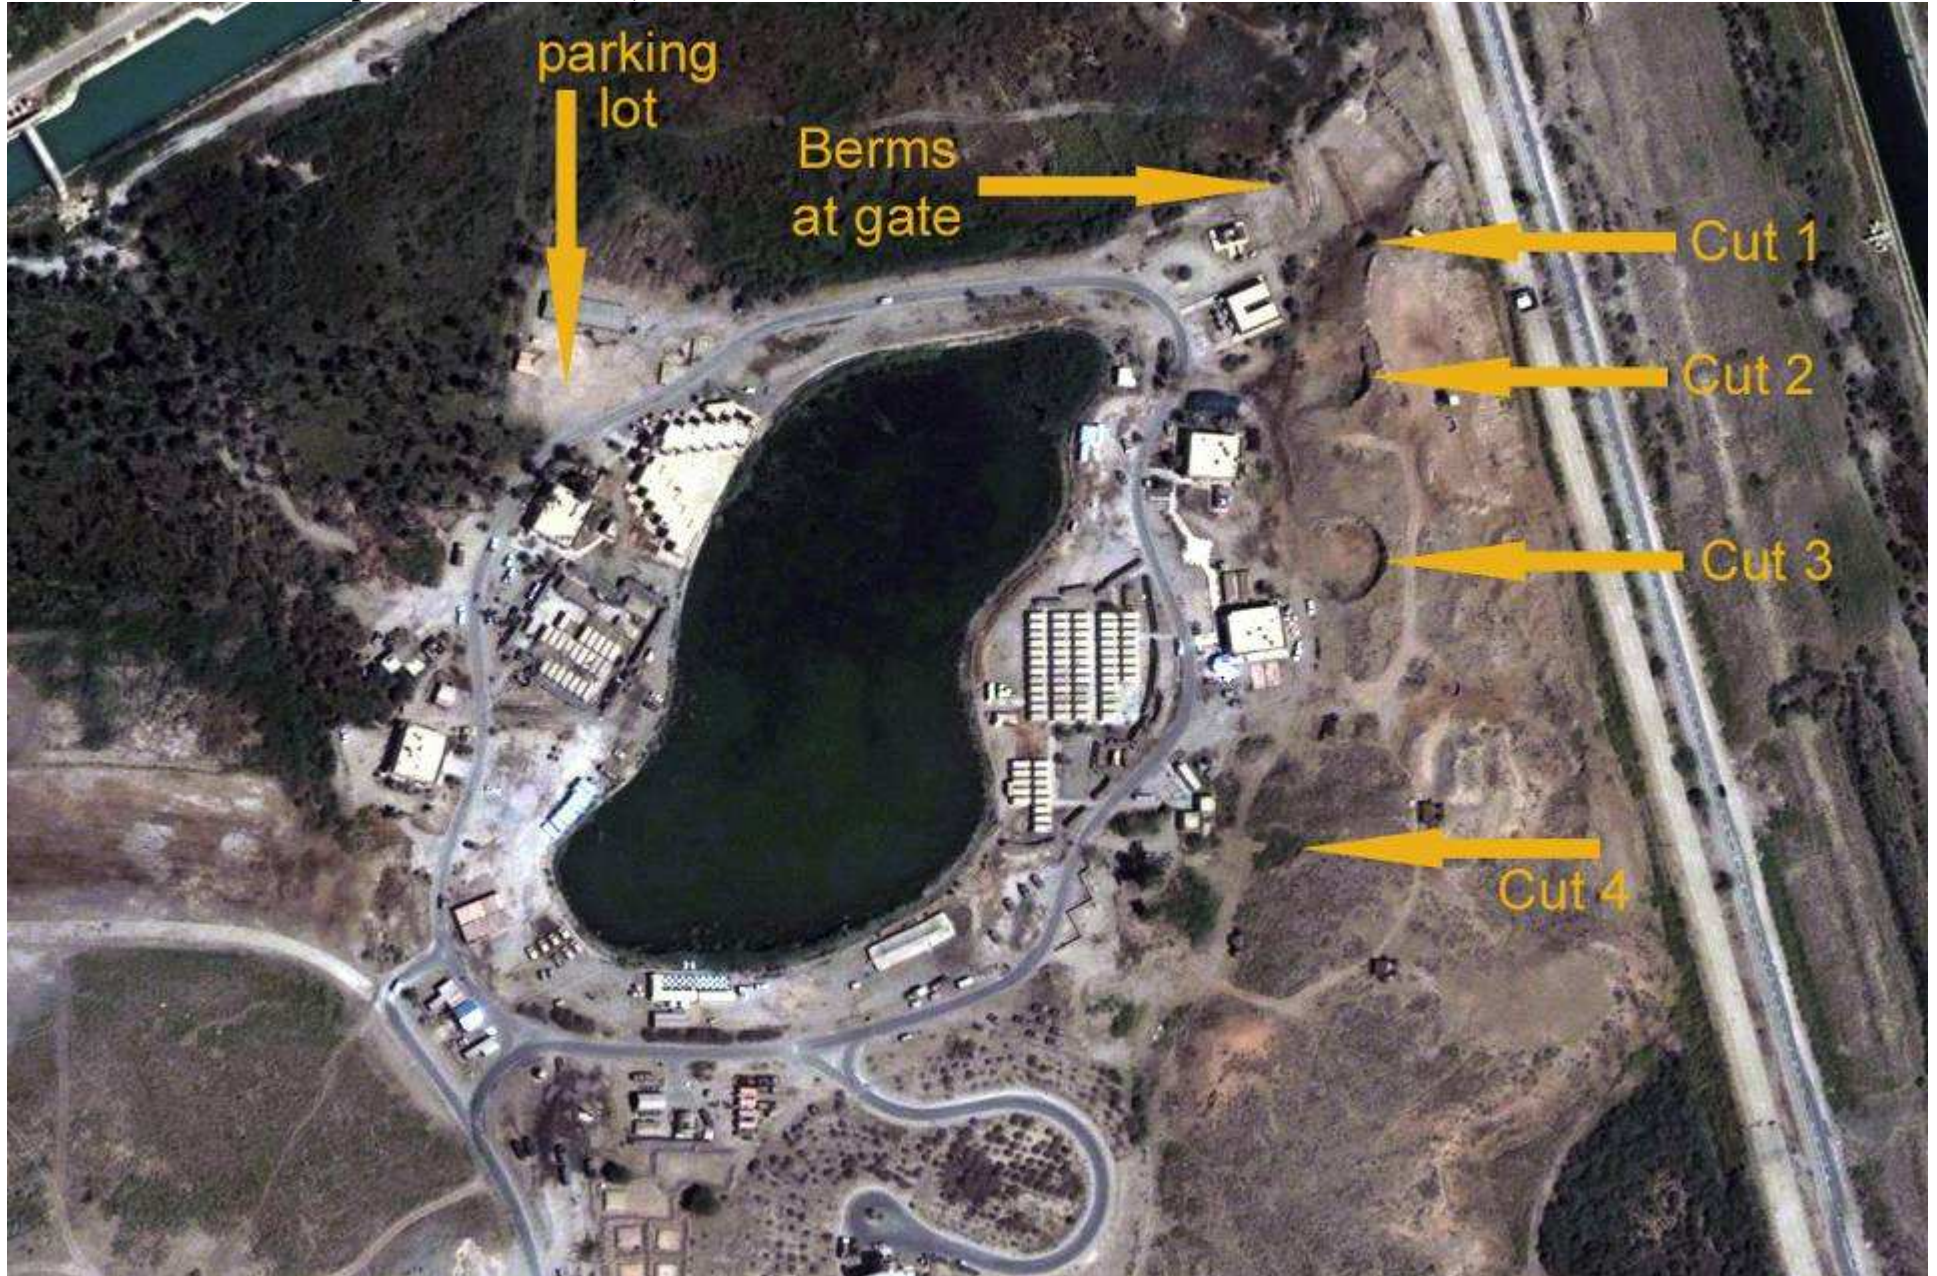
Overview, 25 August 2004, Russell composite

**Russell comment:** Some of the worst damage from the Coalition occupation was in this area.

**Stone report:** This is the area with the most egregious damage to the archaeological site. Three areas were excavated into the archaeological site—reportedly for soil to fill sandbags. These were all dug between the end of the war and August 2003 (Fig. 23). Most of the remaining area around the lake had already been disturbed. There are new structures immediately to the east of the excavated areas, linked by a dirt road.

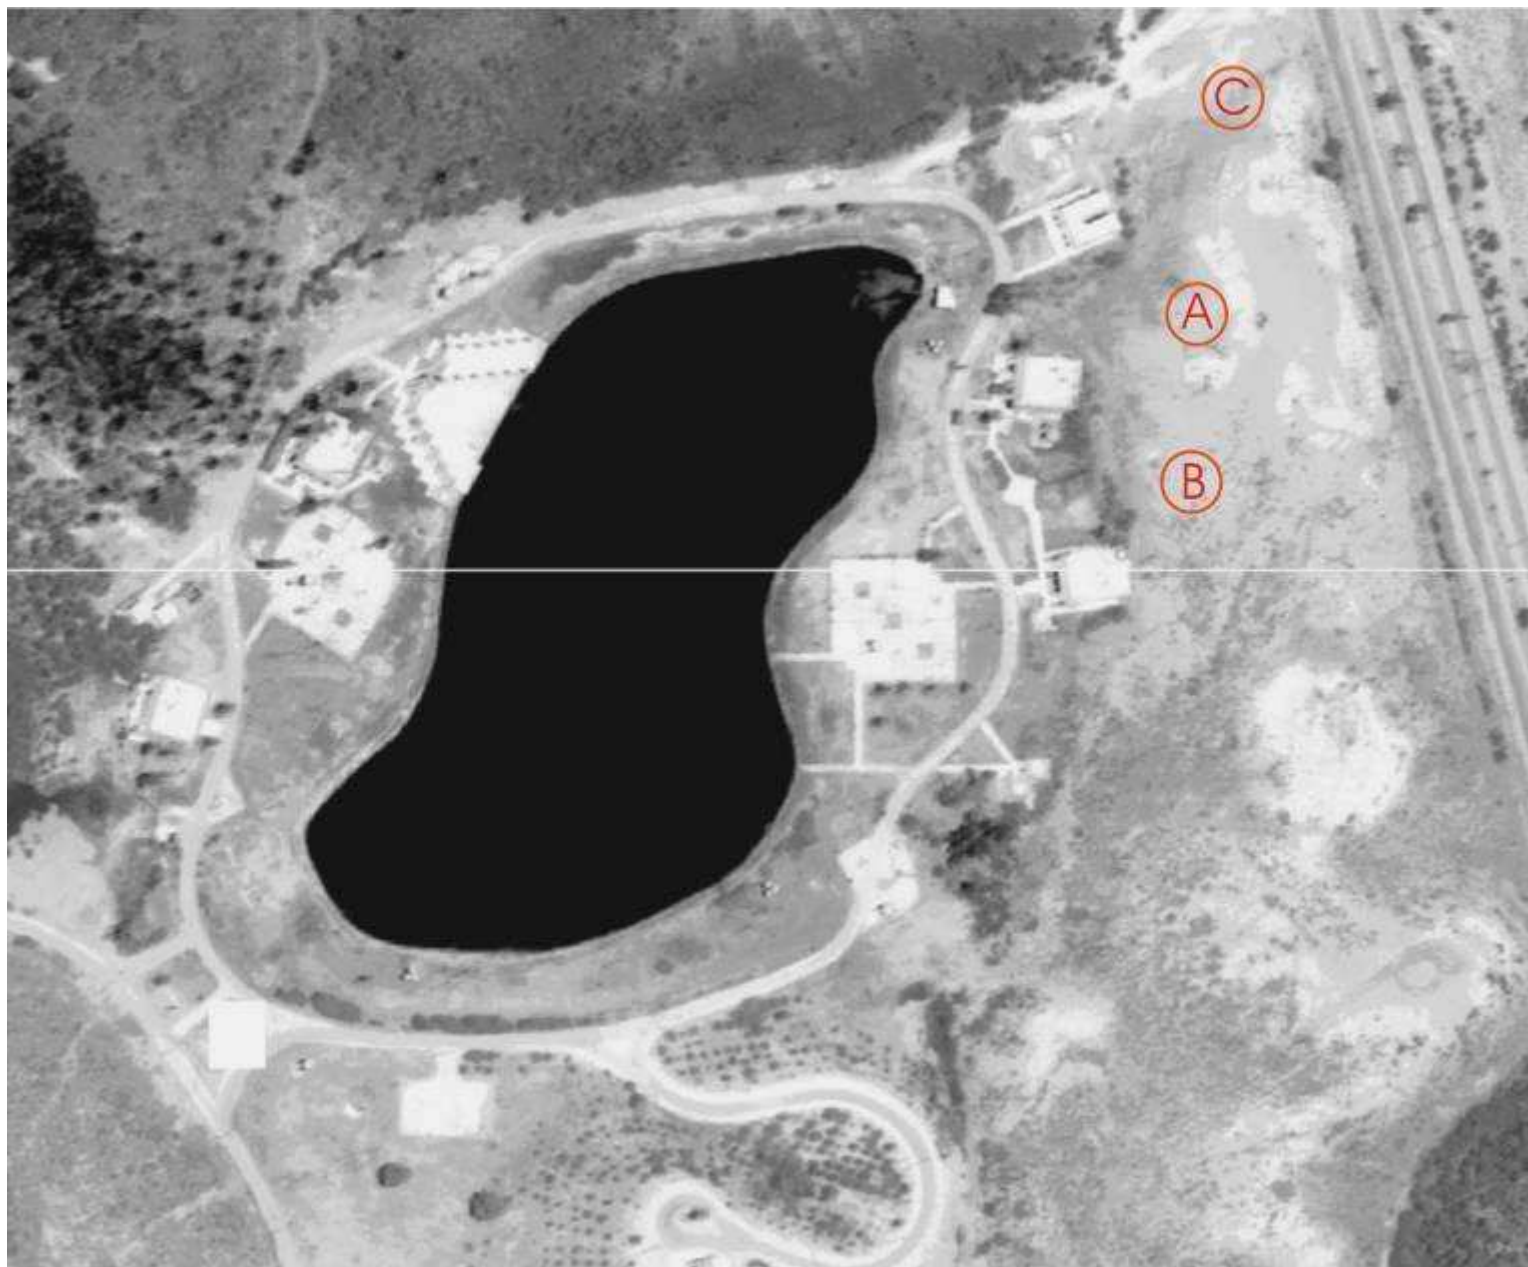
Location of Cuts 2 (A) and 3 (B), Polish report p. 31 (photo © Ministry of Culture and National Heritage, Republic of Poland)

<b>Iraqi preliminary report</b>	<b>Iraqi final report</b>	<b>Curtis report</b>	<b>Polish report</b>
d. The area north and east of the theater: There are cuts in a chain of hills extending along the length of the main road between Baghdad and Babel, starting at the northeast corner of the inner wall and extending to the Marduk Gate in four separate areas distributed along this chain. The German Mission's excavation activities account for a large portion of them.	<p>1. First cut: Its dimensions are 8 x 7 x 6 m. It is located northeast of the theater in a chain of tells that extends along the length of the former main road between Baghdad and al-Hillah (al-Humayrah area). The cut begins approximately in the northeastern corner of the inner wall. The results of the German excavations in Babylon in this area indicate that most of the dirt in the area was originally transported from the area of the ziggurat after Alexander attempted to rebuild the ziggurat after it had been subjected to acts of destruction numerous times. They cleaned the ziggurat and transported the rubble to this area. This area has not been excavated and may contain many antiquities. We will mention the other cuts according to where they were found, moving from north to south (Photo 39).</p> <p>2. Second cut: It is south of, and bigger than, the first cut. It has an area of 30 x 19 x 7 m (Photo 40).</p> <p>3. Third cut: It is south of the second cut (23 x 24 x 5 m) (Photo 41).</p> <p>4. Fourth cut: 5 x 16 x 12 m (Photo 42).</p>	<p>Dr Maryam reported that there were 5 cuttings in this area. We were shown four of the cuttings: -</p> <p>A cutting c. 35m x 20m, depth 6m (<i>Polish Report</i>, pp.43-44, cutting no. A).</p> <p>A cutting "of similar size" (<i>Polish Report</i>, pp.43-44, cutting no. B).</p> <p>A cutting c. 15m x 10m, up to 3m deep; now covered with new vegetation (not in <i>Polish Report</i>).</p> <p>A cutting c. 5m square (not in <i>Polish Report</i>).</p>	<p>Between the pond and the border of the camp there are two places where original material has been cut from the ancient tells.</p> <p>The first cutting area [Cut 2] is marked on the picture by the letter "A." The dimensions of the cutting are about 35 x 20 meters and 6 meters deep. There are two layers in the cutting. The original layers are on the bottom and about halfway up the cutting is heavily mixed soil.</p> <p>Second cutting [Cut 3] (marked on the picture by the letter "B") is of similar size.</p>

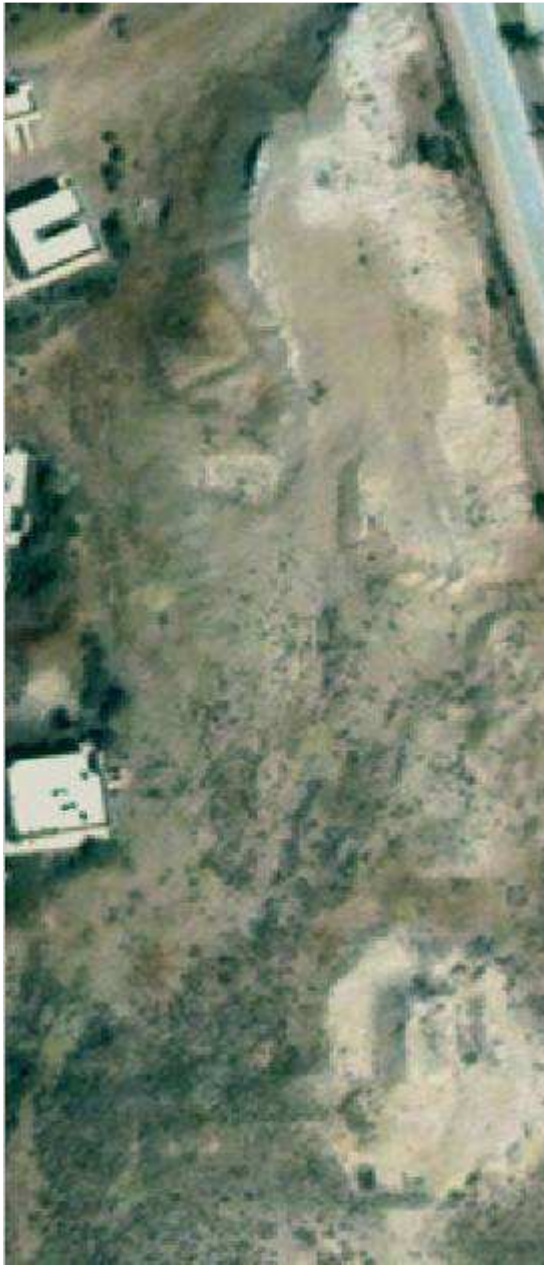
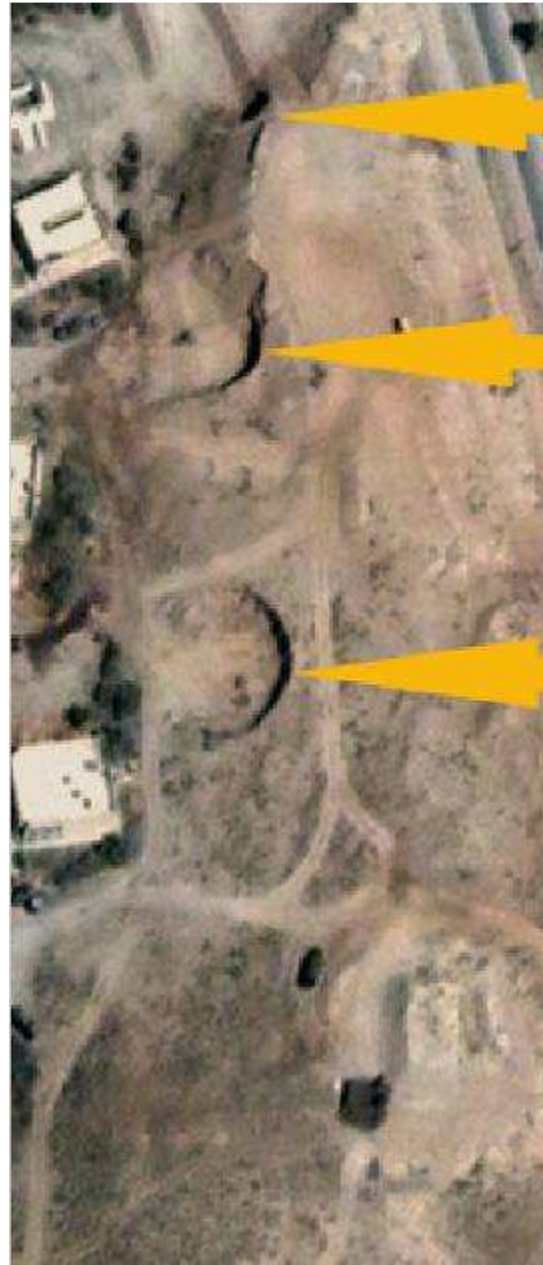
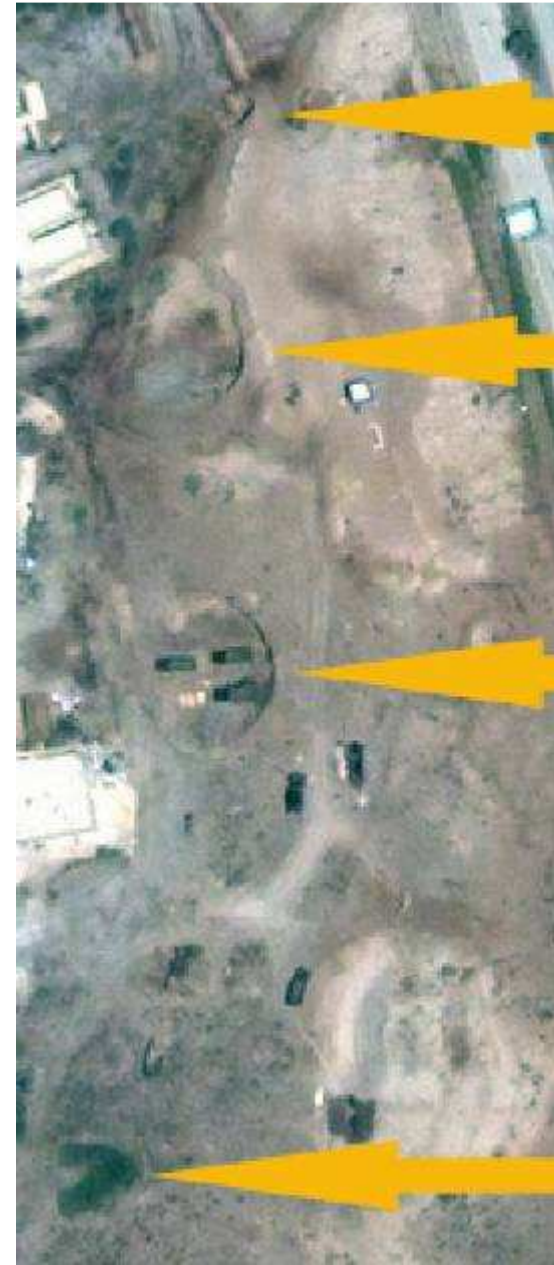
1 April 2003, Russell composite

31 August 2003, Russell composite

Cuts 1, 2, and 3 occurred between 1 April and 31 August 2003. Cut 4 appeared between 31 August 2003 and 4 June 2004.

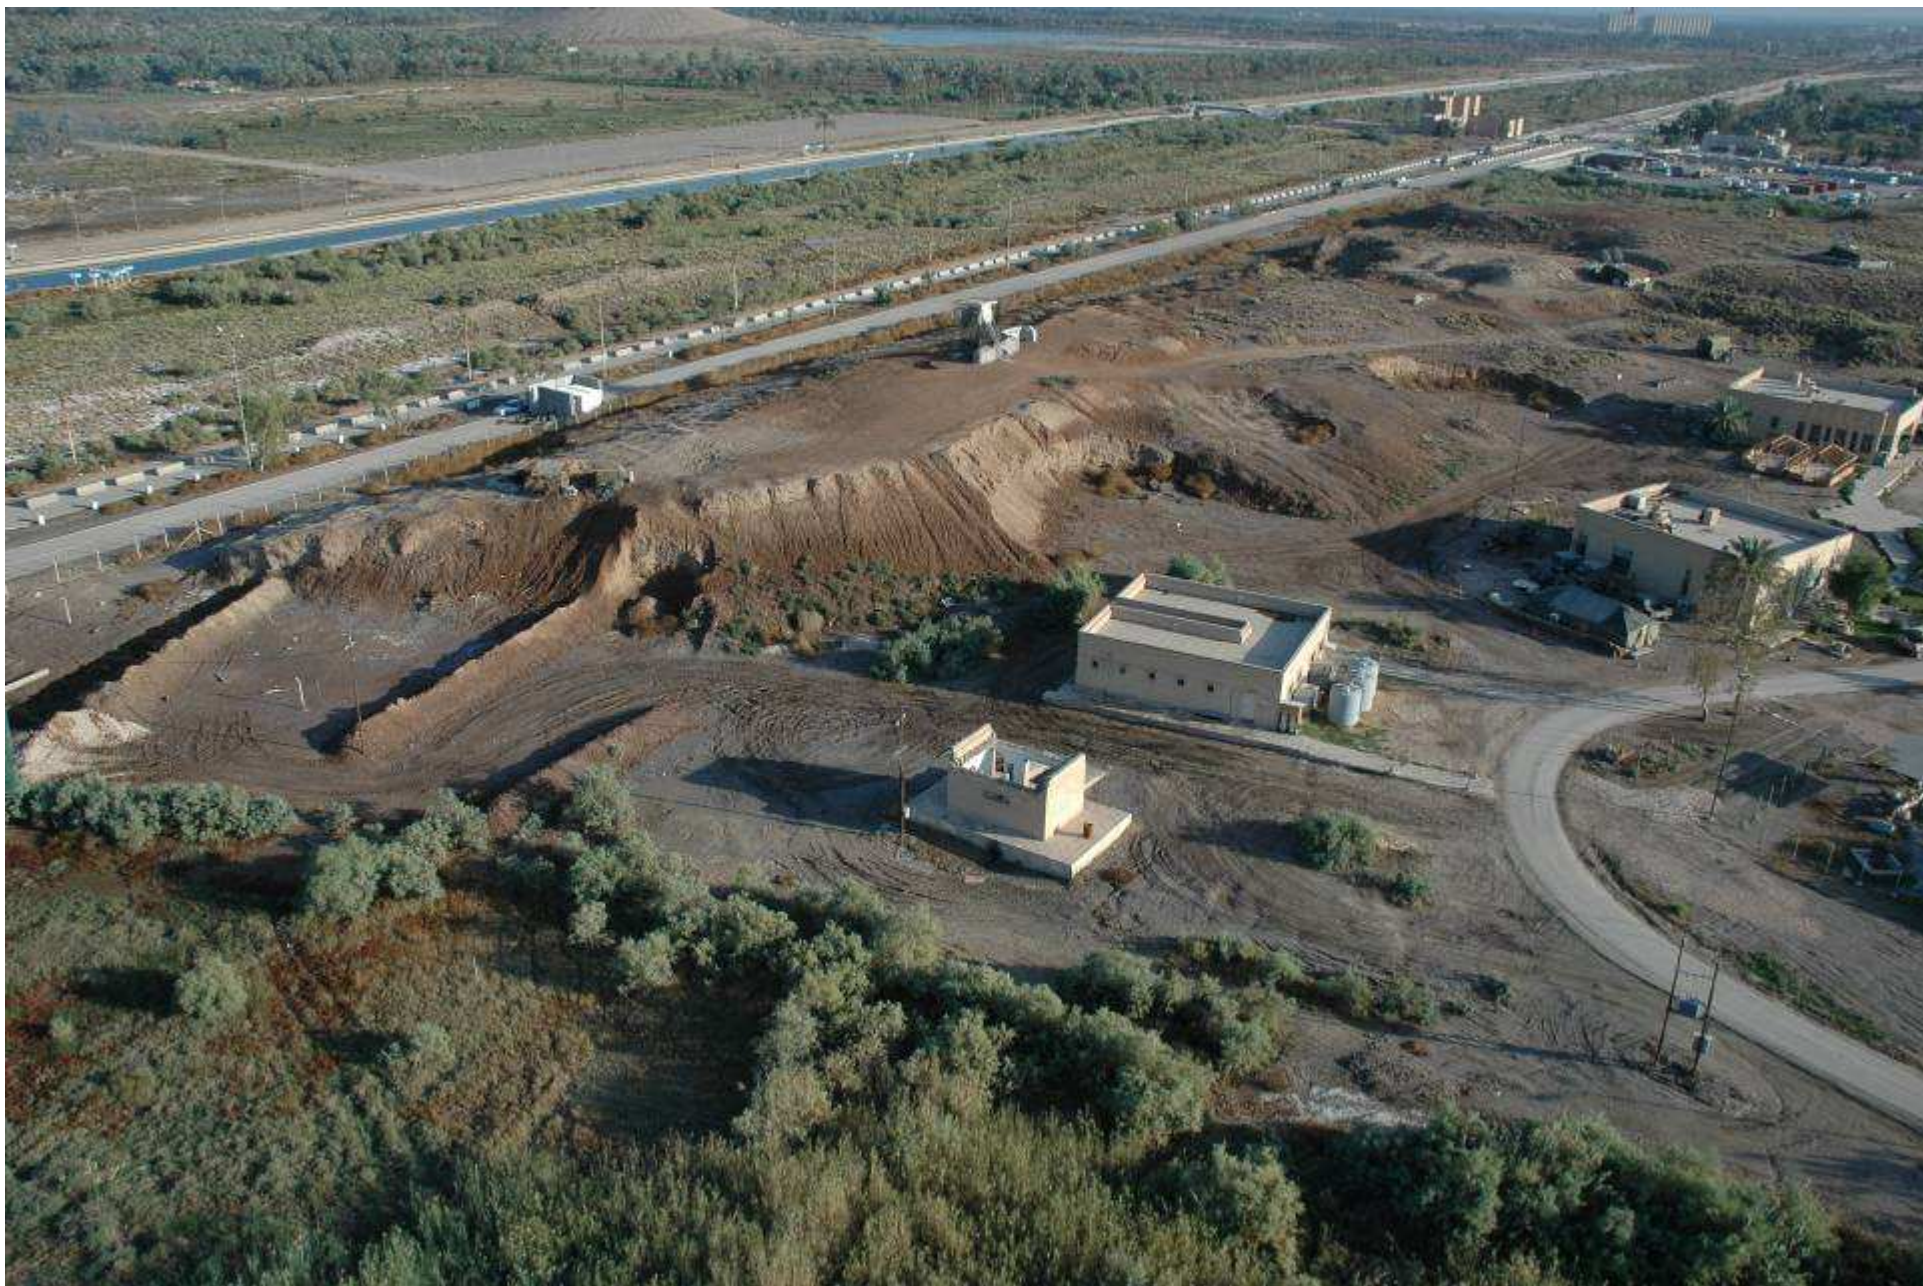
View of berms at entrance and Cuts 1, 2, and 3, Polish photo 157 (photo © Ministry of Culture and National Heritage, Republic of Poland)
