# **Report on Damage to the Site of Babylon, Iraq**

**John Malcolm Russell, Ph.D.**

**Cultural Heritage Center  
Bureau of Educational and Cultural Affairs  
Department of State**

**April 2010**

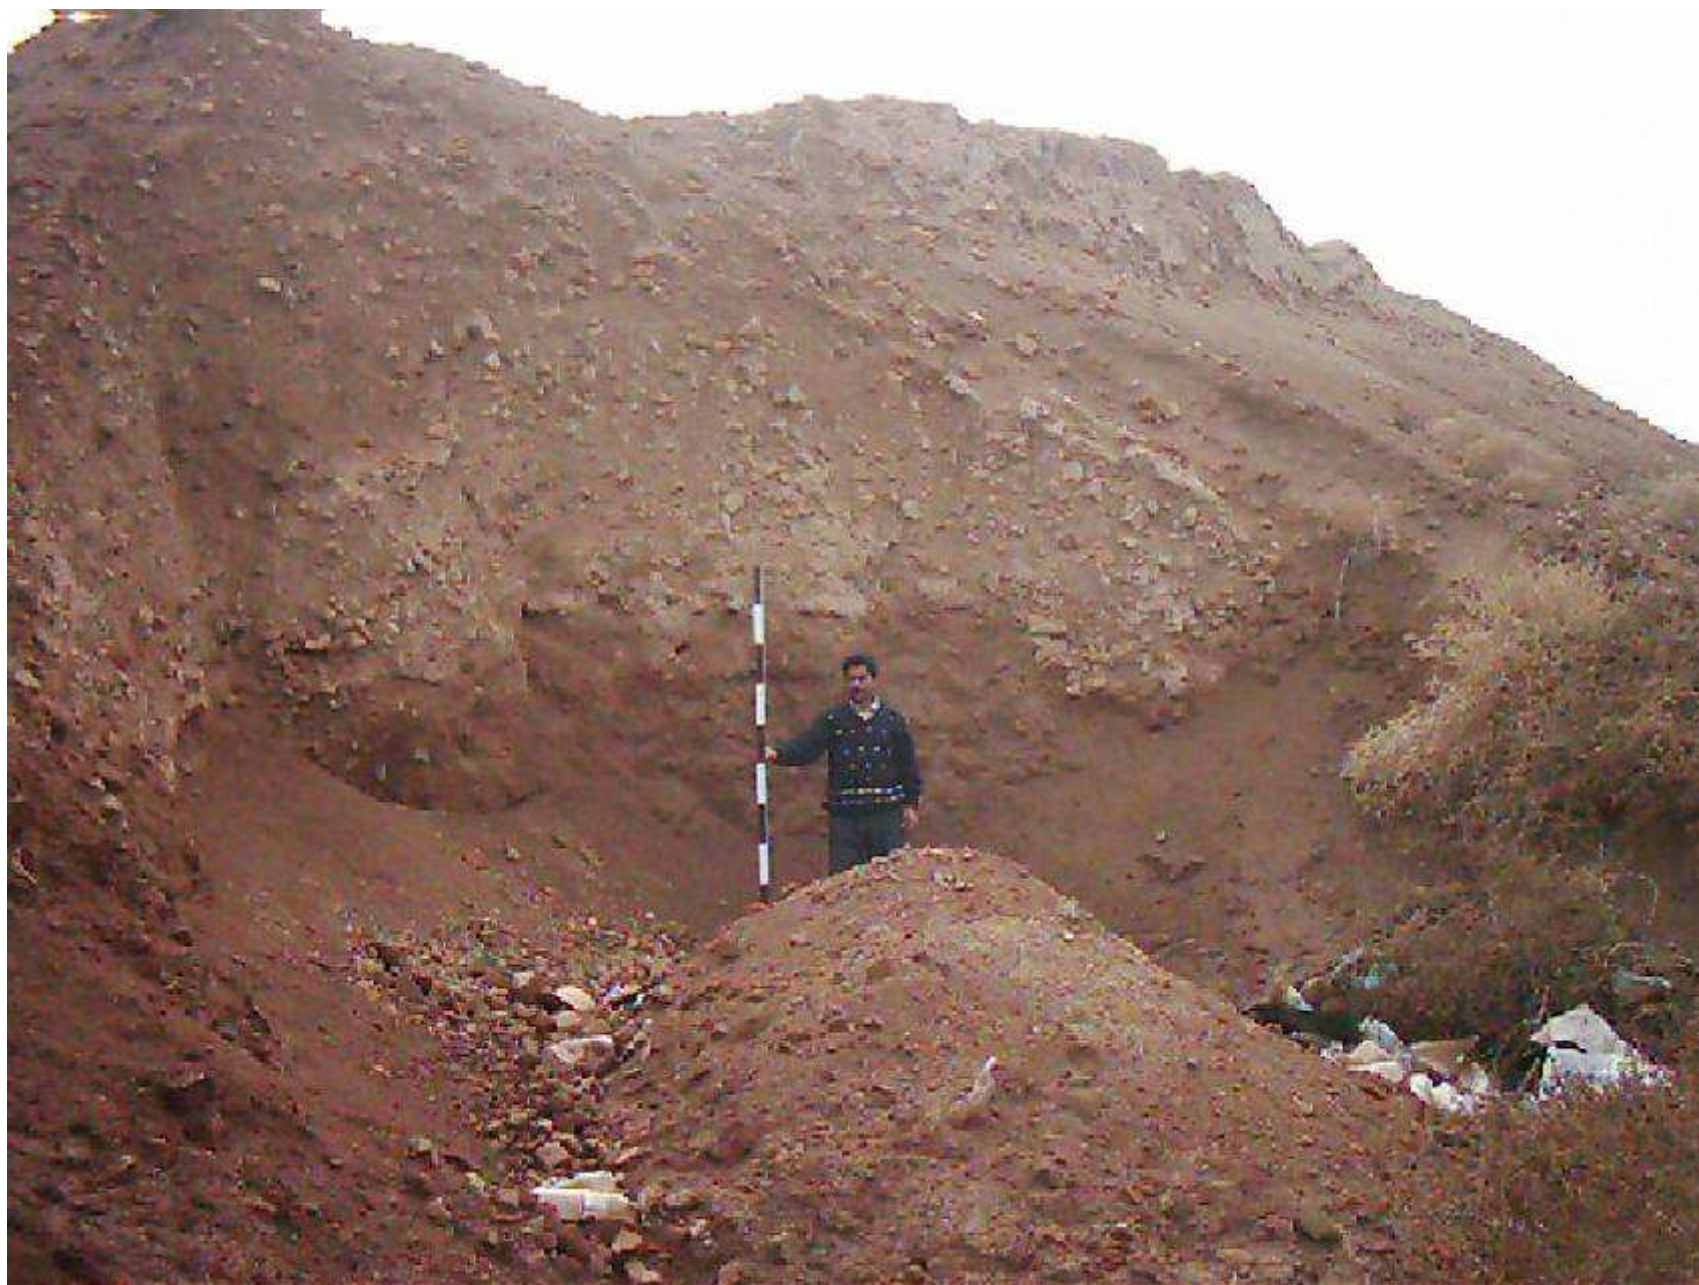
Cut 1, Iraqi final report fig. 39

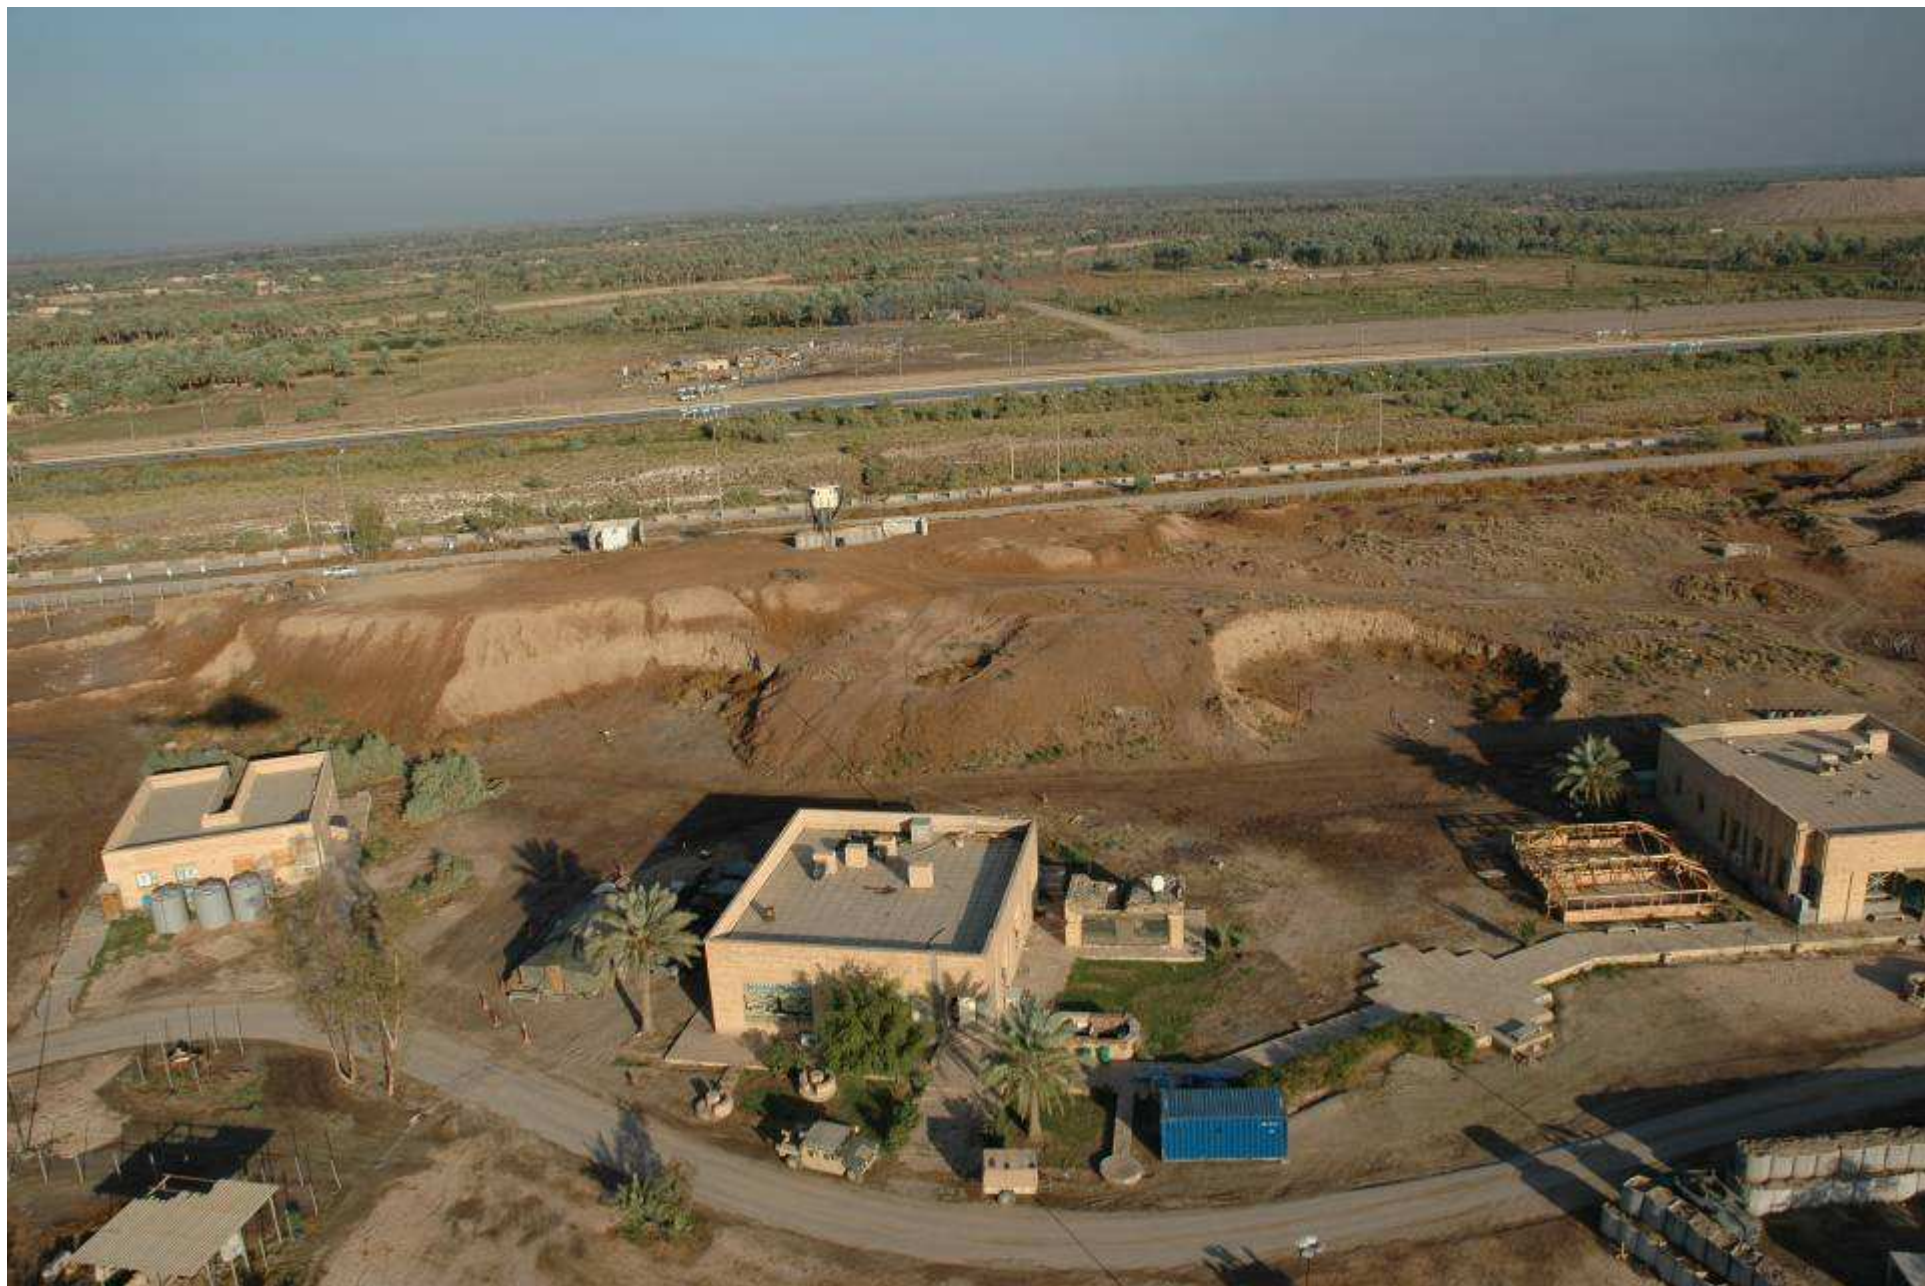
Cuts 2 (left) and 3, Polish photo 149 (photo © Ministry of Culture and National Heritage, Republic of Poland)

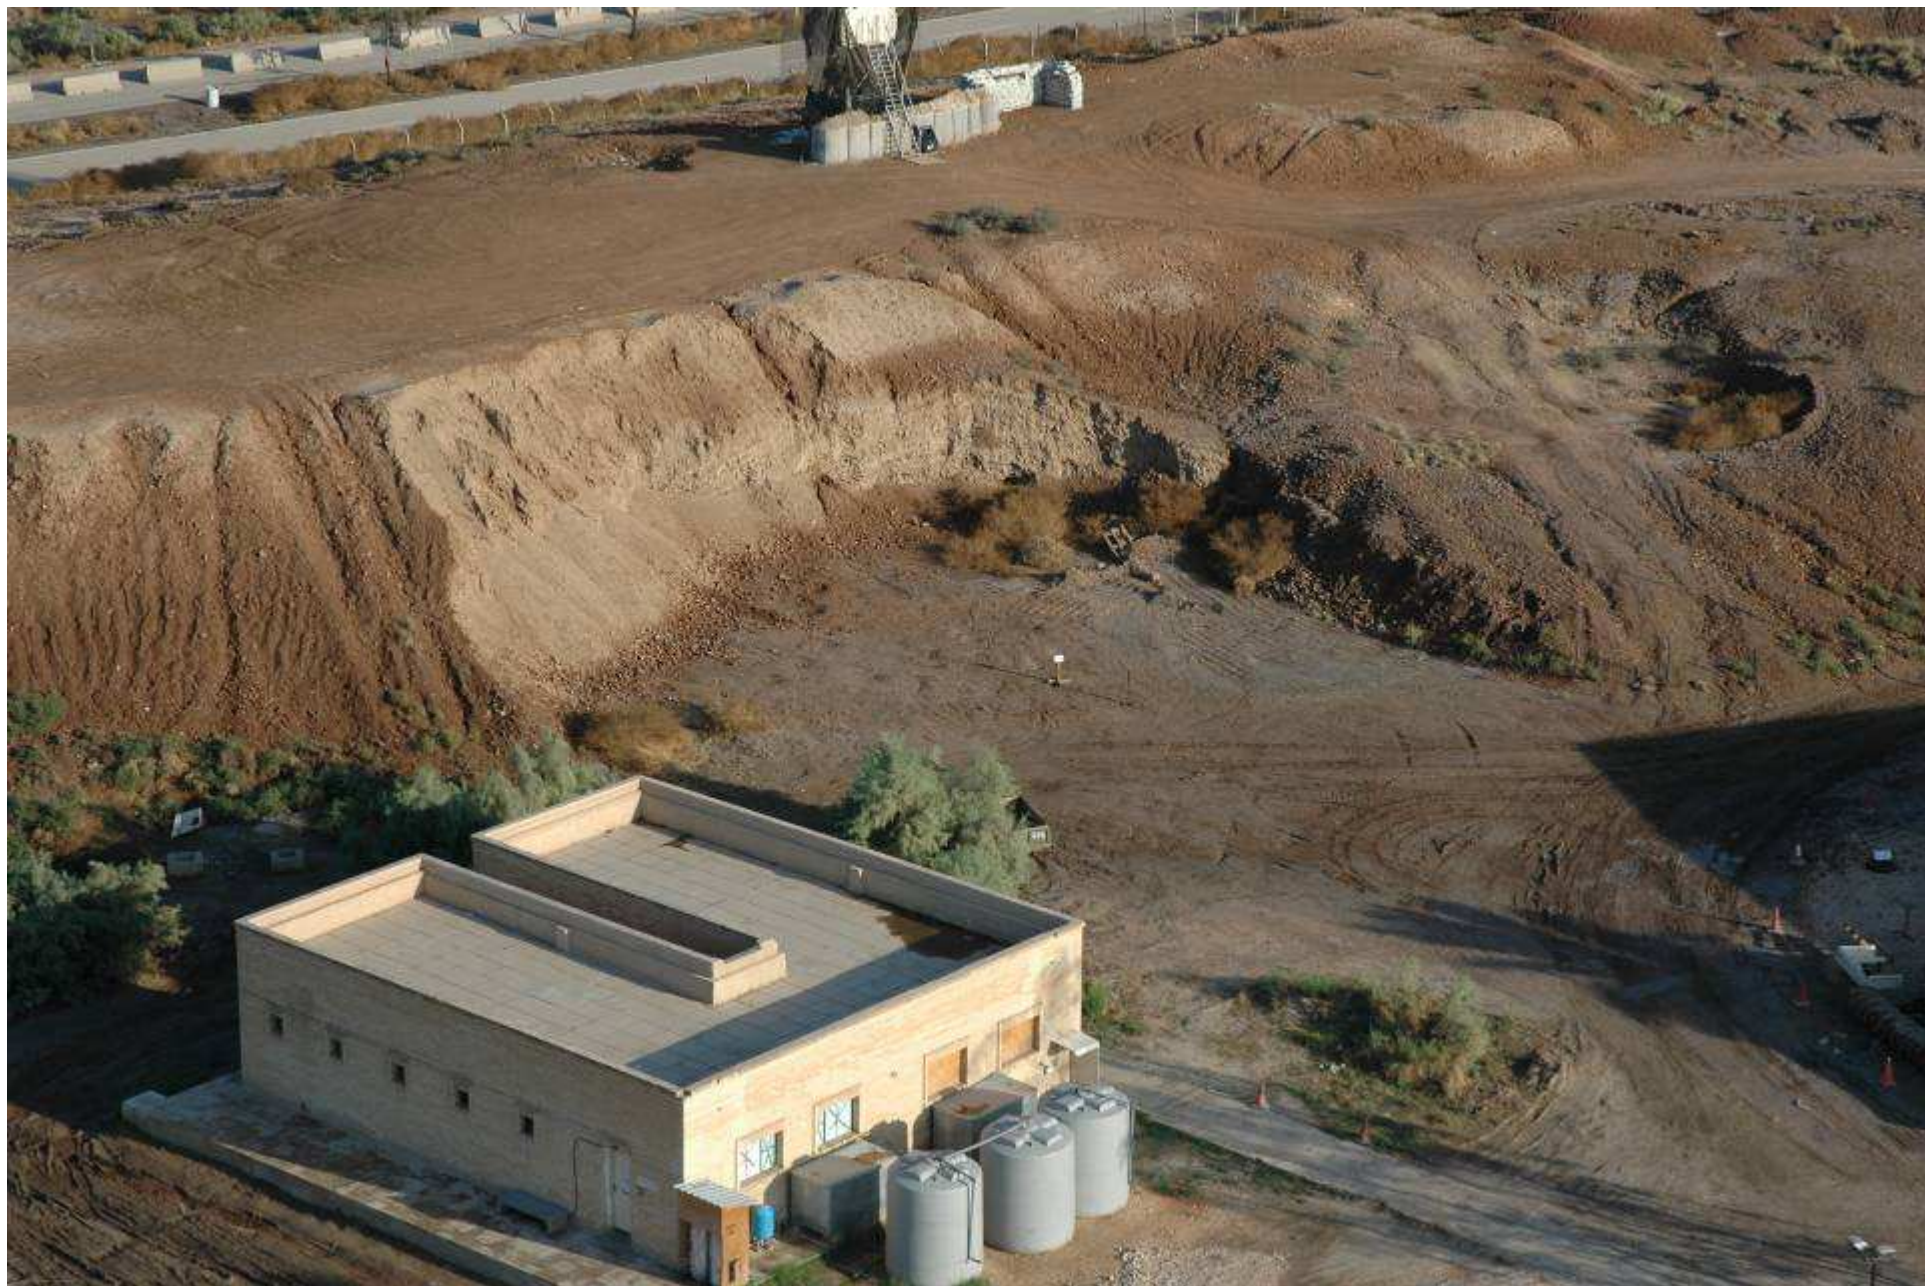
Cut 2, Polish photo 158 (photo © Ministry of Culture and National Heritage, Republic of Poland)

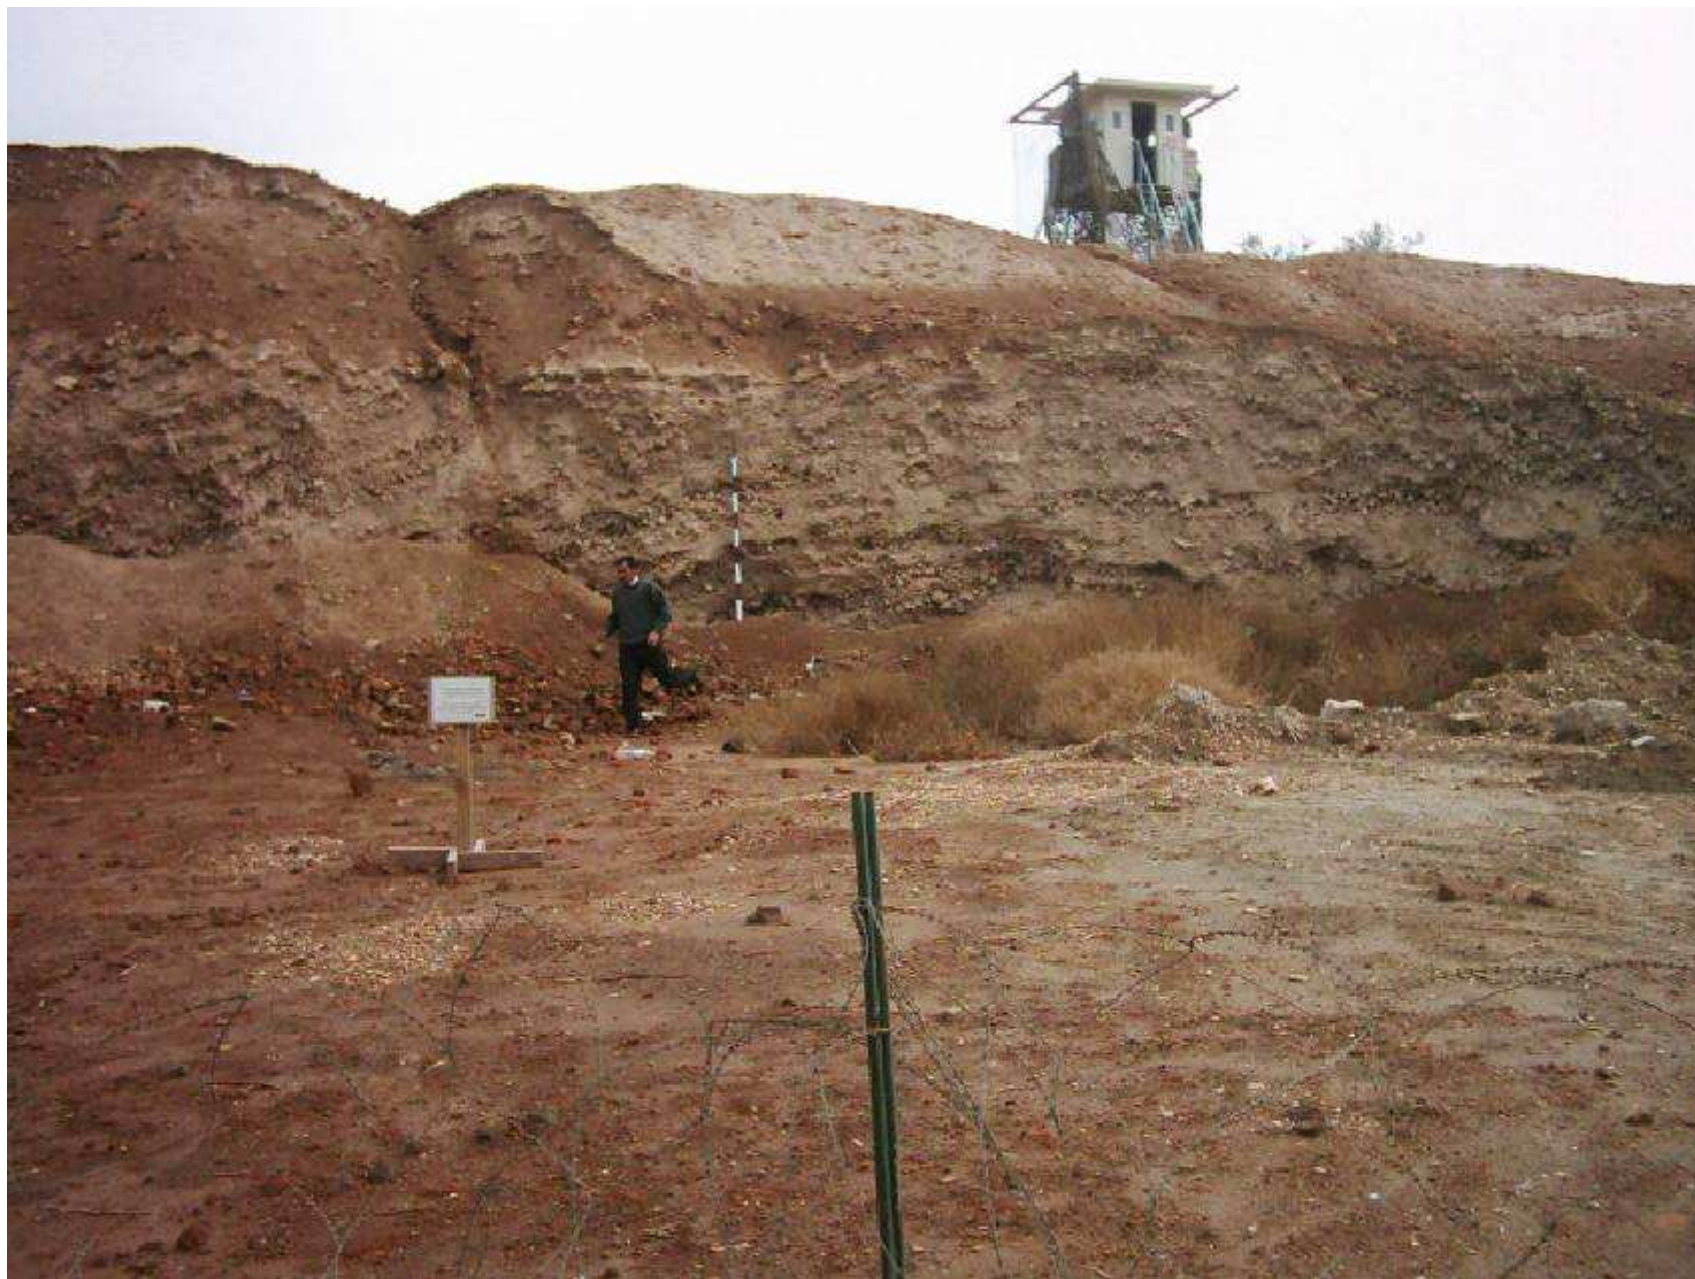
Cut 2, Iraqi final report fig. 40

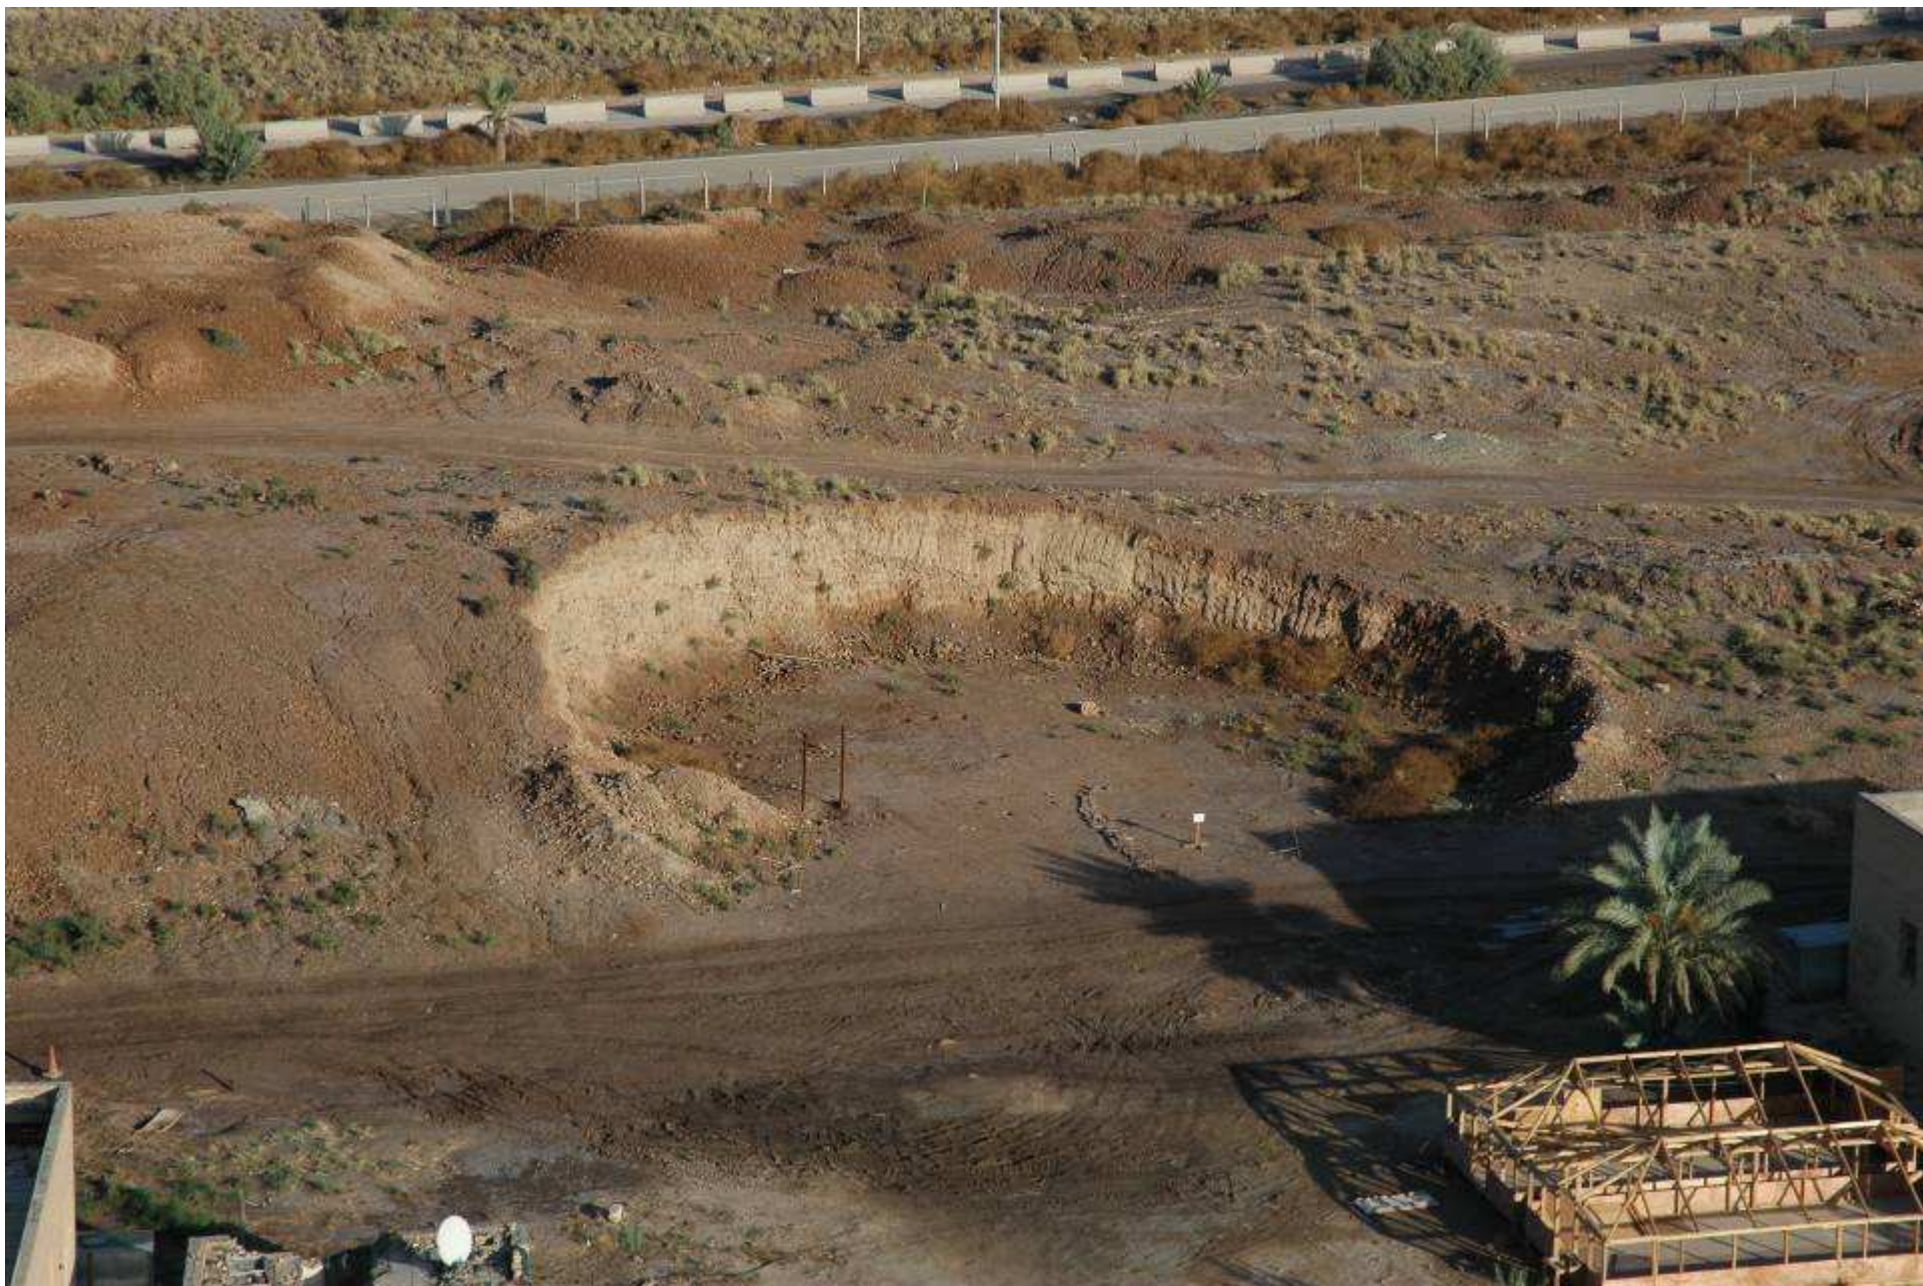
Cut 3, Polish photo 160 (photo © Ministry of Culture and National Heritage, Republic of Poland)

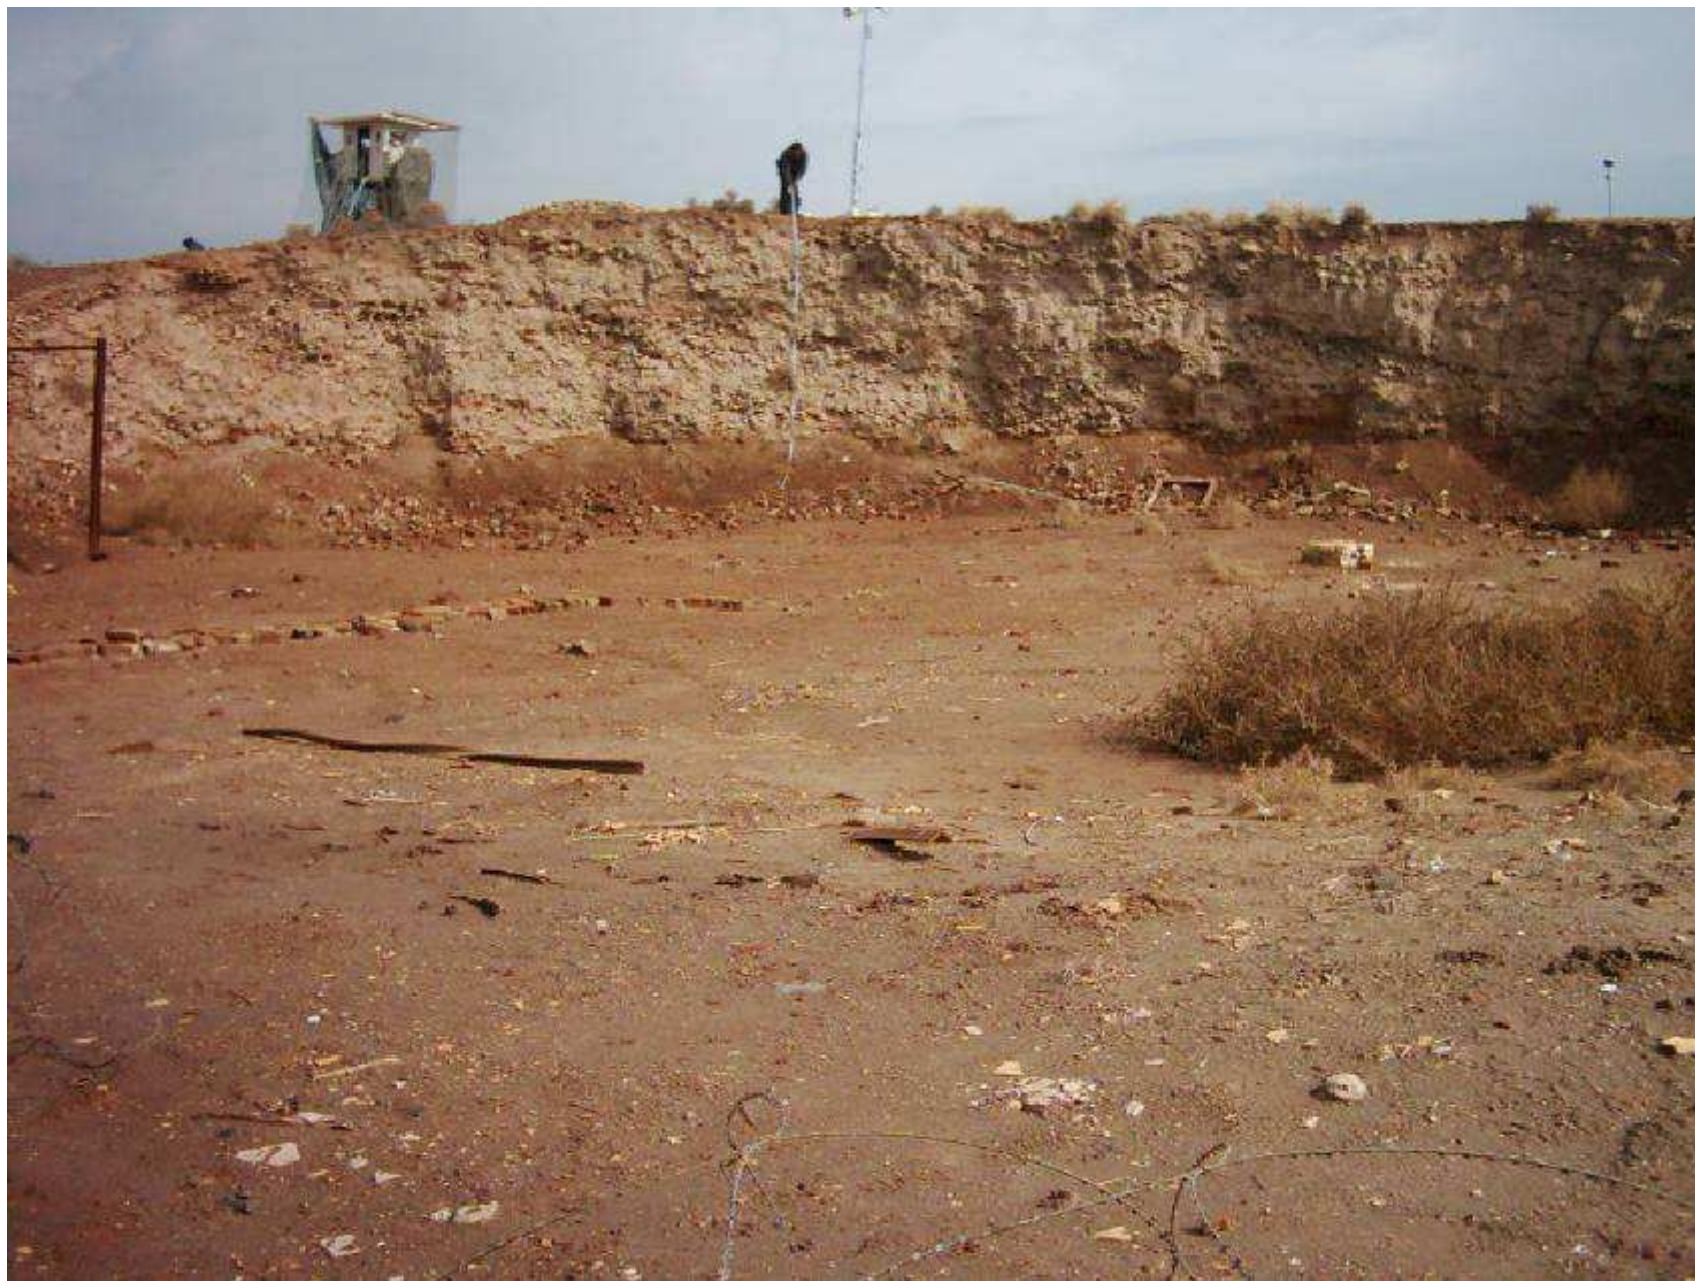
Cut 3, Iraqi final report fig. 41

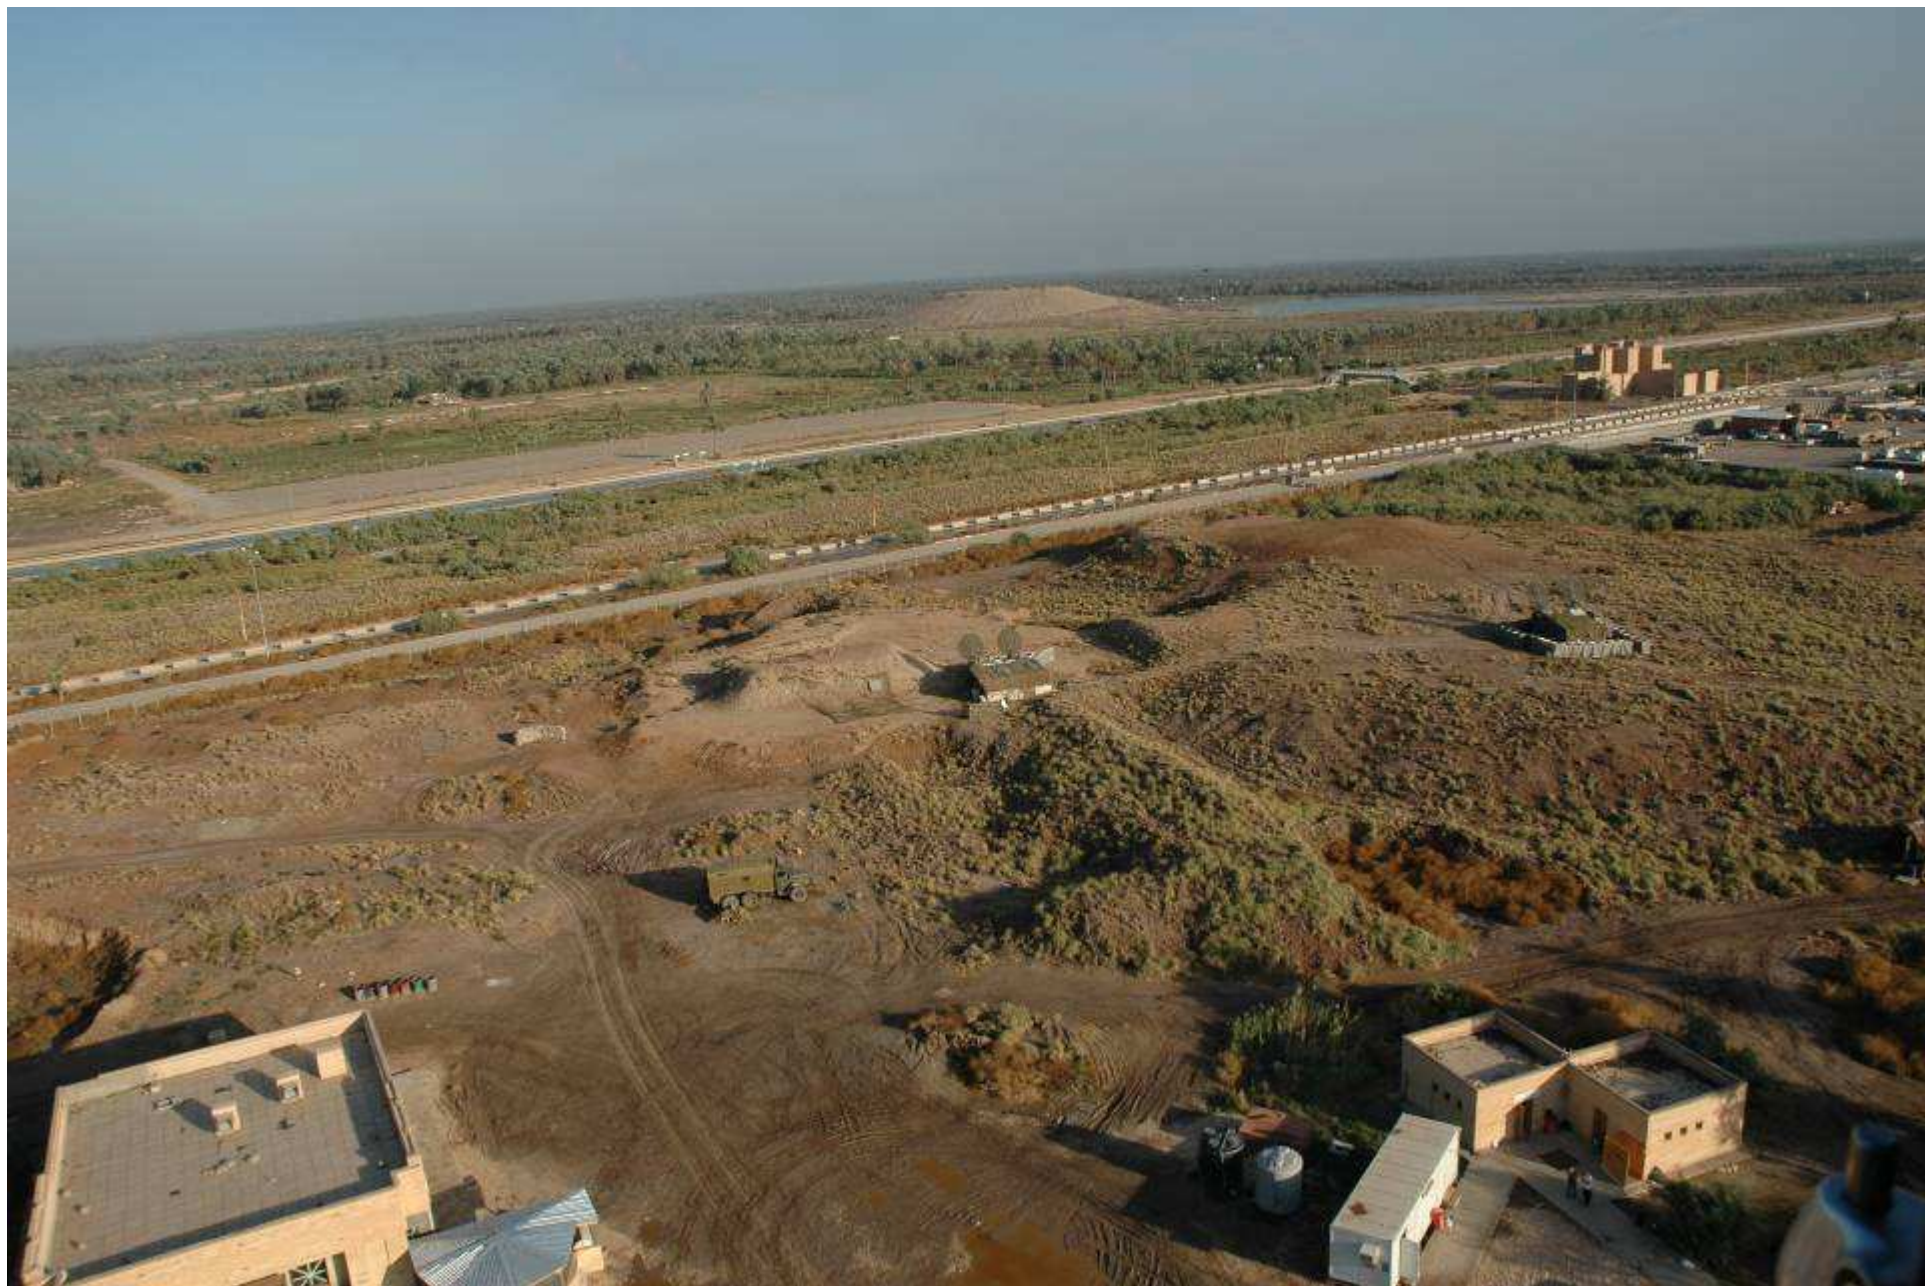
Cut 4 (overgrown at lower right) and truck E, Polish photo 150 (photo © Ministry of Culture and National Heritage, Republic of Poland)

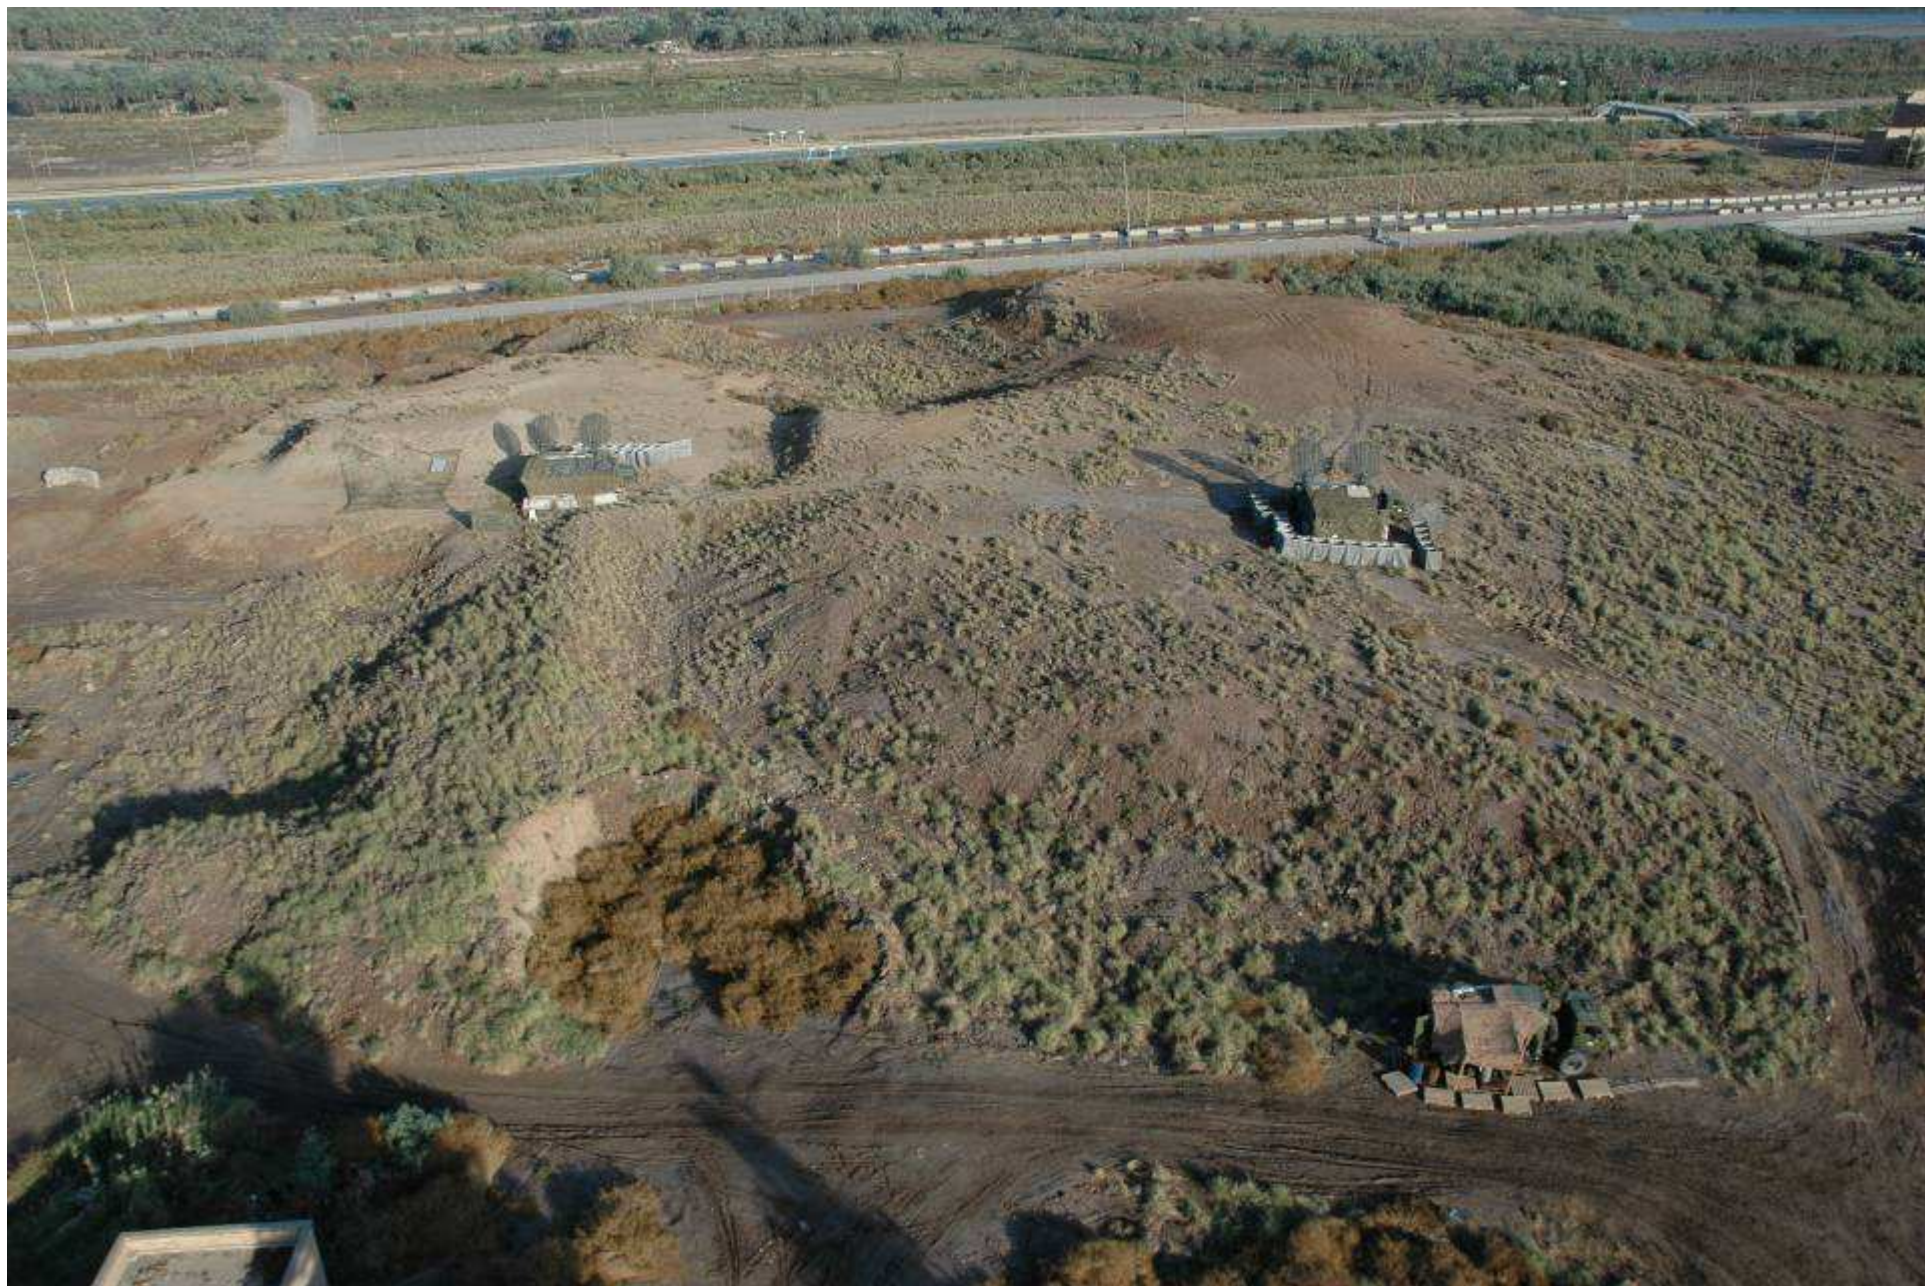
Cut 4 (overgrown), Polish photo 151 (photo © Ministry of Culture and National Heritage, Republic of Poland)

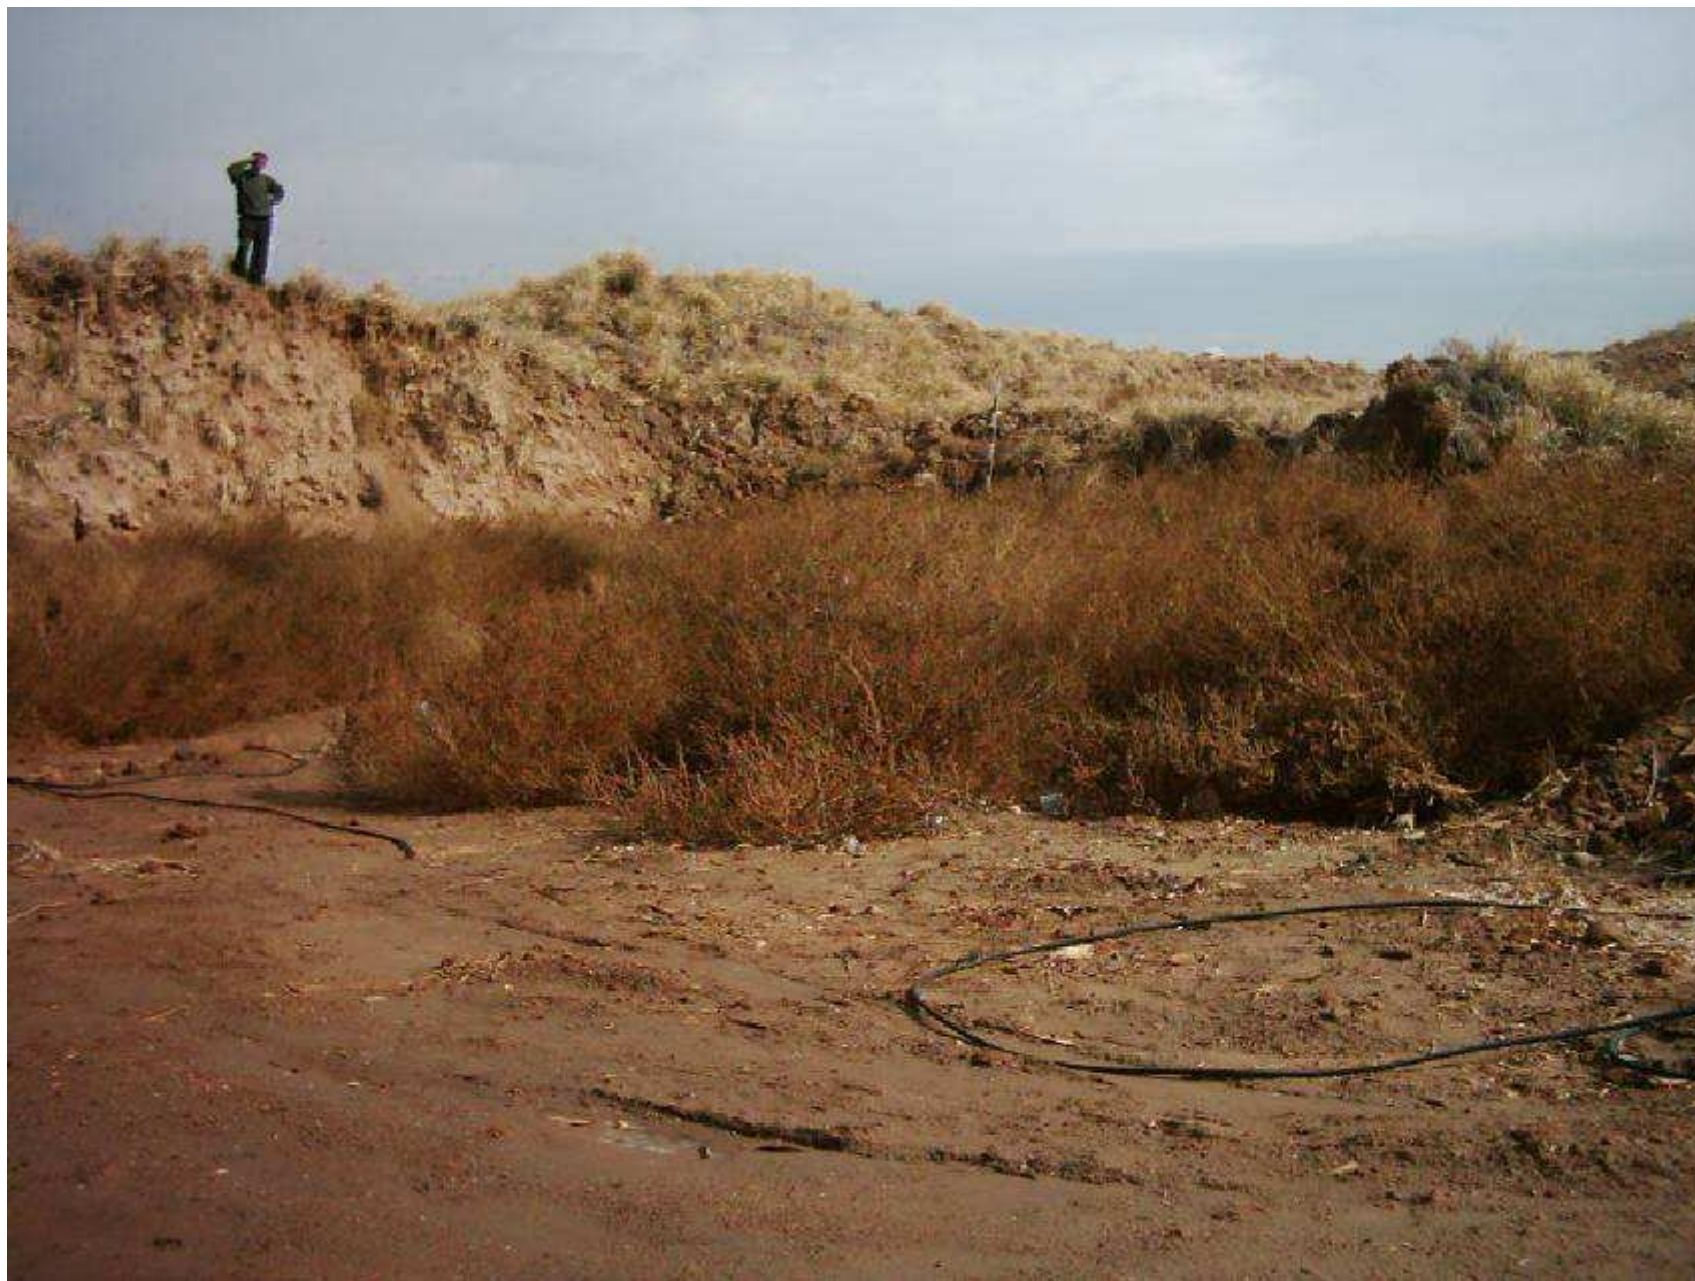
Cut 4, Iraqi final report fig. 42
