# **Report on Damage to the Site of Babylon, Iraq**

**John Malcolm Russell, Ph.D.**

**Cultural Heritage Center  
Bureau of Educational and Cultural Affairs  
Department of State**

**April 2010**

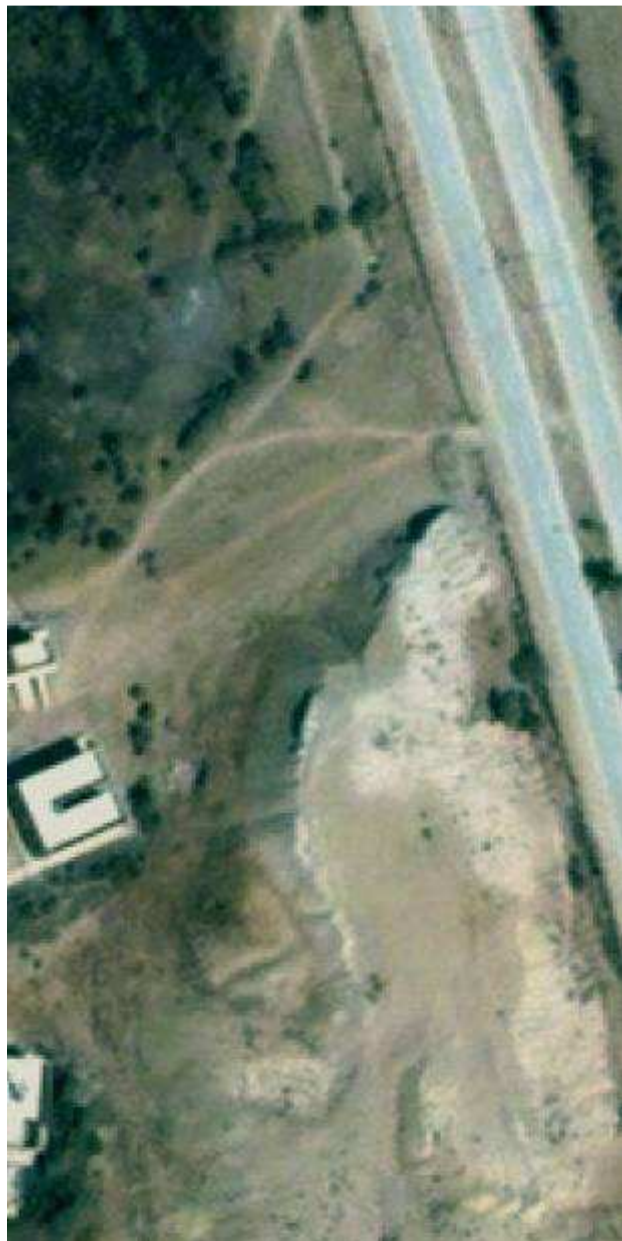
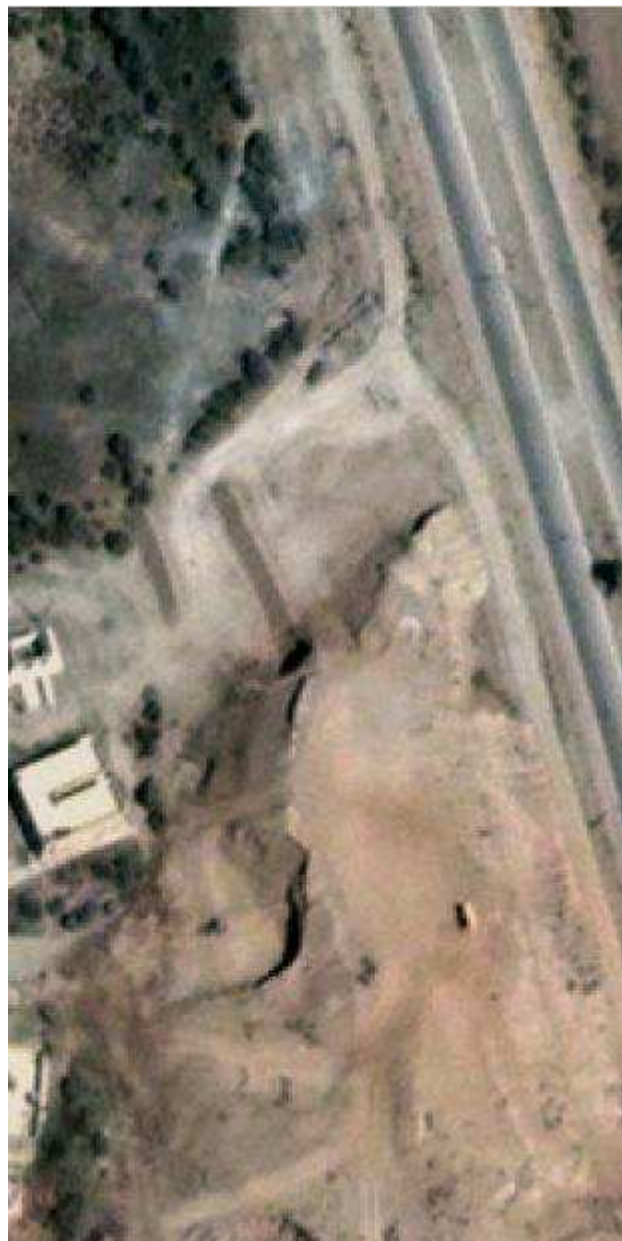
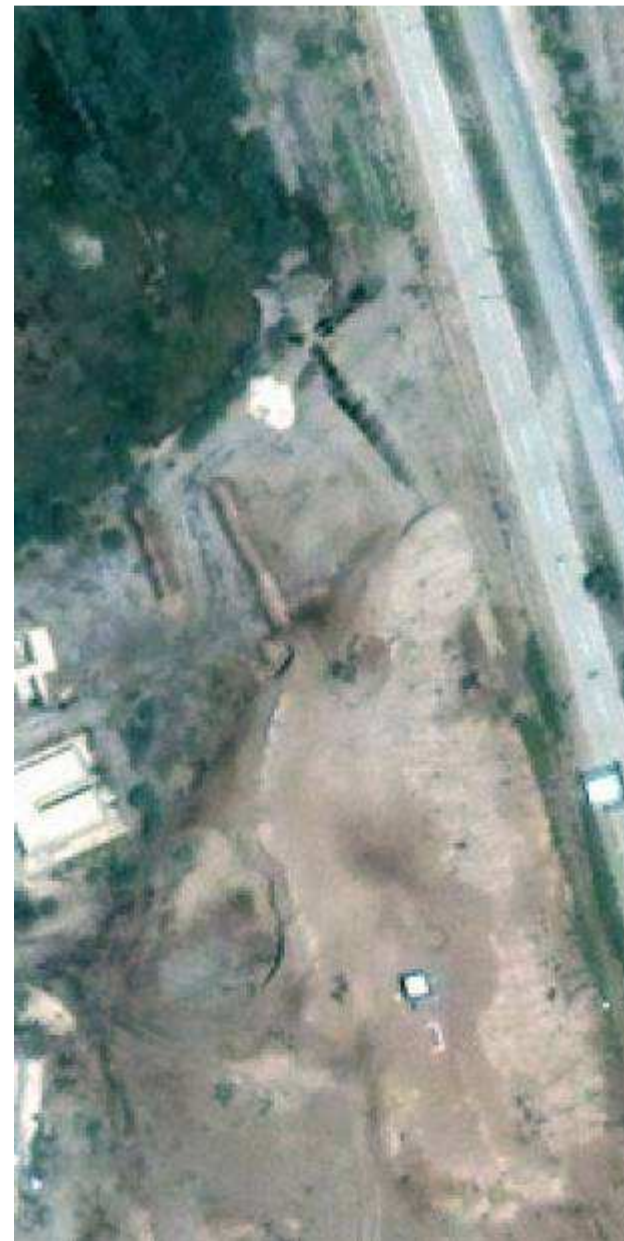
**Russell comment:** This entrance, which provides access to the lake area, was partially blocked with 2 berms by 31 August 2003. A third berm and trench were added by 4 June 2004, completely blocking this entrance, which then apparently went out of use. The earth for the outer berm came from the trench dug at its base. The earth for the middle berm, and possibly also the inner berm, evidently came from Cut 1.

1 April 2003, Russell composite

31 August 2003, Russell composite

4 June 2004, Russell composite

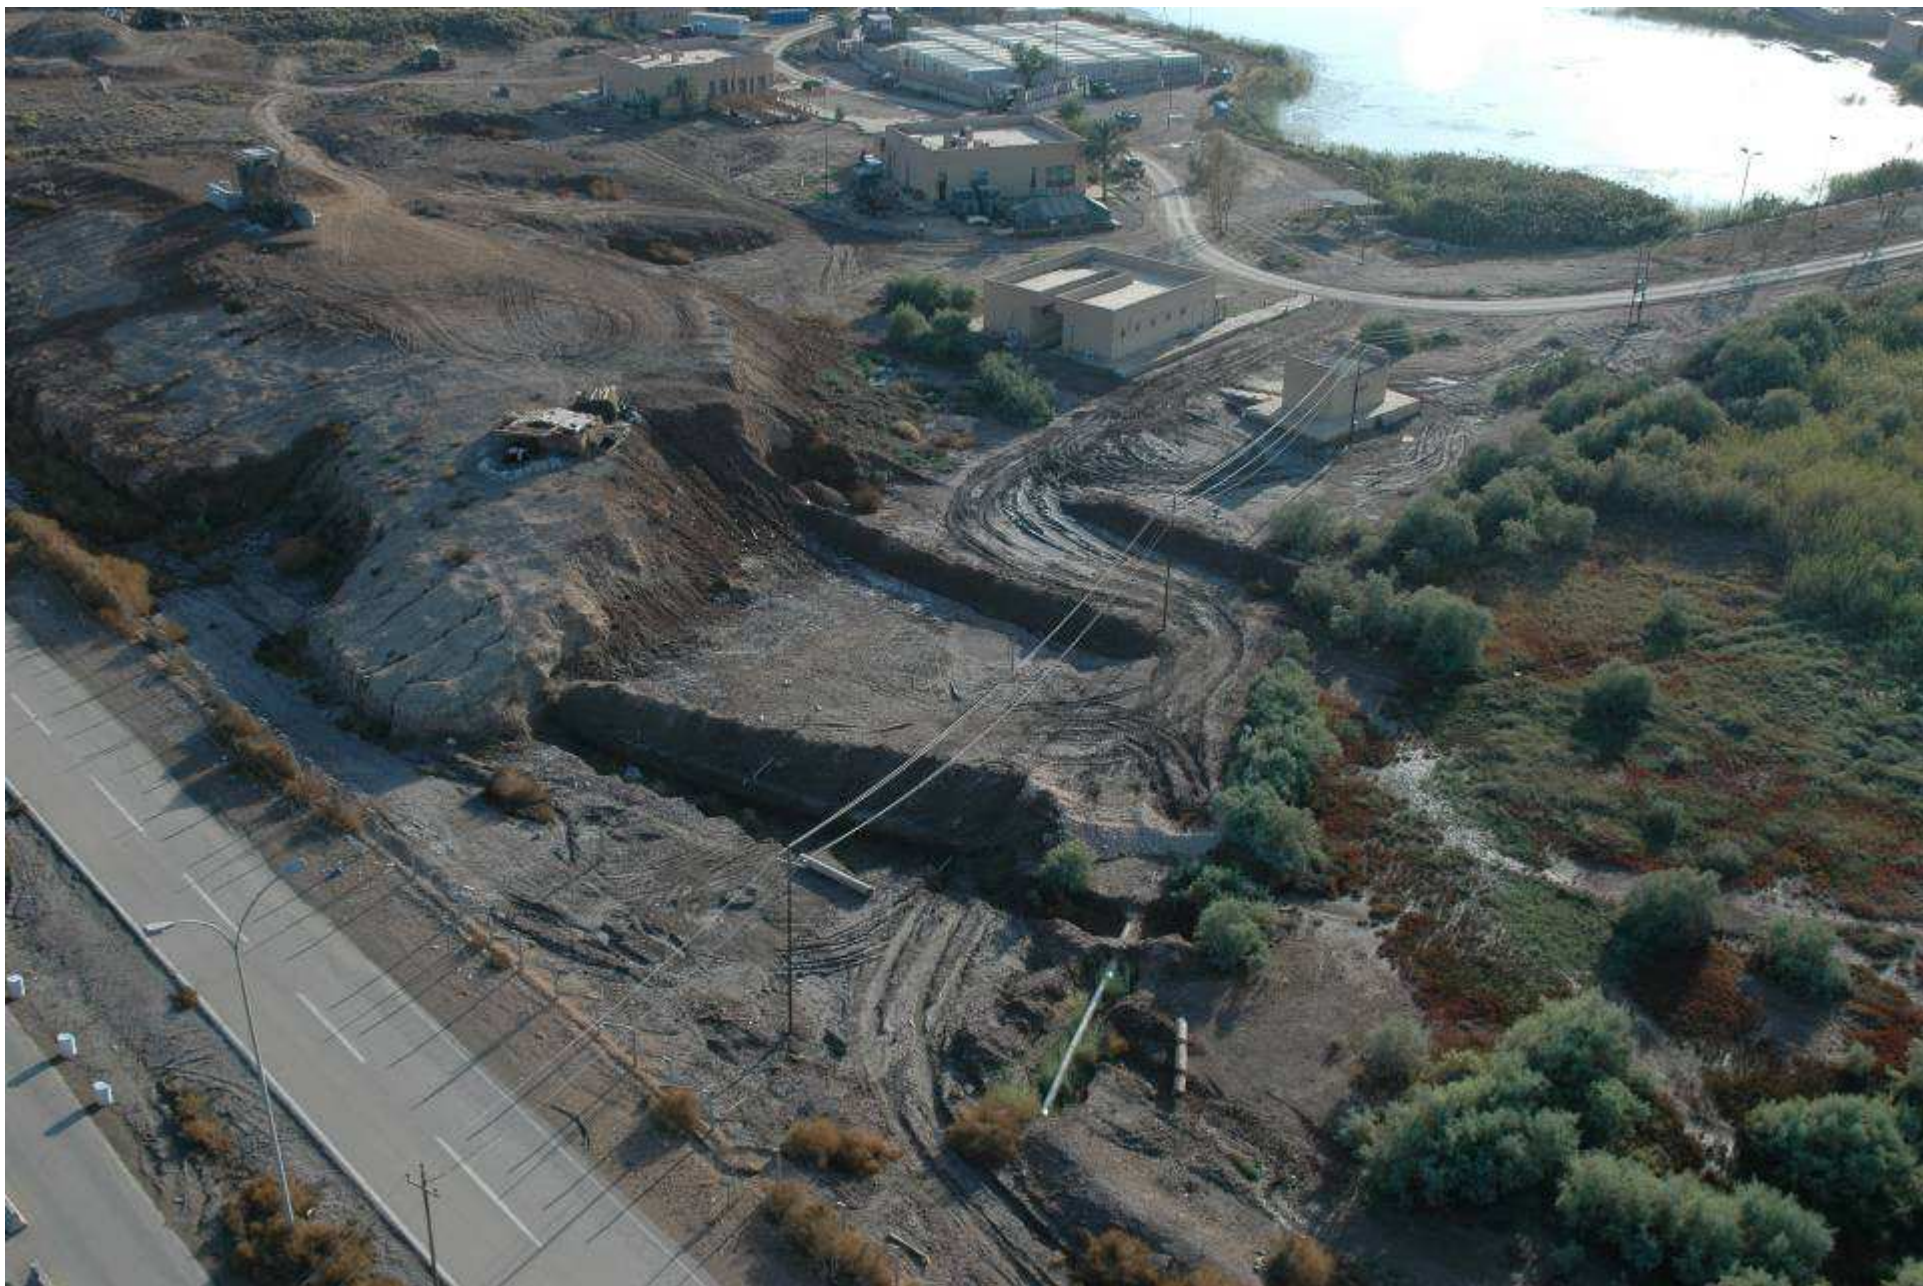
Berms at entrance, Polish photo 155 (photo © Ministry of Culture and National Heritage, Republic of Poland)

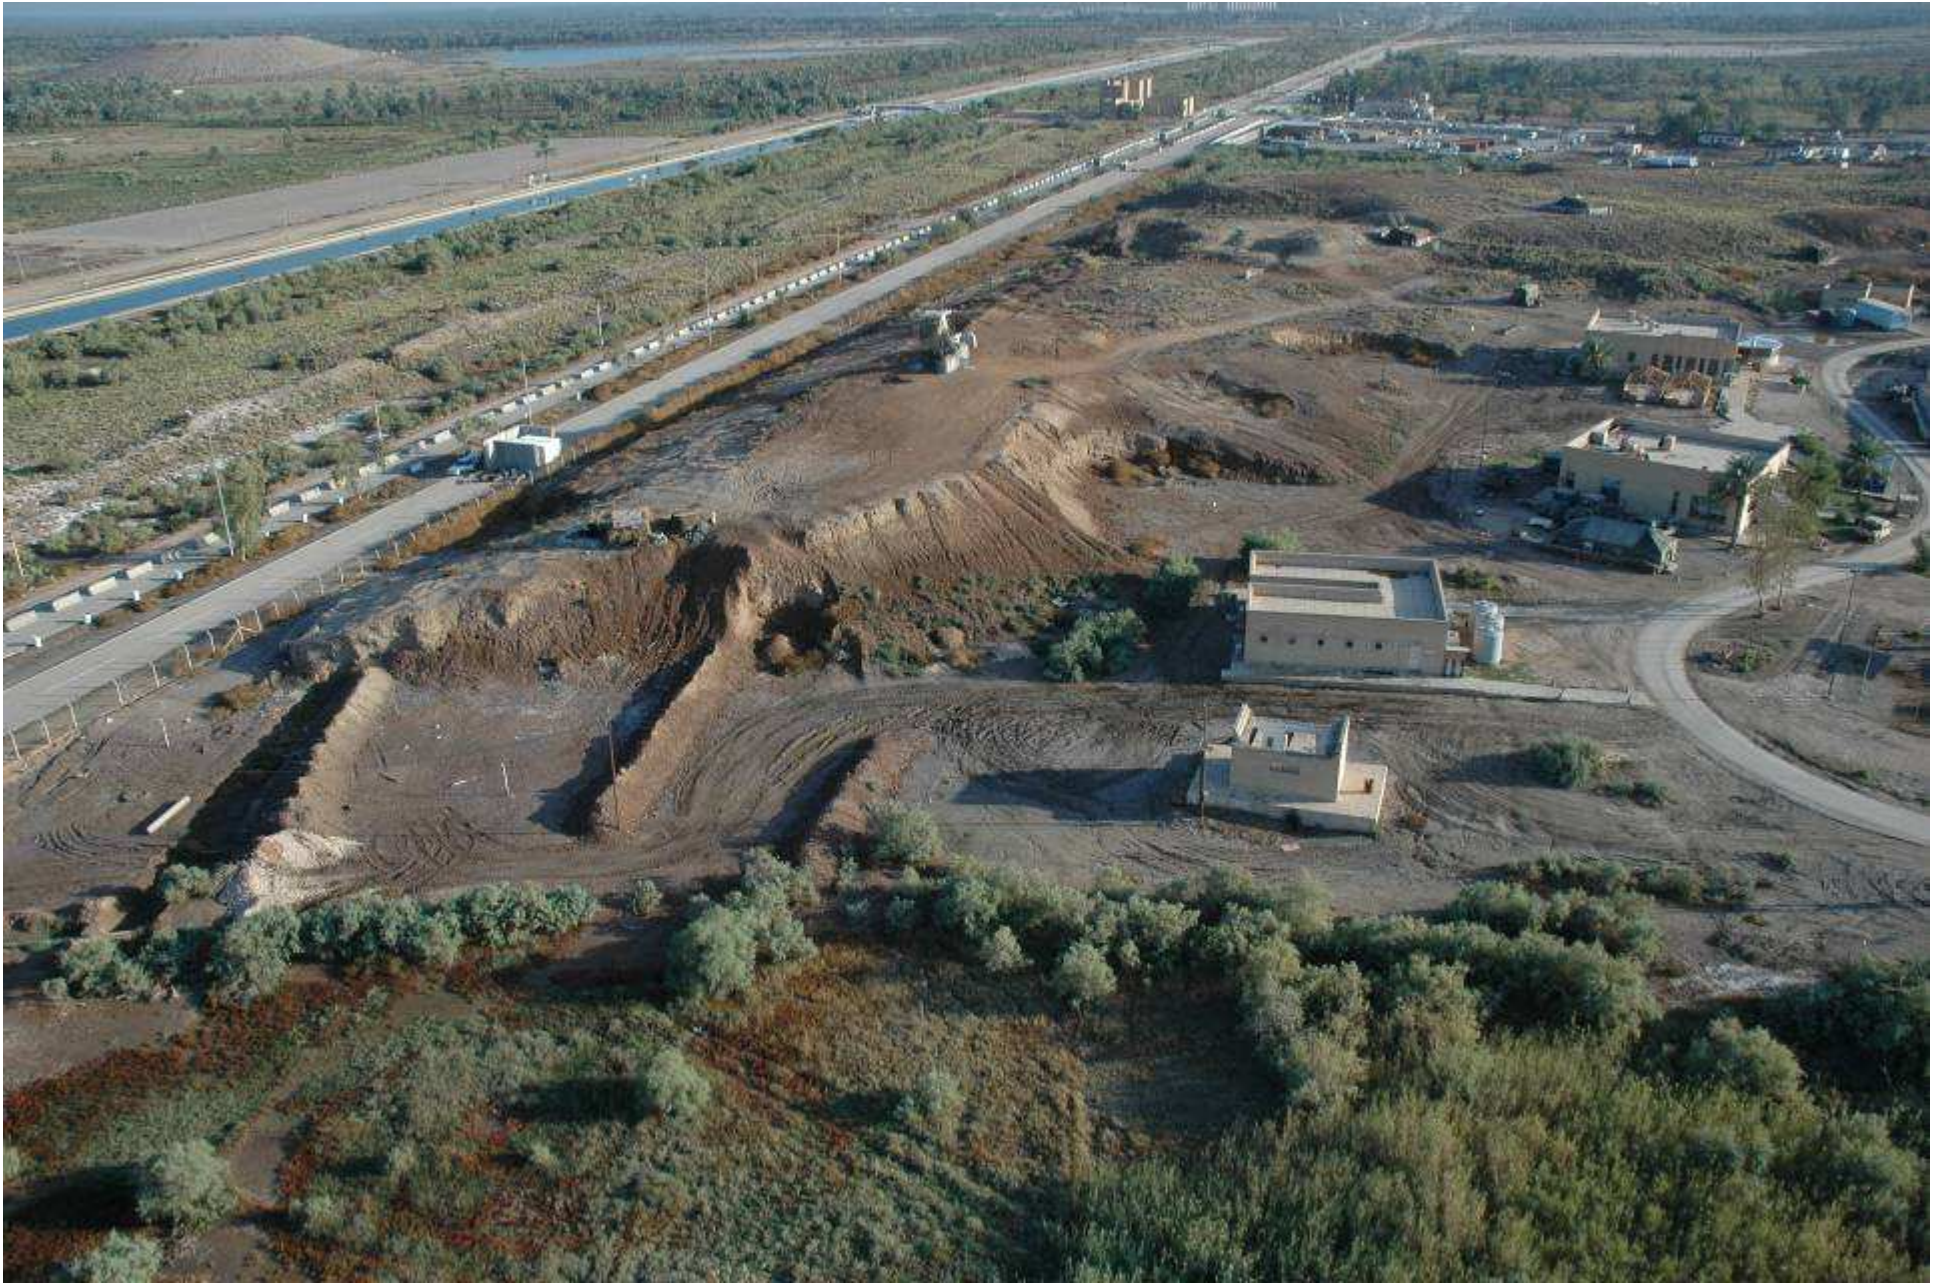
Berms at entrance, Cut 1 (beside end of middle berm), and Cuts 2 and 3 (right middle ground), Polish photo 156 (photo © Ministry of Culture and National Heritage, Republic of Poland)

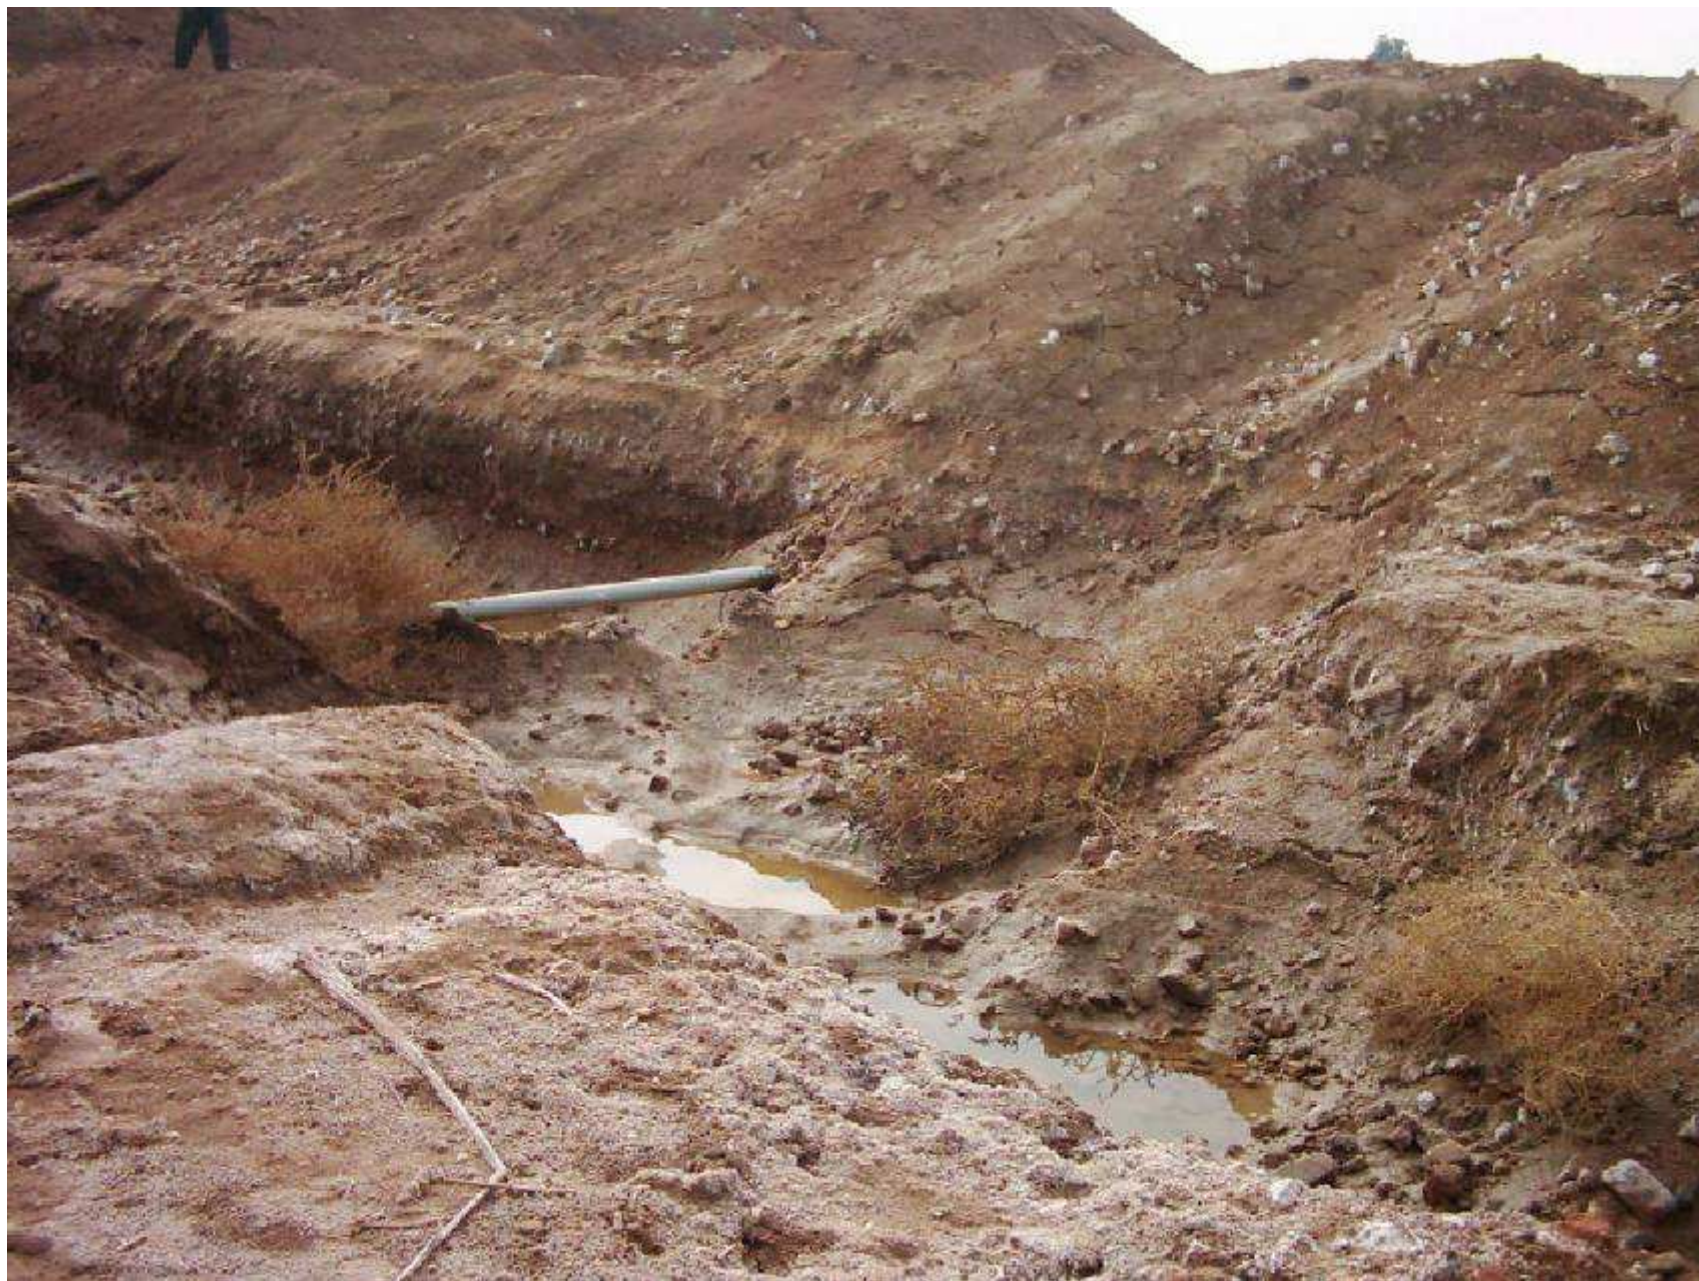
Outer berm and trench, Iraqi final report fig. 63

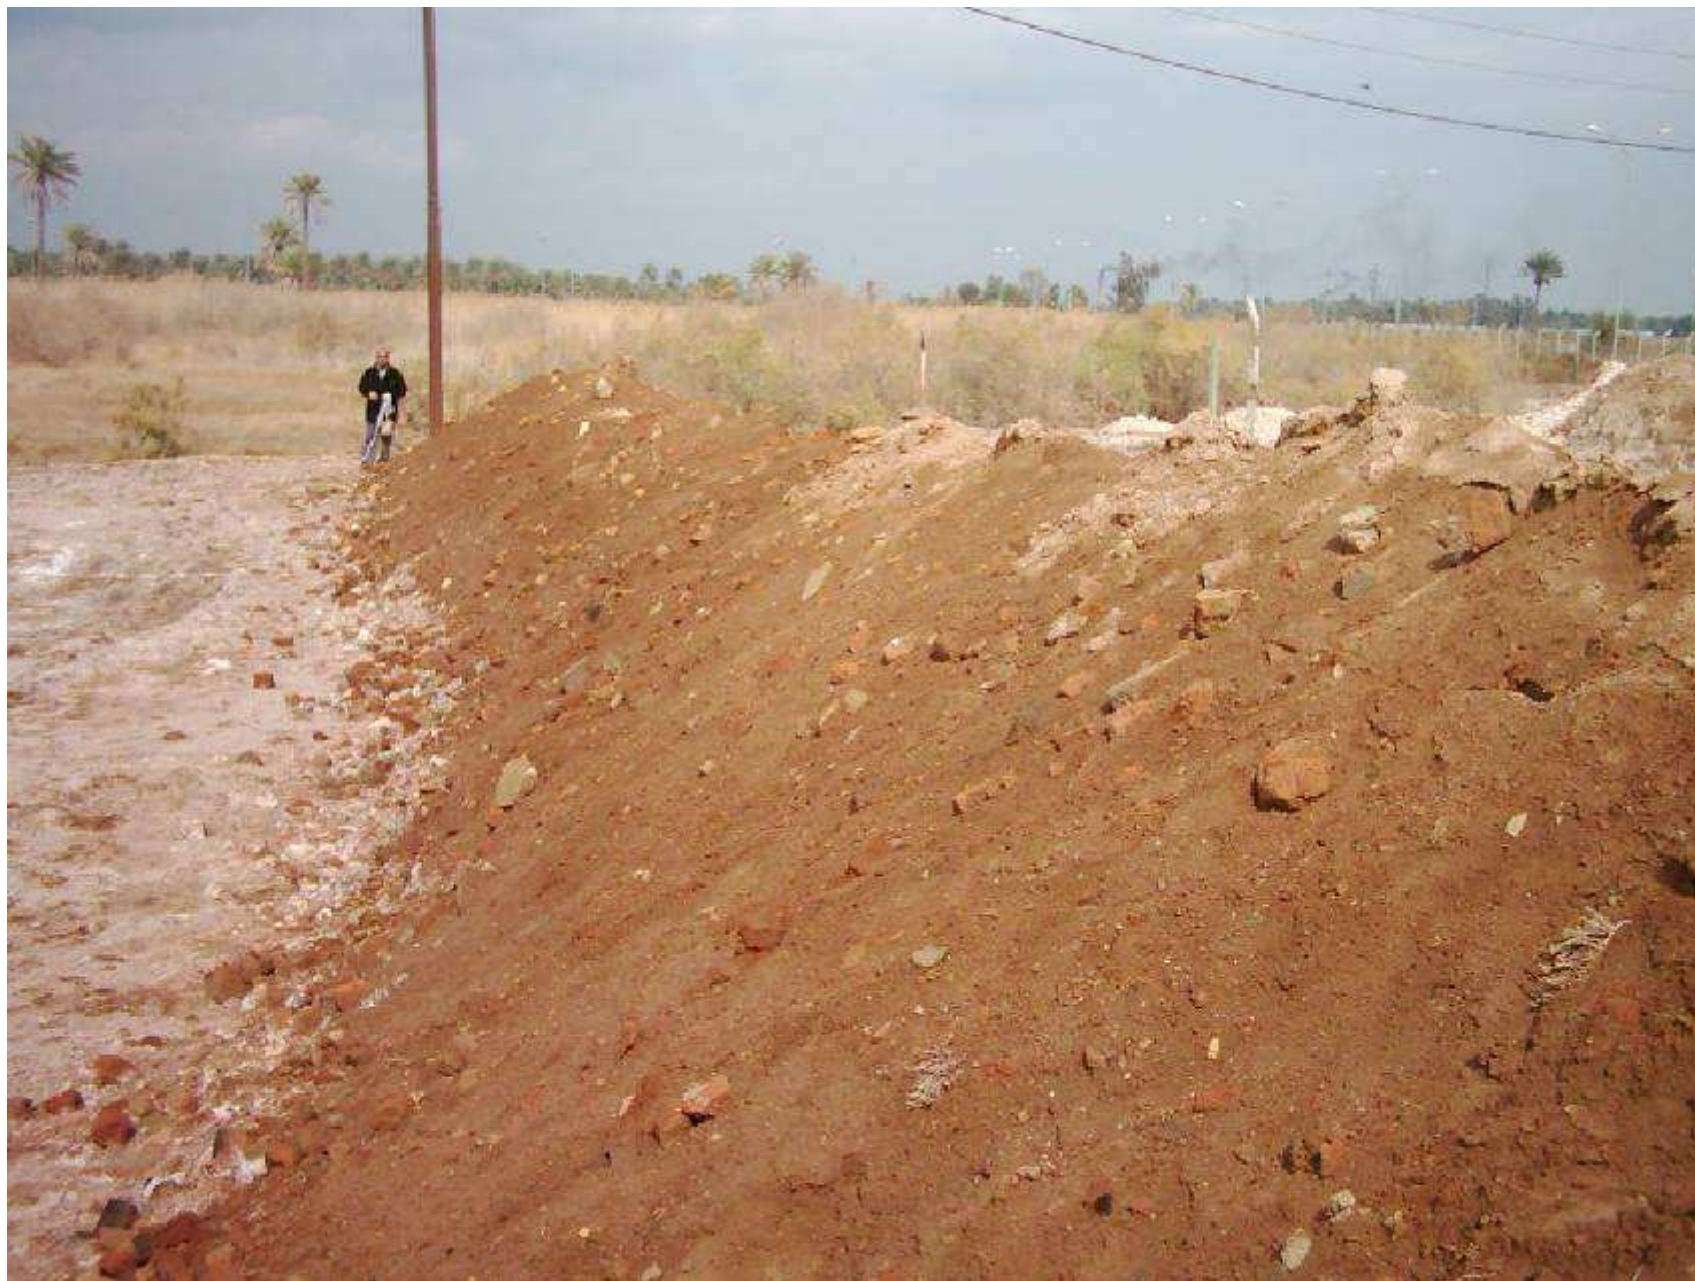
Middle berm, Iraqi final report fig. 64

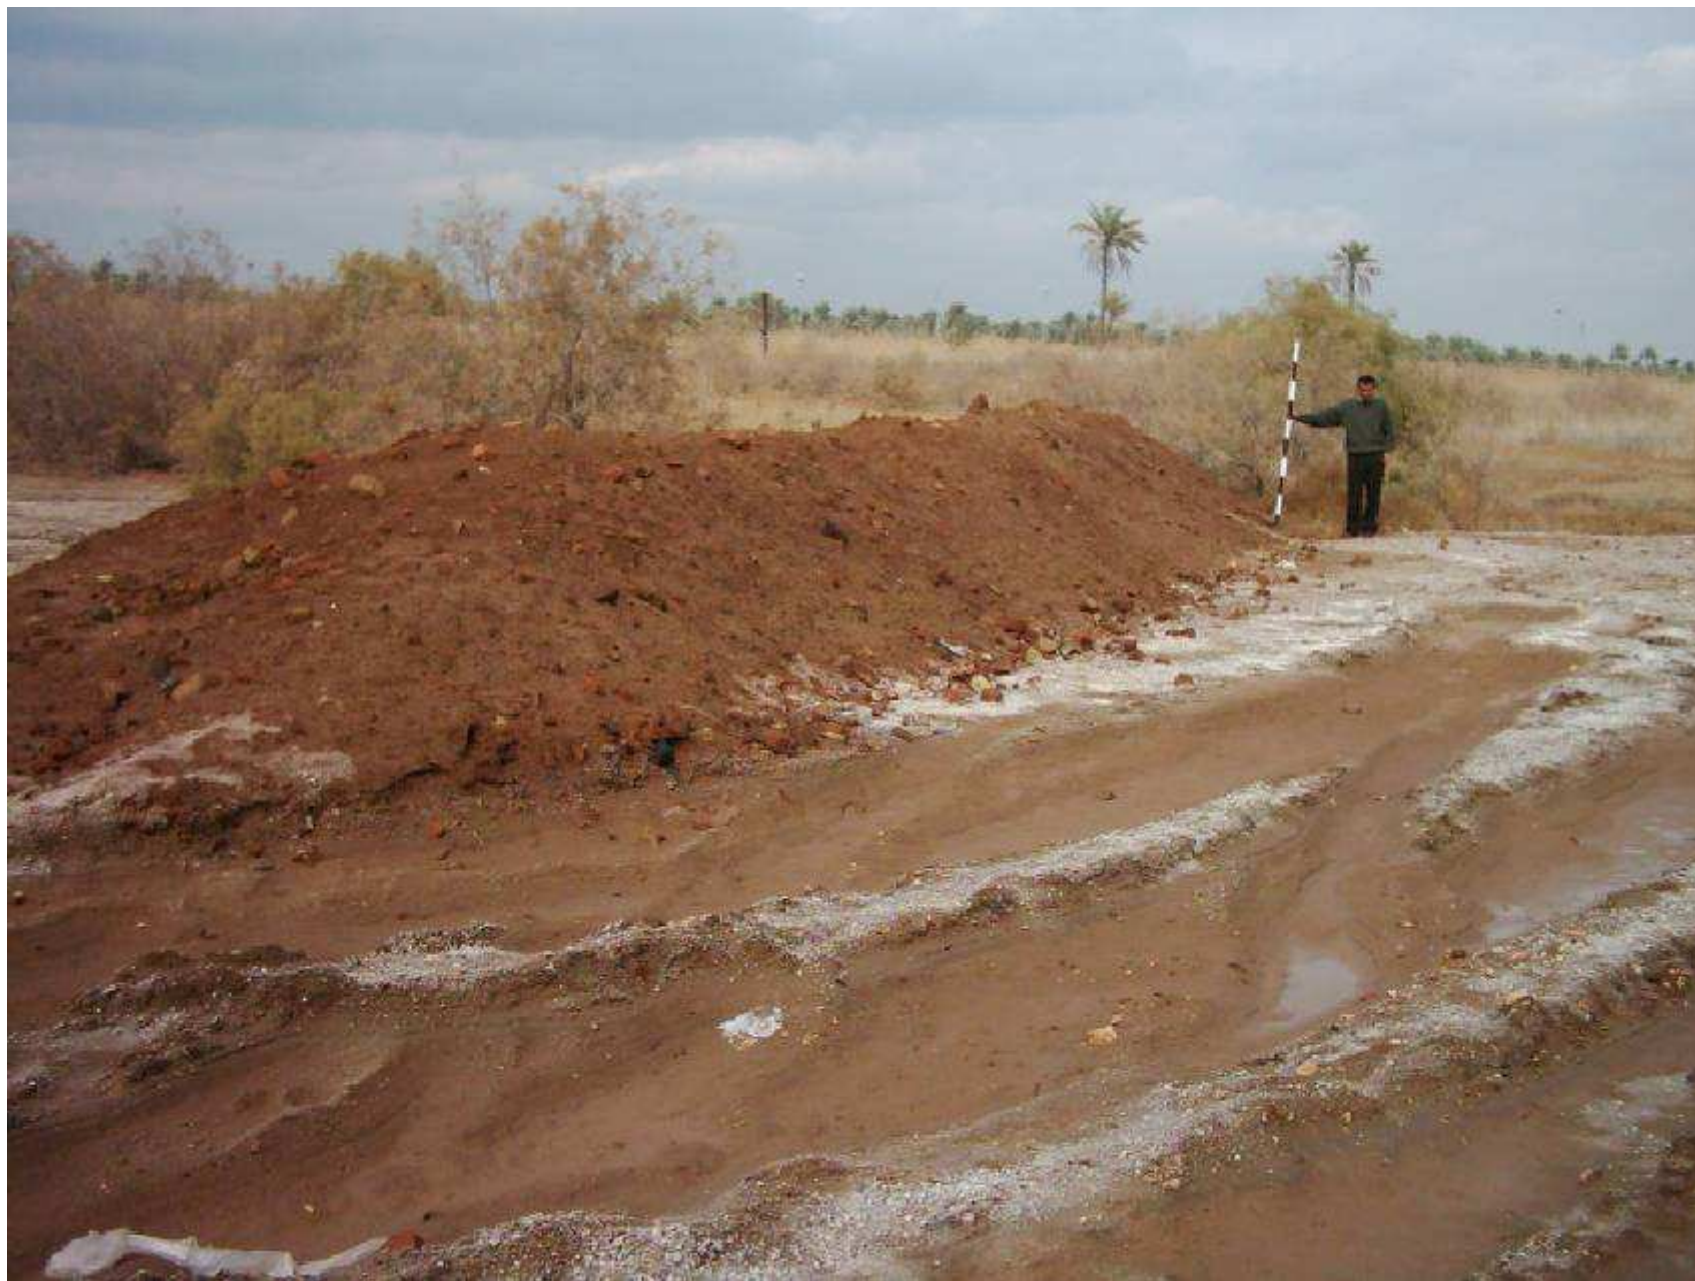
Inner berm, Iraqi final report fig. 65

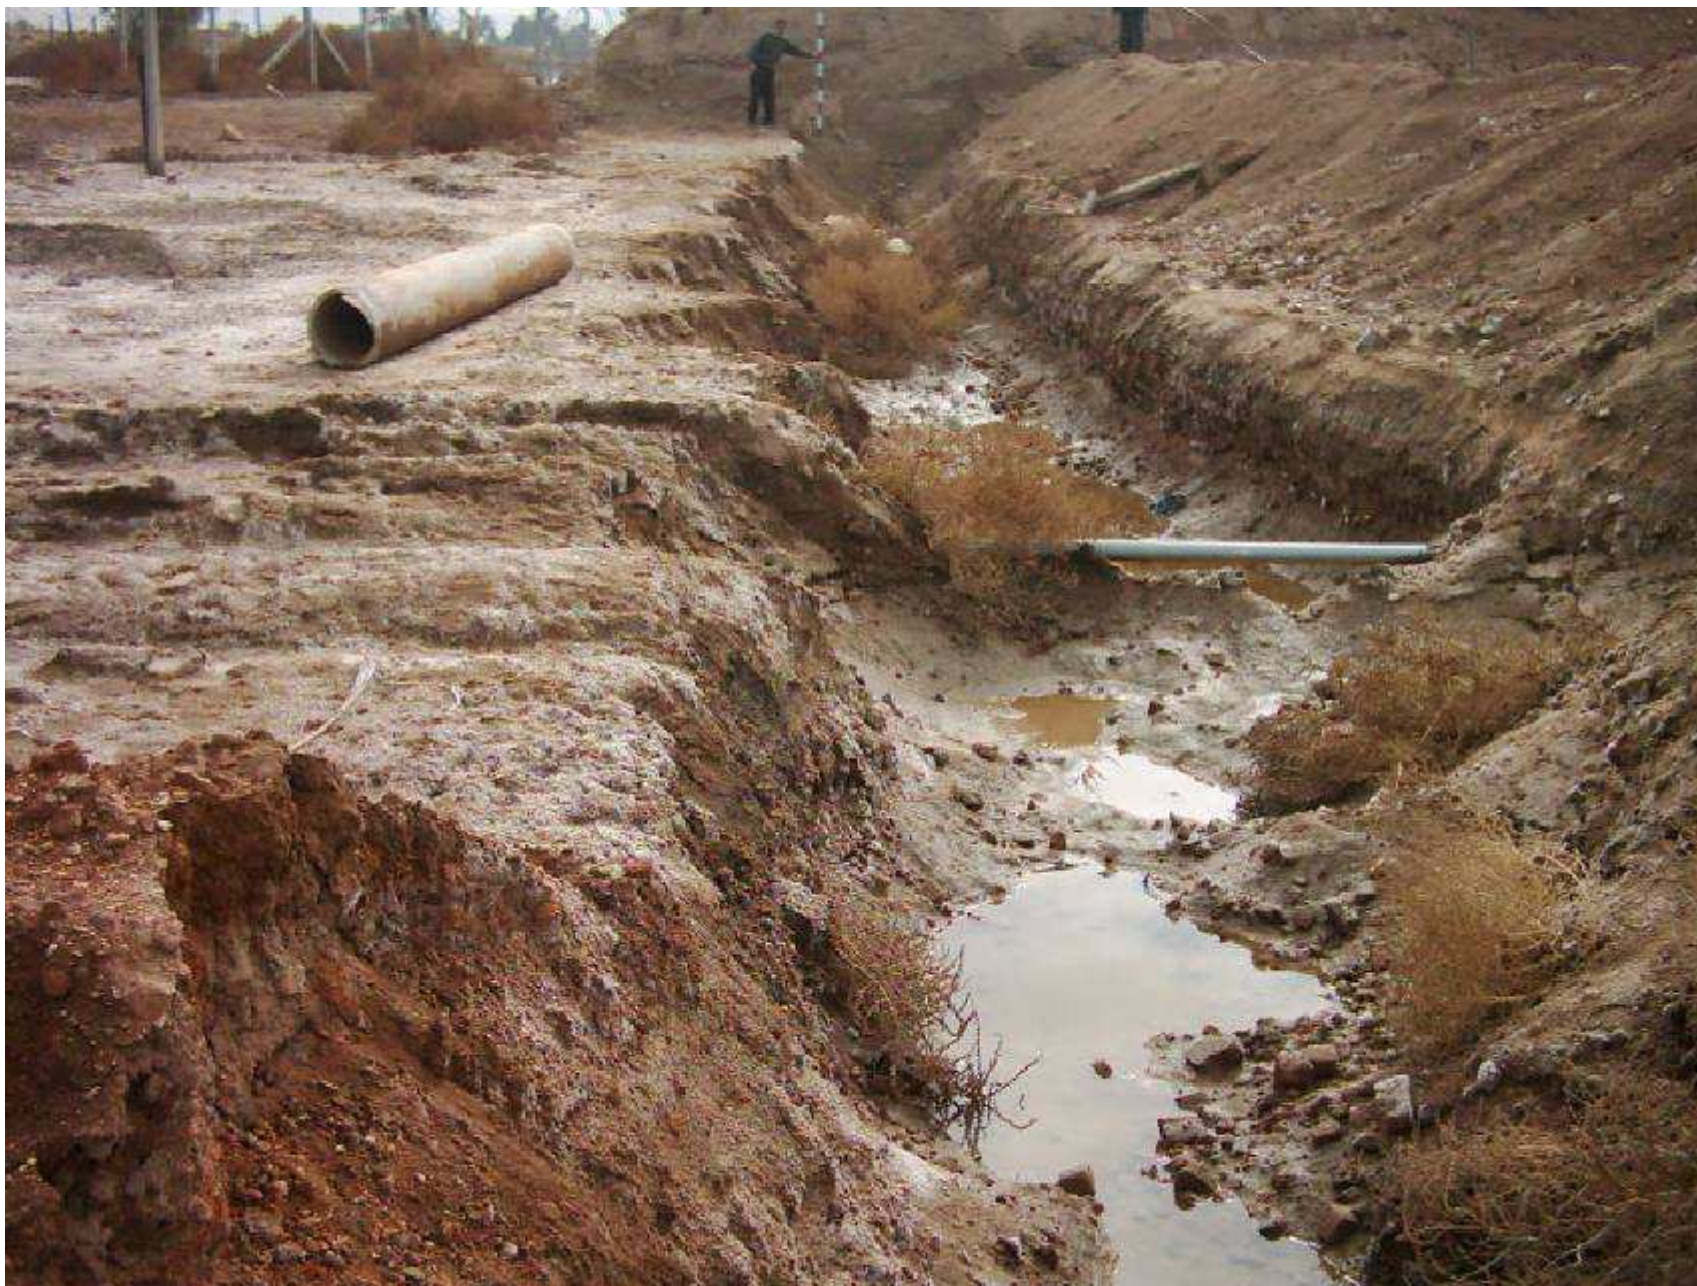
**Russell comment:** The first trench is at the NW gate and was dug at the same time that the outer berm was added, between August 2003 and June 2004, completely blocking this entrance, which then apparently went out of use (image Iraqi final report 22).

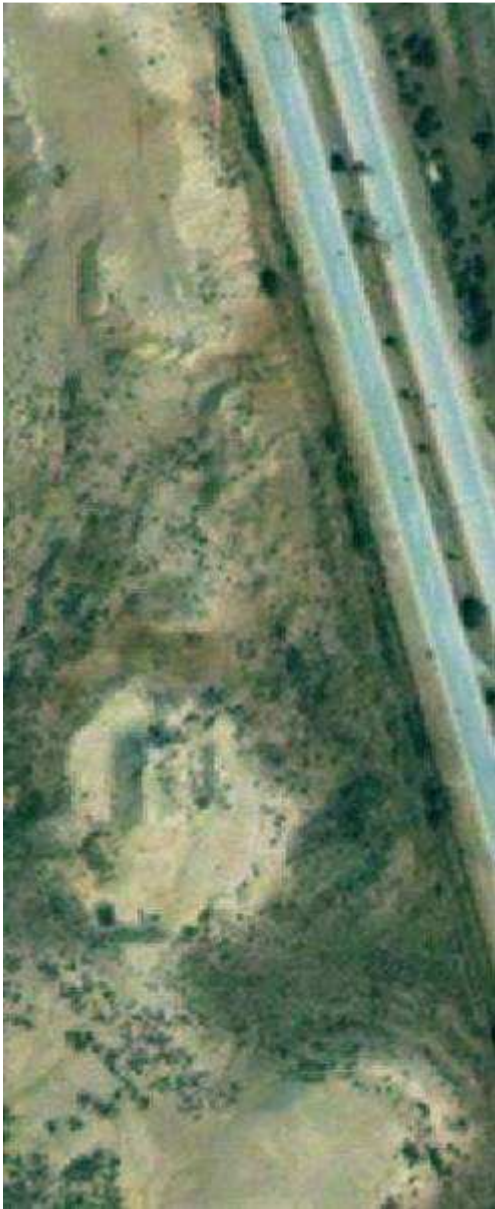
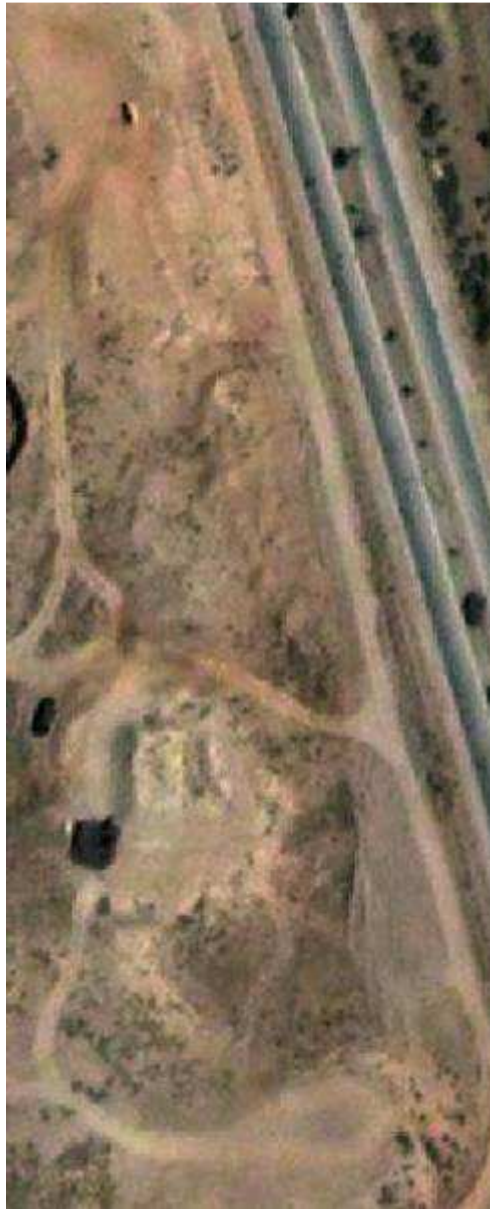
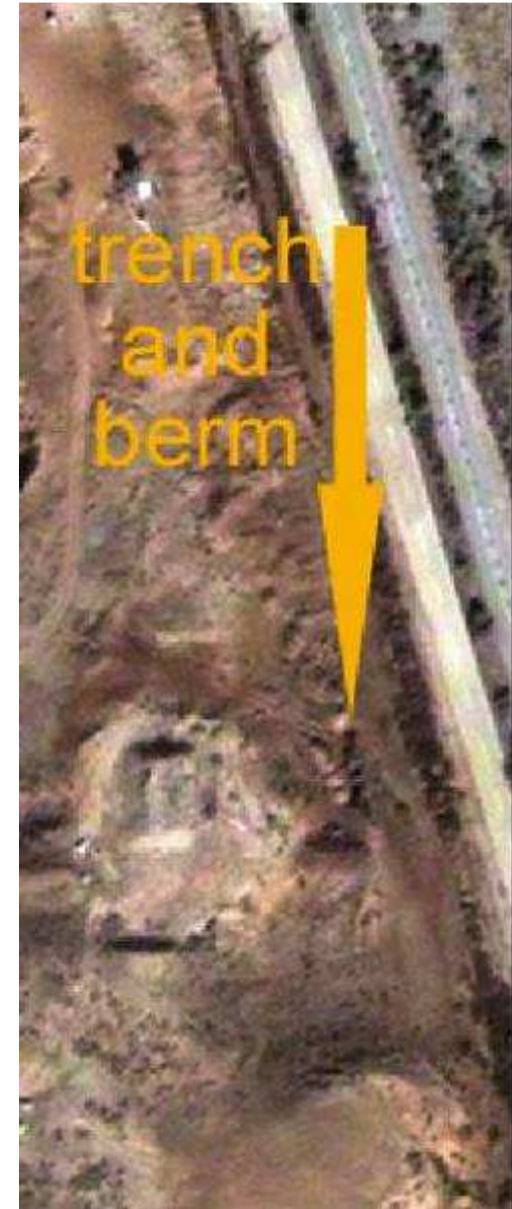
Second trench, 1 April 2003, Russell composite

31 August 2003, Russell composite

26 November 2005, Russell composite

**Russell comment:** The second trench is at the base of the flat-topped center mound of Homera, between the mound and the main road. This appeared between August 2003 and June 2004, and was apparently dug to block the road leading from the main road up to the top of the flat-topped mound.

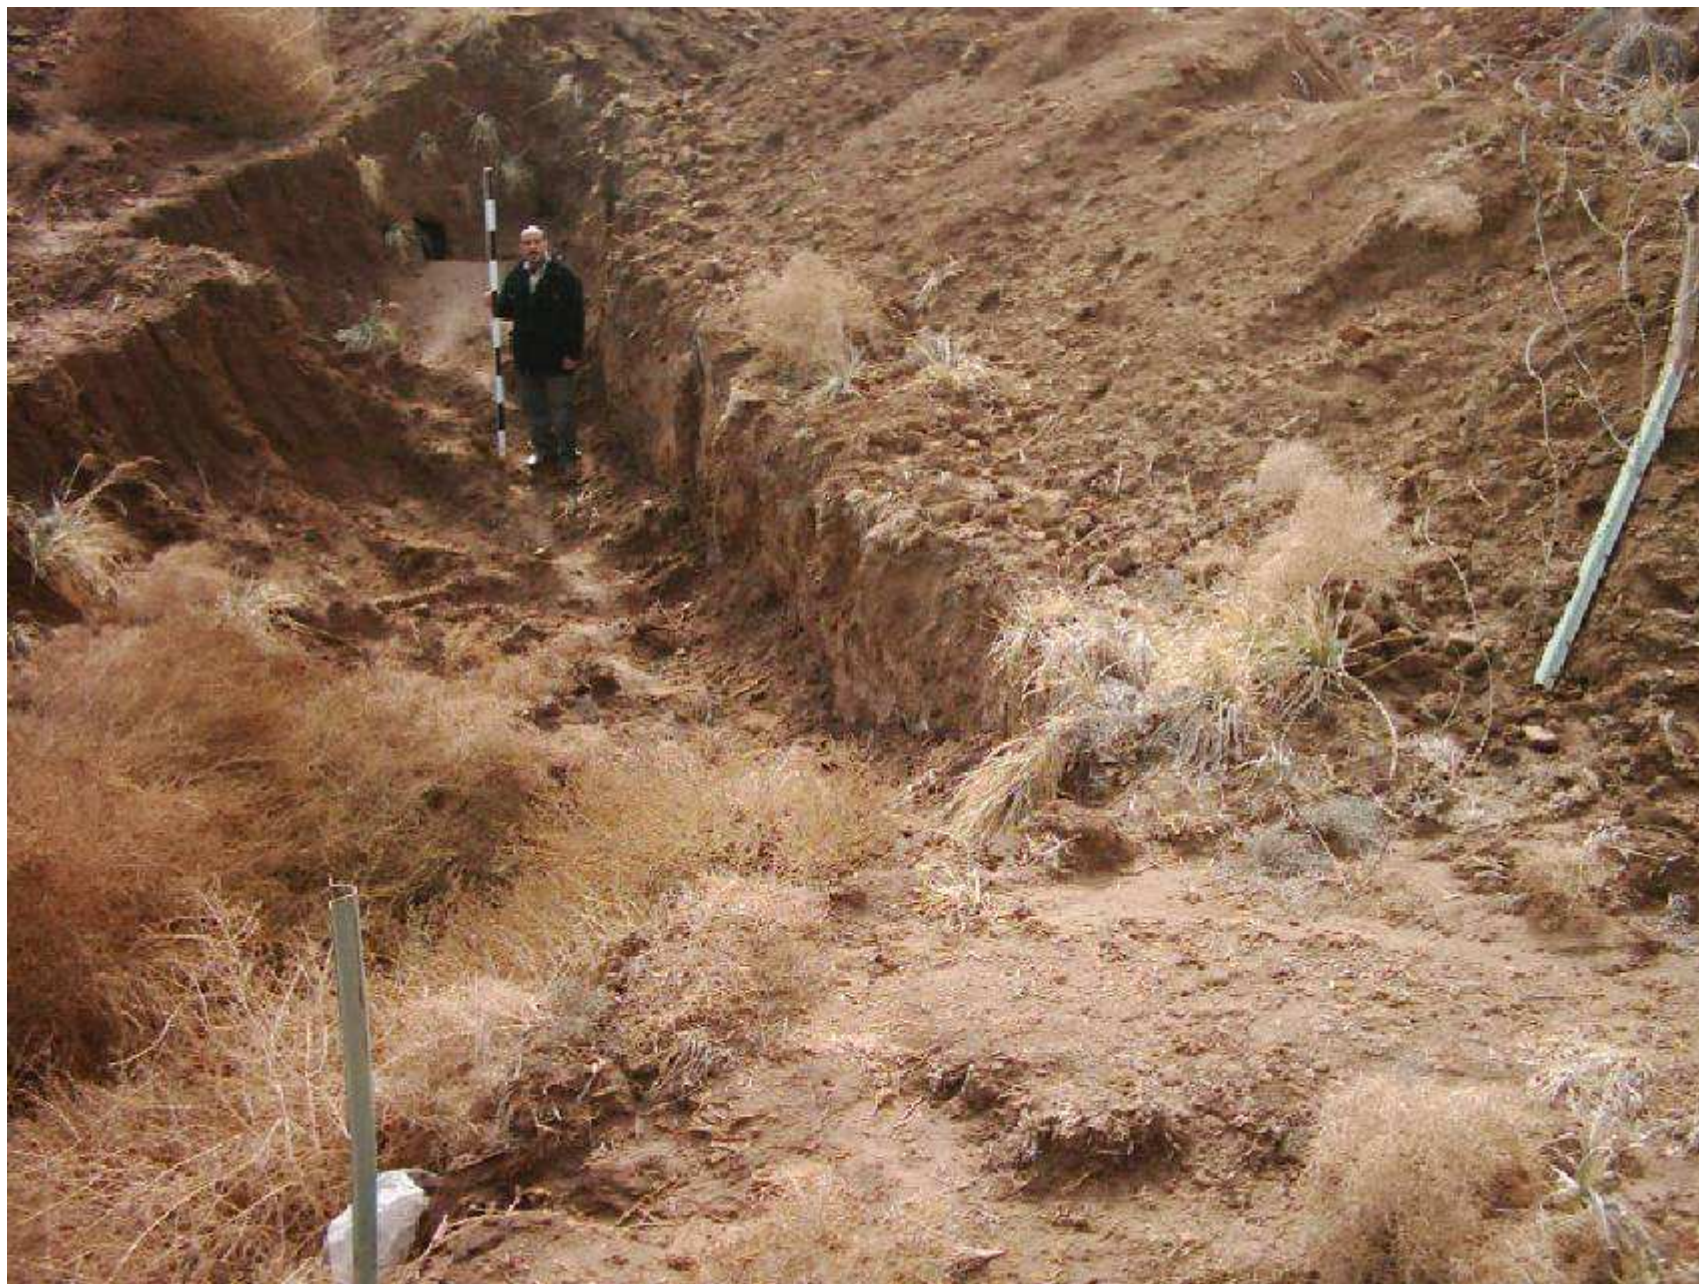
Second trench, Iraqi final report 23

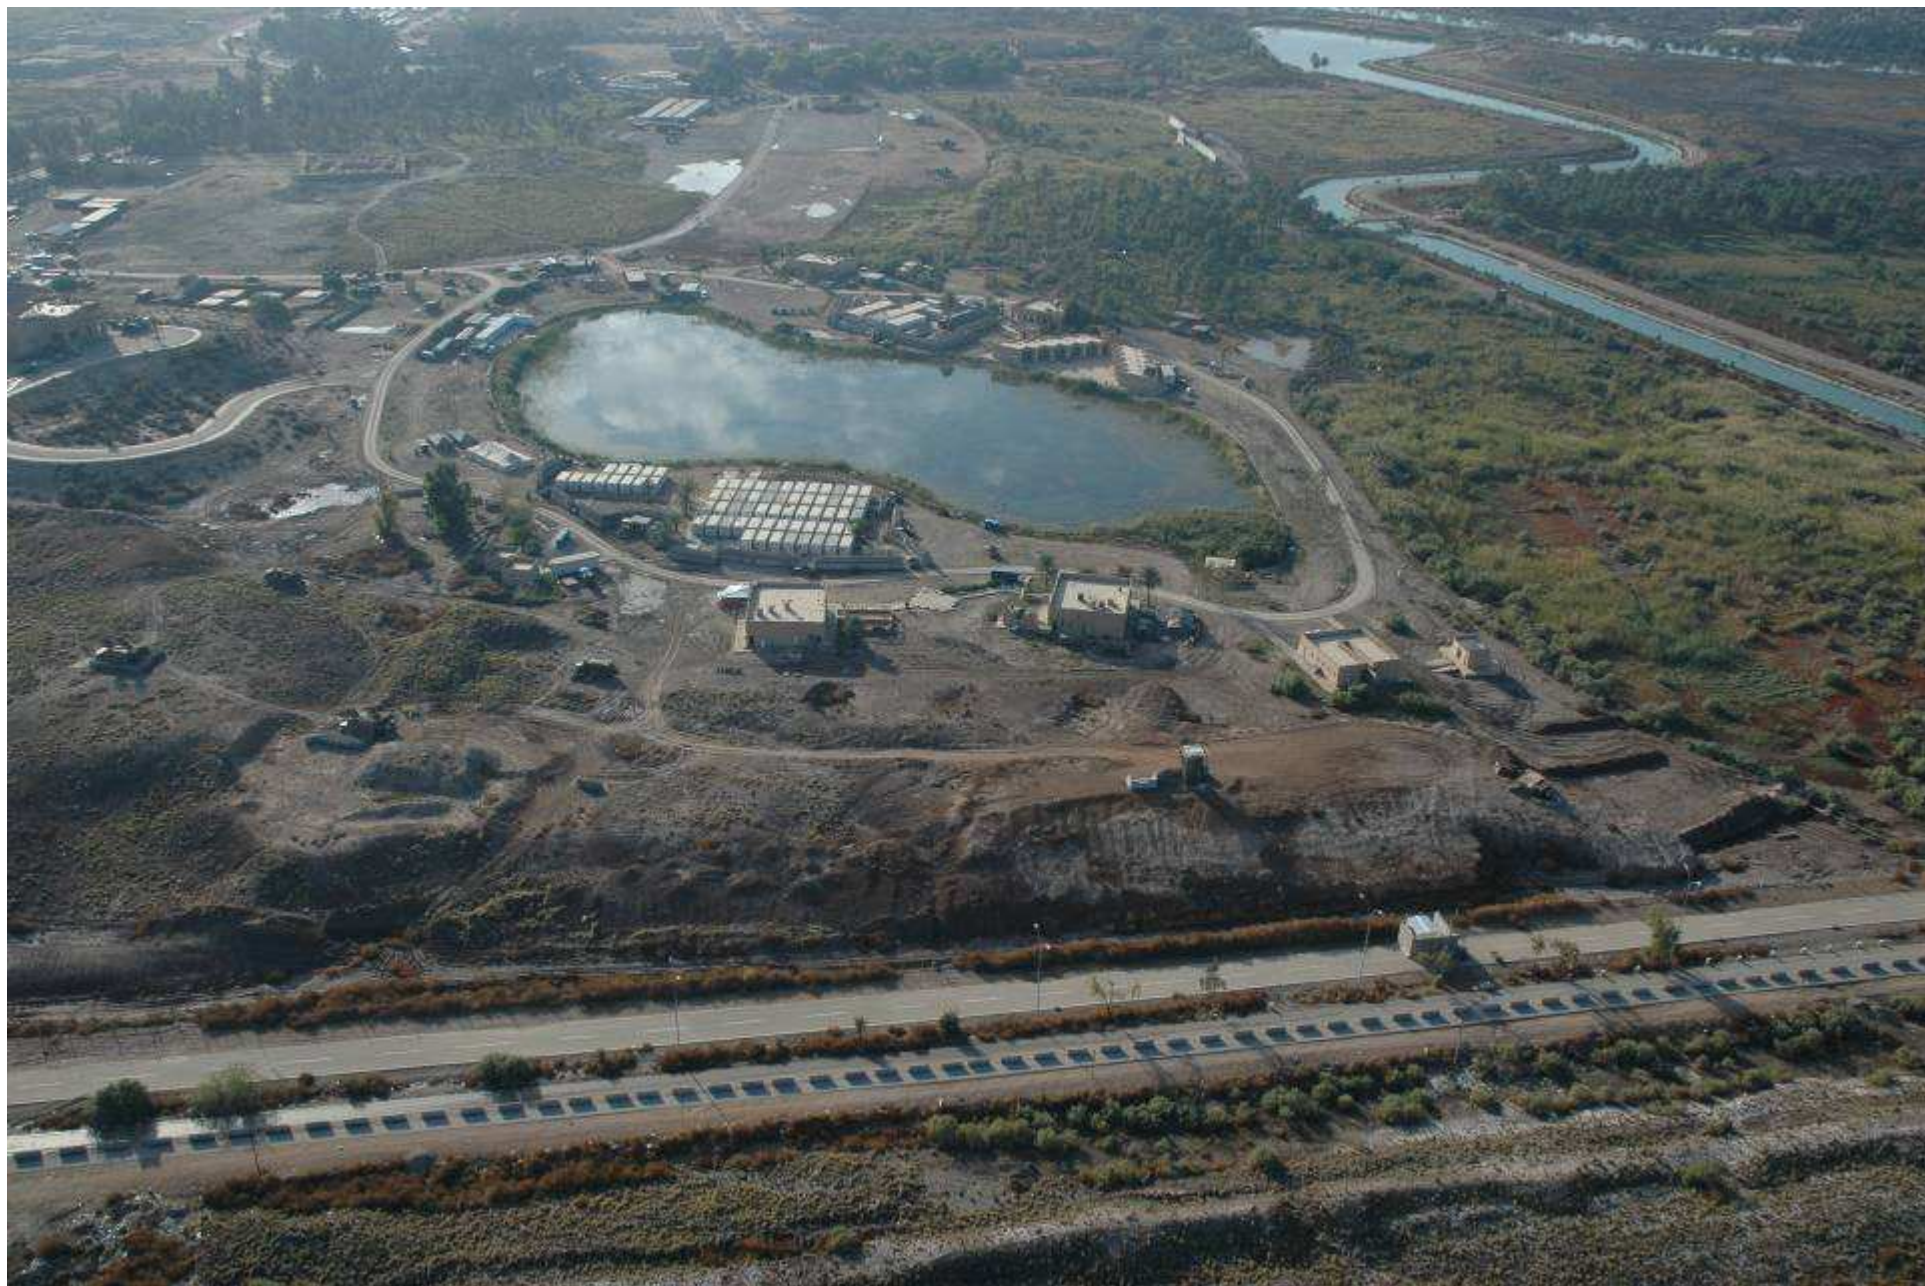
Second trench at lower left, at base of flat-topped mound, Polish photo 16 (photo © Ministry of Culture and National Heritage, Republic of Poland)
