# **Report on Damage to the Site of Babylon, Iraq**

**John Malcolm Russell, Ph.D.**

**Cultural Heritage Center  
Bureau of Educational and Cultural Affairs  
Department of State**

**April 2010**

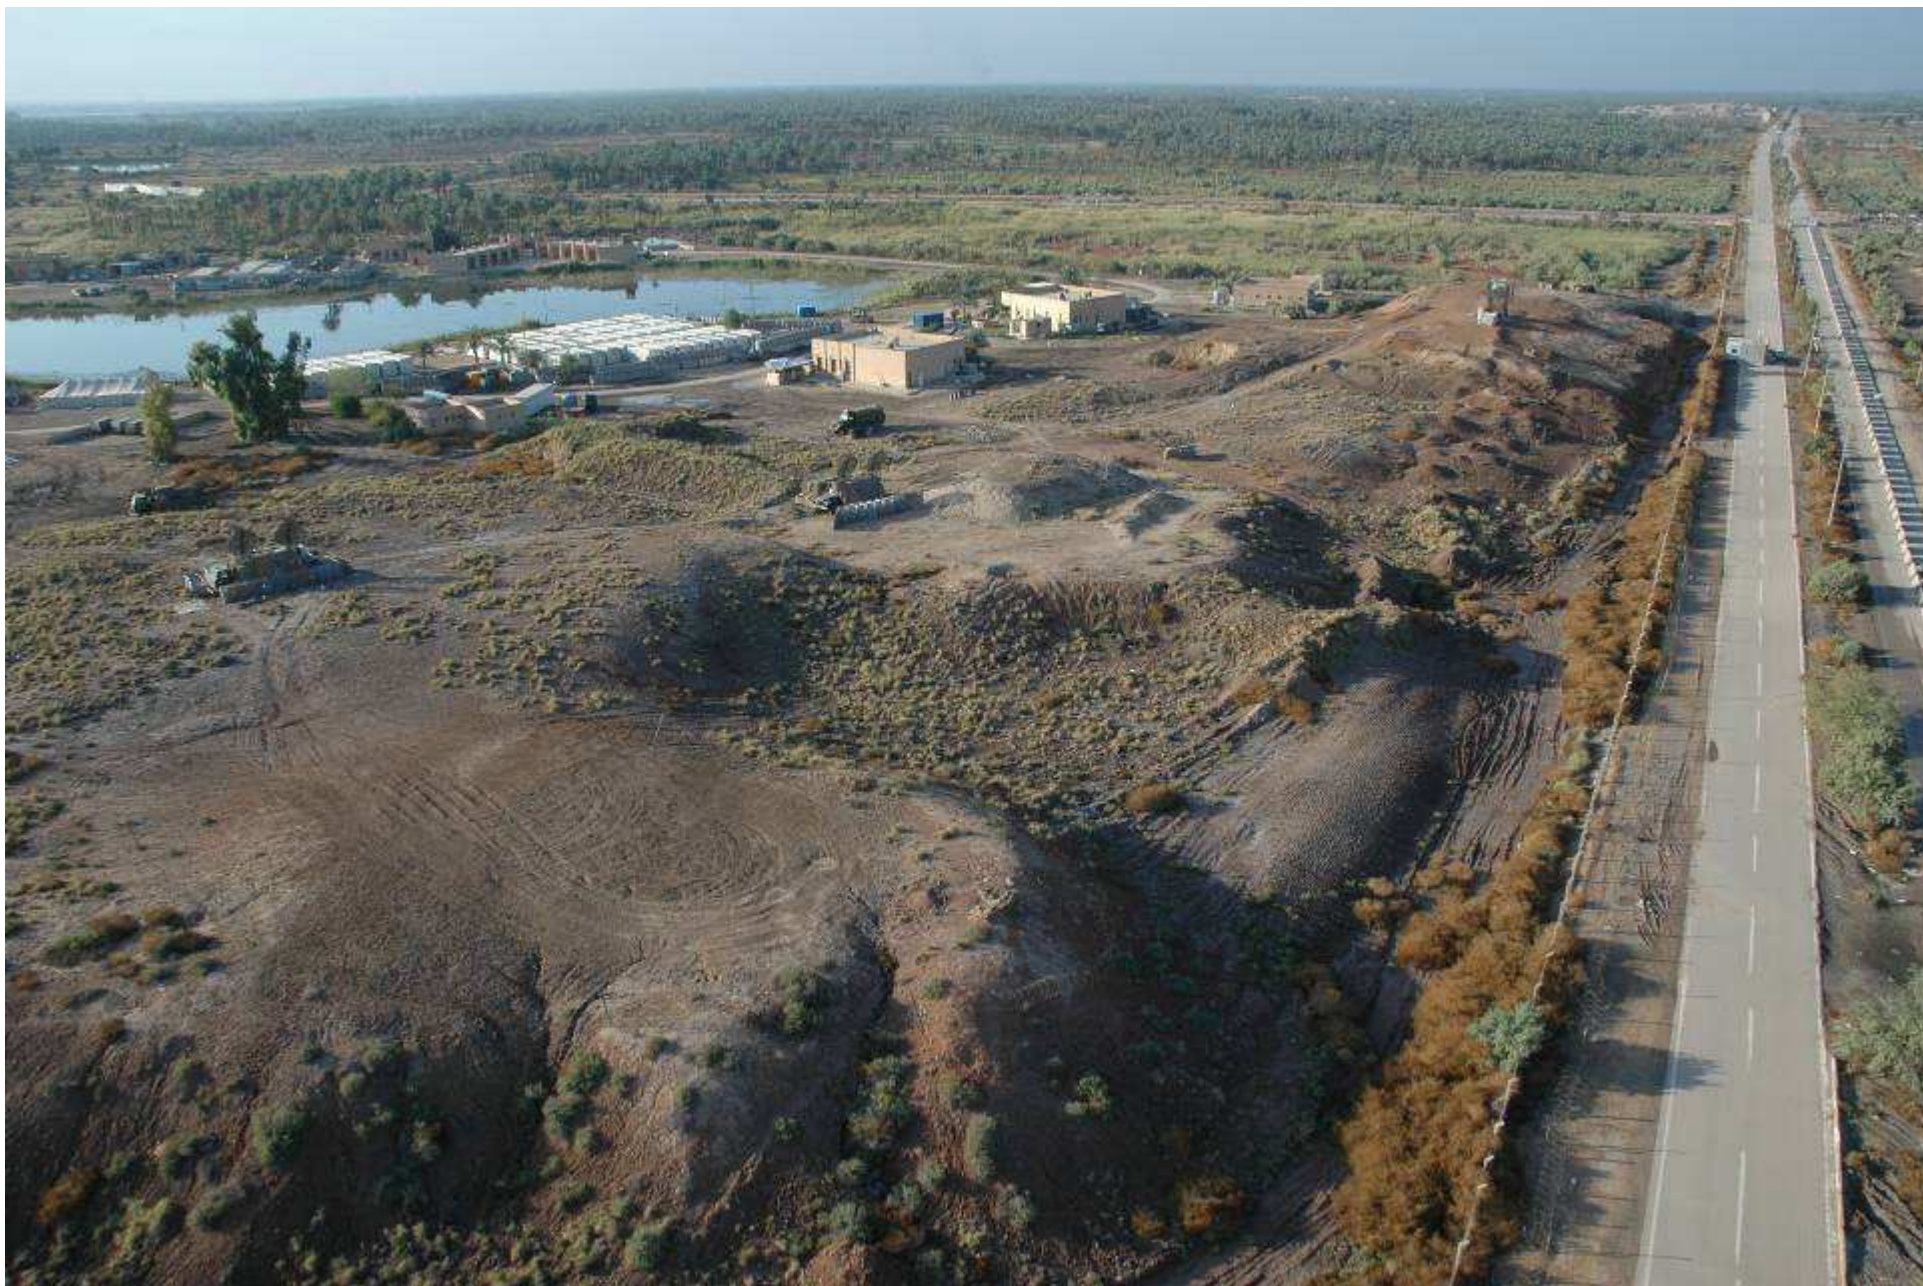
Second trench at right center, at base of flat-topped mound, Polish photo 153 (photo © Ministry of Culture and National Heritage, Republic of Poland)

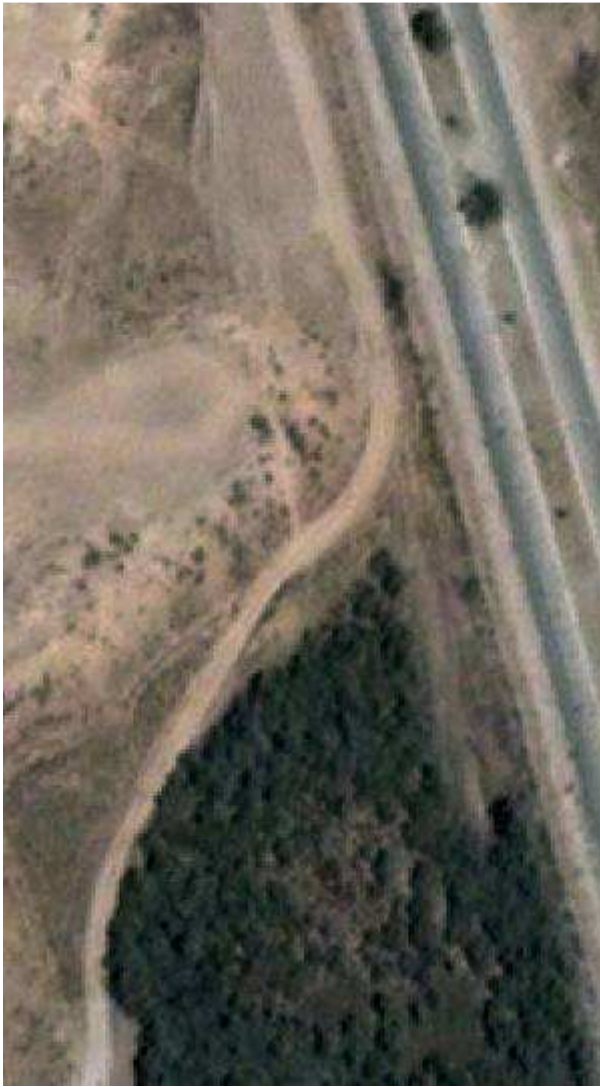
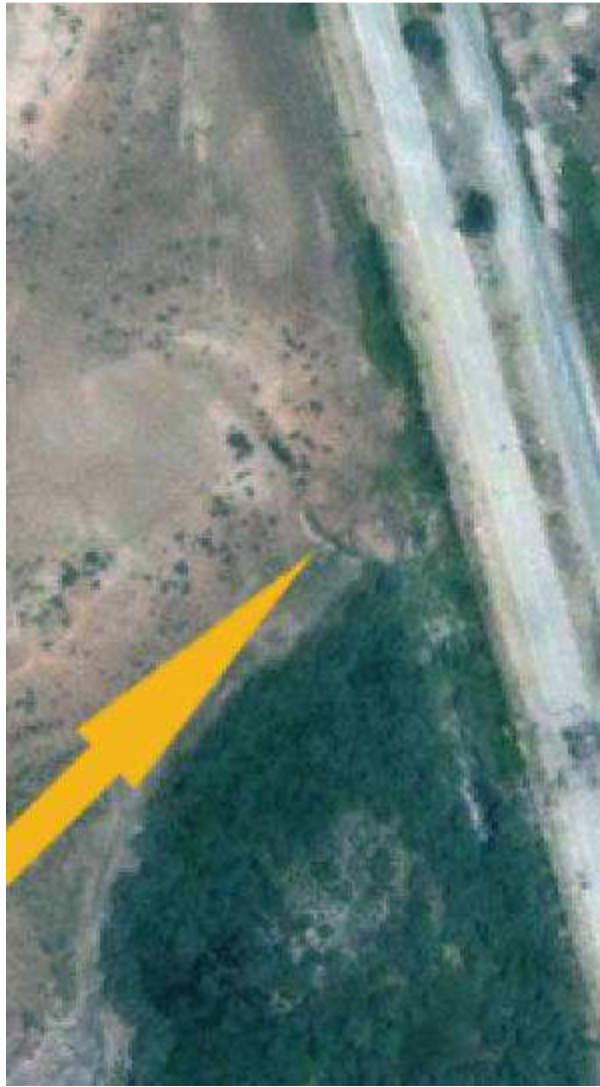
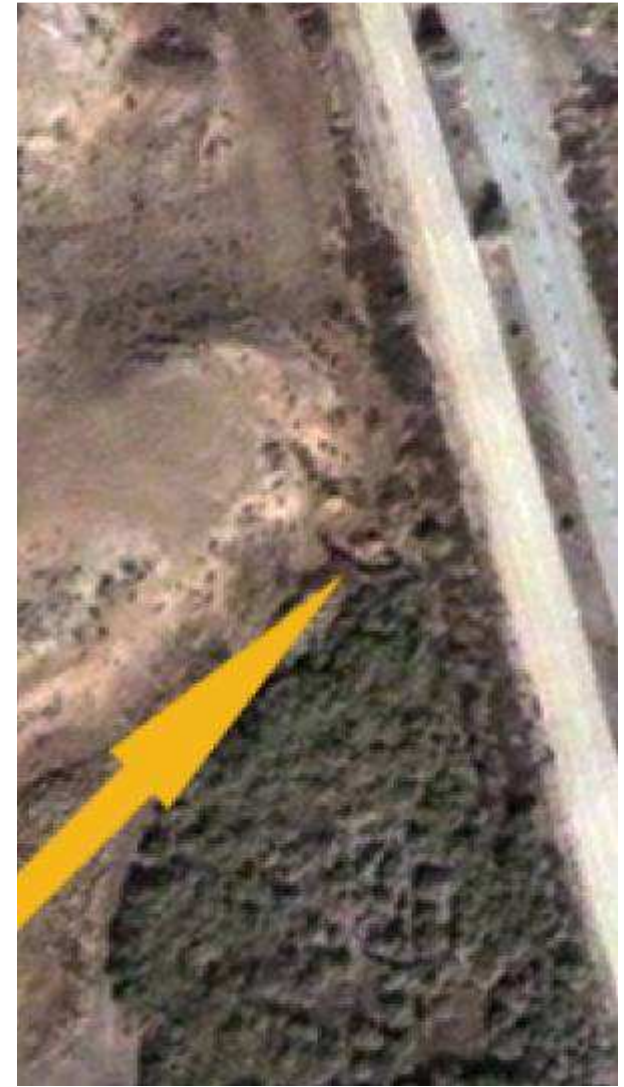
31 August 2003, Russell composite

Third trench, 4 June 2004

26 November 2005

**Russell comment:** The third trench also appeared between August 2003 and June 2004, and was apparently dug to block the road leading from the main road to the NW corner of the eastern-most parking lot.

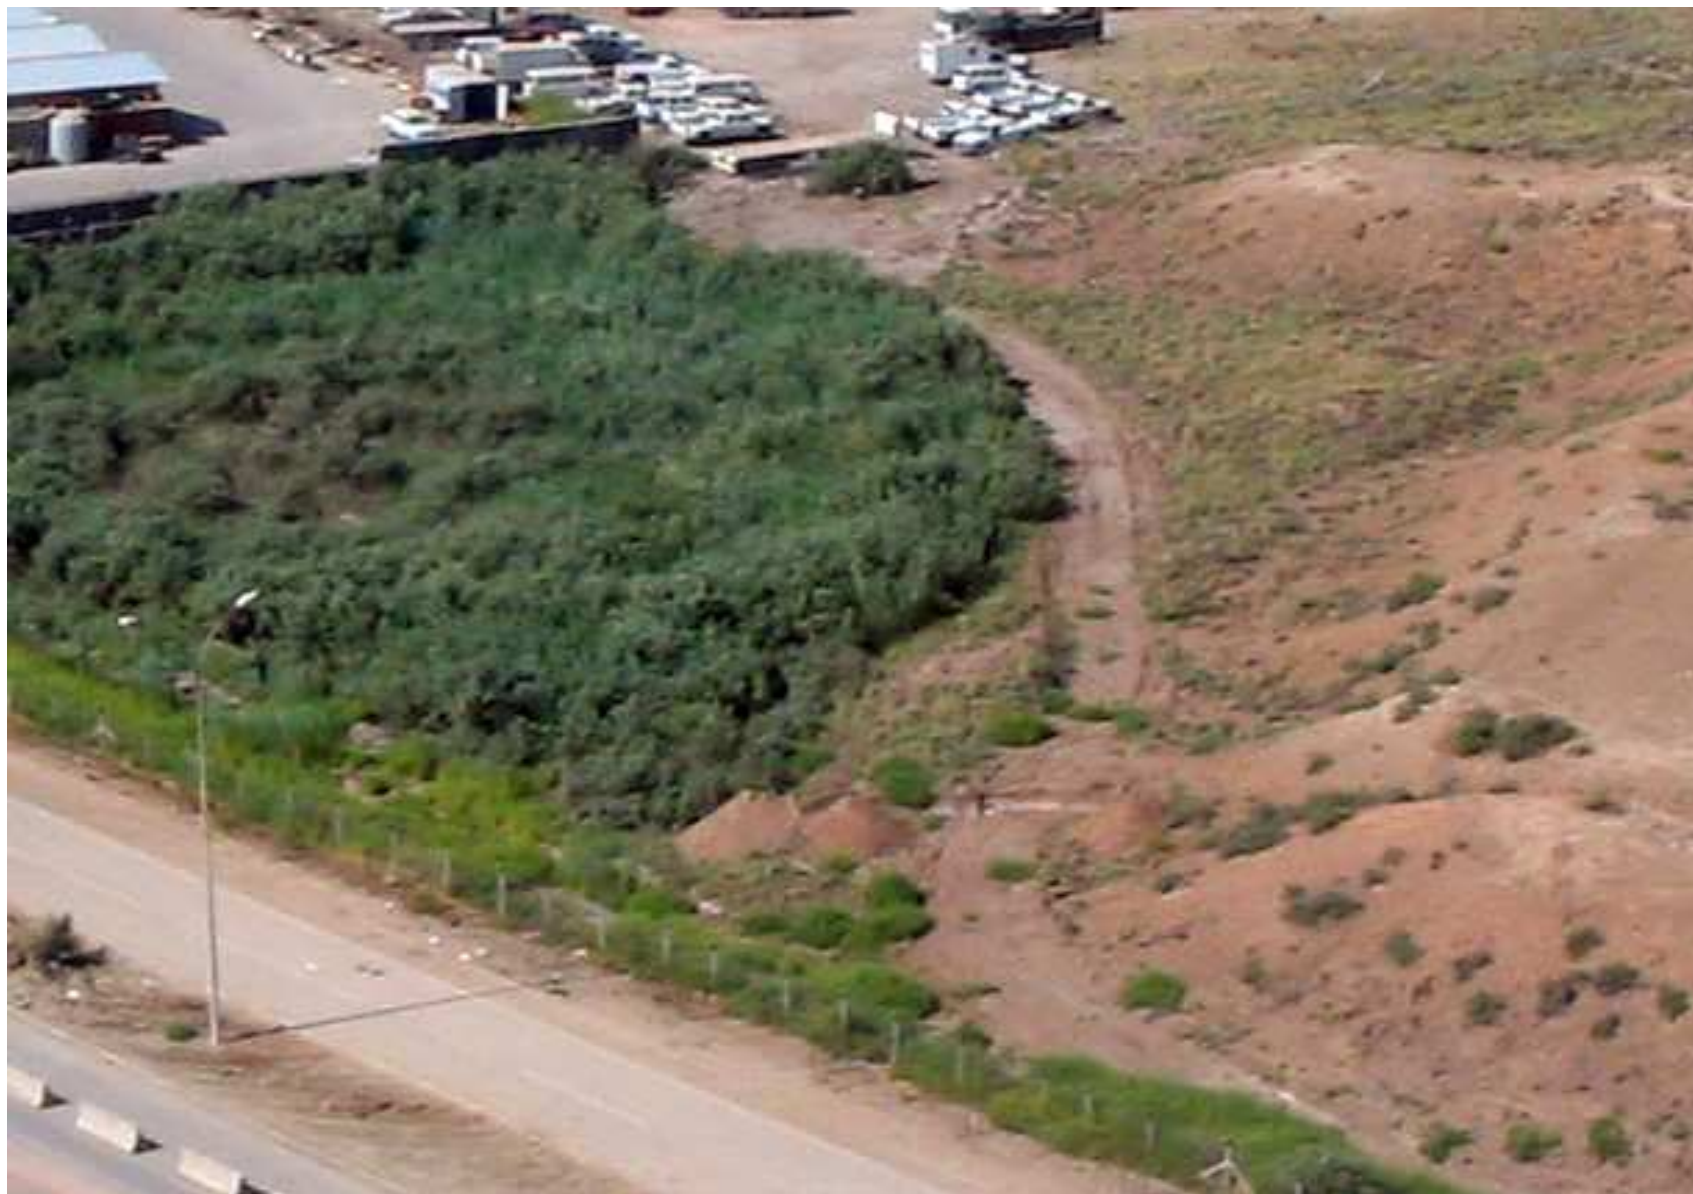
Third trench (lower center), Russell photo 124\_2440, detail (photo © John Russell)

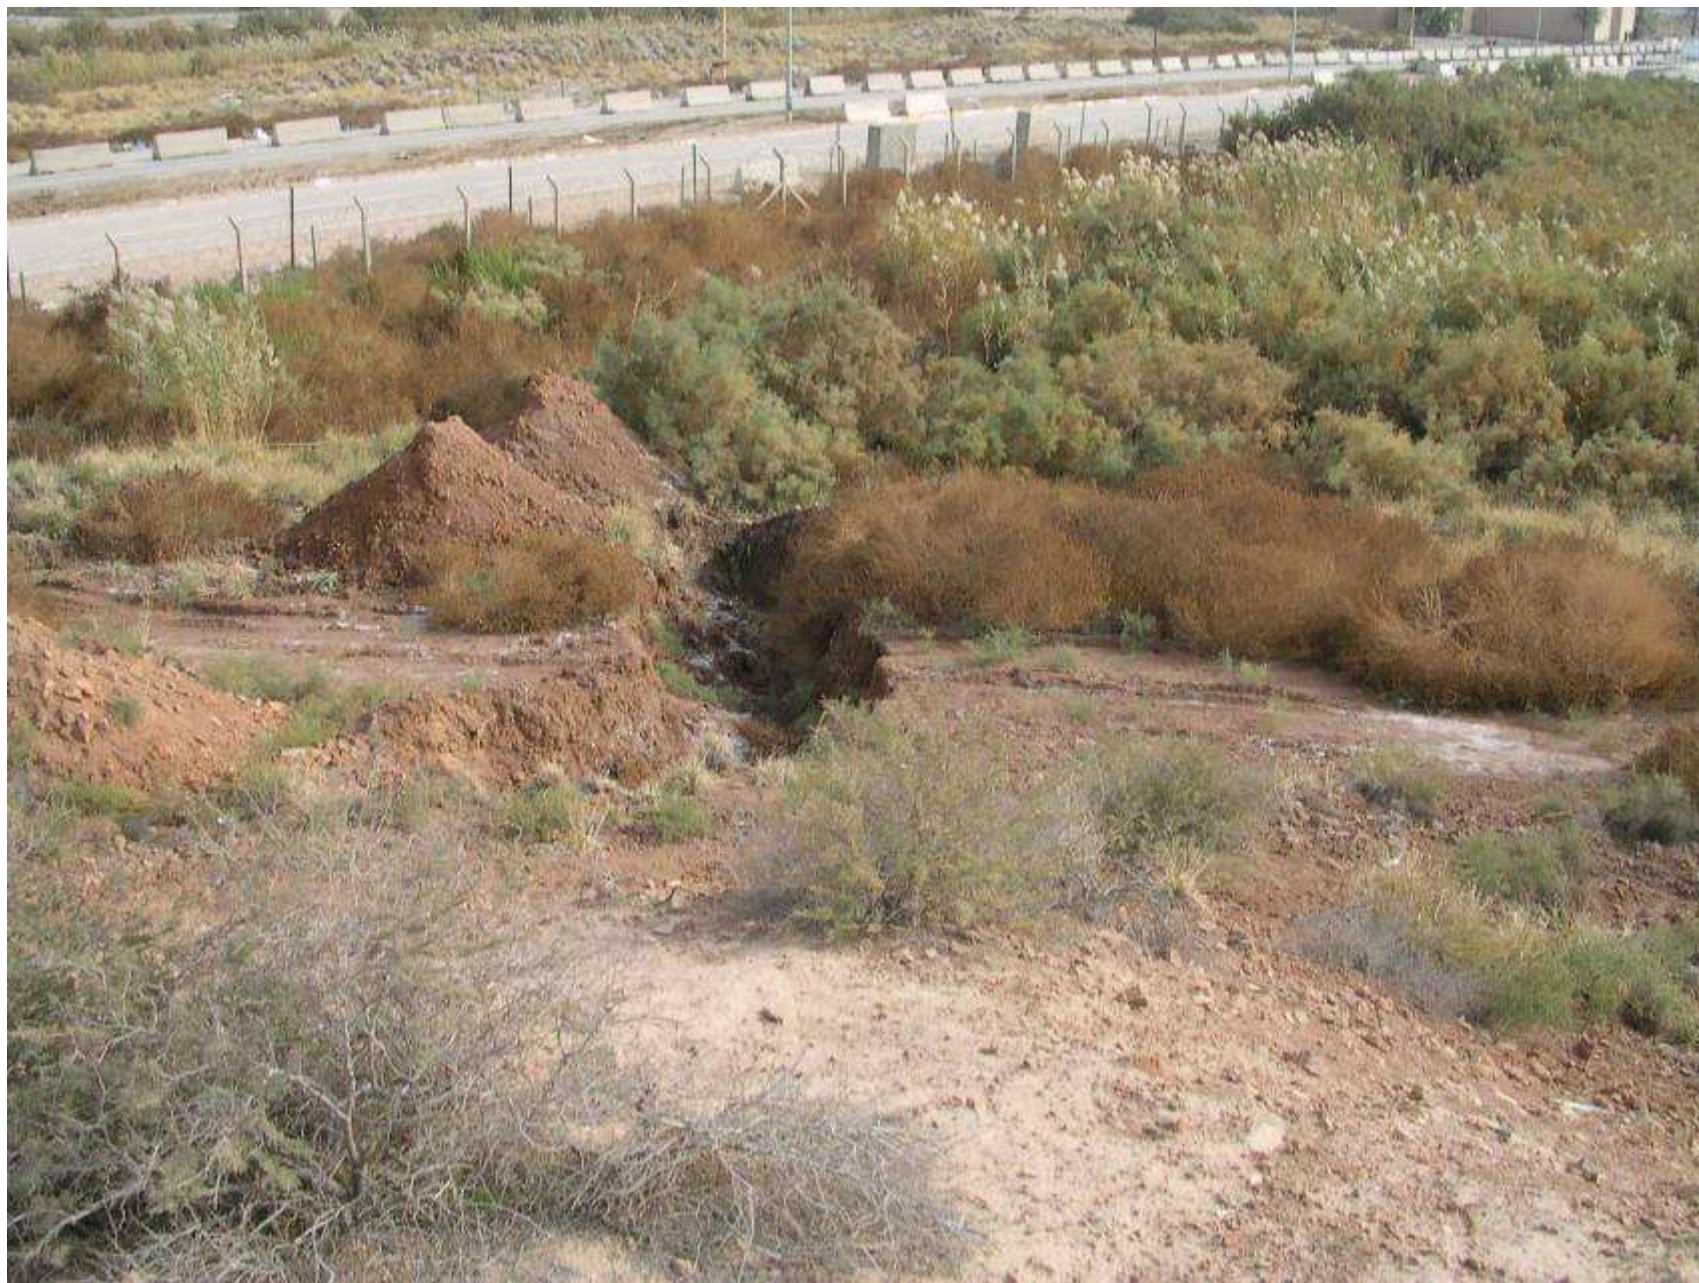
Third trench, Curtis photo 7543 (photo © John Curtis)

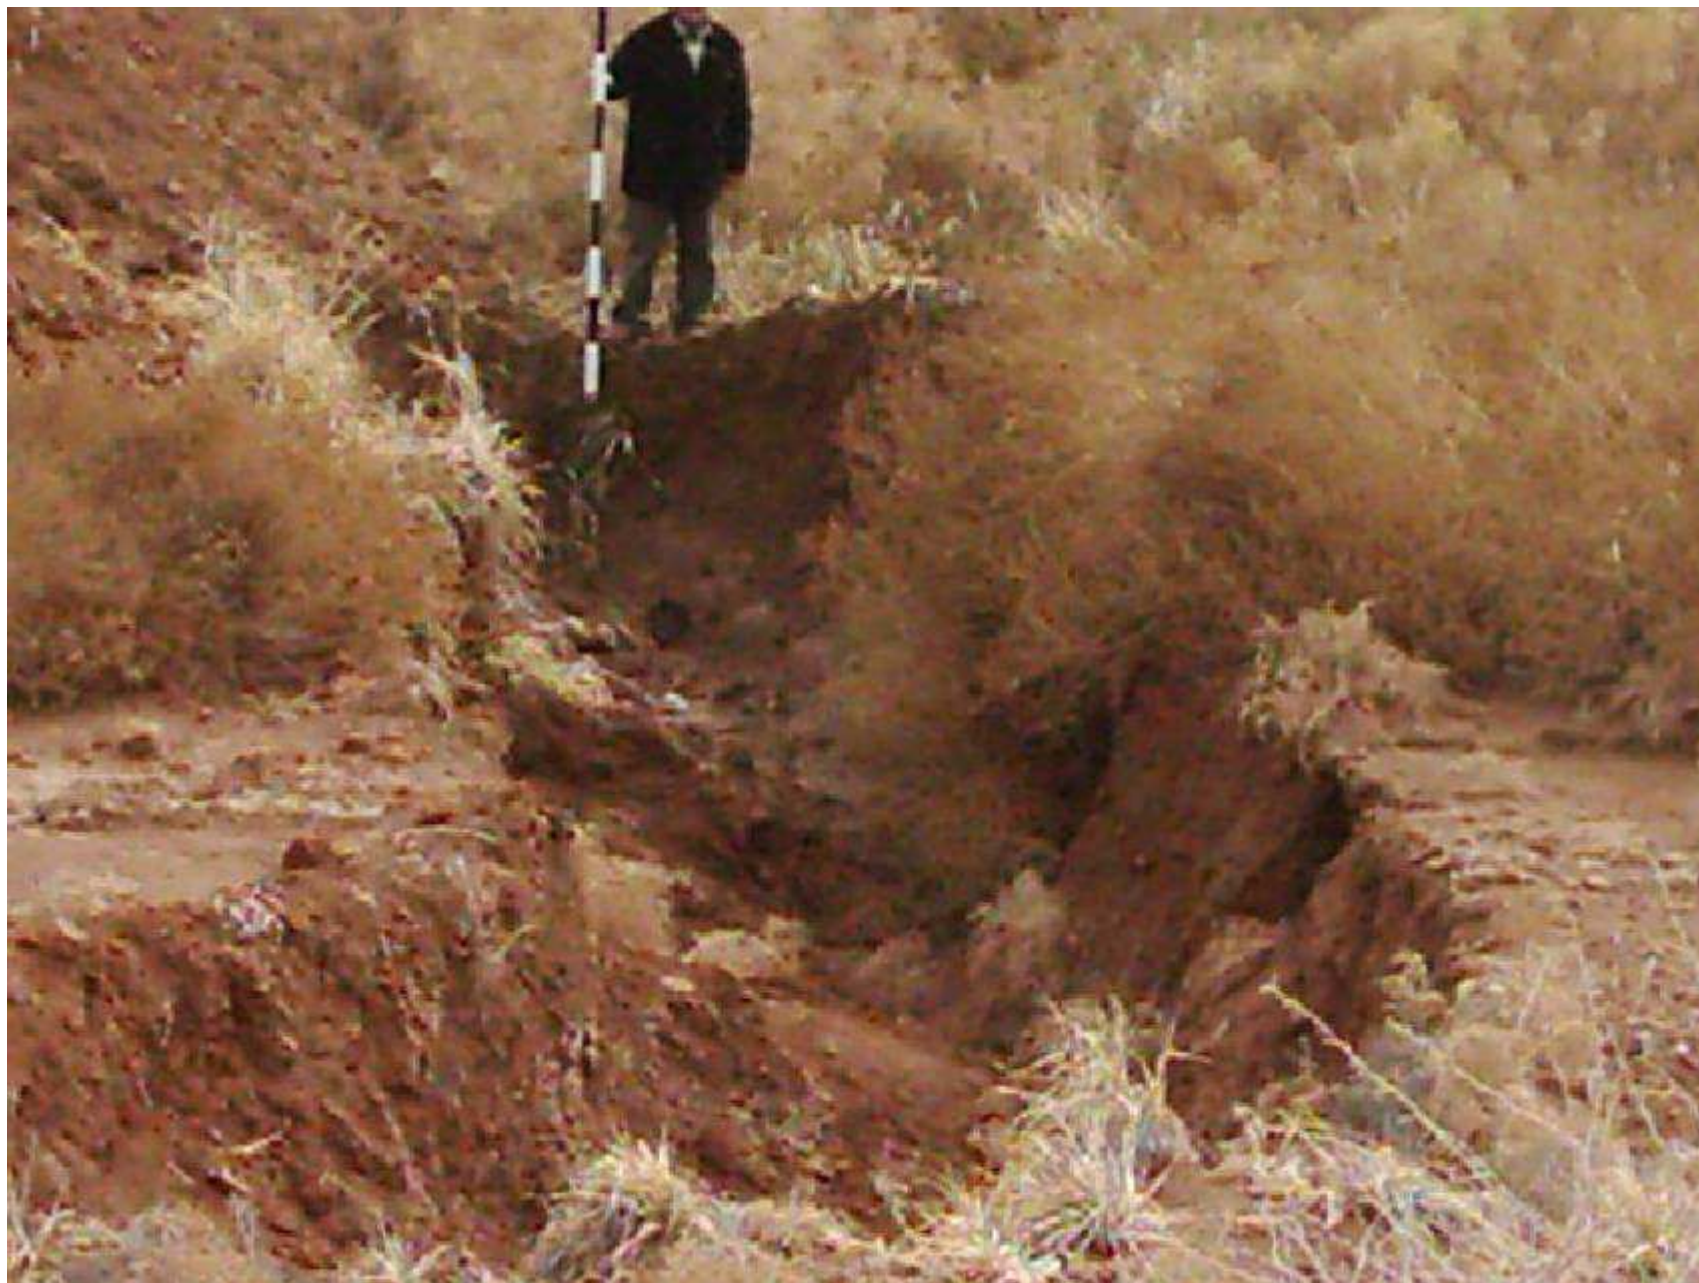
Third trench, Iraqi final report 24

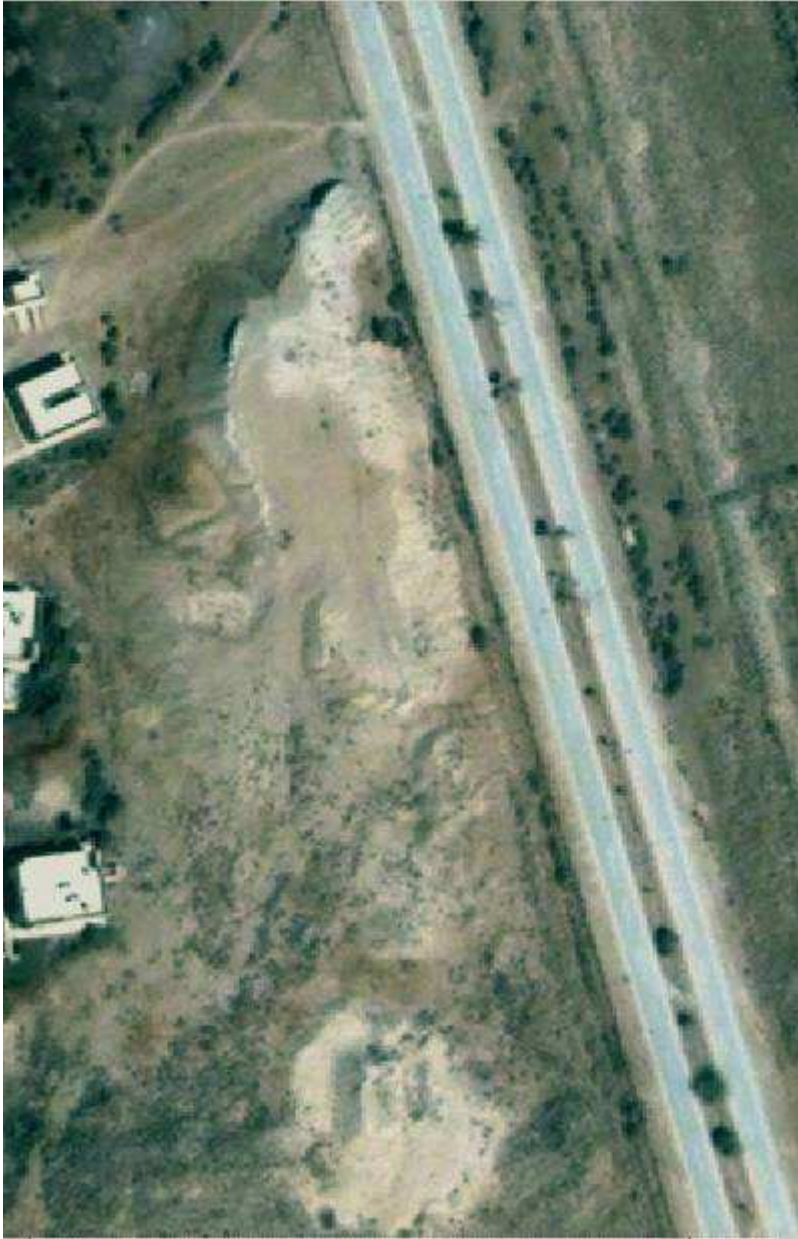
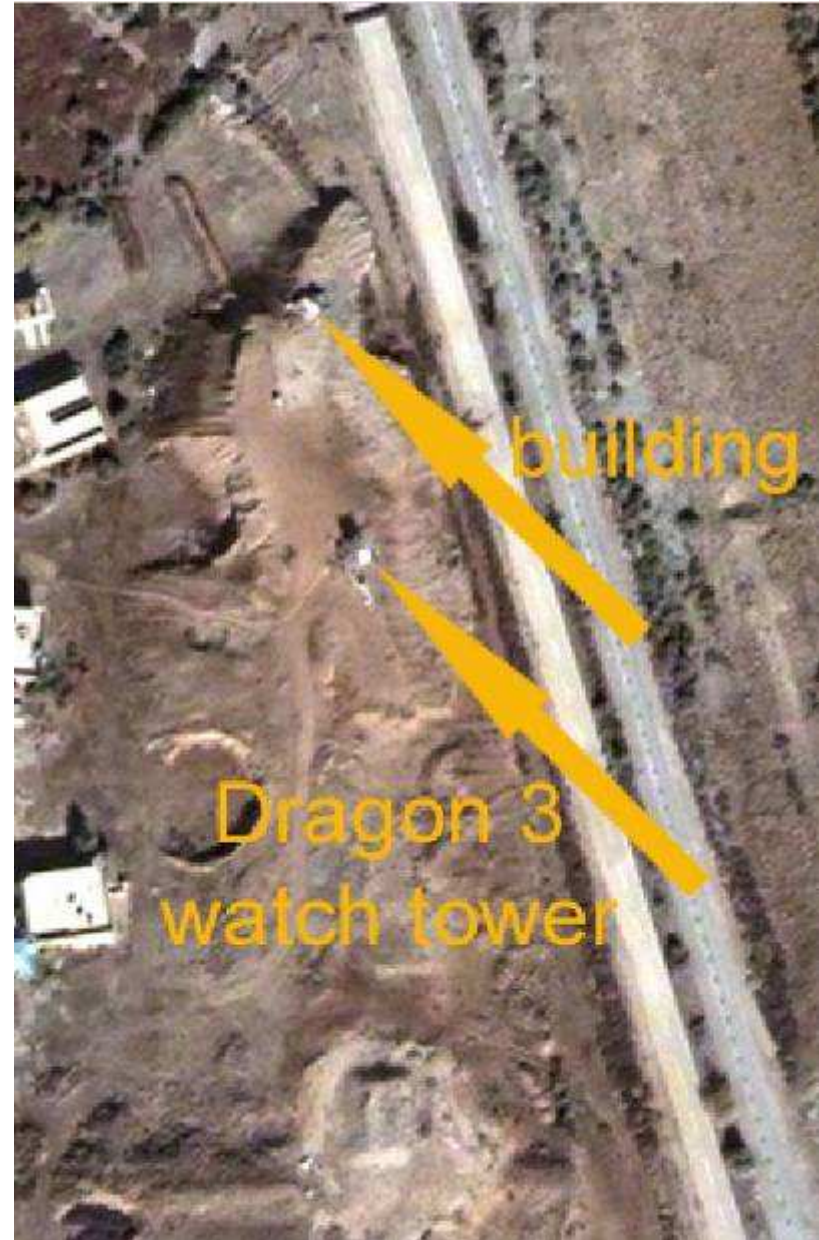
1 April 2003, Russell composite

Observation tower 3 and another building were constructed atop the Homera mounds, and were still there after the military camp was removed.

New buildings, 26 November 2005, Russell composite

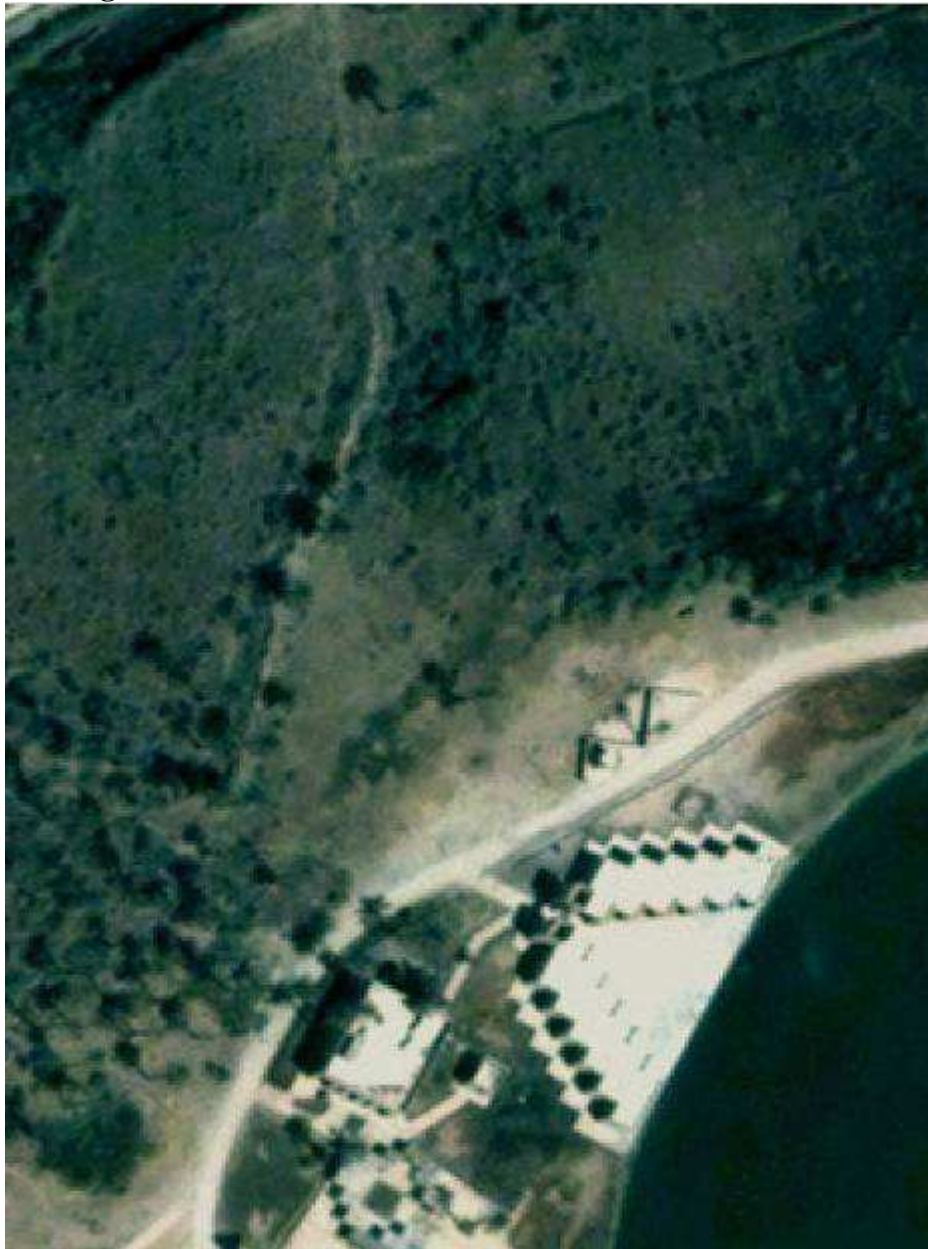
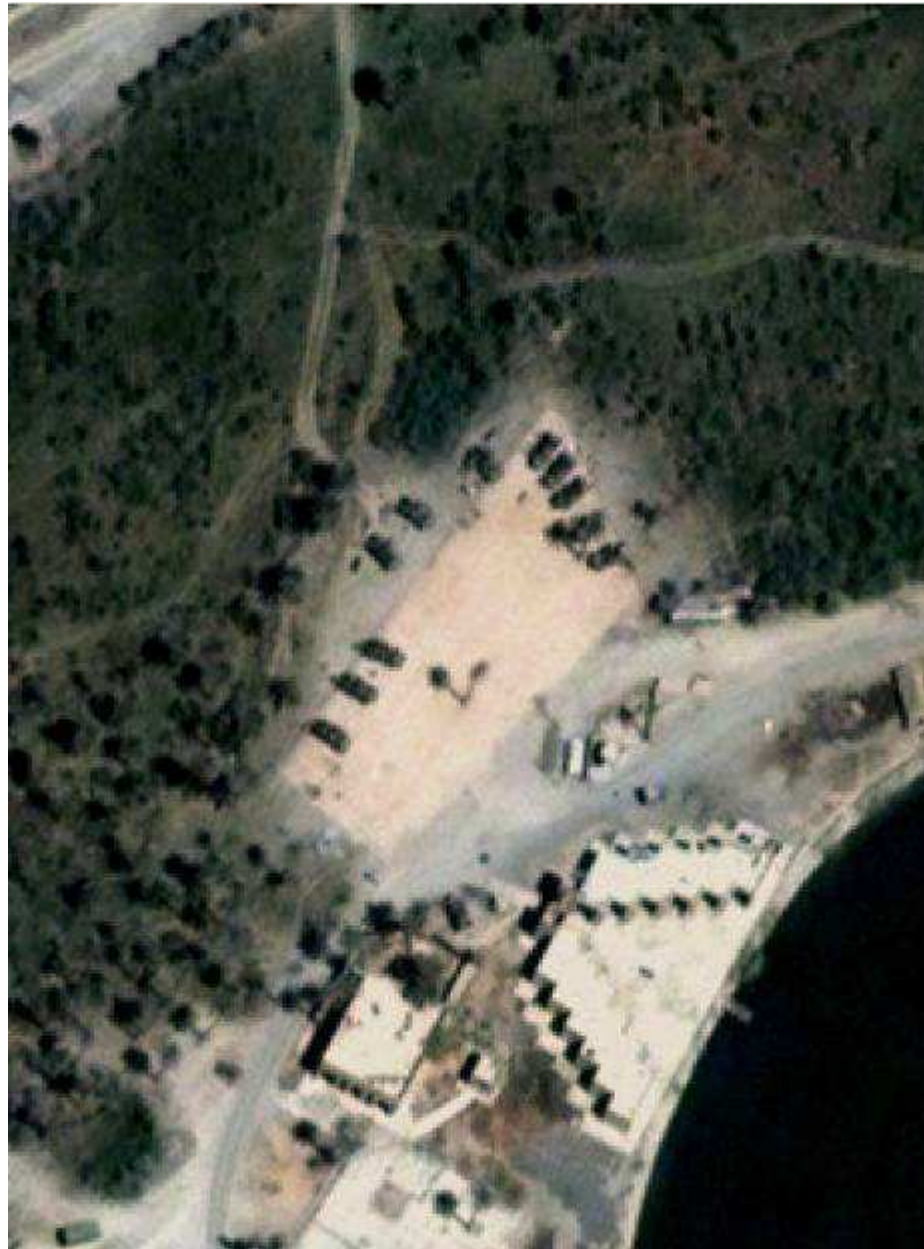
1 April 2003, Russell composite

31 August 2003, Russell composite

A large parking lot was constructed northwest of the lake between 1 April and 31 August 2003.

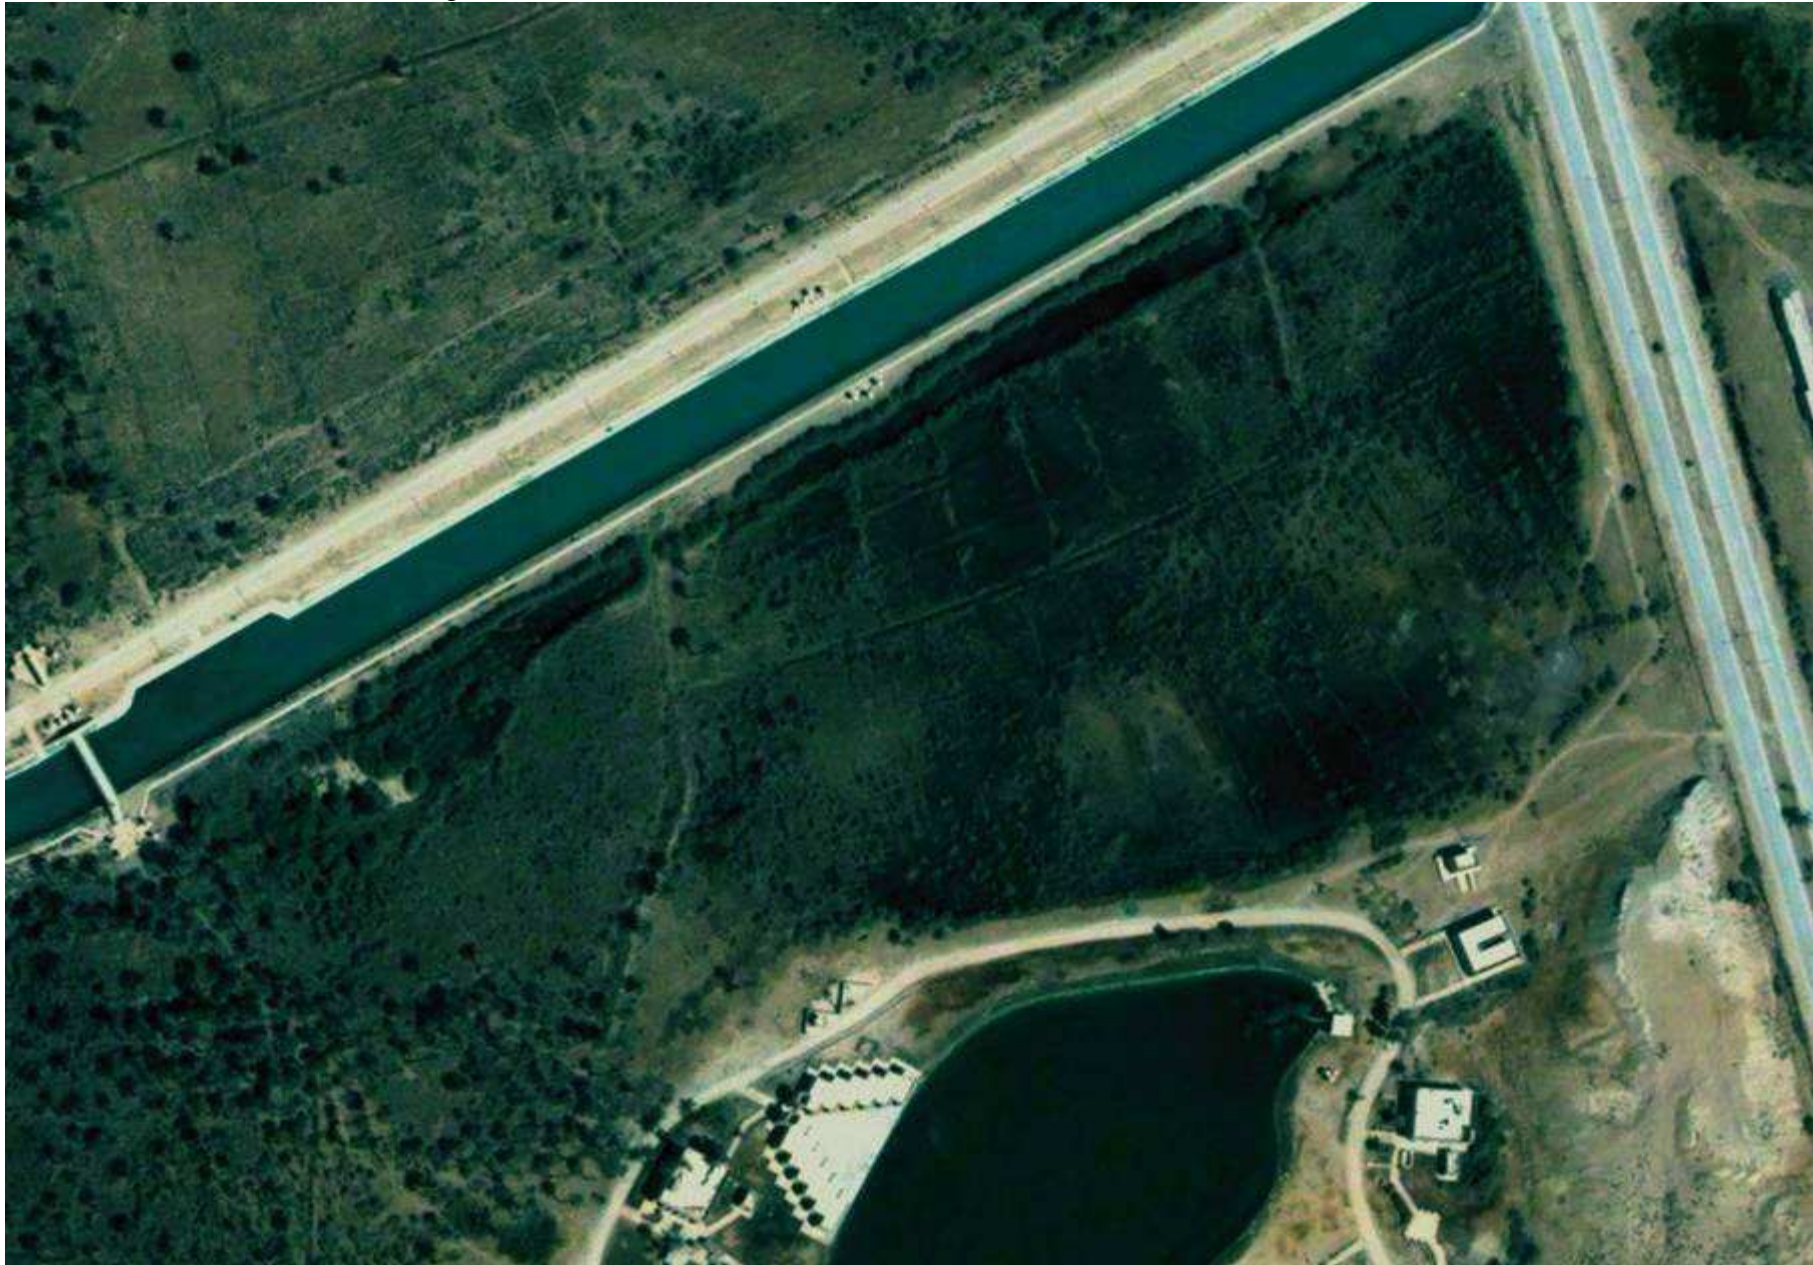
**New roads :** A watch tower (“Dragon 2”) and access roads were built to the north and northeast of the lake.

Area north of lake, 1 April 2003, Russell composite

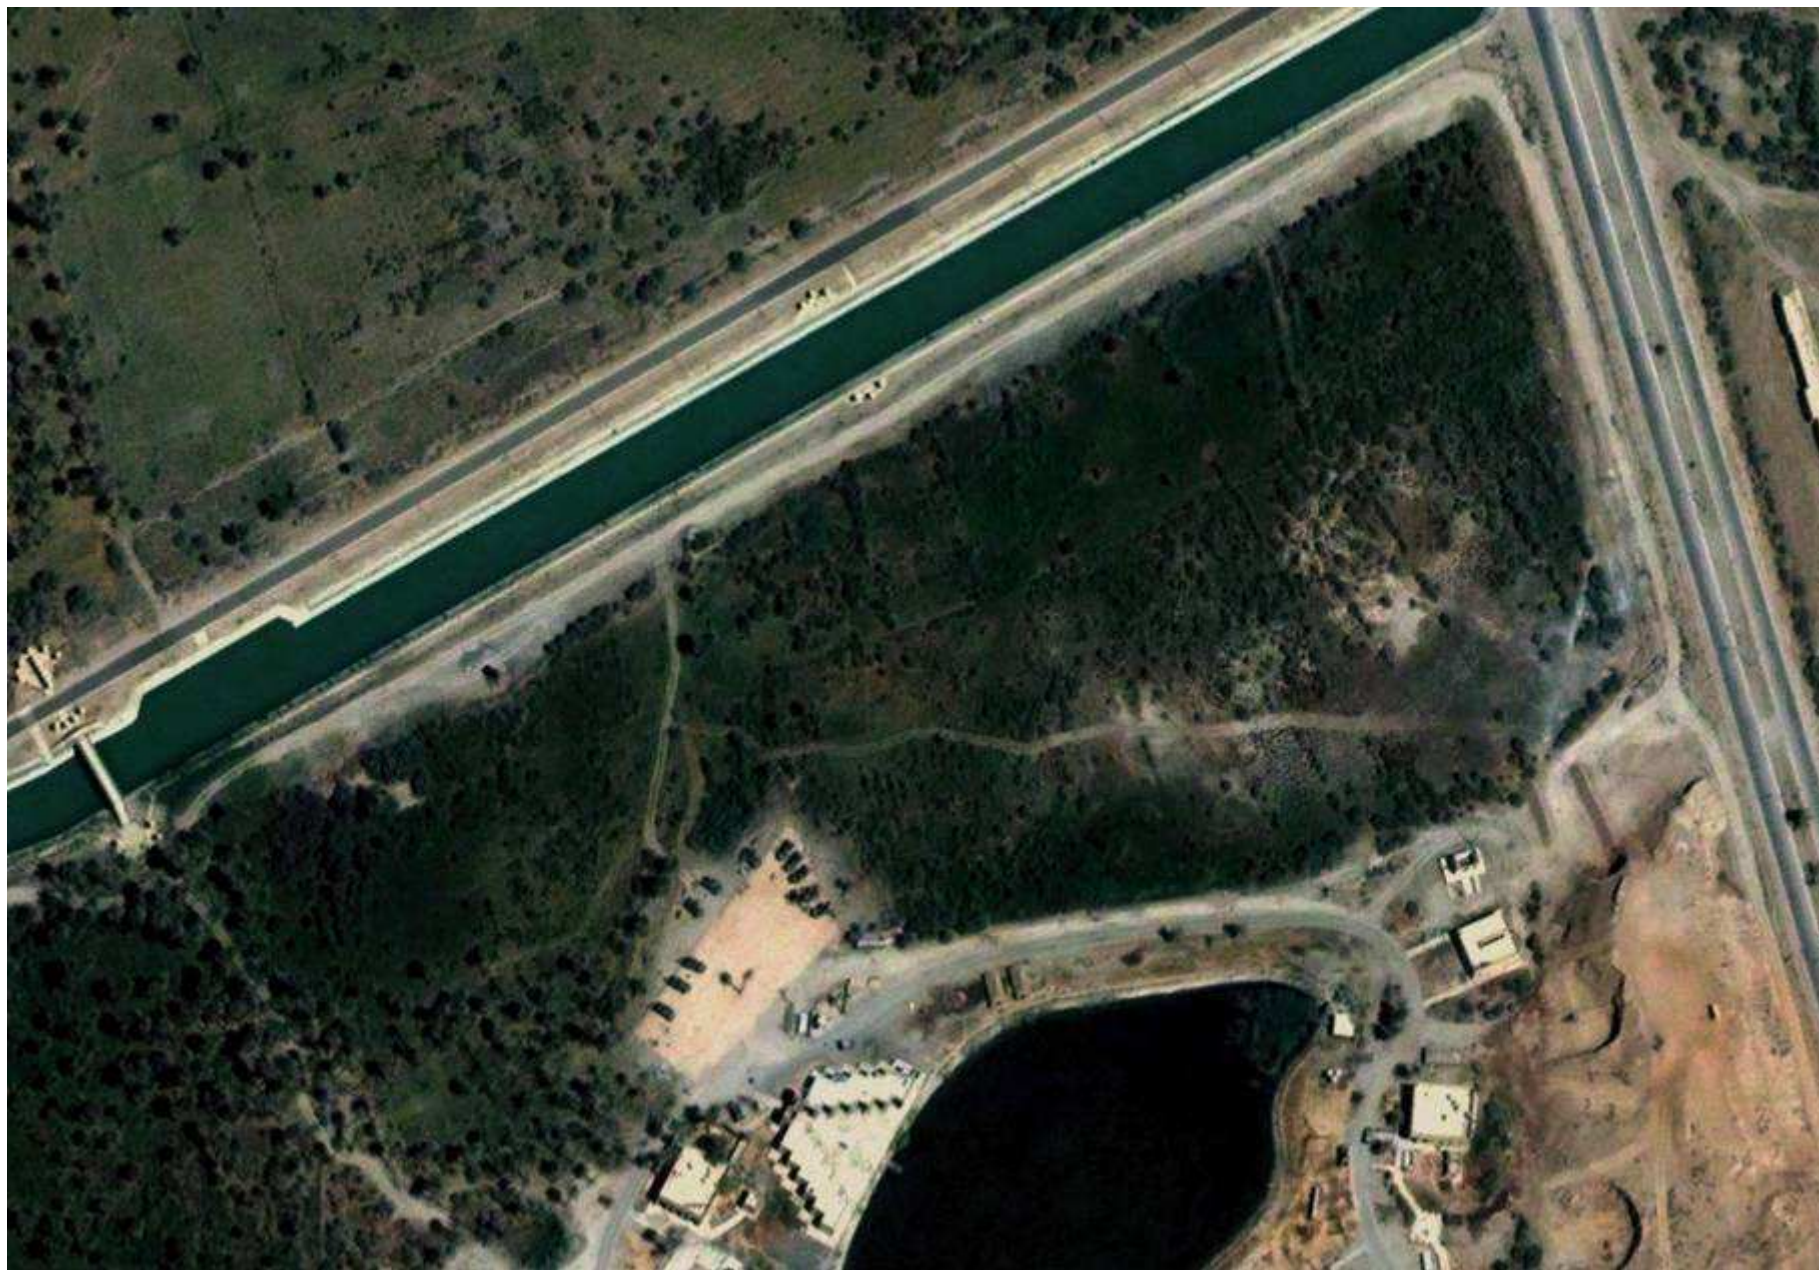
New roads and watch tower north of lake, 31 August 2003, Russell composite

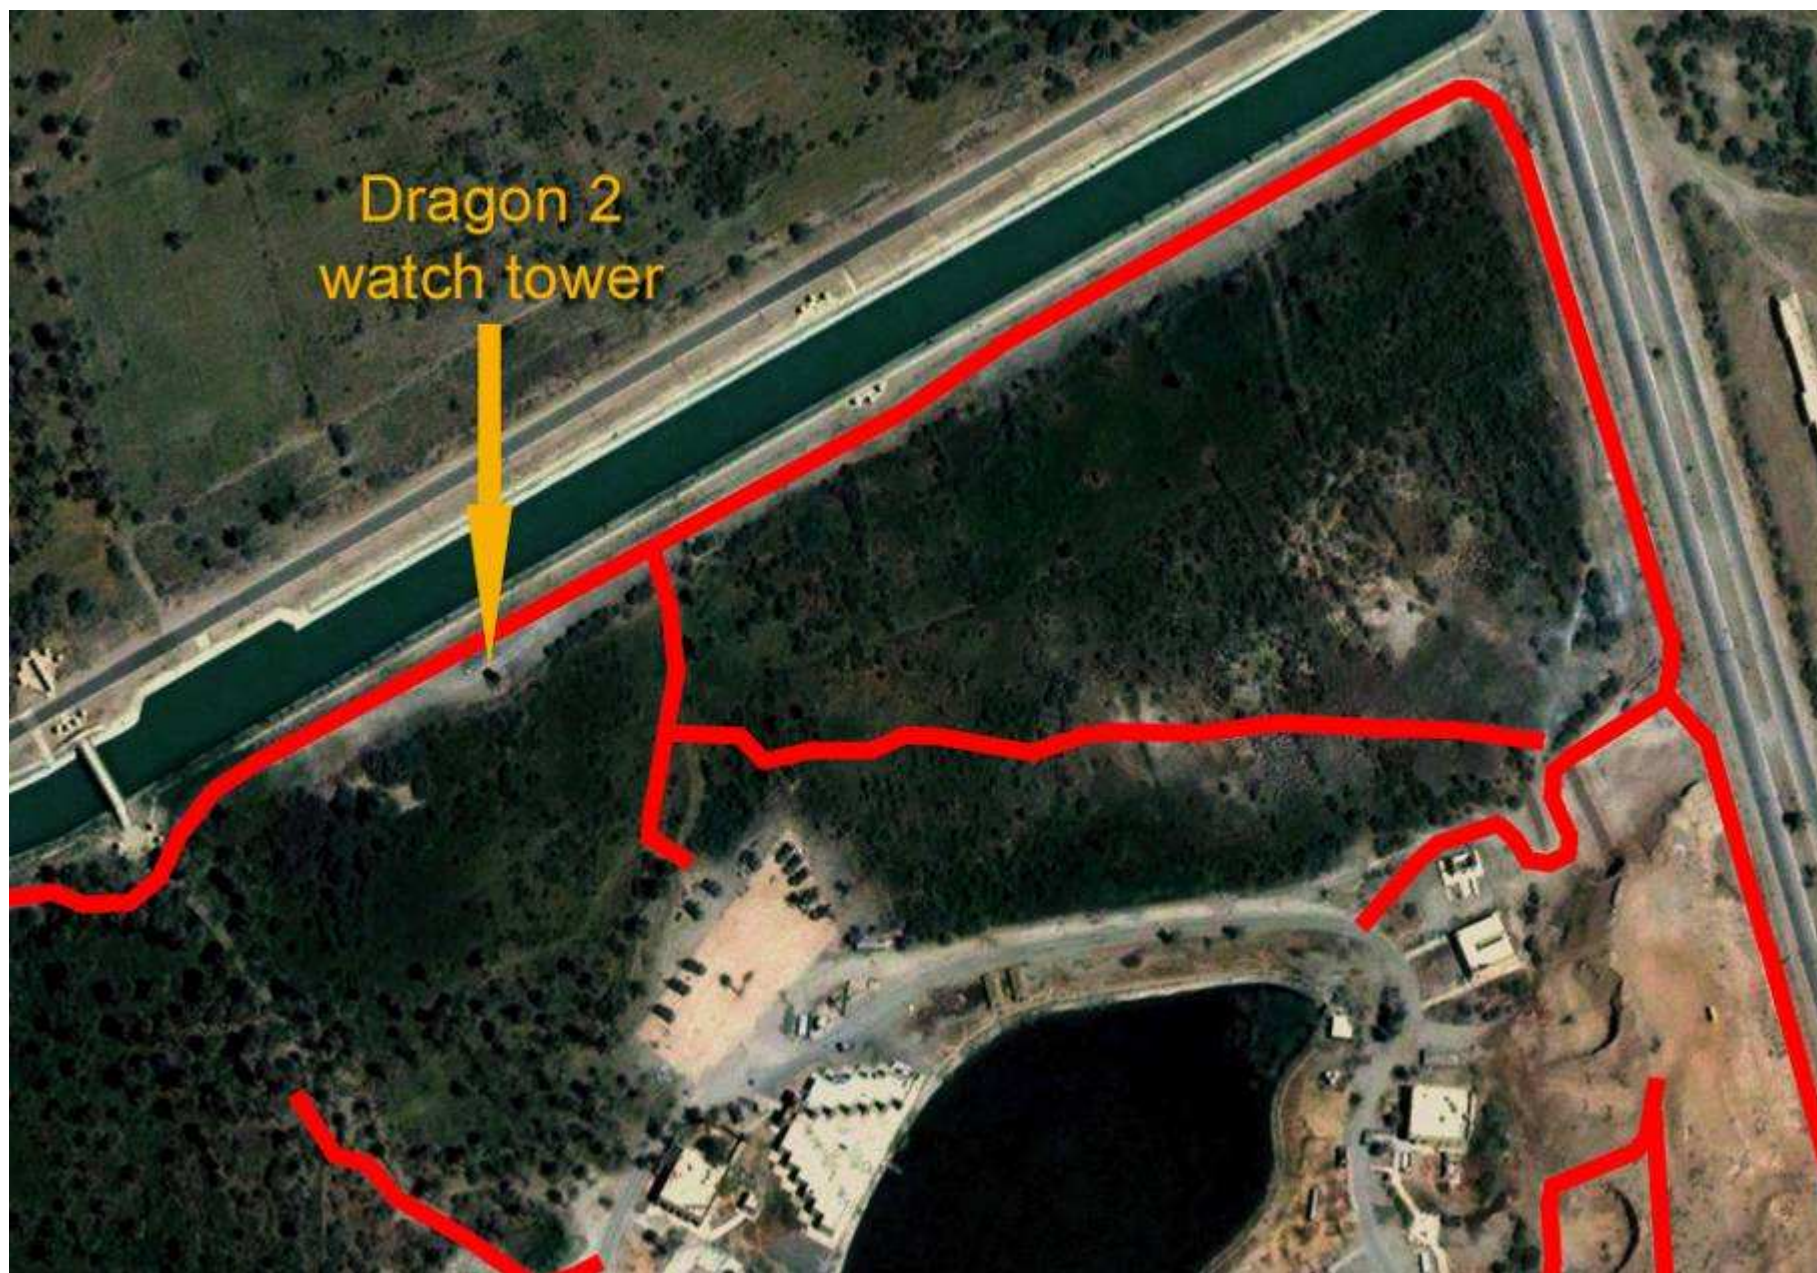
New roads and observation tower 2 north of lake, 31 August 2003, Russell composite

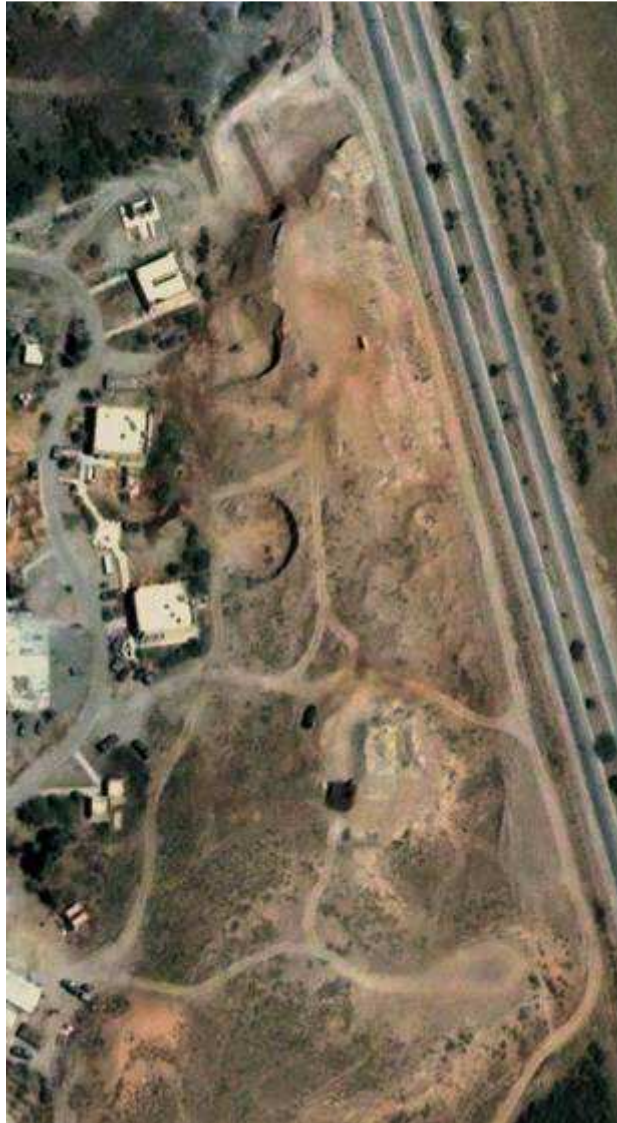
**New roads:** New roads were also built around and across the Homera mounds to the east of the lake.

New roads east of lake, 31 August 2003, Russell composite
