# **Report on Damage to the Site of Babylon, Iraq**

**John Malcolm Russell, Ph.D.**

**Cultural Heritage Center  
Bureau of Educational and Cultural Affairs  
Department of State**

**April 2010**

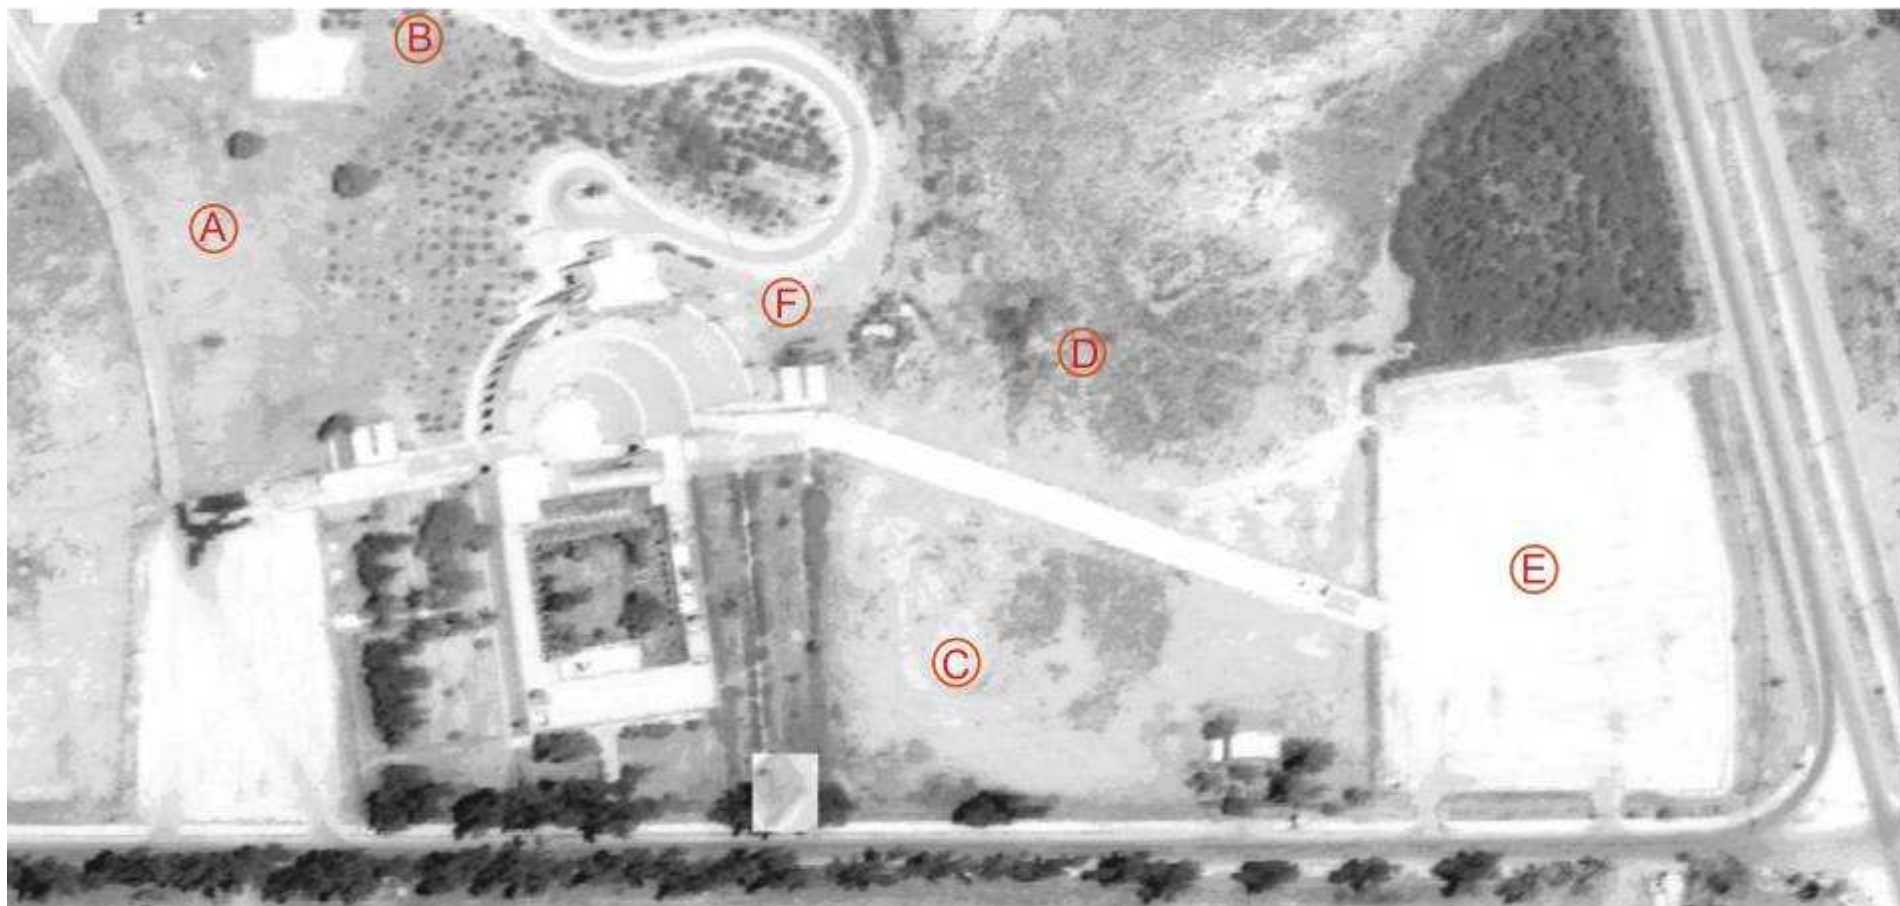
Features described in Polish report, Polish report, p. 34 (photo © Ministry of Culture and National Heritage, Republic of Poland)

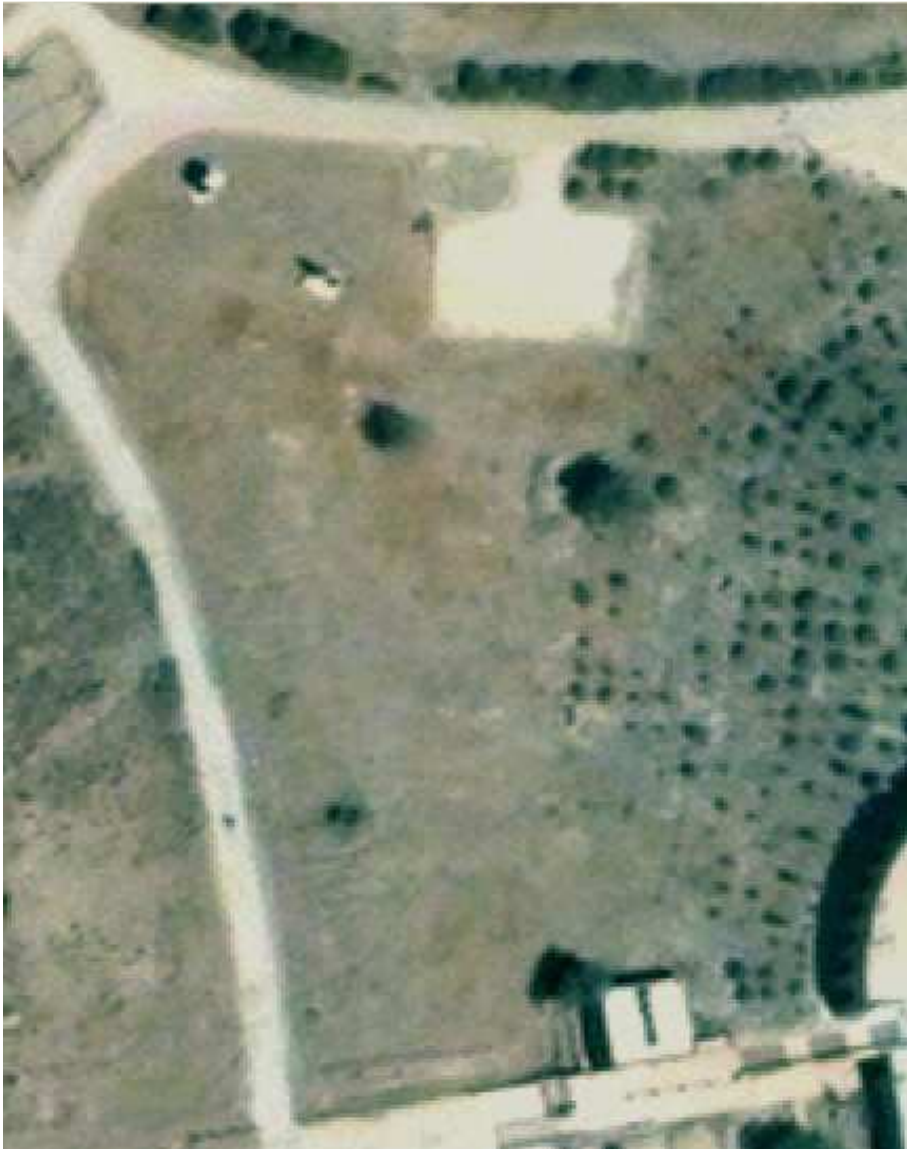
1 April 2003, Russell composite

Before the establishing of Camp Babylon, this was an open flat area to the northwest of the theater. By the time of McDonald's report (29 July 2003), earthen berms had been constructed around 2 fuel bladders.

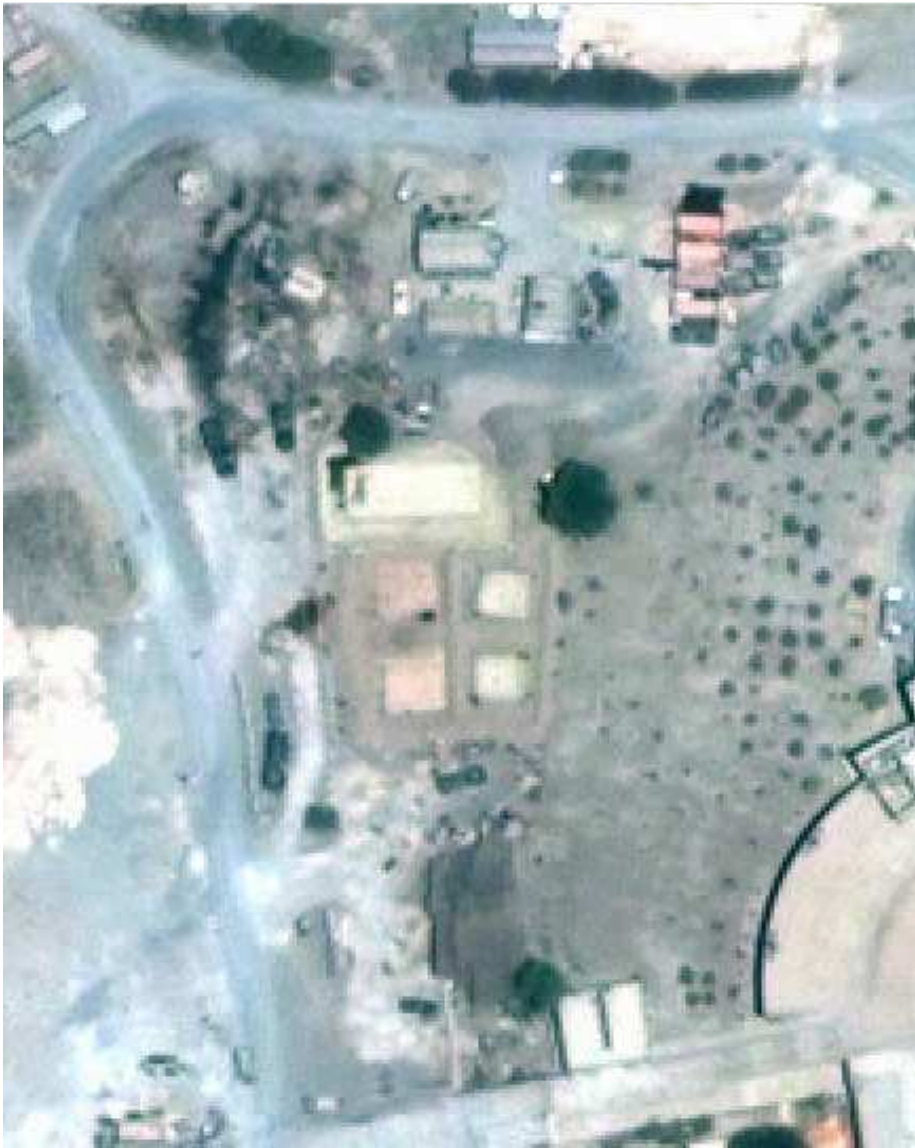
4 June 2004, Russell composite

By June 2004, the berms had been expanded to the east and north to house 5 fuel bladders, plus an additional rectangular area at the northwest of uncertain function. The satellite images show the progressive contamination of the lot to the north of the fuel bladders, presumably with spilled fuel.

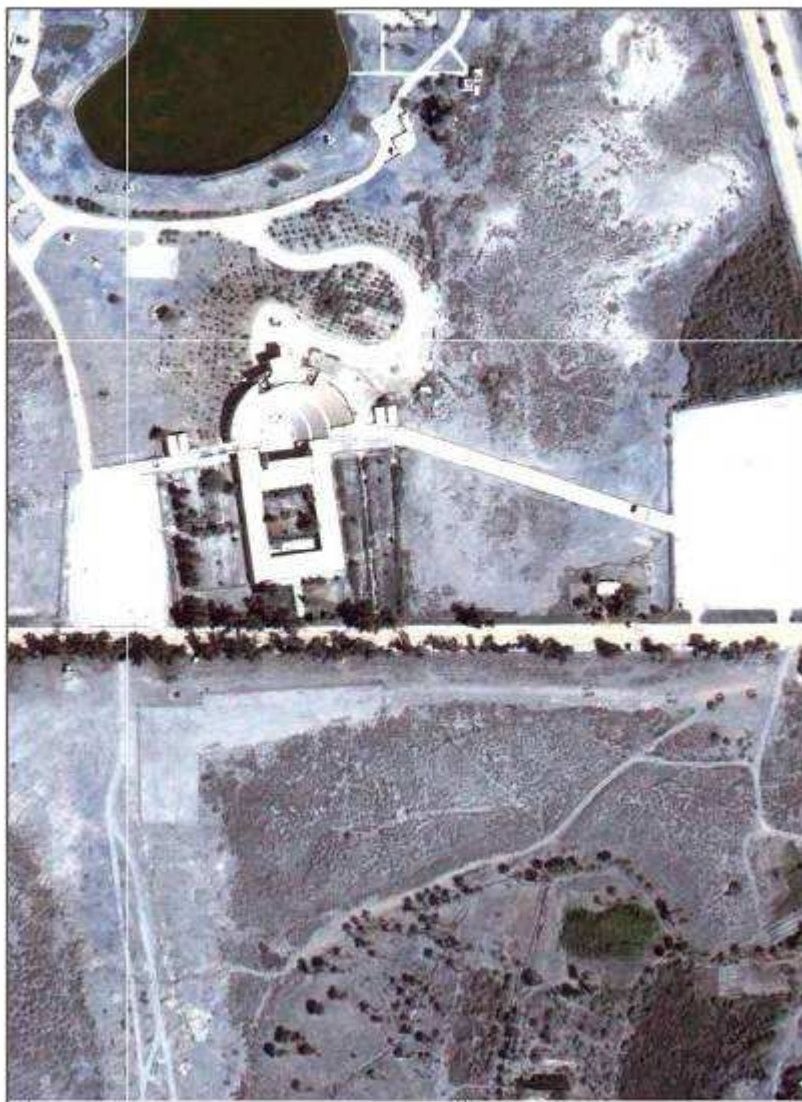
**Stone report:** Two had been constructed by August 2003 (Fig 25), ...

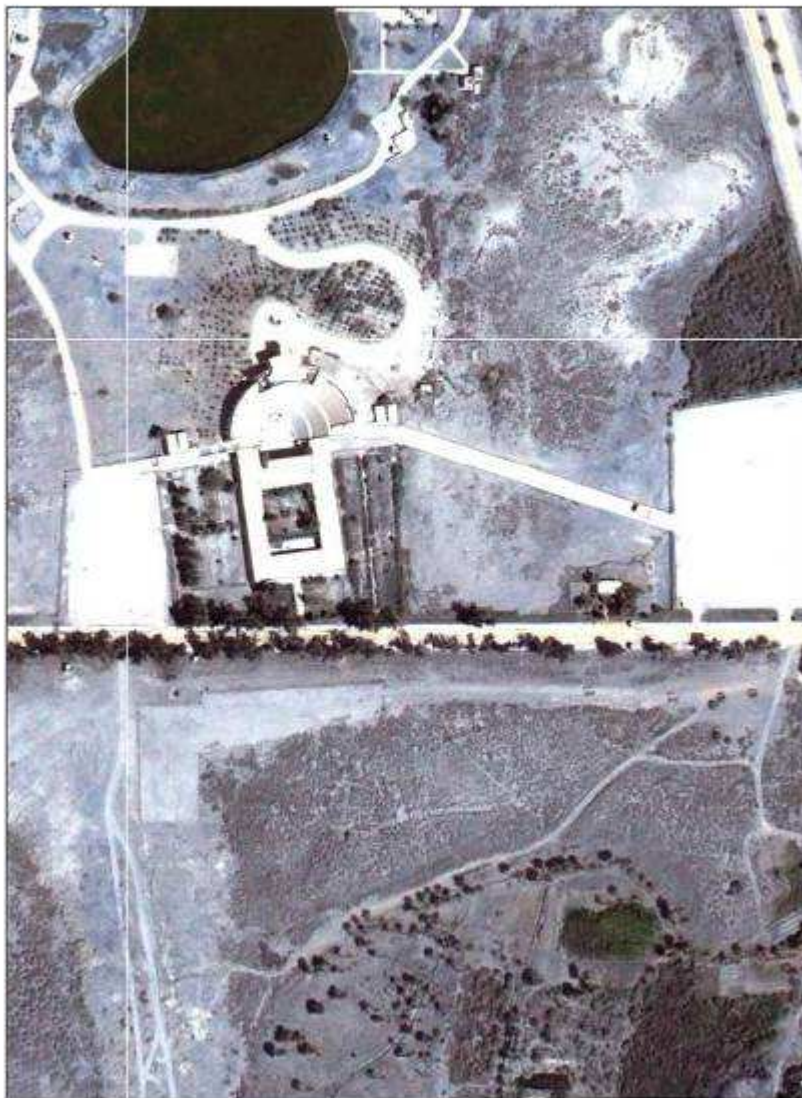
**Stone report:** ...but these increased to five by October 2004 (Fig. 26).

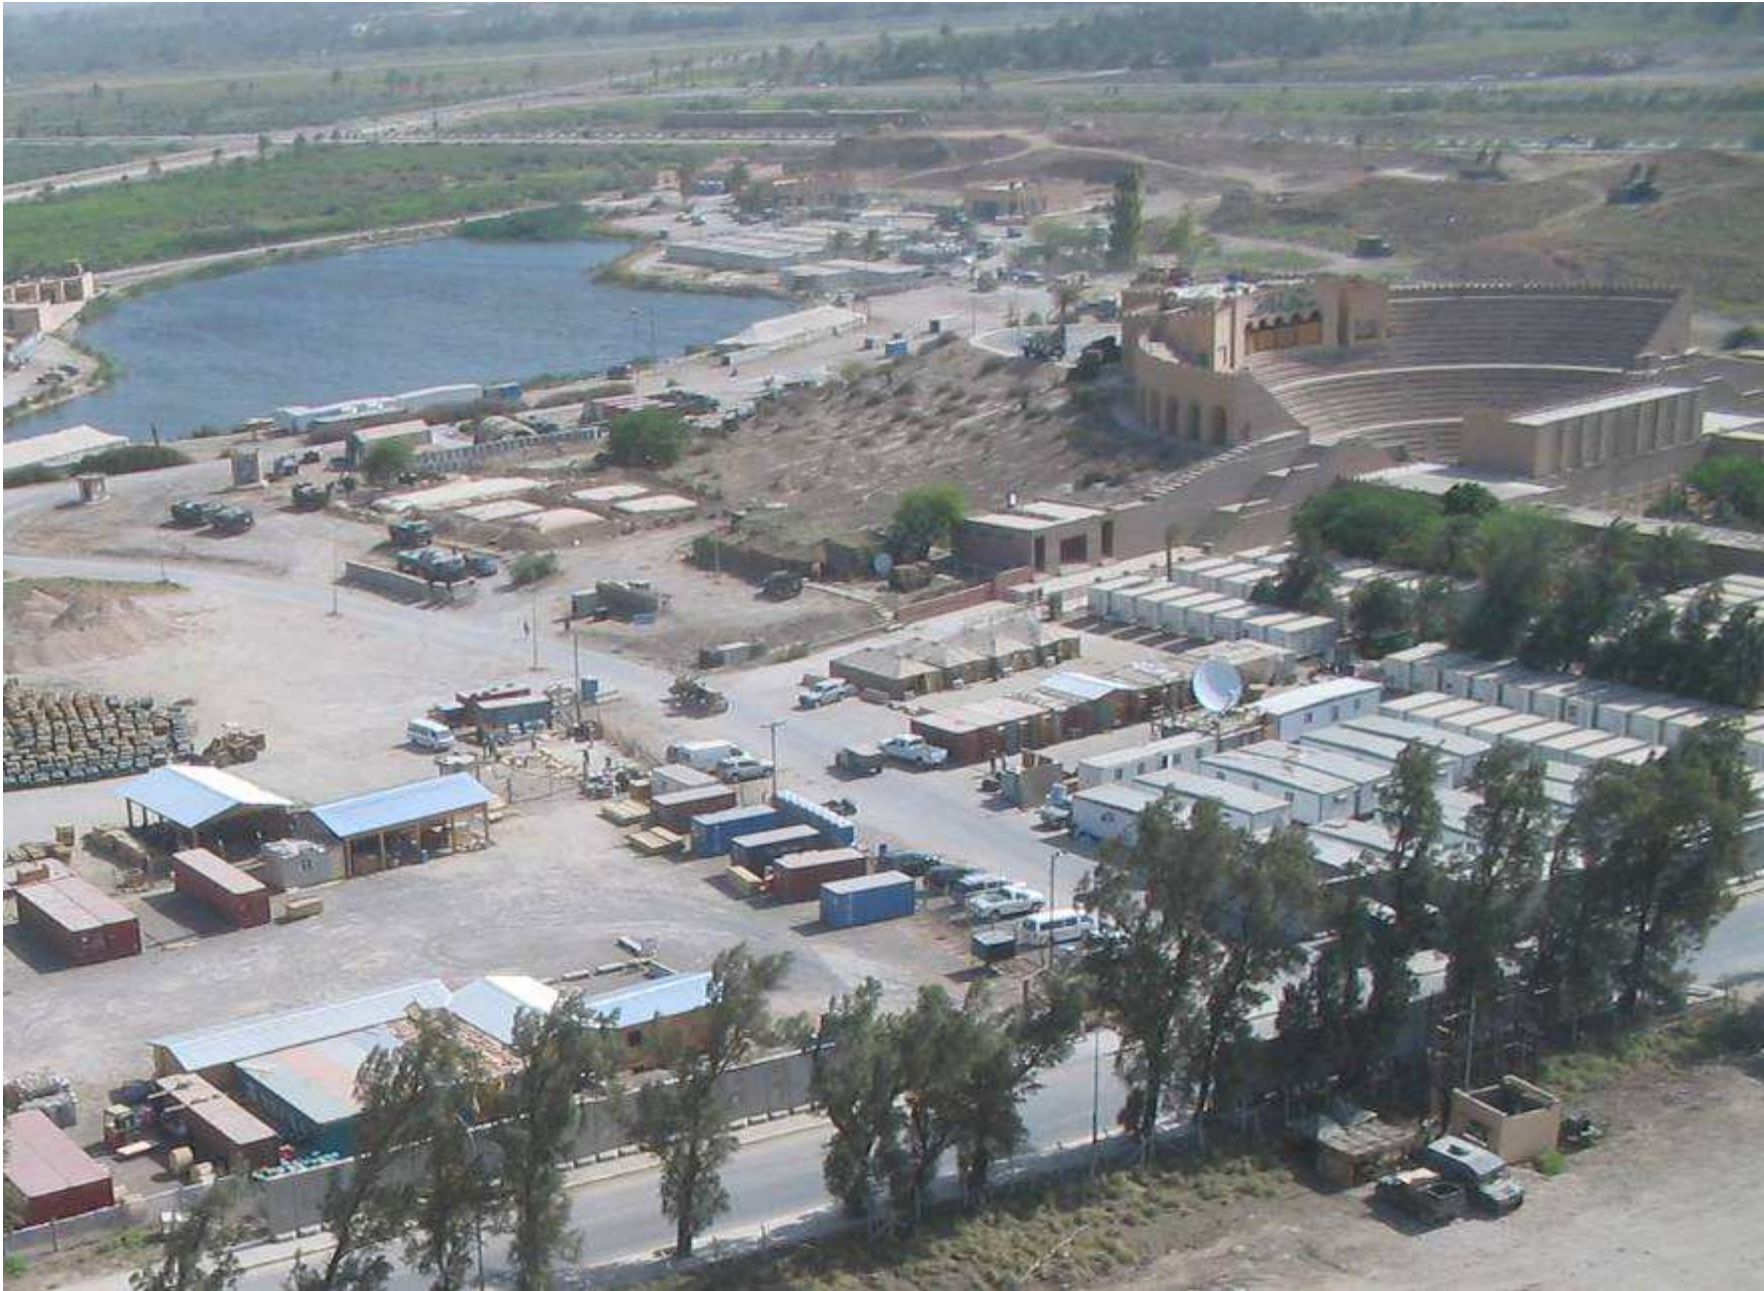
Fuel depot from the south, June 2004, Russell photo 124\_2436 (photo © John Russell)

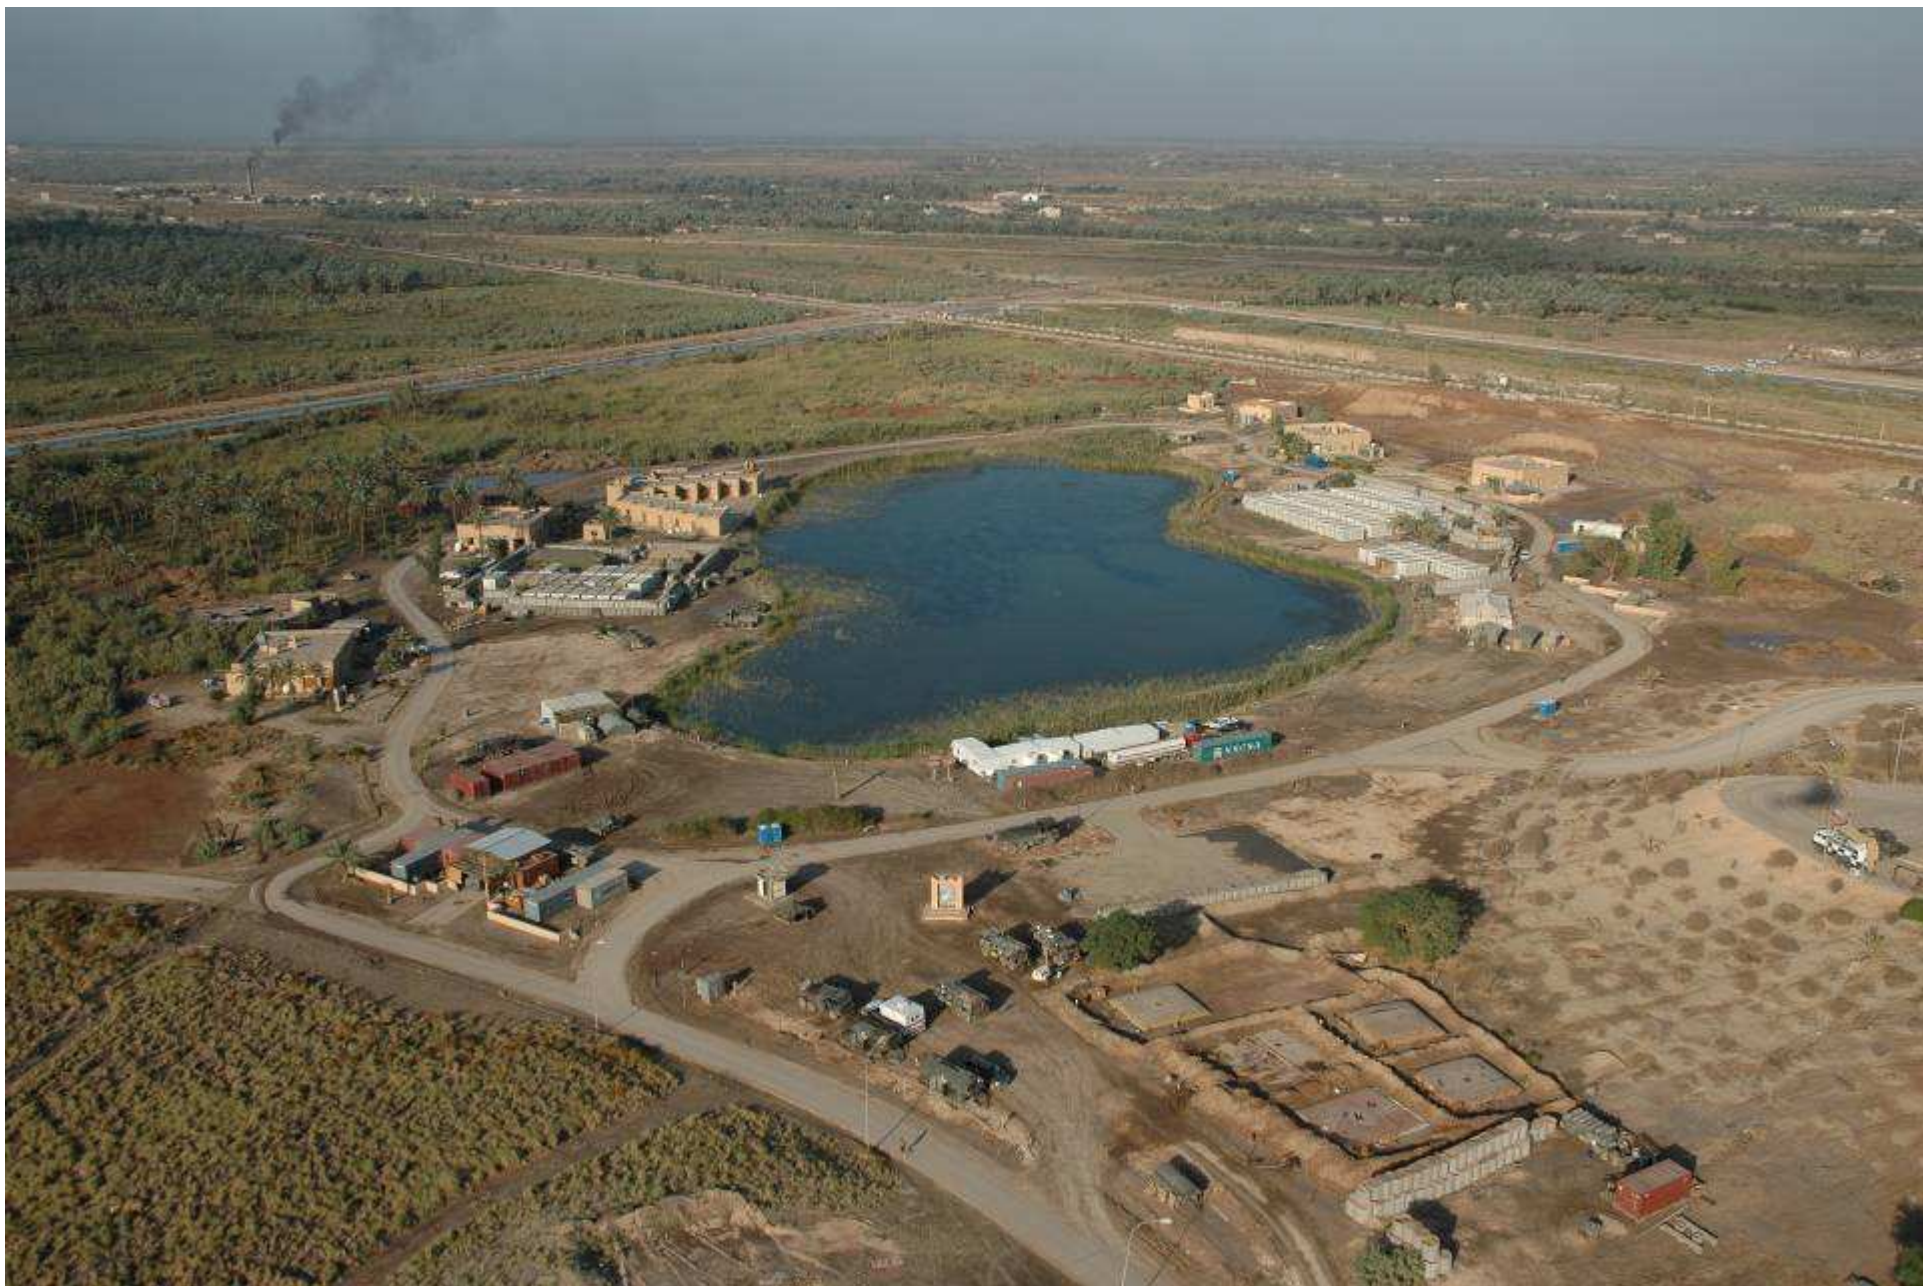
View of fuel depot and fueling area looking northeast, November 2004, Polish photo 65 (photo © Ministry of Culture and National Heritage, Republic of Poland)

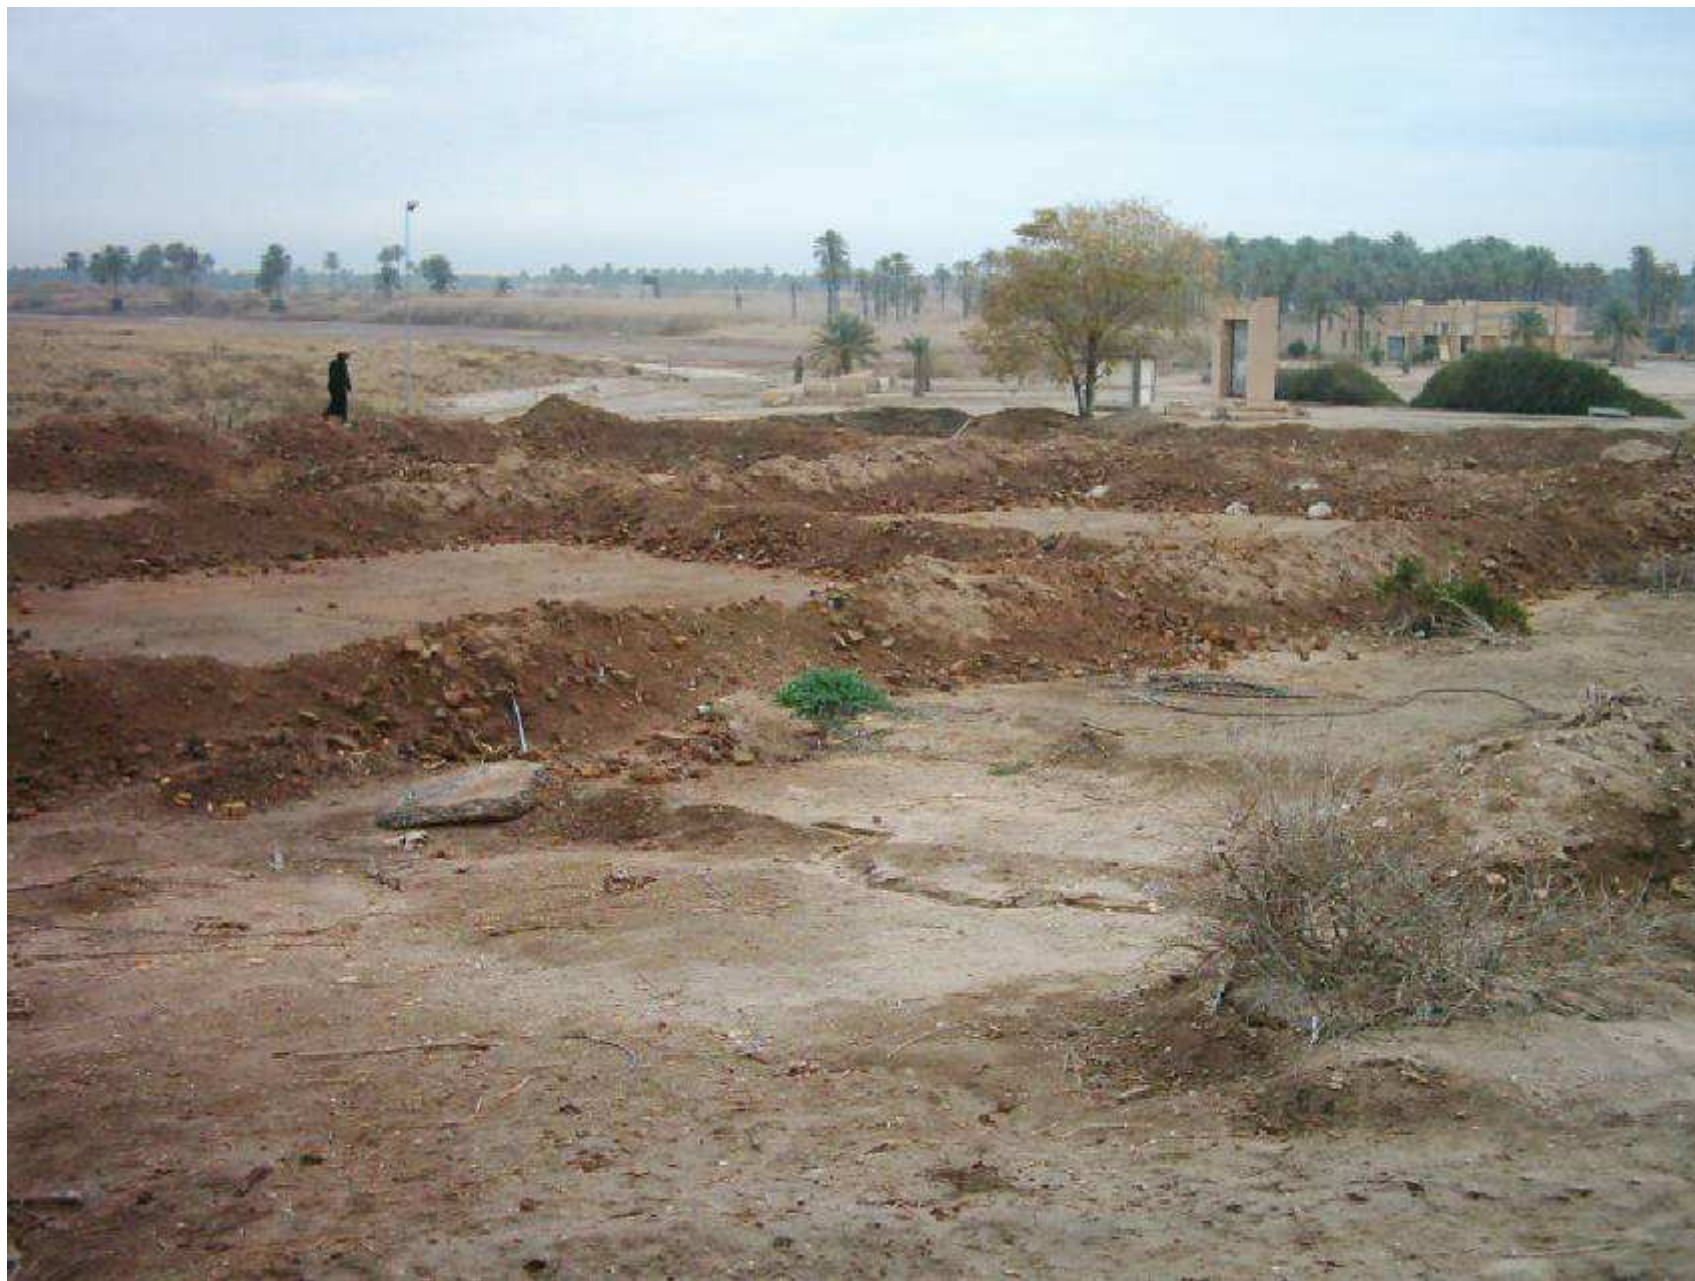
Berms after the evacuation of Camp Babylon, Iraqi final report fig. 67

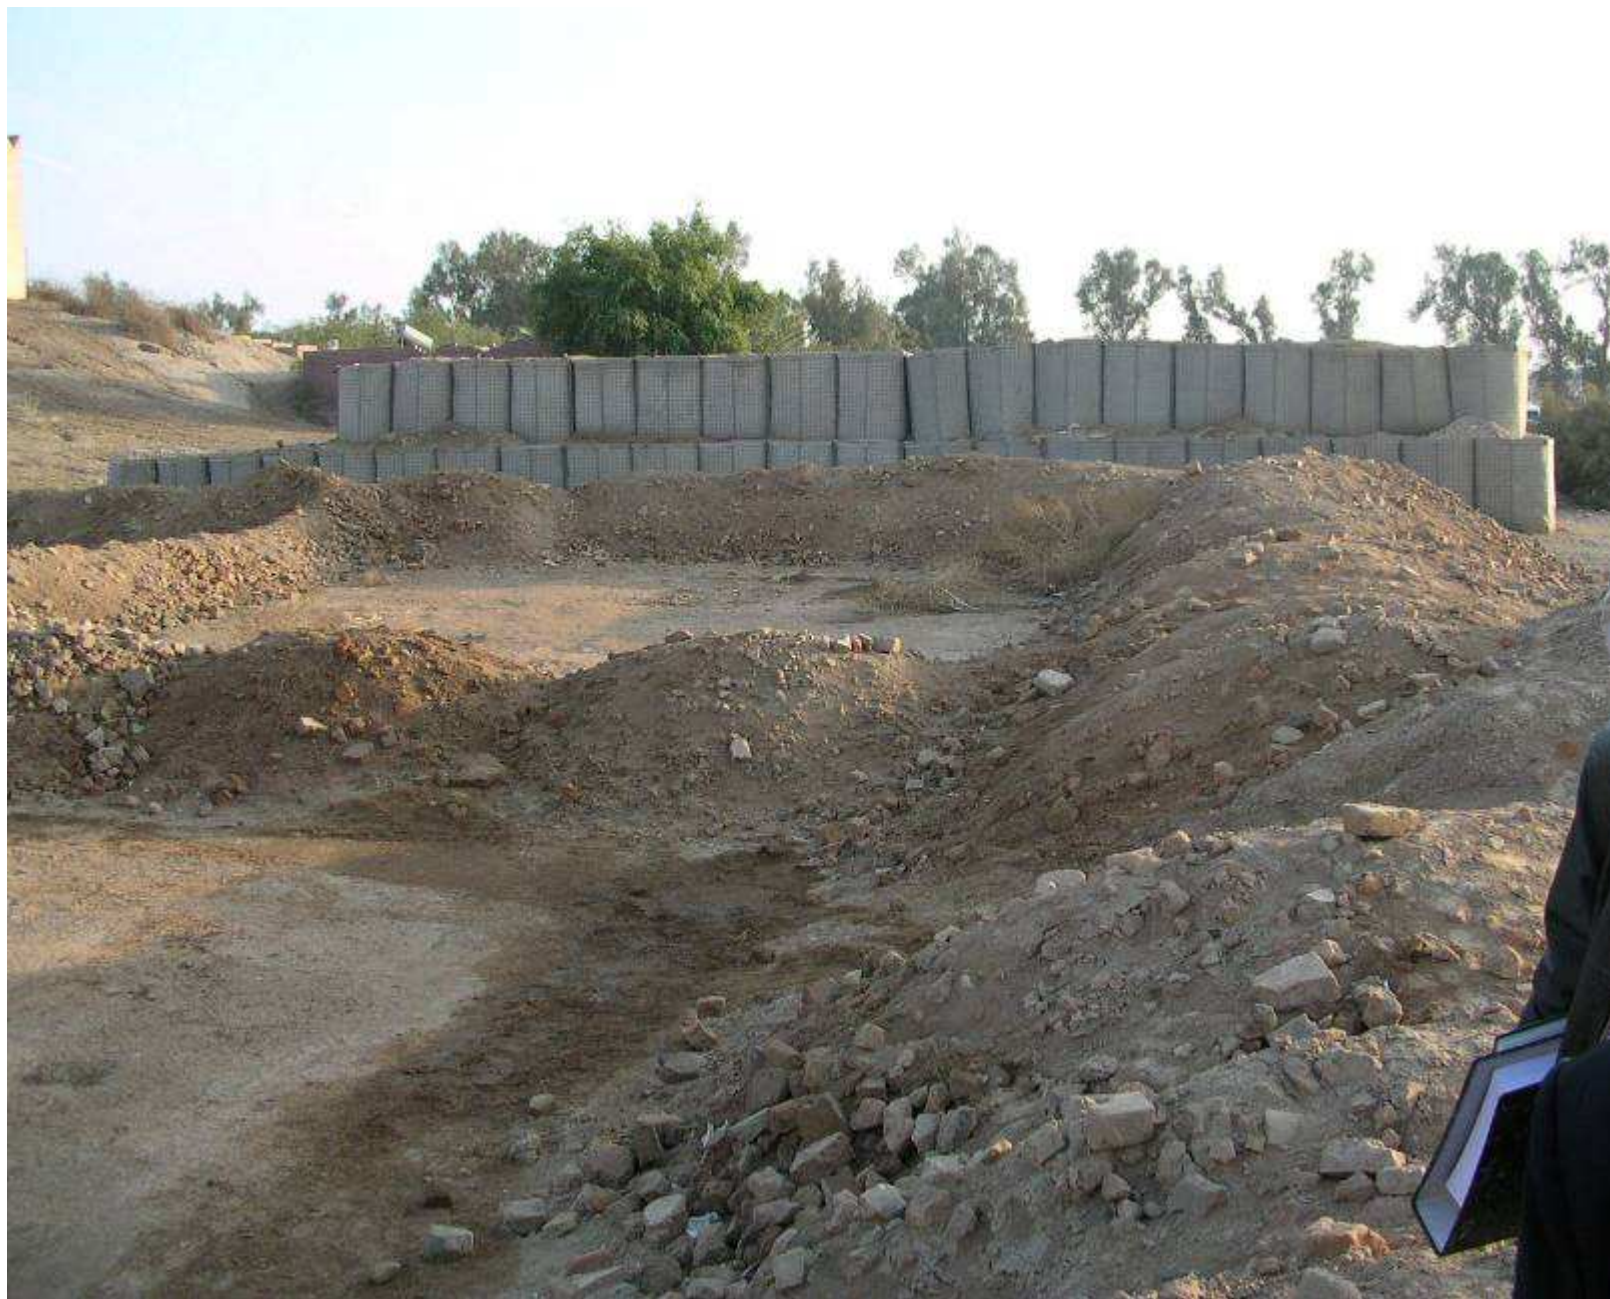
Brick fragments in berm, Curtis photo 7574 (photo © John Curtis)

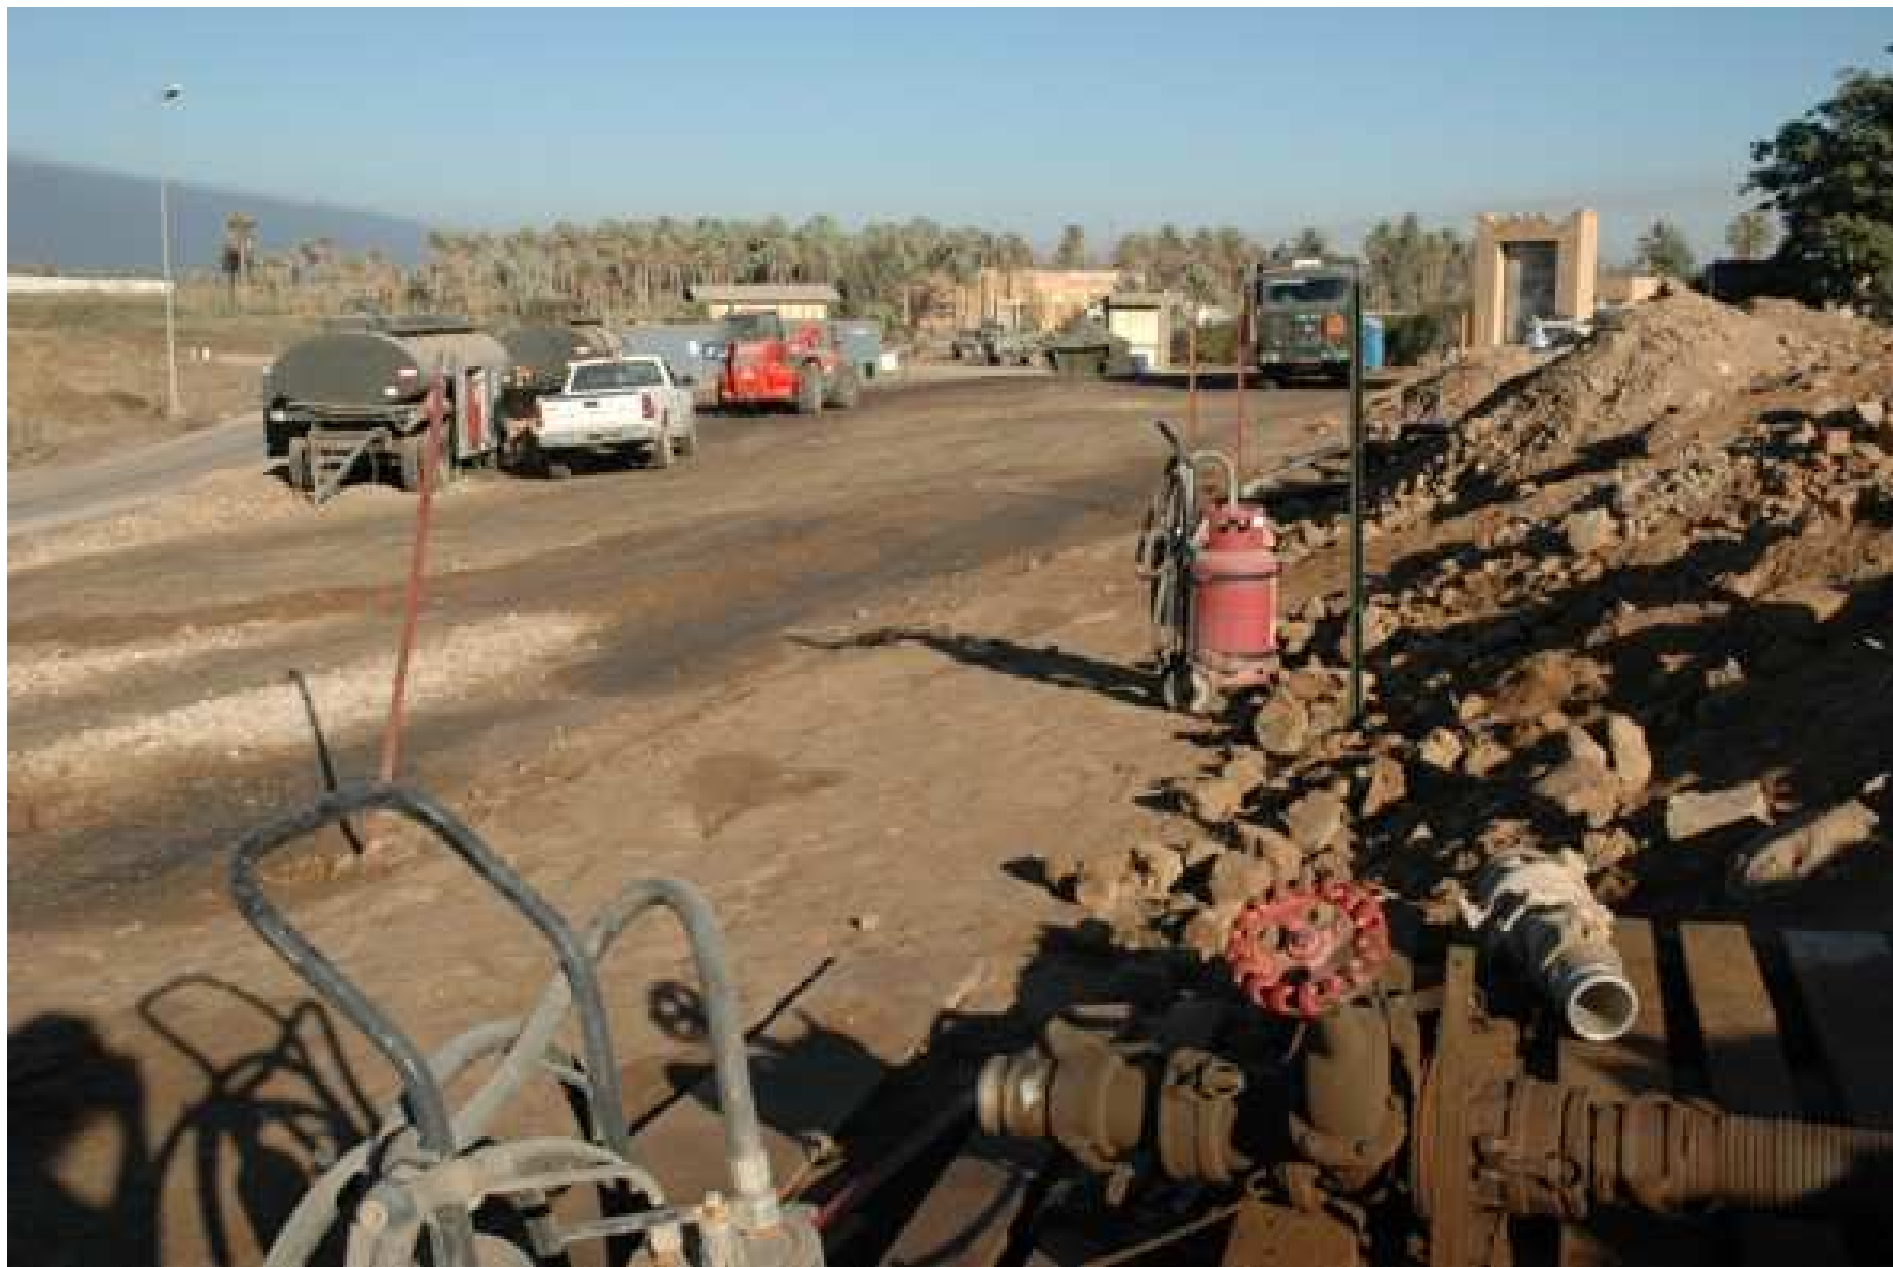
Contamination of surface to NW of fuel storage, Polish report p. 35 (photo © Ministry of Culture and National Heritage, Republic of Poland)

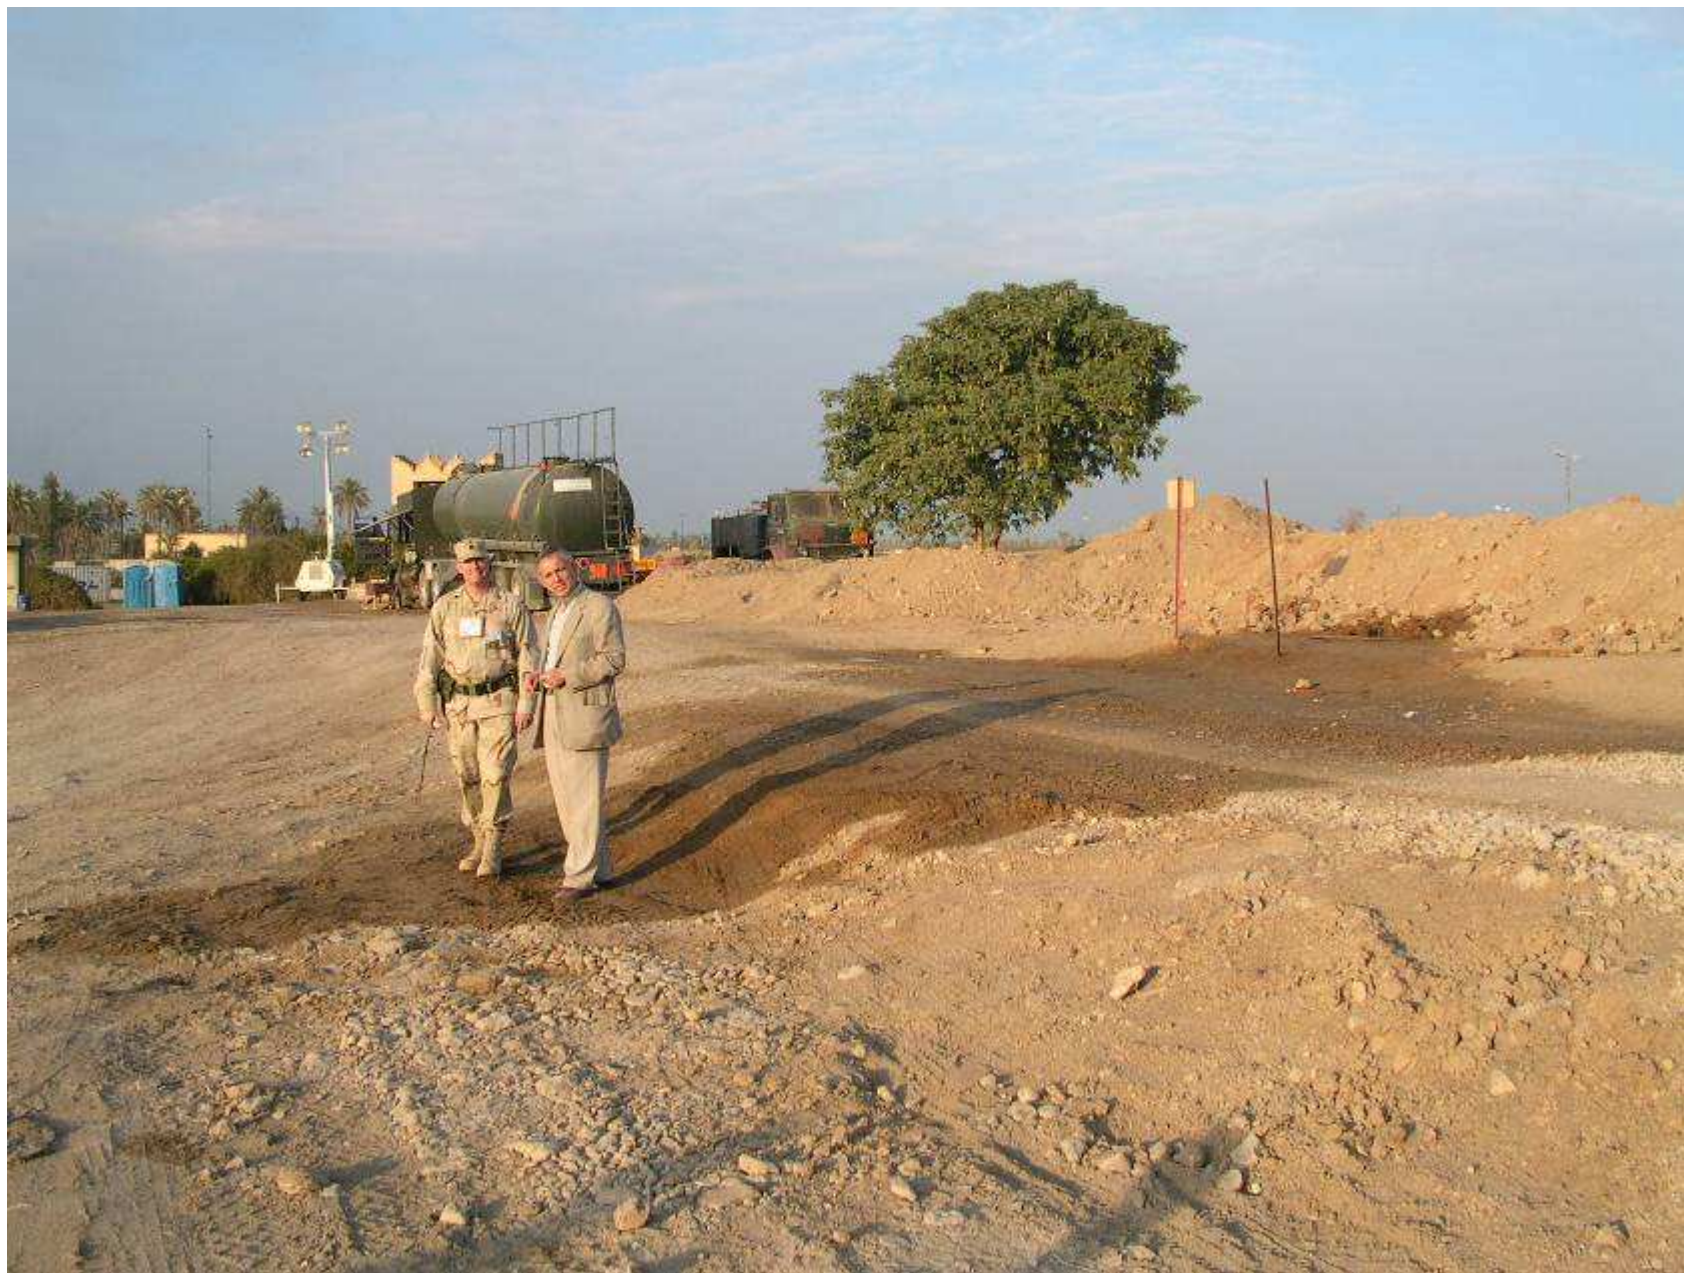
Contamination of surface to west of fuel storage, Curtis photo 7576 (photo © John Curtis)

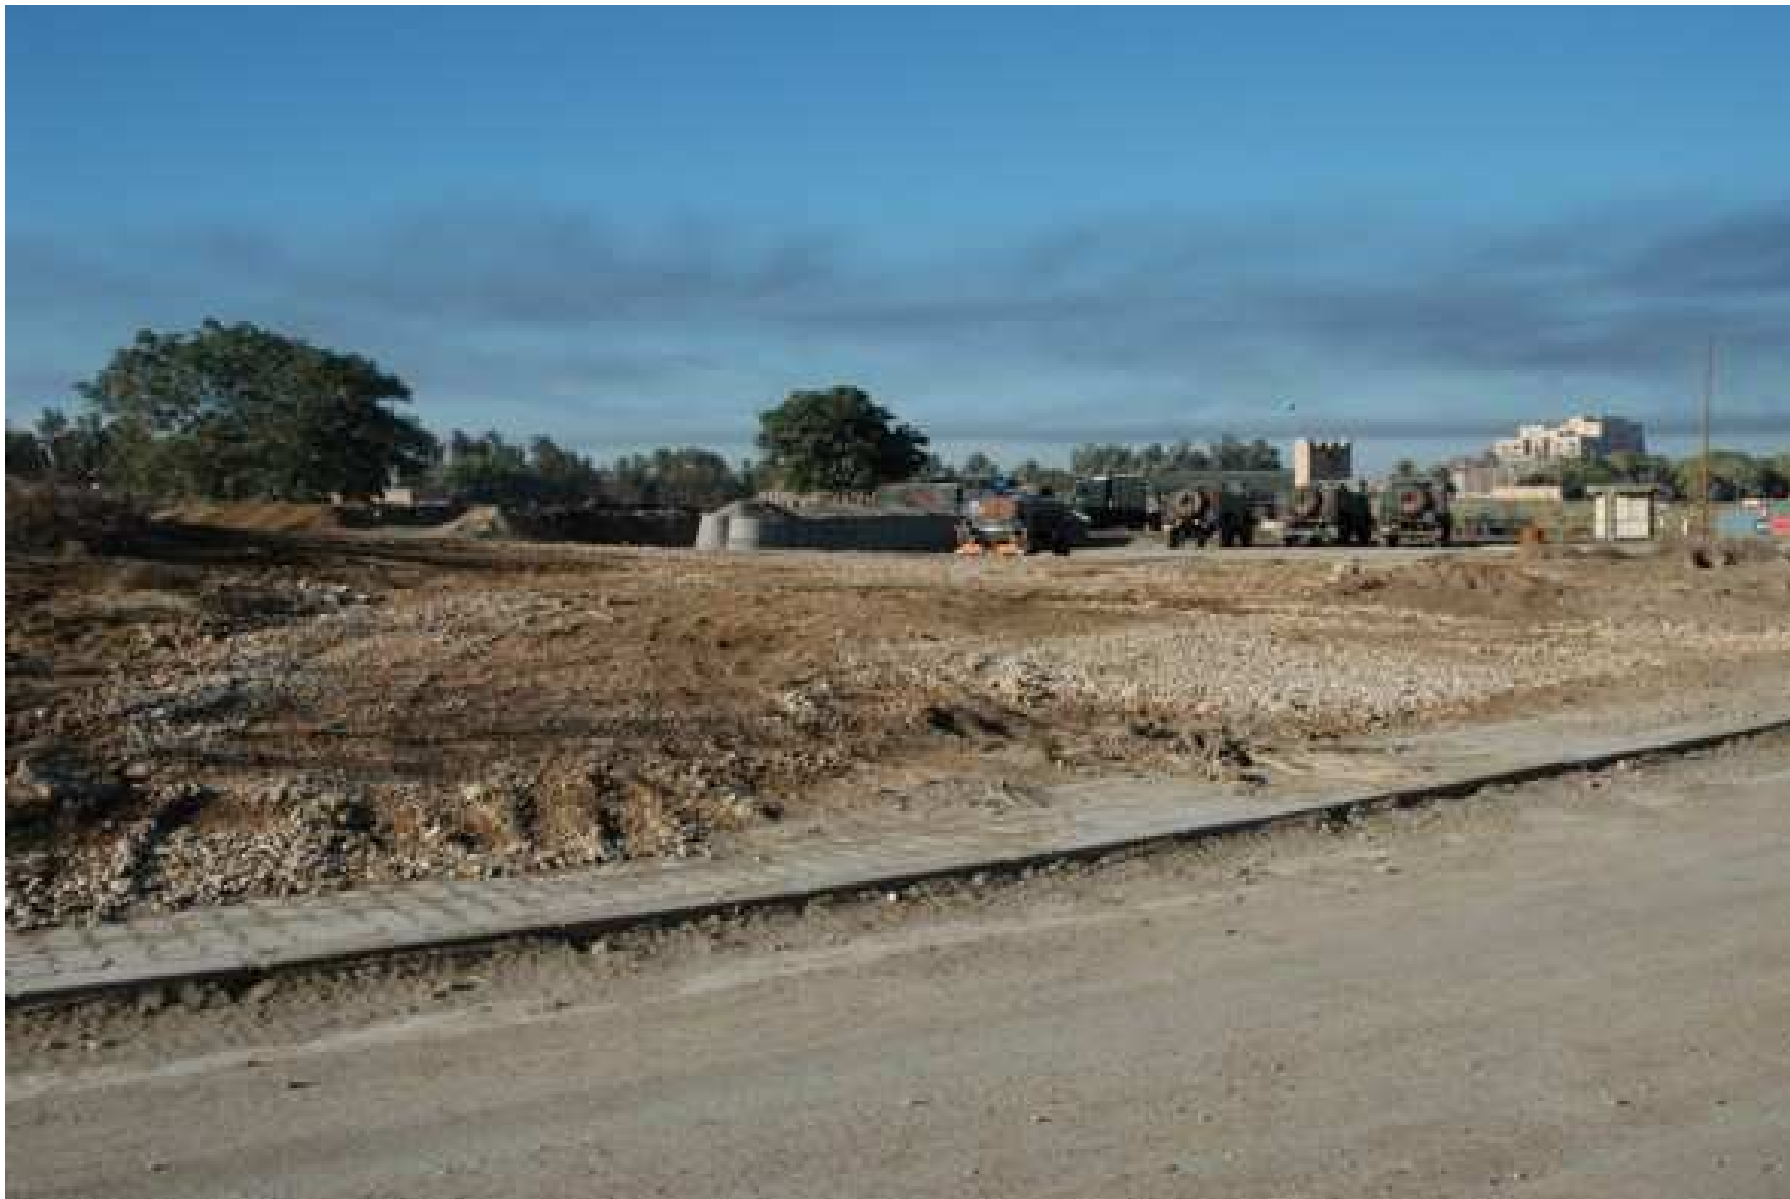
**Polish report:** The area at the northeastern portion of the “Fuel Farm” is covered with gravel. This place is marked on the picture at the beginning as letter “B” (photo Polish report p. 36, © Ministry of Culture and National Heritage, Republic of Poland).
