# **Report on Damage to the Site of Babylon, Iraq**

**John Malcolm Russell, Ph.D.**

**Cultural Heritage Center  
Bureau of Educational and Cultural Affairs  
Department of State**

**April 2010**

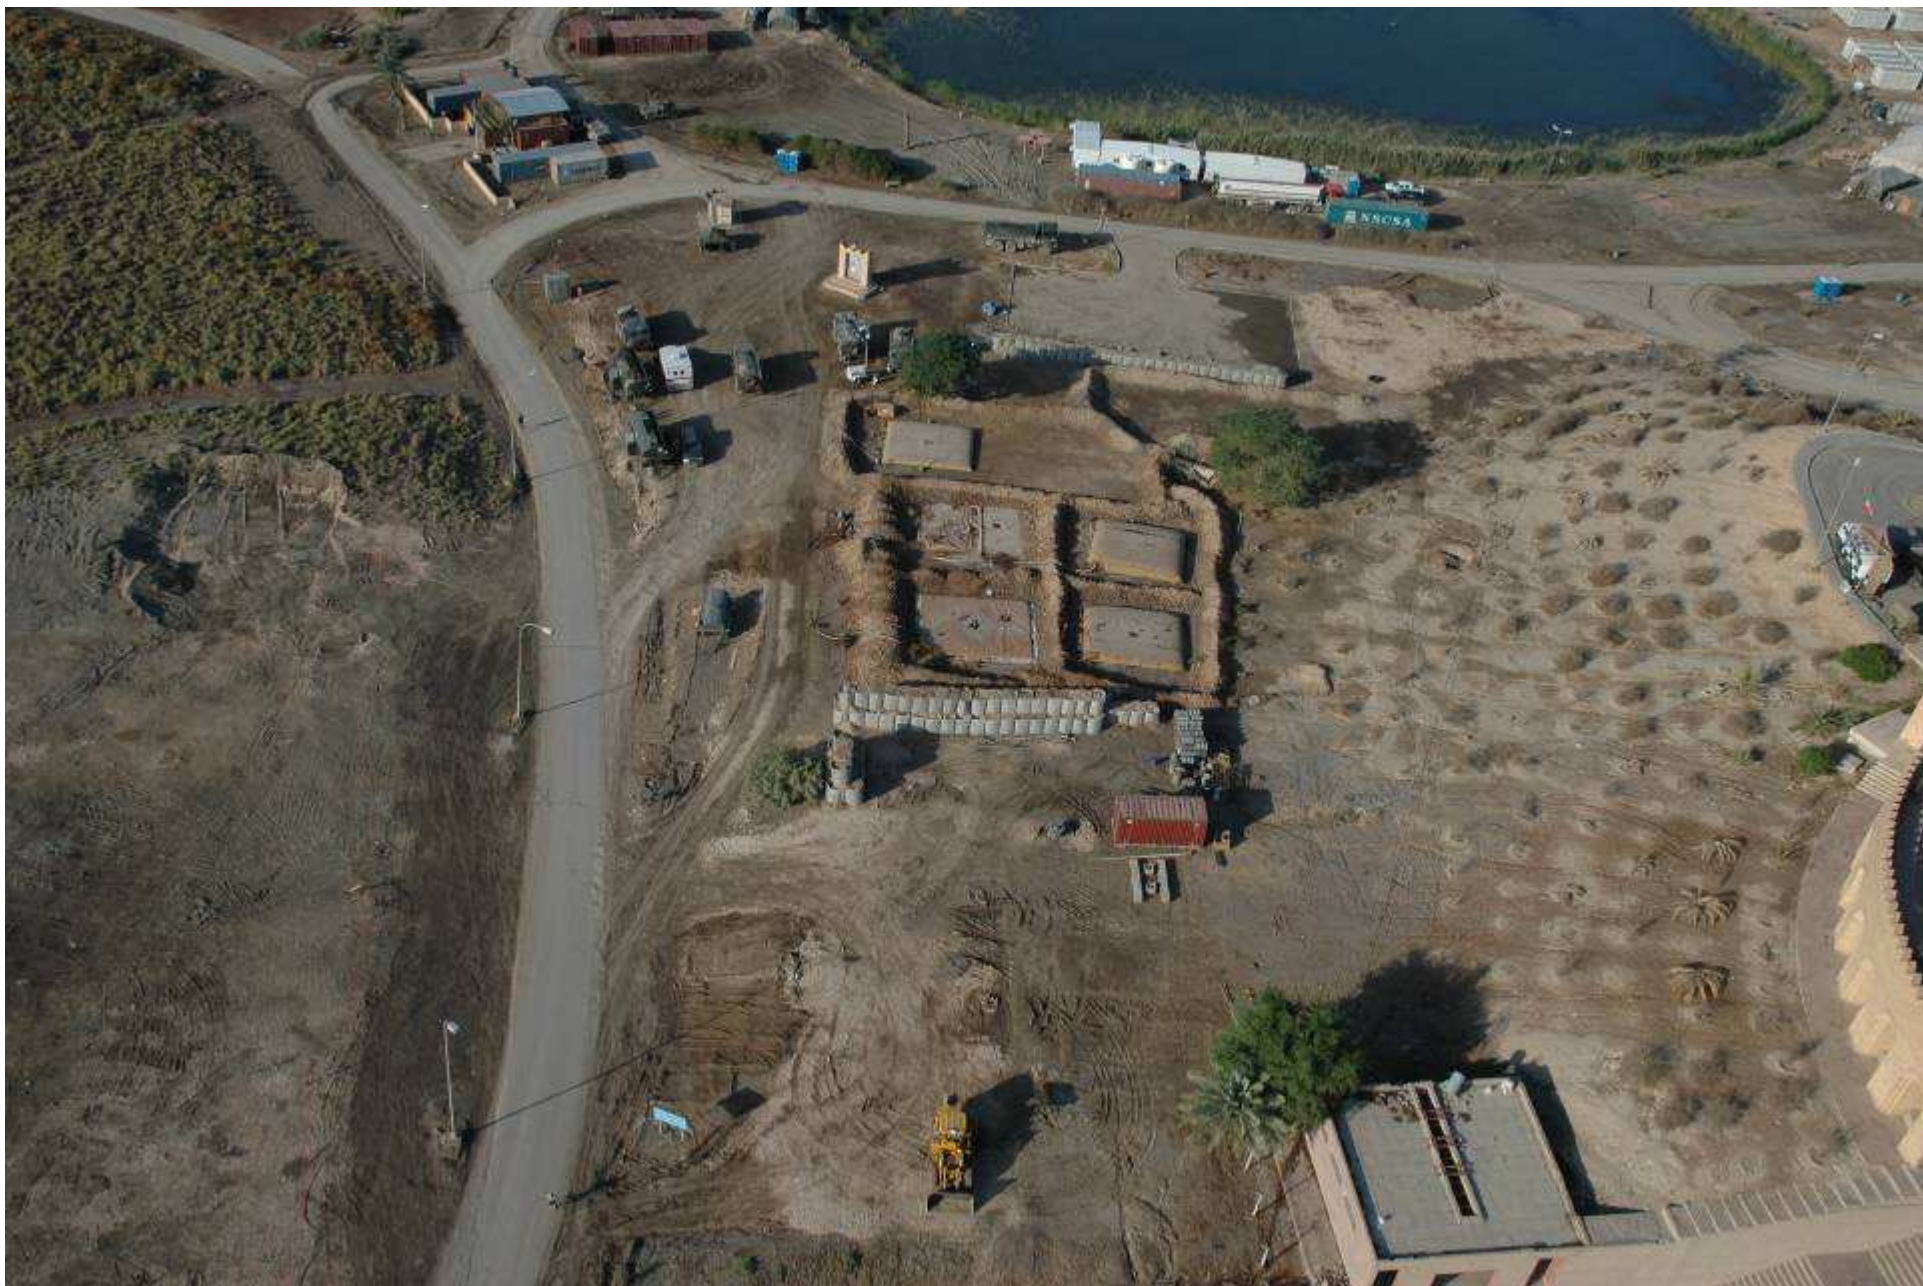
The new gravelled area is at the upper right, beside the old paved lot, Polish photo 66 (photo © Ministry of Culture and National Heritage, Republic of Poland)

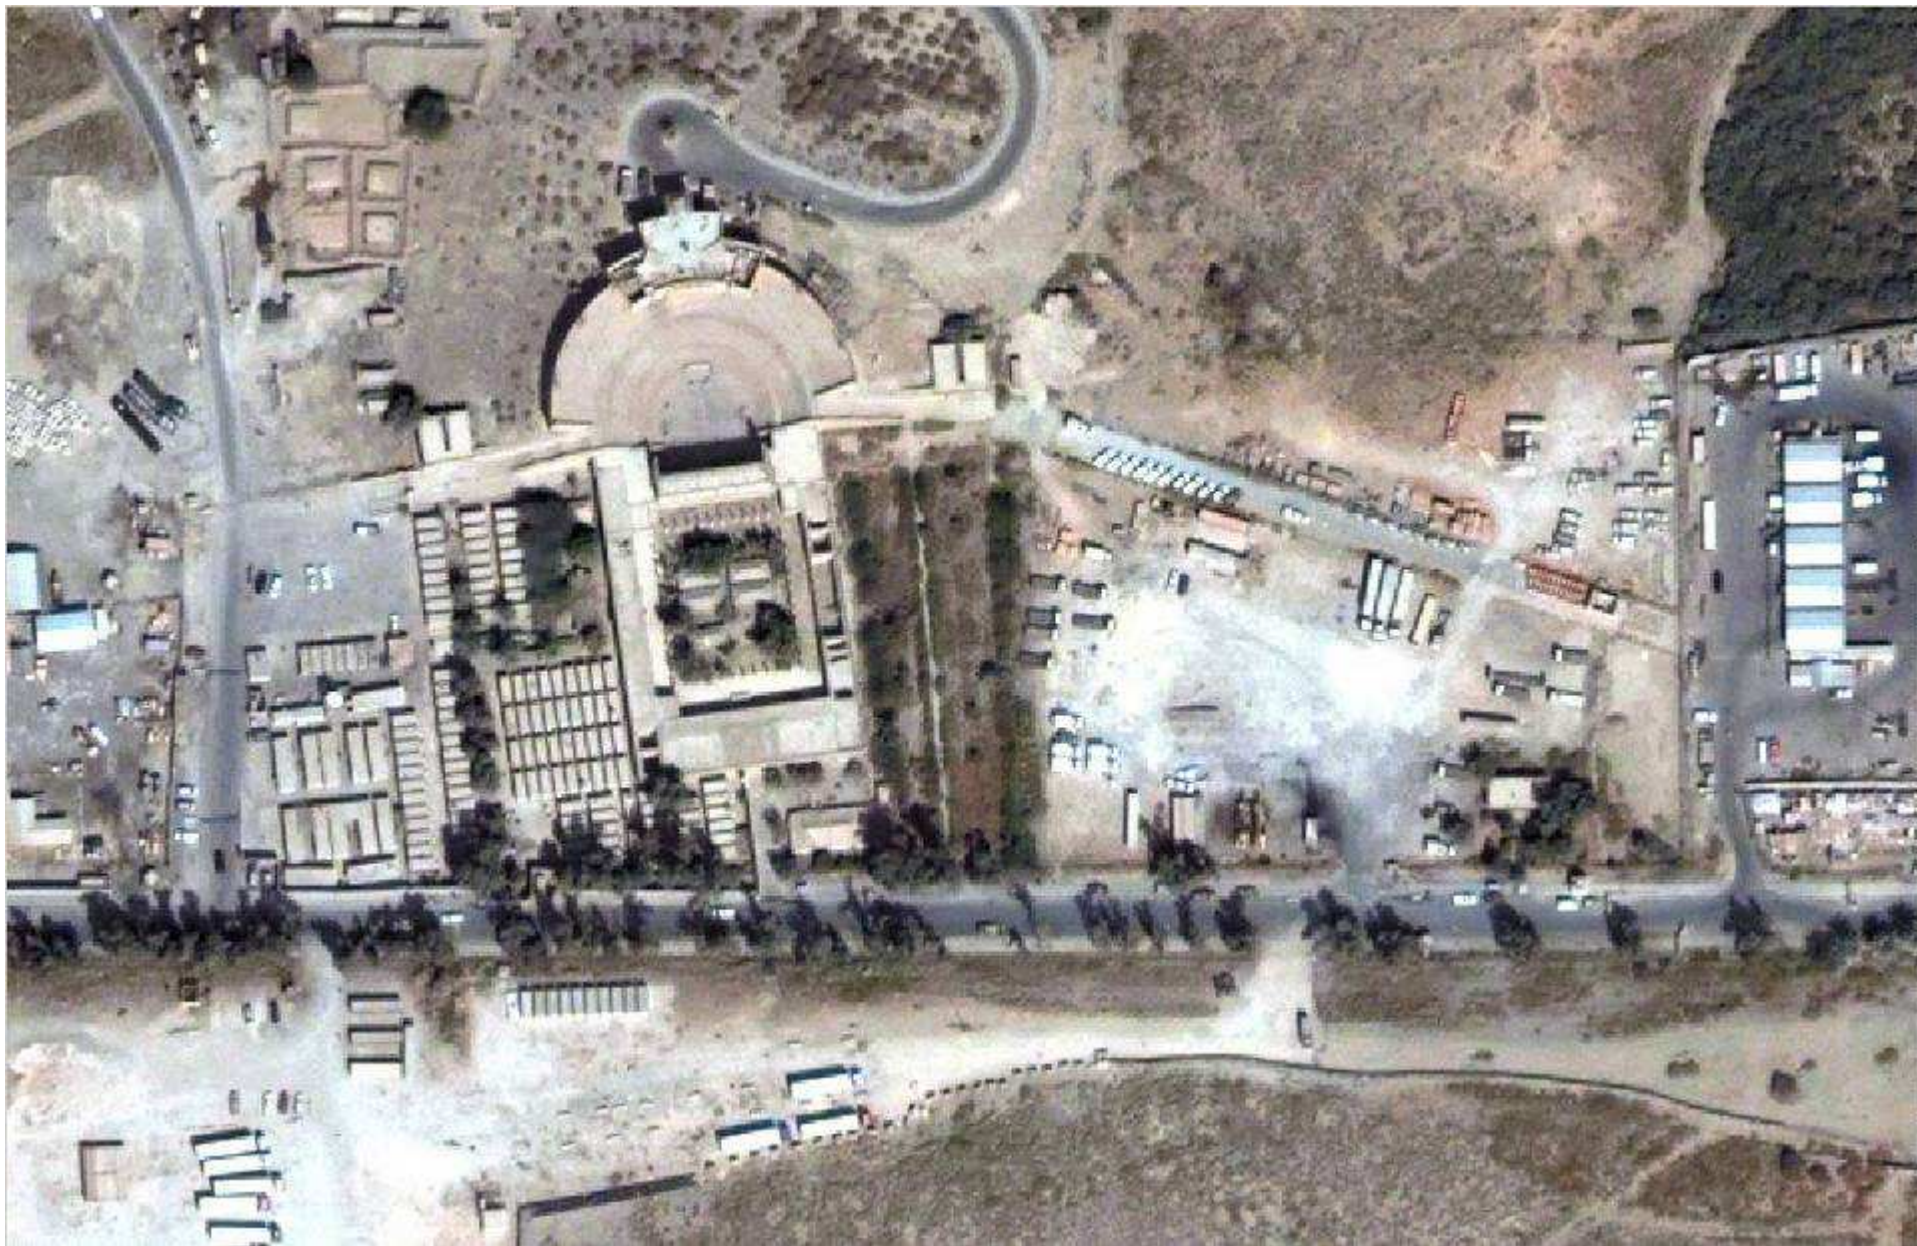
**Russell comment:** Prior to the Coalition occupation of the site, the areas immediately west and south of the theatre were gardens, and the area beyond the garden at the east was a slightly mounded open area. All of these areas were converted to parking by the Coalition.

8 October 2004, showing new parking areas, Russell composite

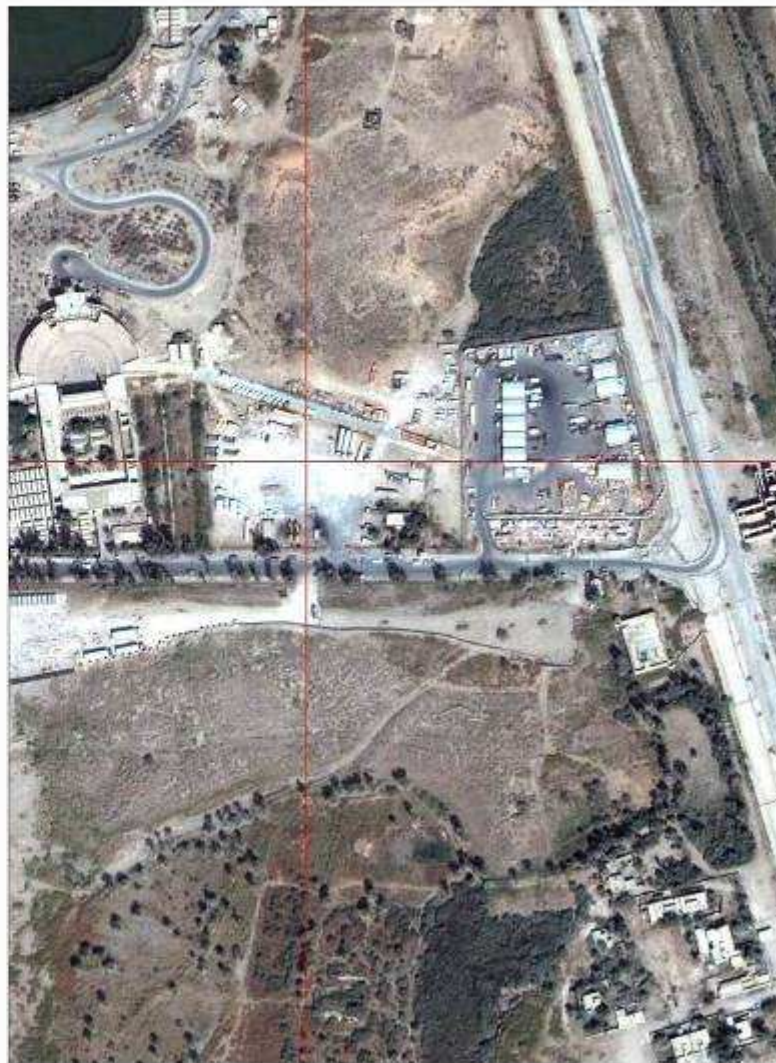
**Stone report:** Some development in this area began in August 2003, but it was not fully developed until 2004 (Fig. 28).

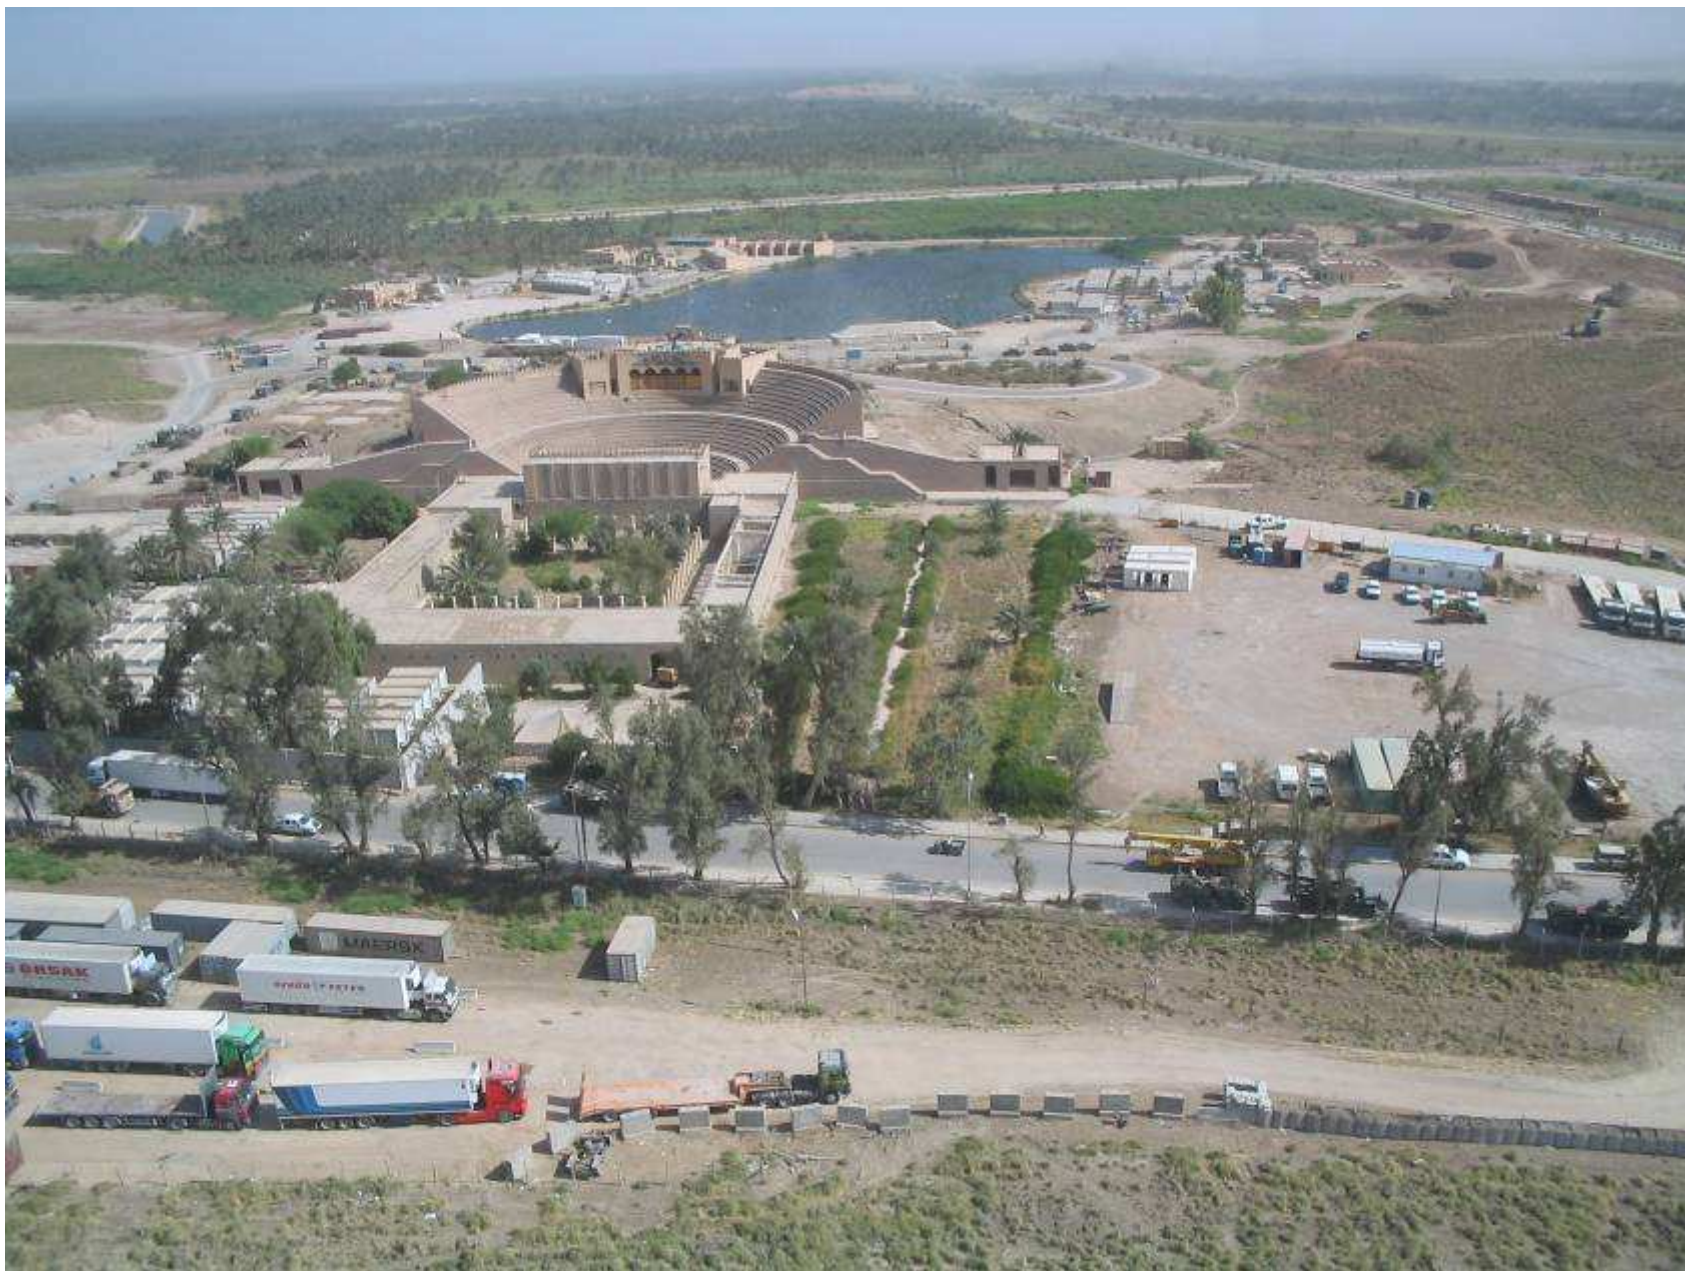
View of parking areas west (left), south, and east of the theatre, June 2004, Russell photo 124\_1437 (photo © John Russell)

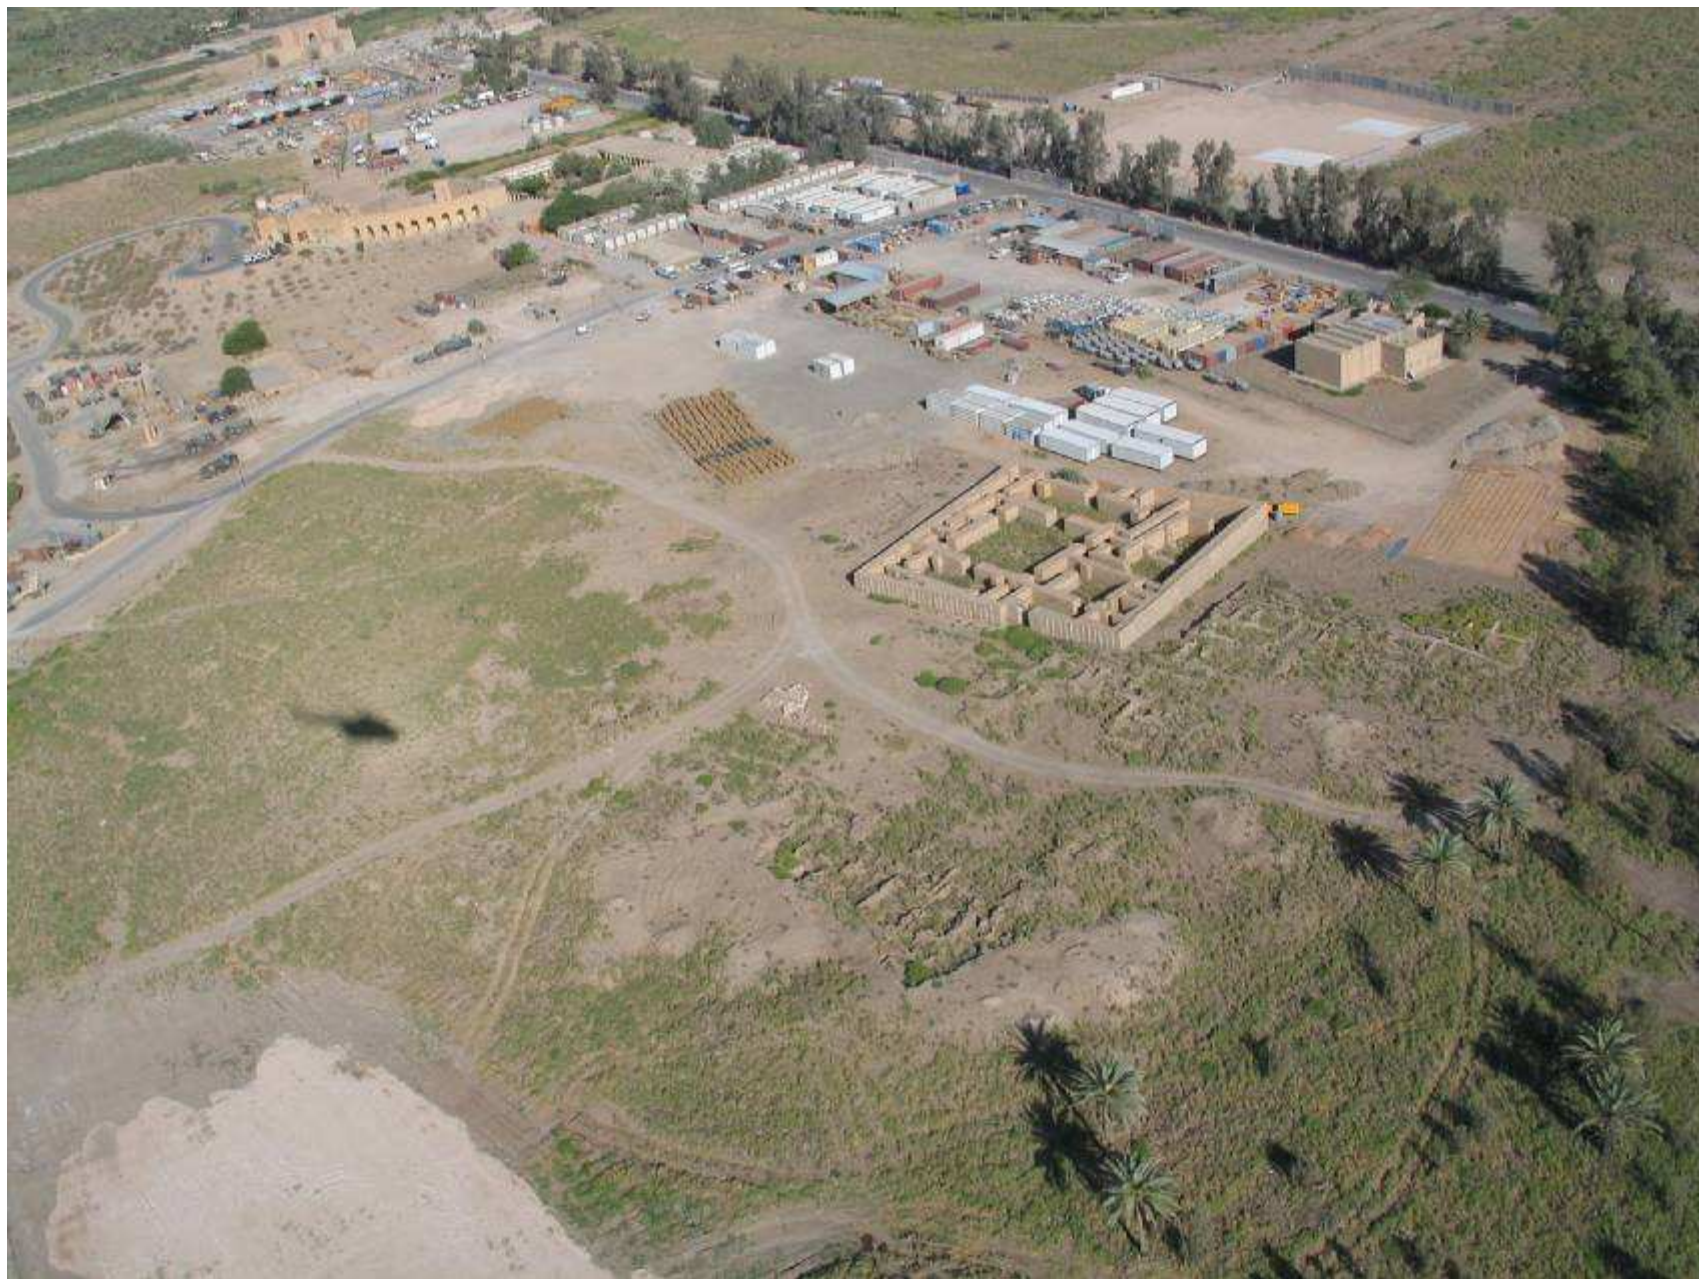
Development west of the theatre, Iraqi final report fig. 57

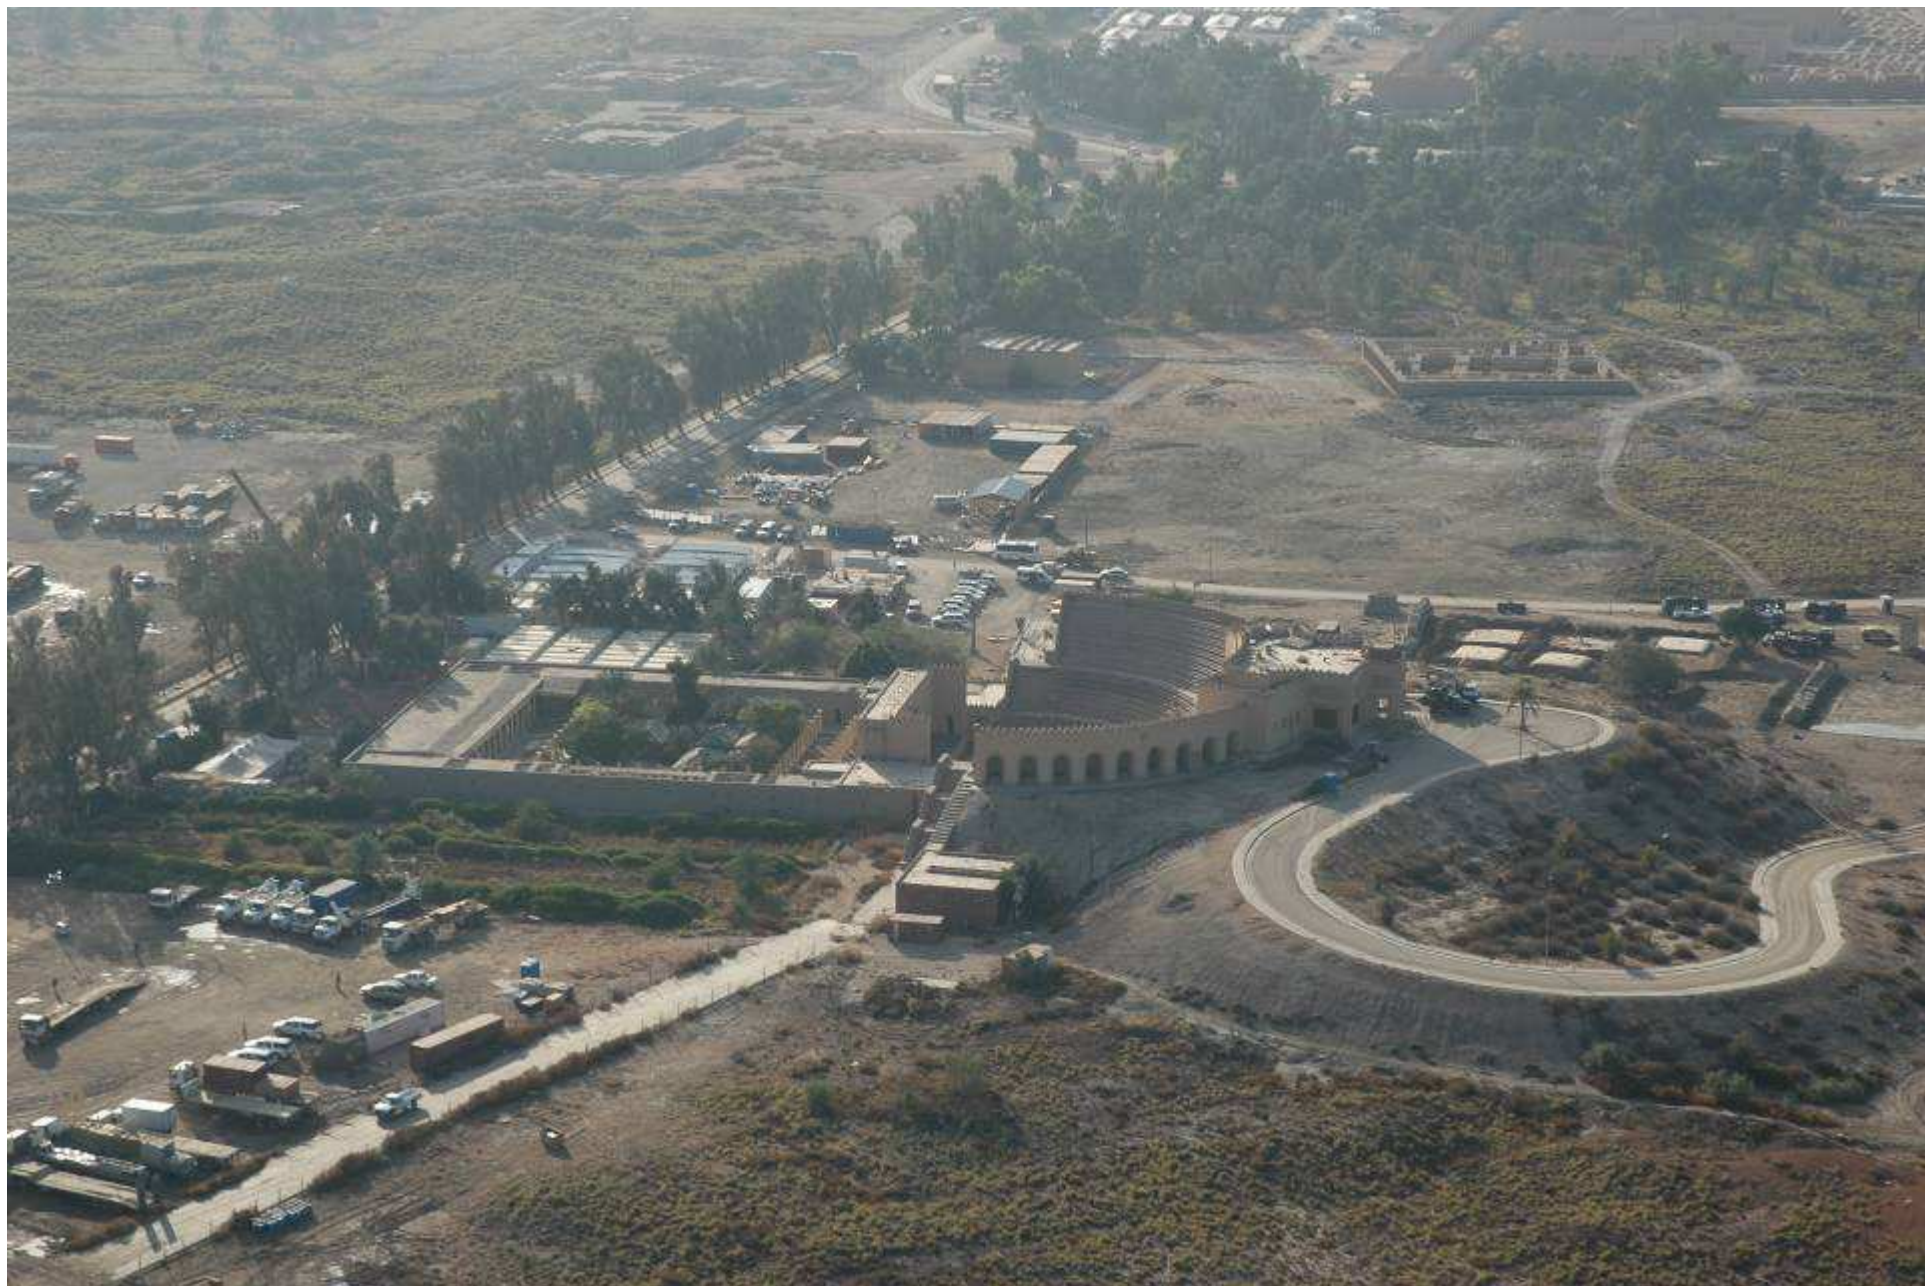
Parking area east of the theatre, Polish photo 15 (photo © Ministry of Culture and National Heritage, Republic of Poland)

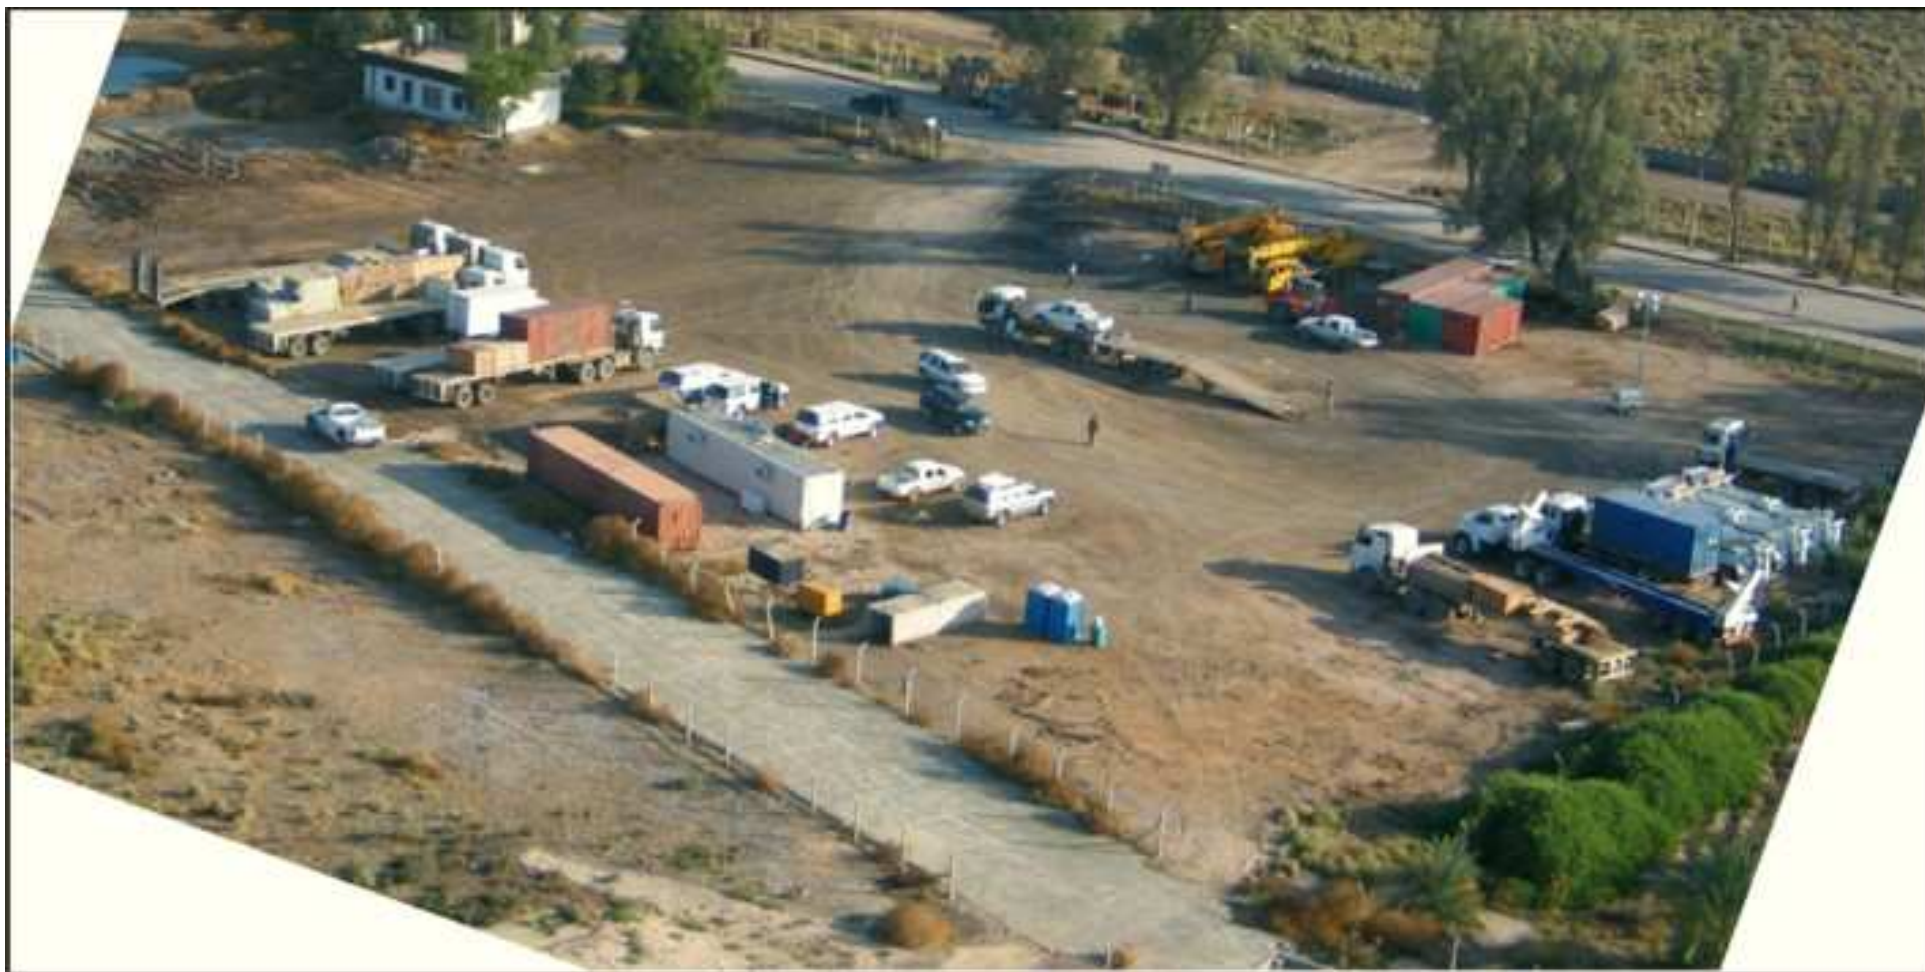
Parking lot east of the theatre ("Lot C"), Polish report p. 36 (photo © Ministry of Culture and National Heritage, Republic of Poland)

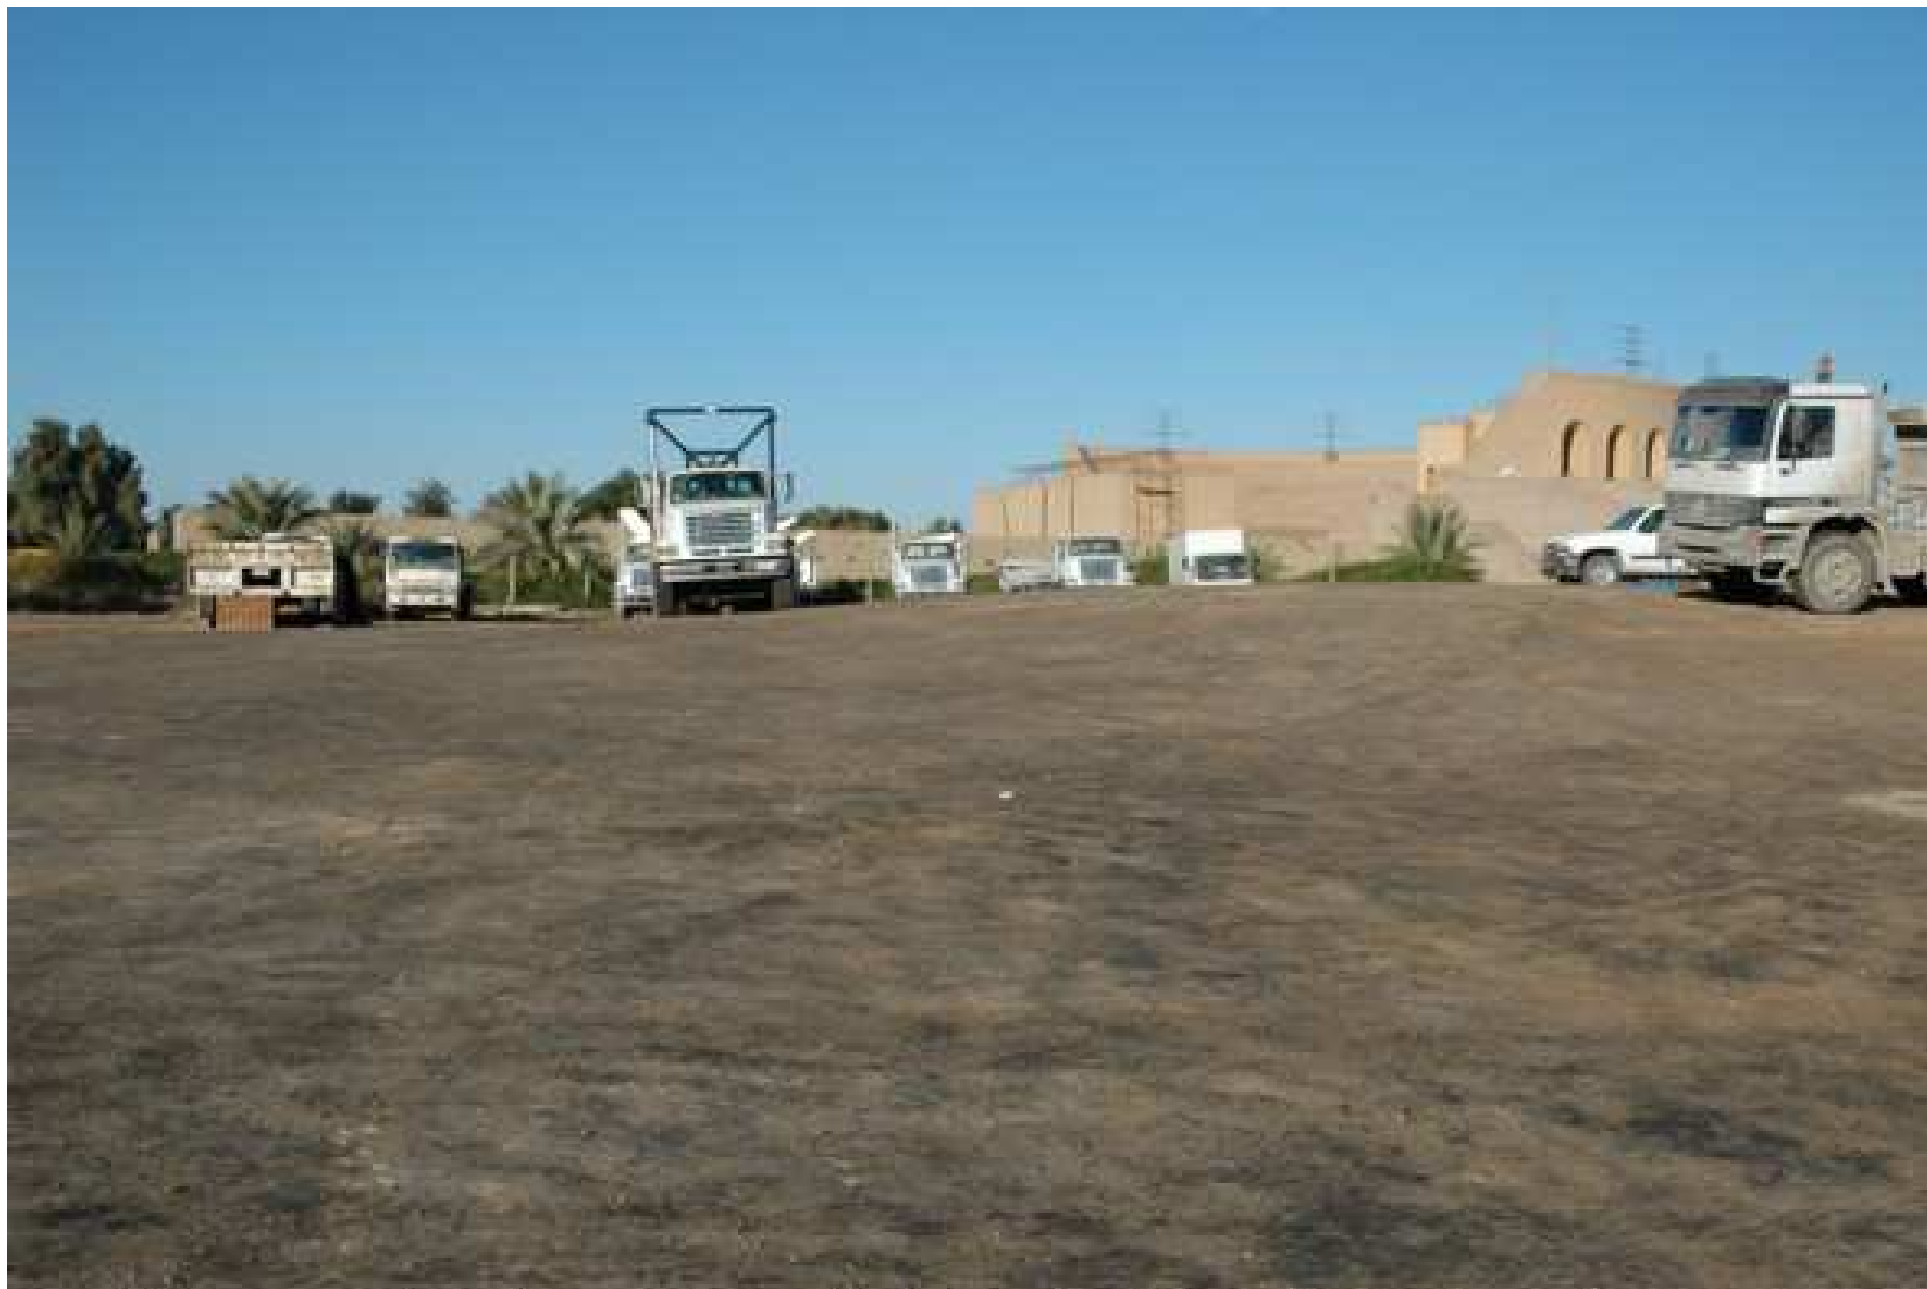
Parking lot east of the theatre ("Lot C"), showing the topography in this area, Polish report p. 37 (photo © Ministry of Culture and National Heritage, Republic of Poland)

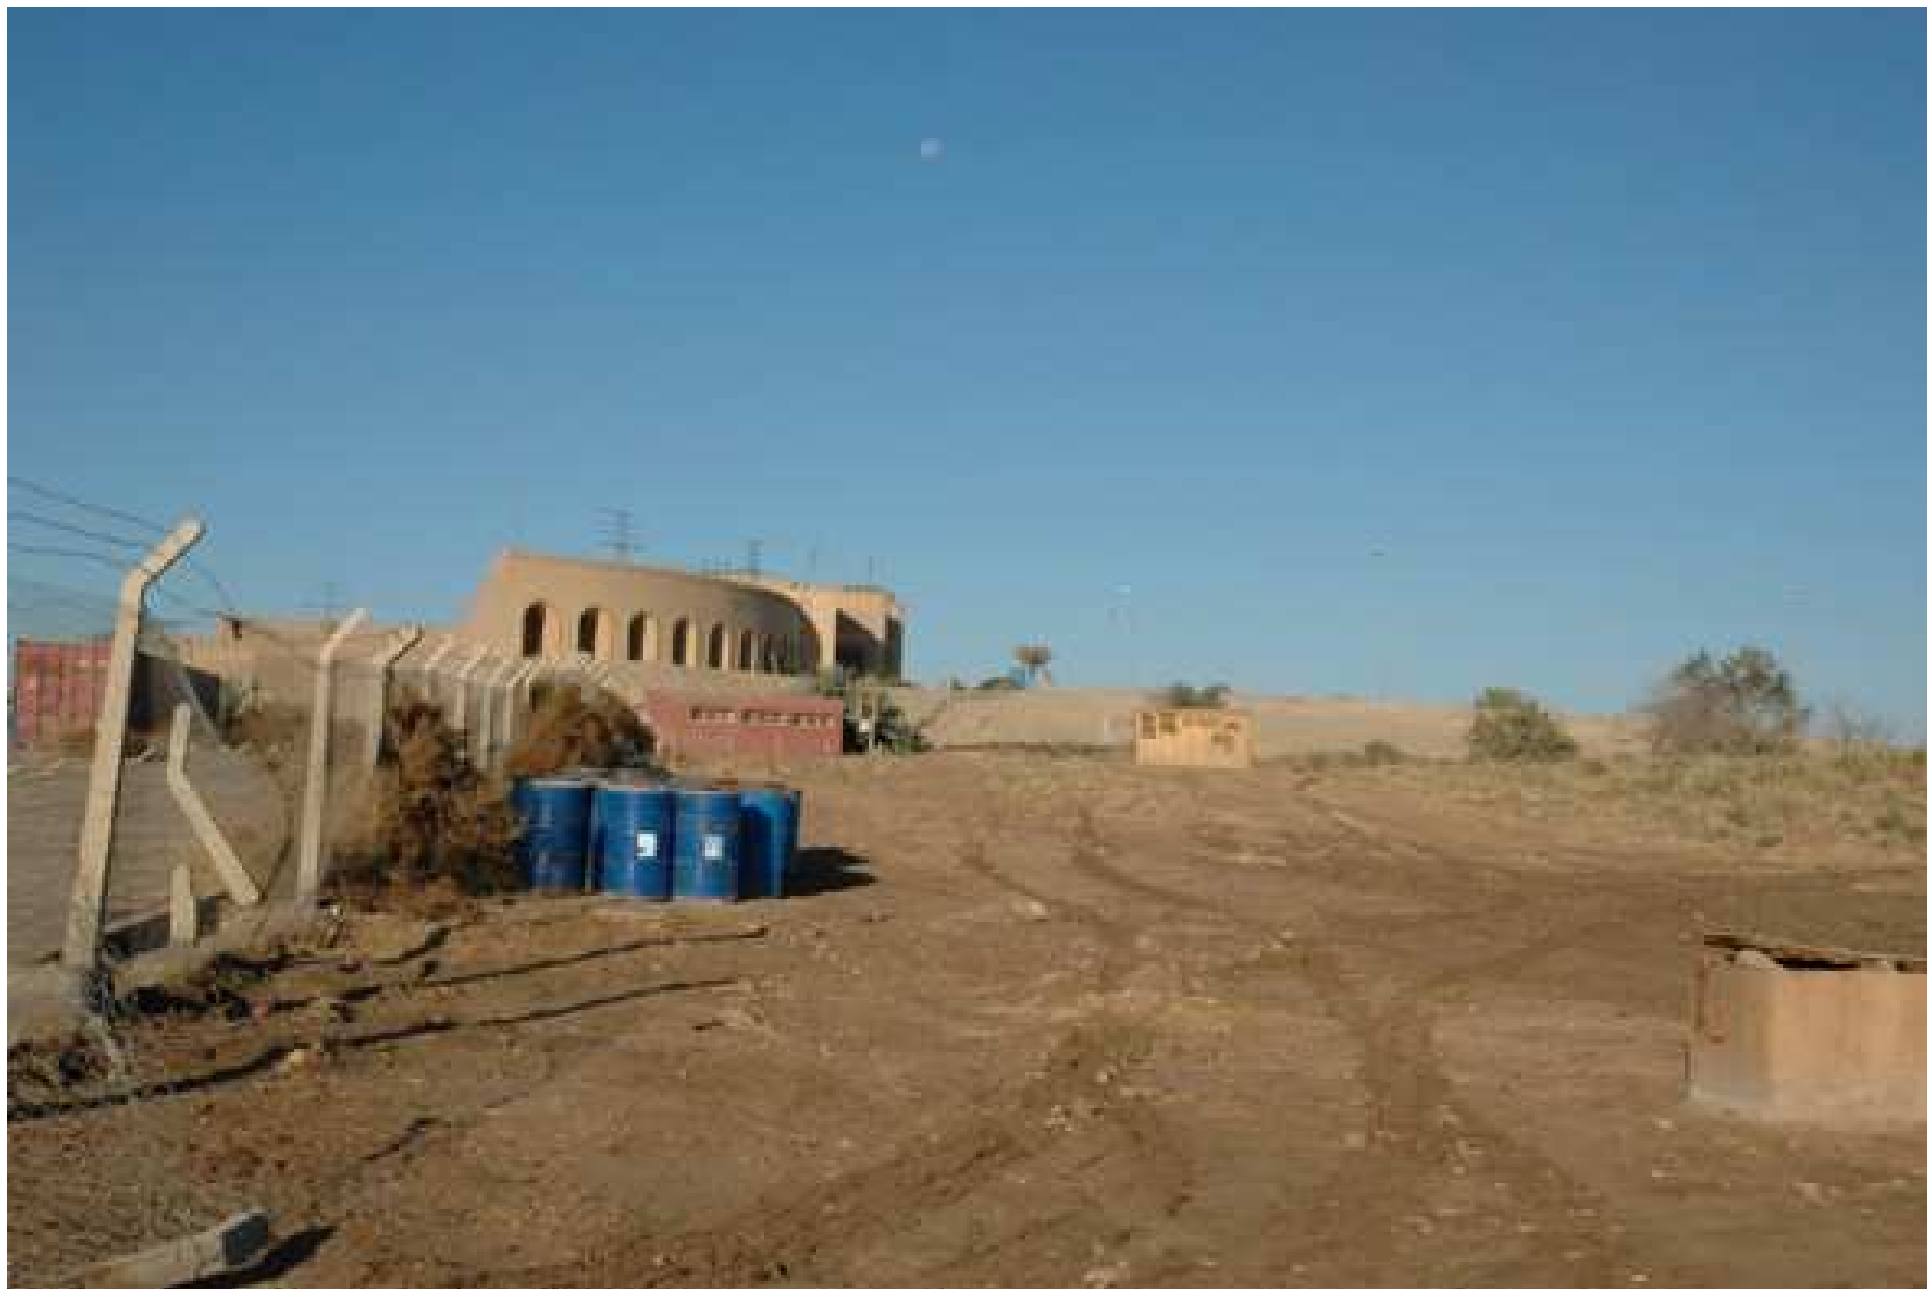
Parking area east of the theatre and north of the walkway ("Lot D"), Polish report p. 37 (photo © Ministry of Culture and National Heritage, Republic of Poland)

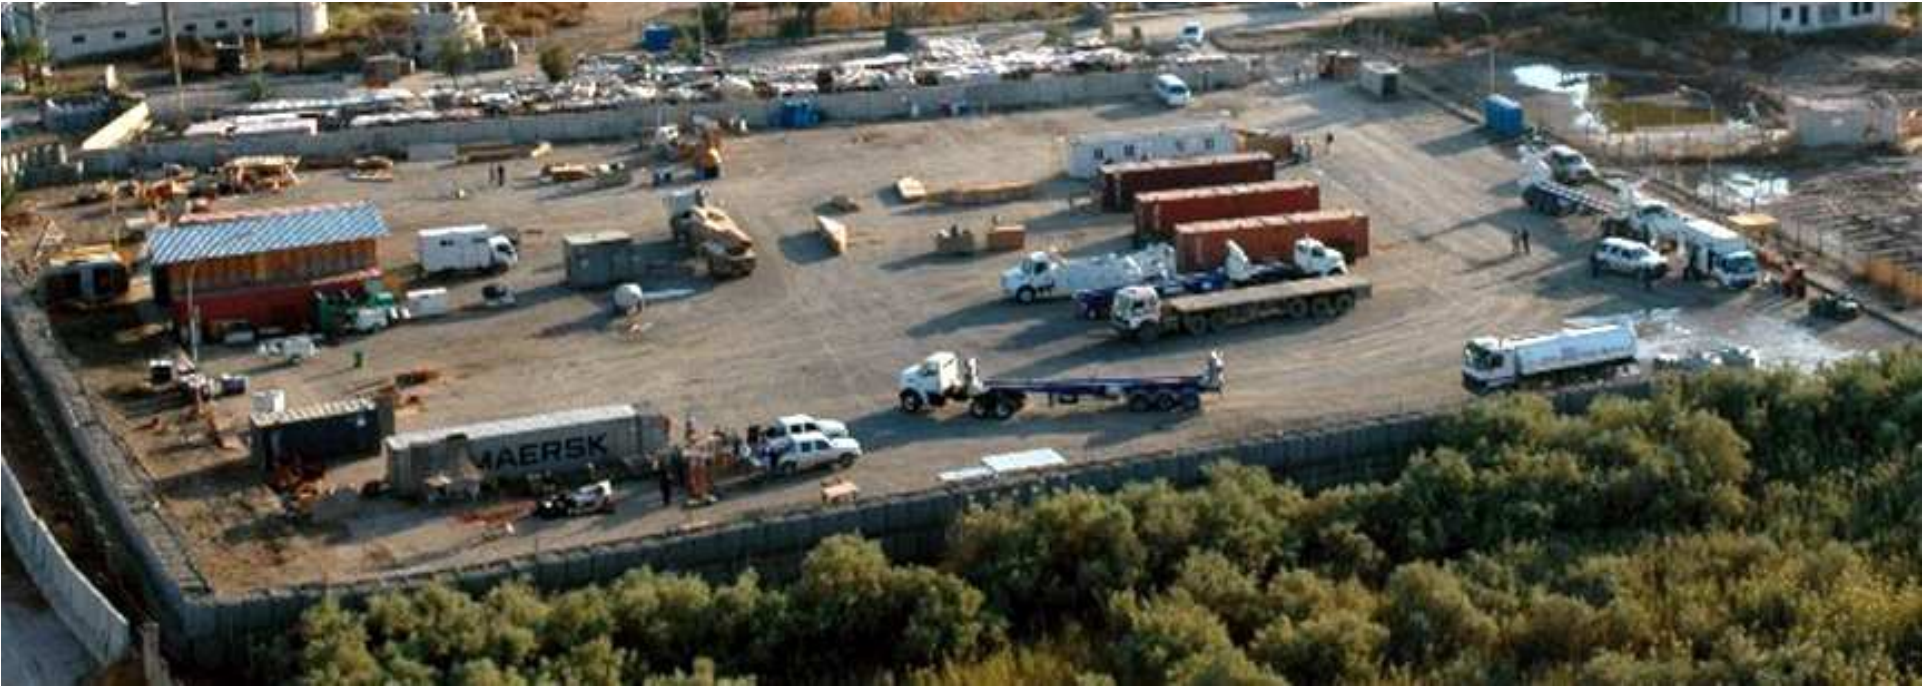
Polish report	Stone report
4) The KBR parking/vehicle maintenance area (marked on the picture by letter “E”) is located North of the market and Ronson gate. This area is enclosed within a chain link fence and asphalt surface. The dimensions for the area are about 100 x 100 meters.	The area further east does not appear to have been mounded based on the contour map, and had already been prepared as a parking area before the war.

**Russell comment:** Note the extensive use of HESCO and concrete block barriers around the lot and on the approach to the east gate.

The KBR parking/vehicle maintenance area, Polish report p. 37 (photo © Ministry of Culture and National Heritage, Republic of Poland)
