# **Report on Damage to the Site of Babylon, Iraq**

**John Malcolm Russell, Ph.D.**

**Cultural Heritage Center  
Bureau of Educational and Cultural Affairs  
Department of State**

**April 2010**

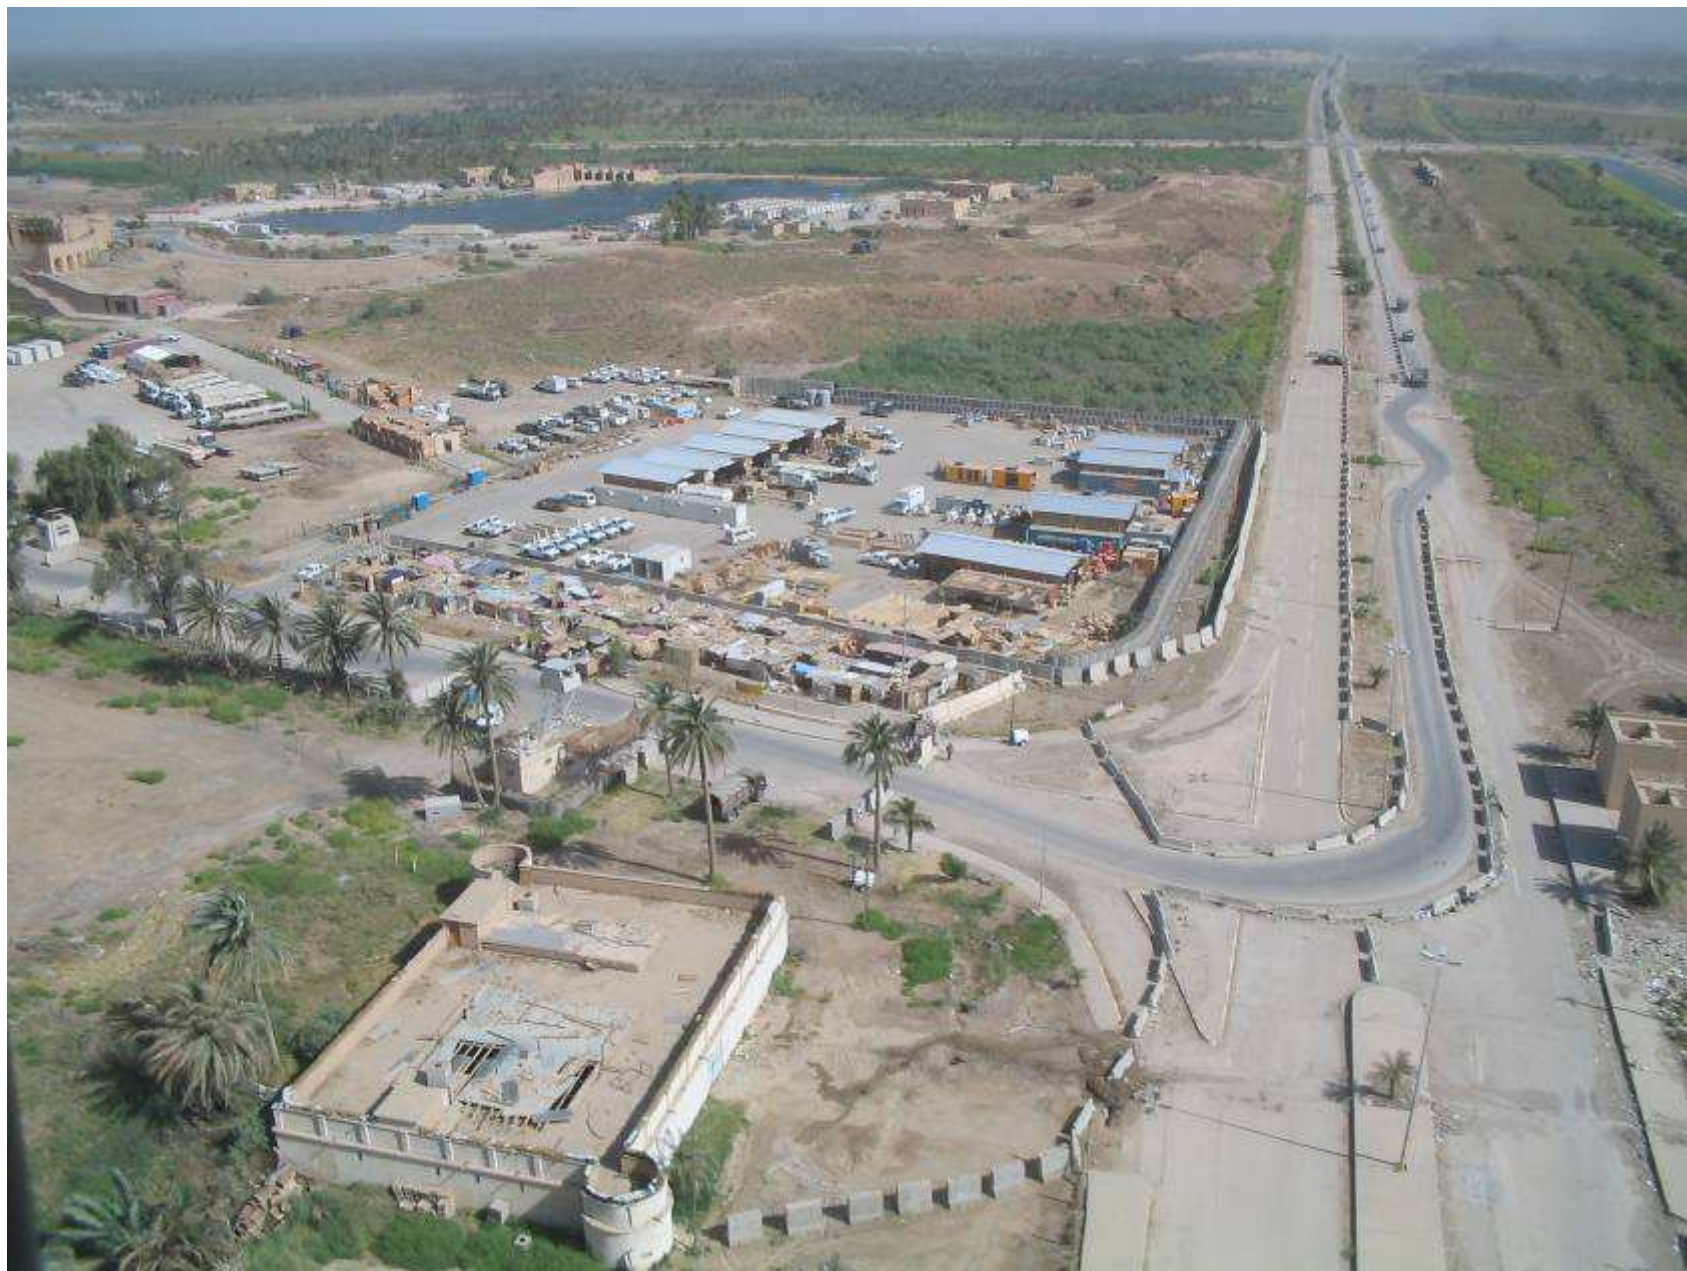
Parking lot west of the Marduk Gate, view from south, Russell photo 124\_2438 (photo © John Russell)

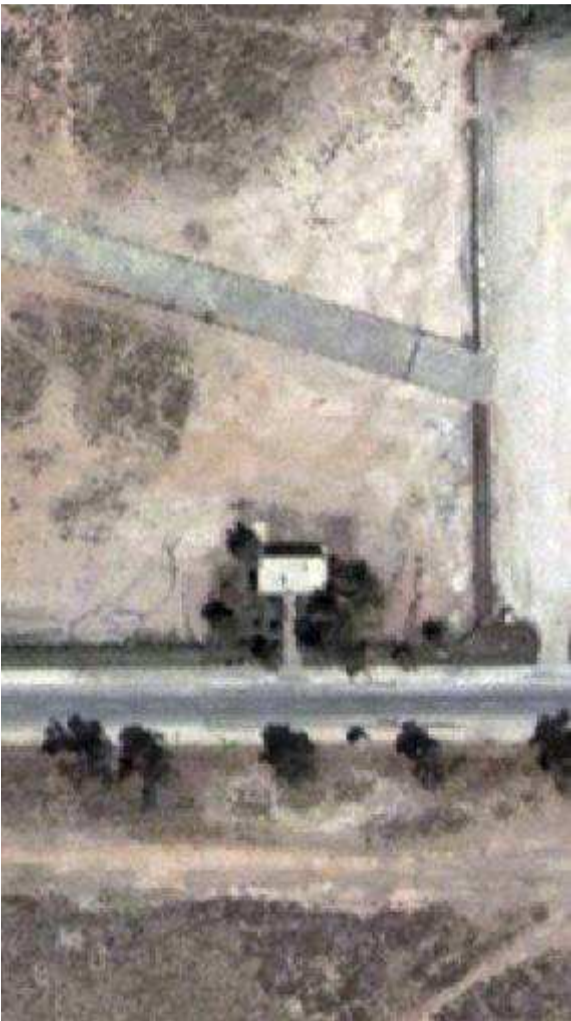
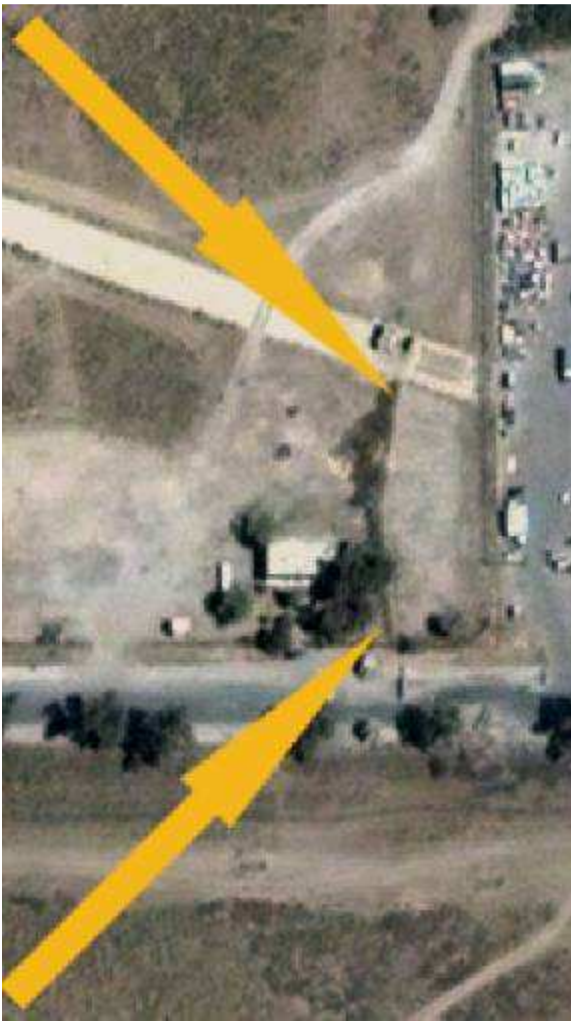
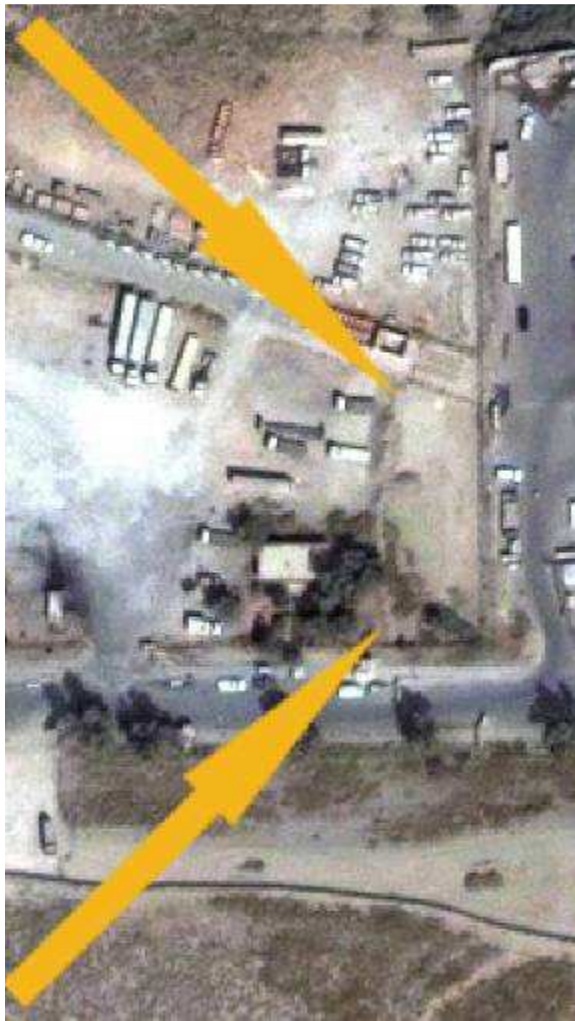
5 July 2002, Russell composite

31 August 2003, Russell composite

8 October 2004, Russell composite

**Russell comment:** This berm forms the eastern boundary of the parking lot located east of the theater. It appears to have served as part of the defenses at the east (“Ronson”) gate. It is already visible in the 31 August 2003 image.

Iraqi final report	Curtis report
2. East of the theater is an earthen barrier with a length of 35 m. It contains pottery fragments that can be seen to the right of the road leading to the center of the city. This barrier is made with surrounding earth that was cut into (Photo 66).	Outside [actually inside] the so-called Ronson Gate, on the north side of the road, topsoil has been scooped off an area c.60m x 20m to create an earthen bank.

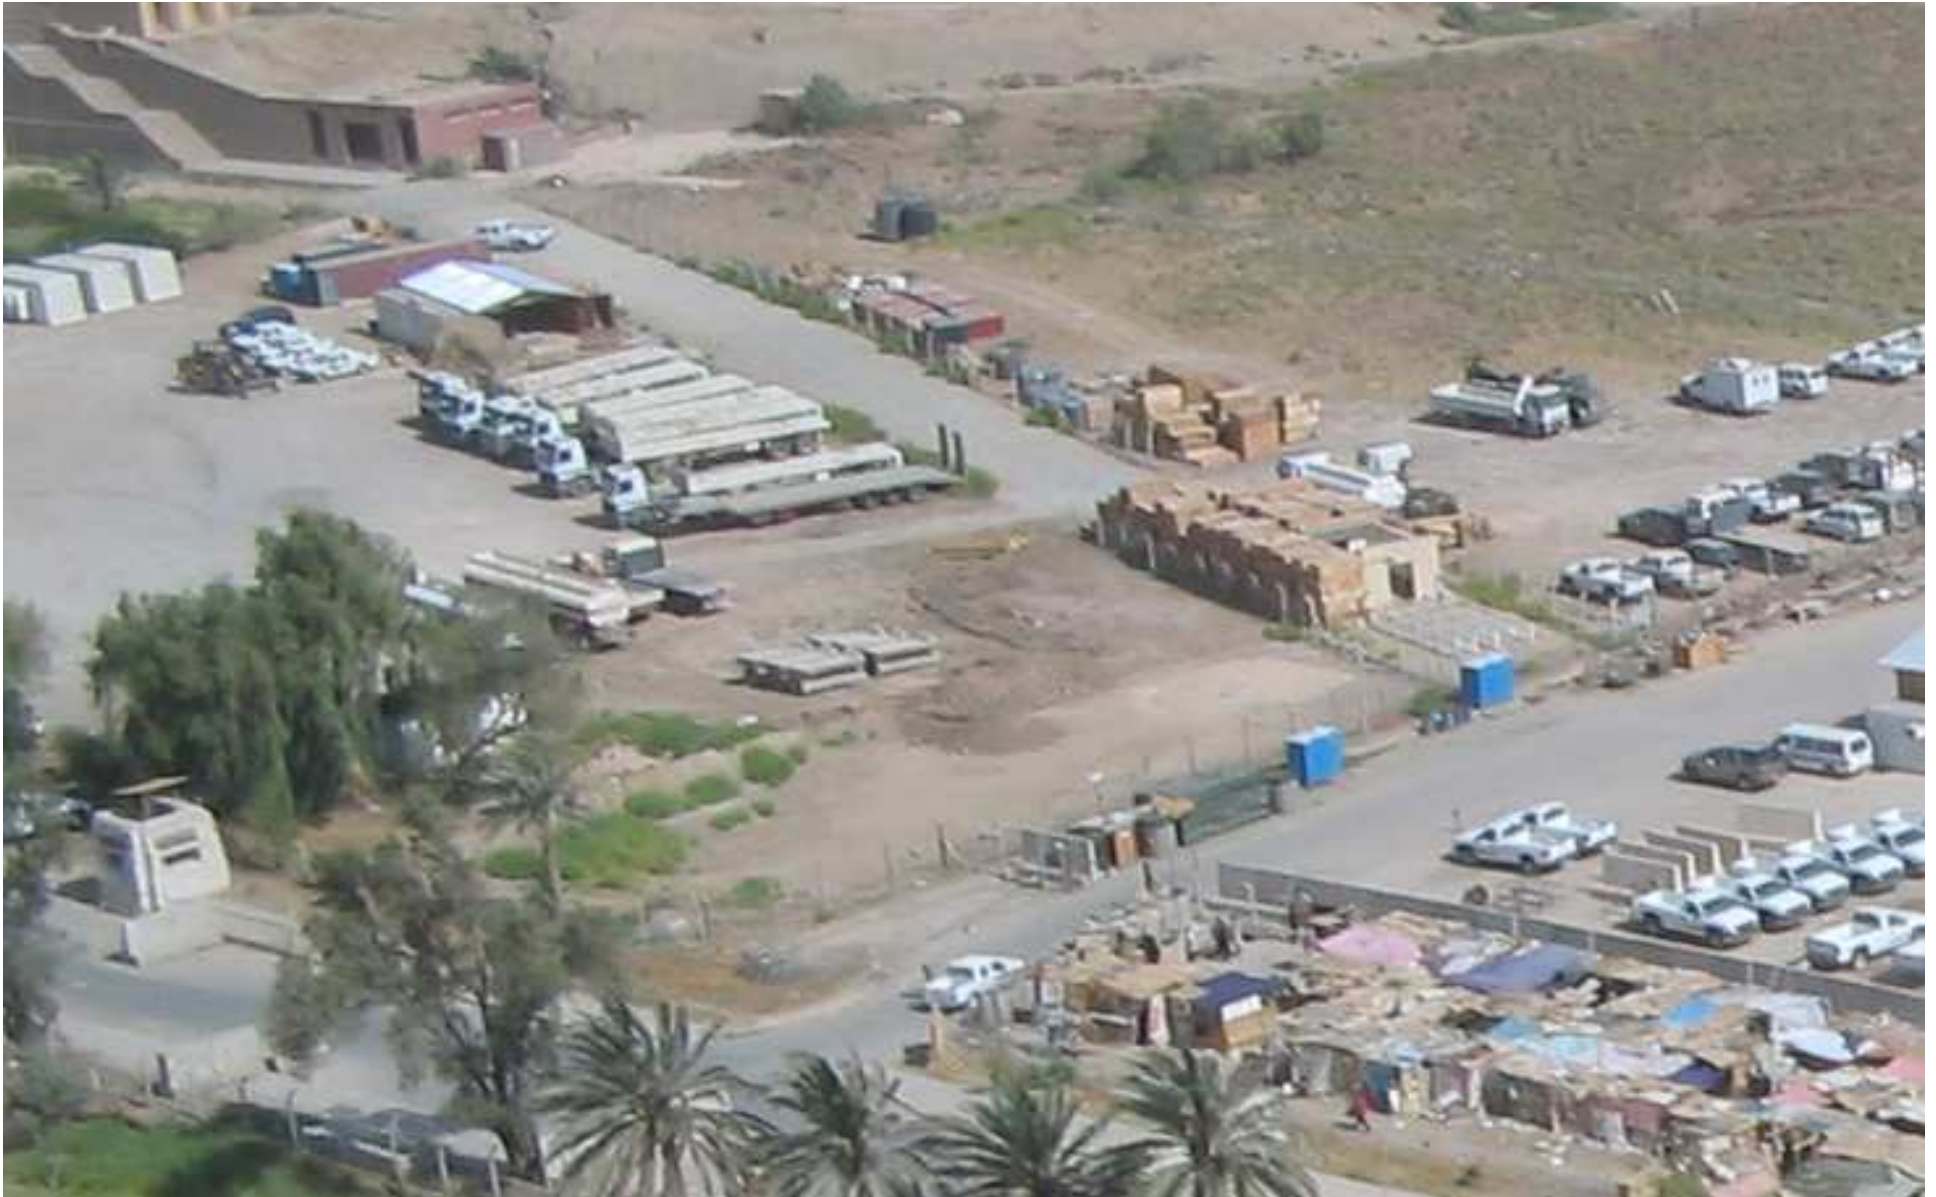
Earthen berm (center) separating the two eastern parking areas, June 2004, Russell photo 124\_2438, detail (photo © John Russell)

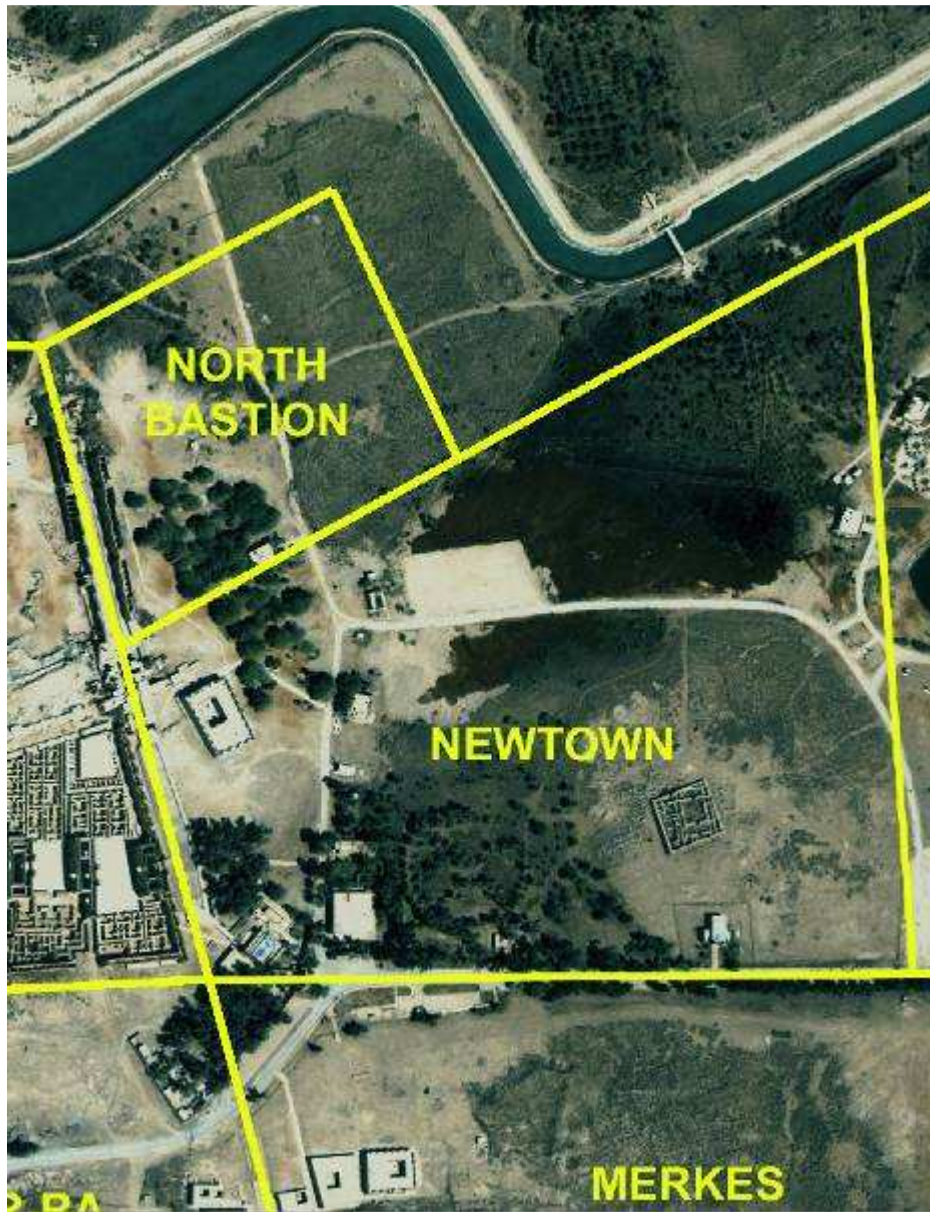
Newtown and North Bastion areas, 1 April 2003, Russell composite.

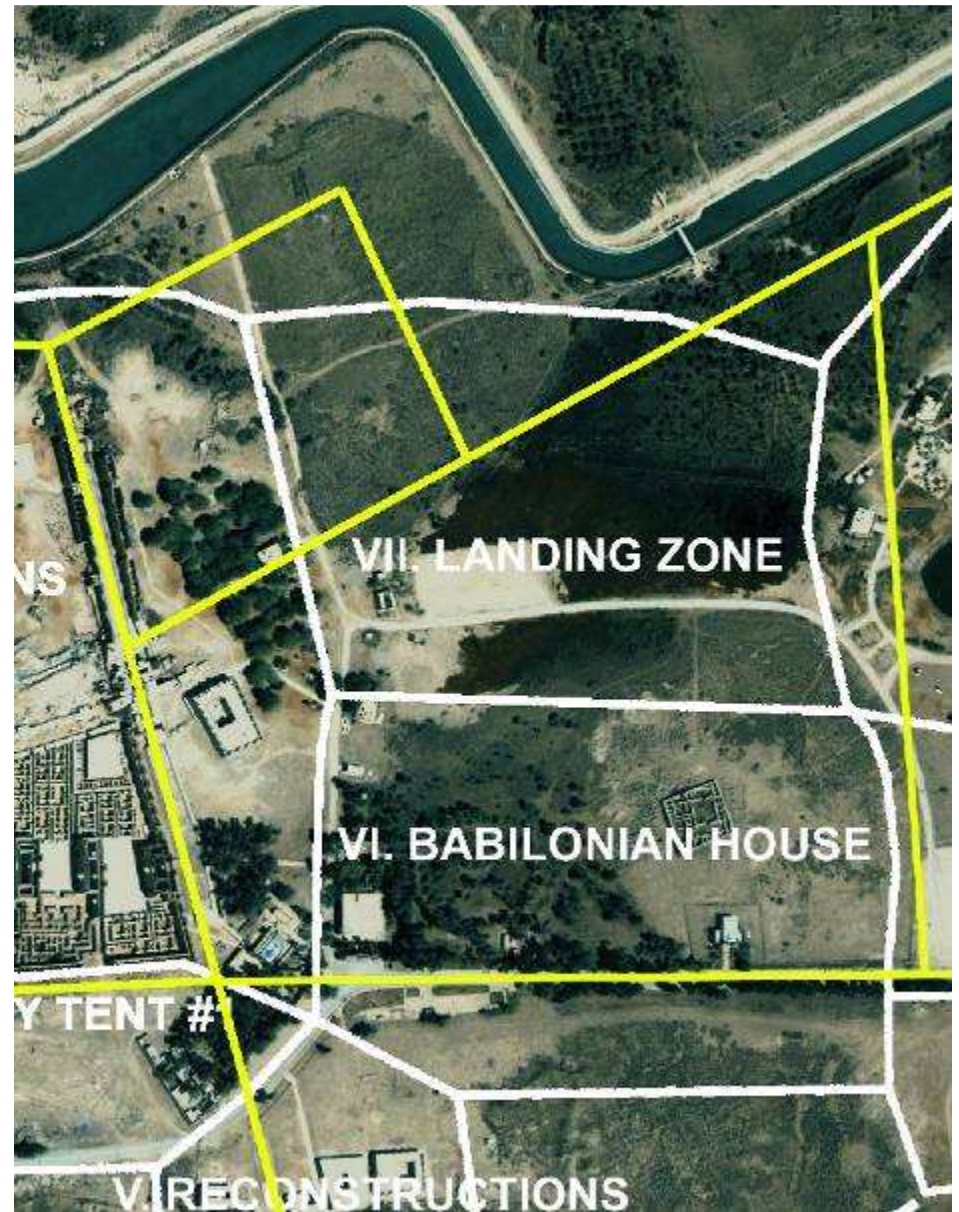
Newtown and North Bastion areas correlated with Polish areas VI, VII.

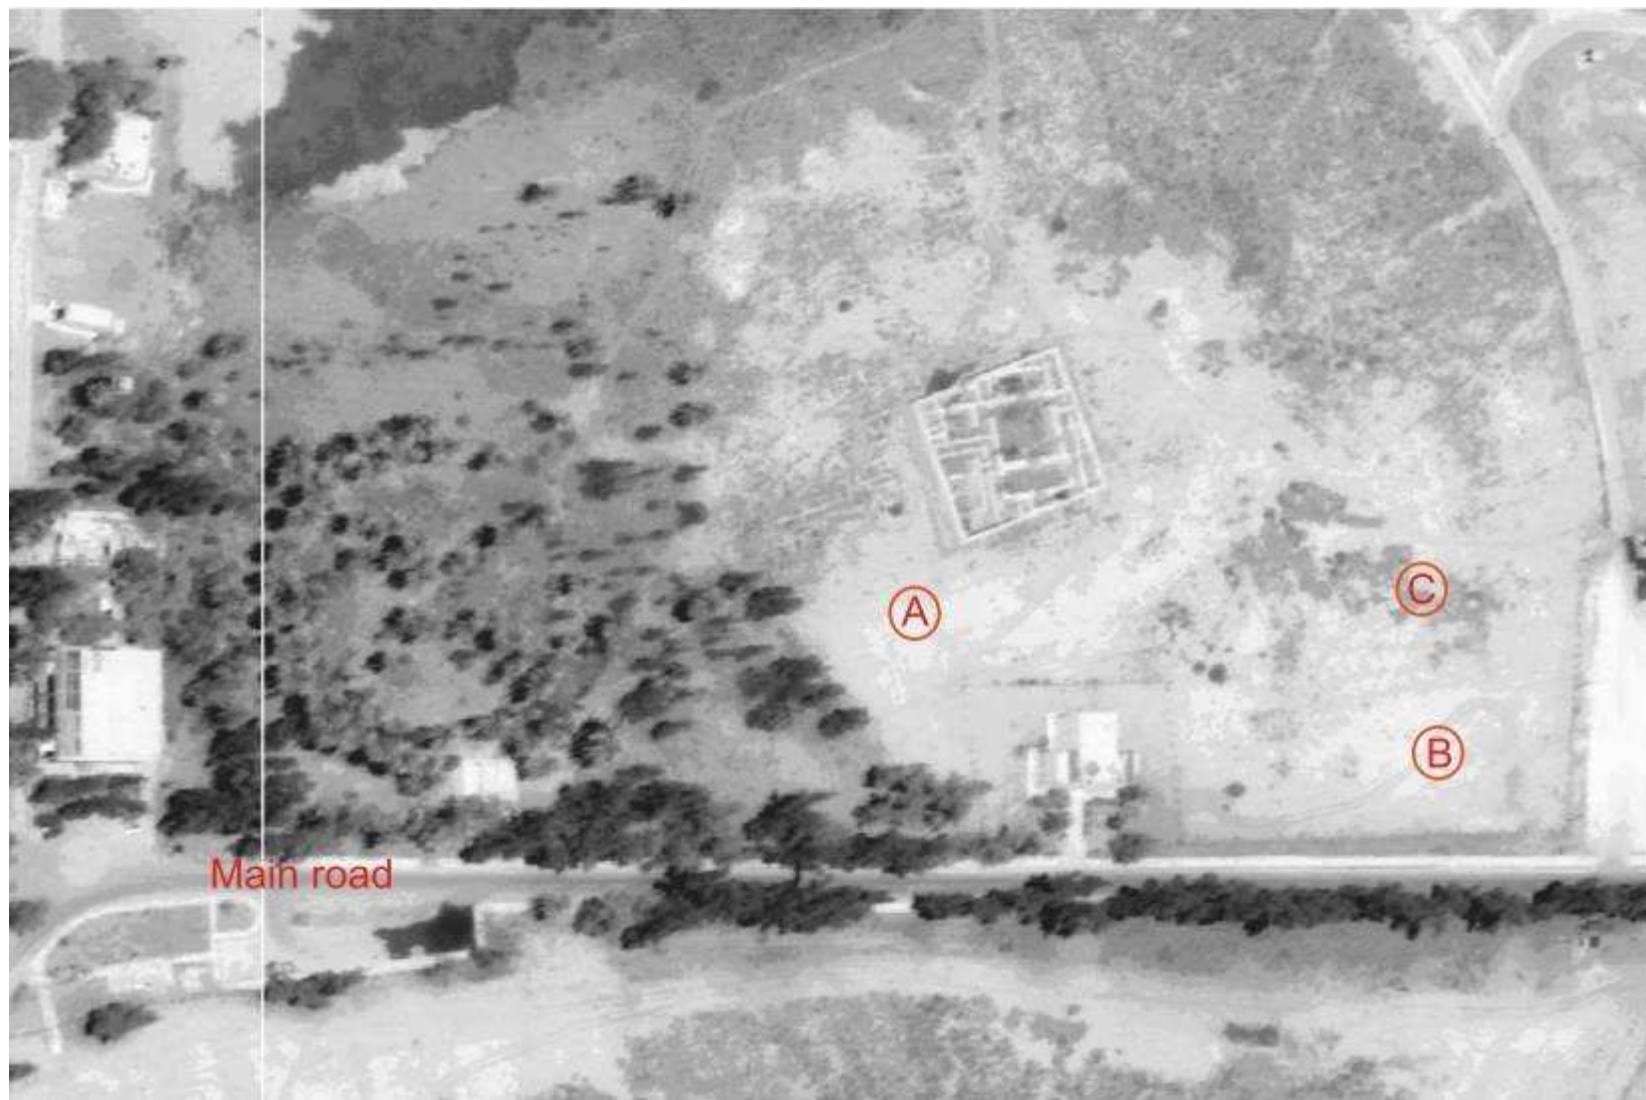
Polish report p. 25 (photo © Ministry of Culture and National Heritage, Republic of Poland)

<b>McDonald report</b>	<b>Iraqi preliminary report</b>	<b>Iraqi final report</b>	<b>Curtis report</b>	<b>Polish report</b>
<p>In the area west of the amphitheatre where archaeological deposits are right at the surface the trucking of heavy machinery is likely to cause considerable damage.</p> <p>On the 25th July [2003] a 'ditch witch' was observed in use in this area, cutting into an area of mound to lay a cable. The driver was asked to desist and agreed, his work does not seem to have authorized by LTC Lebidine.</p>	<p>b. The area surrounding the Babylonian House and the Hammurabi Museum: This area, which served as the headquarters of the KBR Company, was leveled and covered with gravel and sand in all directions.</p> <p>Military equipment and trailers of various types and sizes weighed heavily on this part of the city, especially in the area south and east of the Babylonian House (measuring 10,000 sq meters) and the western part of the Babylonian house.</p>	<p>The Area Surrounding the Babylonian House and the Hammurabi Museum: This 10,000 sq m area, which served as the headquarters of the American KBR Company, was leveled, covered with gravel and sand, and occupied by various pieces of military equipment of varying shapes and sizes and caravans [travel trailers] (Photo 57).</p>	<p>The entire area between the Hammurabi Museum and the Greek Theatre has been levelled and covered with gravel (see <i>Polish Report</i>, fig. on p. 39, centre).</p> <p>At the east end of the area between the Hammurabi Museum and the Greek Theatre, on the north side of the main road, an area <i>c.</i>20m sq. has been scooped out to a depth of <i>c.</i>1m.</p>	<p>Just to the West of the road running from the Amphitheater to the lake there is an area about 120 x 60 meters used as a transportation and storage yard. This area is divided into two parts.</p> <p>The first part, close to the main road is fenced and the ground is covered with gravel (marked on the picture at the beginning of this document by letter "B").</p> <p>The second part (marked on the picture at the beginning of this document by letter "C") is covered with a layer of sand.</p> <p>On the area of the "Babylonian House" there are ruts from cars and trucks.</p>

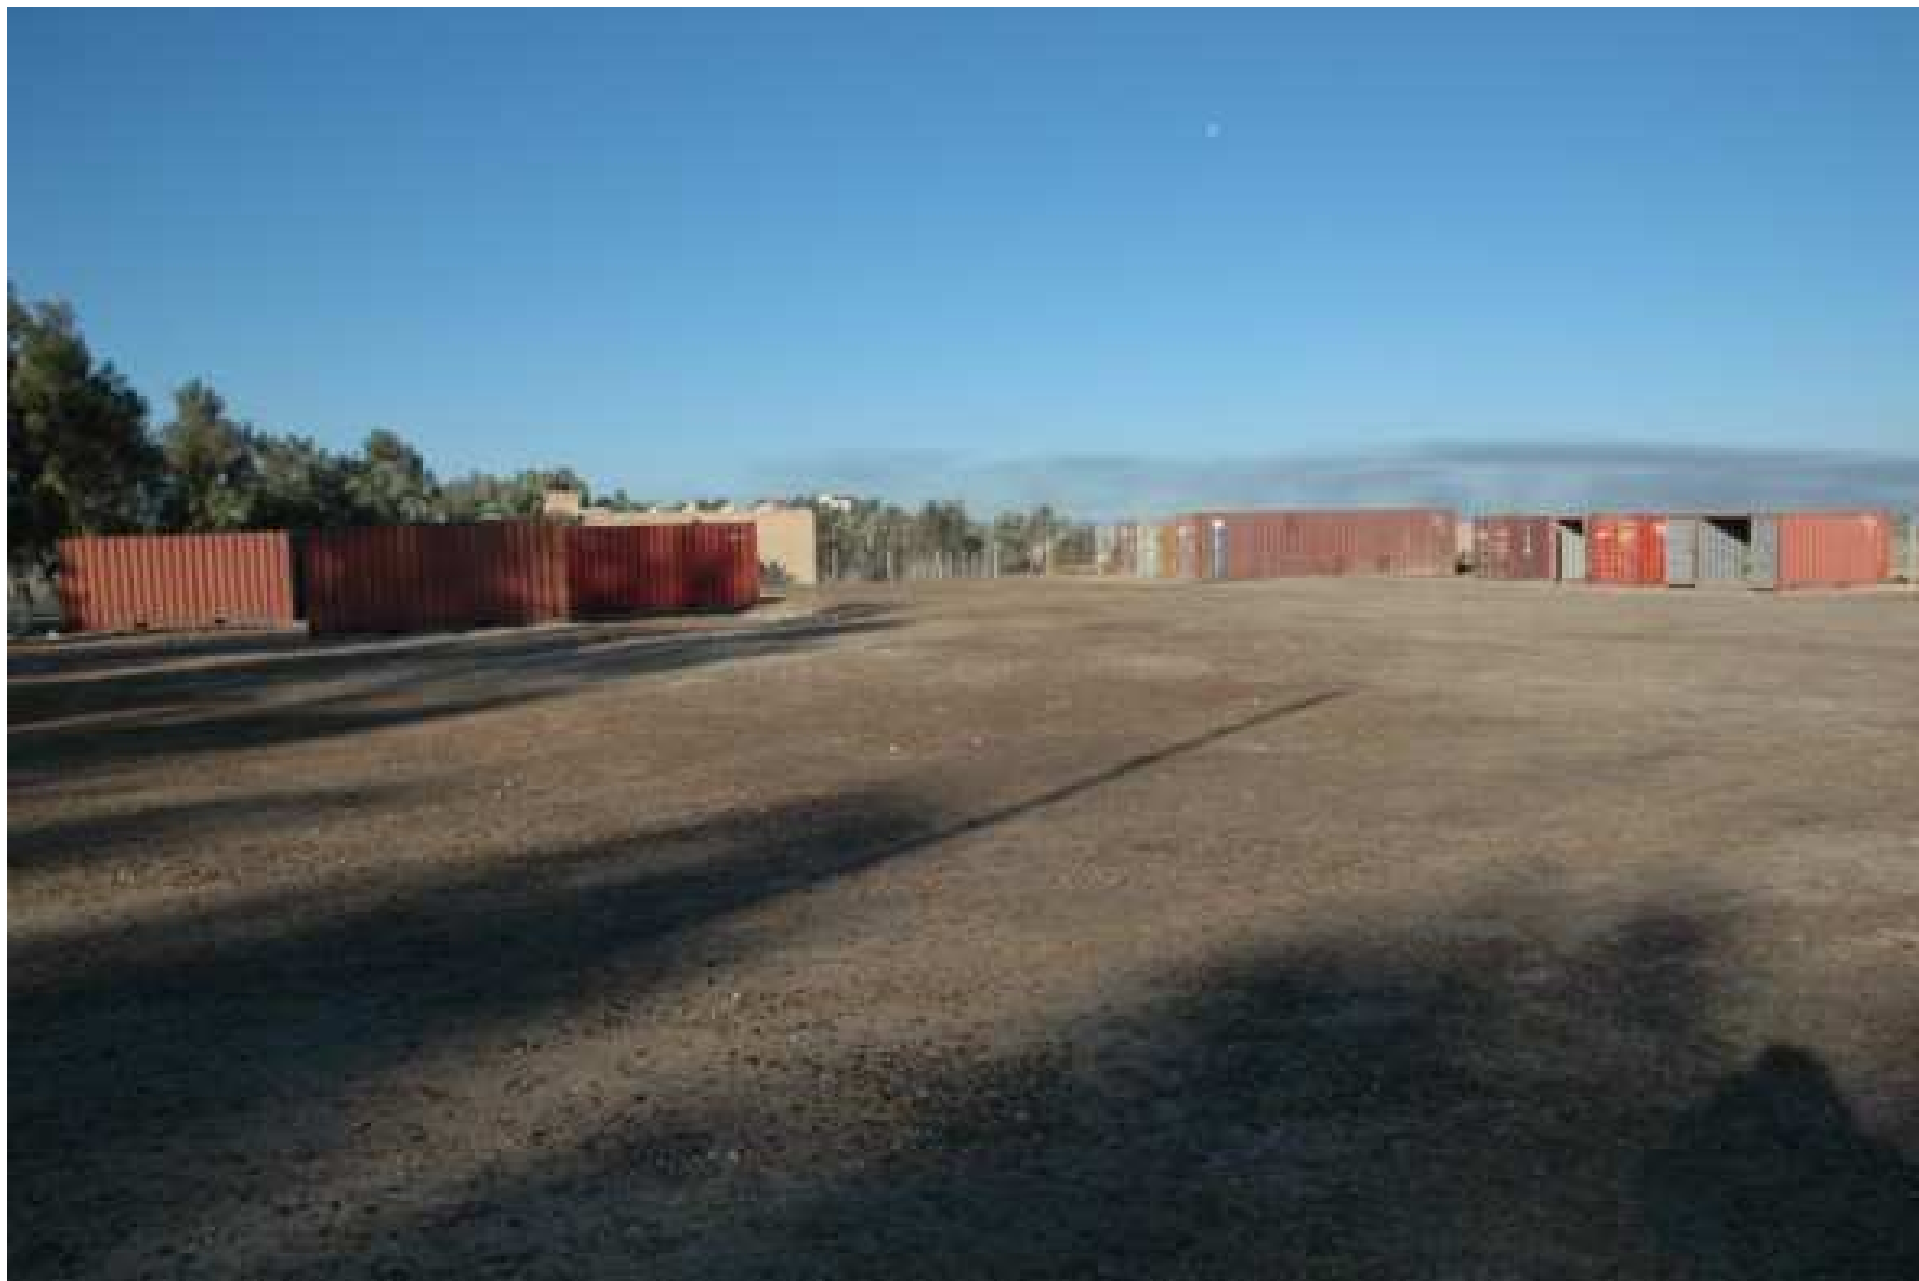
Graveled surface of car park “B” close to the Babylonian House, Polish report p. 27 (photo © Ministry of Culture and National Heritage, Republic of Poland)

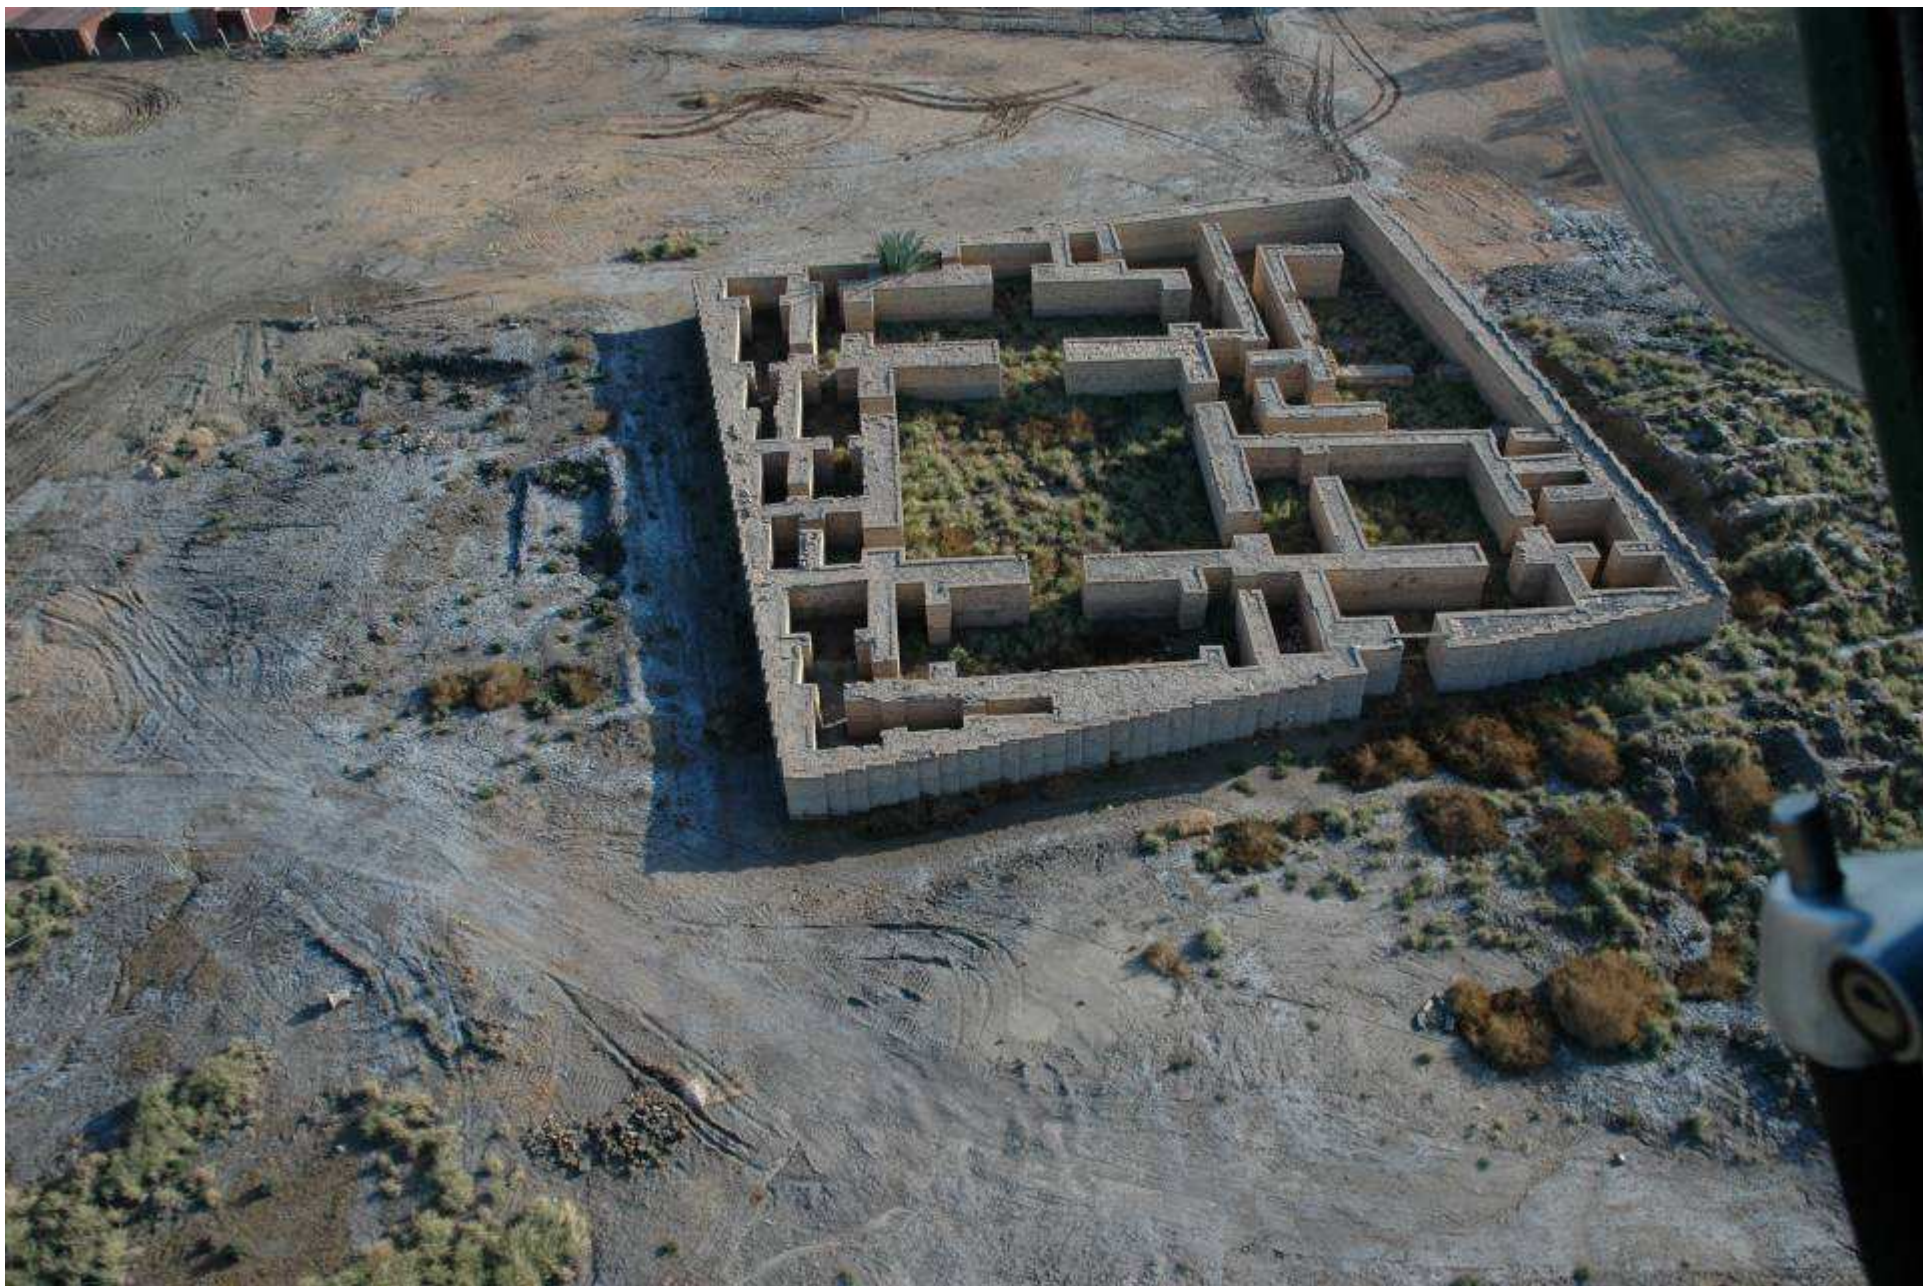
Vehicle wheel ruts close to archaeological features around the Babylonian House, November 2004, Polish photo 81 (photo © Ministry of Culture and National Heritage, Republic of Poland)

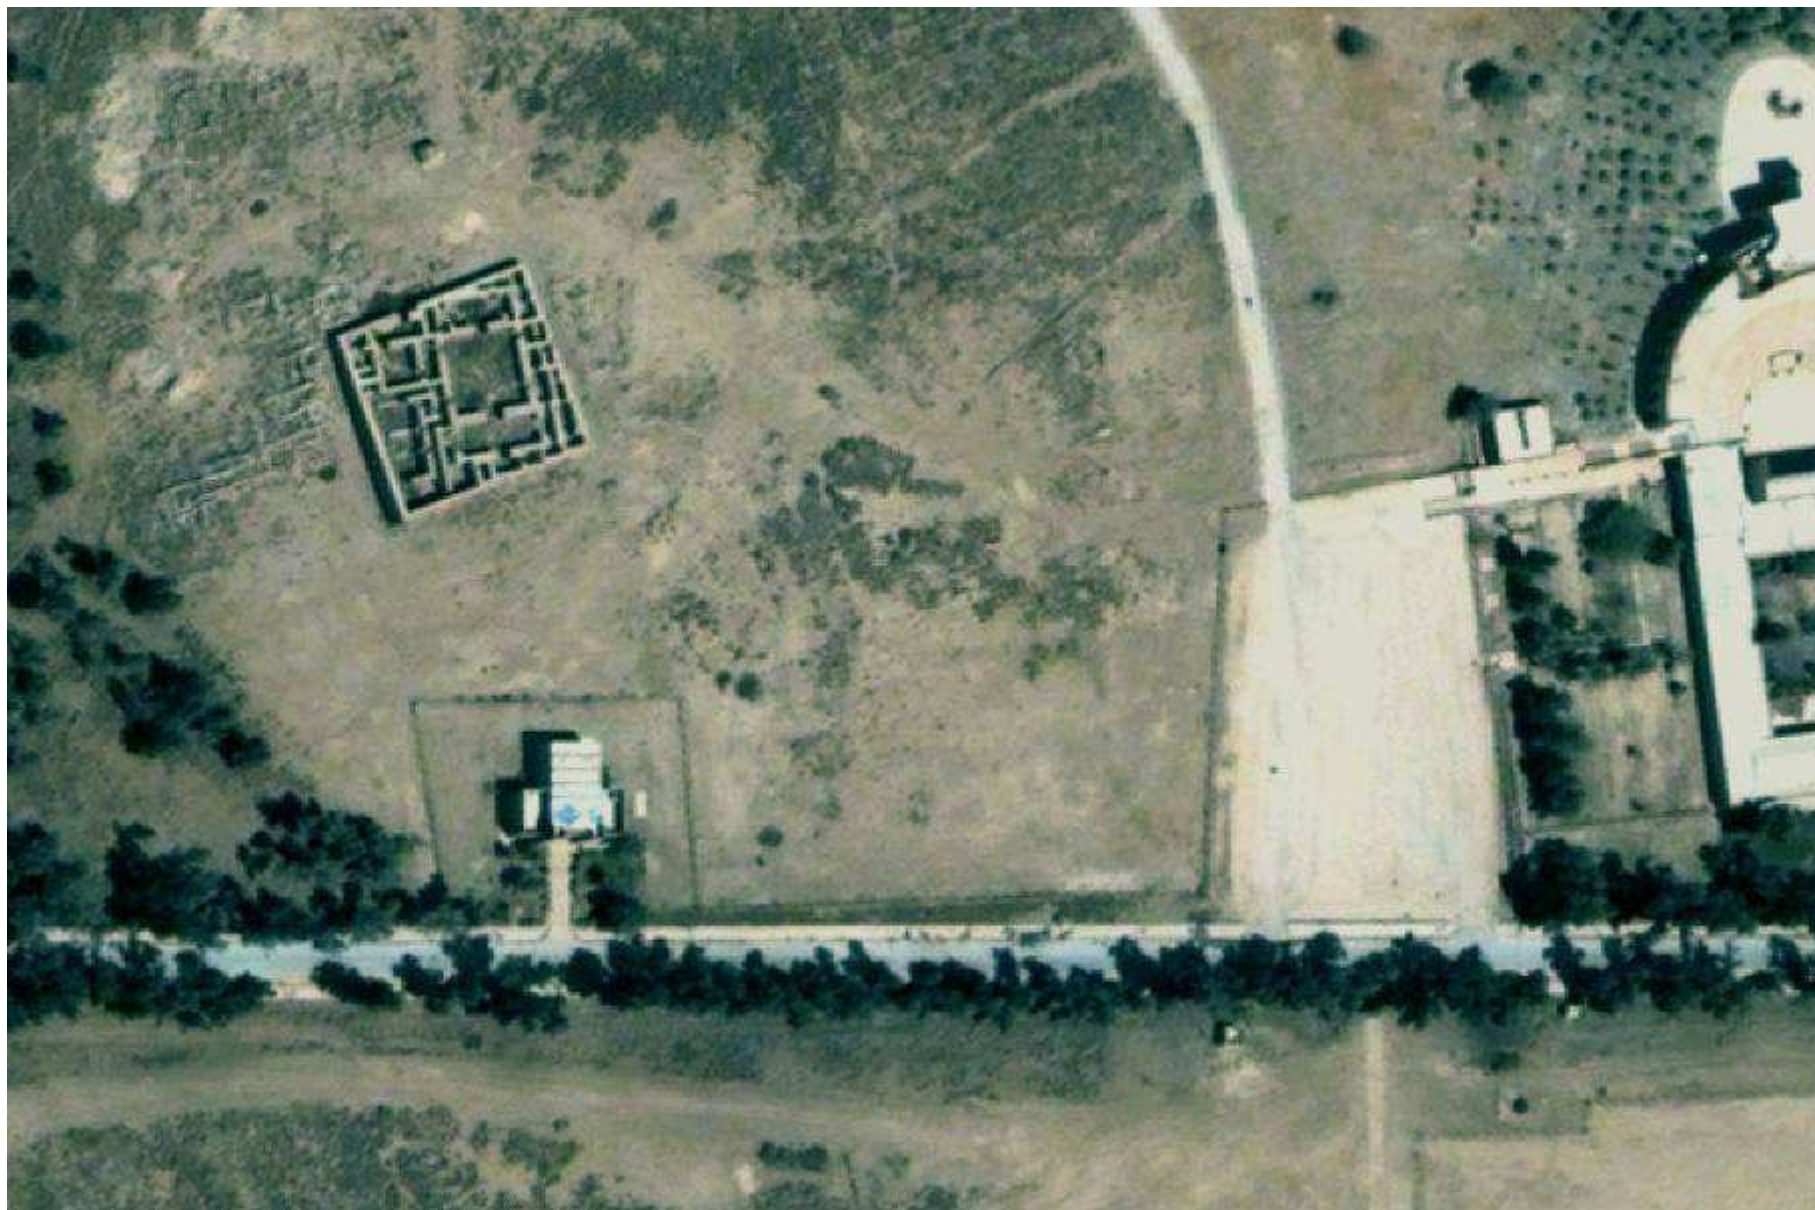
1 April 2003, Russell composite. It is clear that there was still considerable mounding in this area on 1 April 2003..

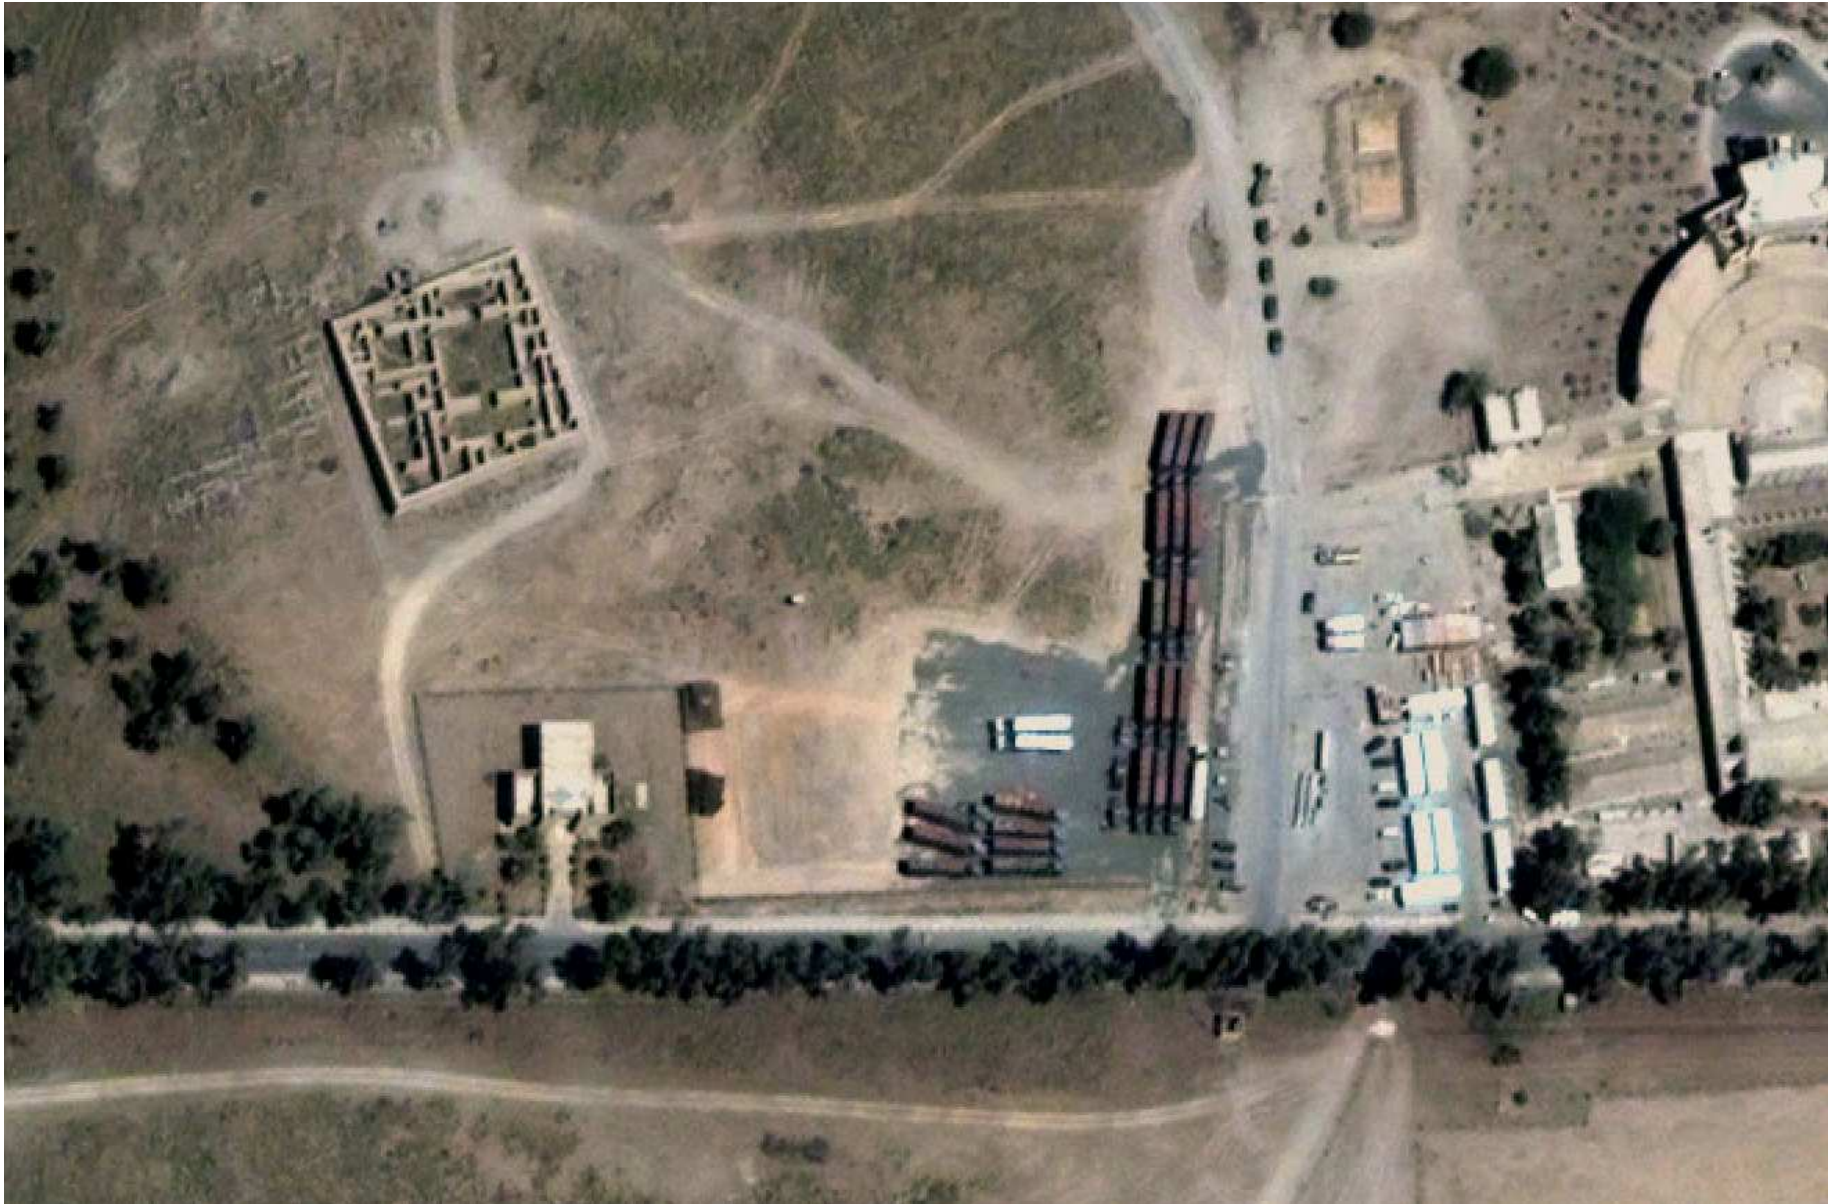
31 August 2003, Russell composite. The earliest expansion is the new graveled lot to the west of the paved lot beside the theater, as described by MacDonald. Further planned expansion as far as the east fence of the Hammurabi Museum was halted after the Iraqi site staff objected that much archaeological material was being disturbed. A new road running from the paved road to the top of the mound north of the Babylonian House can also be seen in this image.

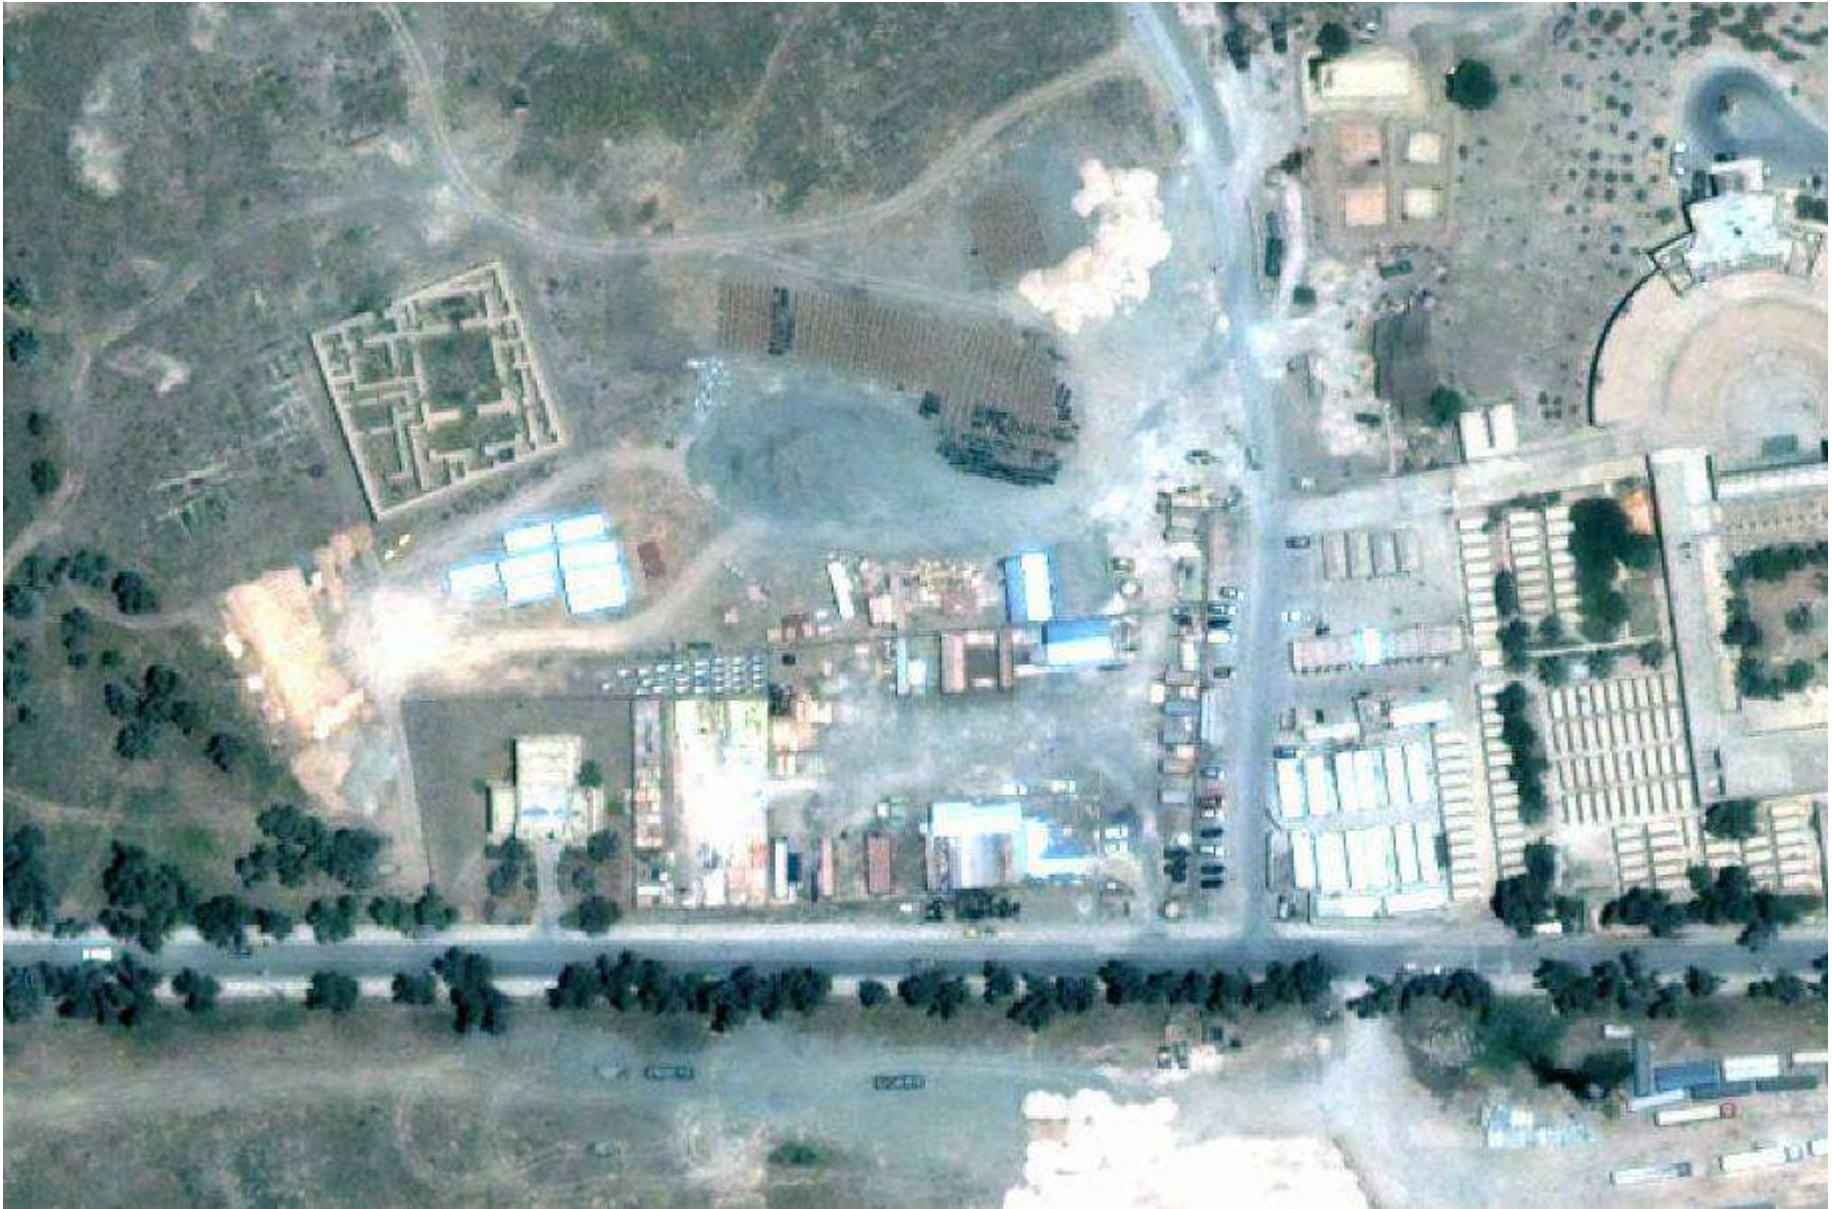
4 June 2004, Russell composite. By this time the cleared area had reached its maximum extent, with the leveling of all the terrain from the theater to well beyond the western side of the Hammurabi Museum. Even the eastern fence of the museum had been crossed, with containers stored directly adjacent to the museum. The area to the north has also been leveled and covered with piles of sandbags and sand. In this image, leveling work was taking place on the final western extension, to the west of the museum, as described in the Iraqi report. This area was evidently never put into use.
