# **Report on Damage to the Site of Babylon, Iraq**

**John Malcolm Russell, Ph.D.**

**Cultural Heritage Center  
Bureau of Educational and Cultural Affairs  
Department of State**

**April 2010**

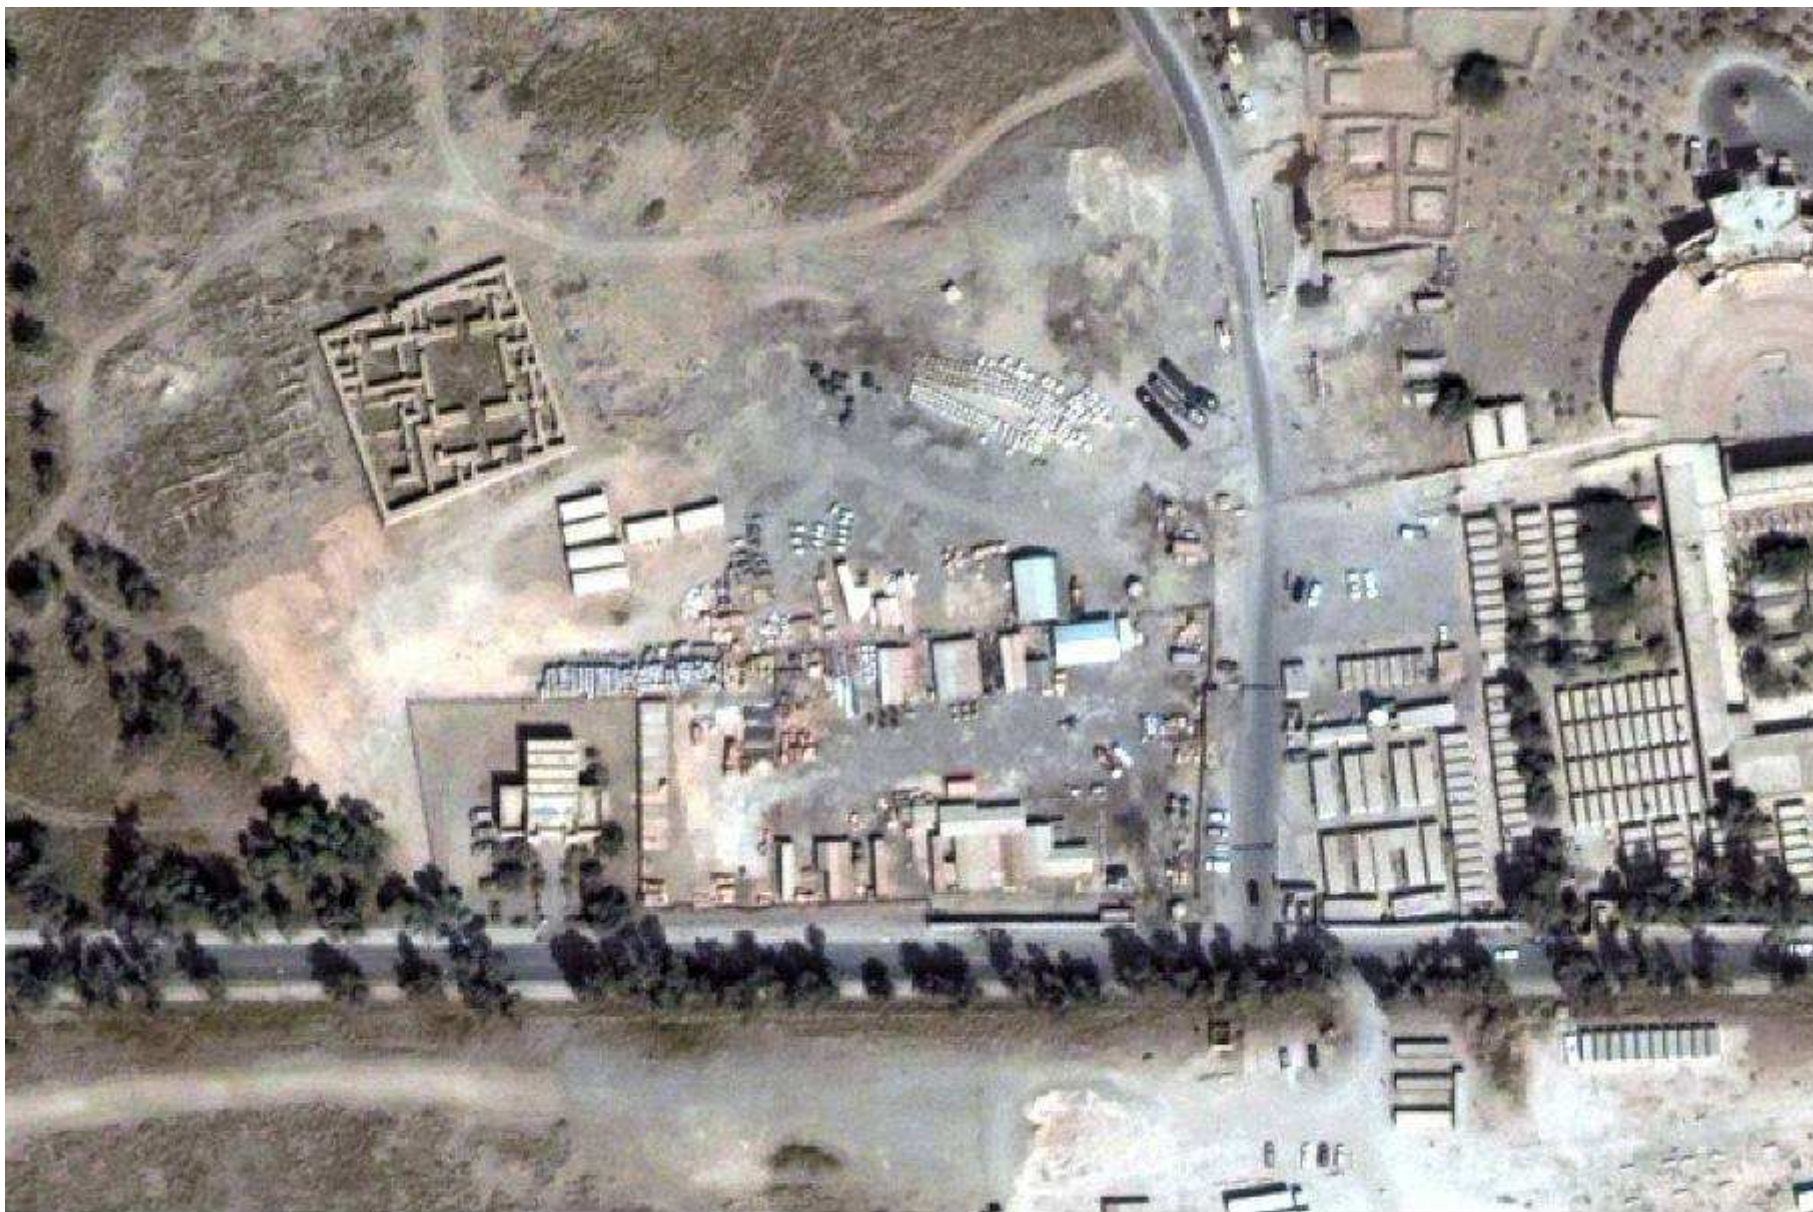
8 October 2004, Russell composite. The bulldozed swath immediately adjacent to the SW corner of the Babylonian House has been extended slightly further to the north.

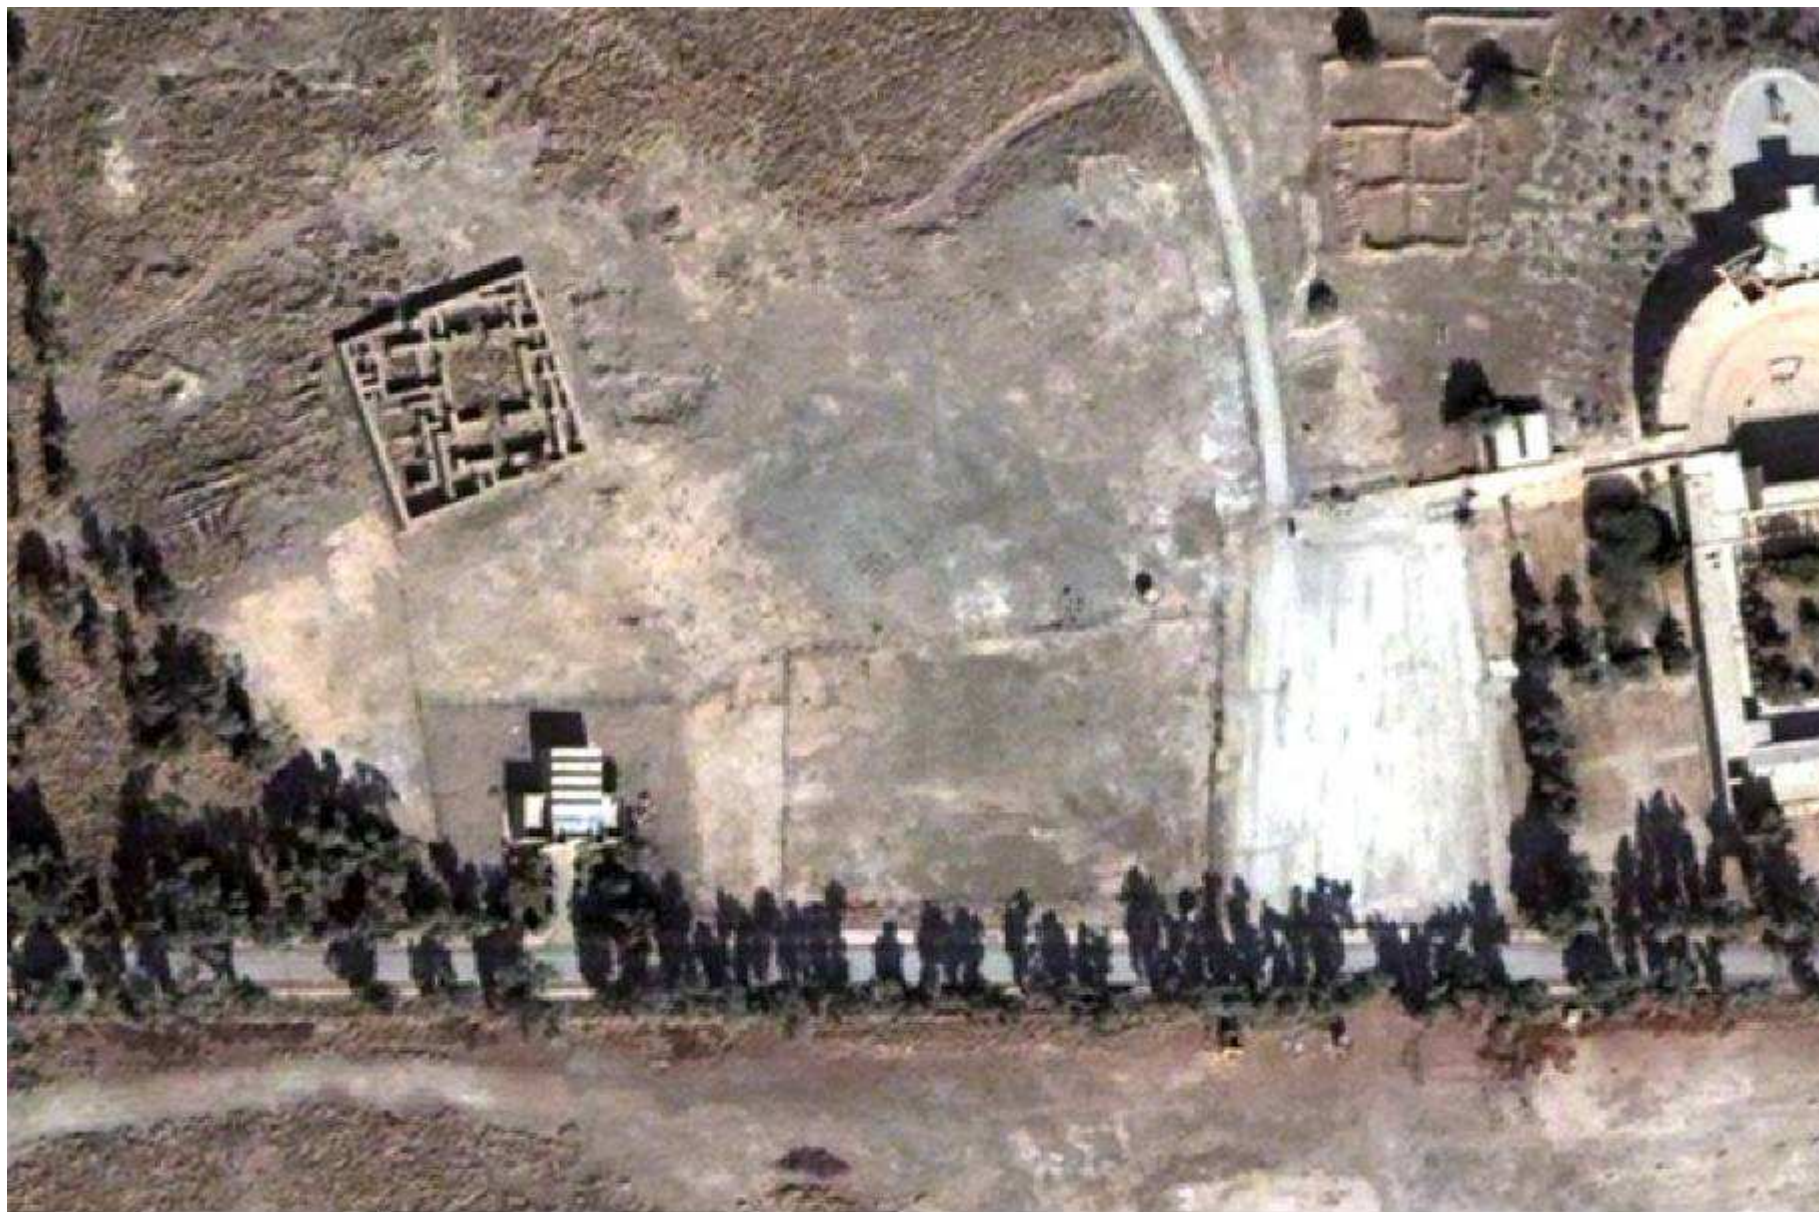
26 November 2005, Russell composite. View of the area after abandonment of Camp Babylon.

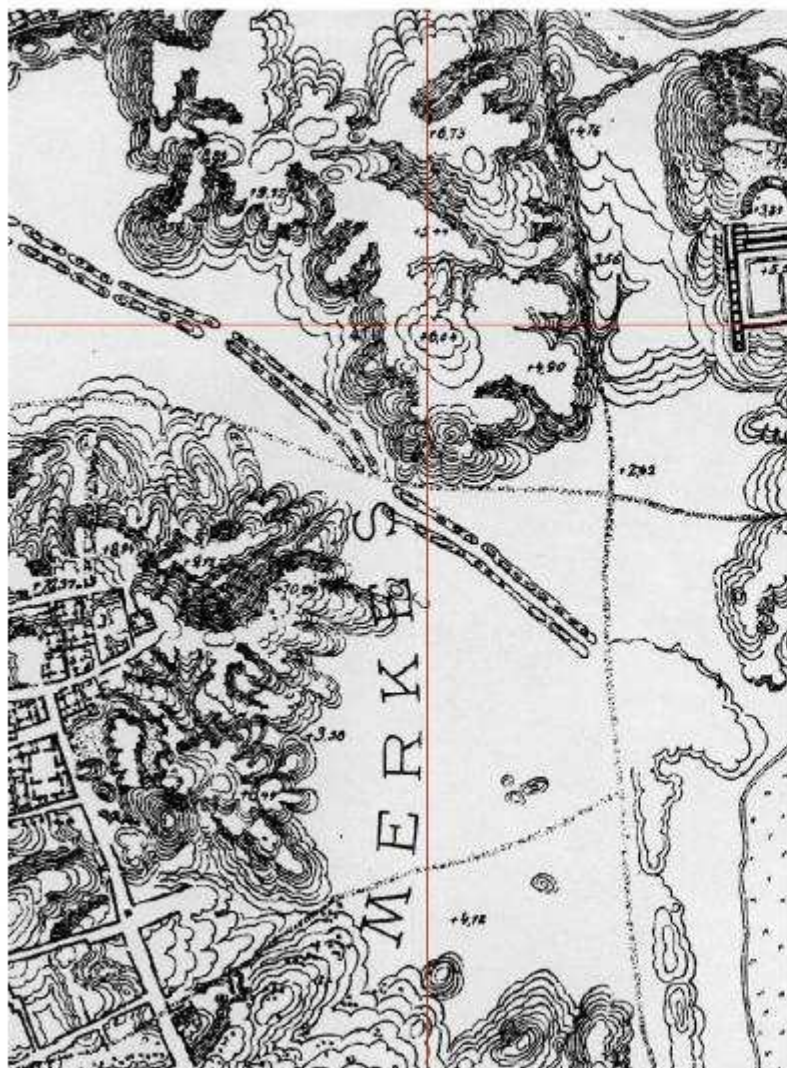
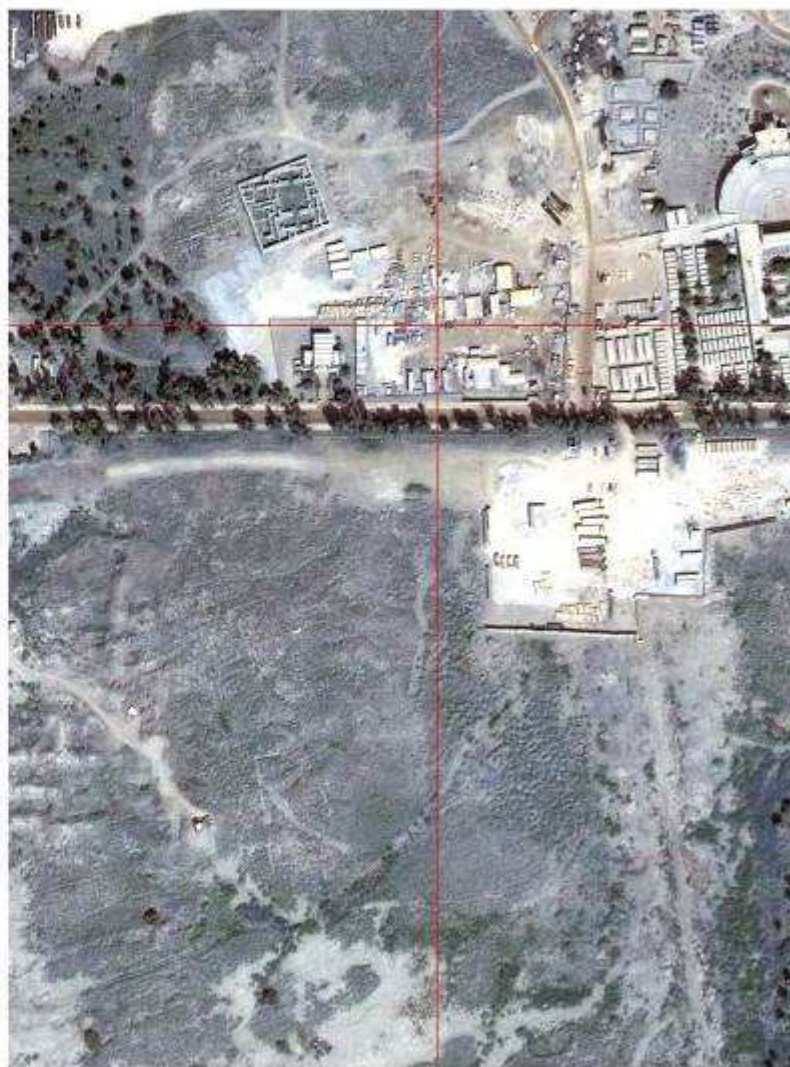
**Stone report:** This is one of the areas where we see considerable damage to an archaeologically sensitive zone. The entire area is mounded, as seen both in the contour map (Fig. 15) ...

**Stone report:** ...and in Koldewey's map (Fig. 16).

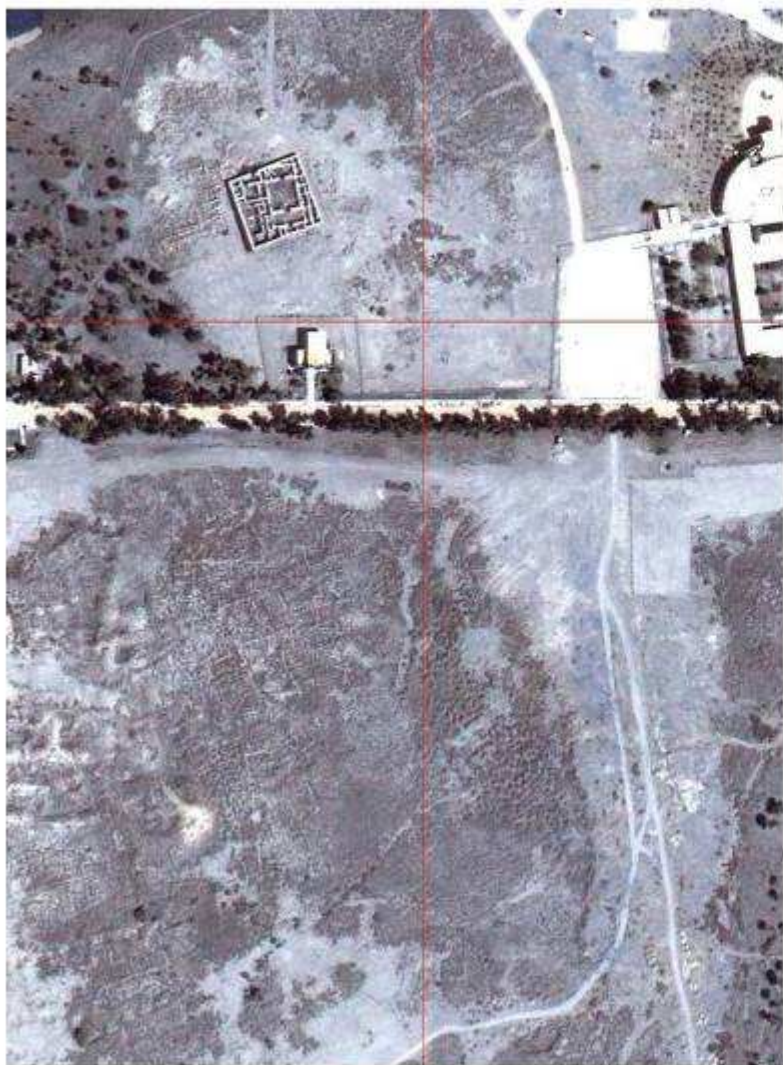
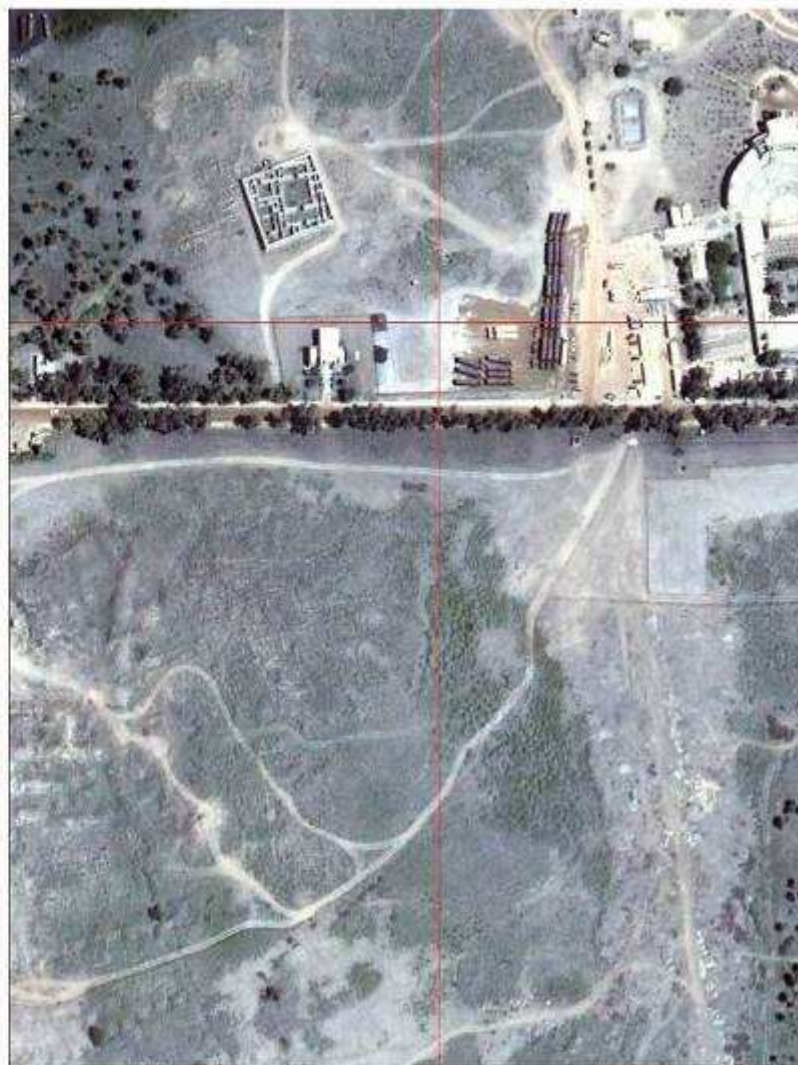
**Stone report:** Apart from the reconstruction of the excavated Babylonian house, and the Hammurabi Museum, this area was undeveloped prior to the war (Fig. 17). The development of this area began slowly, with disturbance only in the southeastern corner in August 2003 (Fig. 17), ...

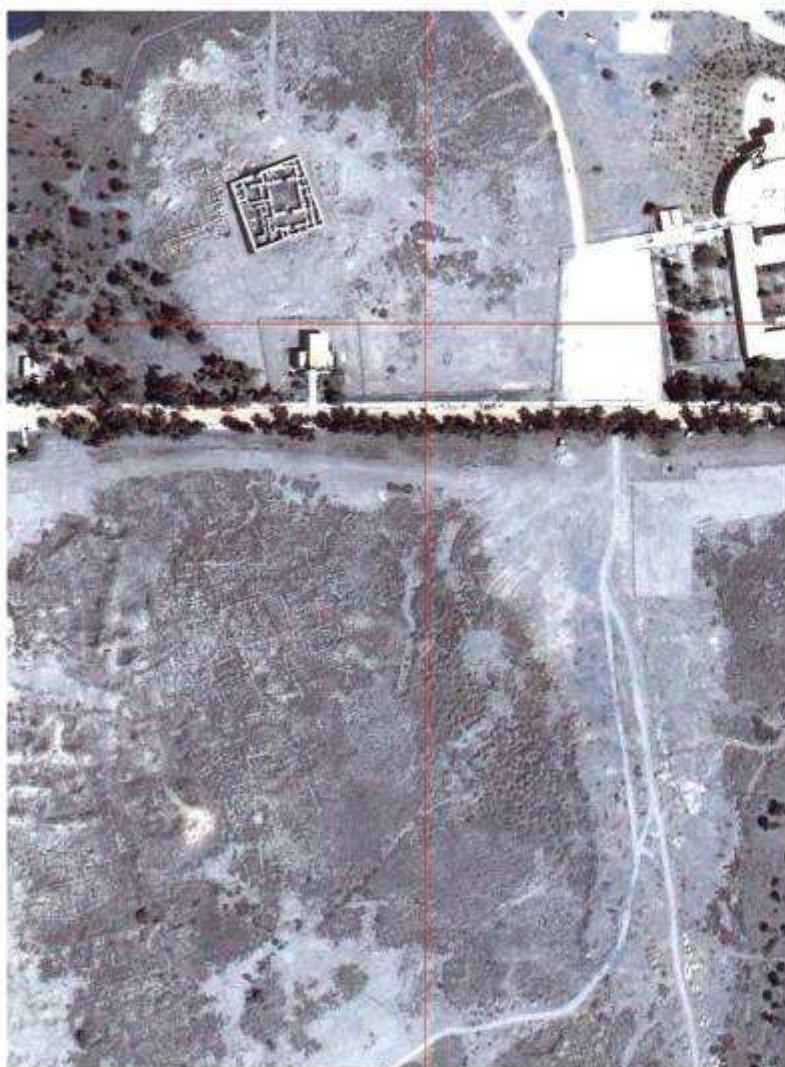
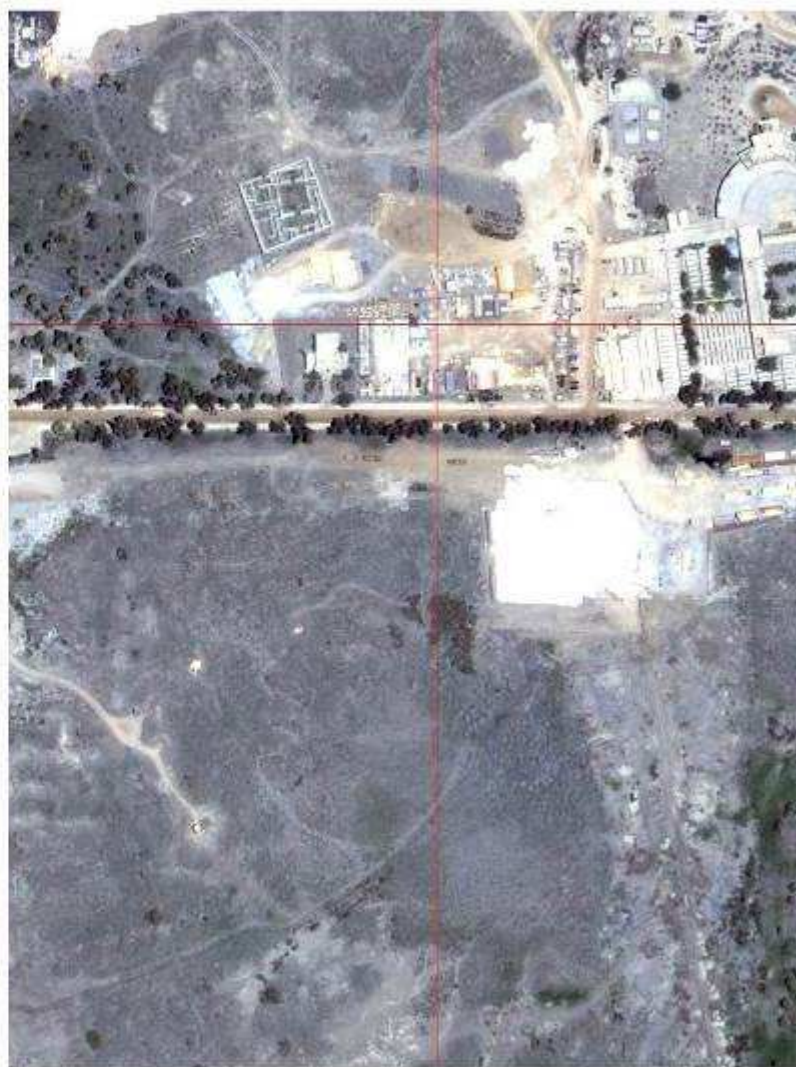
**Stone report:** ...but by July 2004 and continuing until our latest image from October 2004, development of this area continued apace (Figs 15, 16, 18). The photographs included in the Polish report make it clear that this area had been bulldozed flat. [image: Stone report fig. 18]

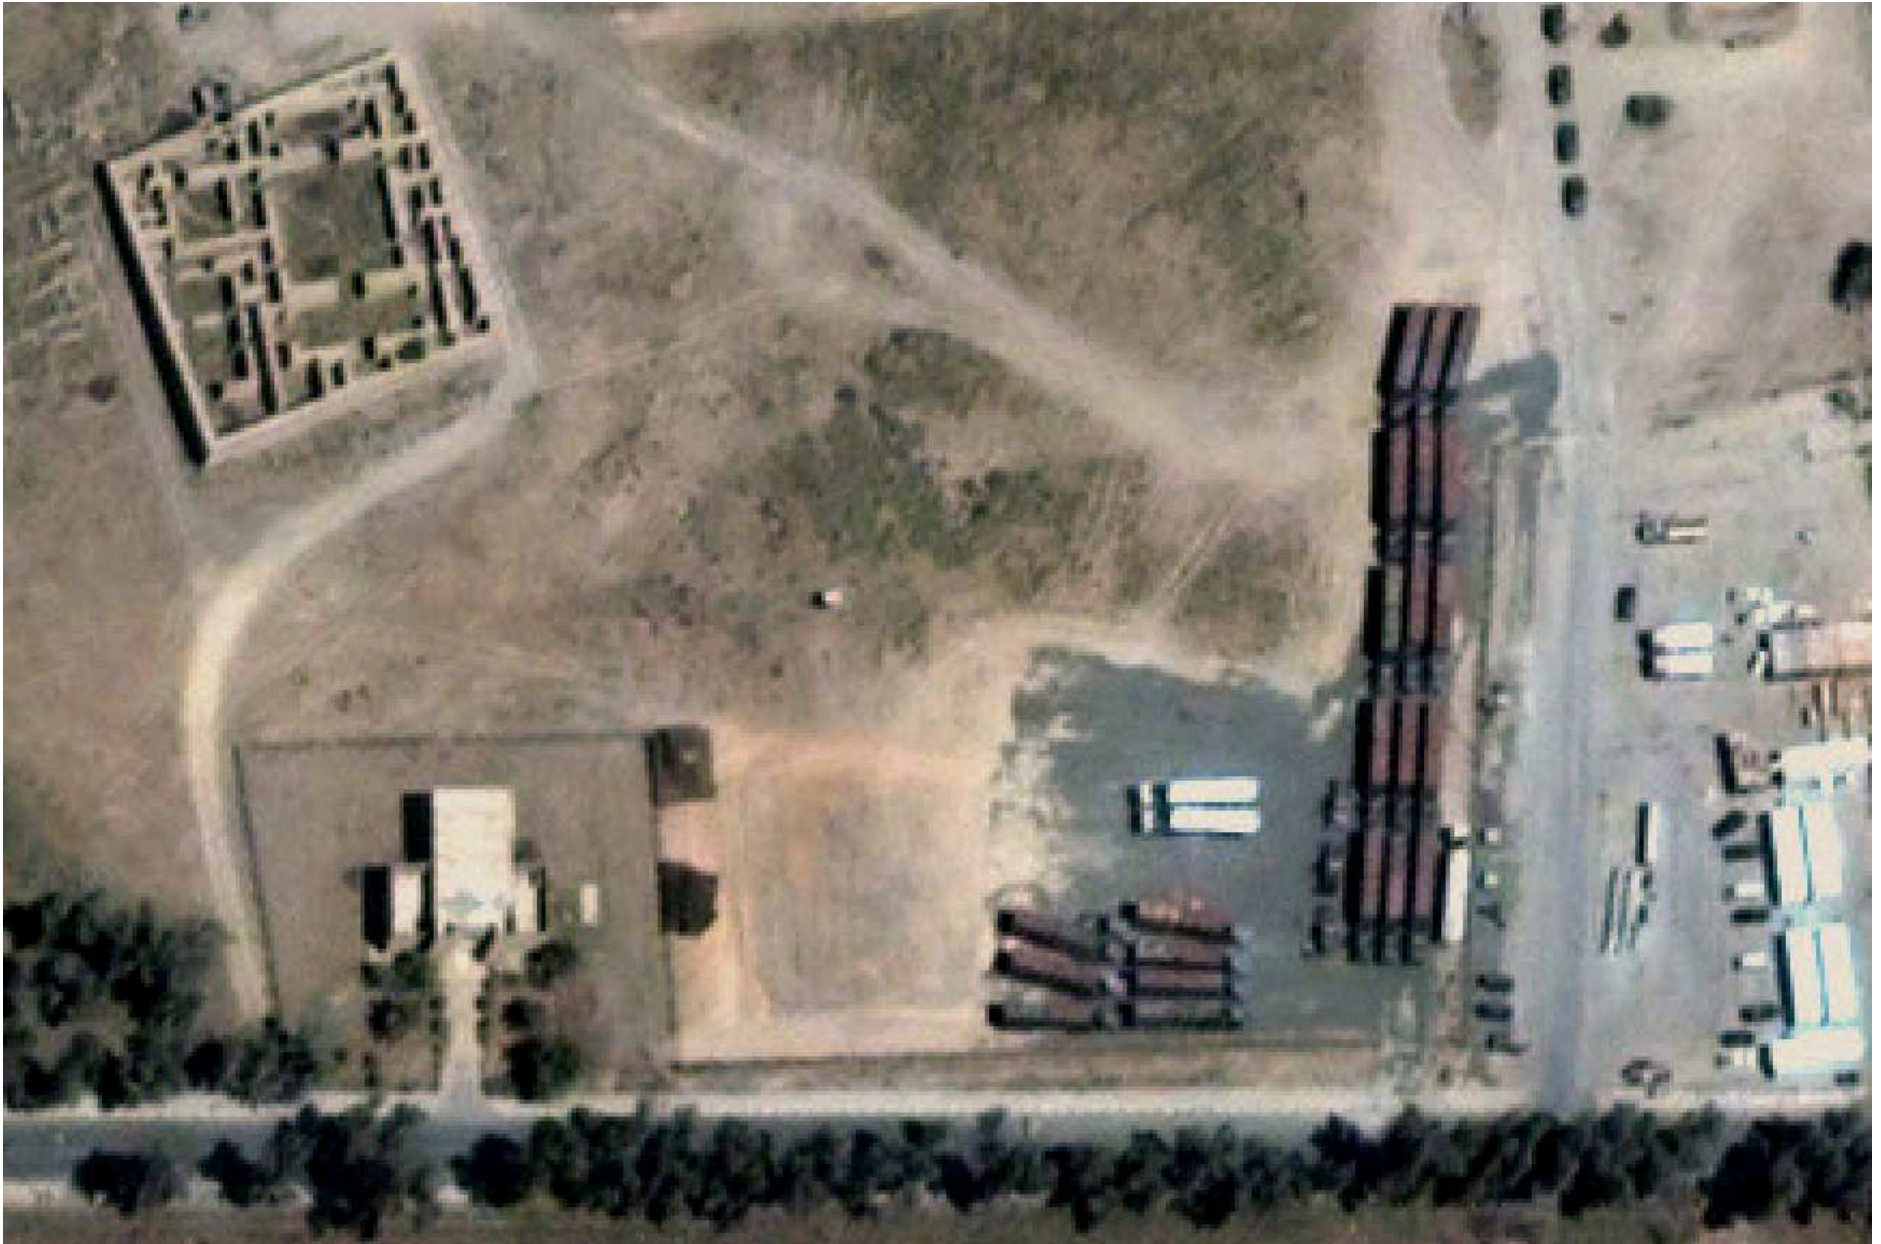
31 August 2003: the gravelled lot immediately west of the paved lot is visible as a dark surface covered with trucks. The light brown space between that lot and the east fence of the Hammurabi Museum is the extension that was stopped By Dr. Miriam and McDonald in July 2003. The area north of the lot is also empty of containers, as McDonald reported. (Russell composite)

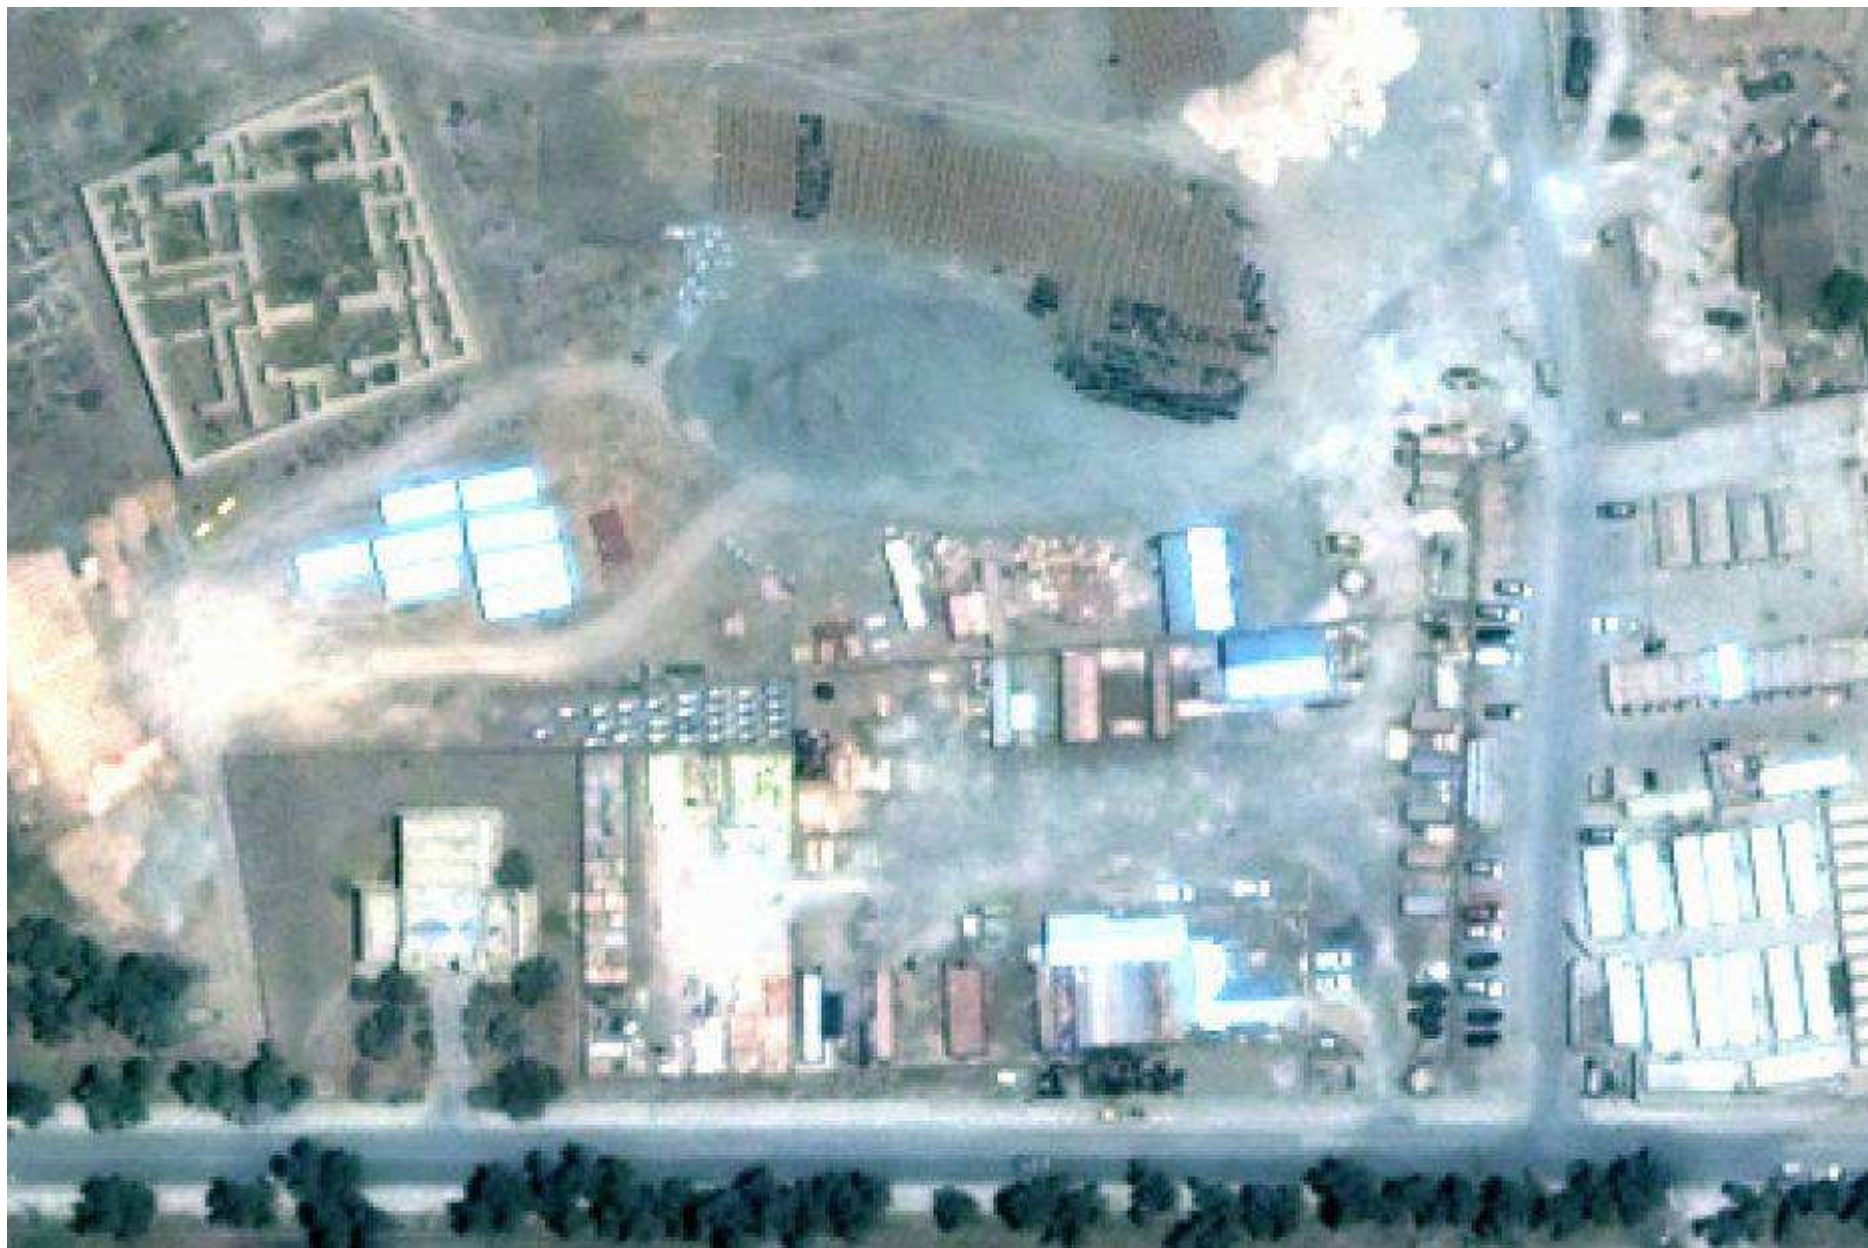
These reprieves were only temporary, as by 4 June 2004 the entire area had been flattened, the east fence by the Hammurabi Museum had been removed, and the entire area was being utilized for parking and storage (Russell composite)

**Russell comment:** The 4 June 2004 image (above) shows this work in progress. The 3 piles of fill dirt and 2 generators next to the southwest corner of the Babylonian house can be seen in photos taken on the site at the time.

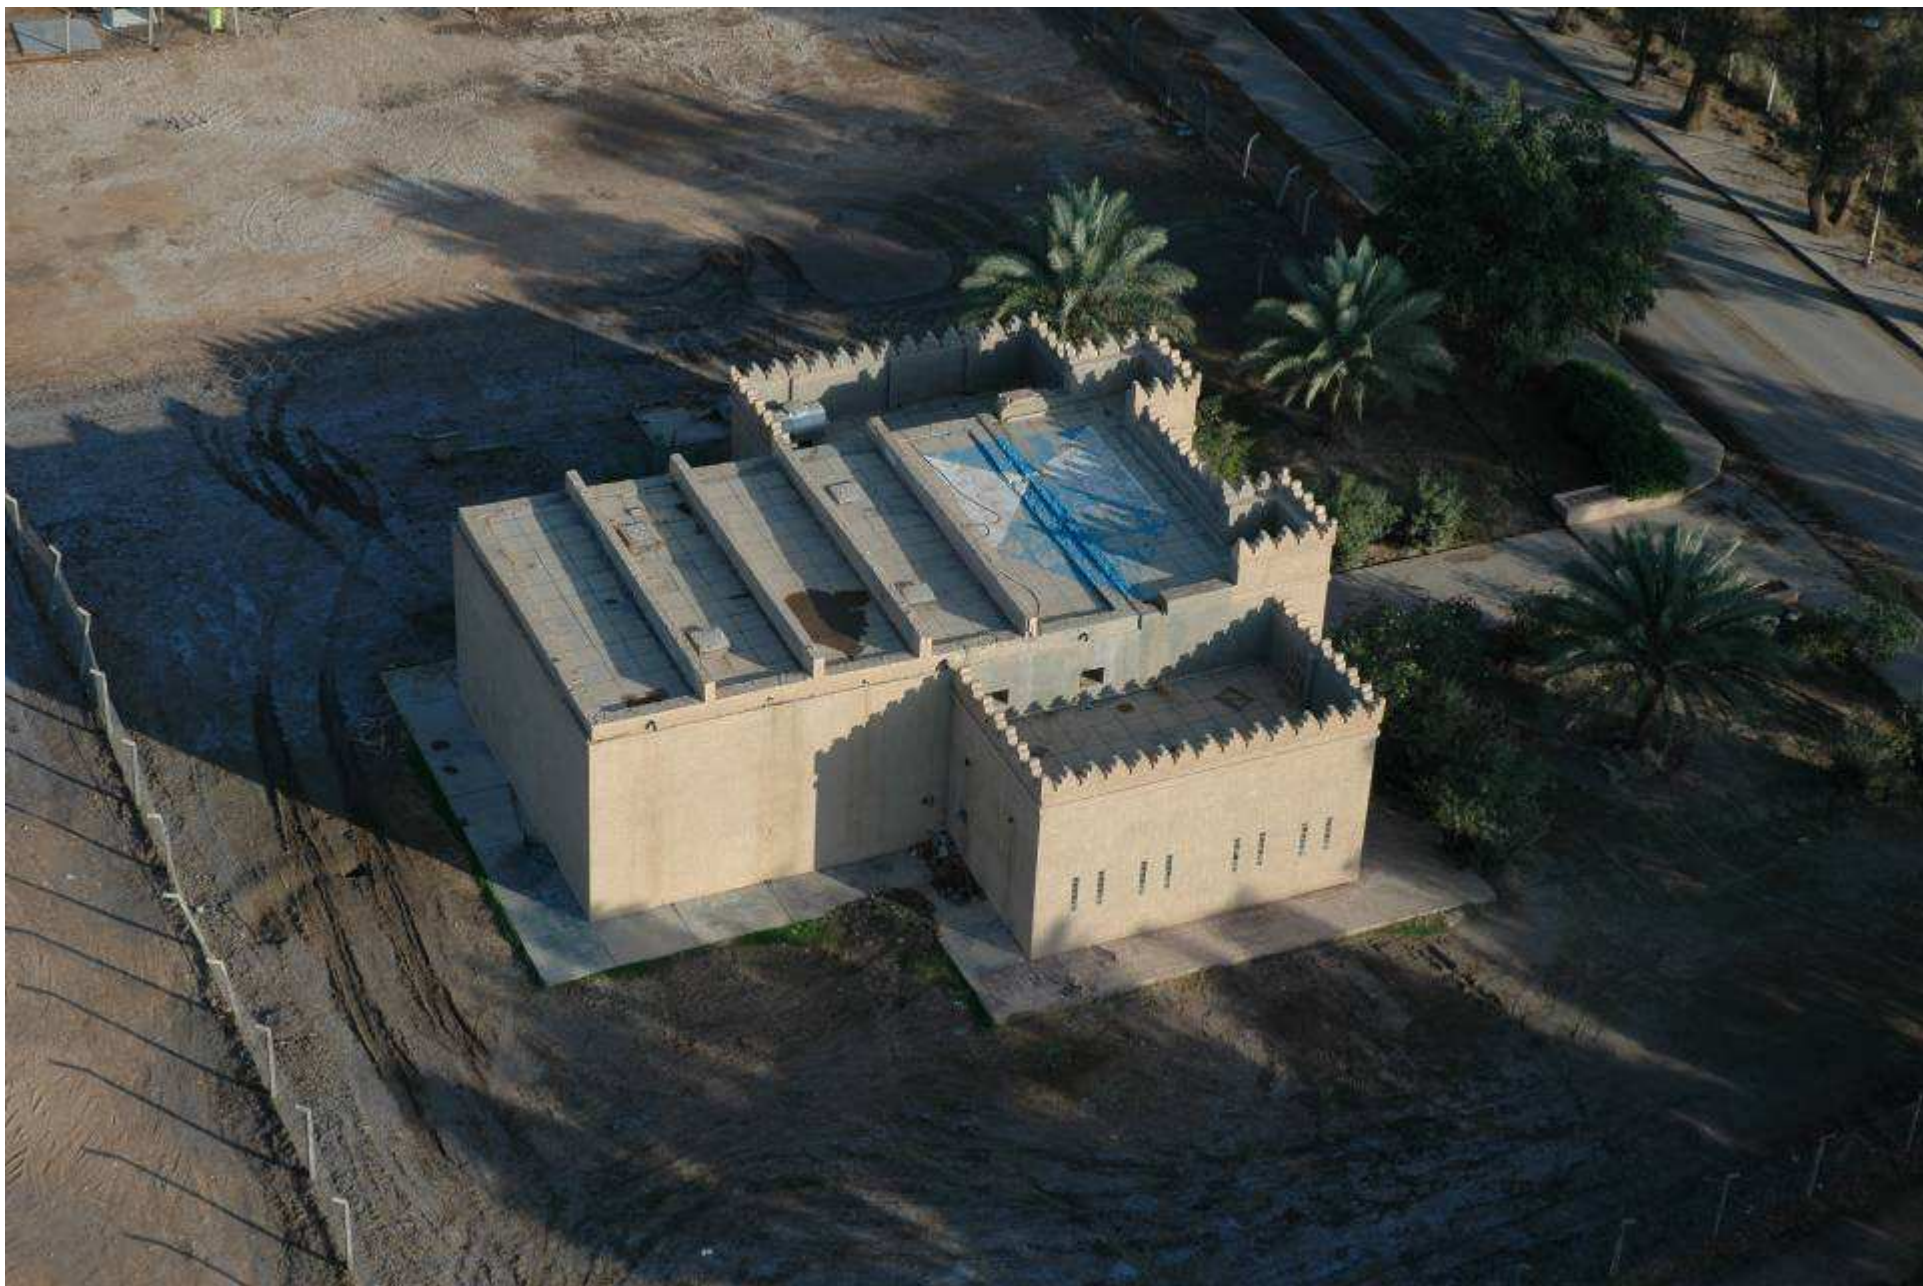
Eastern fence of Hammurabi Museum (formerly at upper left) removed to provide parking space, Polish photo 135 (photo © Ministry of Culture and National Heritage, Republic of Poland)

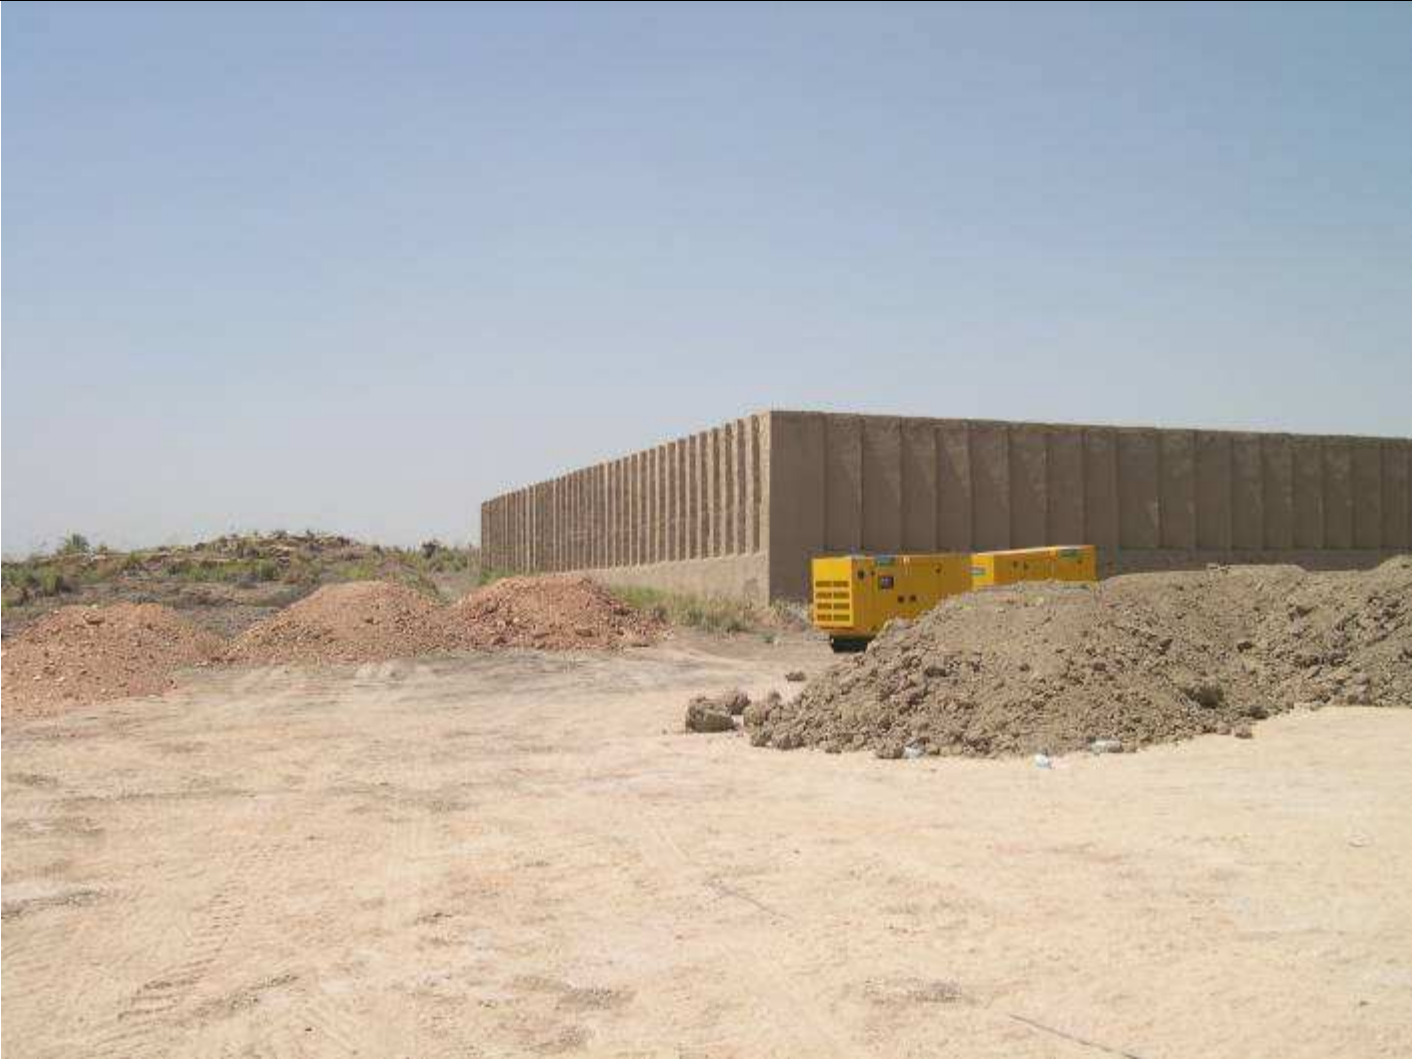
Piles of fill dirt by SW corner of Babylonian House, June 2004, Bahrani photo 2127 (photo © Zainab Bahrani)

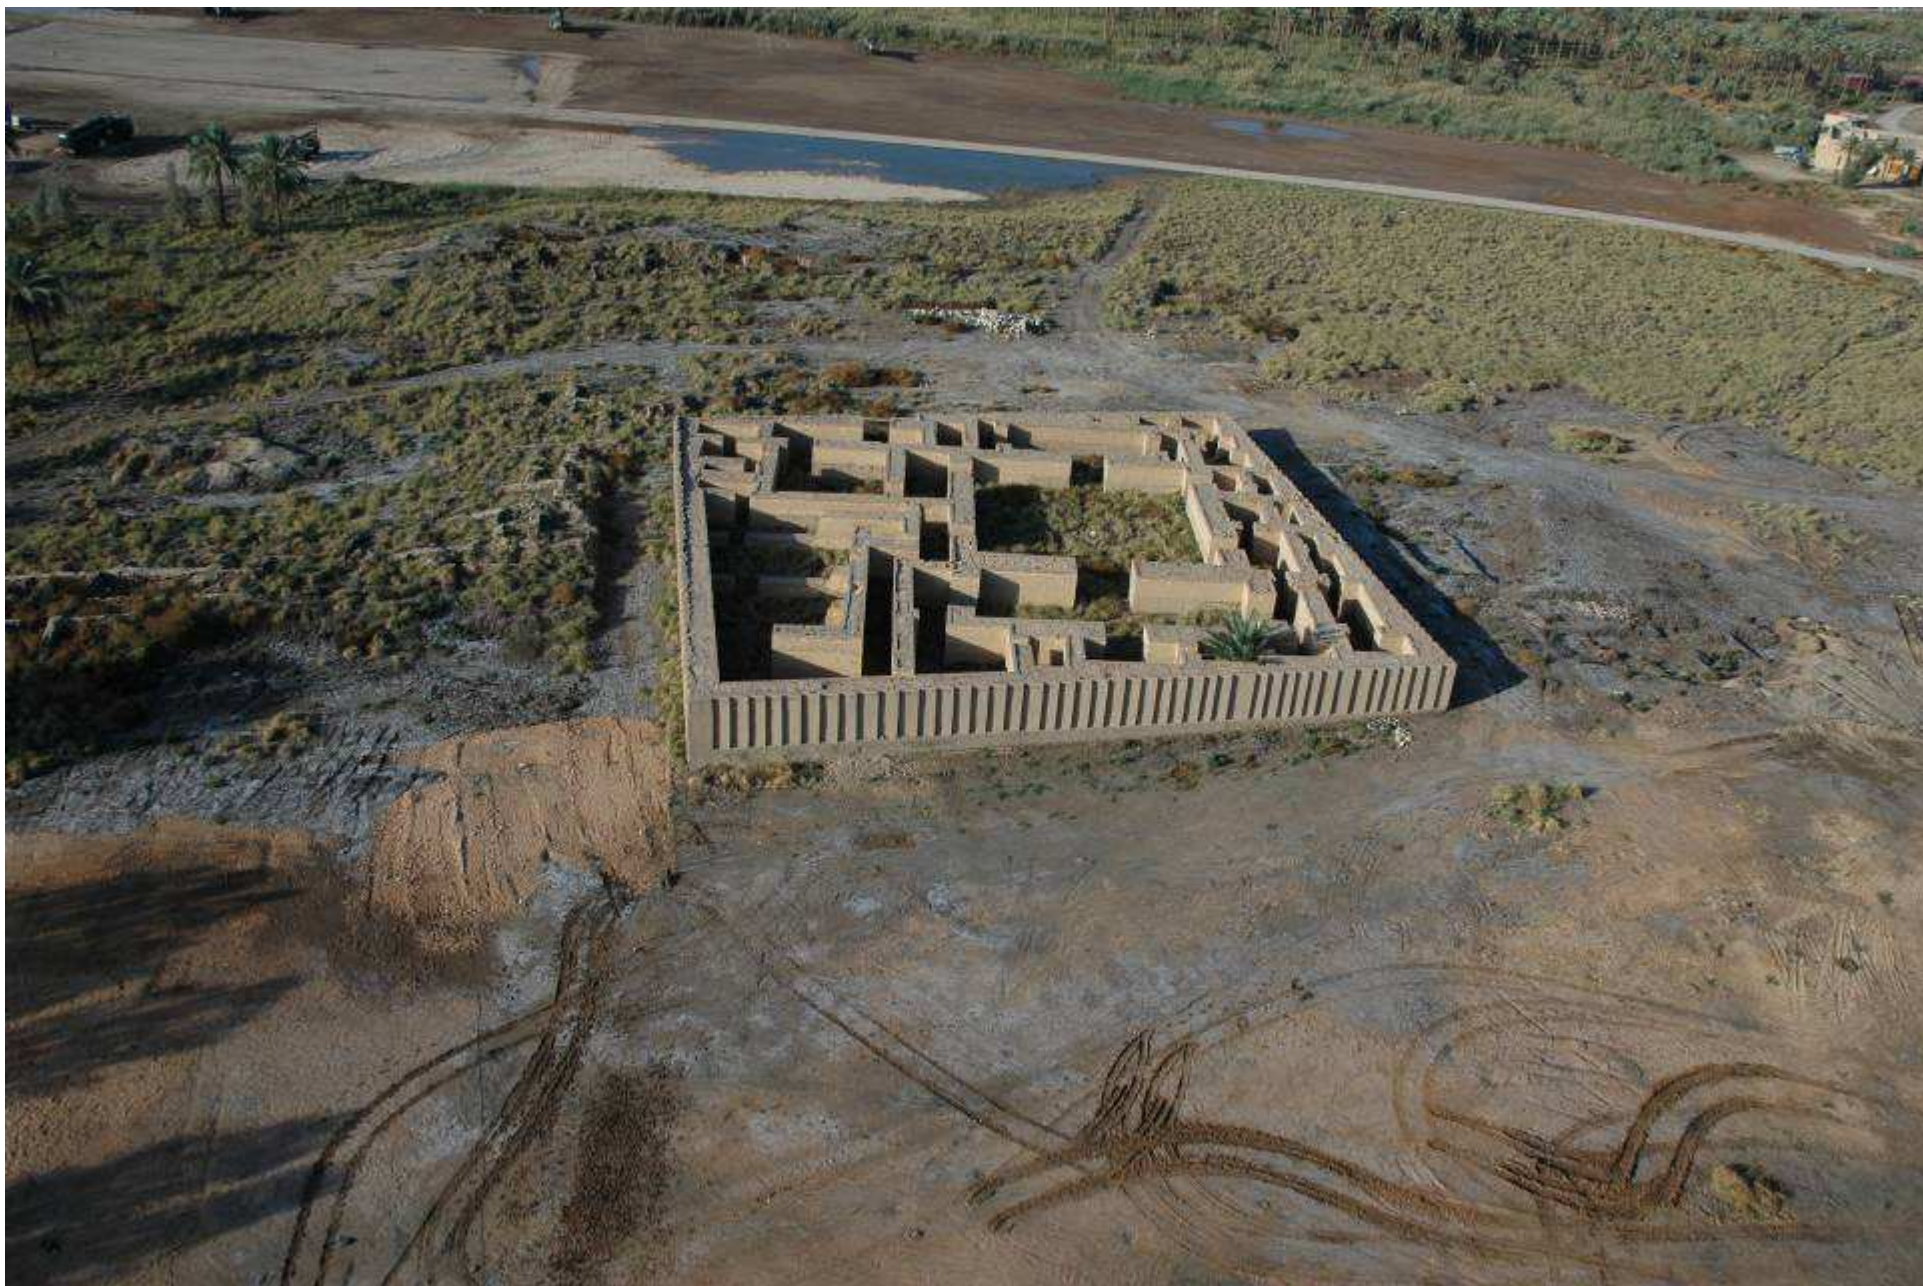
Curtis report	Polish report
To the south-west of the Babylonian House, an area about 80m x 60m has been levelled and covered with gravel (see <i>Polish Report</i> , fig. on p.38).	On the area just to the southwest of the Babylonian House there is a square of sand and gravel (marked on the picture at the beginning of this document as letter “A”).

November 2004, with fill dirt spread at SW corner of Babylonian House, Polish photo 79 (photo © Ministry of Culture and National Heritage, Republic of Poland)

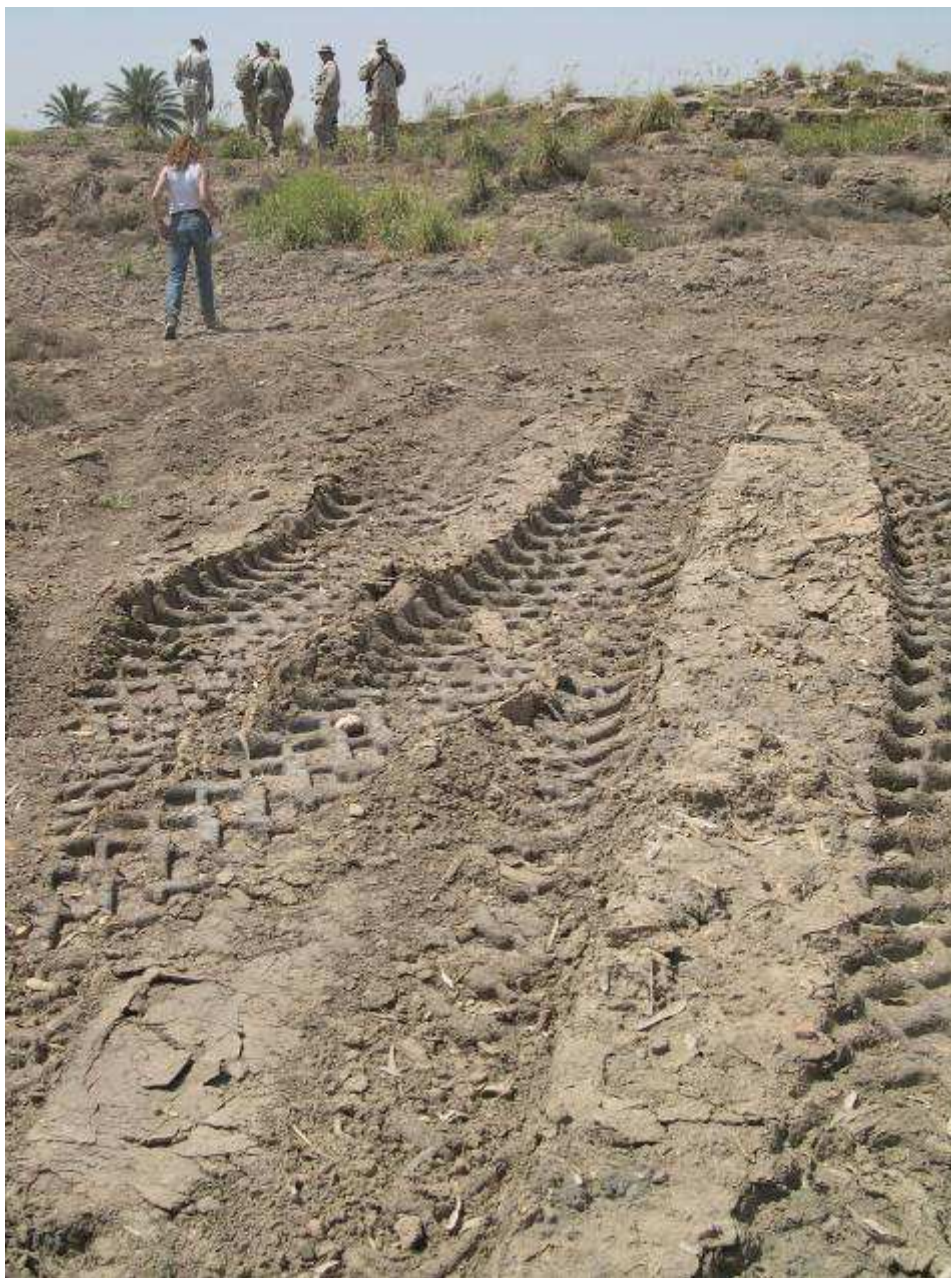
June 2004, tire ruts in construction area southwest of Babylonian House, Bahrani 2137 (photo © Zainab Bahrani)

**Russell comment:** These photos also show the construction of a wooden platform on this area, perhaps intended as the floor of a building. This work was apparently never completed.
