# **Report on Damage to the Site of Babylon, Iraq**

**John Malcolm Russell, Ph.D.**

**Cultural Heritage Center  
Bureau of Educational and Cultural Affairs  
Department of State**

**April 2010**

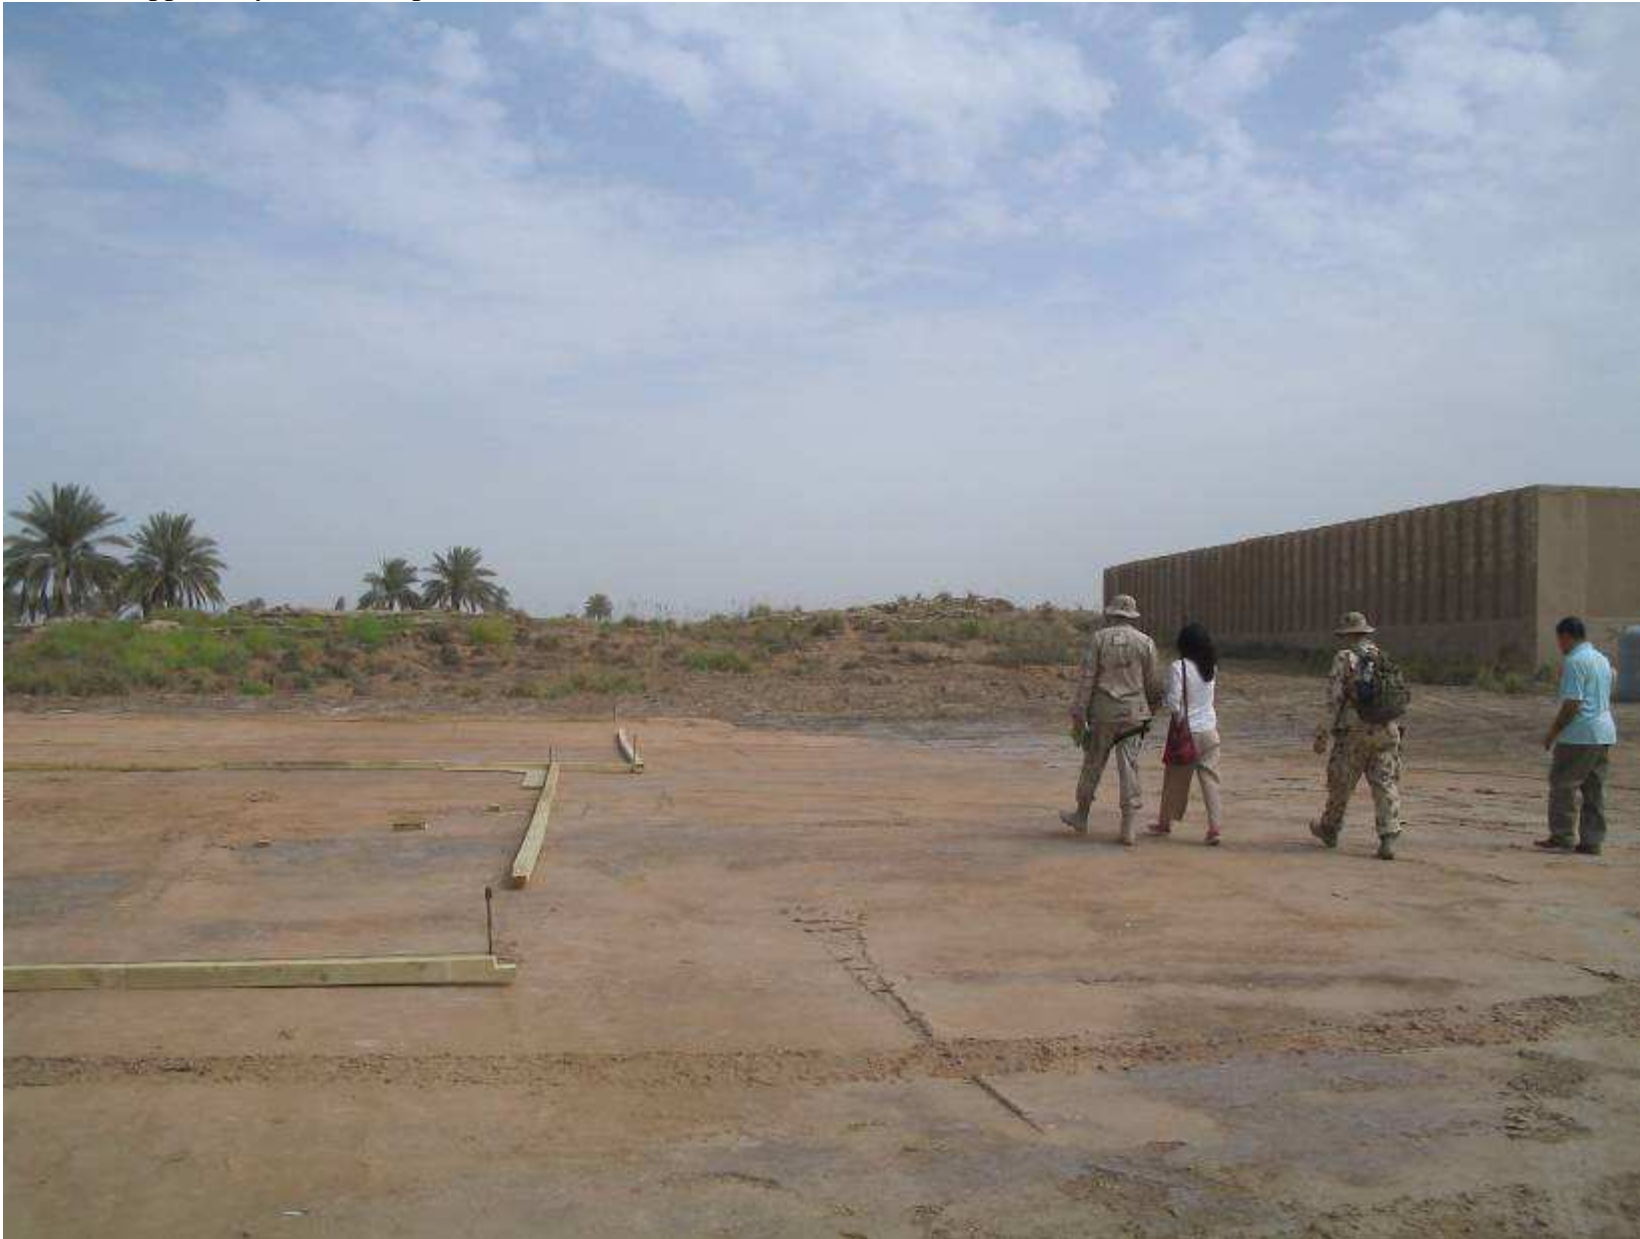
**Russell comment:** These photos also show the construction of a wooden platform on this area, perhaps intended as the floor of a building. This work was apparently never completed.

May 2003, flattened area with beginning of wooden platform, Russell photo 123\_2333 (photo © John Russell)

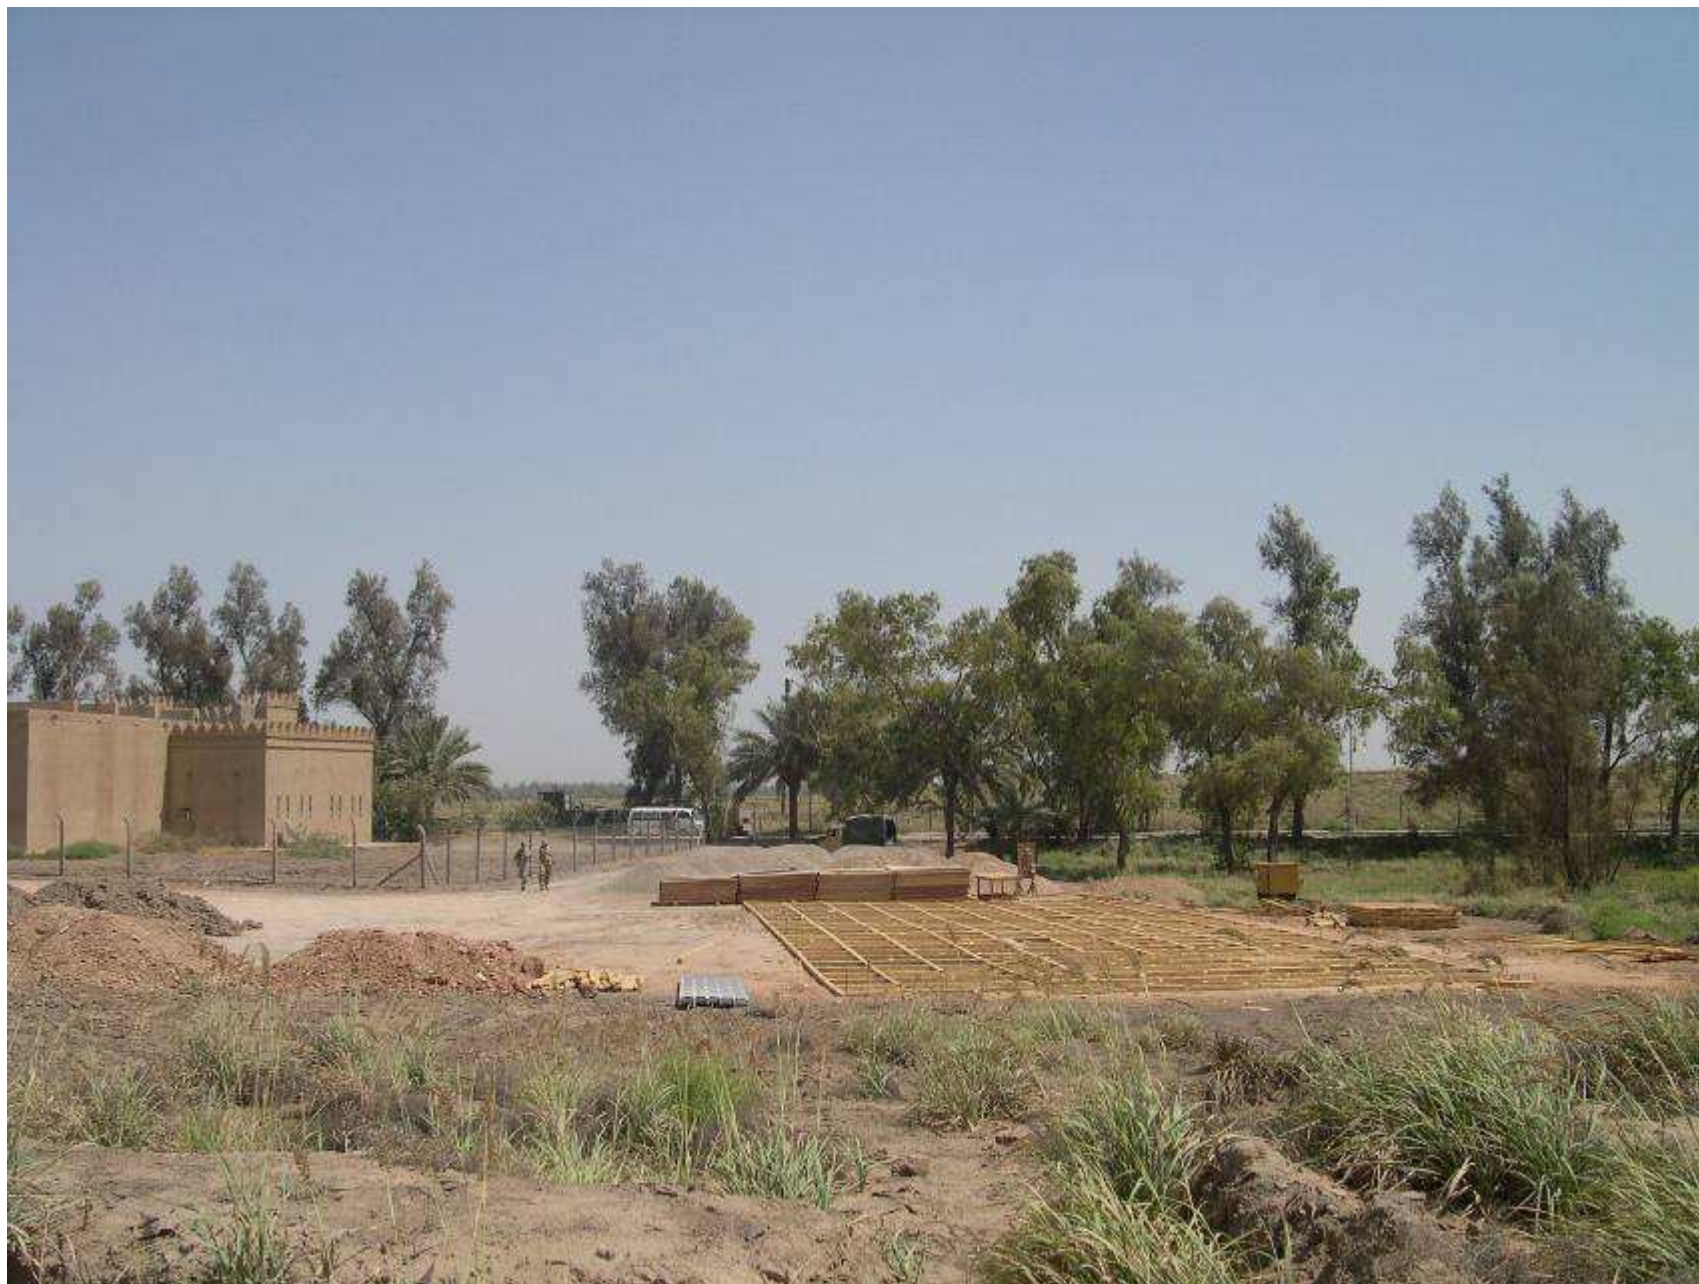
June 2004, wooden platform under construction, Bahrani 2141 (photo © Zainab Bahrani)

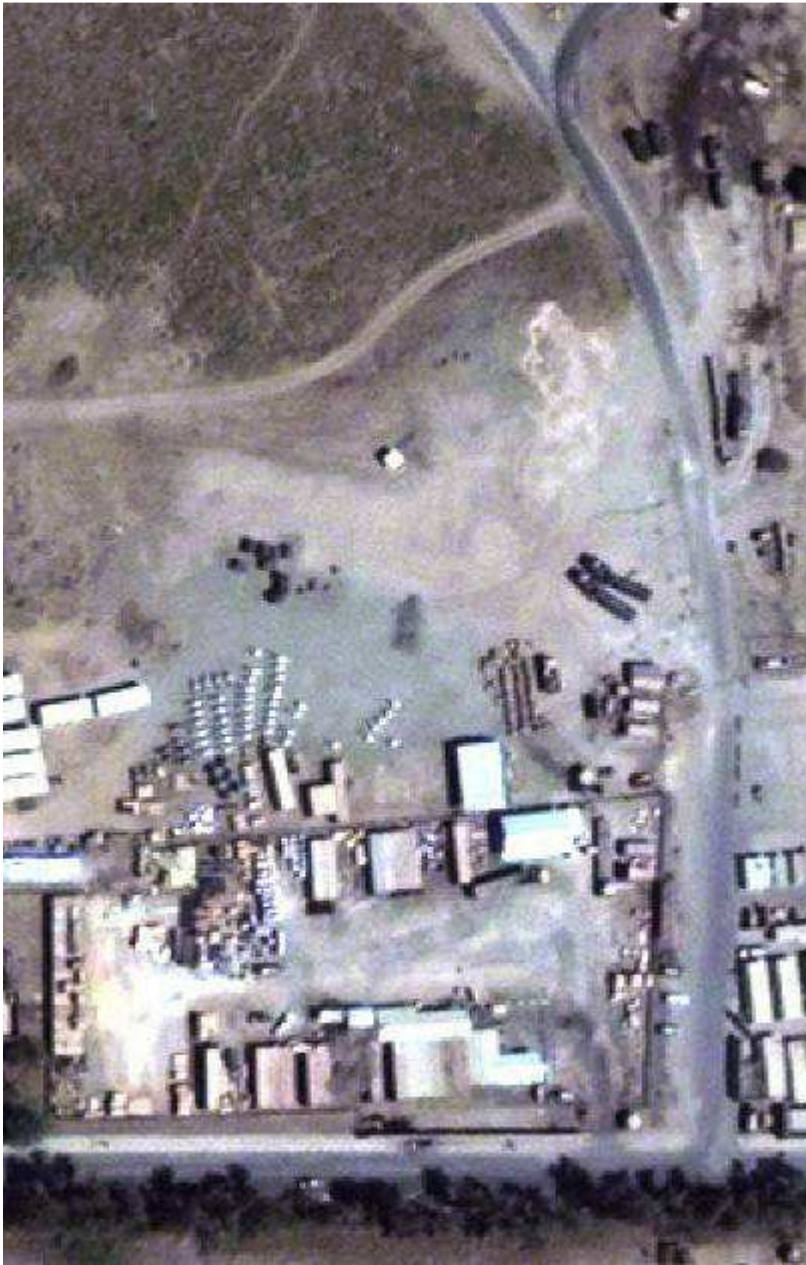
By 25 August 2004, the piles of sand and the sandbags were gone, Russell composite

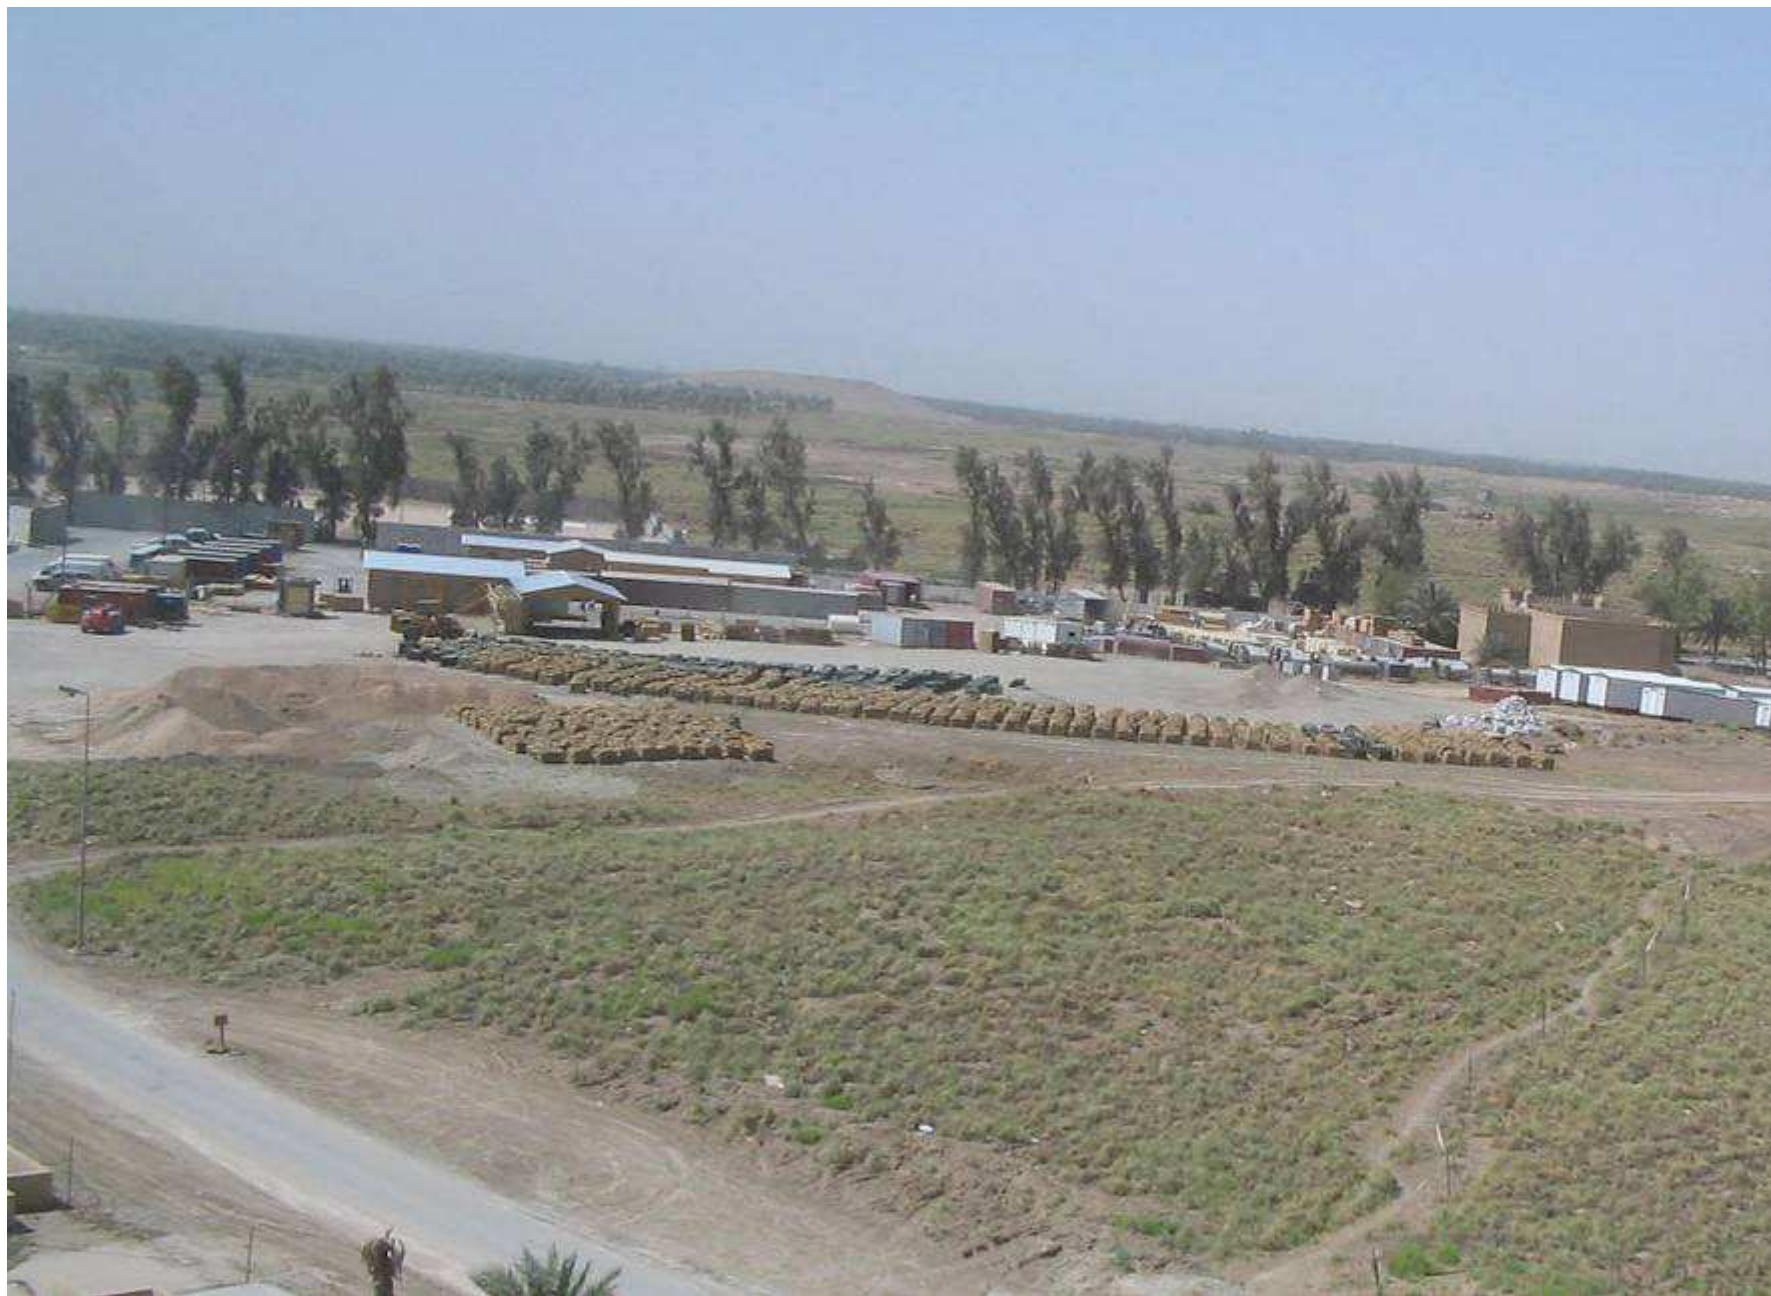
**Russell comment:** Serious damage was done in this area very late in the Coalition occupation, with an archaeological deposit being mined for fill long after orders had been issued to bring in fill sand from outside the site. Presumably the proximity of this area to KBR's bulldozers proved too tempting to resist.

View from north showing sand piles and sandbags, June 2004, Russell photo 124\_2457 (photo © John Russell)

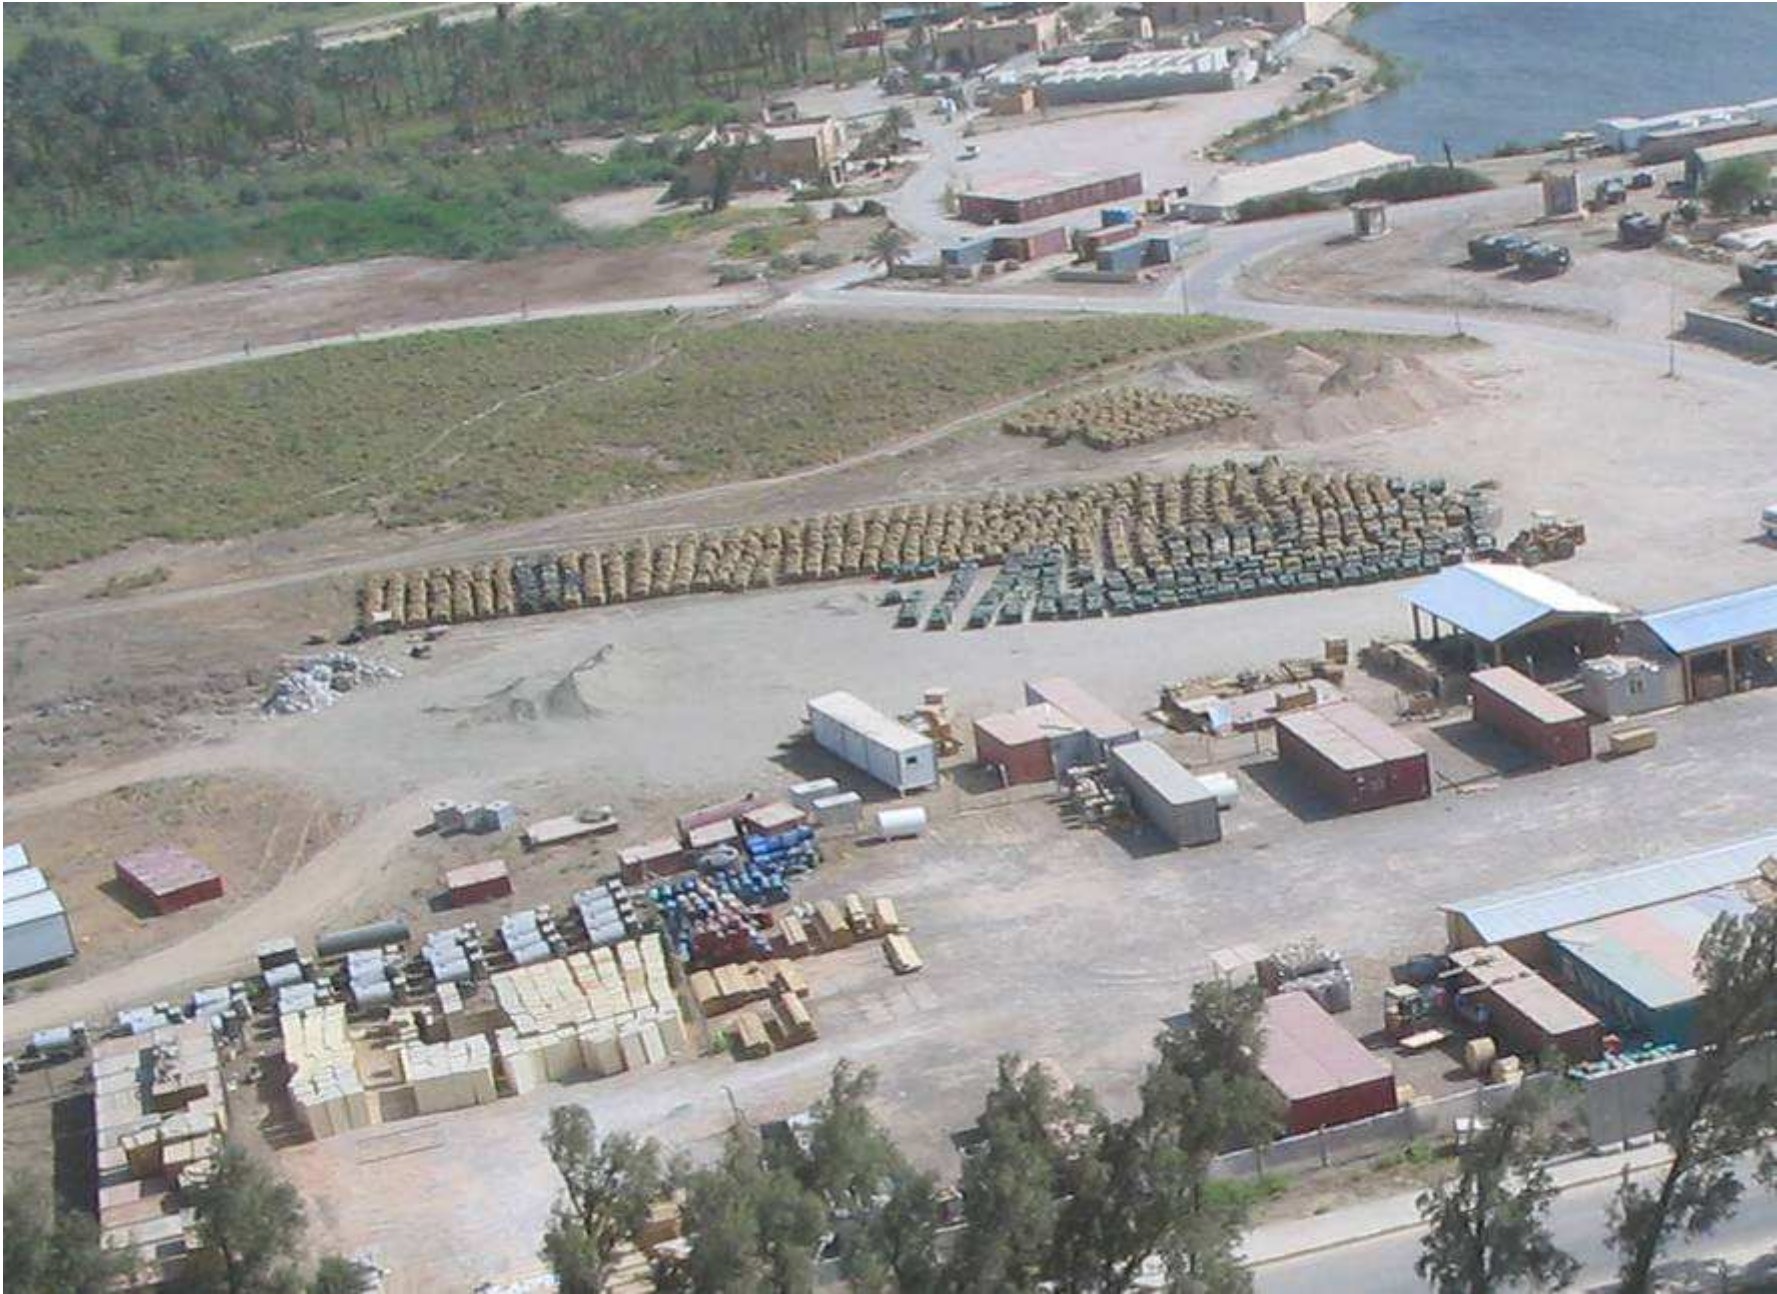
View from south showing sand piles and sandbags, June 2004, Russell photo 124\_2436 (photo © John Russell)

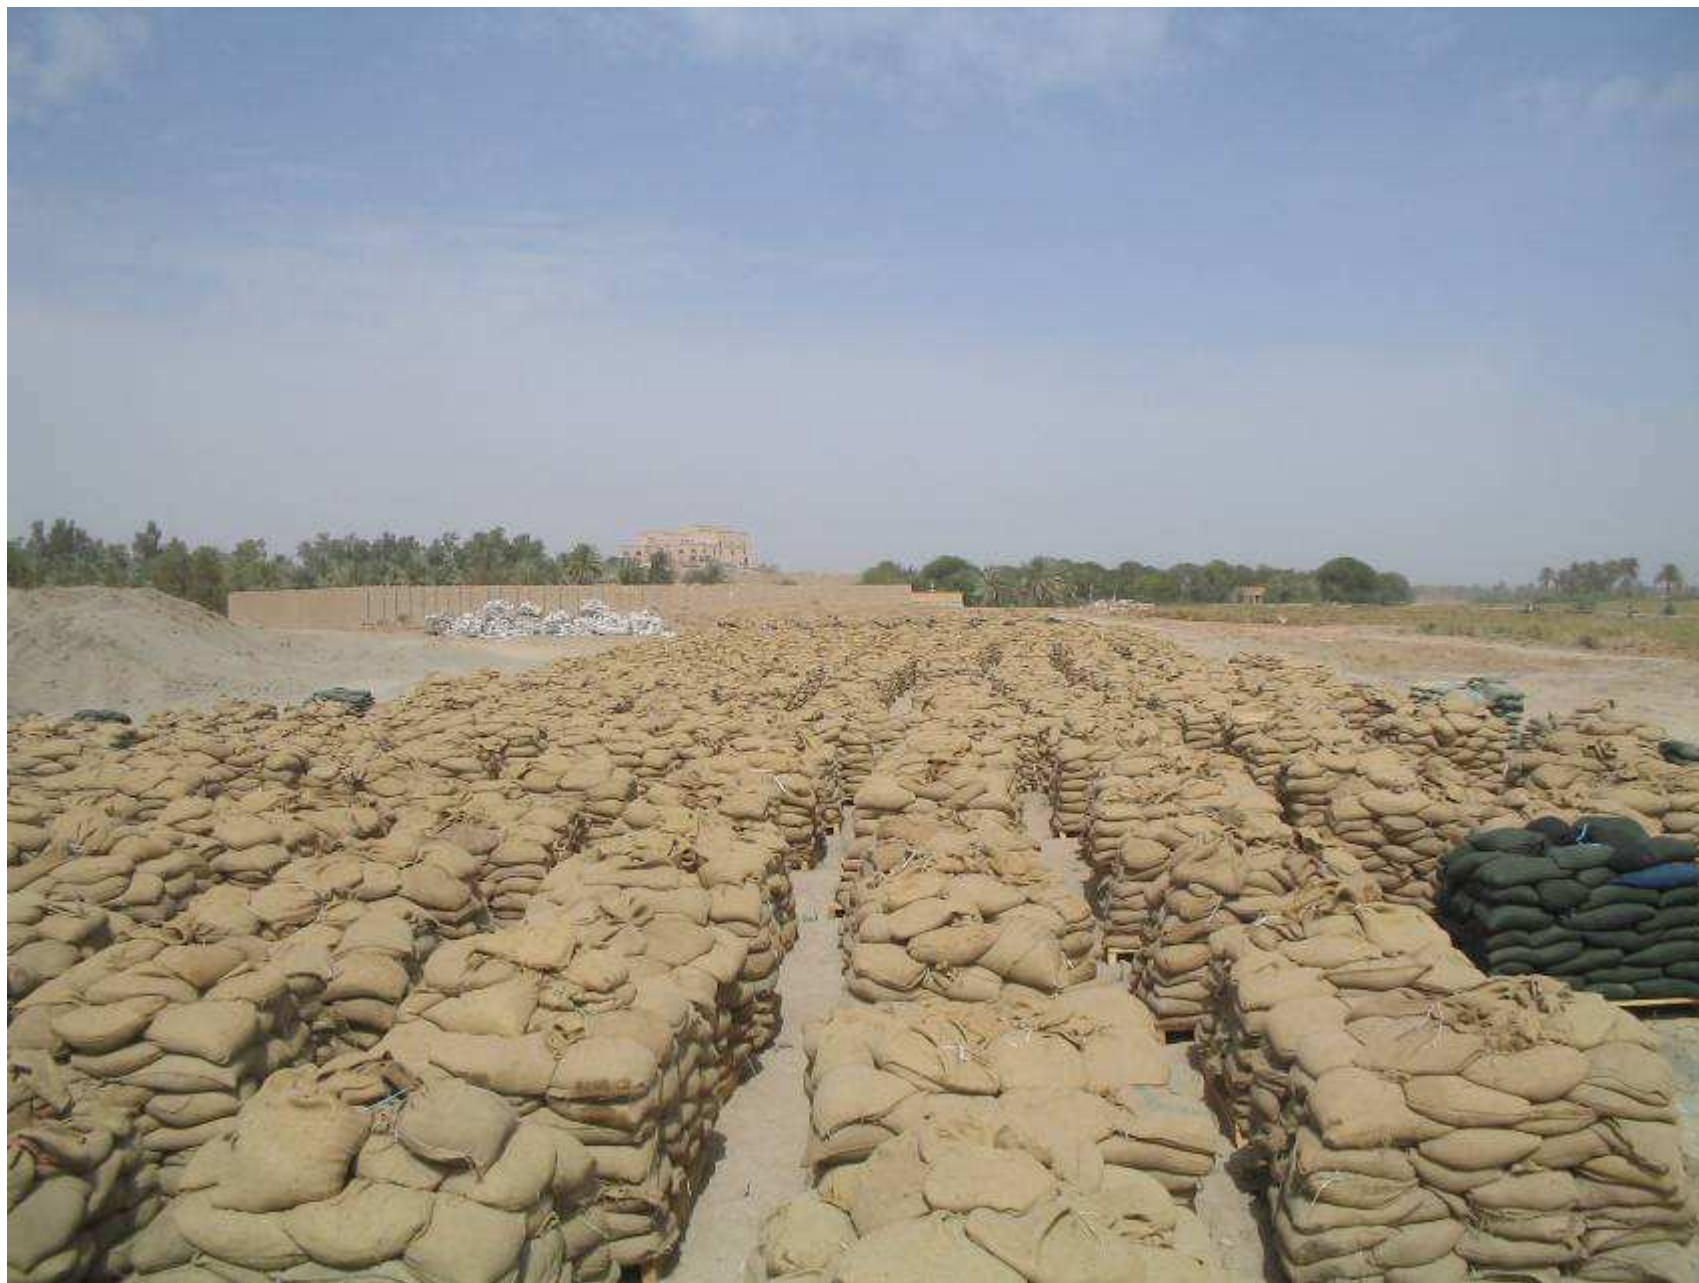
Sandbags, May 2004, Russell photo 123\_2342 (photo © John Russell)

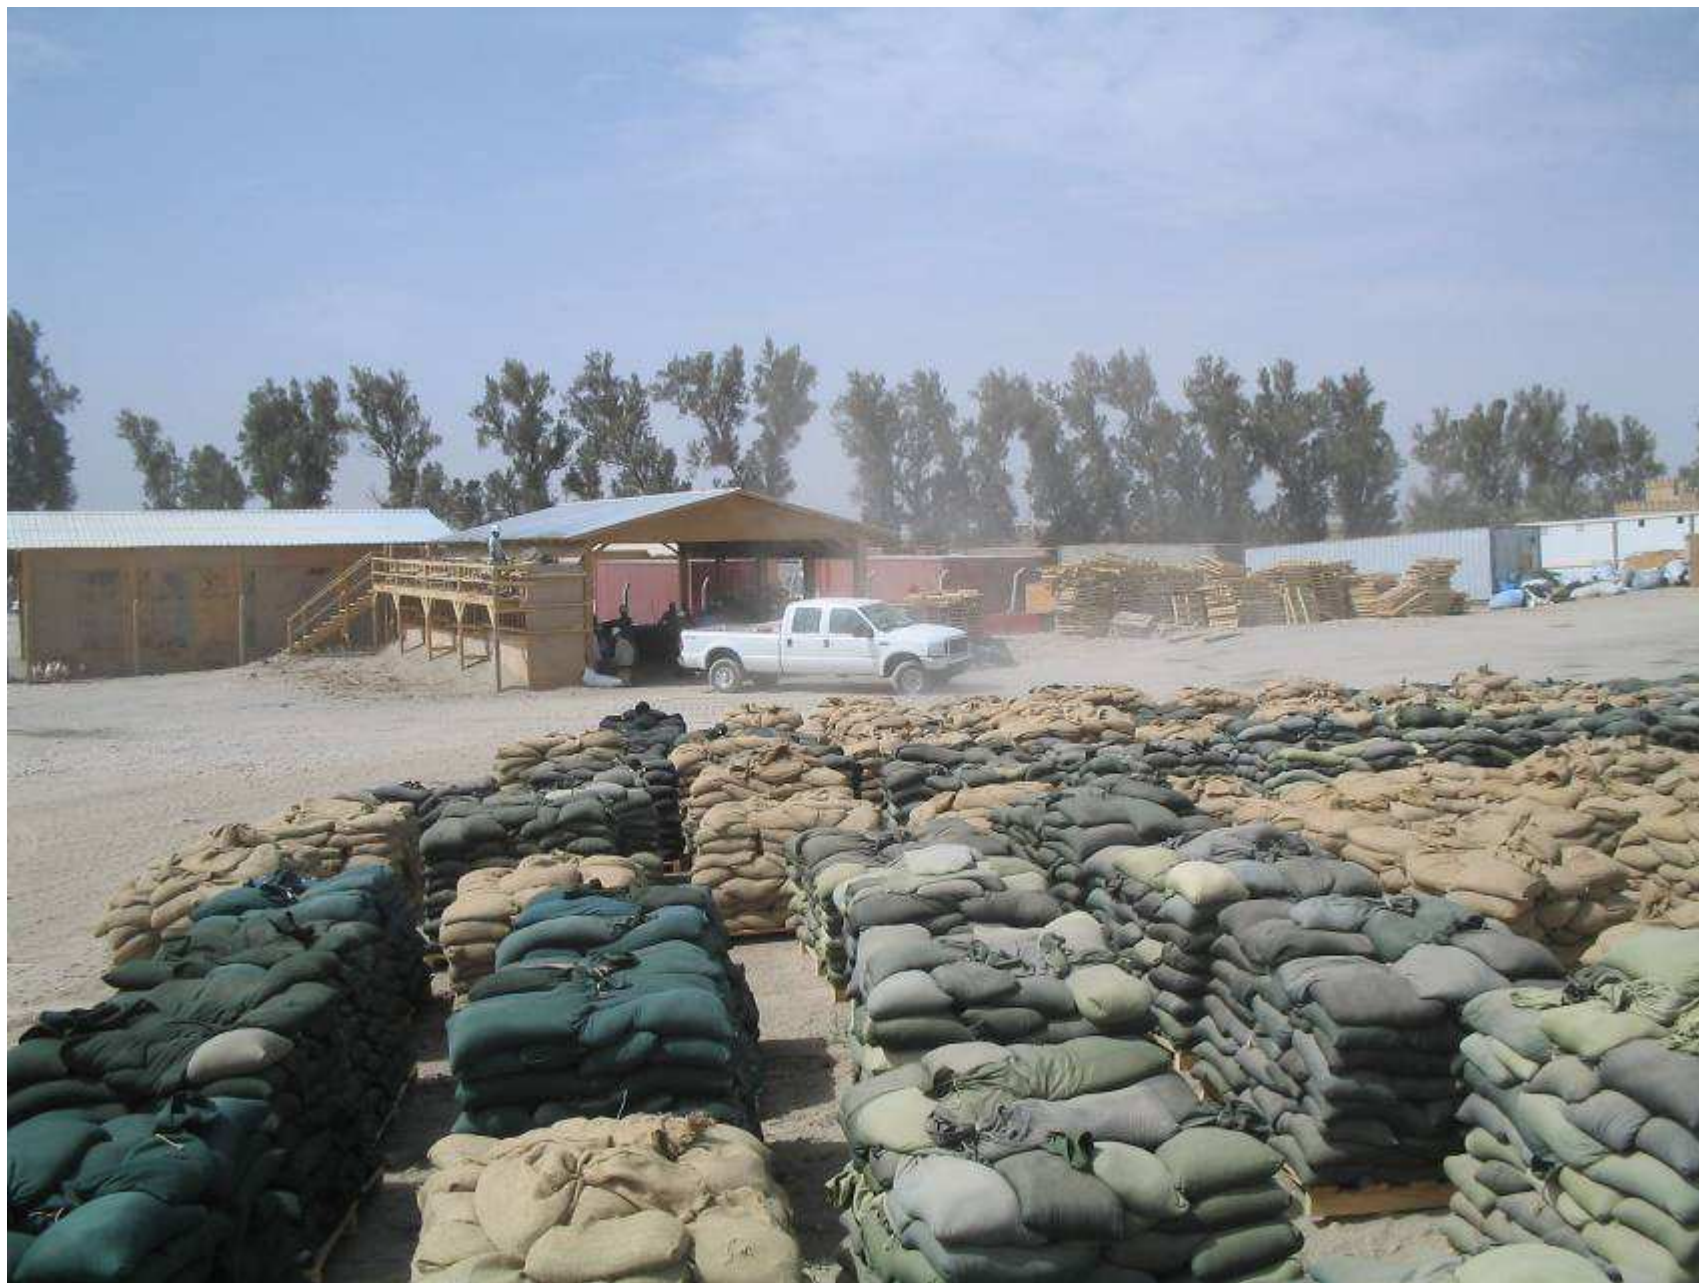
Sandbags, May 2004, Russell photo 123\_2343 (photo © John Russell)

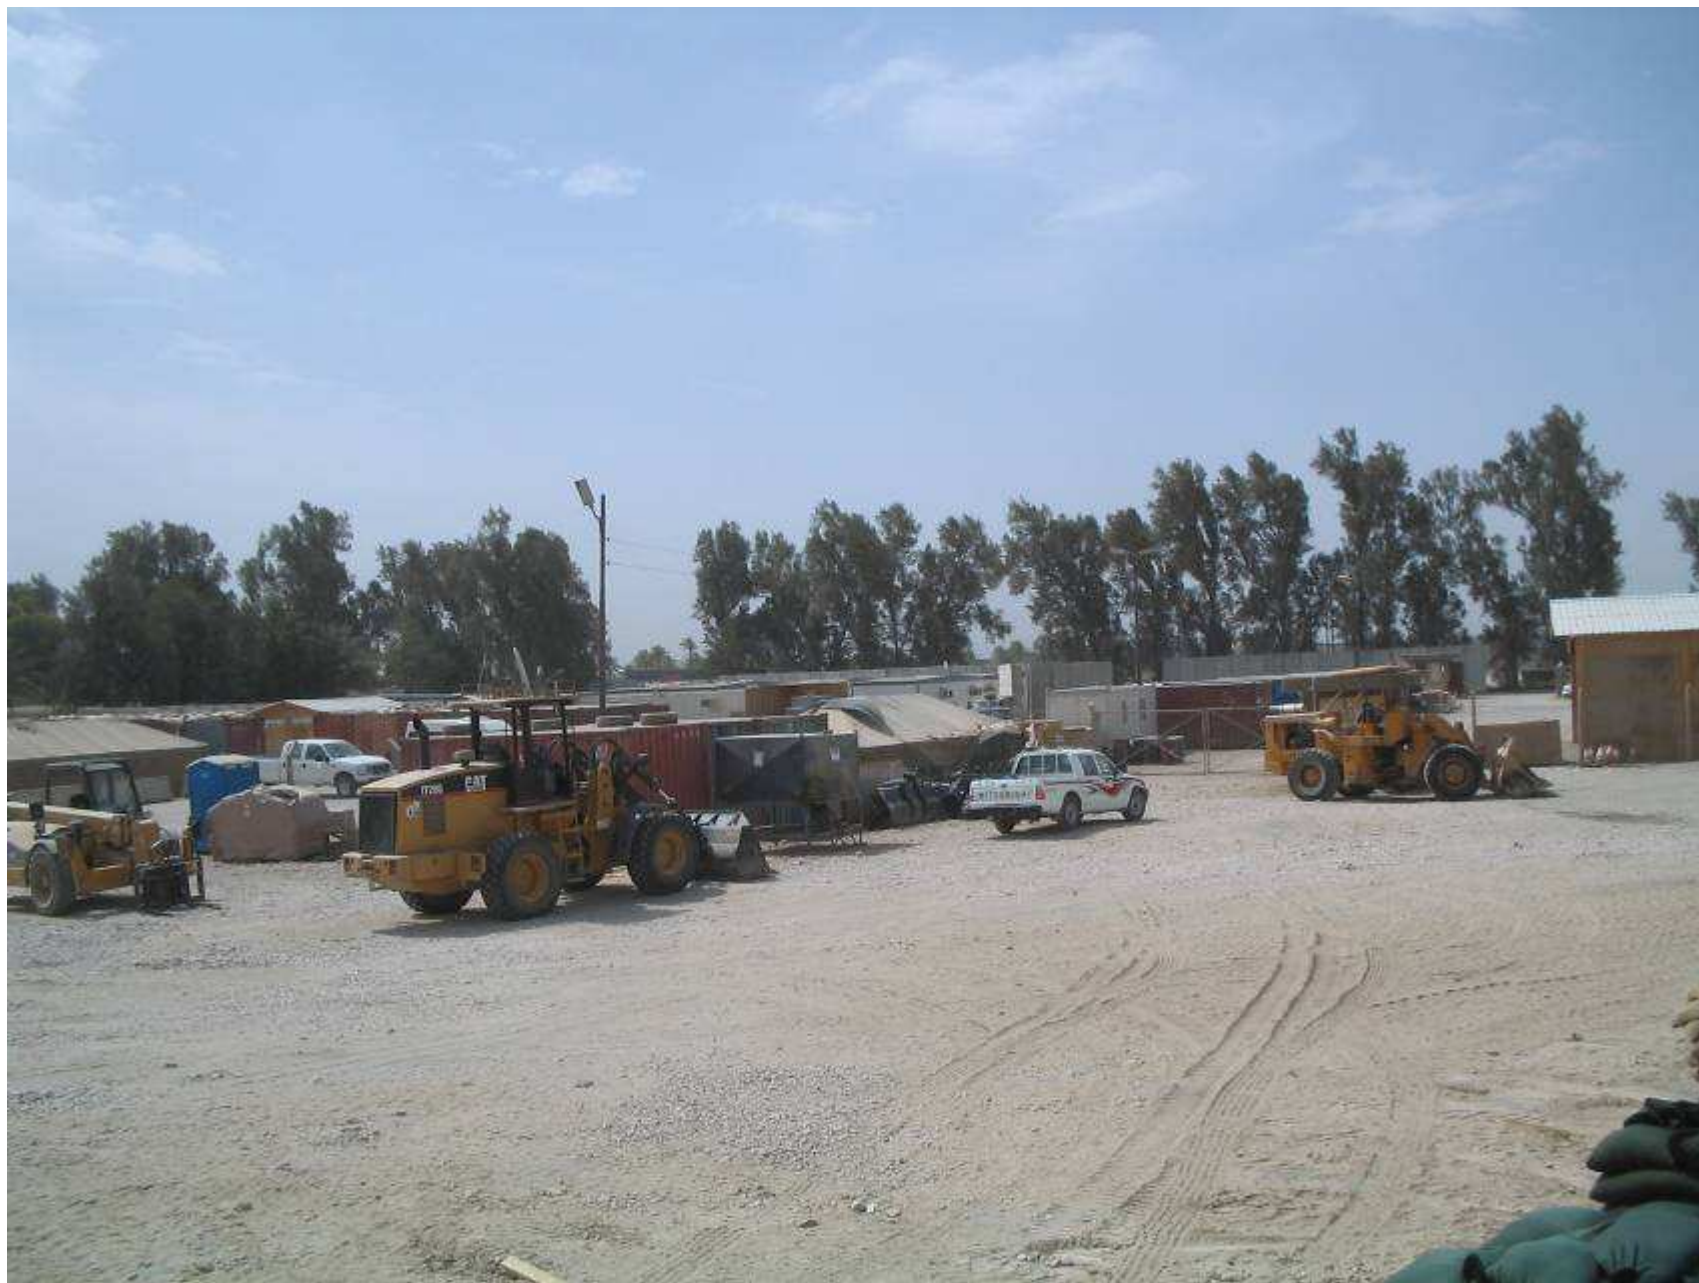
KBR bulldozers, May 2004, Russell photo 123\_2344 (photo © John Russell)

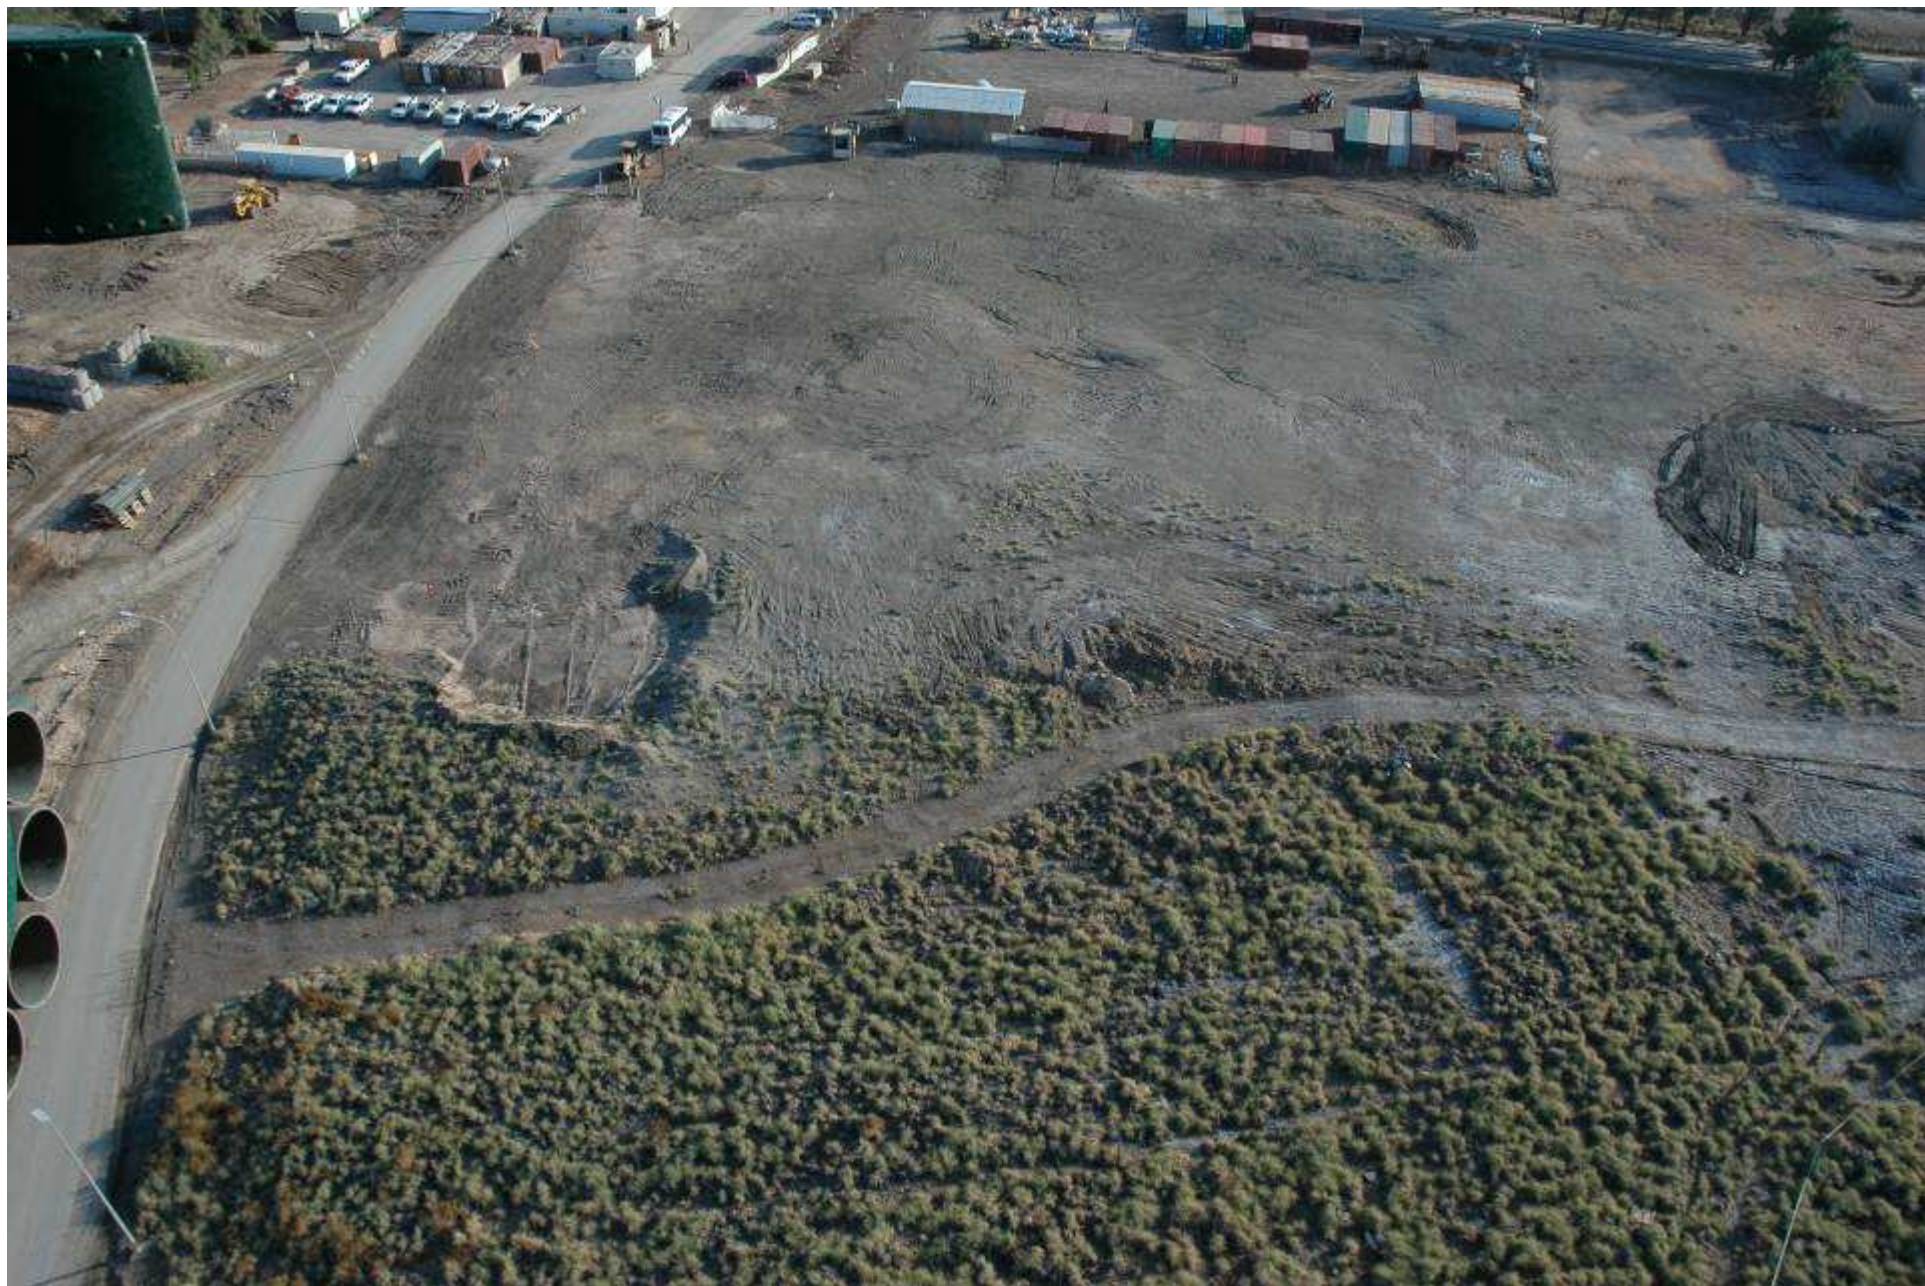
Cut 14, November 2004, Polish photo 134 (photo © Ministry of Culture and National Heritage, Republic of Poland)

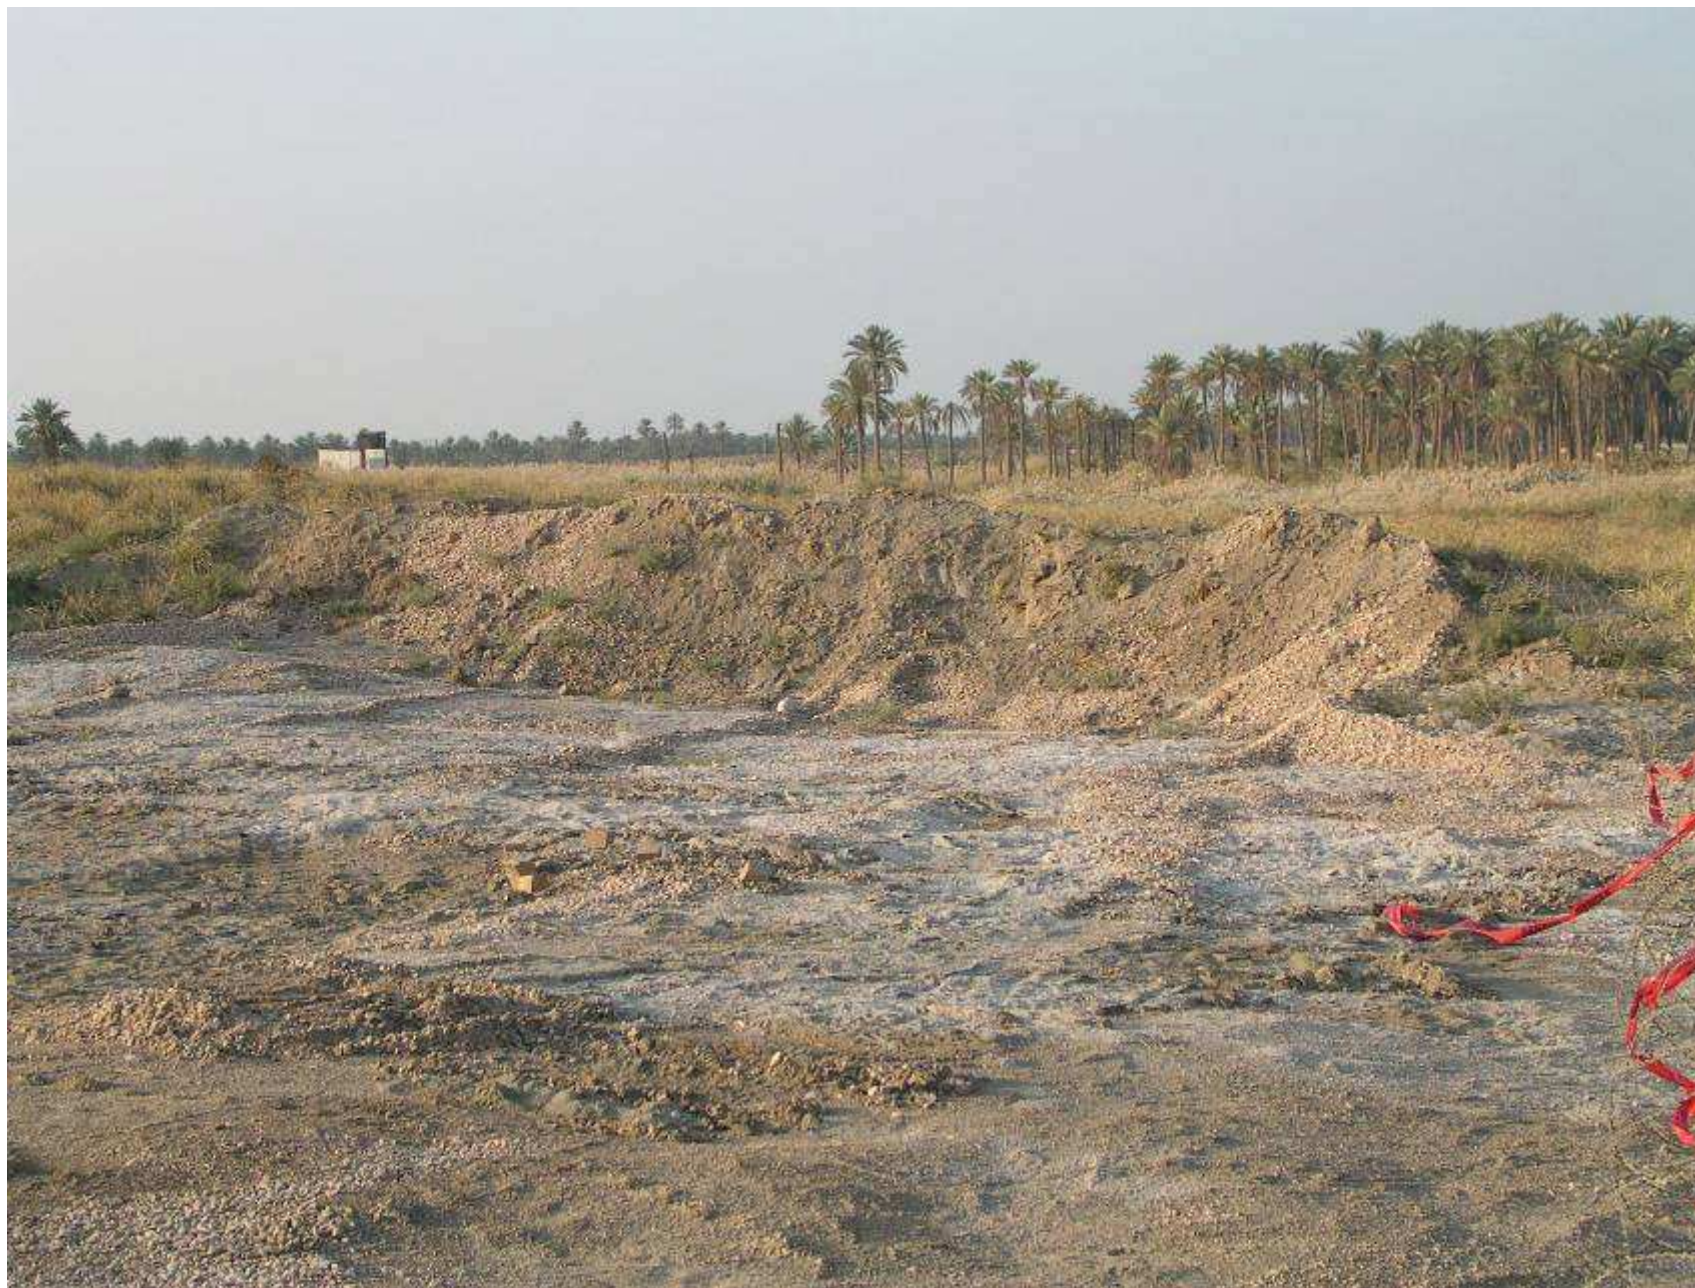
Cut 14, Curtis photo 7568 (photo © John Curtis)
