# **Report on Damage to the Site of Babylon, Iraq**

**John Malcolm Russell, Ph.D.**

**Cultural Heritage Center  
Bureau of Educational and Cultural Affairs  
Department of State**

**April 2010**

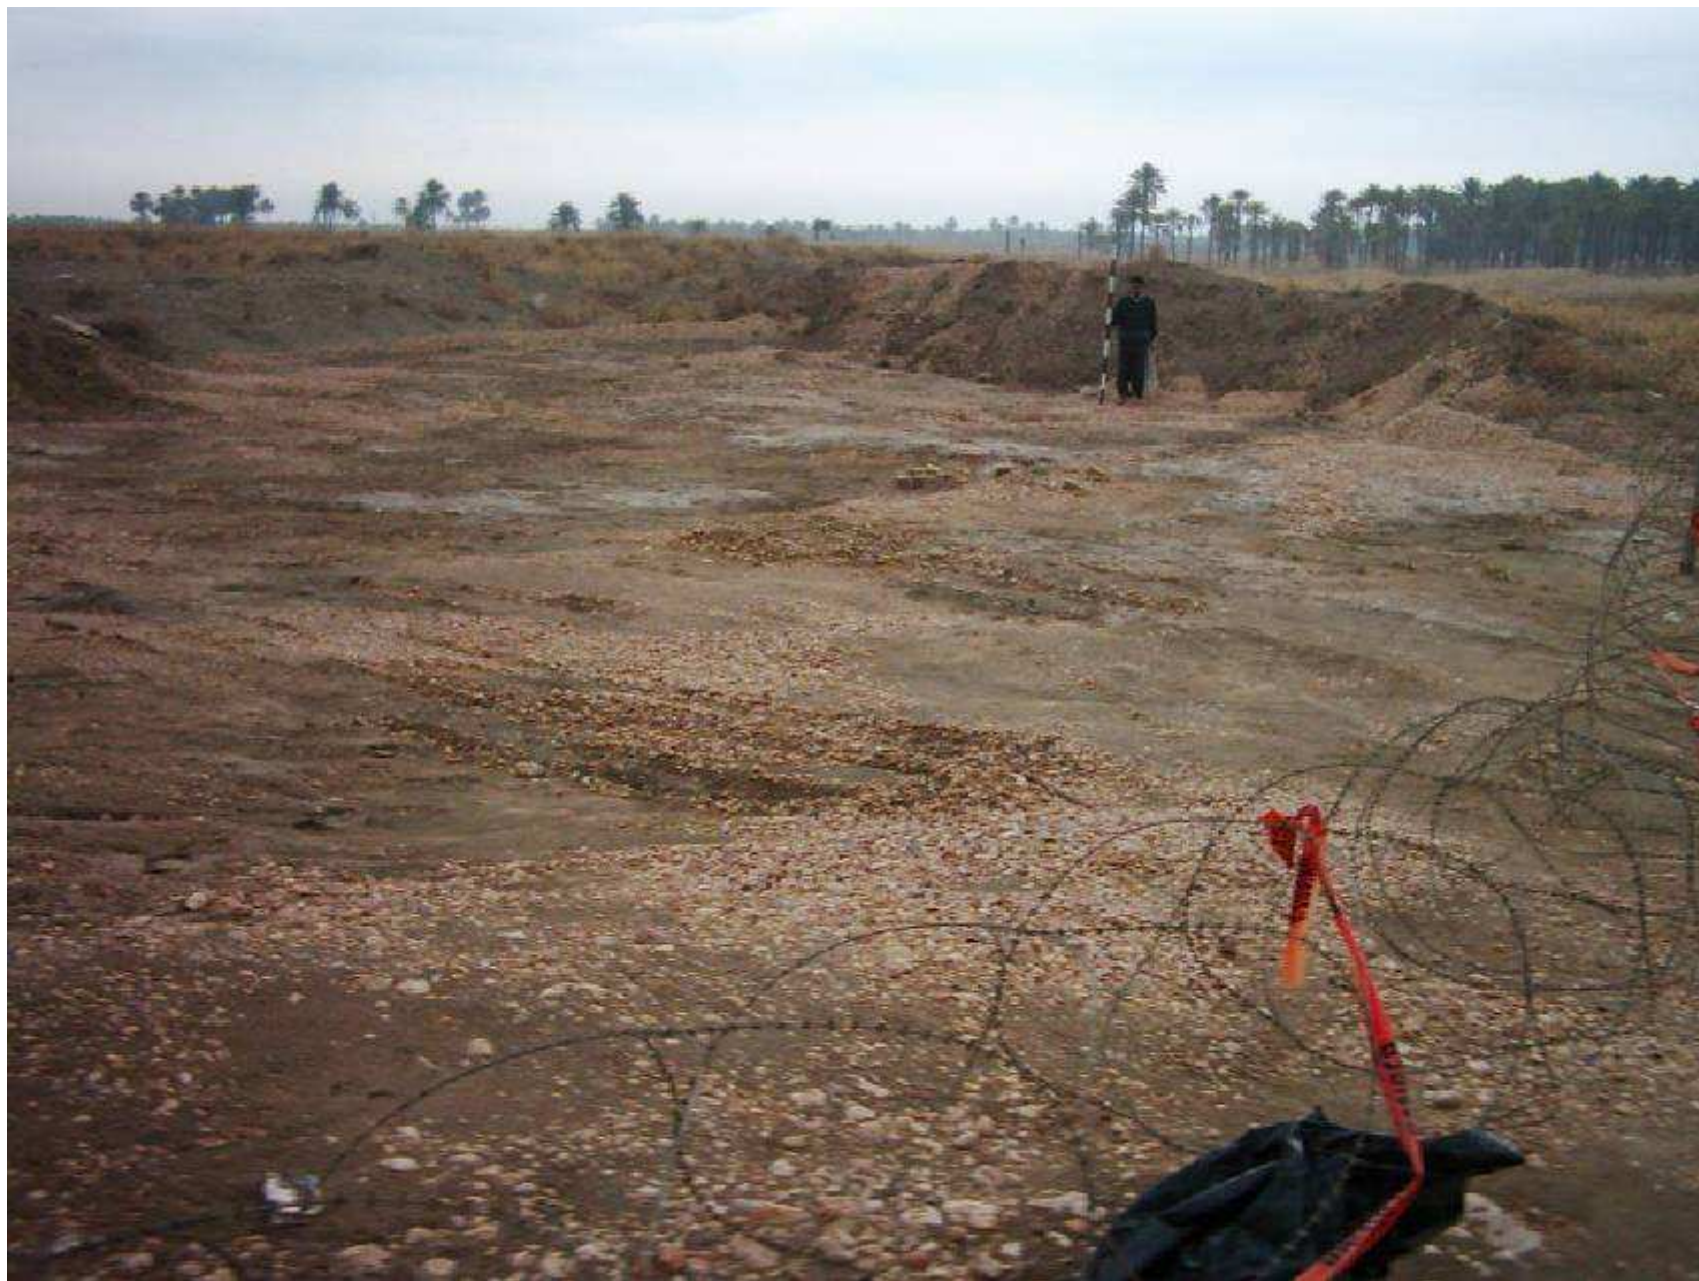
Iraqi final report fig. 52

**Iraqi final report:** The cut also extends to a wall built of baked bricks that is very clear on the surface (Photo 52). To shed light on the damage, a grid was created on a 5 x 5 m square in the same cut (see photo 53). After the grid was created on the square, we cleaned it and determined that the wall was near the surface, at a depth of no more than 10 cm, hence the extent of the damage caused. This wall is part of a structural unit built with baked bricks, with a wall thickness of 40-60 cm. Part of the wall is eroded (see Sketch 3 and Photo 54).

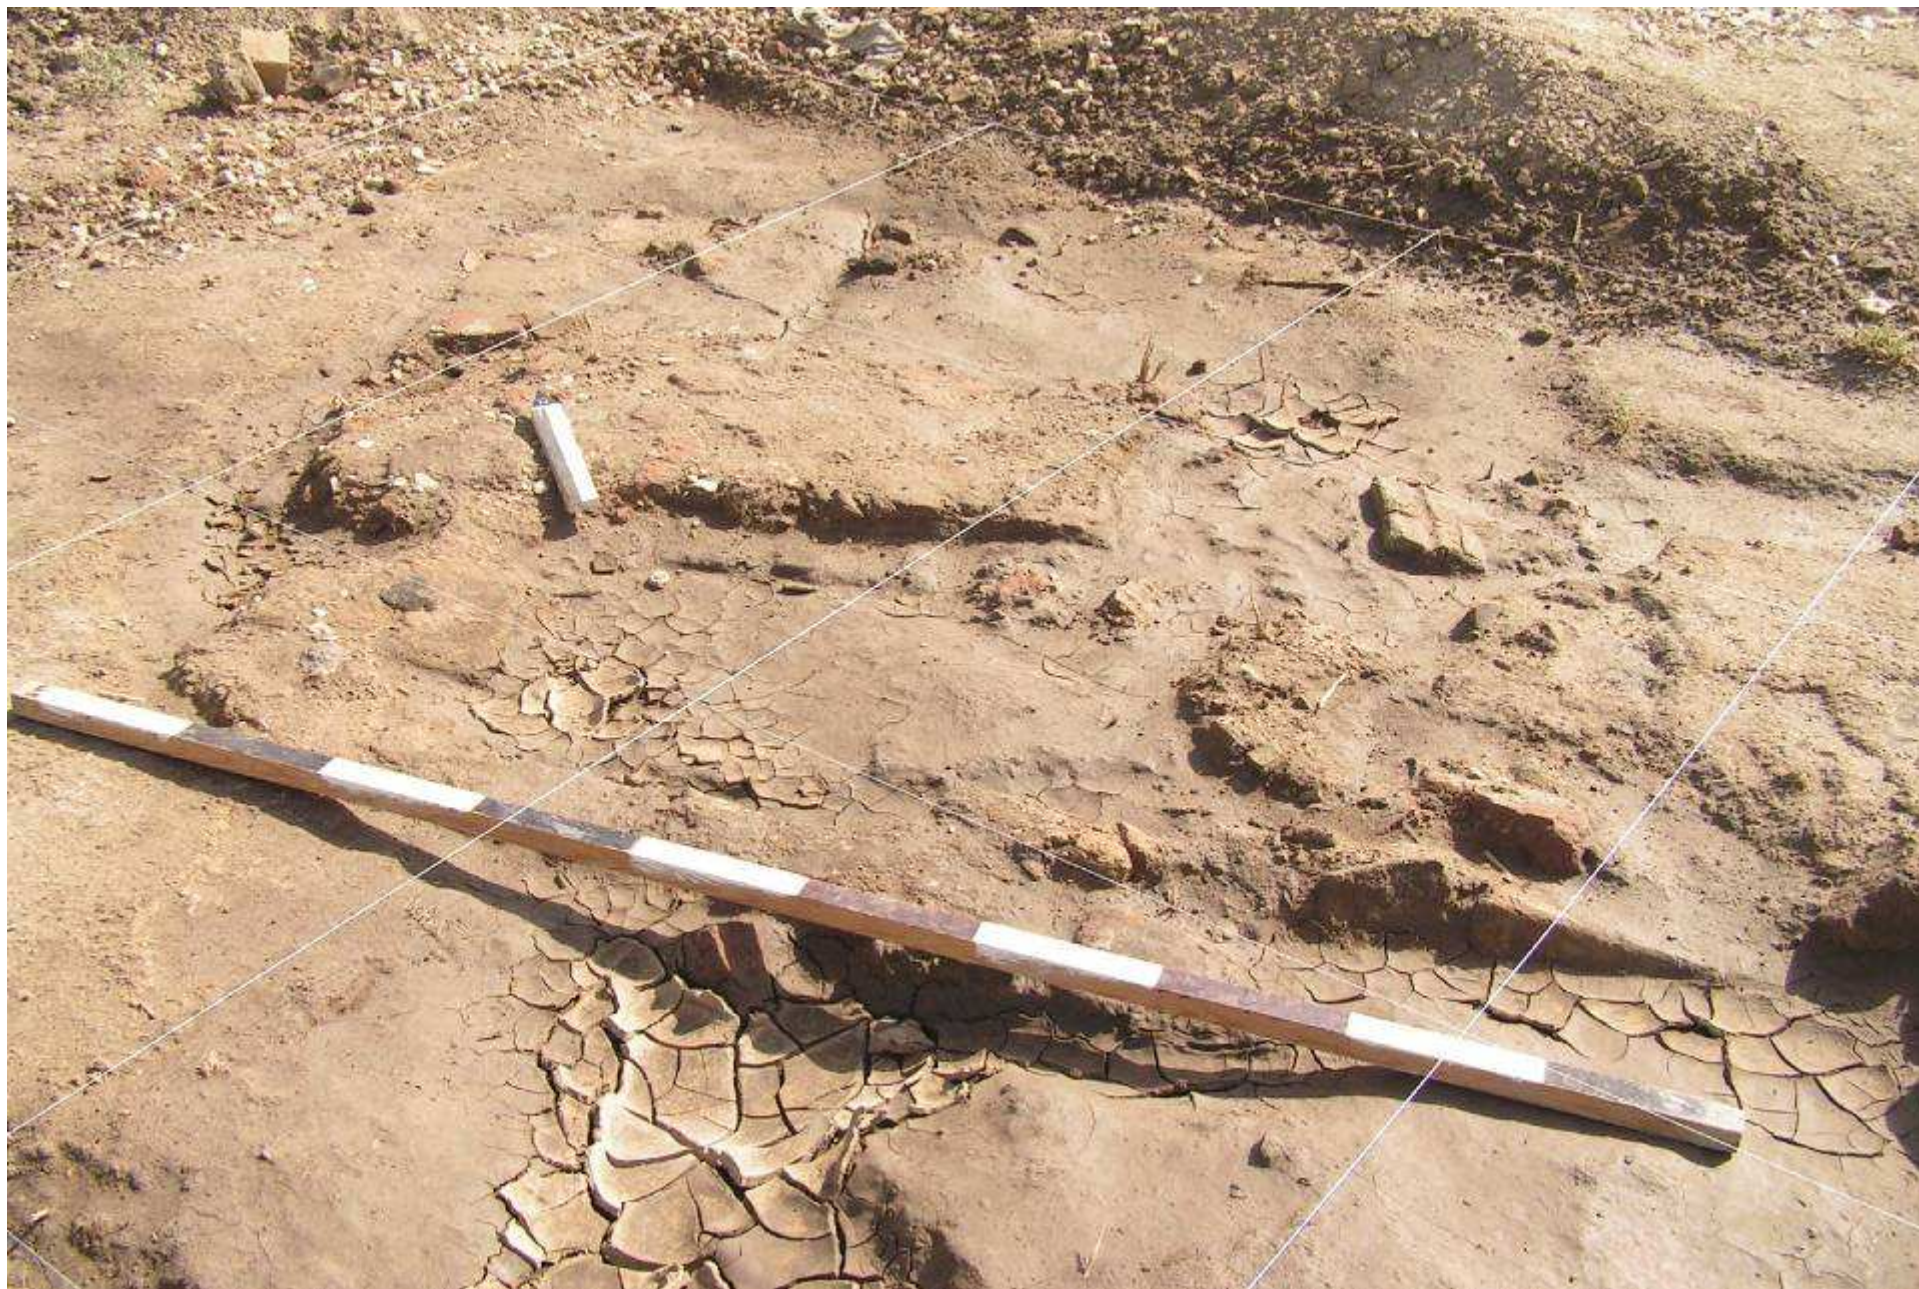
Iraqi final report fig. 55

During the cleaning, we found some shattered pottery dating back to the Parthian period. We also found a tomb built with fragments of baked brick and unbaked bricks with a length of 2 m and a width of 70 cm, coated on the inside with plaster with a thickness of 2 cm. This tomb goes back to a more recent time than the wall, as some of the wall was removed to build the tomb. The southern part of the tomb was completely destroyed, perhaps because of the cut (see Photo 55). In the southwest corner of the square (A5), we found a large jar. Its upper part is totally missing due to the cut made by the MF in the area as mentioned above. The dirt was very hard due to compaction by the heavy machinery that made the cut. The dirt removed from this cut was transported to another location.

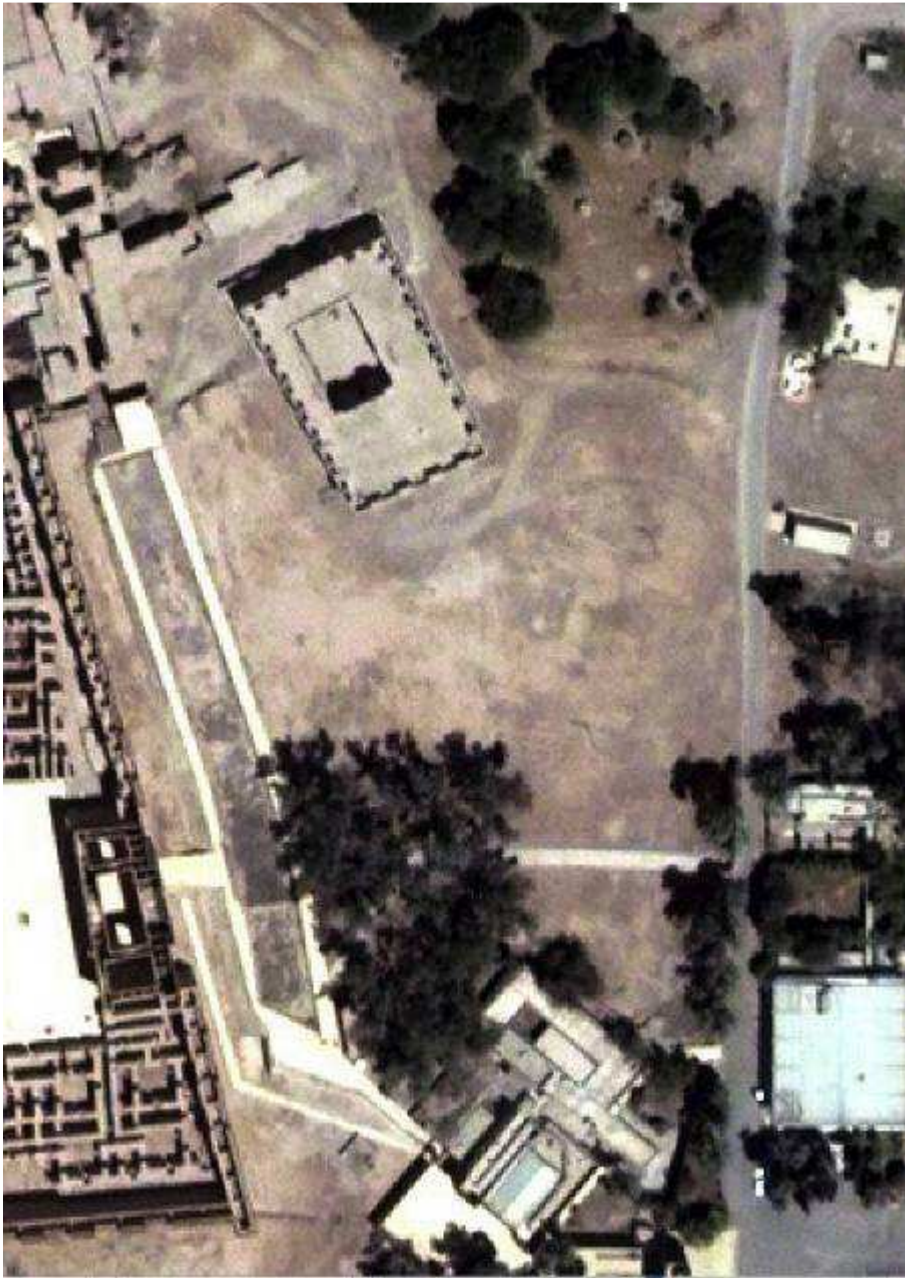
**Comment:** This was already an open area before the arrival of Coalition forces. It is difficult to ascertain from the satellite images how much gravel was added to the surface by the Coalition. Visually, the appearance of the southeastern quarter of this lot appears lighter after its occupation by the Coalition, and it may be that gravel was added only in this area, as seen below in fig. 61 of the Iraqi Final Report.

Before Coalition, 5 July 2002, Russell composite

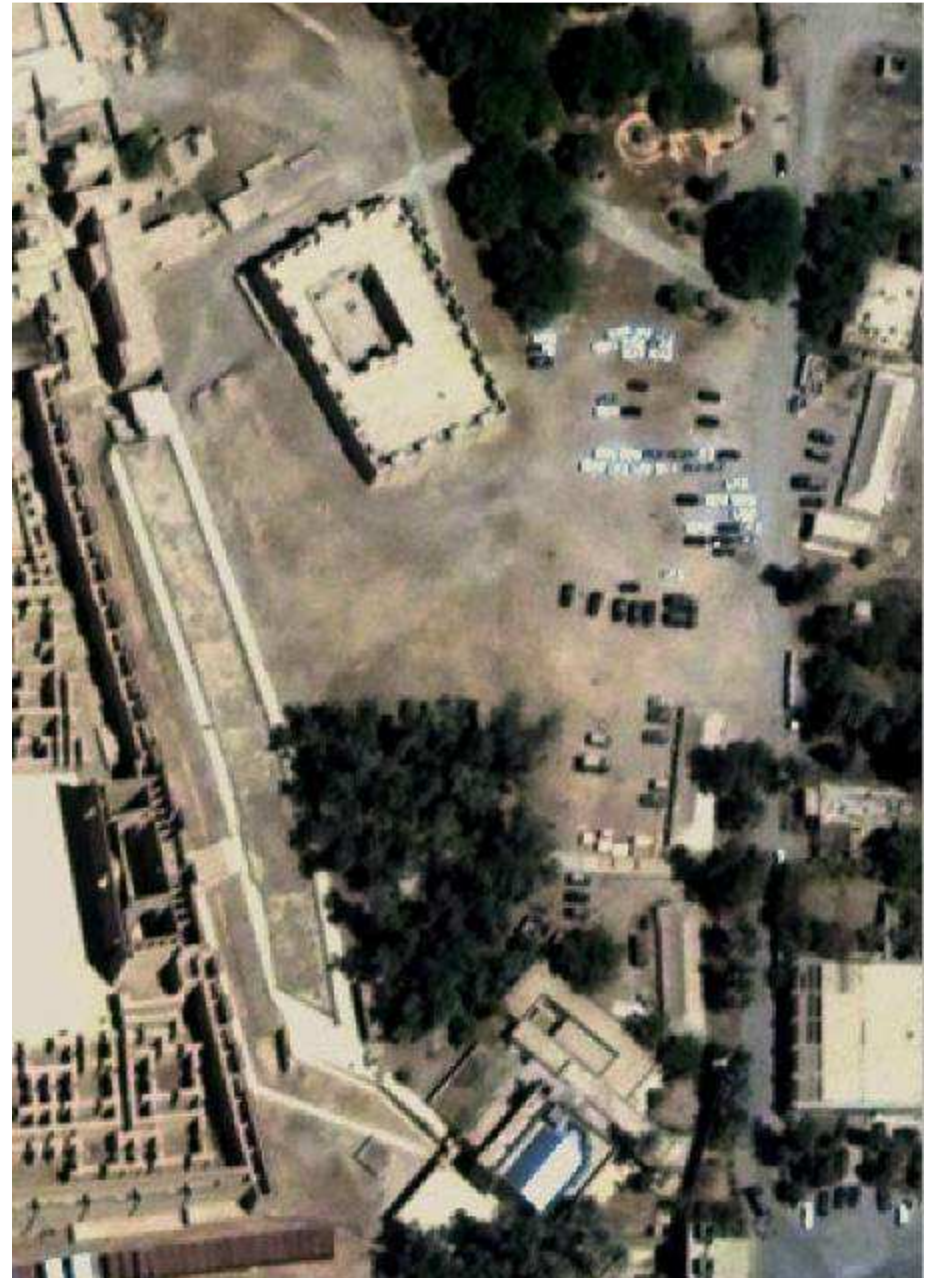
Coalition first phase, 31 August 2003, Russell composite

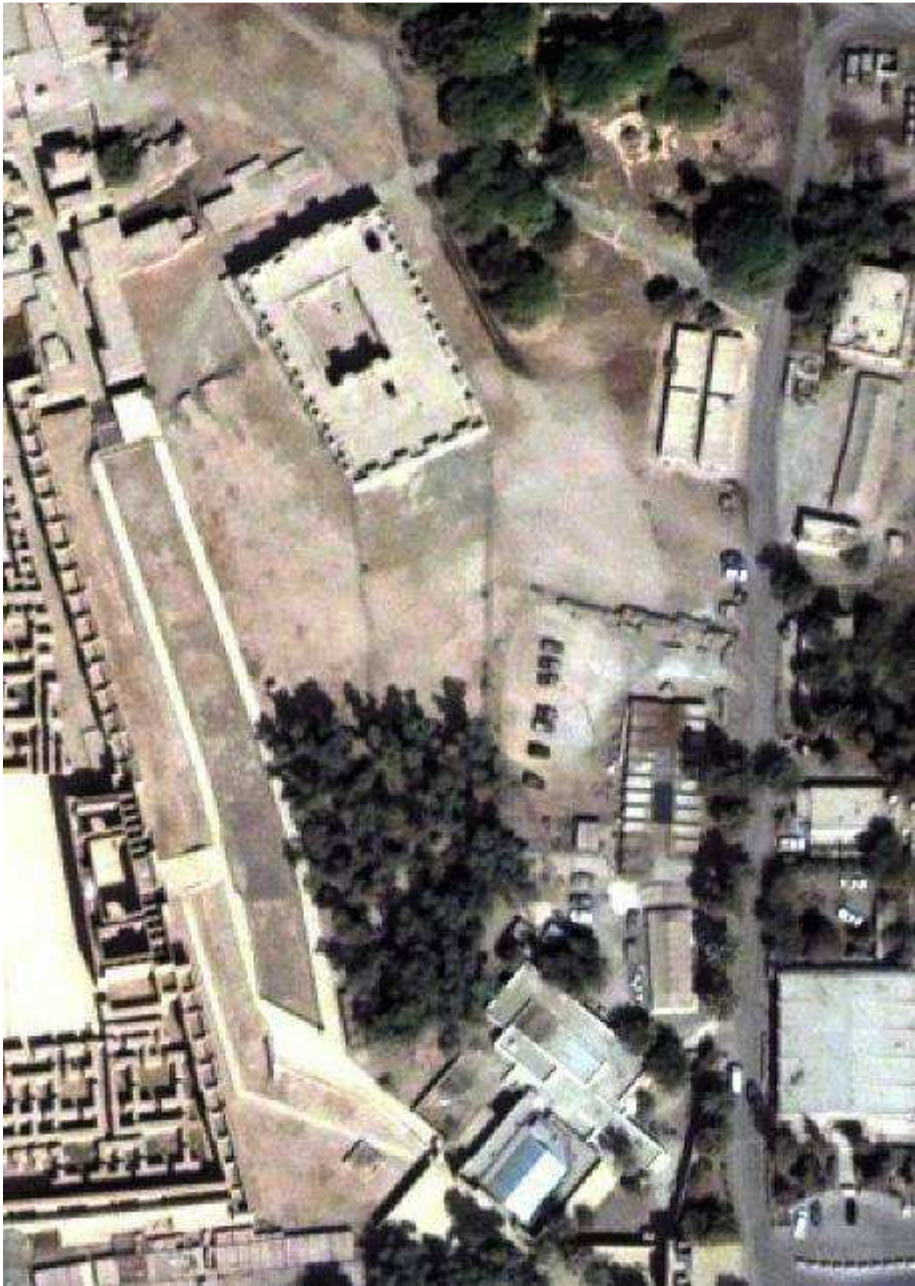
Coalition final phase, 8 October 2004, Russell composite

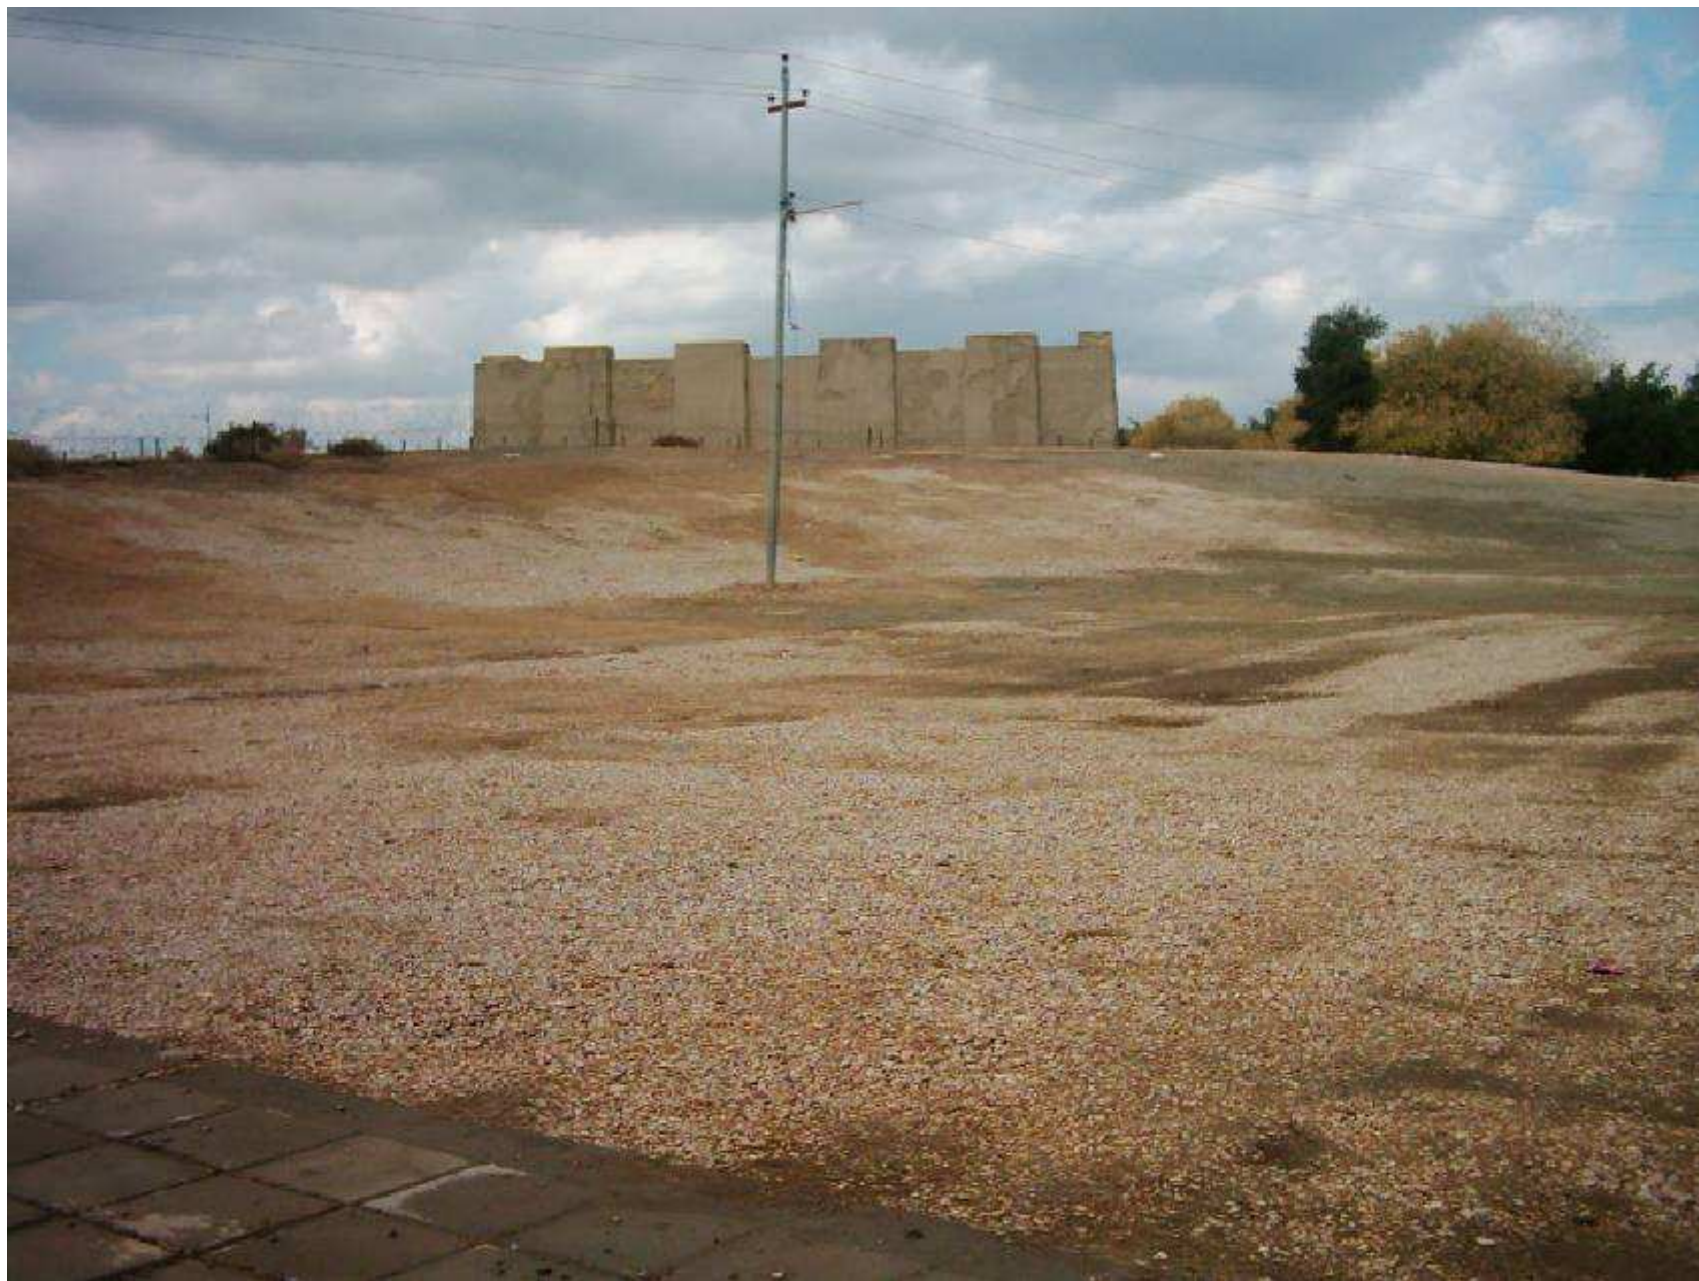
Parking lot, view from the south, Iraqi final report fig. 61

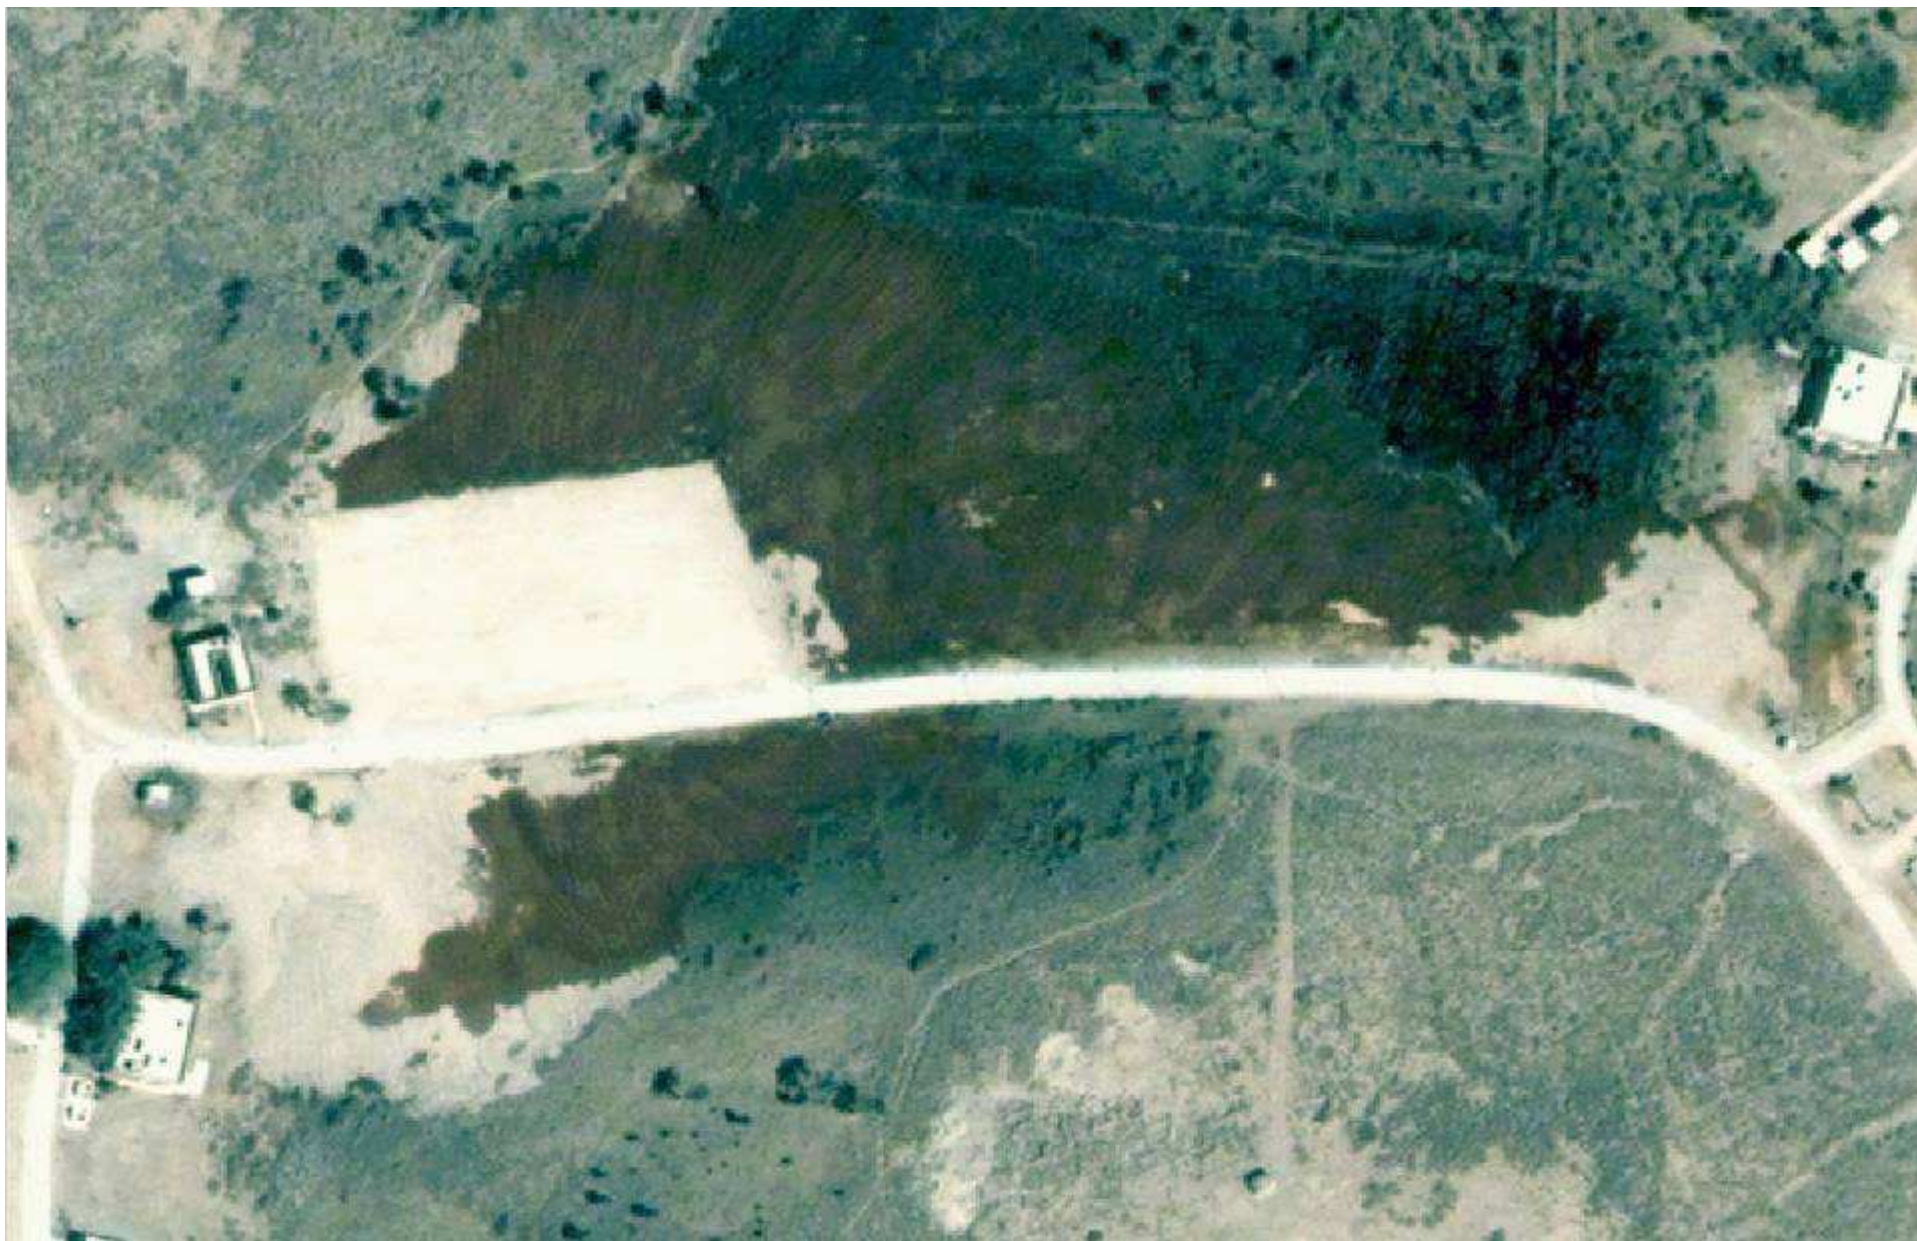
After construction of Landing Zone, prior to founding of Camp Babylon. Surface north and south of road has been bulldozed, graveled and oiled, 1 April 2003, Russell composite

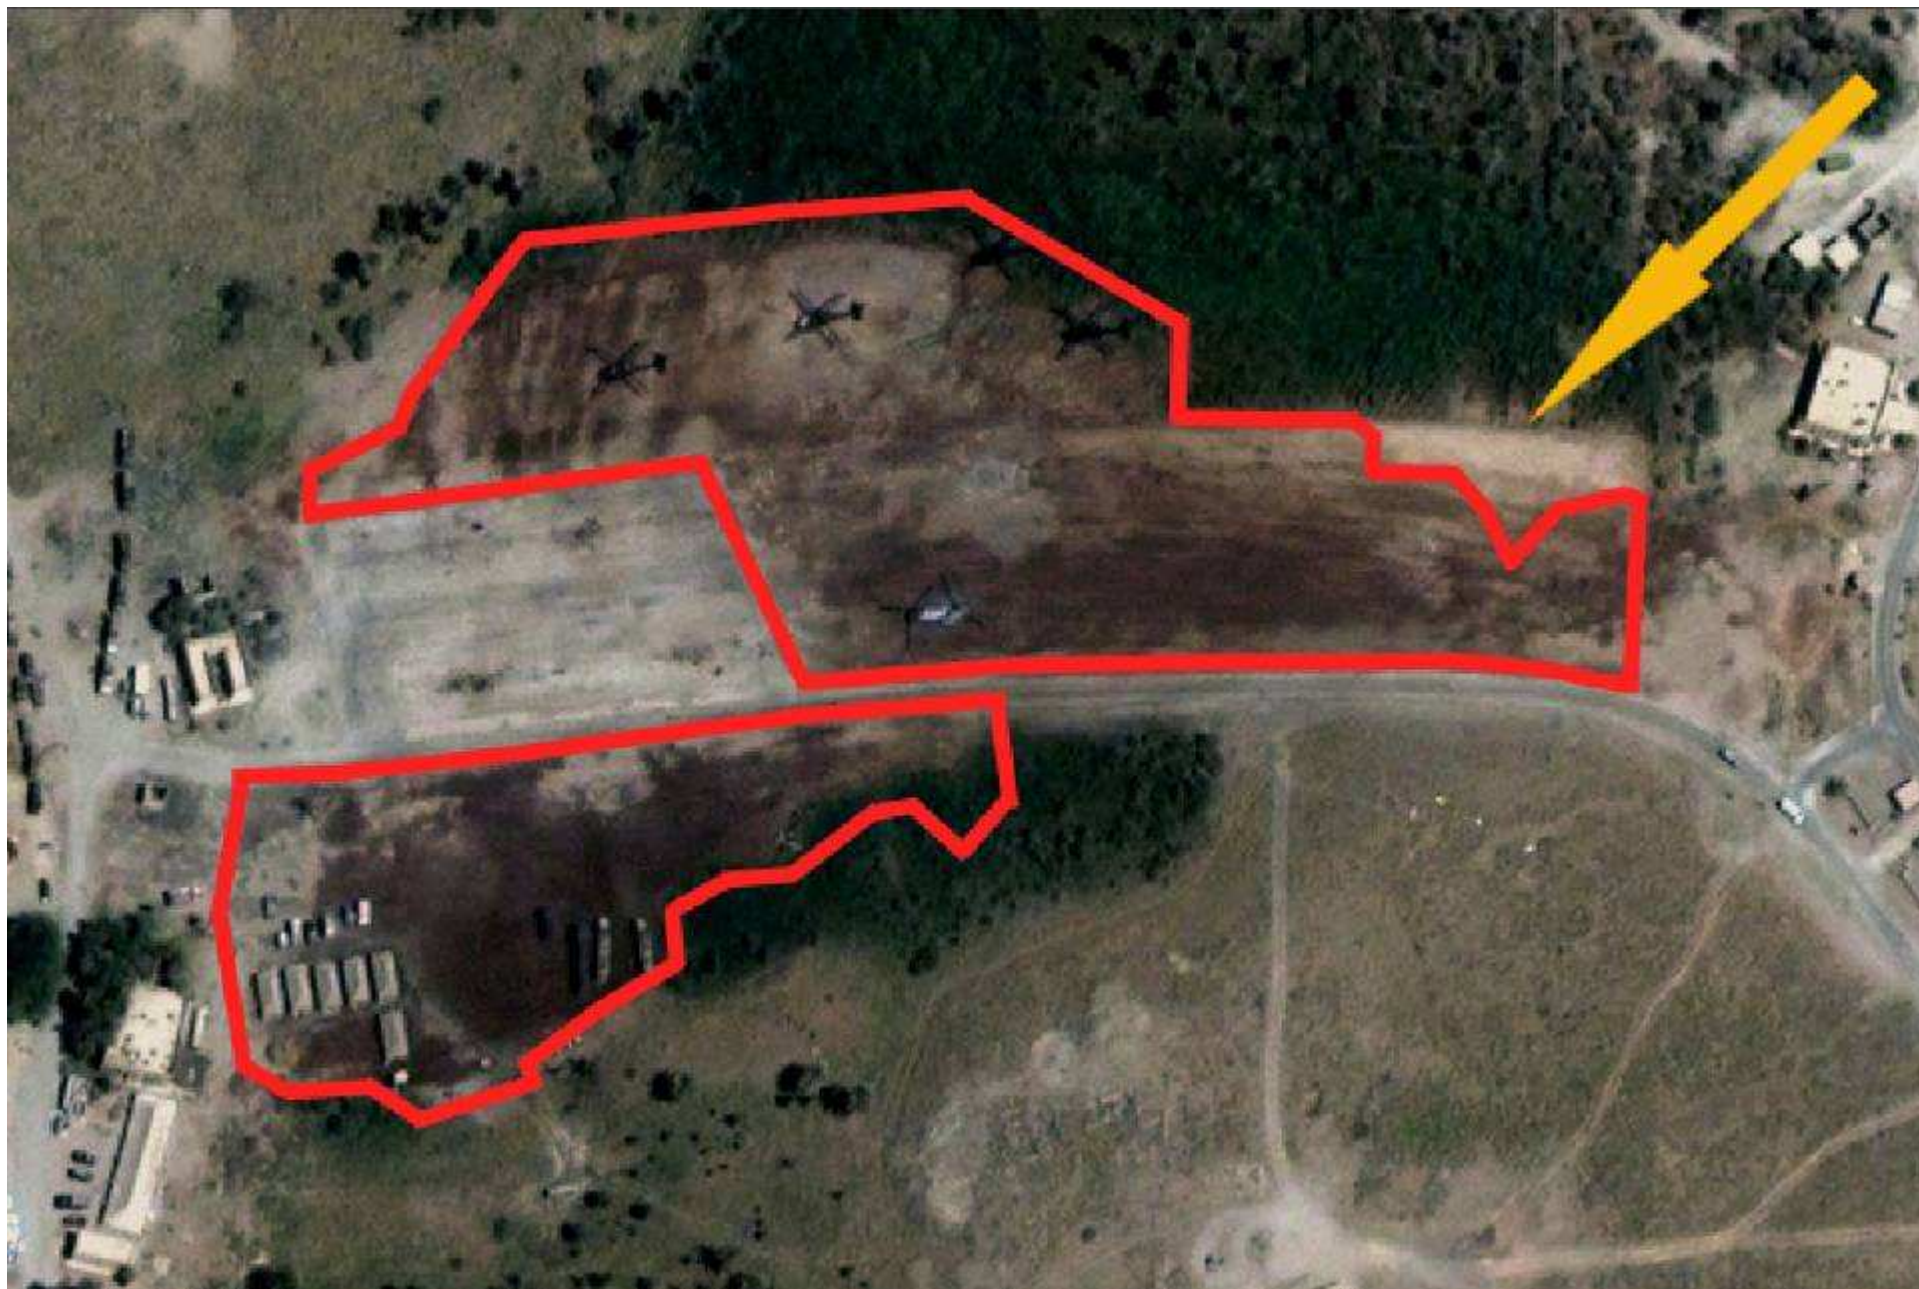
Contrary to what is usually supposed, the satellite images show that the large airstrip to the north of the road and the parking area to the south of the road were both constructed prior to the founding of Camp Babylon. One wonders why such a large airstrip was being constructed at Babylon prior to the 2003 war.

Camp Babylon, airstrip squared off at east end, but otherwise same area as prior to 2003 war, 31 August 2003, Russell composite.

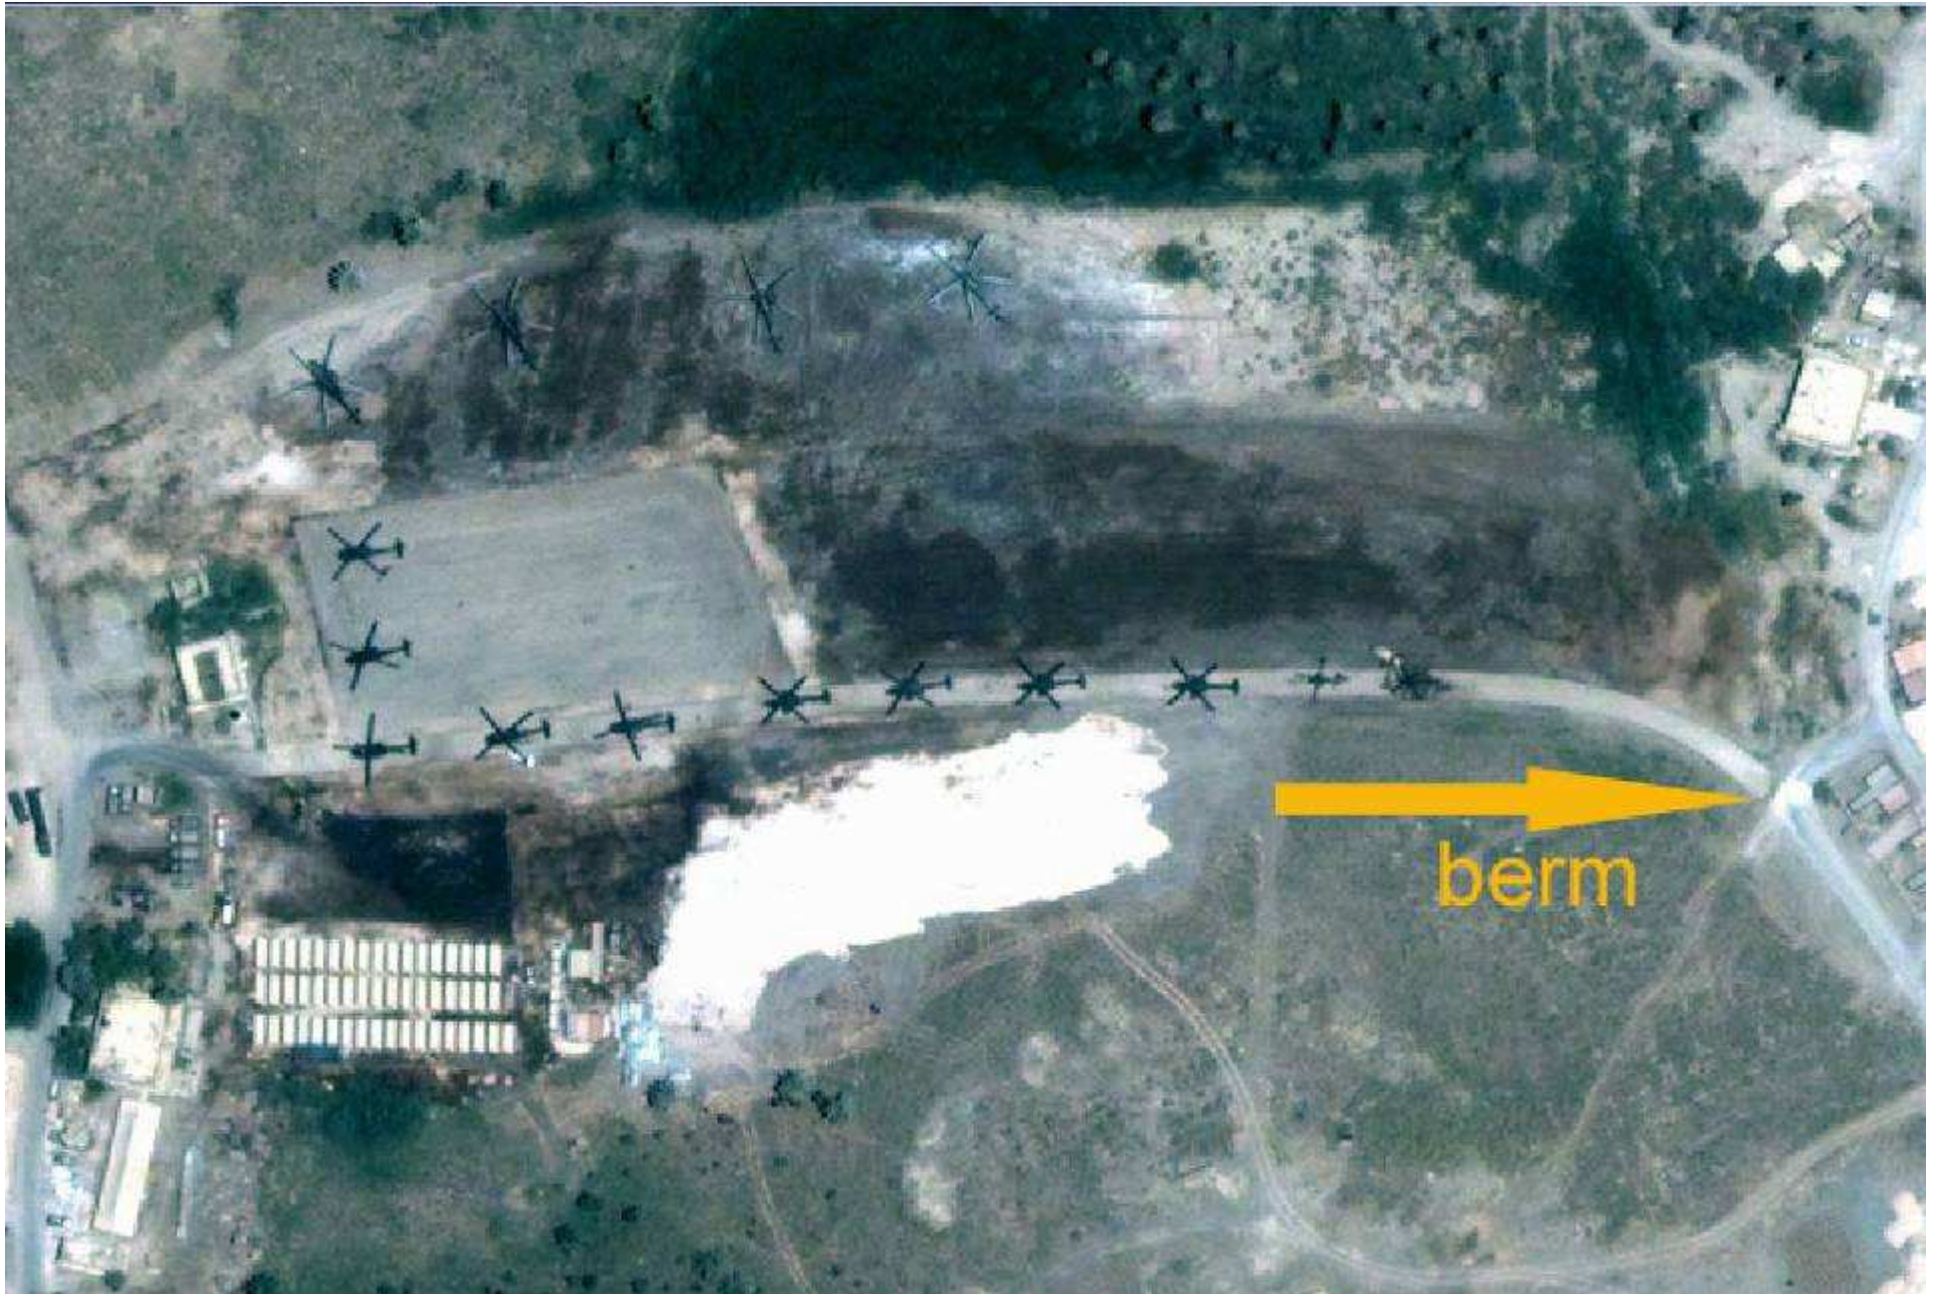
Camp Babylon, earth berm built to block road to landing zone, 4 June 2004, Russell composite

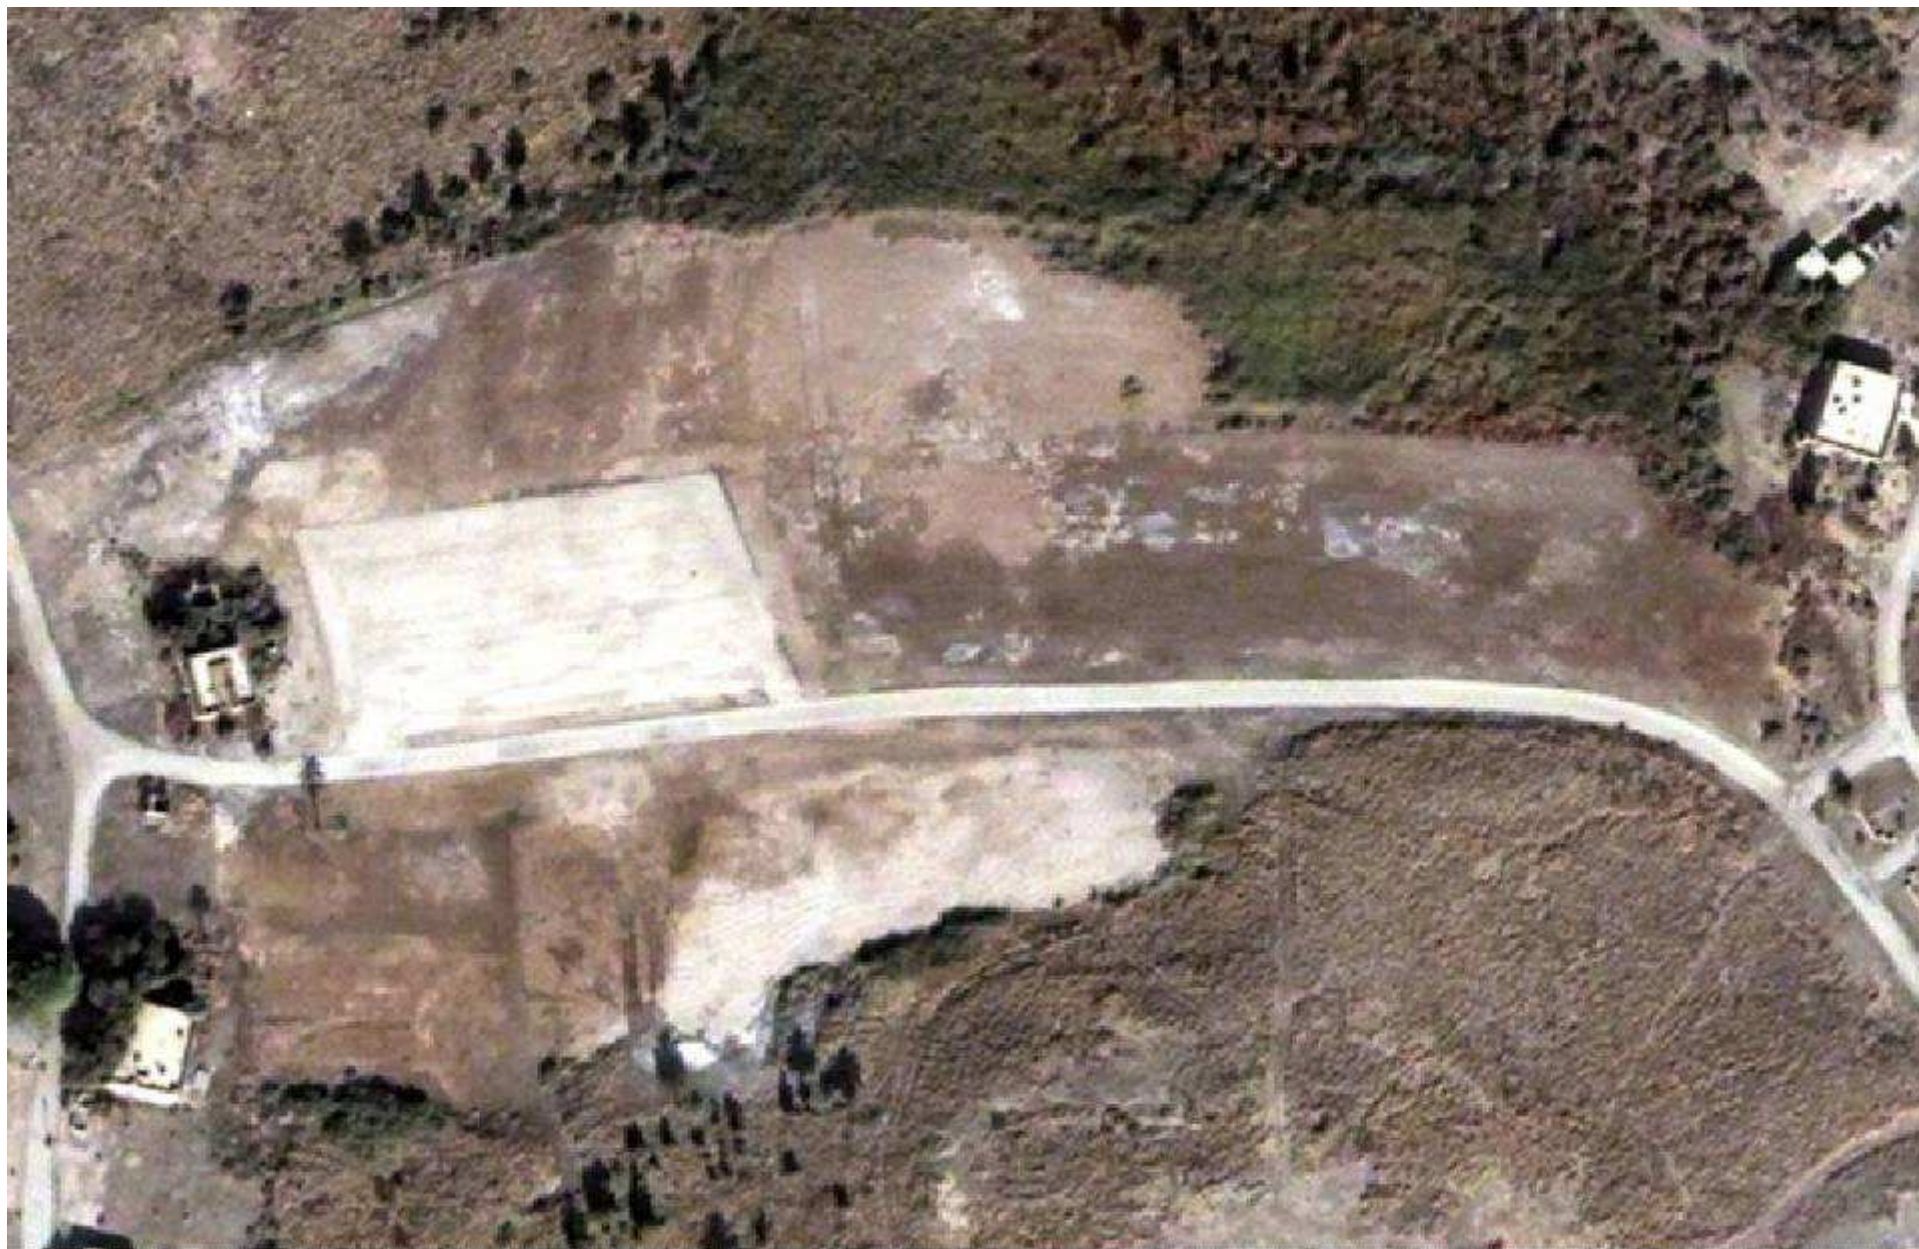
Camp Babylon, extent of bulldozed areas after abandonment of camp, 26 November 2005, Russell composite

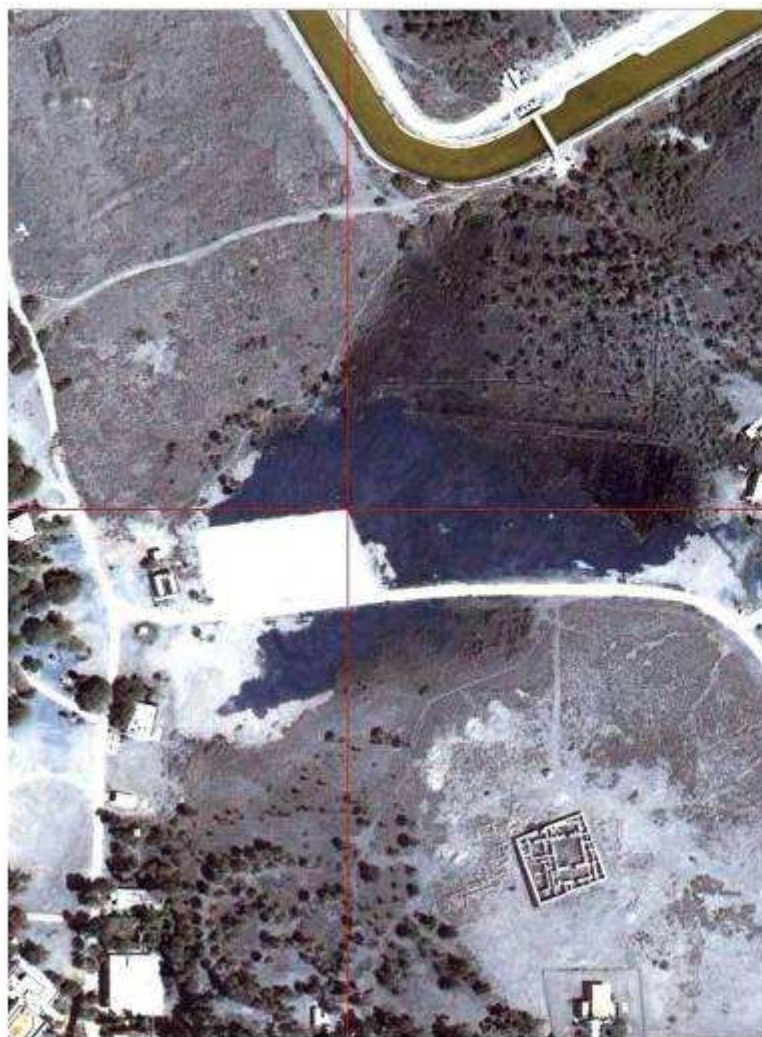
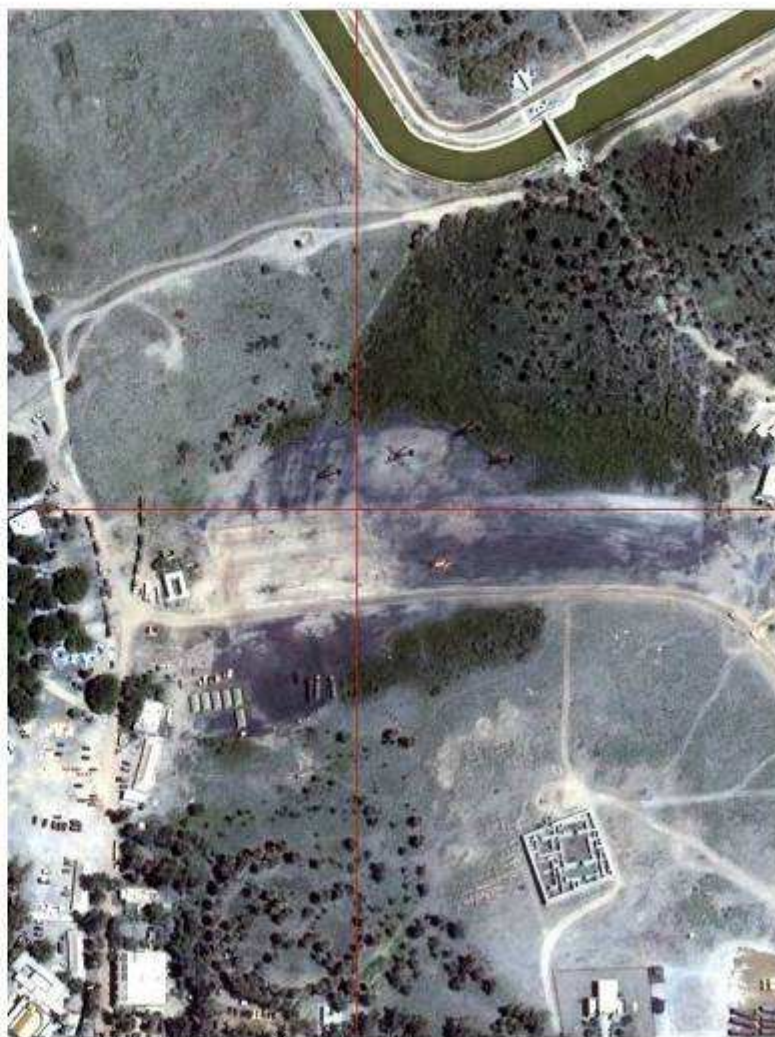
**1 April 2003****31 August 2003**

**Stone report:** It seems to be a flat, unexcavated area, and had already been prepared, presumably as a helicopter pad, before the war (Fig. 20). To the south of the helicopter pad is an area of containers. The latter was already in use in August 2003. At that time, though, only the areas cleared before the war were being used.
