# **Report on Damage to the Site of Babylon, Iraq**

**John Malcolm Russell, Ph.D.**

**Cultural Heritage Center  
Bureau of Educational and Cultural Affairs  
Department of State**

**April 2010**

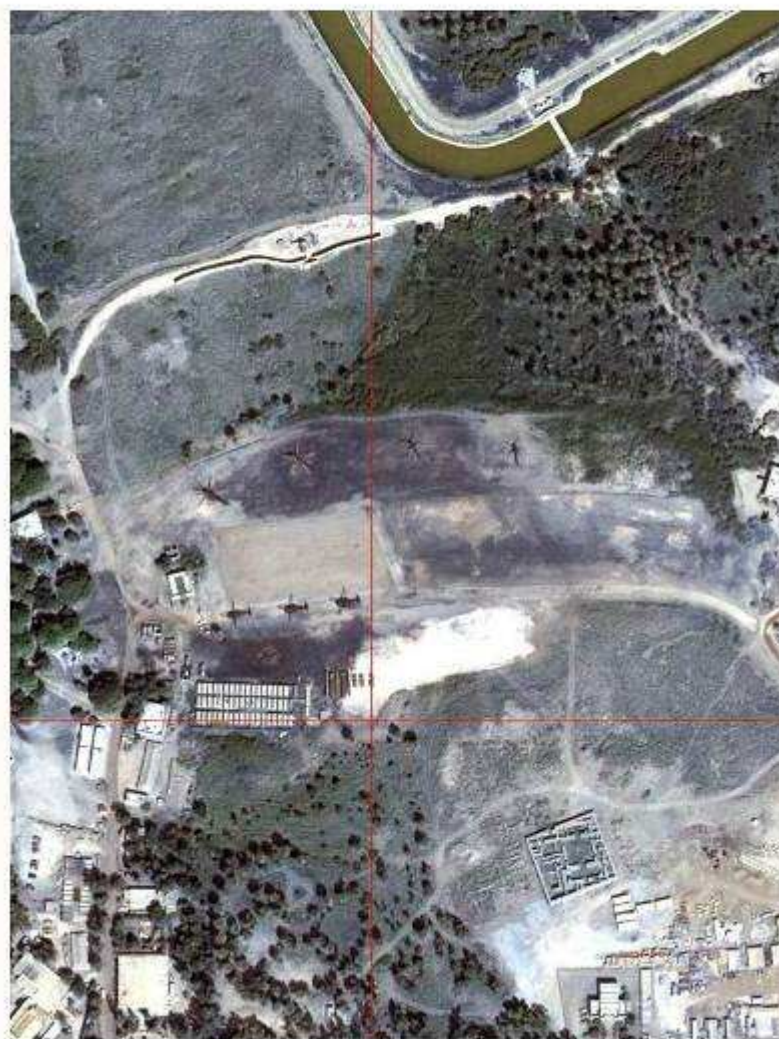
**8 October 2004**

**Stone report:** By June 2004 this area had been expanded to the south, and the resulting spoil heaps are visible, though they are clearest in the October 2004 image (Fig. 21).

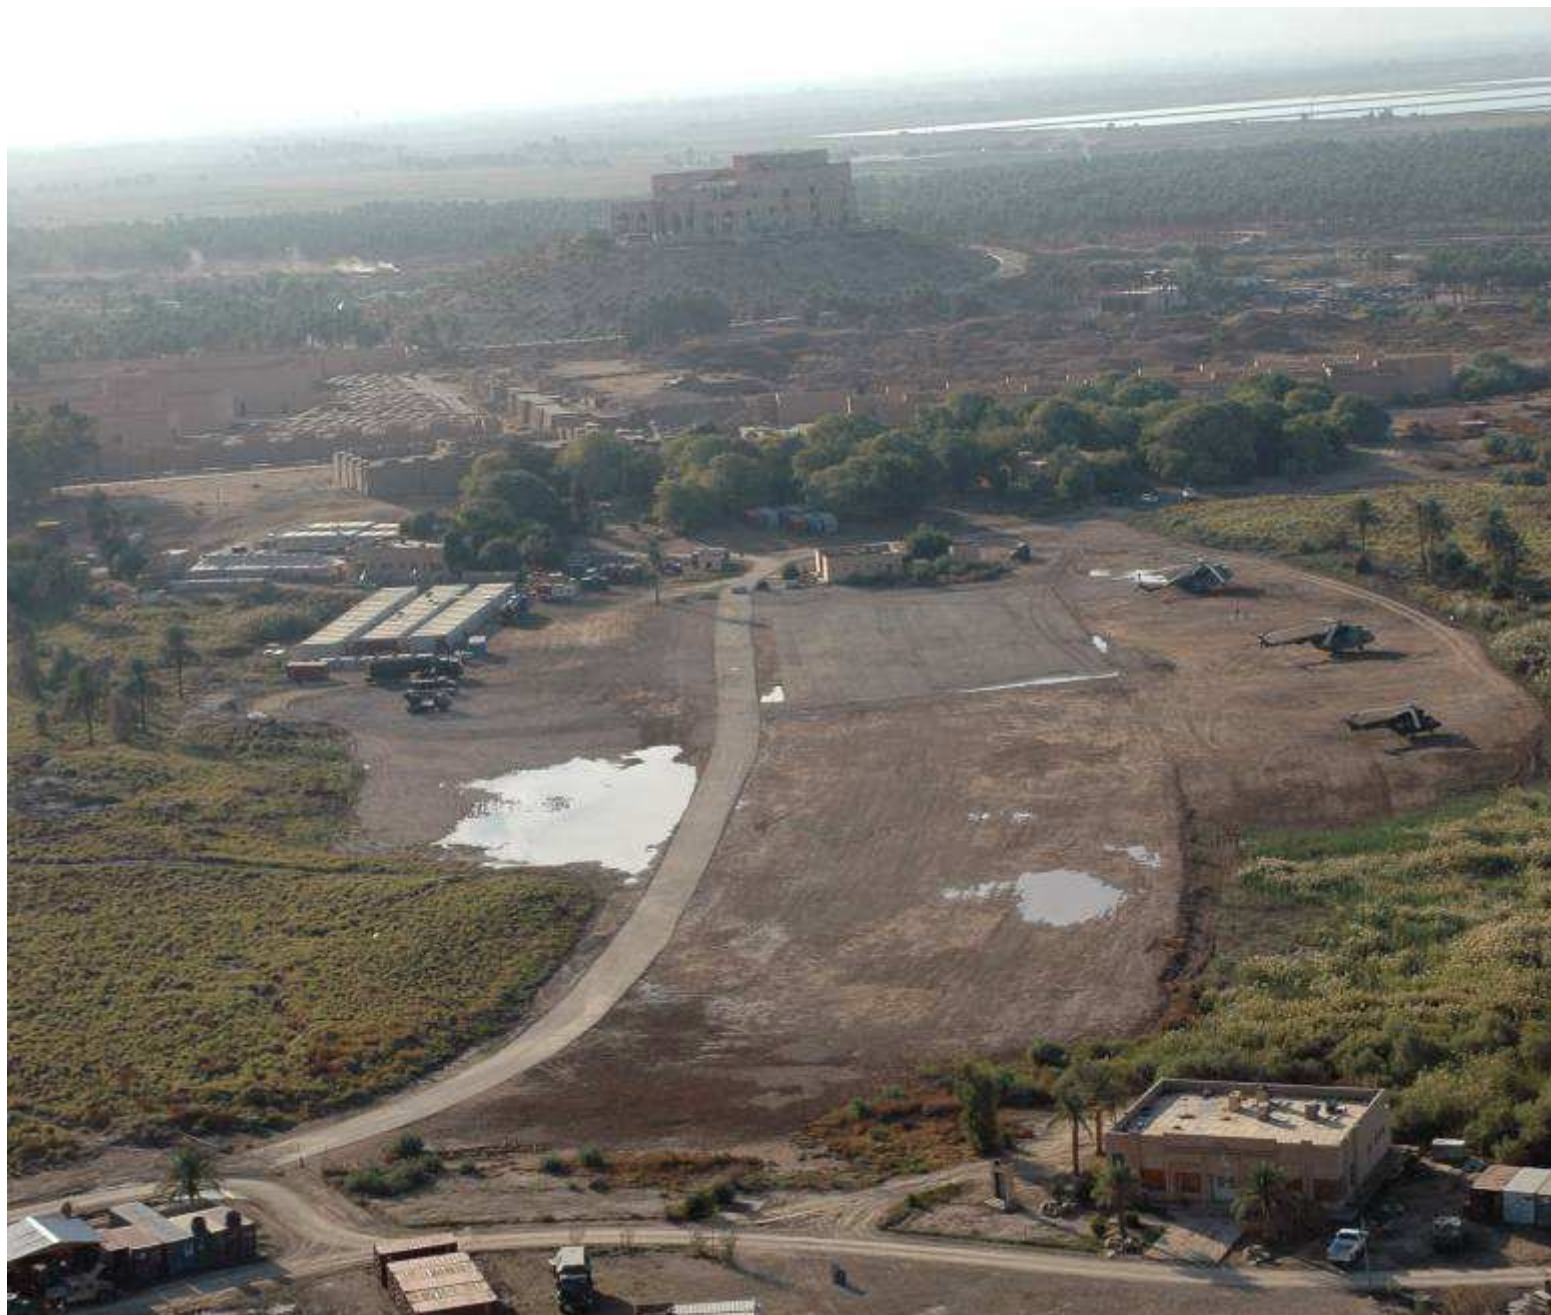
McDonald report	Iraqi preliminary report	Iraqi final report	Curtis report	Polish report
<p>It is in these areas that some of the most extensive surface bulldozing took place. The northern landing zone or LZ is NW of the amphitheatre, east of the processional way and west of one of the lakes.</p> <p>One part of this LZ is an already tarmacked area, this was then extended by bulldozing areas of the mounds flat and compacting them etc.</p> <p>One of these areas was described as clumpy or lumpy. I do not know if these were the remains of excavated mud brick walls that were eroding or the irregular surface of unexcavated mounds, either way the surface was bulldozed flat. It seems likely that this will have damaged archaeological deposits as they are generally close to the surface in this part of the site.</p>	<p>The multinational forces used the area north of the Babylonian House for landing aircraft. The old vehicle parking lot was expanded <u>[A: eastward 7000 sq m and northward 7500 sq m.]</u> 30,000 meters, excluding the parking lot. It was leveled, compacted by rollers, and covered with gravel. In addition, some sections contain fragments of ancient baked bricks that were perhaps brought from areas inside Babel to cover these expansions. This area is an extension of the inner wall to the north, where an important gate to the city is located, and to the south, from the asphalt paved road to the archeological hills north of Babylonian House.</p> <p>During the expansion of this area, parts of the hills consisting of the northern part of the airport were cut to varying degrees with a length of 150 meters. The last [first?] cut has an area of 8 x 7 x 6 meters, the second cut has an area of 30 x 19 x 7 meters, and the third cut has an area of 23 x 24 x 5 meters. The fourth cut has an area of 12 x 16 x 5 meters.</p>	<p>Thirteenth cut: This cut is located in the northern part of the airfield. It has a length of 180 m (Photo 51).</p>	<p>This area between the Processional Street and the lake and close to the Ninmah temple was formerly an asphalted area c.50m x 100m that was used as a car park. It has now been greatly enlarged by an extension of c.50m x 200m to the east to make a landing zone for helicopters. The new area has been flattened, covered with compacted gravel and then treated with a petroleum product to prevent dust.</p>	<p>On this area is located an asphalt road and large (about 50 x 100 meters) area overlaid with asphalt. The Northern terrain adjacent to this asphalted area about 50 meters to the North and about 200 m to the East is covered with gravel.</p>

Landing zone viewed from the east, Polish photo 69, detail (photo © Ministry of Culture and National Heritage, Republic of Poland)

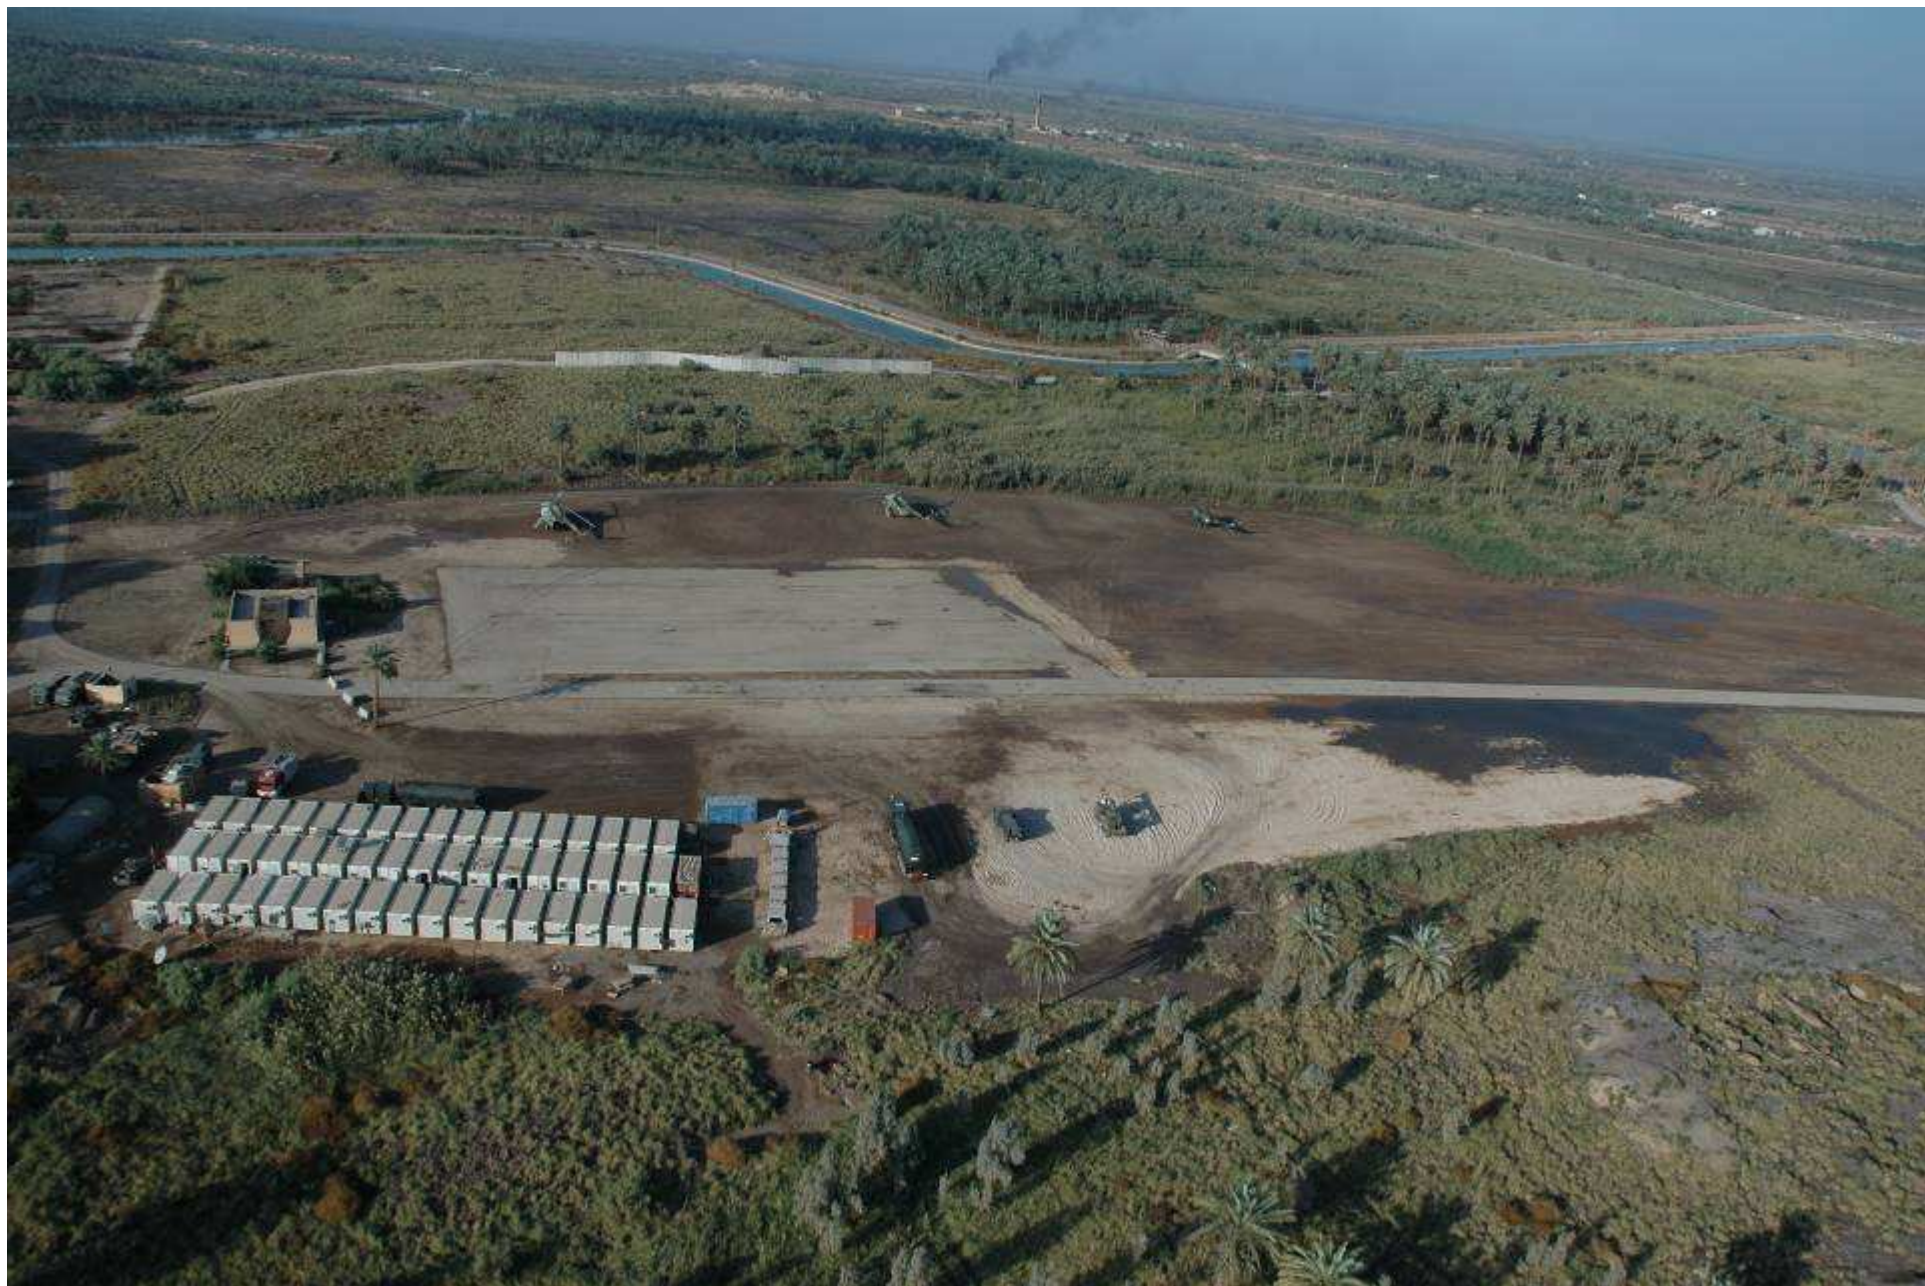
Landing zone, west part, Polish photo 63 (photo © Ministry of Culture and National Heritage, Republic of Poland)

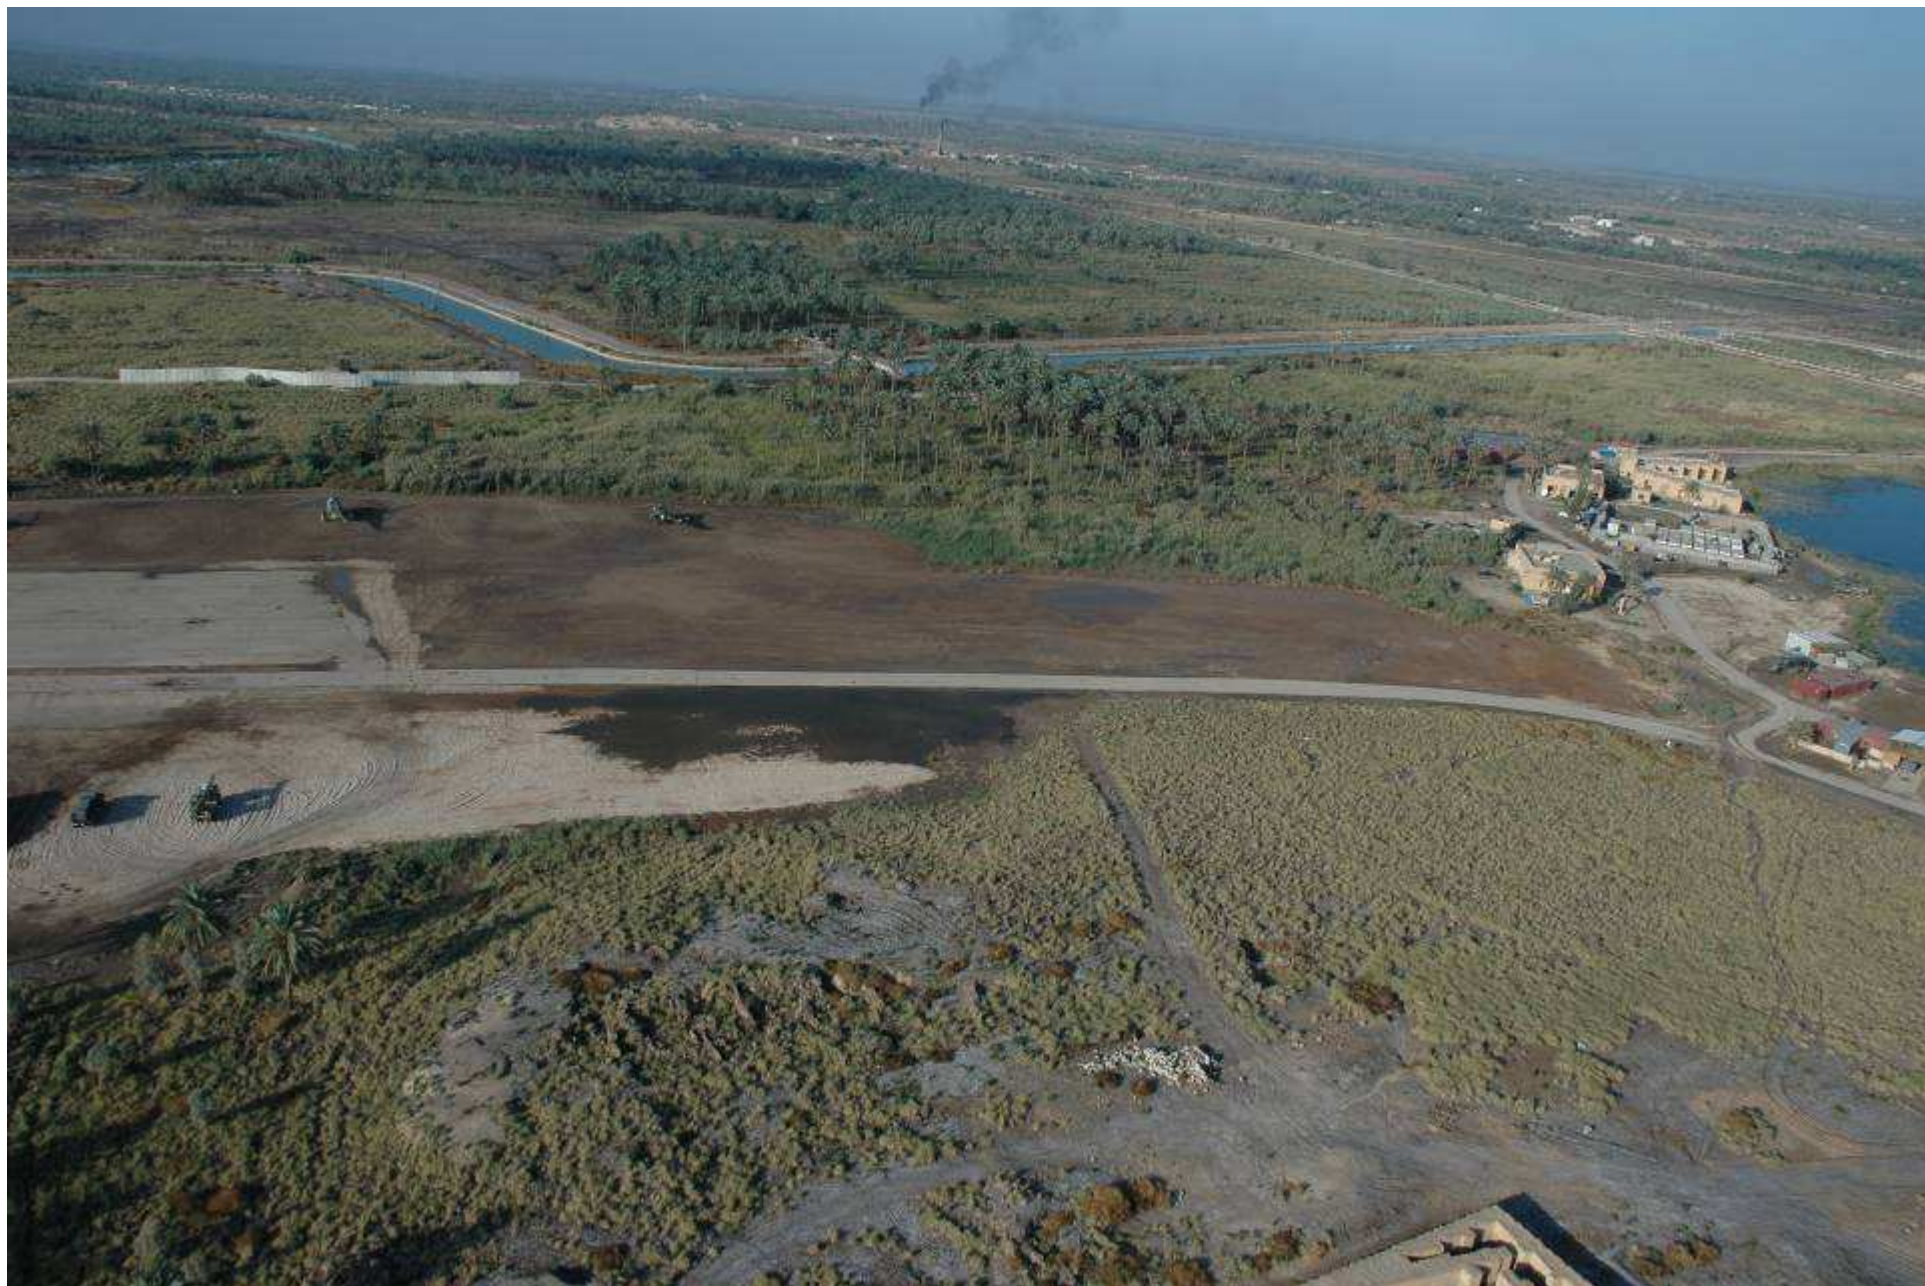
Landing zone, east part, Polish photo 64 (photo © Ministry of Culture and National Heritage, Republic of Poland)

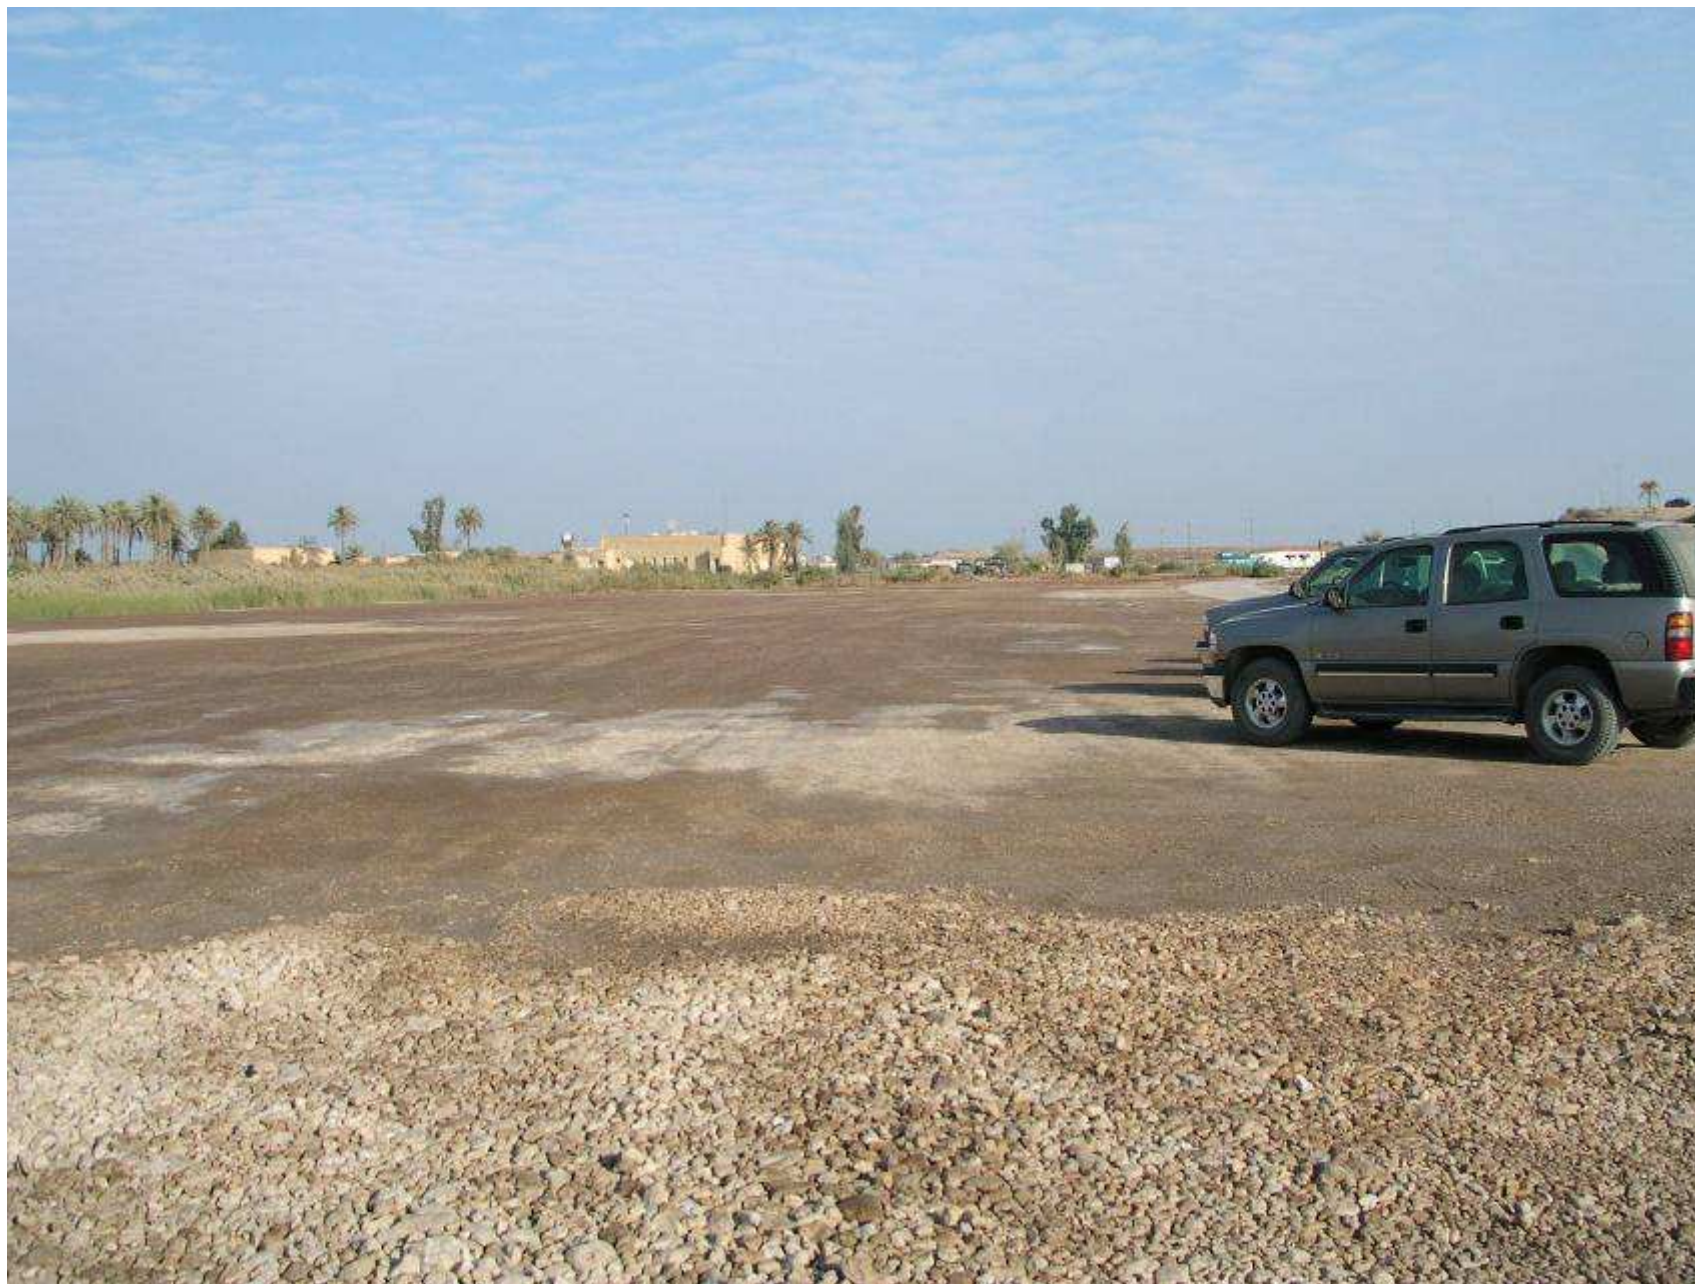
Landing zone looking to east, Curtis photo 7548 (photo © John Curtis)

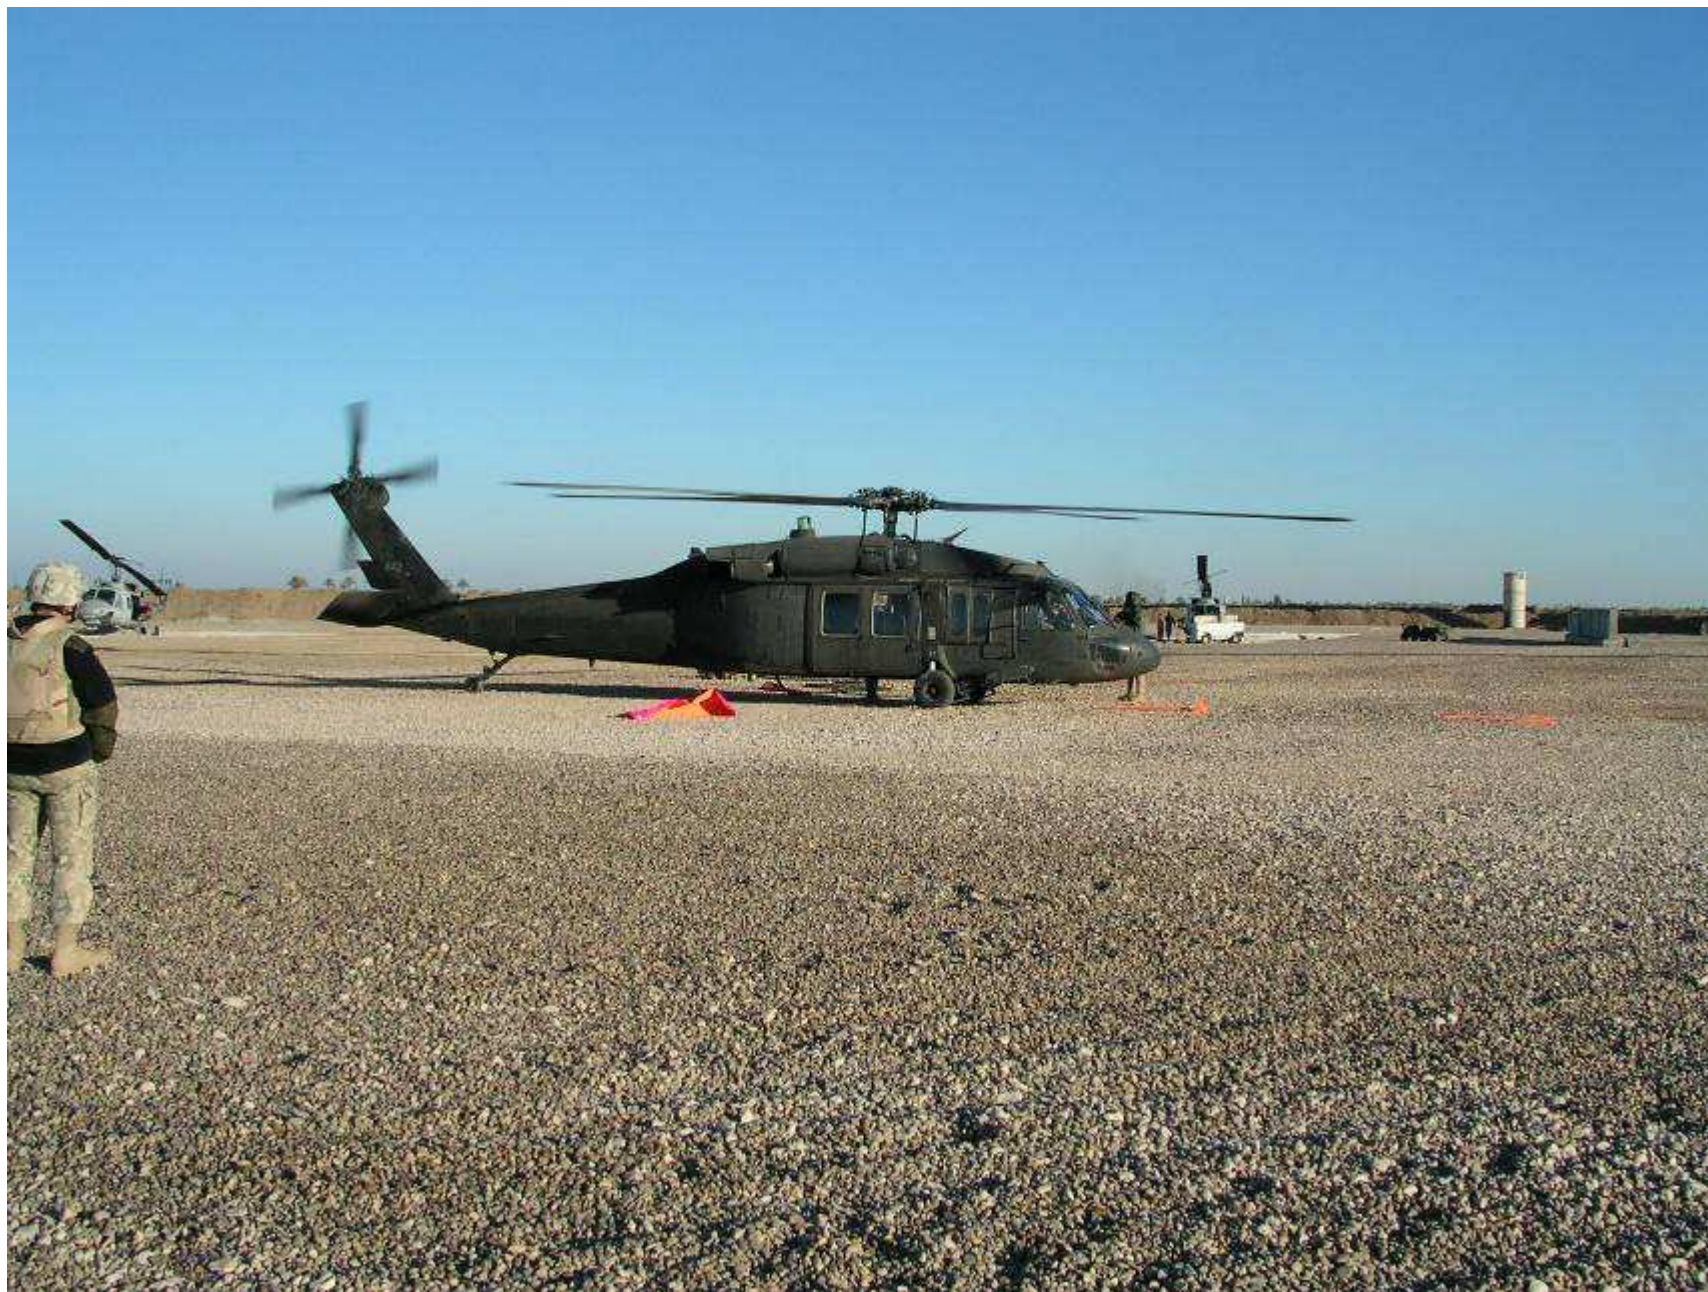
Surface of landing zone, Curtis photo 7707 (photo © John Curtis)

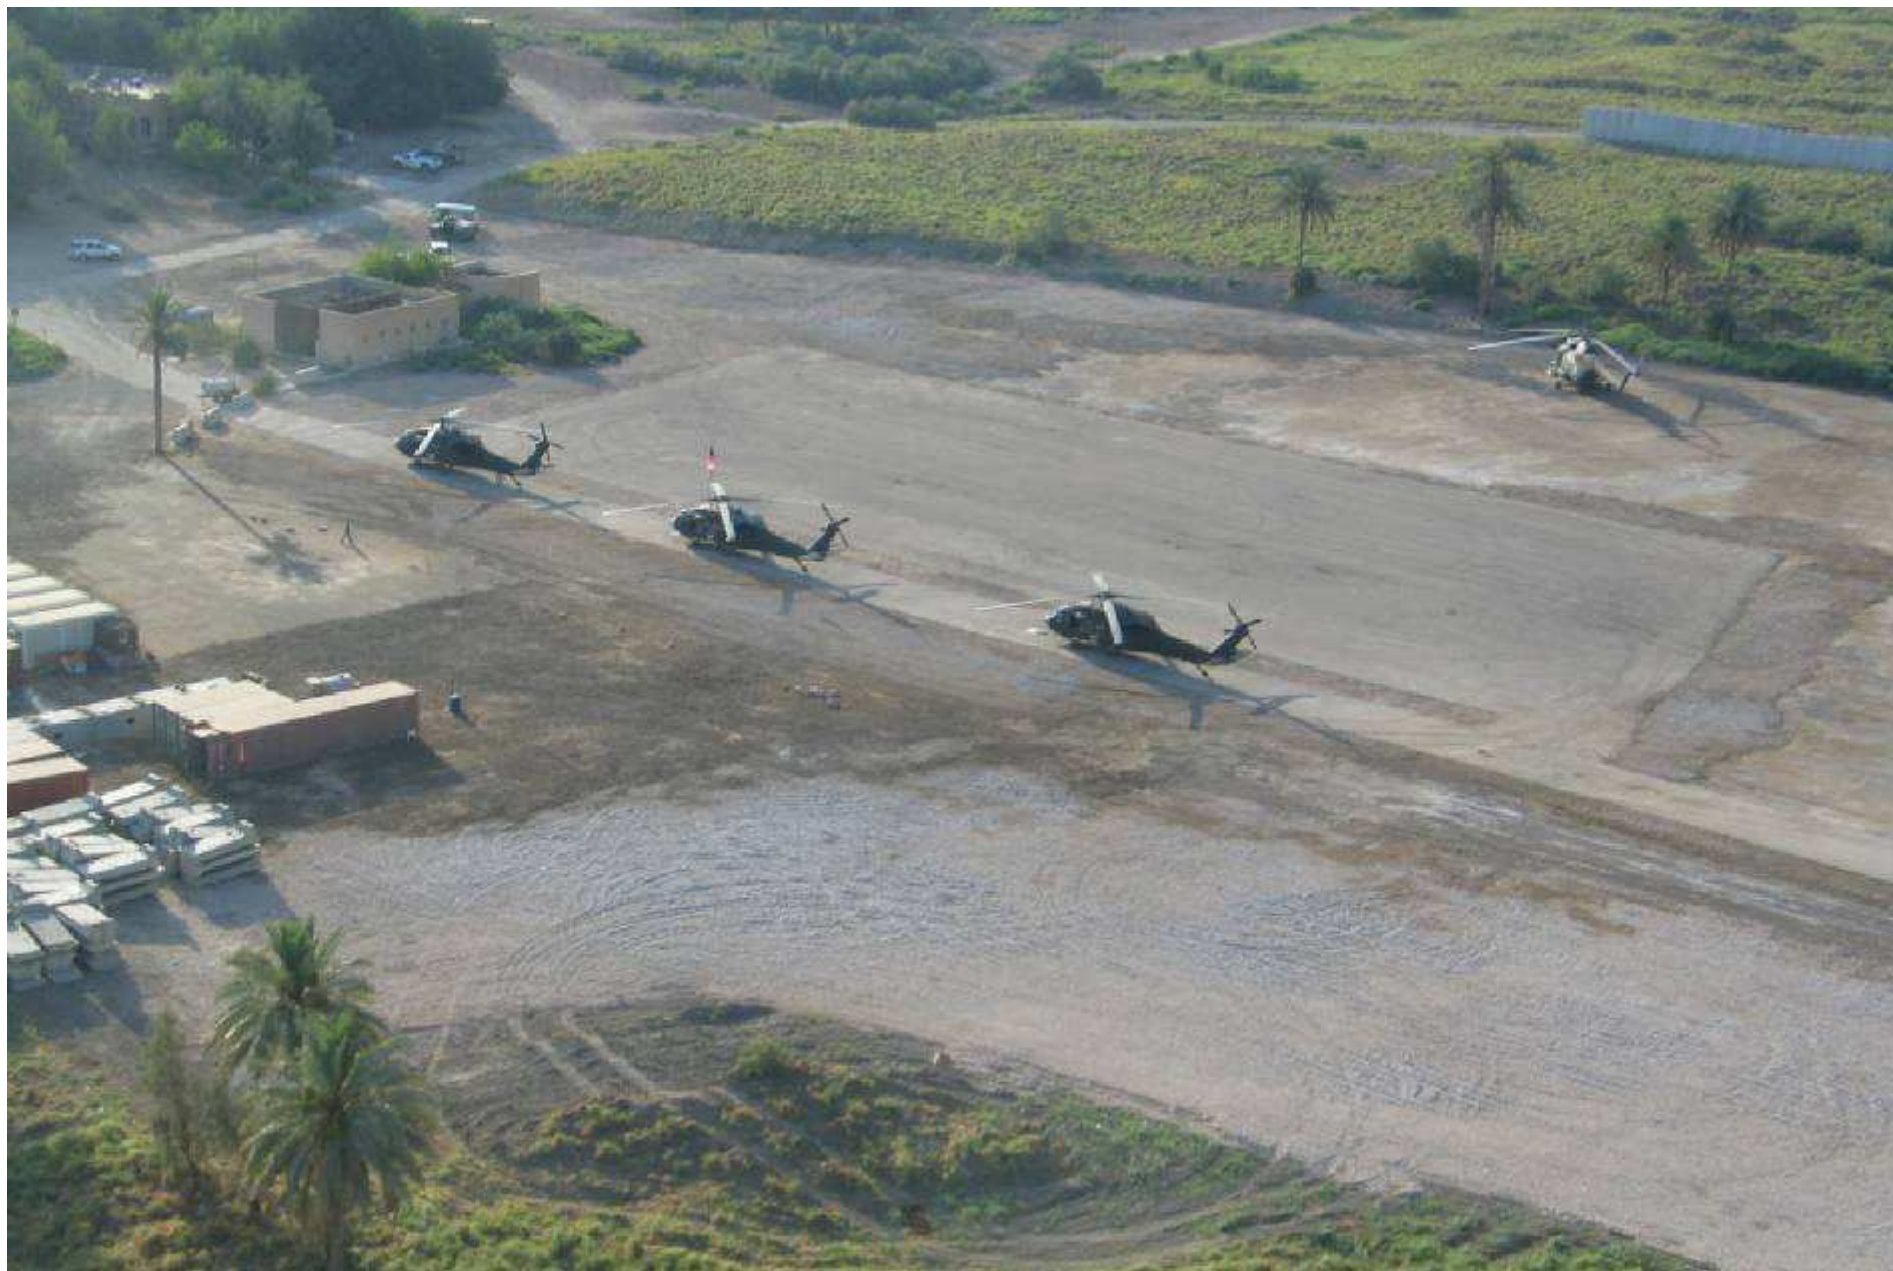
**Russell comment:** Already by July 2003 in McDonald's report there is confusion about when this airstrip was created. It is also interesting that the airstrip is attributed to the Coalition in the first Iraqi report but is omitted entirely from the Iraqi final report, except for a mention of a cut at the northern part of the airfield.

Cut 13 at the NW edge of the airfield, Iraqi final report fig. 51

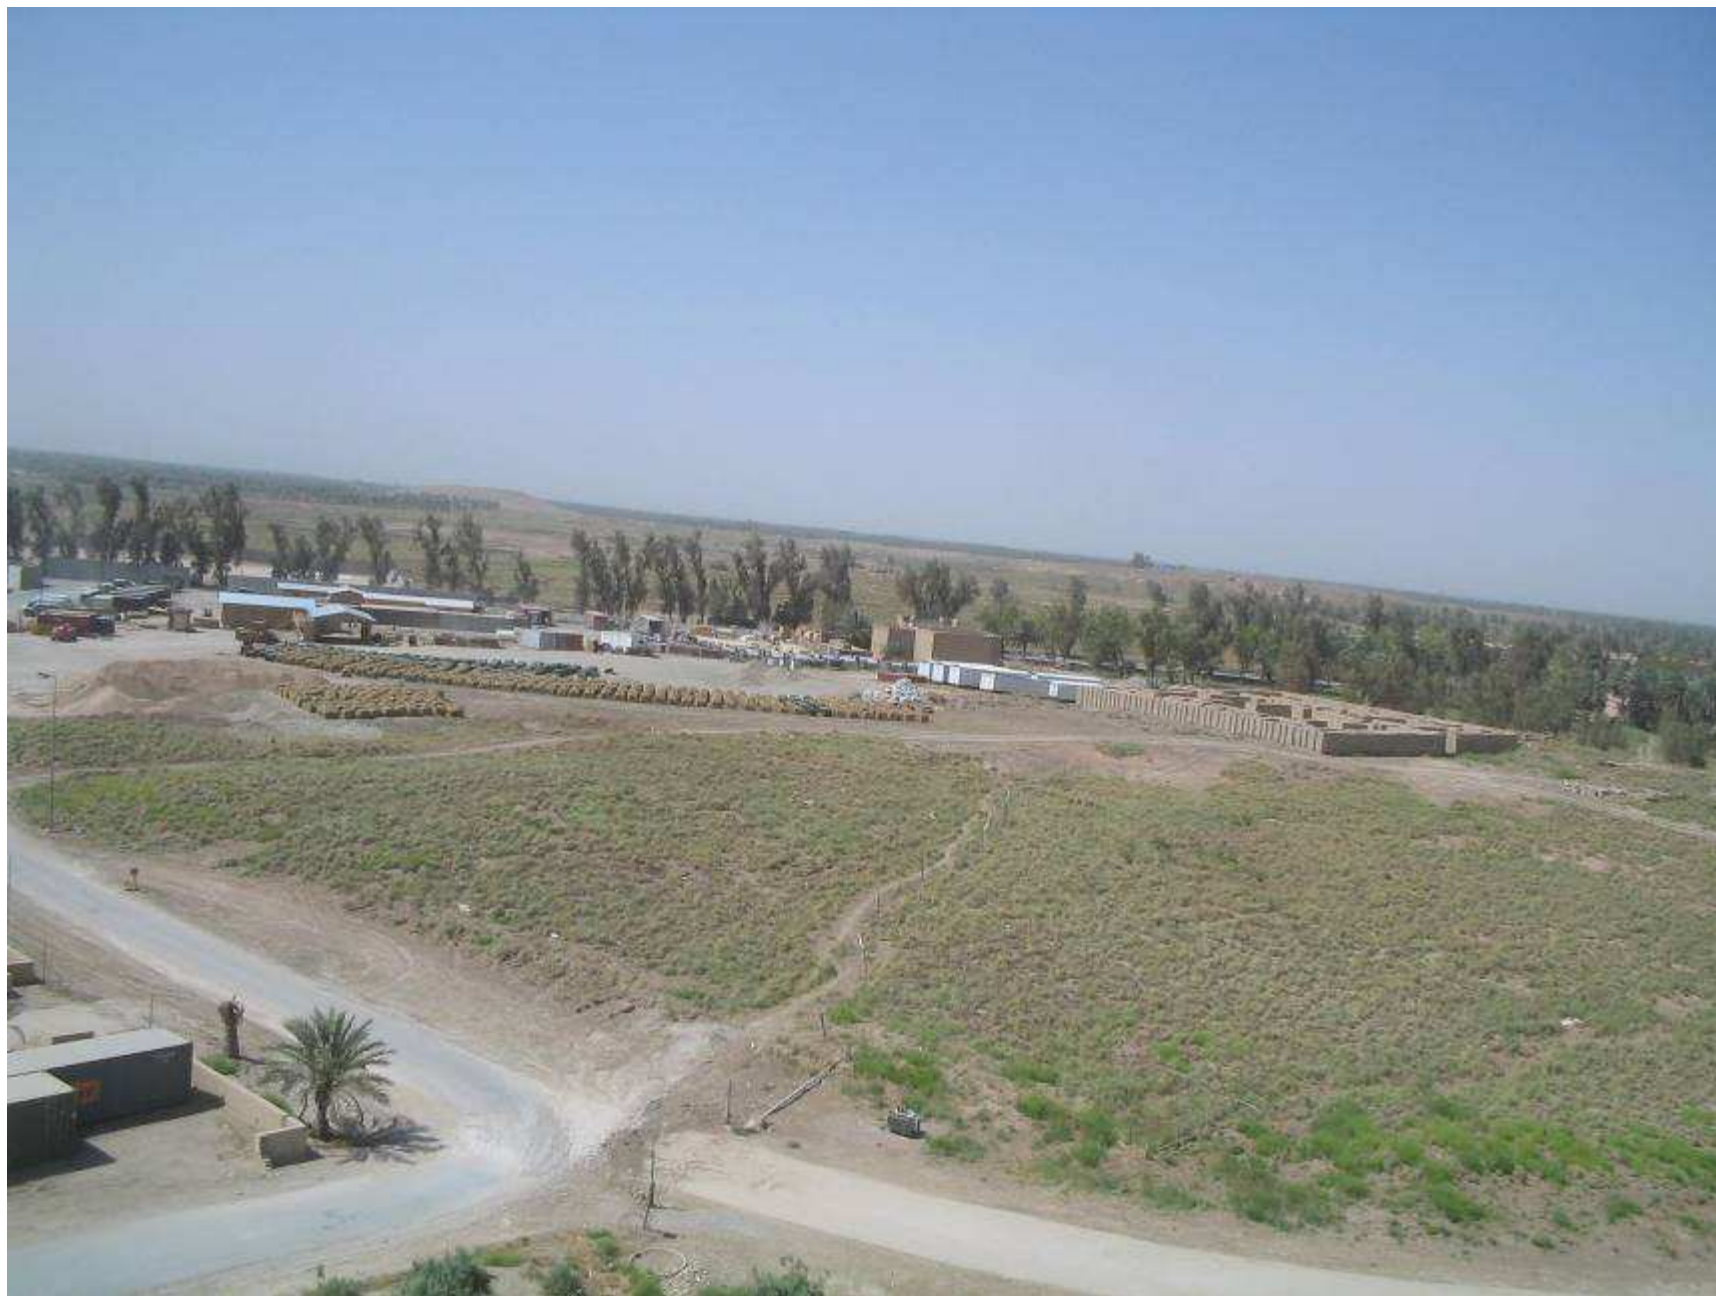
Berm that blocks the road to the landing zone (lower center), Russell photo 124\_2457 (photo © John Russell)

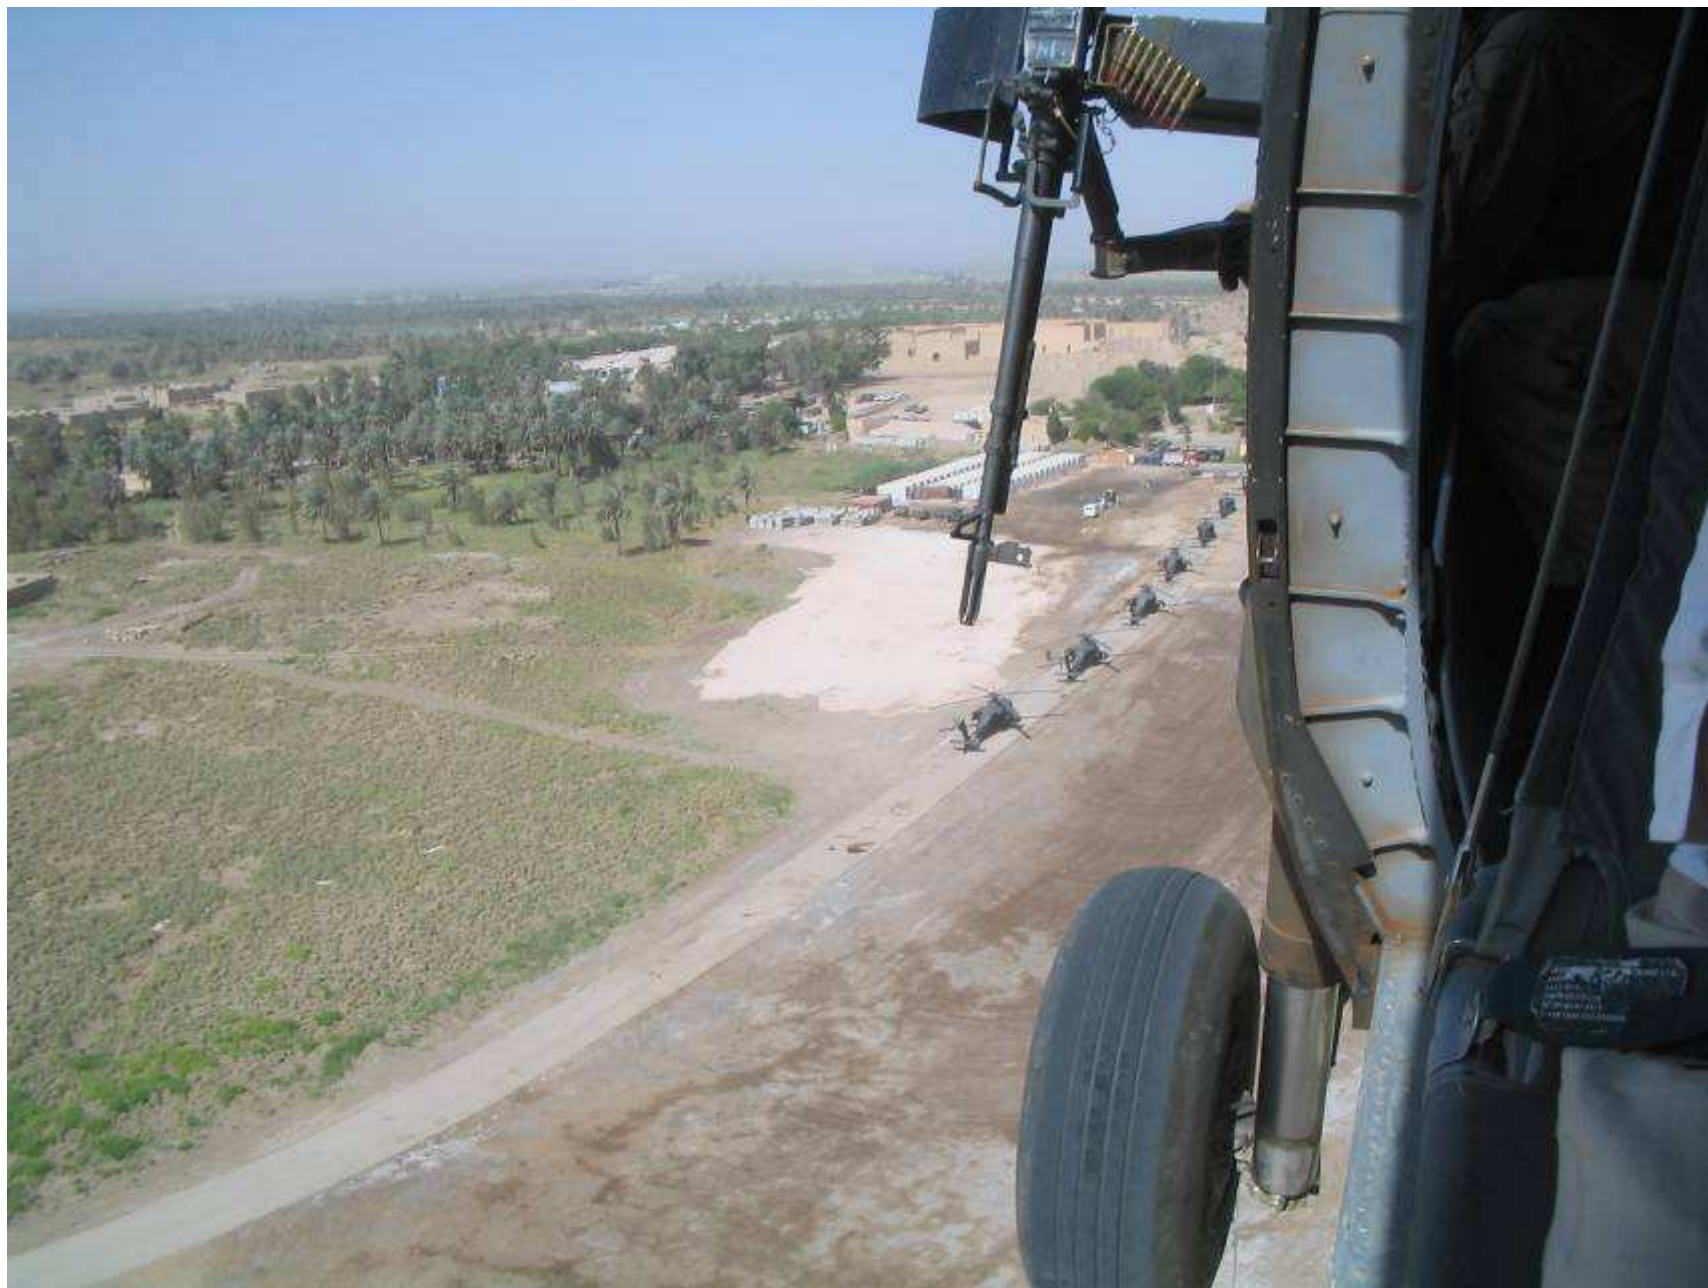
<b>Iraqi preliminary report</b>	<b>Iraqi final report</b>	<b>Curtis report</b>	<b>Polish report</b>
It [A: includes 7500 sq m <u>that</u> ] was covered with coarse gravel and used as housing areas.	<p>12. Twelfth cut: It is located north of the Babylonian house and has a length of 150 m. Parts of tells were removed (Photo 50).</p> <p>South of the asphalt-paved street, and north of the Babylonian House, several tells were cut, and the area was leveled, covered with coarse gravel, and used as a residential area (Photo 58).</p>	On the other side of the road bordering the landing field on the south side, a large area (c.60m x 100m) has been flattened and covered with gravel to create a parking lot.	The area South of the asphalt road (60 x 100 meters) is used for living containers and airfield support vehicles. The south-eastern border of this zone is a triangular area about 80 meters on each side covered by gravel. Some contamination is present over the entire area except the south-eastern triangular area.

View of parking area south of the airstrip, June 2004, Russell photo 124\_2442 (photo © John Russell)

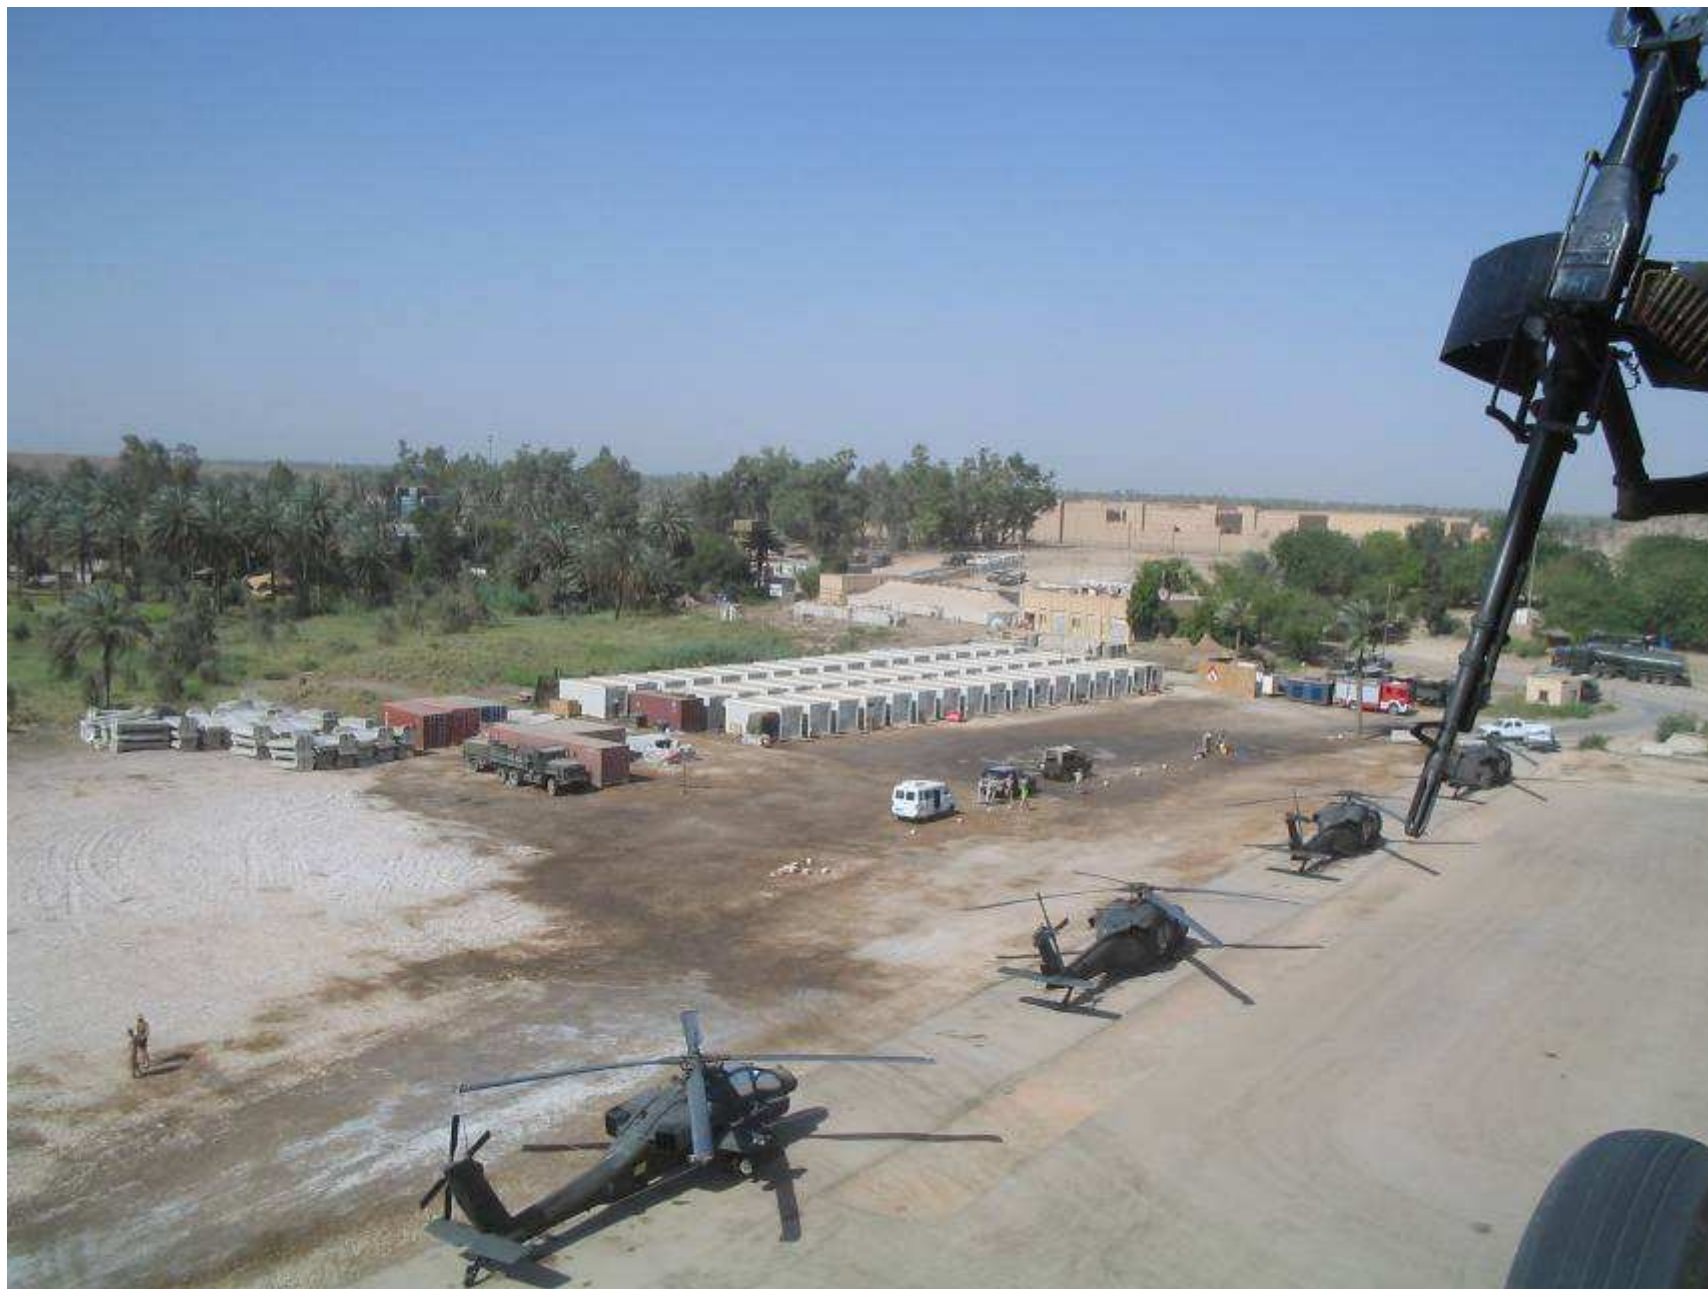
View of parking area south of the airstrip, June 2004, Russell photo 124\_2443 (photo © John Russell)
