# **Report on Damage to the Site of Babylon, Iraq**

**John Malcolm Russell, Ph.D.**

**Cultural Heritage Center  
Bureau of Educational and Cultural Affairs  
Department of State**

**April 2010**

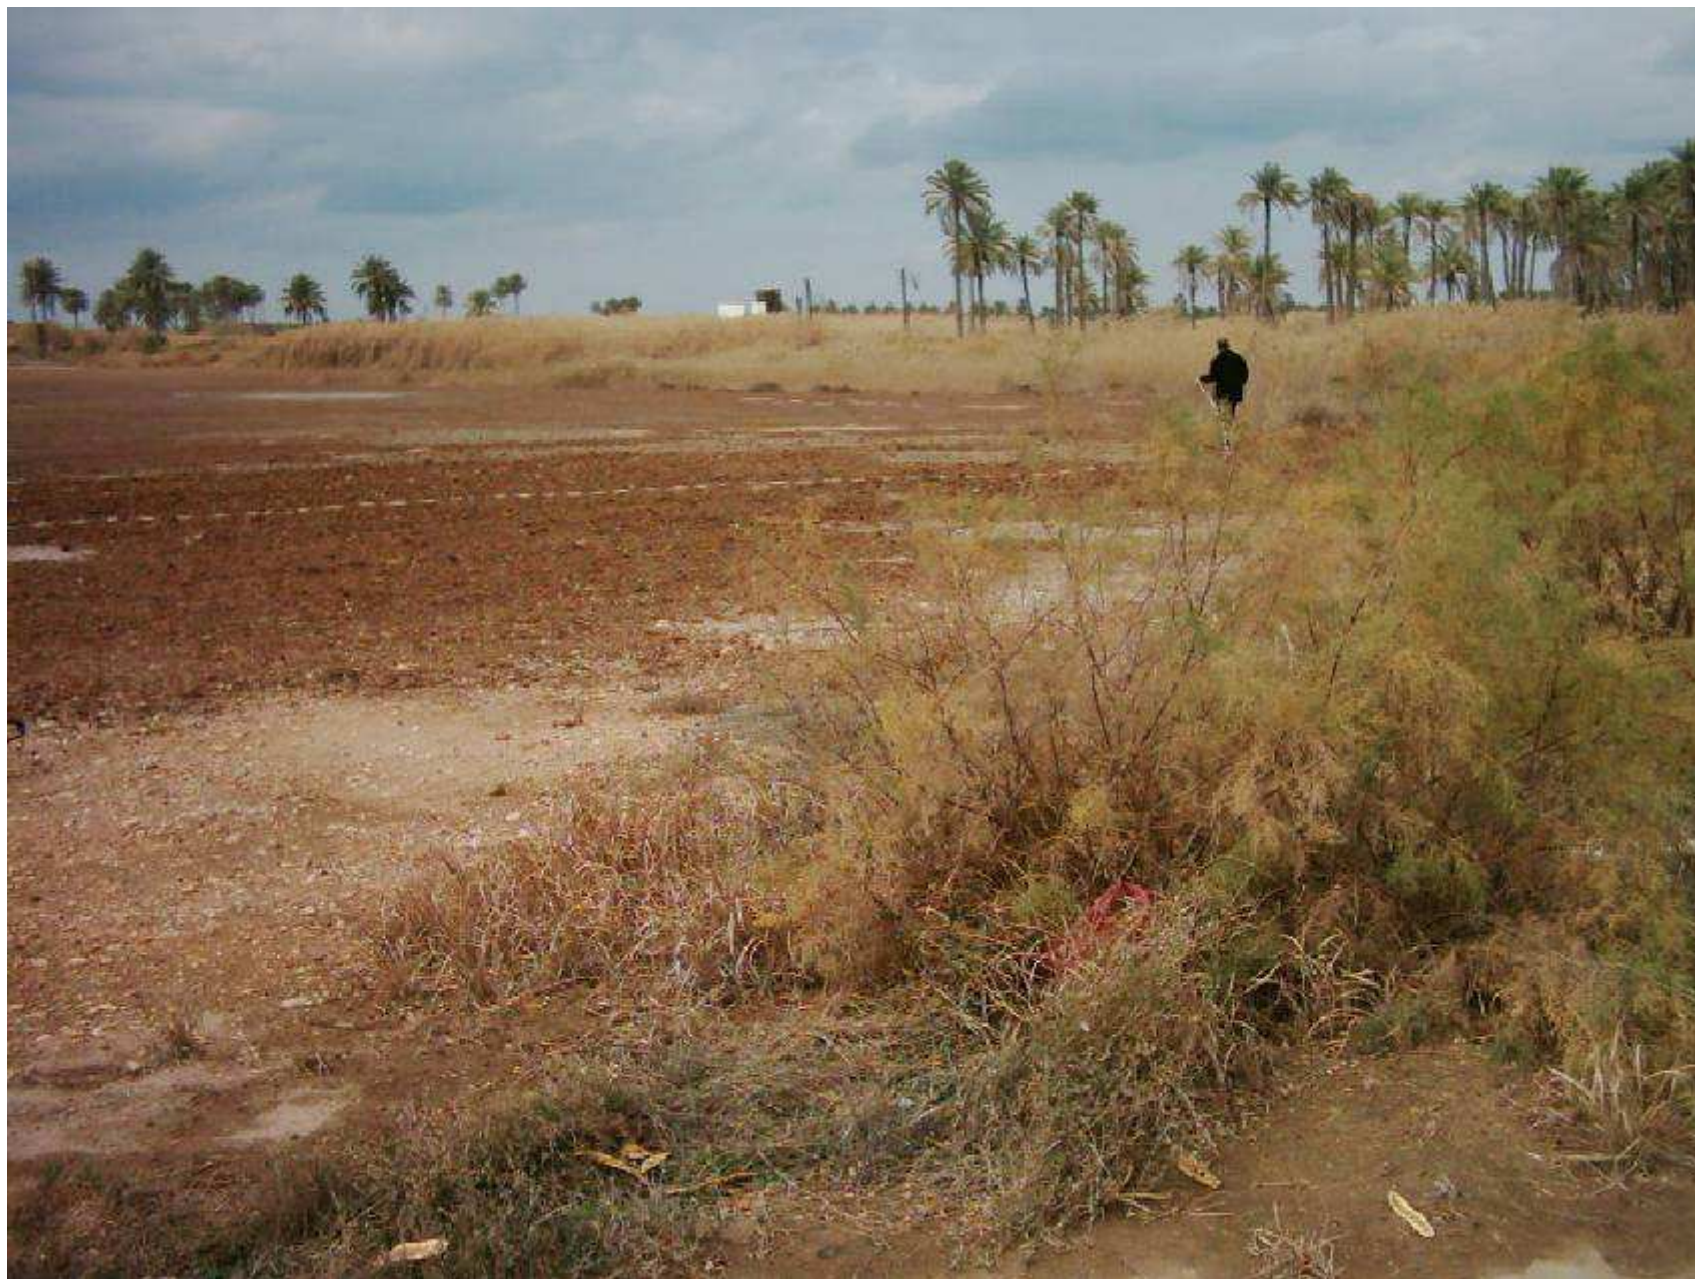
Cut 12, in parking area south of the airstrip, Iraqi final report fig. 50

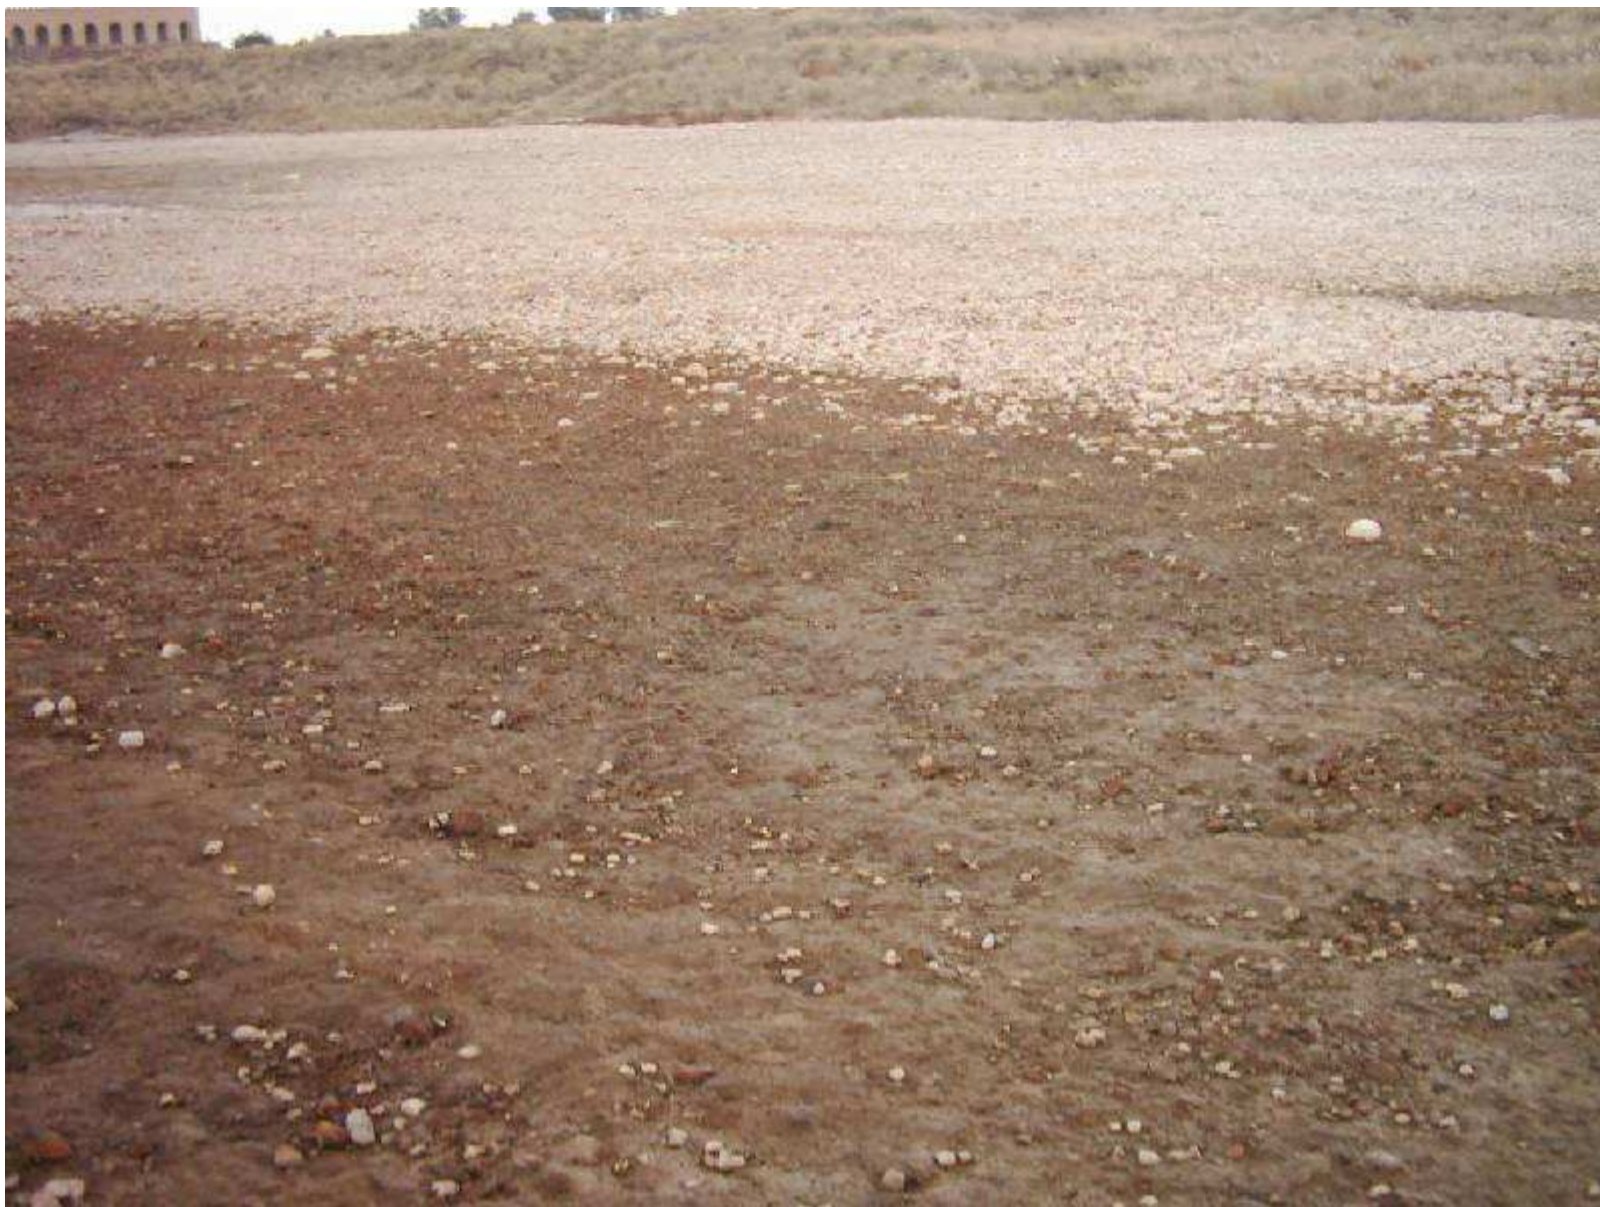
View of parking area south of the airstrip, Iraqi final report fig. 58

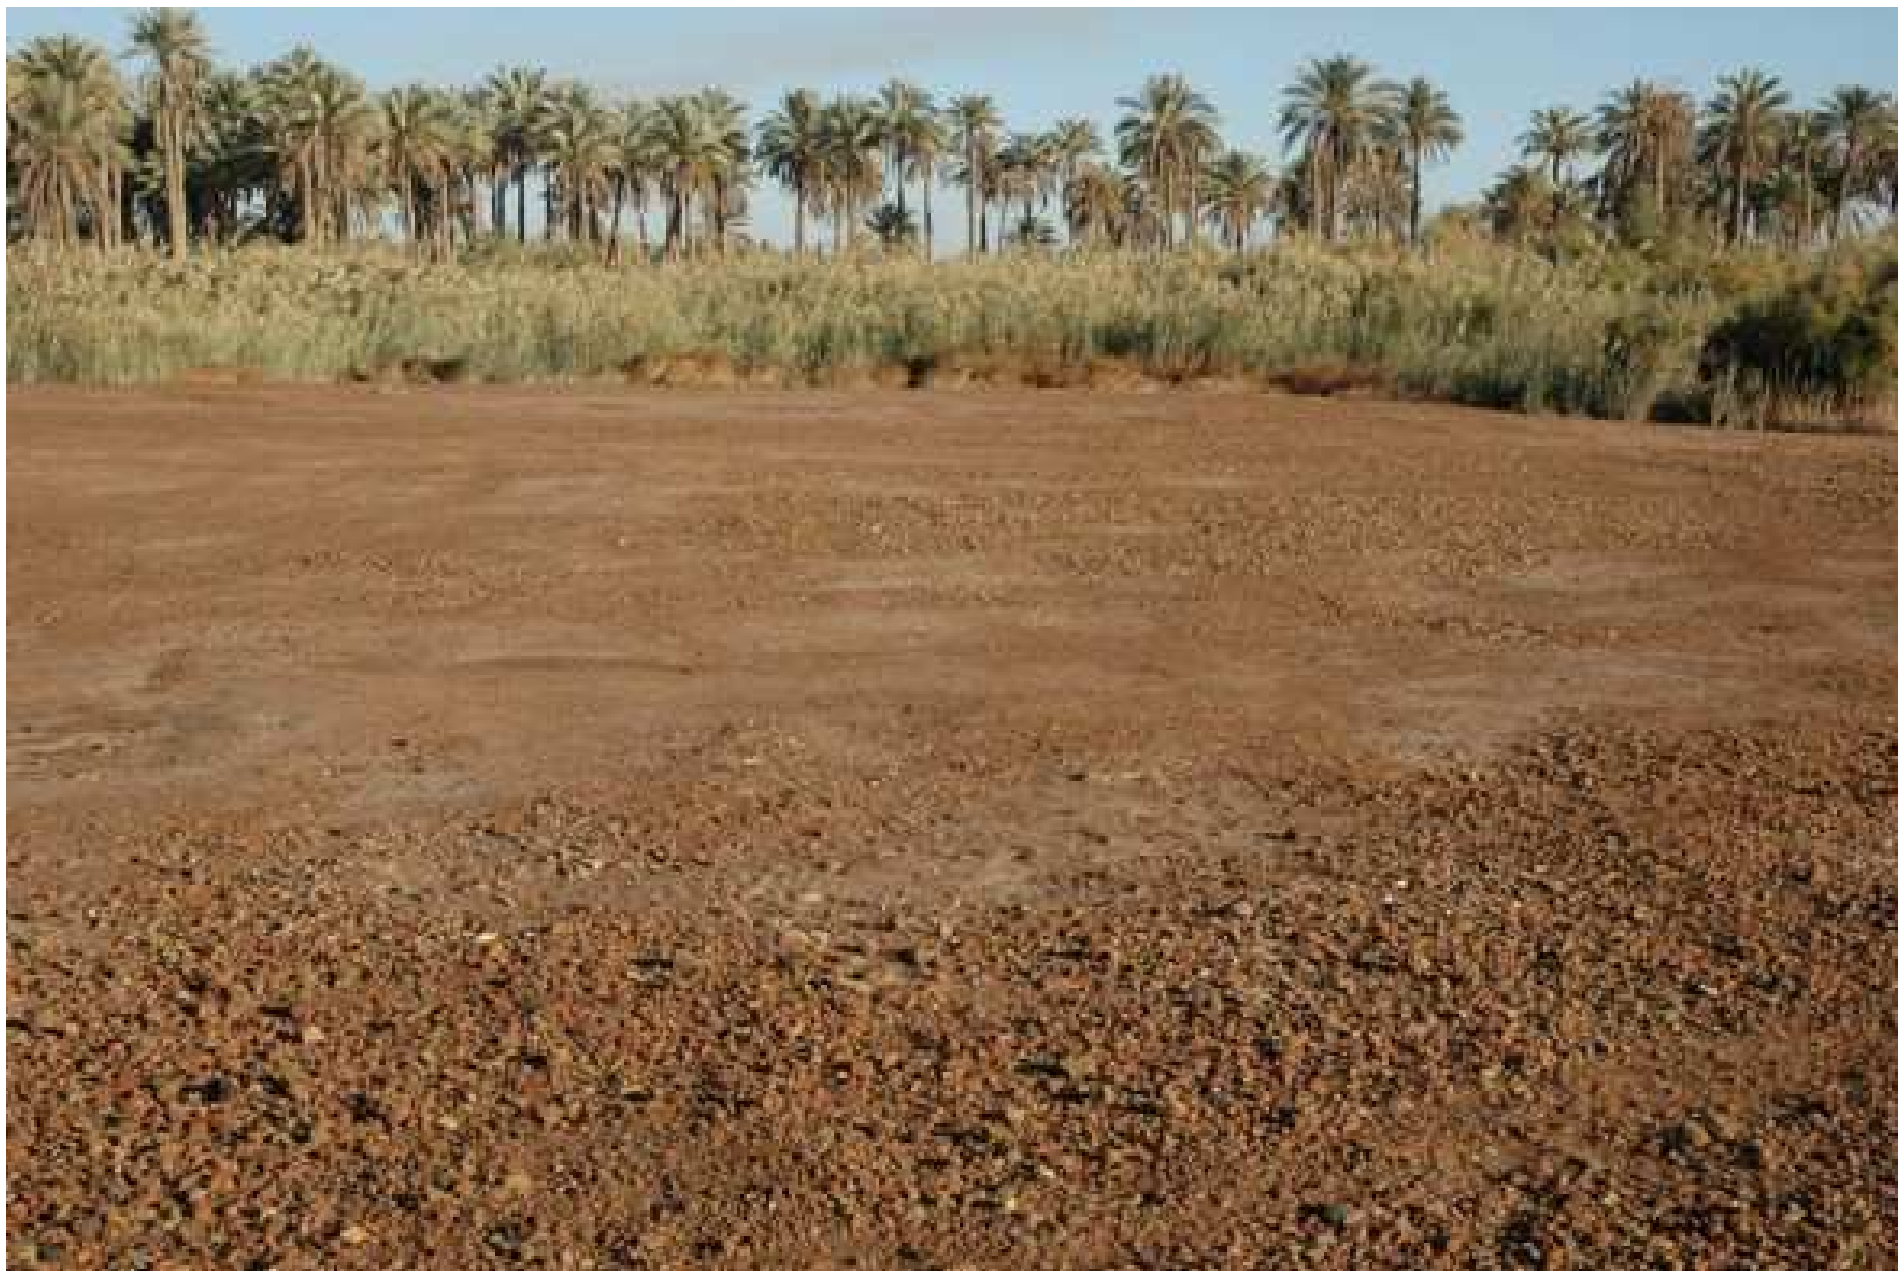
“Surface of the Landing Zone (with contamination),” Polish report, p. 29 (photo © Ministry of Culture and National Heritage, Republic of Poland)

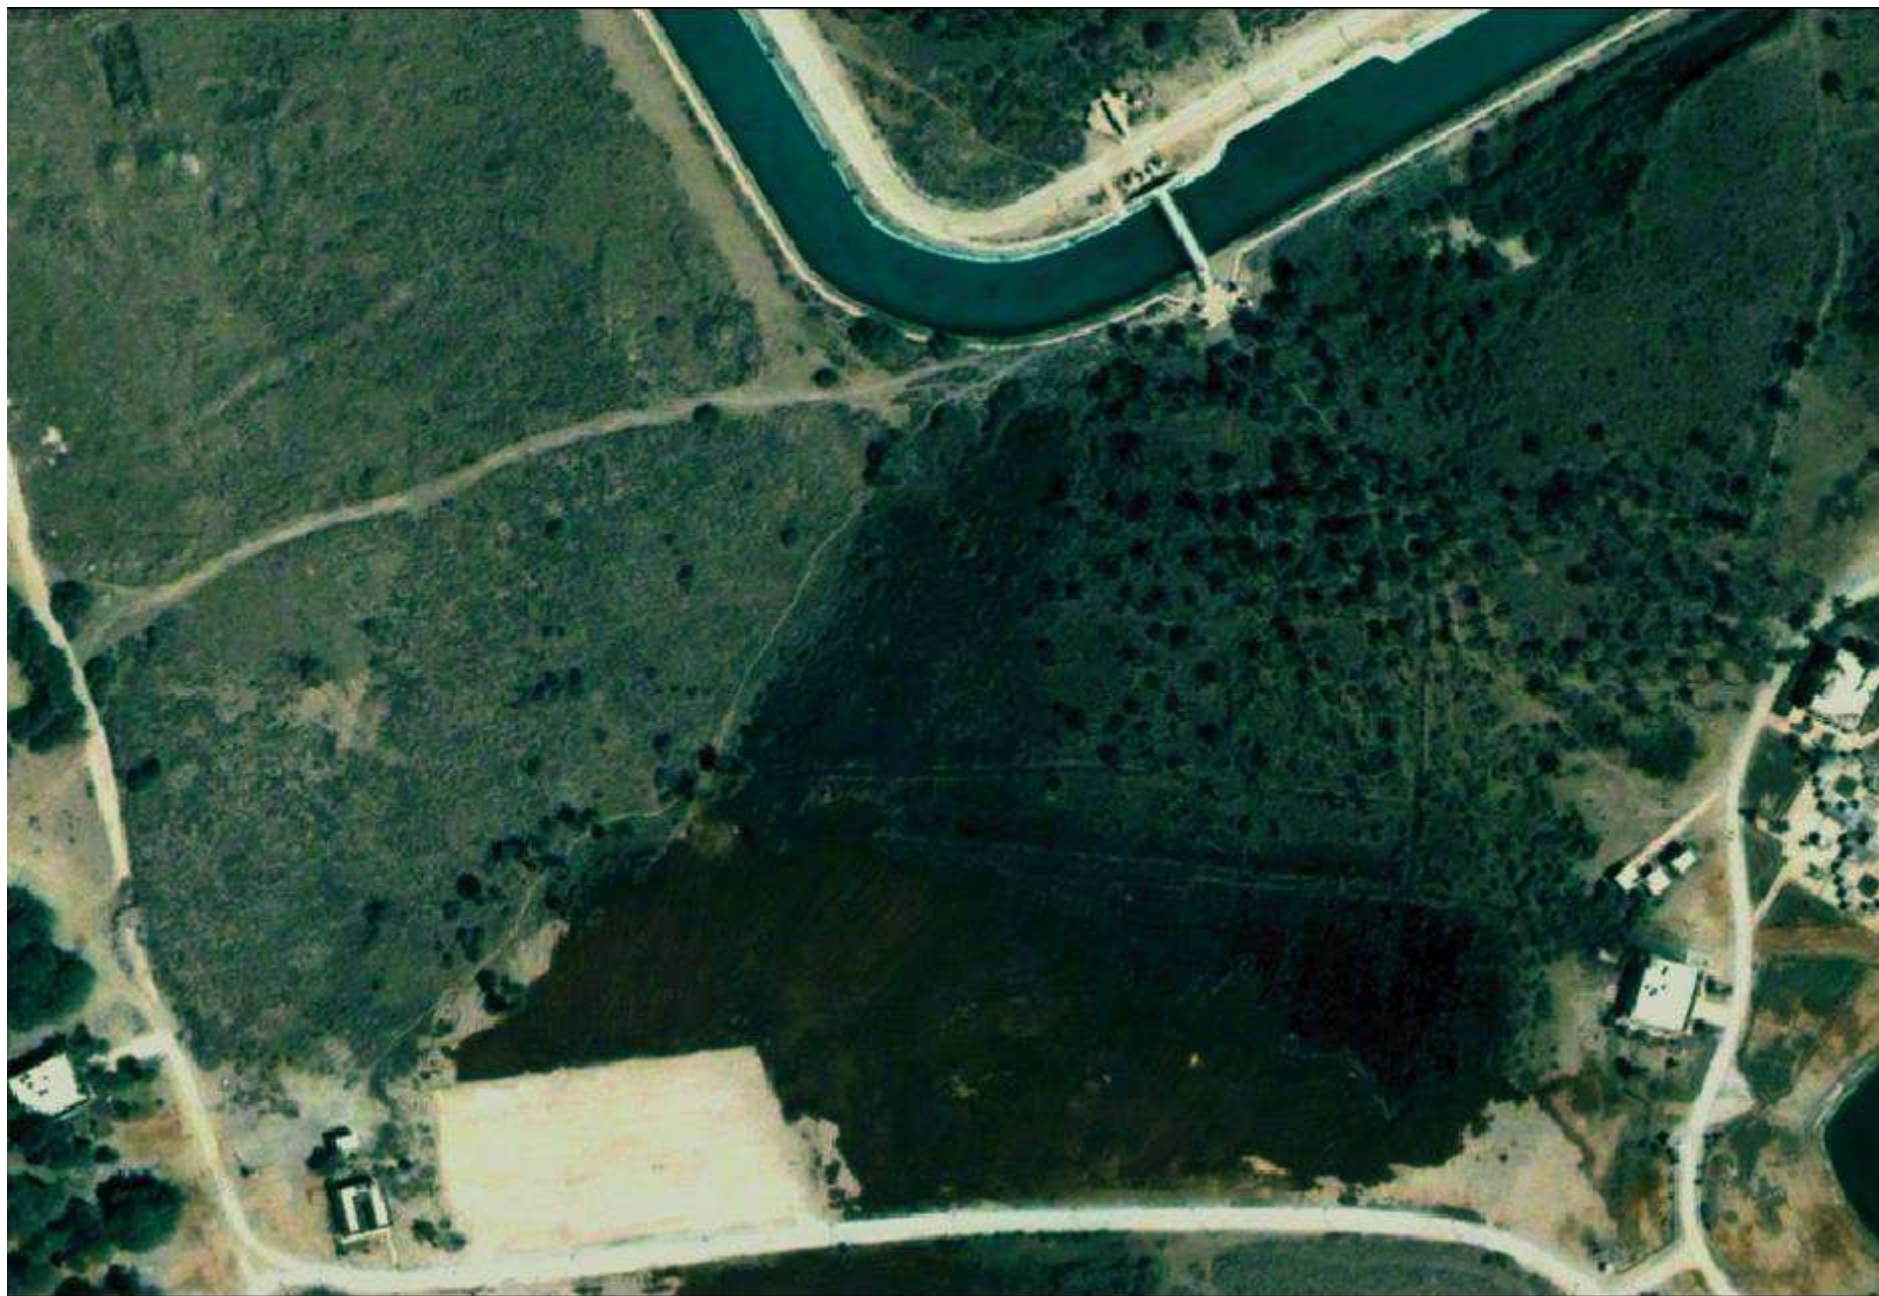
**Russell comment:** New roads were constructed to the east and north of the landing zone area between 1 April and 31 August 2003. The north road runs across an archaeological mound. A concrete barrier had been installed along part of this road by 4 June 2004 (contrary to Stone), but the barrier is difficult to see in the image because the sun is directly overhead.

Landing zone area prior to construction of new roads, 1 April 2003, Russell composite

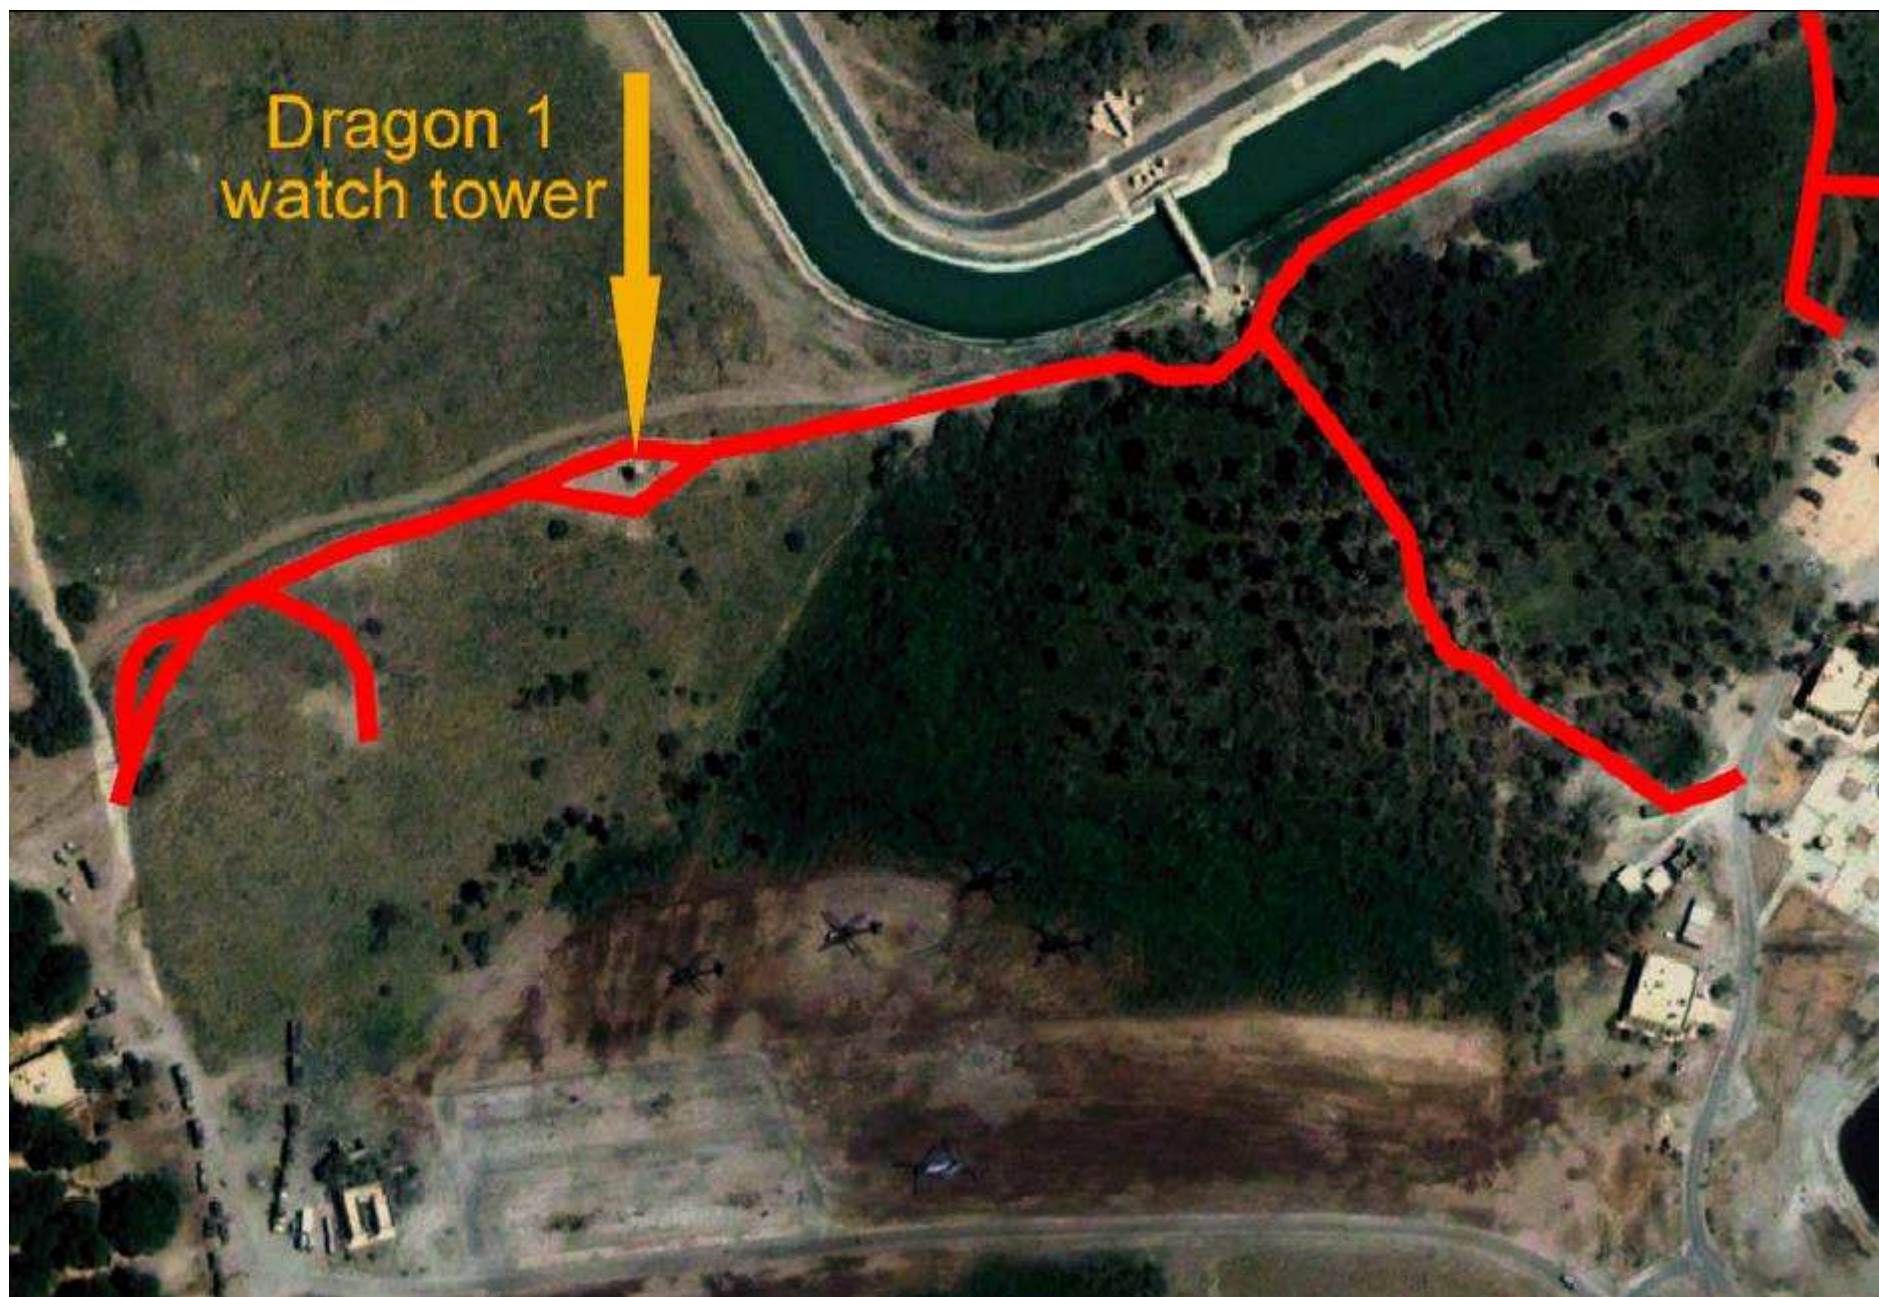
Landing zone area with new roads to east and north, 31 August 2003, Russell composite

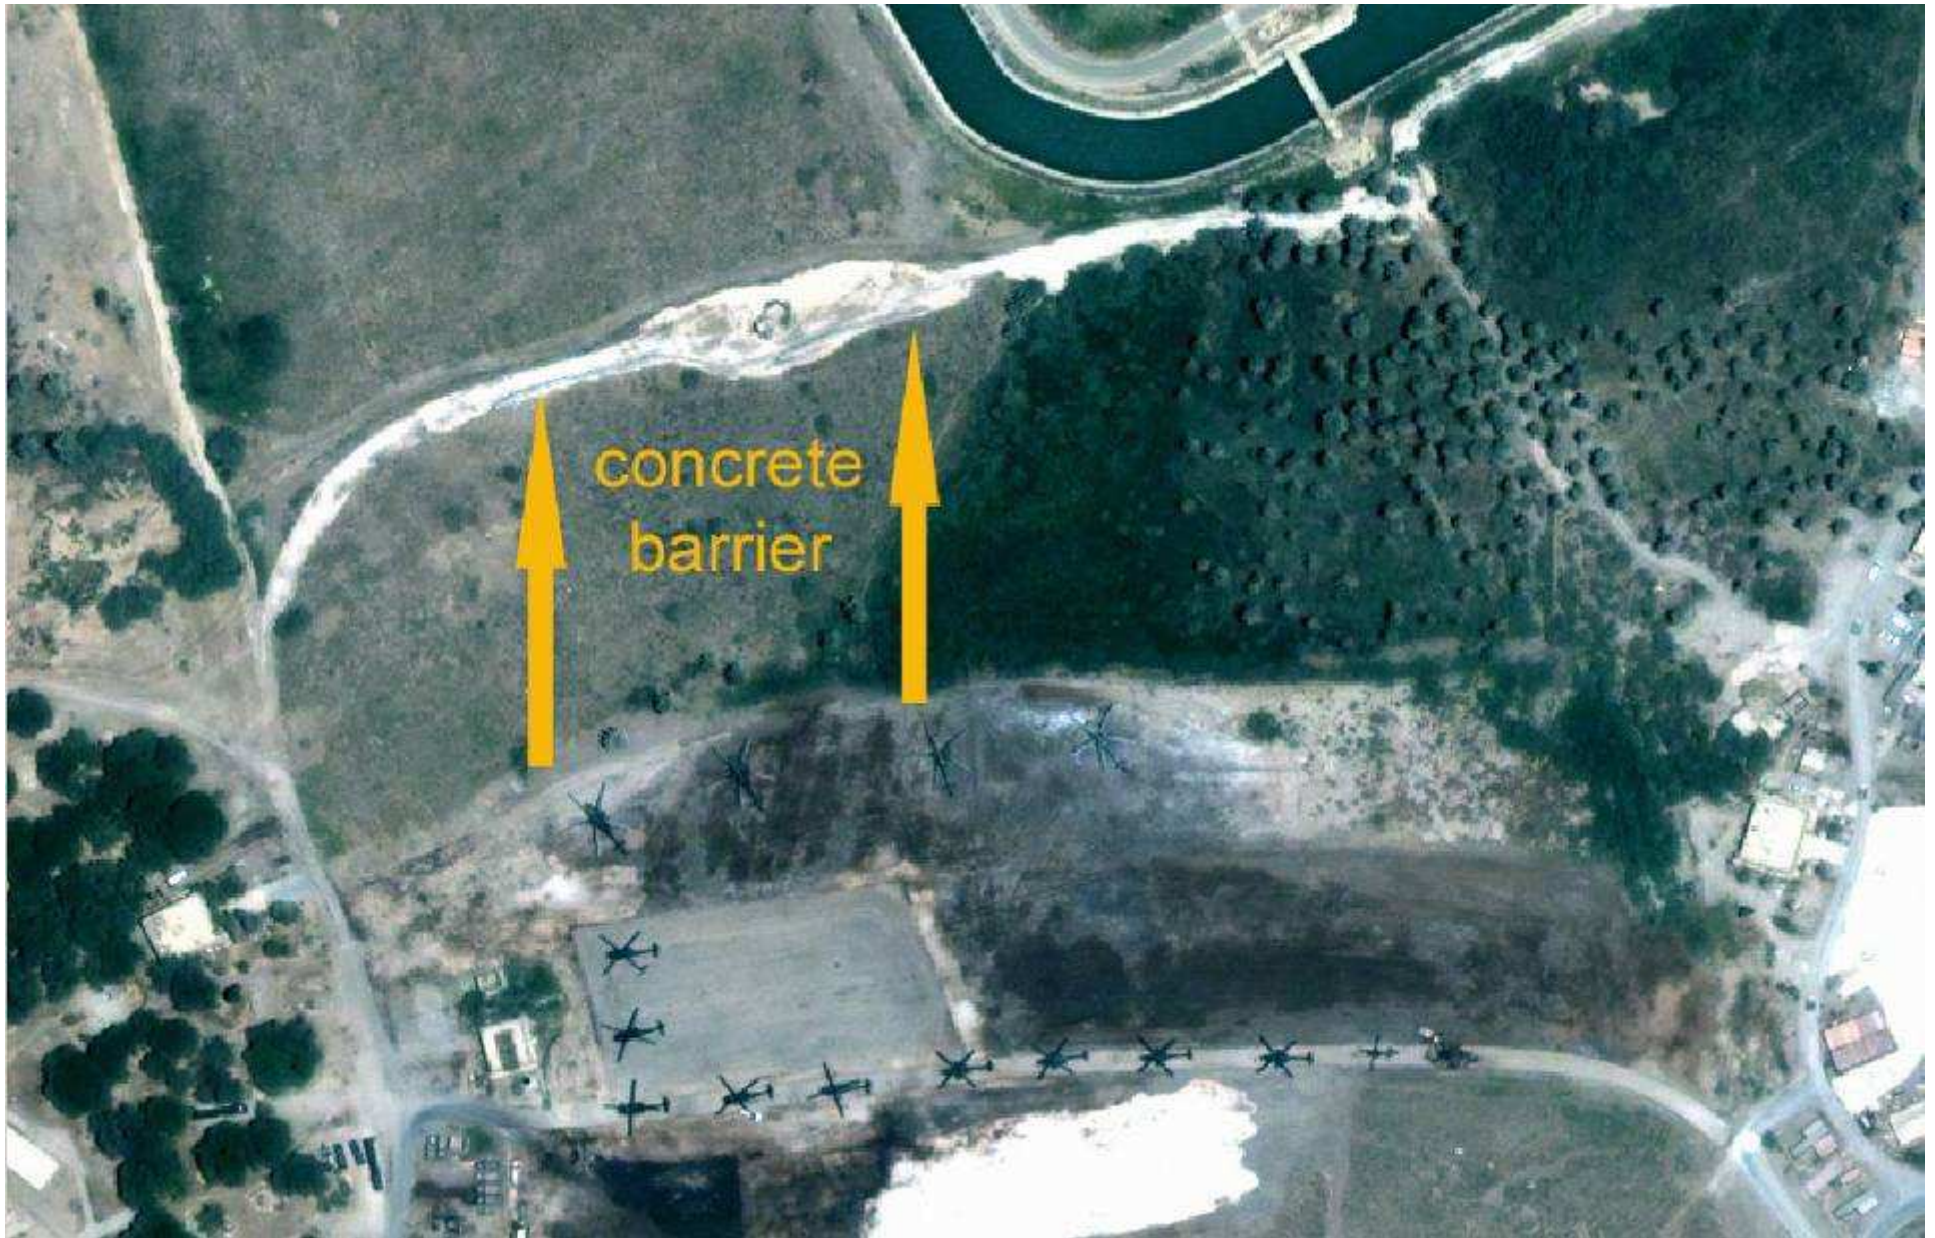
Earliest image with concrete barrier, though difficult to see because sun is directly overhead, 4 June 2004, Russell composite

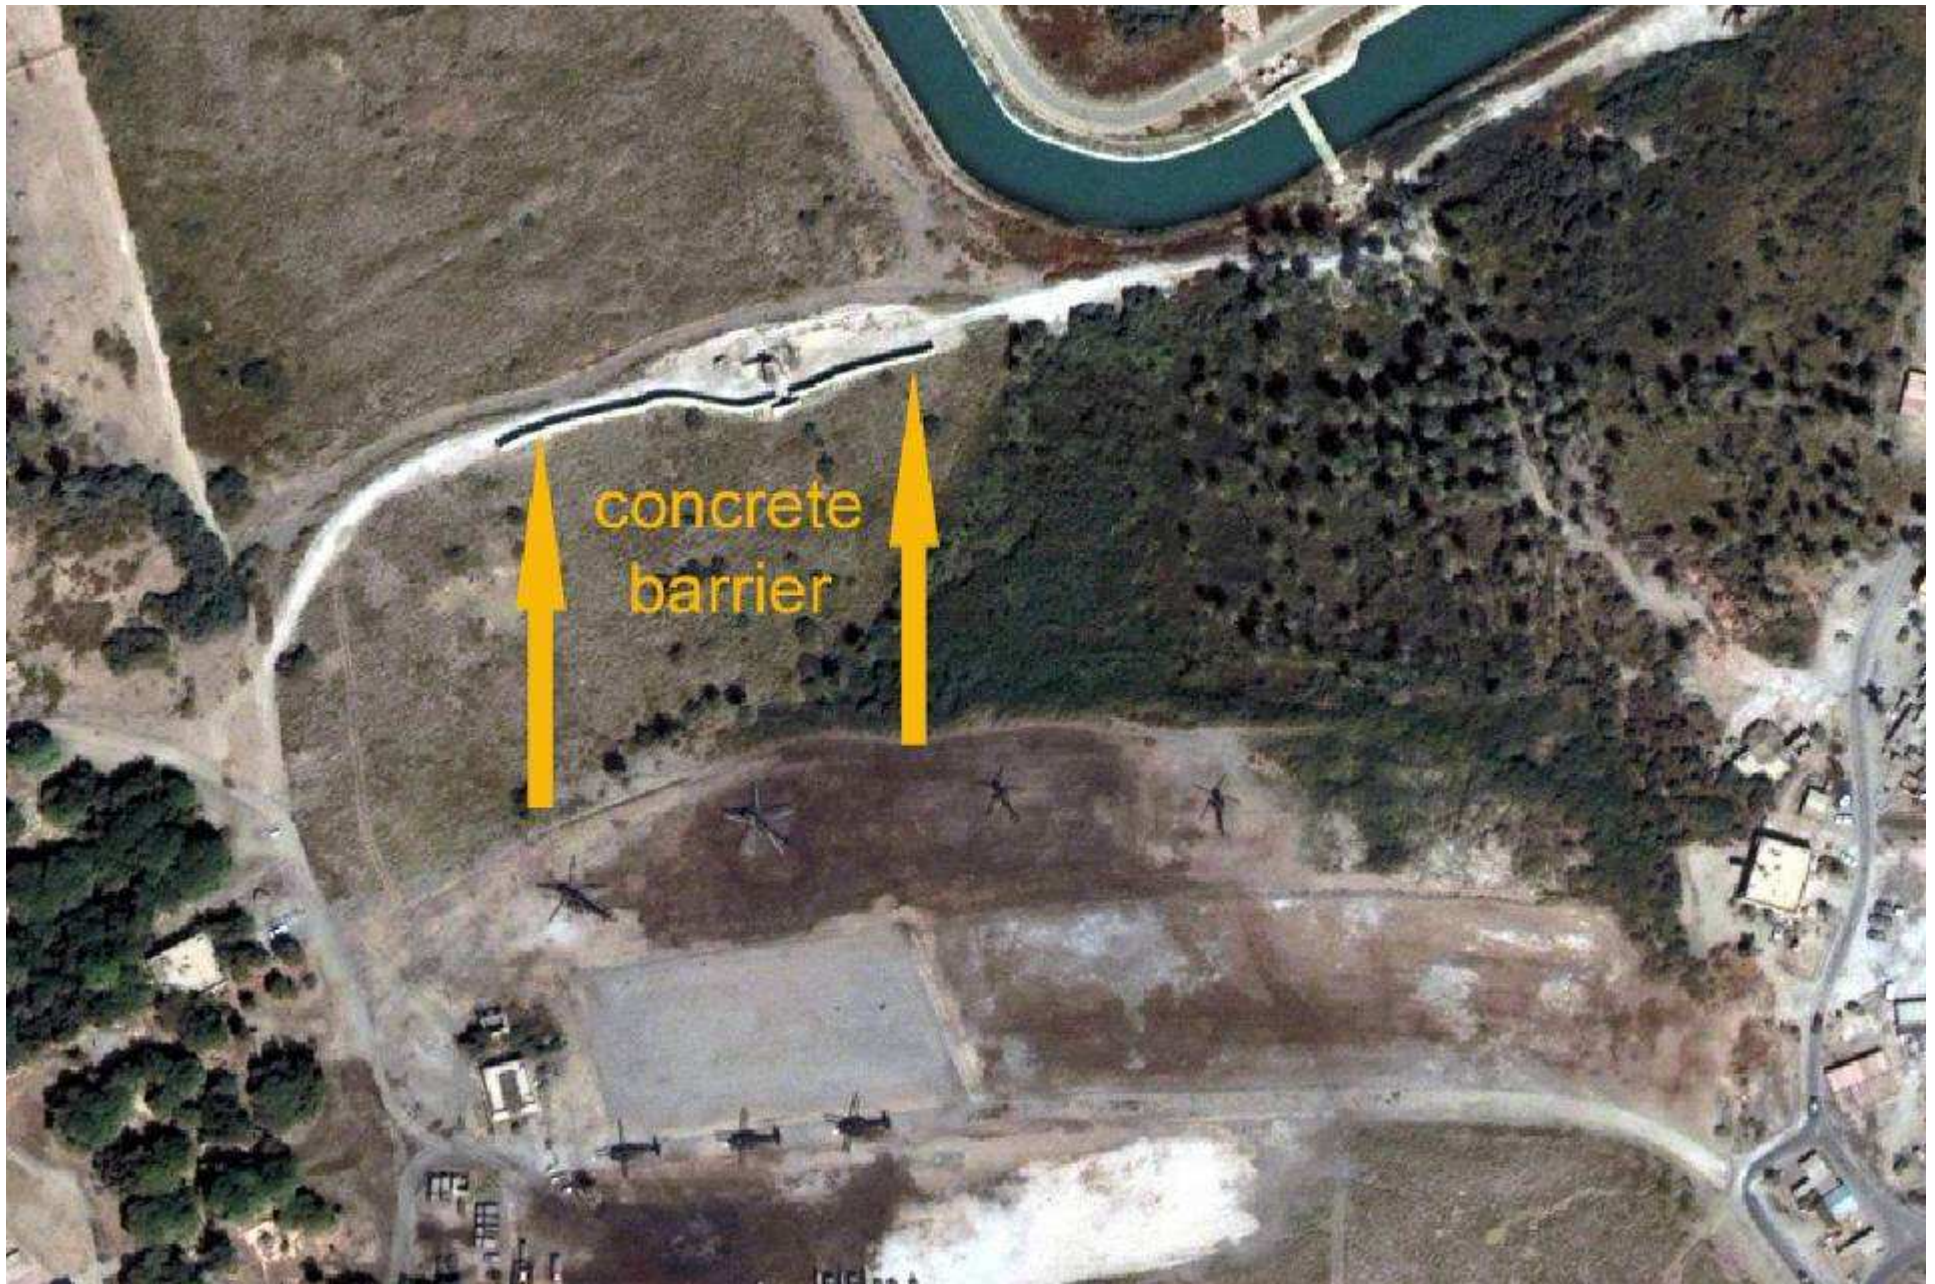
Clearer view of concrete barrier, 8 October 2004, Russell composite

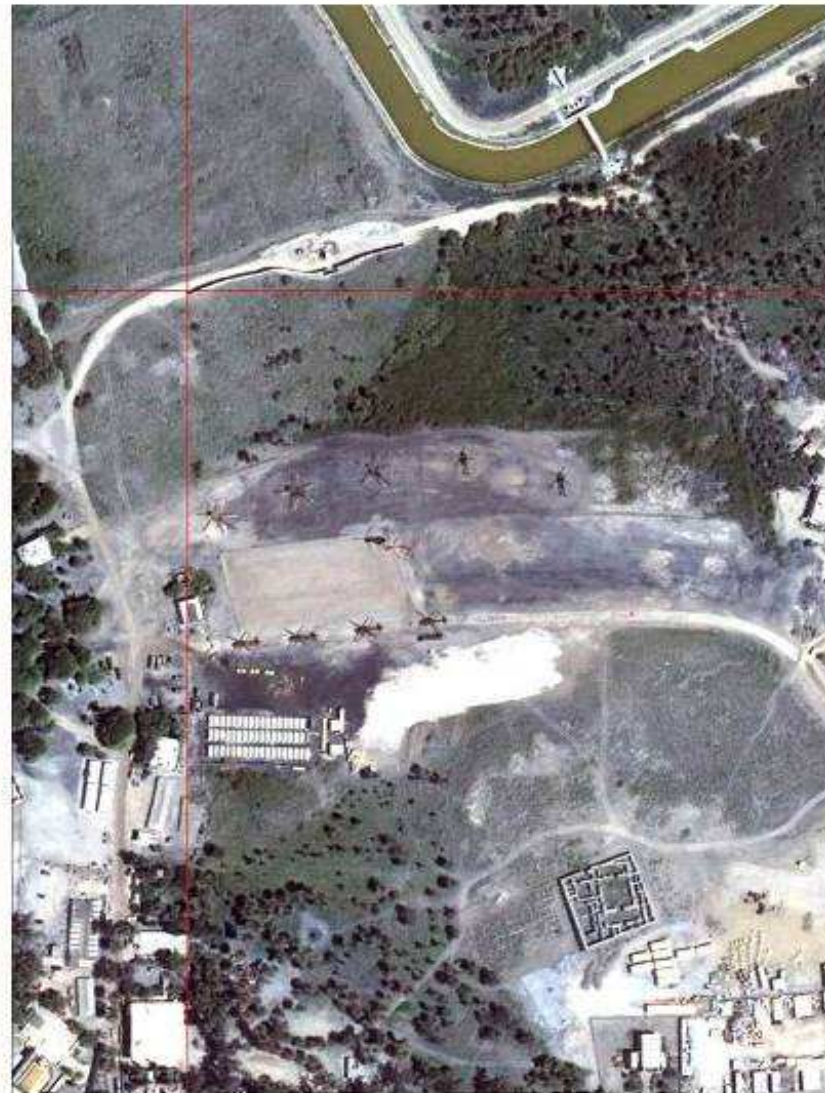
**8 October 2004**

**Stone report:** The barriers north of the helipad are built in an archaeological area. These were constructed between June and August 2004 (Fig 22).

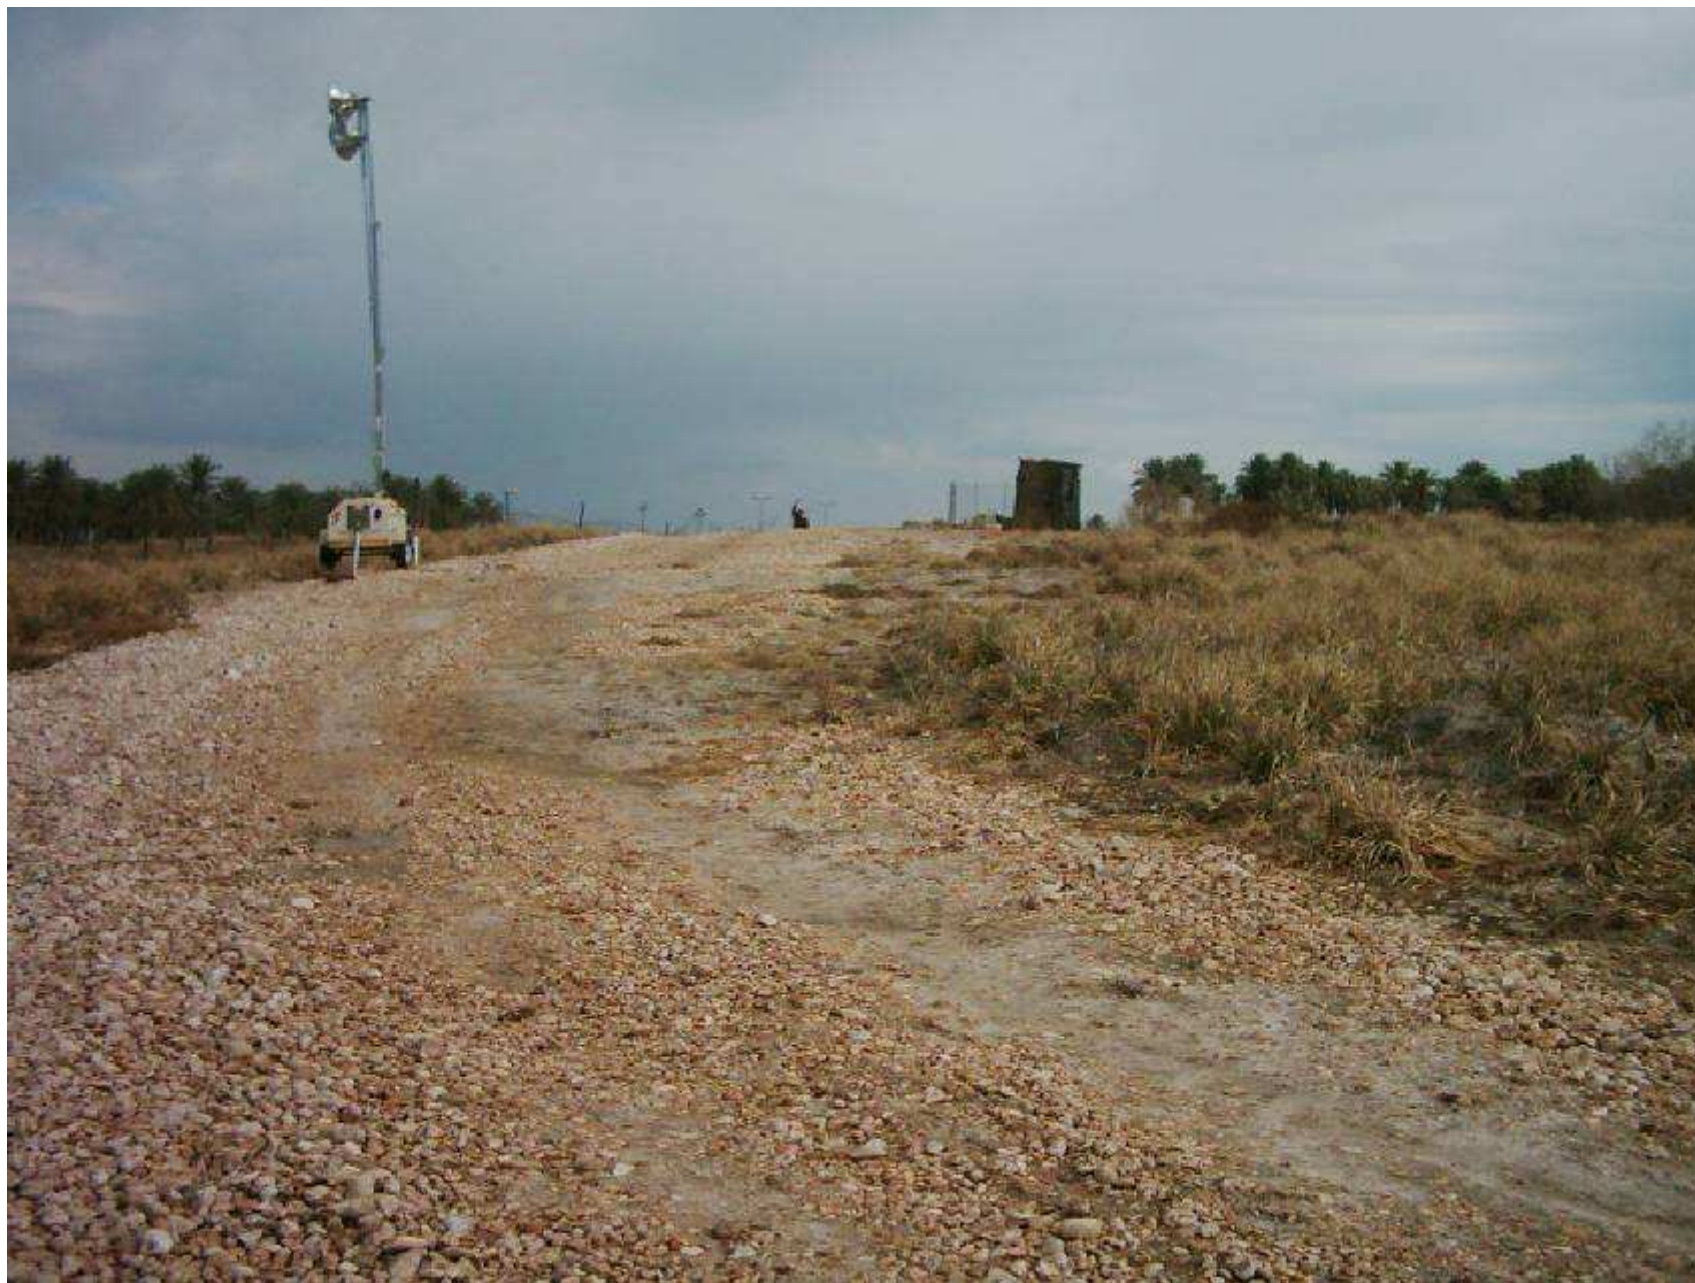
Iraqi preliminary report	Iraqi final report	Curtis report	Polish report
<p>e. The area north of the airport: A road with a length of 100 meters and a width of 8-10 meters was built leading westward from the observation tower north of the airport to a hill located in this area. The roadway was leveled, covered with gravel, and surrounded by 100 concrete blocks. The area covered totals 1300 meters. Another road with a length of about 300 meters was built east of the tower, leading toward the lake. The area surrounding the tower totals 400 meters.</p>	<p>A road with a length of 130 m and a width of 8-10 m was built to the observation tower north of the airfield. The tower was built on a tell in this area. The road was leveled, covered with gravel, and surrounded by concrete blocks. The area covered totals 1300 sq m (Photo 62). In addition, another road with a length of about 300 m and a width of 8-10 m was built east of the tower. It leads to another tower near the lake, north of the theater. The [encroached] area surrounding the tower is 400 [sq] m.</p>	<p>About 100m to the north of the landing field is an east-west dirt track now densely covered with small stones. There are also many large stones at the sides of the road. There are deep ruts in the area from the wheels of heavy vehicles. On the south side of this road there were formerly about 100 tall concrete blocks, to protect the helipad from gunfire (see <i>Polish Report</i>, fig. on p.42). The last of these blocks was removed on 11<sup>th</sup> December 2004.</p>	<p>About 100 meters North of the landing zone there is a road covered with gravel. There are about 100 concrete barriers along the South side of the road near the tower.</p>

Road, Iraqi final report fig. 62

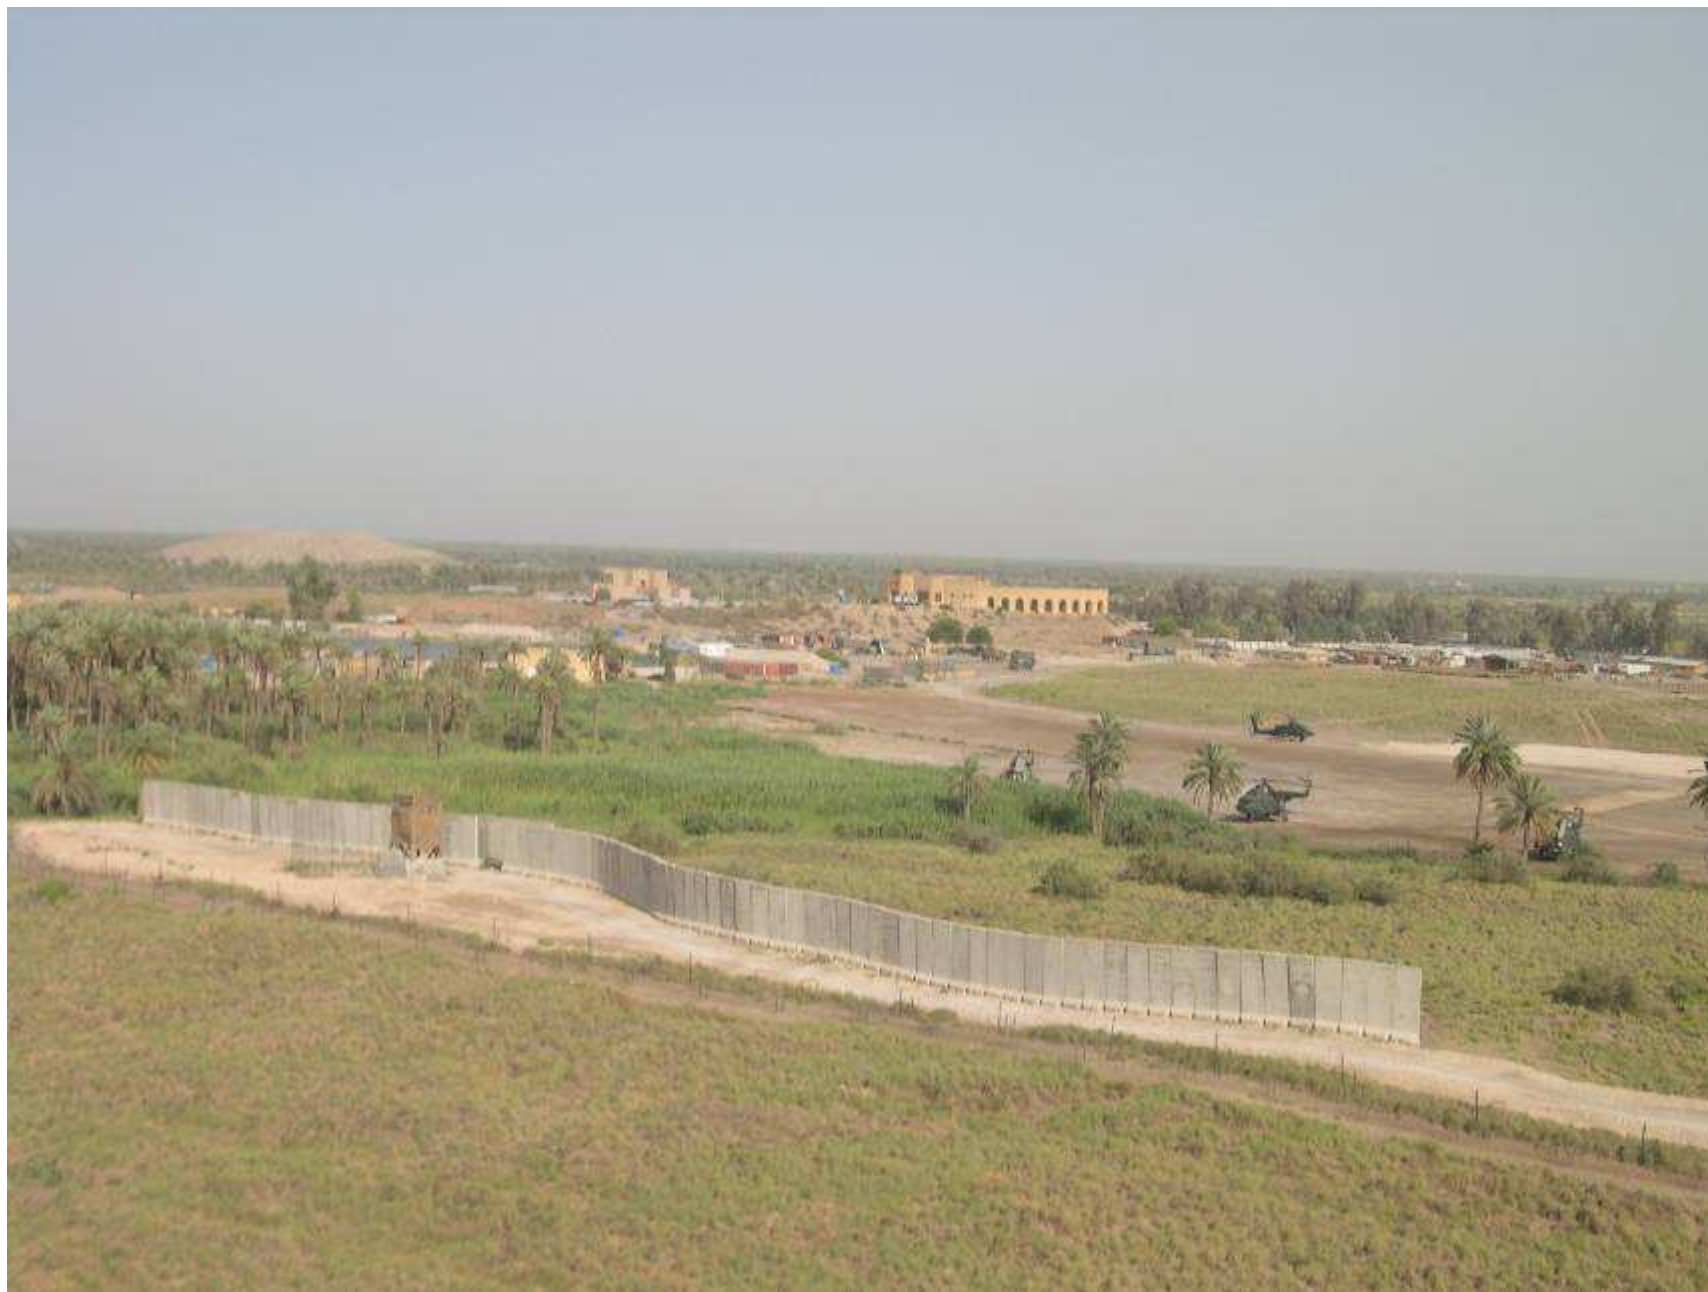
Concrete barriers north of the landing zone, June 2004, Bahrani 2156 (photo © Zainab Bahrani)
