# **Report on Damage to the Site of Babylon, Iraq**

**John Malcolm Russell, Ph.D.**

**Cultural Heritage Center  
Bureau of Educational and Cultural Affairs  
Department of State**

**April 2010**

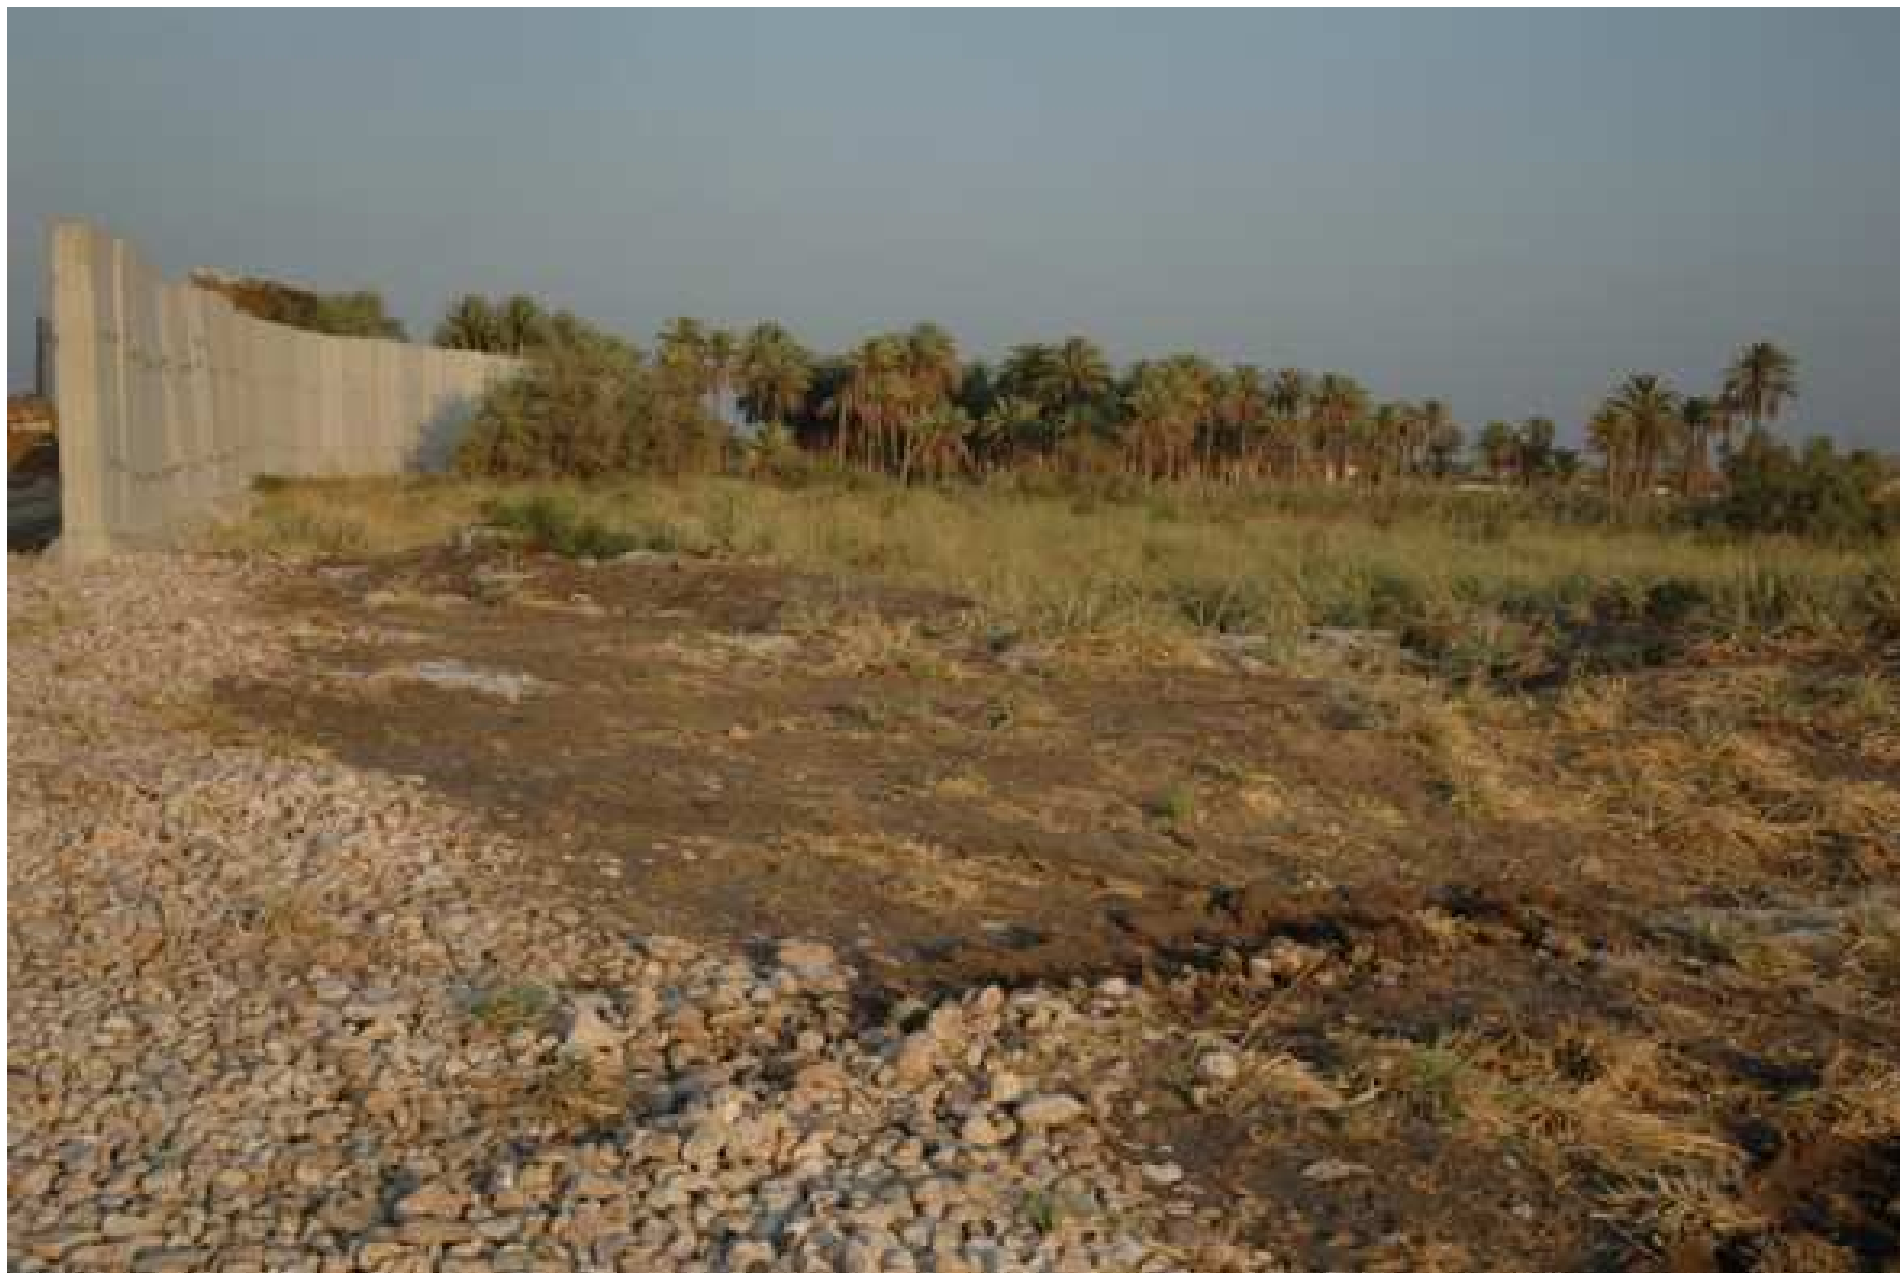
“Concrete barriers on the North of the landing zone.” Polish report, p. 30 (photo © Ministry of Culture and National Heritage, Republic of Poland)

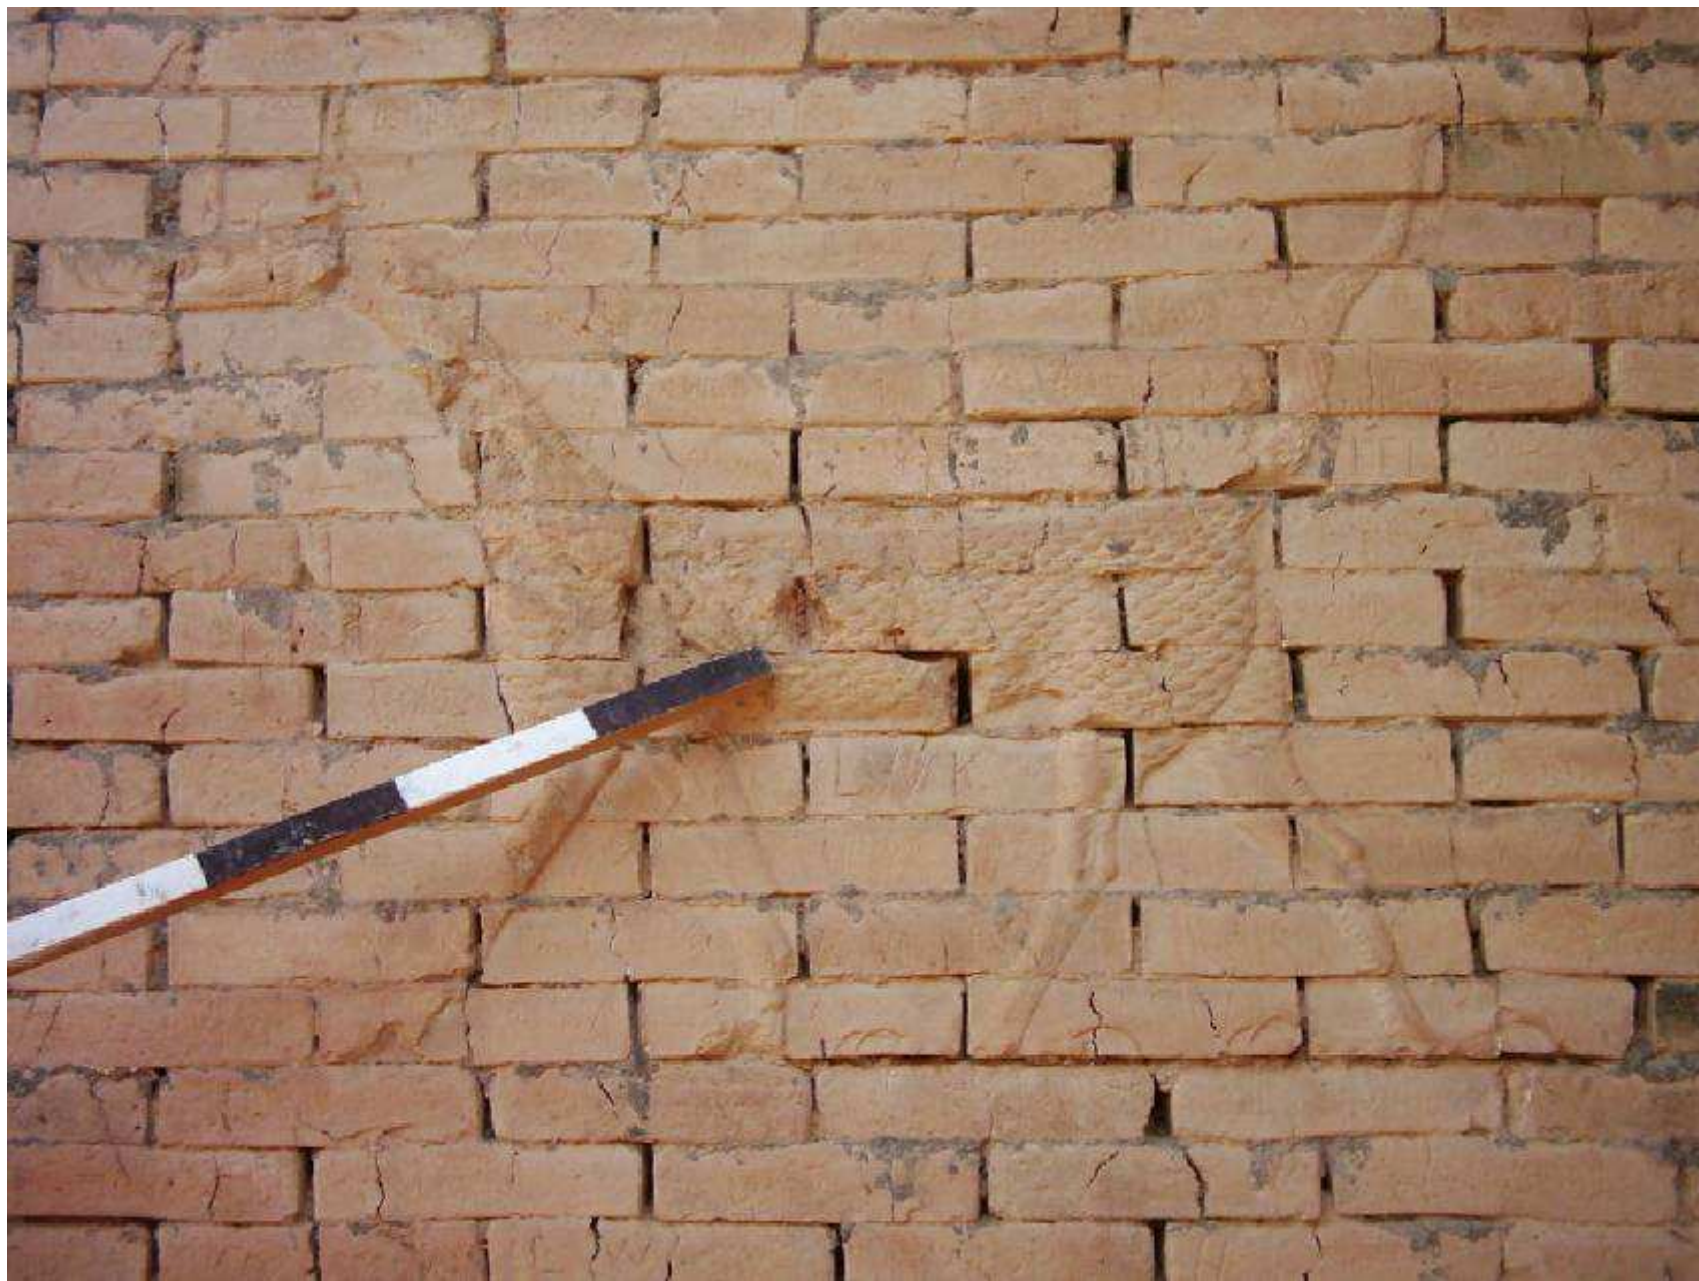
Iraqi final report fig. 73

Iraqi preliminary report	Iraqi final report	Curtis report
<p>The Ishtar Gate is one of the most prominent structures rising up in the city of Babel. Some of the encroachments cited in their prepared report, of which there are photographs, are old, dating to before the entry of the multinational forces. However, new encroachments are very apparent and were photographed upon our request. These encroachments affect nine of the animals that adorn the gate, depicting the legendary dragon that represents the symbol of the god Marduk, the main god of the city of Babel. Some of these encroachments happened very recently. Notice to that effect was sent in an official letter. The damage includes the cutting of small parts of the <i>mu-shakh-shu</i> [dragon] animal on the eastern and western sides.</p> <p>The other photographs in the report show old damage and the effects of natural factors—e.g., rain, ground water, and salt—which had a major effect, particularly on the lower portions of the gate. There is also a crack that starts above the western side of the gate and runs downward.</p>	<p>Gate of Ishtar: The gate of Ishtar is a prominent, towering archeological structure in the city, serving as its northern access. The damage to the gate includes cuts on nine of the bodies of the animals adorning the gate. These animals depict the legendary dragon-snake, the symbol of Marduk, the god of the city of Babylon (see Photos 73, 74, and 75).</p>	<p><u>Ishtar Gate</u></p> <p>The iron gates at either end of the sunken part were stolen in the looting after the war, but were recovered and have now been reinstated. However, parts have been broken off the gates and they can no longer render the area secure.</p> <p>Dr Maryam pointed to the following damage to the moulded brick reliefs:-</p> <ol style="list-style-type: none"> <li>1. There are bad cracks in tier 2 (see <i>Polish Report</i>, fig. on p. 90).</li> <li>2. Extensive damage to body of dragon (<i>mušhuššu</i>) in tier 19 (see <i>Polish Report</i>, fig. on p.103).</li> <li>3. Damage to hindquarters of dragon (<i>mušhuššu</i>) in tier 21 (see <i>Polish Report</i>, fig. on p. 104).</li> <li>4. Damage to central part of body of dragon (<i>mušhuššu</i>) in tier 22 (see <i>Polish Report</i>, fig. on p. 105).</li> <li>5. Damage to head and central part of body of dragon (<i>mušhuššu</i>) in tier 23 (see <i>Polish Report</i>, fig. on p. 106).</li> <li>6. Damage to central part of body of dragon (<i>mušhuššu</i>) in tier 24 (see <i>Polish Report</i>, fig. on p. 106).</li> <li>7. Damage to front middle part of body of dragon (<i>mušhuššu</i>) in tier 27 (see <i>Polish Report</i>, fig. on p. 110).</li> <li>8. Damage to lower part of body of dragon (<i>mušhuššu</i>) in tier 29 (see <i>Polish Report</i>, fig. on p. 113).</li> <li>9. Damage to upper middle part of body of dragon (<i>mušhuššu</i>) in tier 30 (see <i>Polish Report</i>, fig. on p. 113).</li> <li>10. Damage to neck and upper front part of body of dragon (<i>mušhuššu</i>) in tier 31 (see <i>Polish Report</i>, fig. on p. 114).</li> </ol> <p><i>Note:</i> The worst damage is to the <i>mušhuššu</i> in tier 19 (no.2). This was already noted and photographed by the British Museum team in June, 2003. At that time, no damage was noted to the other <i>mušhuššu</i> figures. It has been suggested that most of the damage to the other <i>mušhuššu</i> figures was caused at the same time by a person or persons trying to remove a decorated brick.</p>

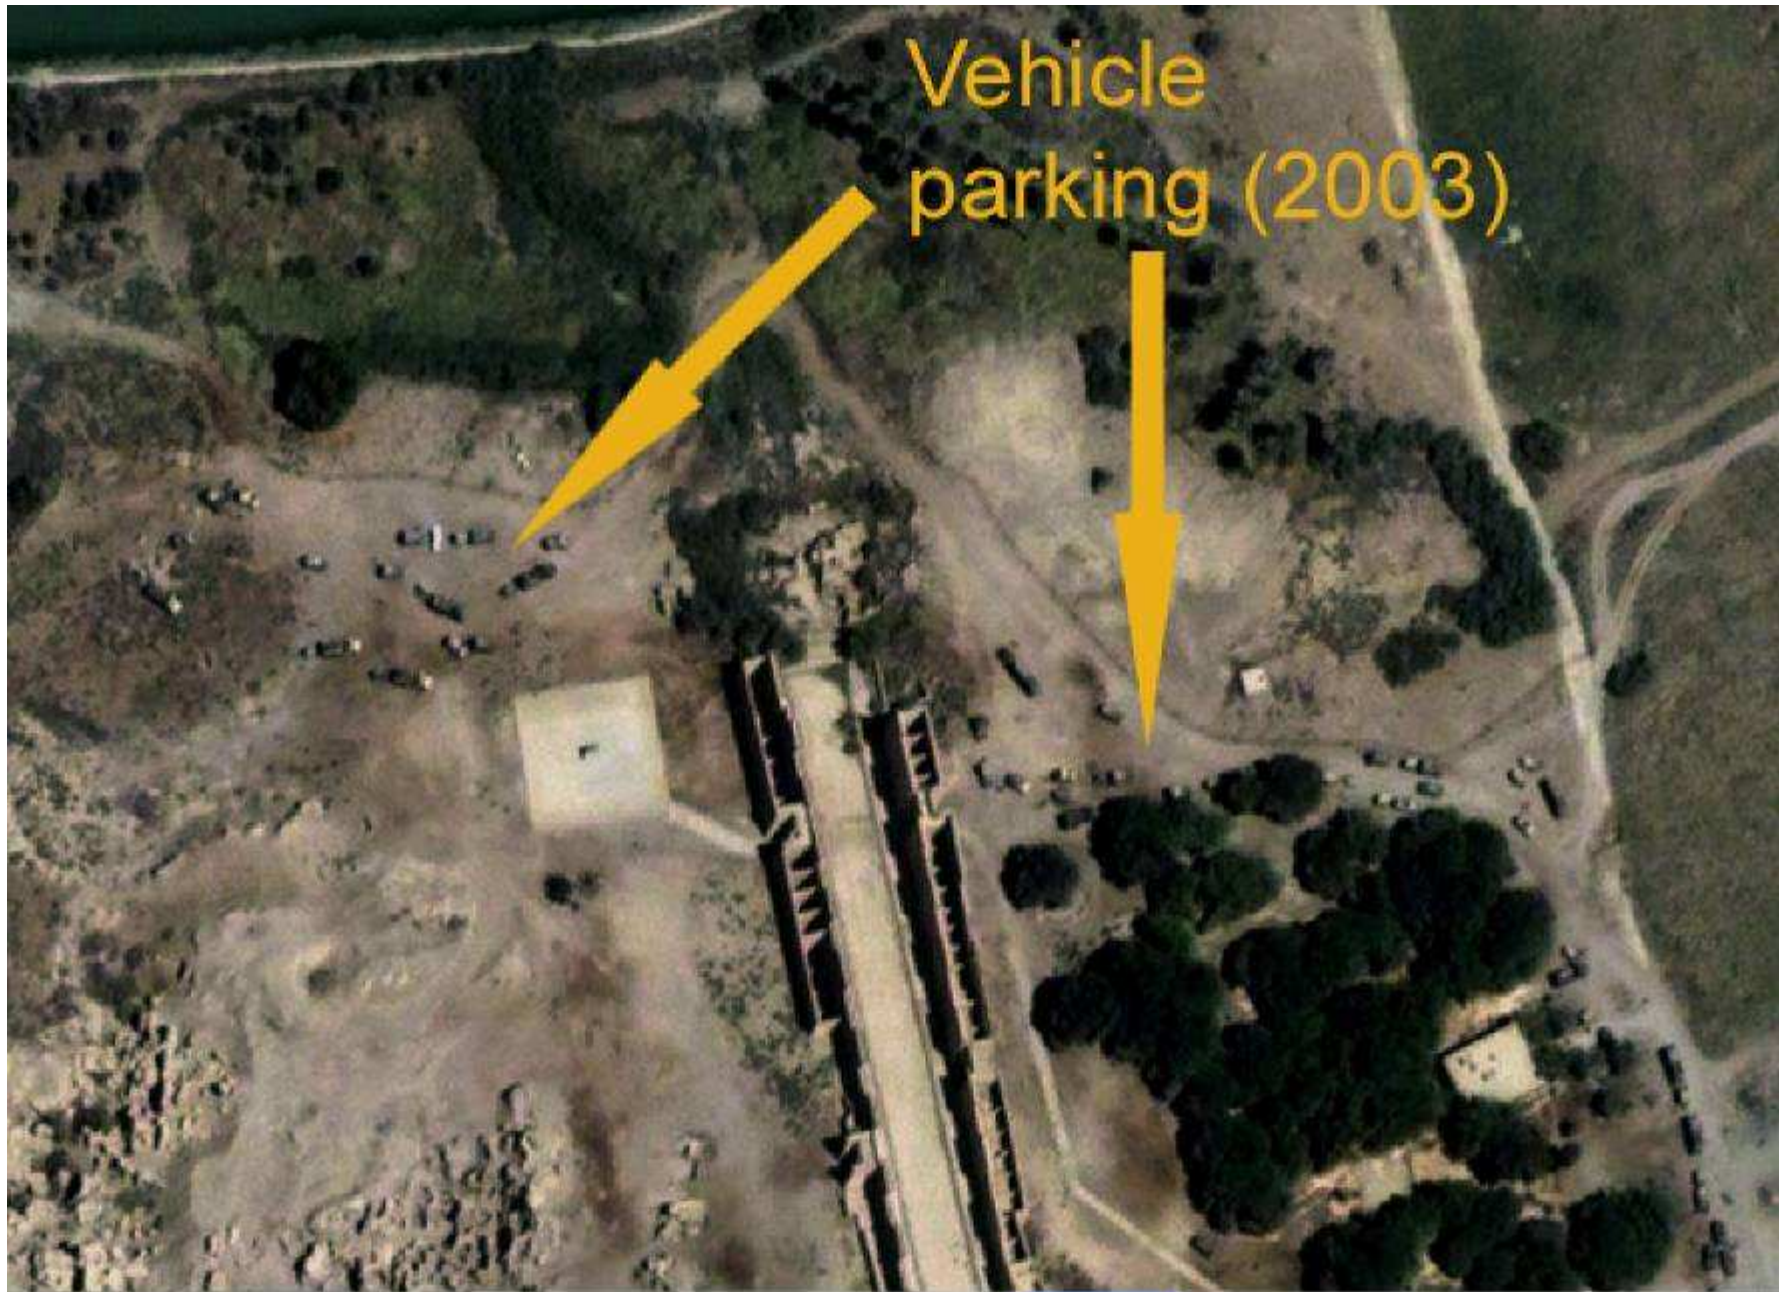
Vehicle parking, 31 August 2003, Russell composite

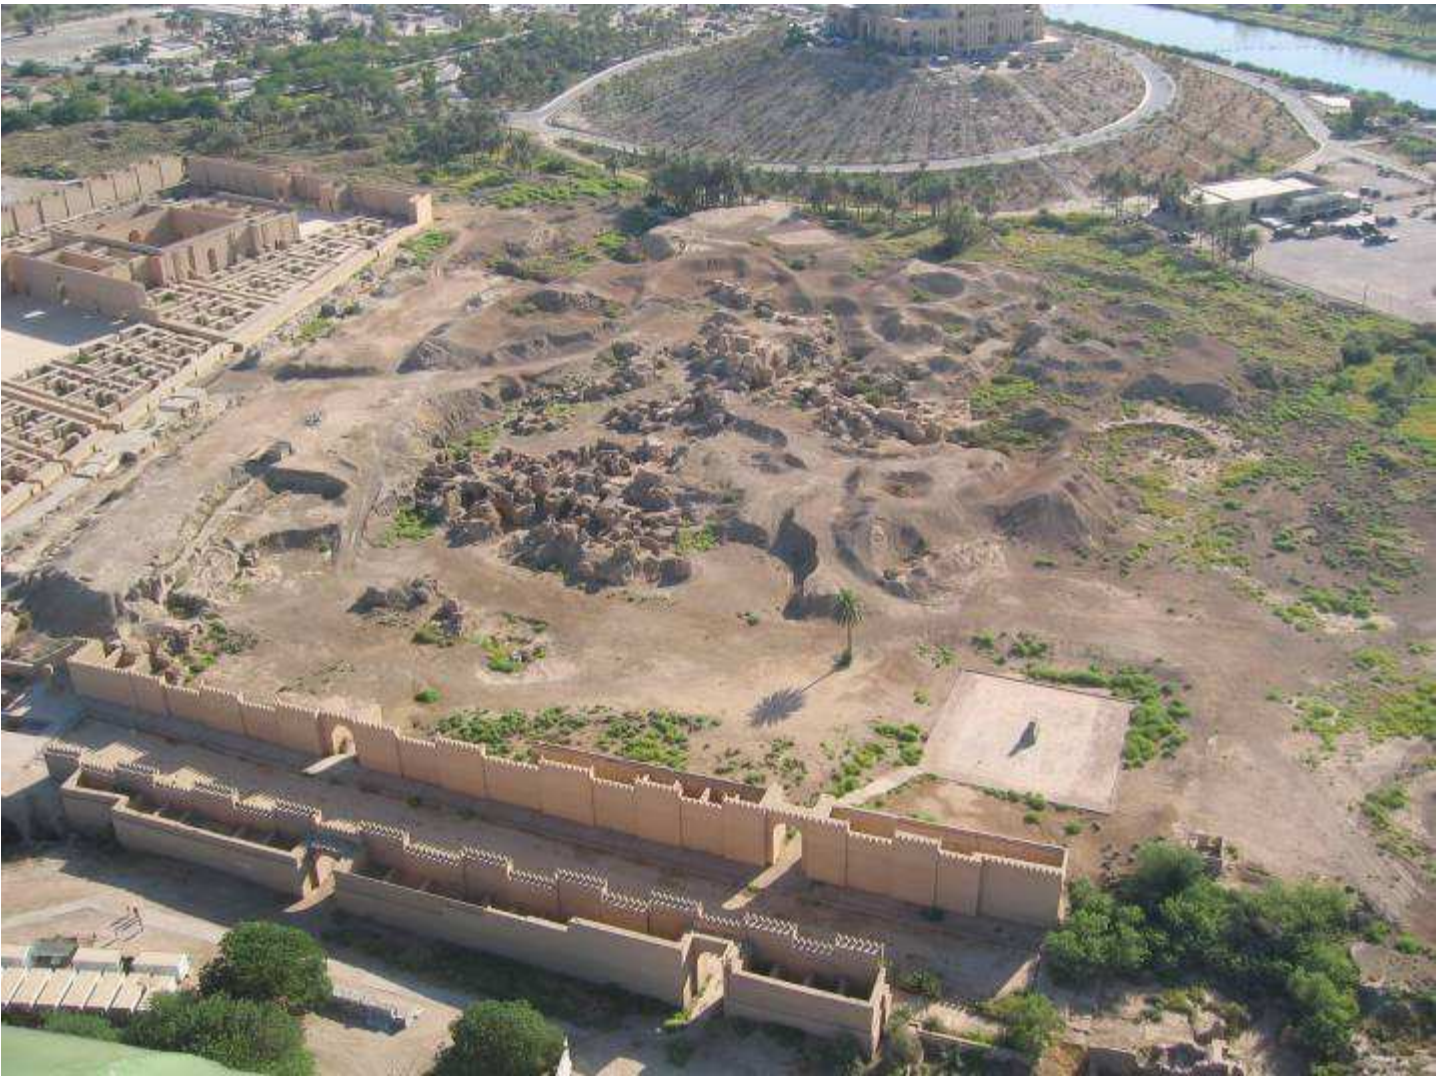
Polish report	Stone report
North of the Ishtar Gate close to the first entrance to the Northern Palace West of Processional Street there is a pit shown in the picture below.	The Polish report also mentions a robber pit in the Processional Way, but this is not visible in our imagery.

Photo of area of robber pit (pit is not visible), Polish photo 36 (photo © Ministry of Culture and National Heritage, Republic of Poland)

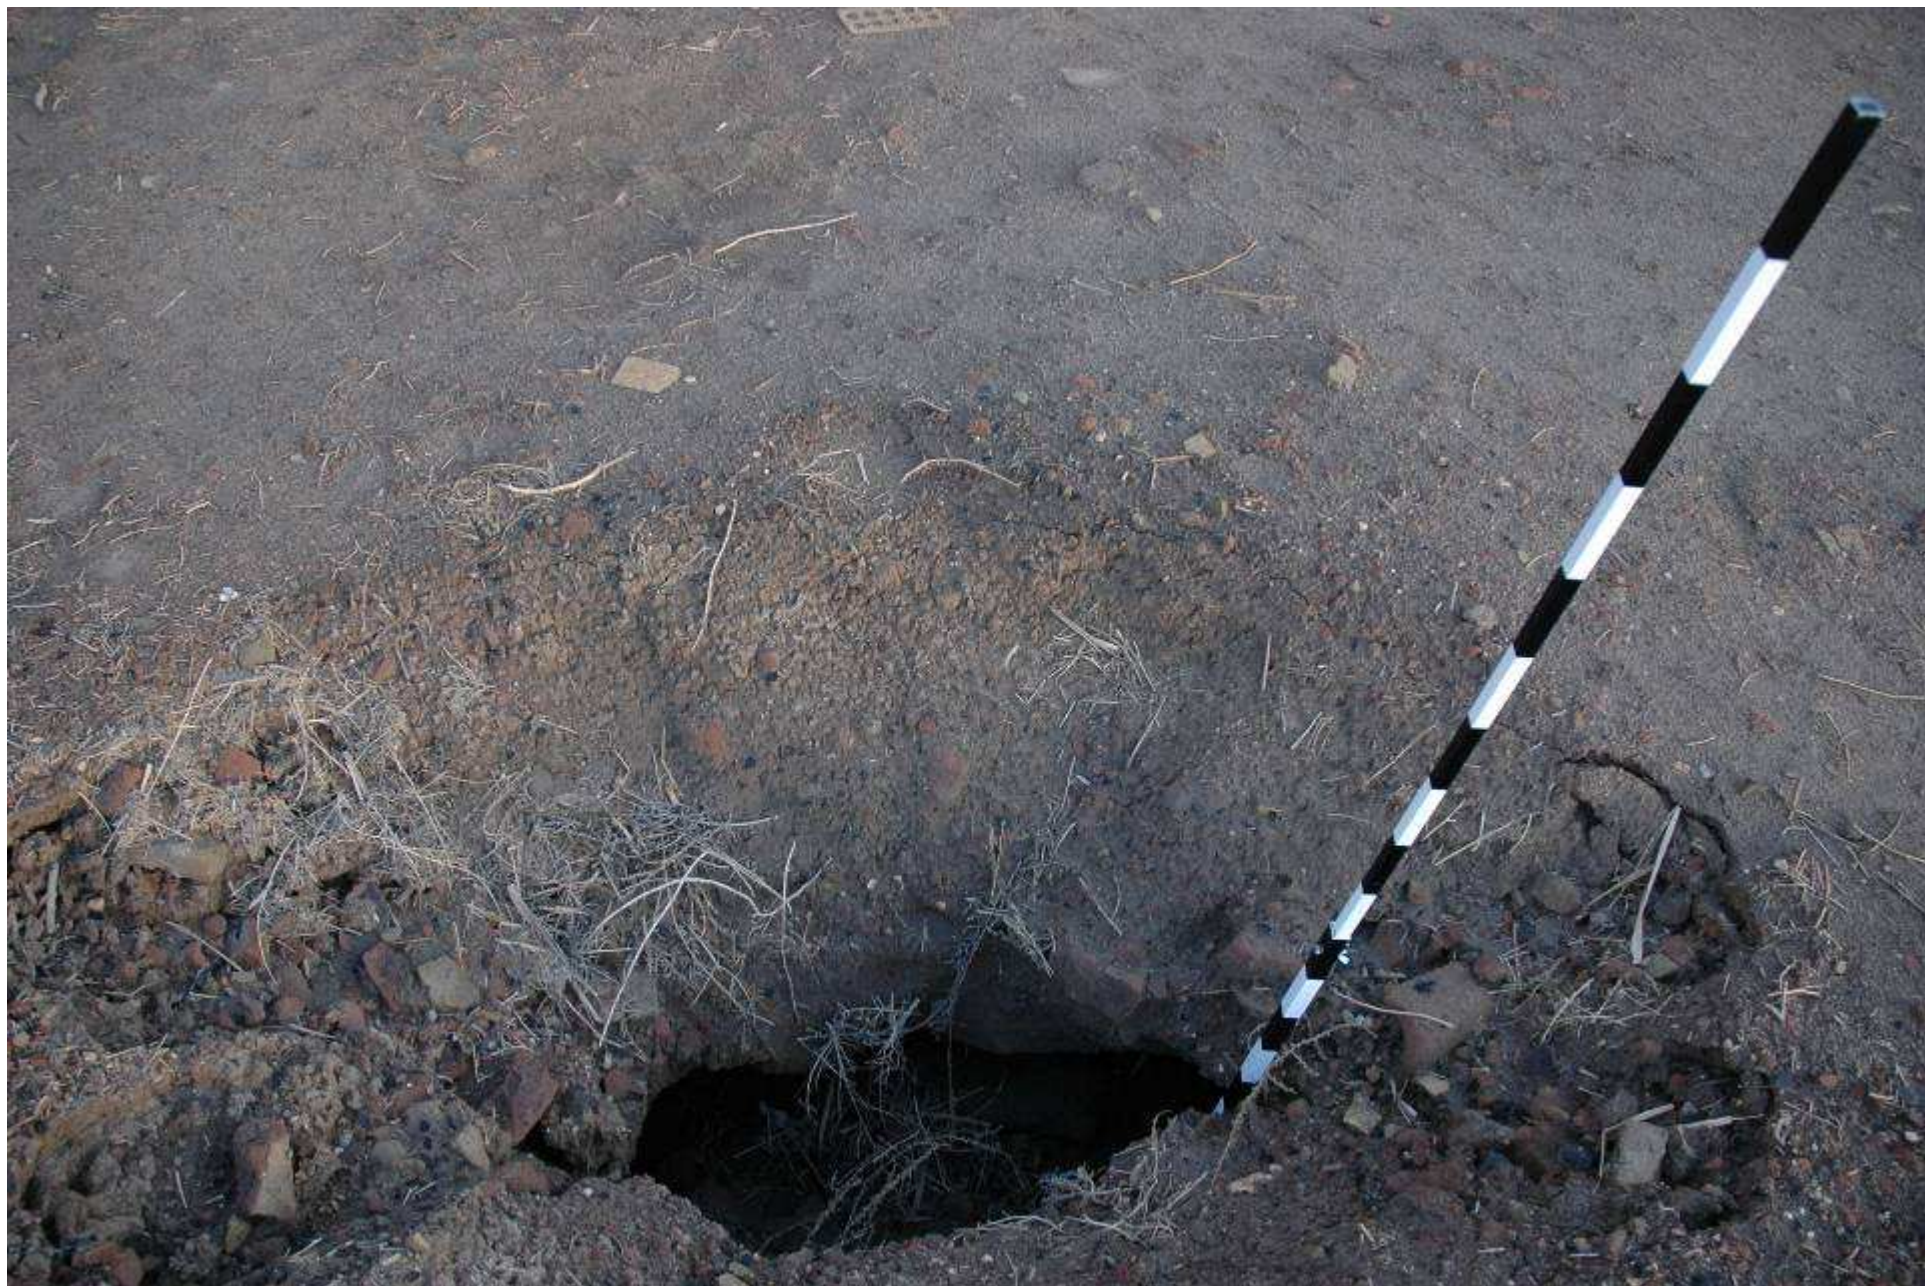
Robber pit, Polish Northern Palace photo 11 (photo © Ministry of Culture and National Heritage, Republic of Poland)

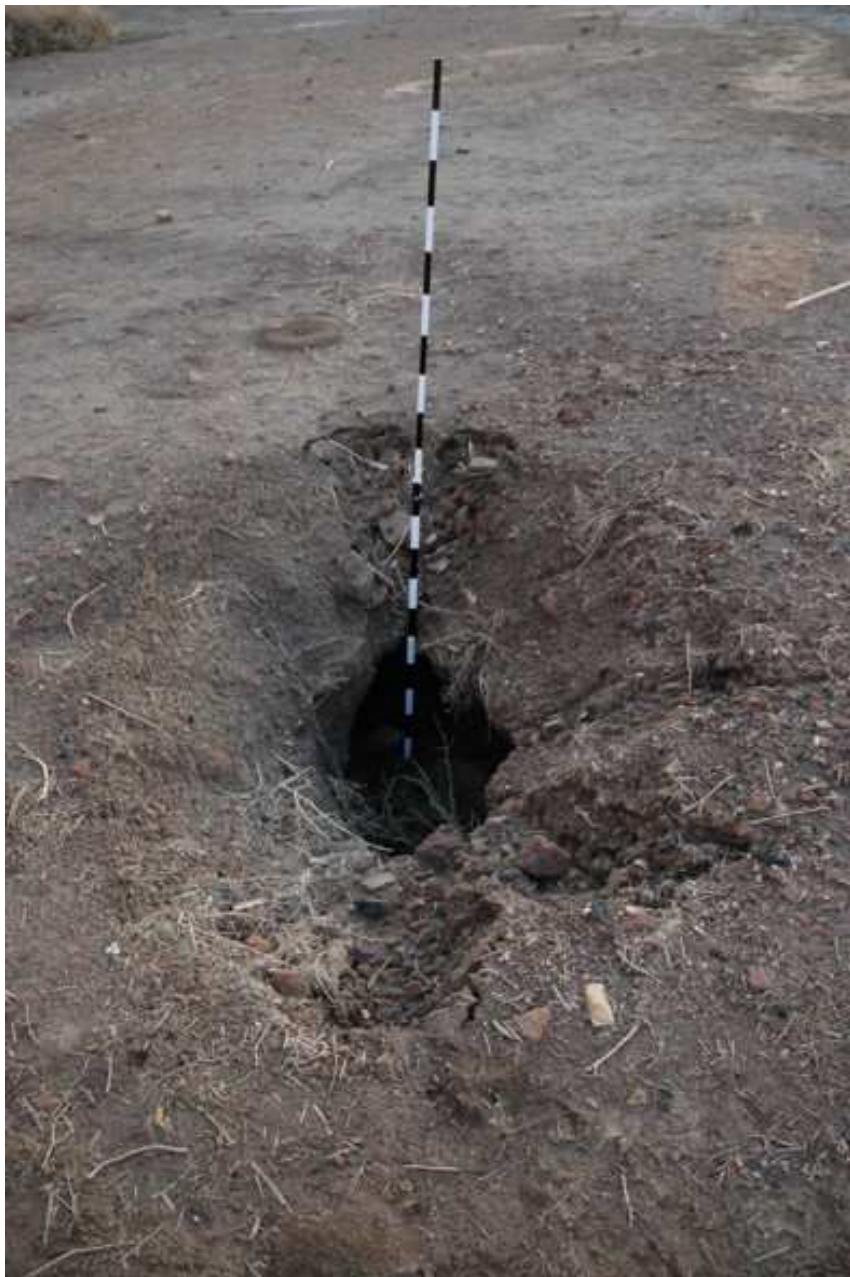
robber pit, Polish report p. 14 (photo © Ministry of Culture and National Heritage, Republic of Poland)

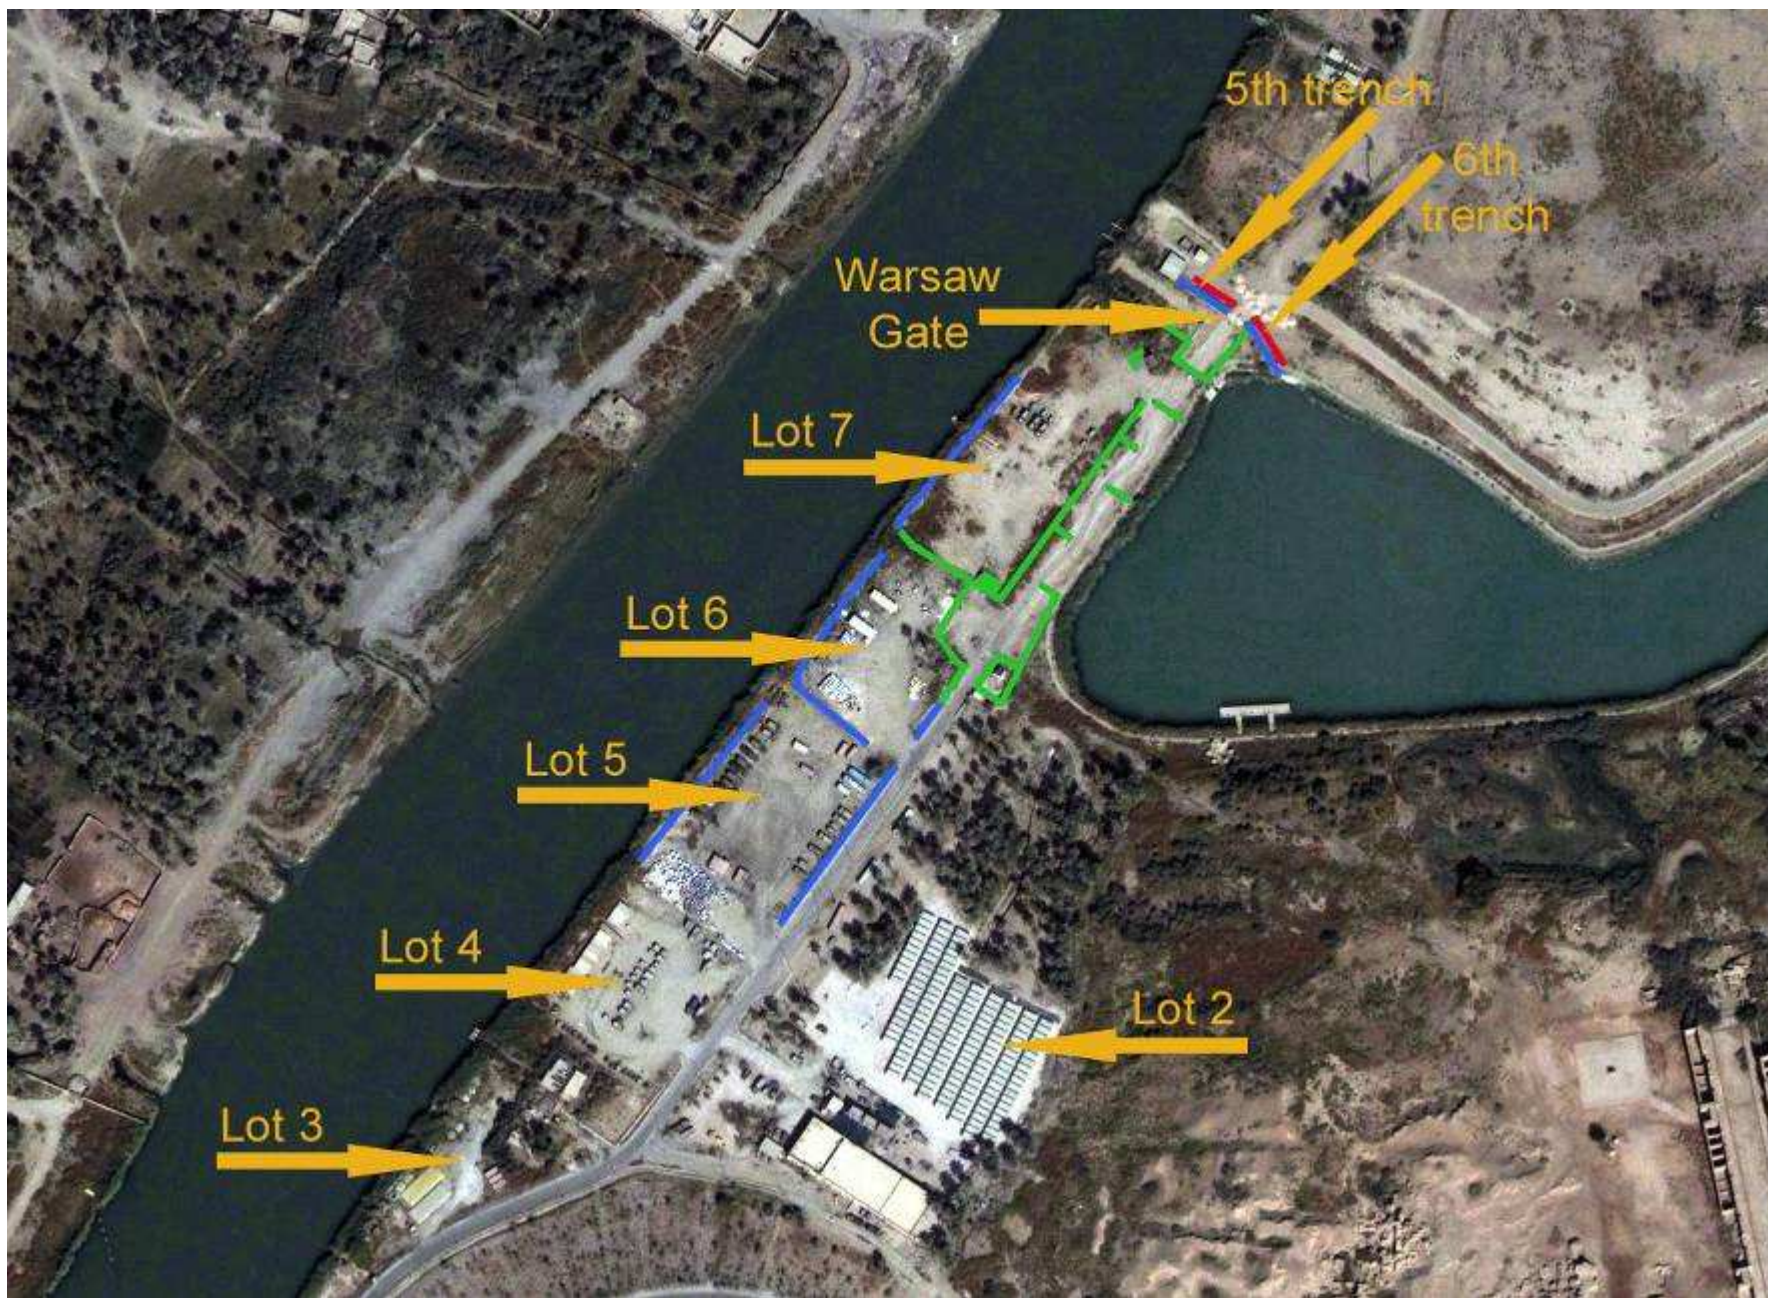
<b>Russell</b>	<b>McDonald report</b>	<b>Polish report</b>	<b>Stone report</b>
<p>Key to plan below:</p> <p>Red = trench Blue = berm Green = HESCO</p>	<p>The riverside area north of the Saddam palace mound has been used as a truck and car park as well as the site of various portakabins. The areas here were very flat already so they were just graveled, they would not have needed skimming apparently. Further north of this riverside area is the site of building debris that was presumably left over from the building of the Saddam Palace. The track at the base and to the west of the Saddam mound has been 'prepped' (ie. Skimmed, earth dumped, watered, compacted) and graveled. It is regularly watered to keep the dust down.</p>	<p>The terrain is suitable for parking lots at numbers 2, 4, 5, 6 and 7 in the picture above [below]. A water treatment station is located in the vicinity of number 3 on the picture above.</p>	<p>As noted in the Polish report, this area was used primarily for parking areas for vehicles and containers and a water-treatment plant. It is an area which is not included in the detailed map of Babylon prepared by Koldeway. Most of it is not included in the Iraqi contour map either. This is because much of this area is where the ancient river flowed in antiquity.</p> <p>The imagery shows that although there were cleared areas there before the establishment of Camp Alpha, over the time of the camp these experienced increasing development. In terms of chronology, the development of the road from the north in Area 1 was in place by August 31, 2003, as was some occupation of Parking Lots 2, 3, 4, 5, and 6 (Fig. 1).</p>

Reference view, final phase, 8 October 2004, Russell composite

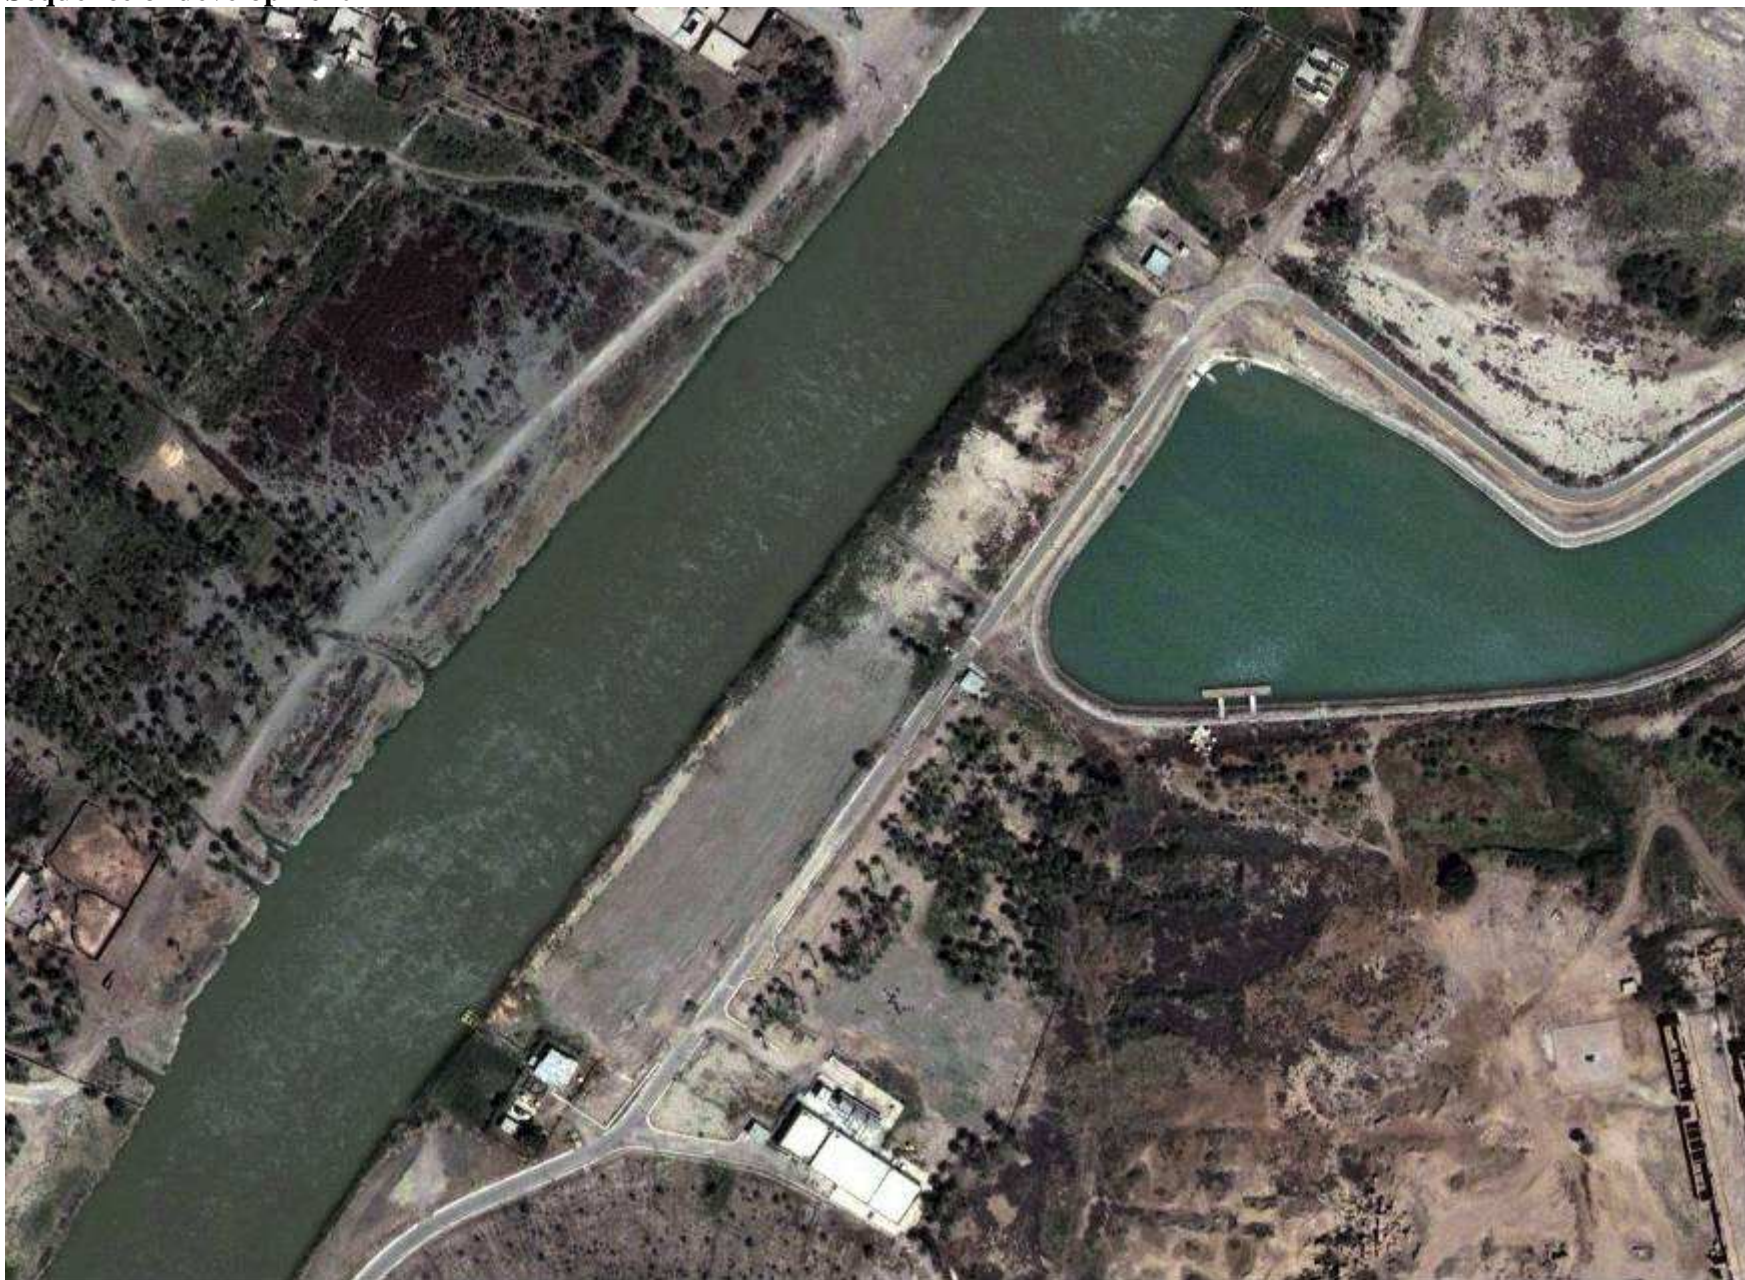
Prior to Coalition development, 5 July 2002, Russell composite

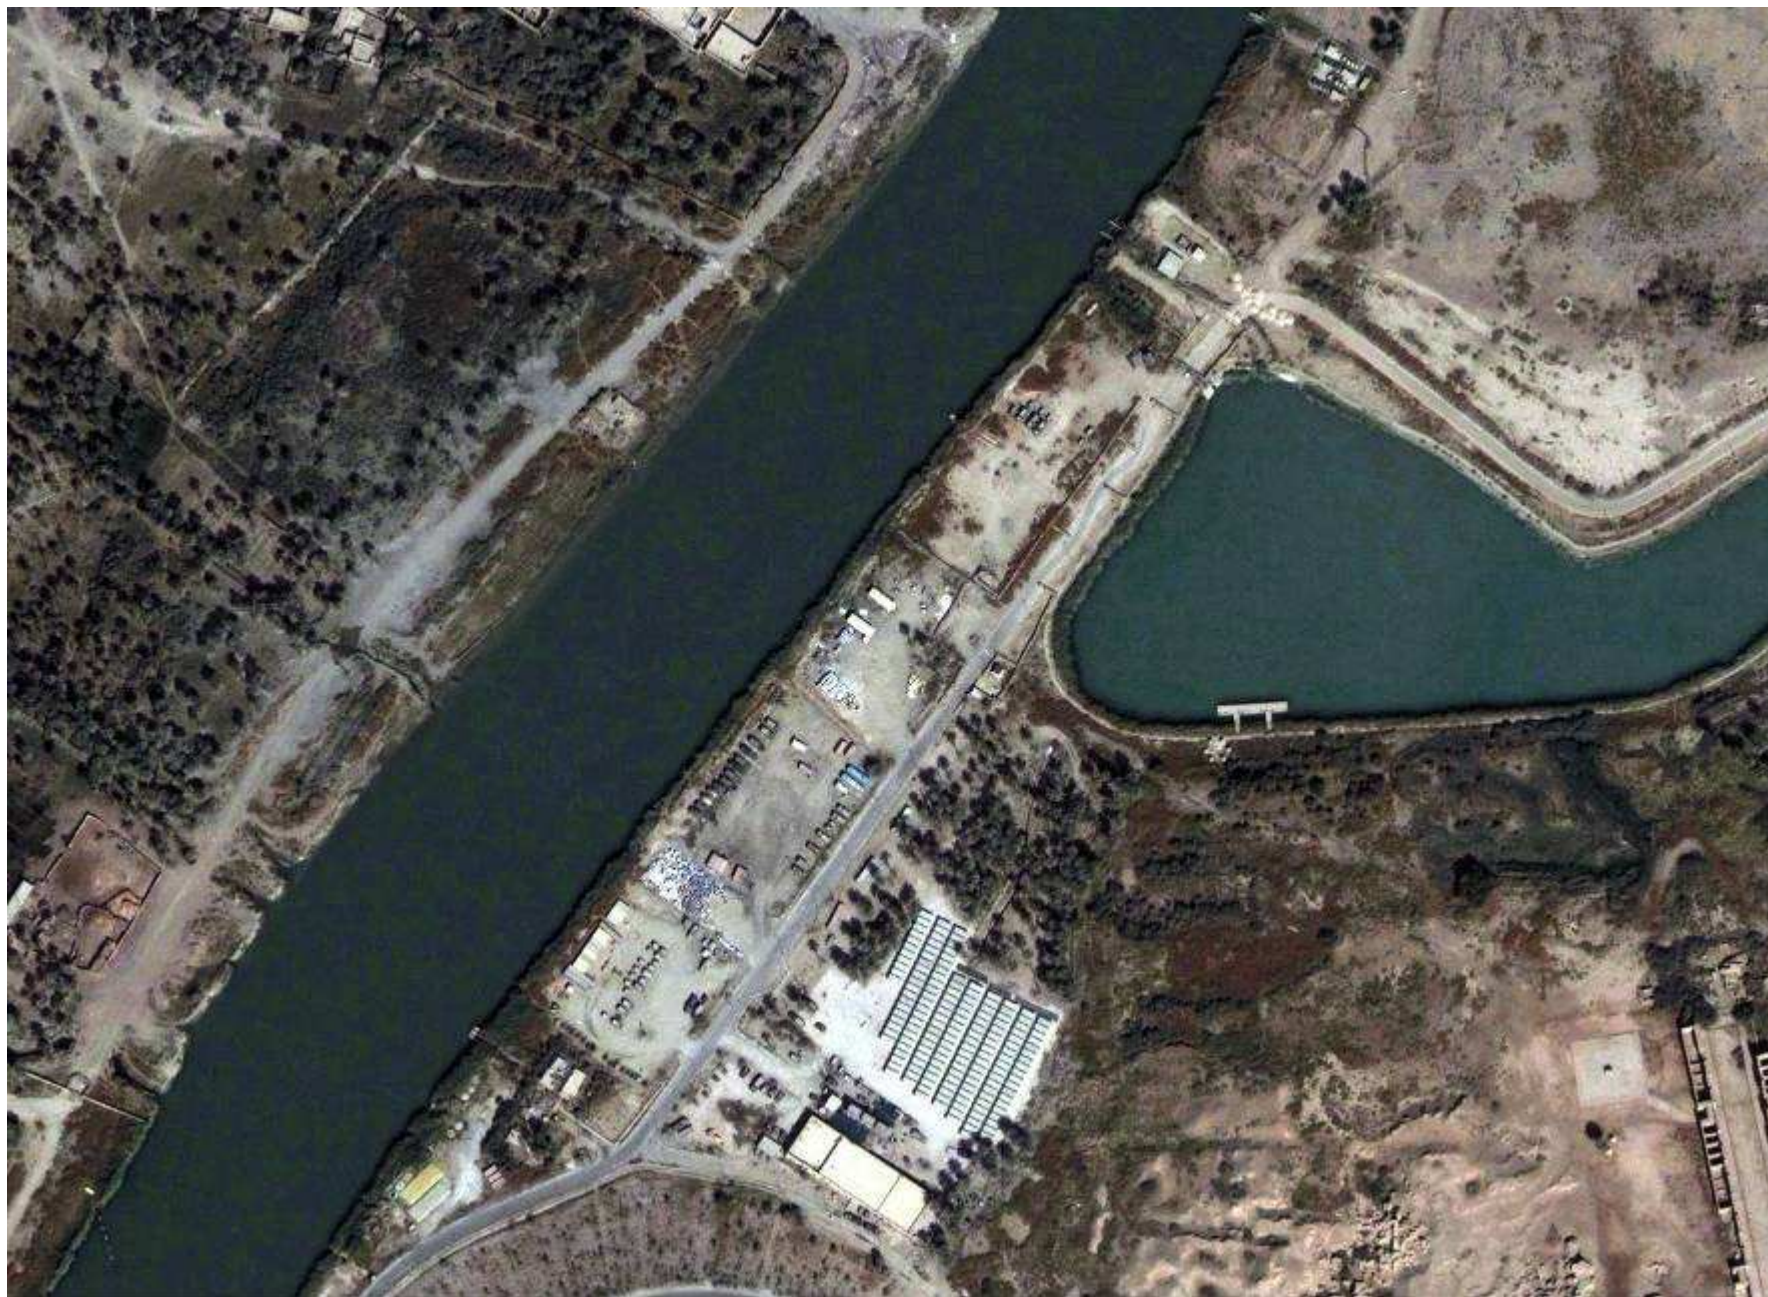
Final phase of Coalition development, north gate is blocked and berms and HESCO containers are now in place, 8 October 2004, Russell composite

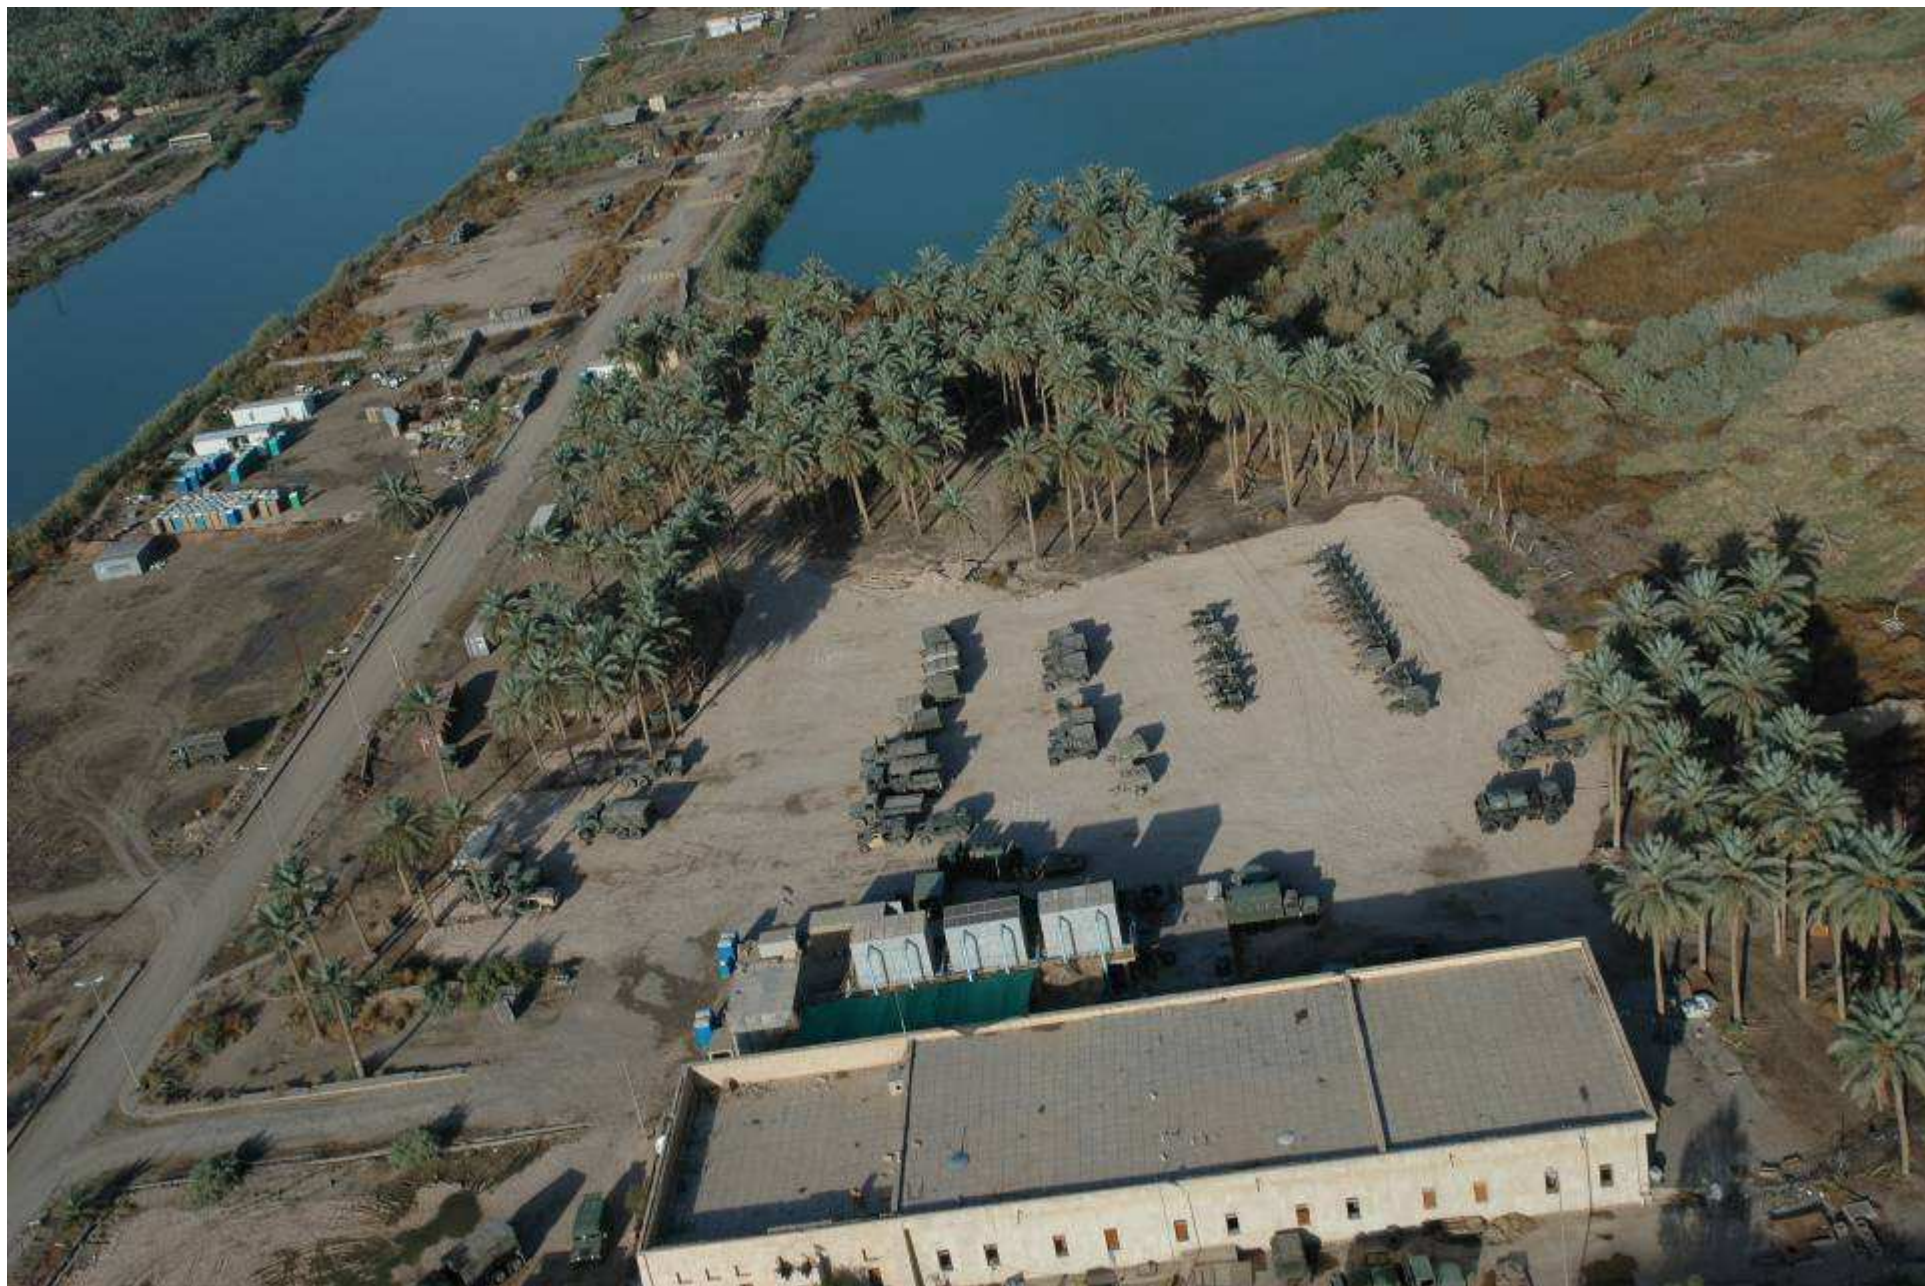
View from south, with Lot 2 at right, Polish photo 59 (photo © Ministry of Culture and National Heritage, Republic of Poland)
