# **Report on Damage to the Site of Babylon, Iraq**

**John Malcolm Russell, Ph.D.**

**Cultural Heritage Center  
Bureau of Educational and Cultural Affairs  
Department of State**

**April 2010**

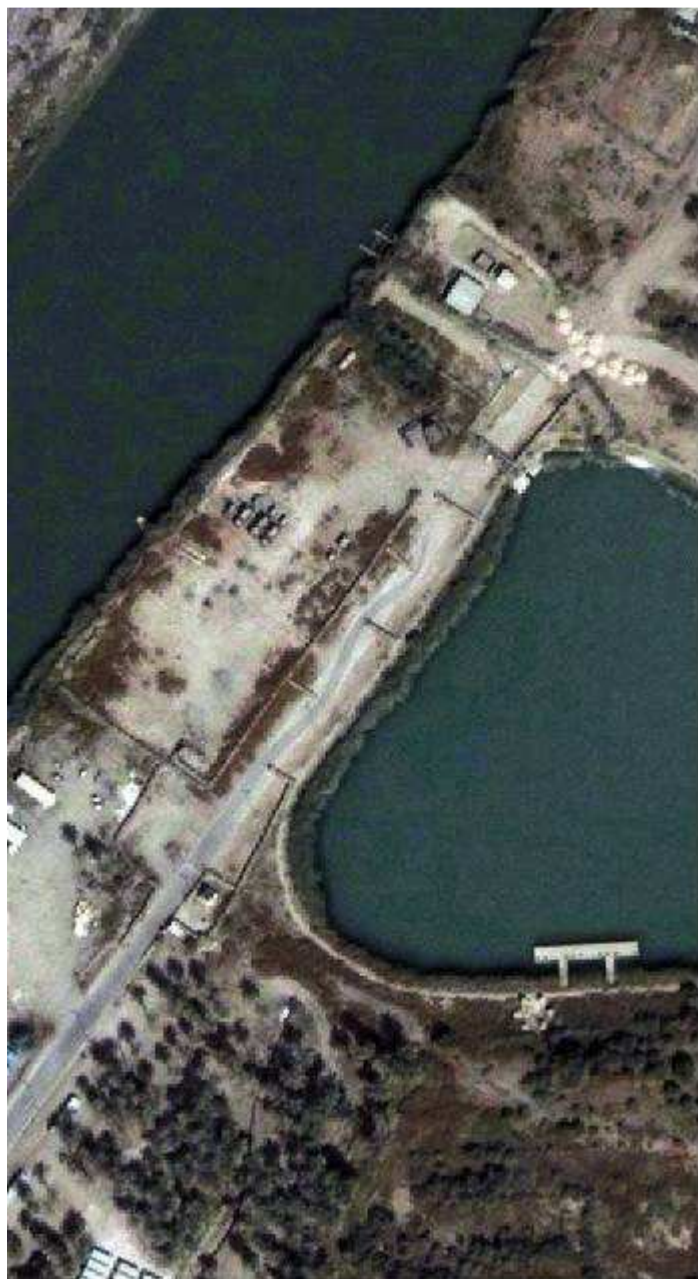
HESCO bags at gate, 8 October 2004, Russell composite

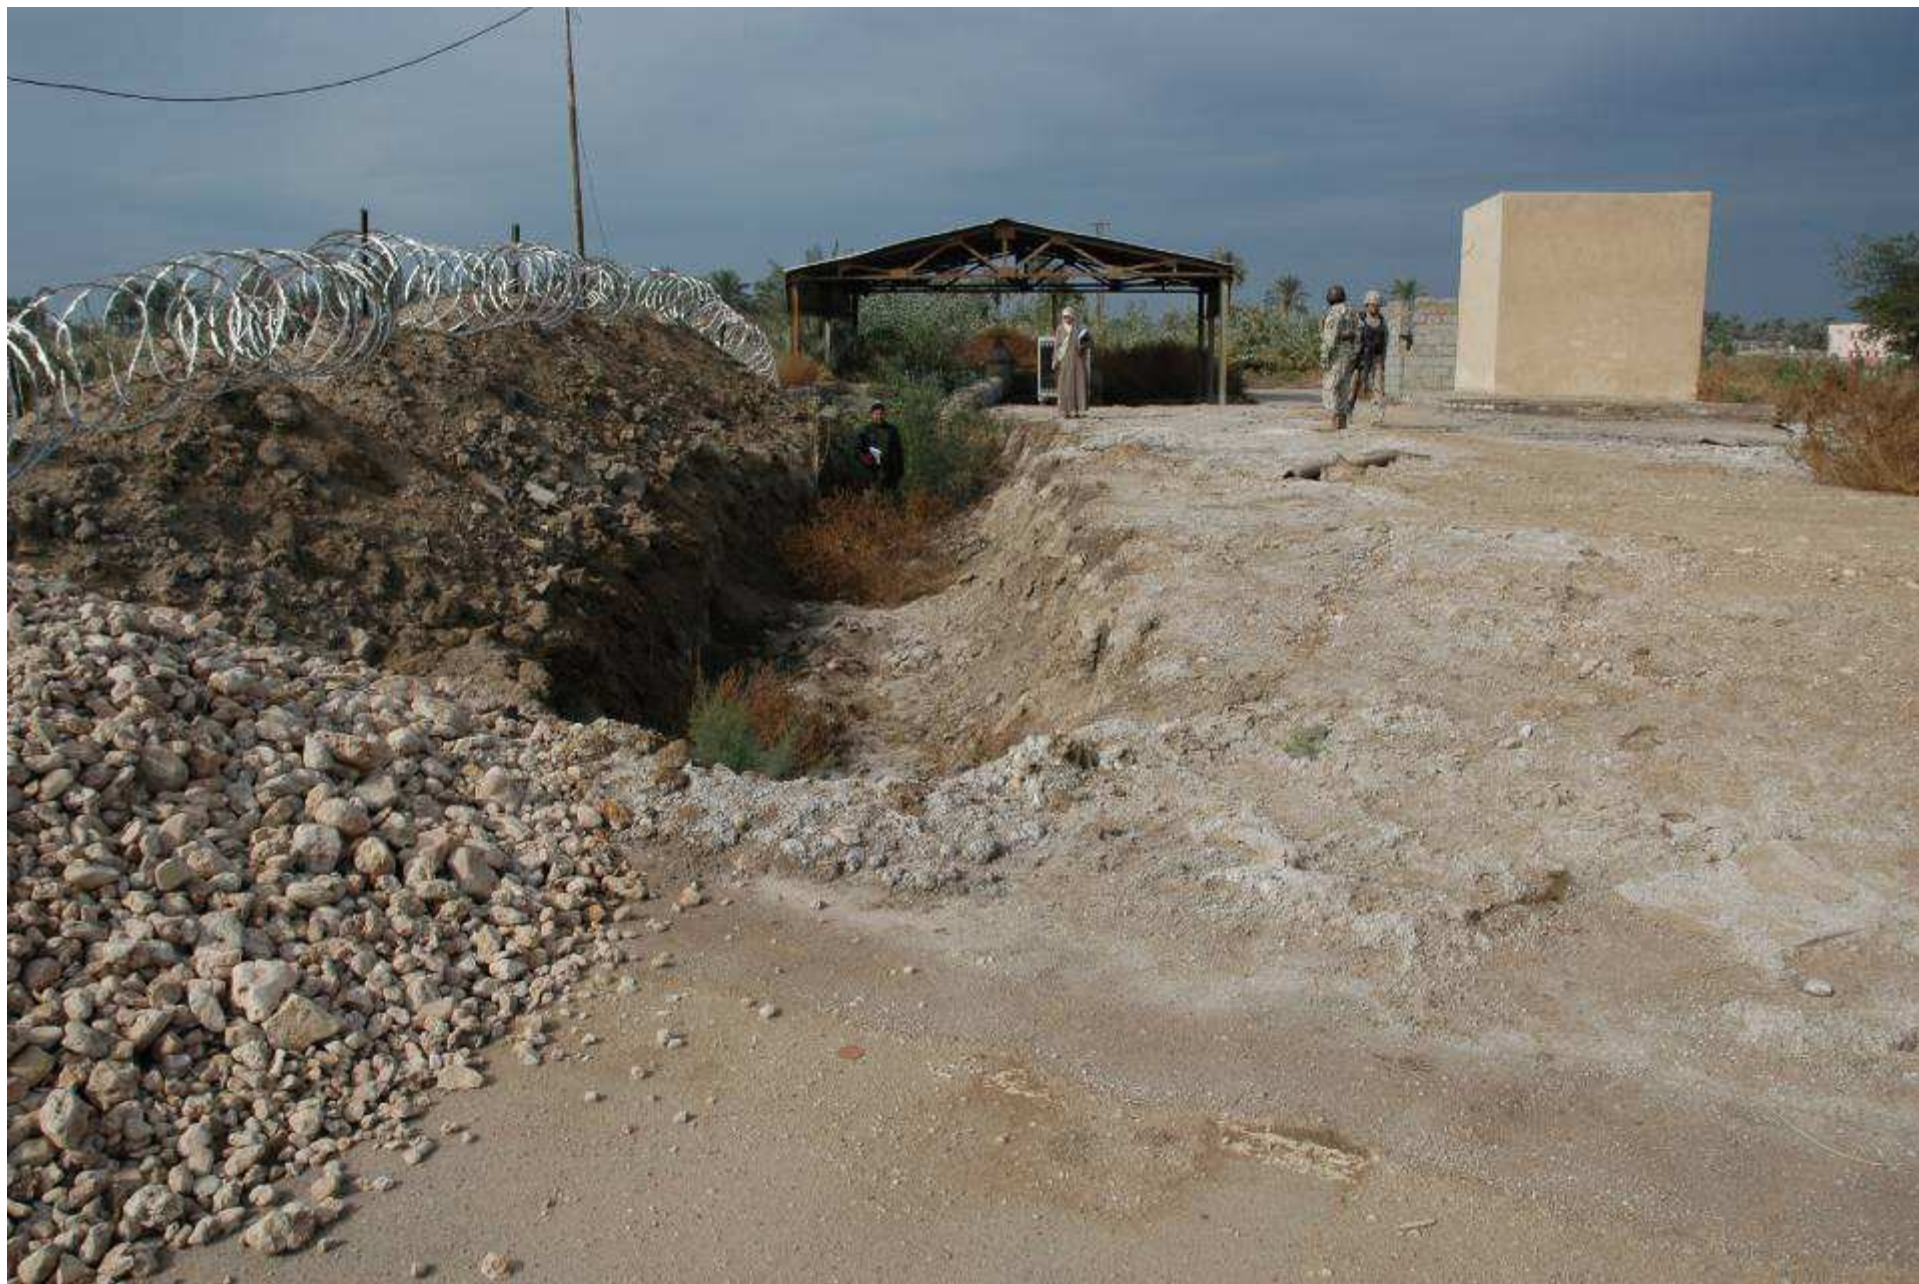
Feature	Iraqi preliminary report	Iraqi final report	Curtis report	Polish report
<b>Intro.</b>	c. In the area located [ <u>A: northwest of the eastern portion of the city.</u> ] north of the palace, to the left of the Shatt al-Hillah Canal, there are, on the two sides at the entrance, two trenches on the left and right sides.		Outside the so-called Warsaw Gate which is in the north-west corner of the camp there are 2 trenches, each c.20m long. See <i>Polish Report</i> , fig. on p.16. In the piles of spoil alongside the trenches there are many fragments of brick, some with inscriptions of Nebuchadnezzar.	1) „Warsaw” Gate At the “Warsaw” gate there is a ditch running from Shatt al-Hilla to the channel lying on the other side of road. In front of this ditch are stacks of gravel.
<b>Western trench</b>	The first trench has a length of 18 meters, a width of 2 meters, and a depth of 1.5 meters.	5. A fifth trench is located north of the presidential palace, to the left of al-Hillah waterway. This area is the northern access to the city. The fifth trench has a length of 18 m, a width of 2 m, and a depth of 1.15 m (see Photo 26).

5th trench, Iraqi final report fig. 26

**Russell comment:** As with the trenches at the north gate, it is not clear why there should be so many brick fragments in the berms and HESCO containers in an area that was apparently on the west bank of the Euphrates River in antiquity, and one wonders if the earth containing them was deposited in more recent times.

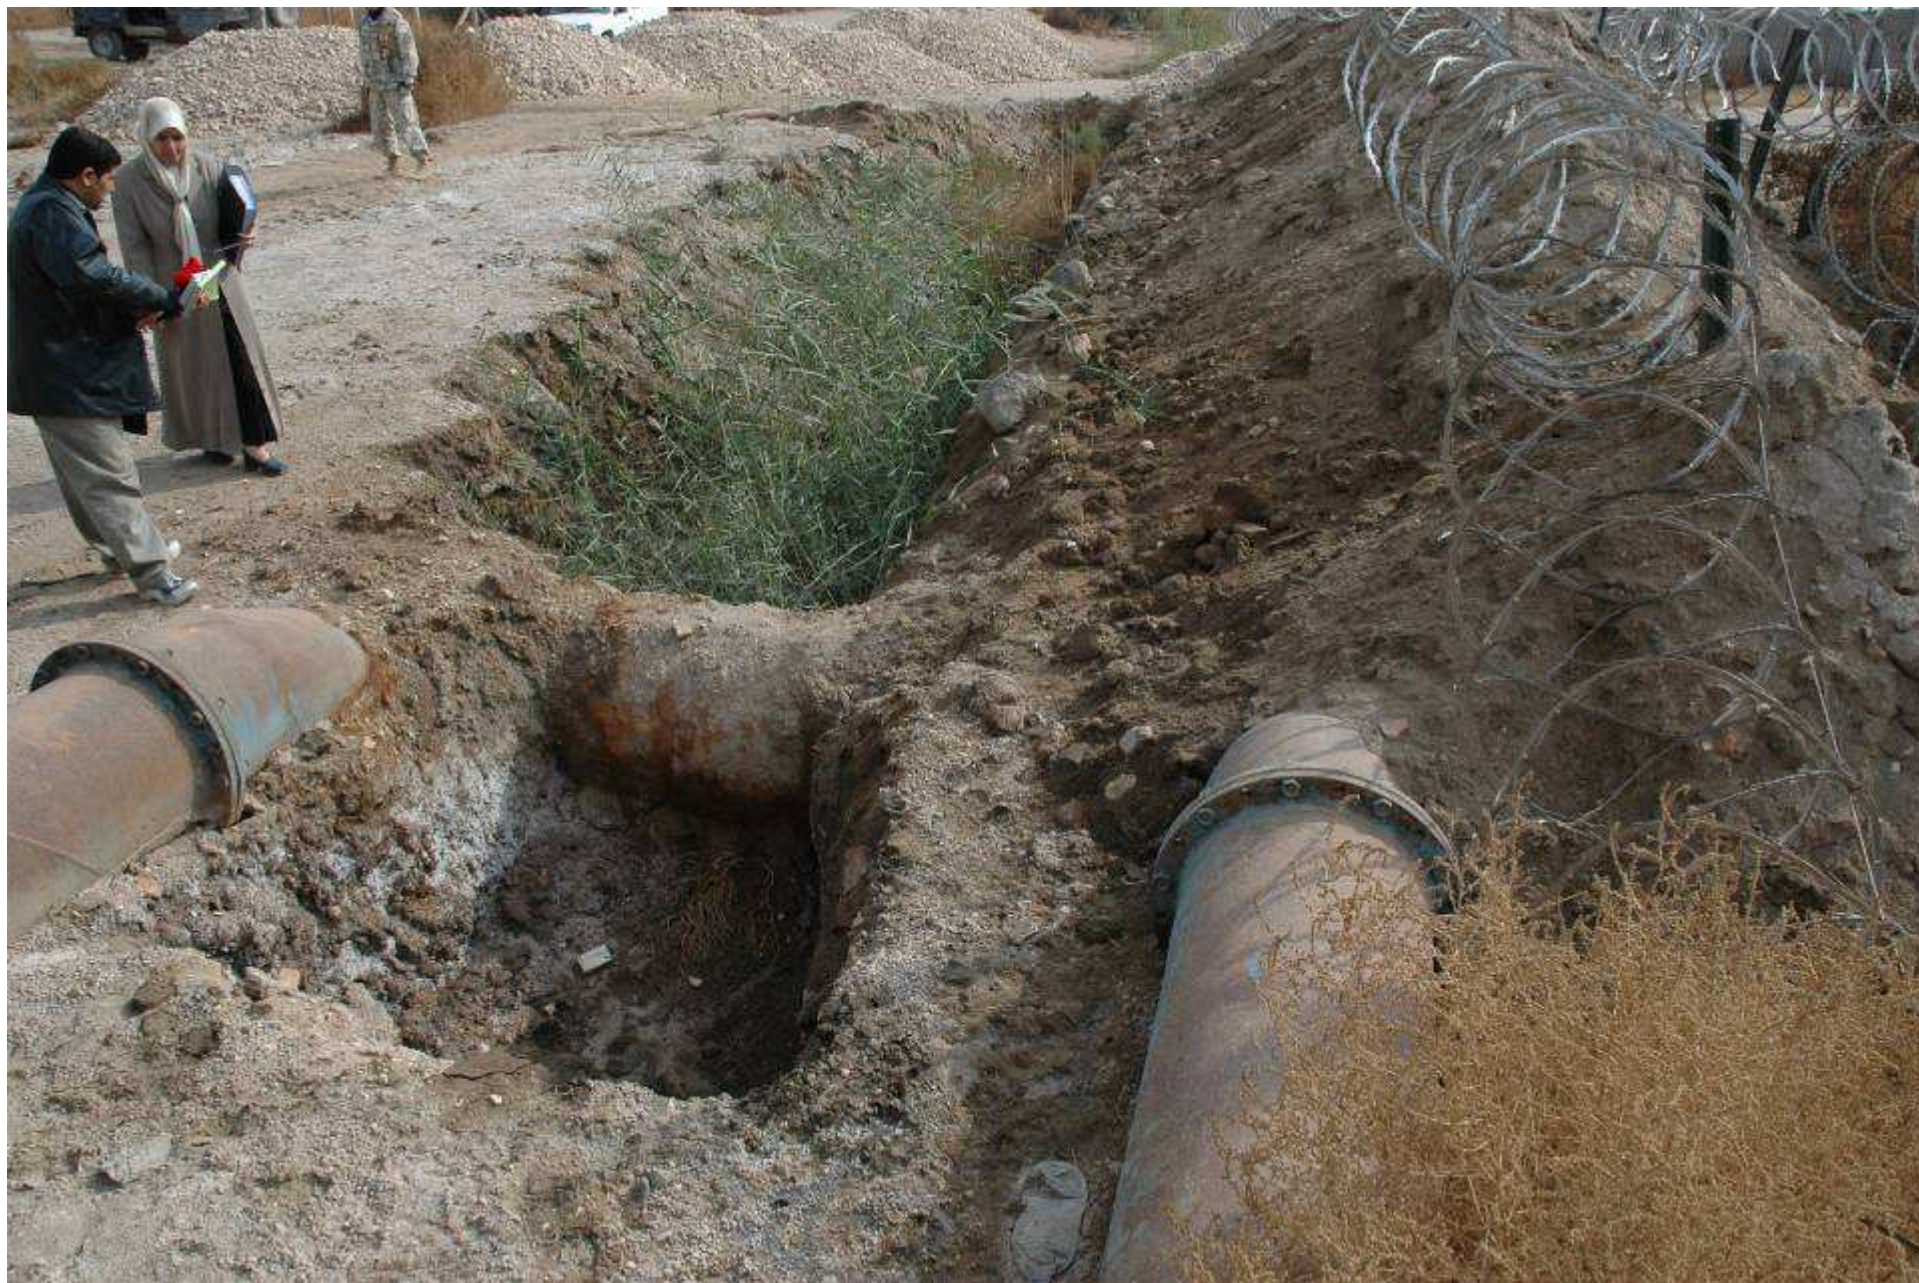
<b>Eastern trench</b>	The second trench has a length of 25 meters, a width of 2-3 meters, and a depth of 1.5 meters.	6. A sixth trench is located on the same expanse, on the right side of the entrance. It has a length of 25 m, a width of 2-3 m, and a depth of 1.15 m (Photo 27).

6th trench, Iraqi final report fig. 27

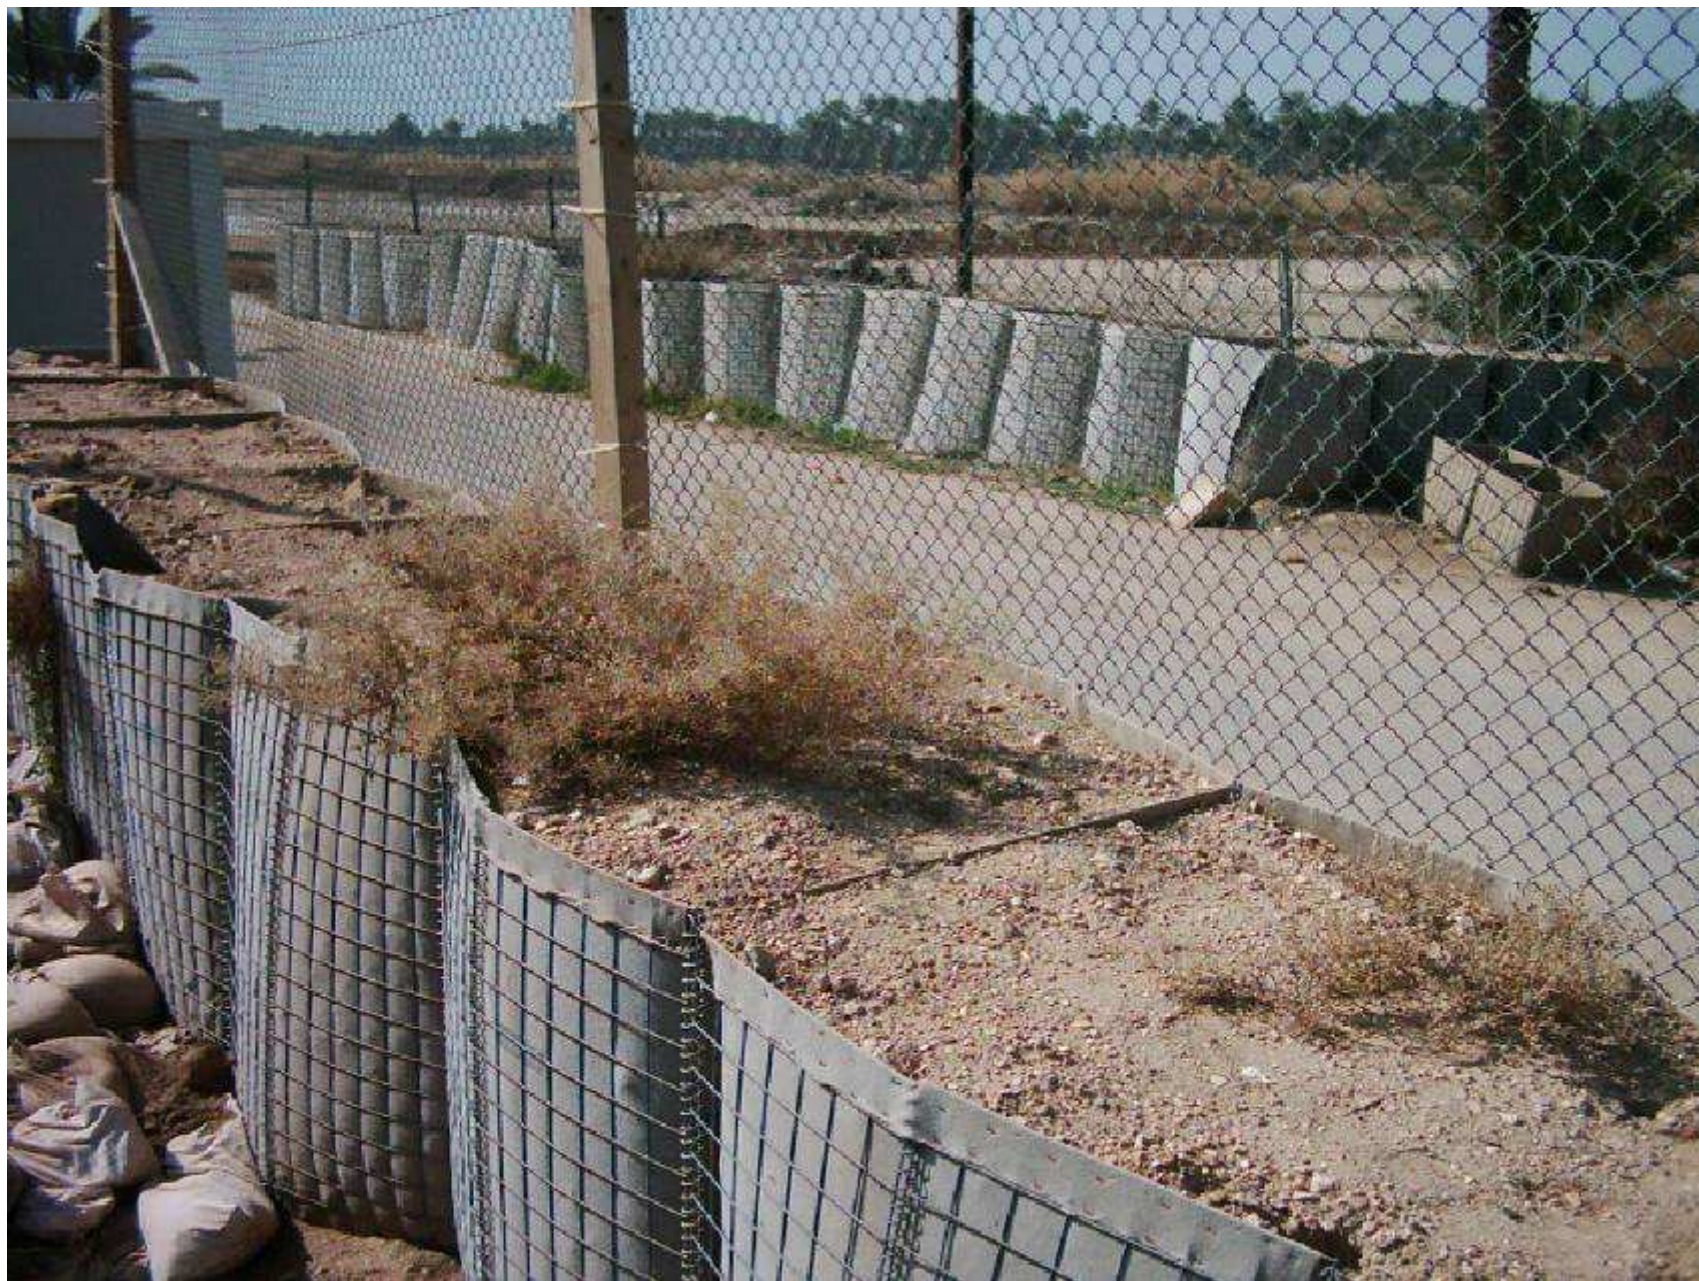
Feature	Iraqi preliminary report	Iraqi final report	Curtis report	Polish report
<b>Berms</b>	On top of the dirt removed from the two trenches are fragments of an ancient baked brick, a portion of which bears cuneiform writing consisting of an impression of a well-known seal pertaining to King Nebuchadnezzar II, and various pottery fragments.	The dirt removed from both the fifth and sixth trenches contains fragments of ancient baked brick and various pottery fragments.		
<b>HESCO bags</b>	<p>At the Warsaw Gate, HESCO bags were filled with dirt from inside Babel [and were placed in an area] with a length of 47 meters.</p> <p>According to their [the Polish] report on the Warsaw Gate, several bags of dirt from Babel are located along the northern gate. Many of these bags contain ancient baked bricks, some of which bear cuneiform writing.</p>	Along the northern entrance of the city, north of the presidential palace, on the two sides of the entrance, are dirt-filled HESCO bags covering a length of 200 m. Some of the bags contain fragments of pottery and baked bricks. Each HESCO container has a height of 1.5 m and a width of 1.10 m (Photo 70).

HESCO containers, Iraqi final report fig. 70

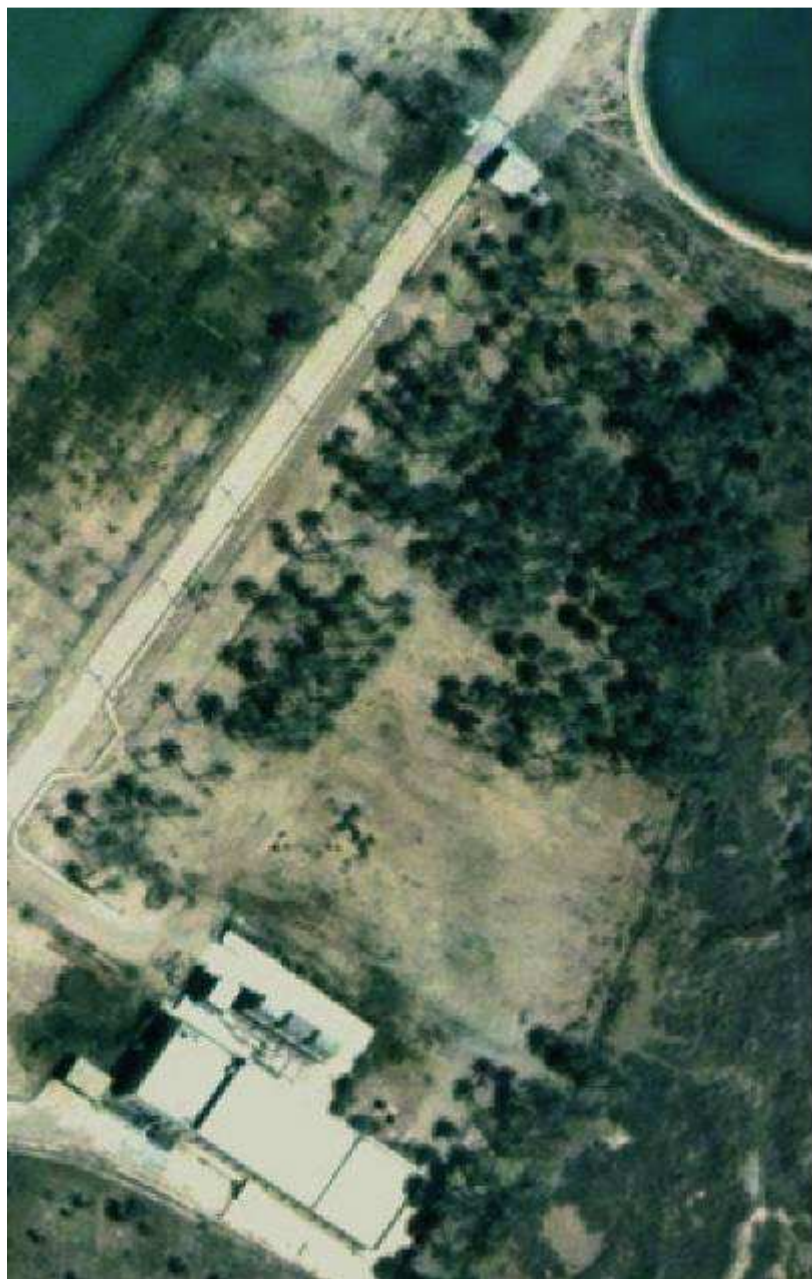
**Russell comment:** This lot already existed prior to the arrival of Coalition forces. I cannot tell from the satellite images if it was already graveled prior to the arrival of Coalition forces. McDonald is evidently referring to campsites in the palm grove north of Lot 2.

Before Coalition, 1 April 2003, Russell composite

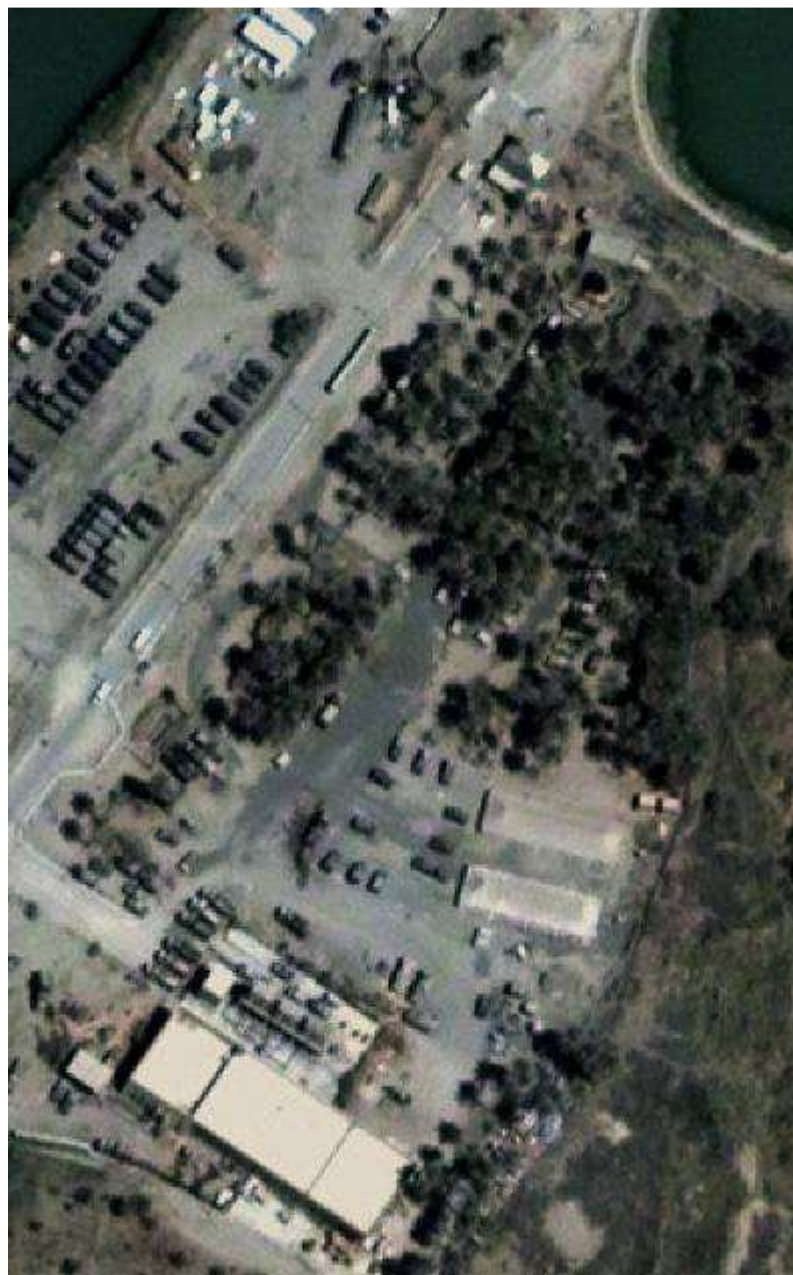
During Coalition, 31 August 2003, Russell composite

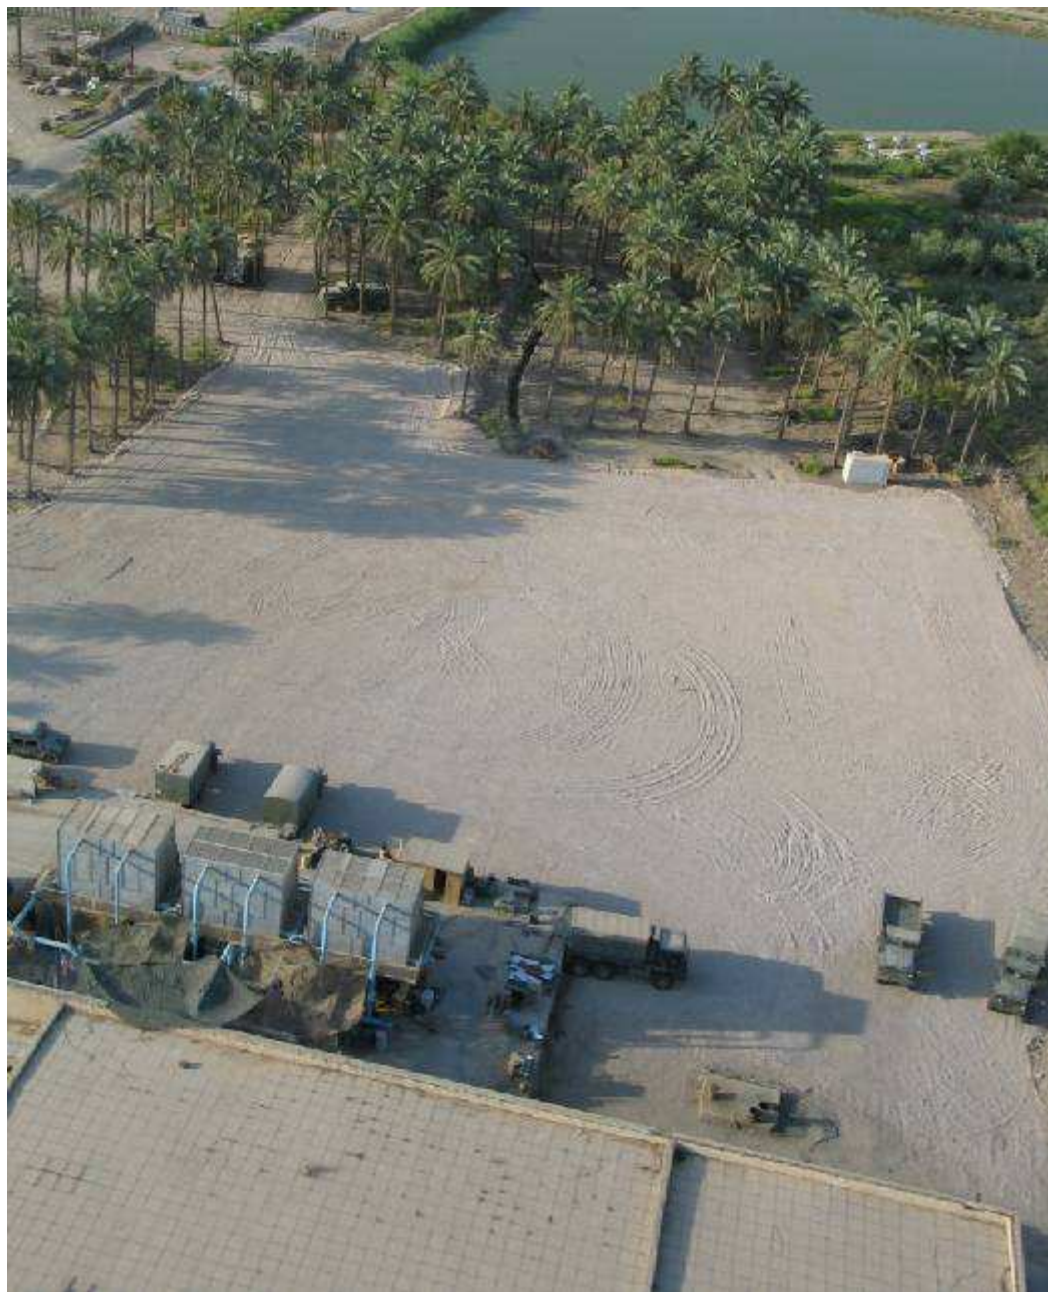
Lot 2, Iraqi final report fig. 59

<b>McDonald report</b>	<b>Iraqi preliminary report</b>	<b>Iraqi final report</b>	<b>Curtis report</b>	<b>Polish report</b>
Other campsites include: NE of the Saddam palace mound in groves of palm trees several tents were pitched with some graveling between the trees for vehicles etc.	c. The area north of the Presidential Palace: This area—which is located in the northwest part of the eastern part of the city and measures an estimated [A: <u>5000 sq m according to their report</u> ] 20 x 80 meters—was leveled and covered with gravel.	This 80 x 70 m area, which is located in the northwestern part of the eastern part of the city, has been modified and covered with coarse gravel (Photo 59).  A trench made by the MF was observed in photographs taken by the MF. It is located in the northern part of the area north of the presidential palace. The MF filled in the pit at the time (Photo 59)	There is a large parking lot to the north-east of Saddam's Palace (seen through the trees) that is now covered with gravel.	2) Parking lot The whole surface of this parking lot (about 5000 square meters) is covered by a layer of gravel.

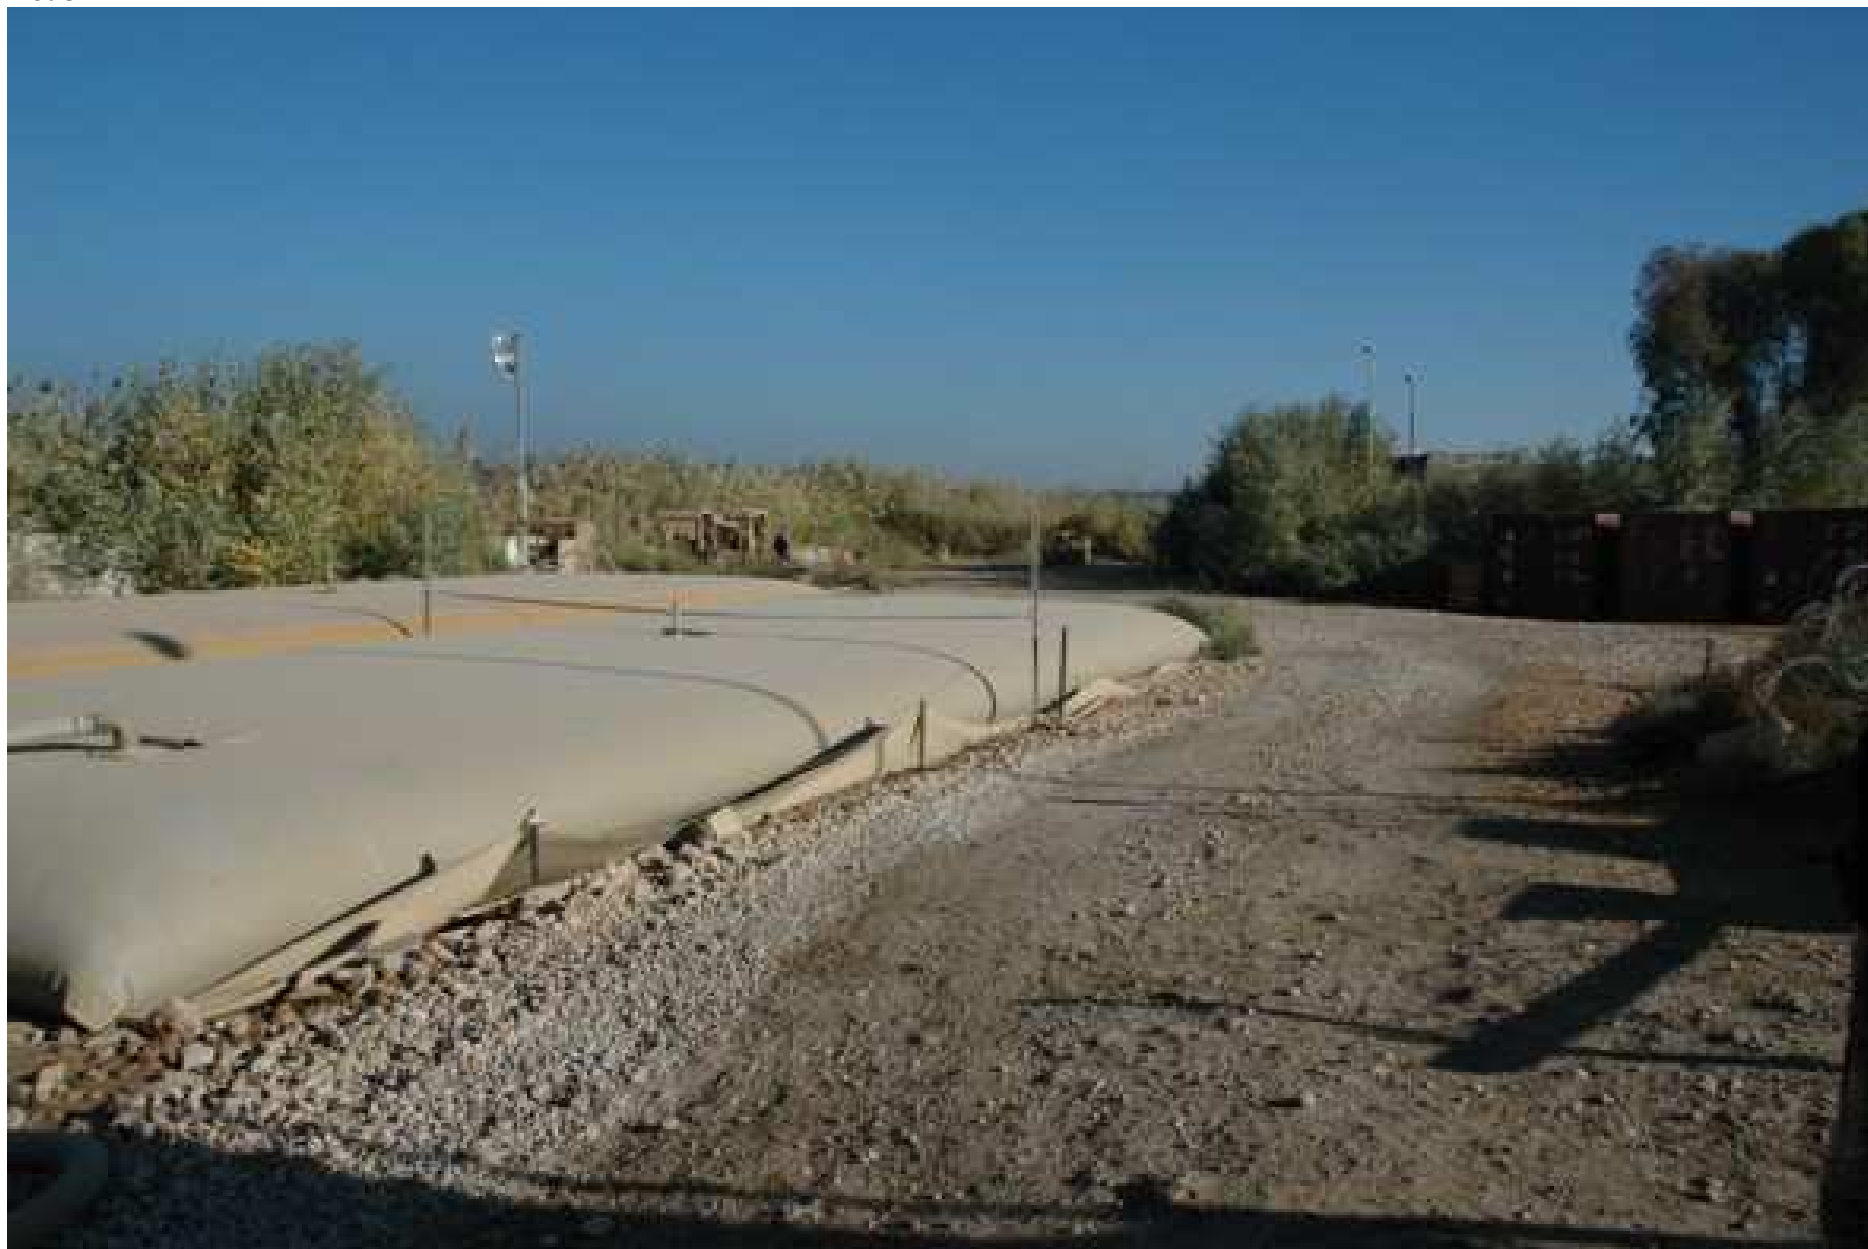
**Polish report:** "Station of the water treatment. Area of the station of the water treatment is covered by a layer of gravel," (photo: Polish report p. 5, © Ministry of Culture and National Heritage, Republic of Poland)

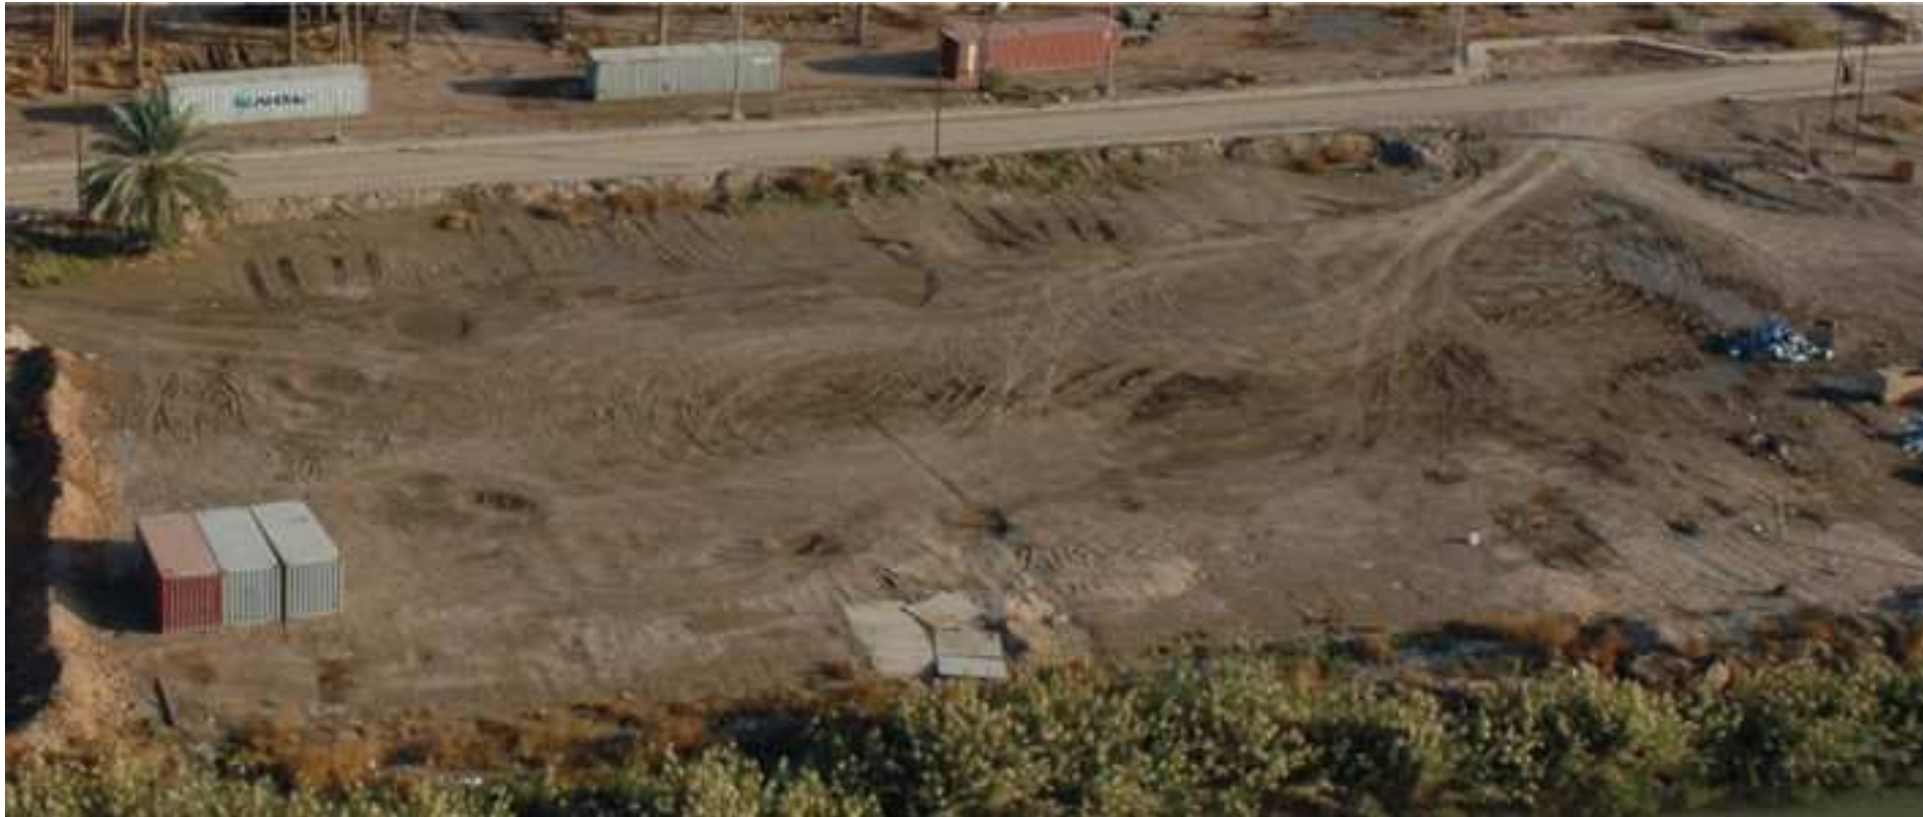
Lot 5, earth berms were built along the east and west sides of this lot, Polish report p. 5 (photo © Ministry of Culture and National Heritage, Republic of Poland)

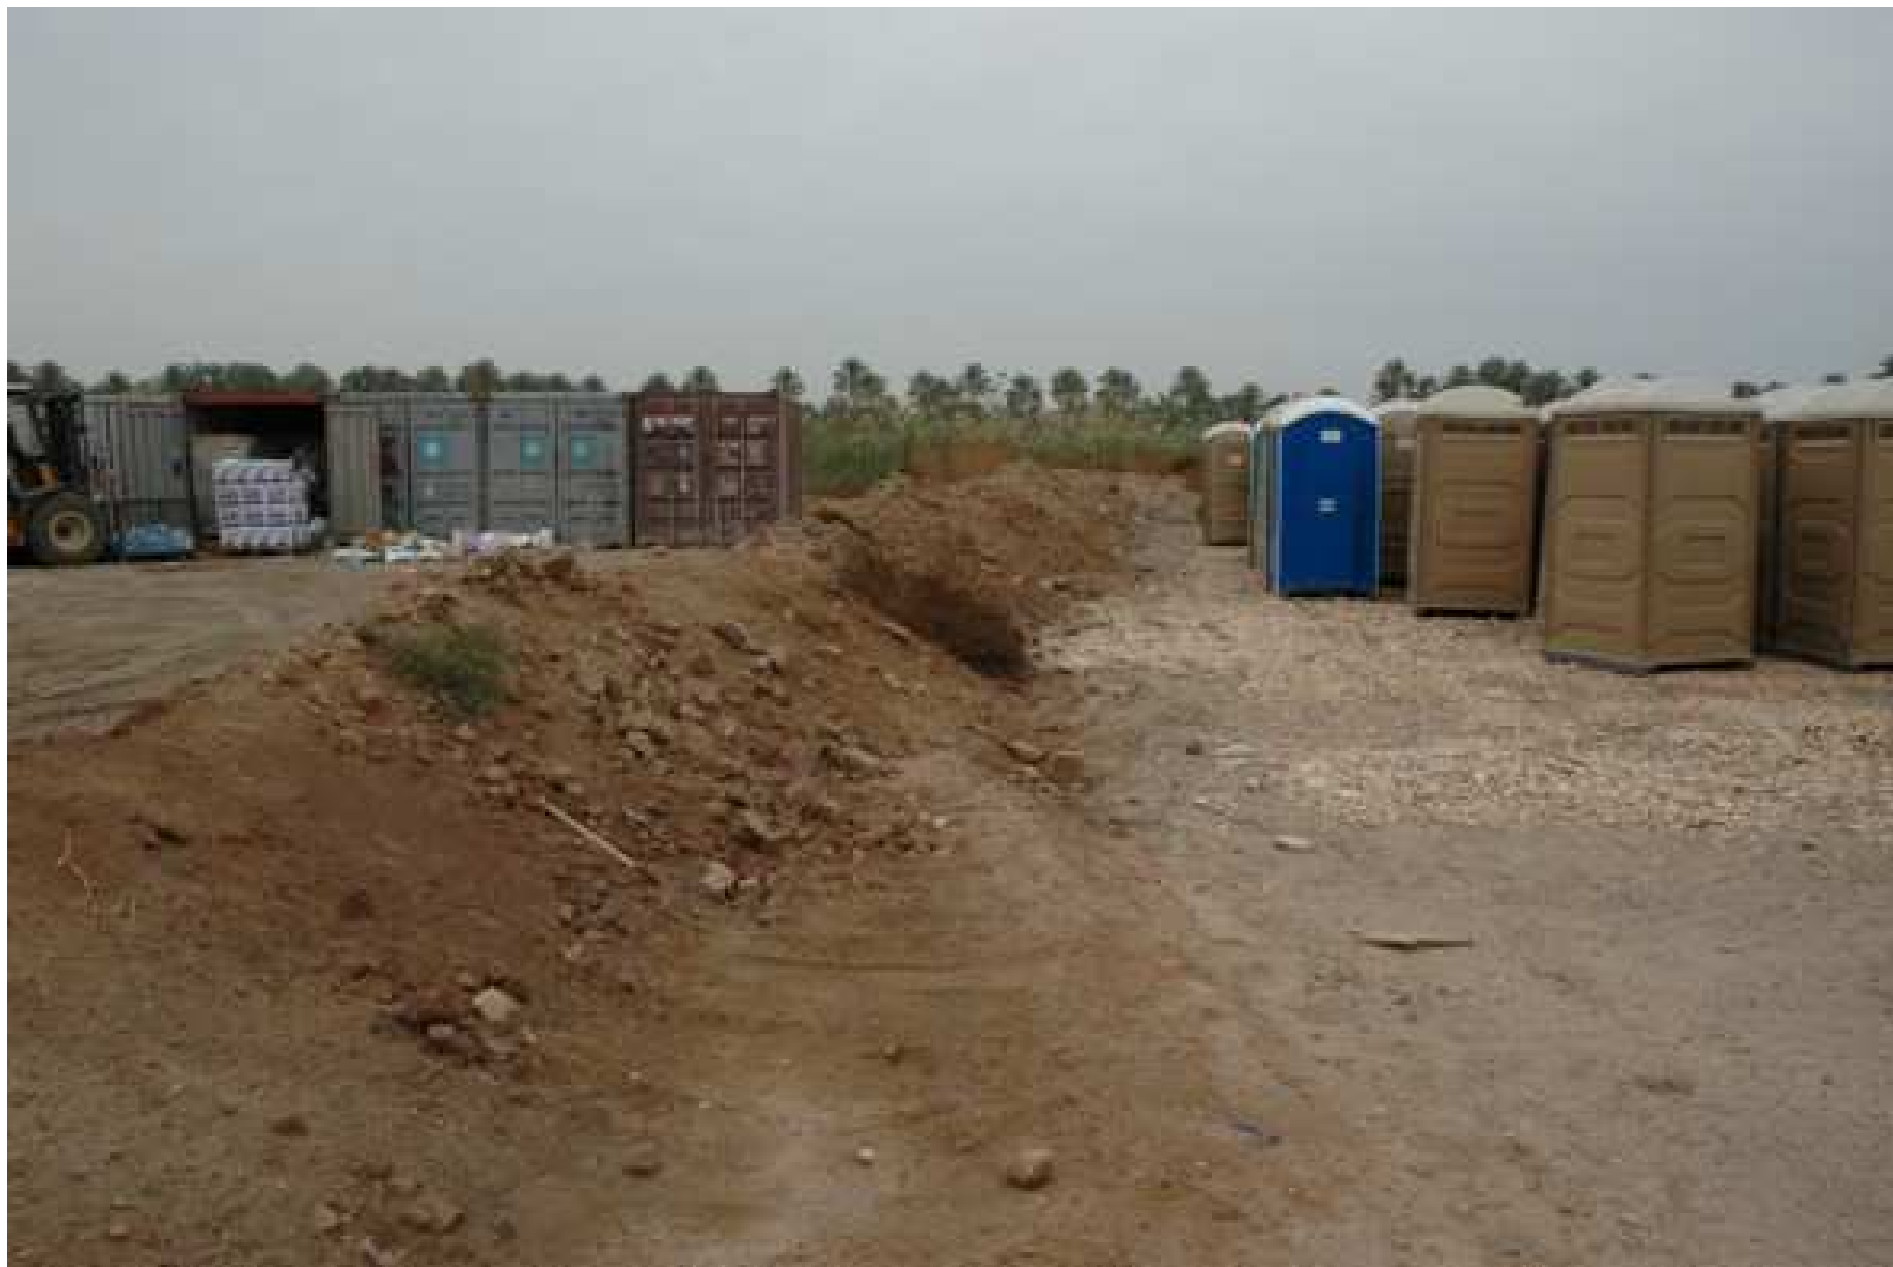
Berm between Lots 5 and 6, Polish report p. 6 (photo © Ministry of Culture and National Heritage, Republic of Poland)

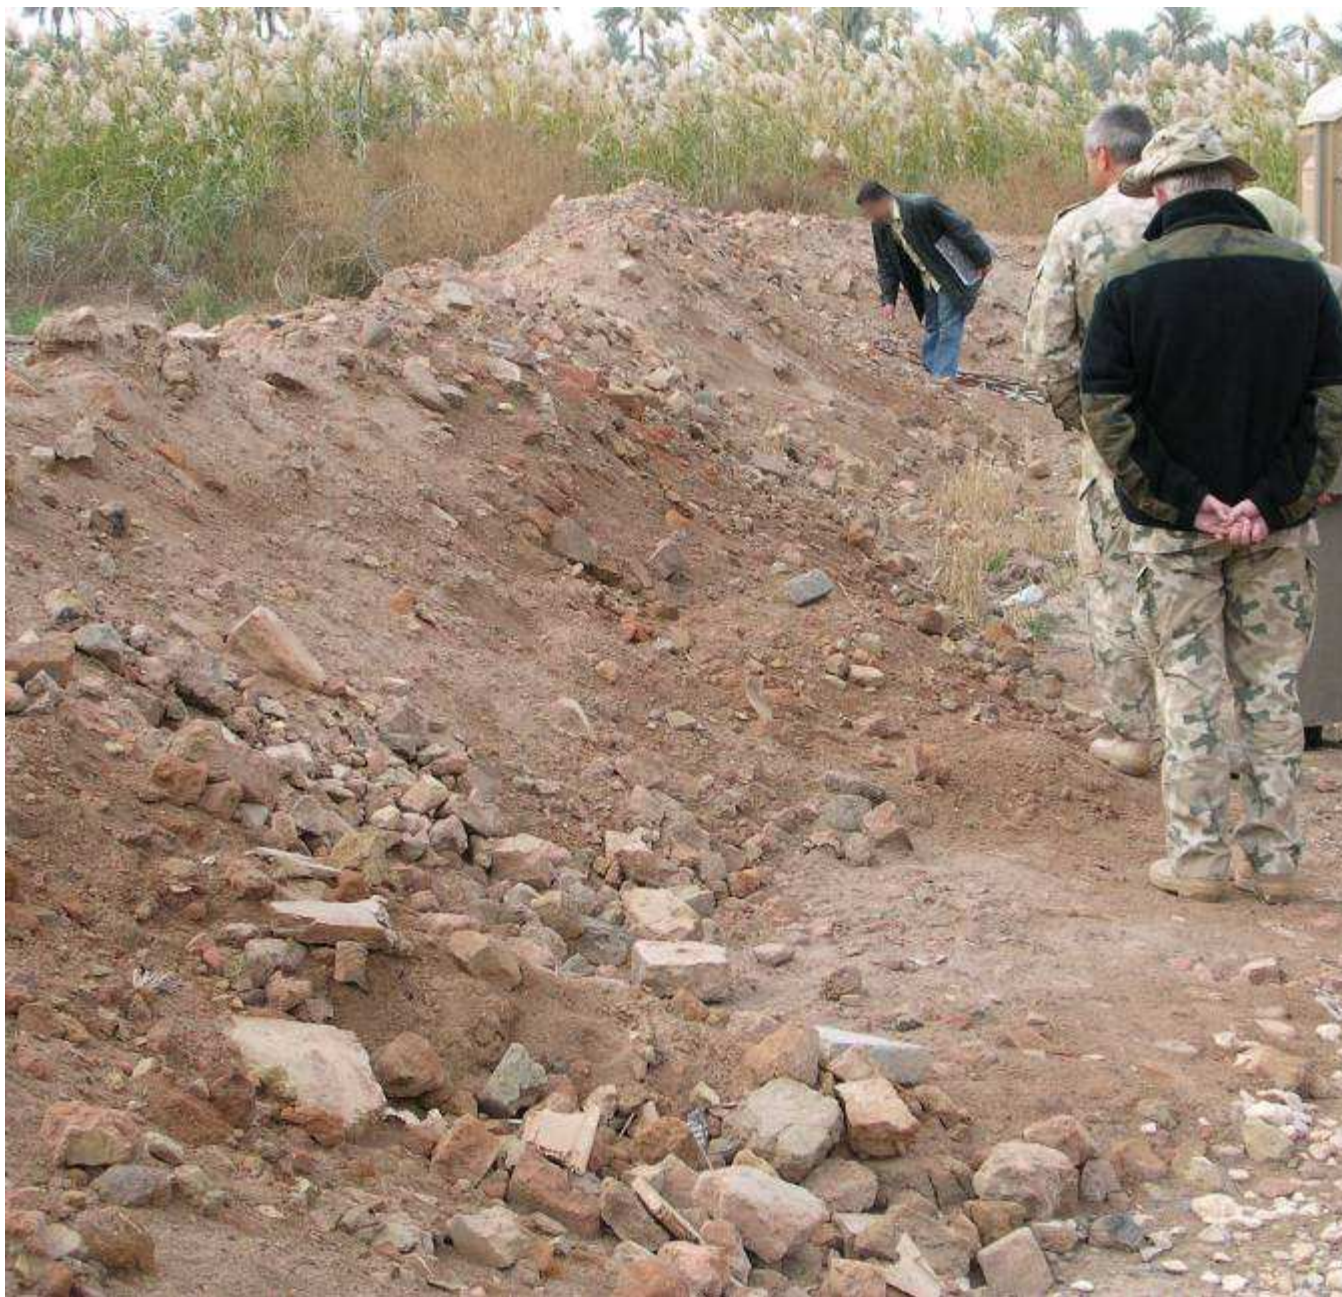
Berm between Lots 5 and 6, Curtis photo 7630 (photo © John Curtis)
