# **Report on Damage to the Site of Babylon, Iraq**

**John Malcolm Russell, Ph.D.**

**Cultural Heritage Center  
Bureau of Educational and Cultural Affairs  
Department of State**

**April 2010**

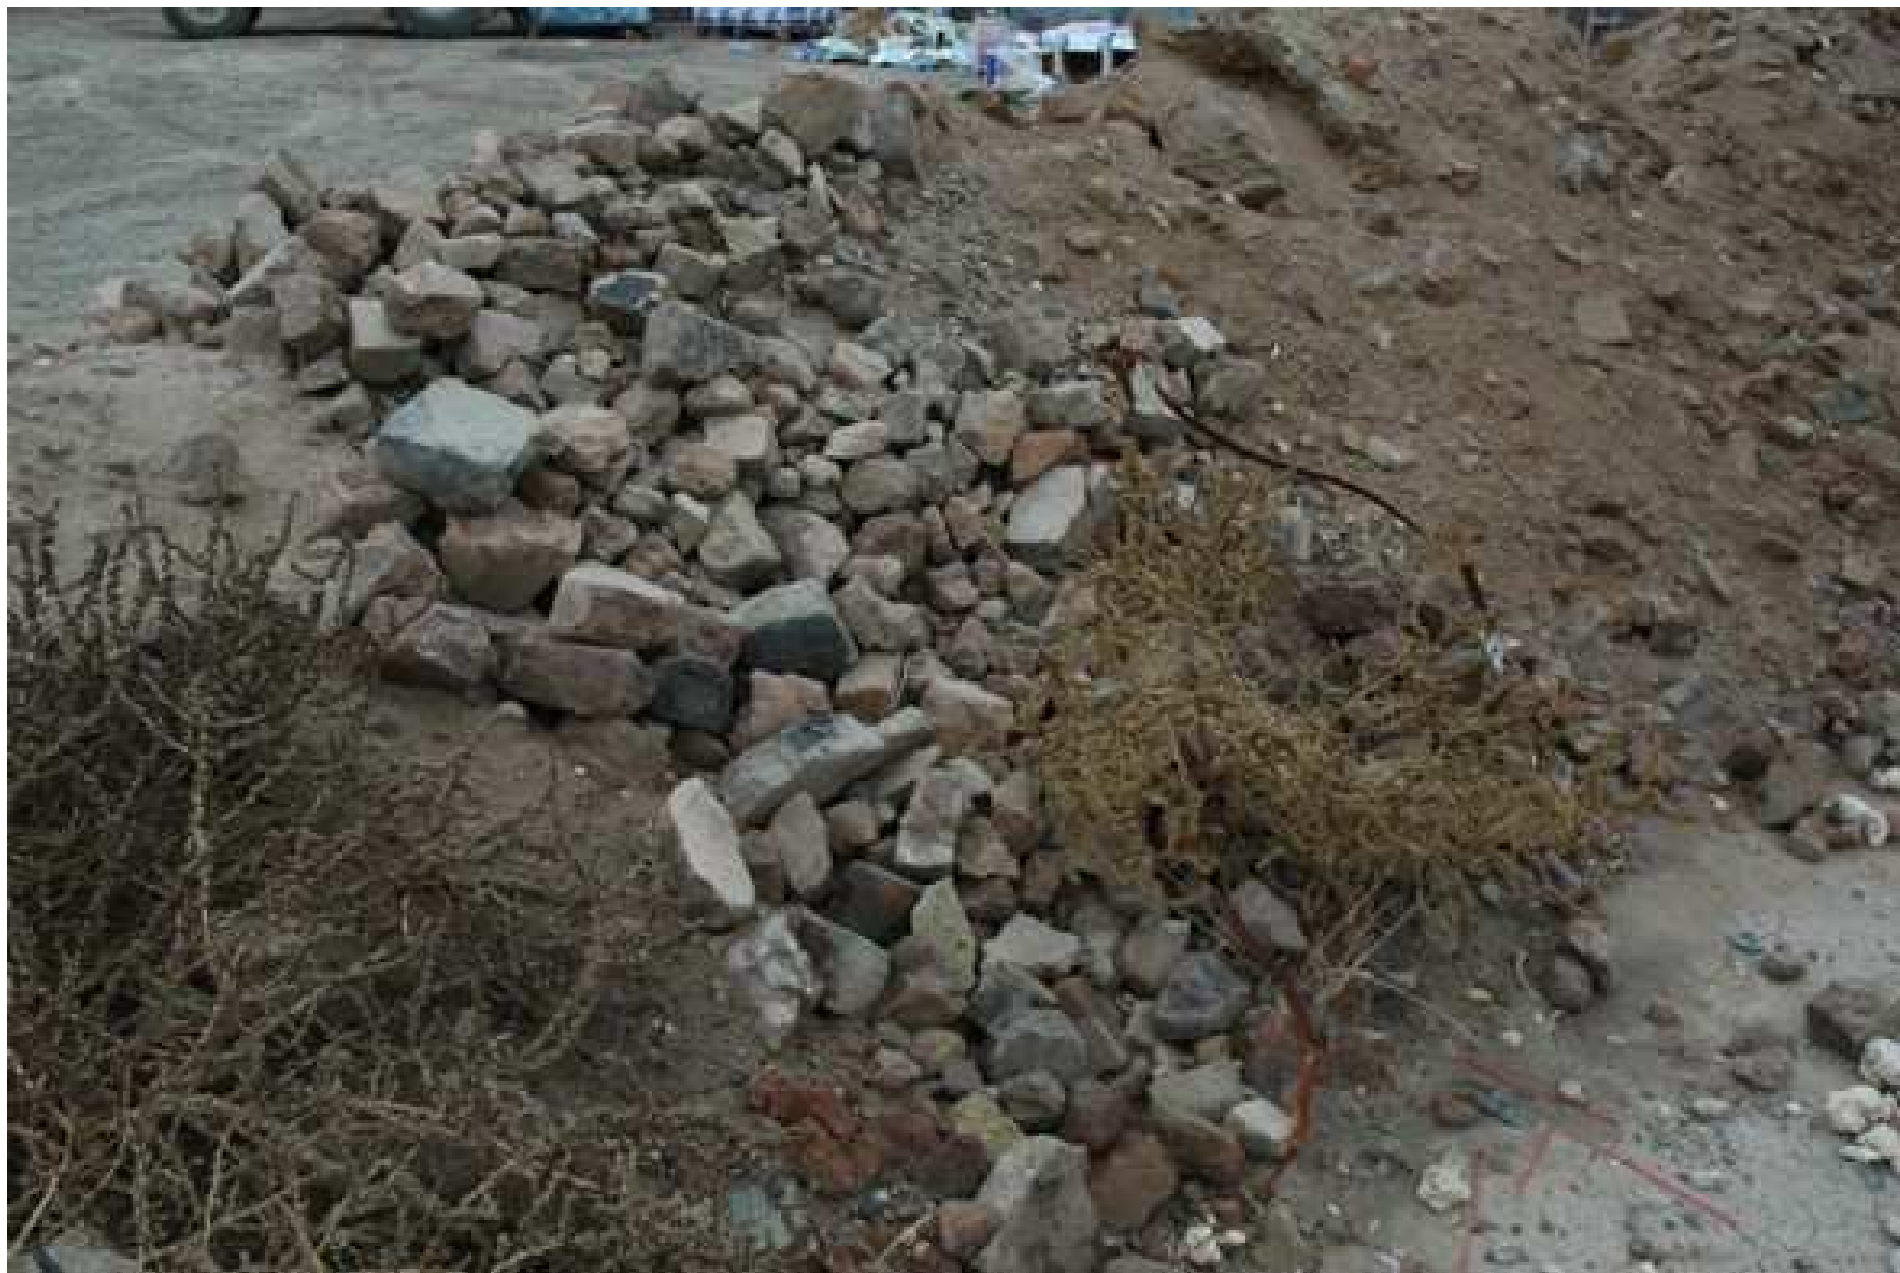
Berm between Lots 5 and 6, Polish report p. 6 (photo © Ministry of Culture and National Heritage, Republic of Poland)

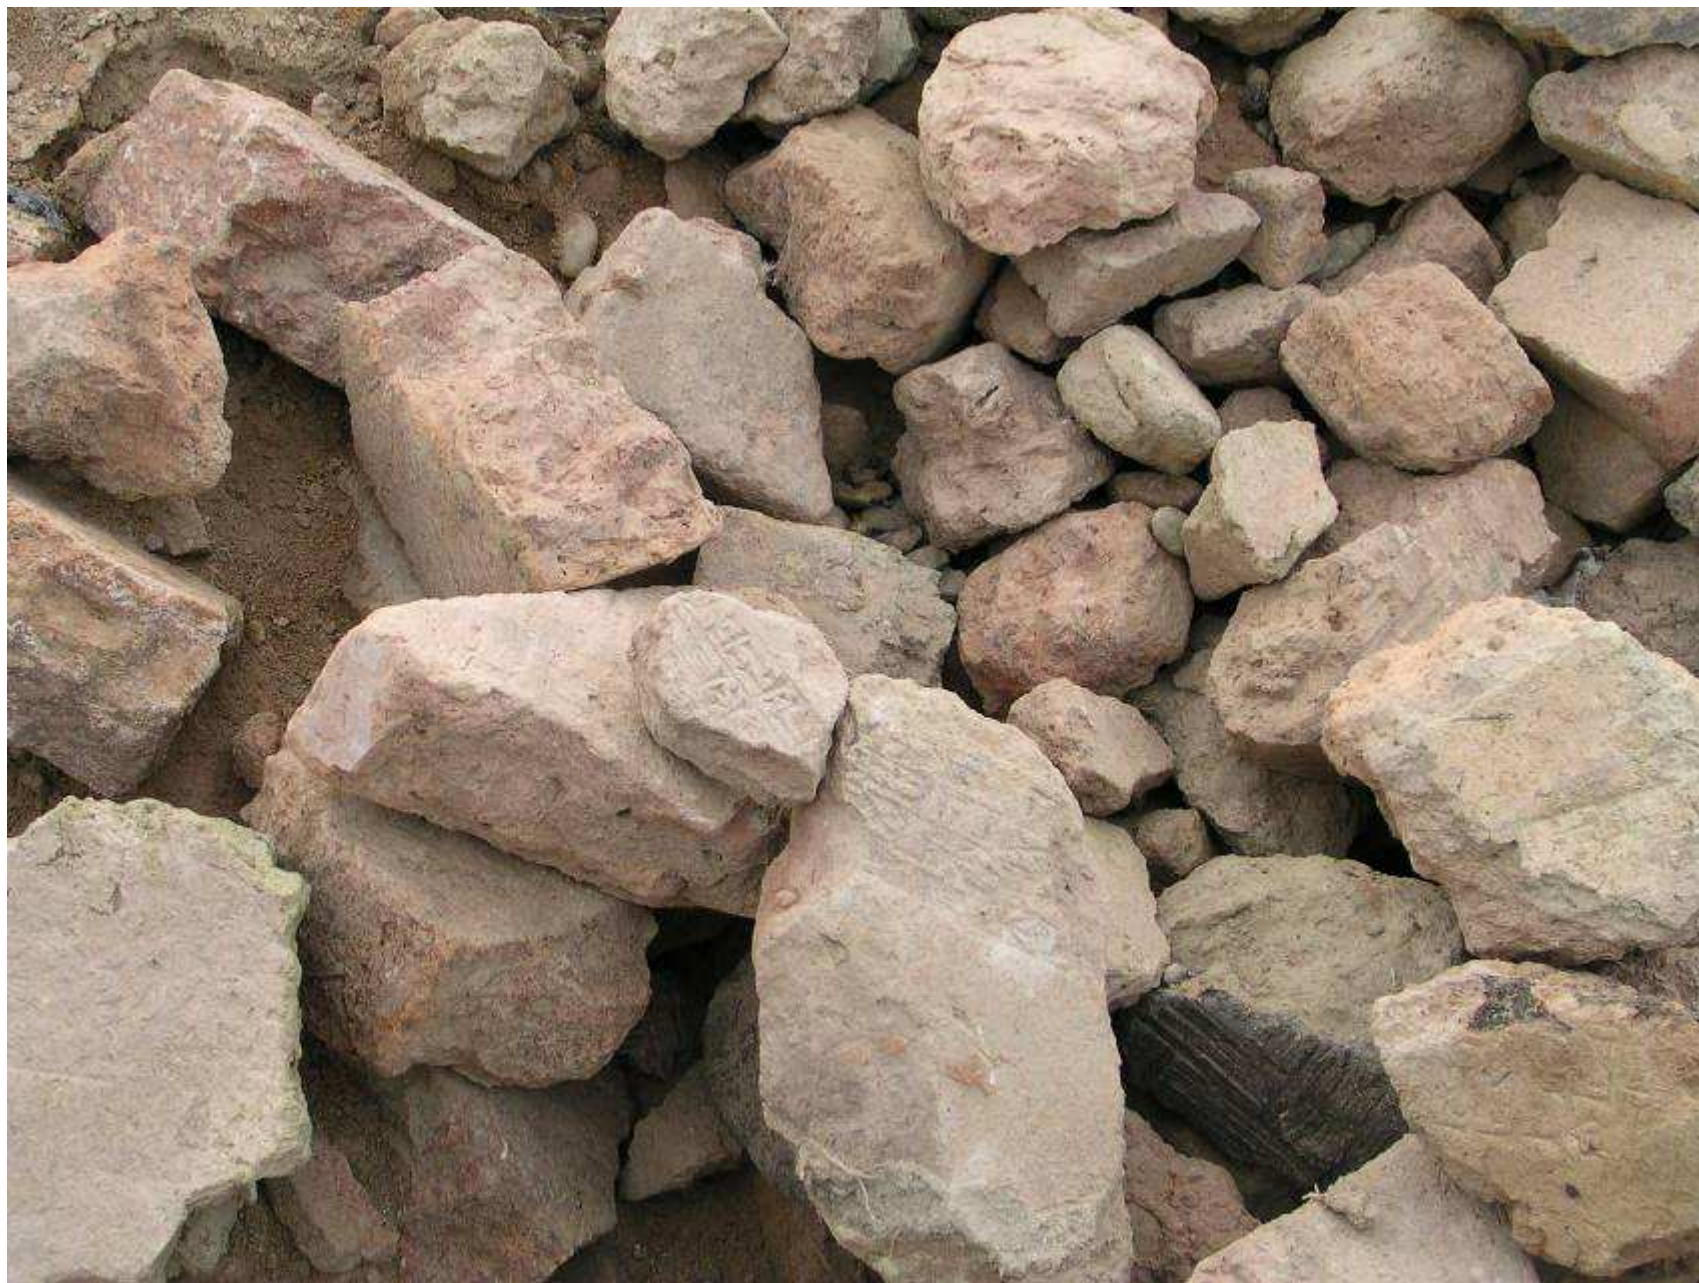
Berm between Lots 5 and 6, Curtis photo 7631 (photo © John Curtis)

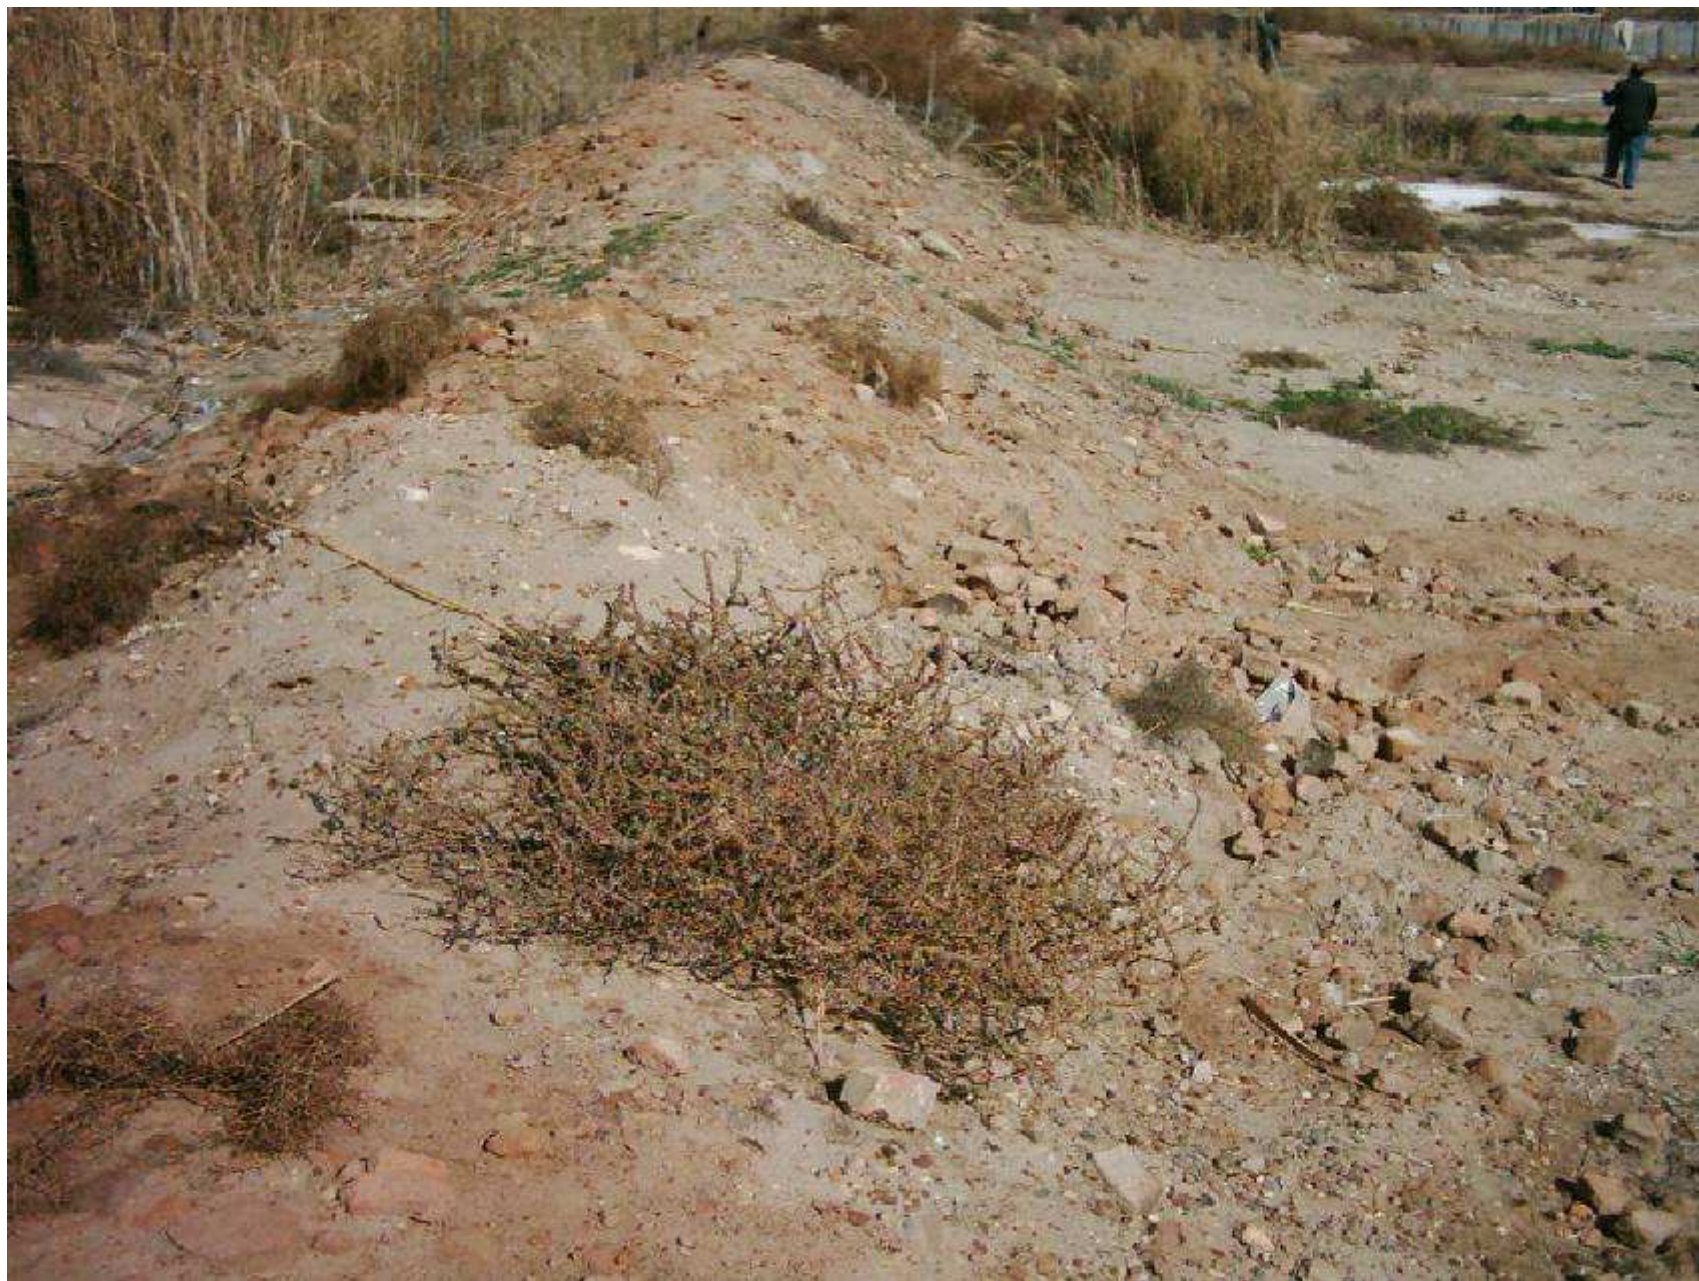
Lot 6, berm running beside river, Iraqi final report fig. 68

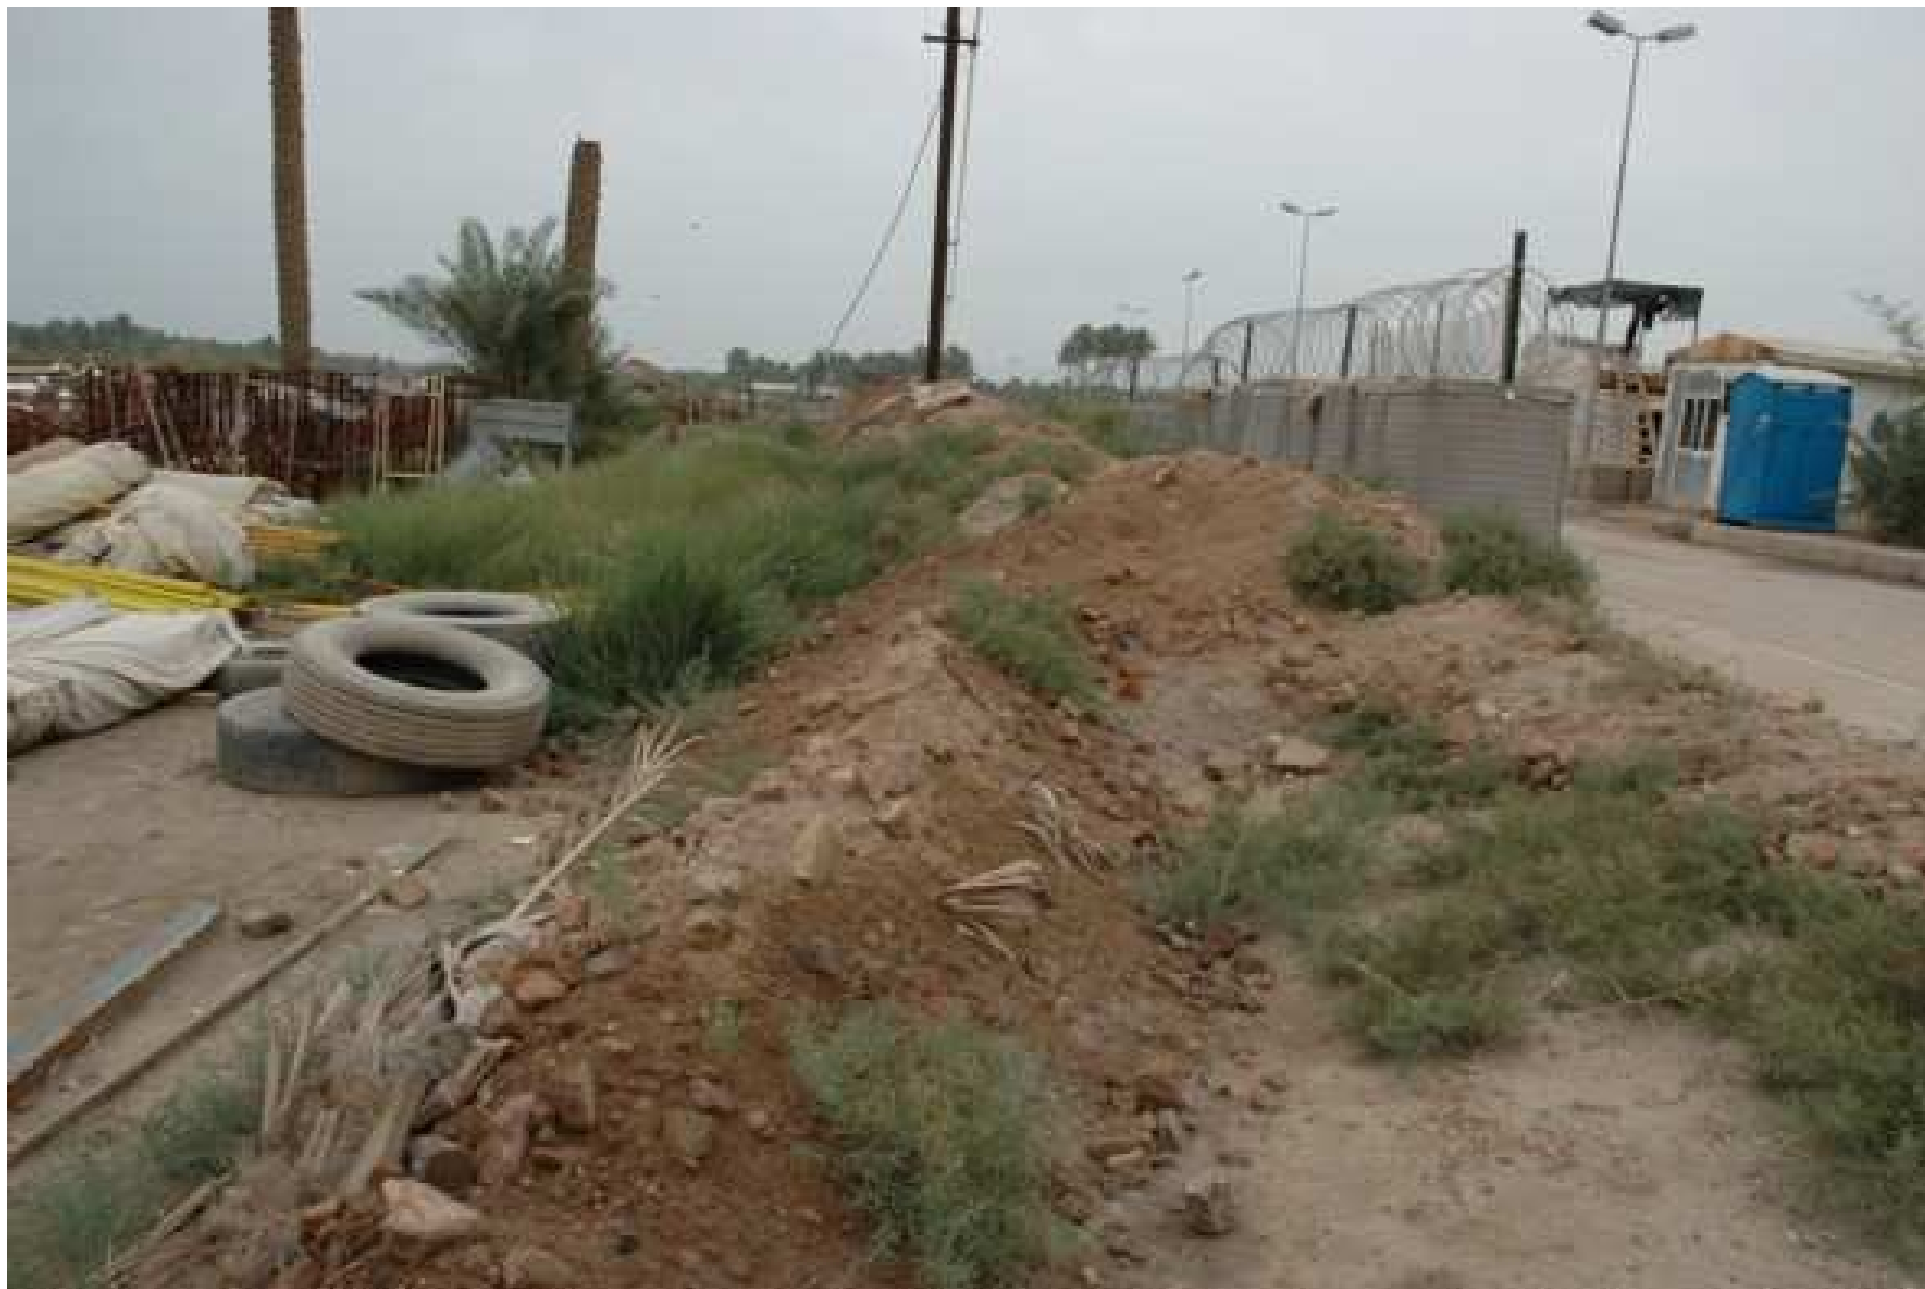
Lot 6, Berm and HESCO barrier at east side alongside the road, Polish report p. 7 (photo © Ministry of Culture and National Heritage, Republic of Poland)

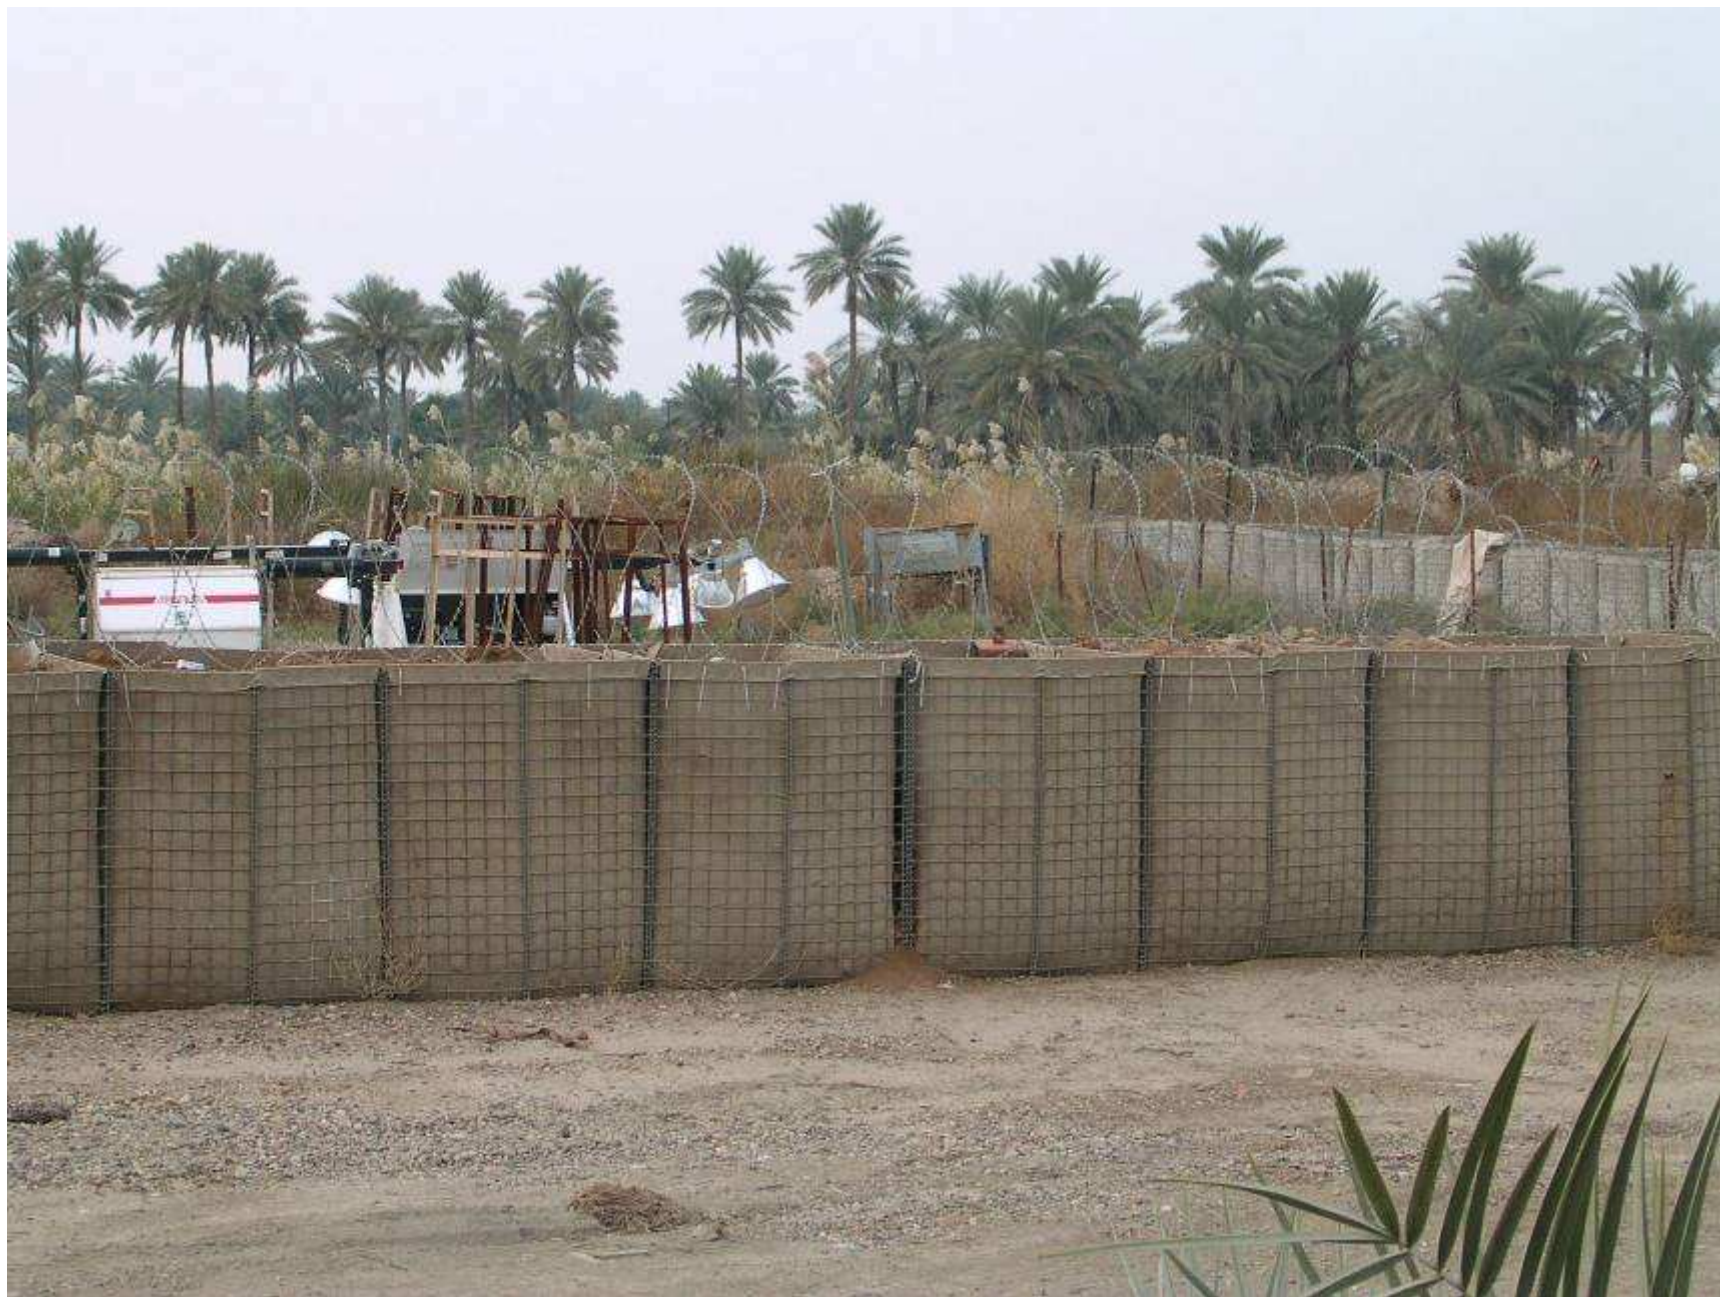
Lot 6, HESCO barriers along east and north sides, Curtis photo 7625 (photo © John Curtis)

Euphrates North, Lot 6, HESCO barriers along east and north sides, Curtis photo 7625 (photo © John Curtis)

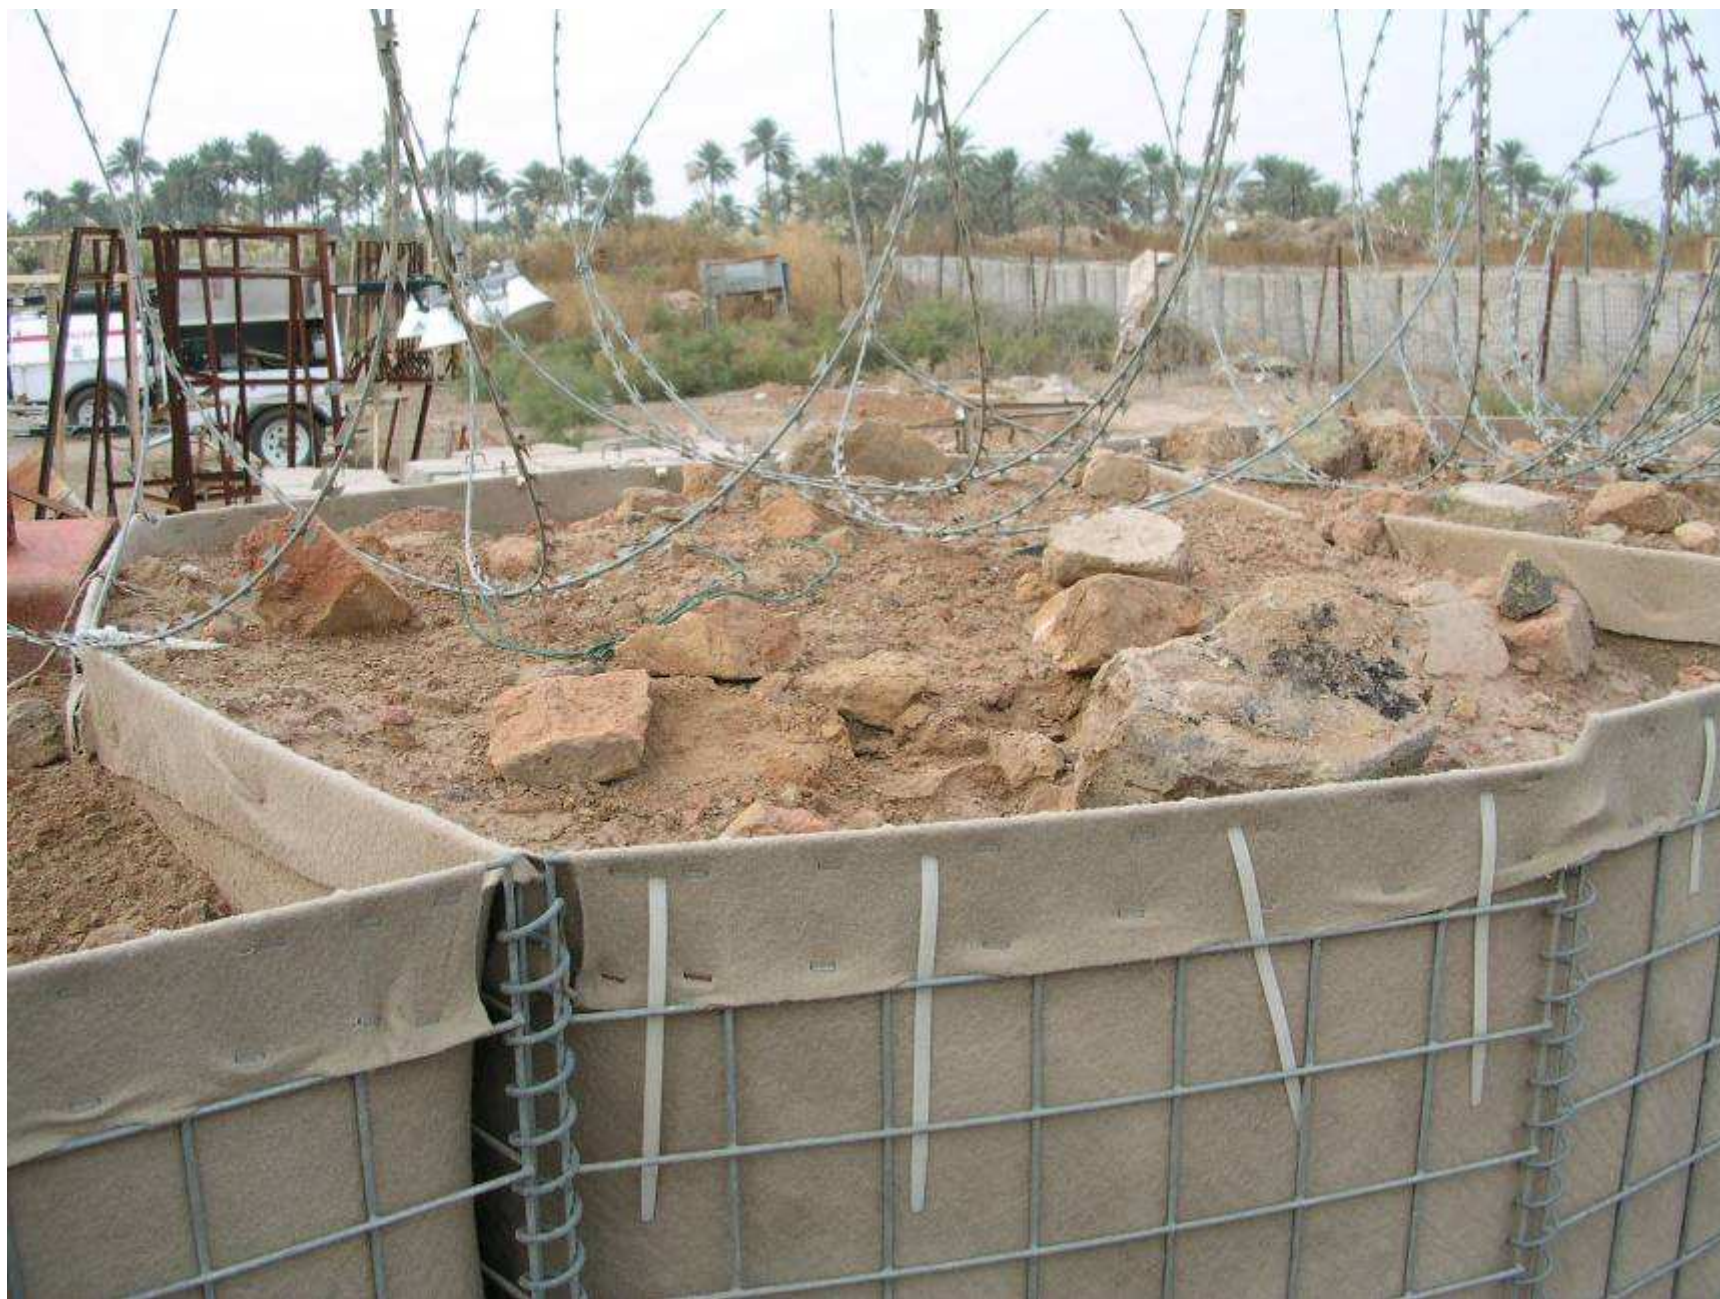
Lot 6, HESCO barrier along east side, Curtis photo 7624 (photo © John Curtis)

Euphrates North, Lot 6, artifact-filled earth in HESCO barrier along east side, Curtis photo 7624 (photo © John Curtis)

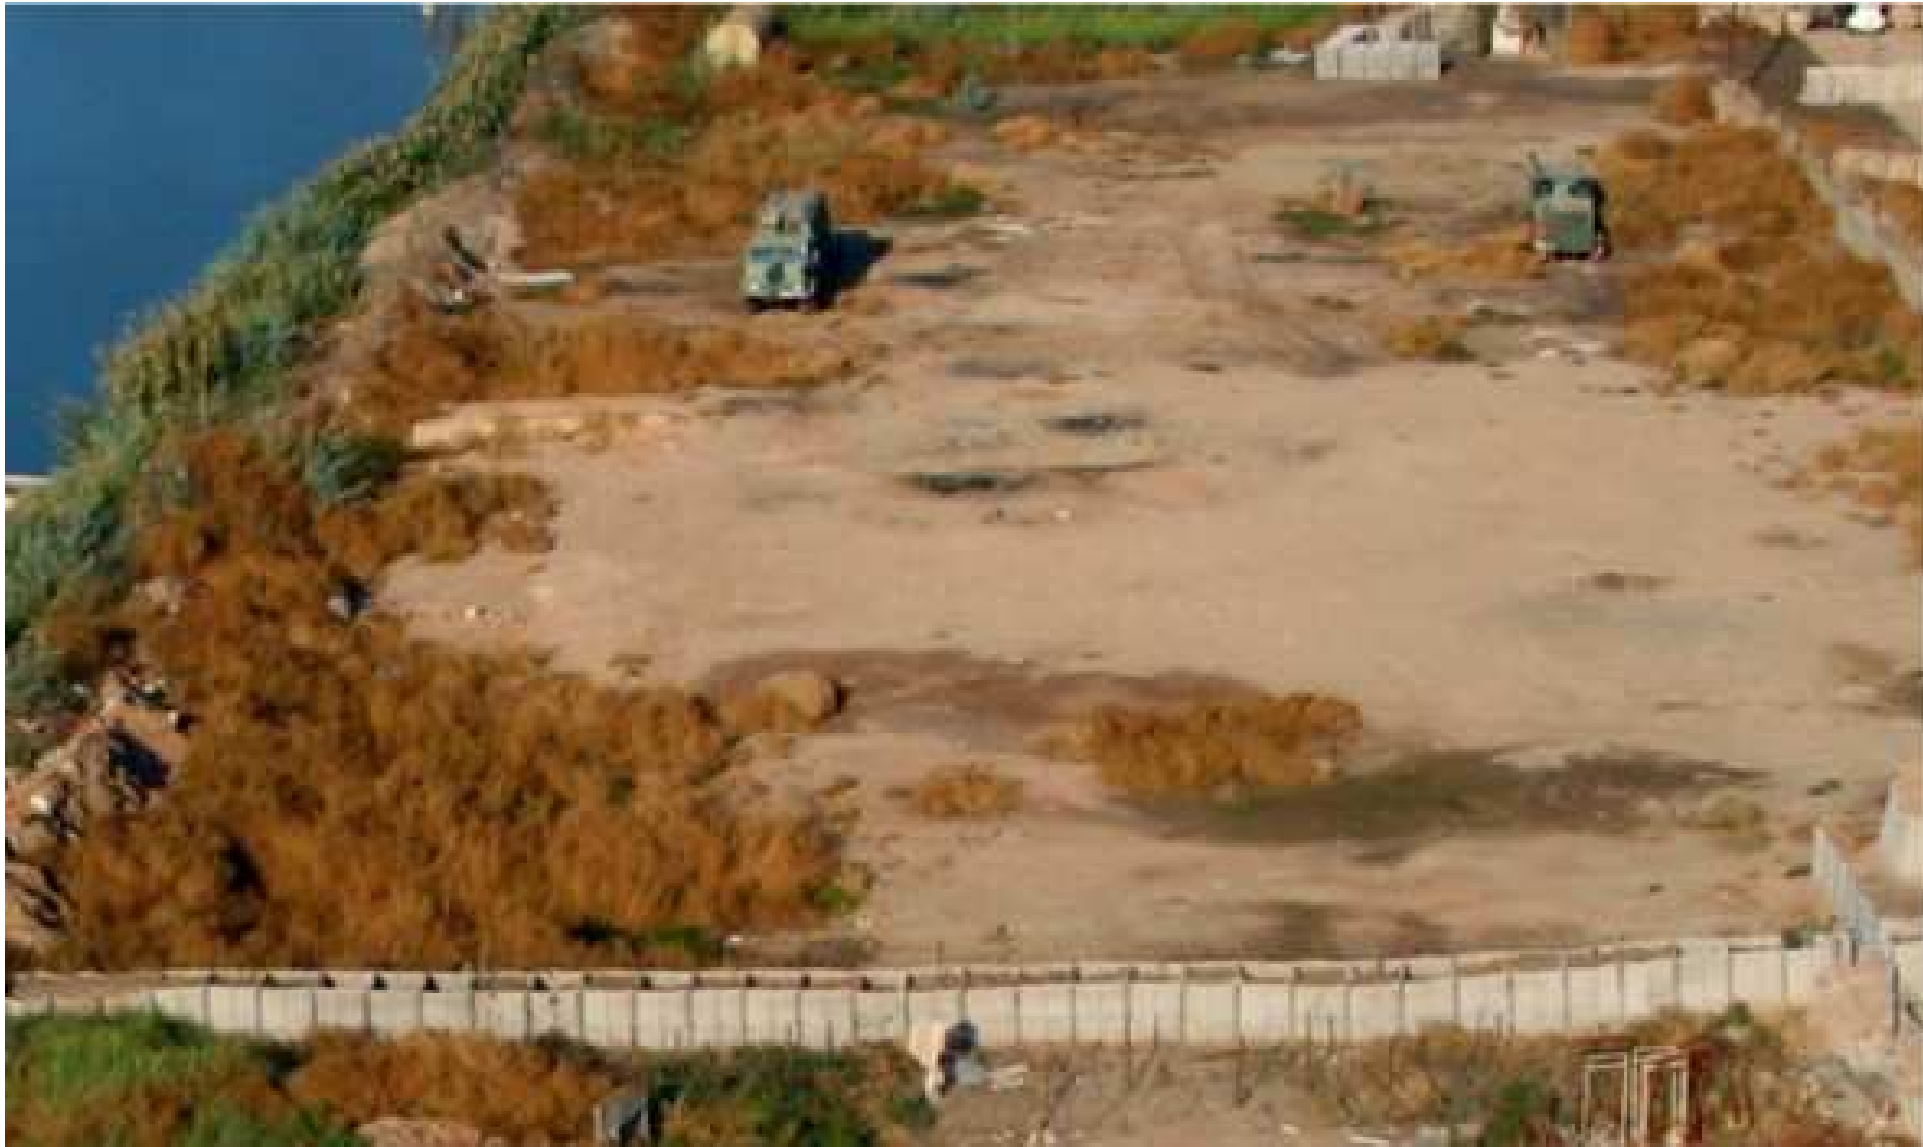
Lot 7, "Car parking lot" (photo: Polish report p. 7, © Ministry of Culture and National Heritage, Republic of Poland)

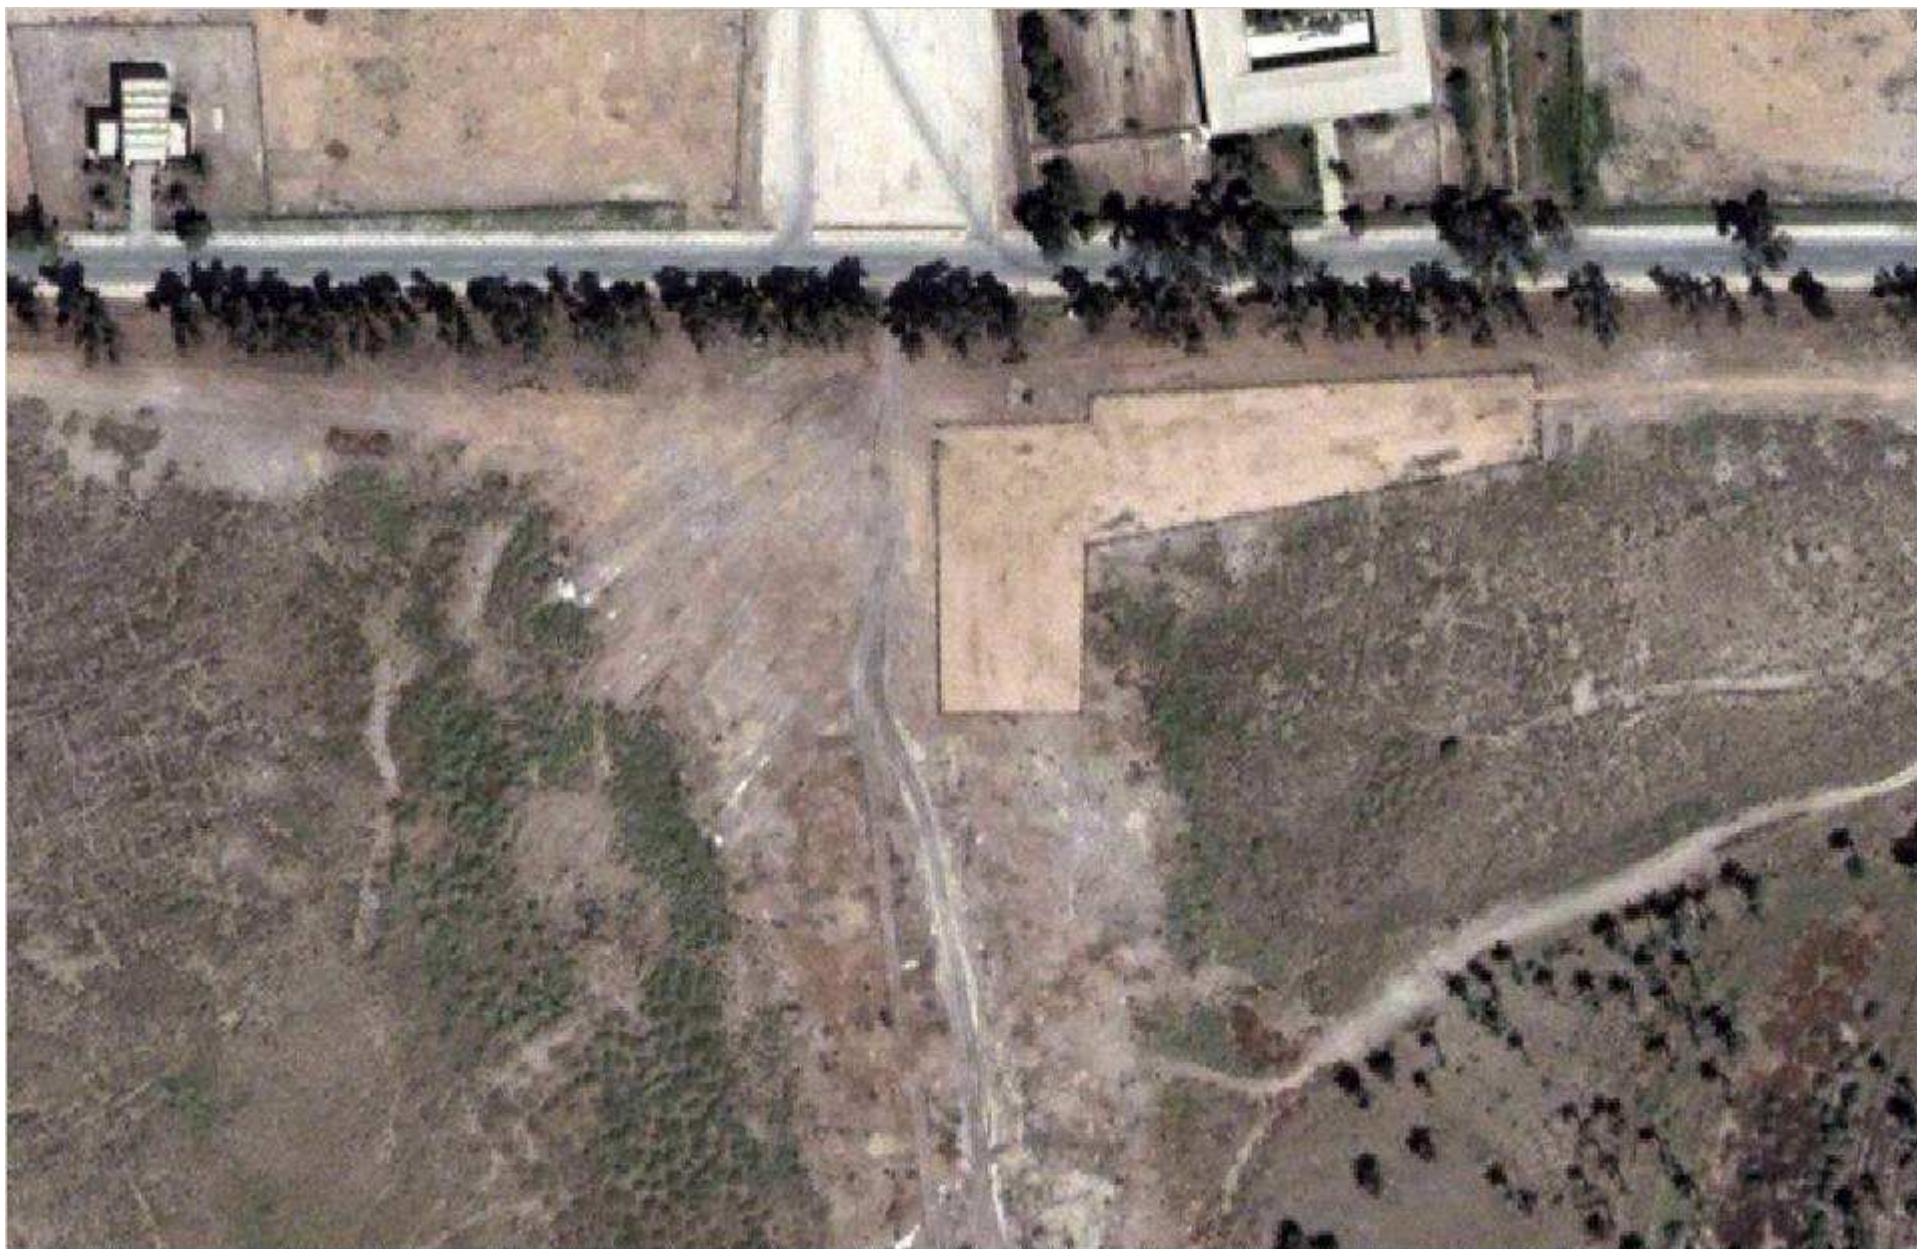
5 July 2002 showing extent of area before Camp Babylon, Russell composite

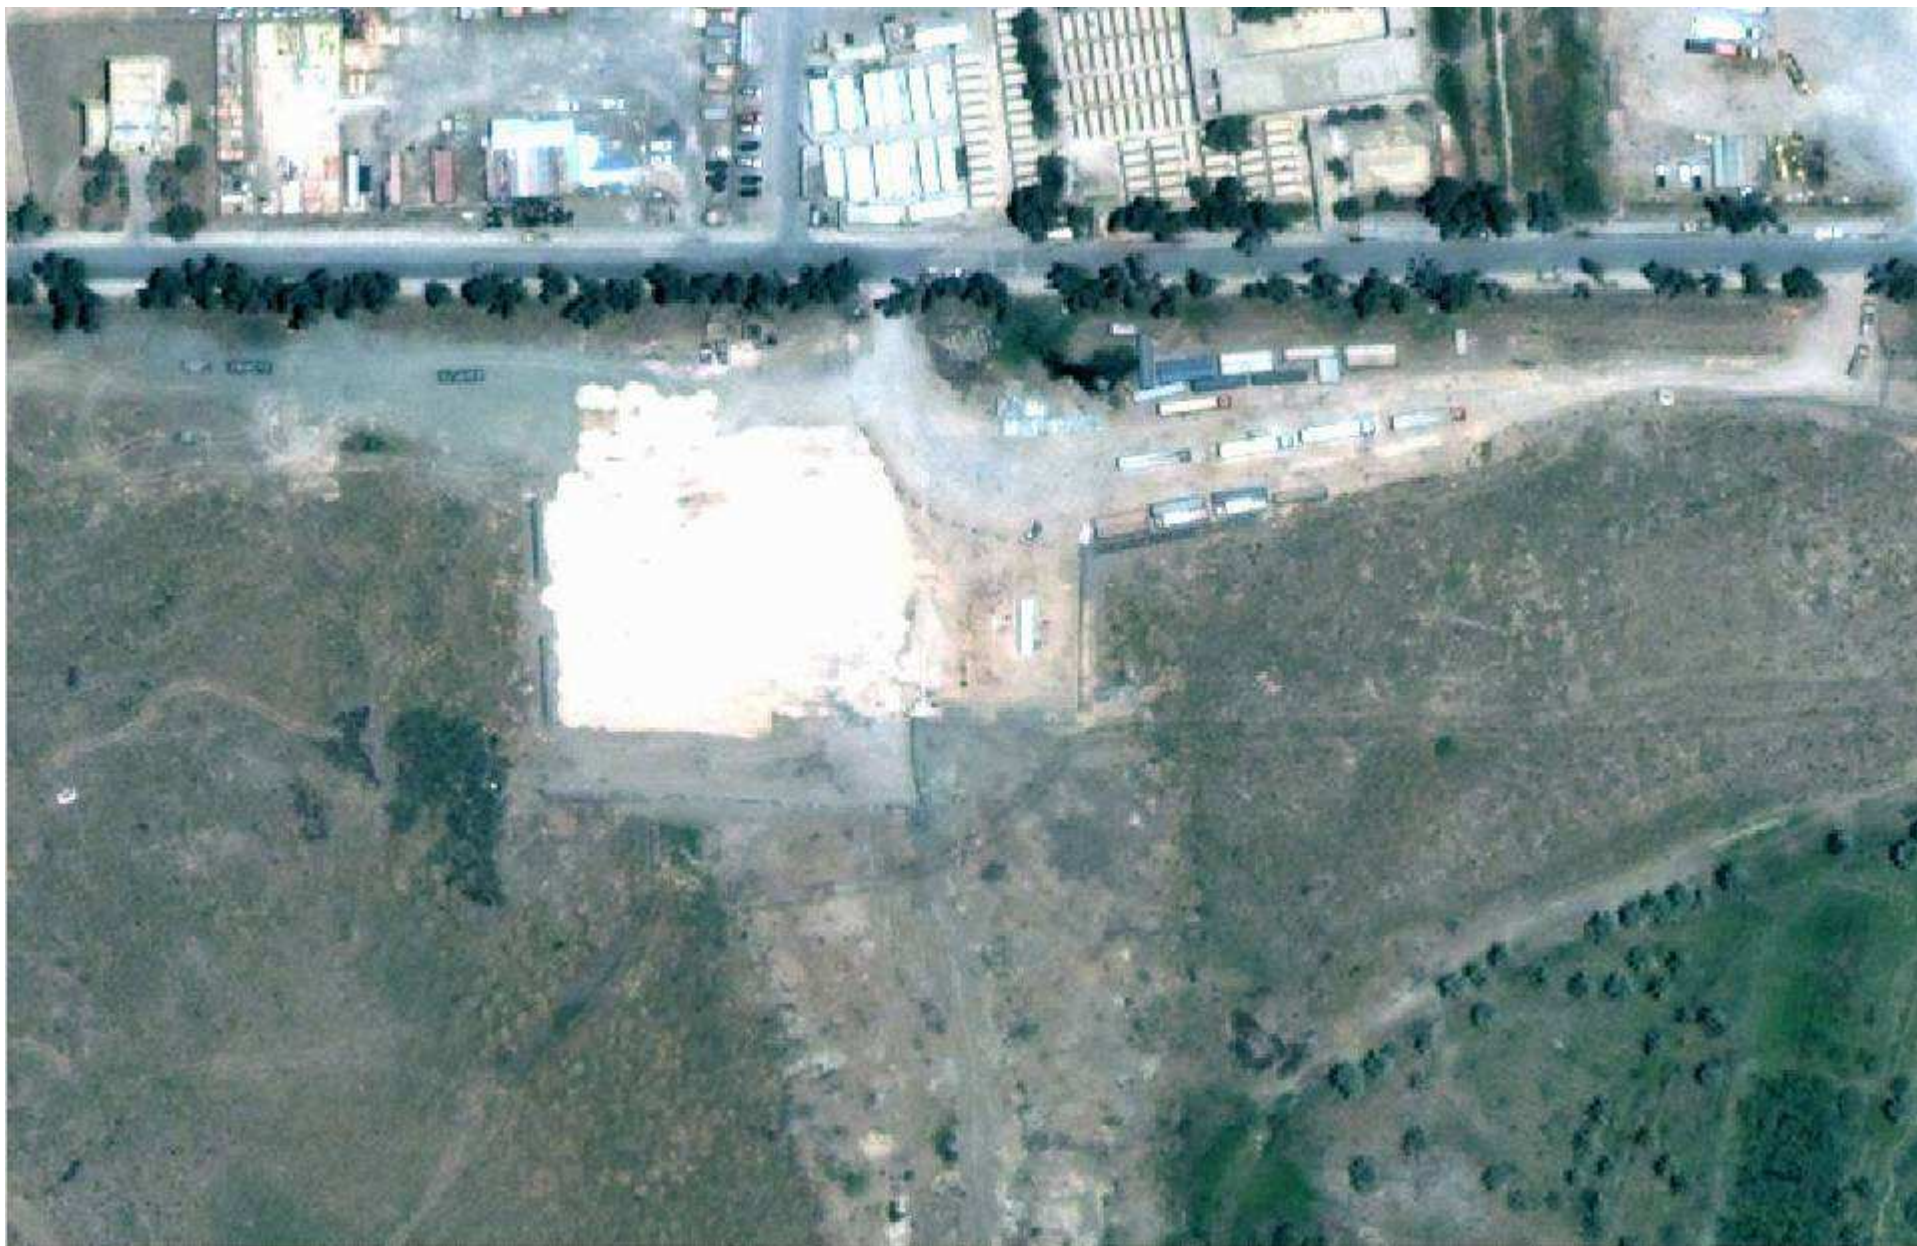
**Russell comment:** The measurements of this area differ in each of the 3 Iraqi reports. The final figure of 2075 sq m seems most likely. By May 2004, the southwestern corner of this area had been expanded into the mounded archaeological area and covered with gravel in order to build a third landing zone, visible in Photo 56 of the Iraqi final report. By August 2004, the landing zone had reverted to truck parking.

4 June 2004 showing greatest extent of area and new entrance to east, gravel has been spread to the south and piles of gravel are still visible at the north, Russell composite
