# **Report on Damage to the Site of Babylon, Iraq**

**John Malcolm Russell, Ph.D.**

**Cultural Heritage Center  
Bureau of Educational and Cultural Affairs  
Department of State**

**April 2010**

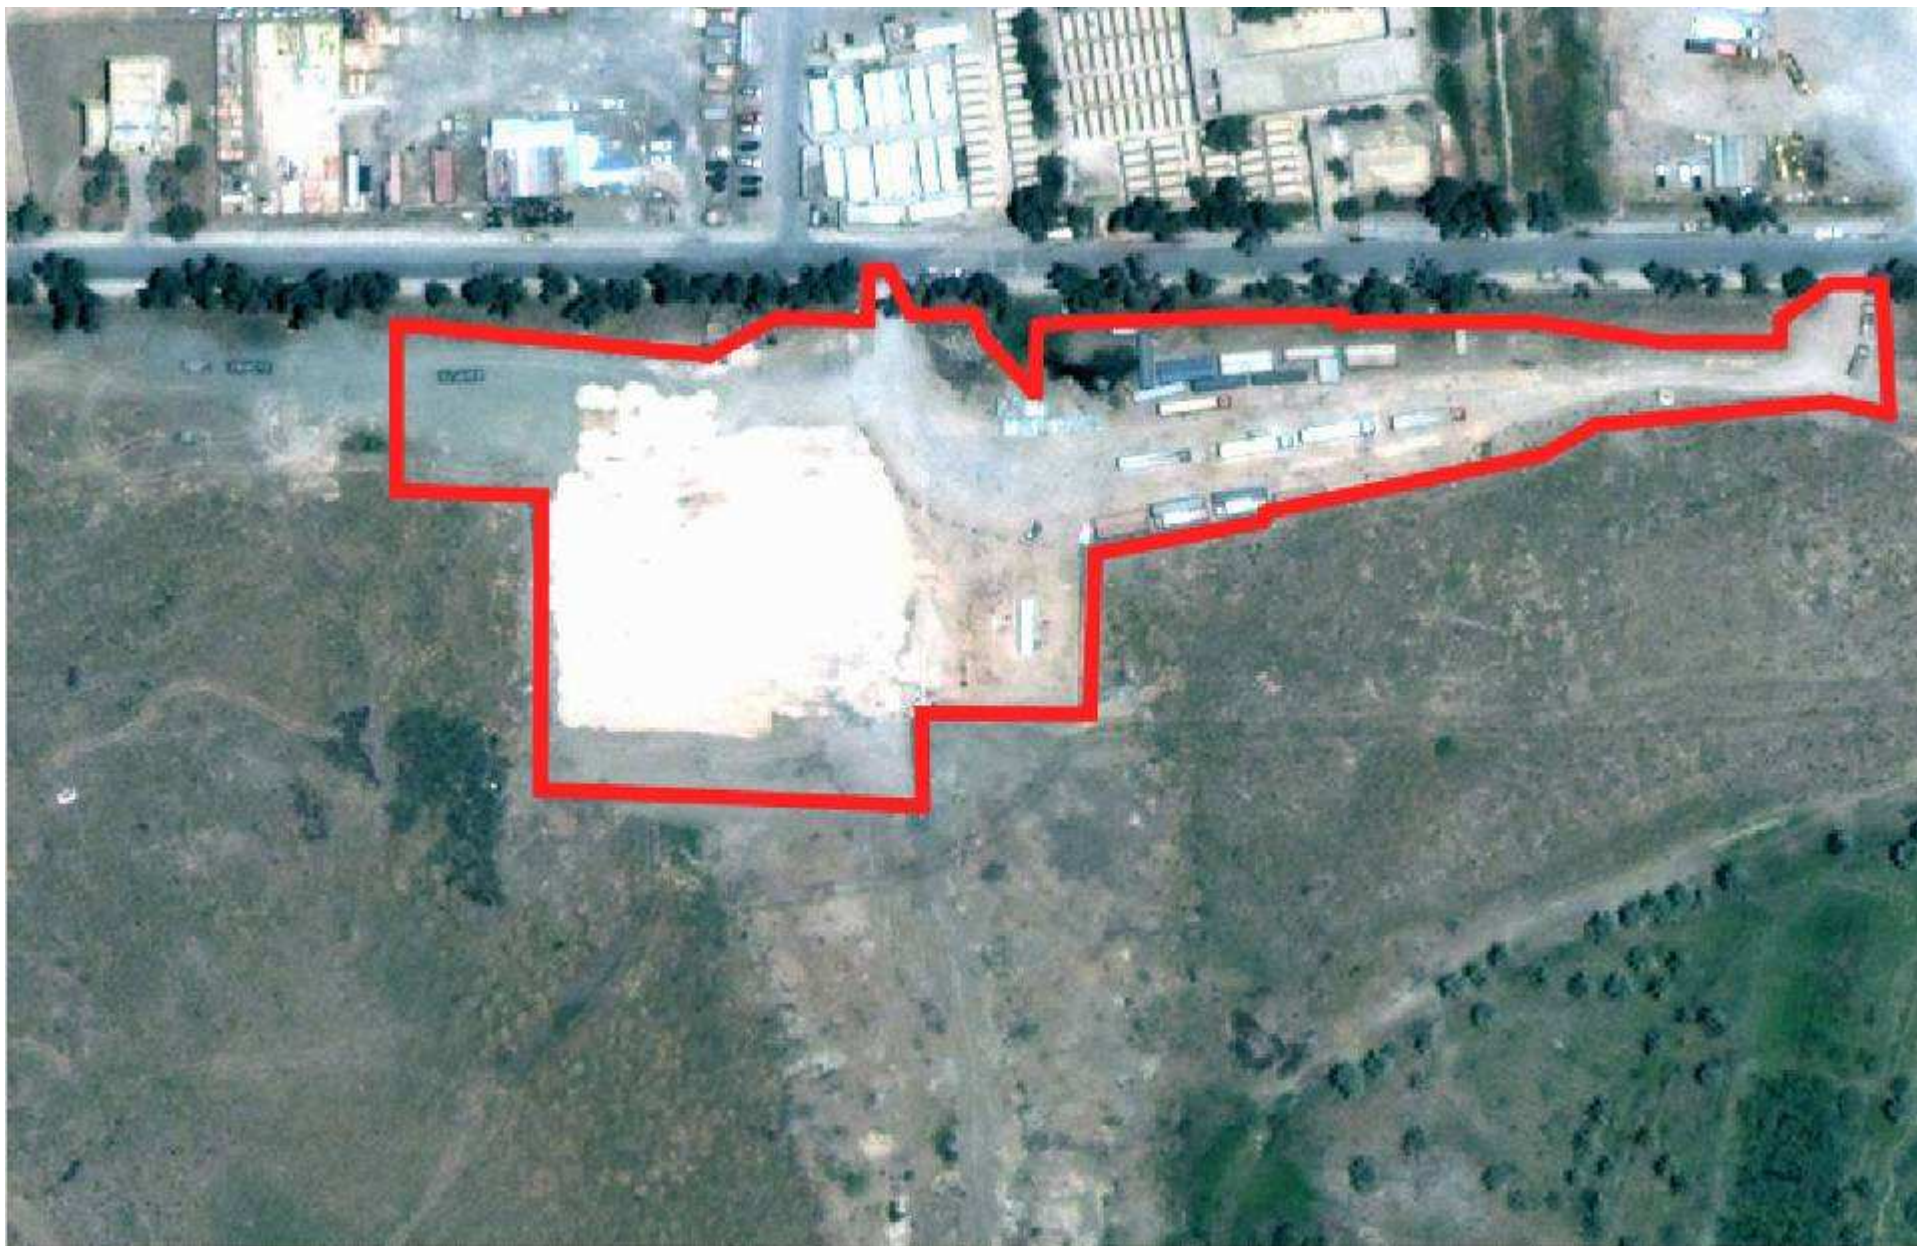
4 June 2004, landing zone with outline of greatest extent, Russell composite

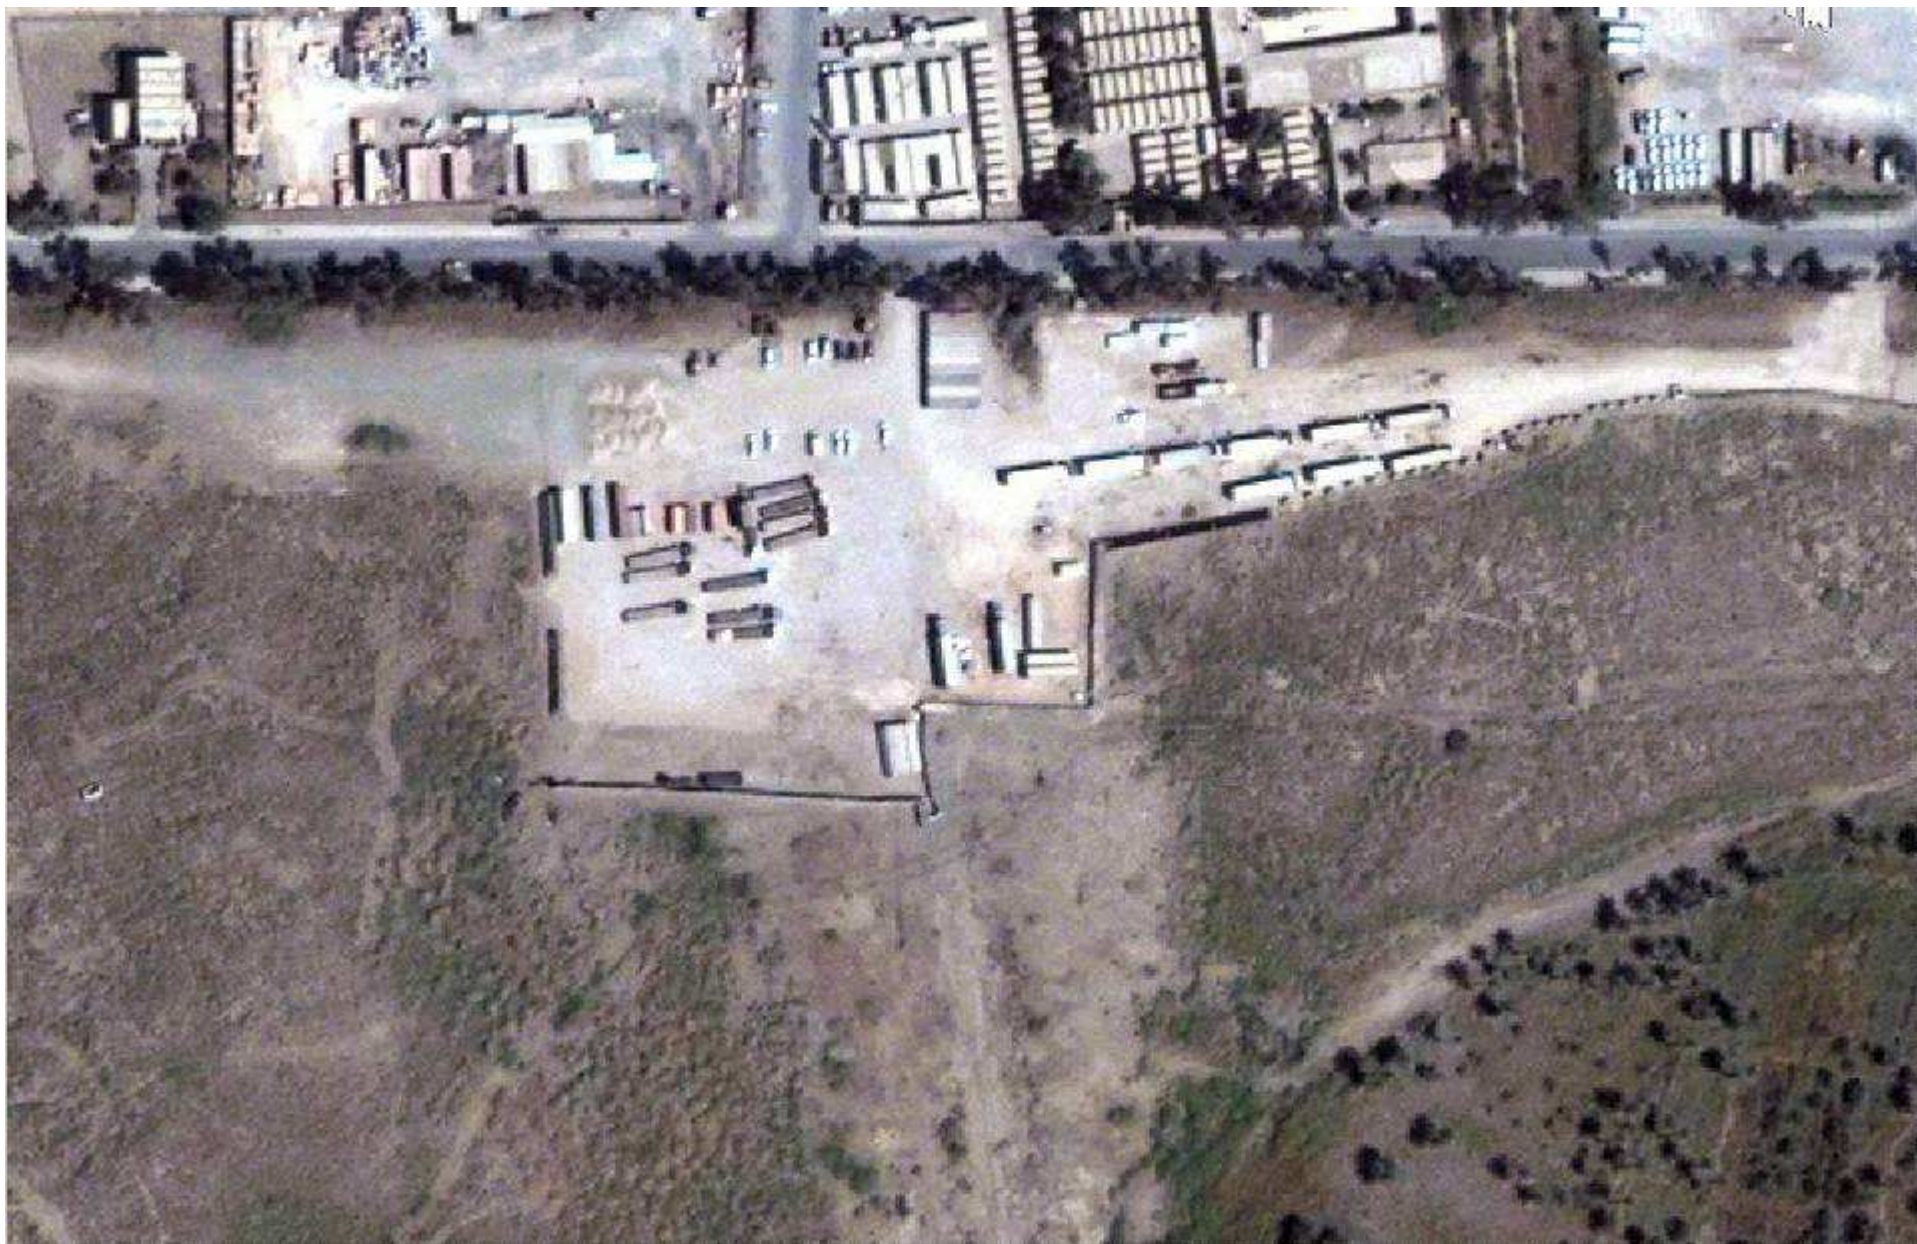
25 August 2004, landing zone being used for truck parking, Russell composite

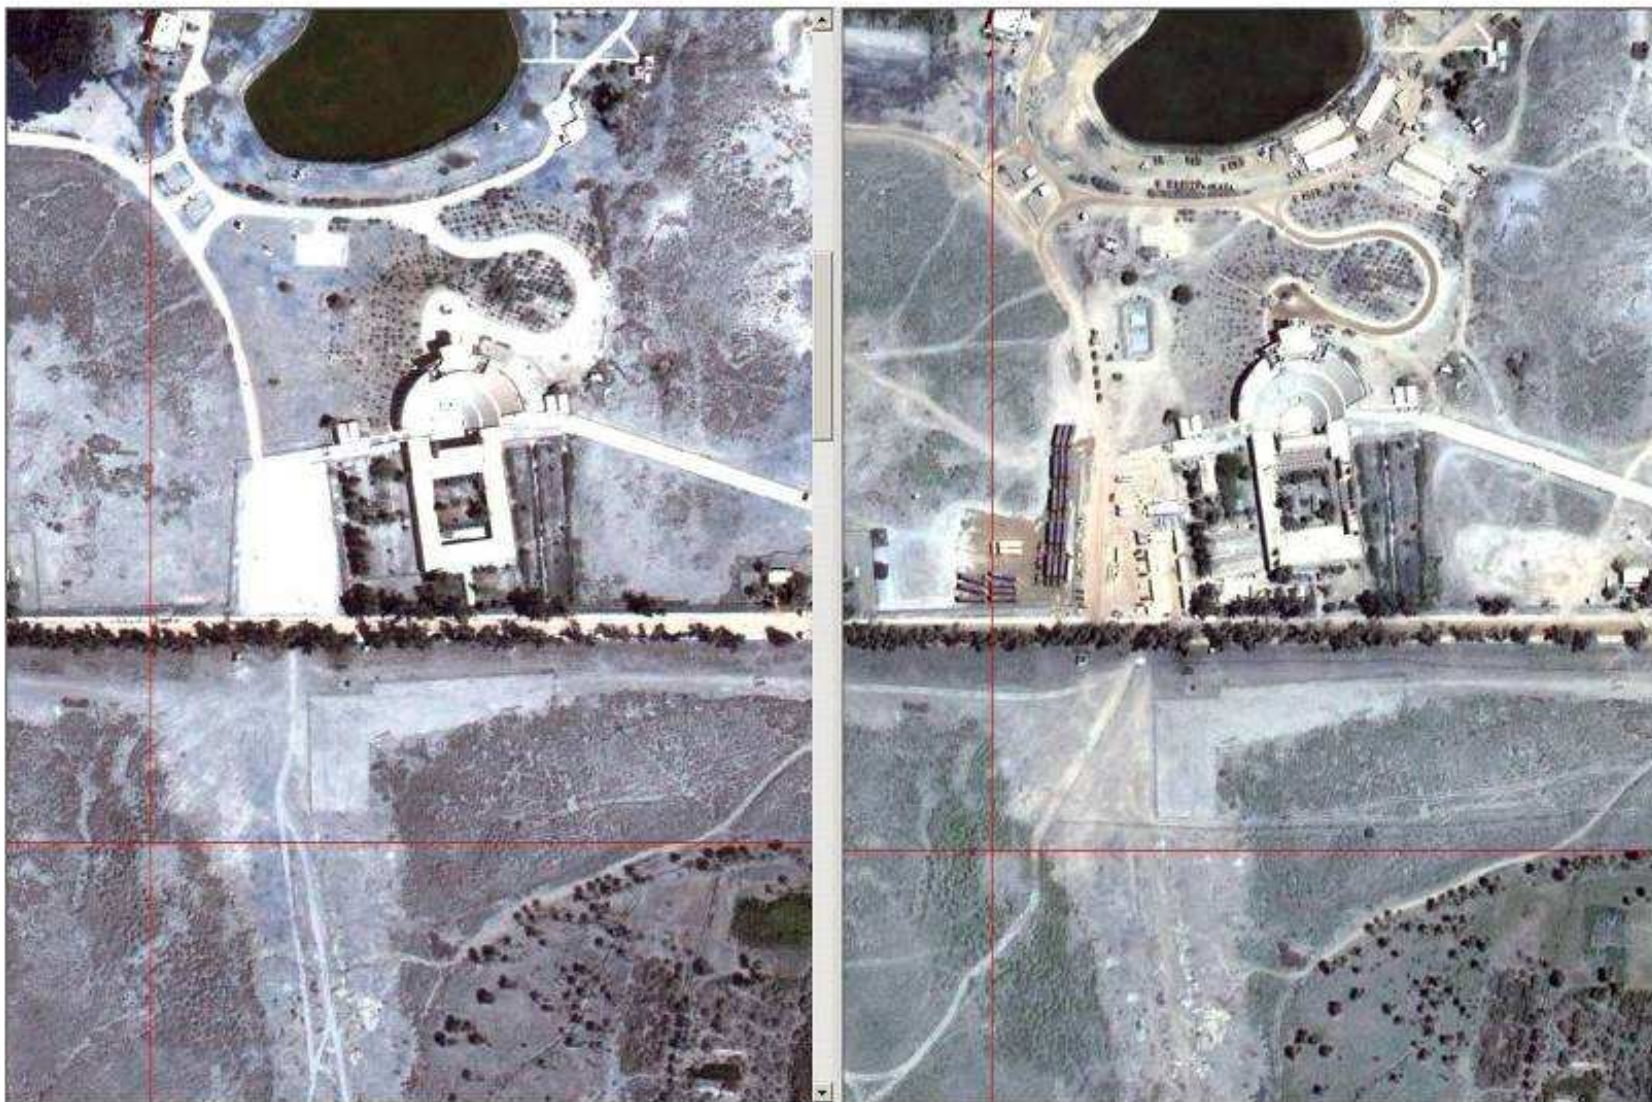
**Stone report:** This area to the south of the road was developed as a parking area after August 2003 (Fig. 29).

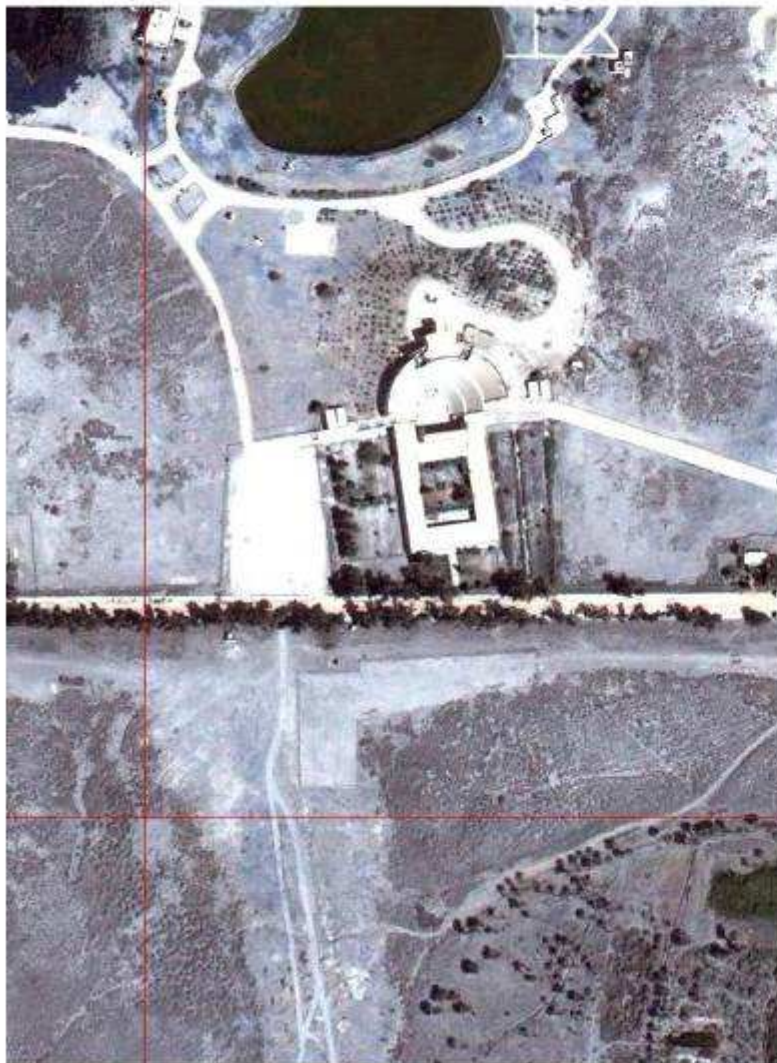
**8 October 2004**

**Stone report:** By October 2004 it had expanded beyond the area slightly prepared before the war, chewing into the edge of the mound (Fig. 30).

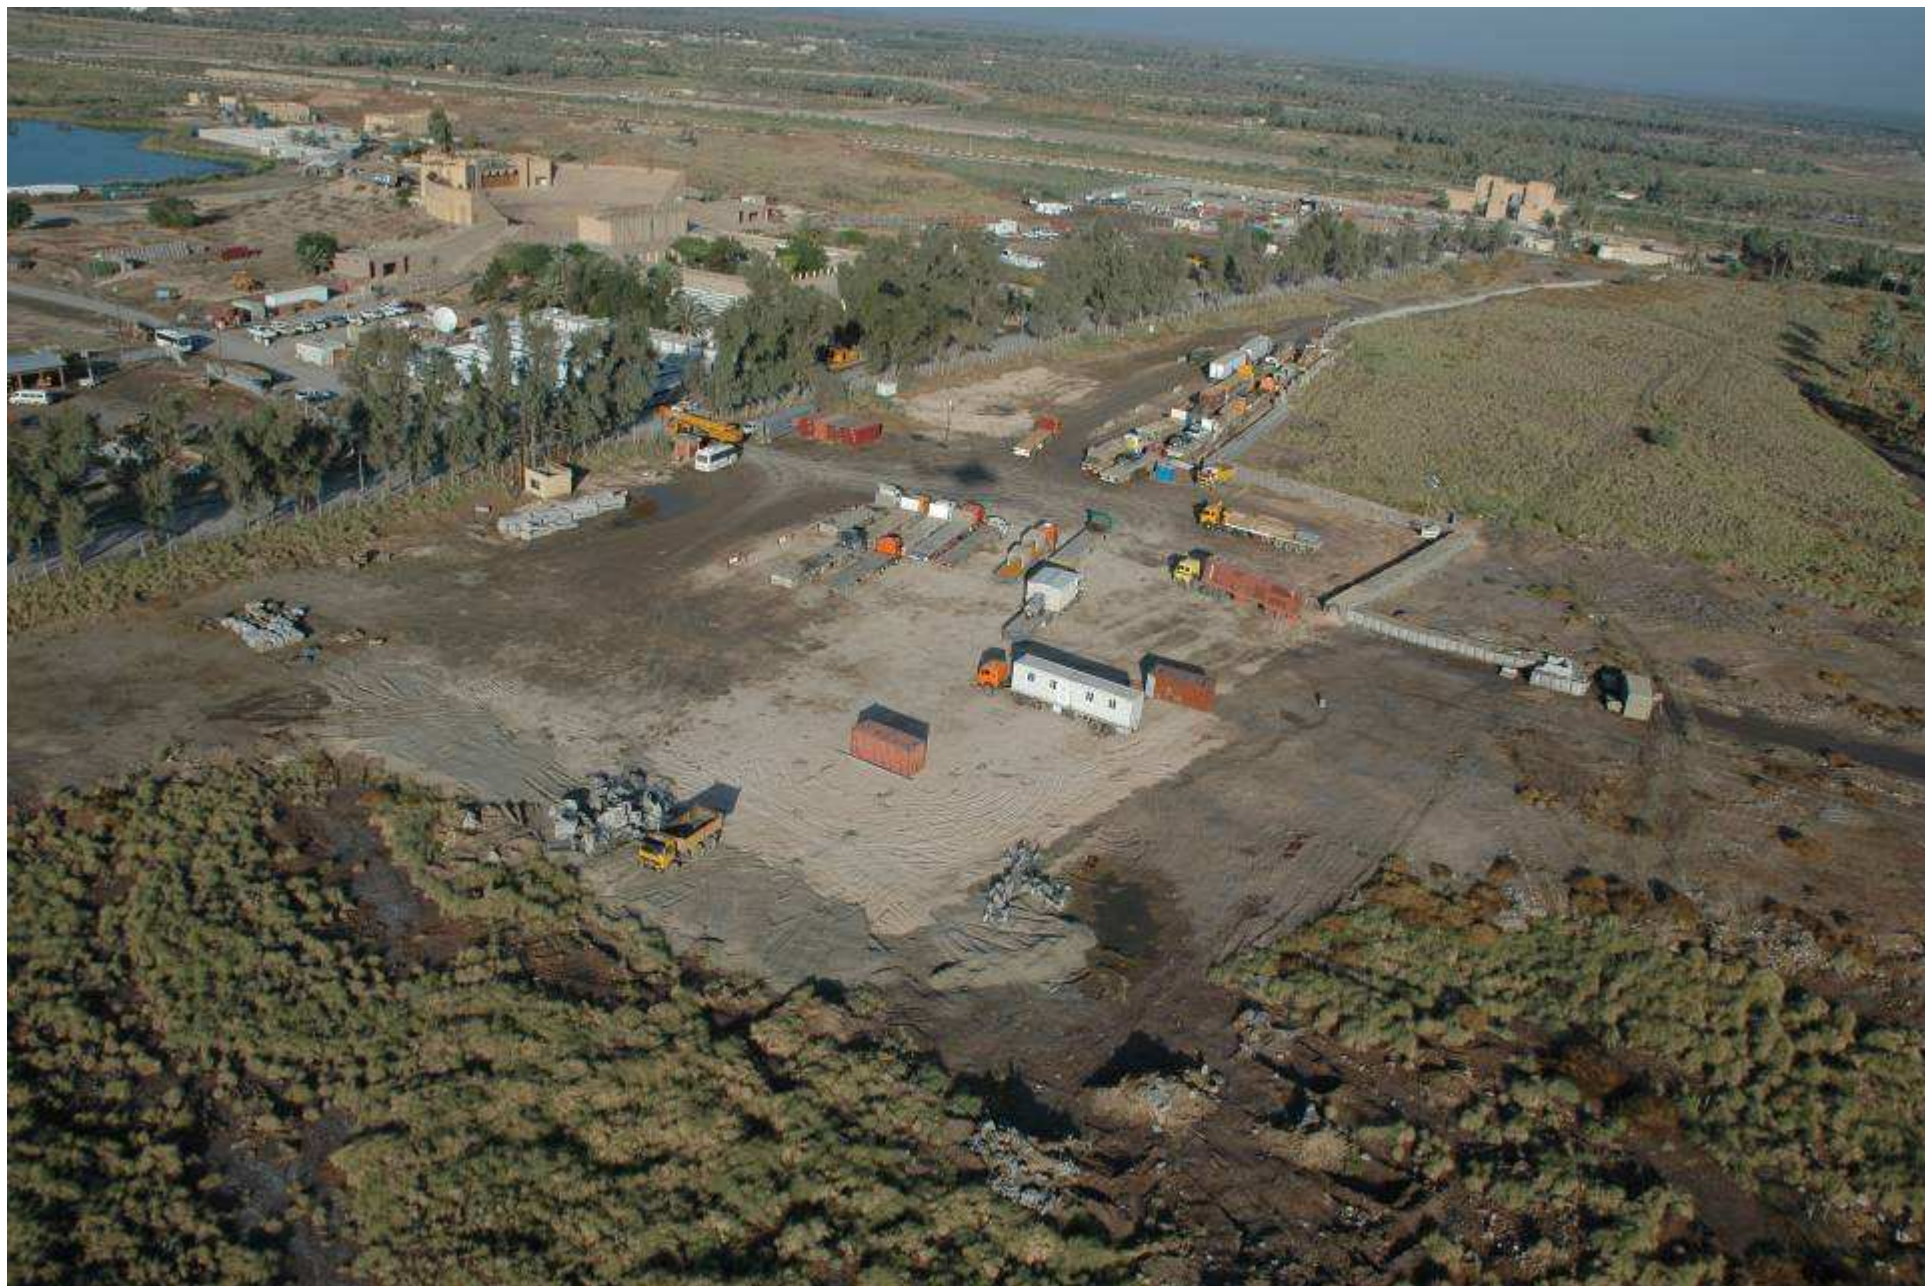
Parking area, November 2004, Polish photo 137 (photo © Ministry of Culture and National Heritage, Republic of Poland)

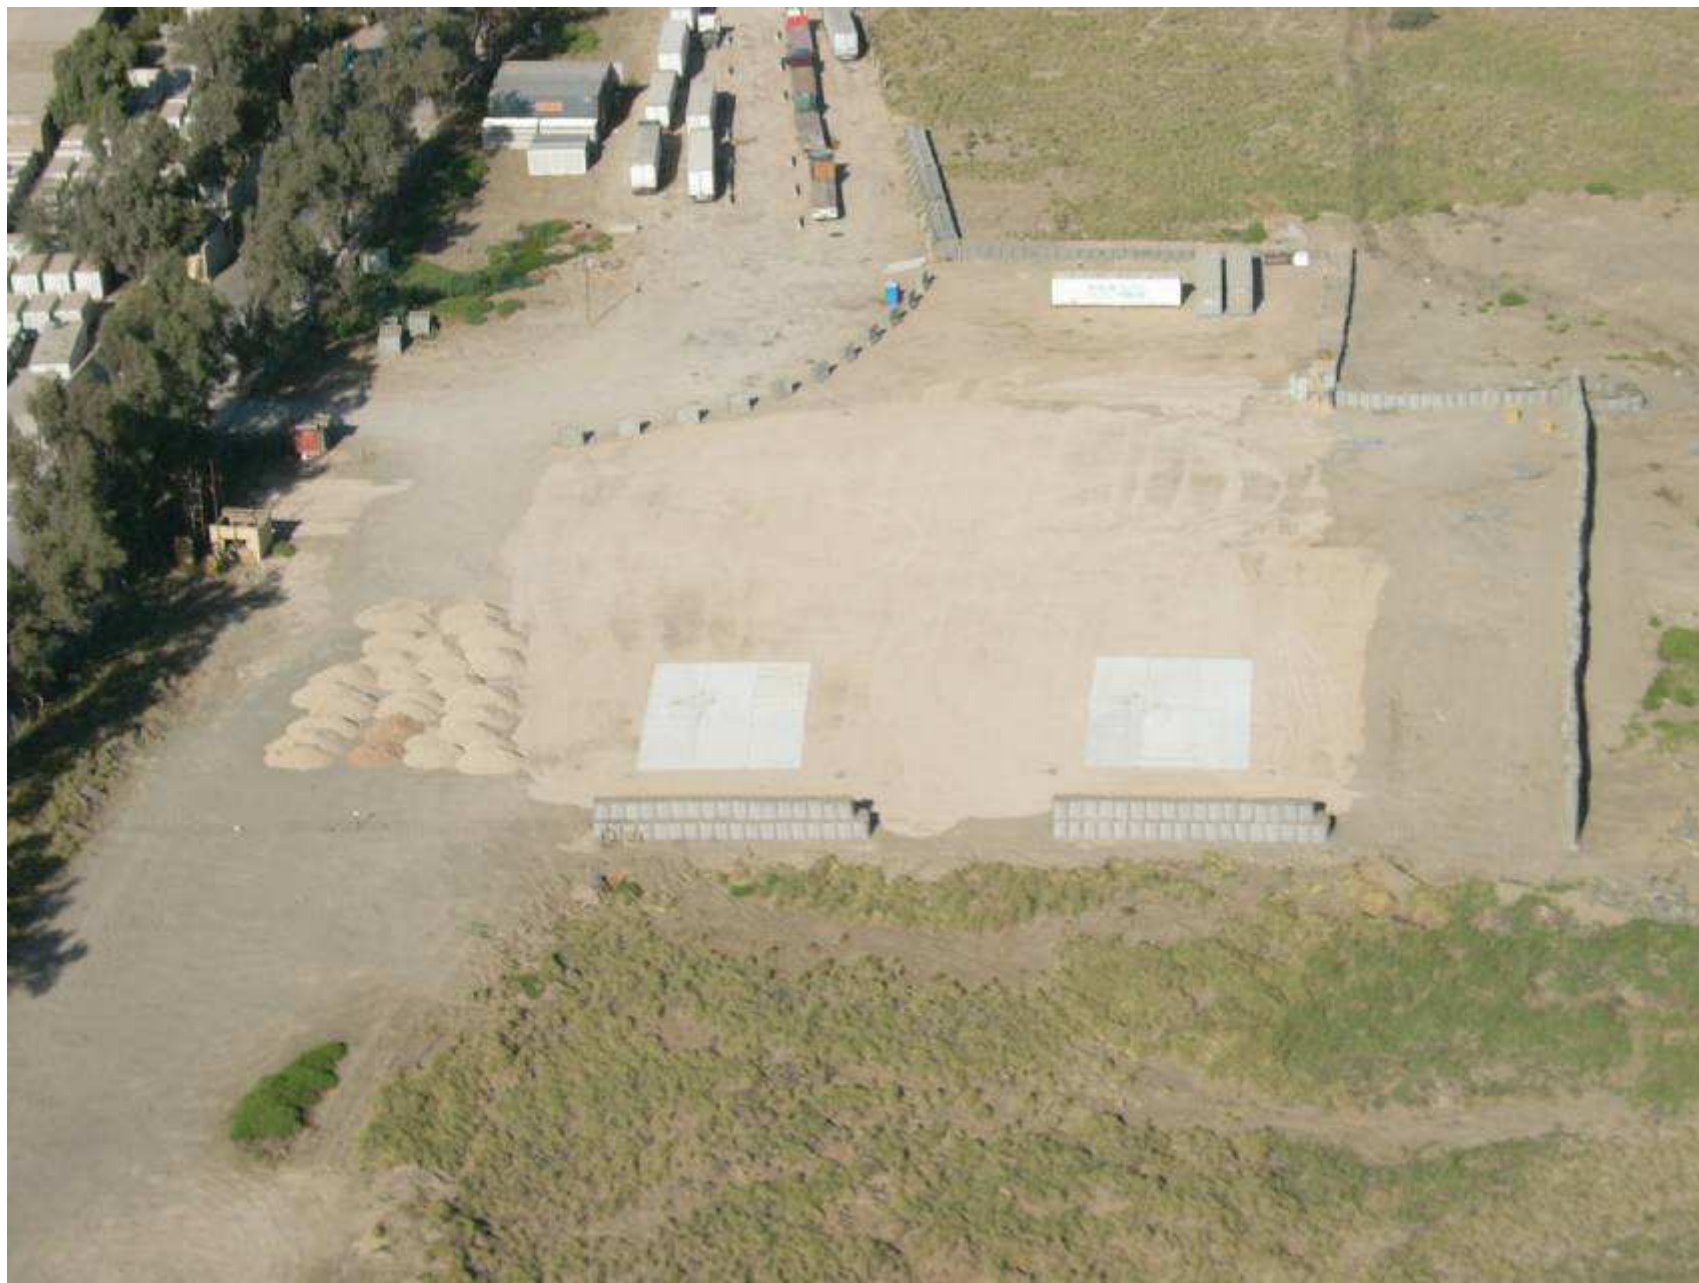
Landing zone 3 with freshly-spread gravel, Iraqi final report fig. 56

**Russell comment:** The measurements of this area differ in each of the 3 Iraqi reports. The final figure of 2075 sq m seems most likely. By May 2004, the southwestern corner of this area had been expanded into the mounded archaeological area and covered with gravel in order to build a third landing zone, visible in Photo 56 of the Iraqi final report. By August 2004, the landing zone had reverted to truck parking.

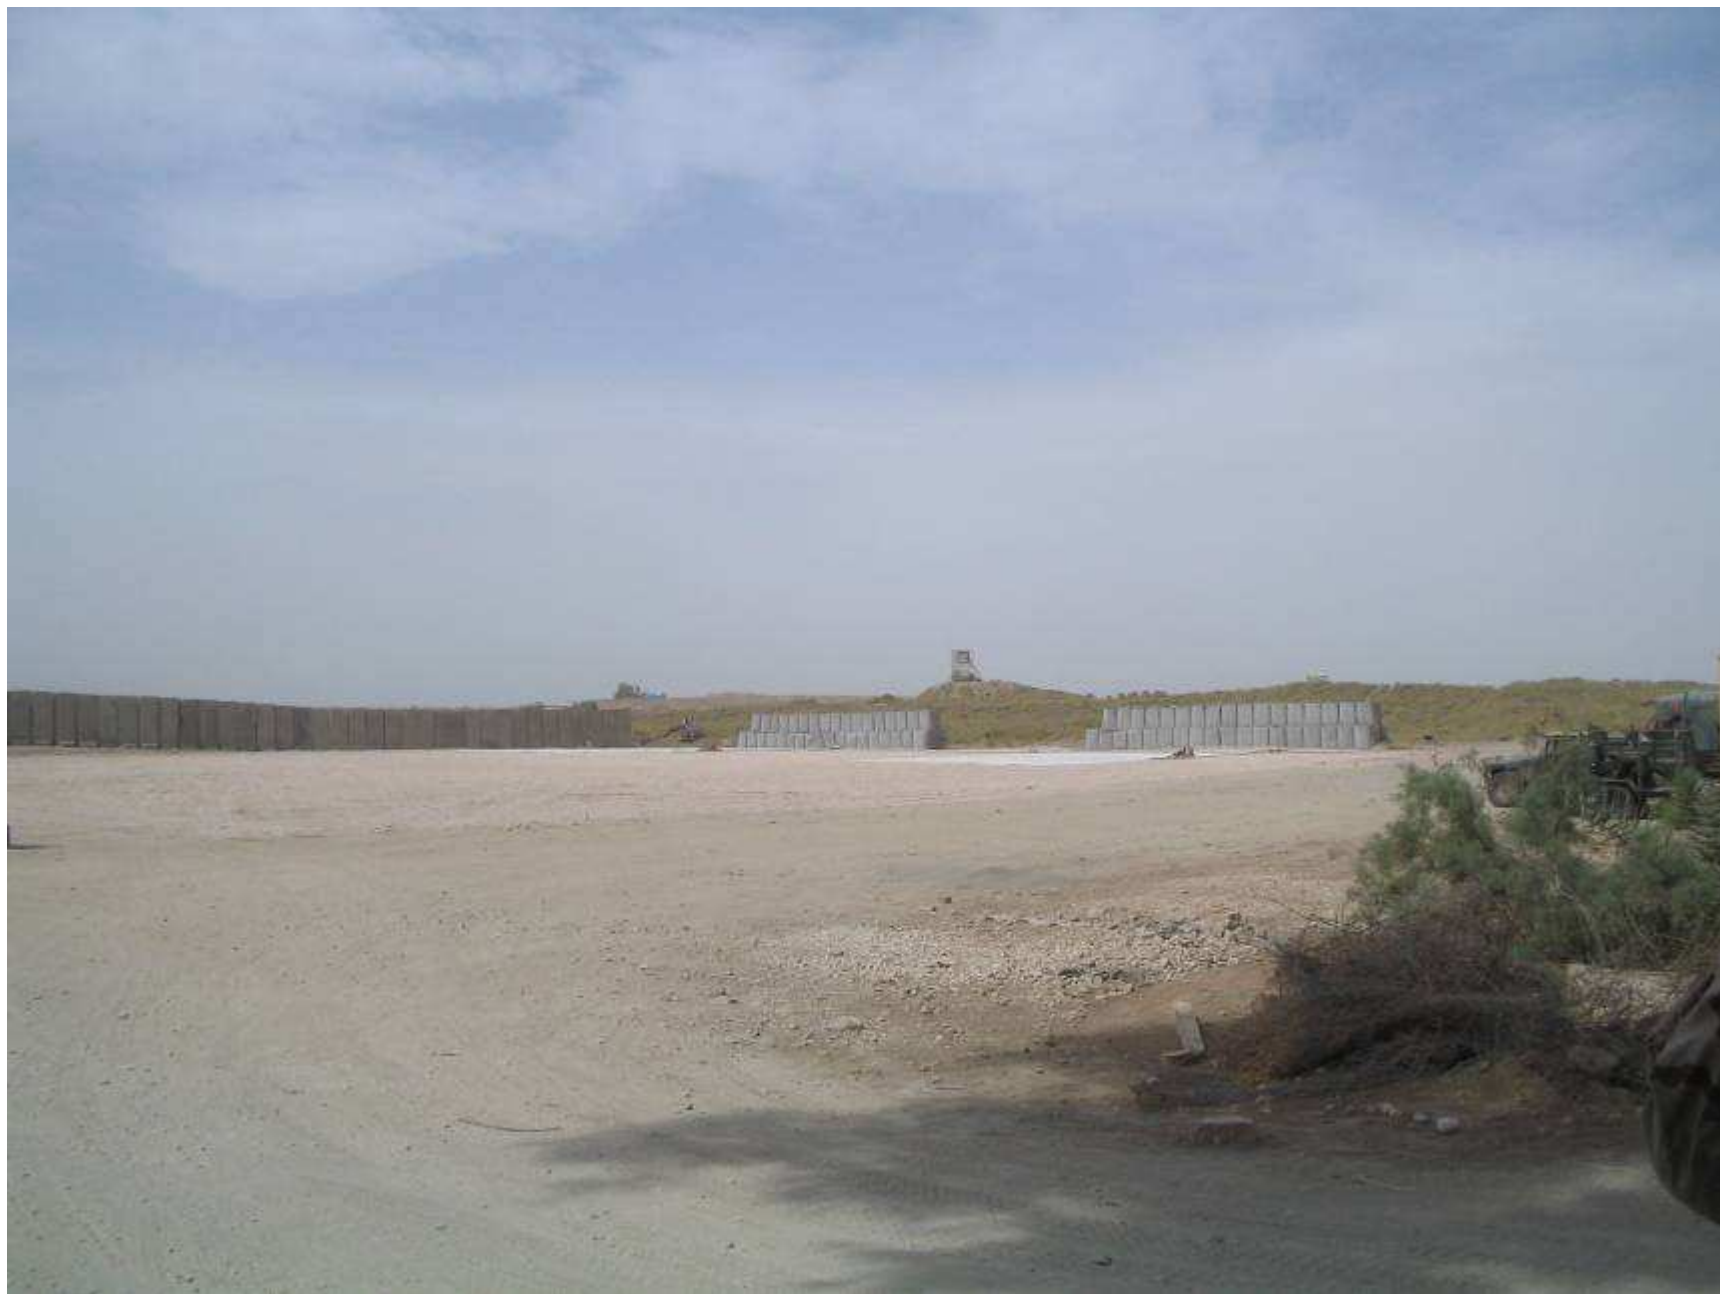
Landing zone 3, with archaeological mound behind, May 2003, Russell photo 123\_2350 (photo © John Russell)

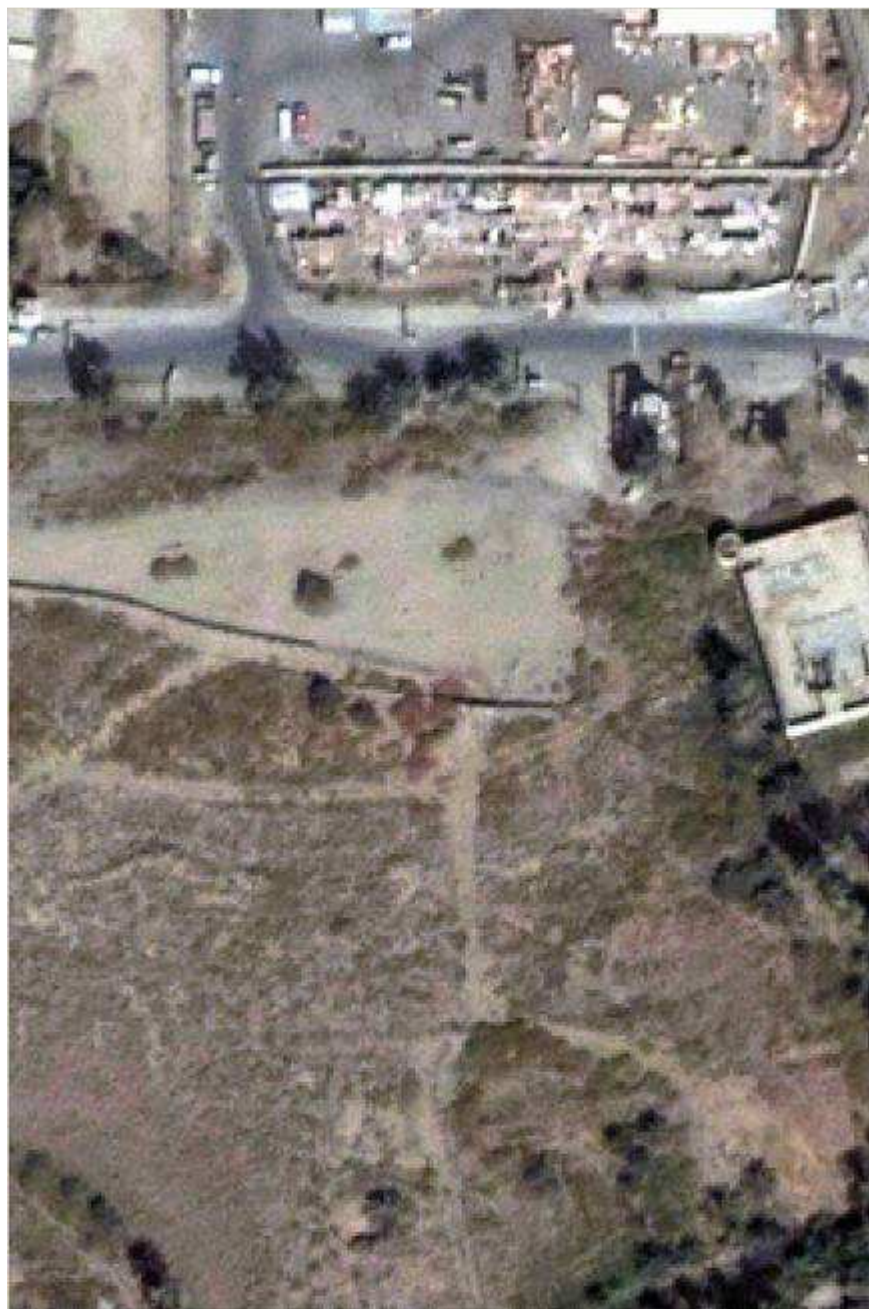
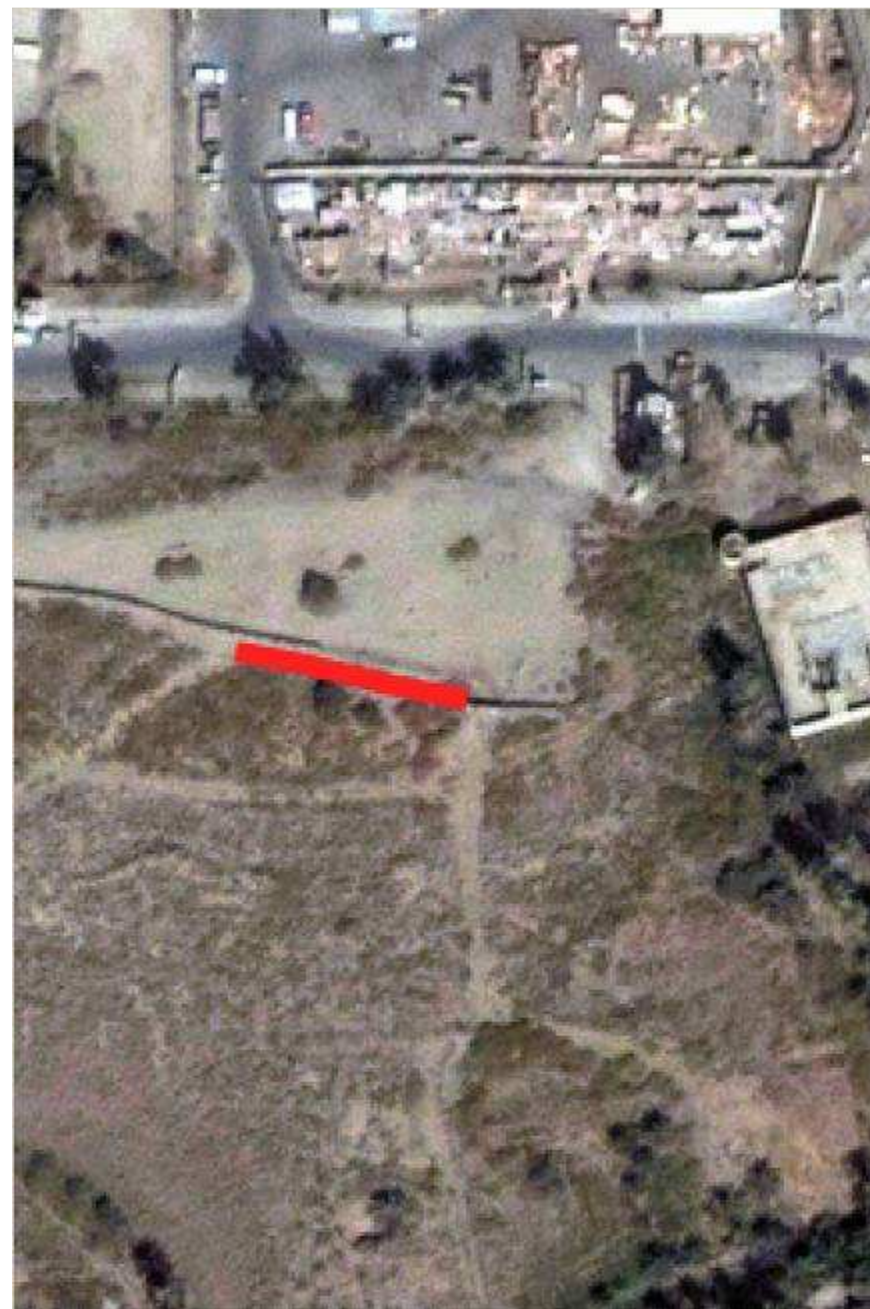
<b>Iraqi preliminary report</b>	<b>Iraqi final report</b>	<b>Curtis report</b>
<p>b. To the west of the Marduk Gate, along Marduk Street, according to the Babylonian map drawn based on the Babel topographical texts, there is a trench that we could not reach at the time because the area was surrounded by barbed wire. We were able to see it from the observation tower with the expert Dr. John Curtis, Director of Near East Archeology, the British Museum and Dr. René, the Cultural Advisor in the US Embassy. Its length was determined to be approximately 30-35 meters. This trench was dug in January of this year. The archaeological coordinator was notified in this regard. Upon the department's request, work was suspended, and the trench was not expanded. At the time, we also requested to photograph this trench but were prevented from doing so. After the evacuation of the city, the committee measured this trench and found it to be 35 meters long, 2 meters wide, and between 25 cm and 1 meter deep.</p>	<p>Fourth trench: West of the Gate of Marduk, to the left of the main entrance of the city, alongside Marduk Street according to the Babylon map created based on the Babylon topographic texts. This fourth trench is 30 m in length, has a width of 2 m, and its depth is 25 cm to 1 m (Photo 25).</p>	<p>From the observation tower at the gate, a trench could be seen beyond the east-west barrier of barbed wire and conix containers that is about 100m to the south of the road. This trench could be observed through a gap of about 30m in the conix containers. It is unknown how long it is.</p> <p>[Apparently another account of the same trench:] About 70m to the south of the road, there is an east-west trench about 25m long which we could only see from a distance, as the area is thought to be mined.</p>

Trench 4, 8 October 2004, Russell composite

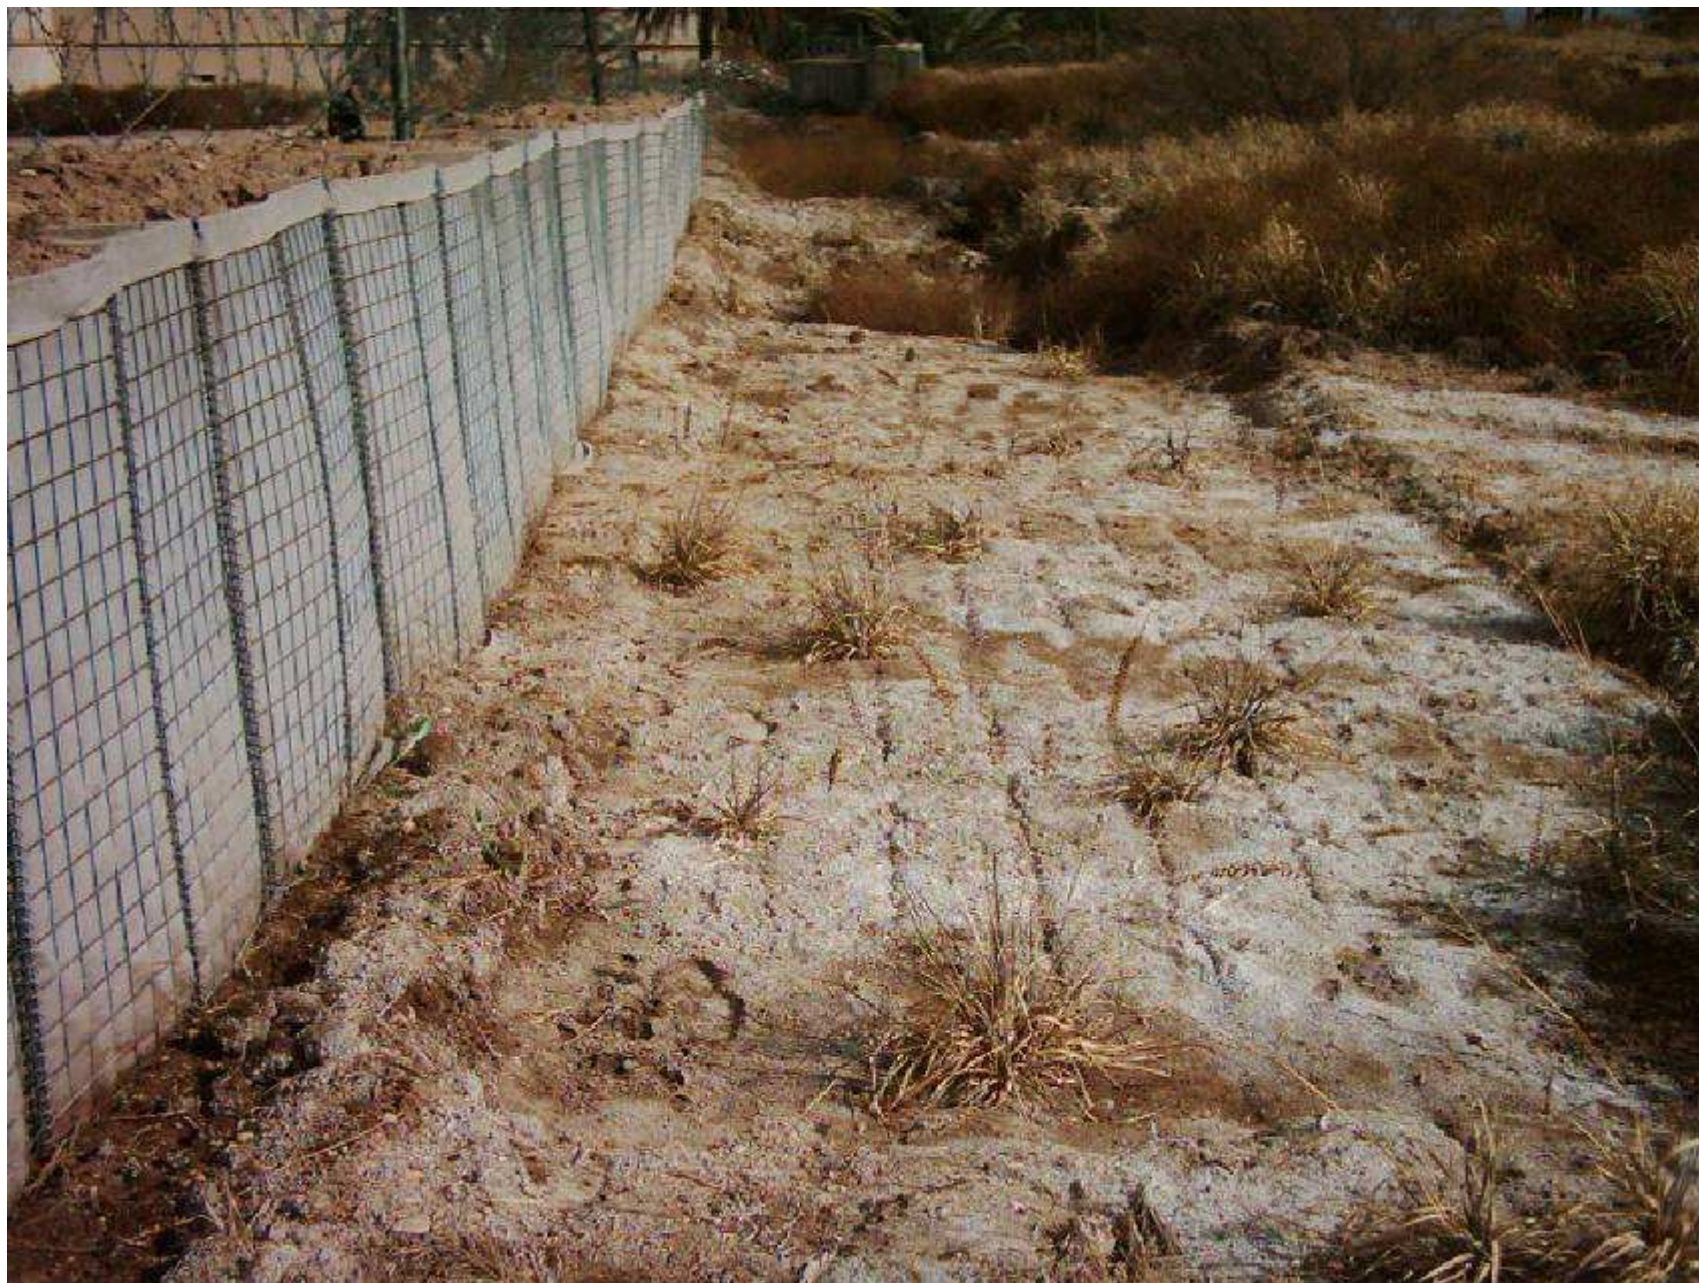
**Russell comment:** This trench was presumably dug to provide earth to fill the adjacent HESCO containers (image Iraqi Final Report 25)

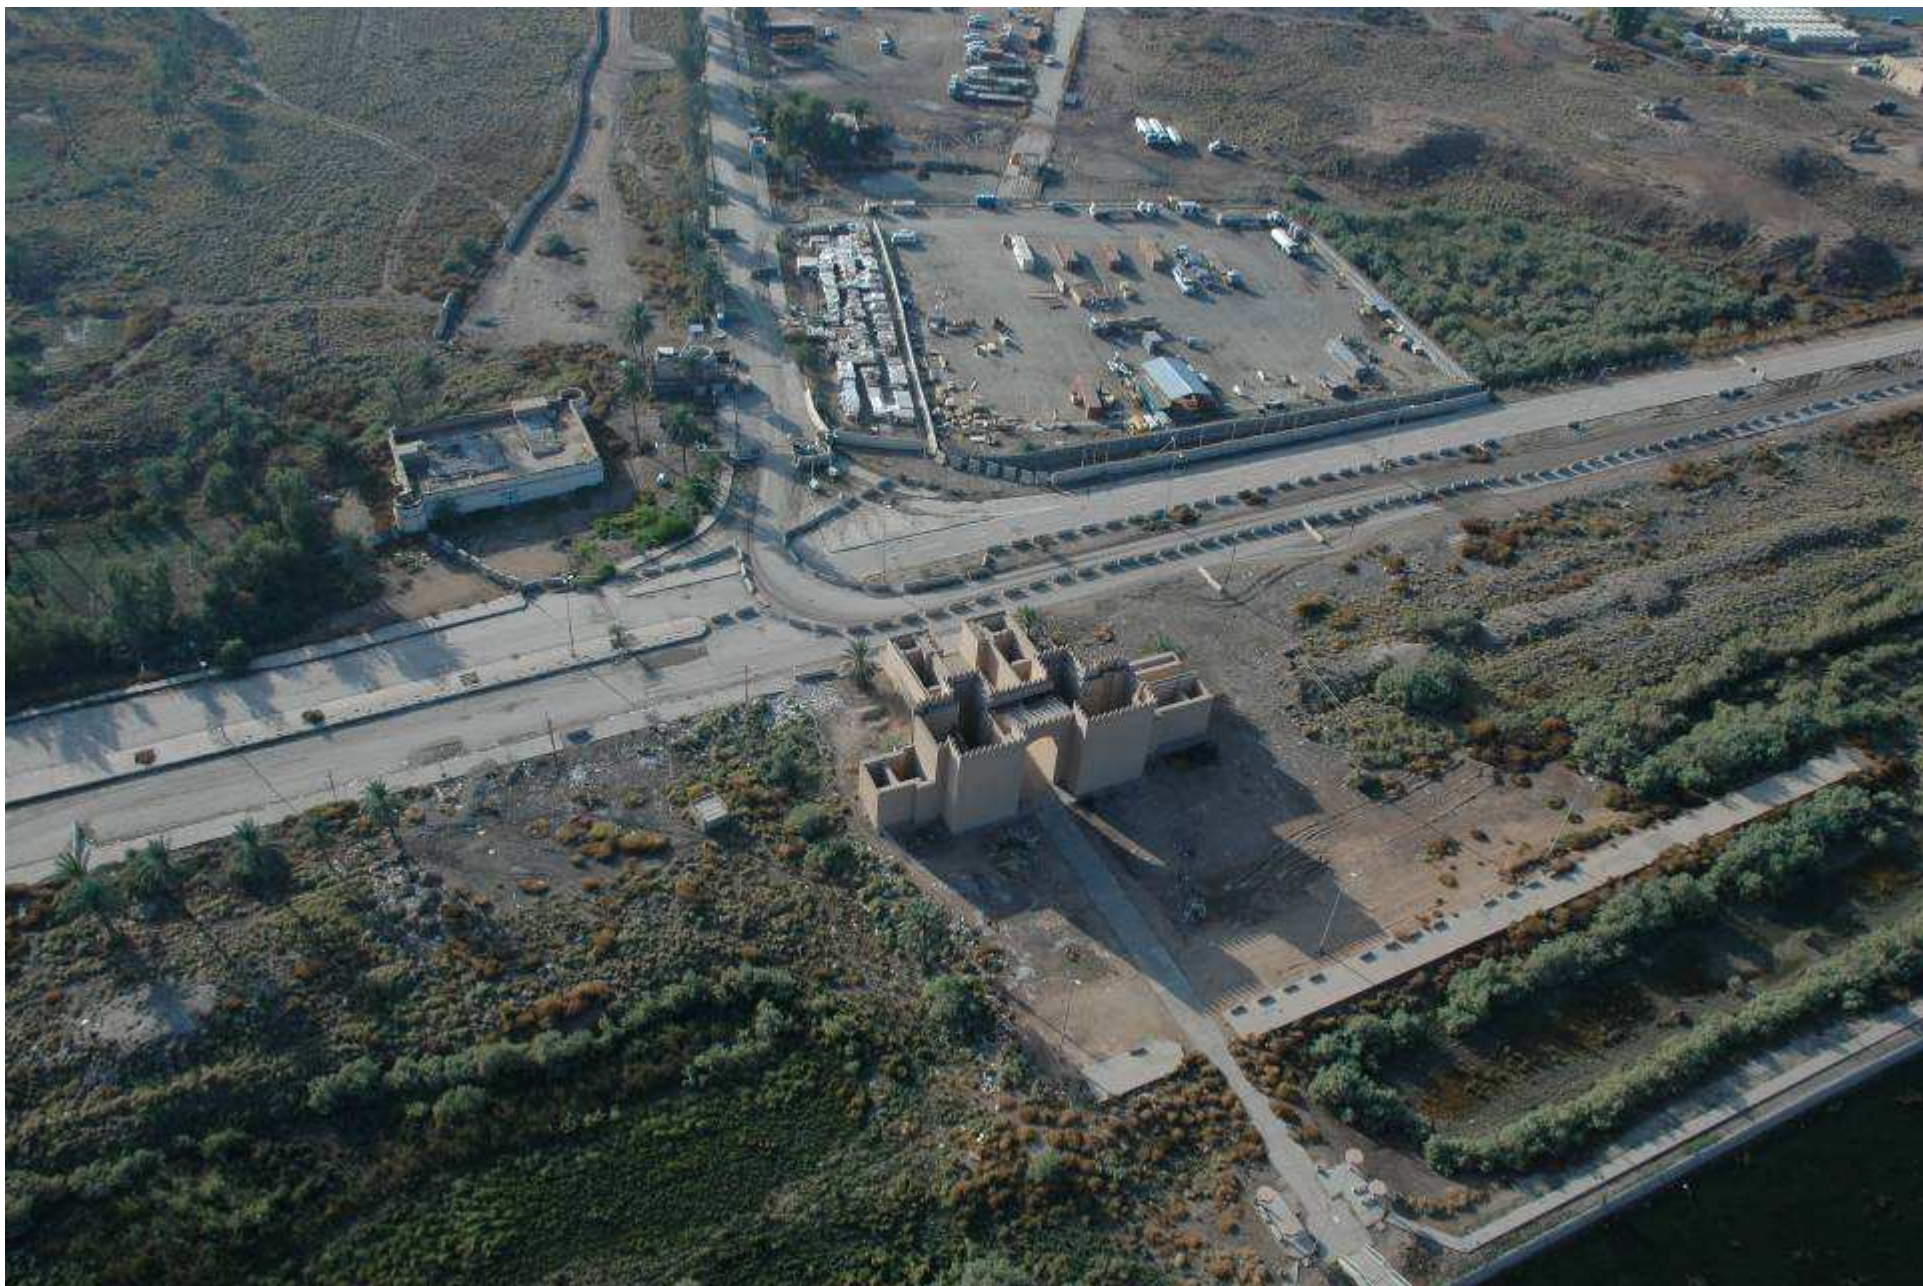
This shallow trench can be seen running along the left side of the HESCO barriers at the upper left center, Polish photo 13 (photo © Ministry of Culture and National Heritage, Republic of Poland)
