# **Report on Damage to the Site of Babylon, Iraq**

**John Malcolm Russell, Ph.D.**

**Cultural Heritage Center  
Bureau of Educational and Cultural Affairs  
Department of State**

**April 2010**

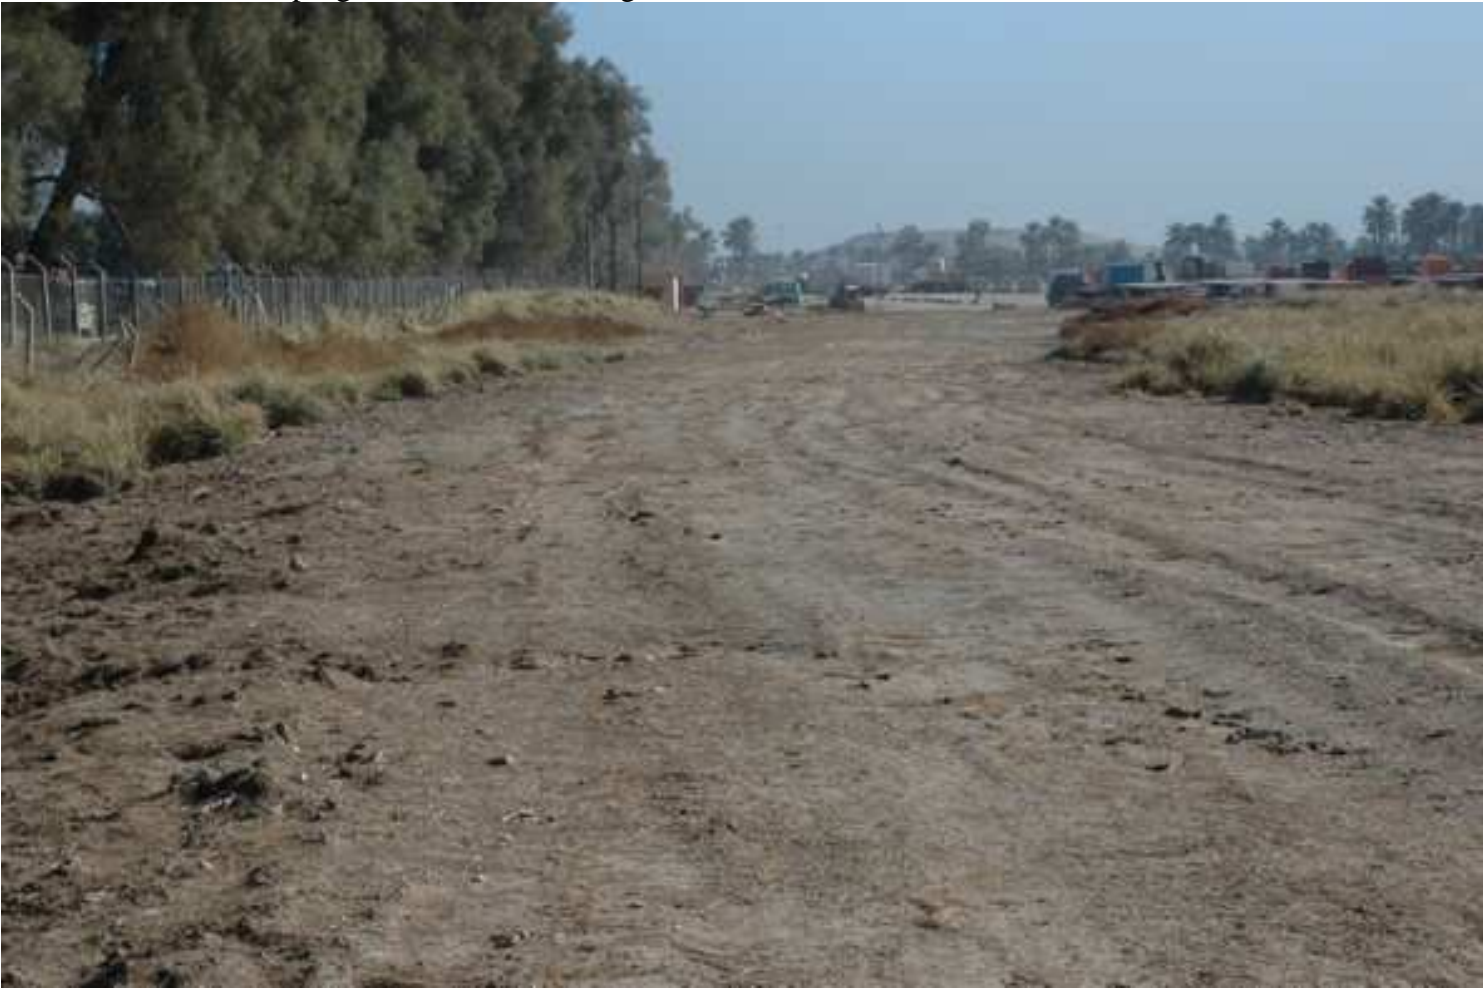
**Russell comment:** The Polish report illustrates, but does not describe, the dirt road south of the Hammurabi Museum. It runs south of, and parallel to, the paved road. As Stone notes, this area is already open space in the 2002 image, but received harder use during the Coalition occupation. This road is visible at the top right in the satellite images below.

Un-surfaced road South of the main road. Polish report p. 27 (photo © Ministry of Culture and National Heritage, Republic of Poland)

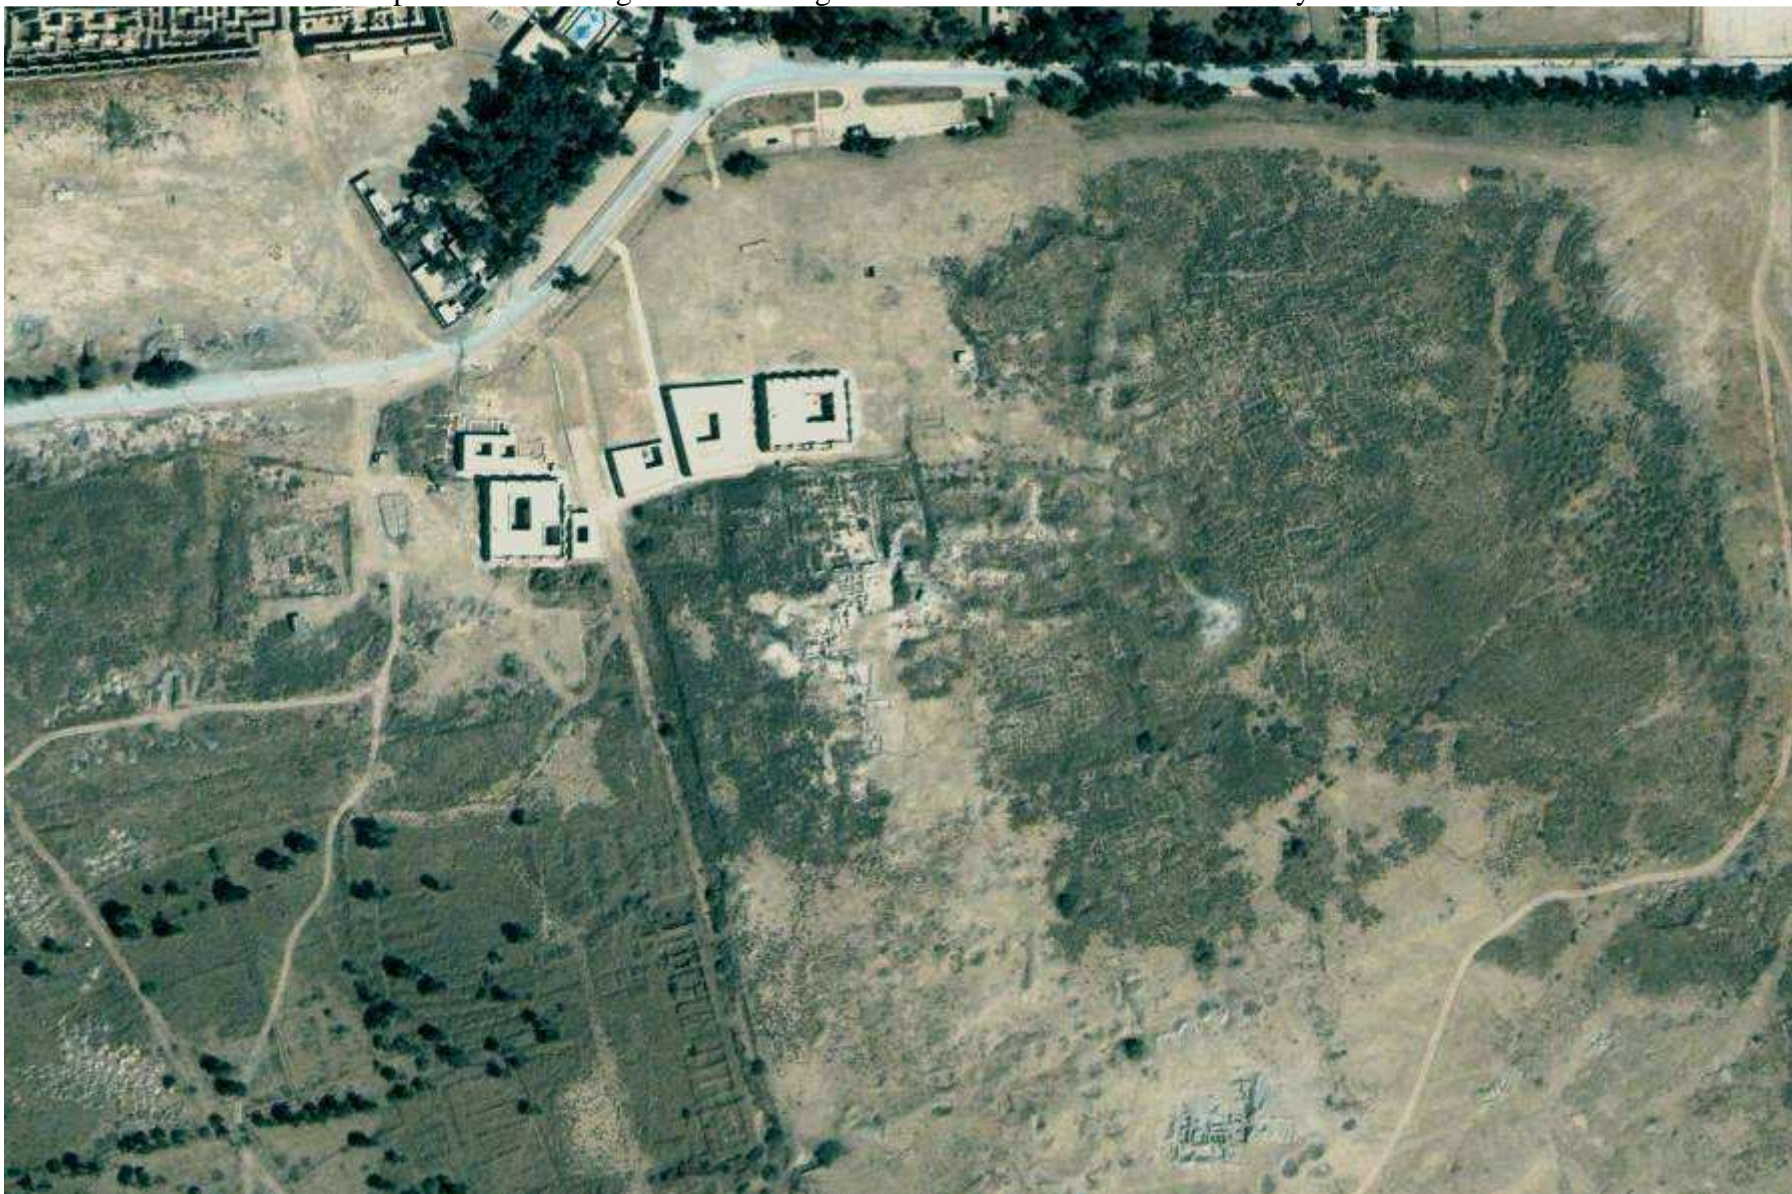
Ancient central city mound before construction of new roads, 1 April 2003, Russell composite image

The satellite images show ancient architecture visible on the surface in the Merkes area. In addition to the road mentioned above, a large network of new roads was cut into this important archaeological area during the first 5 months of the site's use by Coalition forces.

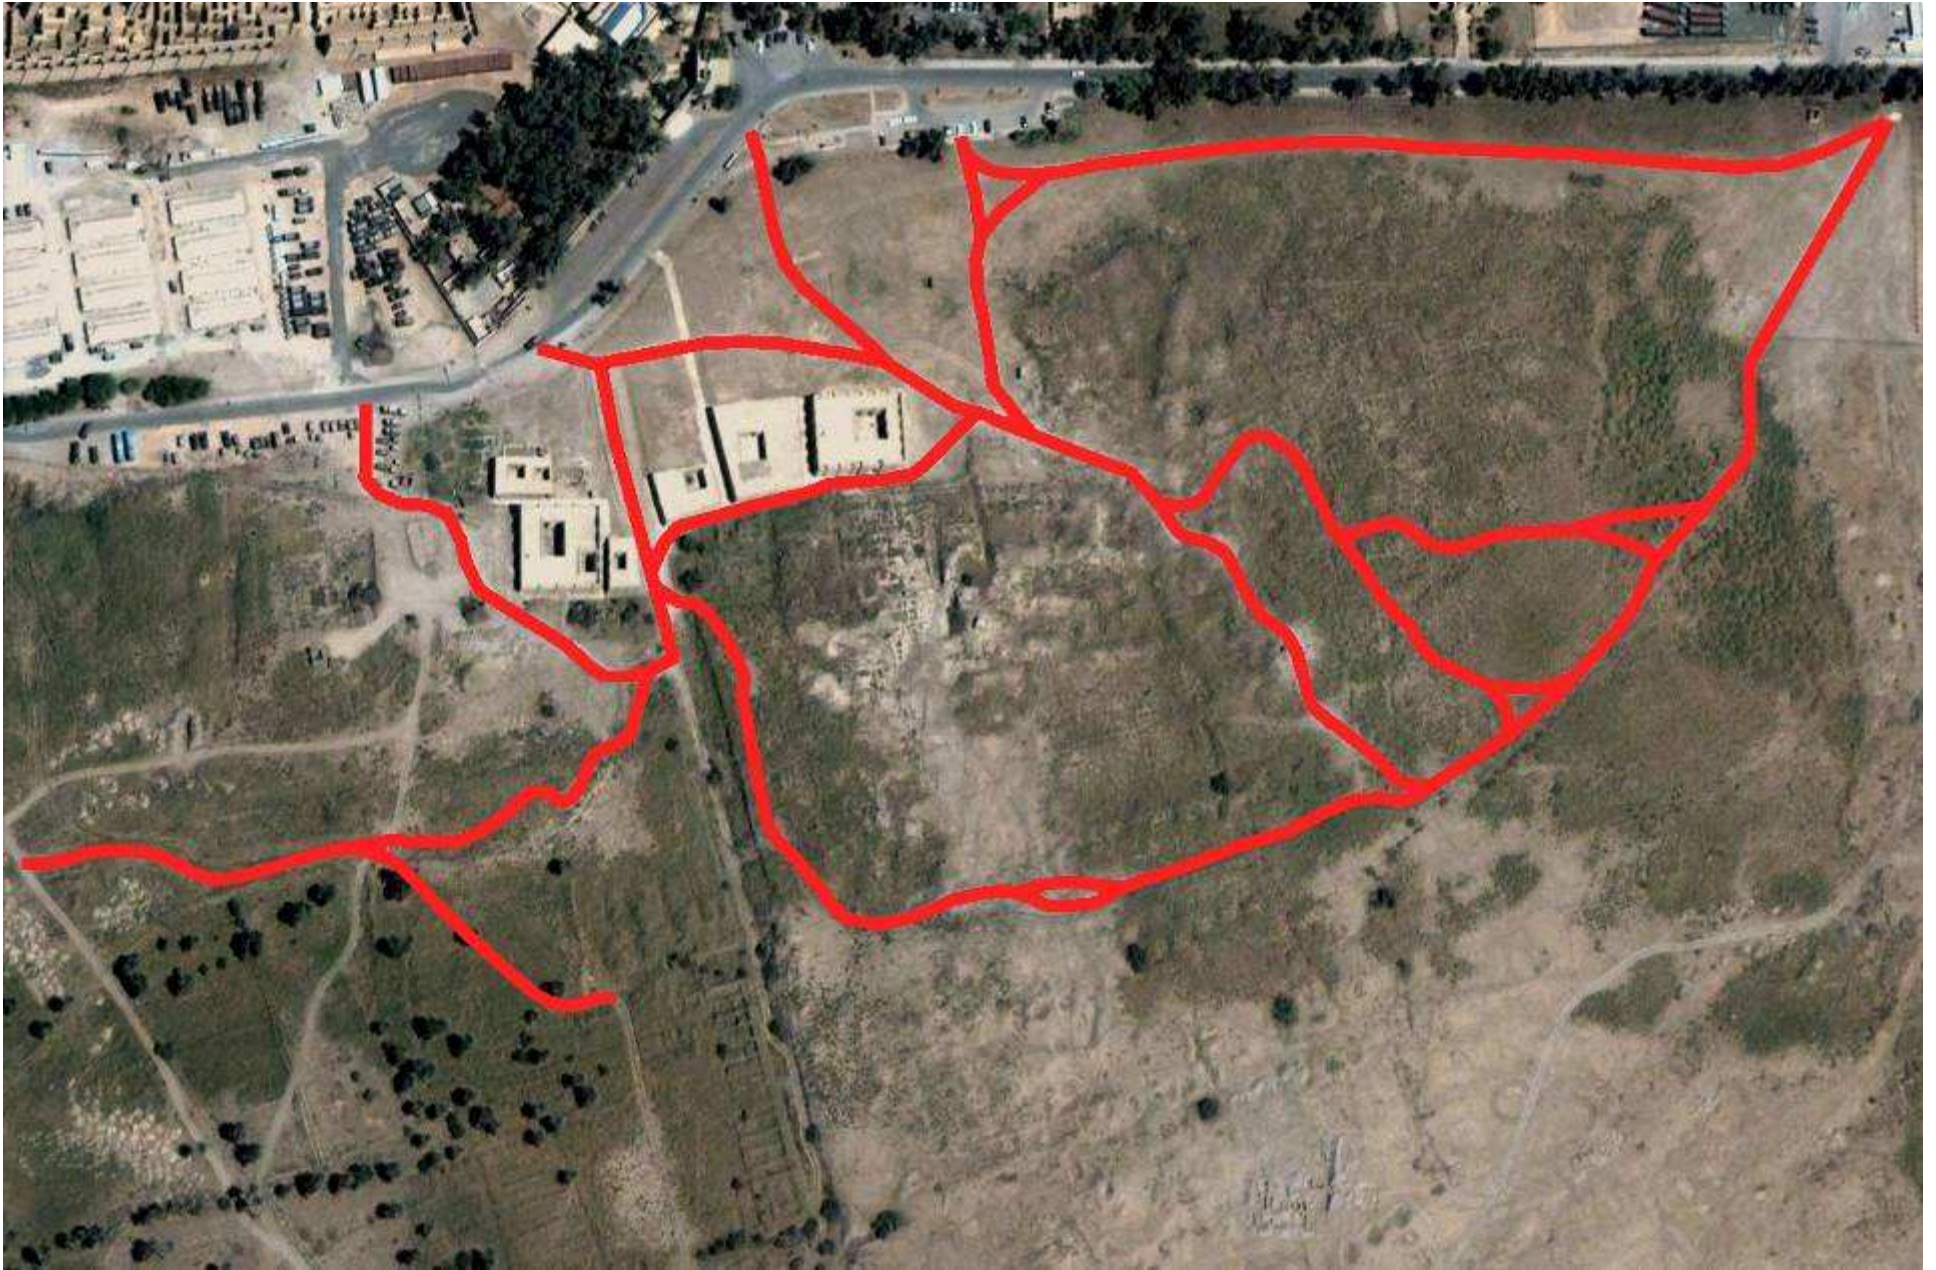
Ancient central city area with network of new roads highlighted, 31 August 2003, Russell composite image

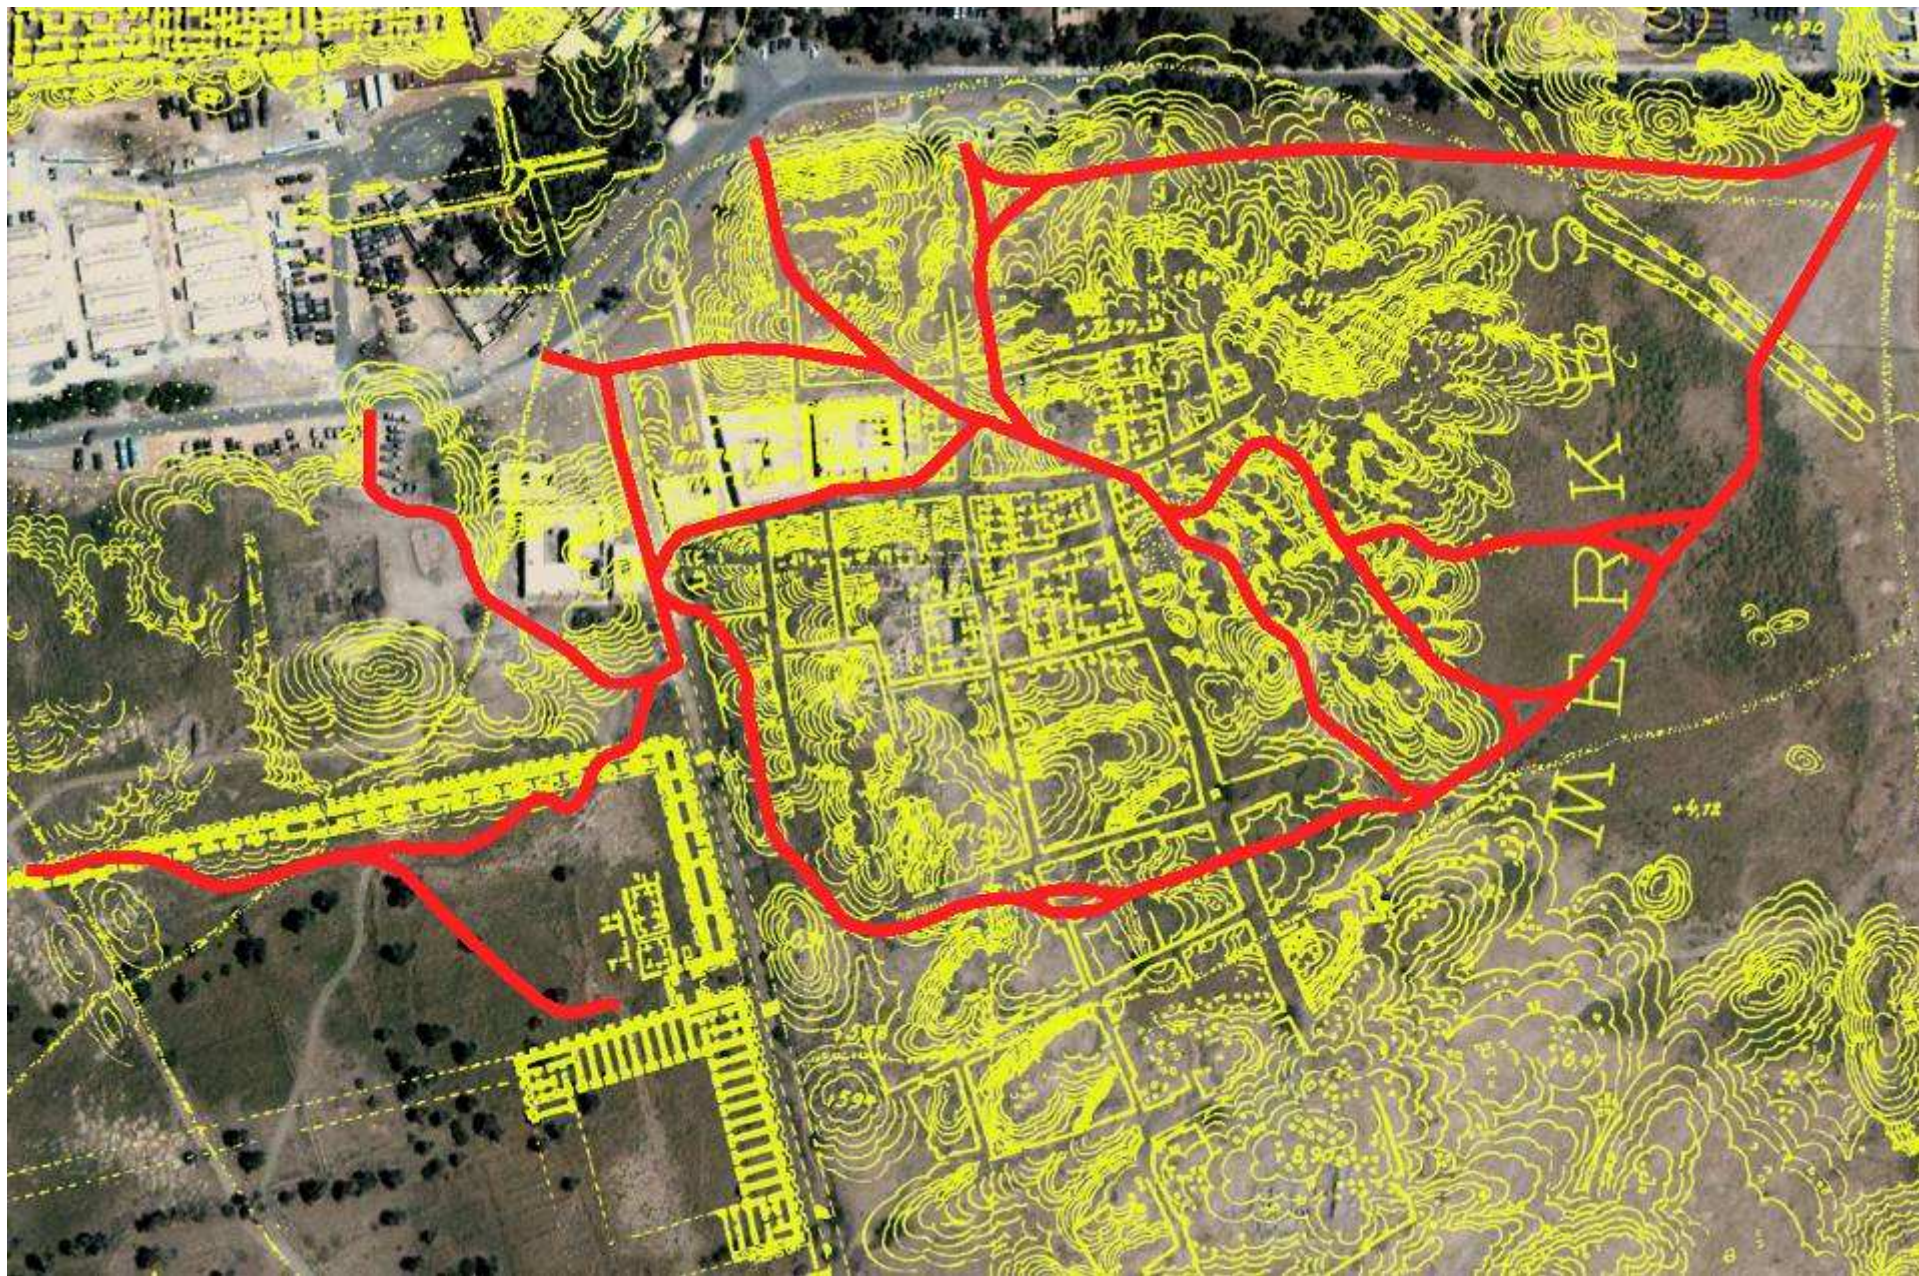
Ancient central city area with Koldewey's 1913 plan of architecture and new roads overlaid, 31 August 2003, Russell composite image

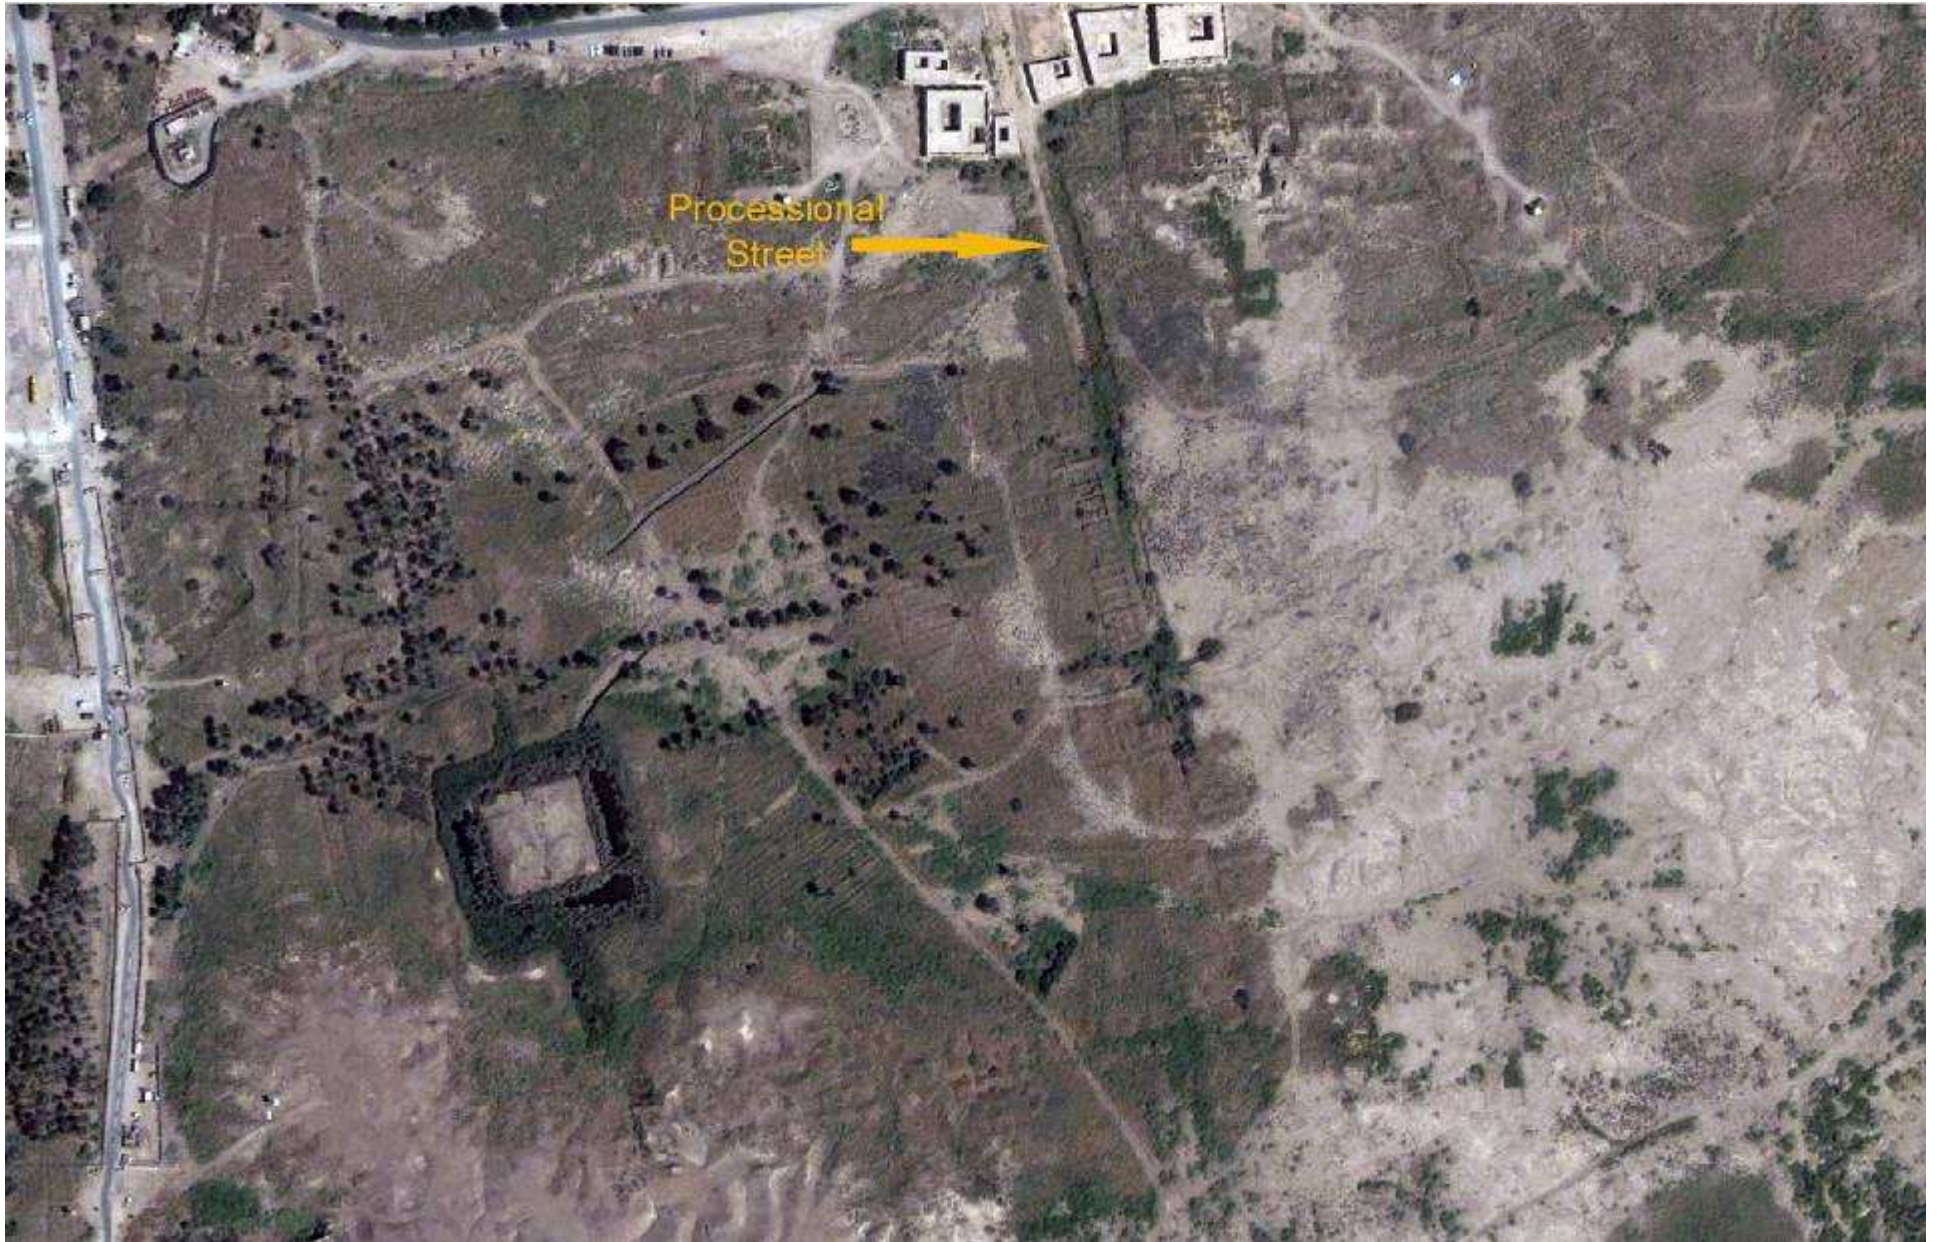
Processional Street with walls of ziggurat enclosure visible on the surface, 25 August 2004, Russell composite

**Russell comment:** It appears that more of the pavement bricks are exposed in the May 2004 photos than in the November/December 2004 photos, which suggests that someone put some dirt over the bricks after May 2004. As the Iraqi reports stress, the earthen banks to either side of the Processional Street are the ancient mud brick walls of the ziggurat enclosure and other ancient structures, and therefore are not a good place to drive fence posts.

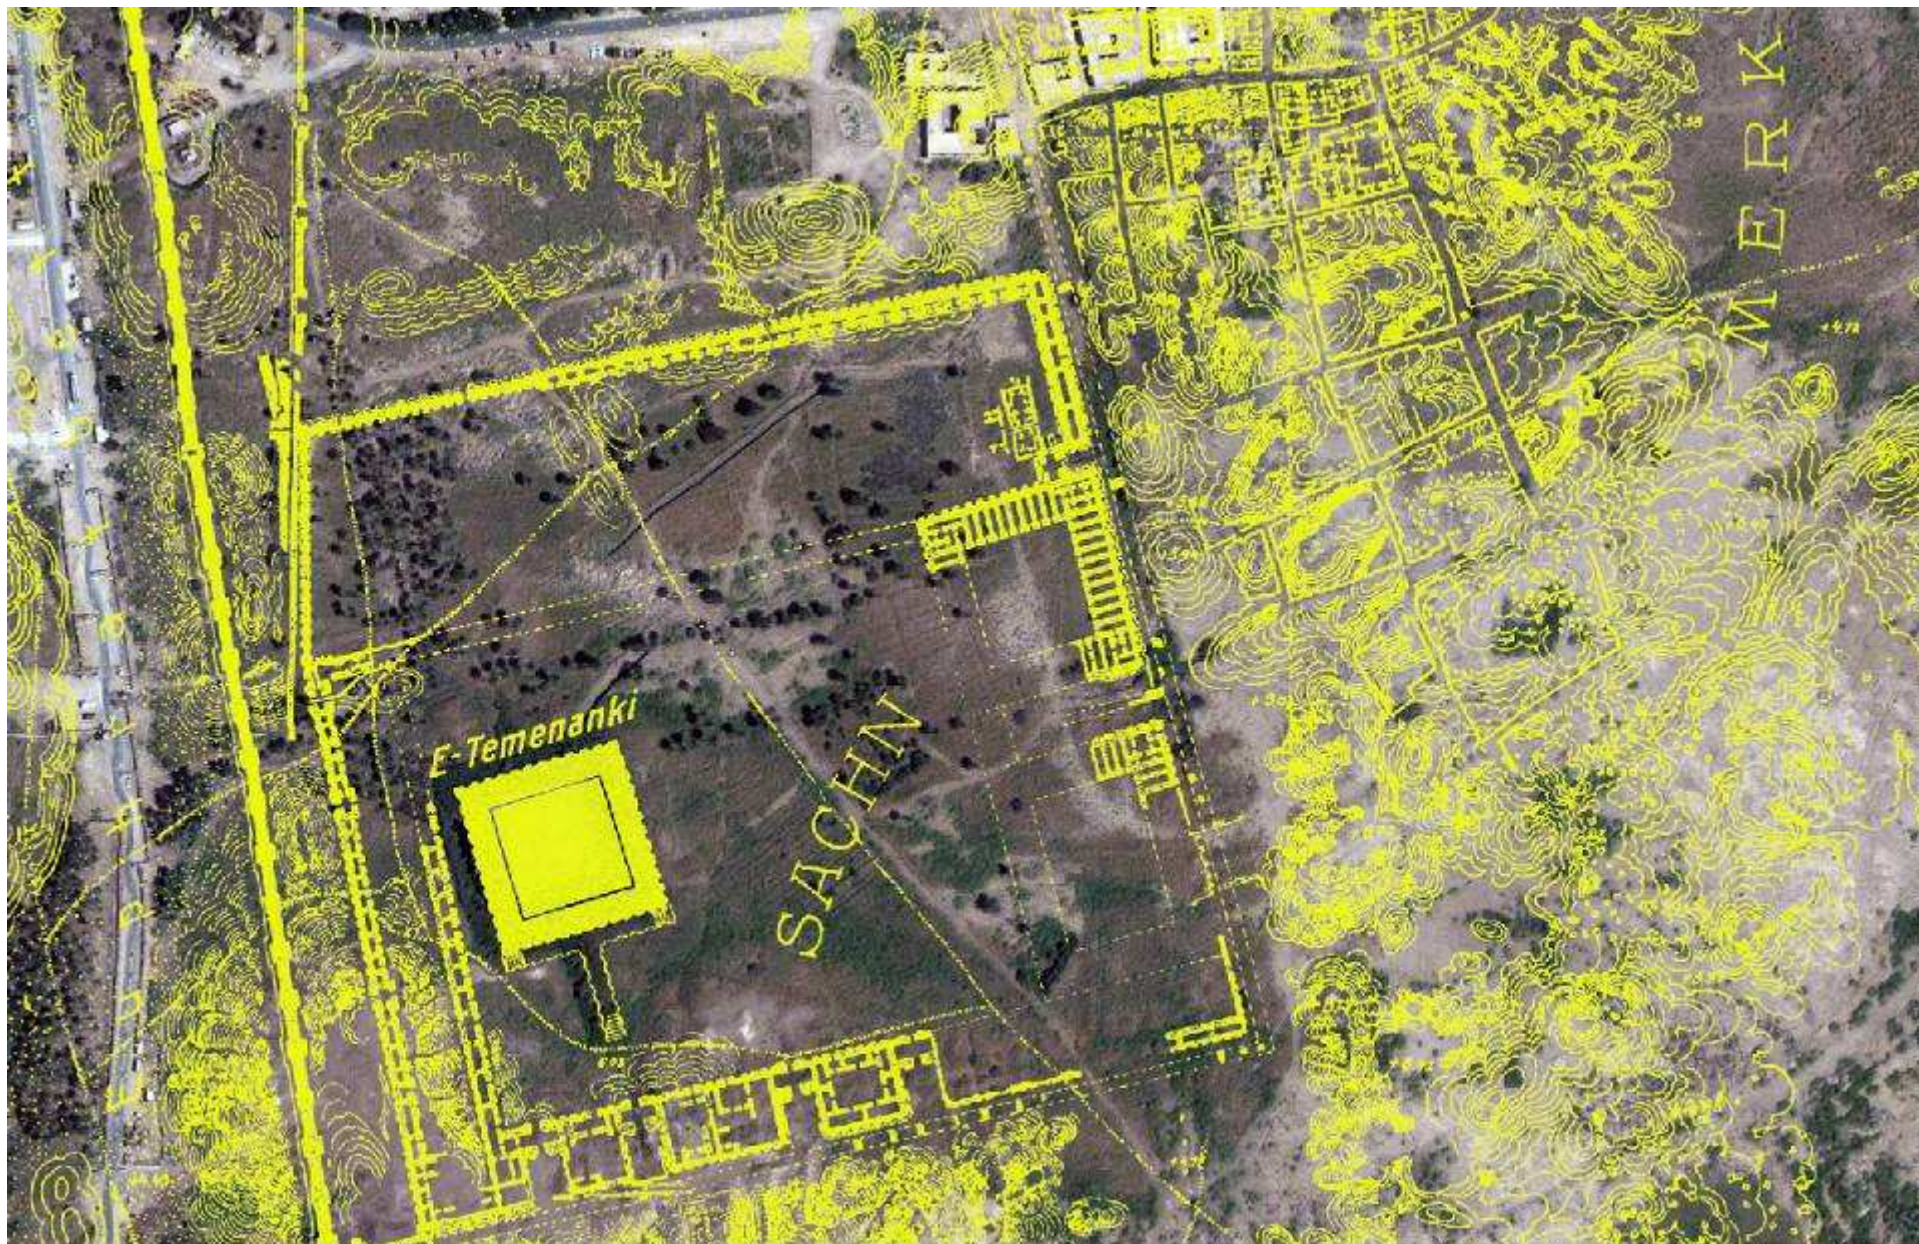
Processional Street with overlay of Koldewey 1912 map showing walls of ziggurat enclosure, 25 August 2004, Russell composite

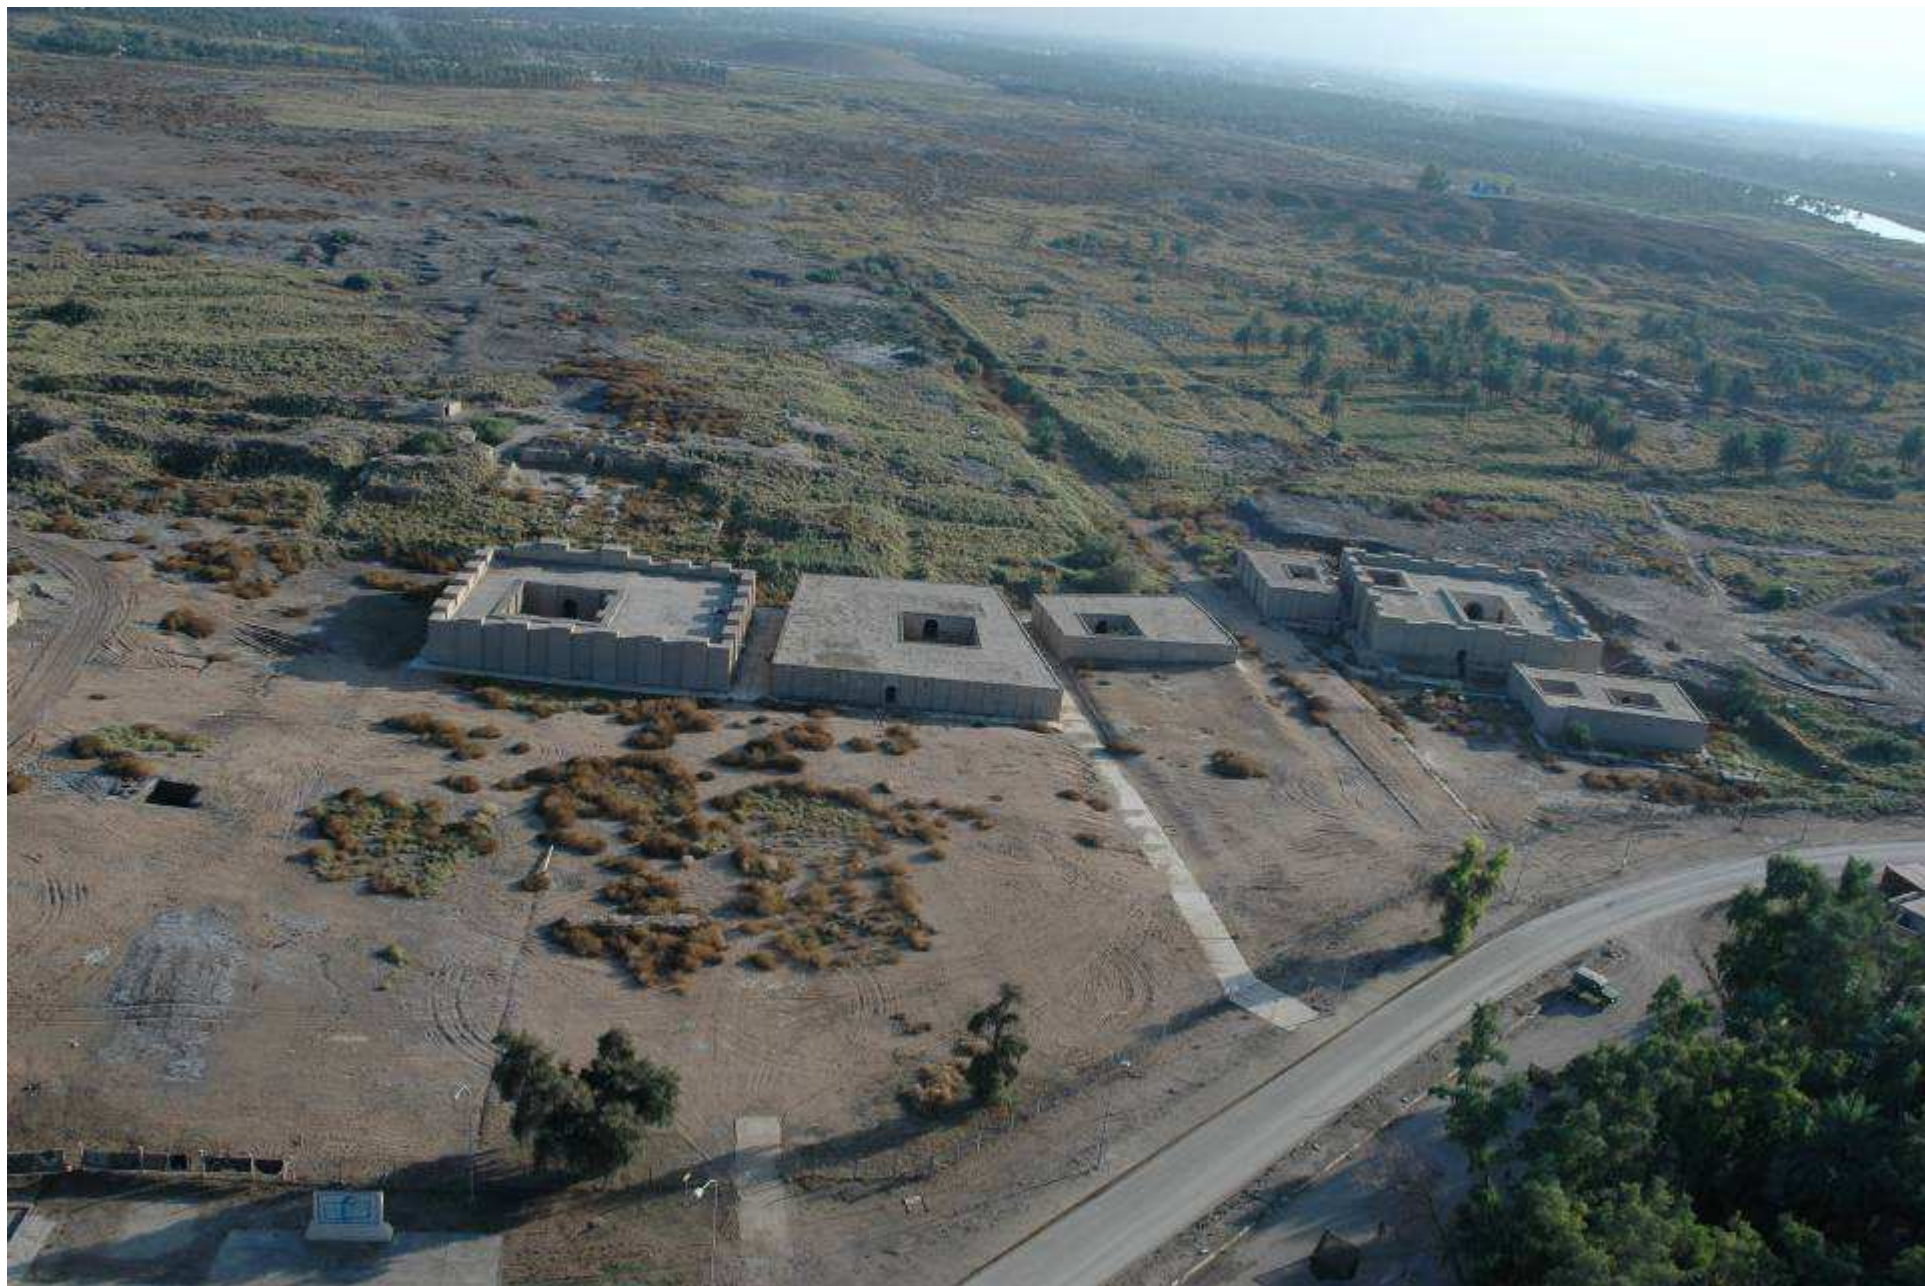
Processional Street looking south, Polish photo 117 (photo © Ministry of Culture and National Heritage, Republic of Poland)

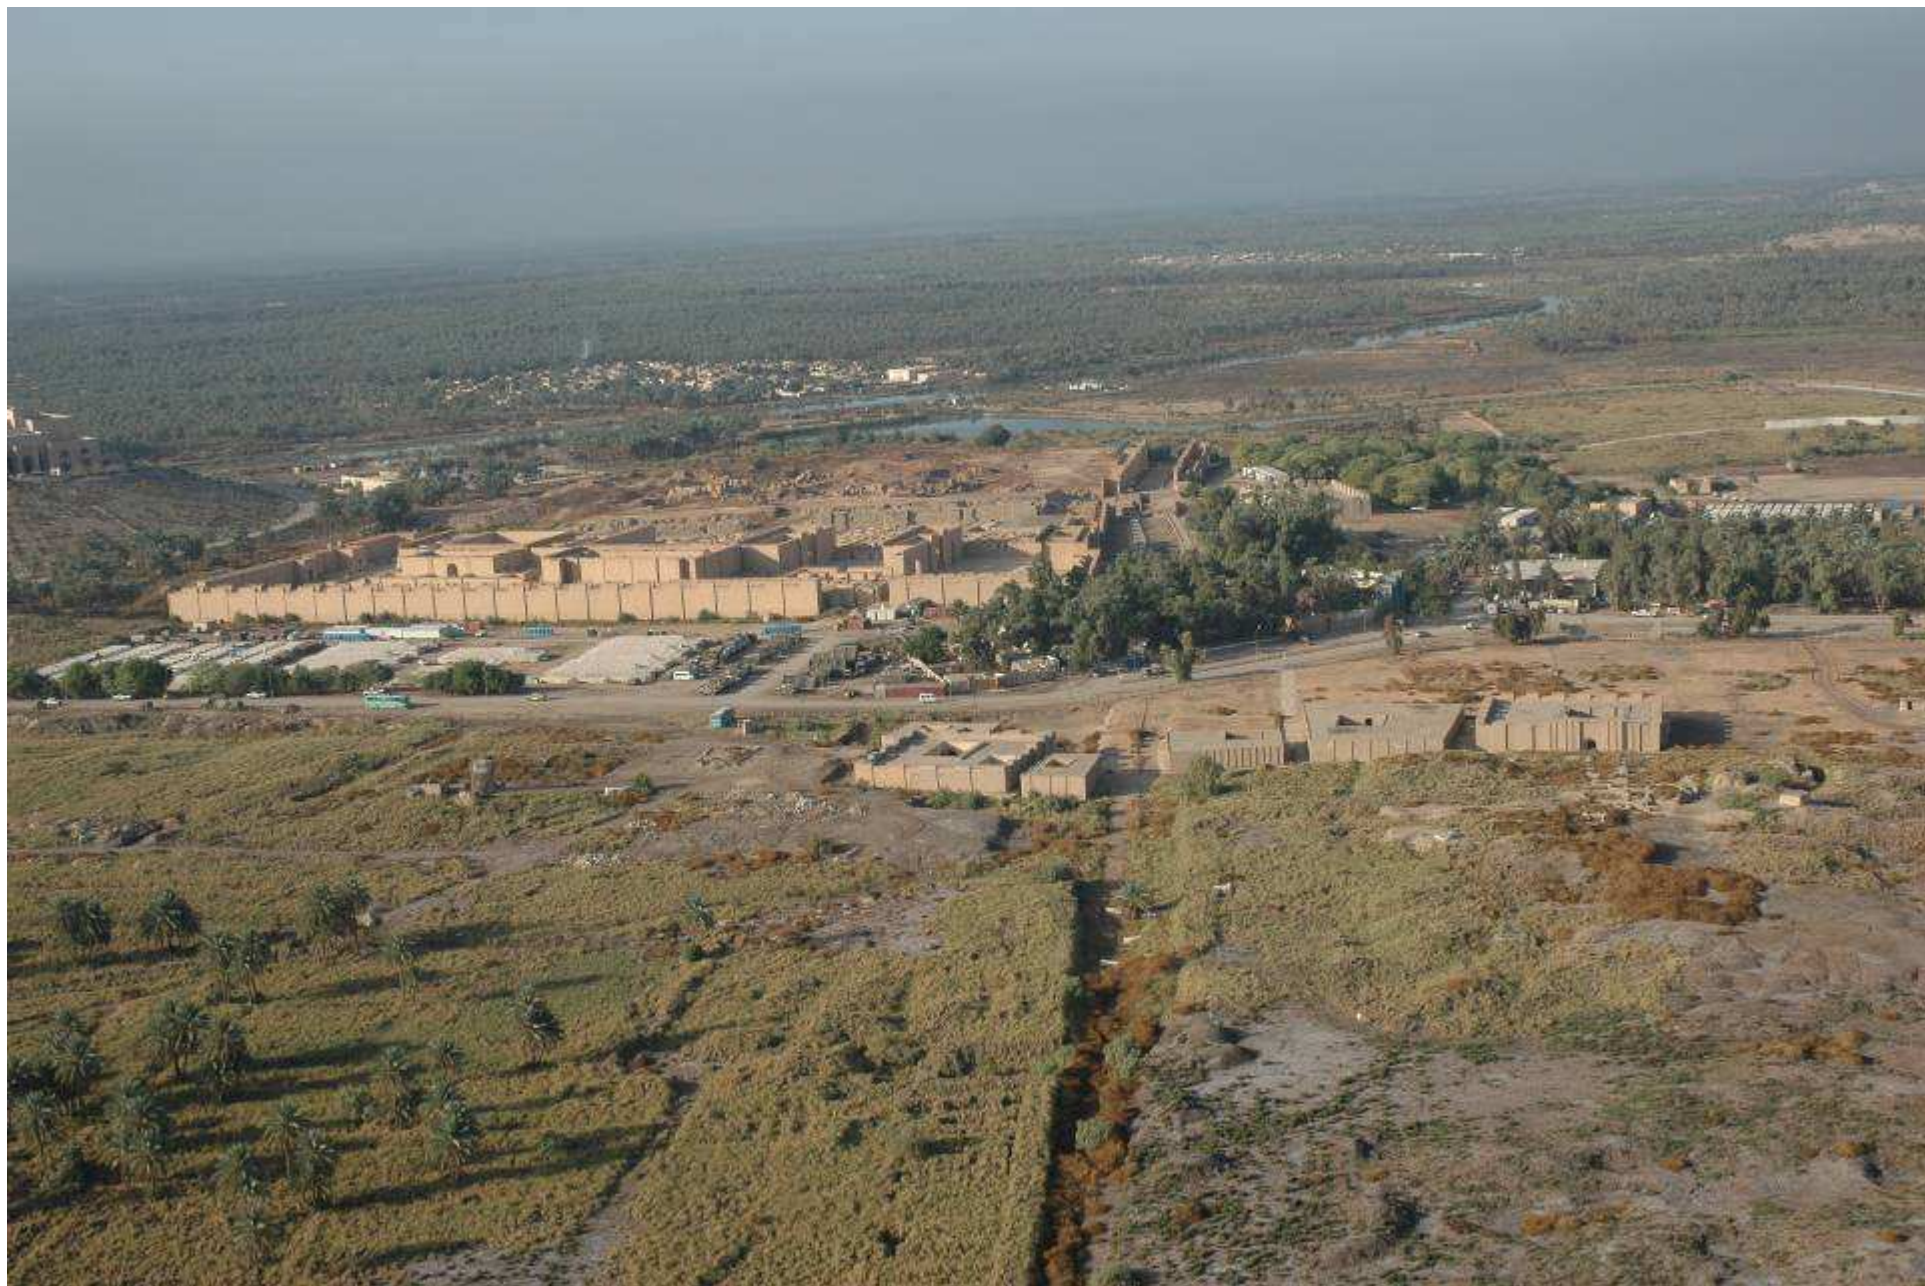
Processional Street looking north, Polish photo 8 (photo © Ministry of Culture and National Heritage, Republic of Poland)

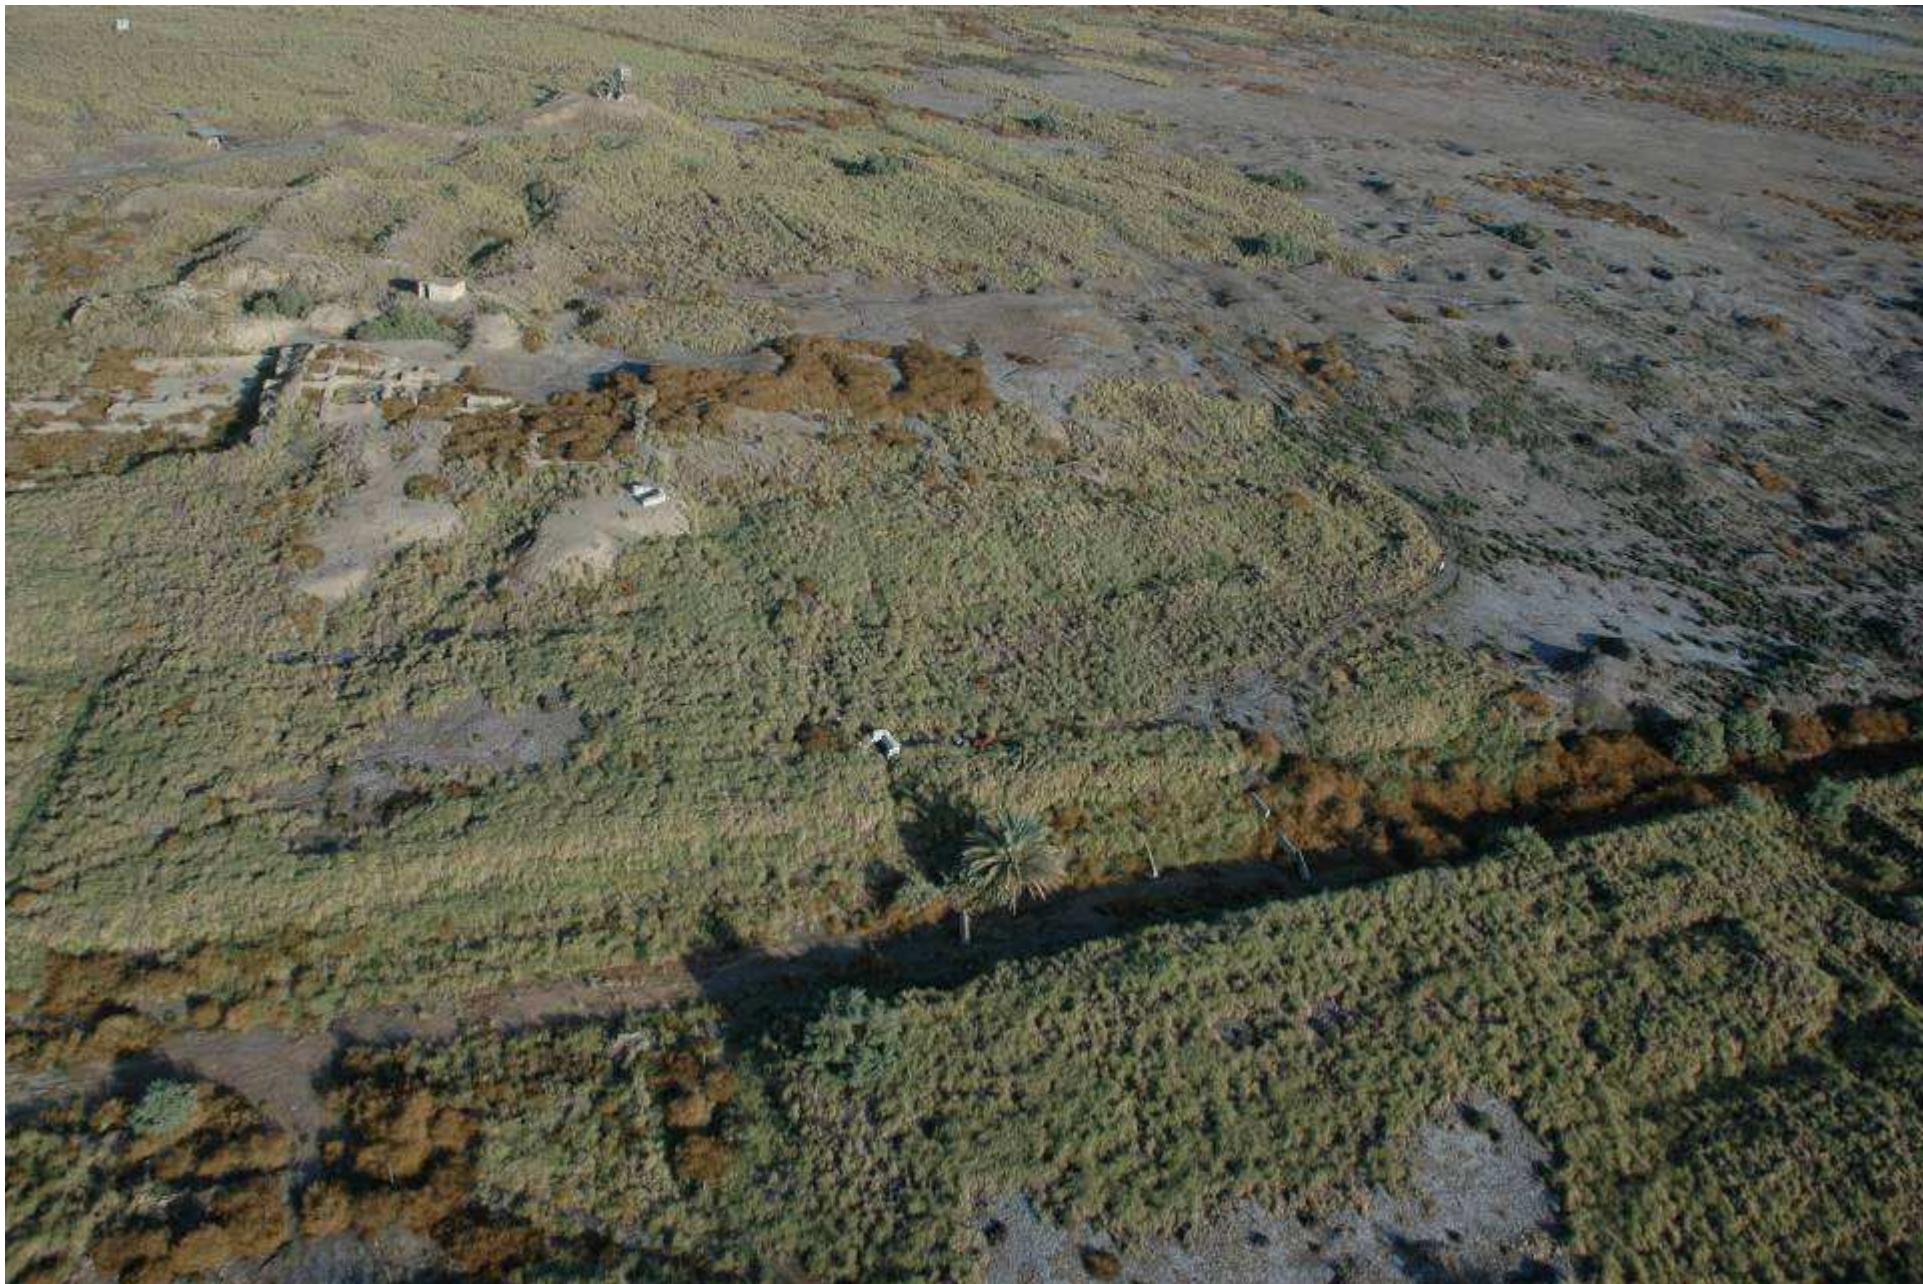
Processional Street looking east, with ziggurat enclosure walls in foreground, Polish photo 120 (photo © Ministry of Culture and National Heritage, Republic of Poland)
