# **Report on Damage to the Site of Babylon, Iraq**

**John Malcolm Russell, Ph.D.**

**Cultural Heritage Center  
Bureau of Educational and Cultural Affairs  
Department of State**

**April 2010**

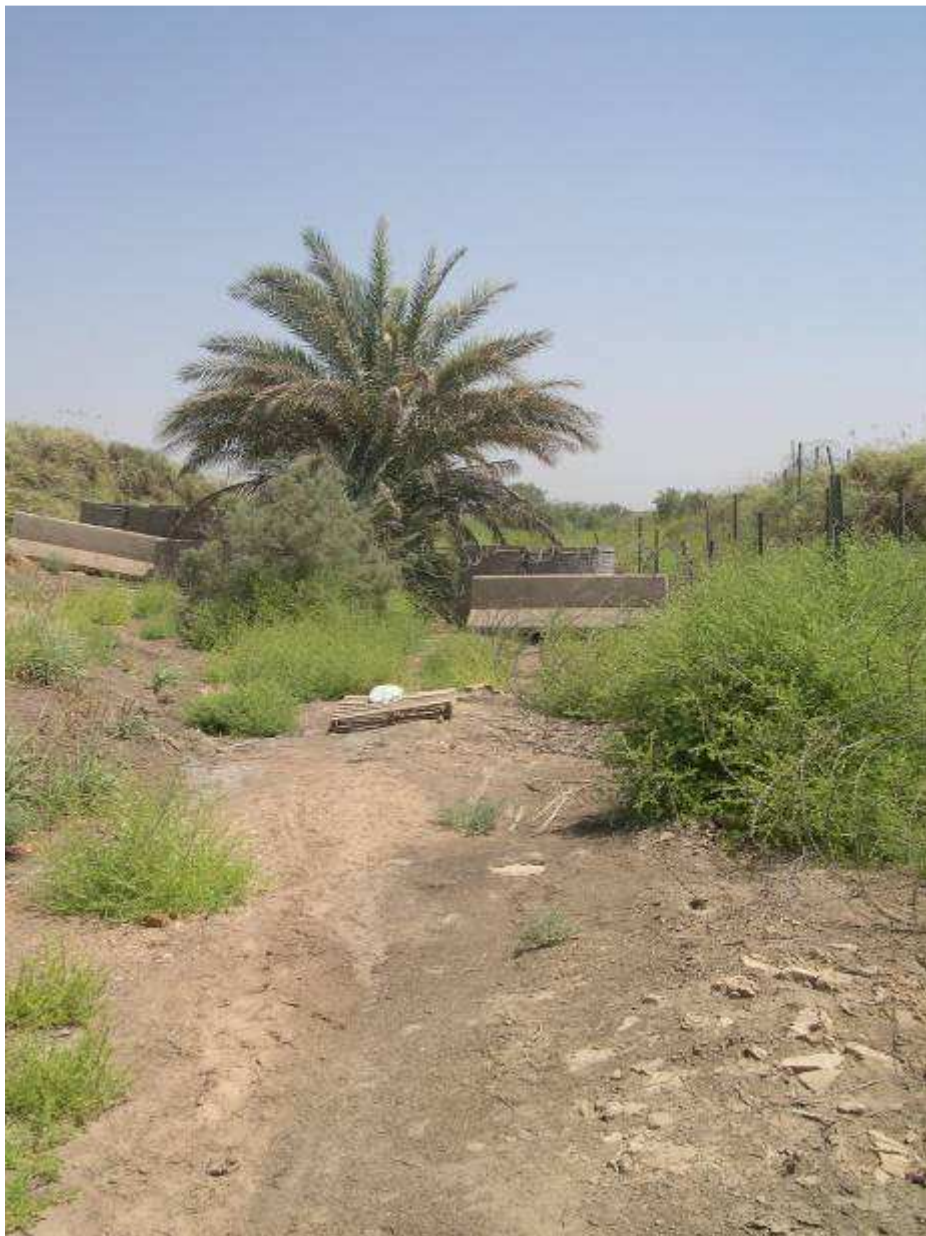
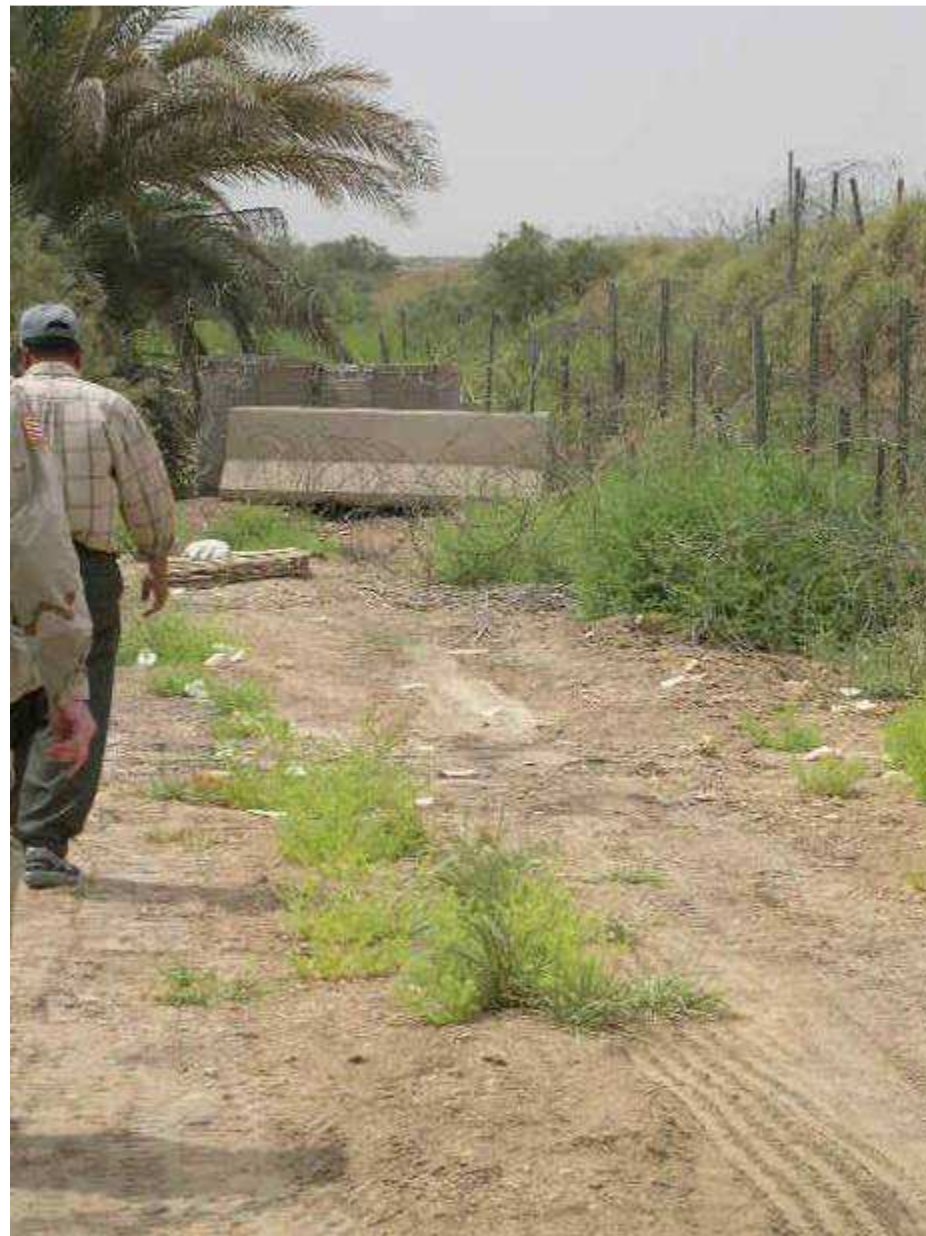
Concrete barricade blocks on the Processional Street. (photos © Zainab Bahrani)

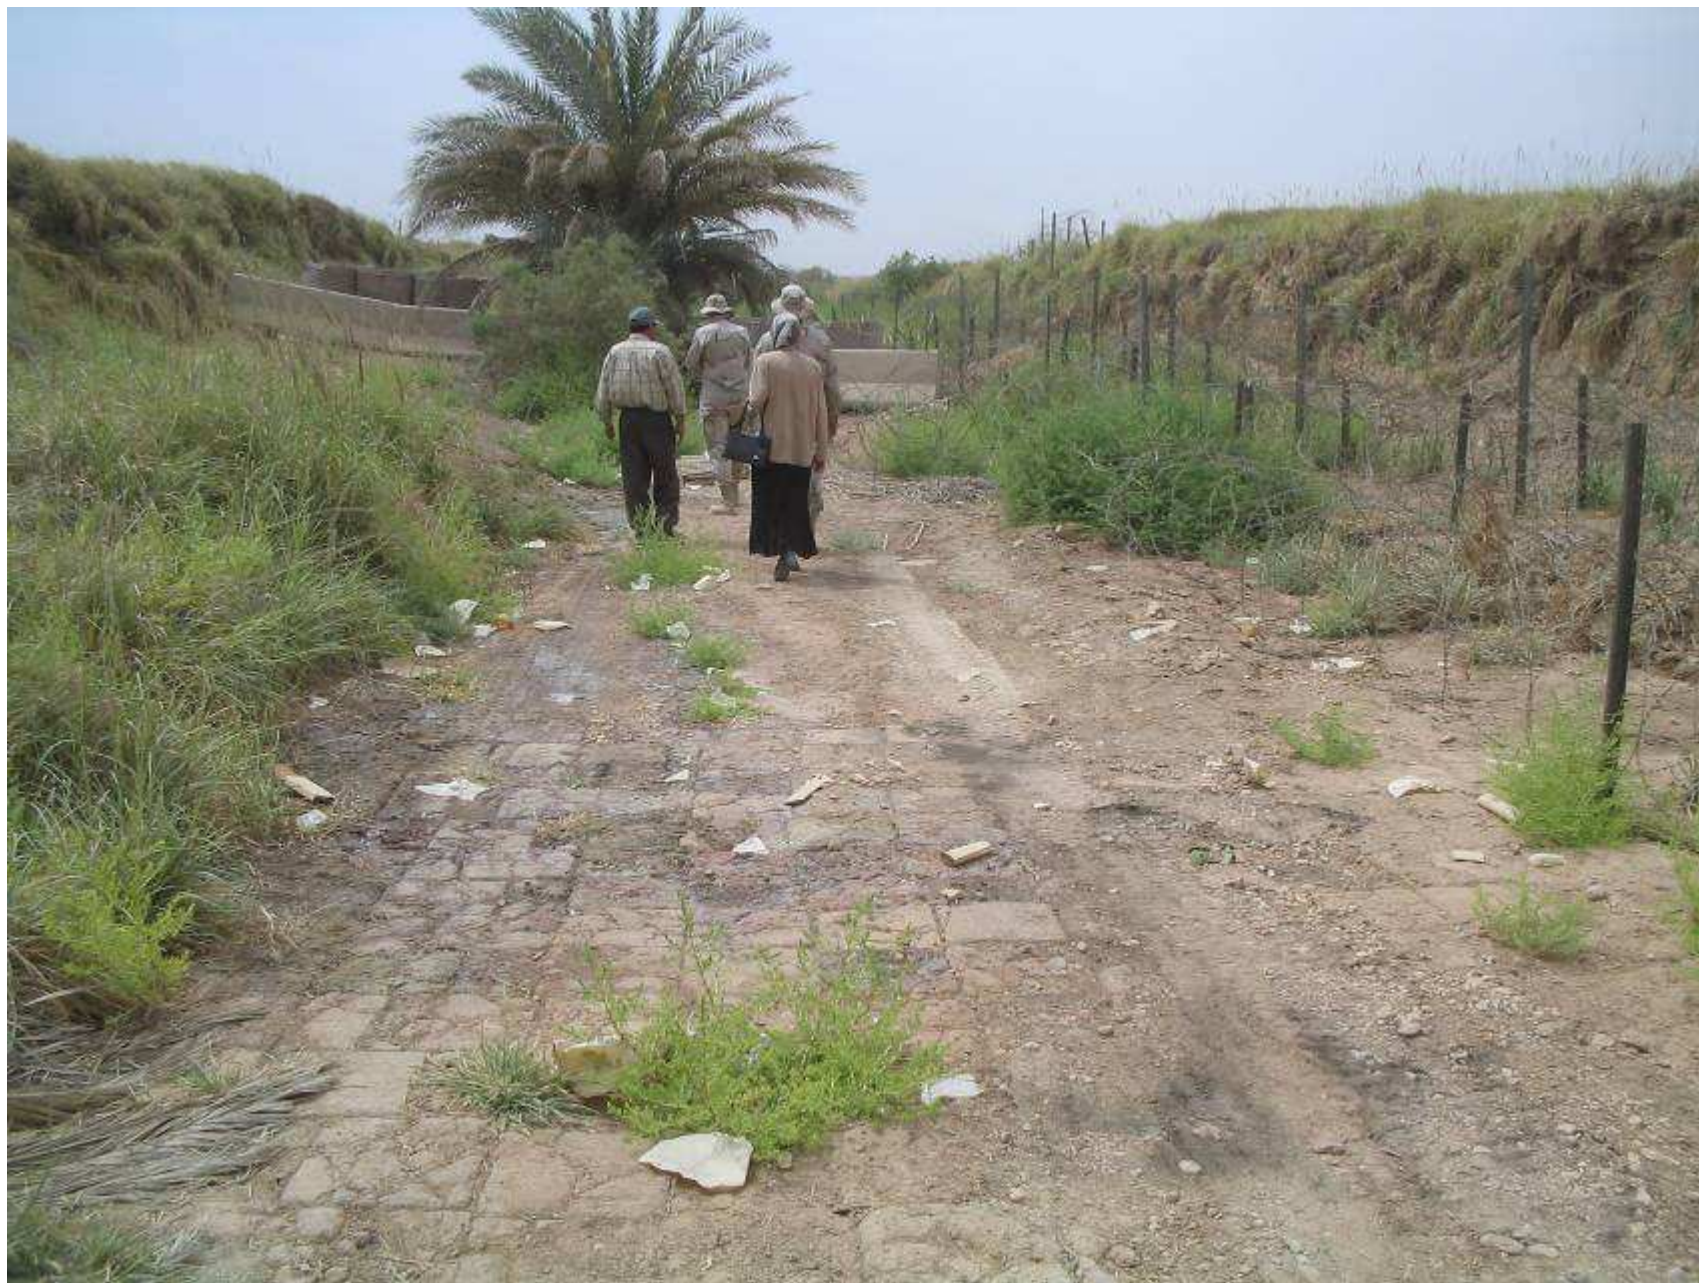
View to south on the Processional Street with concrete barricade blocks, May 2004, Russell photo 123\_2355 (photo © John Russell)

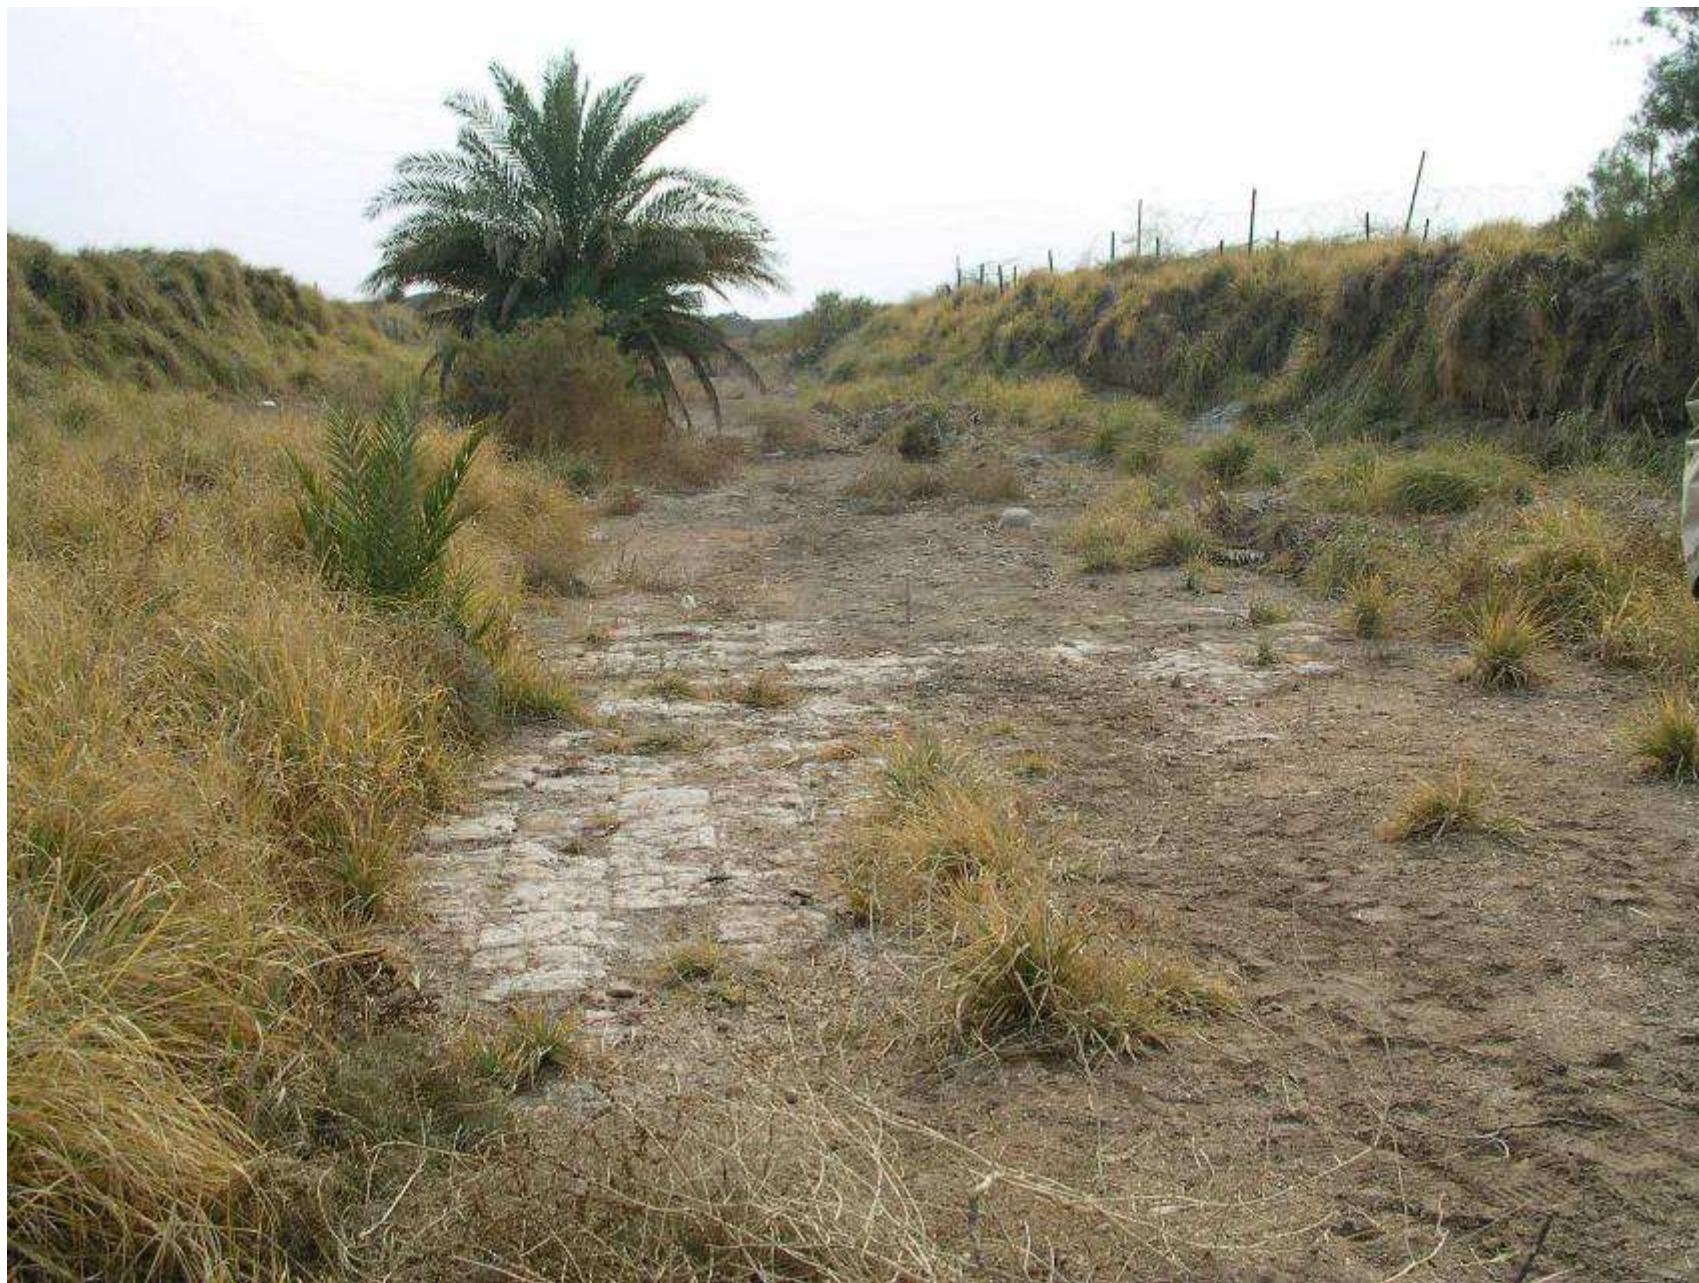
View to south on the Processional Street after removal of concrete barricade blocks, Curtis photo 7598 (photo © John Curtis)

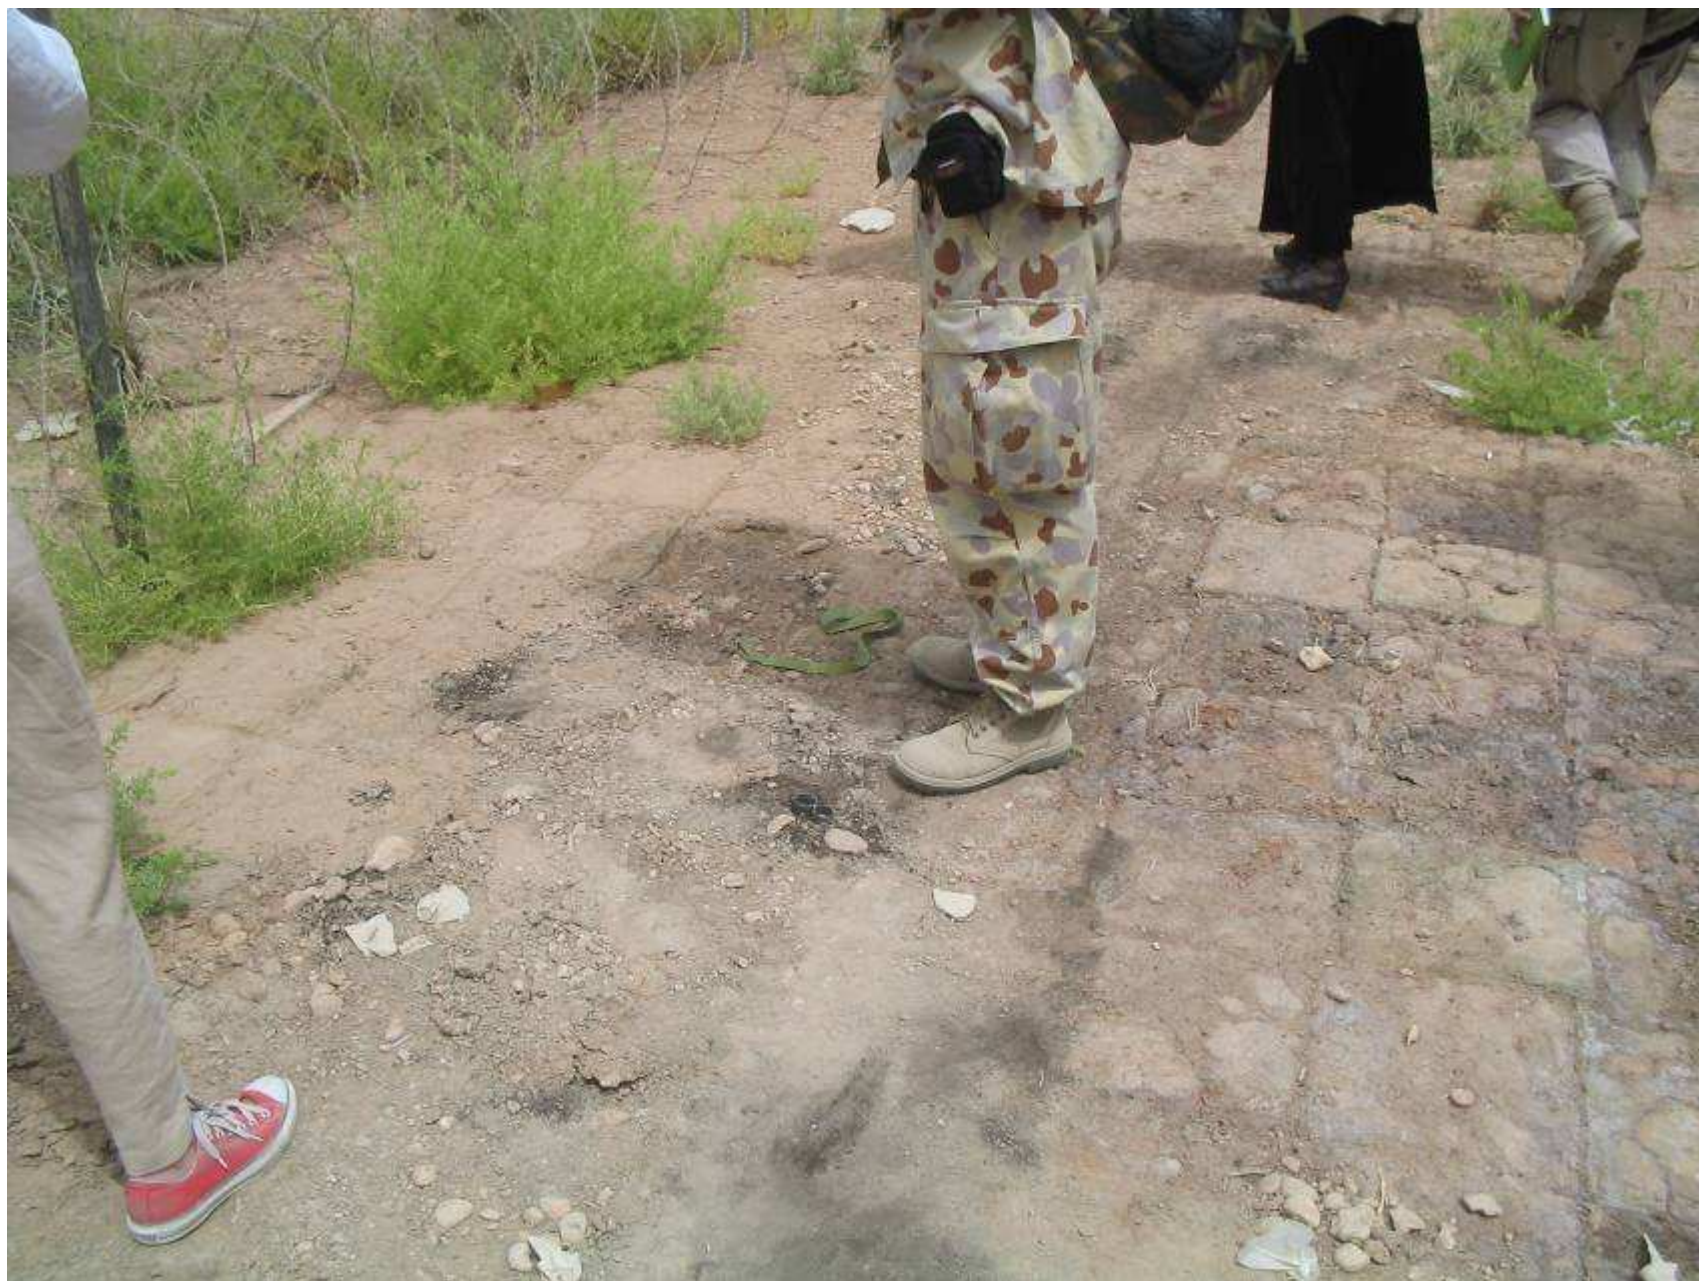
Processional Street, view showing steel fence posts driven into pavement, May 2004, Russell photo 123\_2356 (photo © John Russell)

**Russell comment:** It appears that more of the pavement bricks are exposed in the May 2004 photos than in the November/December 2004 photos, which suggests that someone put some dirt over the bricks after May 2004. As the Iraqi reports stress, the earthen banks to either side of the Processional Street are the ancient mud brick walls of the ziggurat enclosure and other ancient structures, and therefore are not a good place to drive fence posts.

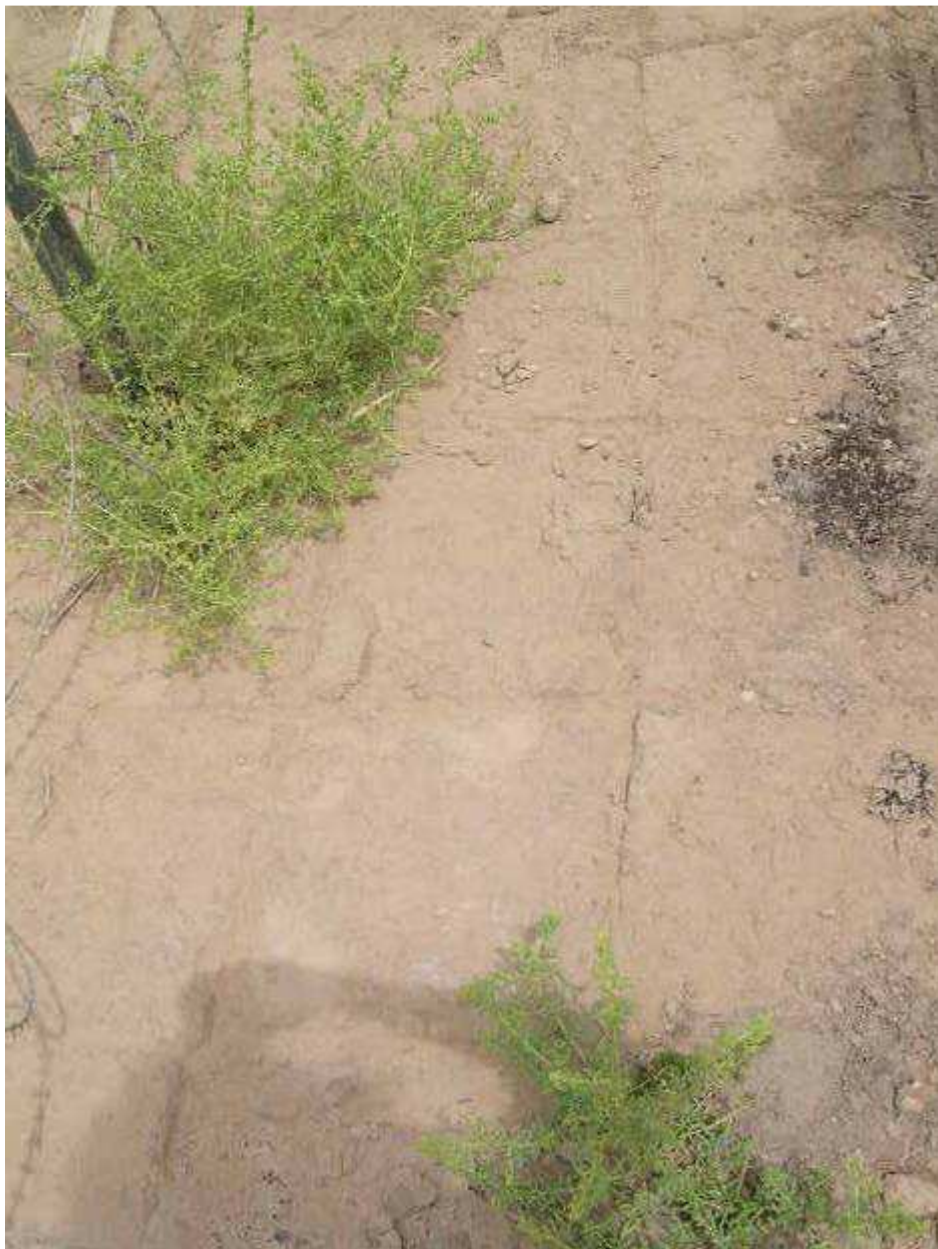
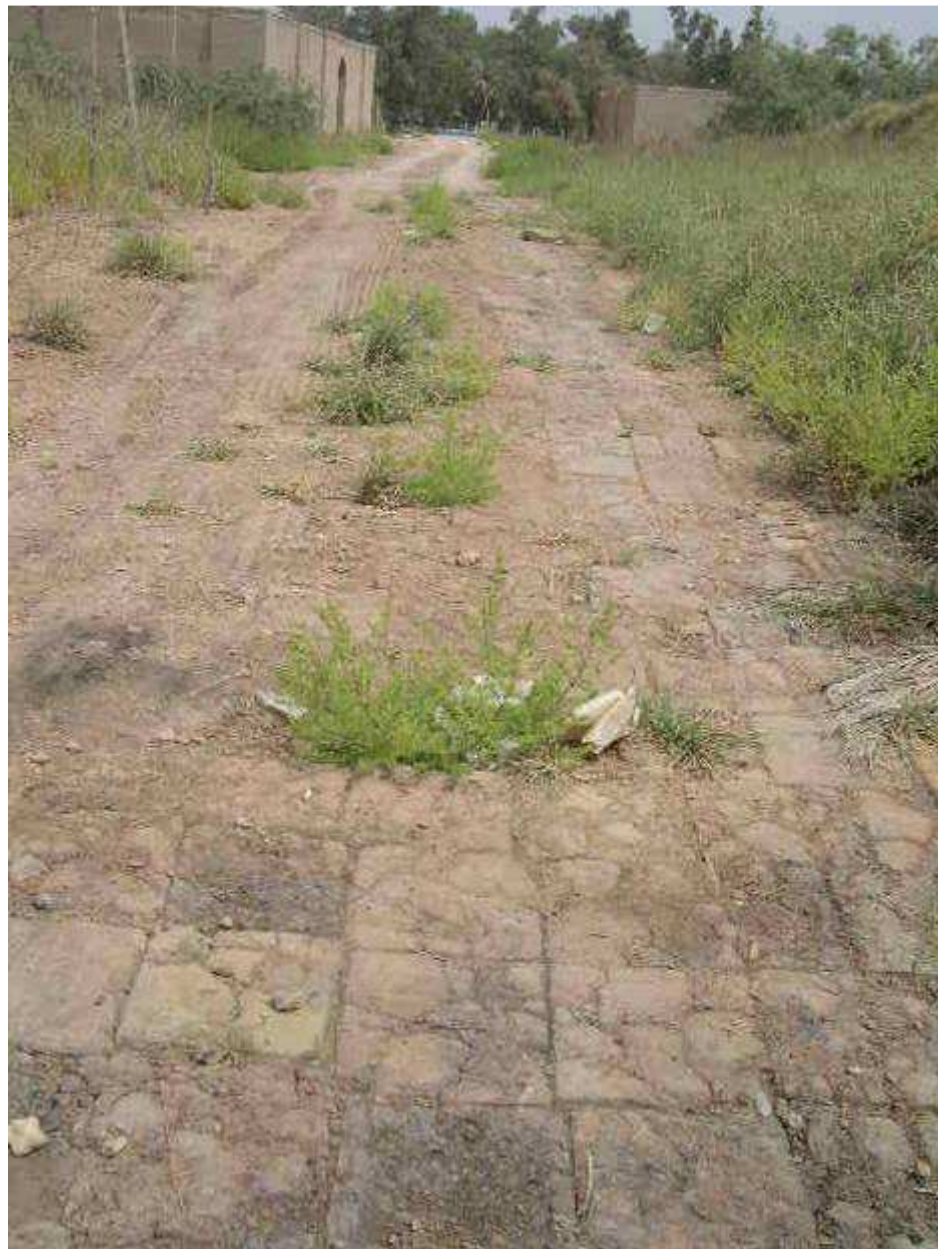
Processional Street, steel fence posts driven into pavement (left) and view to north, at right (photos © Zainab Bahrani).

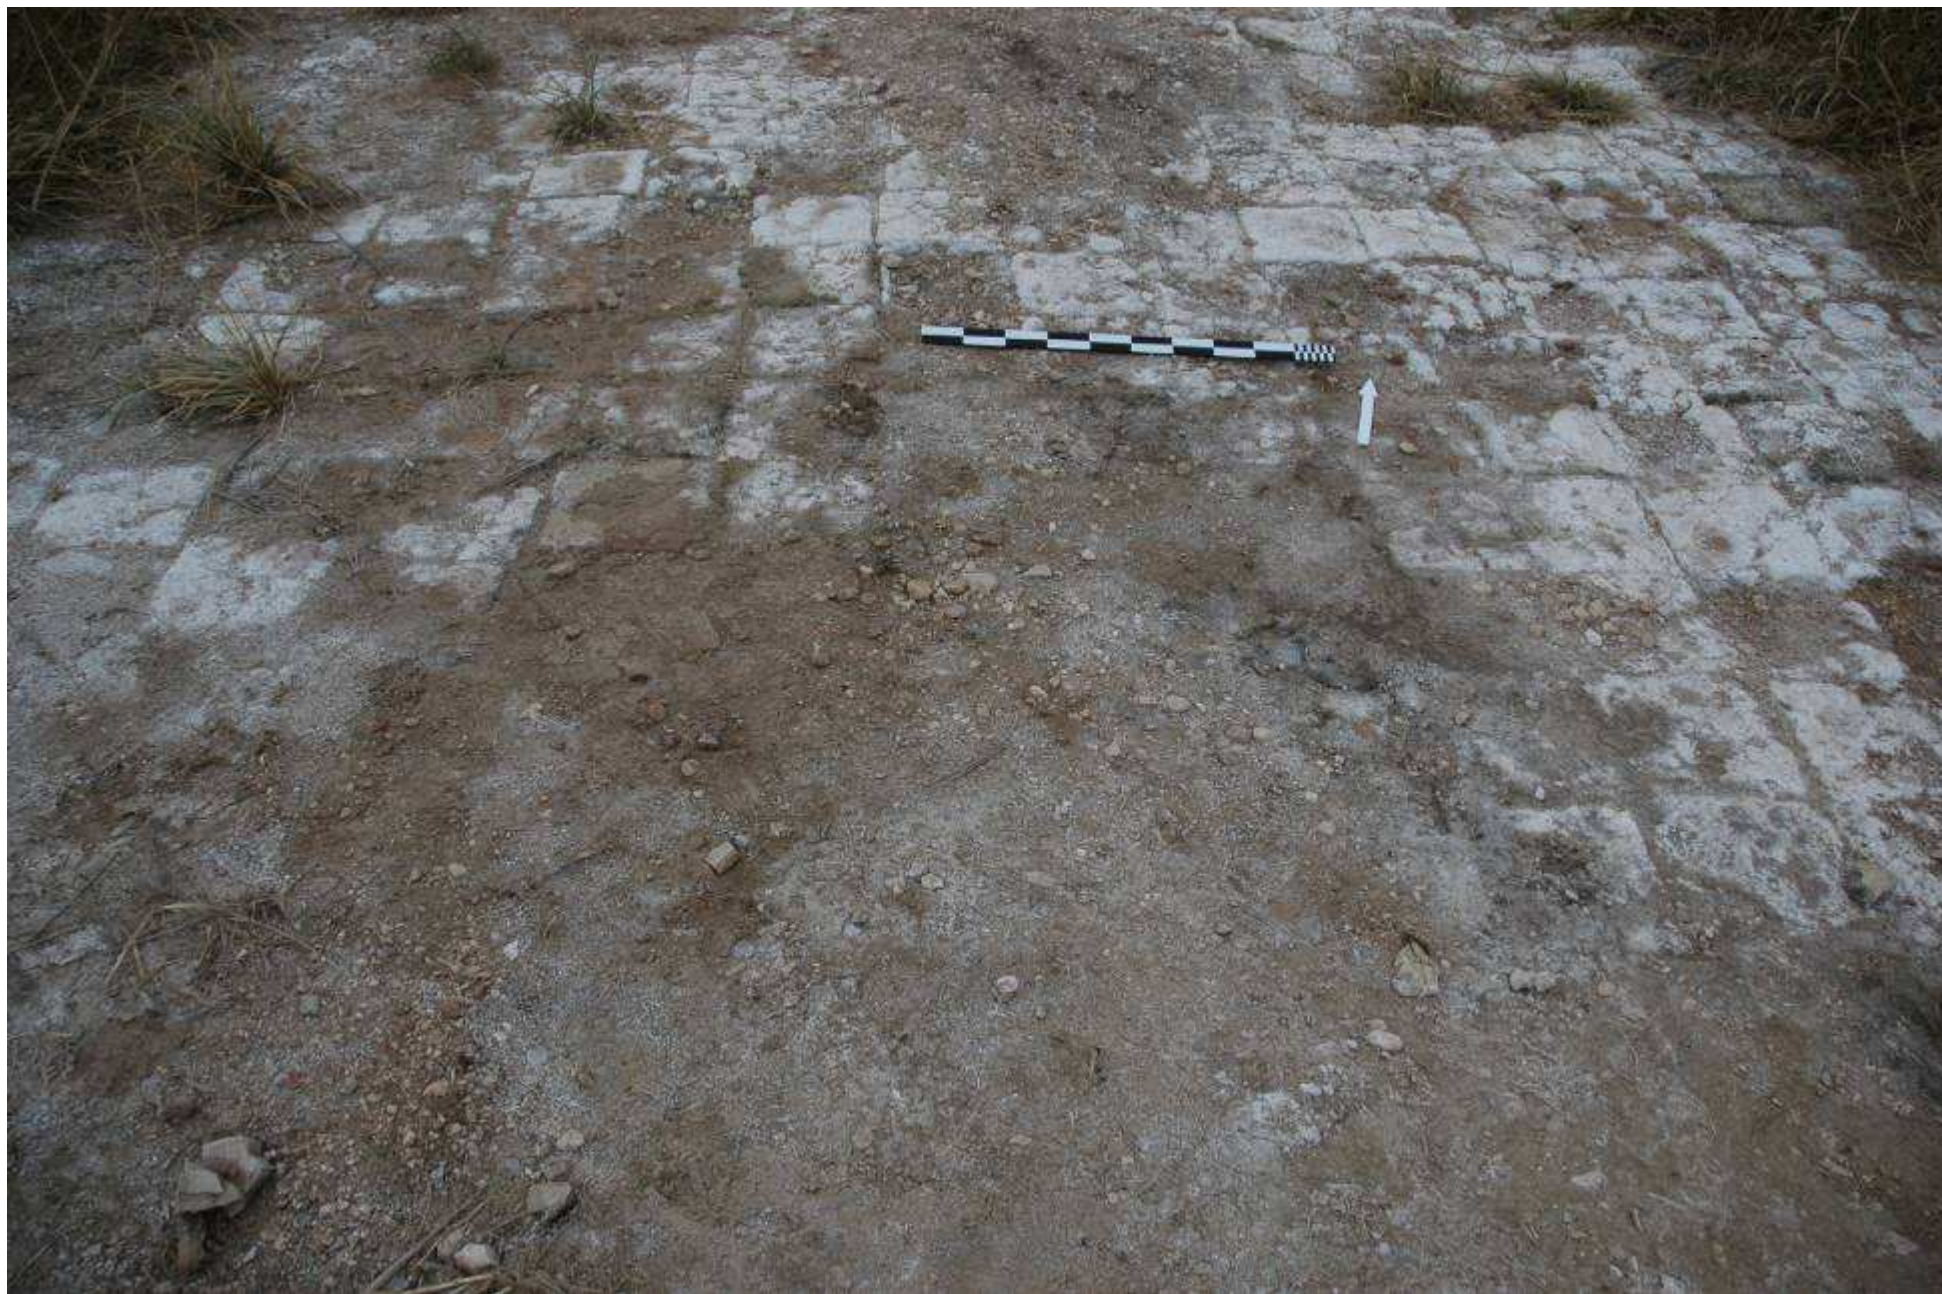
Processional Street, pavement crushed by vehicles, Iraqi final report fig. 76

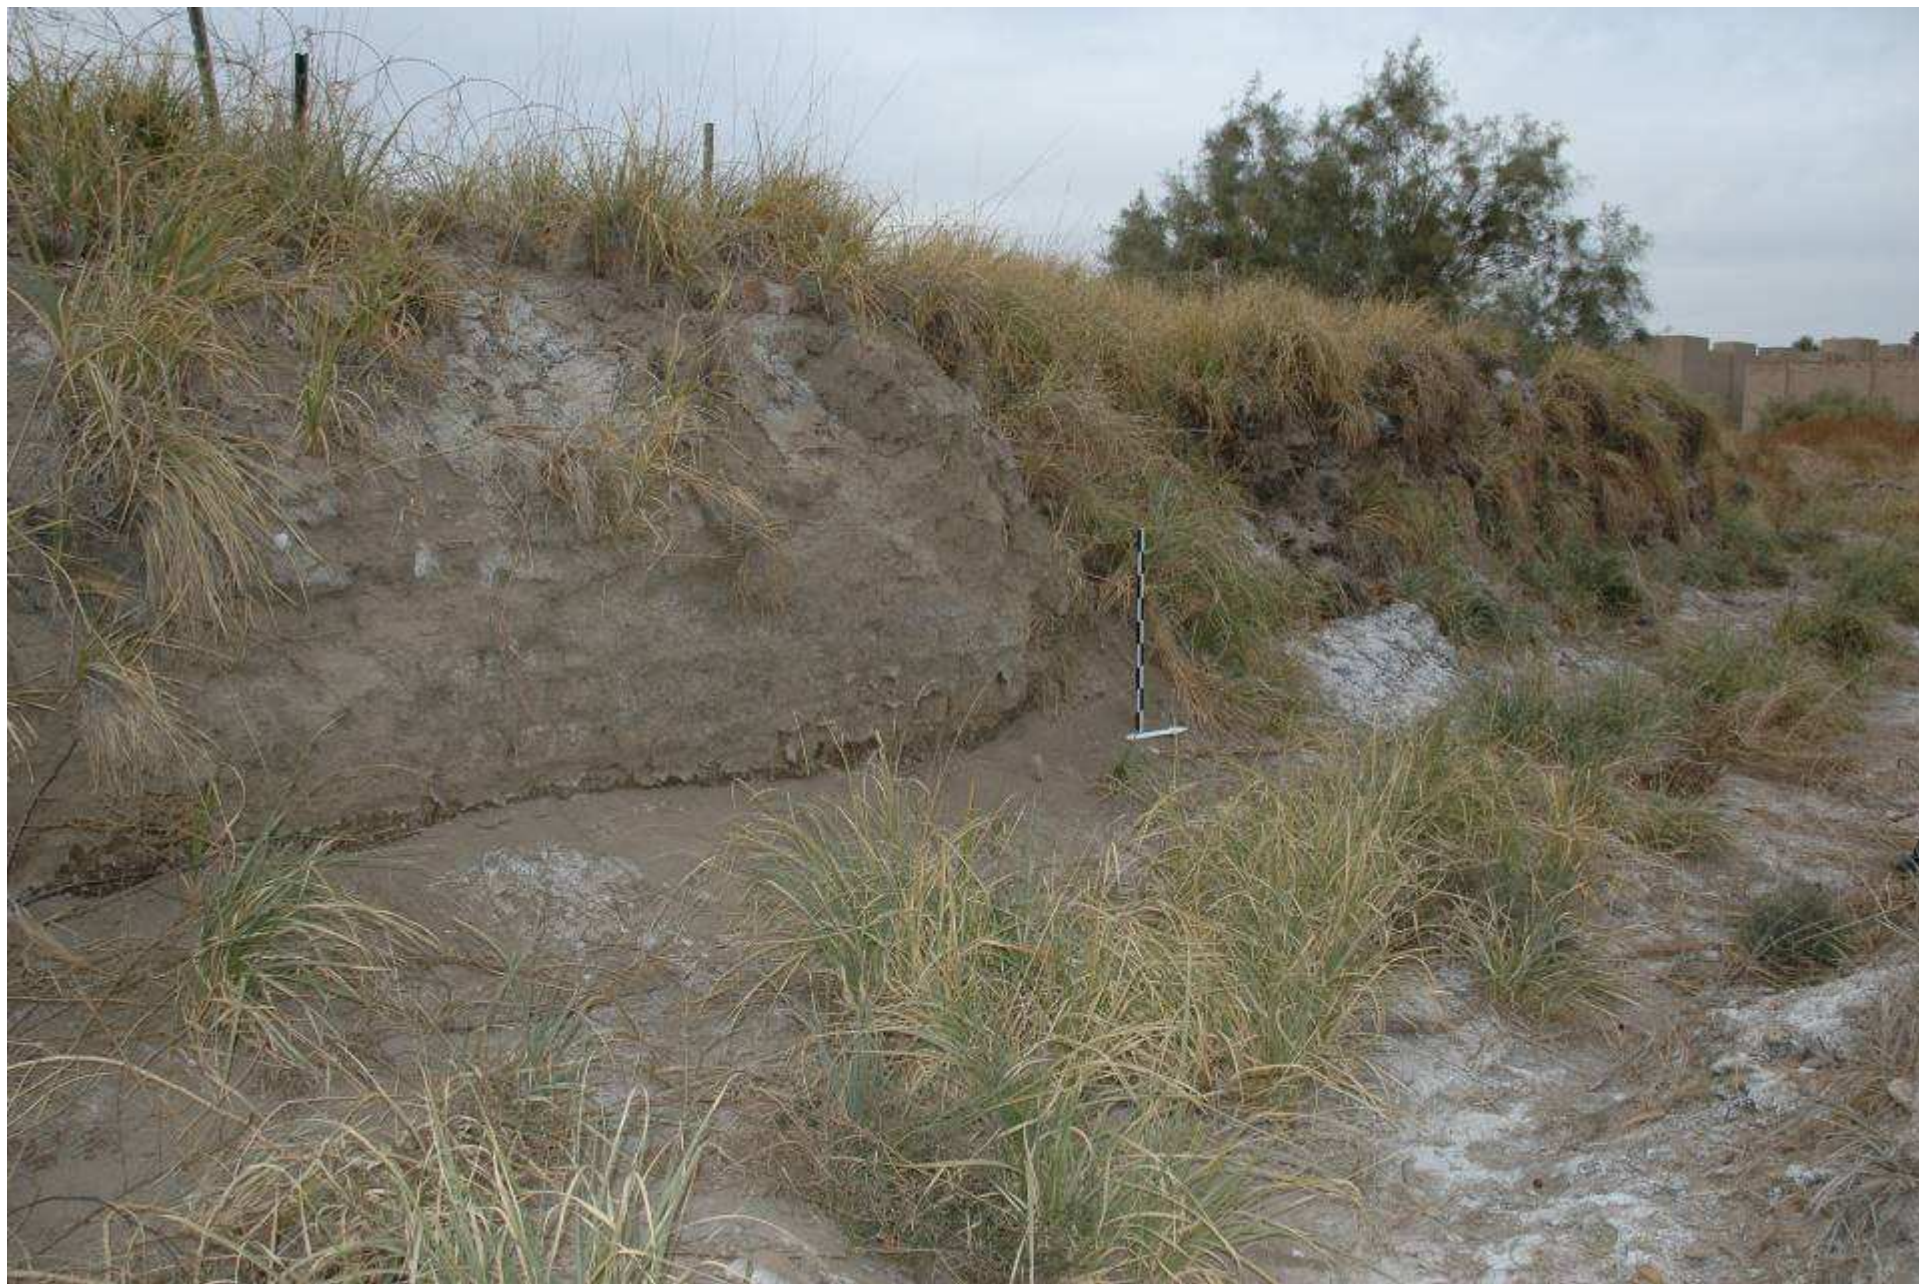
Processional Street, steel fence posts driven into the wall of the ziggurat enclosure, Iraqi final report fig. 77

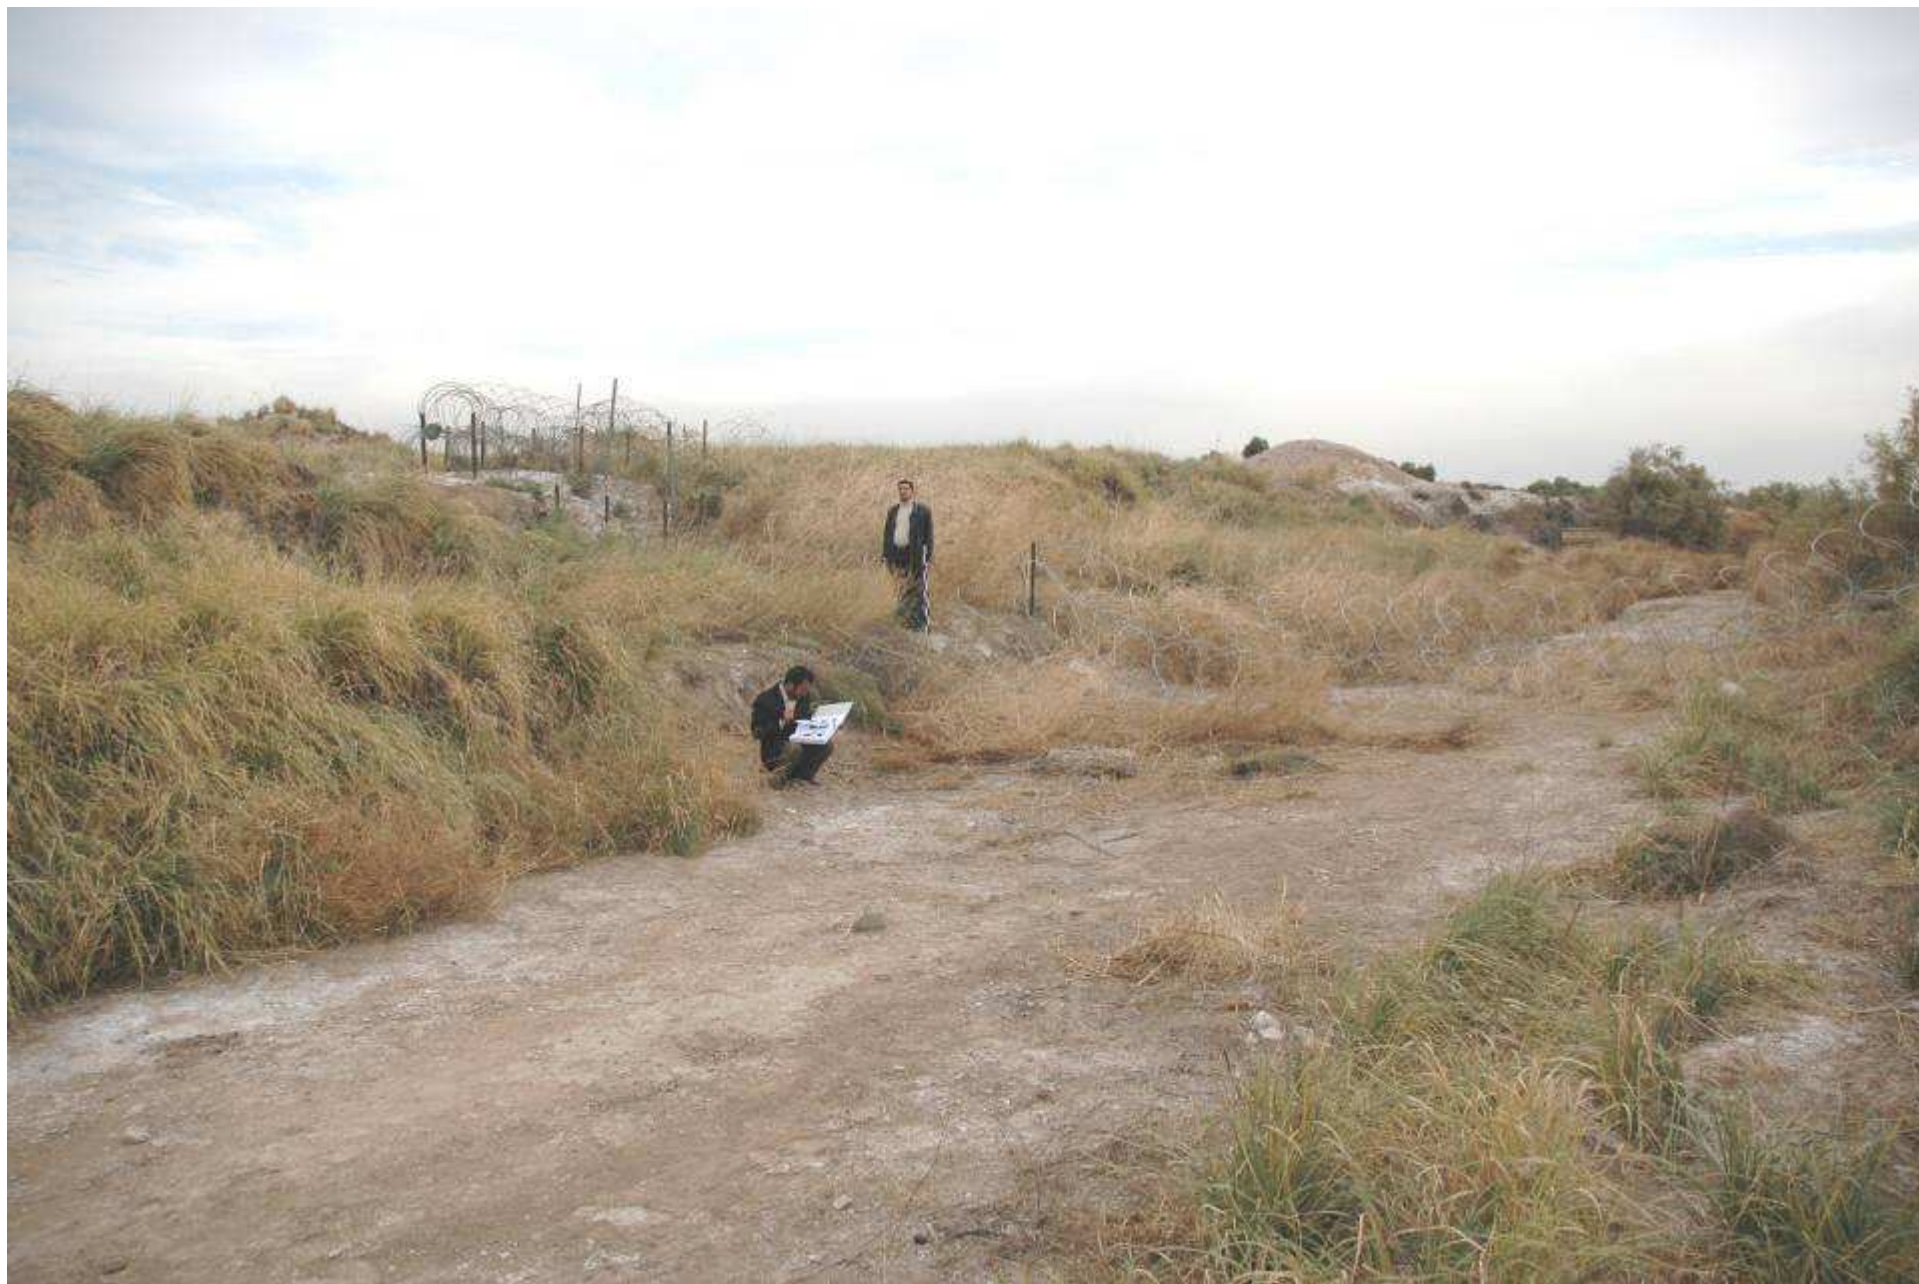
Processional Street, steel fence posts driven into the wall of the ziggurat enclosure, Iraqi final report fig. 78

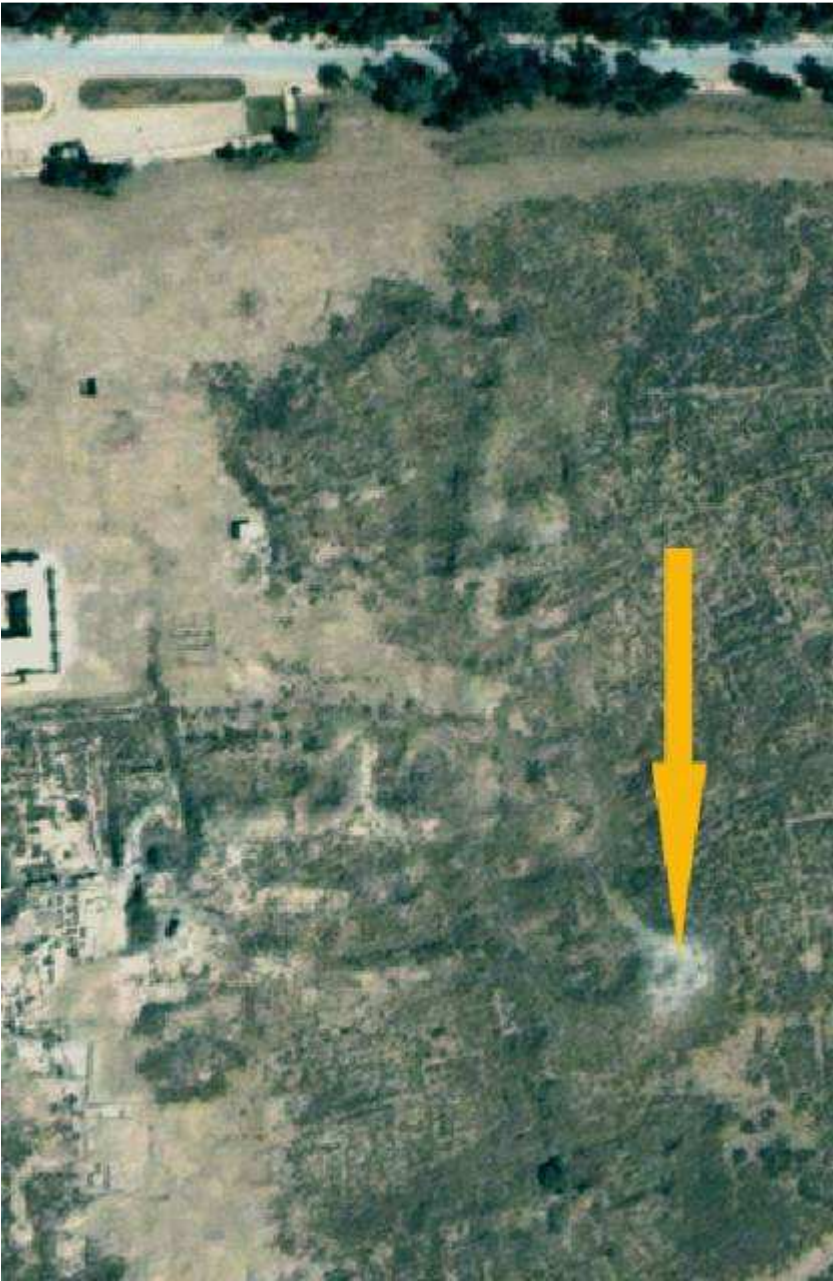
Before construction of tower, 1 April 2003, Russell composite

**Russell comment:** The satellite images confirm that the construction and intensive use of this road caused considerable damage to the surface of the site, particularly the southern half of the road, which cuts across mounds with visible ancient architecture. Cut 11 appears to be associated with the water tank located directly behind it, though its purpose is unclear.

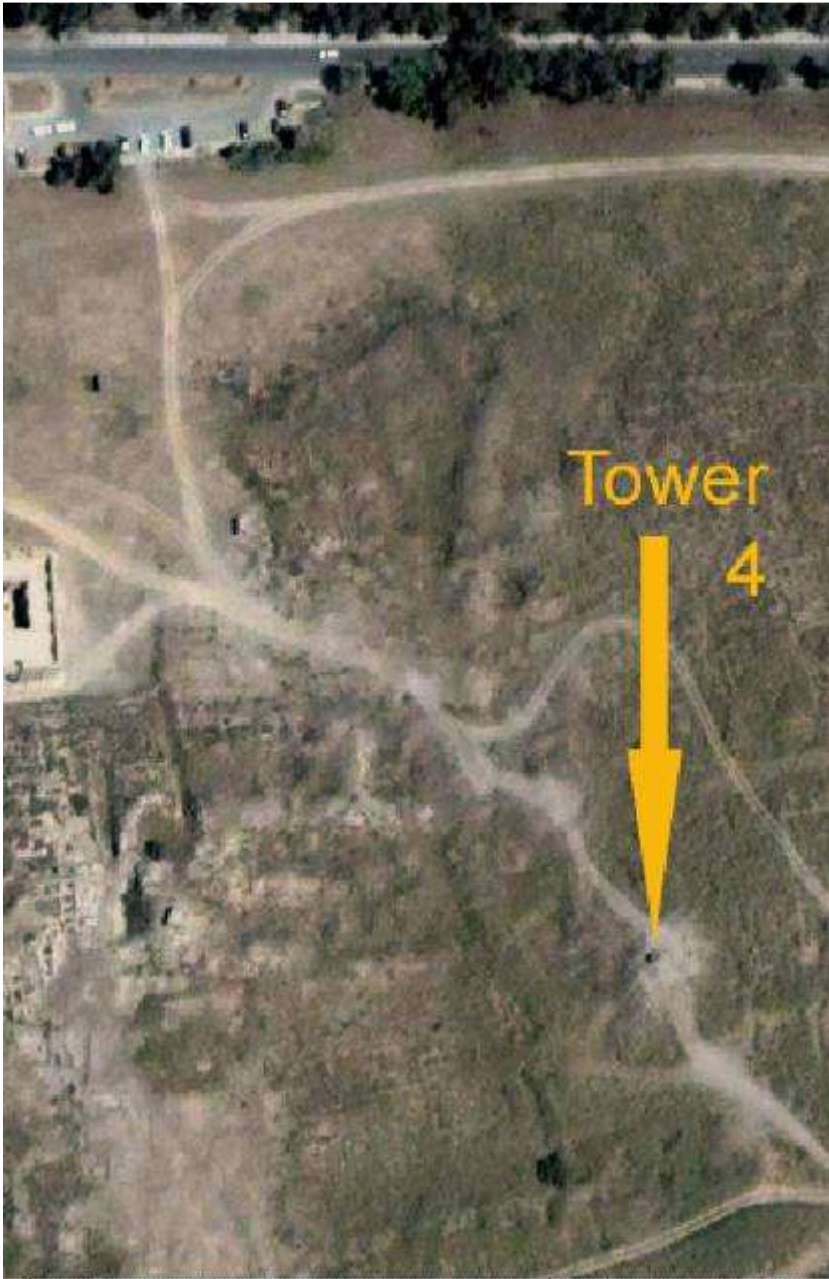
Tower 4, first phase, 31 August 2003, Russell composite

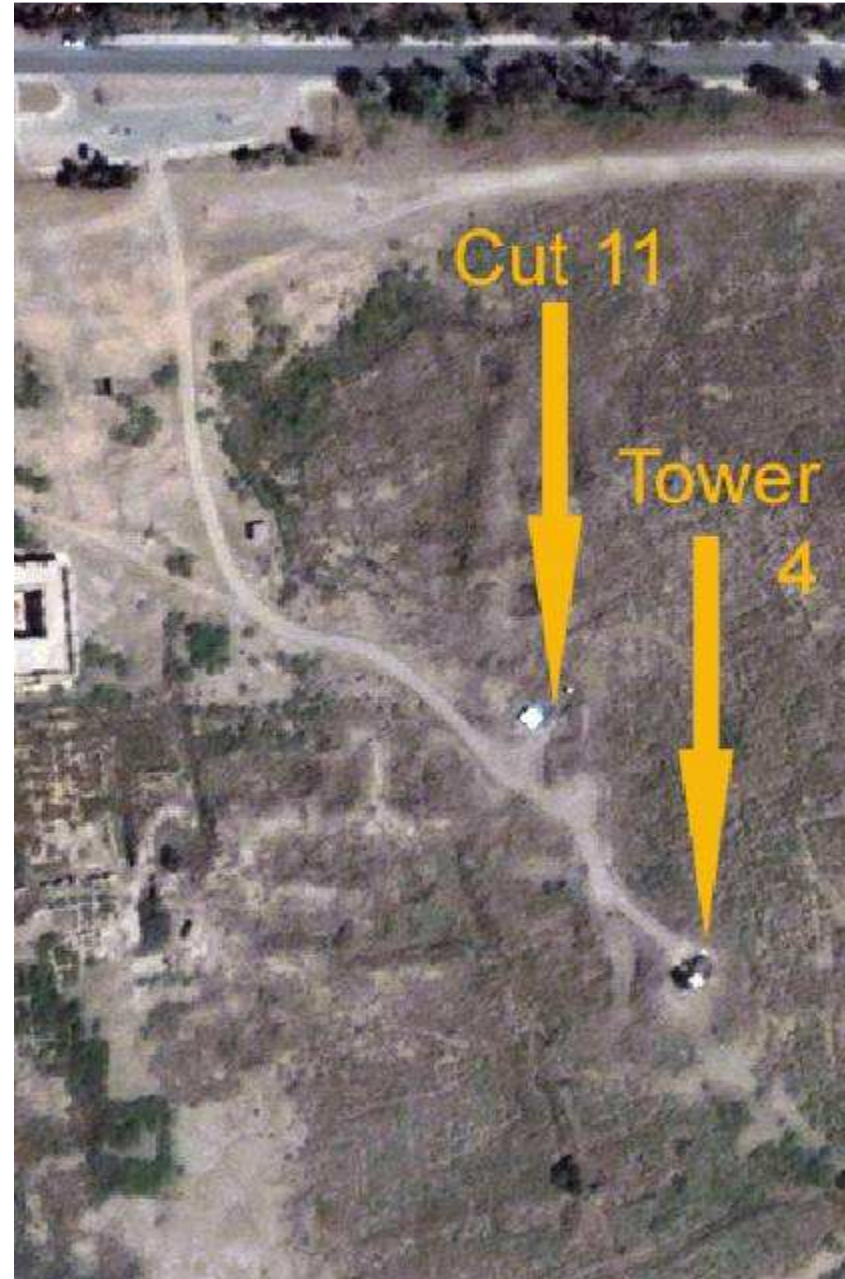
Tower 4, final phase, with Cut 11, 25 August 2004, Russell composite
