# **Report on Damage to the Site of Babylon, Iraq**

**John Malcolm Russell, Ph.D.**

**Cultural Heritage Center  
Bureau of Educational and Cultural Affairs  
Department of State**

**April 2010**

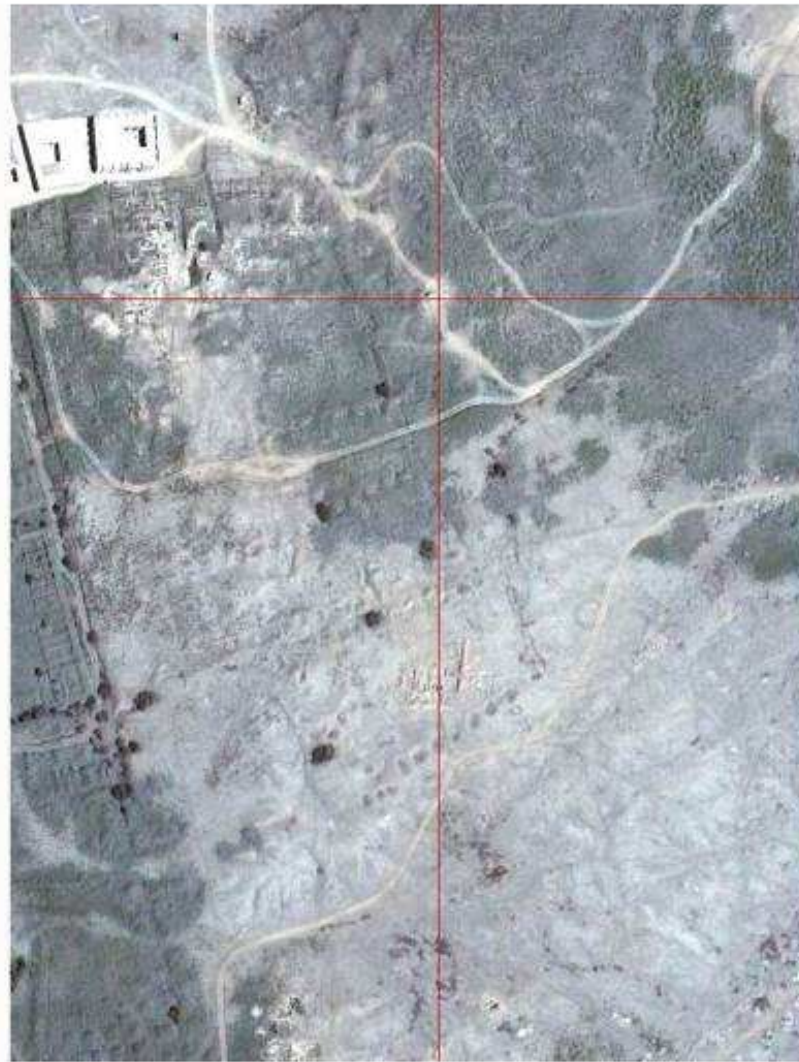
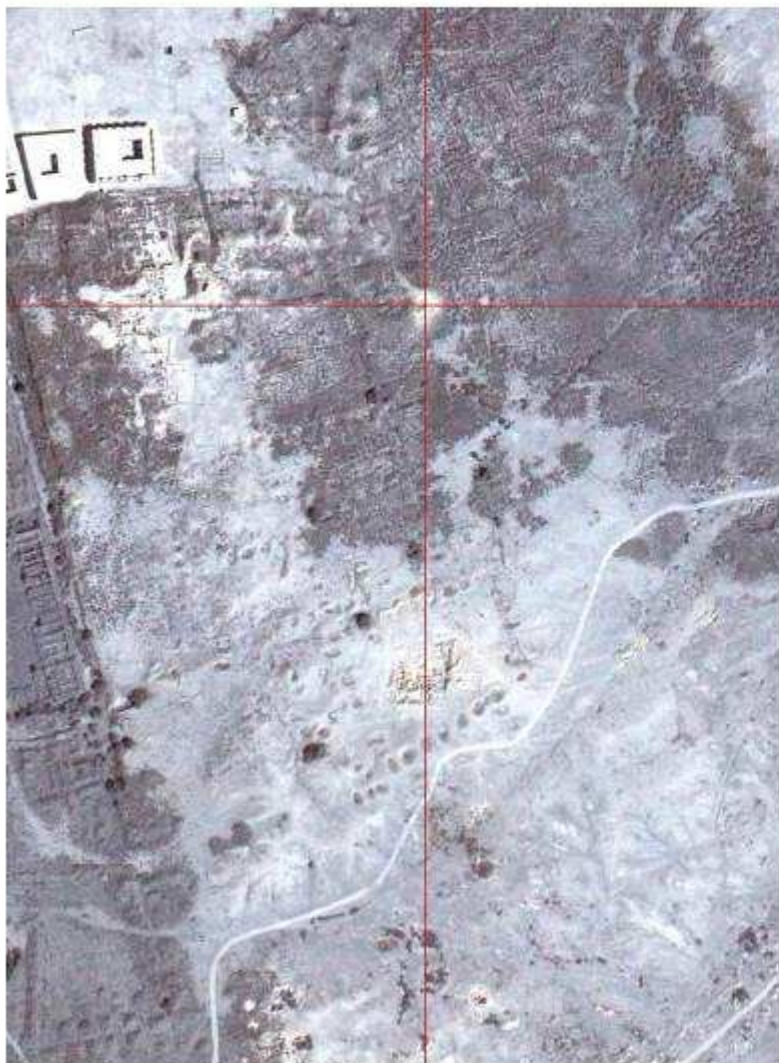
**Stone report:** The effect of the construction of two watchtowers can also be seen. That in the east was present in August 2003, along with the dirt road providing access (Fig 34), ...

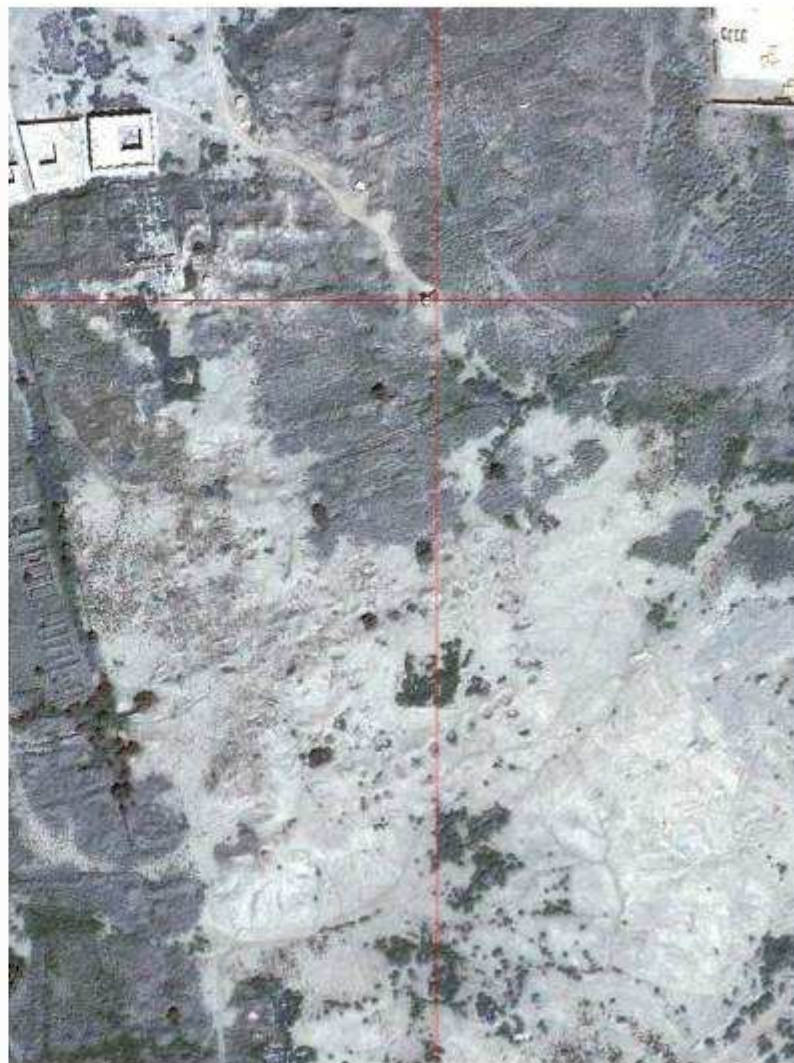
**Stone report:** ...but was developed further by October 2004, and the track was more firmly established by that time (Fig 35).

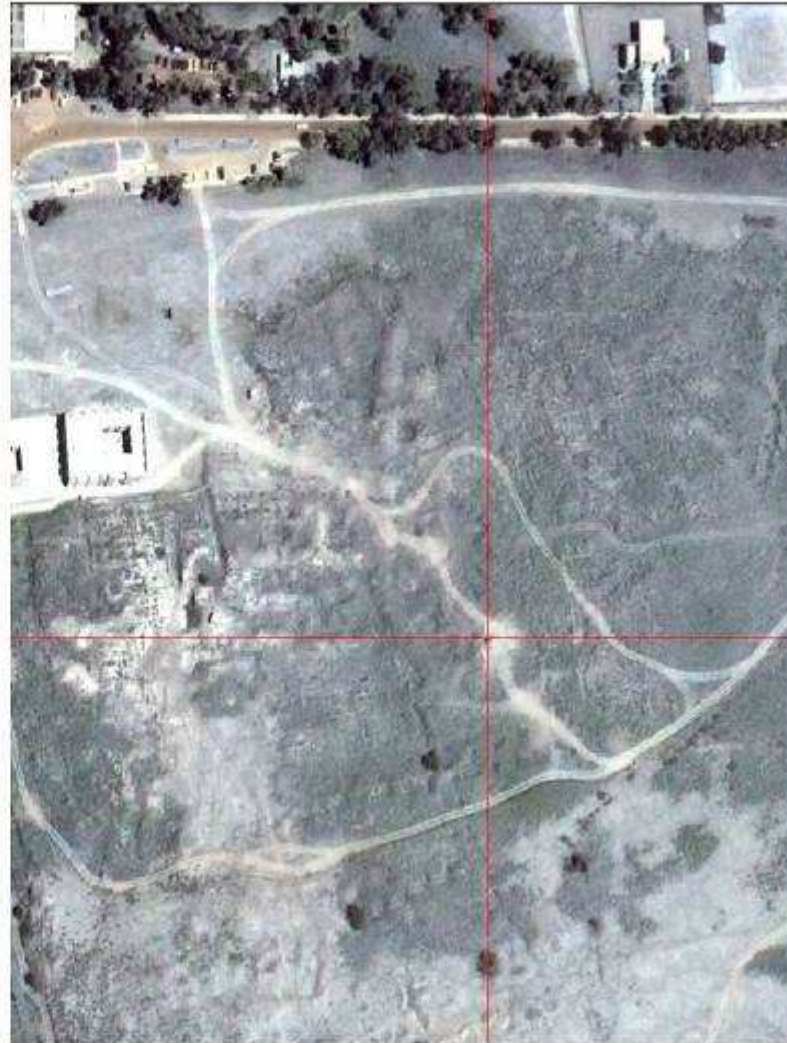
**Stone report:** It was built on an eminence which is seen clearly in the contour map (Fig. 36).

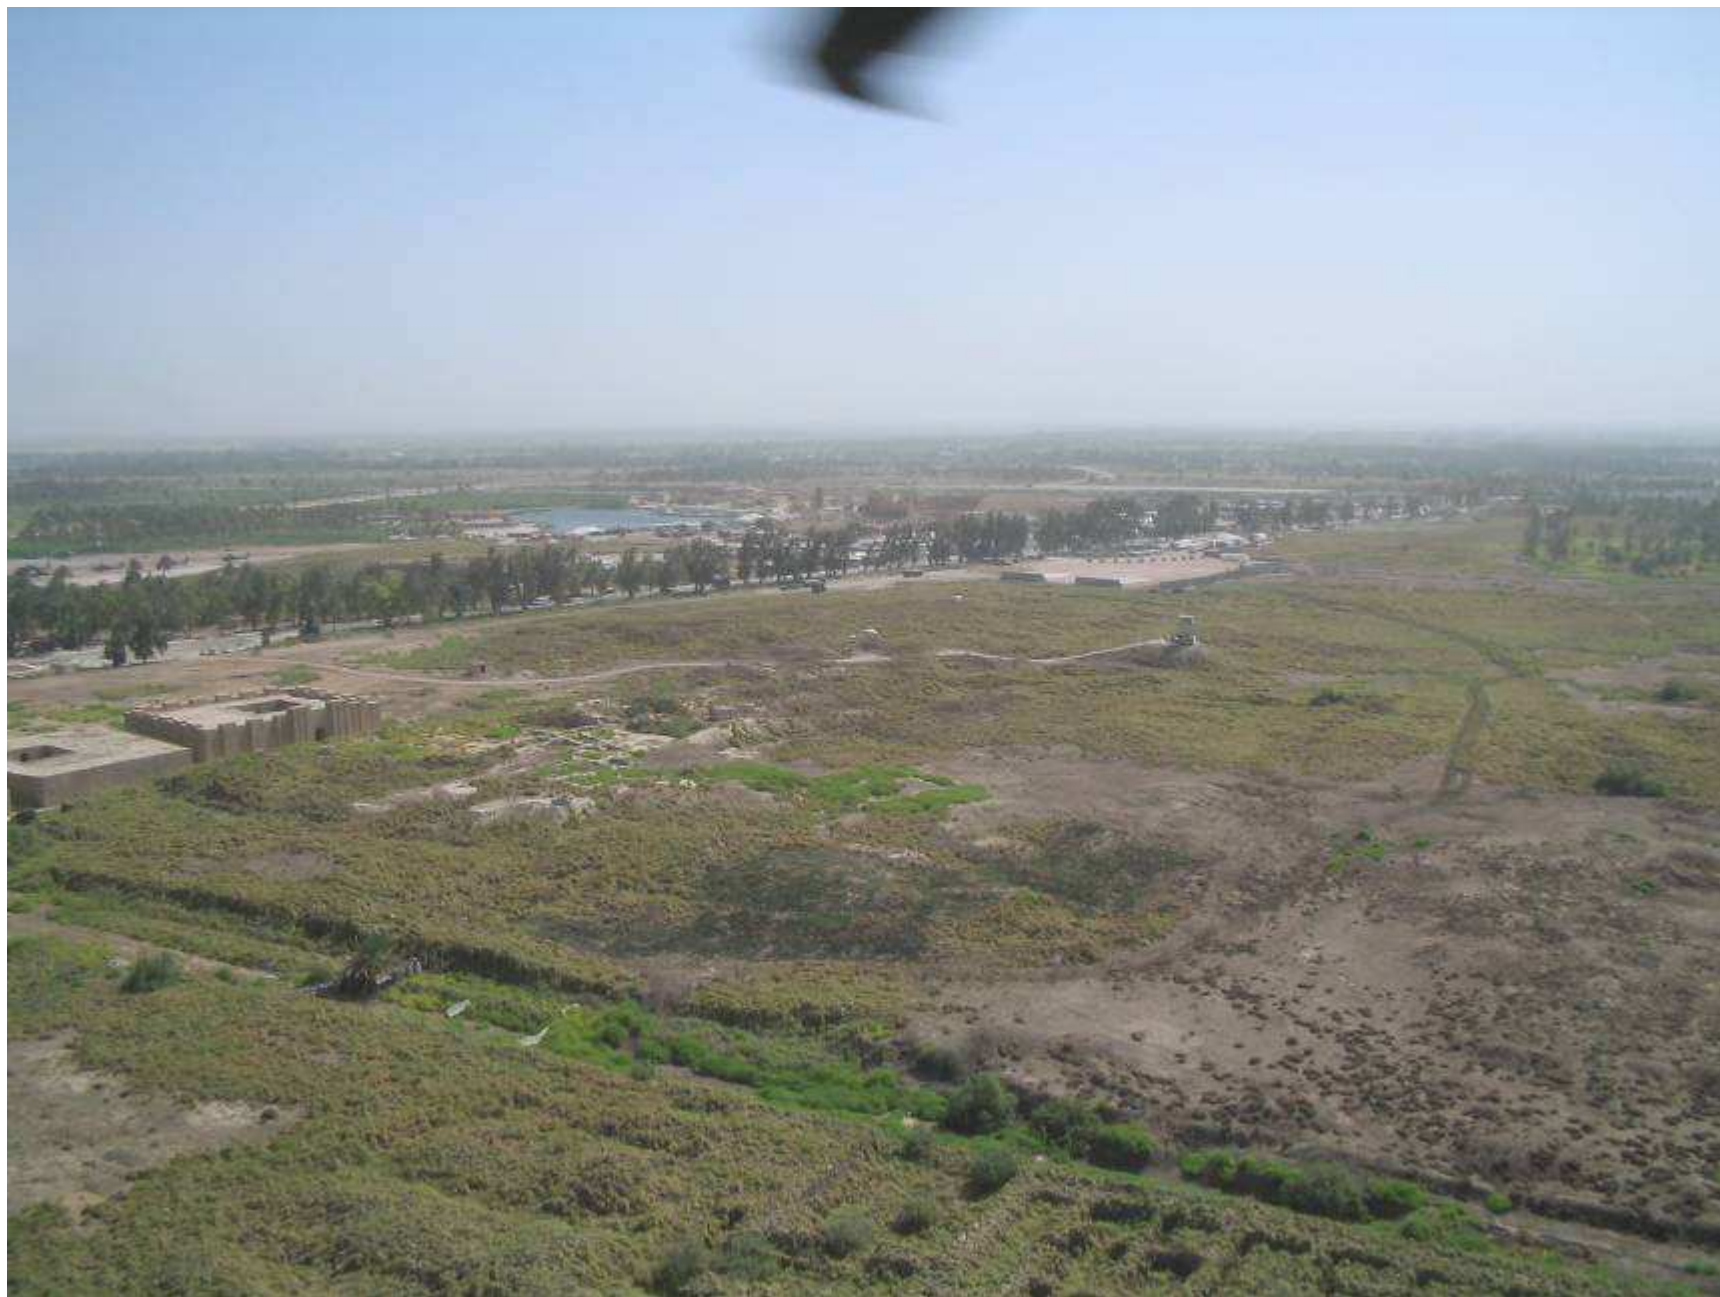
Observation tower 4 with access road, June 2004, Russell photo 124\_2449 (photo © John Russell)

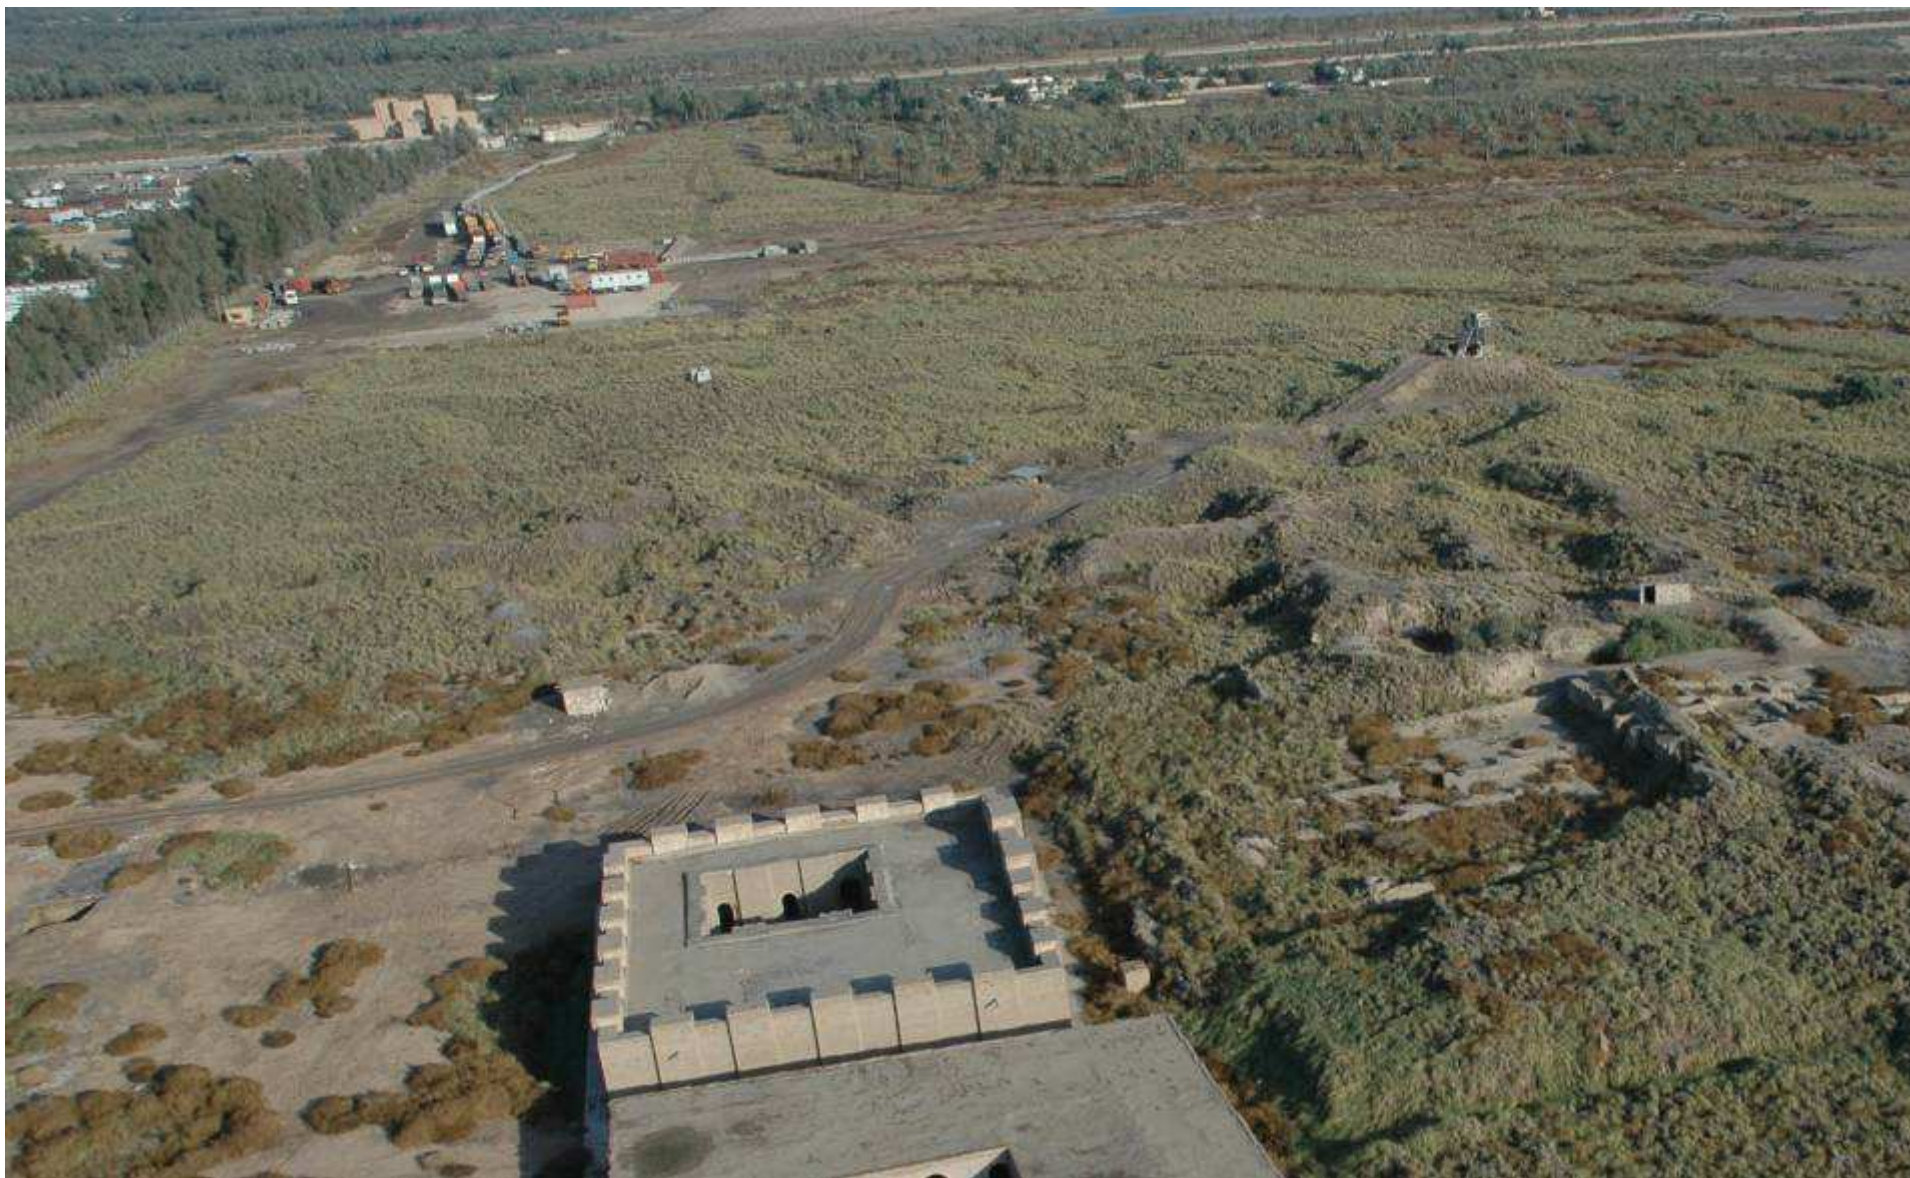
Observation tower 4 with access road, November 2004, Polish photo 119, detail (photo © Ministry of Culture and National Heritage, Republic of Poland)

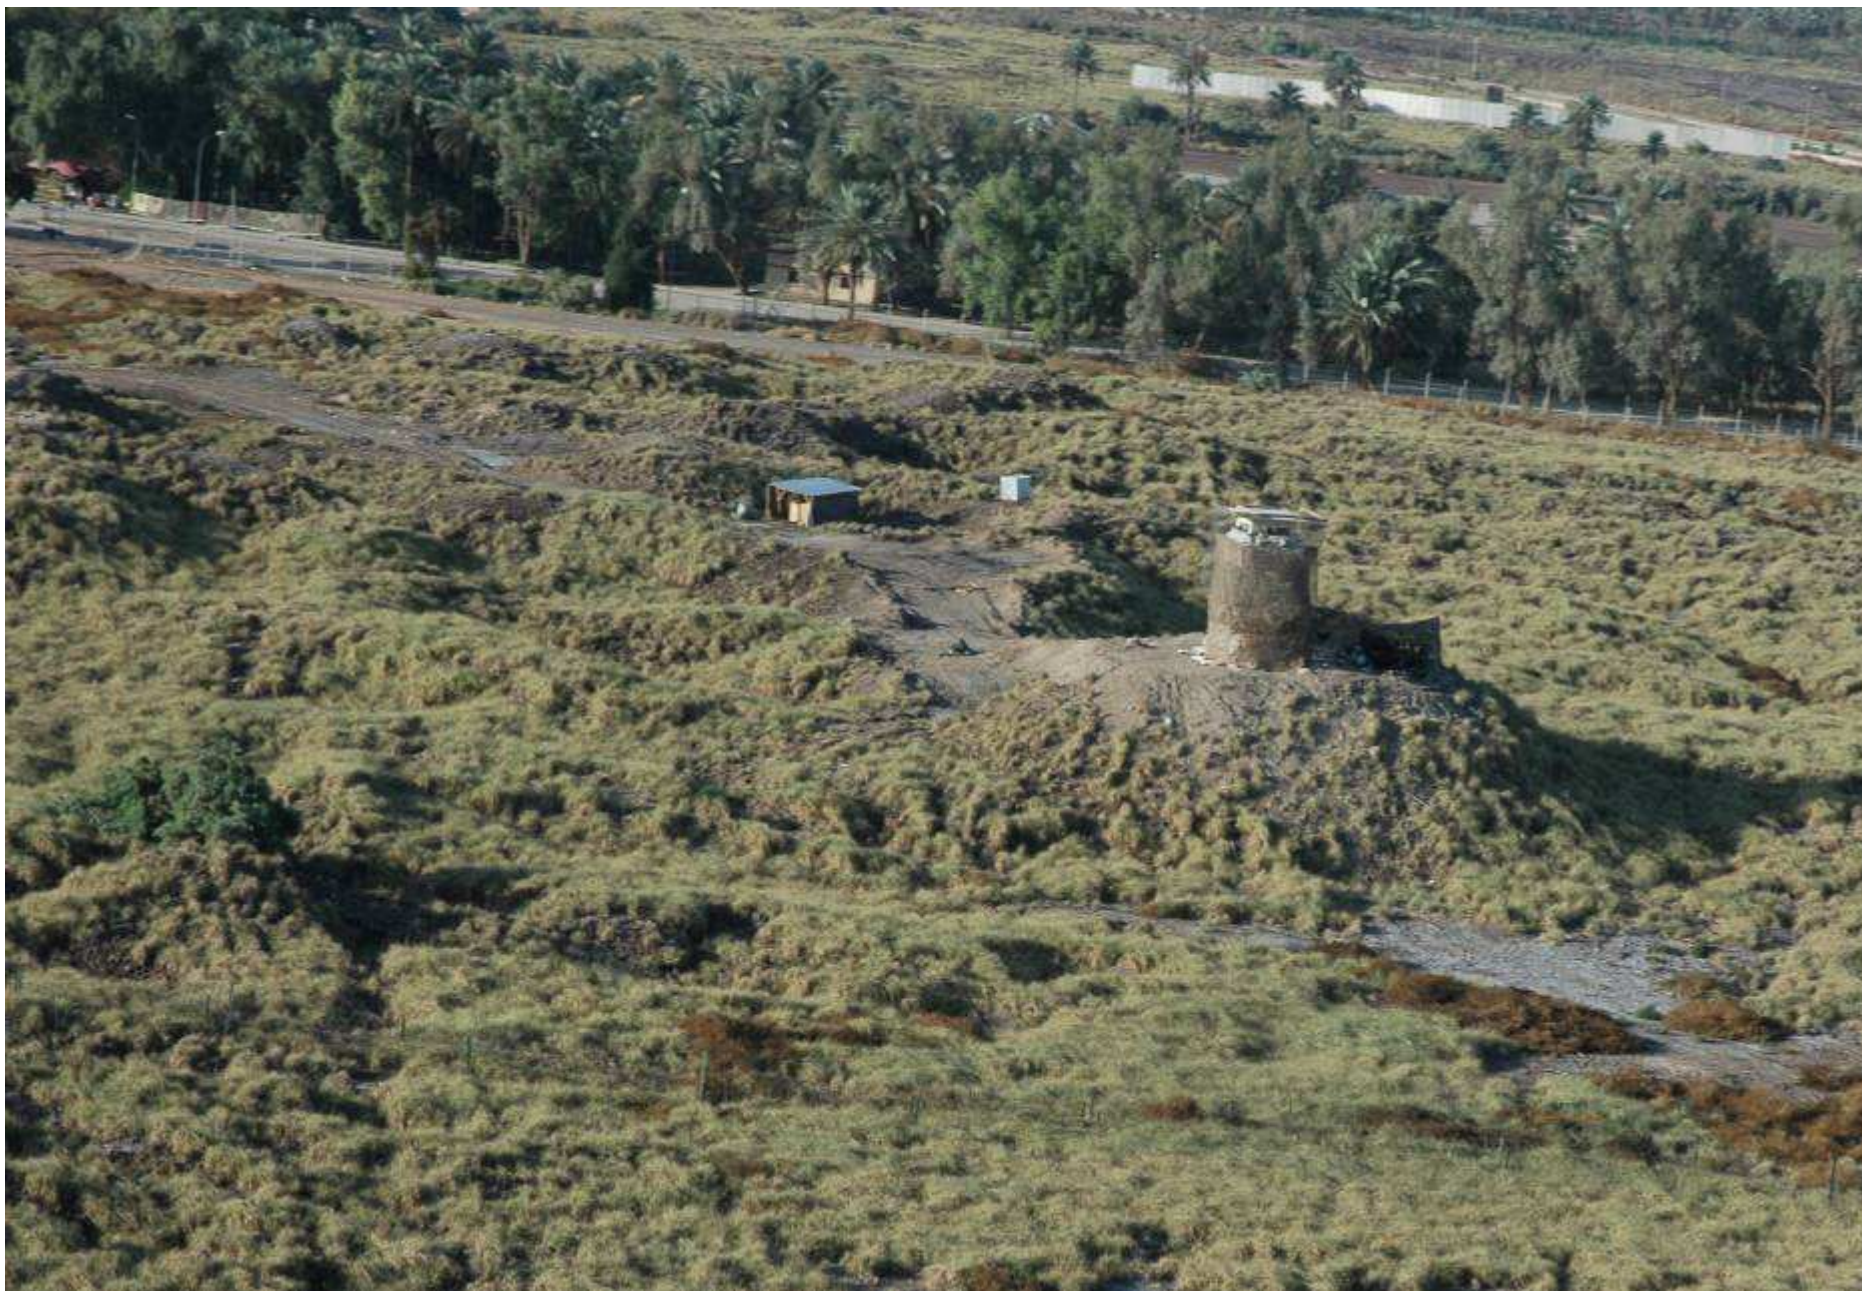
View of tower and access road, with Cut 11 (beside shed) and a road cut near the base of the tower mound, Polish photo 125, detail (photo © Ministry of Culture and National Heritage, Republic of Poland)

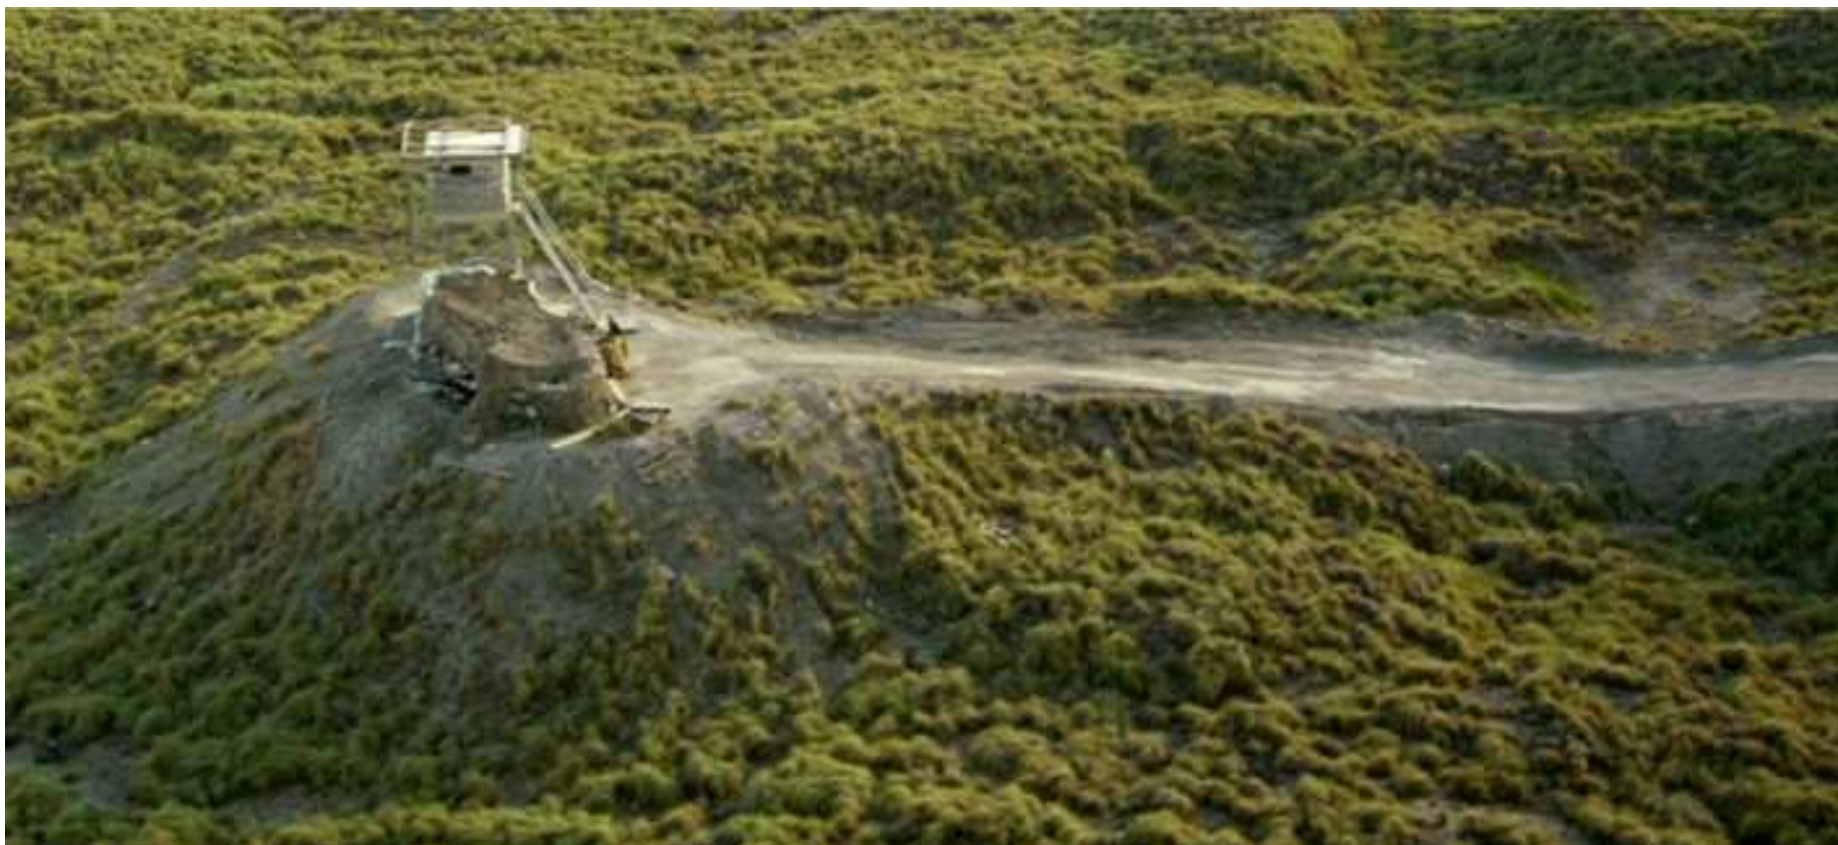
Tower 4, detail of access ramp, Polish report p. 42 (photo © Ministry of Culture and National Heritage, Republic of Poland)

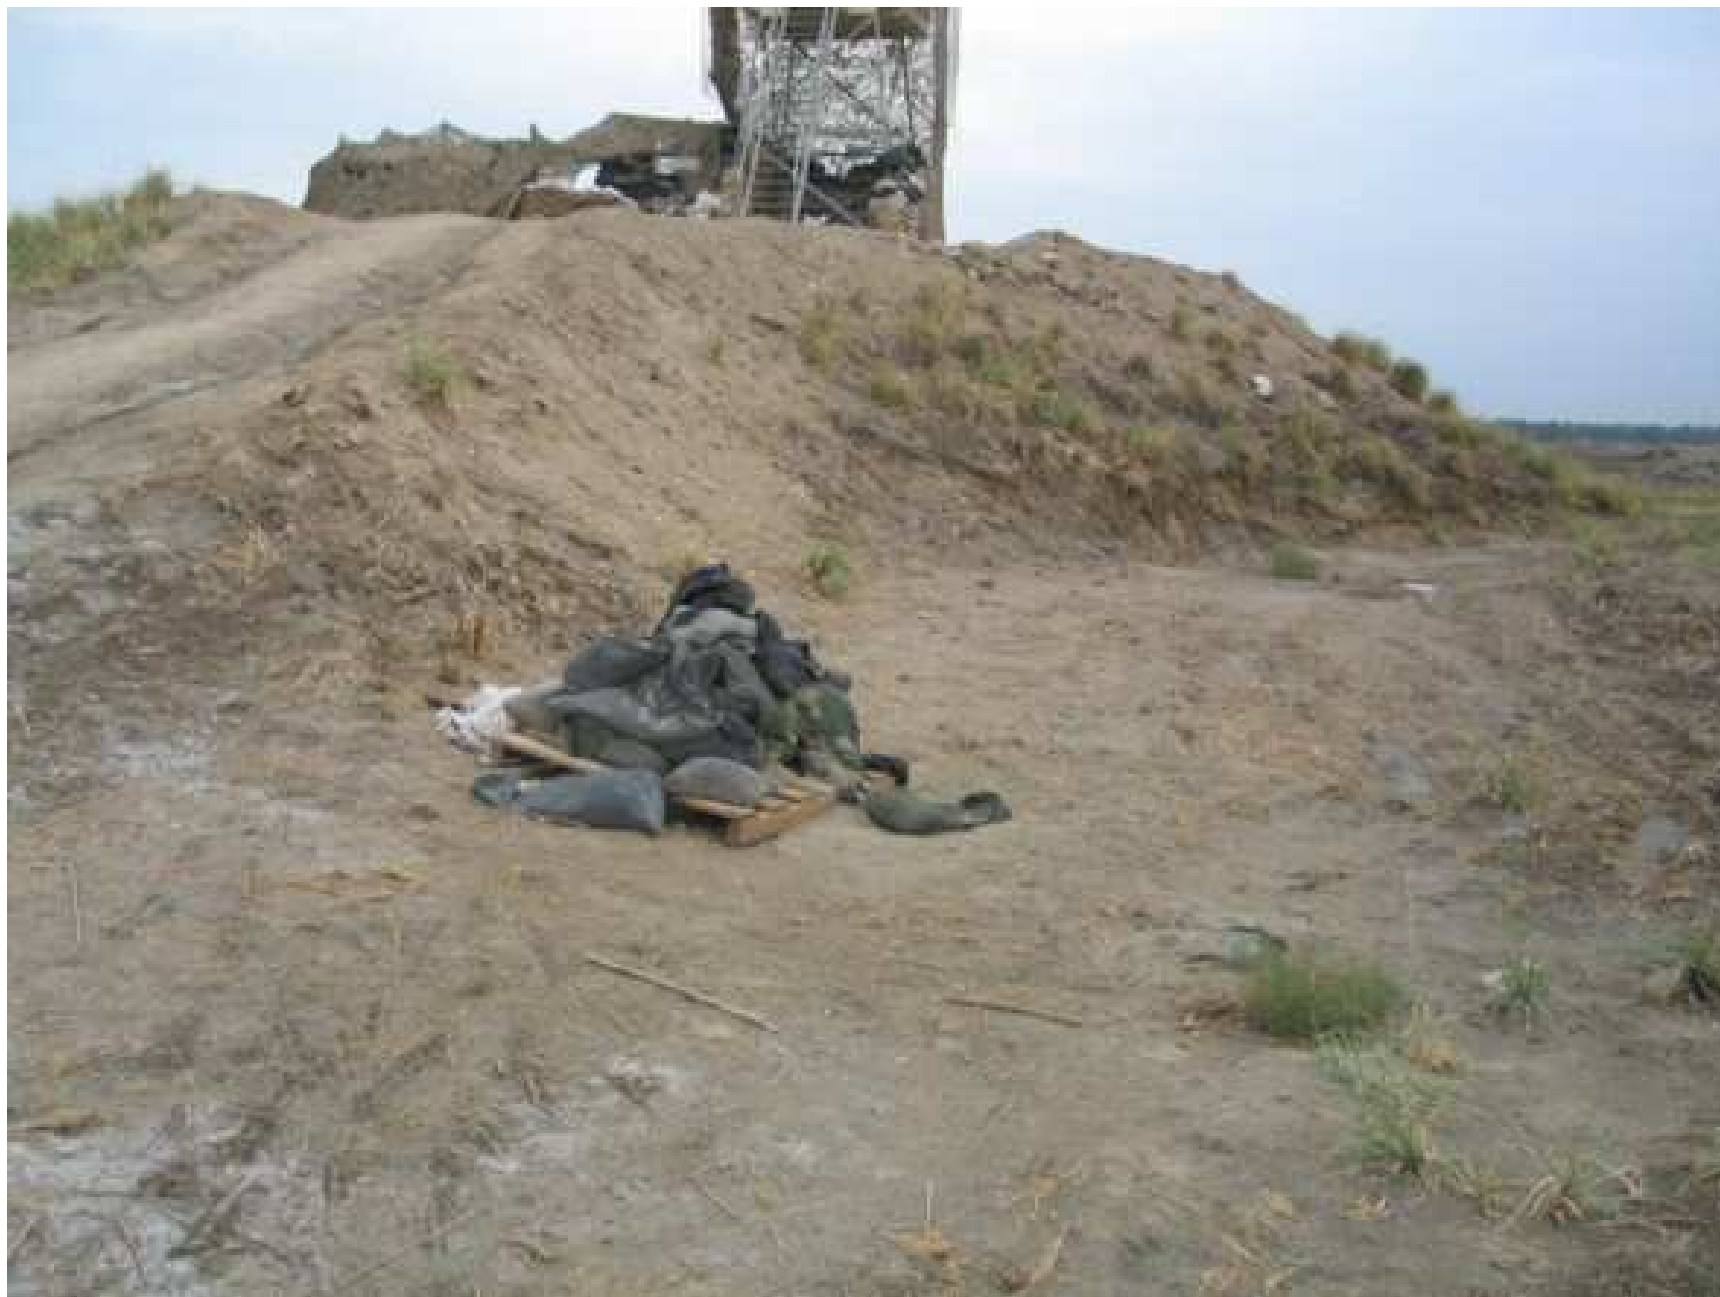
Tower 4, detail of access ramp, Polish report p. 42 (photo © Ministry of Culture and National Heritage, Republic of Poland)

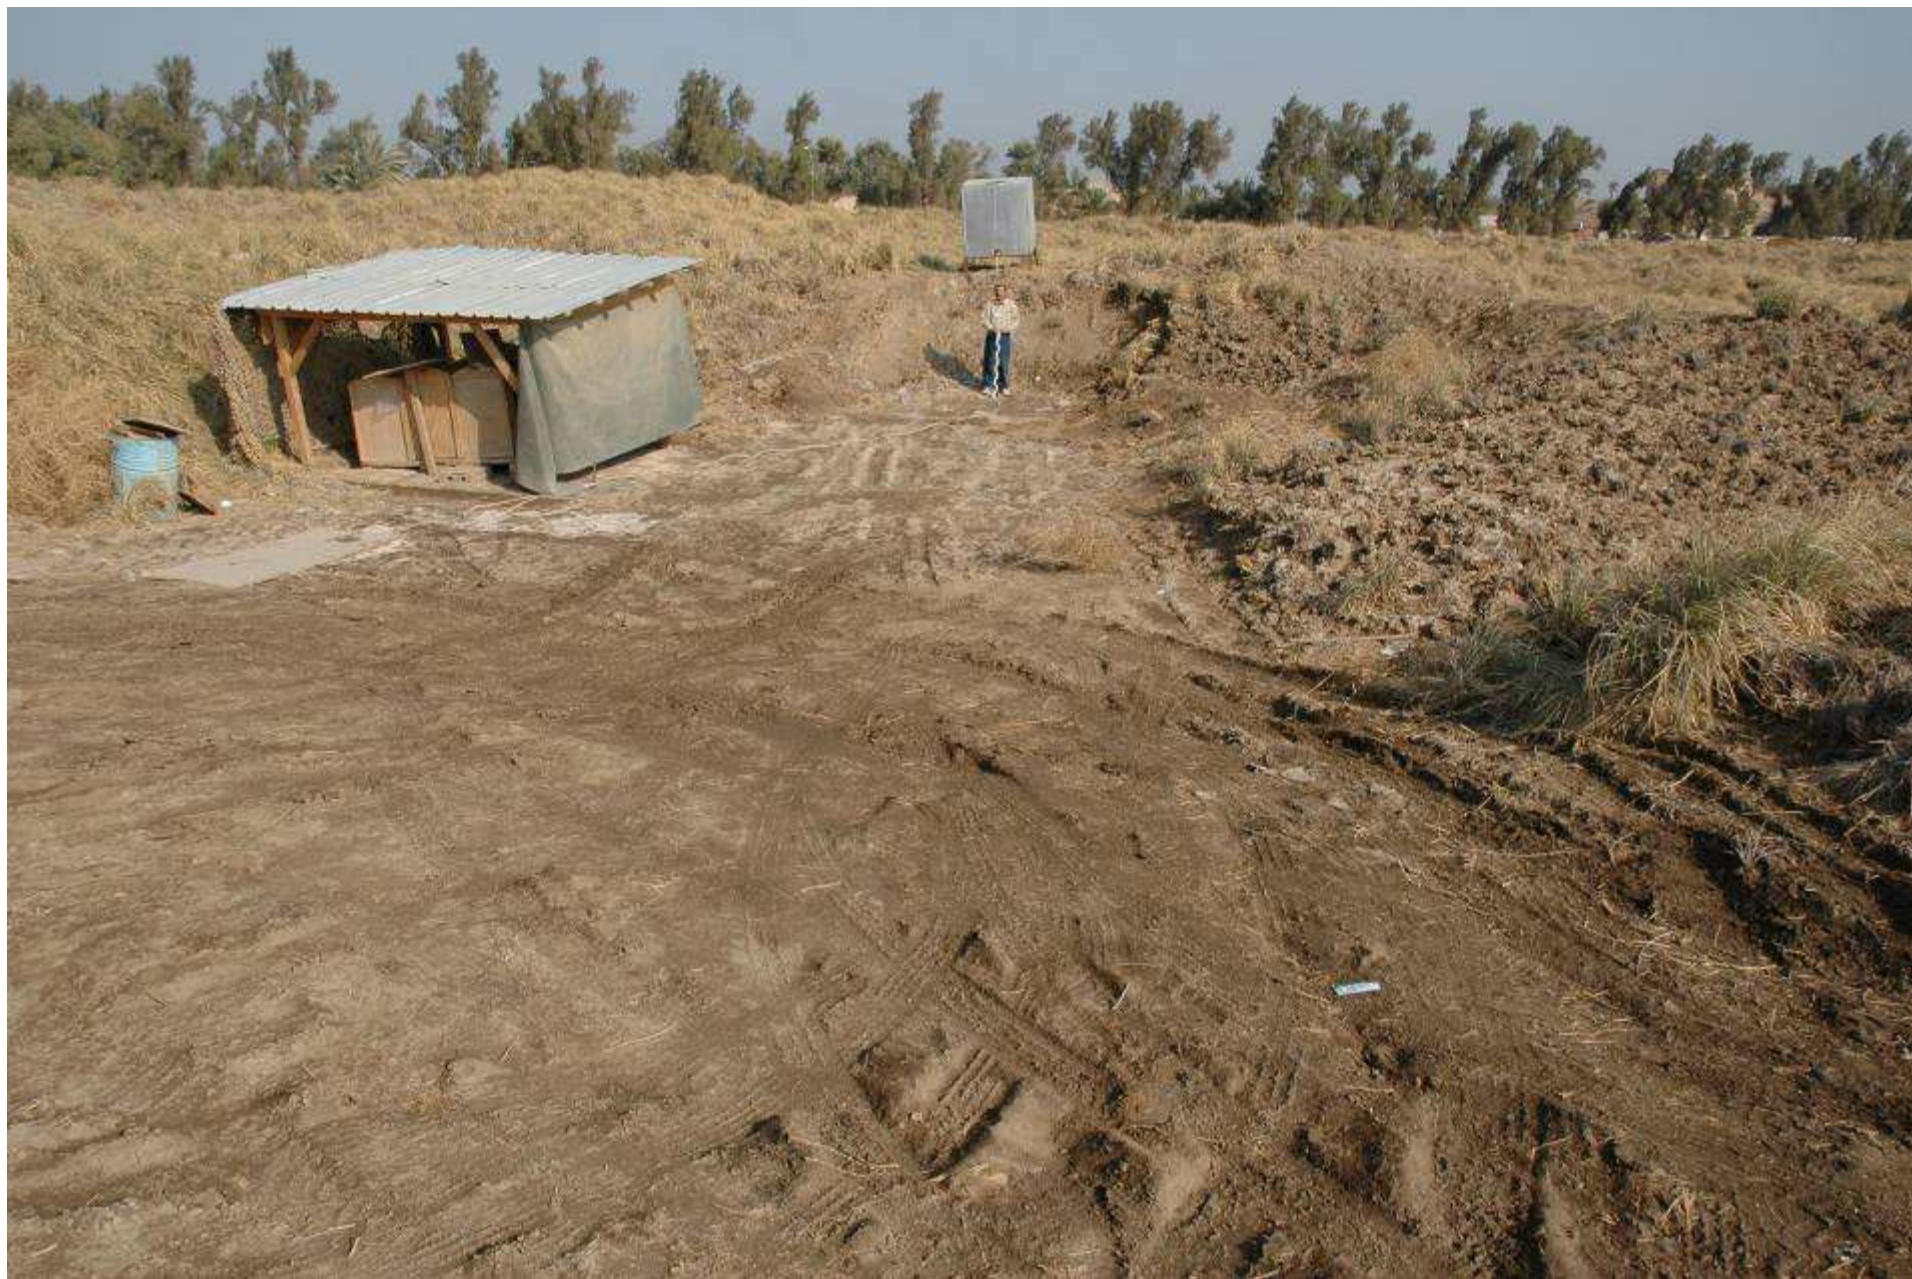
Cut 11 near observation tower 4. This cut appears to be associated with the tank directly above it, Iraqi final report fig. 49

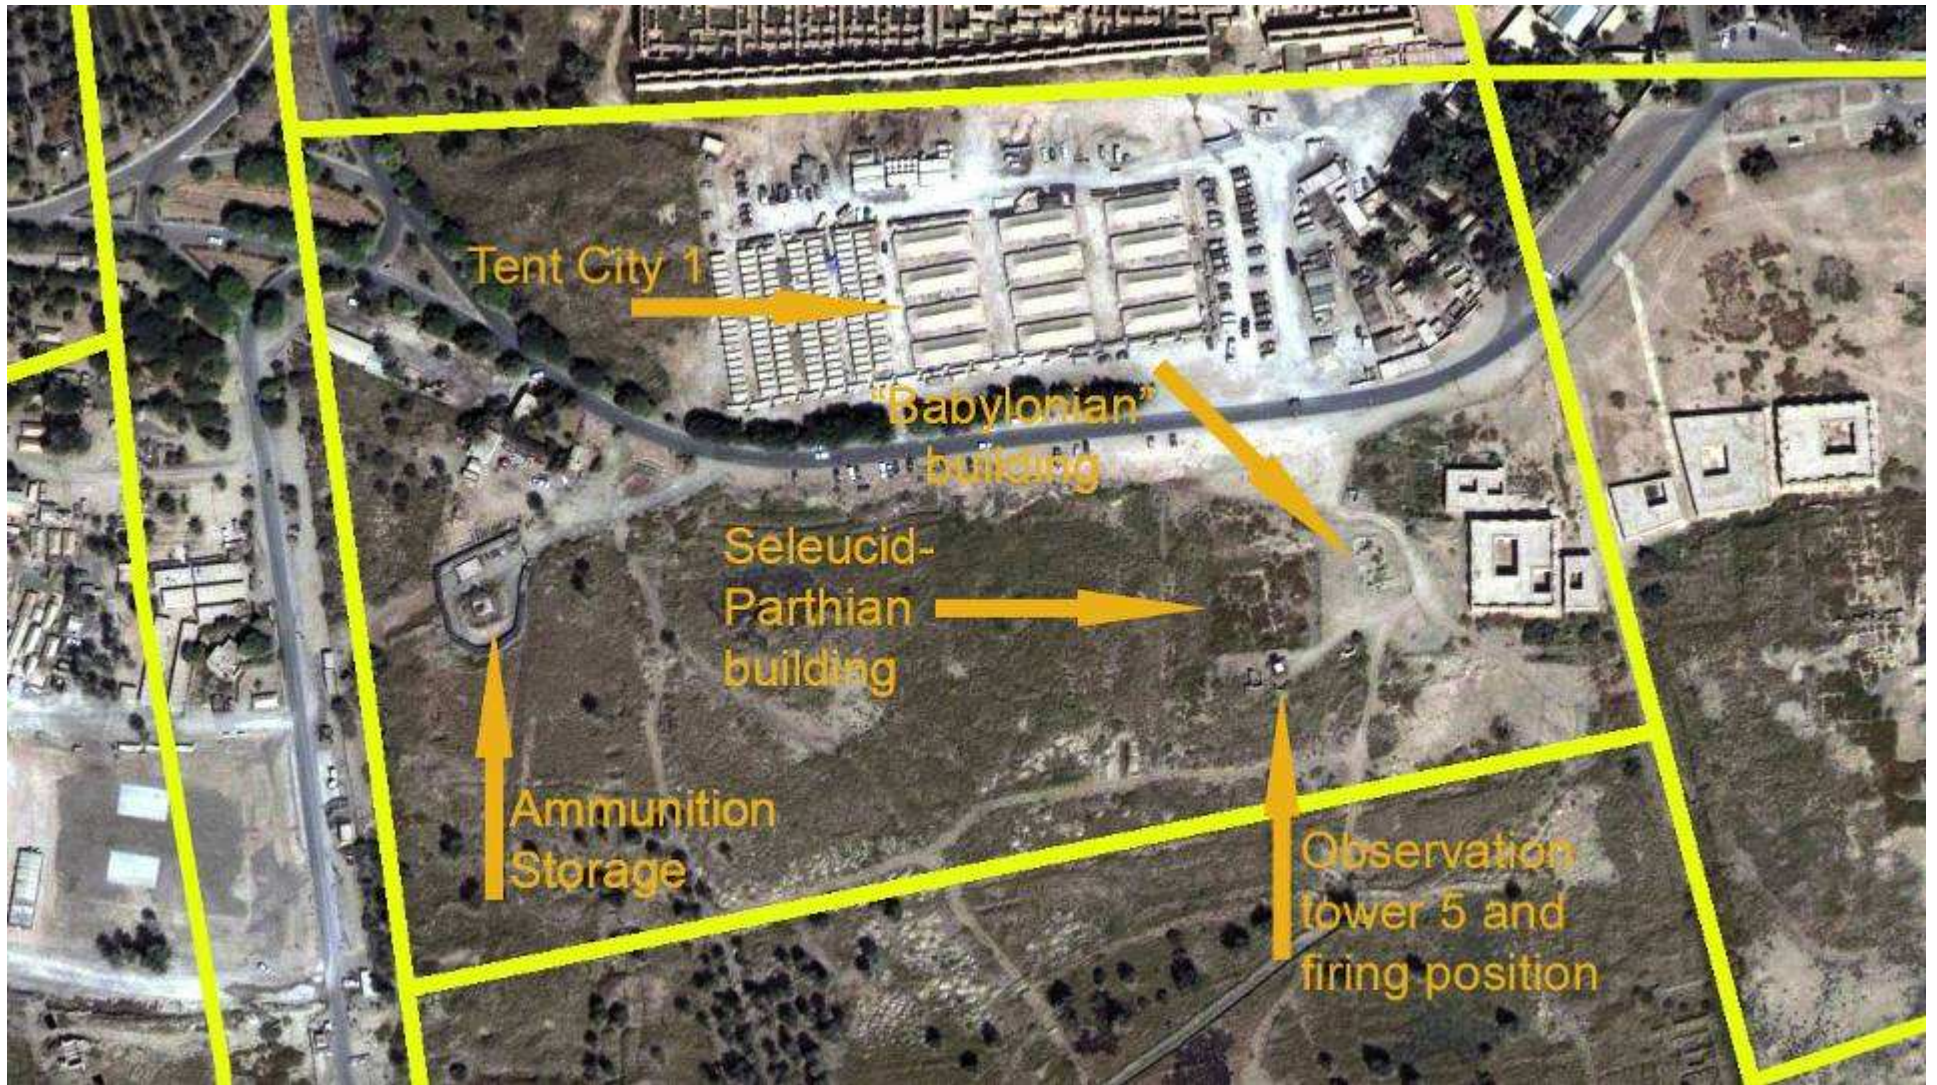
Ka-Dingir-Ra area with features discussed, 8 October 2004, Russell composite.

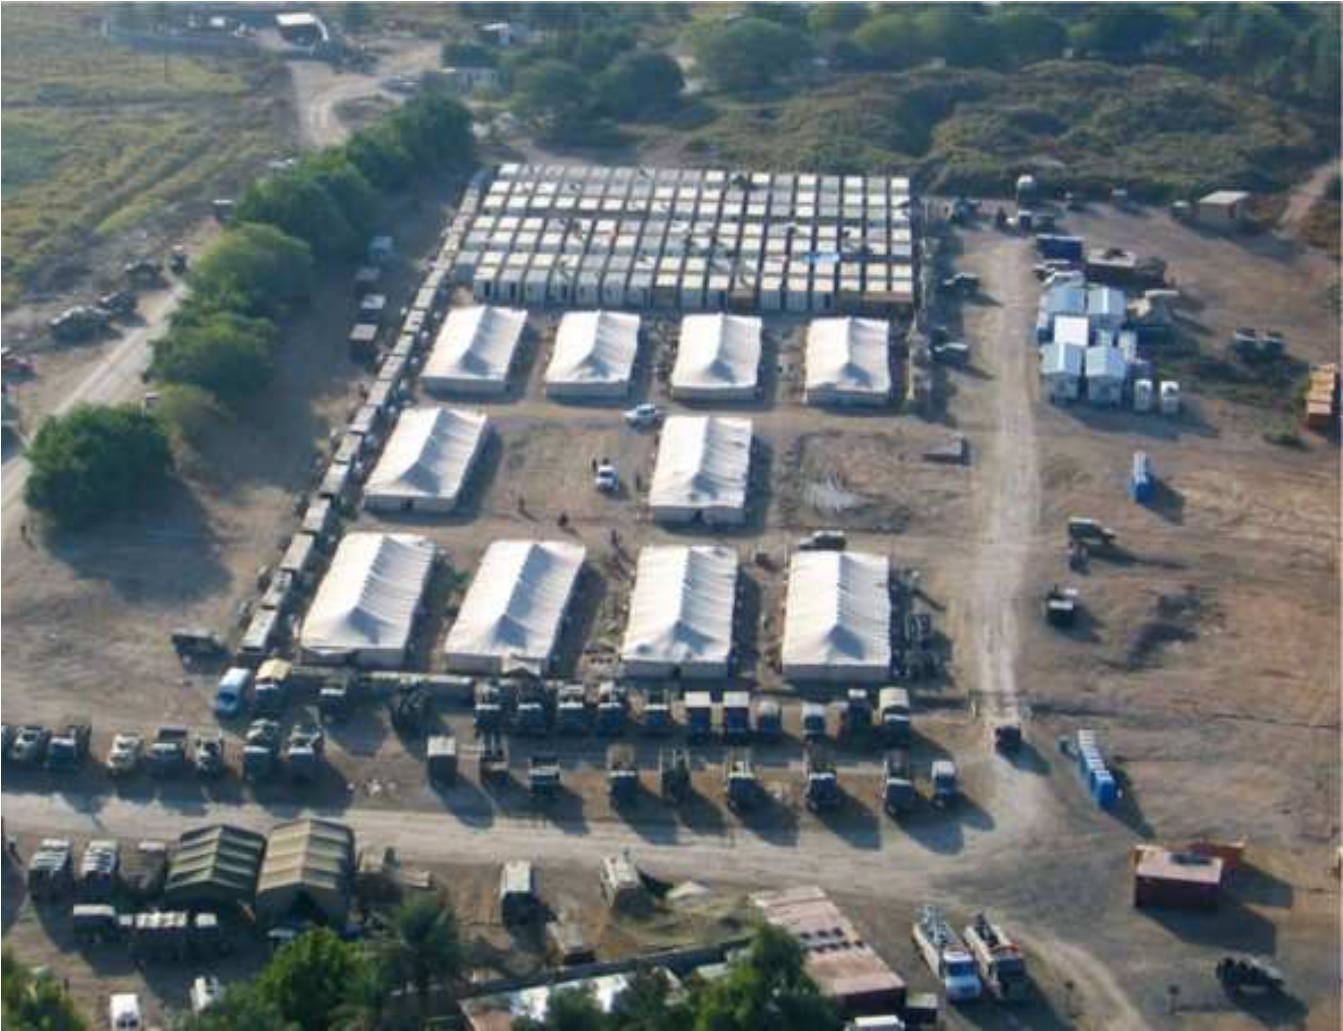
Polish report p. 20 (photo © Ministry of Culture and National Heritage, Republic of Poland)

McDonald report	Iraqi preliminary report
Immediately S of the reconstructed Southern palace of Nebuchadnezzar. This was already a flat area (possibly as a result of the reconstruction of the Southern Palace). Therefore it will not have required any bulldozing or flattening. The usual red earth was dumped, compacted and graveled and portakabins then placed on it, one area is used for large trucks.	Cutting Works: b. The area south of the southern palace: This area, estimated to be 1200 sq meters, was used, possibly for housing.

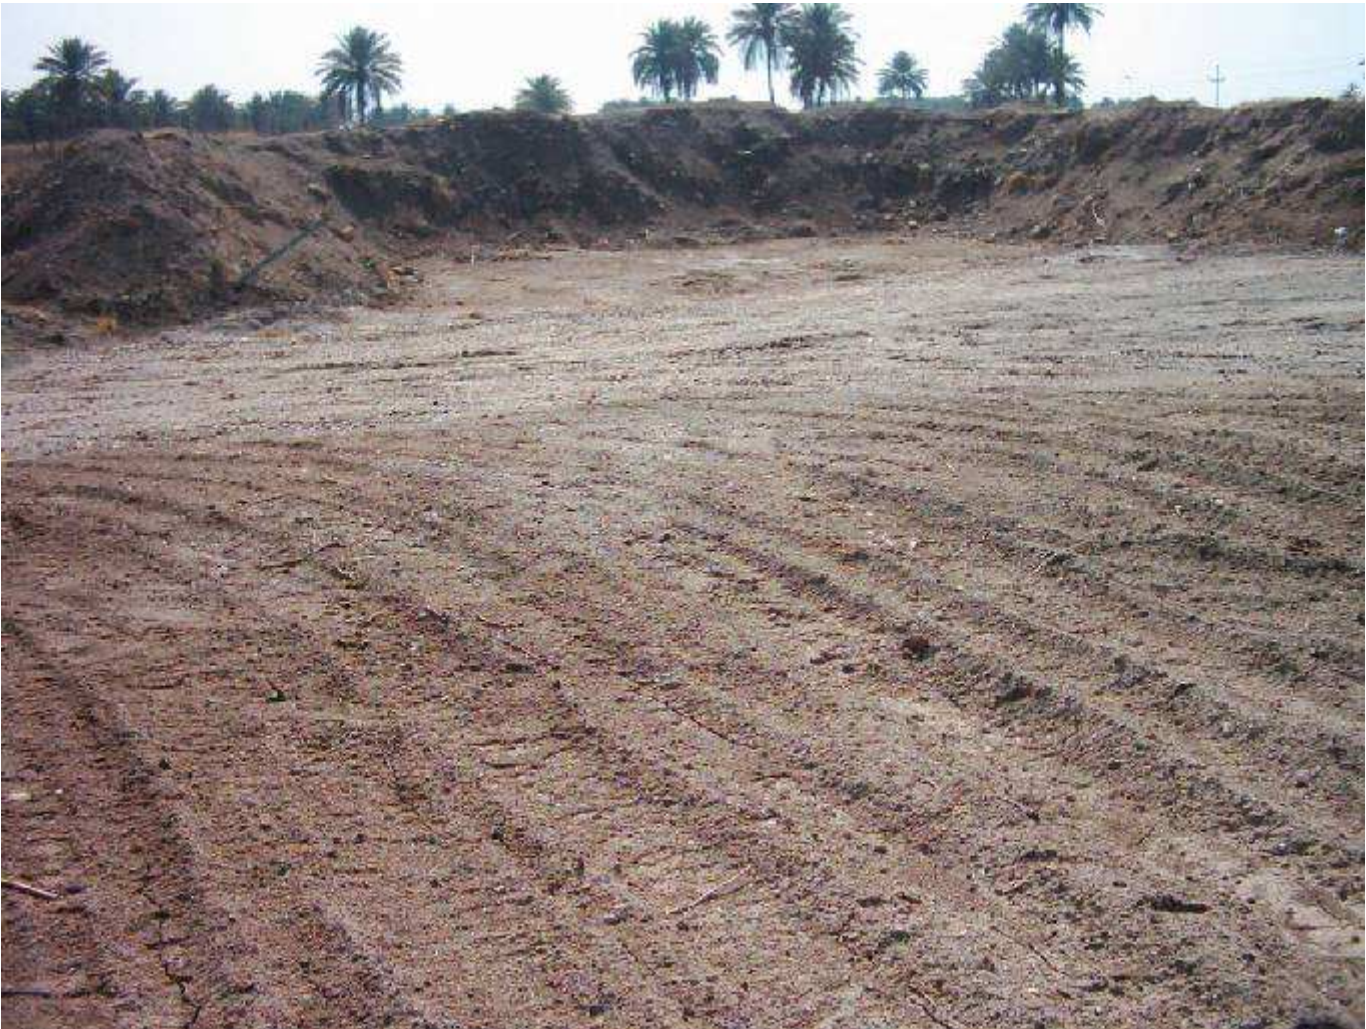
Iraqi preliminary report	Iraqi final report
It is surrounded by earthen barriers and bags packed with sand as an additional barrier. Consequently, parts of the hills were cut, leading to a change in the features and topography of the area. Traces of the cutting are clear on some fragments of ancient baked bricks and pottery shards of different shapes and types.	10. Tenth cut: The area south of the Southern Palace was subjected to an encroachment consisting of a cut with a length of 30 m. The dirt removed was mixed with sand brought from outside Babylon and used to create an earthen barrier. (Photo 48)

View of earth banks at the west(?) side of the area, Iraqi final report fig. 48

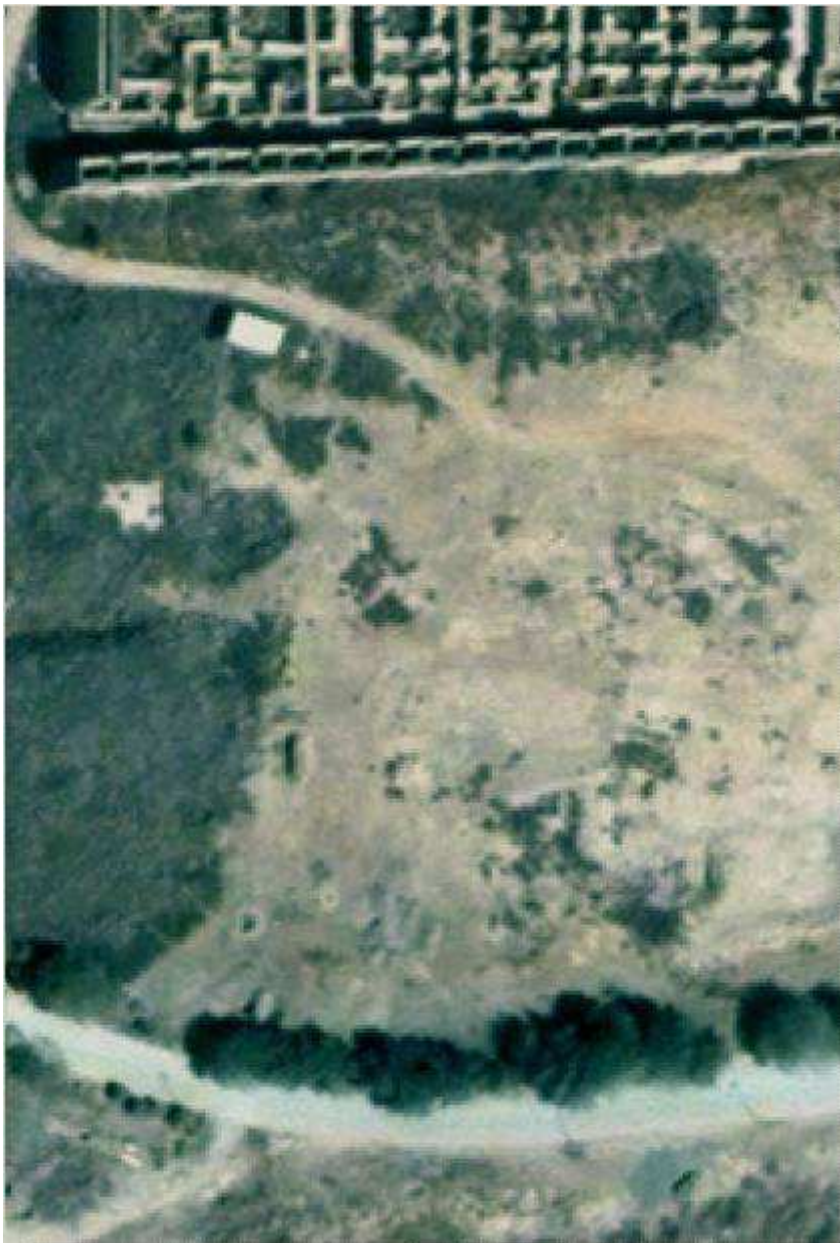
**Russell comment:** The cutting at the west edge is readily visible in before and after images that include the Iraqi topographic map as a reference.

1 April 2003, Russell composite
