# **Report on Damage to the Site of Babylon, Iraq**

**John Malcolm Russell, Ph.D.**

**Cultural Heritage Center  
Bureau of Educational and Cultural Affairs  
Department of State**

**April 2010**

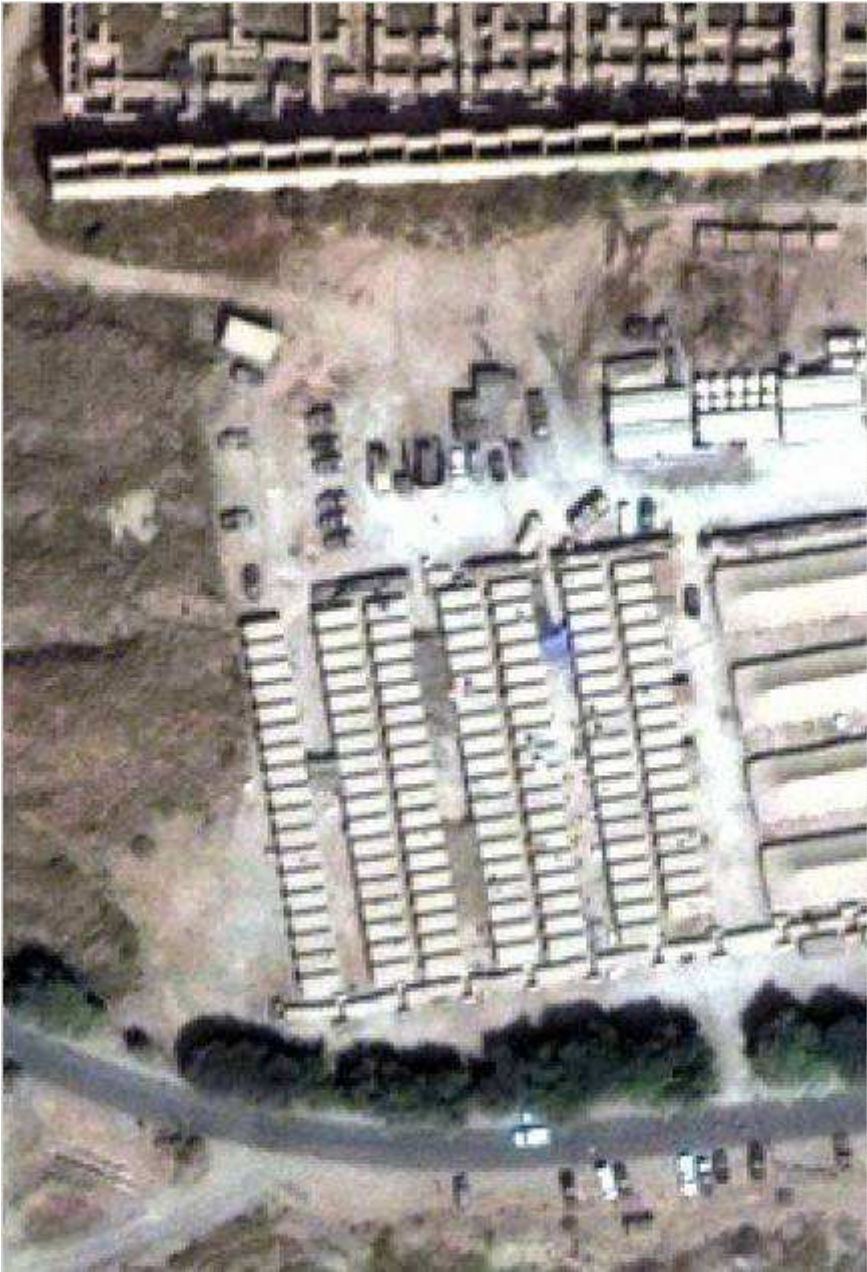
8 October 2004, Russell composite

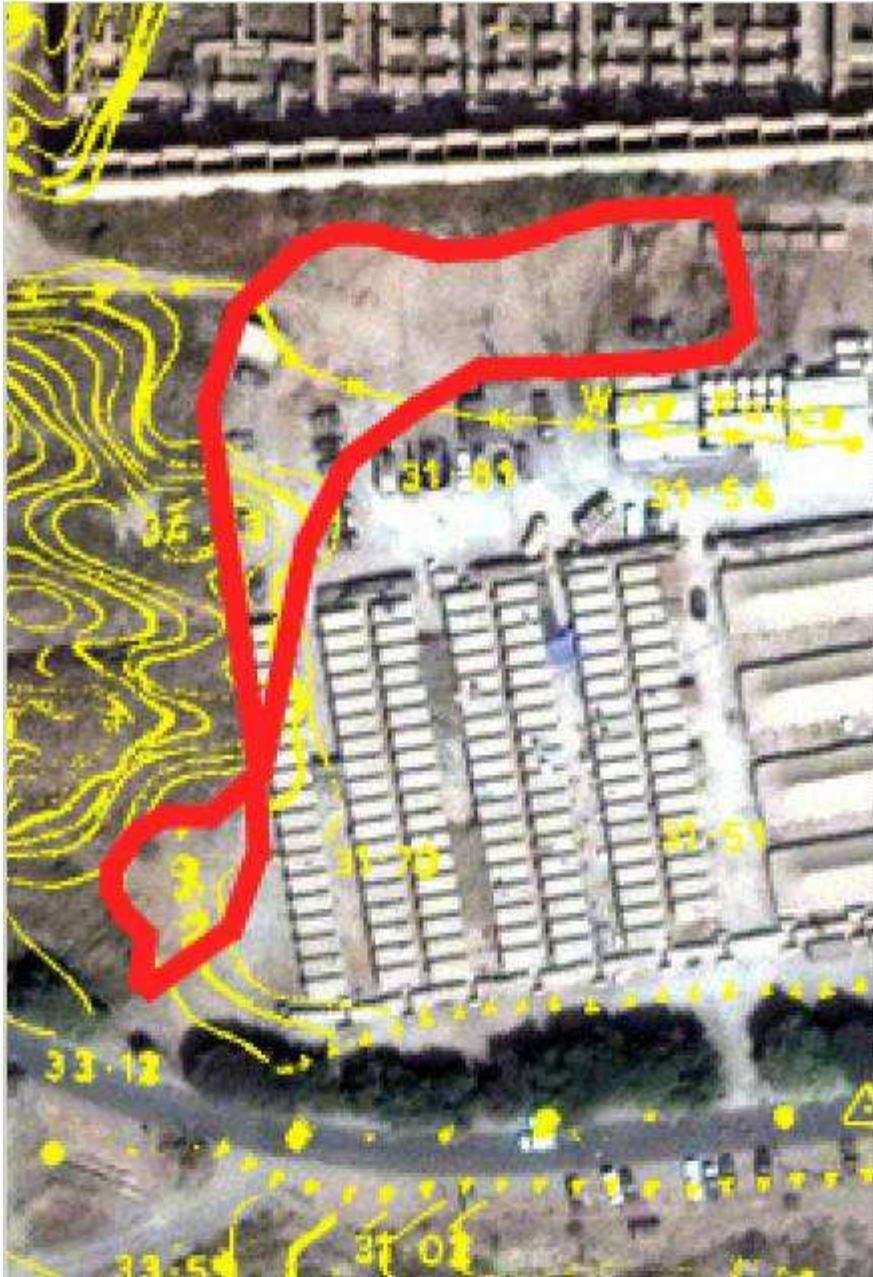
**Russell comment:** The cutting at the west edge is readily visible in before and after images that include the Iraqi topographic map as a reference.

8 October 2004, with flattened areas outlined, Russell composite

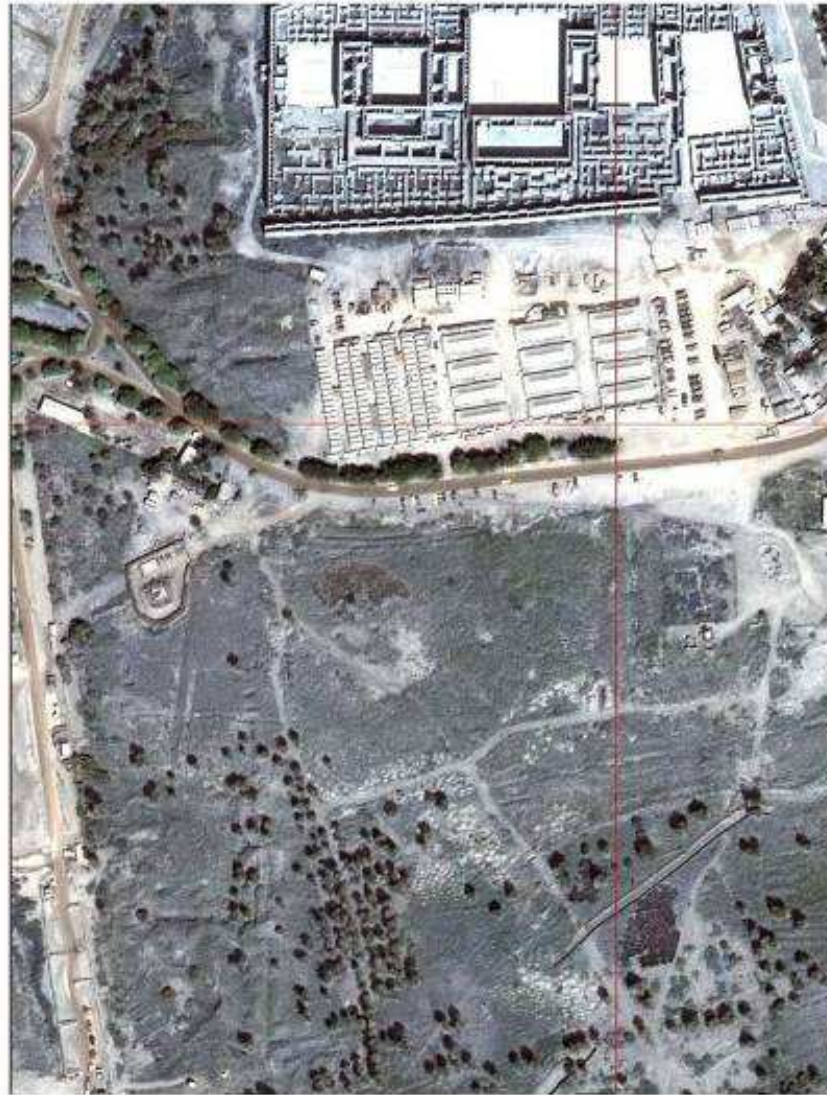
**Stone report:** This is a flat area immediately to the south of the reconstructed palace (Fig. 11).

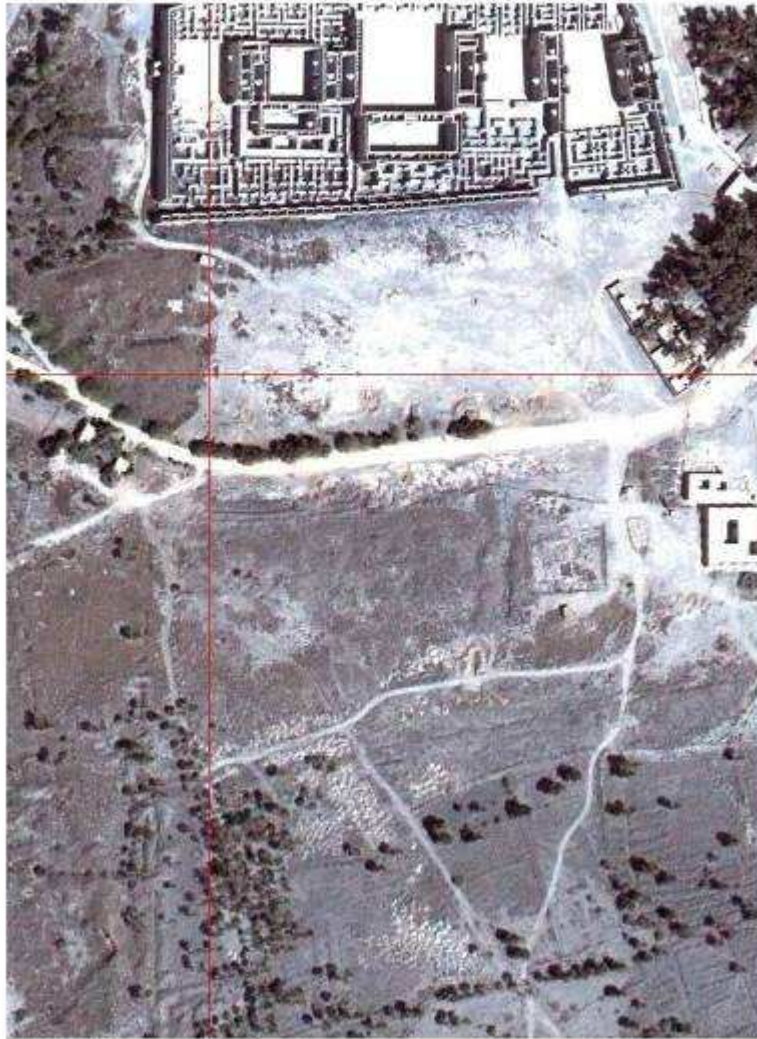
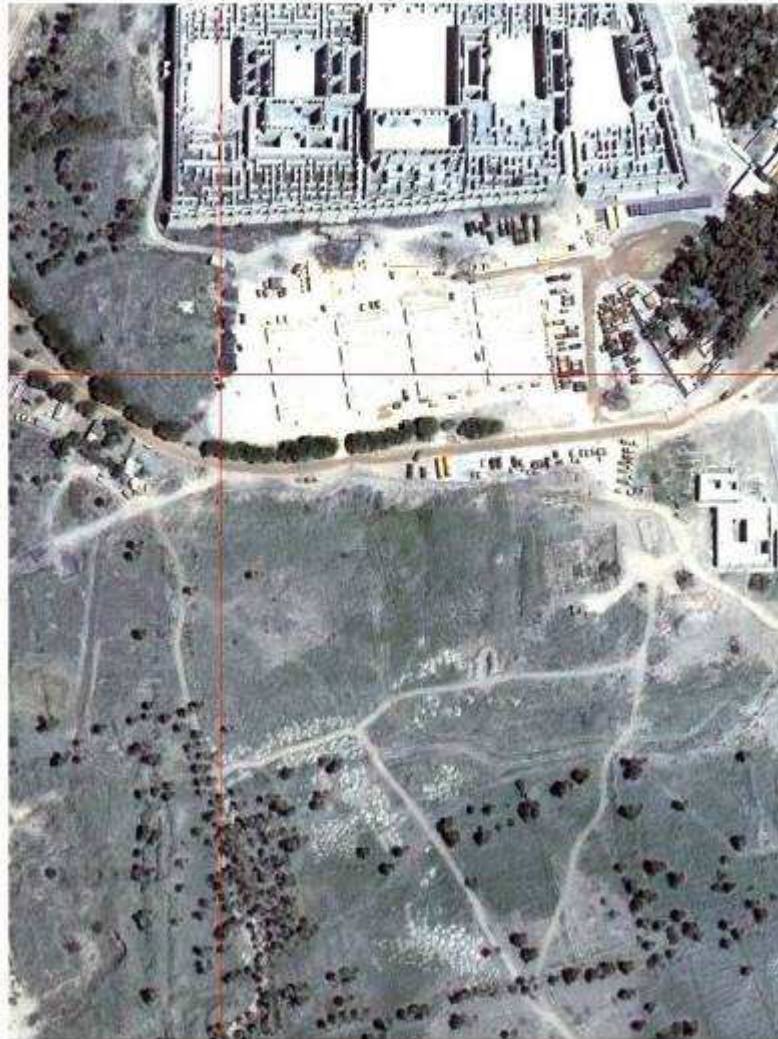
**Stone report:** An area to its west is heavily mounded, as is the area to the south, on the other side of the road. The eastern edge of the mound to the west appears to have been somewhat chewed away by the encampment. This appears to have been an ongoing process during the occupation of Babylon, with what I interpret as dark tents erected in this area by August 2003 (Fig. 12).

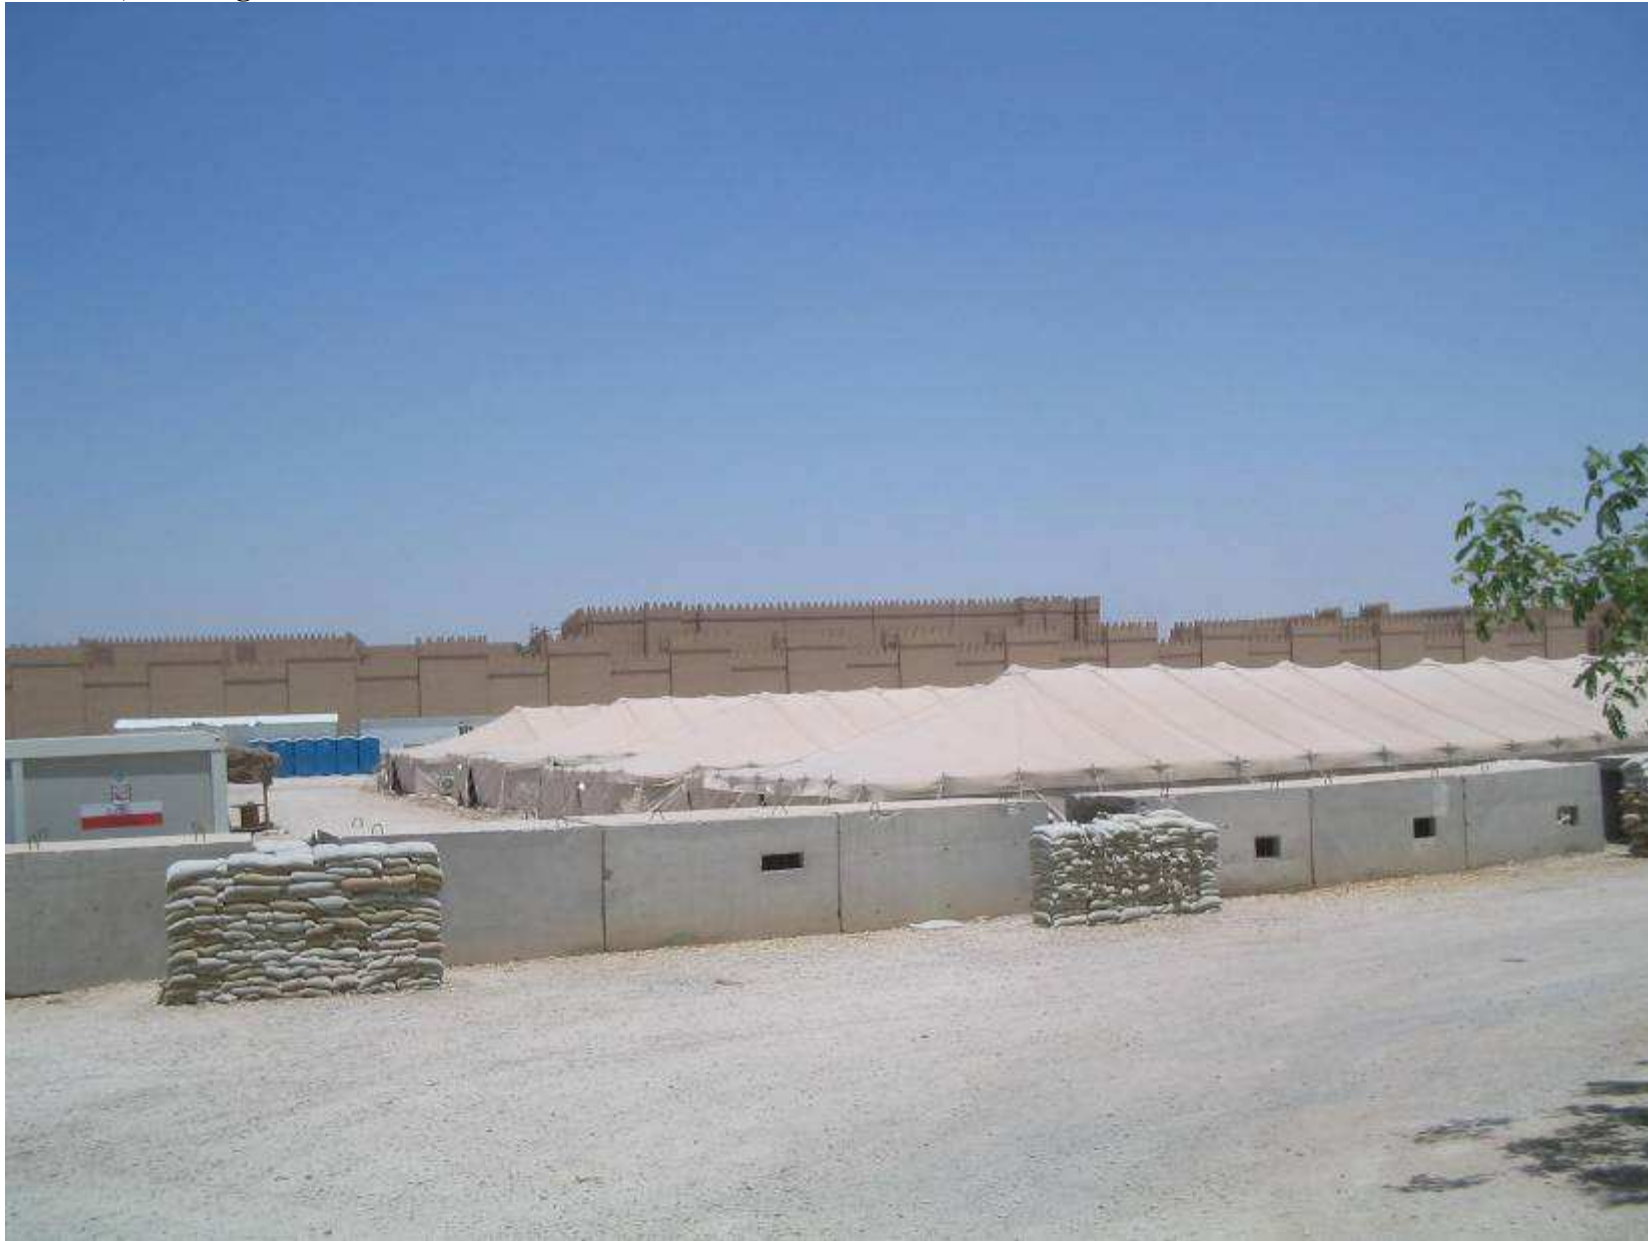
The tent area was protected on the south side and southern half of the east side by cast concrete bunkers laid end-to-end, with a gap for entrance every 3 bunkers. These gaps were shielded by piles of sandbags (May 2004, Russell 124\_2463).

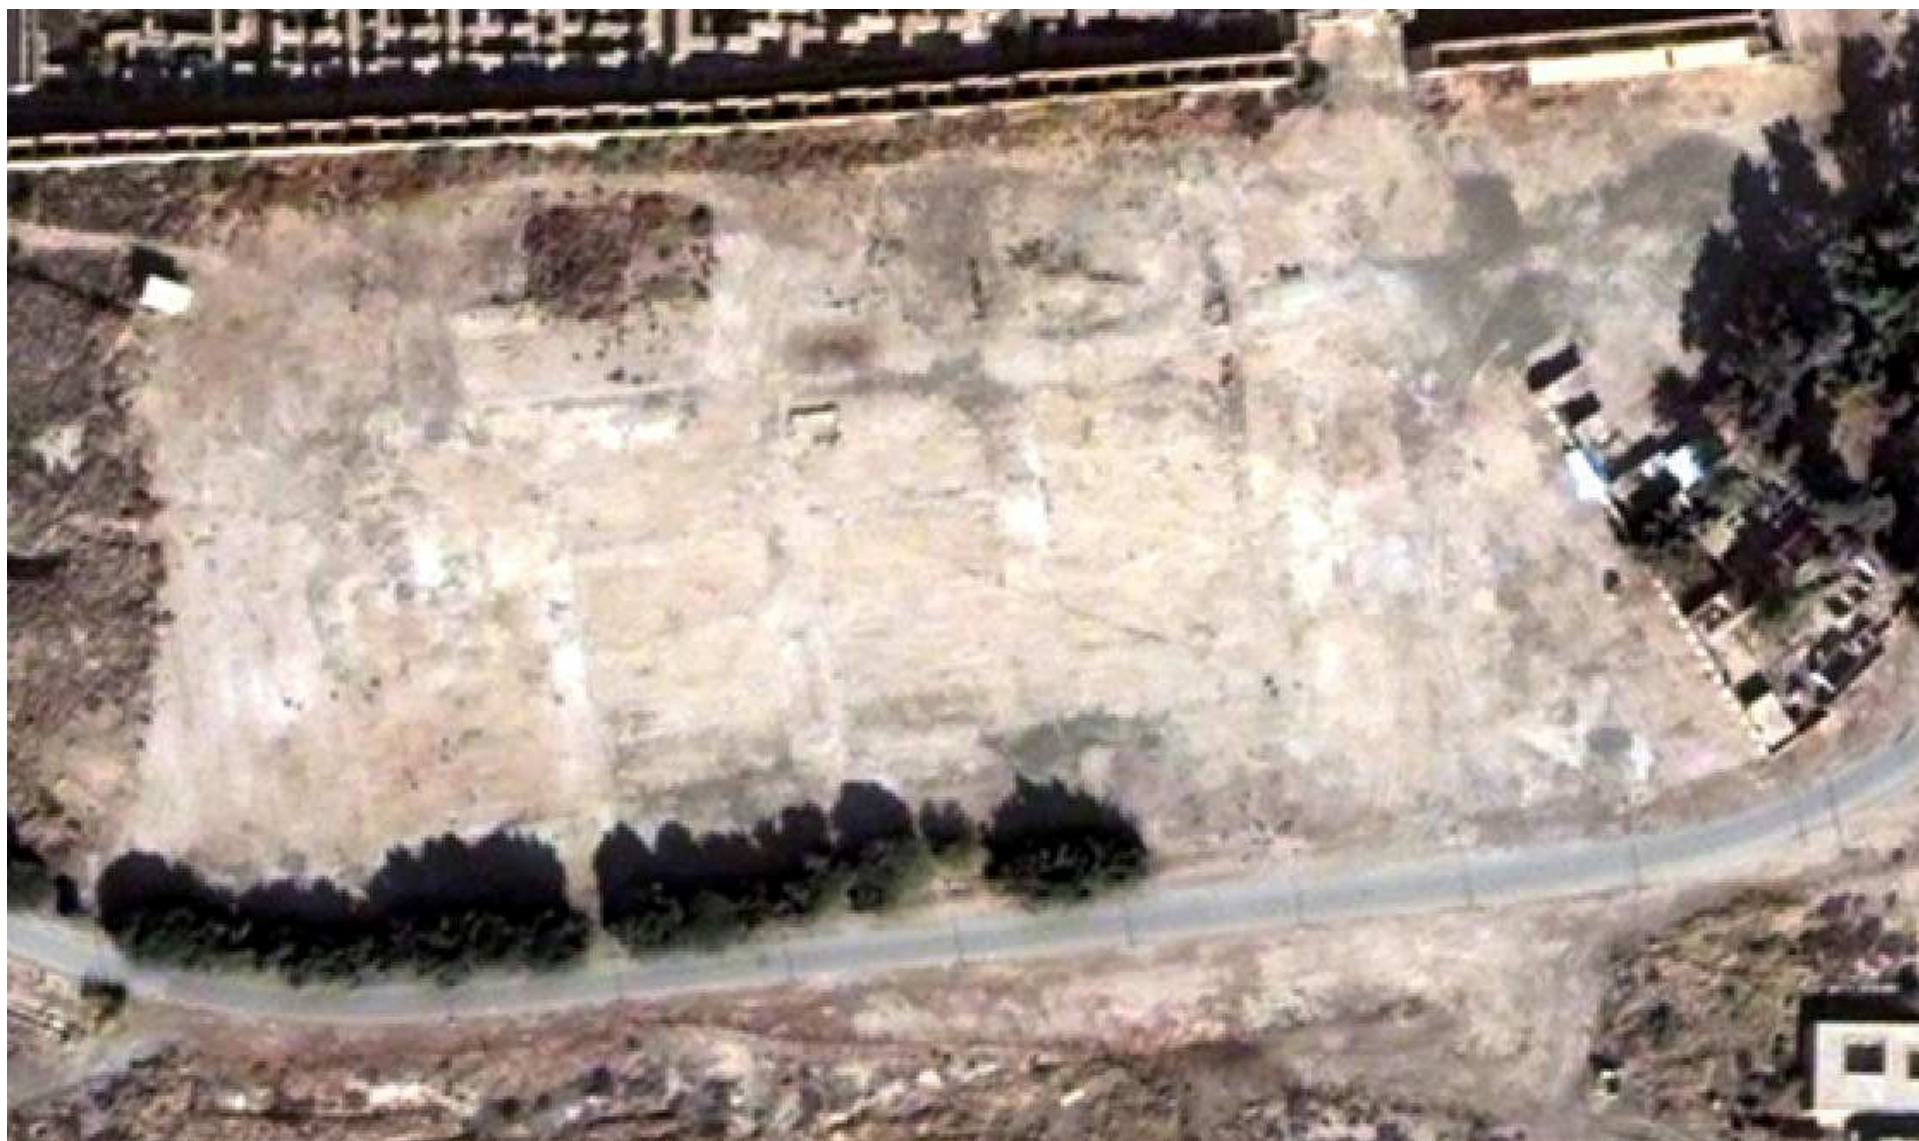
The bunkers and possibly also the sandbags were removed when the camp was evacuated (image 26 November 2005, Russell composite).

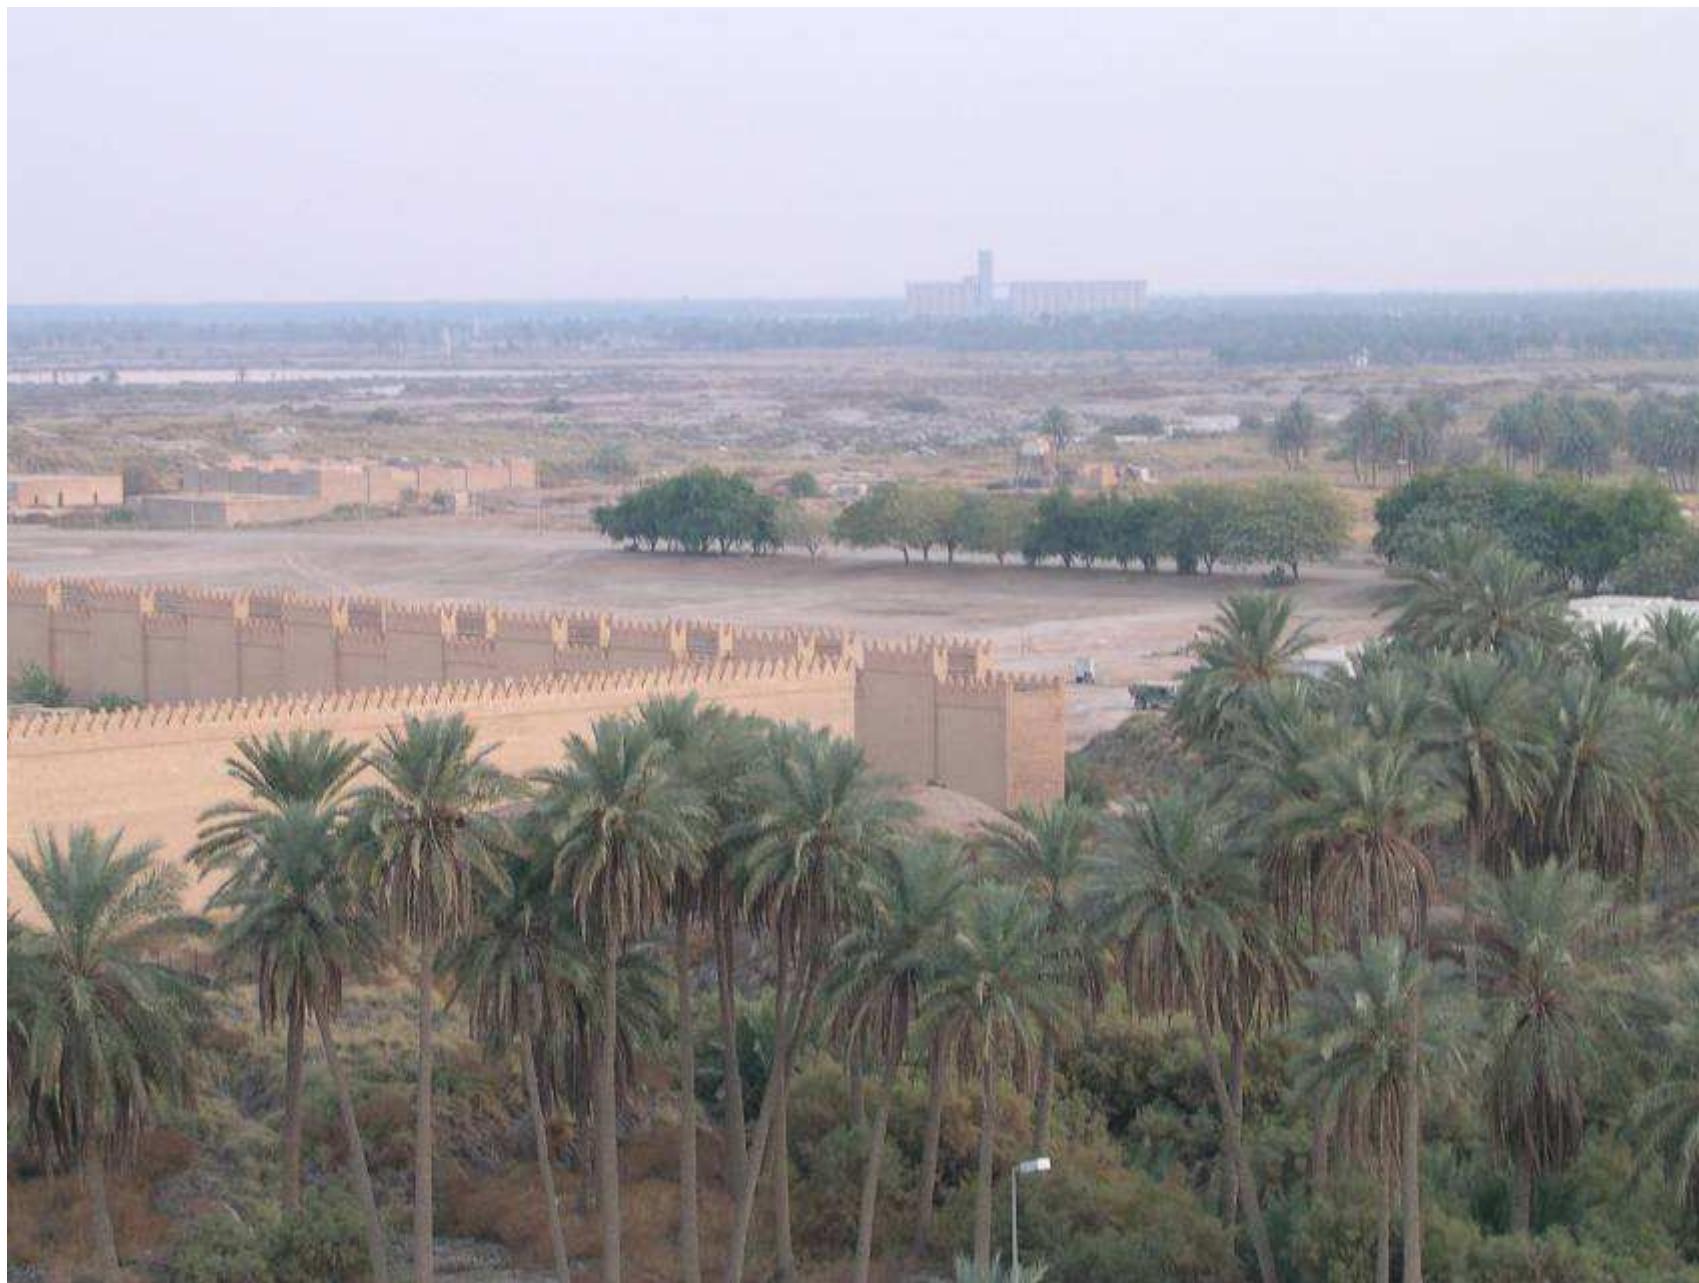
December 2005, after removal of camp, Curtis photo 7636 (photo © John Curtis)

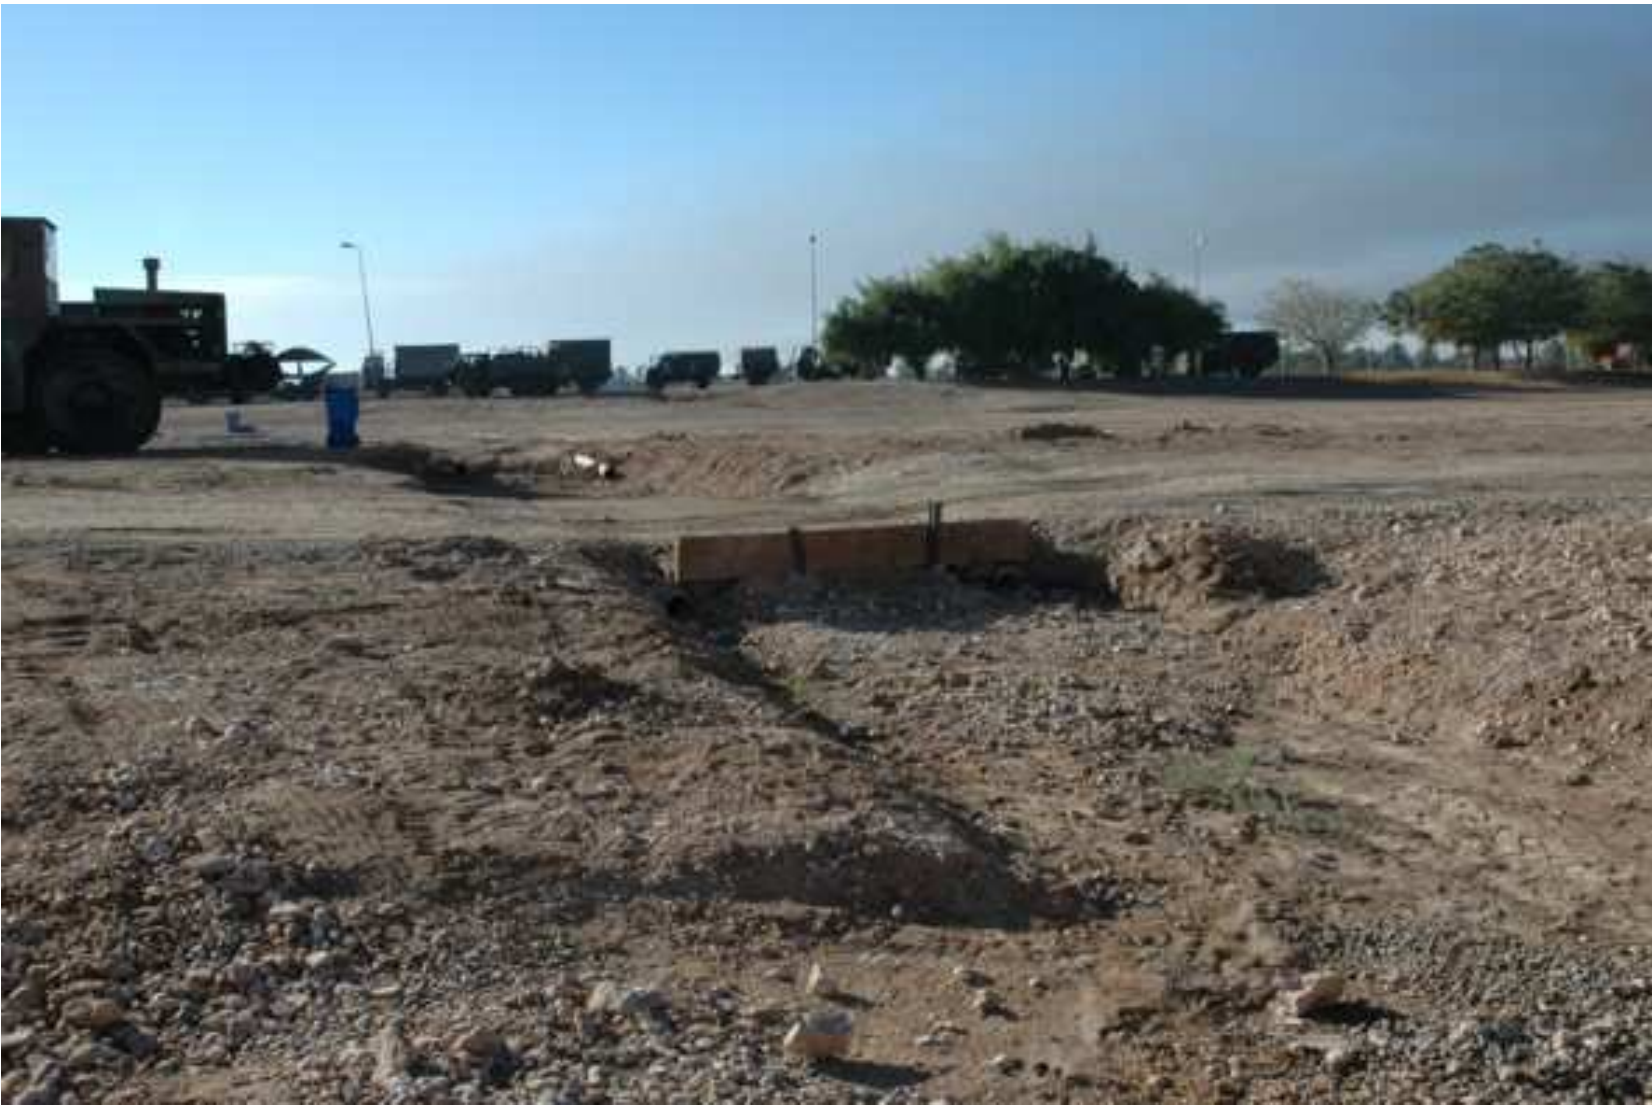
**Ditch:** This ditch is associated with the eastern end of the tent camp, and may have served for drainage.

Polish report	Stone report
On this area is a ditch running across one-third width of the described zone. The ditch is 35 meters long, 2 meters wide and depth close to 0.5 meters.	Neither the trench nor the pit recorded in the Polish report are visible in our imagery.

View of ditch, Polish report p. 21 (photo © Ministry of Culture and National Heritage, Republic of Poland)

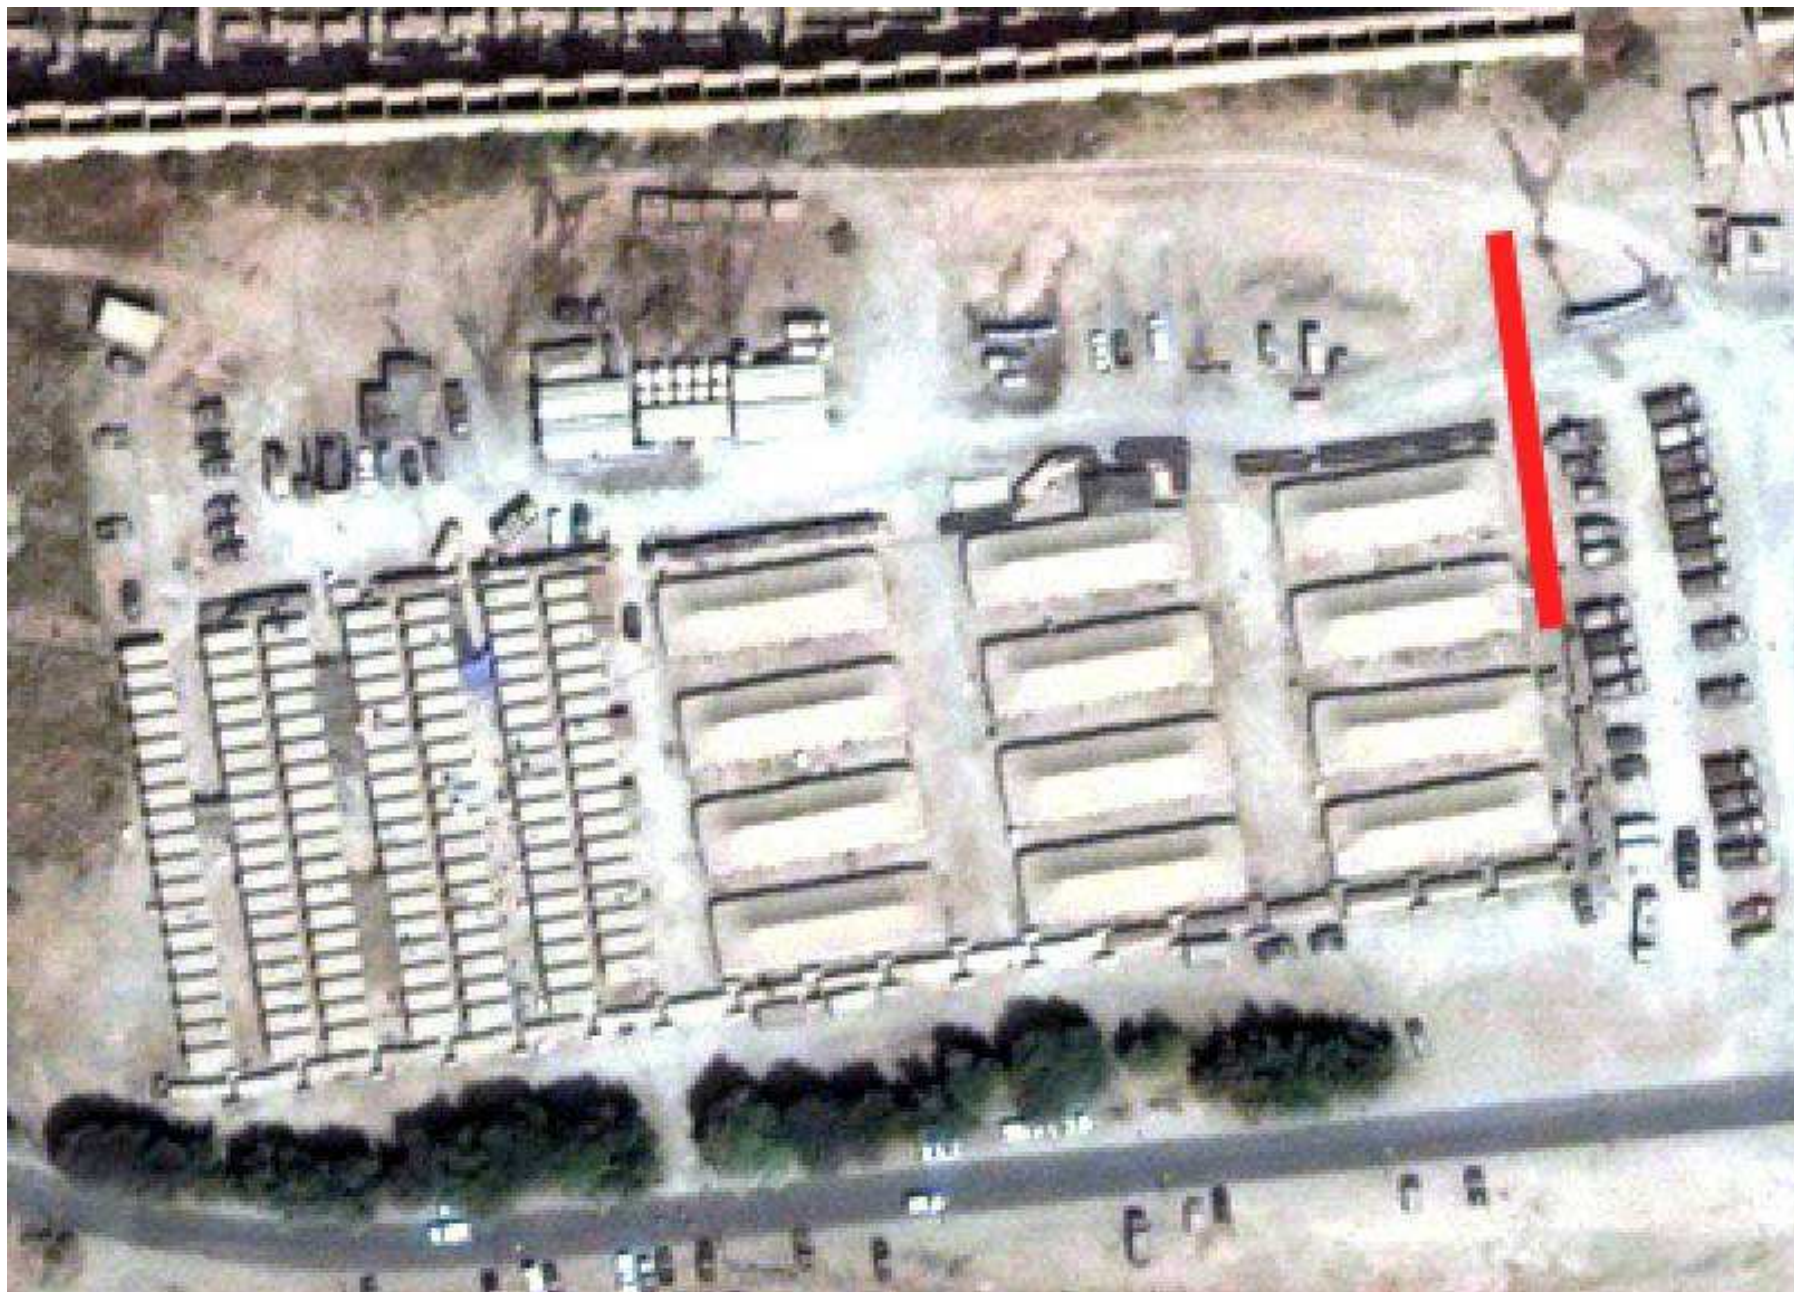
Location of ditch, Russell composite

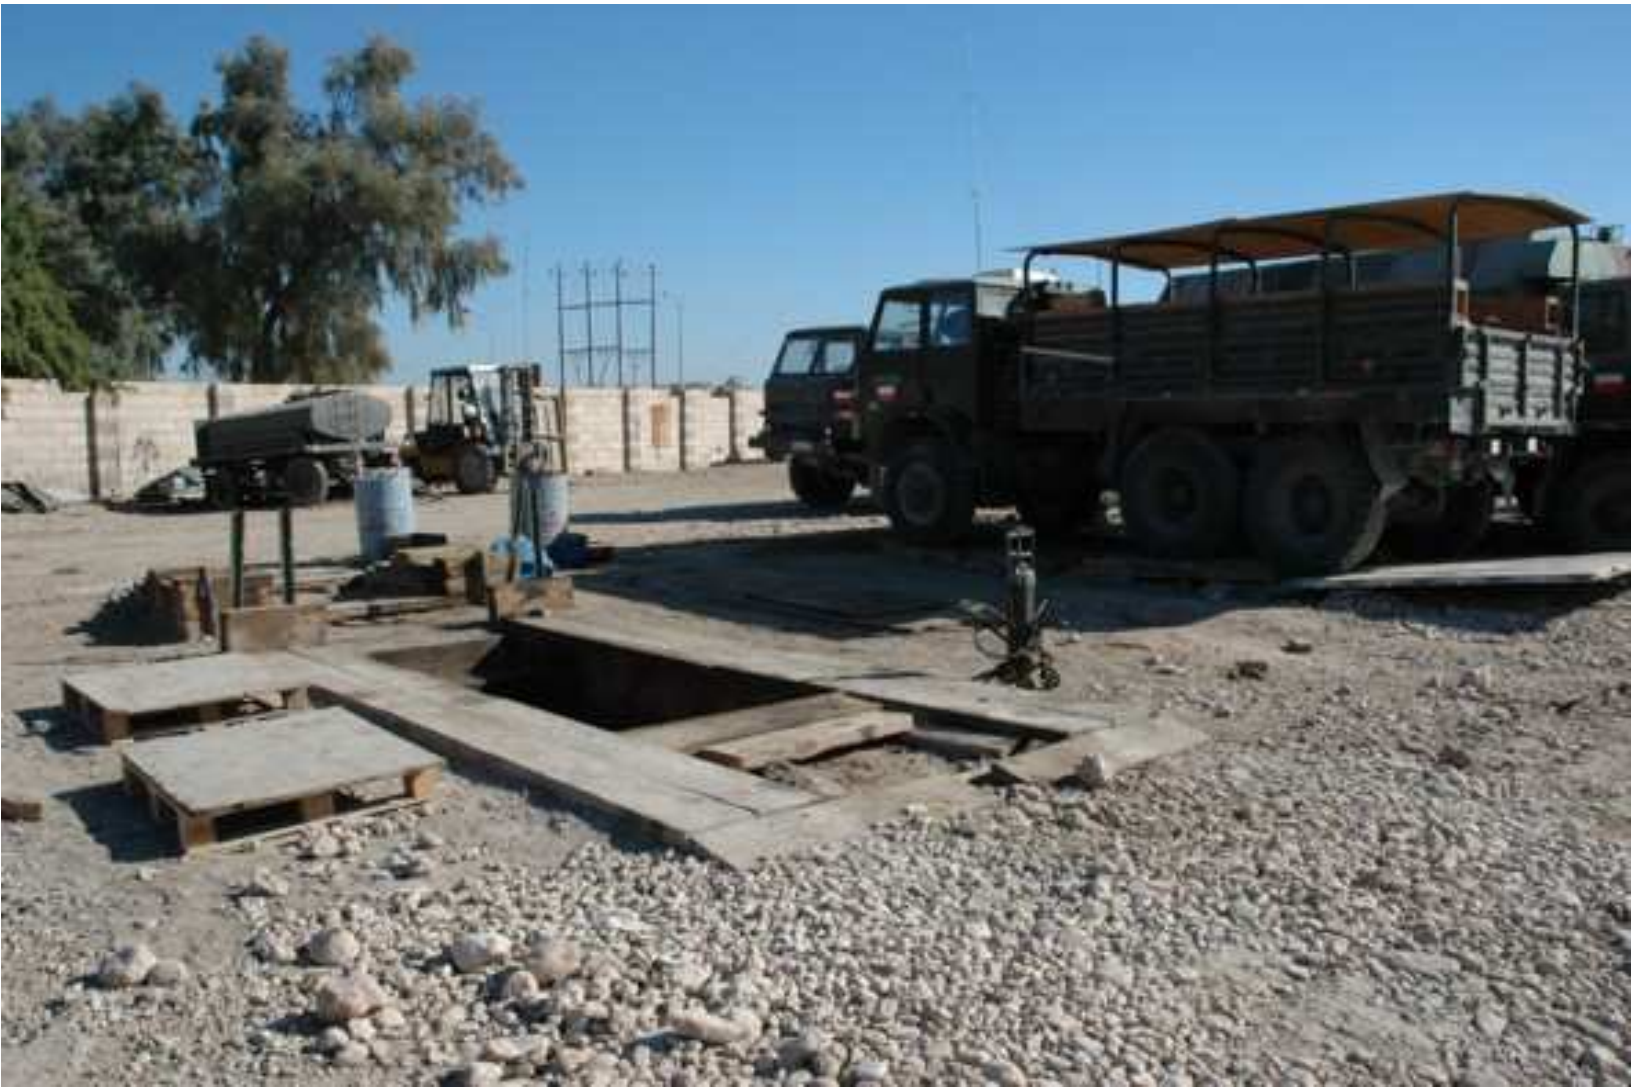
Polish report p. 21 (photo © Ministry of Culture and National Heritage, Republic of Poland)

**Pit:** This is a vehicle underbody service pit. The contamination is presumably spilled vehicle fluid. The photograph in the Polish report confirms that it is in the SE corner of the area, but it is not recognizable in the satellite imagery.

Polish report	Stone report
On the Southeast corner of the area there is a pit. The area around the pit shows some contamination.	Neither the trench nor the pit recorded in the Polish report are visible in our imagery.

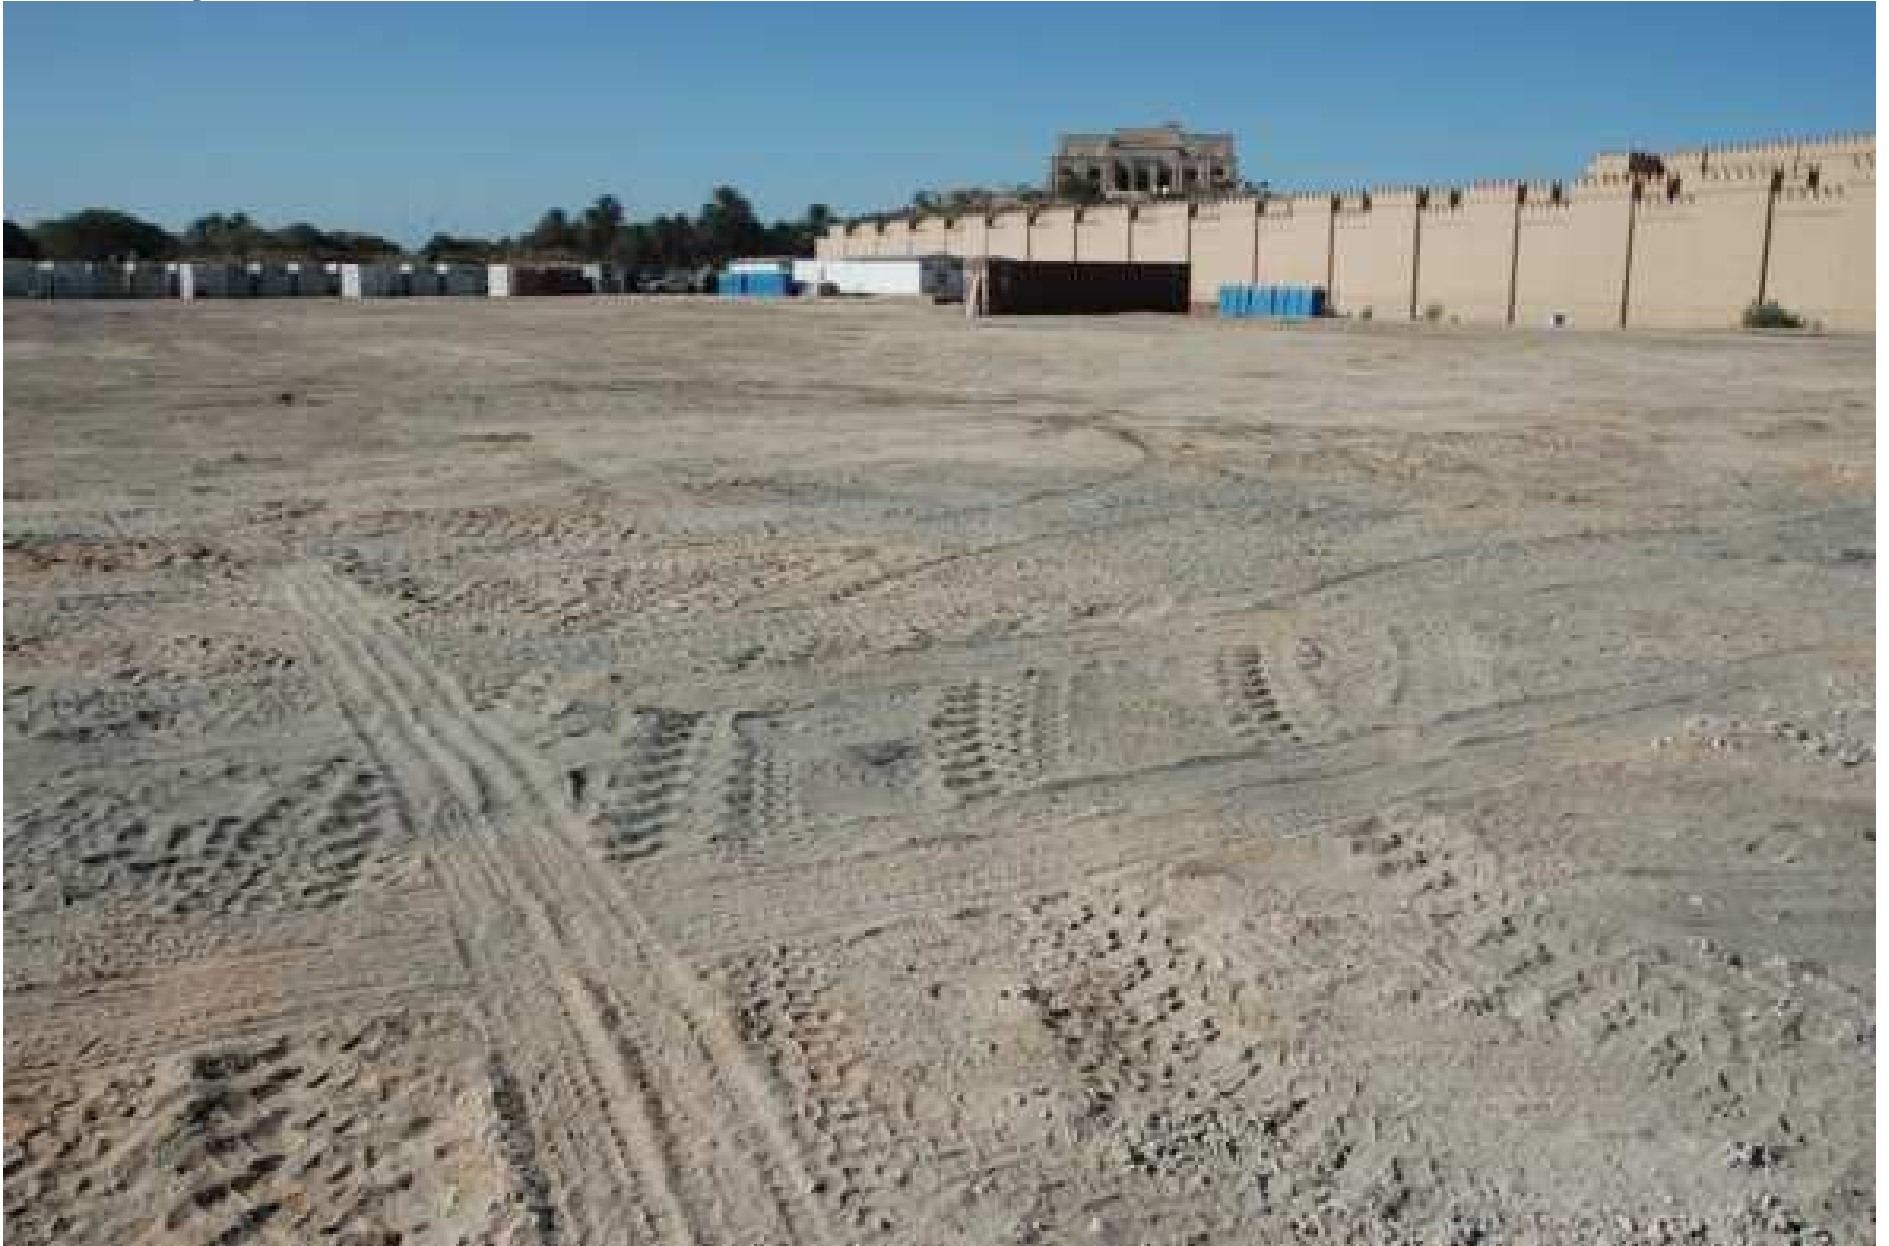
**Polish report:** “On the entire area there are ruts from car and truck traffic” (photo: Polish report p. 22, © Ministry of Culture and National Heritage, Republic of Poland)

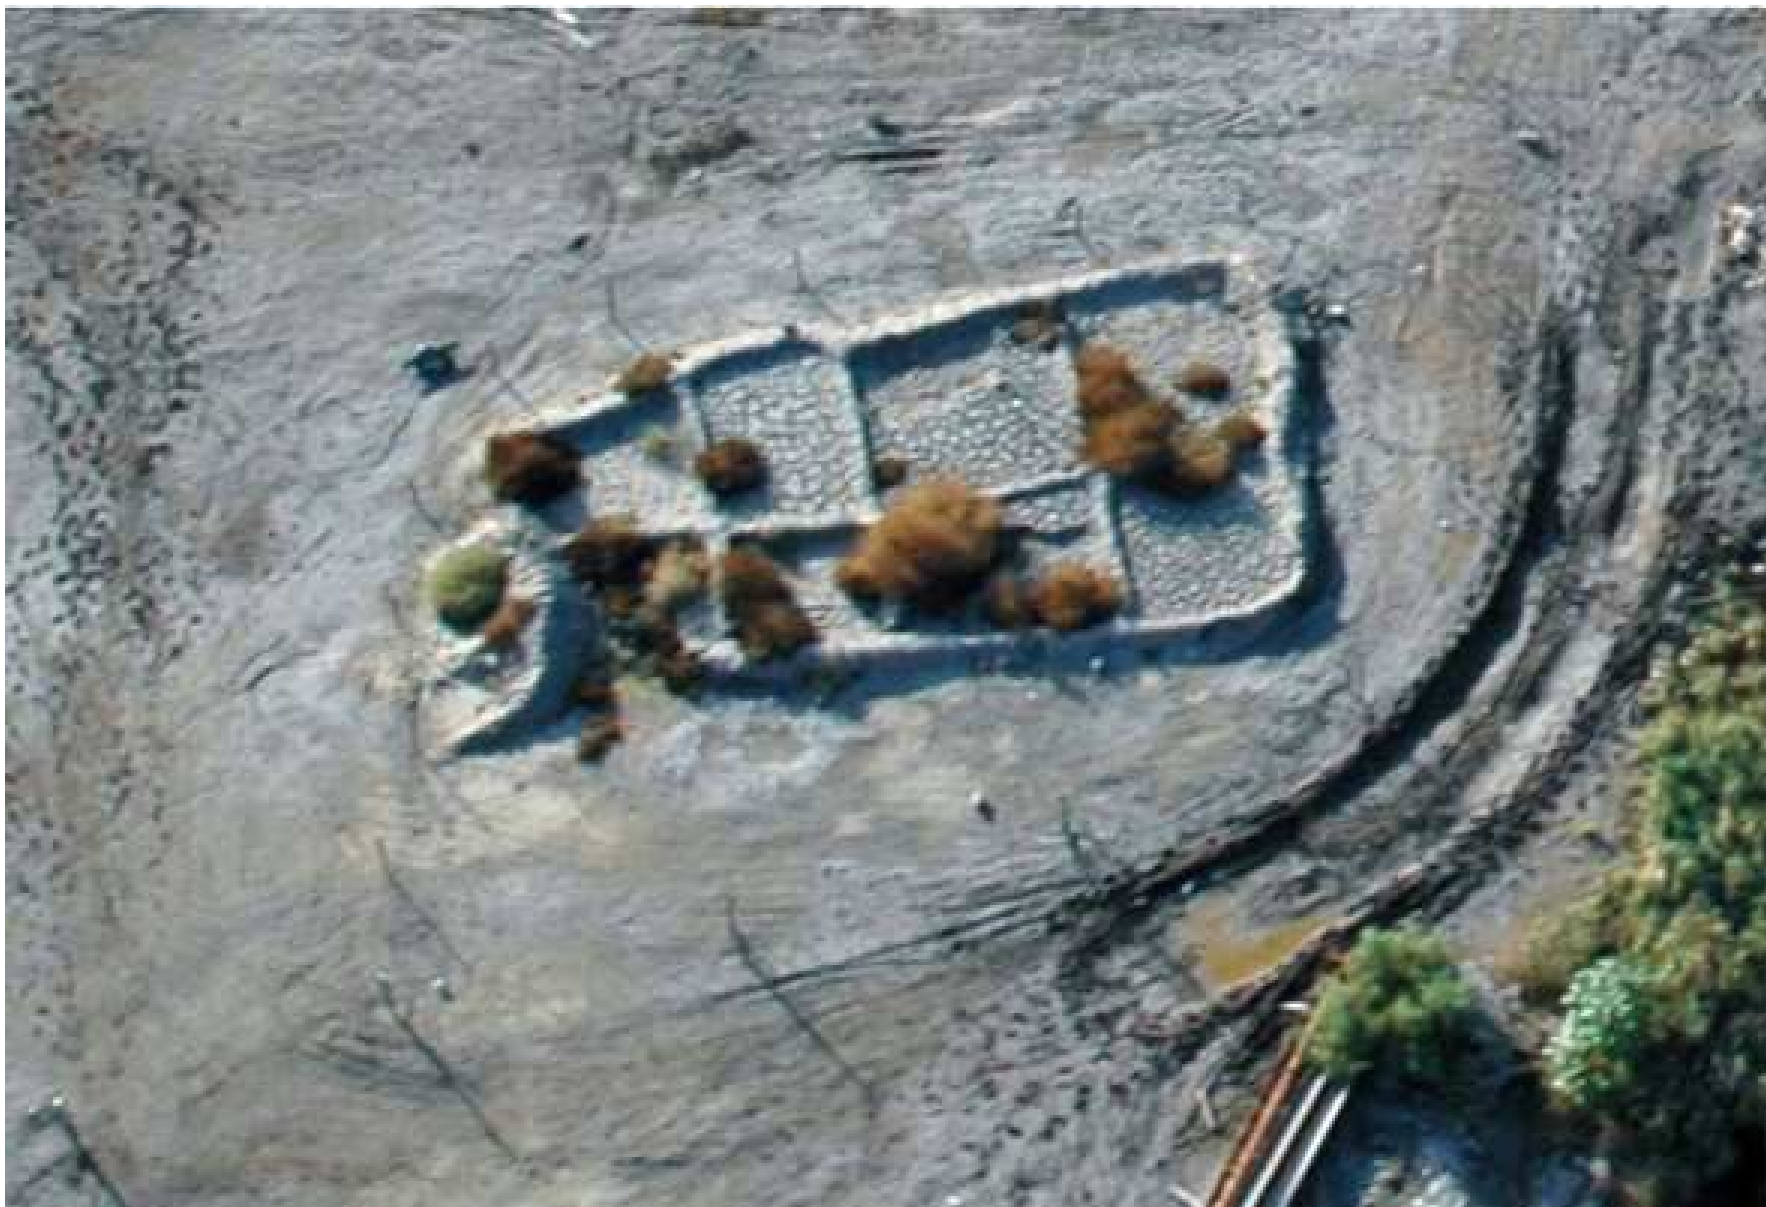
Polish report: "The entire zone shows signs of car and truck traffic. Just West of Nabu-sha-Hare Temple are the remains of a house from ancient Babylon where ruts are visible" (photo: Polish report p. 24, © Ministry of Culture and National Heritage, Republic of Poland).
