# **Report on Damage to the Site of Babylon, Iraq**

**John Malcolm Russell, Ph.D.**

**Cultural Heritage Center  
Bureau of Educational and Cultural Affairs  
Department of State**

**April 2010**

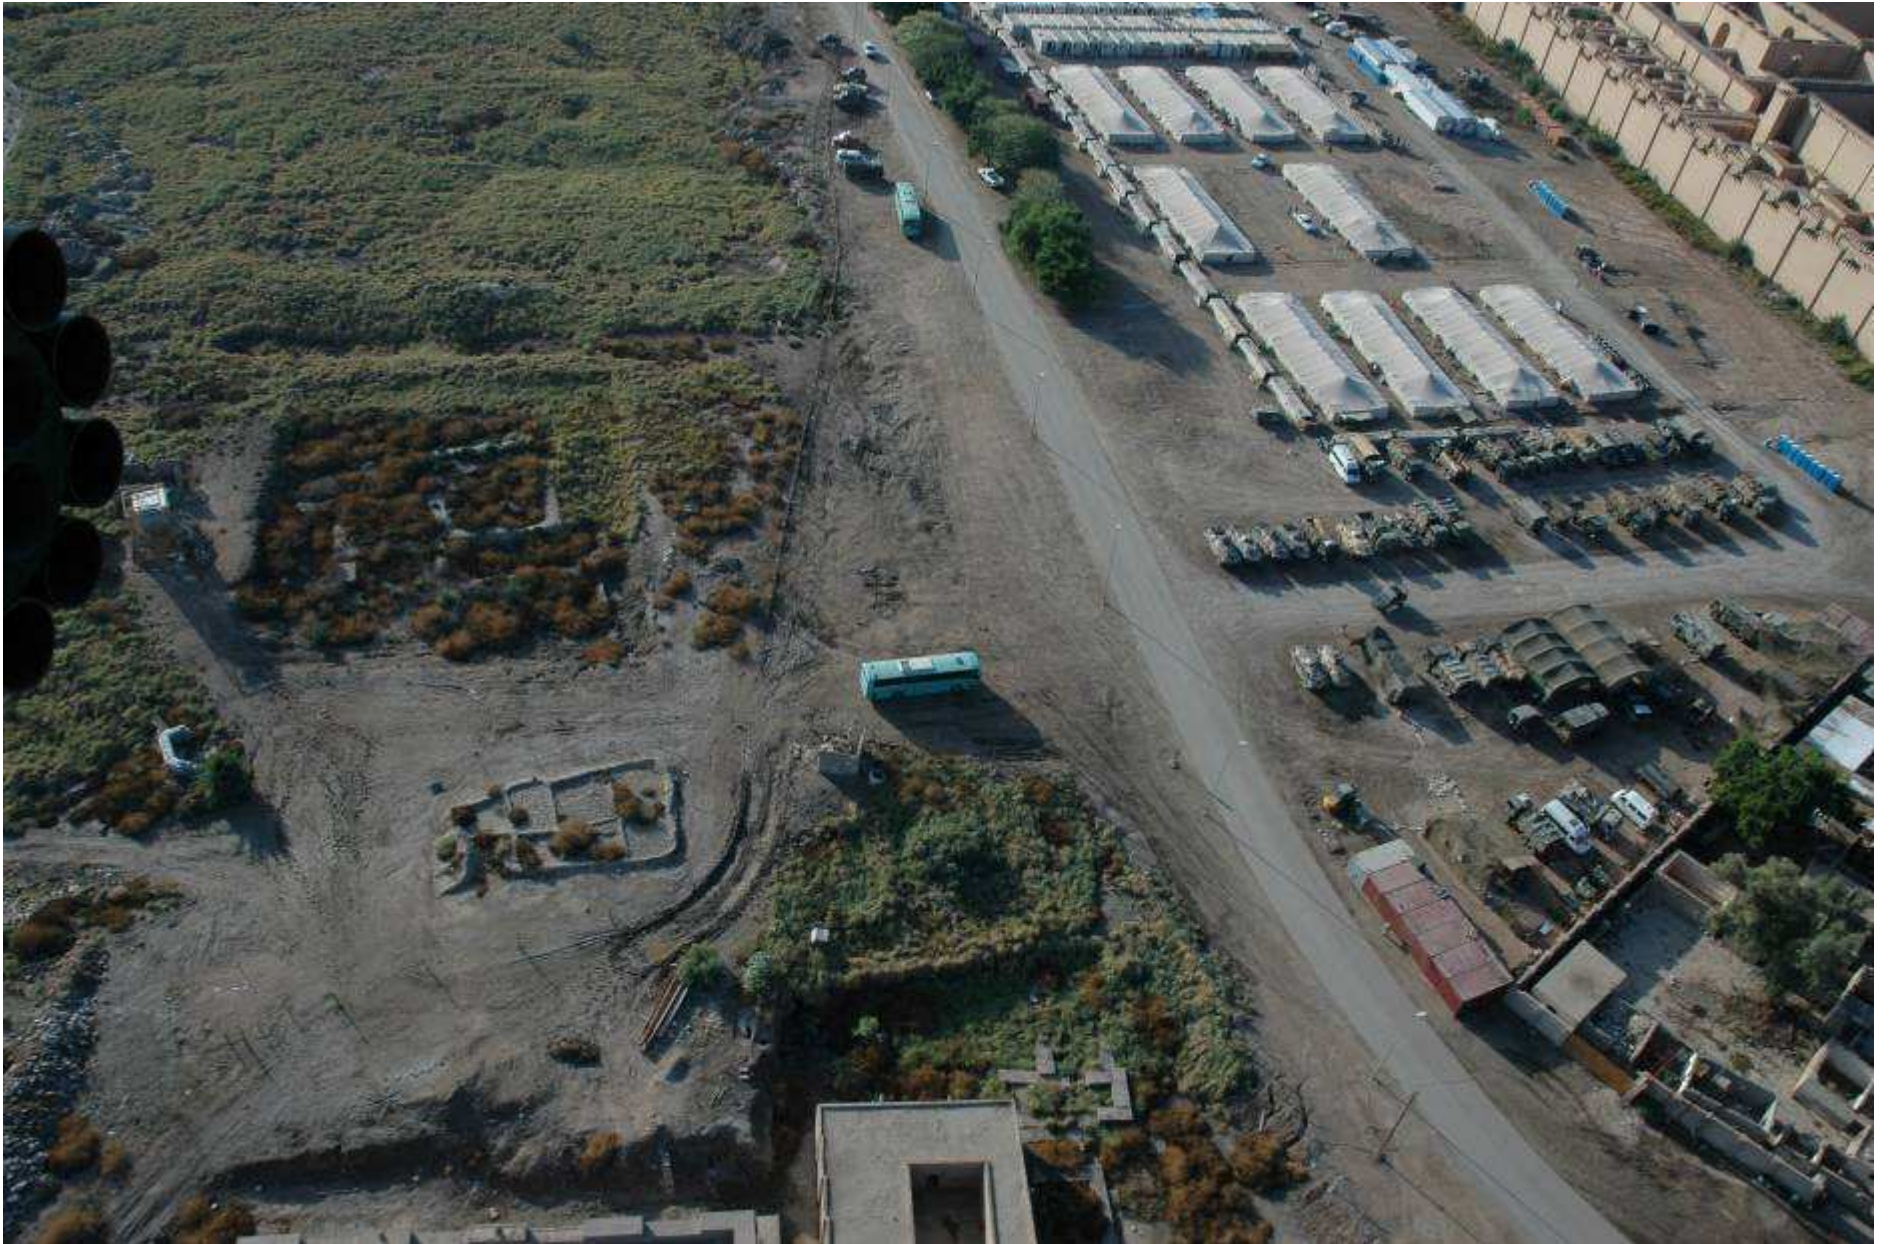
Ruts around ancient house, Polish photo 31 (photo © Ministry of Culture and National Heritage, Republic of Poland)

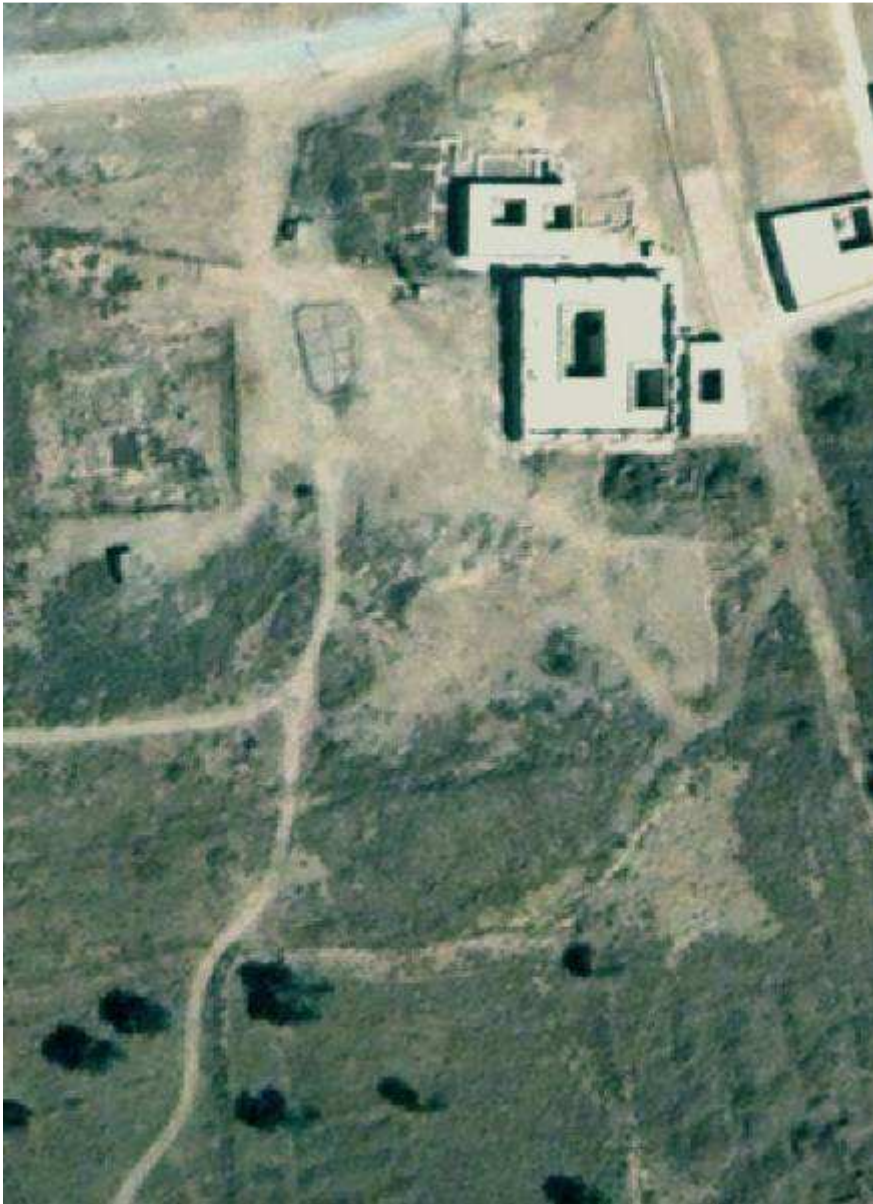
The dirt road that runs south from the paved road and loops around the north and east sides of the ancient house provides access to several light-duty dirt tracks that run through the temple area (image 1 April 2003, Russell composite)

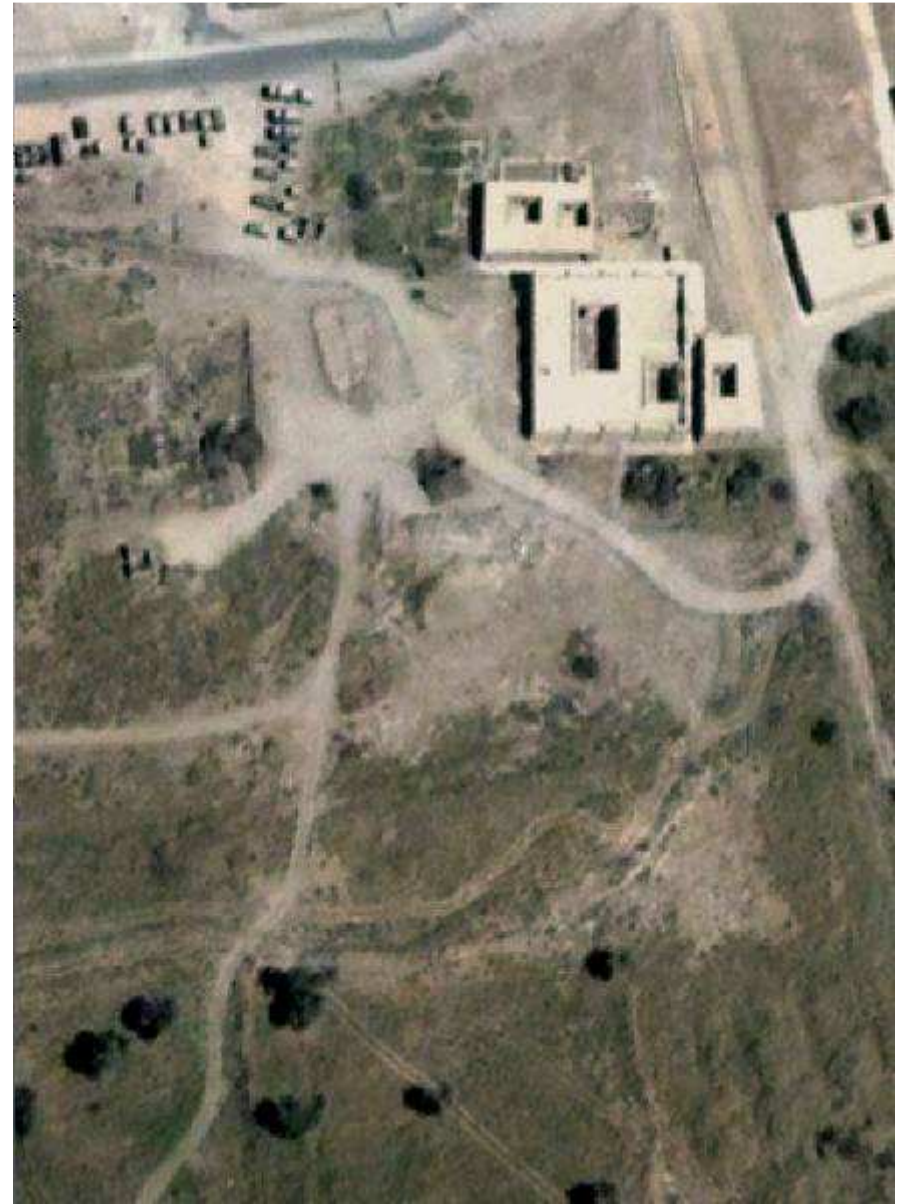
This road received much heavier use after the establishment of Camp Babylon, first being extended to the east into a new road south of the Nabu Sha-Hare temple (image 31 August 2003, Russell composite).

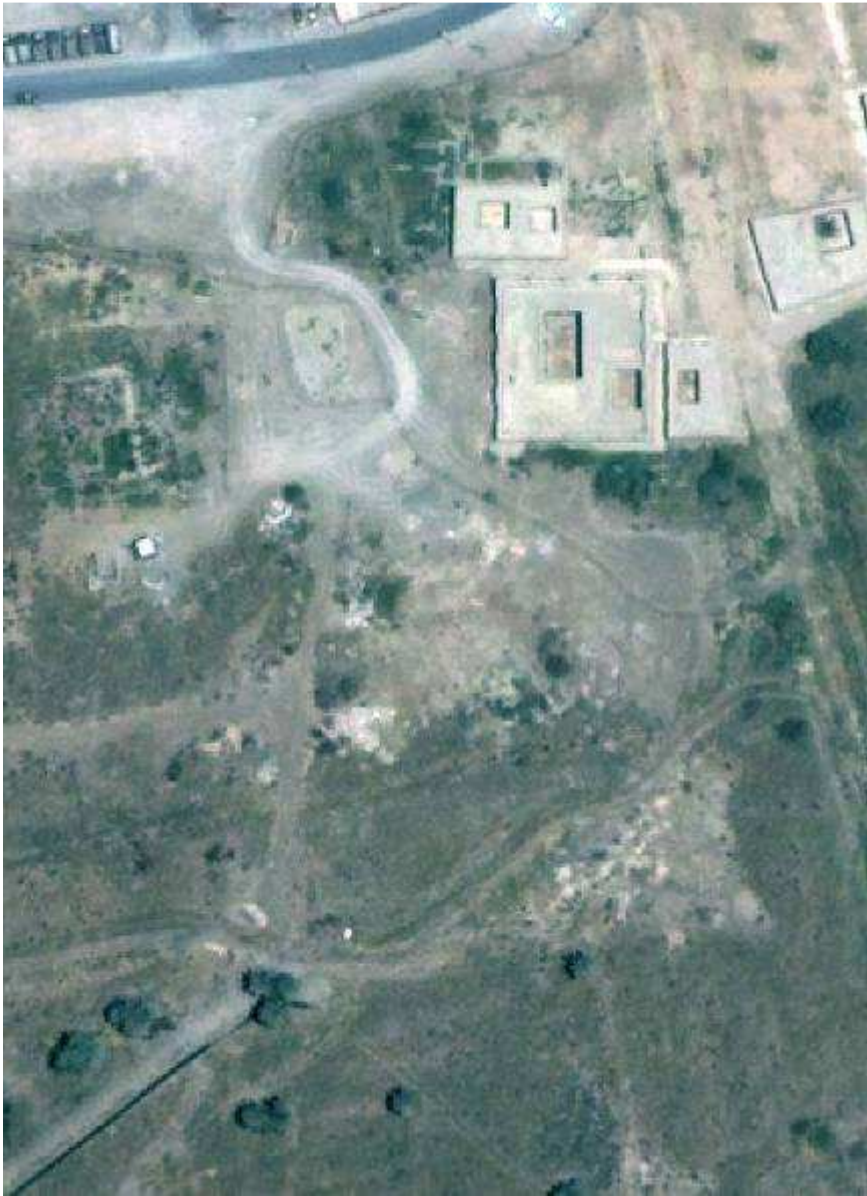
After the construction of the Dragon 5 watch tower, this road was extended to the west to provide access to the tower and to the long diagonal trench south of the camp (image 4 June 2004, Russell composite).

Heavy use of this road caused deep ruts in the archaeological earth by the northeast corner of the ancient house, and apparently also on the hill south of the Nabu Sha-Hare temple (image 26 November 2005, Russell composite).

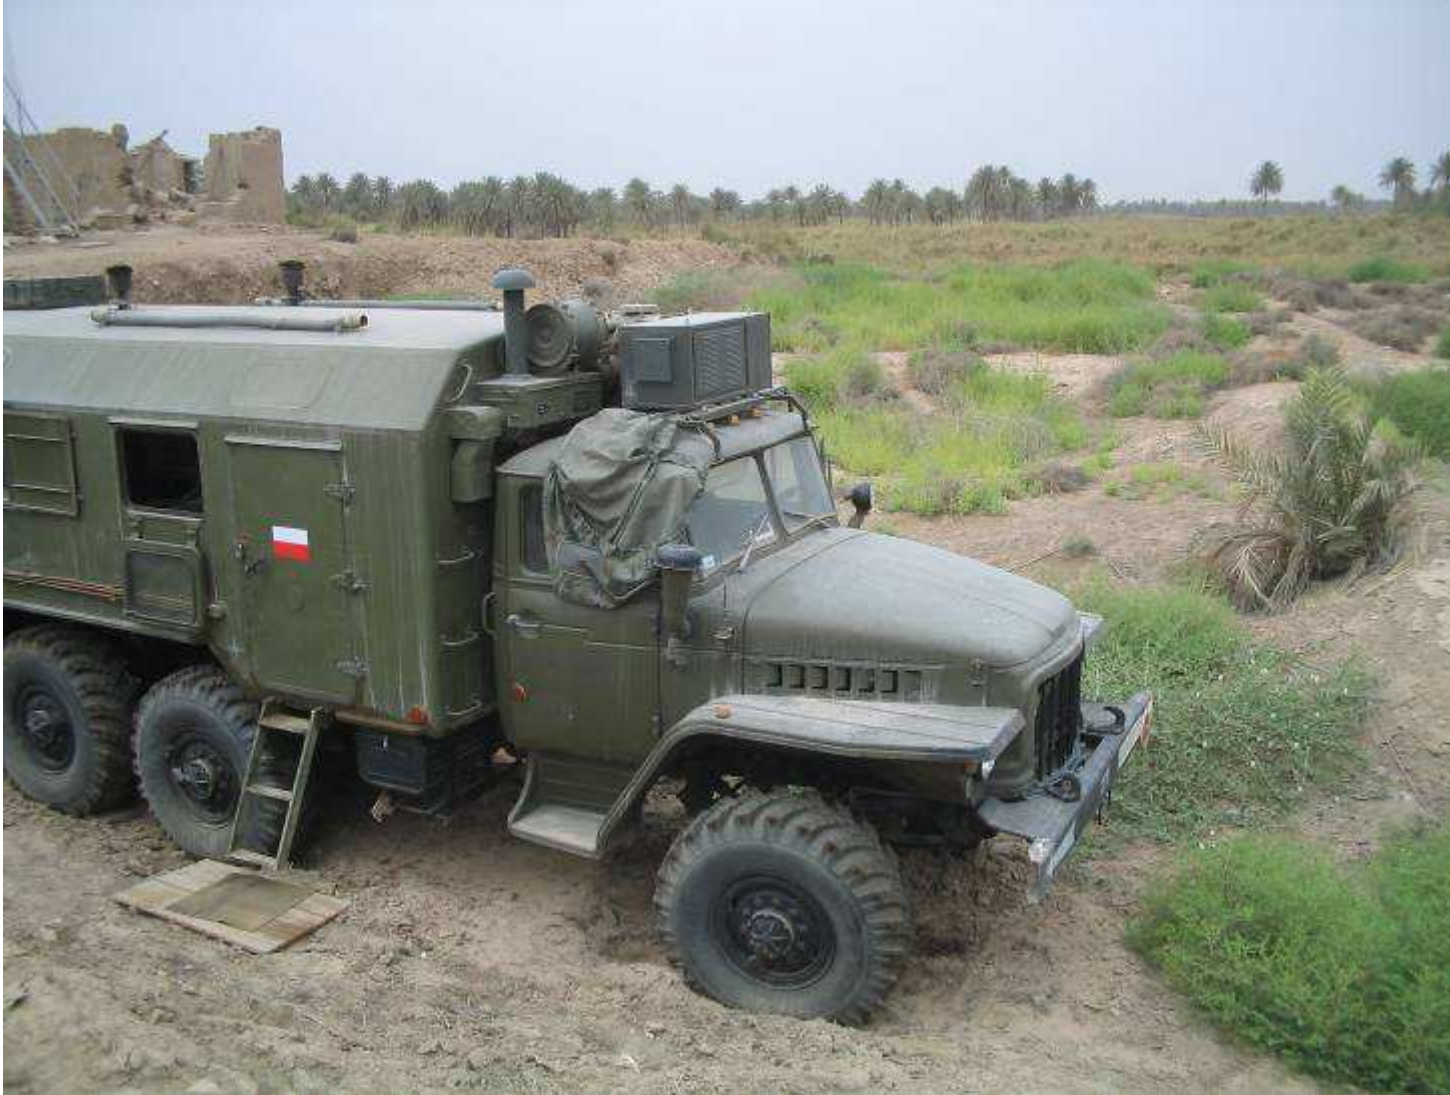
Russell photo 123\_2358 (photo © John Russell)

**Curtis report:** Dr Maryam pointed out that at one stage a vehicle was standing in the Seleucid-Parthian building to the west of the Nabu-sha-Hare Temple. (This is just to the north of the tower Dragon no.5).

**Russell comment:** The vehicle referred to by Dr. Maryam, director of the Babylon site, was photographed in the Seleucid-Parthian house trench by John Russell and Zainab Bahrani on 27 May 2004 (images below).

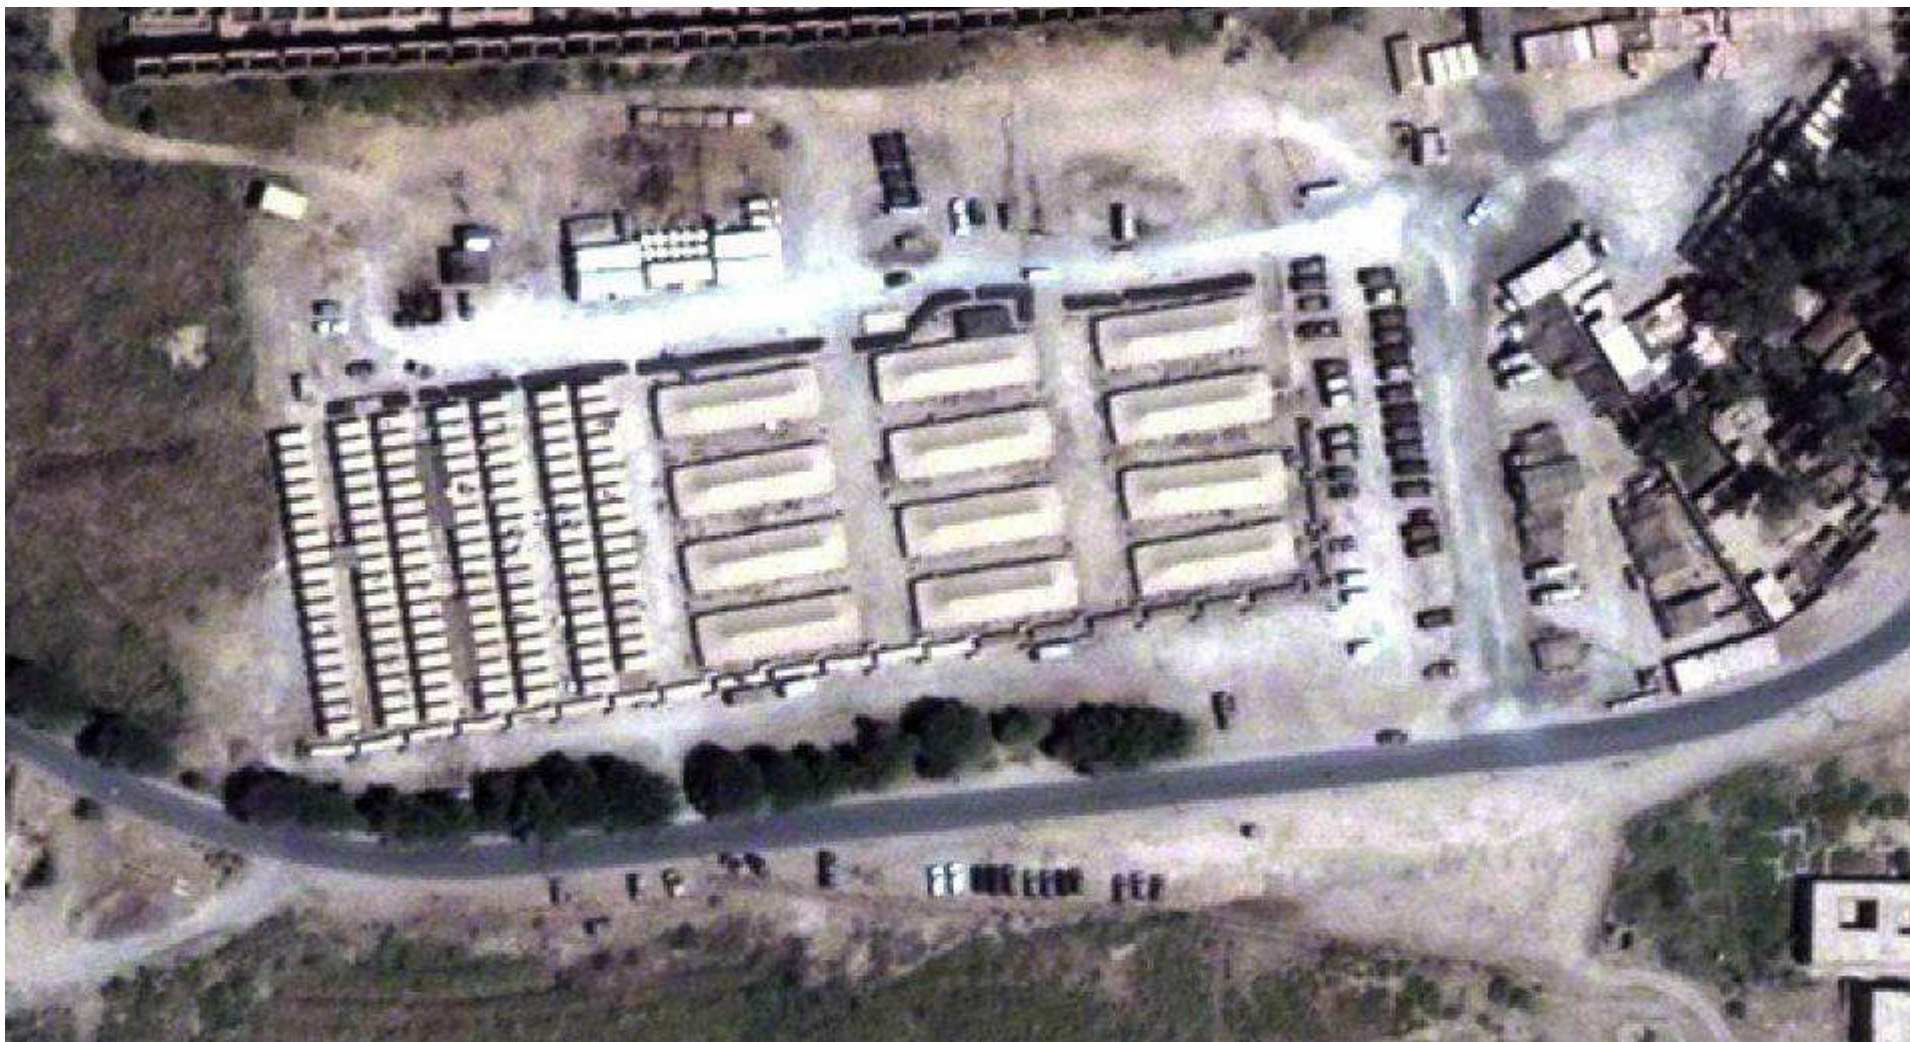
The parking area to the south of Tent City #1 and north of the Seleucid-Parthian building was used during the Camp Babylon period, but it does not seem to have expanded into the adjacent archaeological mounds to the south, 25 August 2004, Russell composite

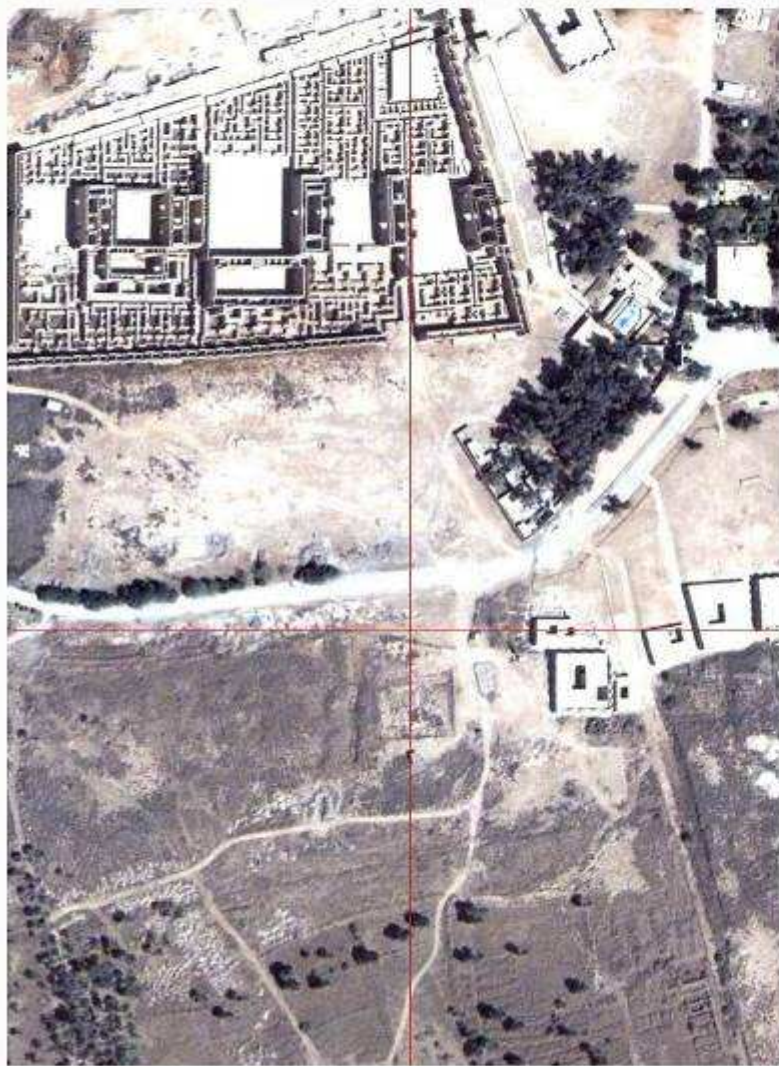
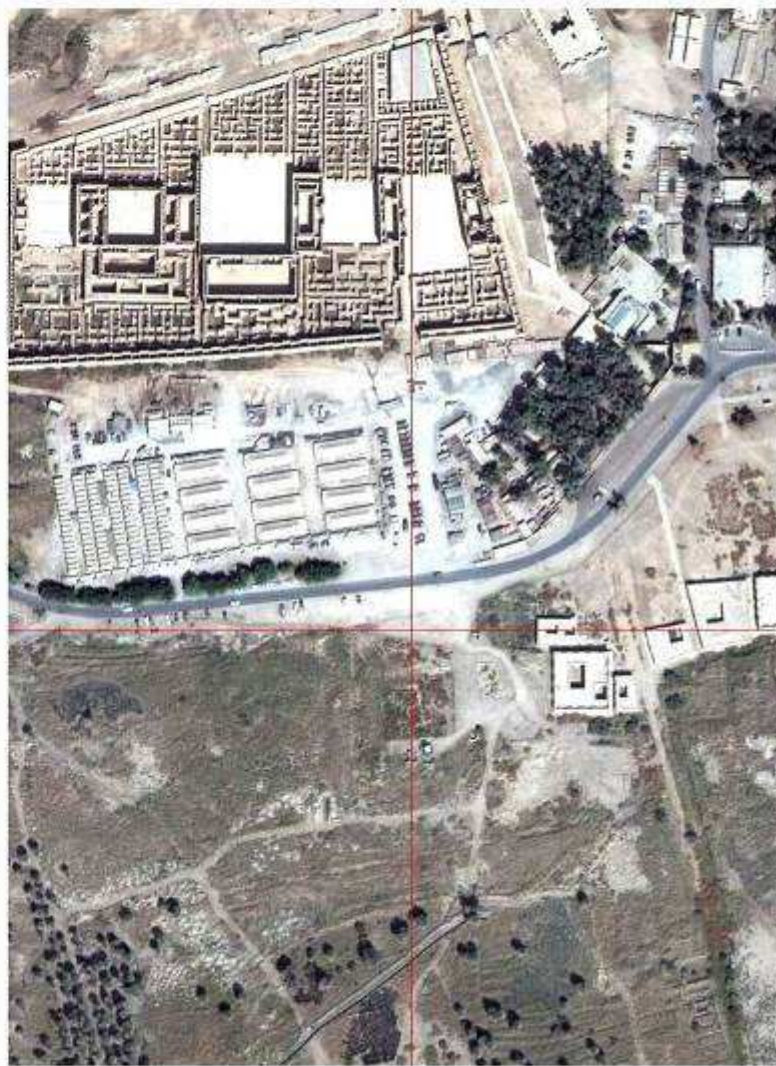
**Stone report:** The parking area in the northwest of this area may have impinged on the site (Fig 14). This is already clearly visible in the August 2003 imagery.

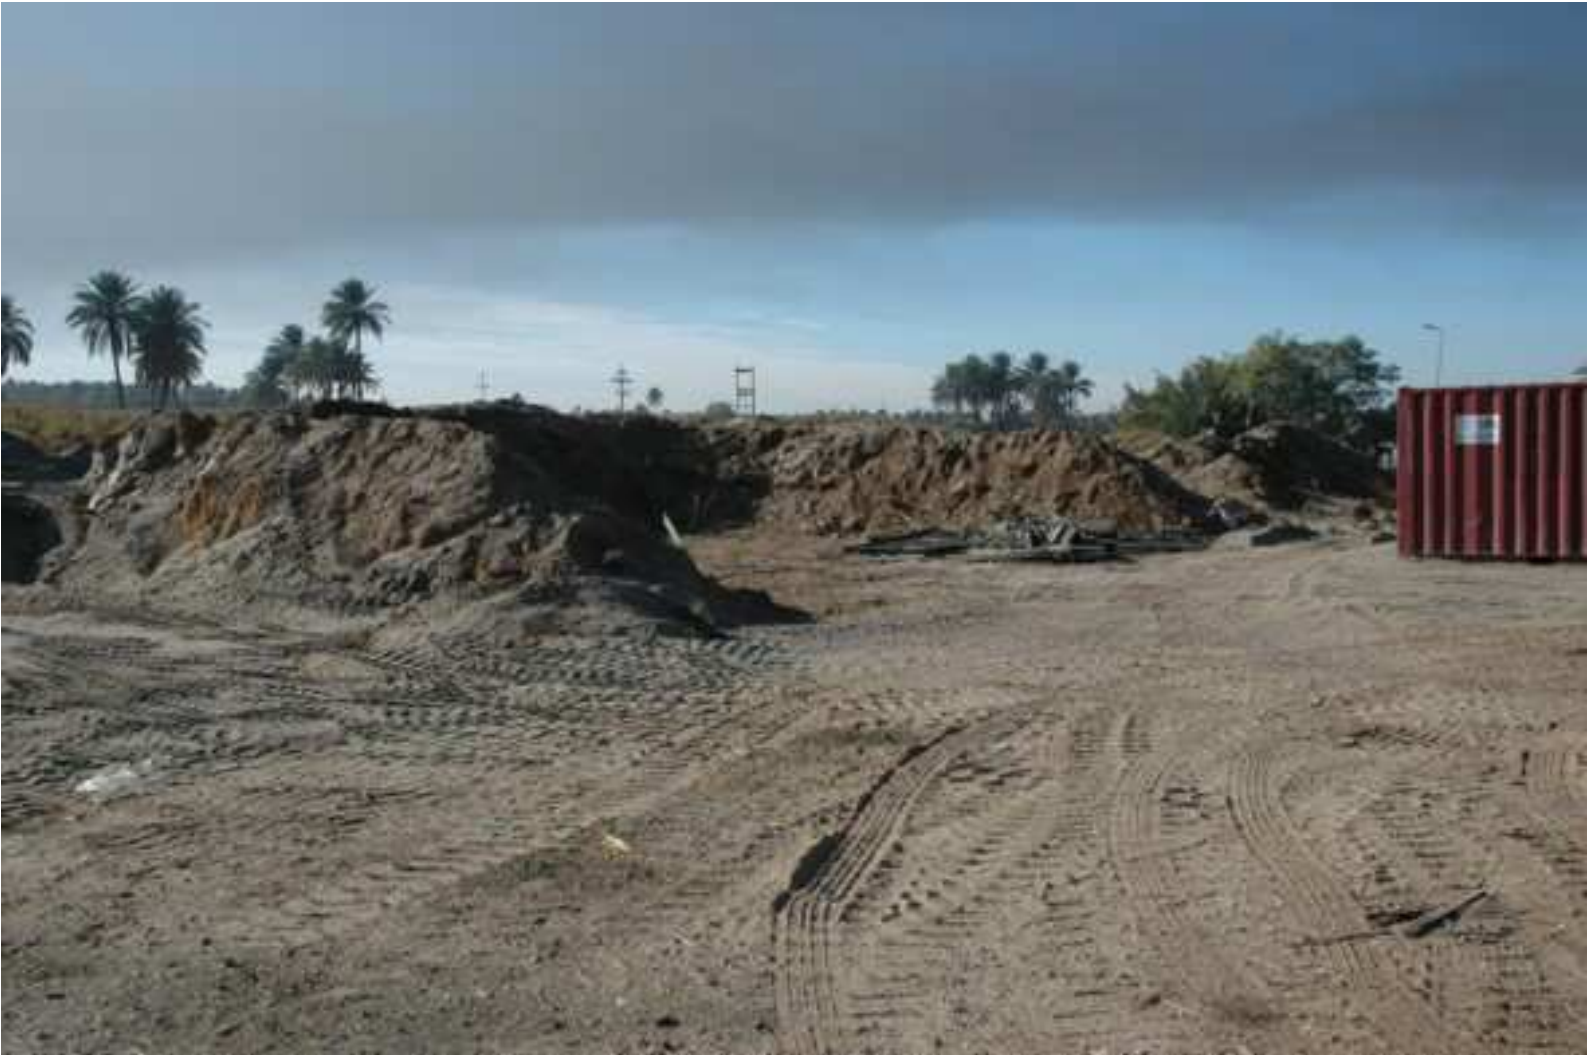
Curtis report	Polish report
In the northern part of Tent City #2 there is much disturbance in an area used as an ammunition store. What remains is a horseshoe-shaped berm made up of deposits emptied from HESCO bags. These deposits clearly come from archaeological contexts. Much sand, said to have been brought in from the desert, has also been deposited in this area. See the <i>Polish Report</i> , fig. on p.31.	Ammunition Storage Facility marked by letter “E”. After removal of the Ammunition Storage sand was left from the Hesco bastions used to create the ammunition bunkers.

Berm for ammunition storage facility, Polish report p. 19 (photo © Ministry of Culture and National Heritage, Republic of Poland)

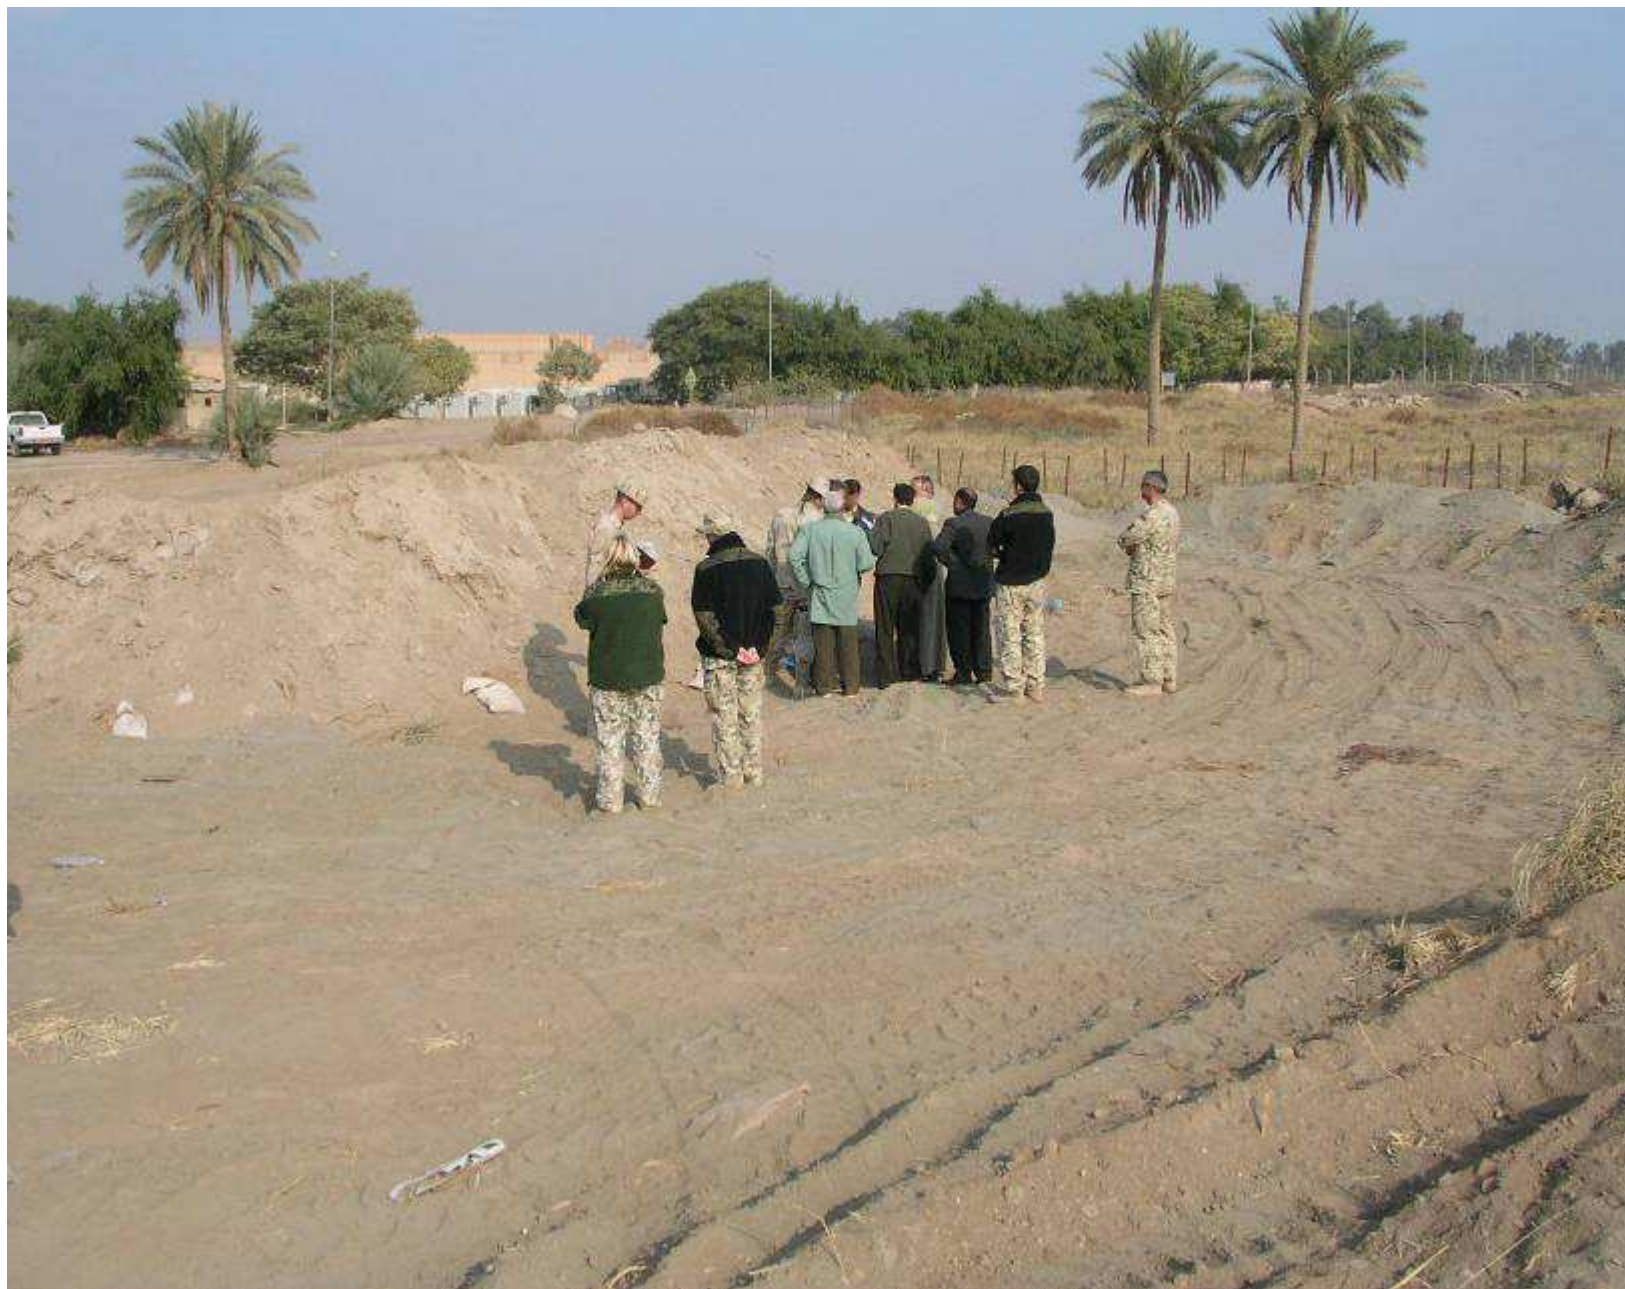
Berm (center left), apparently surrounded by flattened fill from HESCO bags, Curtis photo 7610 (photo © John Curtis)

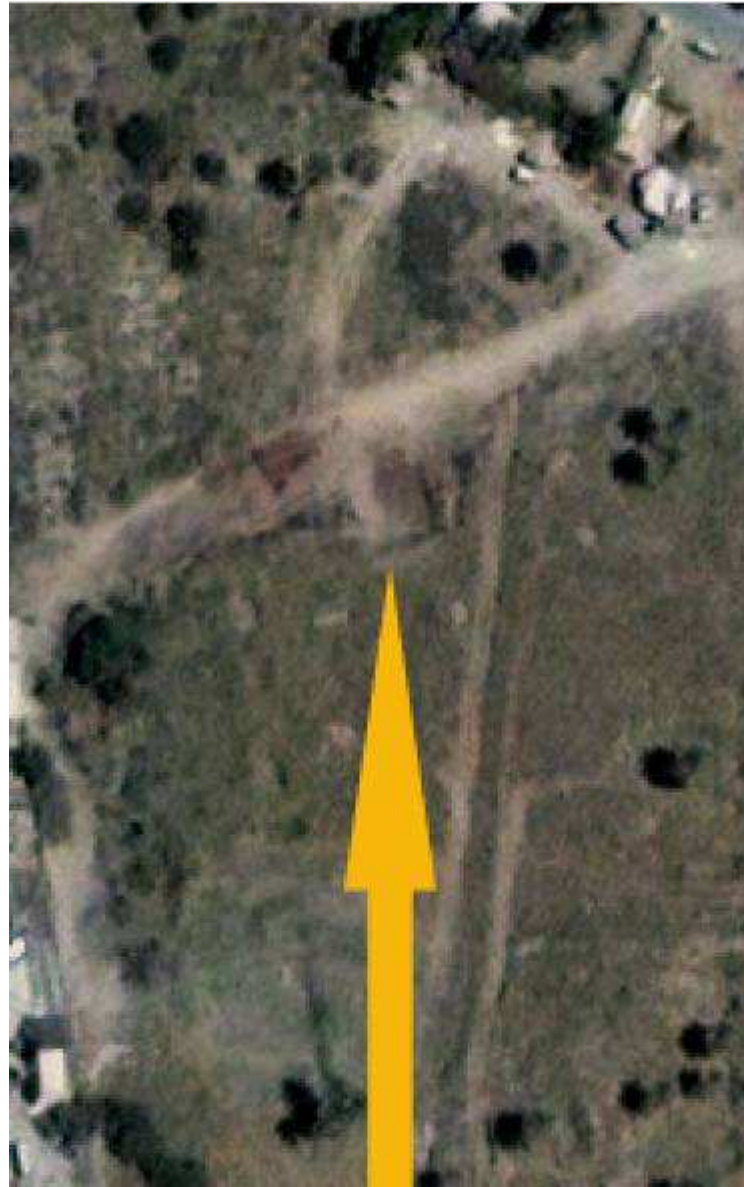
The ammunition storage facility is at the southern edge of the camp. At least two pits, perhaps defensive works, were already in this position in July 2002. By August 2003, the berm for the facility had been constructed.

Berm for facility, 31 August 2003, Russell composite

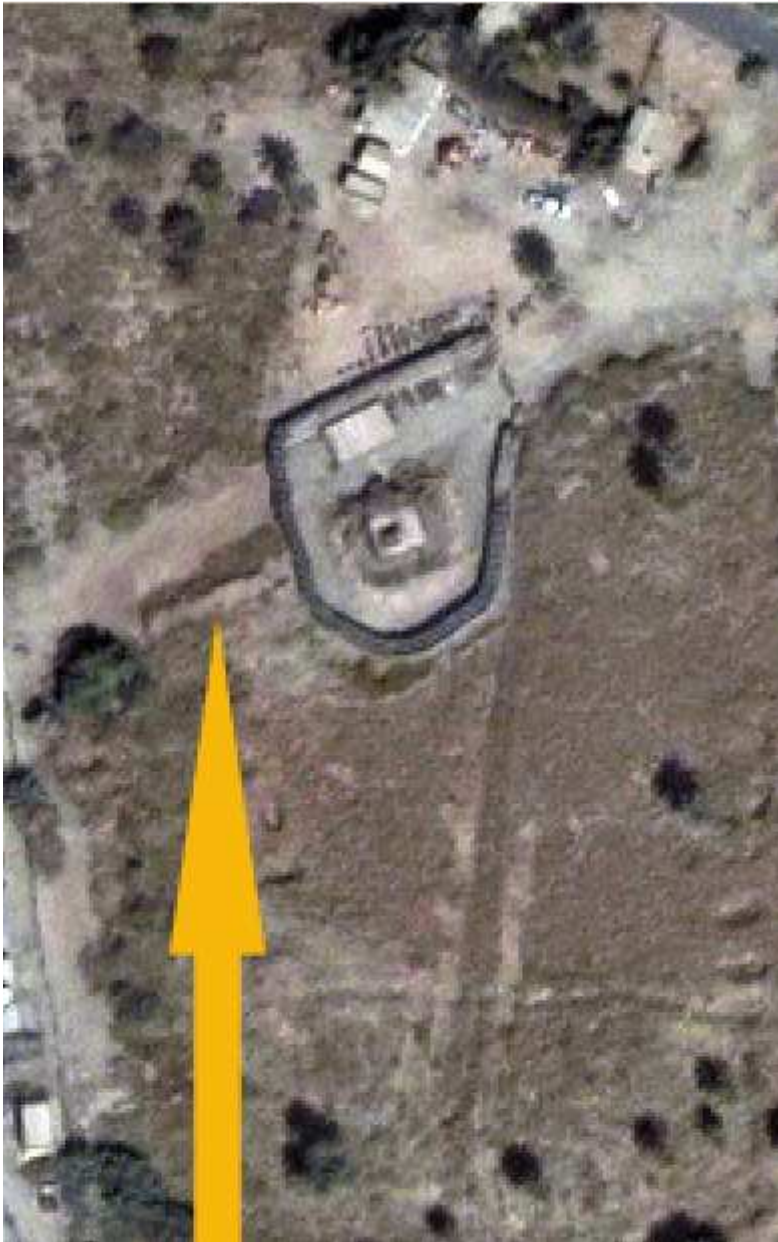
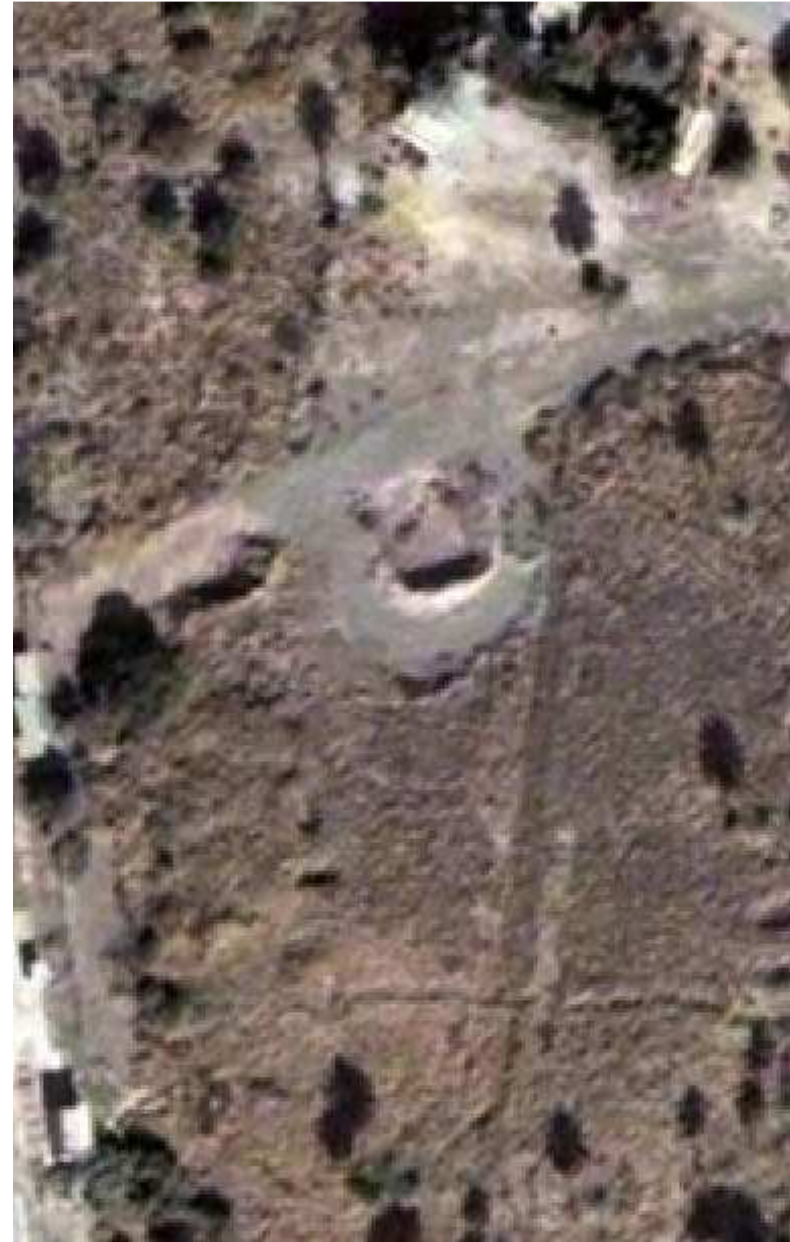
Complete facility, additional berm (arrow), October 2004

Abandoned facility, November 2005

The facility was complete by June 2004, with an additional berm extending towards the west. The facility had been dismantled by December 2004, with only the remains of the berm still visible

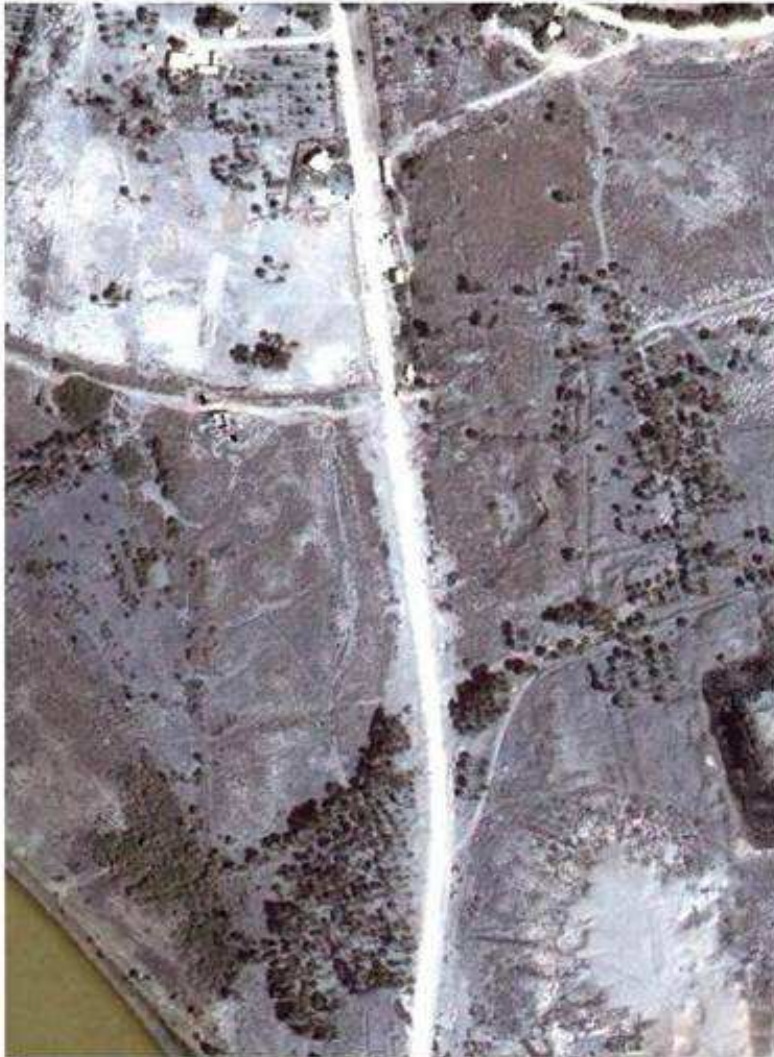
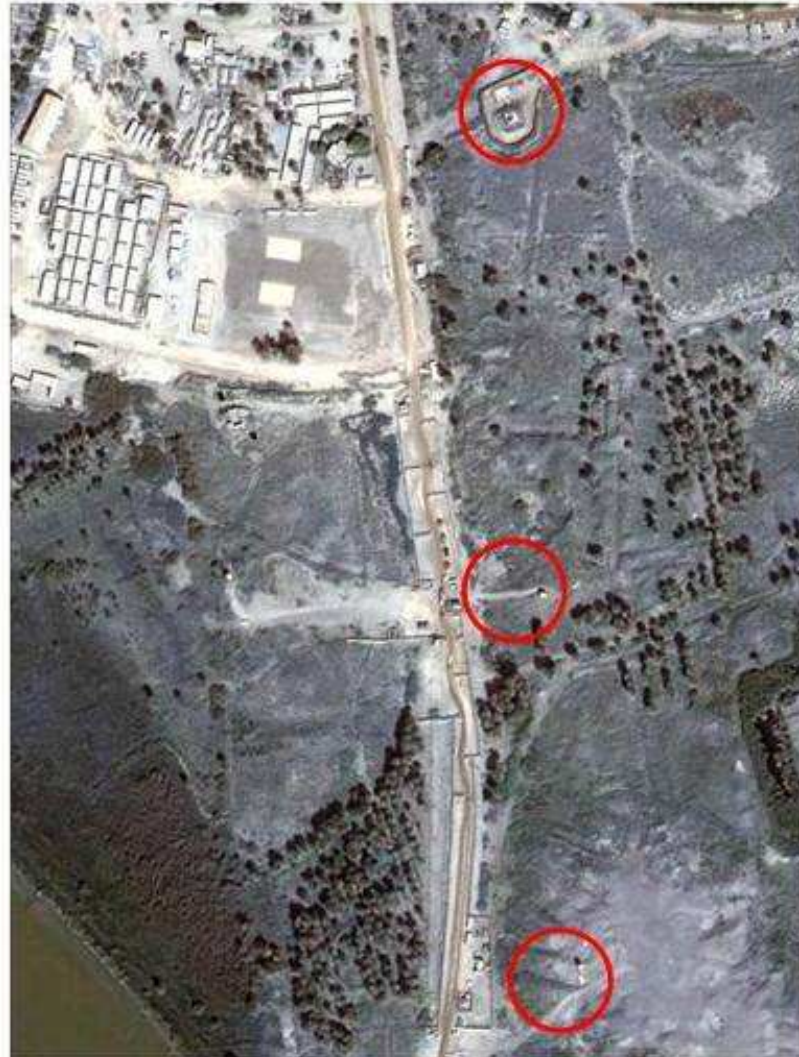
**Stone report:** Not reported in the Polish report are two other watchtowers located to the east of the main road into the camp from the south, as well as another structure further north. The watchtowers have dirt roads leading to them, and the structure is surrounded by a berm (Fig. 39).

**Stone report:** Not reported in the Polish report are two other watchtowers located to the east of the main road into the camp from the south, as well as another structure [ammunition storage] further north. The watchtowers have dirt roads leading to them, and the structure is surrounded by a berm (Fig. 39).

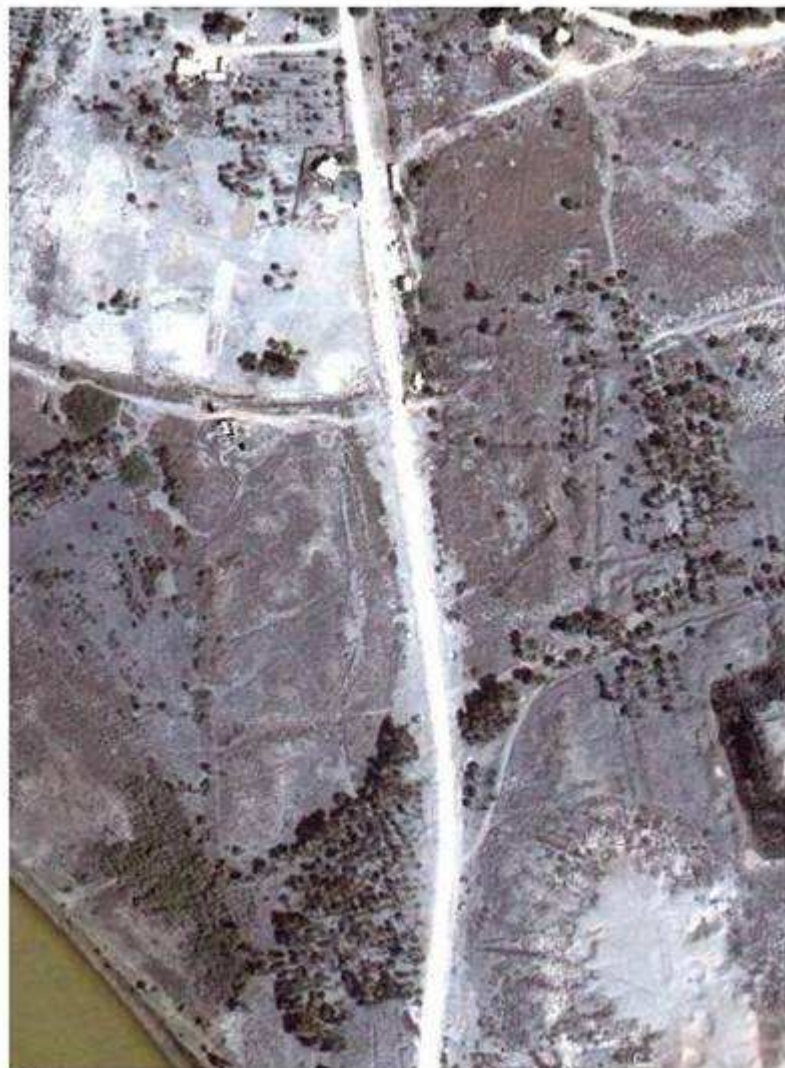
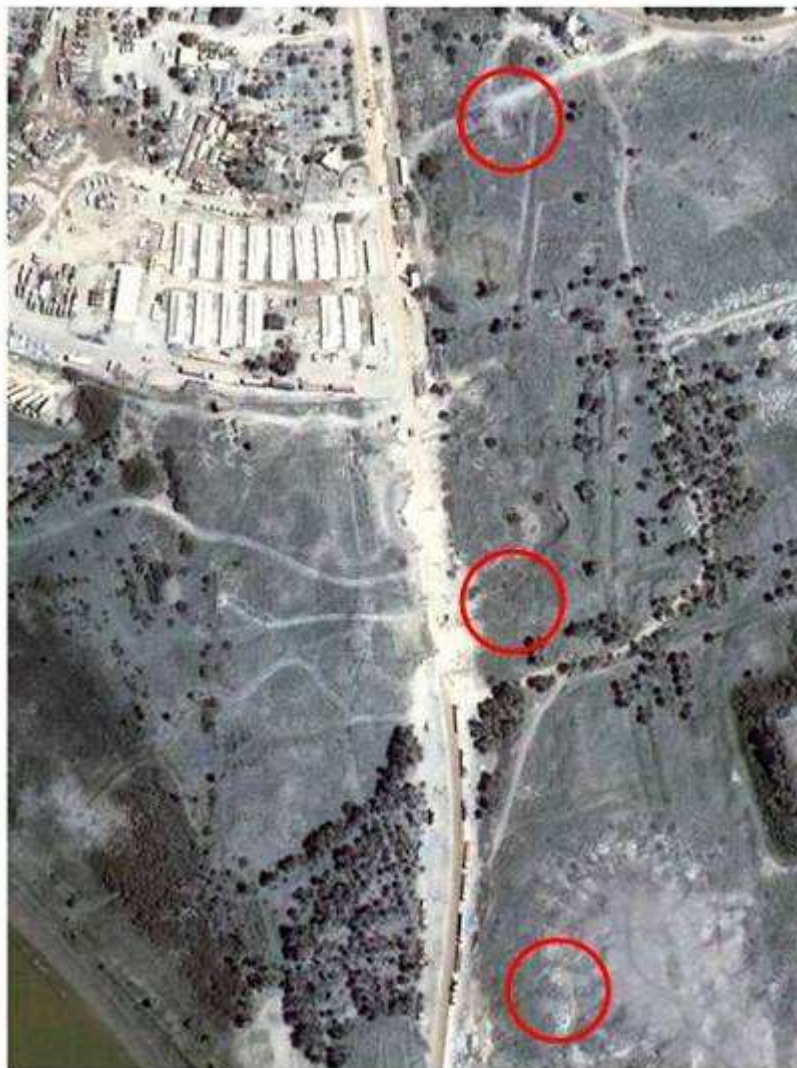
**Stone report:** None of these were present in August 2003 (Fig. 40), but both watchtowers were in place by June 2004, and the structure was under construction.

**Stone report:** None of these were present in August 2003 (Fig. 40), but both watchtowers were in place by June 2004, and the structure was under construction.
