# **Report on Damage to the Site of Babylon, Iraq**

**John Malcolm Russell, Ph.D.**

**Cultural Heritage Center  
Bureau of Educational and Cultural Affairs  
Department of State**

**April 2010**

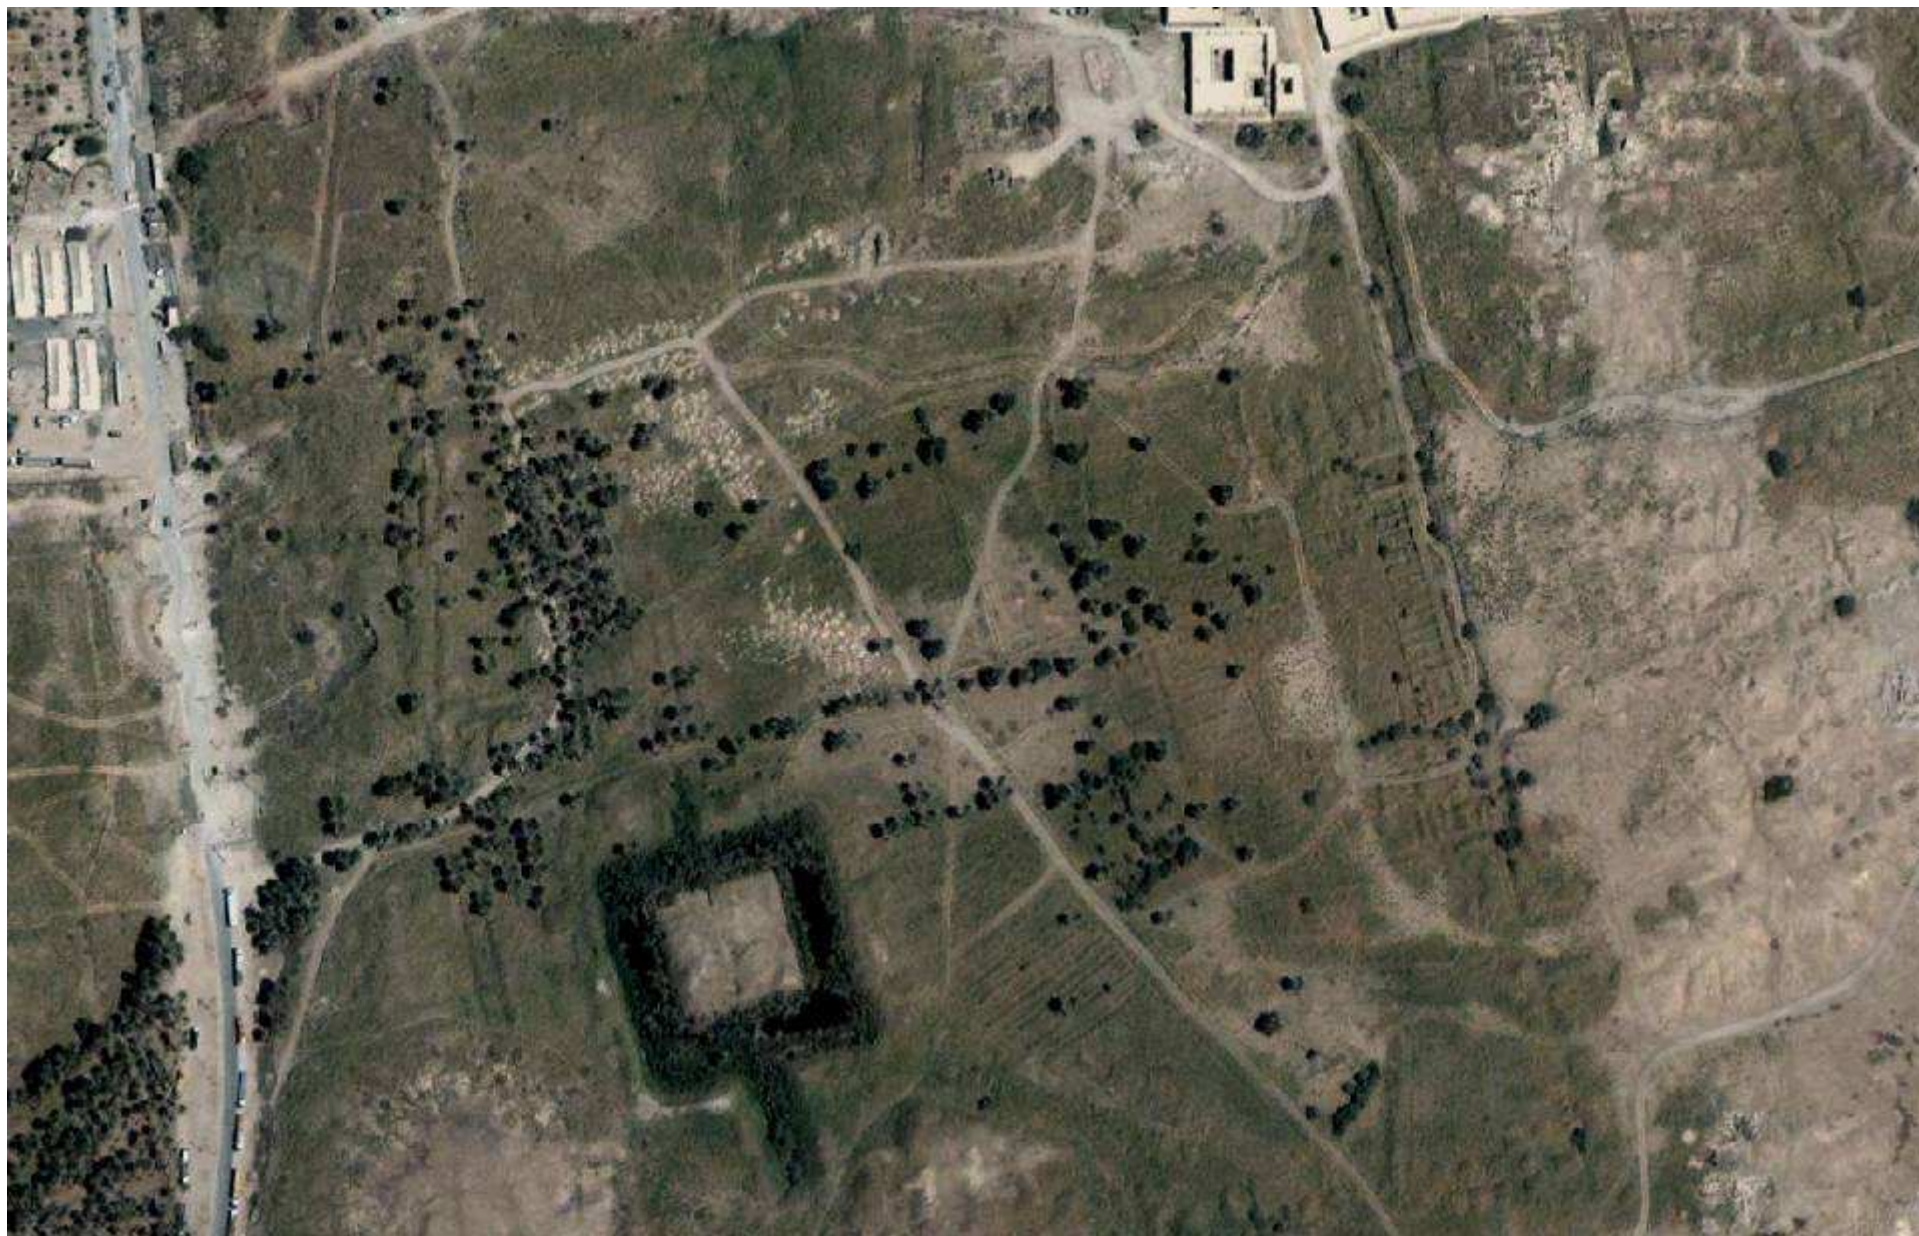
Before trenches were dug, August 2003, Russell composite

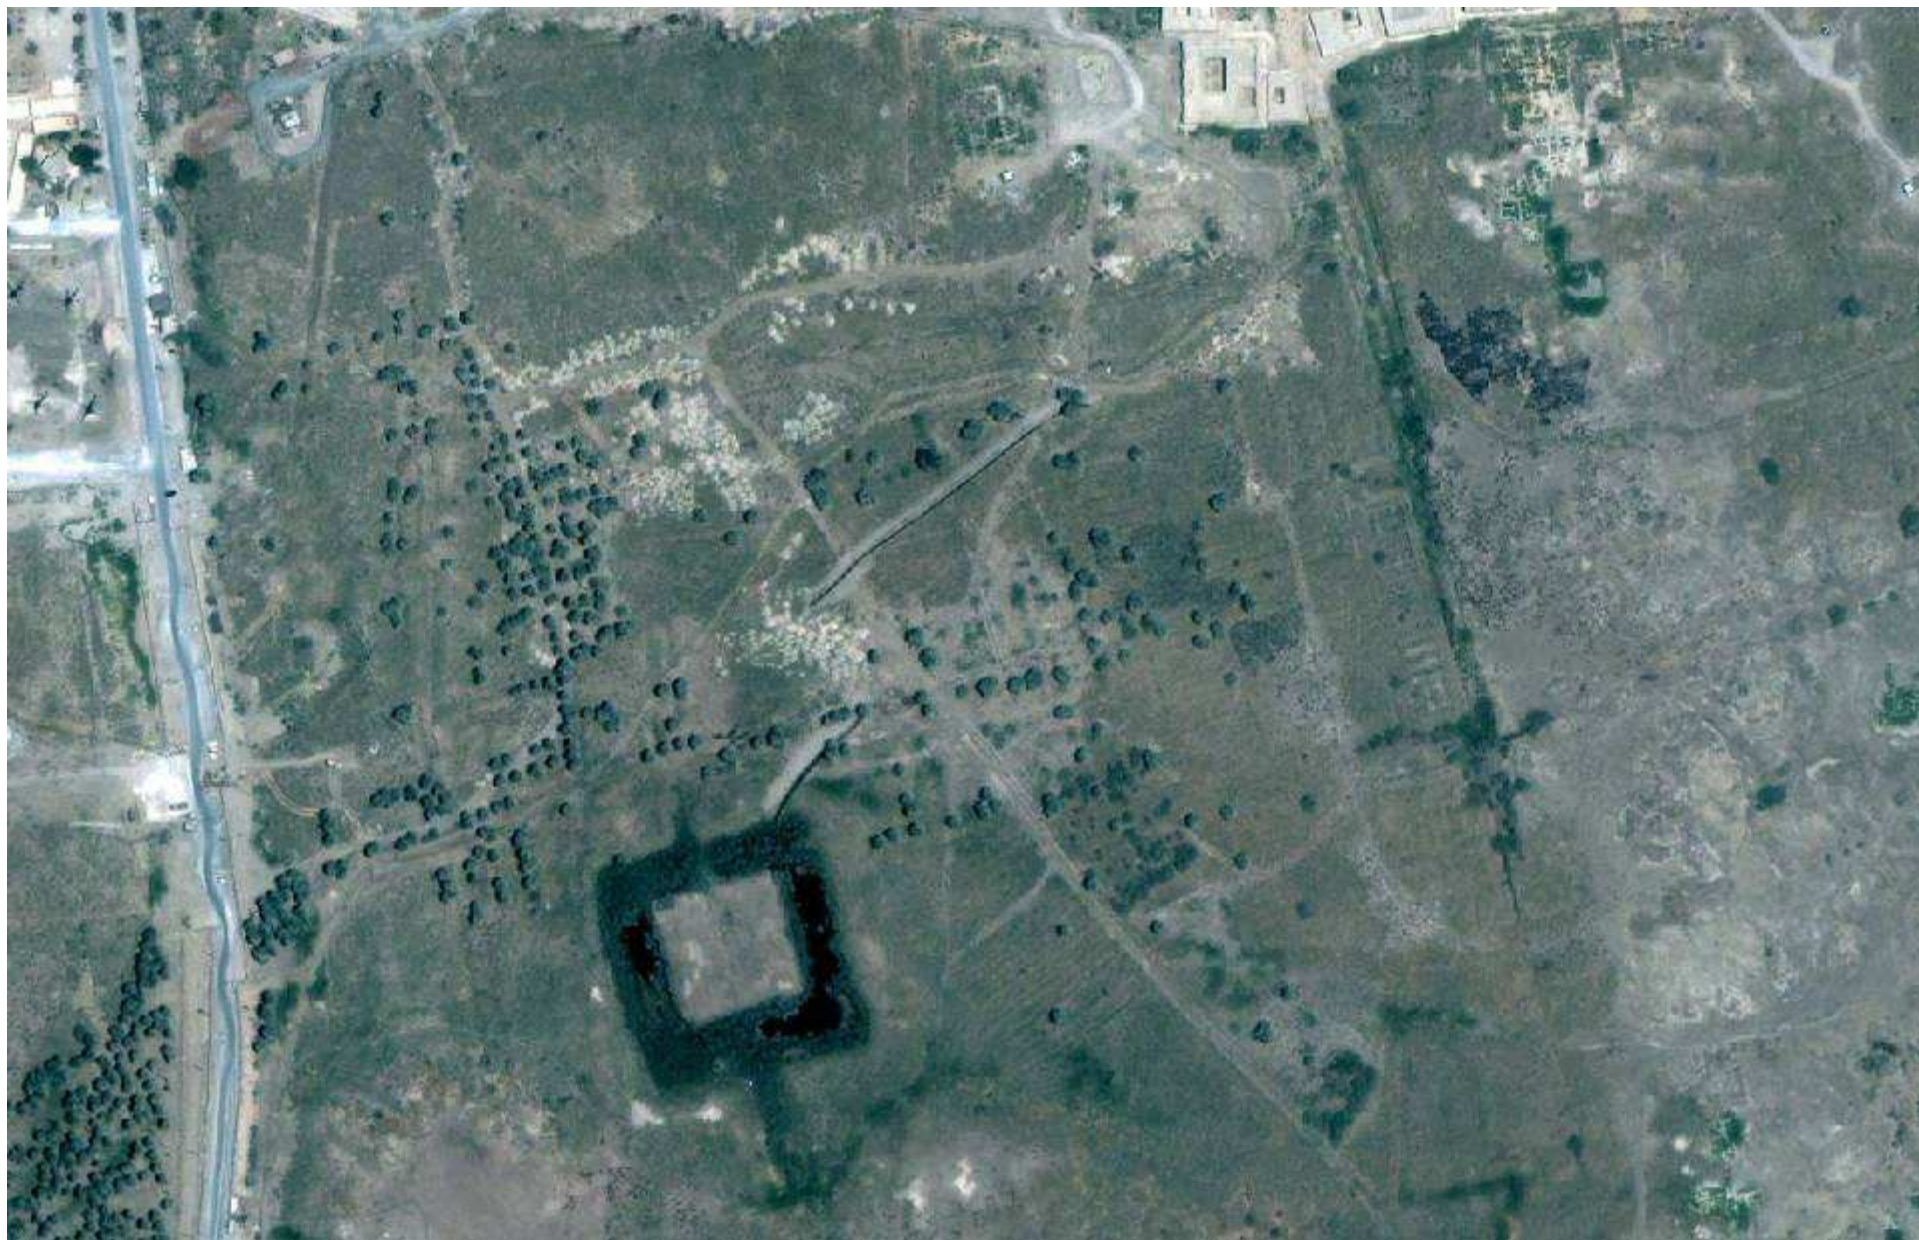
**Russell comment:** These two long trenches were evidently dug to block vehicle access to the southern edge of the camp across the relatively flat temple area to the east of the southern "Reno" gate. Trench 2 cuts two existing roads, and Trench 1 keeps vehicles from sneaking between the ziggurat and the debris field. This is, however, an unfortunate location for such trenches, as they cut directly through the ancient main temple courtyard.

View of trenches, June 2004, Russell composite

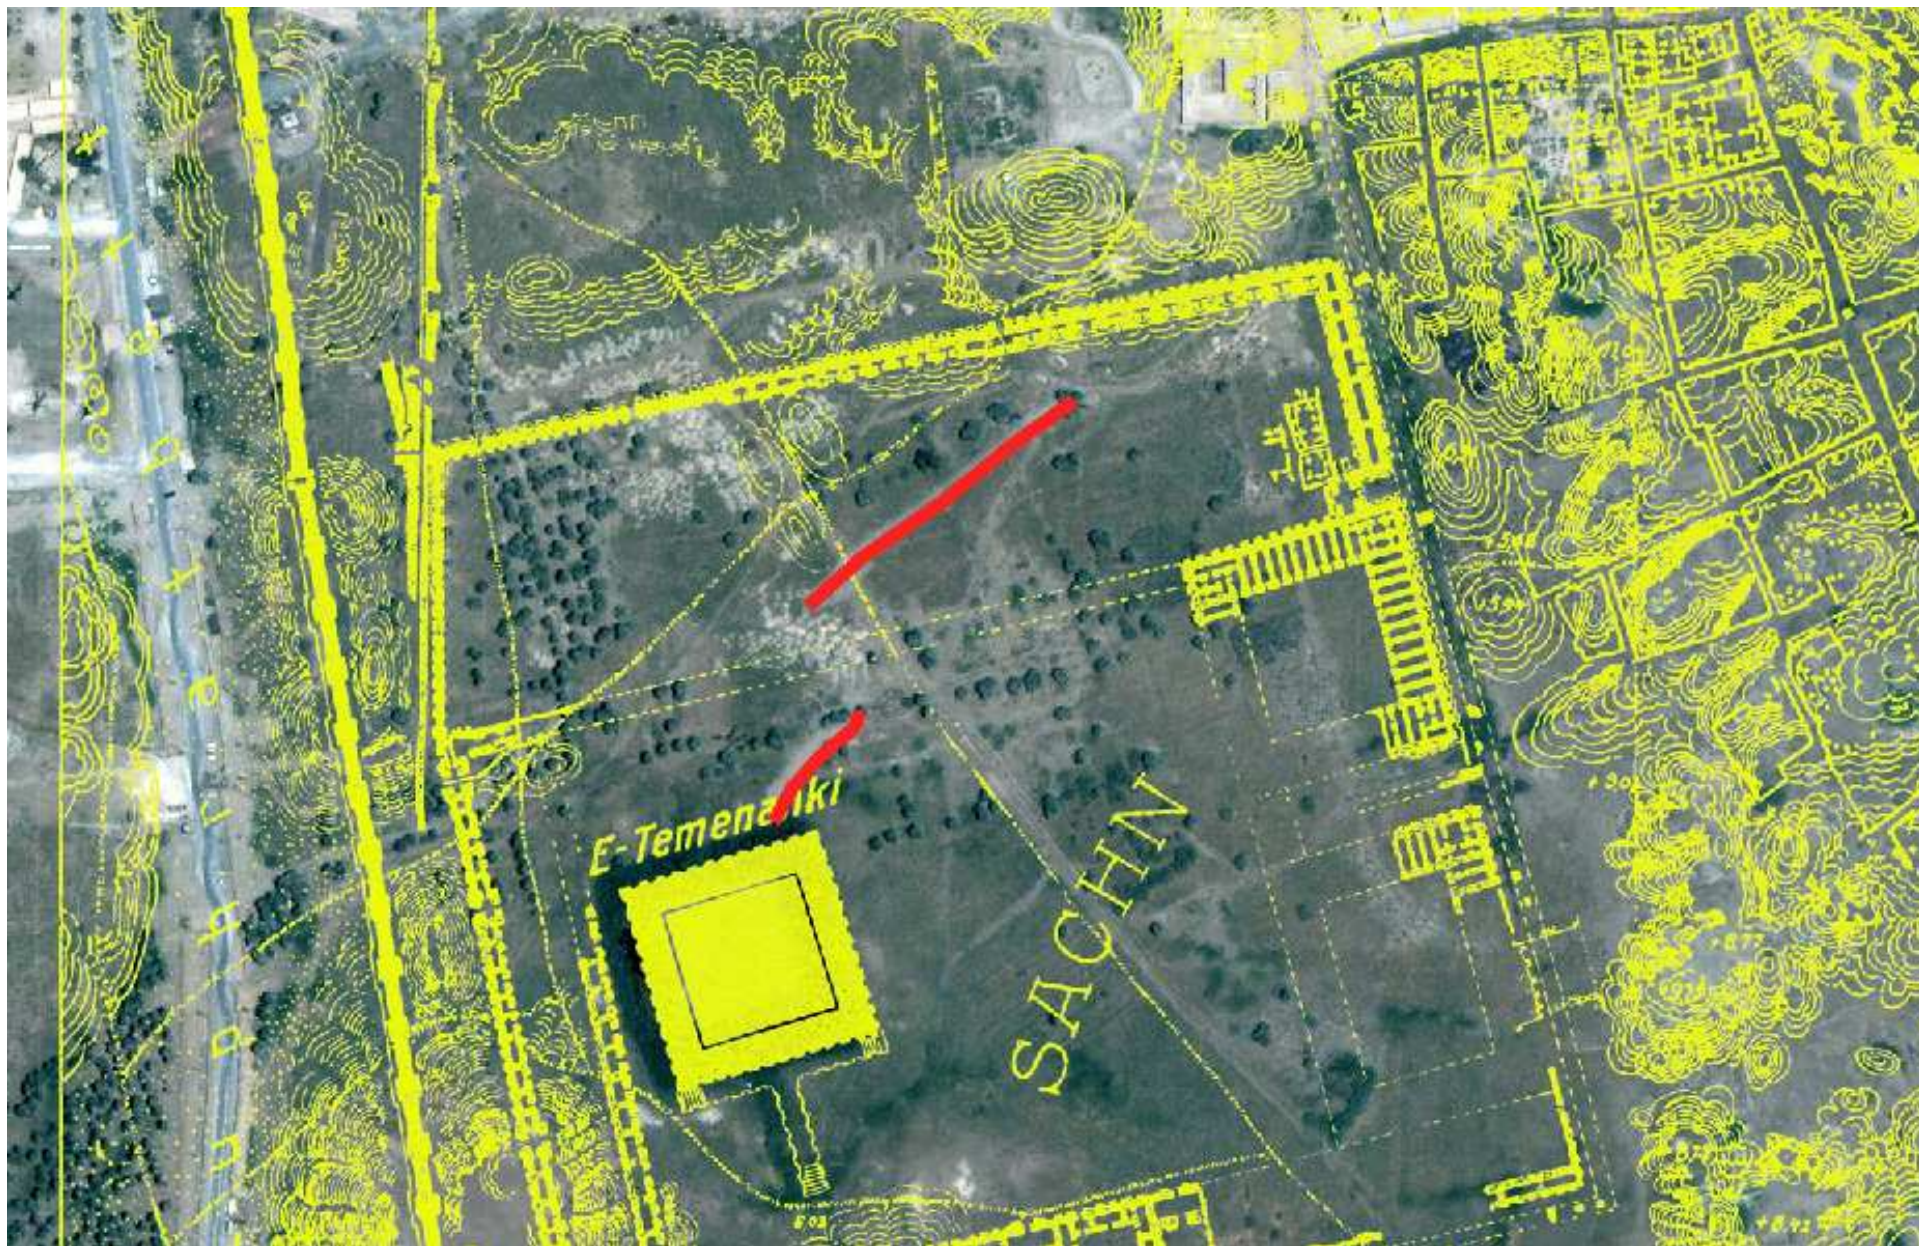
Trench 7 (below) and Trench 8 (above) in red, with Koldewey 1912 map overlay to show architectural features, June 2004, Russell composite

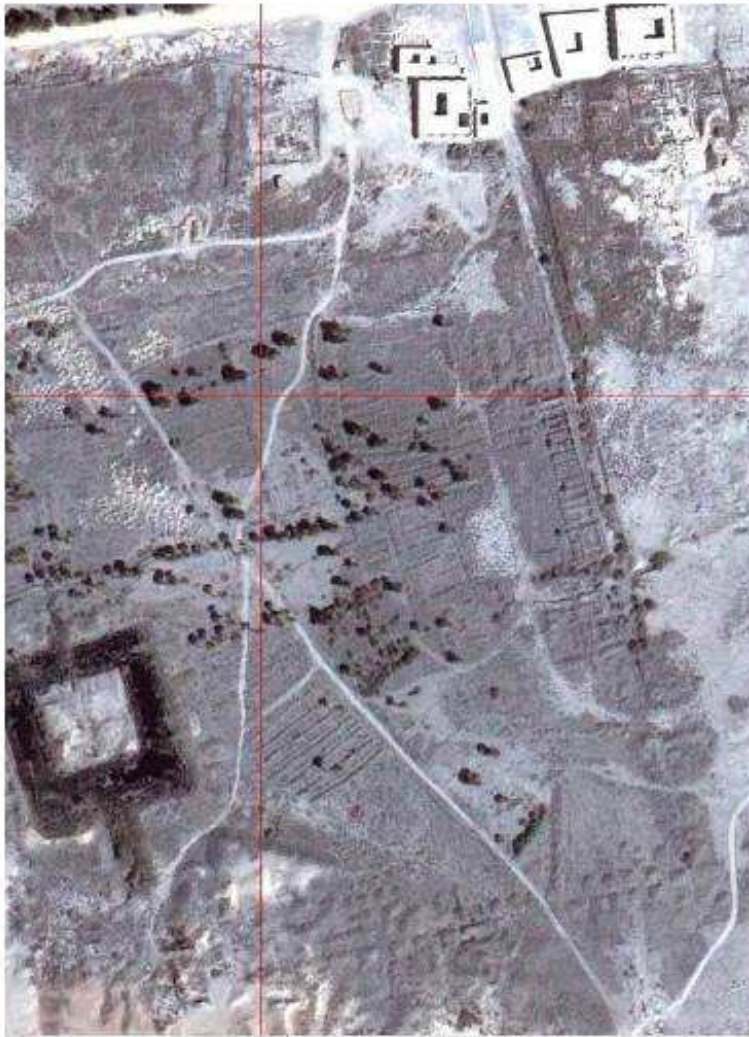
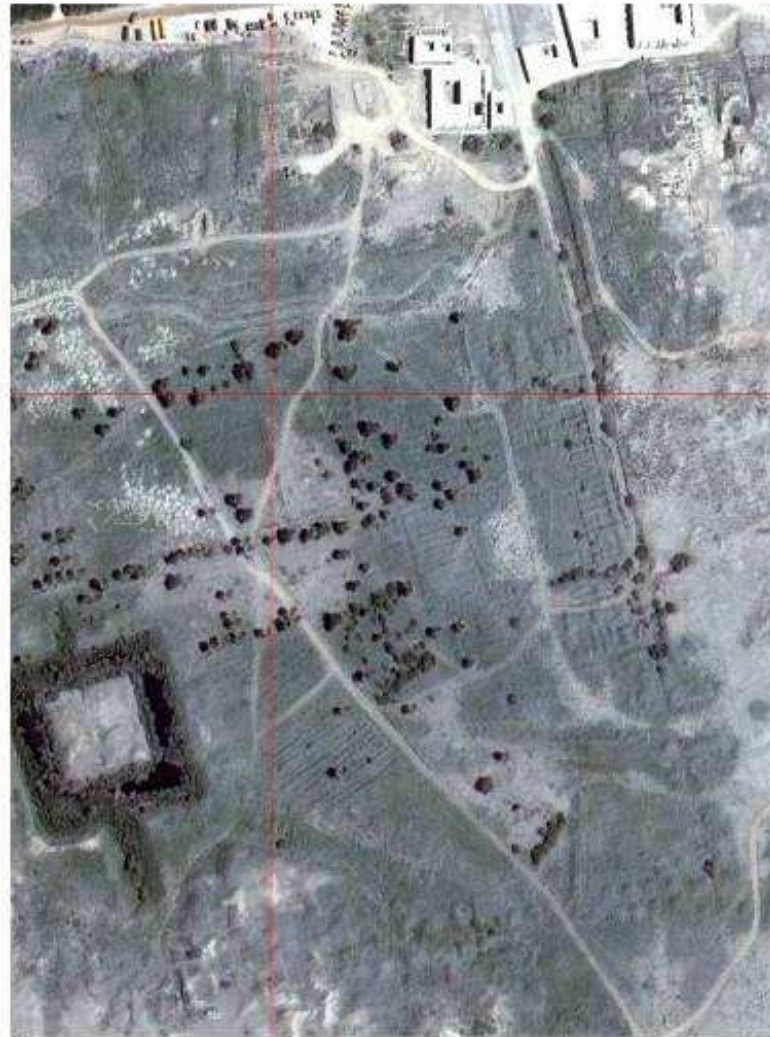
**Stone report:** This is another area where there is evidence for significant disturbance of the archaeological site. Two bulldozer trenches were excavated into what was once the sacred area of Babylon, one dug near the northwest corner of the ziggurat, and the other further to the northeast. These were not present in August 2003 (Fig. 31), ...

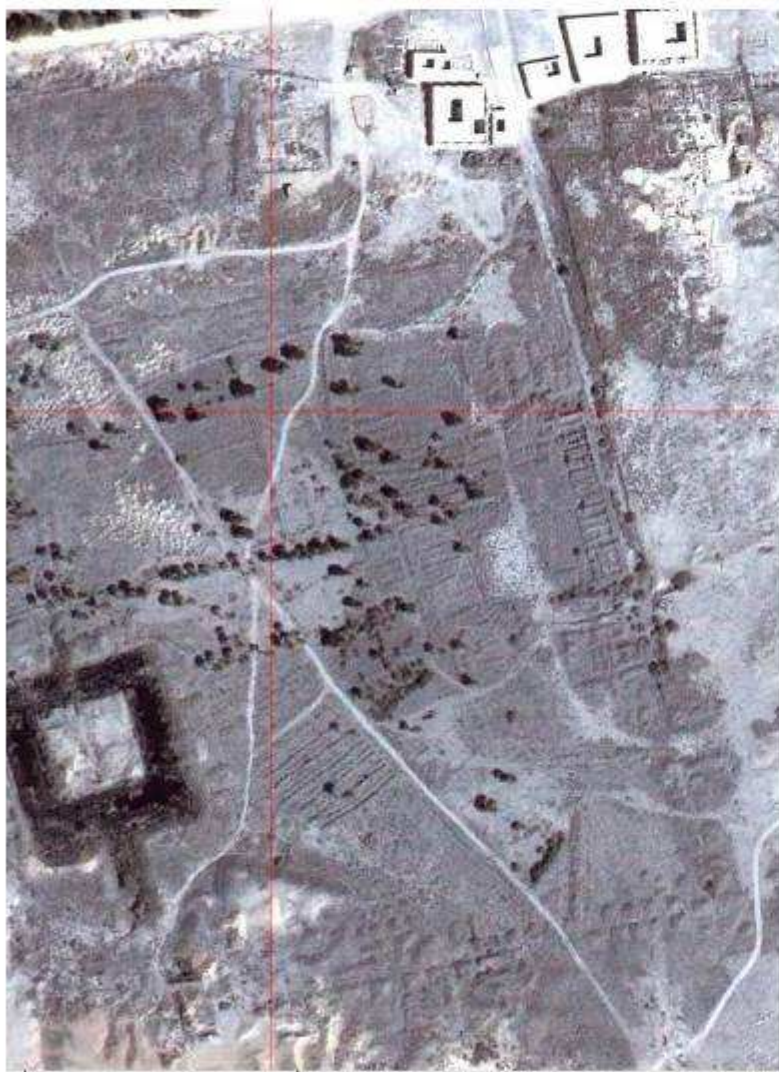
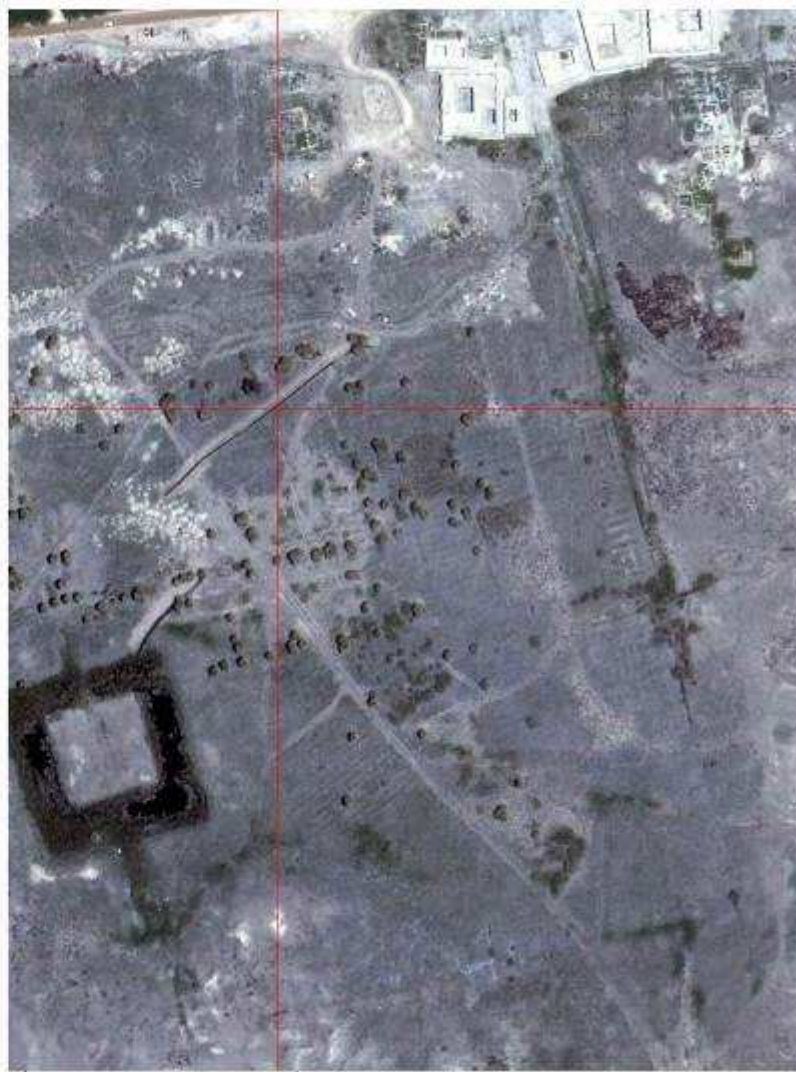
**Stone report:** ...but were present by July 2004 (Fig 32).

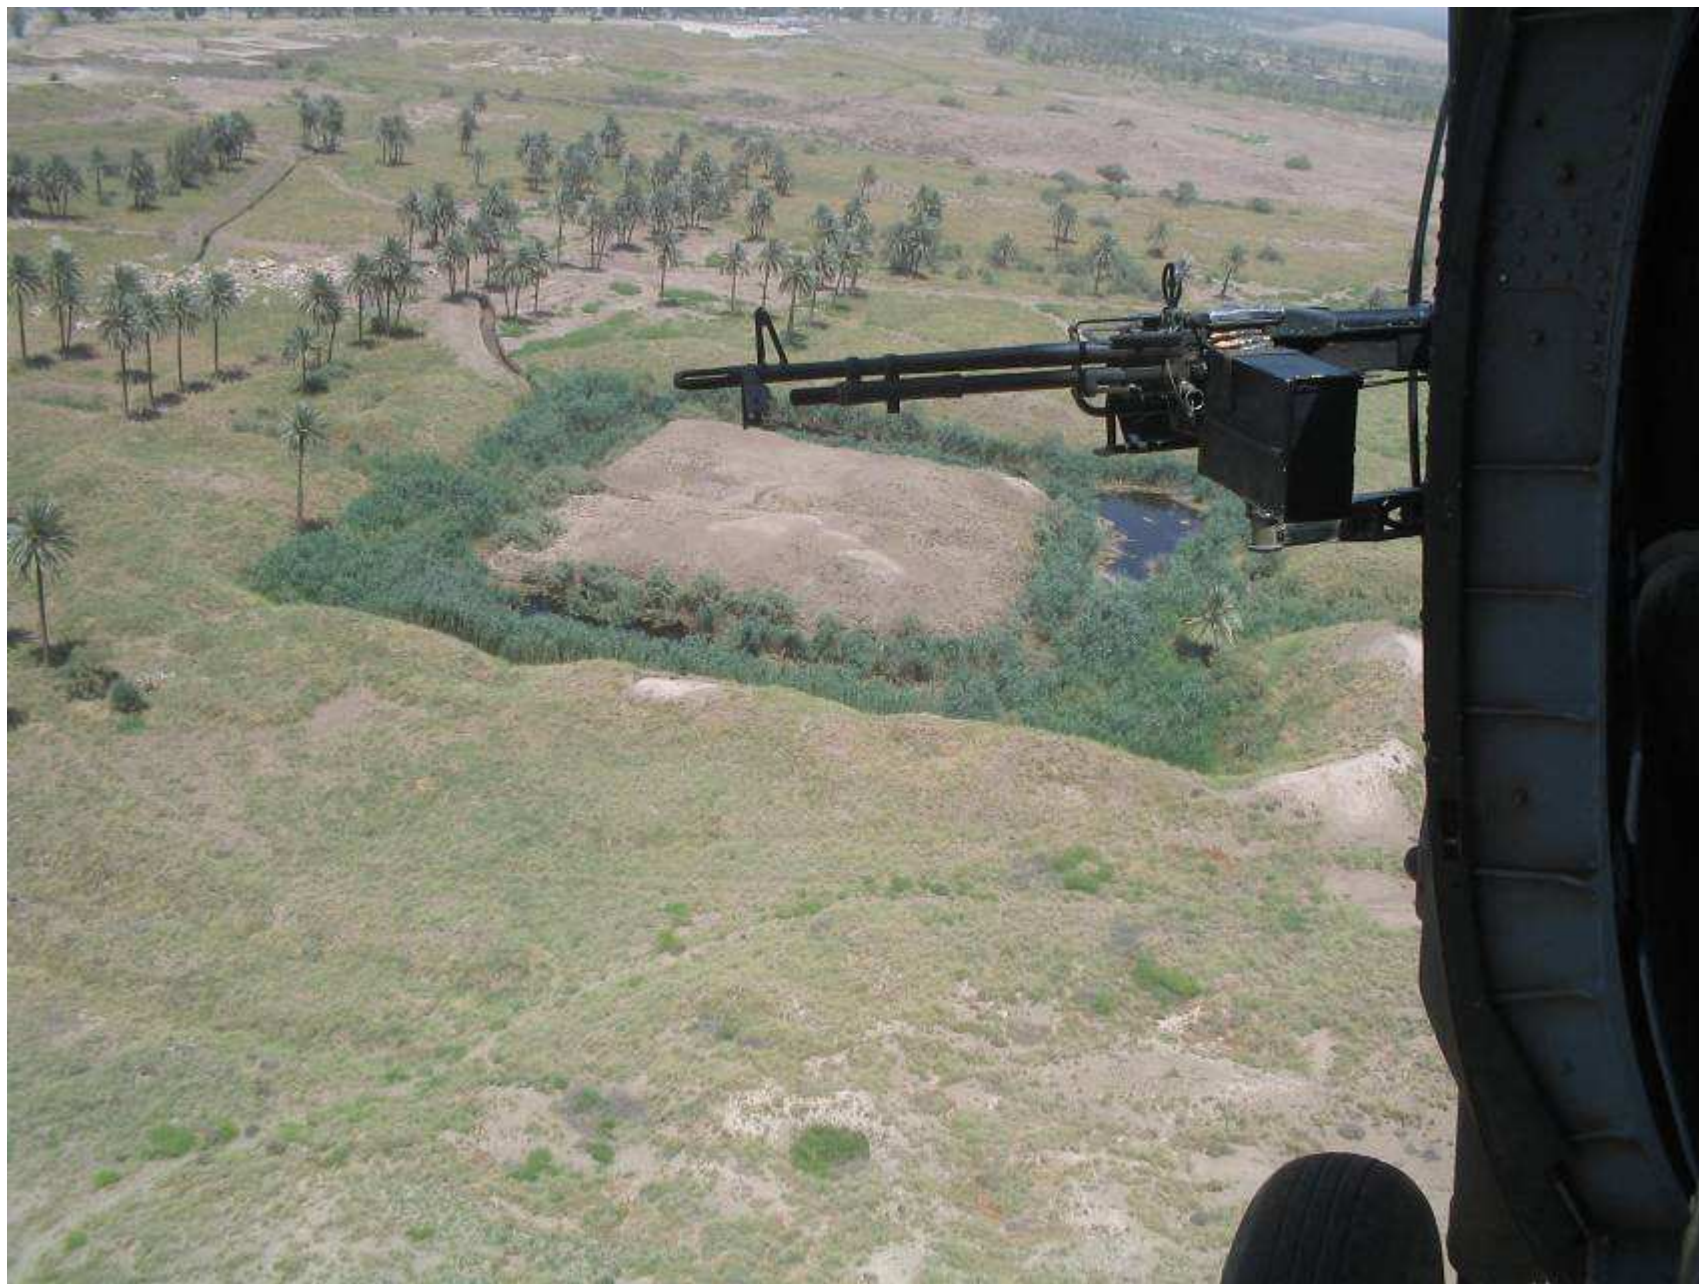
Trenches 1 and 2 at upper left, June 2004, Russell photo 124\_2470 (photo © John Russell)

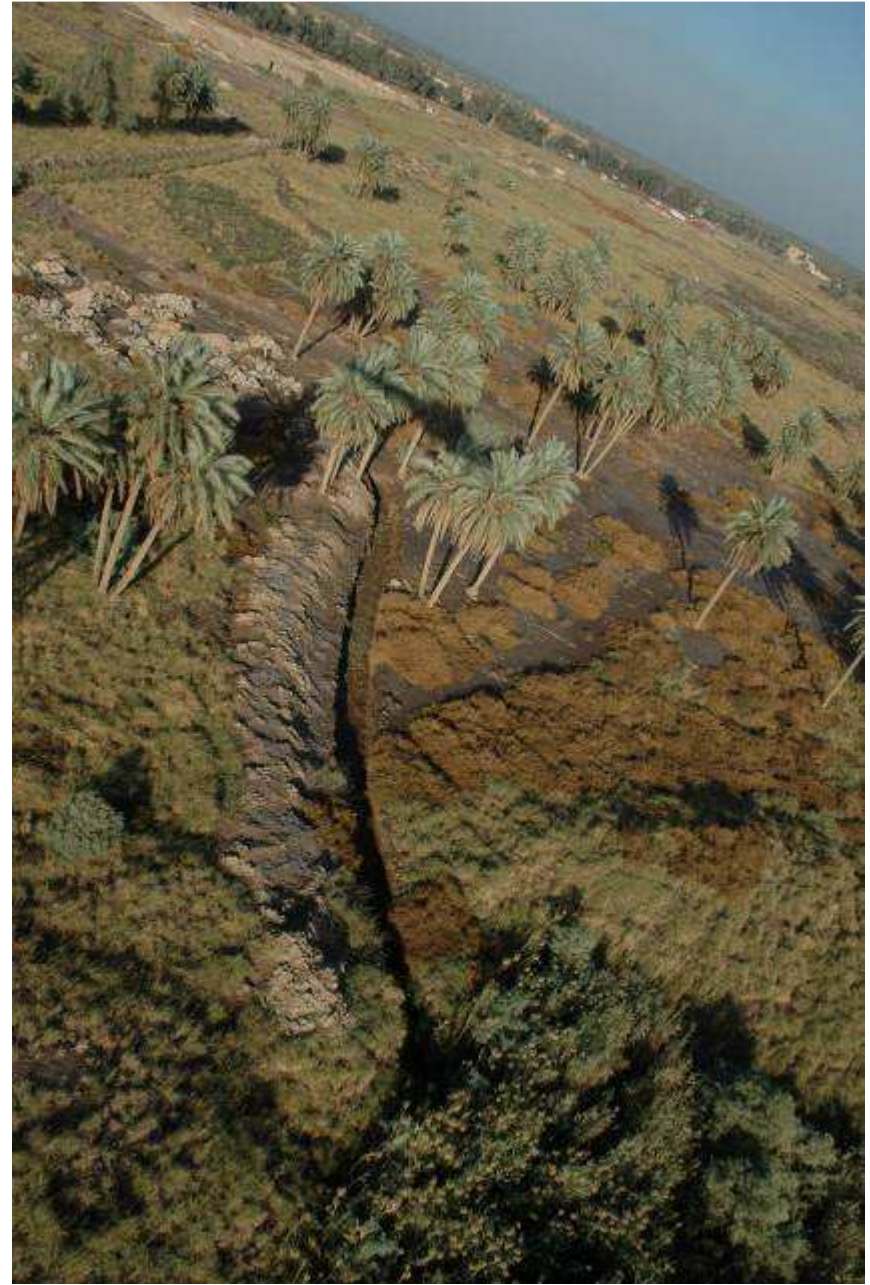
<b>Iraqi preliminary report</b>	<b>Iraqi final report</b>	<b>Curtis report</b>	<b>Polish report</b>
The first trench has a length of 62 meters, a width of 2-3 meters, and a depth of 2 meters. The dirt removed from, and placed on one side of, the trench contains fragments of ancient baked bricks and various pottery fragments.	7. The seventh trench is considered the one that has been damaged the most, because it was dug at the start of the northeast corner of the ziggurat—a blatant encroachment on the city and the tower itself. The Tower of Babel appears in Sumerian writings as E-temen-an-ki. Greek and Roman authors have treated this tower, and artists have reconstructed it in many different drawings and images. The trench has a length of 62 m, a width of 2-3 m, and a depth of 2.5 m. The dirt removed from the trench was placed on the two sides of the trench. It contains various pottery fragments and baked brick fragments (Photo 28).	A trench with length 45m. No pottery, bricks or bones observed in the spoil. (Ditch A in the <i>Polish Report</i> , see figs. on pp. 53, 55-56).	3) Ditch 'A' The ditch is near of the ziggurat Etemenanki. It starts nearby its north-eastern corner and runs about 45 meters in the north-eastern direction. It is about 2.5 meters wide and 2.5 meters deep. There is no archeologically significant material found in the pile of earth on the northern side of the ditch.

Trench 7, view from ziggurat toward debris field, Polish photo 101

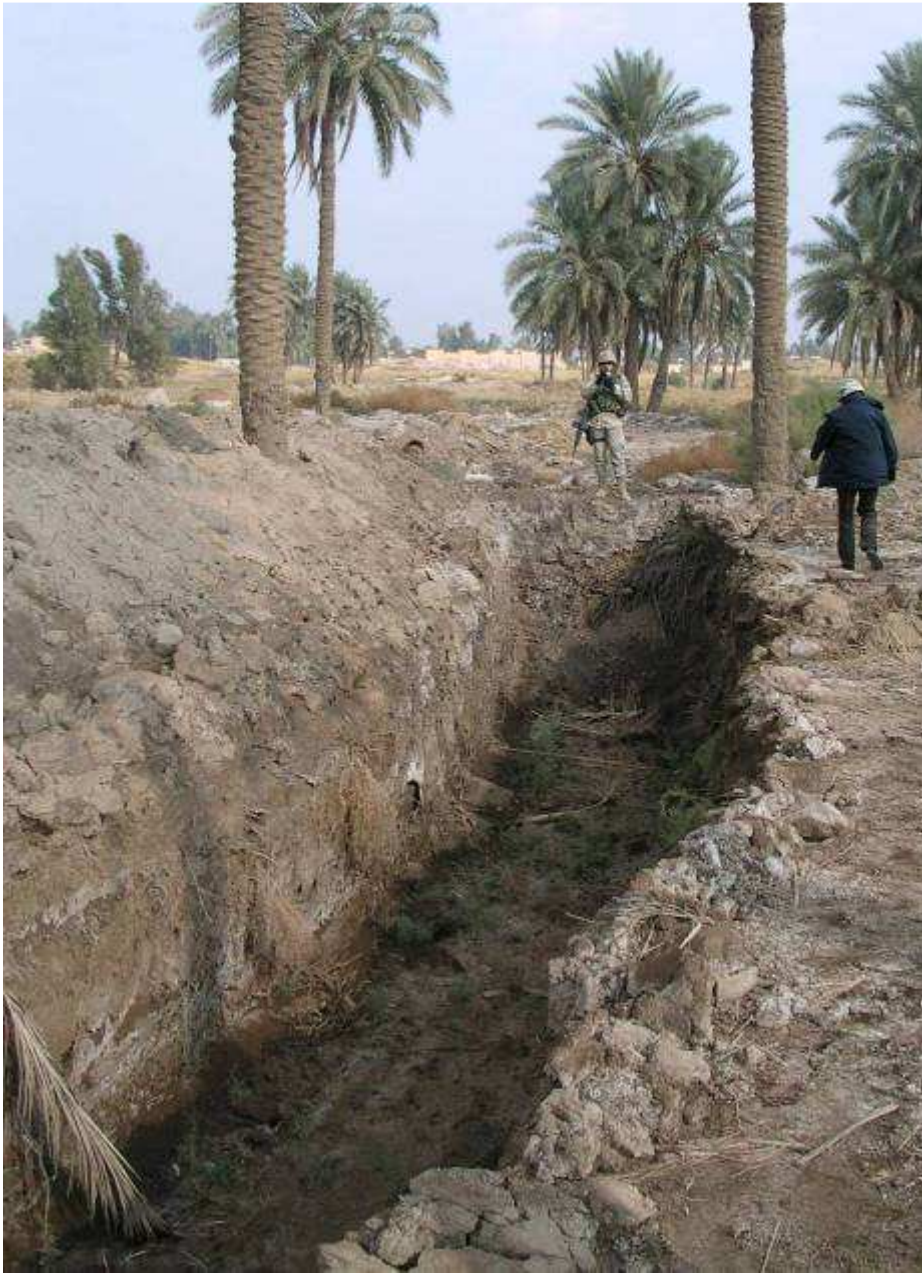
Trench 7, NE end, Curtis photo 7584 (photo © John Curtis)

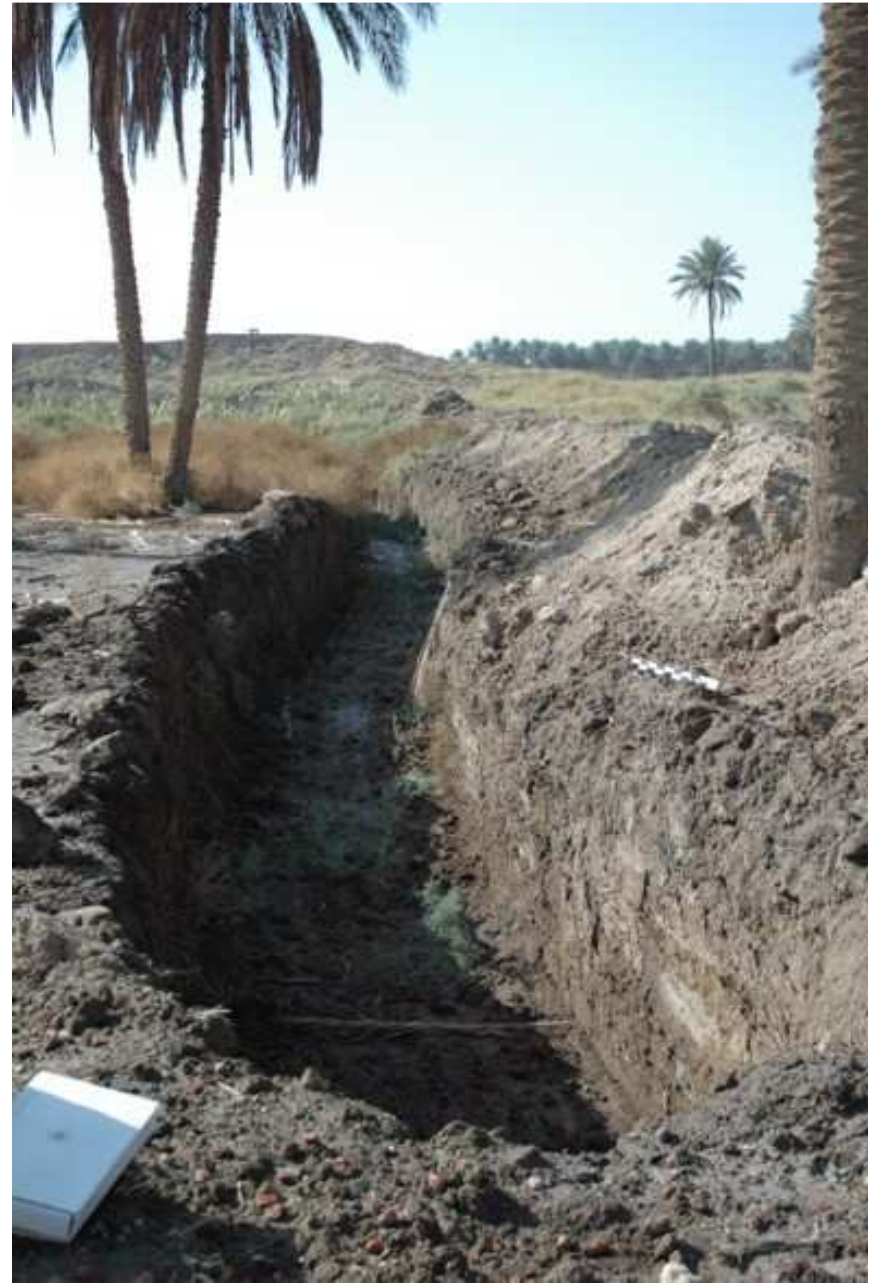
Trench 7, view to SW from the NE end, Polish report p. 44 (photo © Ministry of Culture and National Heritage, Republic of Poland)

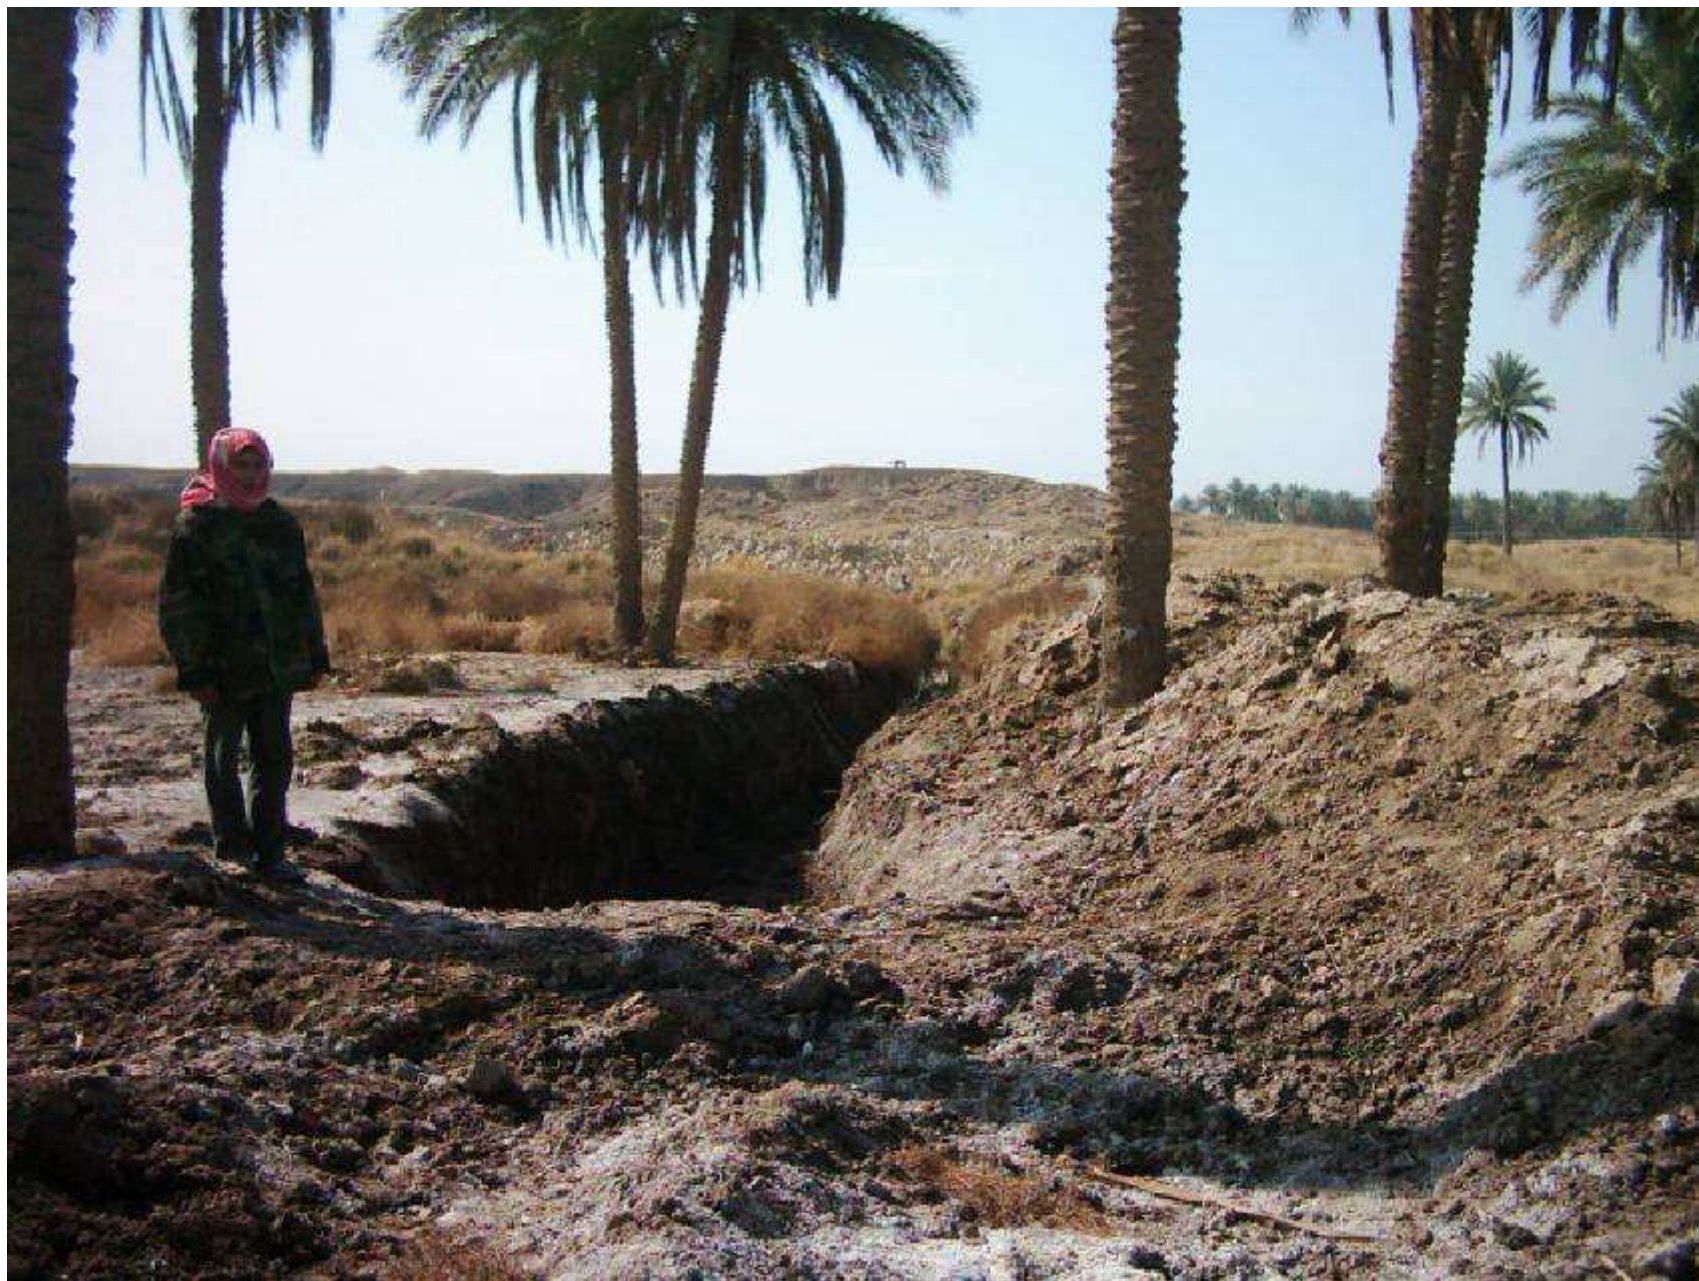
Trench 7, view to SW from the NE end, Iraqi final report fig. 28
