# **Report on Damage to the Site of Babylon, Iraq**

**John Malcolm Russell, Ph.D.**

**Cultural Heritage Center  
Bureau of Educational and Cultural Affairs  
Department of State**

**April 2010**

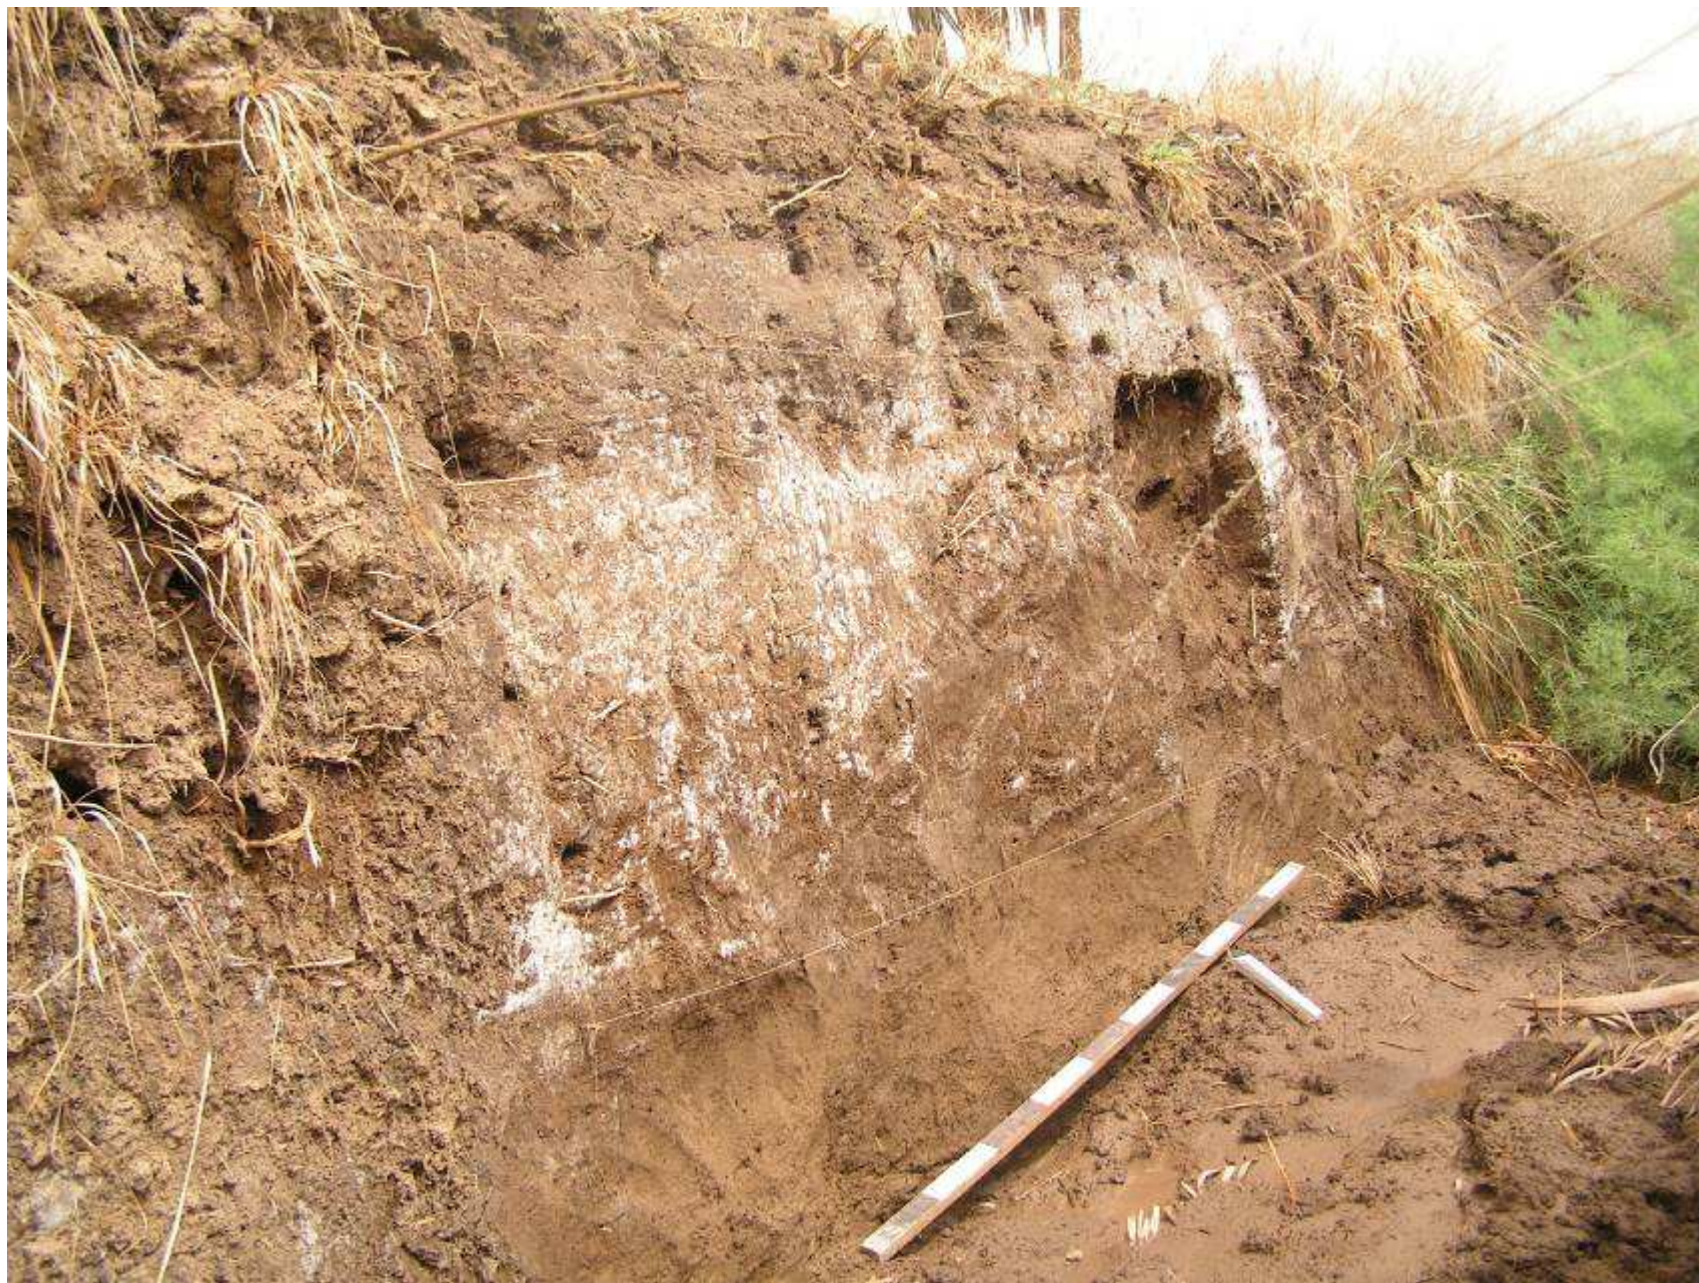
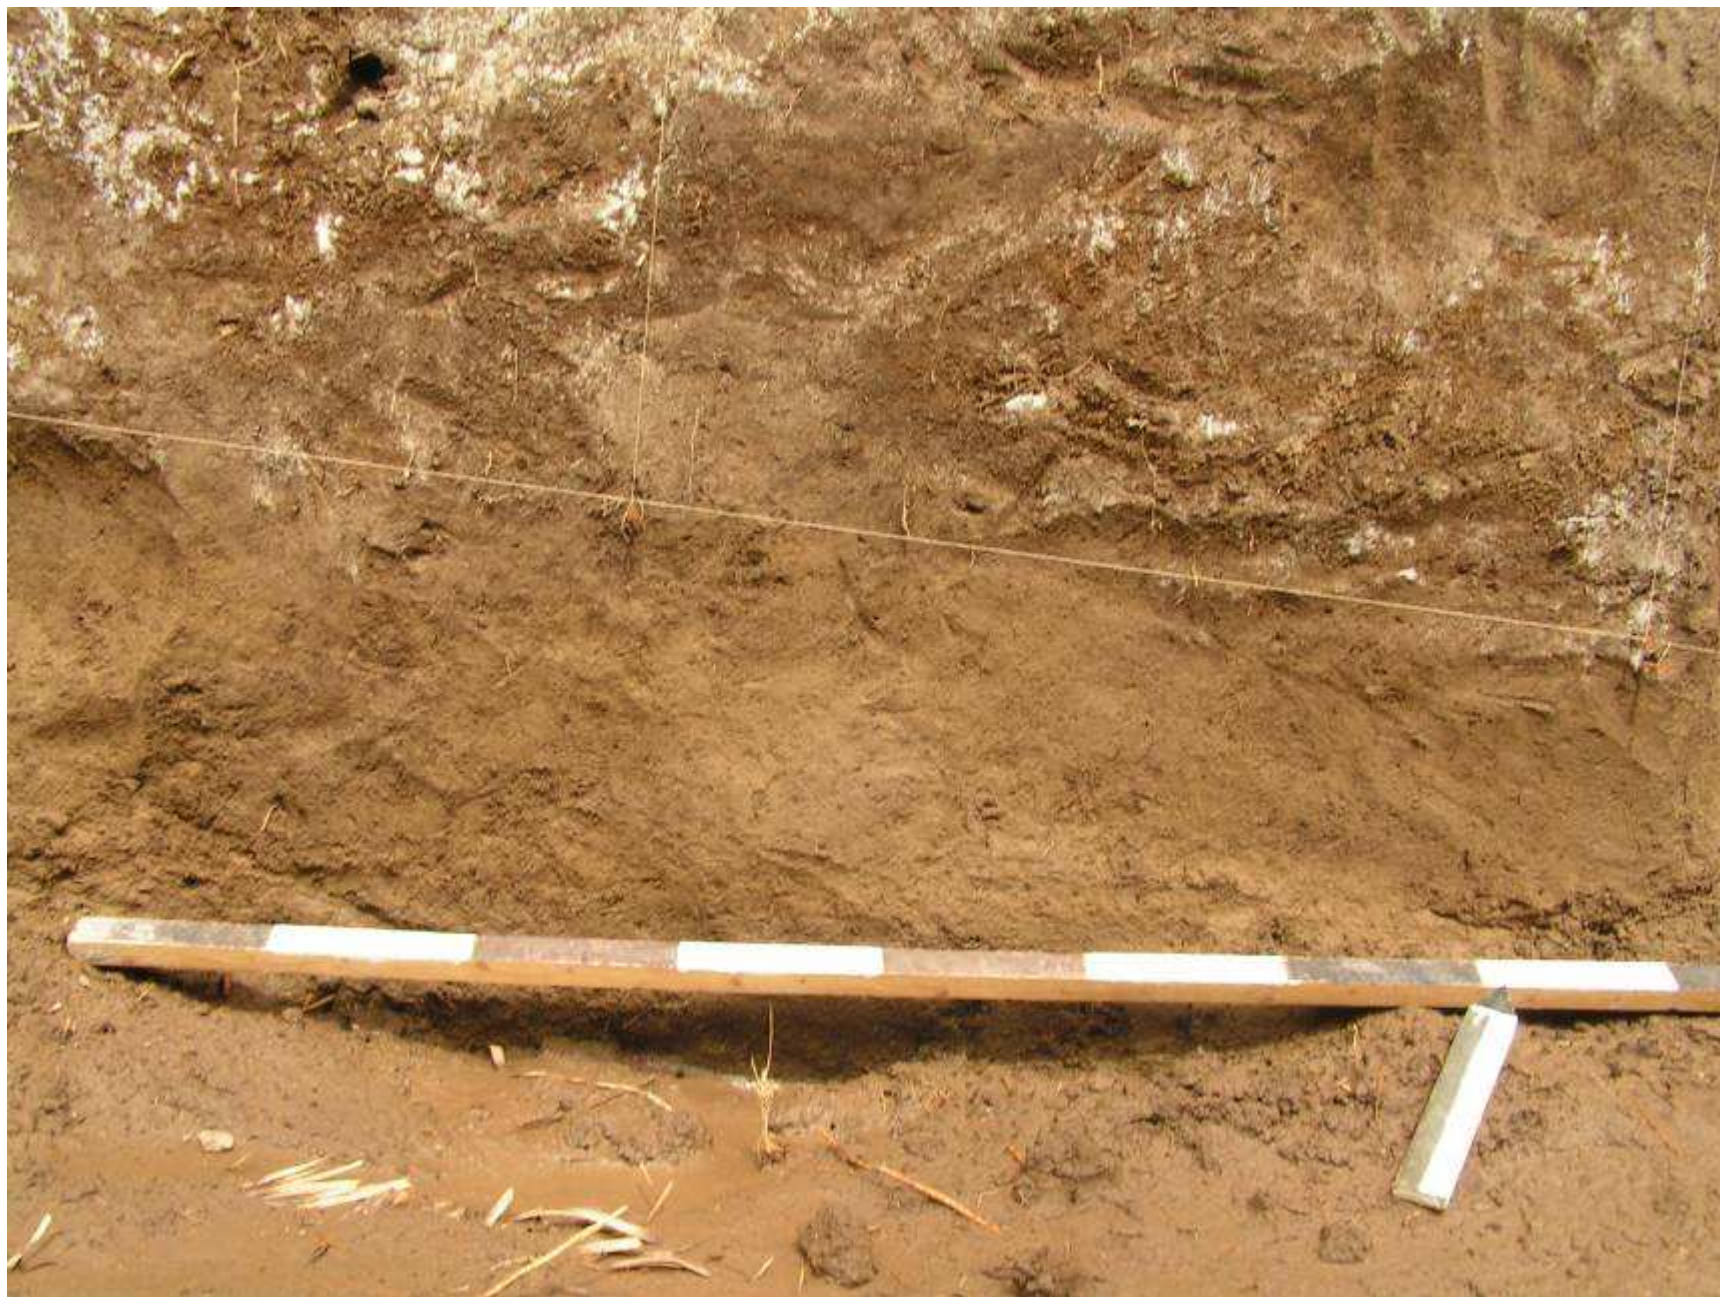
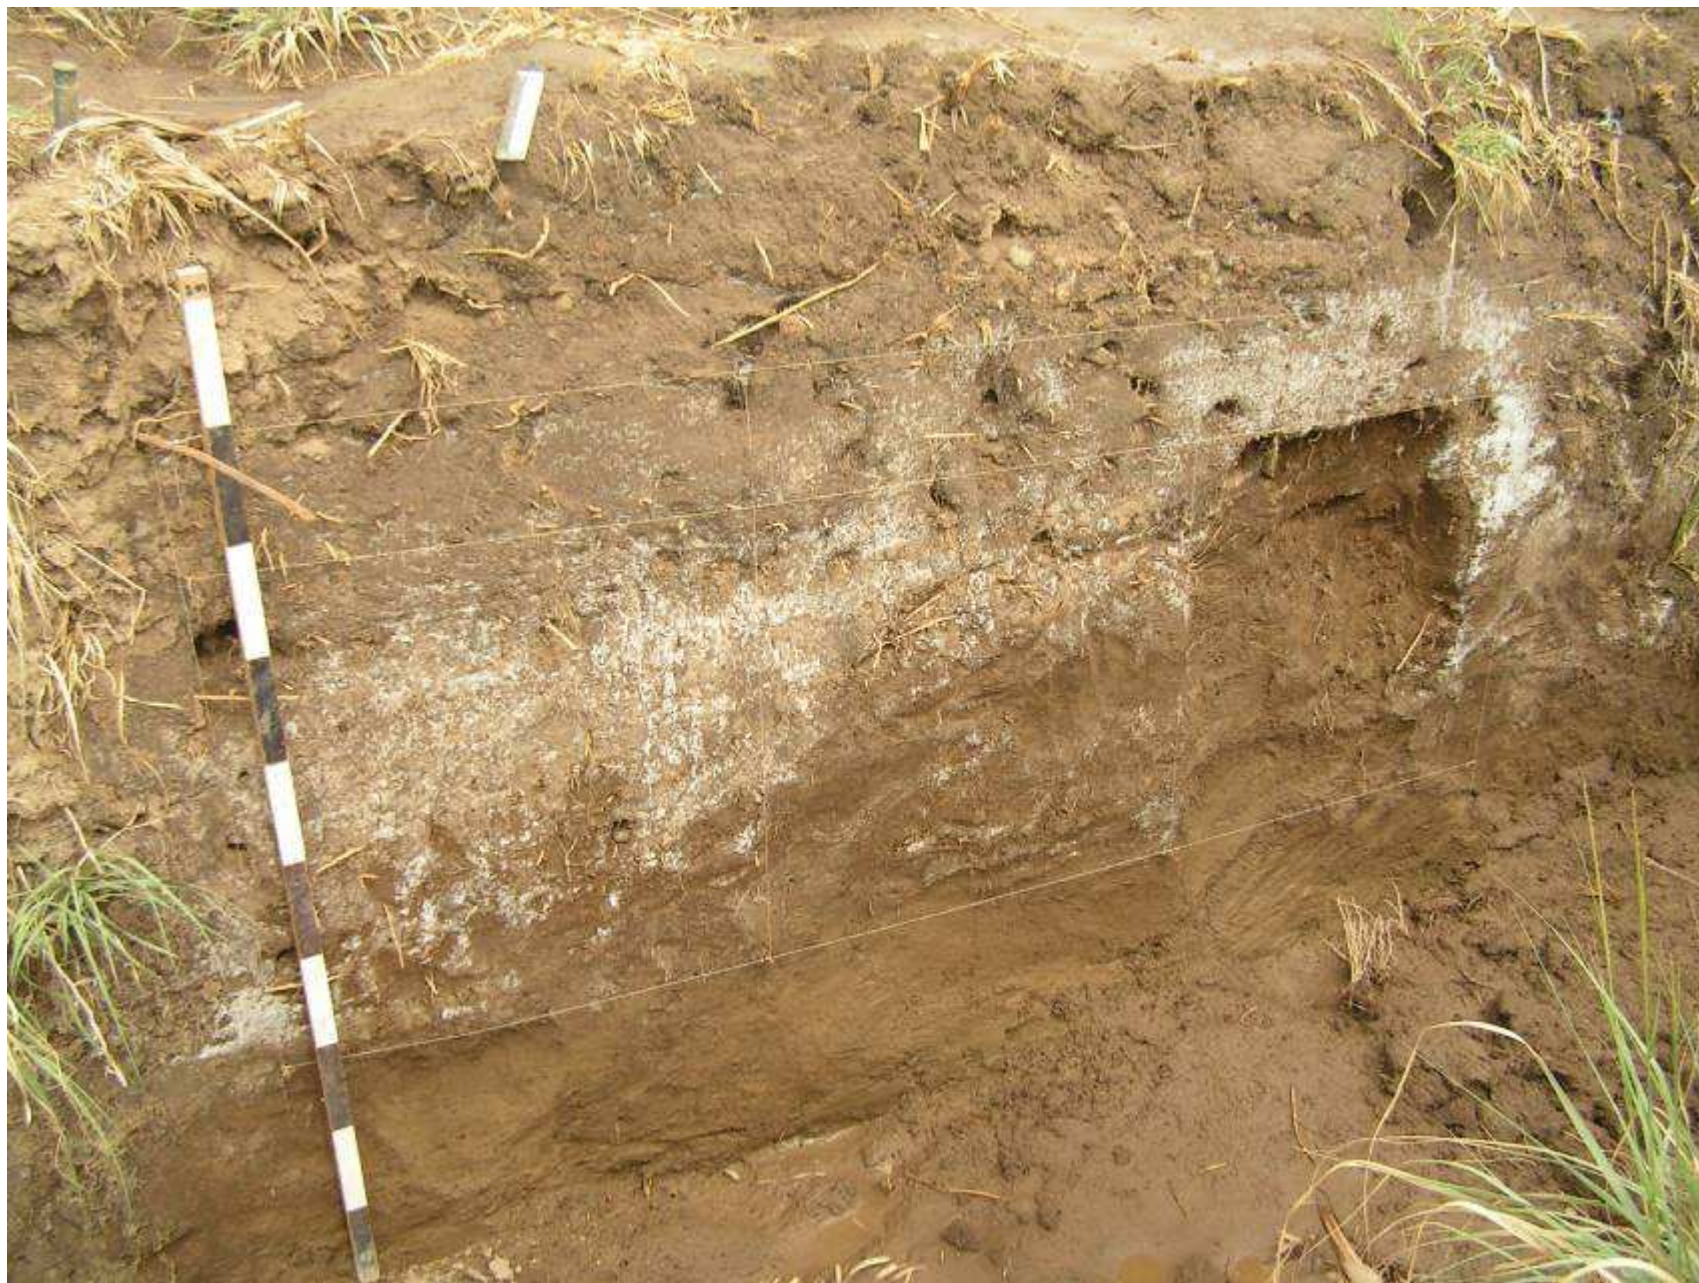
**Iraqi final report:** To ascertain the damage, a cross section was made on the western side of the trench, i.e., near the Tower of Babel. After creating a grid of squares, we conducted minor scraping. It became evident that there are a number of layers. The first is black and contains a few pottery fragments. The second contains baked brick fragments of different sizes mixed with tar. The third is clayey and grey in color. The fourth has yellow clay. The fifth has red clay. The last layer is sand. See Sketch No. 1 and Photos 29, 30, and 31.

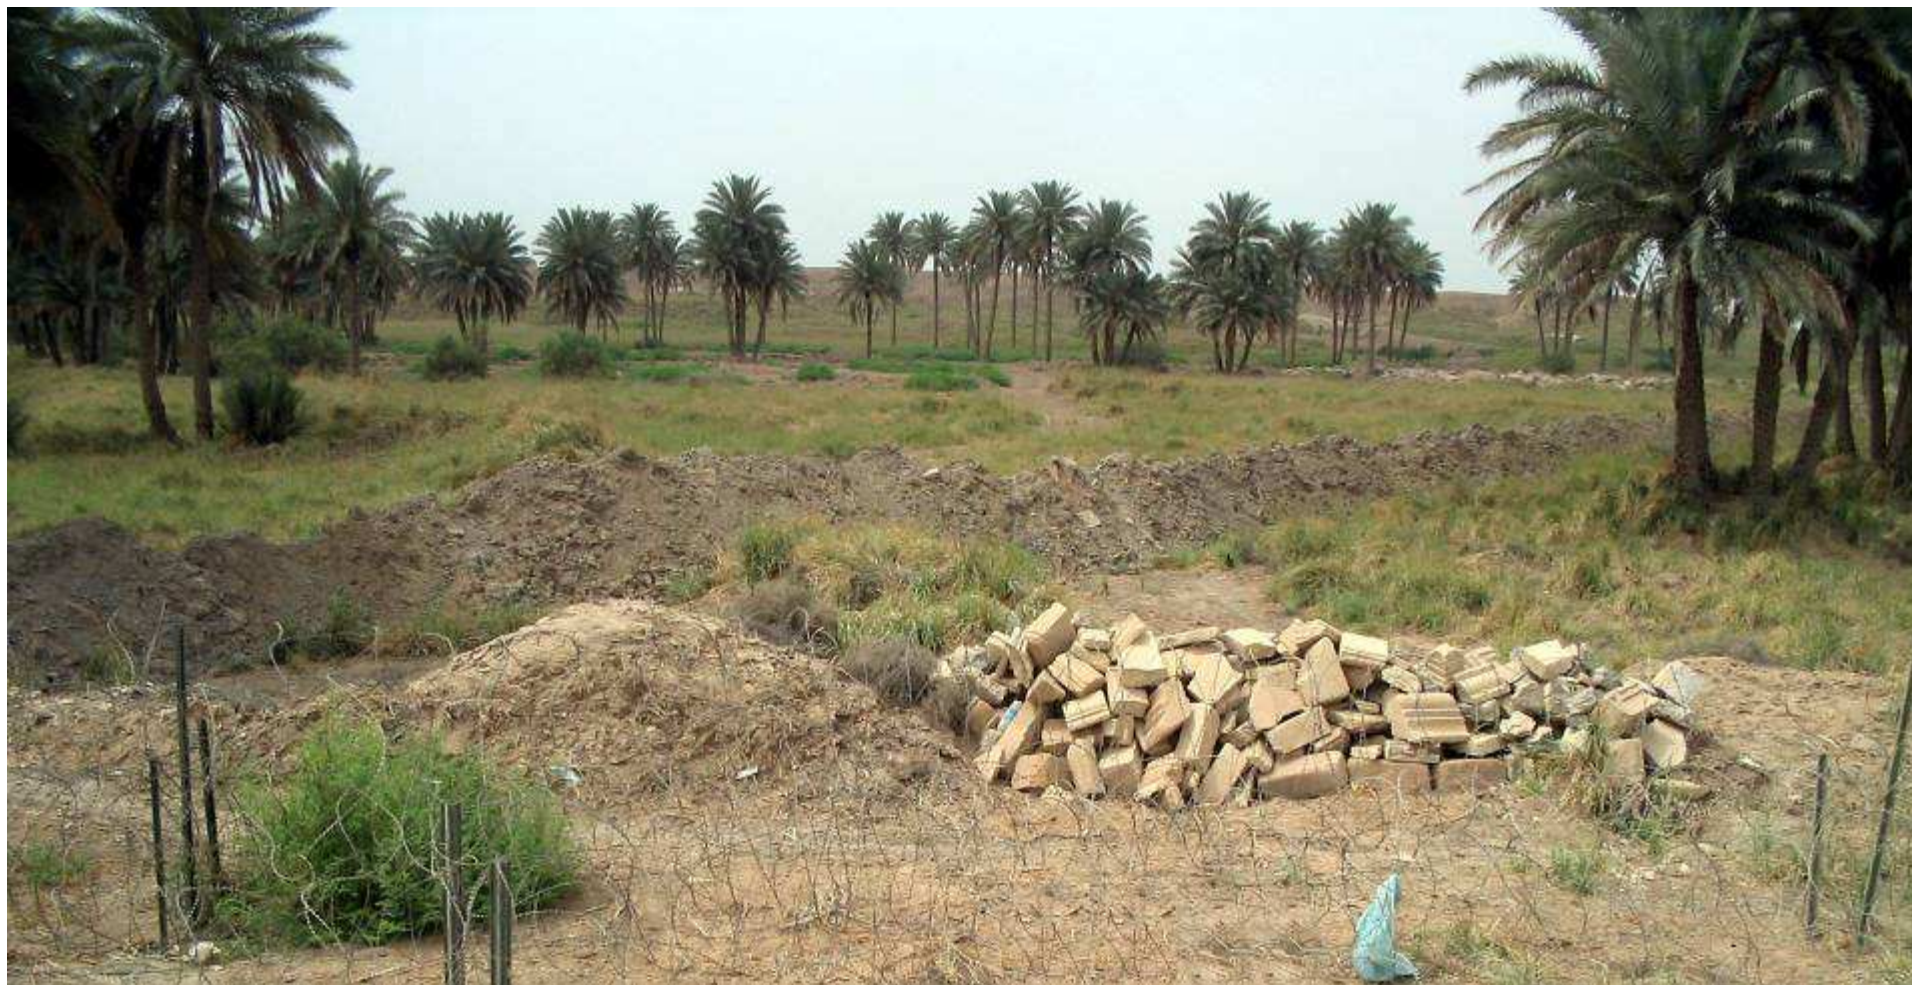
Iraqi preliminary report	Iraqi final report	Curtis report	Polish report
<p>To the north of it is another trench [<u>A: described in the report as being 50 m in length. This trench actually has</u>] with a length of 162 meters, a width of 1-1.5 meters, and a depth of 2 meters.</p> <p><u>[A: Its northern part terminates in two branches; the length of the southern branch is 5 m. One of the branches lies in the direction of]</u></p> <p><u>[B: Branching from the south side is a small trench with a length of 10 meters. One of them extends toward]</u></p> <p>the Processional Street [Shari' al-Mawkib]. The dirt removed from the trench contains pottery fragments and fragments of baked bricks of various sizes, some of which have cuneiform writing and bear an impression of the seal of the Babylonian king, Nebuchadnezzar.</p>	<p>8. Eighth trench: This is the longest trench dug in the city. It is located in the religious area of the city, north of the seventh trench. It is 162 m in length, 1-1.5 m in width, and 2 m in depth. A trench with a length of 10 m branches off from its eastern side. The dirt removed from the trench contains pottery fragments and baked brick fragments of various sizes. Some of the fragments have Sumerian inscriptions in the form of an impression of the Babylonian King Nebuchadnezzar's stamp. The most prominent find is a small cup with a piece missing (see Photo 32).</p>	<p>E-W trench, length c.170m (paced out), c.2m deep, and 1.0-1.5m wide. Much pottery and many fragments of brick with cuneiform inscriptions of Nebuchadnezzar were observed in the bank of spoil on the north side of the trench. (Ditch B in the <i>Polish Report</i>, see figs on pp.53, 57-58).</p>	<p>4) Ditch "B"</p> <p>Ditch "B" starts about 50 m from the northern end of ditch "A". The end of the ditch forks into a letter 'Y'. The width of the ditch varies between 1.2 to 1.8 meters. It is about 2 meters deep. The ditch is strongly overgrown. On the pile located on the northern side of the ditch are scattered numerous fragments of ceramic. About 30 m from the north-eastern end of the ditch; fragments of bricks are beginning to emerge.</p>

Trench 8 shortly after it was dug, viewed from the road, looking south, May 2004, Russell photo 123\_2360, detail (photo © John Russell)

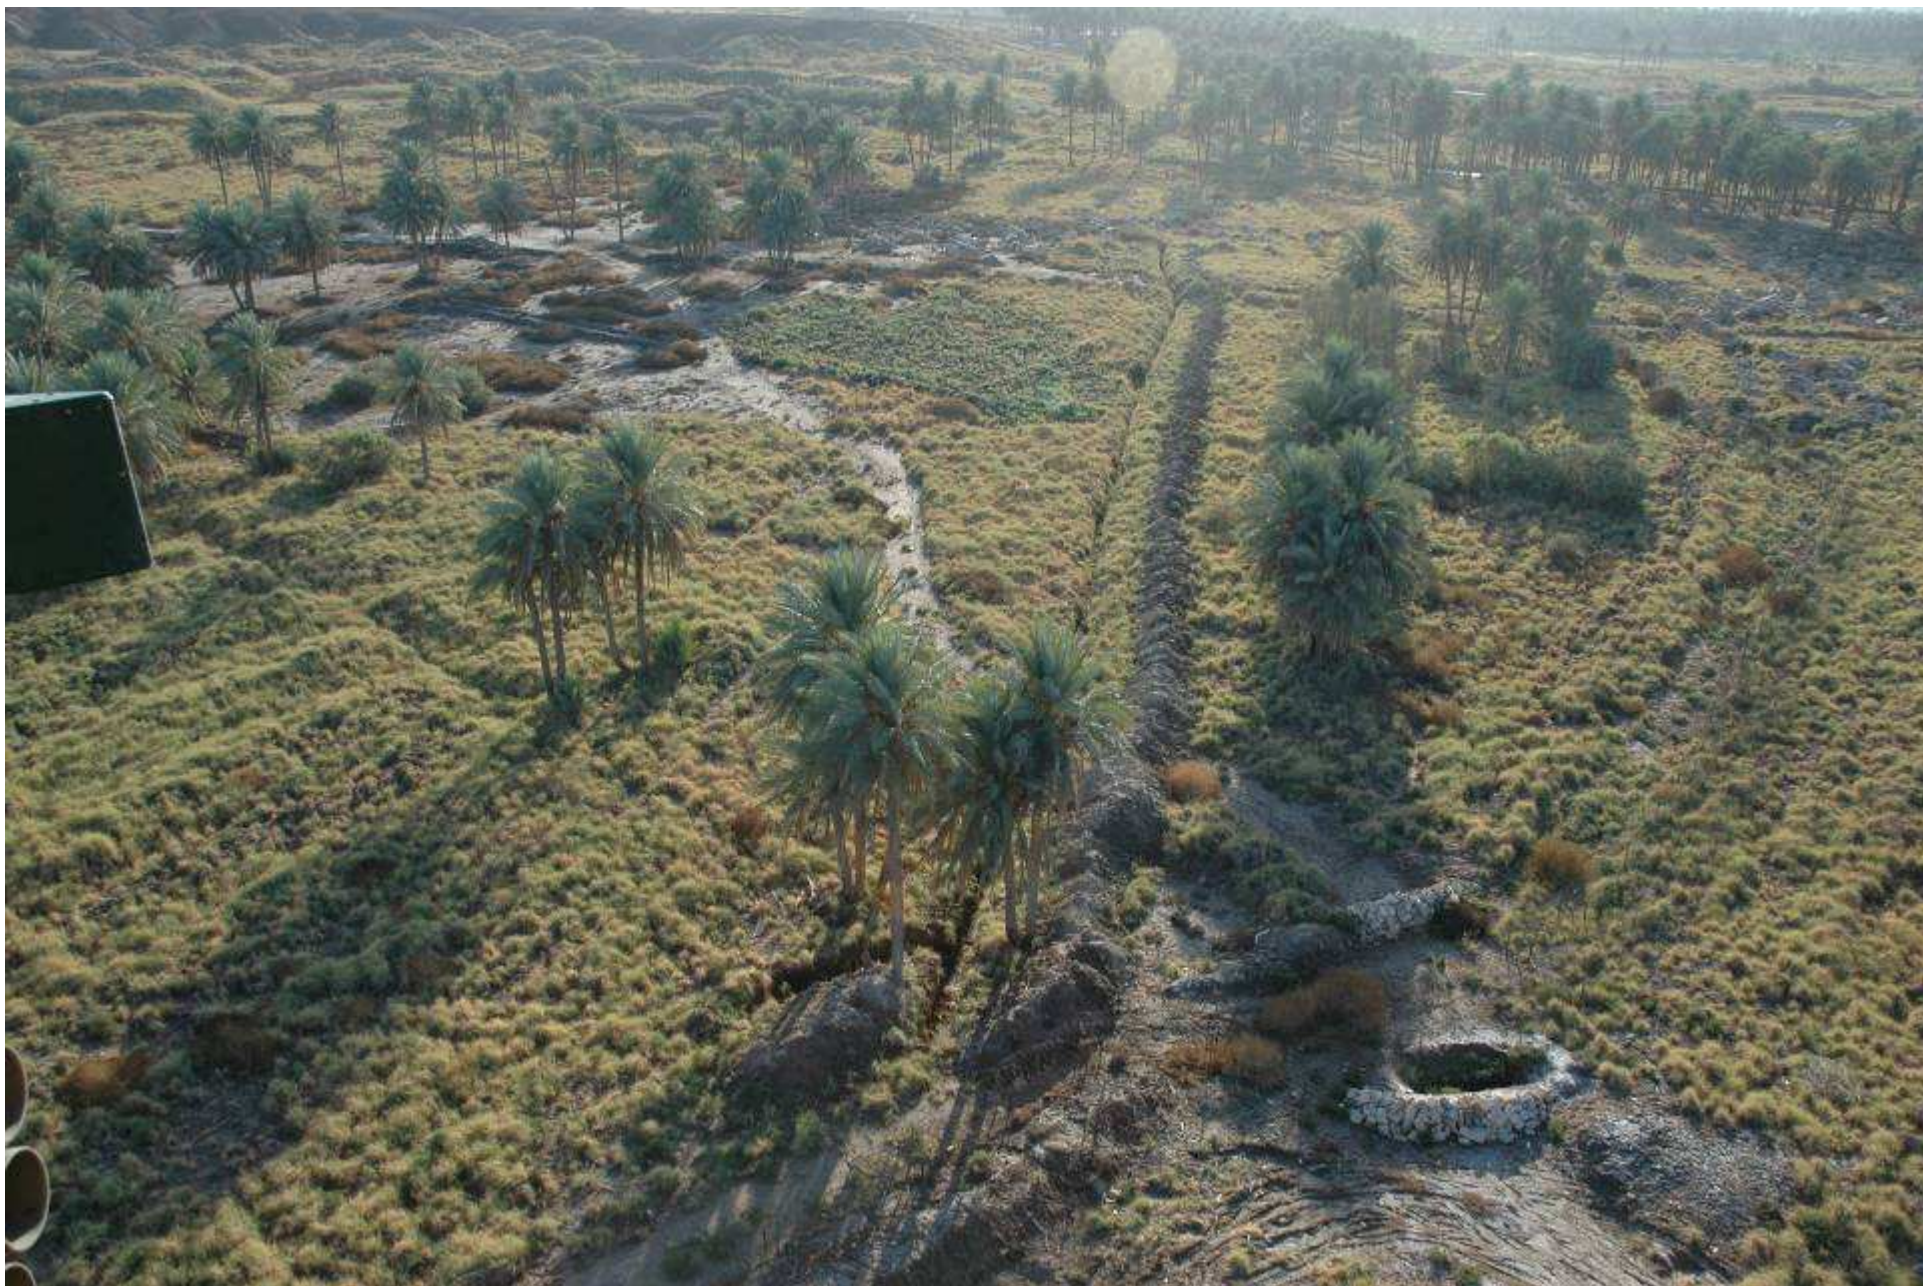
Trench 8, view from the NE end toward the SW, November 2004, Polish photo 109 (photo © Ministry of Culture and National Heritage, Republic of Poland)

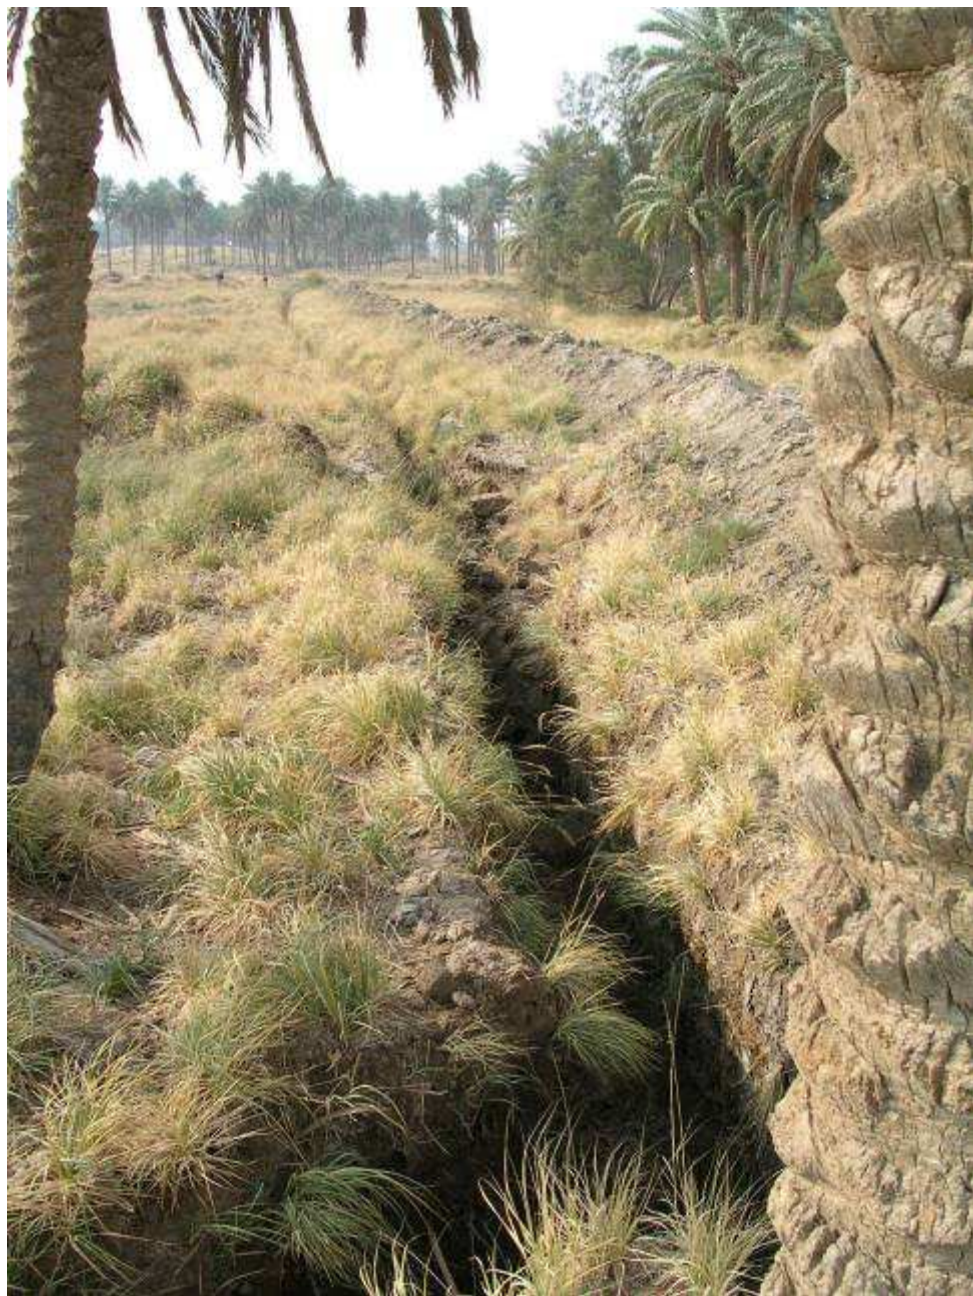
Trench 8, looking toward SW, Curtis photo 7589 (photo © John Curtis)

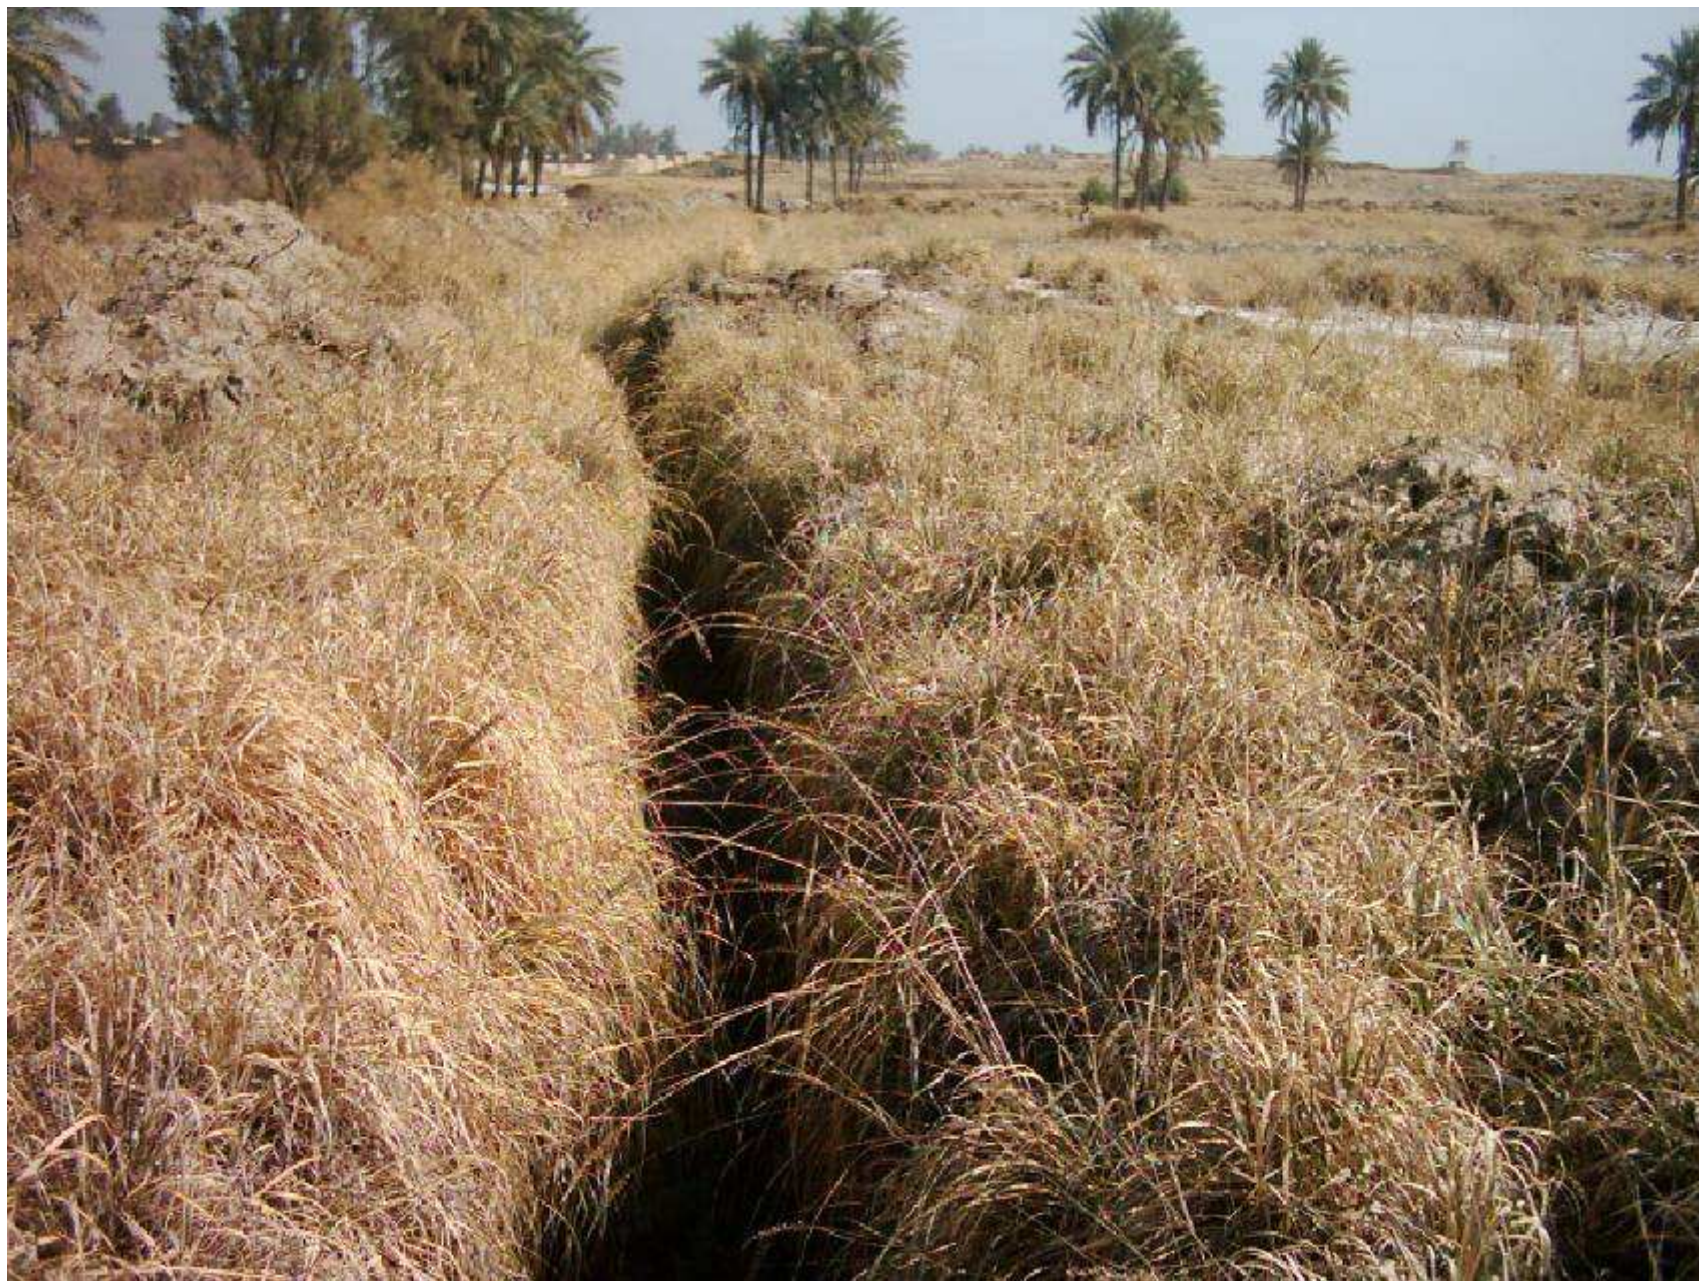
Trench 8 looking toward NE, Iraqi final report fig. 32

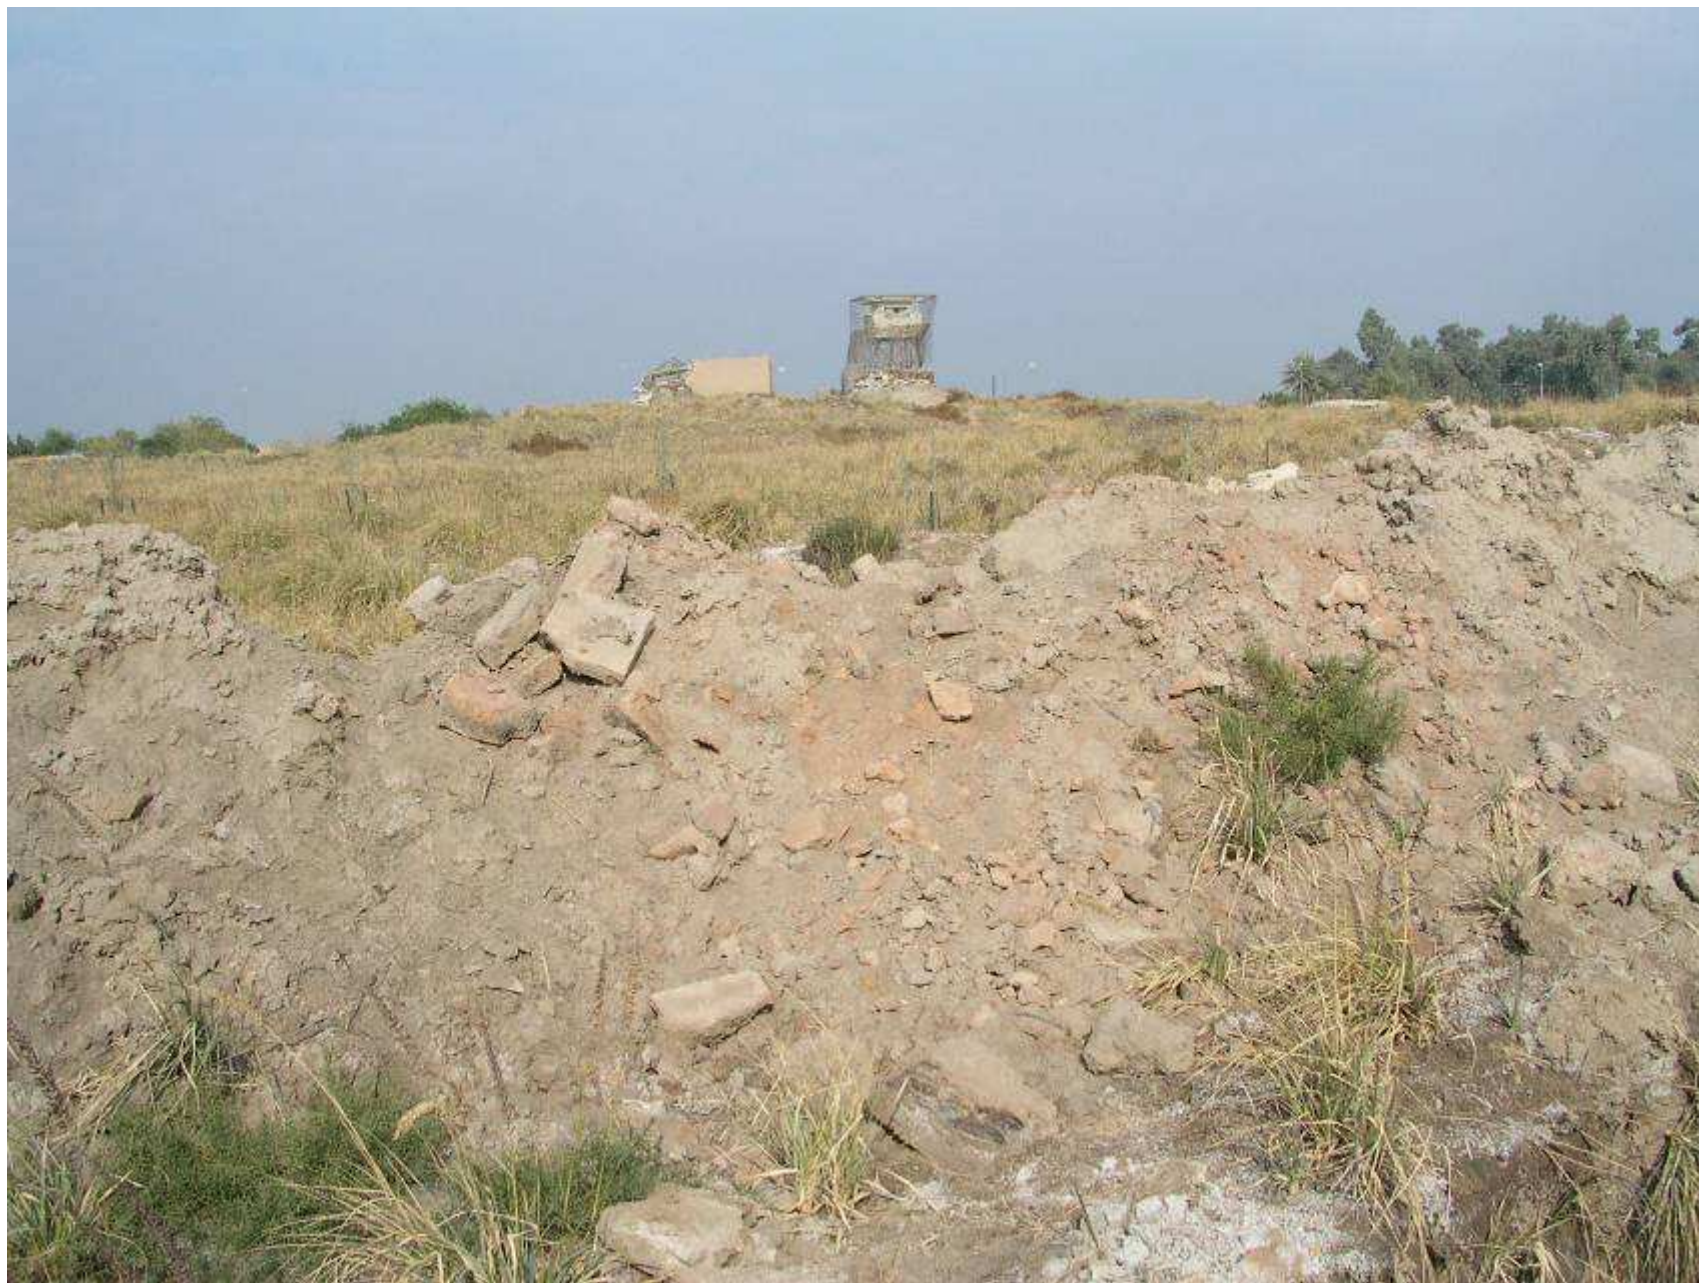
Trench 8, fill, Curtis photo 7587 (photo © John Curtis)

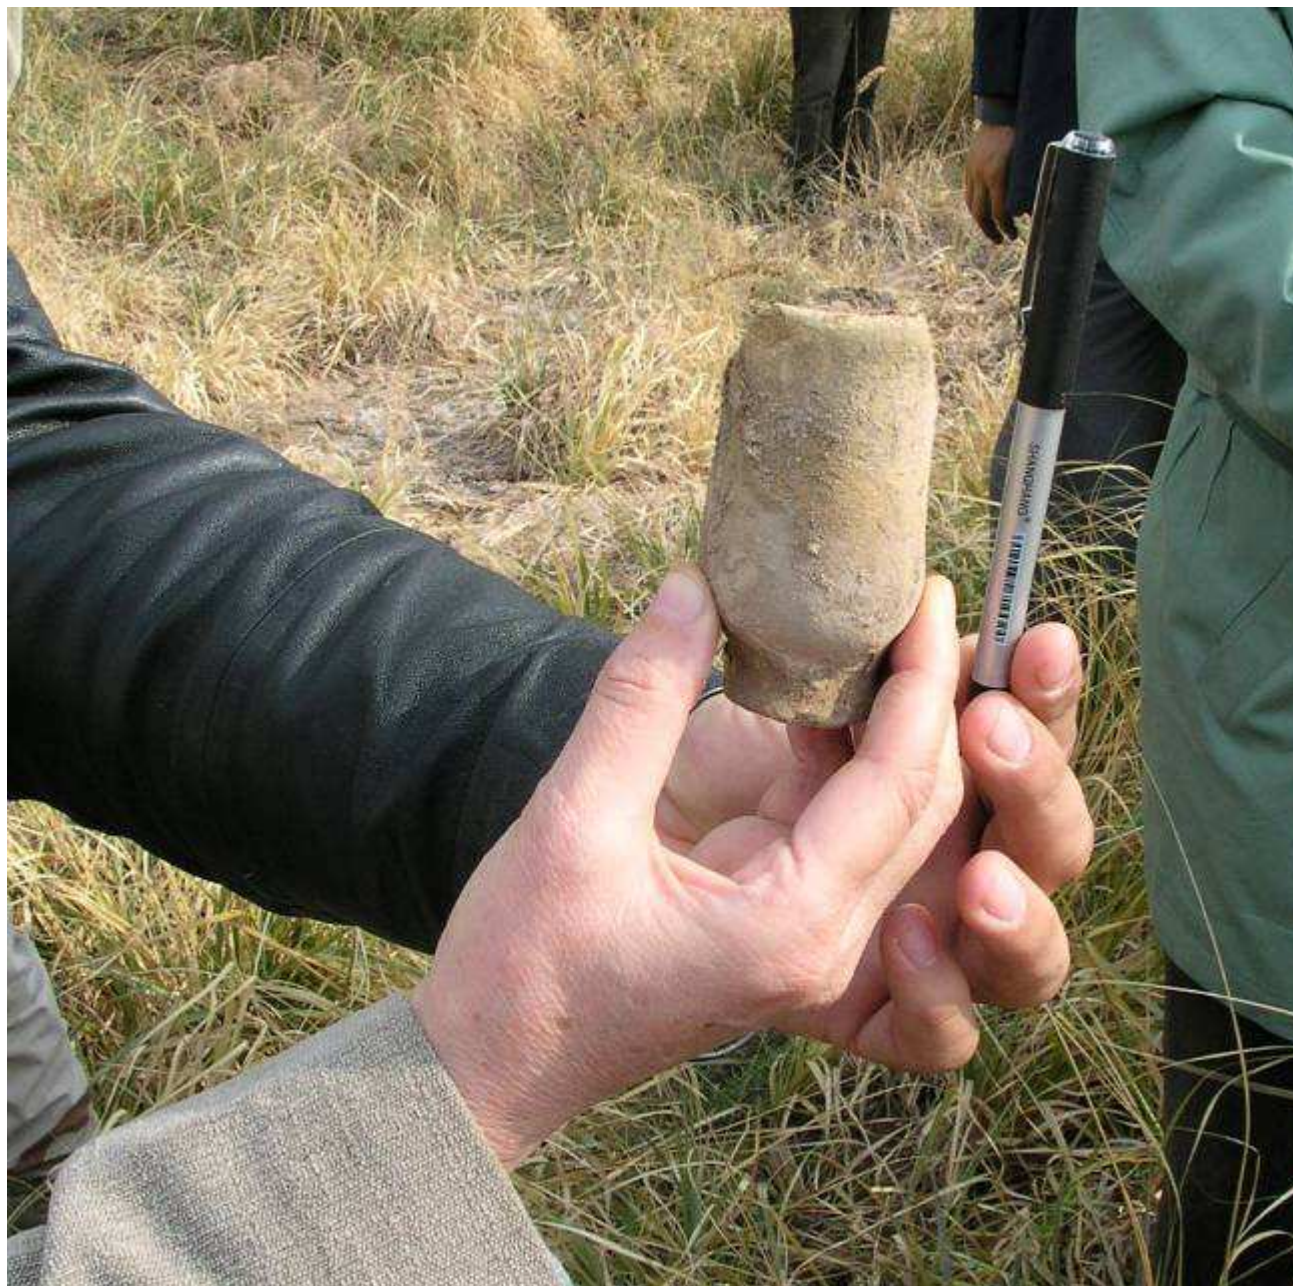
Trench 8 fill, small cup reported in Iraqi final report, Curtis photo 7592 (photo © John Curtis)
