# **Report on Damage to the Site of Babylon, Iraq**

**John Malcolm Russell, Ph.D.**

**Cultural Heritage Center  
Bureau of Educational and Cultural Affairs  
Department of State**

**April 2010**

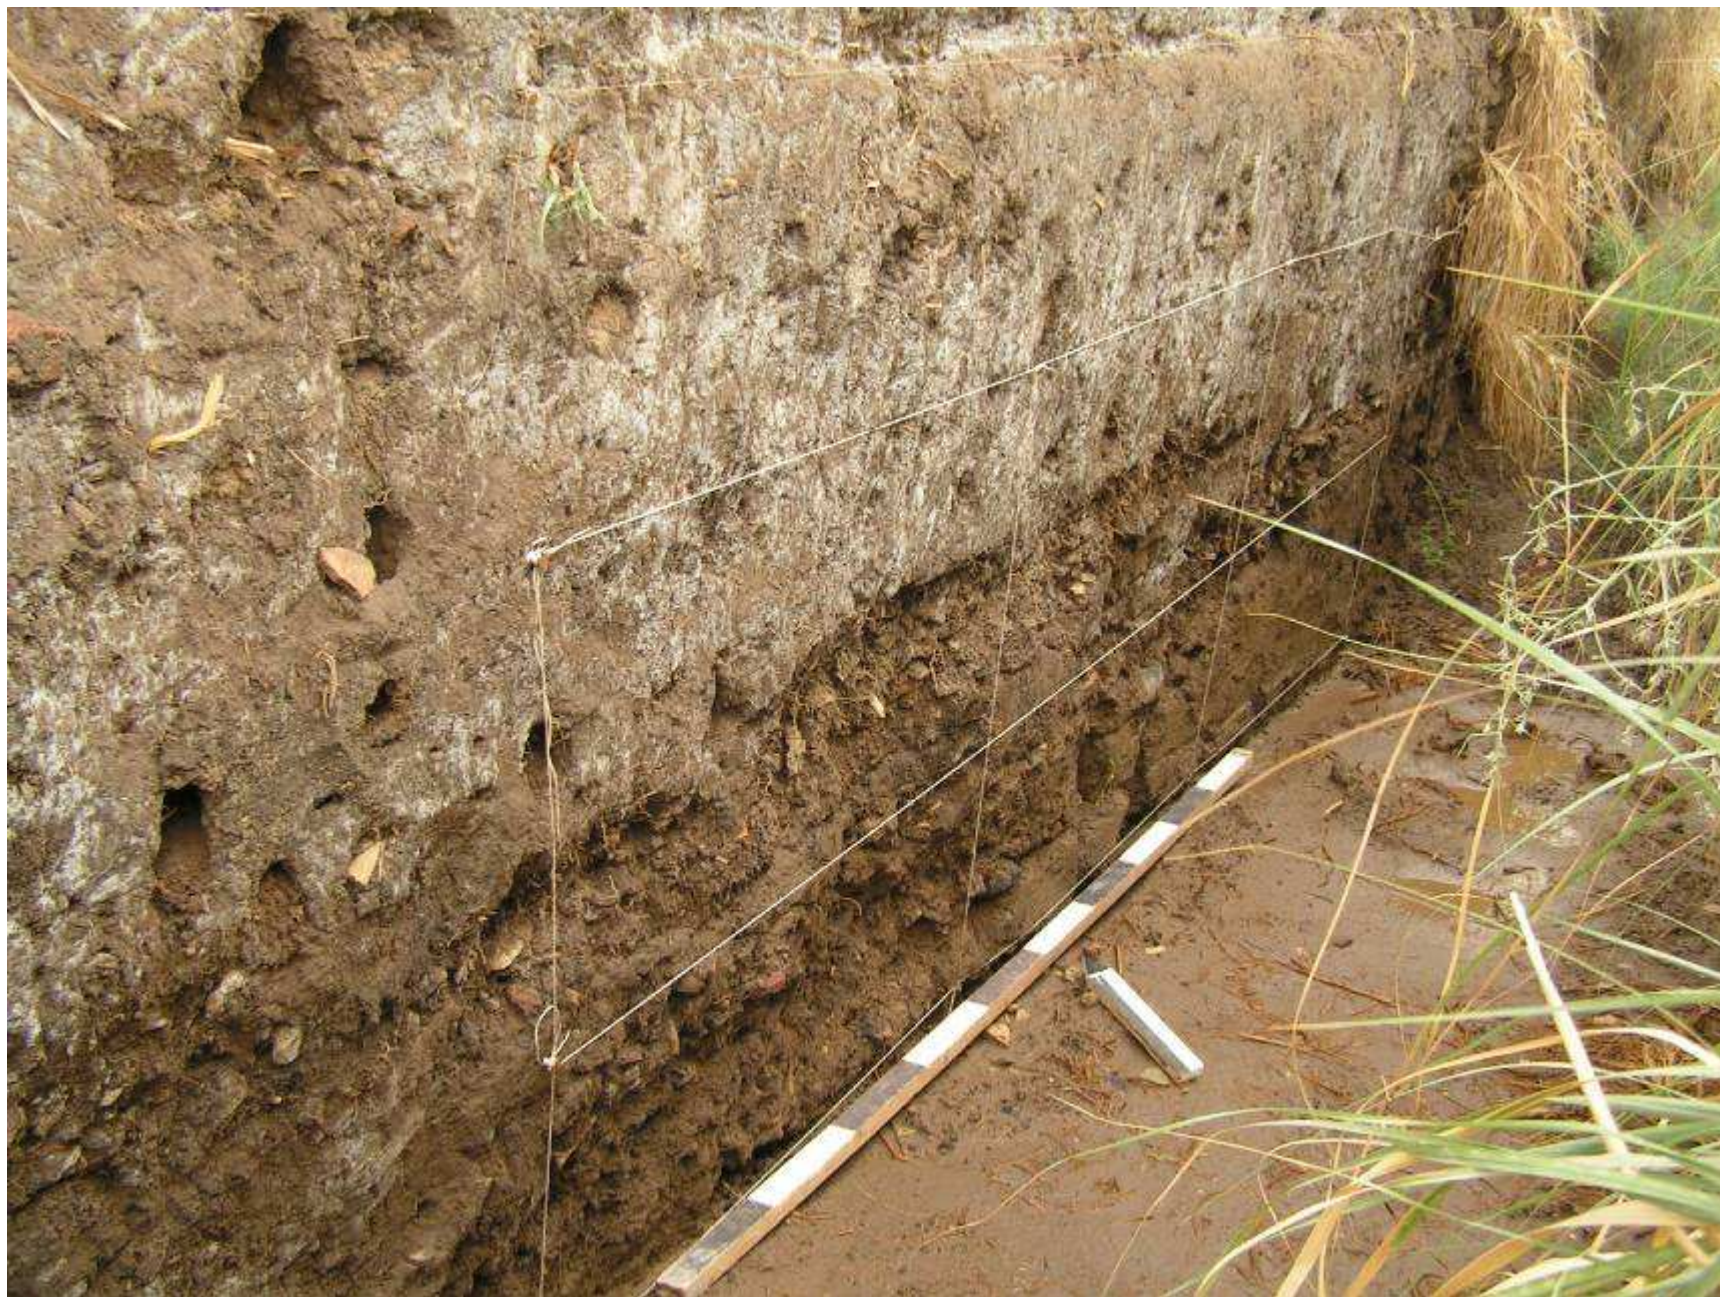
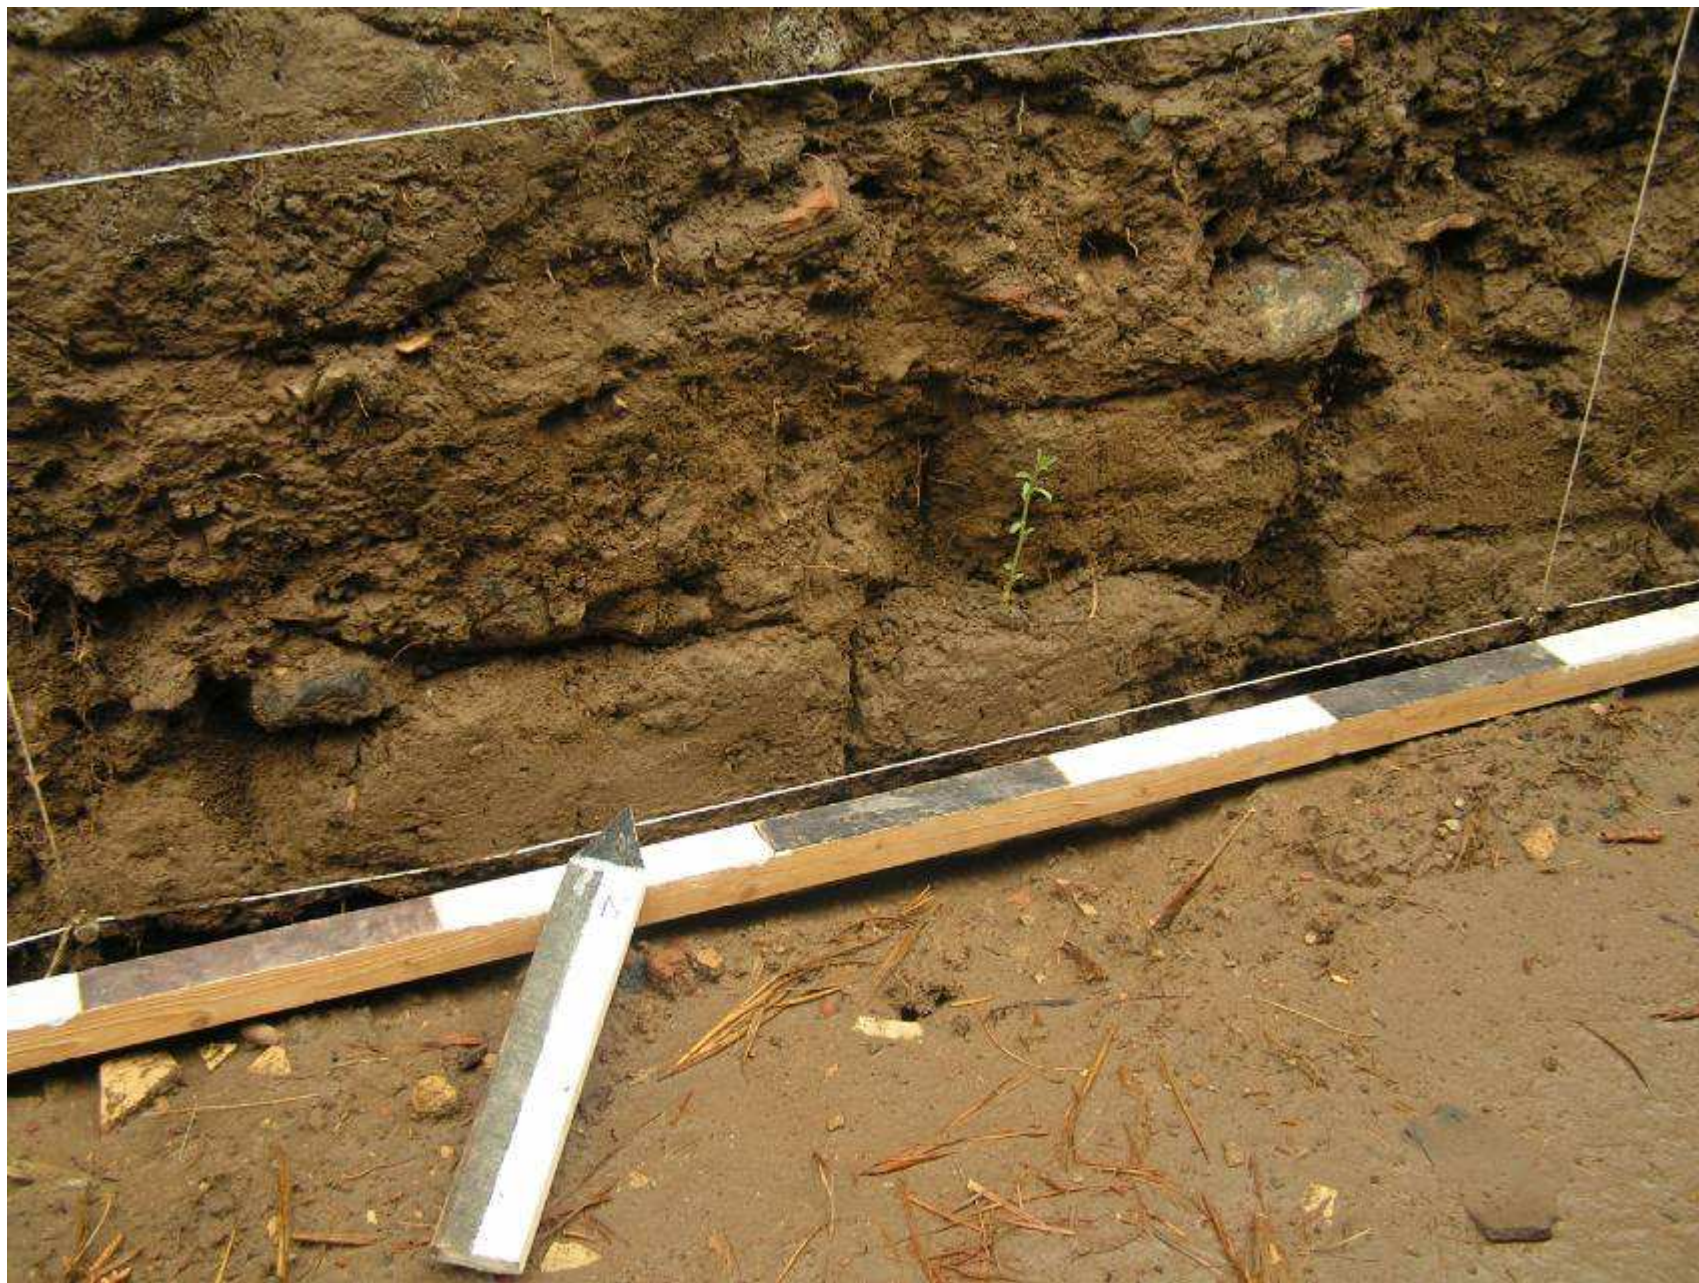
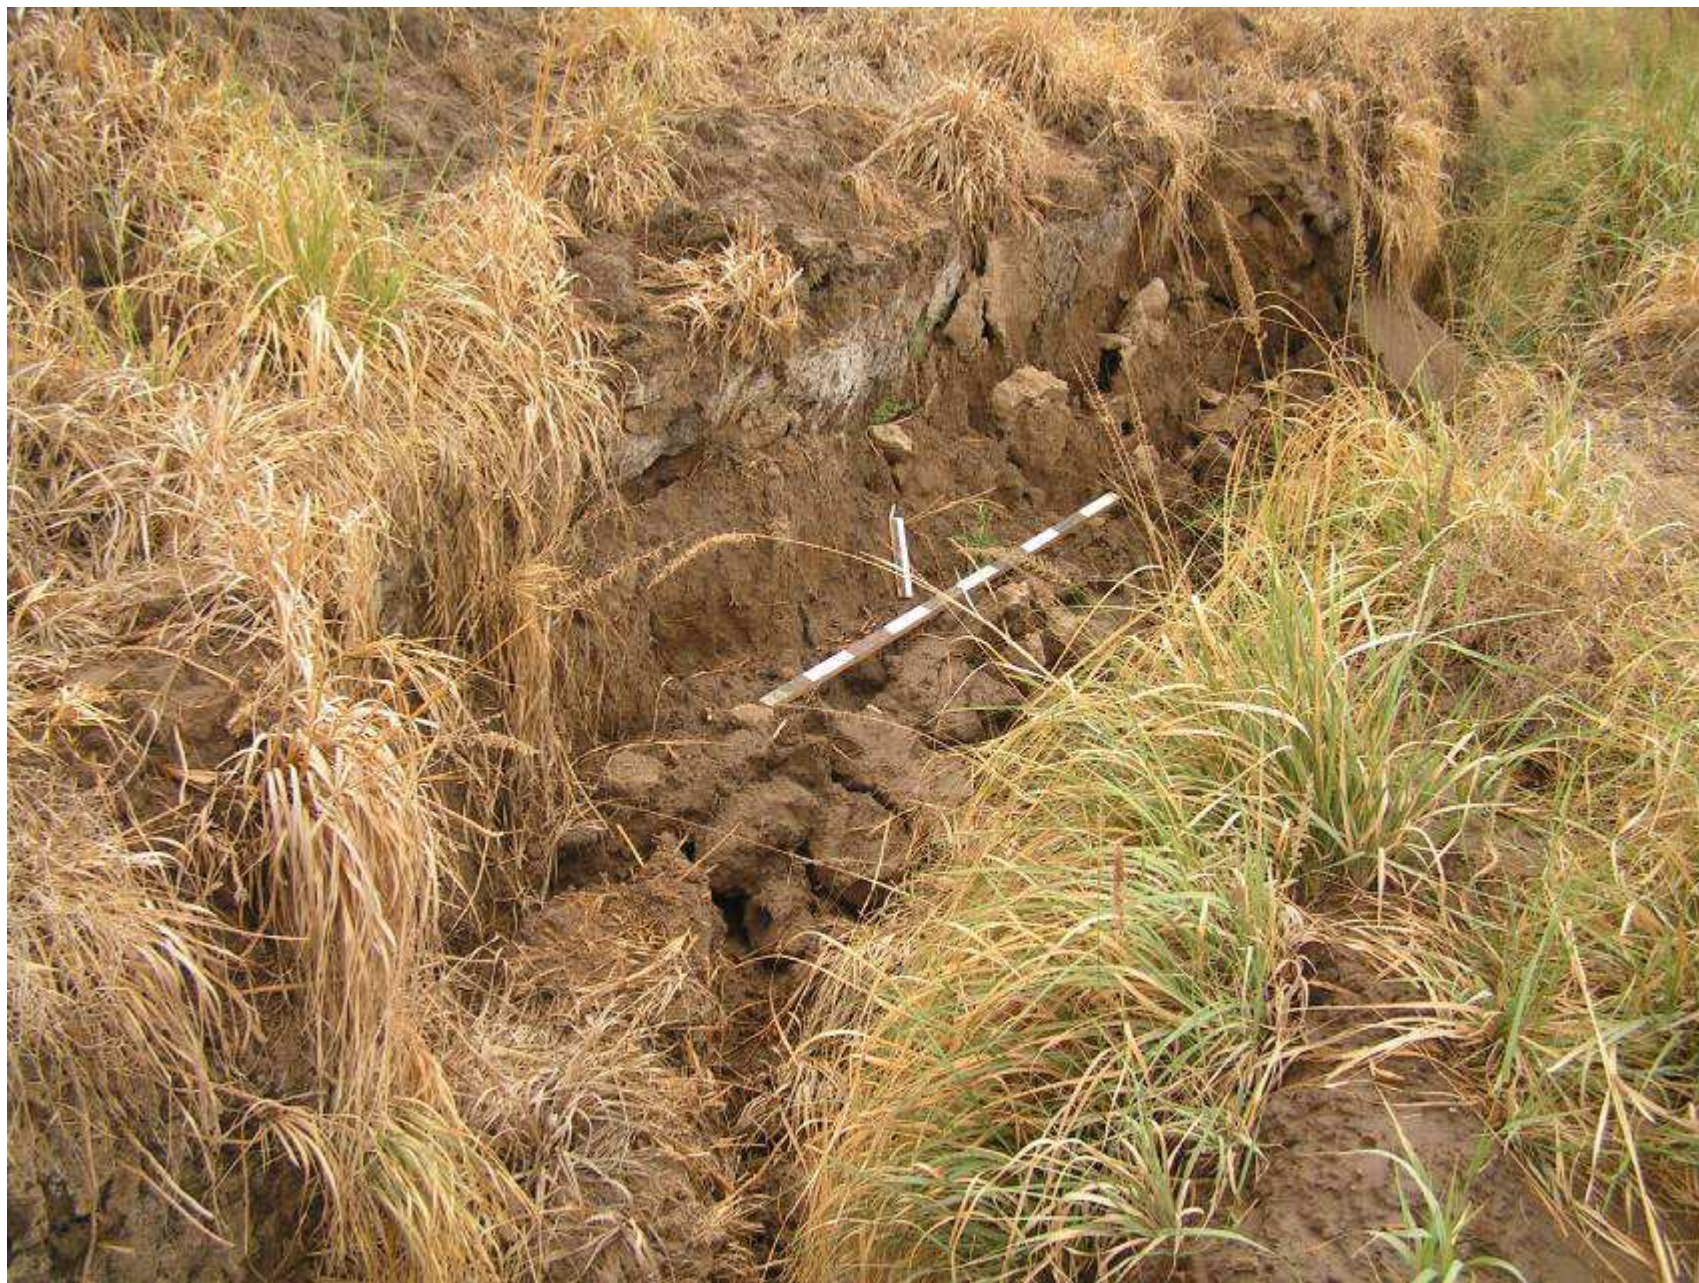
**Iraqi final report:** To ascertain the extent of the damage, we selected the middle-most portion of the trench. We created a grid in an area of 3 x 2 m (see Photo 33). We were able to distinguish a number of layers. The first is light yellow clay with a thickness of 45 cm. Interspersed in it is a layer of pottery fragments with a thickness of 5 cm. The second layer is light in color and has a thickness of 35 cm. The third is dark in color and has a thickness of 40 cm. The fourth layer comprises clay and pottery fragments. It has a thickness of 30-50 cm. In the same cross section, in the lower part of the trench, we found a row of sandy bricks, each measuring 32 x 32 x 10 cm (see Sketch 2 and Photo 34). This row of unbaked bricks points to the existence of an unbaked brick wall that may be part of a structure that extends to a deeper level and a greater distance. This structure may belong to the Neo-Babylonian period based on the dimensions of the unbaked brick, as such dimensions are known in the Neo-Babylonian period (32 x 32 x 10 cm). Pottery fragments were also found here. This trench has begun to collapse and cause additional damage. In two areas of the middle part of the trench, two collapses have occurred. The first has a length of 8 m. The other has a length of 10 m (see Photo 35).

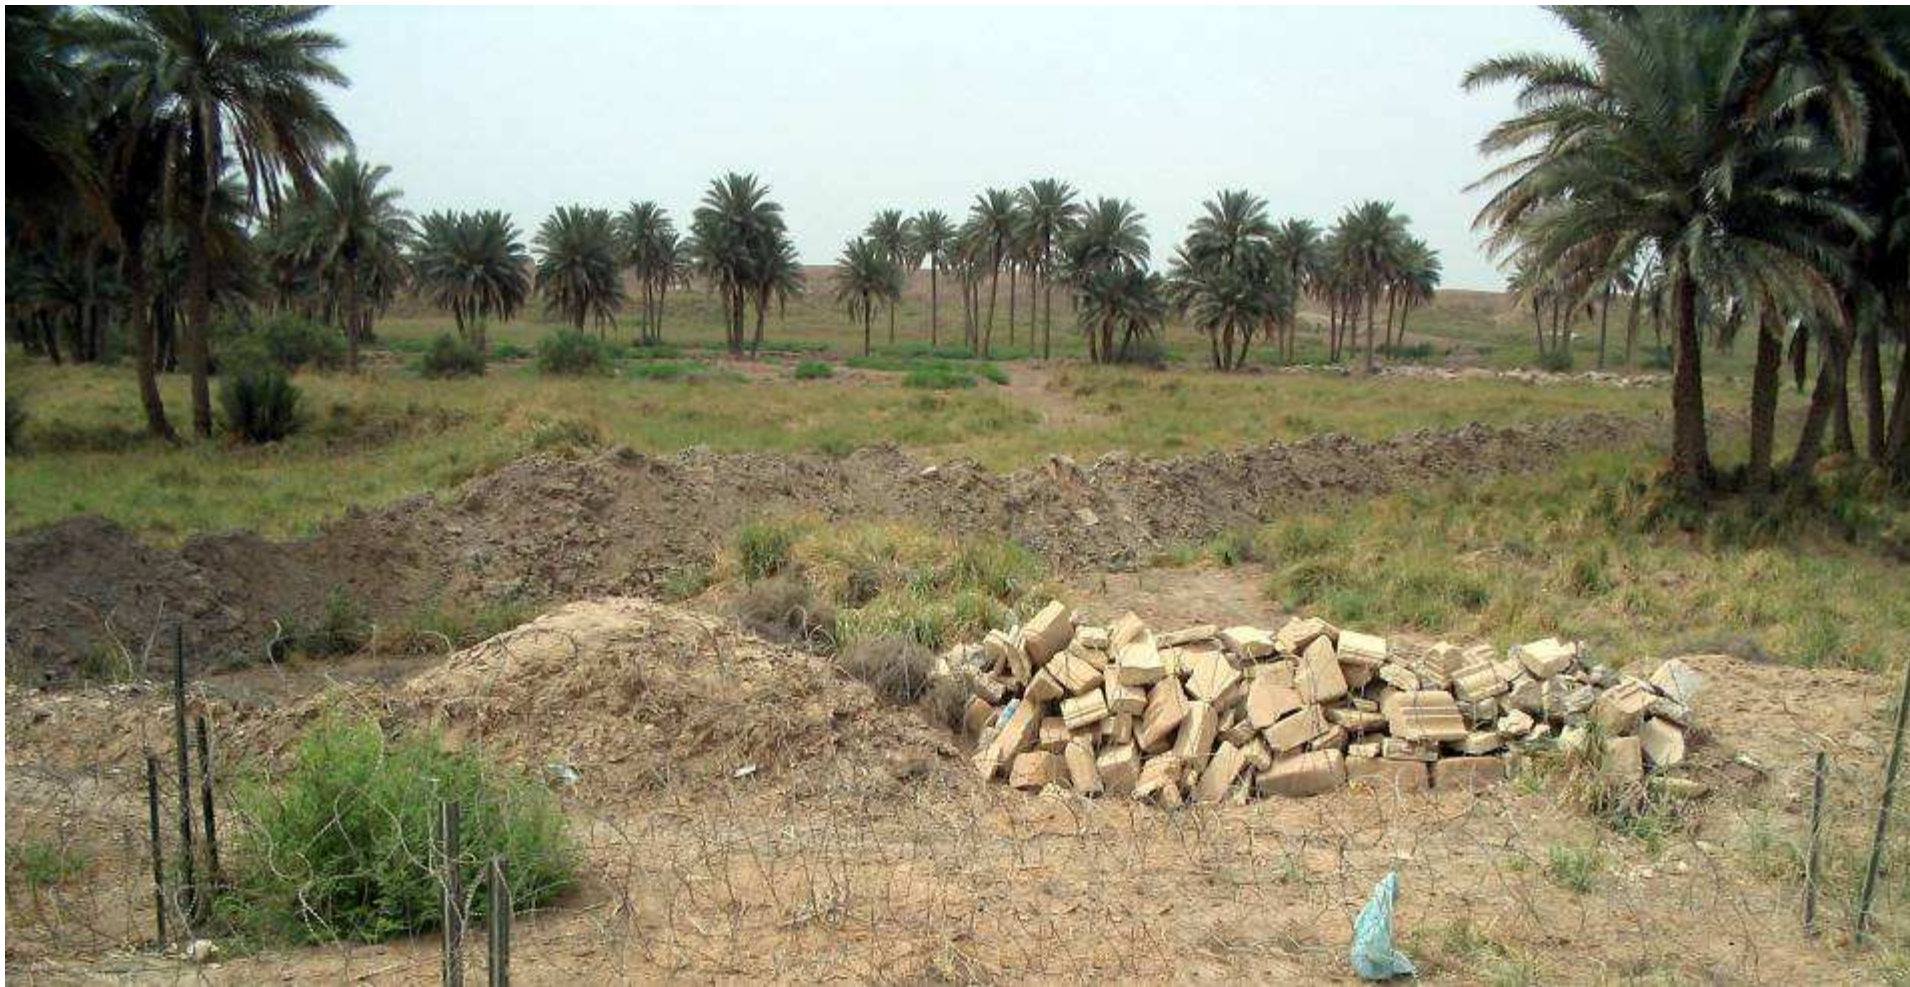
Earth and fired bricks were used to block a road leading south near the N end of Trench 8, May 2004, Russell photo 123\_2360 (photo © John Russell)

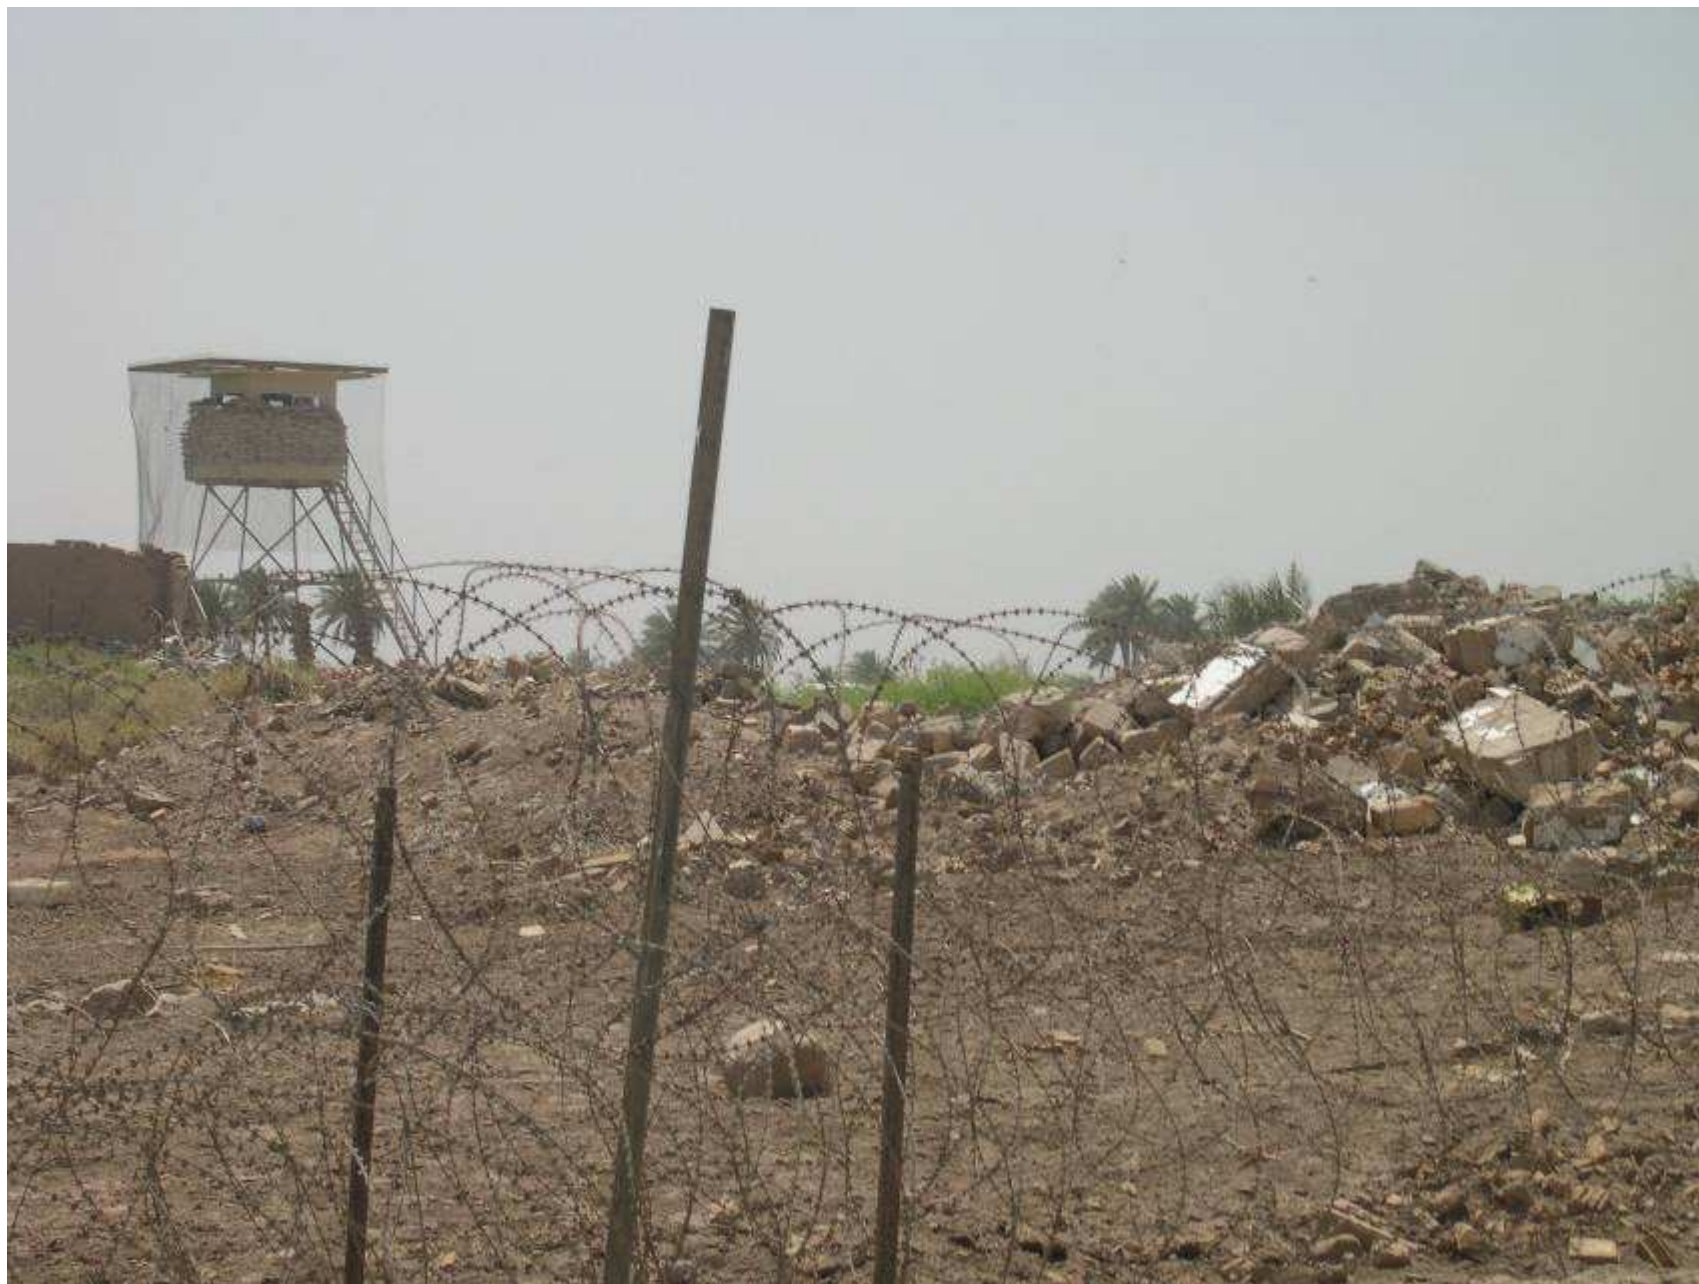
Berm viewed from the south, June 2003, Bahrani 2125 (photo © Zainab Bahrani)

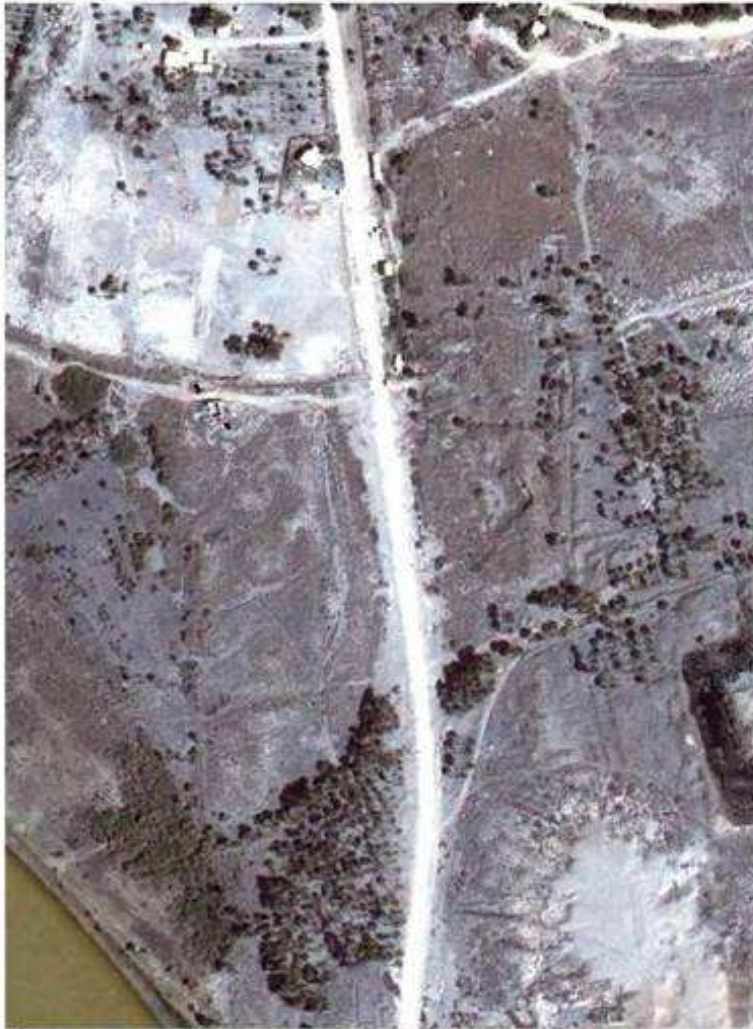
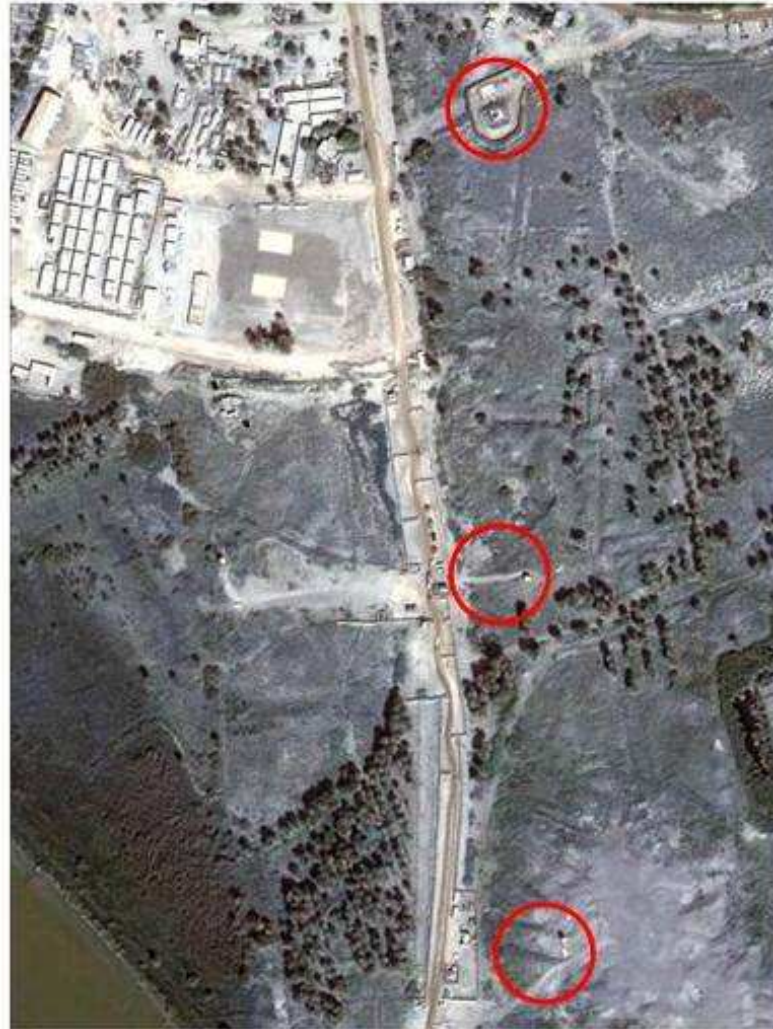
**Russell comment:** In addition to the two towers identified below by Stone east of the road, there is also a tower west of the road by the outer gate.

**Stone report:** Not reported in the Polish report are two other watchtowers located to the east of the main road into the camp from the south, as well as another structure [ammunition storage] further north. The watchtowers have dirt roads leading to them, and the structure is surrounded by a berm (Fig. 39).

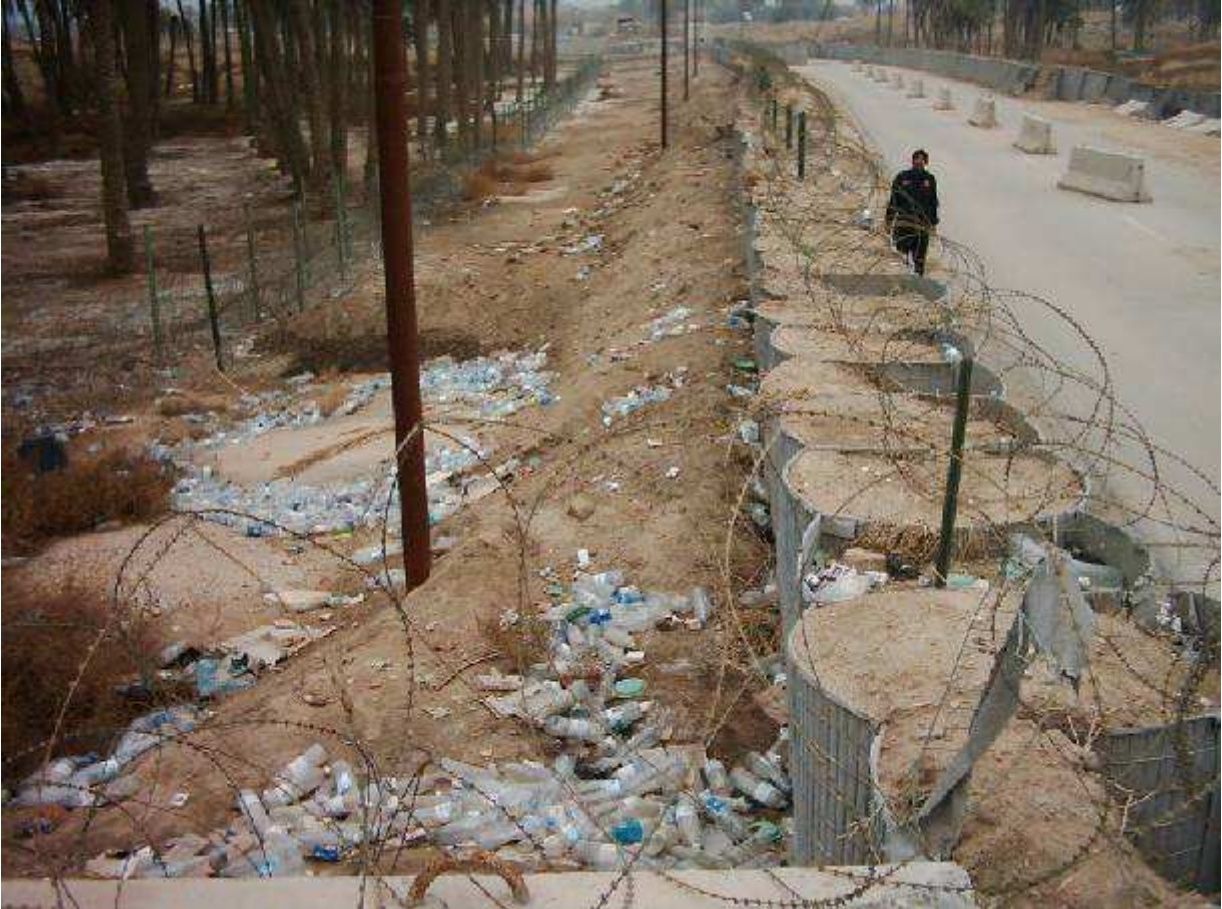
Iraqi final report fig. 69

Iraqi preliminary report	Iraqi final report	Curtis report
<p>Parts of the hills along both sides of the road were removed. <u>[A: whose length totals 300-400 m, were removed, and the traces of cutting are very apparent. They have been filled in with sand bags.]</u> a. Gate to the village of al-Jumjumah: Along the road, on the left side, HESCO bags were filled [and positioned to cover an area] with a length of 340 meters. The length of the area covered by the bags on the right side of the road is 285 meters. There are many fragments of ancient baked bricks and pottery visible inside the HESCO bags <u>[A: large fabric bags in wire mesh containers that are filled with earth or sand].</u></p>	<p>HESCO bags are present along both sides of al-Jumjumah Road, within the boundaries of the city of Babylon, covering a length of 380 m on the left and 250 m on the right side of the road. The bags are all filled with dirt from the city of Babylon containing pottery fragments and baked brick fragments (Photo 69).</p>	<p>To the south of the Reno Gate for a distance of about 200m the road is lined by HESCO bags that have clearly been filled with deposits from the Babylon site, containing sherds, bones, etc.</p>

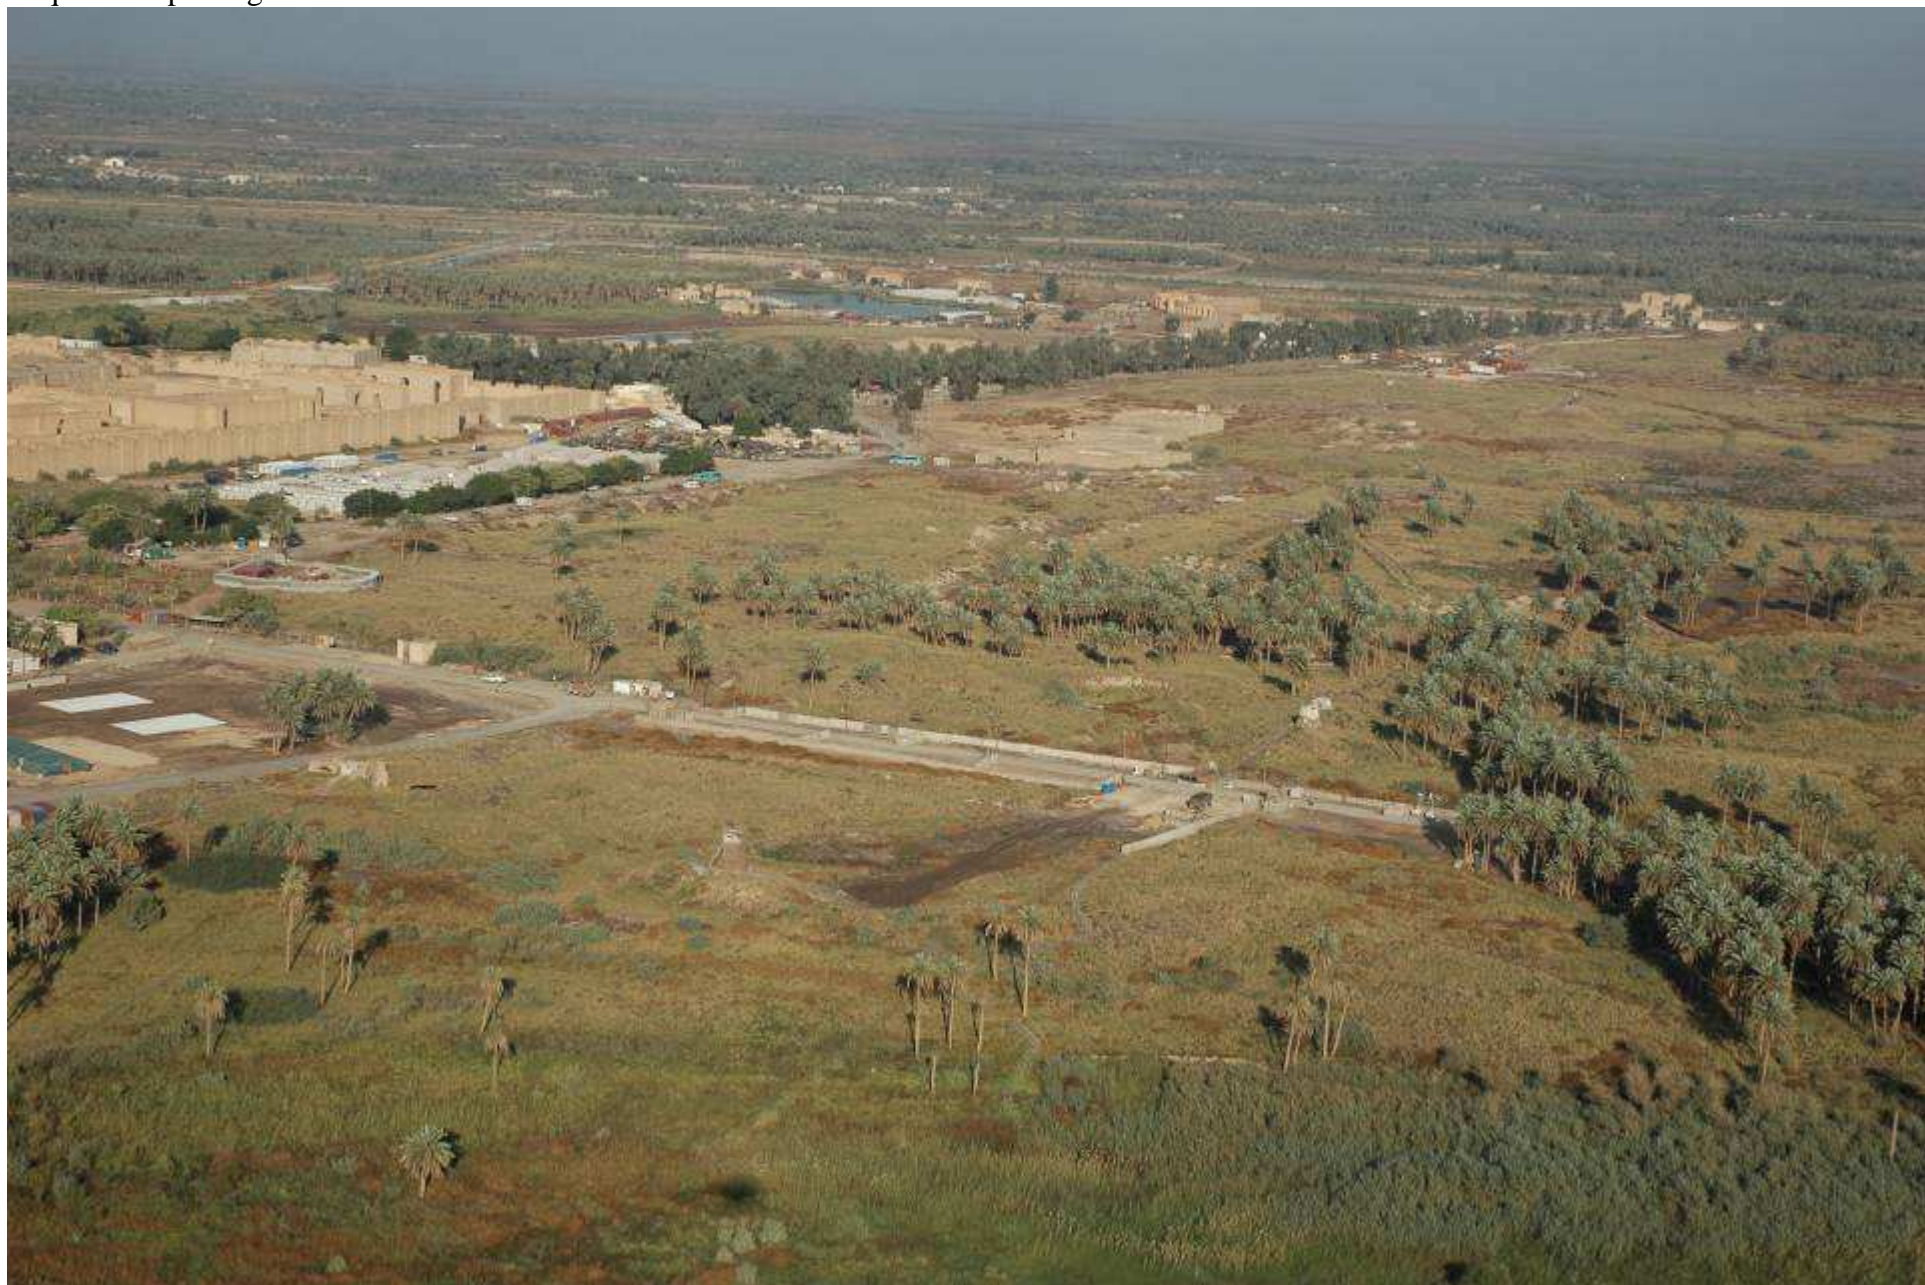
View of south (Reno) gate looking NE with HESCO barriers lining road, Polish photo 26 (photo © Ministry of Culture and National Heritage, Republic of Poland)

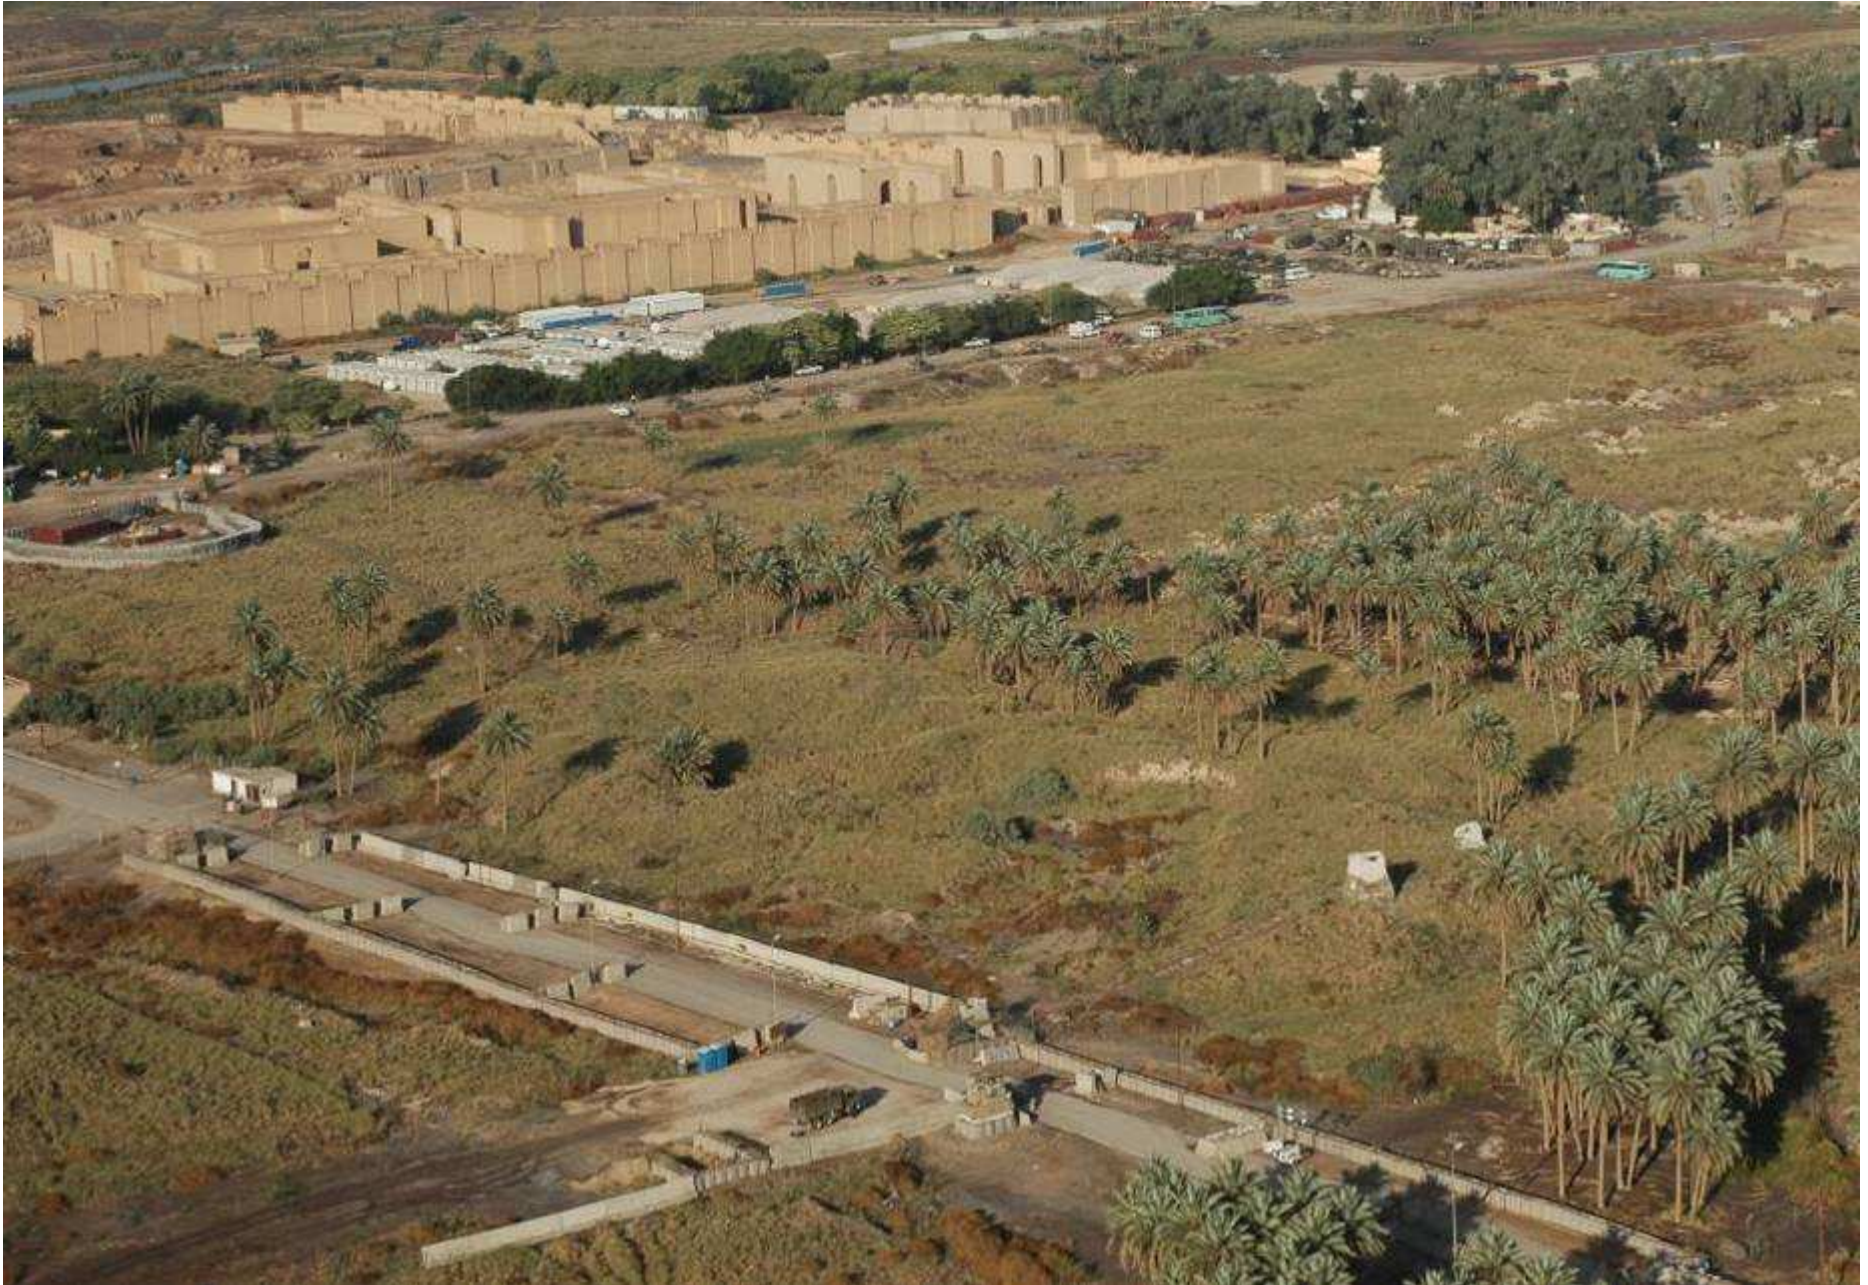
View of south (Reno) gate looking NE with HESCO barriers lining road, Polish photo 27, detail (photo © Ministry of Culture and National Heritage, Republic of Poland)

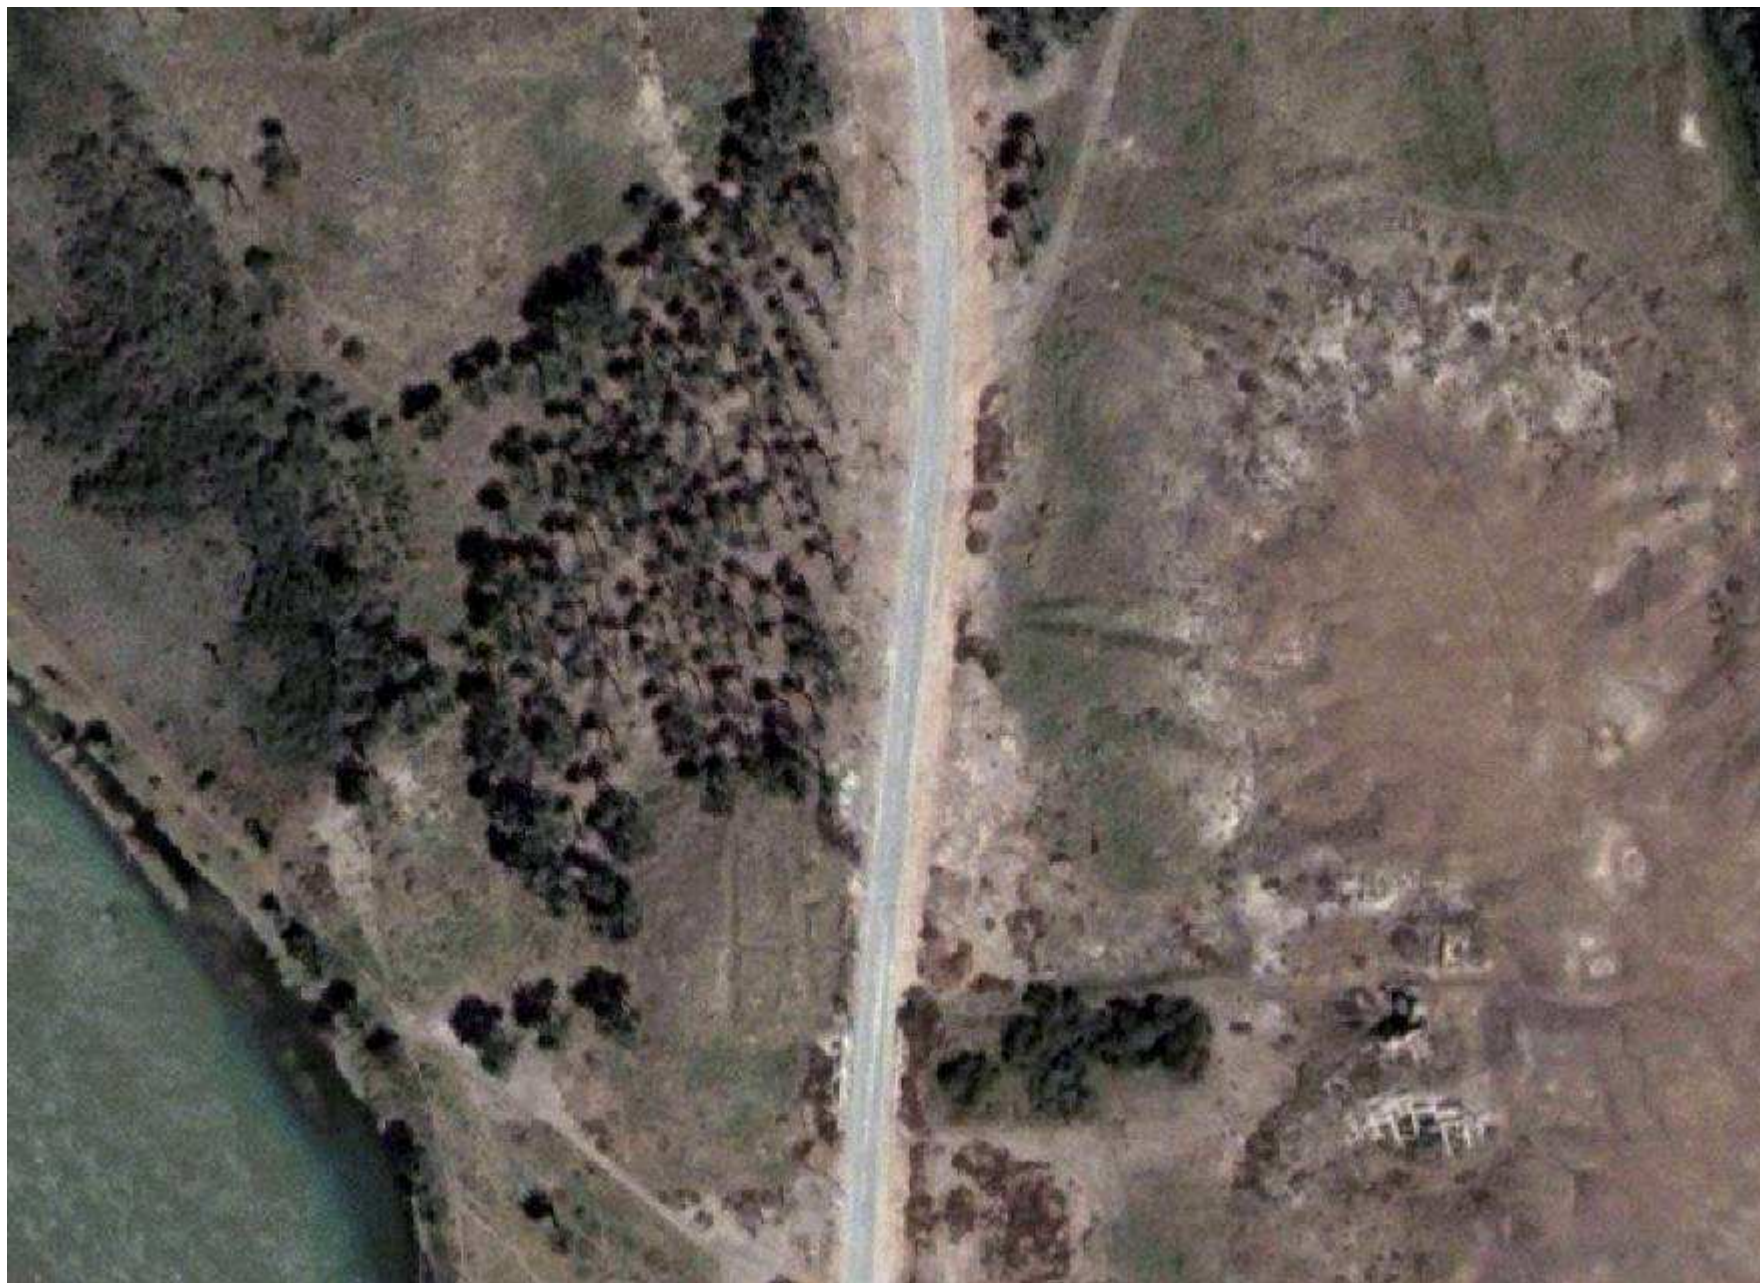
<b>Iraqi preliminary report</b>	<b>Iraqi final report</b>	<b>Curtis report</b>
<p>There are also cuttings outside the gate and on the left, covering an area of 38 meters x 6 meters and cuttings on the right adjacent to the gate with an area of 30 right [sic] 8 meters.</p>	<p>5. Fifth cut: This cut is in the southern part of the city, west of the street that links the city to the village of al-Jumjumah. The objective of the cutting works in this area was to create earthen barriers. Most of the earthen barriers and obstacles located in this area contain fragments of baked bricks and pottery. The fifth cut has a length of 38 m, a width of 6 m, and a height of 3 m. The cross-section resulting from the cutting works contains various fragments (Photo 43).</p> <p>6. Sixth cut: It is on the eastern side of the street, close to and similar to the fifth cut, it contains ancient pottery fragments, etc. It has a length of 30 m, a width of 1-8 m, and a height of 6 m (Photo 44).</p>	<p>There are further large cuttings to the south of the barbed wire perimeter that we were not allowed to visit.</p>

Area of 5th and 6th cuts, 5 July 2002, Russell composite
