# **Report on Damage to the Site of Babylon, Iraq**

**John Malcolm Russell, Ph.D.**

**Cultural Heritage Center  
Bureau of Educational and Cultural Affairs  
Department of State**

**April 2010**

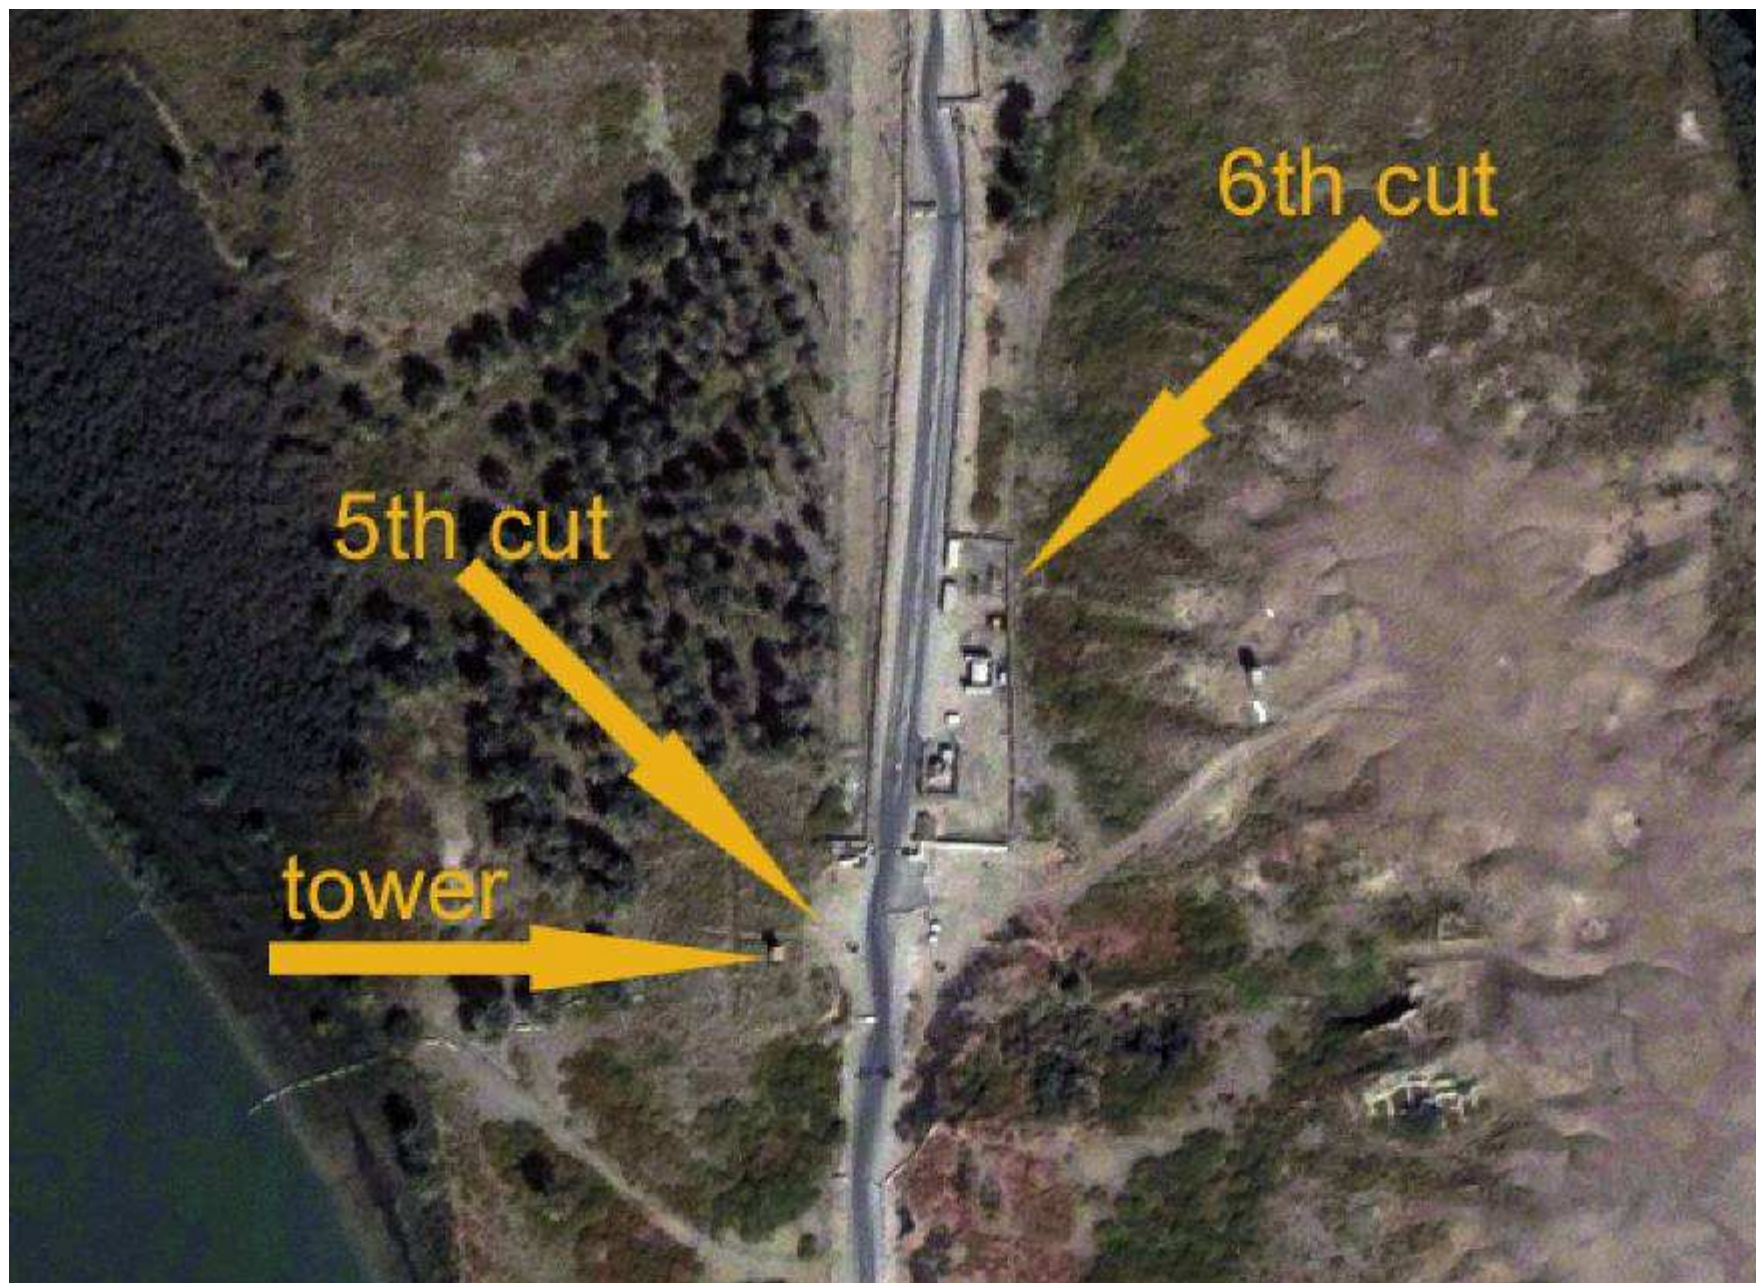
5th and 6th cuts, 8 October 2004, Russell composite

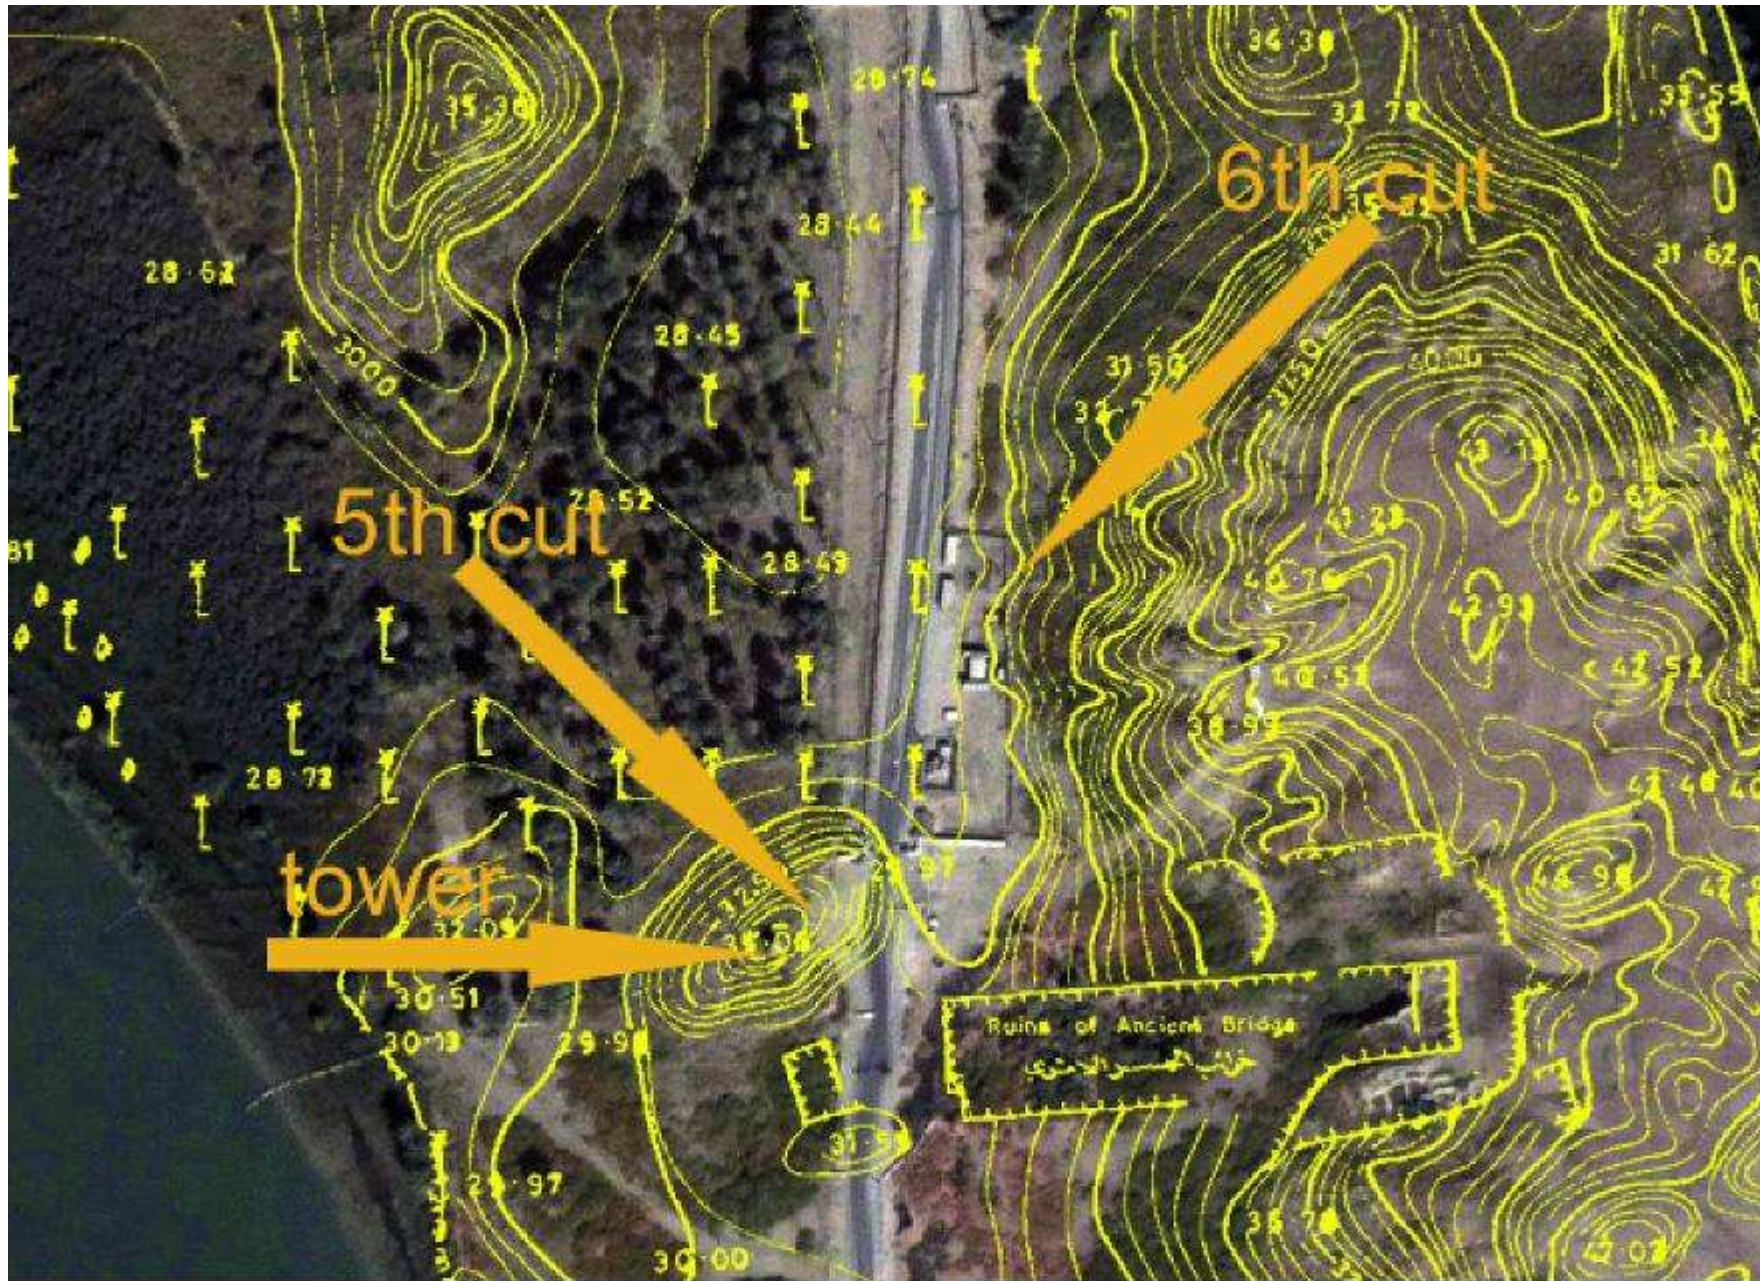
Area of 5th and 6th cuts with original topography, 8 October 2004, Russell composite

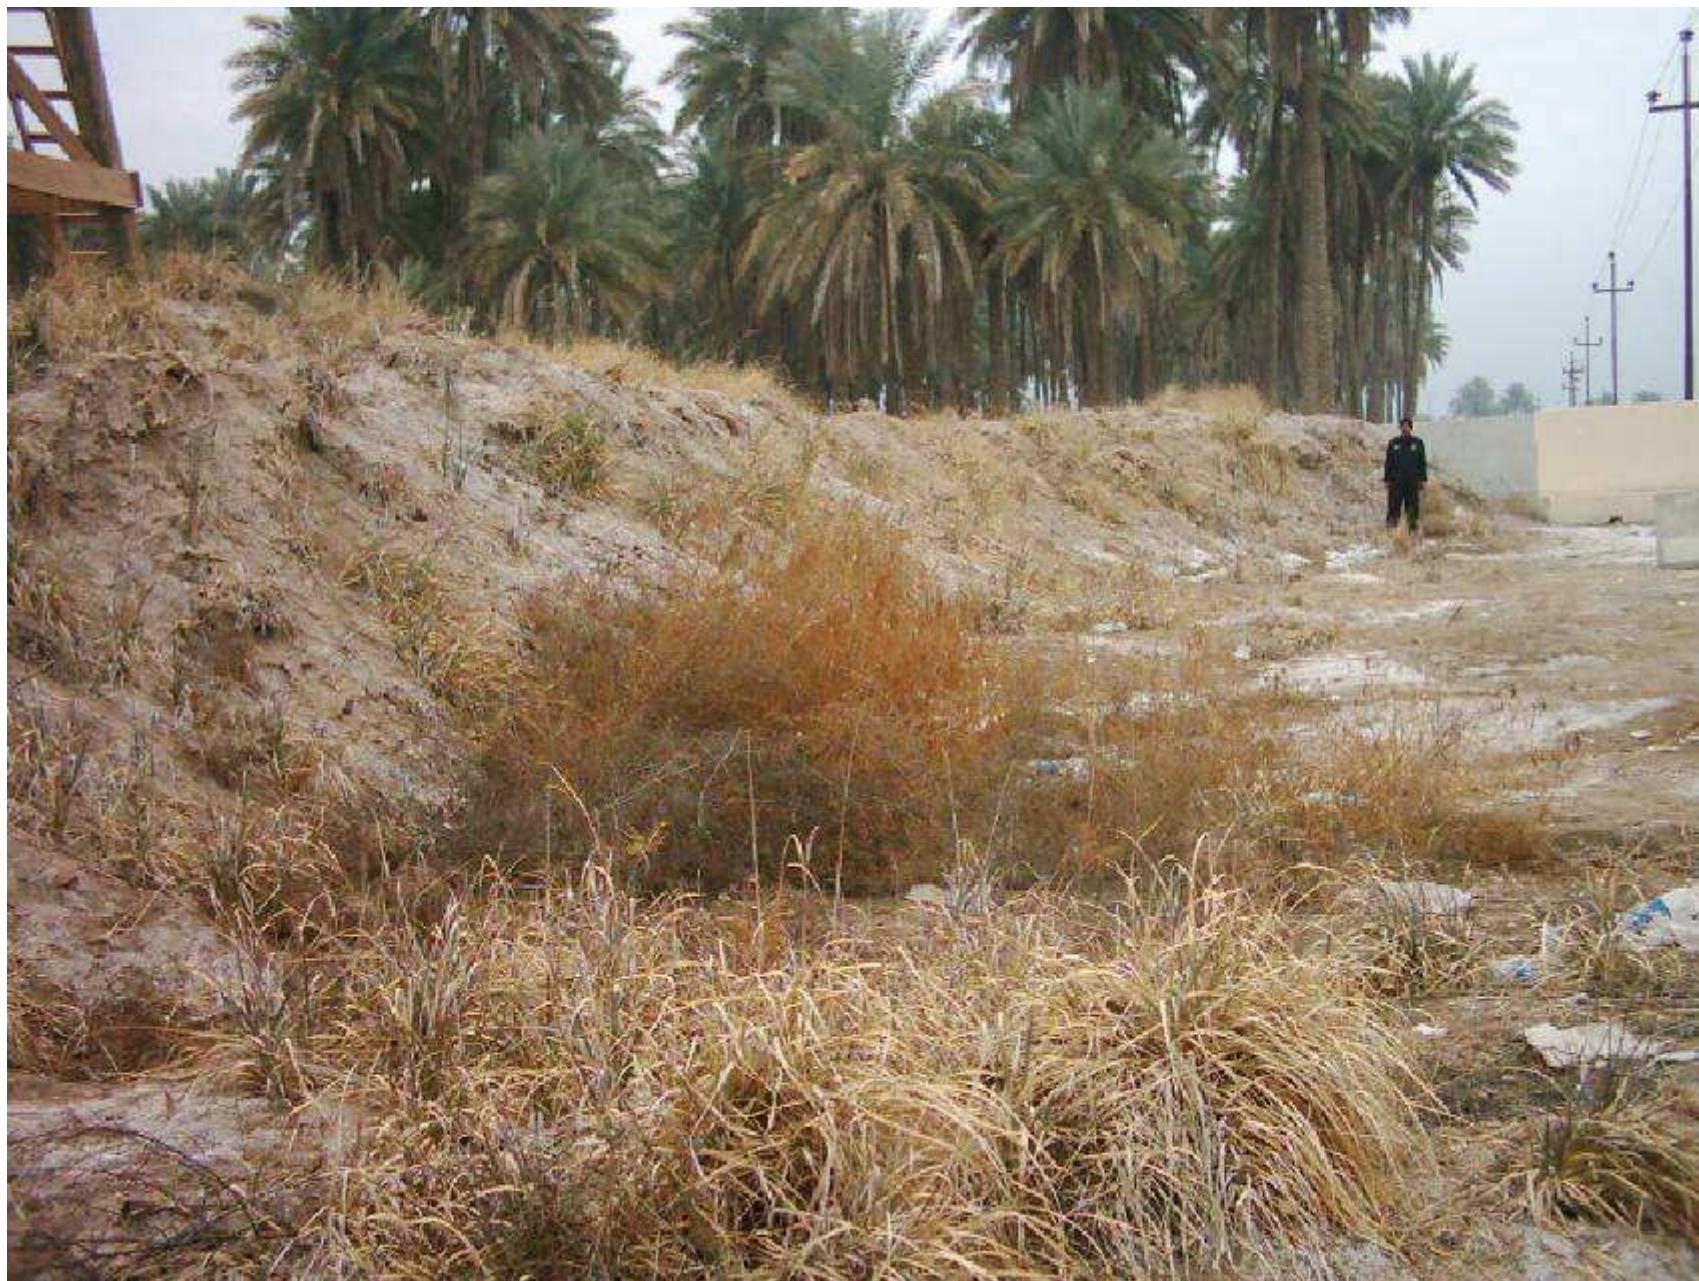
5th cut, view looking north with watch tower at left, Iraqi final report fig. 43

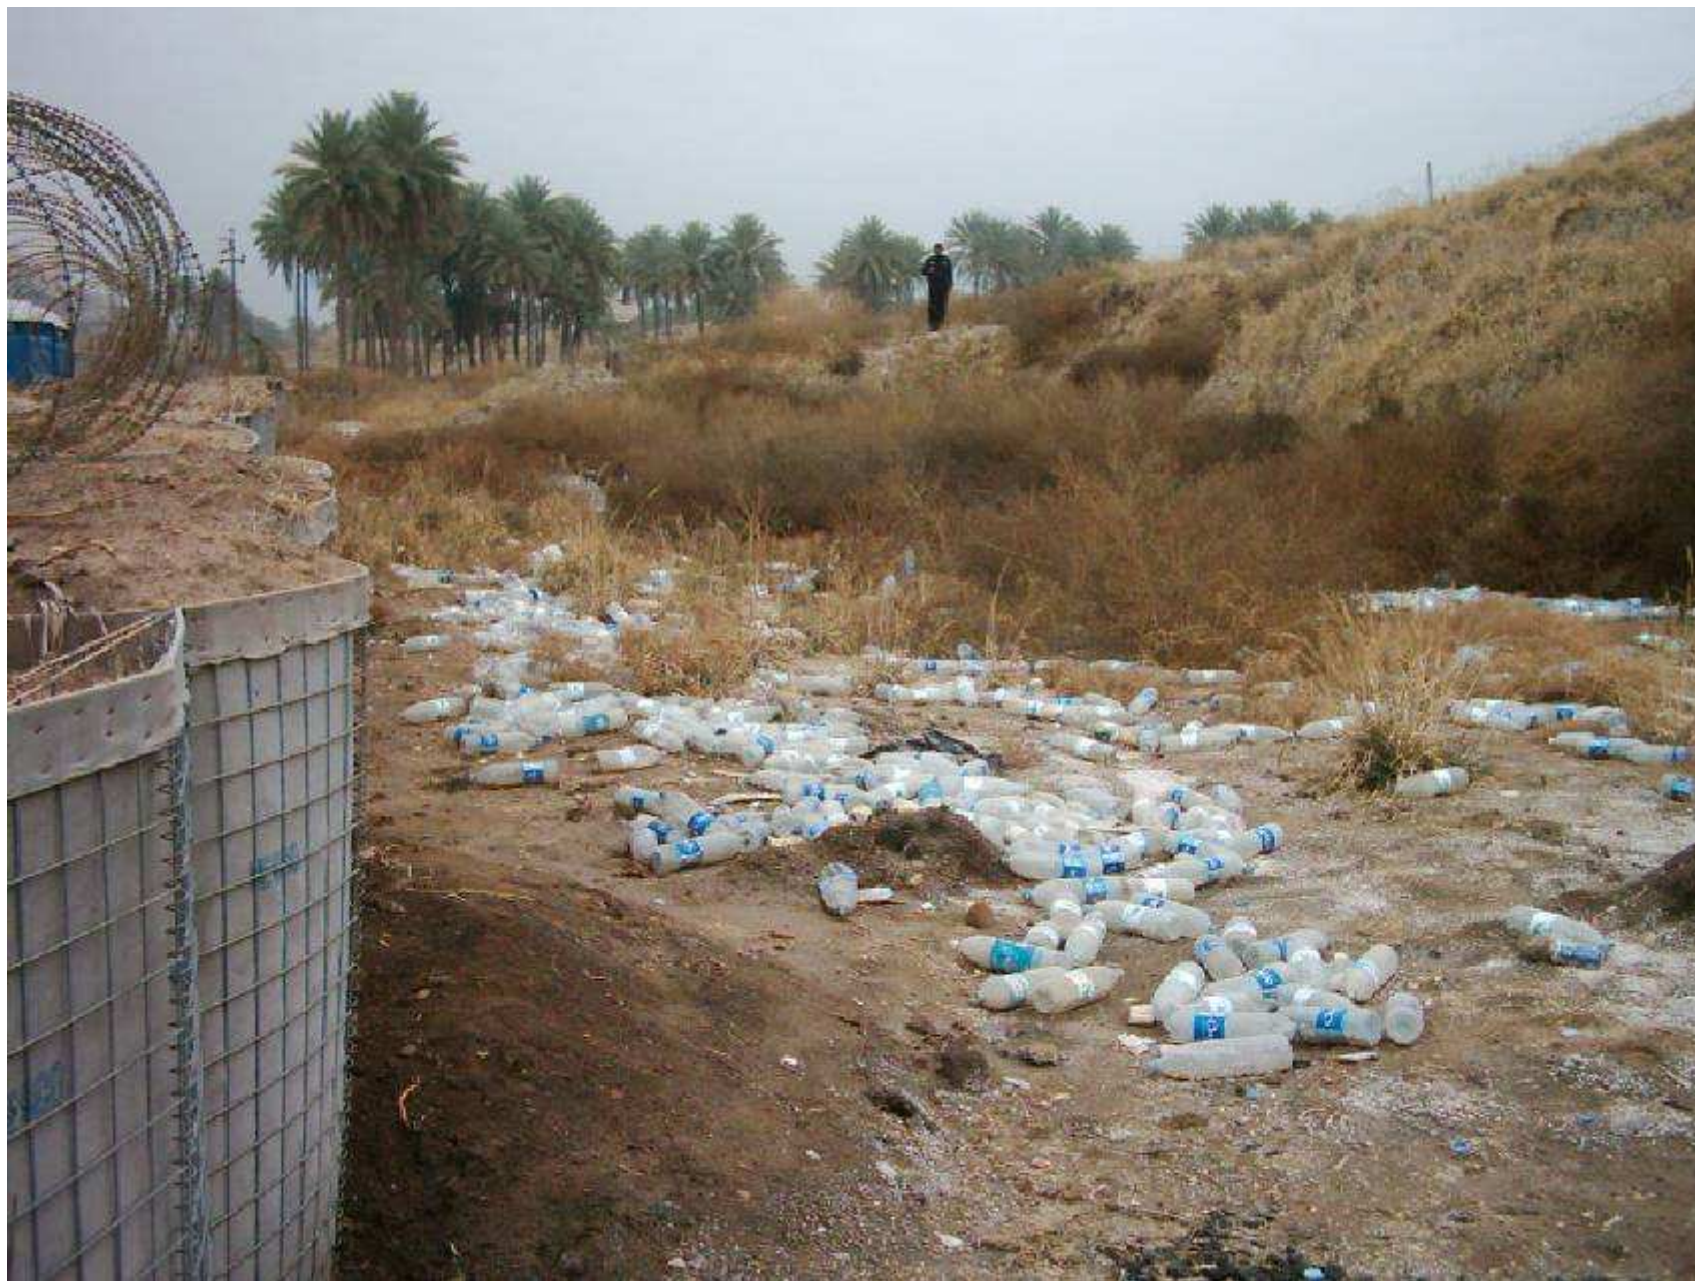
6th cut, view looking north, Iraqi final report fig. 44

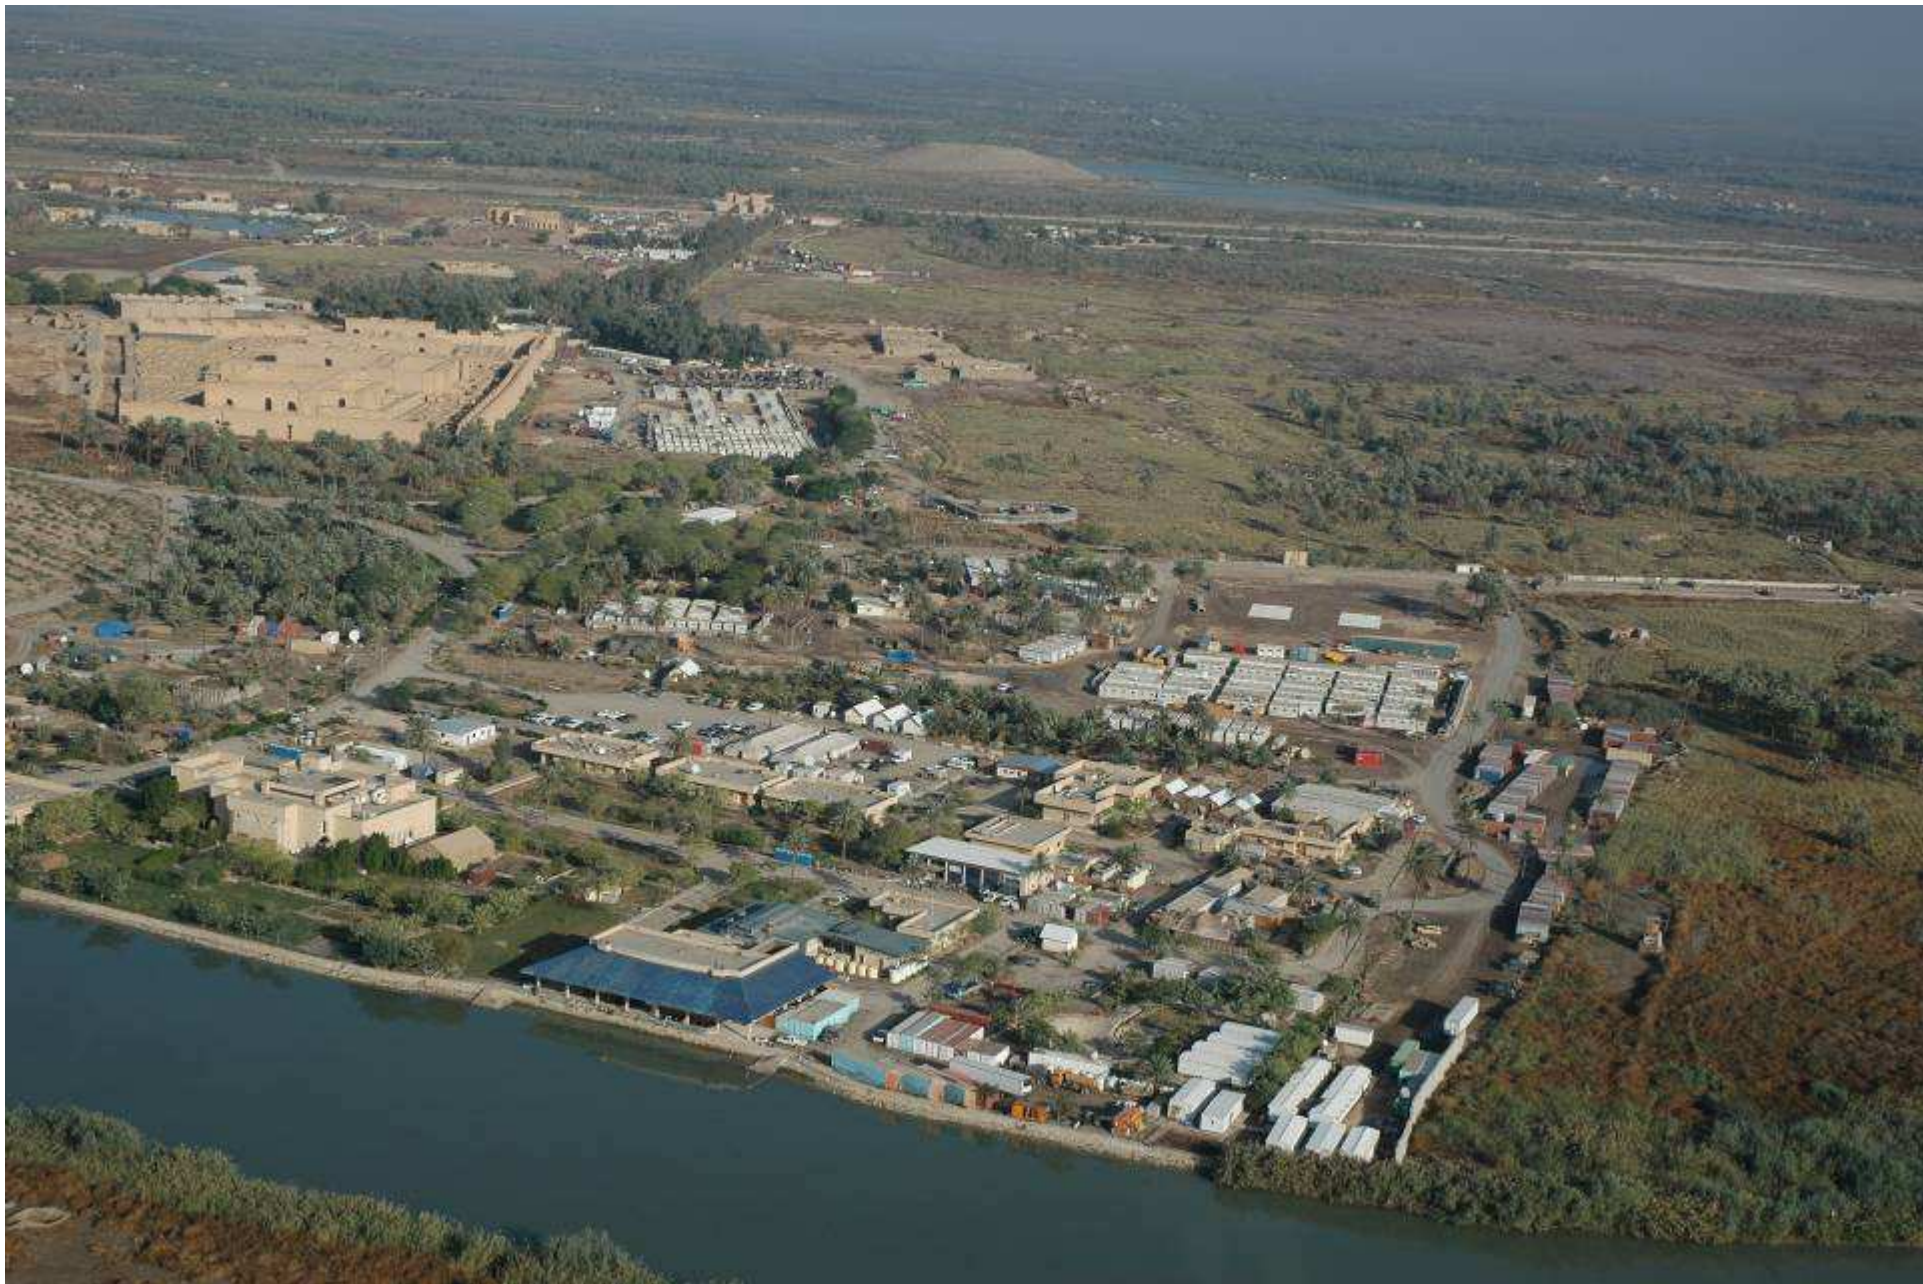
Modern infrastructure (foreground) and Tent City #2 (middle ground) viewed from the west, Polish photo 23 (photo © Ministry of Culture and National Heritage, Republic of Poland)

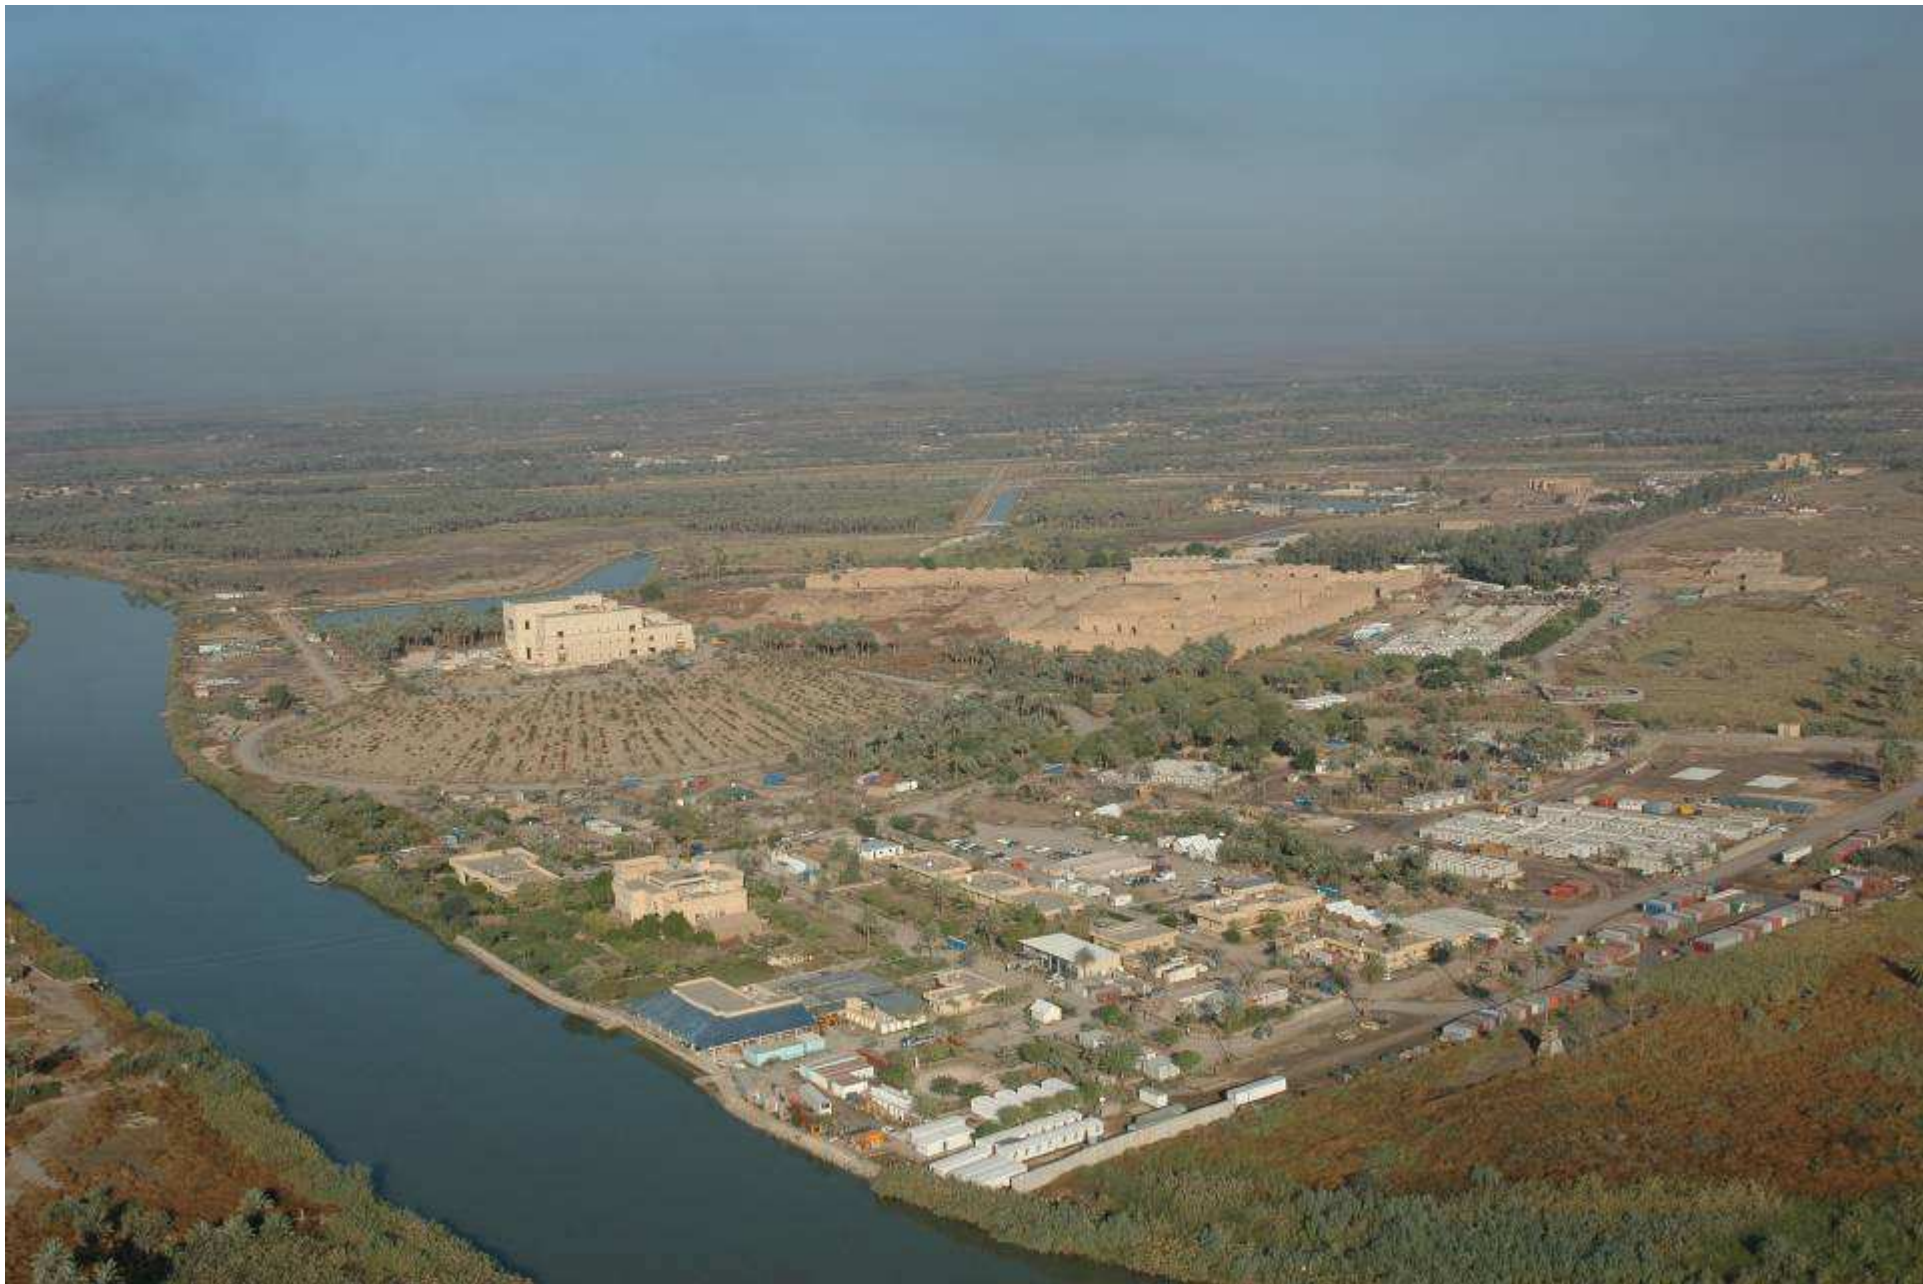
Modern infrastructure (foreground) and Tent City #2 (right middle ground) viewed from the southwest, Polish photo 24 (photo © Ministry of Culture and National Heritage, Republic of Poland)

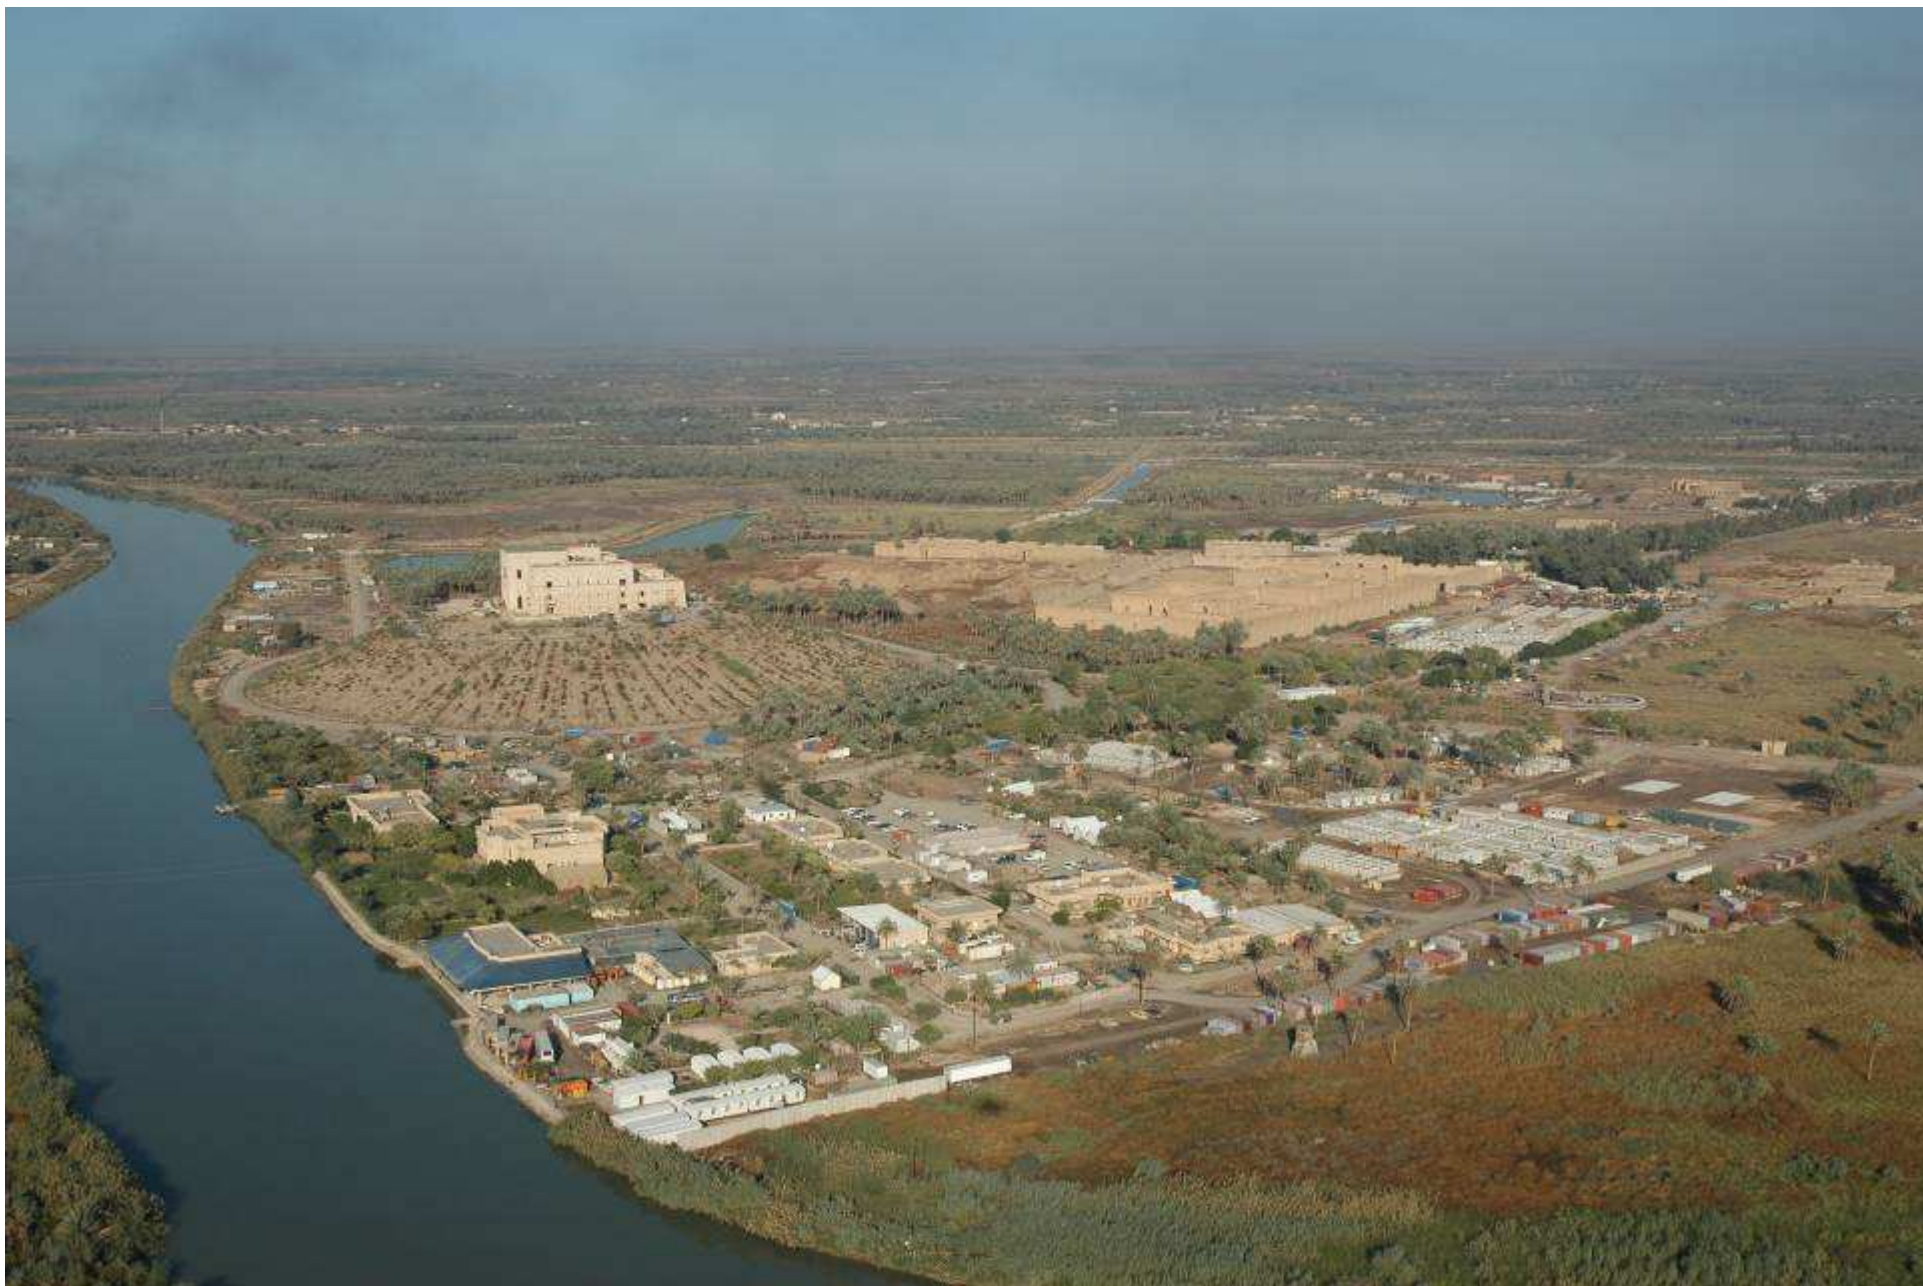
Modern infrastructure (left) and Tent City #2 (right) viewed from the south, Polish photo 25 (photo © Ministry of Culture and National Heritage, Republic of Poland)

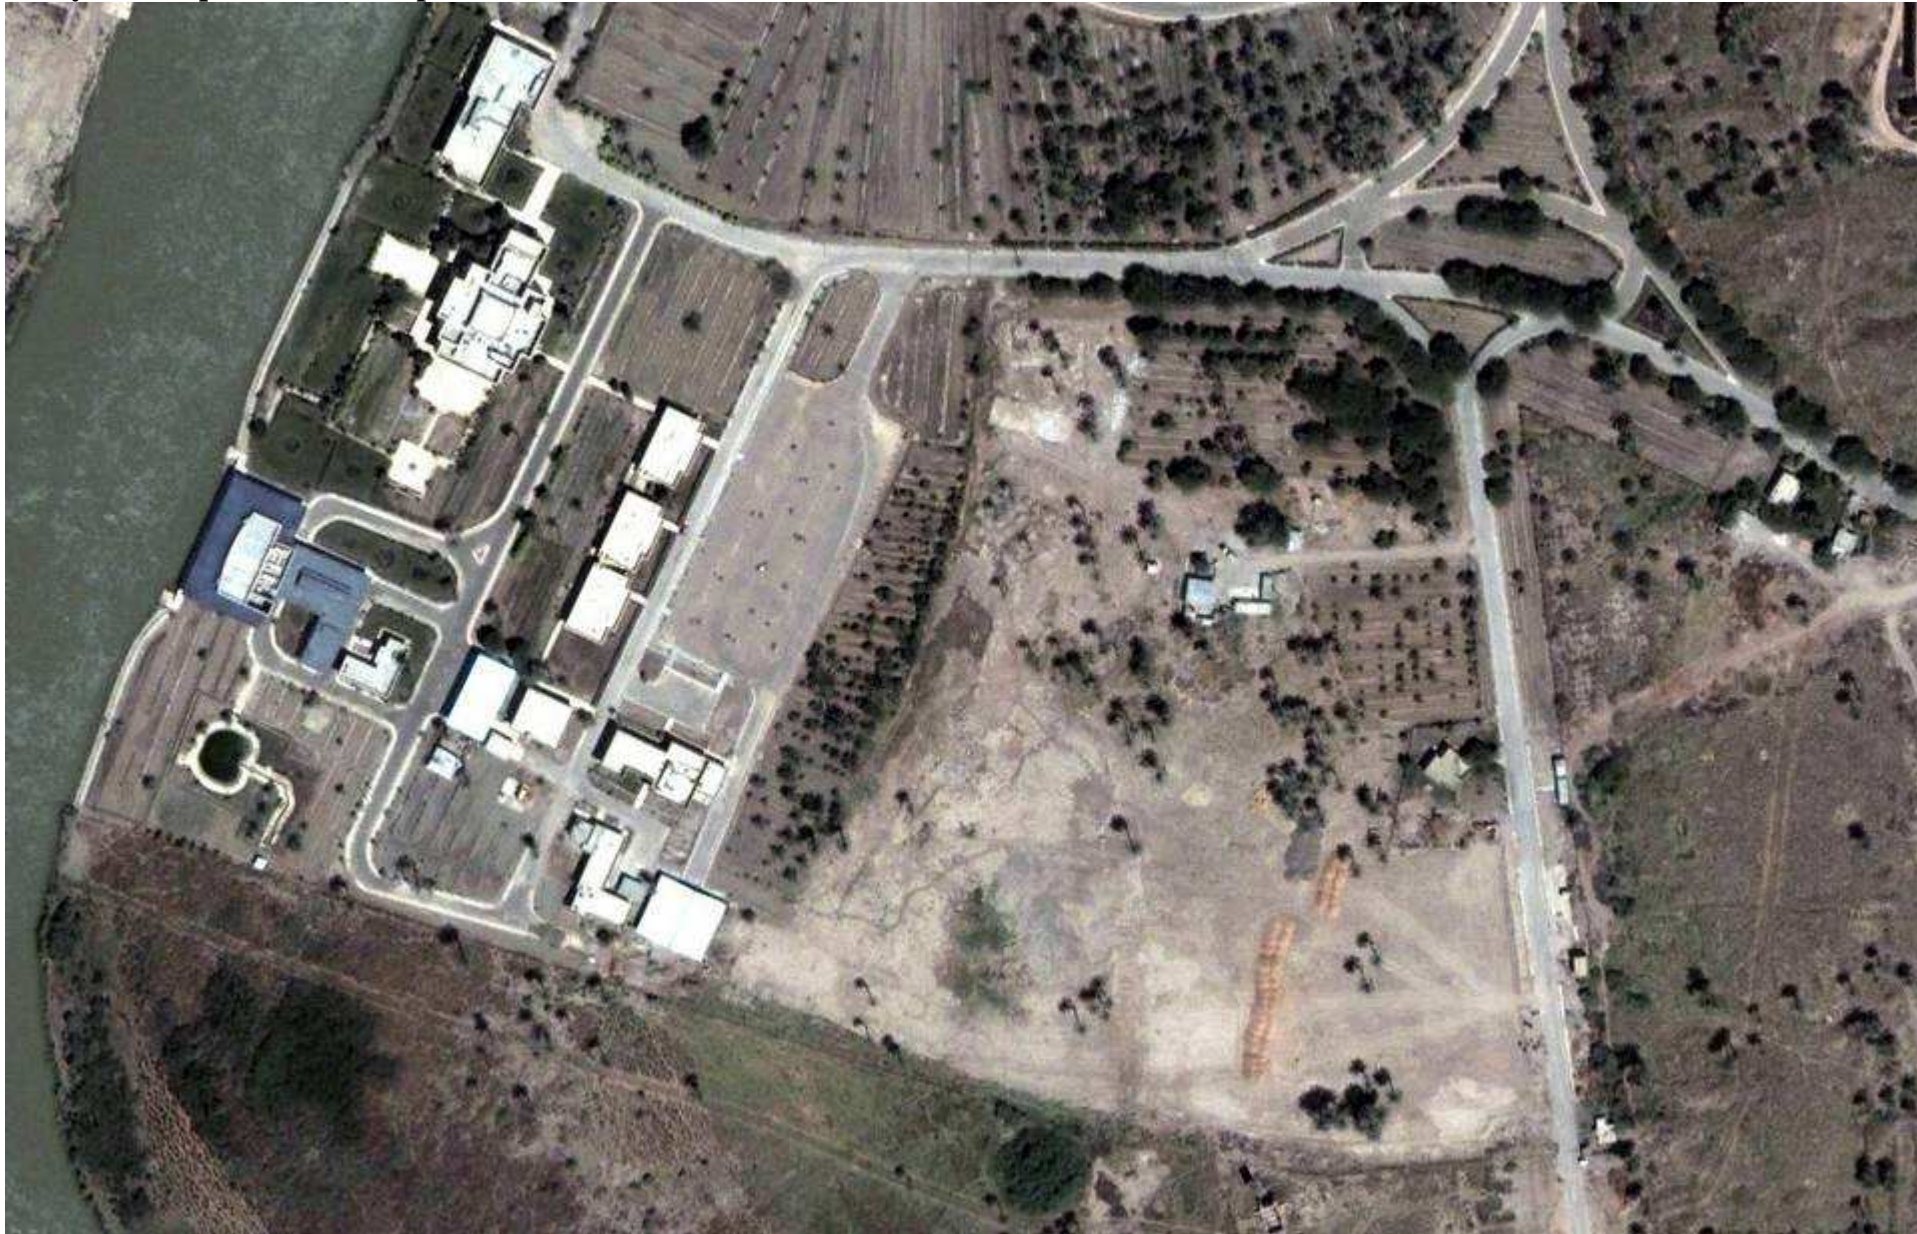
Under Saddam, the area beside the river south of his palace was developed with modern buildings and parking lots, while the adjacent area to the east was left open. (image 5 July 2002, Russell composite).

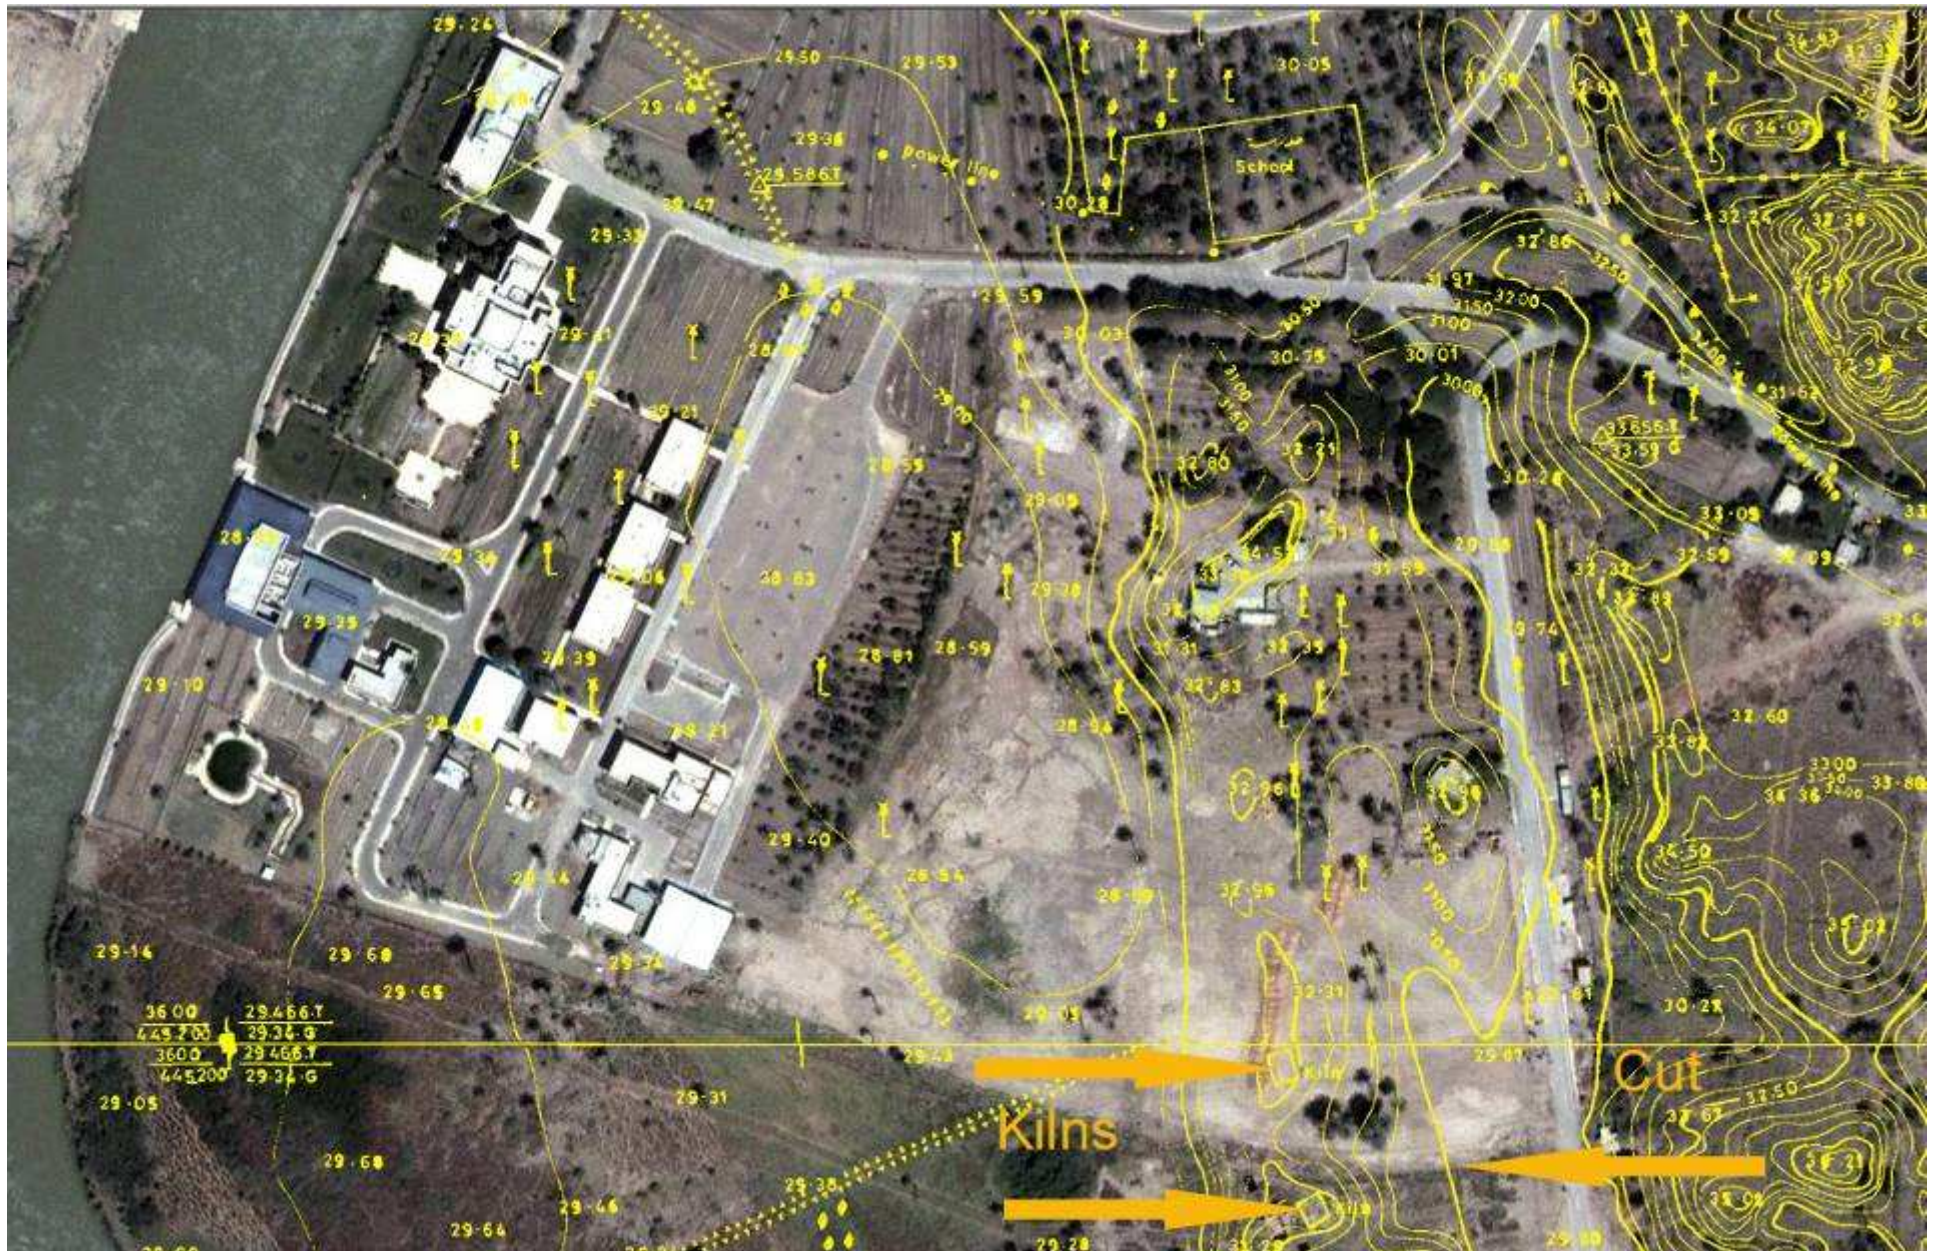
According to the Iraqi 1980 survey map, the western part of this area was level while the eastern part, adjacent to the former course of the river, was mounded and was occupied by two brick kilns. Between 1980 and 2002, the southeast corner of this area was leveled, removing the north kiln and creating a 2-meter-high cut just north of the southern kiln (image 5 July 2002, with Iraqi 1980 map overlay, Russell composite).
