# **Report on Damage to the Site of Babylon, Iraq**

**John Malcolm Russell, Ph.D.**

**Cultural Heritage Center  
Bureau of Educational and Cultural Affairs  
Department of State**

**April 2010**

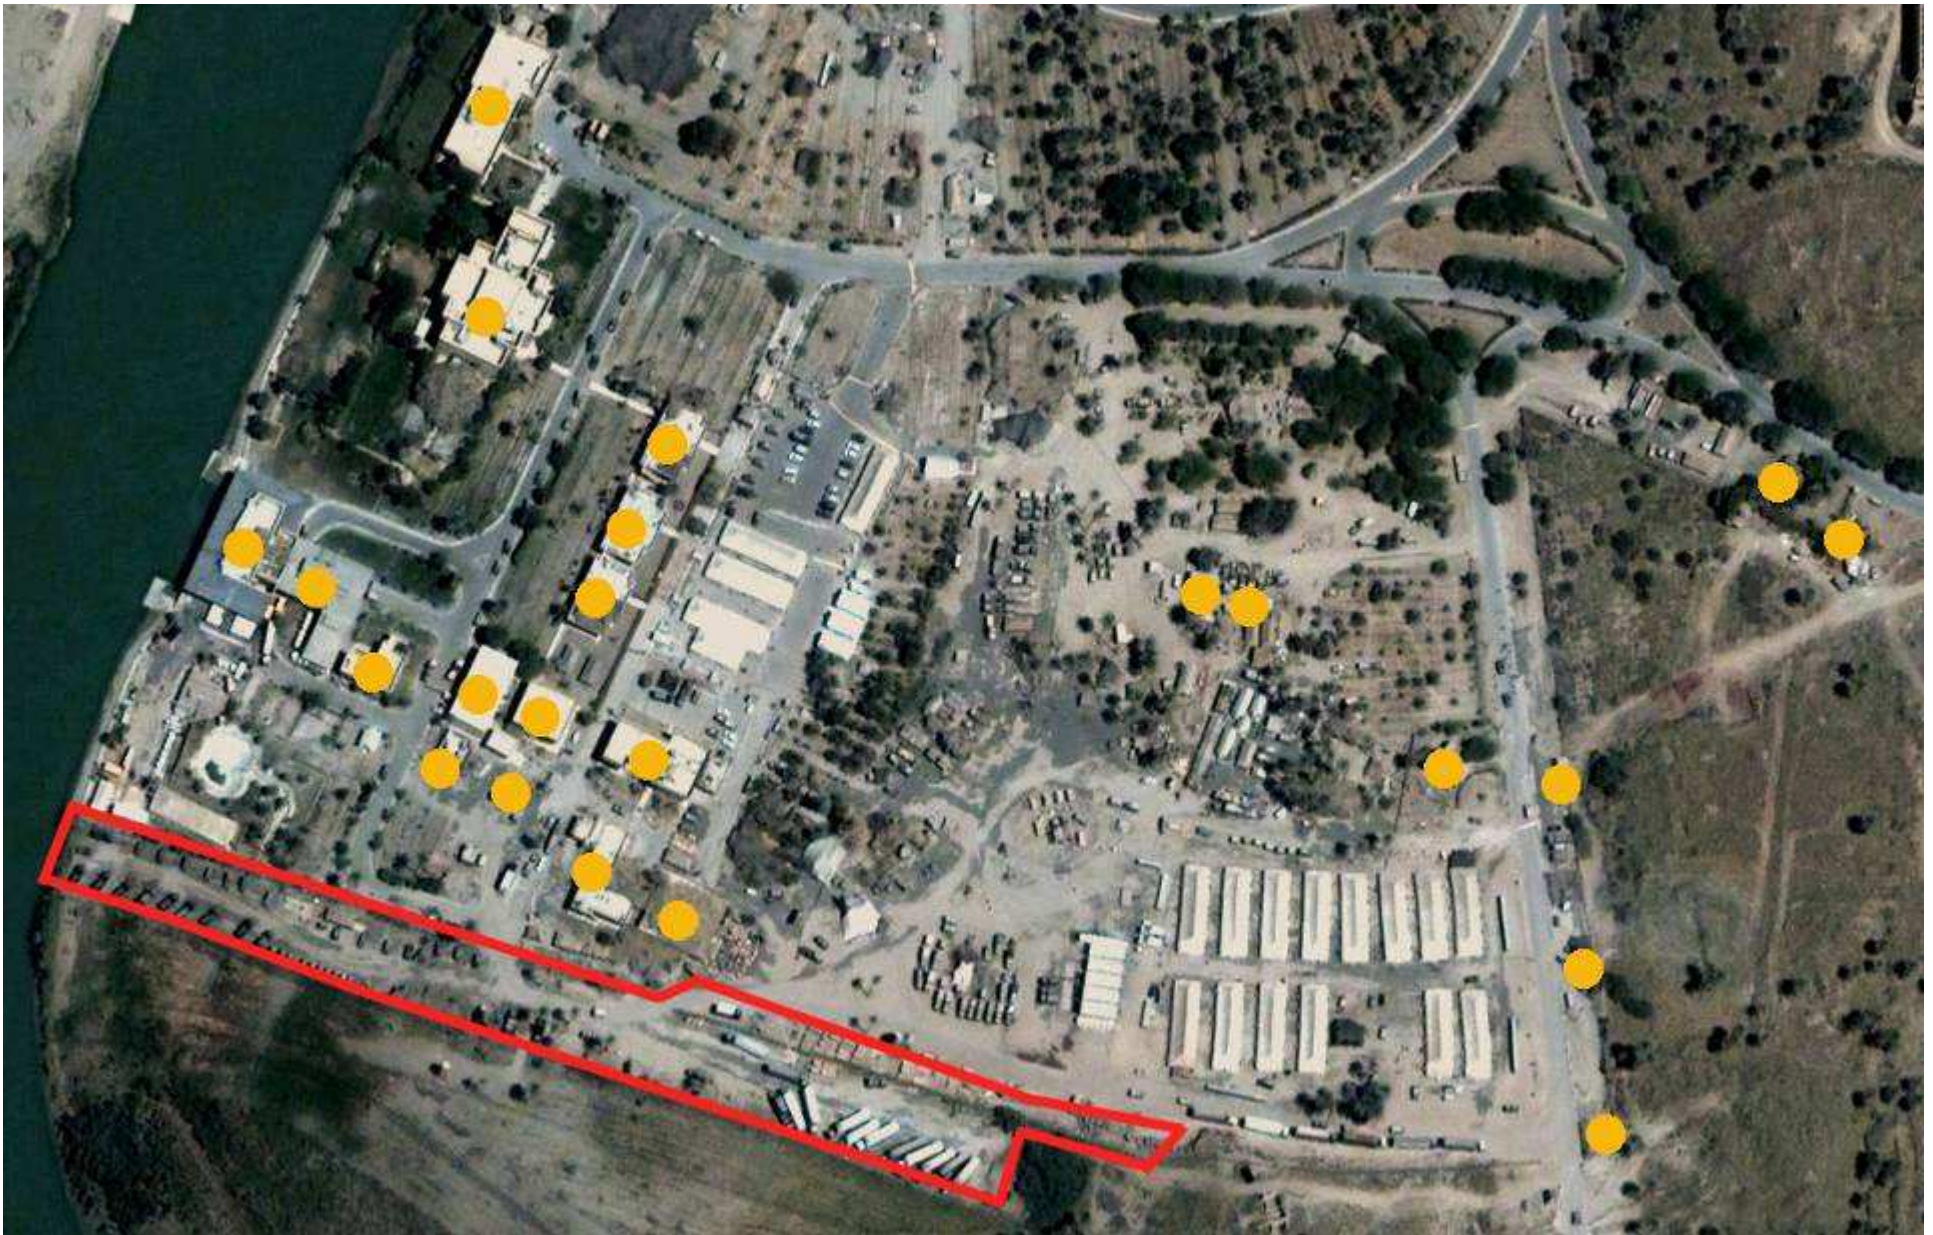
During the initial phase of Coalition occupation, this area was intensively developed with temporary structures, and a parking area was expanded to the south (red outline). Here, existing buildings are marked with orange dots to distinguish them from new construction (image 31 August 2003, Russell composite).

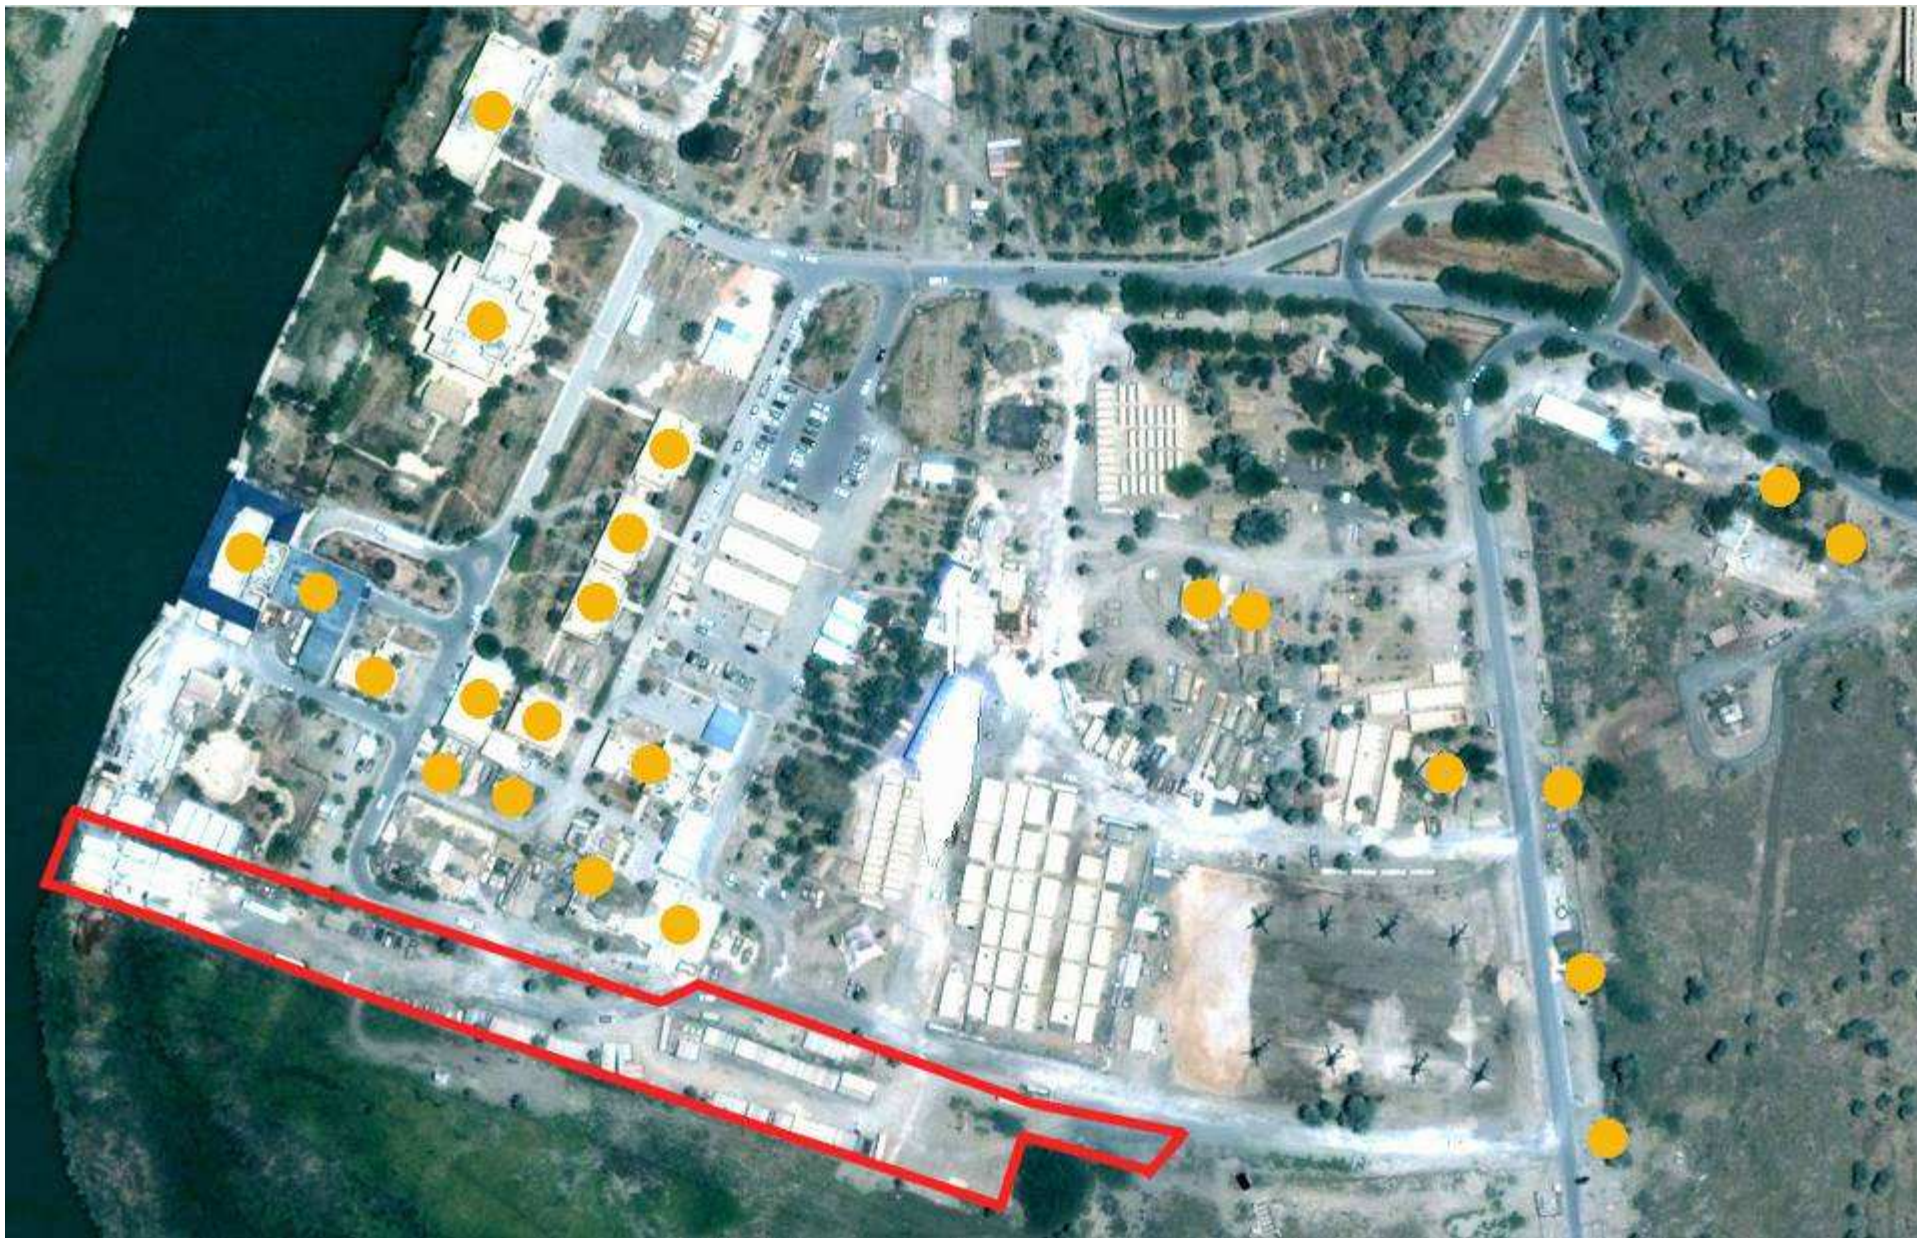
Final phase of Coalition development showing landing zone. Pre-Coalition buildings are marked with orange dots (image 4 June 2004, Russell composite).

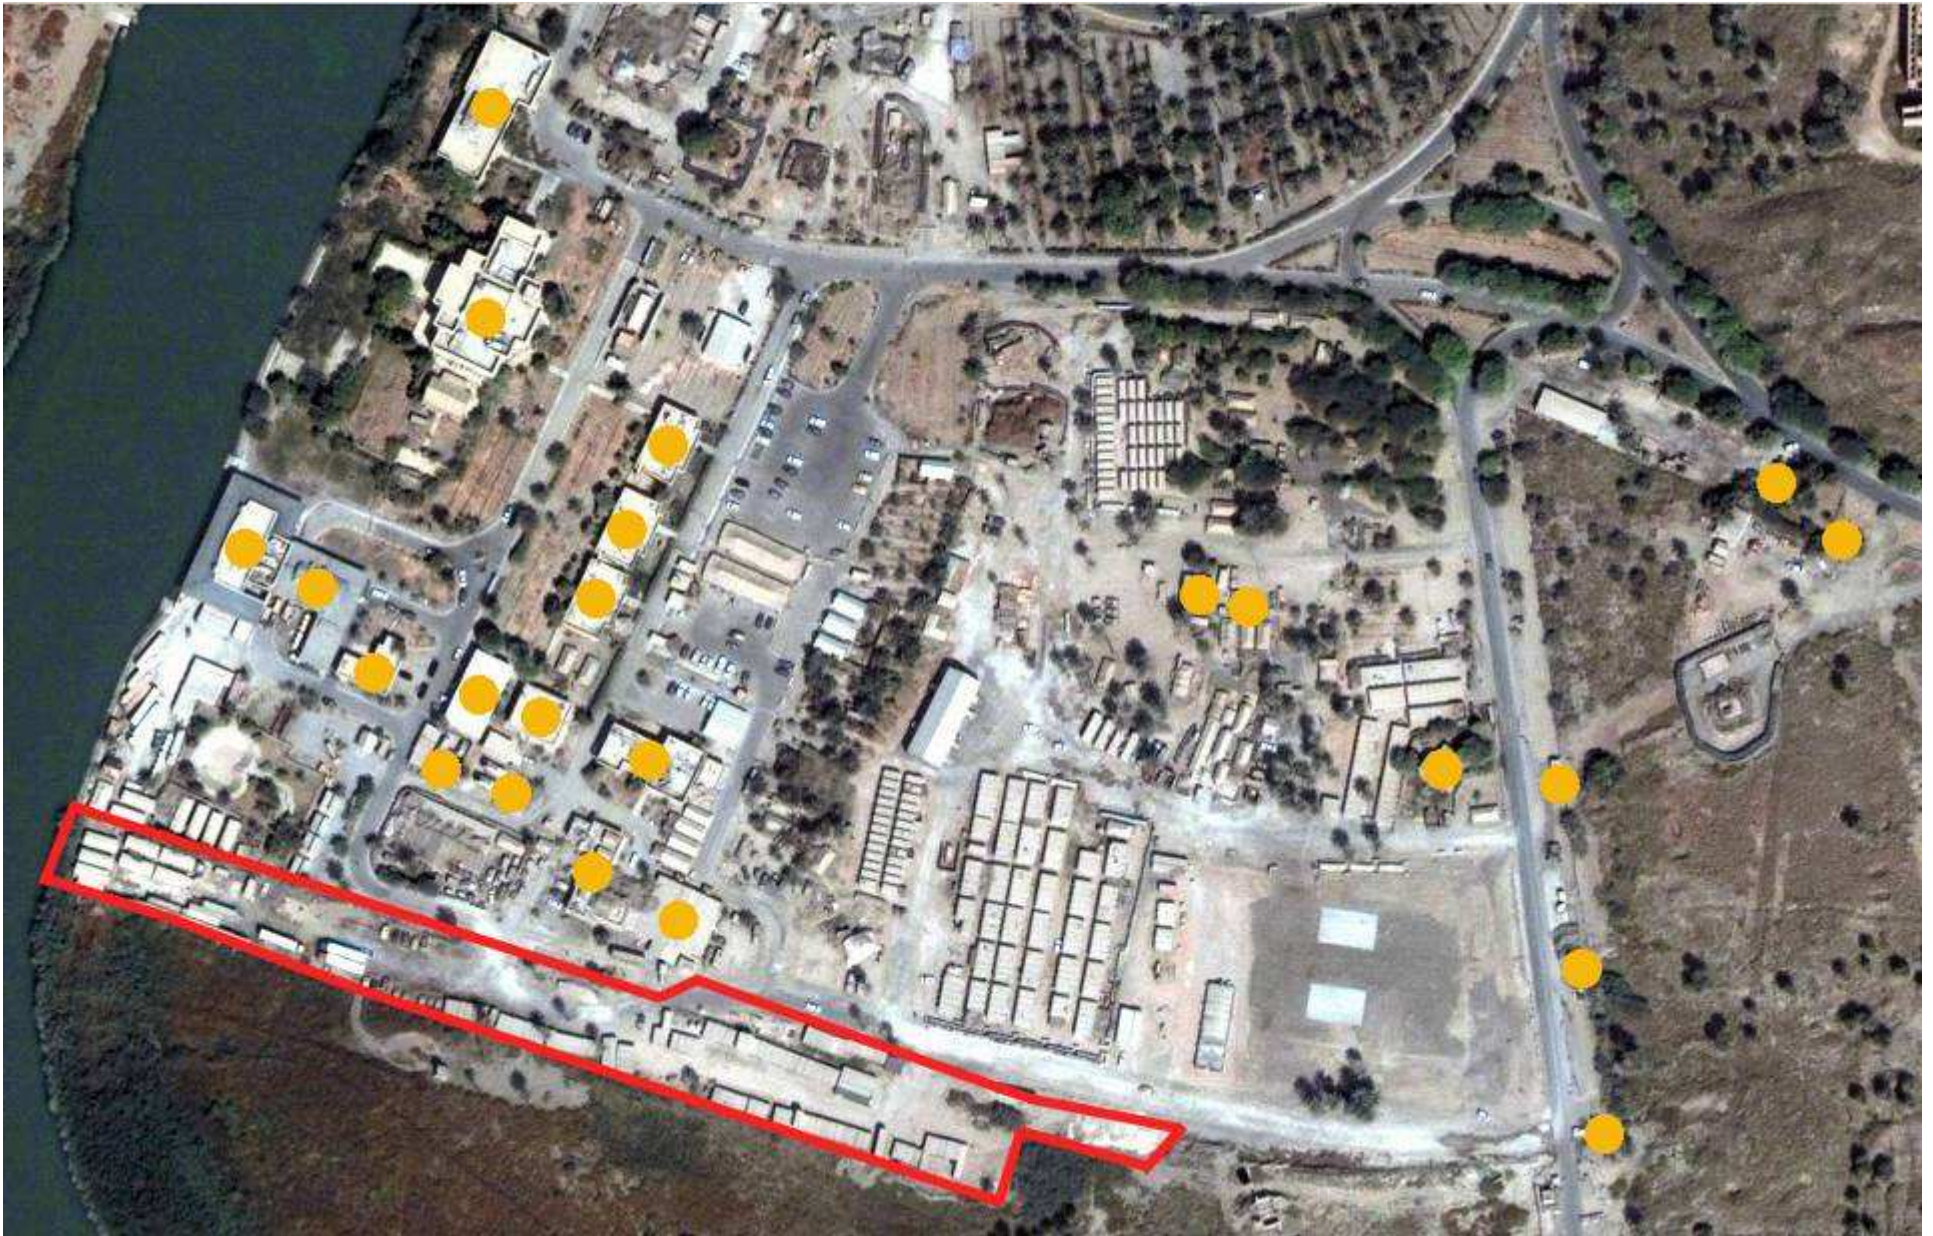
Final phase of Coalition development. Pre-Coalition buildings are marked with orange dots (image 8 October 2004, Russell composite).

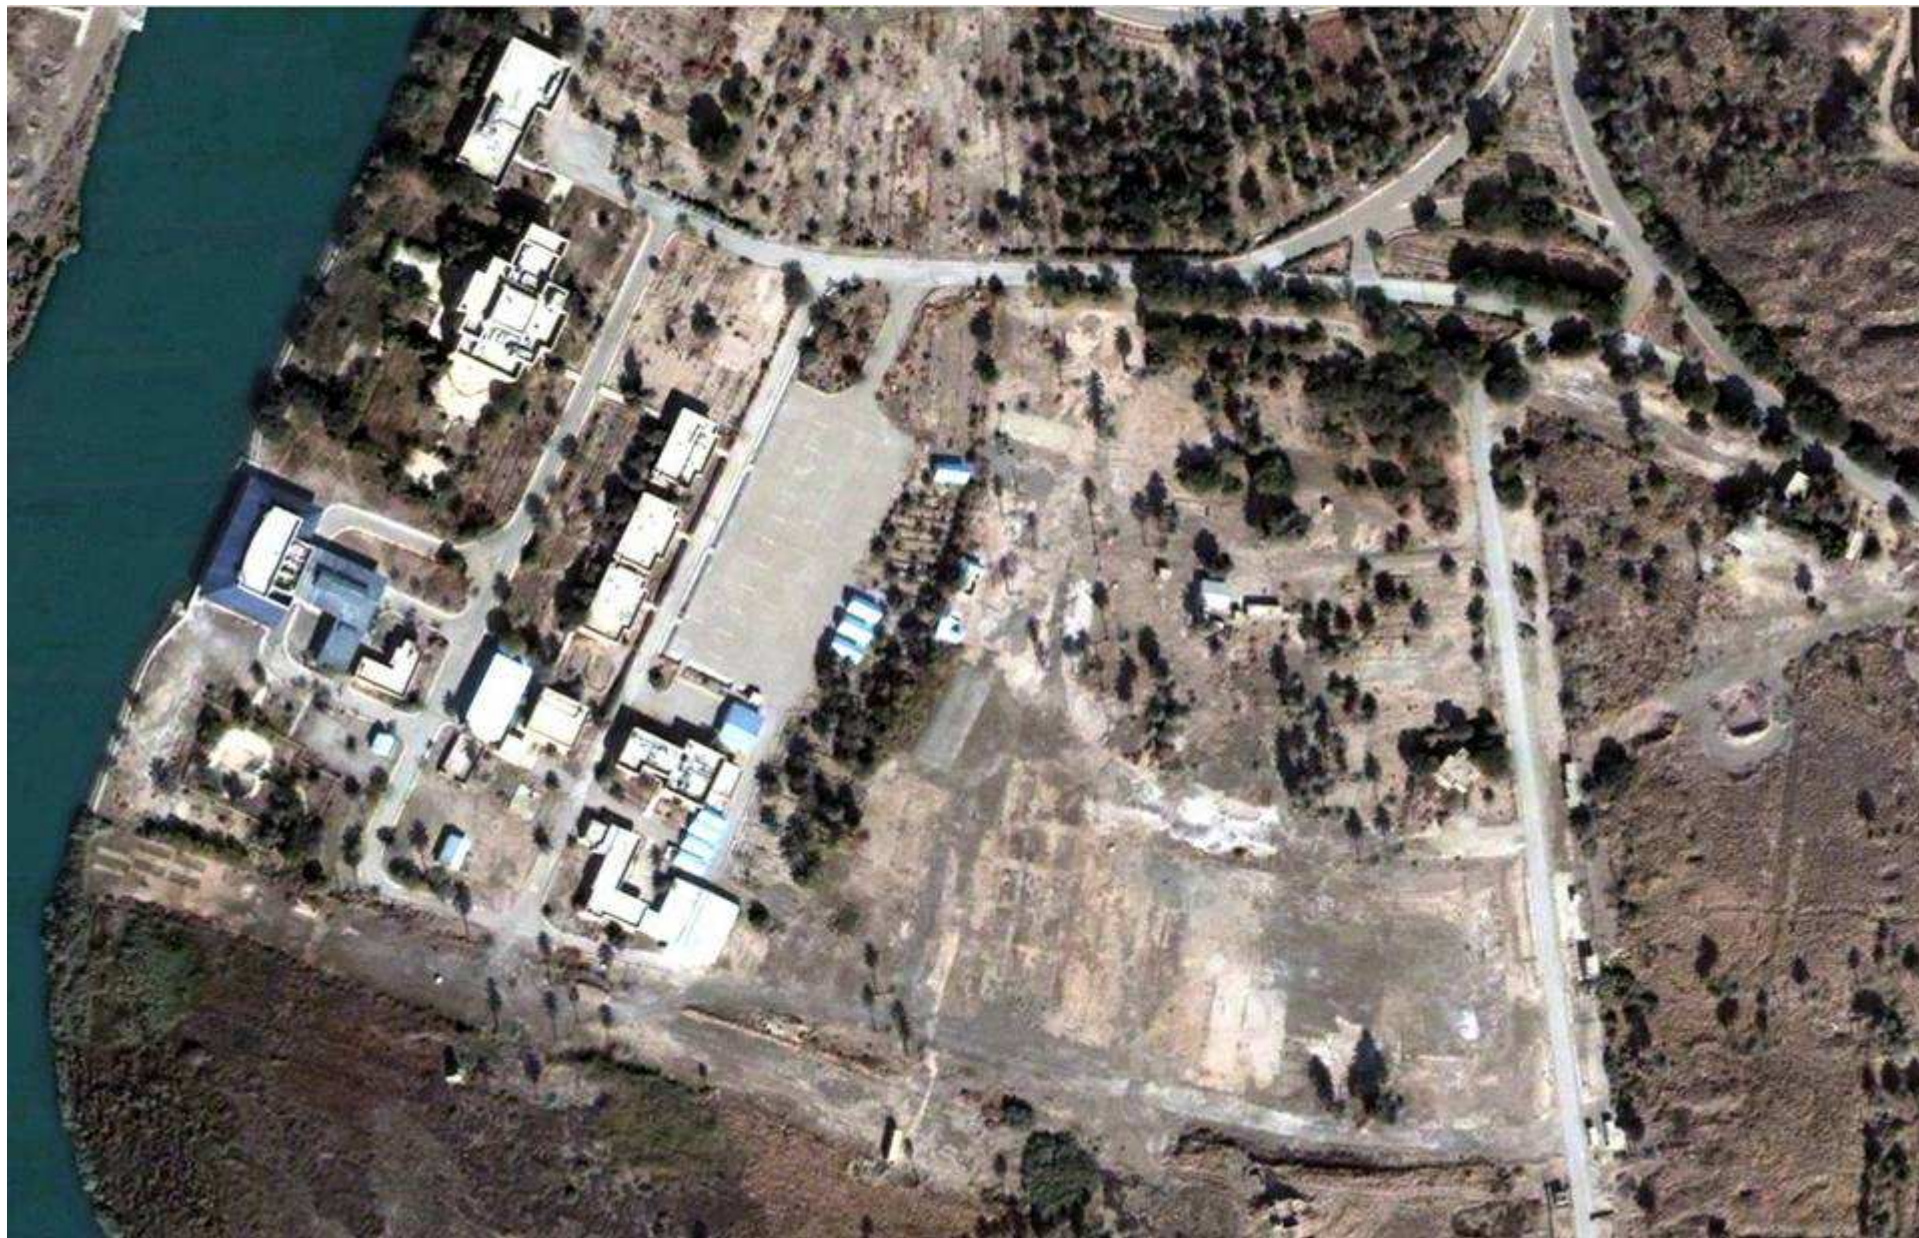
Condition of area after departure of Coalition Forces (image 26 November 2005, Russell composite).

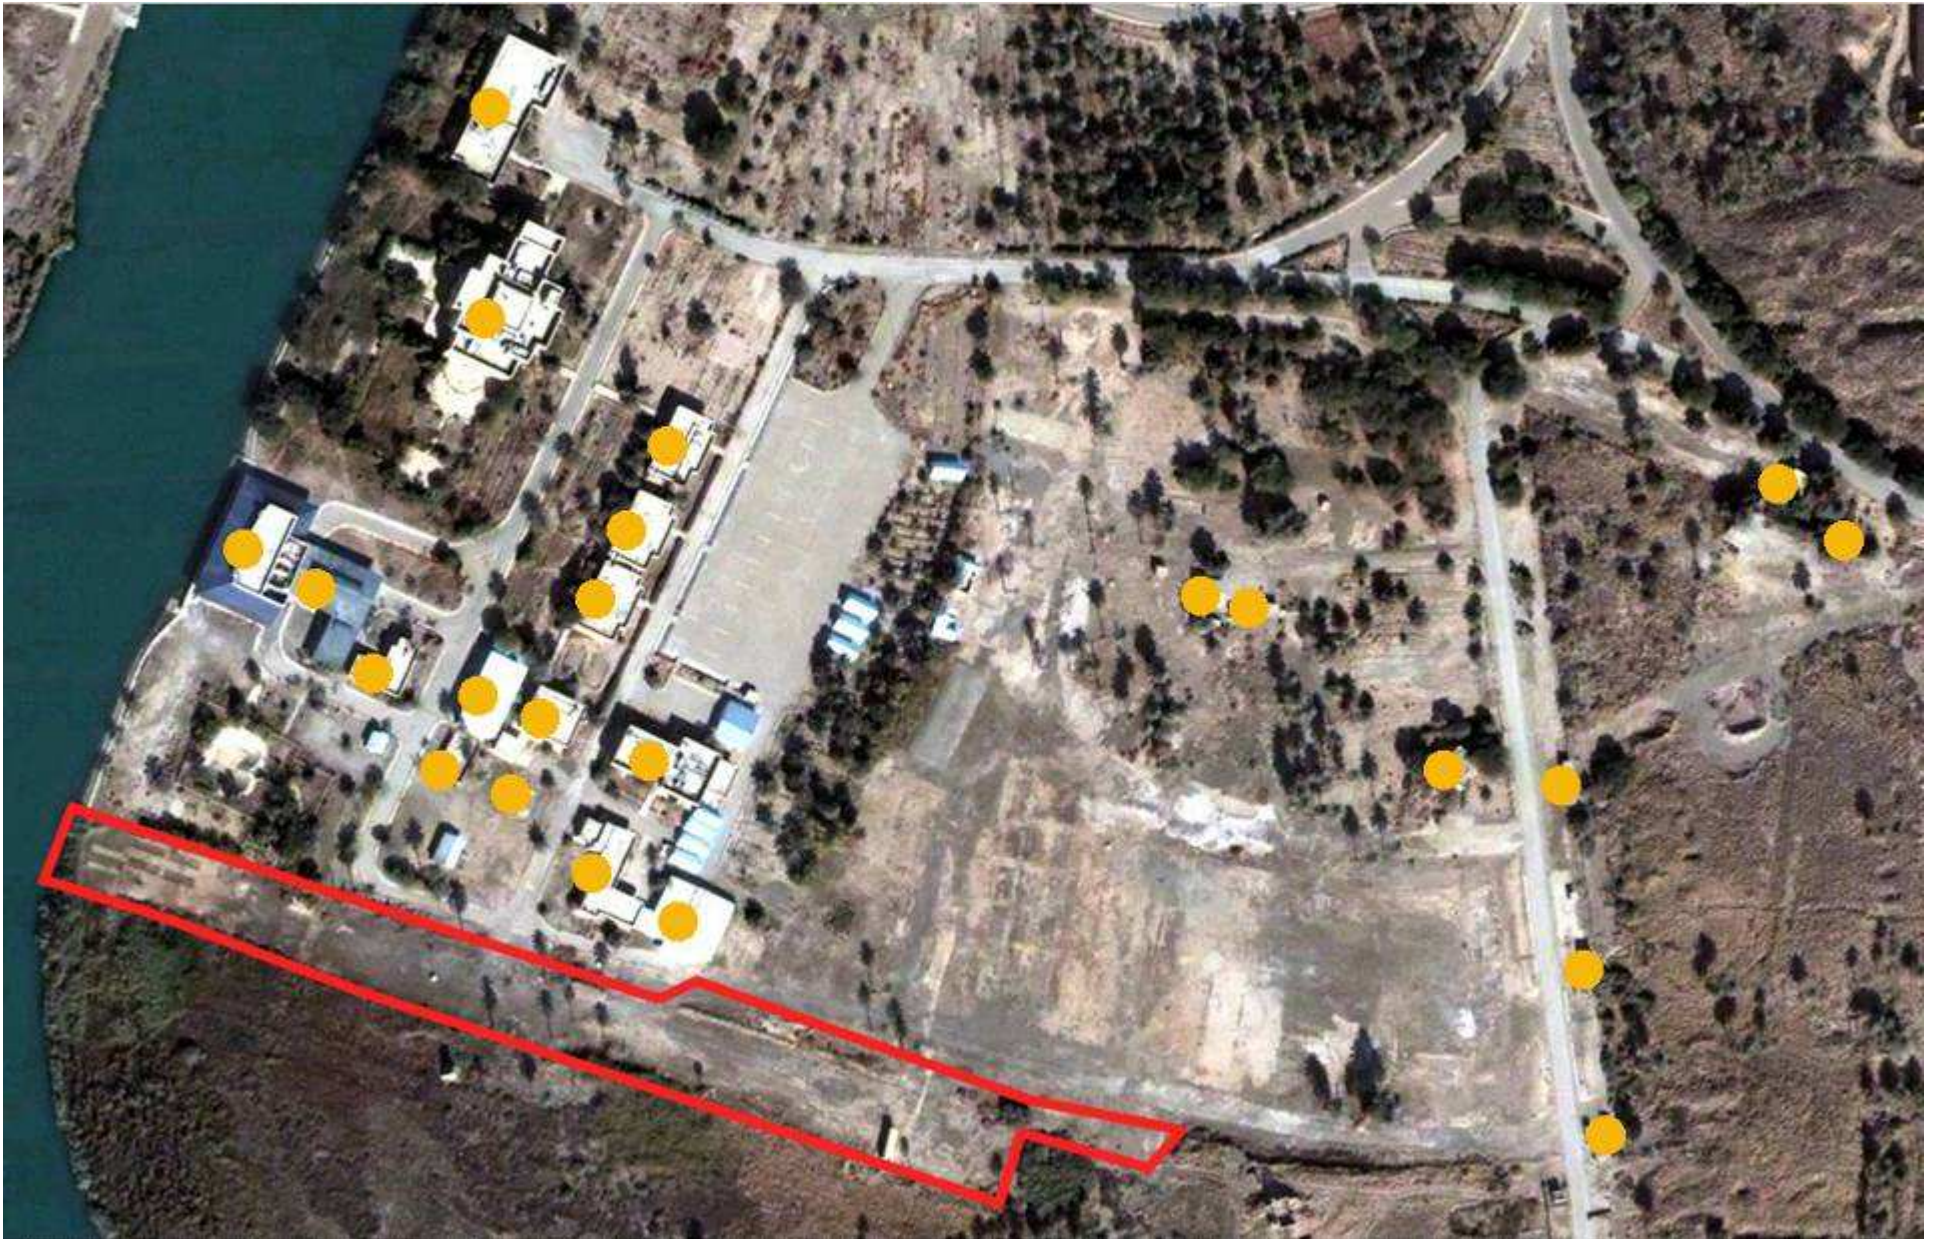
Condition of area after departure of Coalition Forces. Pre-Coalition buildings are marked with orange dots (image 26 November 2005, Russell composite).

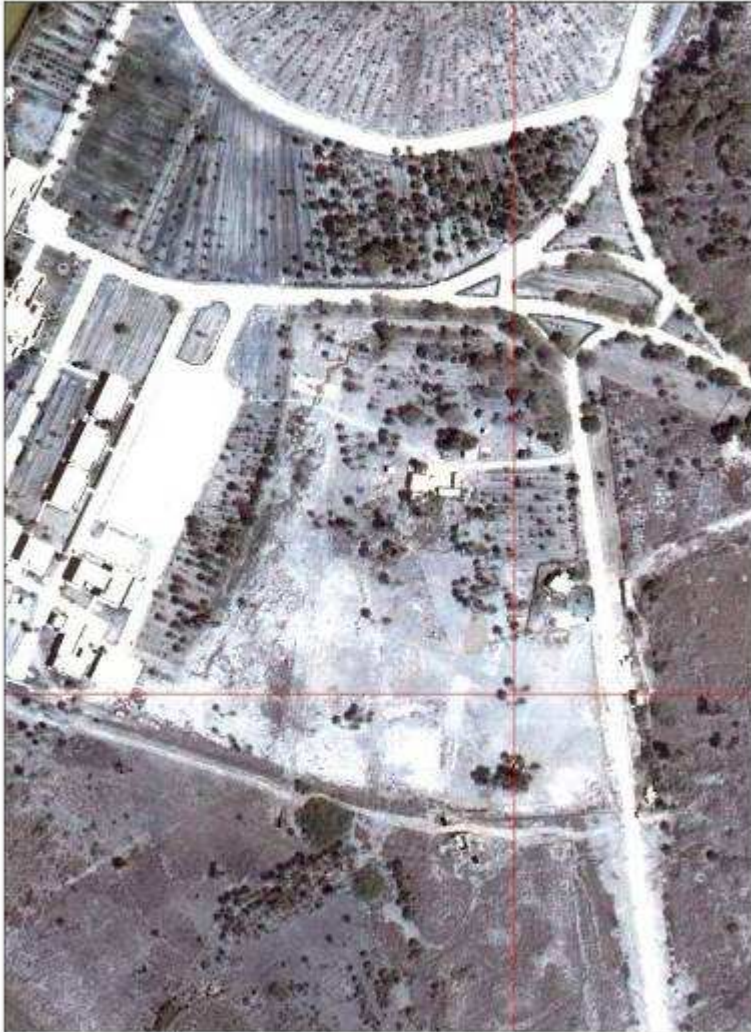
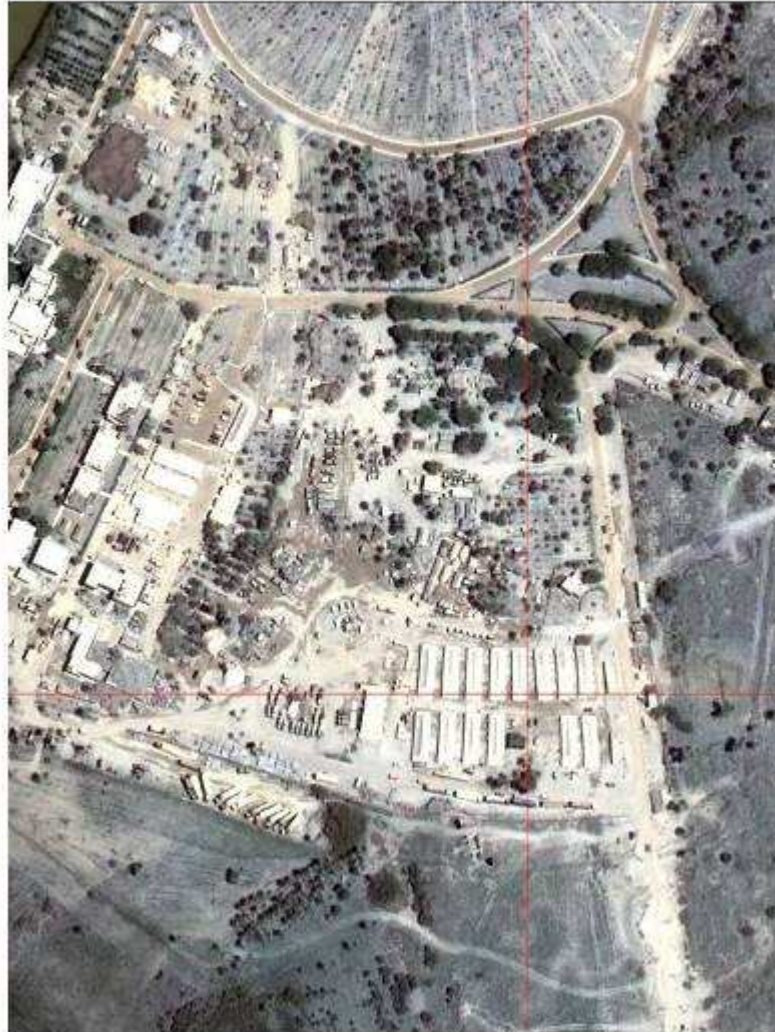
**Stone report:** The imagery shows this area as being used for tents by August 2003, although much of the original surface seems to have remained intact at this time. Most of the disturbance was located in the southern part, where some palm trees had been removed, and the difference in color of the surface suggests that it may have been flattened. [Stone report fig. 8]

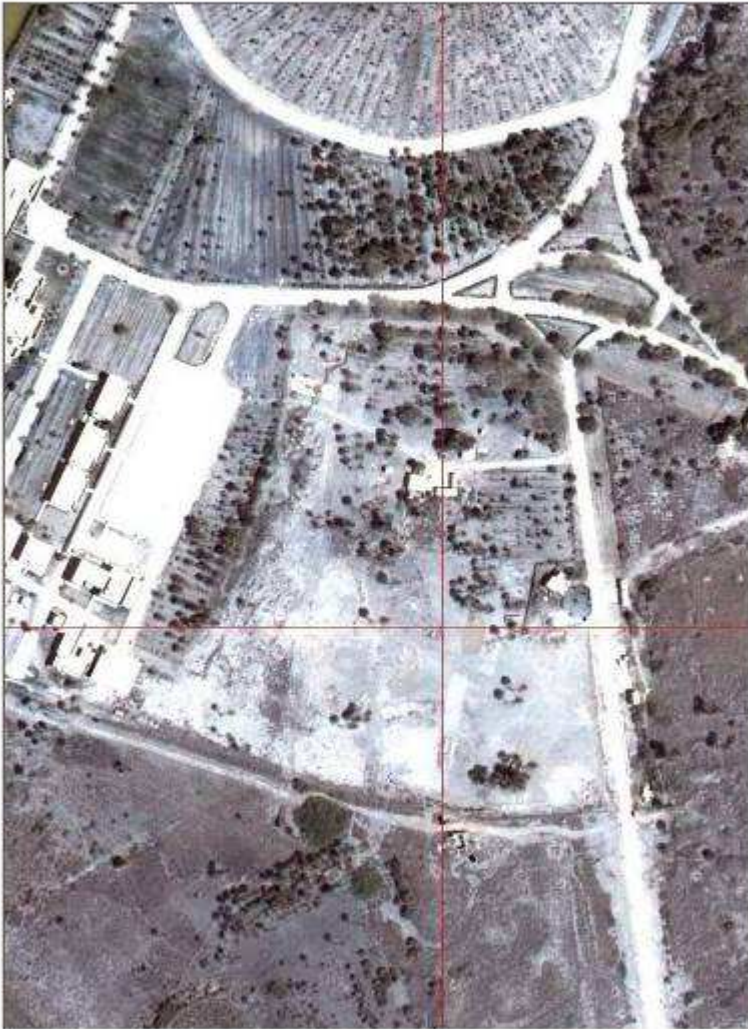
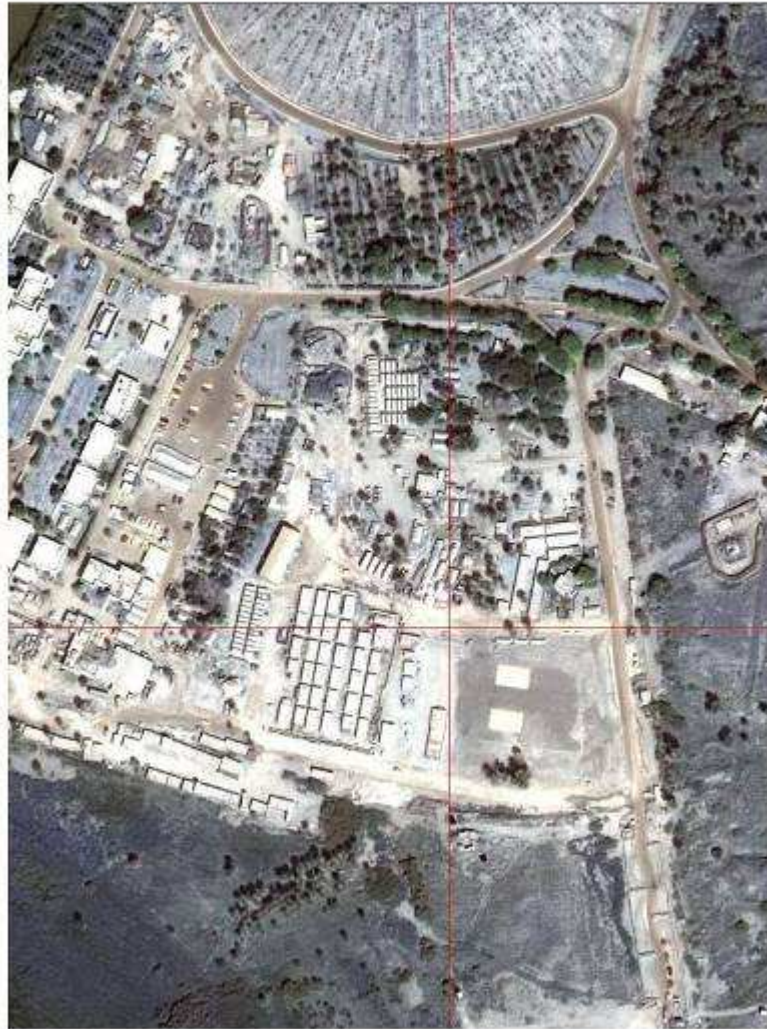
**Stone report:** By October 2004, a helicopter pad had been developed in the SE part of this area, and the evidence for disturbance is much greater throughout this area (Fig 9), something also seen in the photographs contained in the Polish report. Photographs taken by John Russell show the helicopter pad to be level with the road [Russell 124\_2468], which was not the case before the war, as indicated by the contour map.

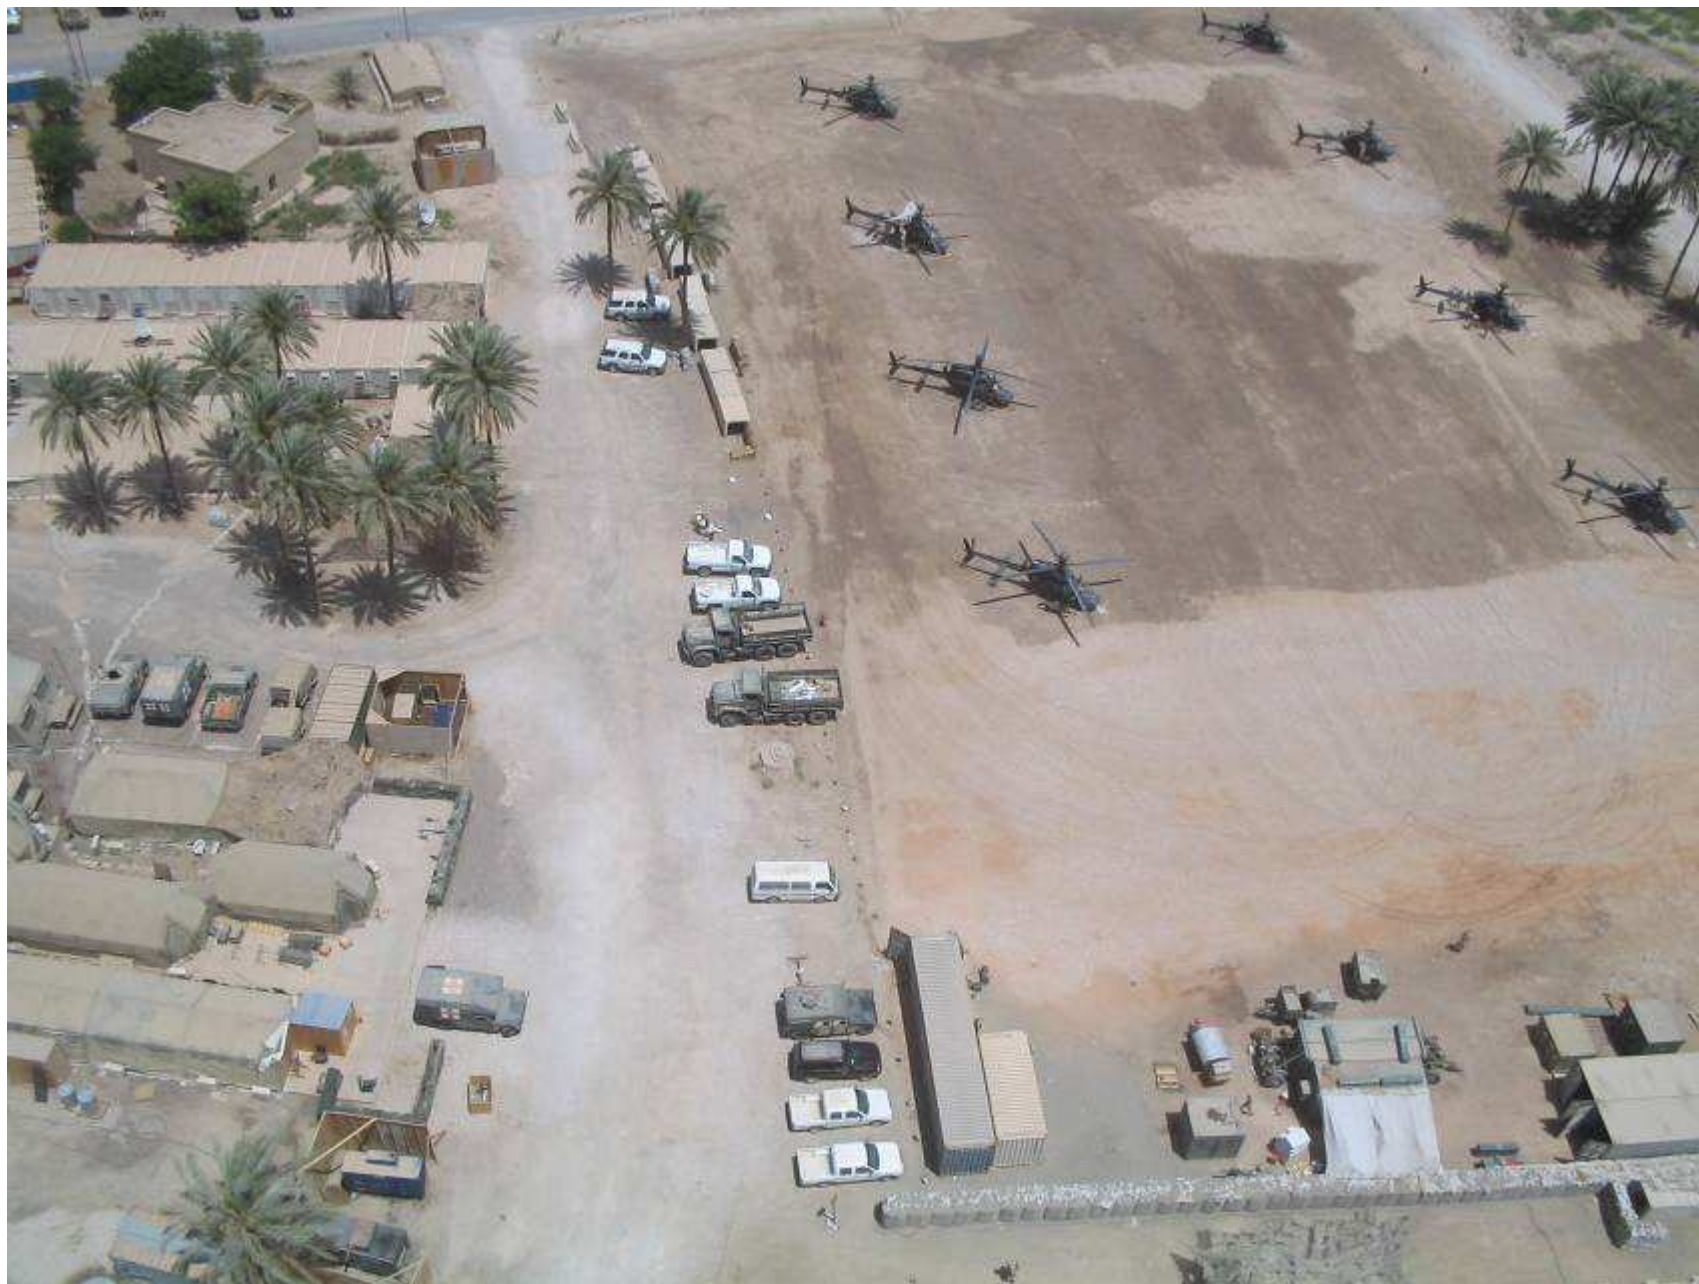
Landing zone viewed from the west, June 2004, Russell 124\_2468

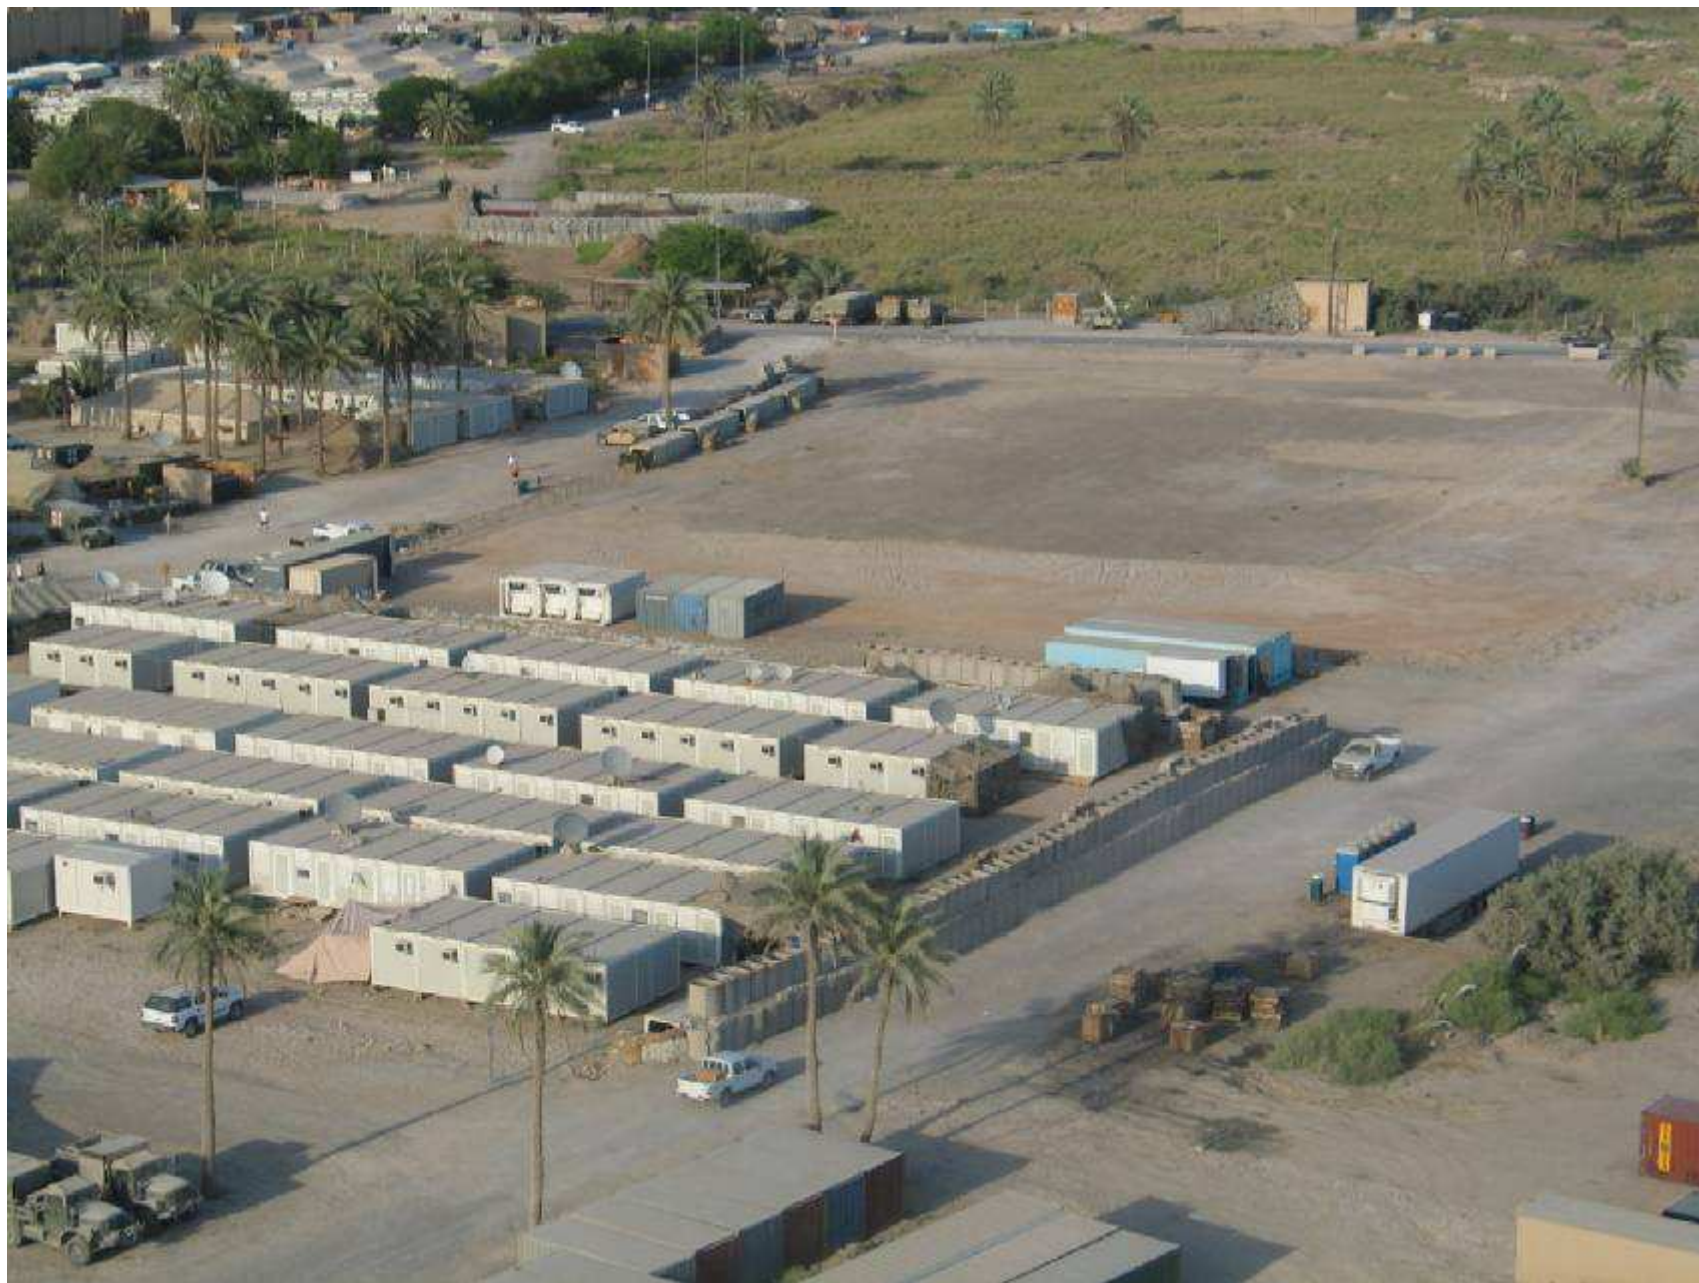
Trailers and landing zone viewed from the southwest, Iraqi final report fig. 60

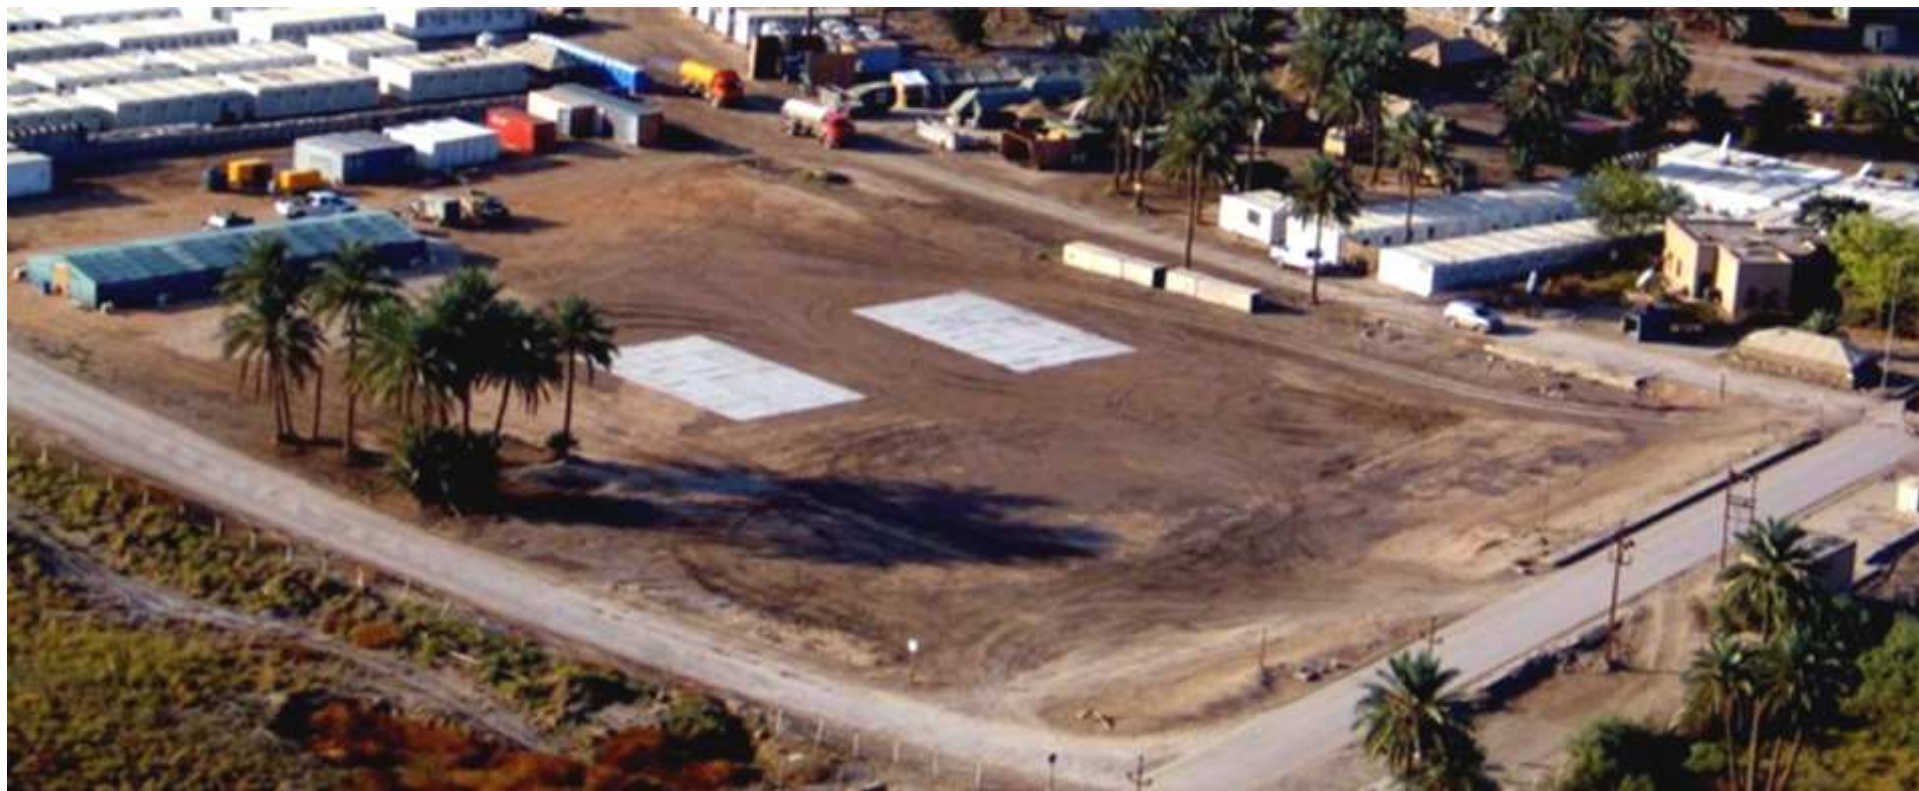
Landing zone viewed from the southeast, Polish report p. 17 (photo © Ministry of Culture and National Heritage, Republic of Poland)
