# **Report on Damage to the Site of Babylon, Iraq**

**John Malcolm Russell, Ph.D.**

**Cultural Heritage Center  
Bureau of Educational and Cultural Affairs  
Department of State**

**April 2010**

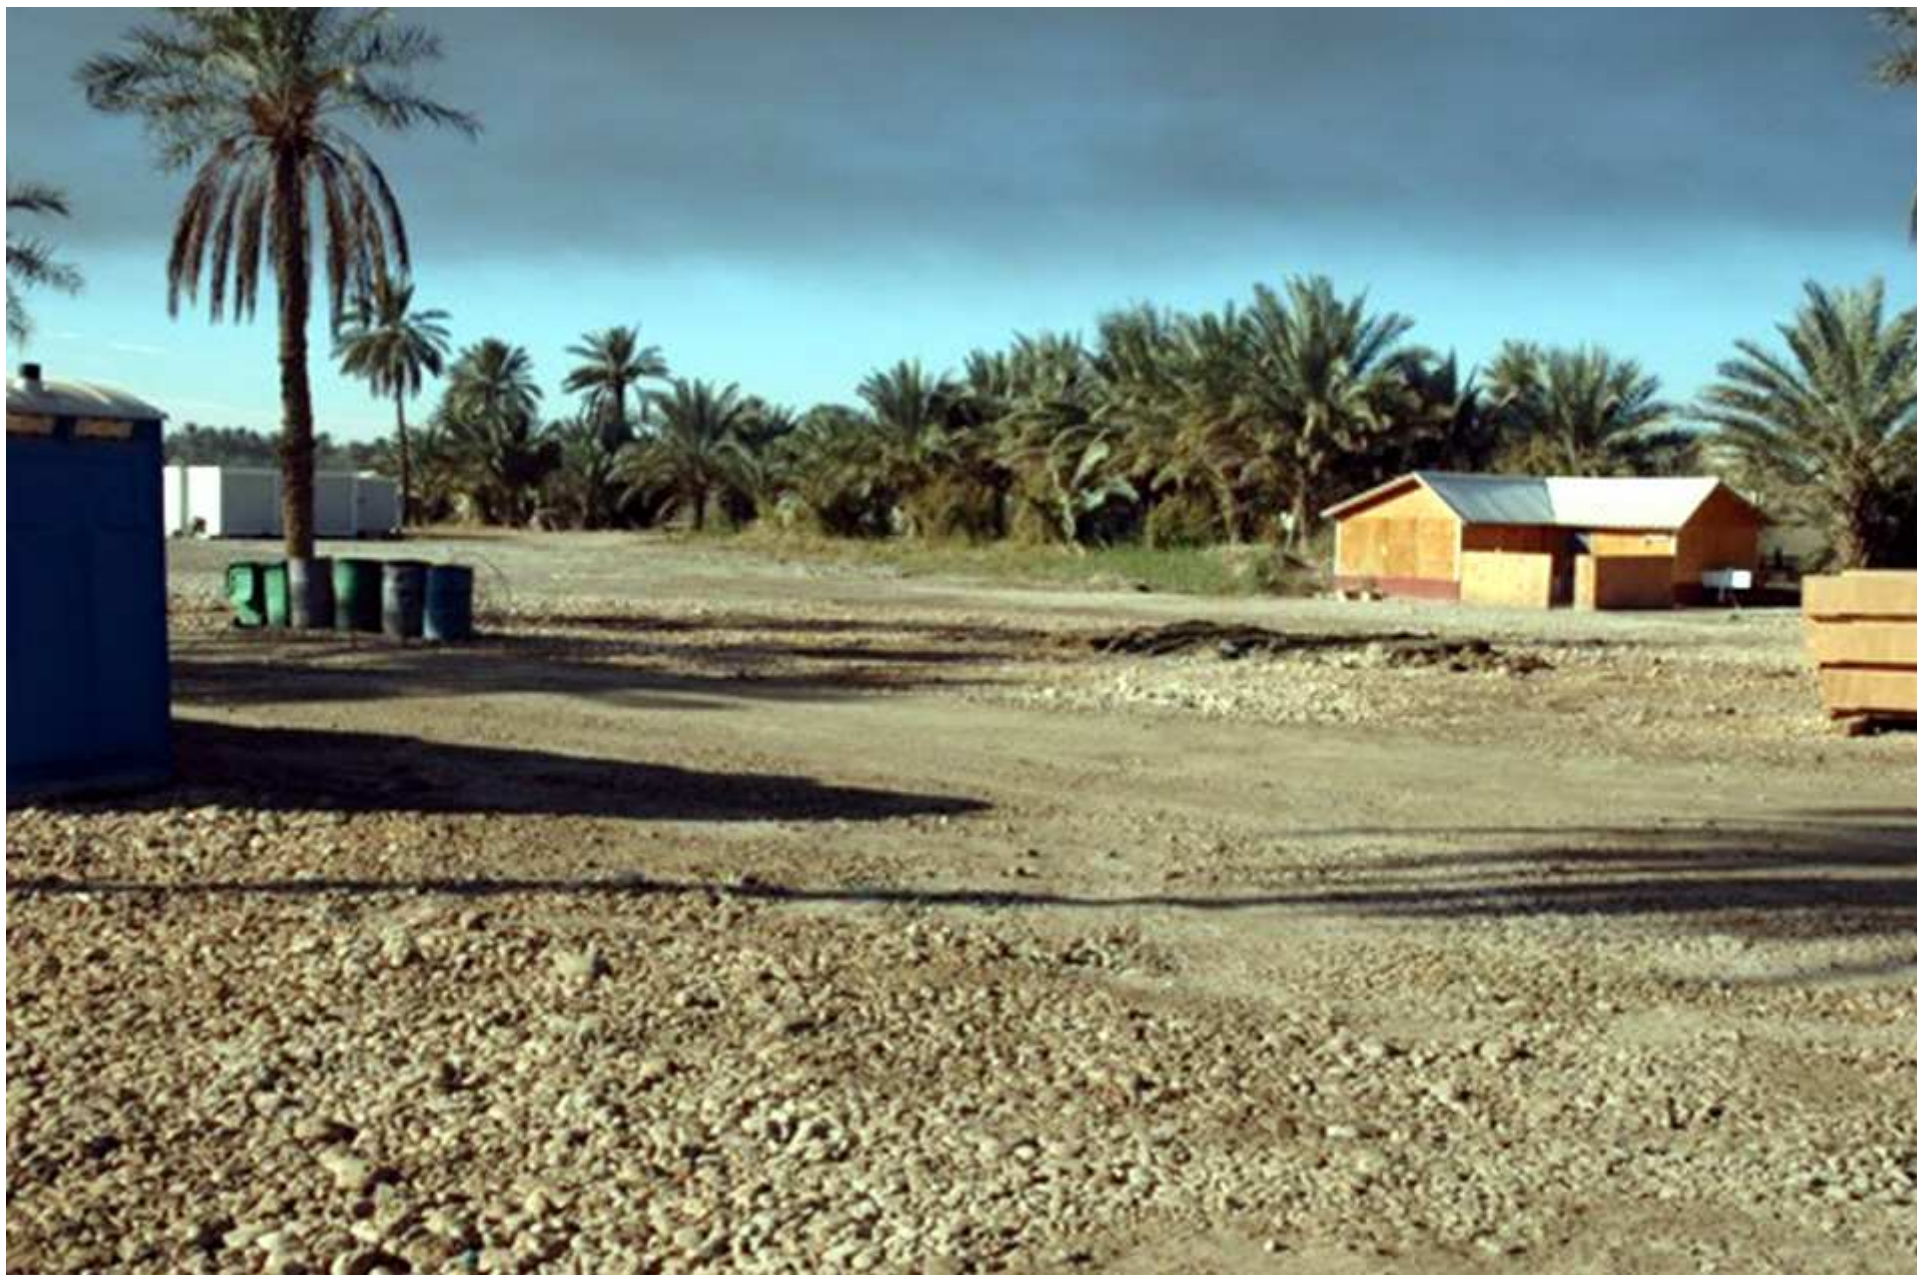
Gravel, Polish report p. 16 (photo © Ministry of Culture and National Heritage, Republic of Poland)

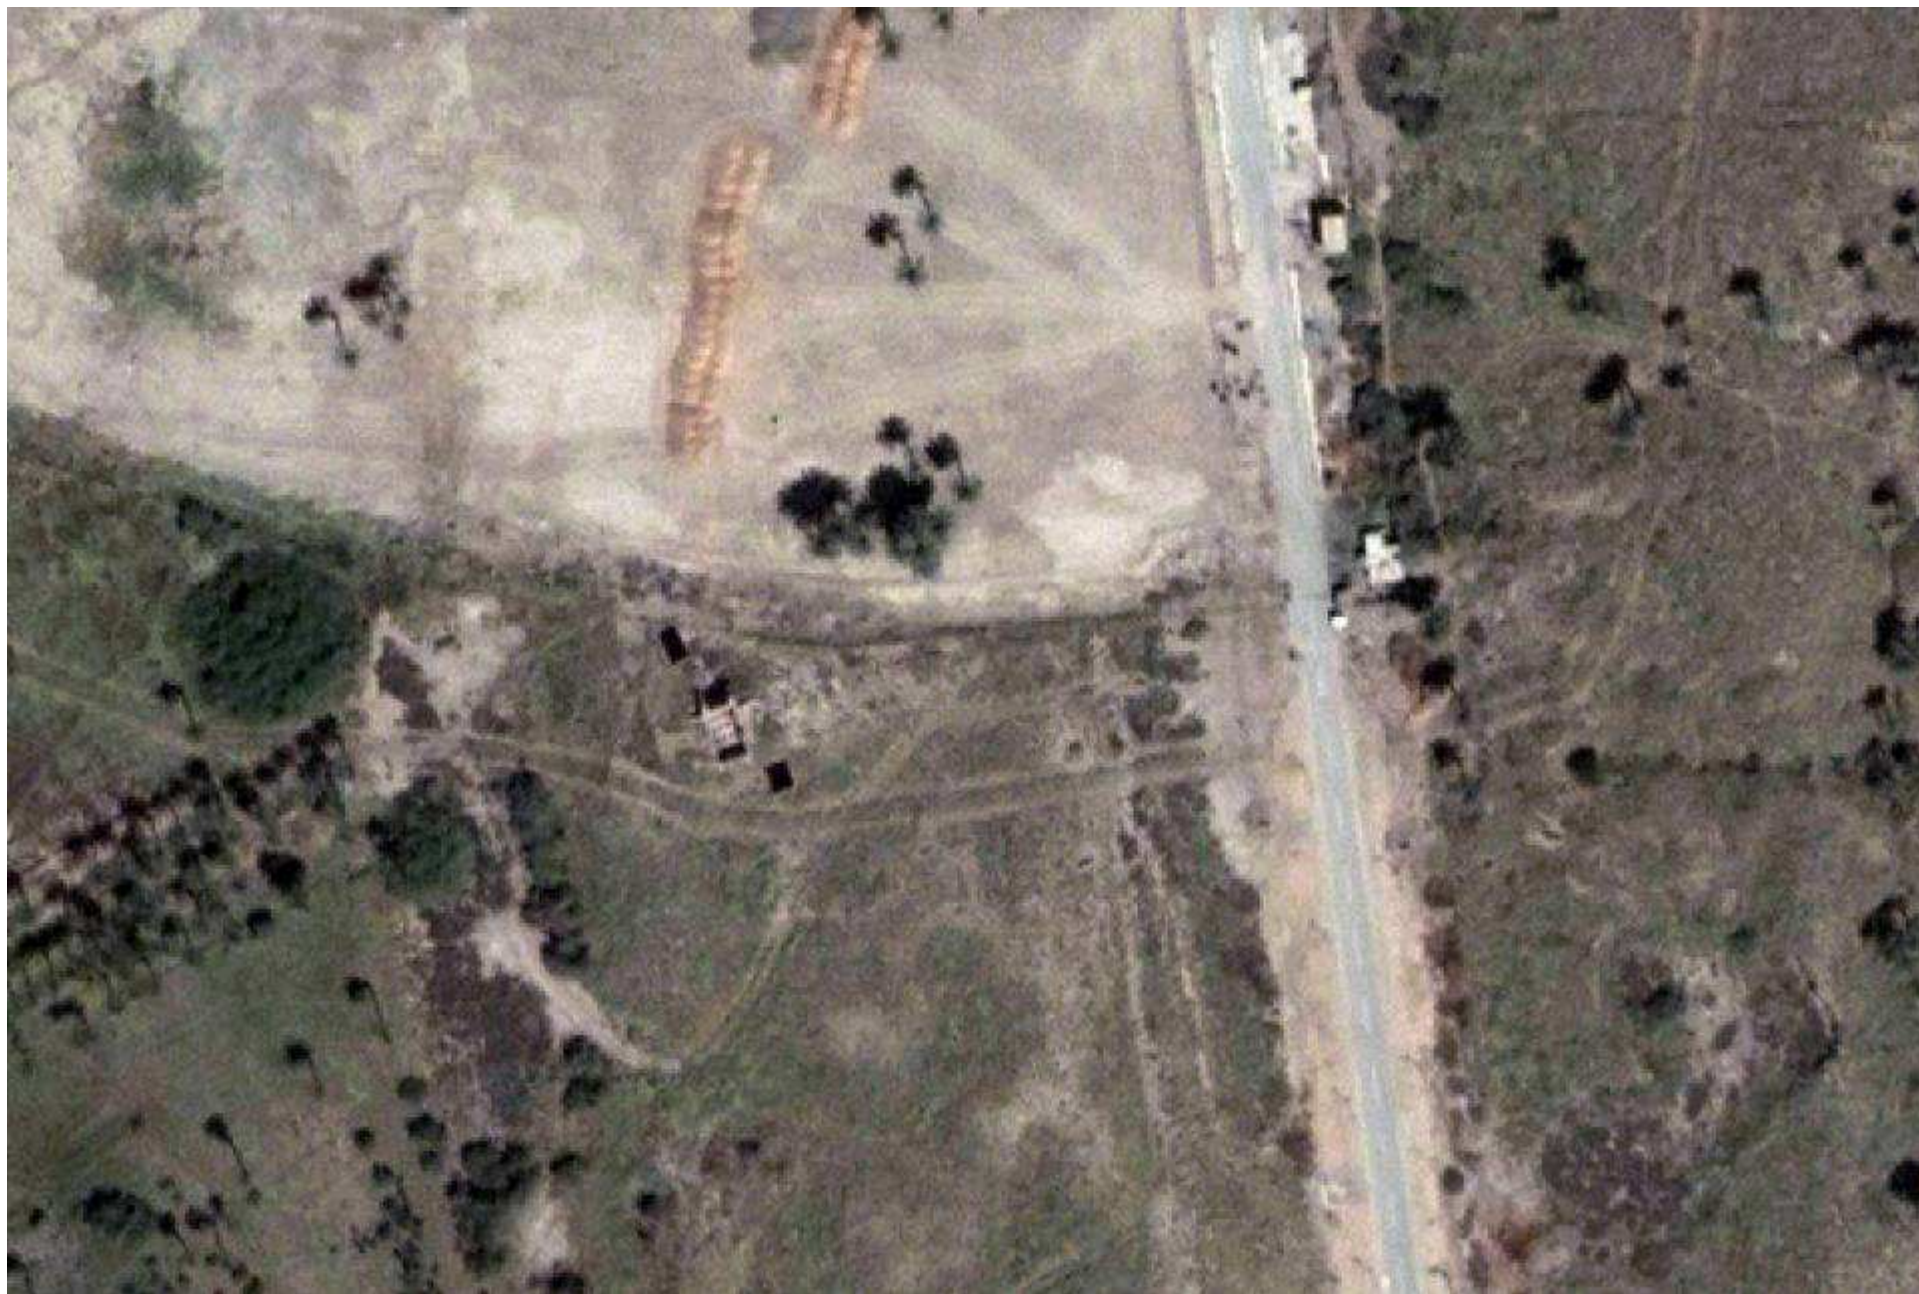
**Russell comment:** As noted above, it appears that the 7<sup>th</sup> cut predates the arrival of Coalition Forces. It is not clear why the Polish report refers to this area as level, as there is a 2-3 meter high cut in this location.

Area of 7th and 9th cuts and pits 10 and 11 before the Coalition occupation. The 7th cut is already present, 5 July 2002, Russell composite

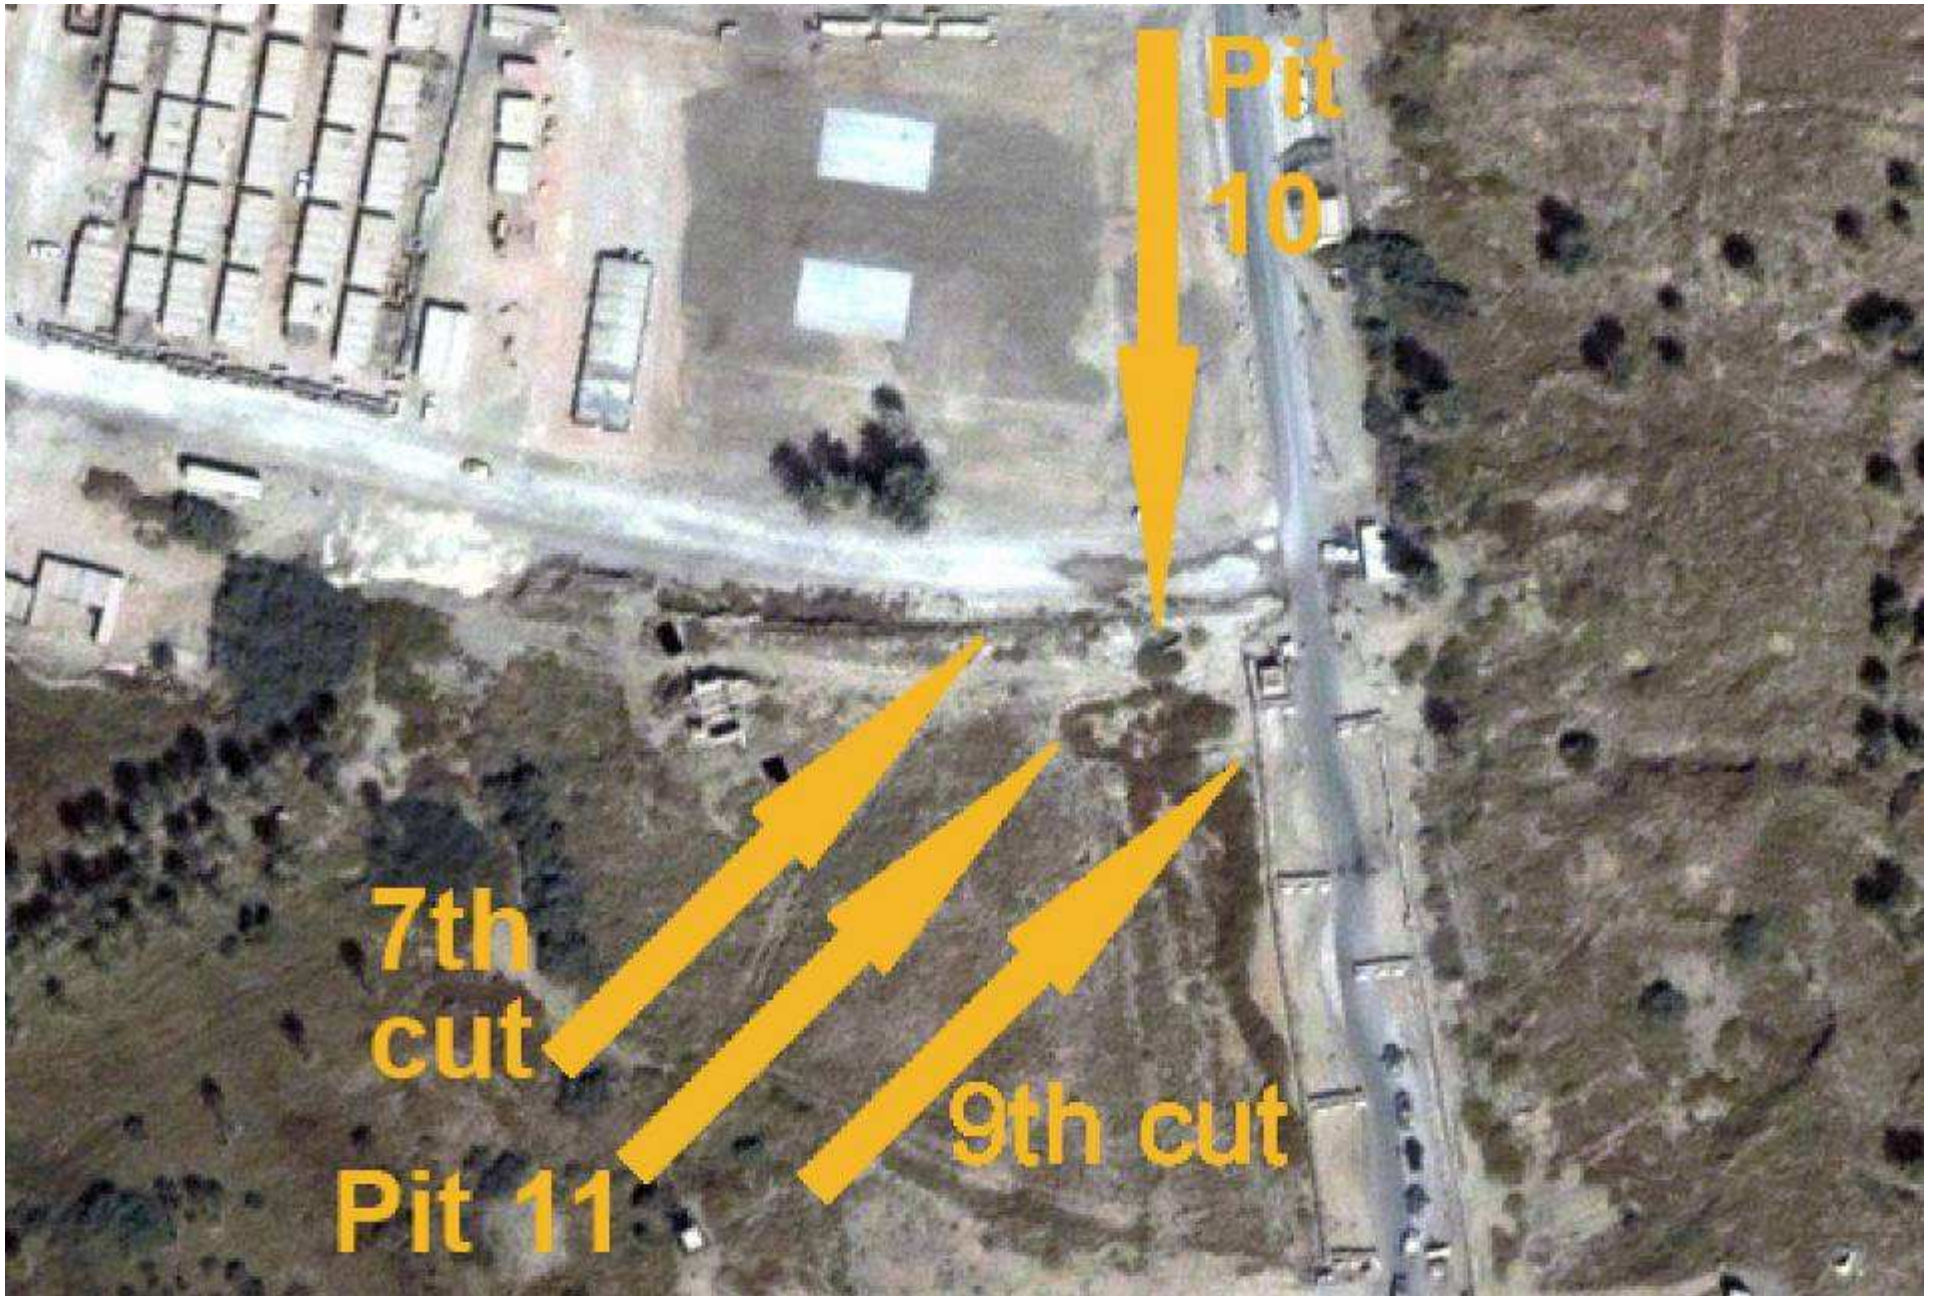
Areas of 7th and 9th cuts and pits 10 and 11, 8 October 2004, Russell composite

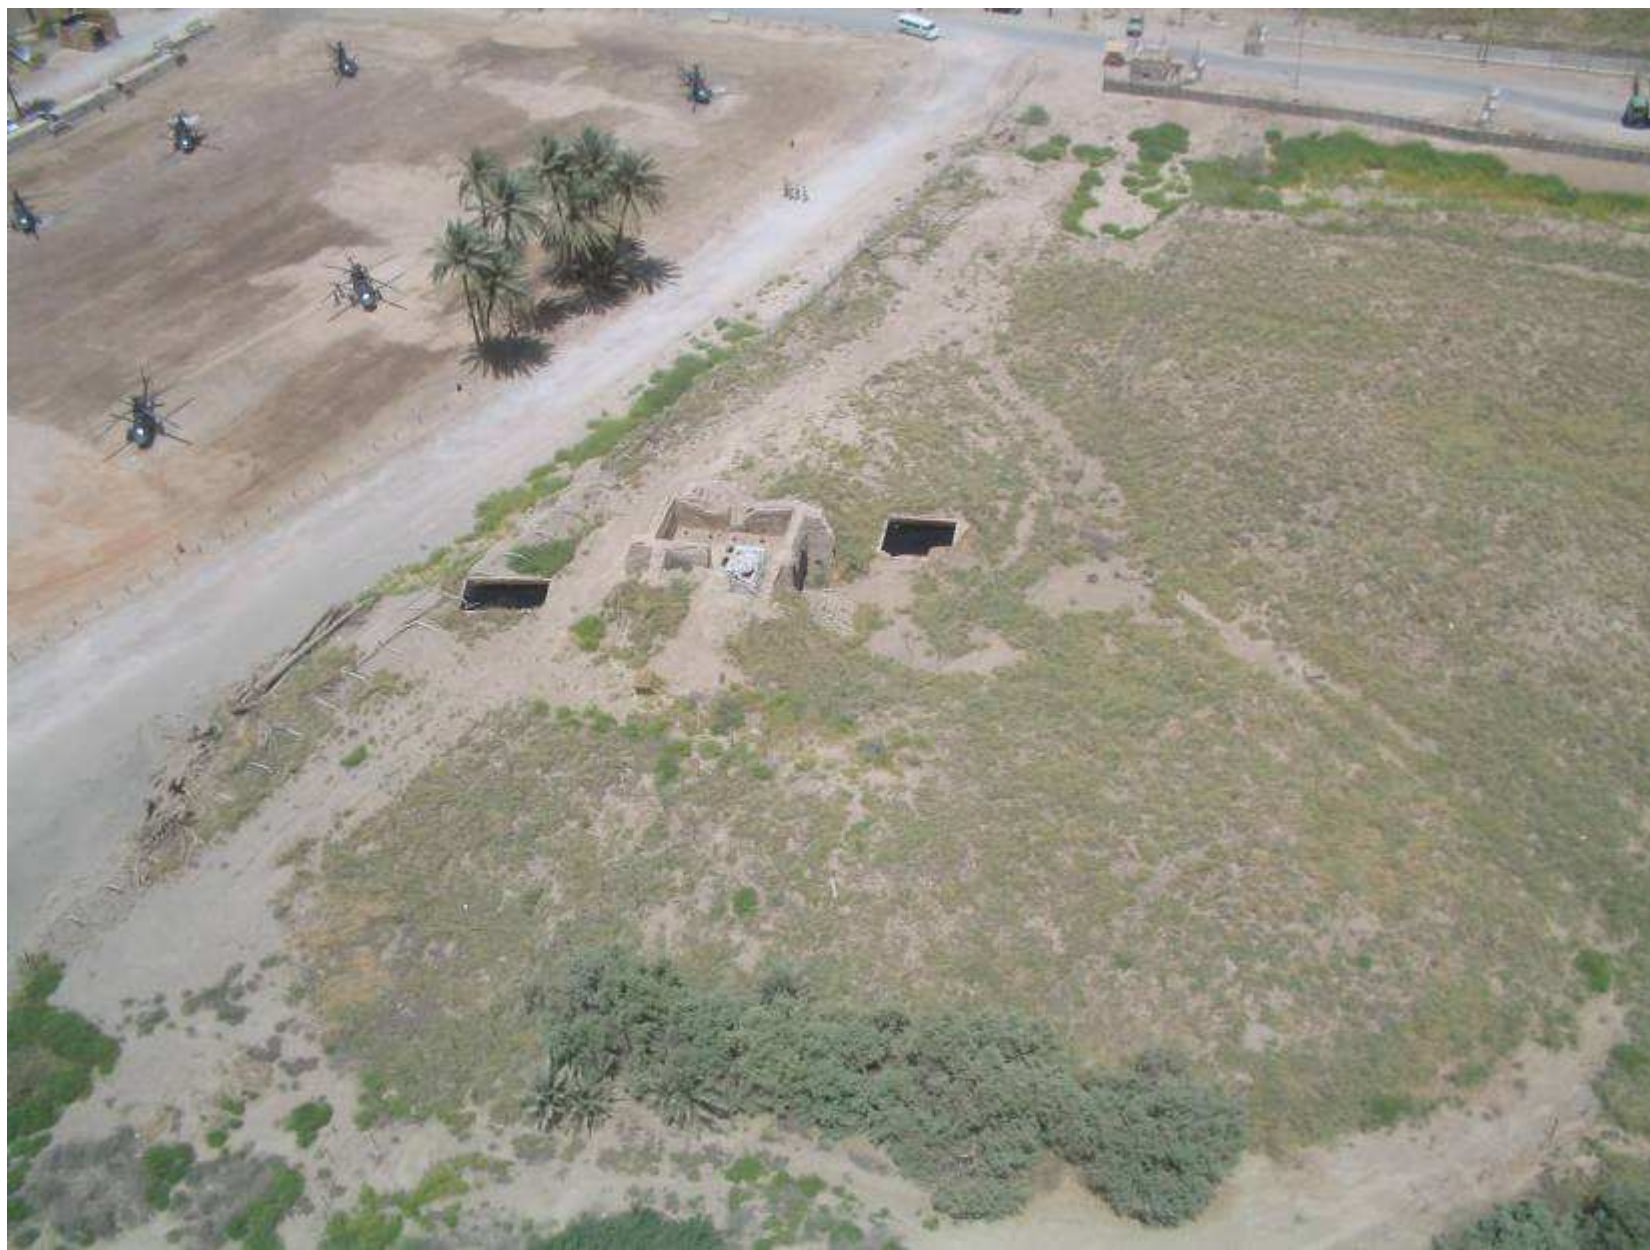
View looking NE with southern brick kiln in center, 7th cut along the right side of the road, and 9th cut and pits 10 and 11 at the top, June 2004, Russell 124\_2469

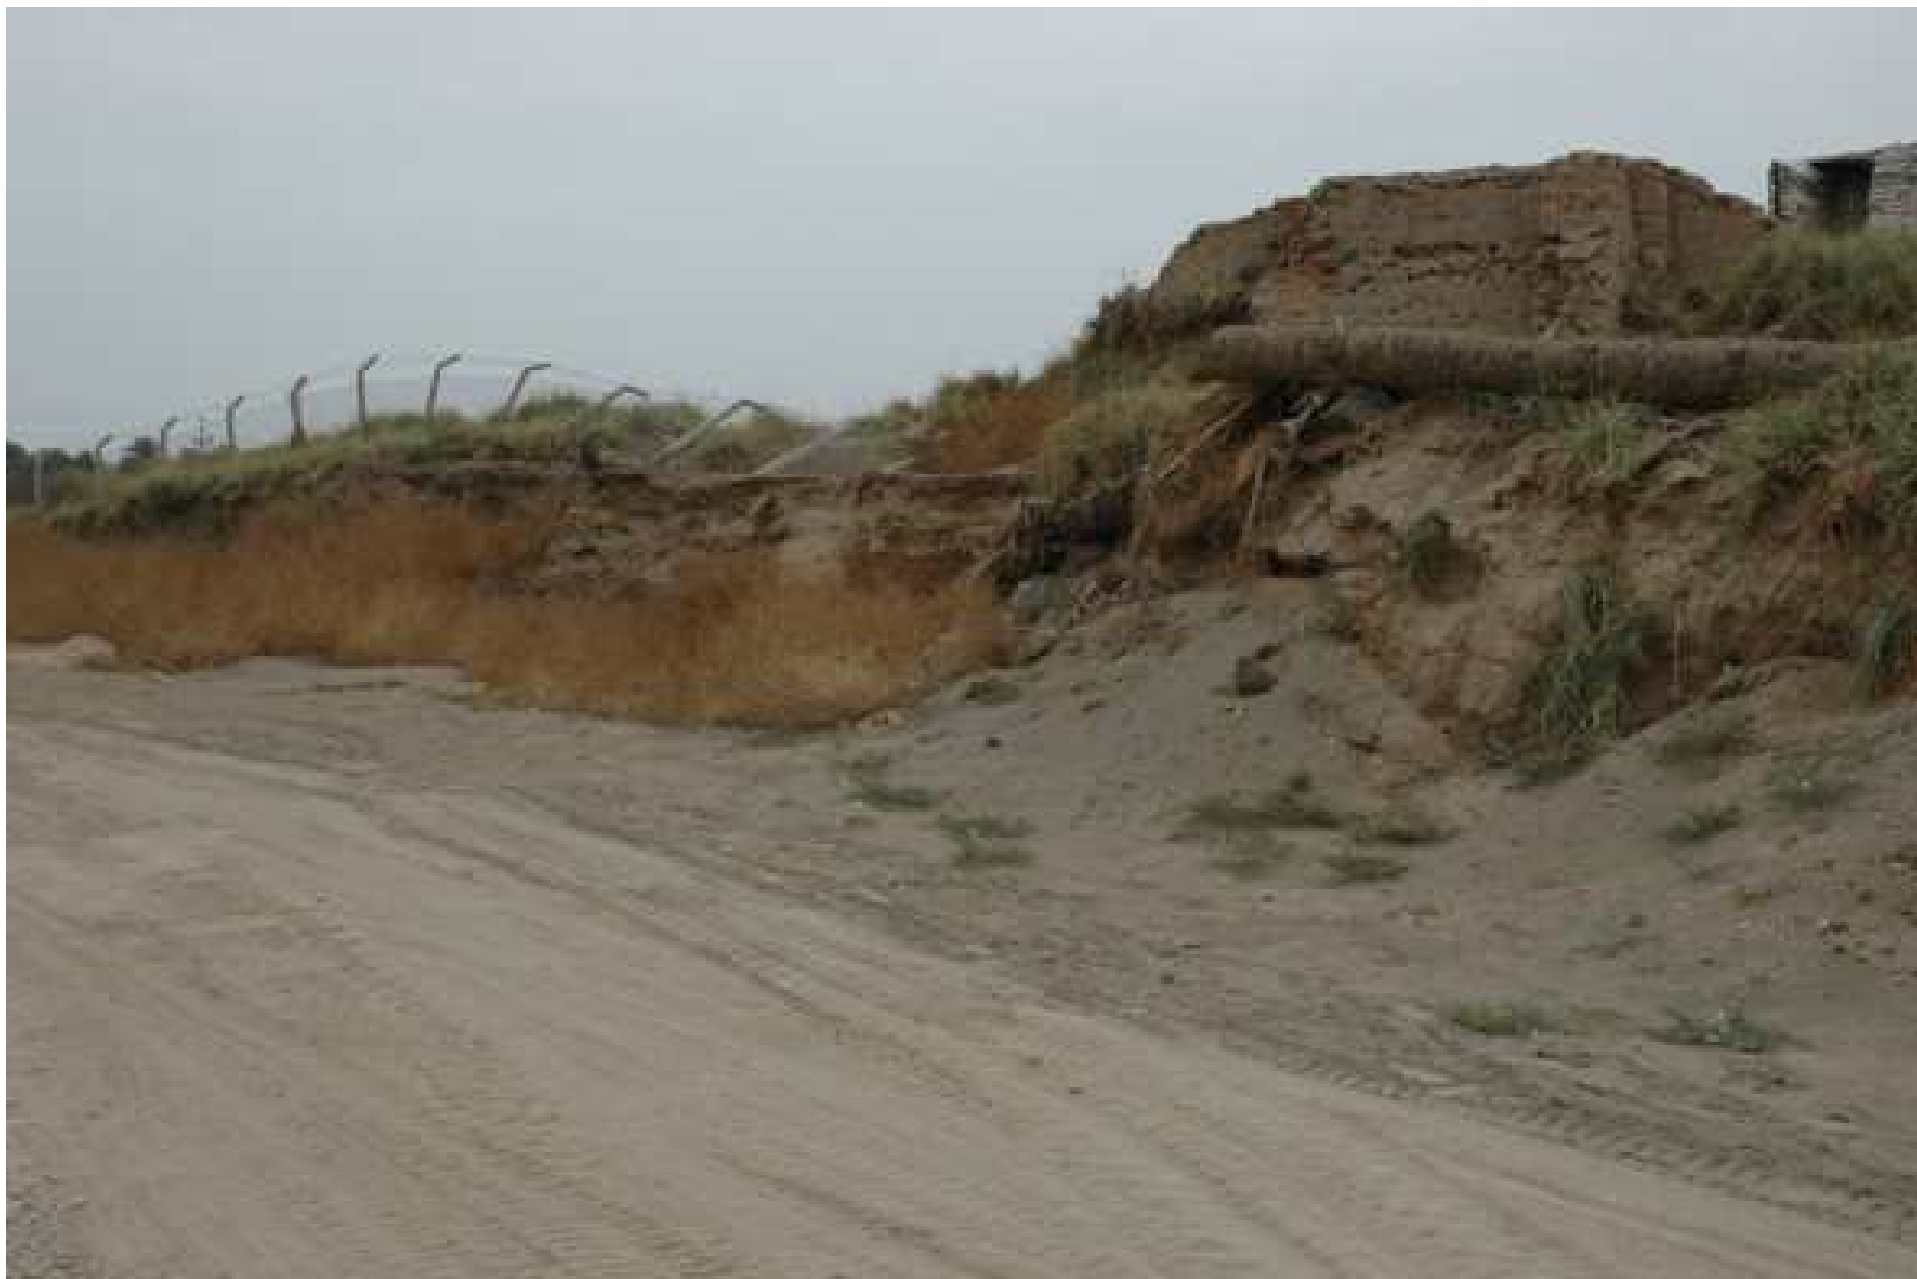
<b>McDonald report</b>	<b>Iraqi preliminary report</b>	<b>Iraqi final report</b>	<b>Curtis report</b>	<b>Polish report</b>
<p>The one area of the southern helicopter landing zone where archaeological damage may have been done is at its southeastern end close to the road where a mound was cut leaving a six foot section in some places. Outside the fence line the rest of this particular mound has a late Islamic ruin on top of it which is being used as an observation post. This landing zone is now going out of use and the helicopters are being replaced by tents for the Polish Coalition forces.</p>	<p>There are also two pits  <u>[A: near the control point leading to the village of al-Jumjumah]</u>  <u>[B: in the southern part of the city, on the road leading to the village of al-Jumjumah.]</u></p> <p>The first has dimensions of 10 x 10 meters and a depth of 2 meters.</p> <p>The second is a smaller pit with dimensions of approximately 5 x 8 meters and a depth of 2.5 meters.</p>	<p>7. Seventh cut: It is north of cuts 5 and 6, to the west of the main road, near the area of the brick kiln, south of the southern airfield built by the MNF-I. The cut was made to build a road for vehicles transporting supplies and food to residential locations. The cut is 60 m in length, 3 m in width, and 3 m height (Photo 45).</p> <p>9. Ninth cut: Located to the east of the brick kiln, it has a length of 100 m. The dirt removed from this cut was used to make HESCO<sup>1</sup> barriers and earthen obstacles. Parts of the tells located on the two sides of the road were removed, as evidenced by the pottery fragments in the HESCO containers (Photo 47).</p> <p>10. Pit. In the southern part of the city, on the road that leads to the village of al-Jumjumah to the west and that links the archeological city of Babylon to the village of al-Jumjumah and the city of al-Hillah, there is a pit with an almost circular shape, a diameter of 7 m, and a depth of 5.2 [2.5?] m. The dirt removed from the pit from was packed into bags or used to fill containers (Photo 37).</p> <p>11. Pit. Near the pit mentioned in the previous paragraph is another pit. It is larger in area and is approximately circular in shape, with a diameter of 10 m and a depth of 2 m (Photo 38).</p>	<p>On the south side of the road to the west of the Reno Gate, in front of a brick factory, there is a cutting with maximum height 3m where the road has been widened (<i>Polish Report</i>, centre fig. on p.29).</p>	<p>The Southern boundary of the area is located near the road on the South. The terrain is level. On the picture this place is marked as letter "B"</p>

7<sup>th</sup> cut, Polish report p. 17 (photo © Ministry of Culture and National Heritage, Republic of Poland)

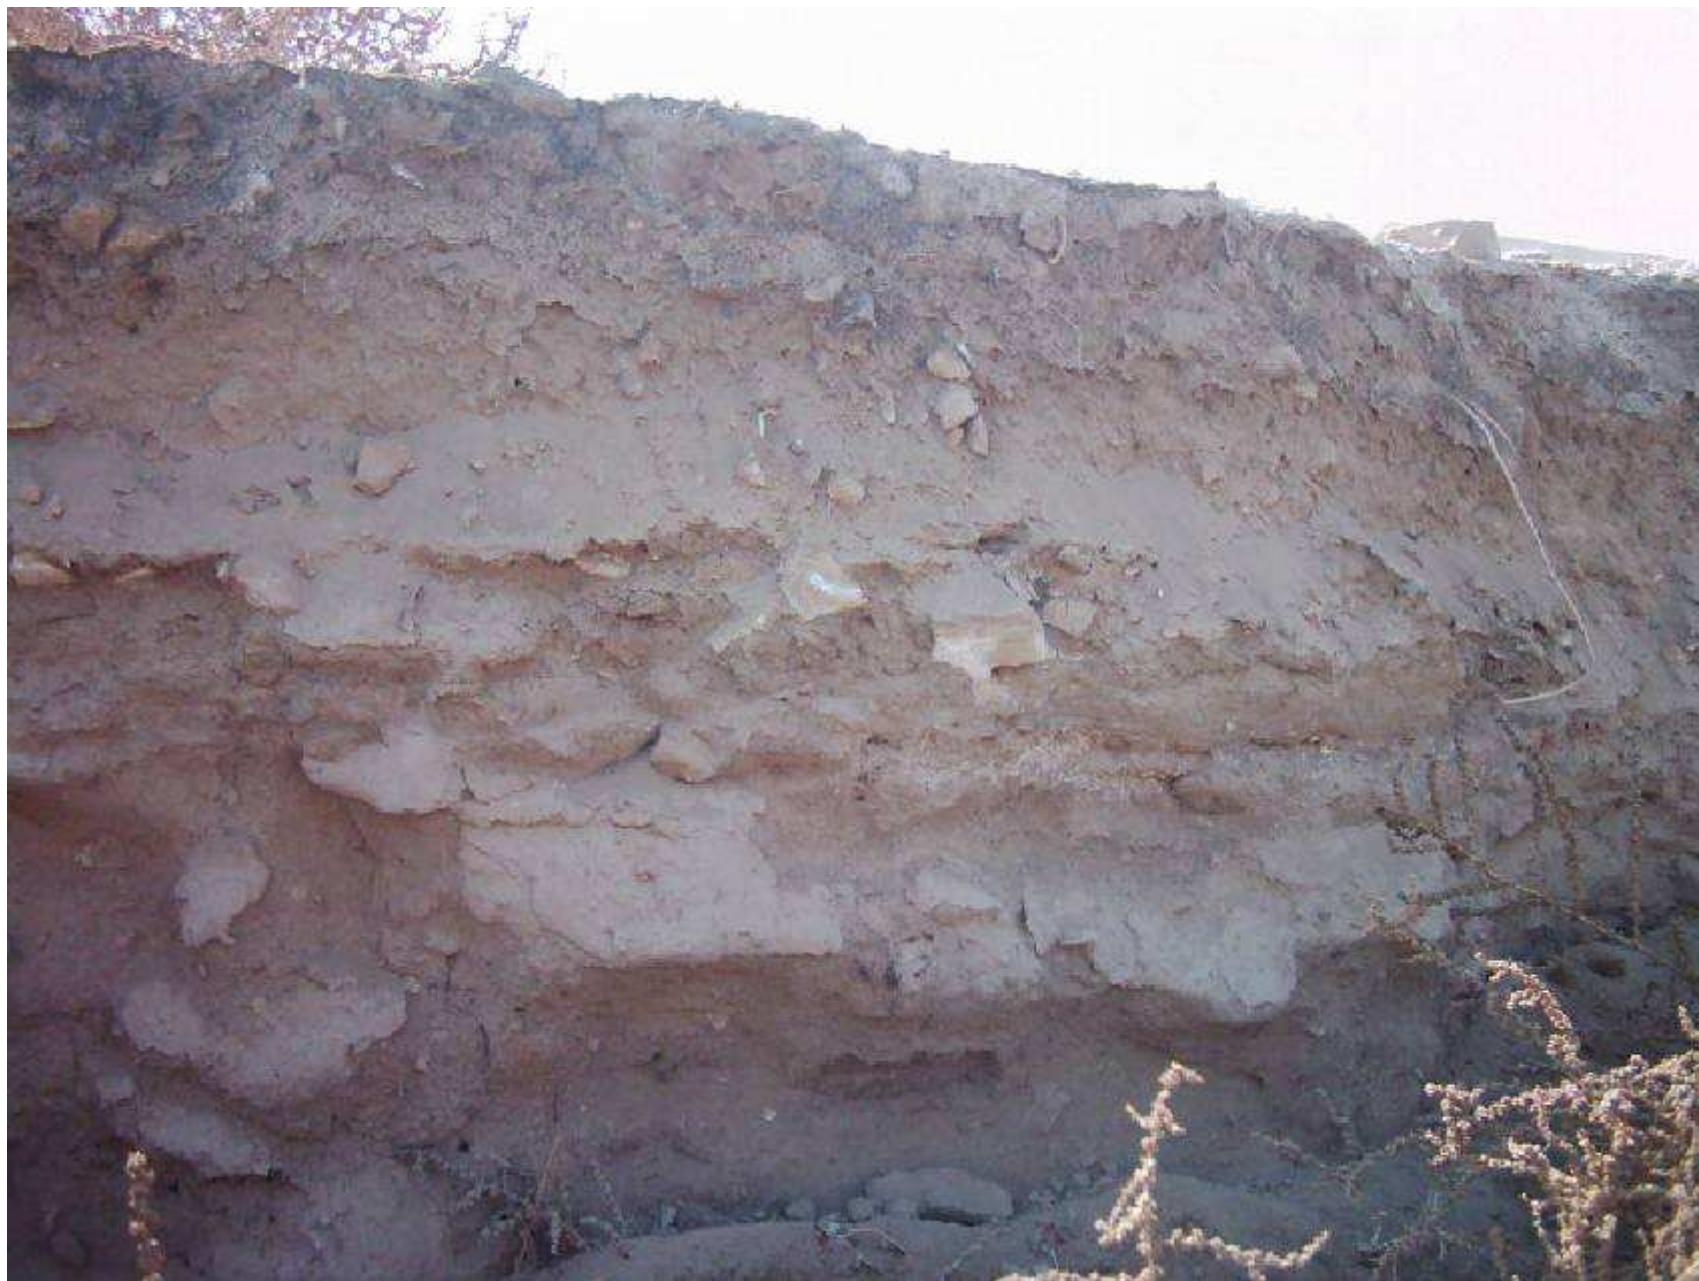
7th cut, Iraqi final report fig. 45

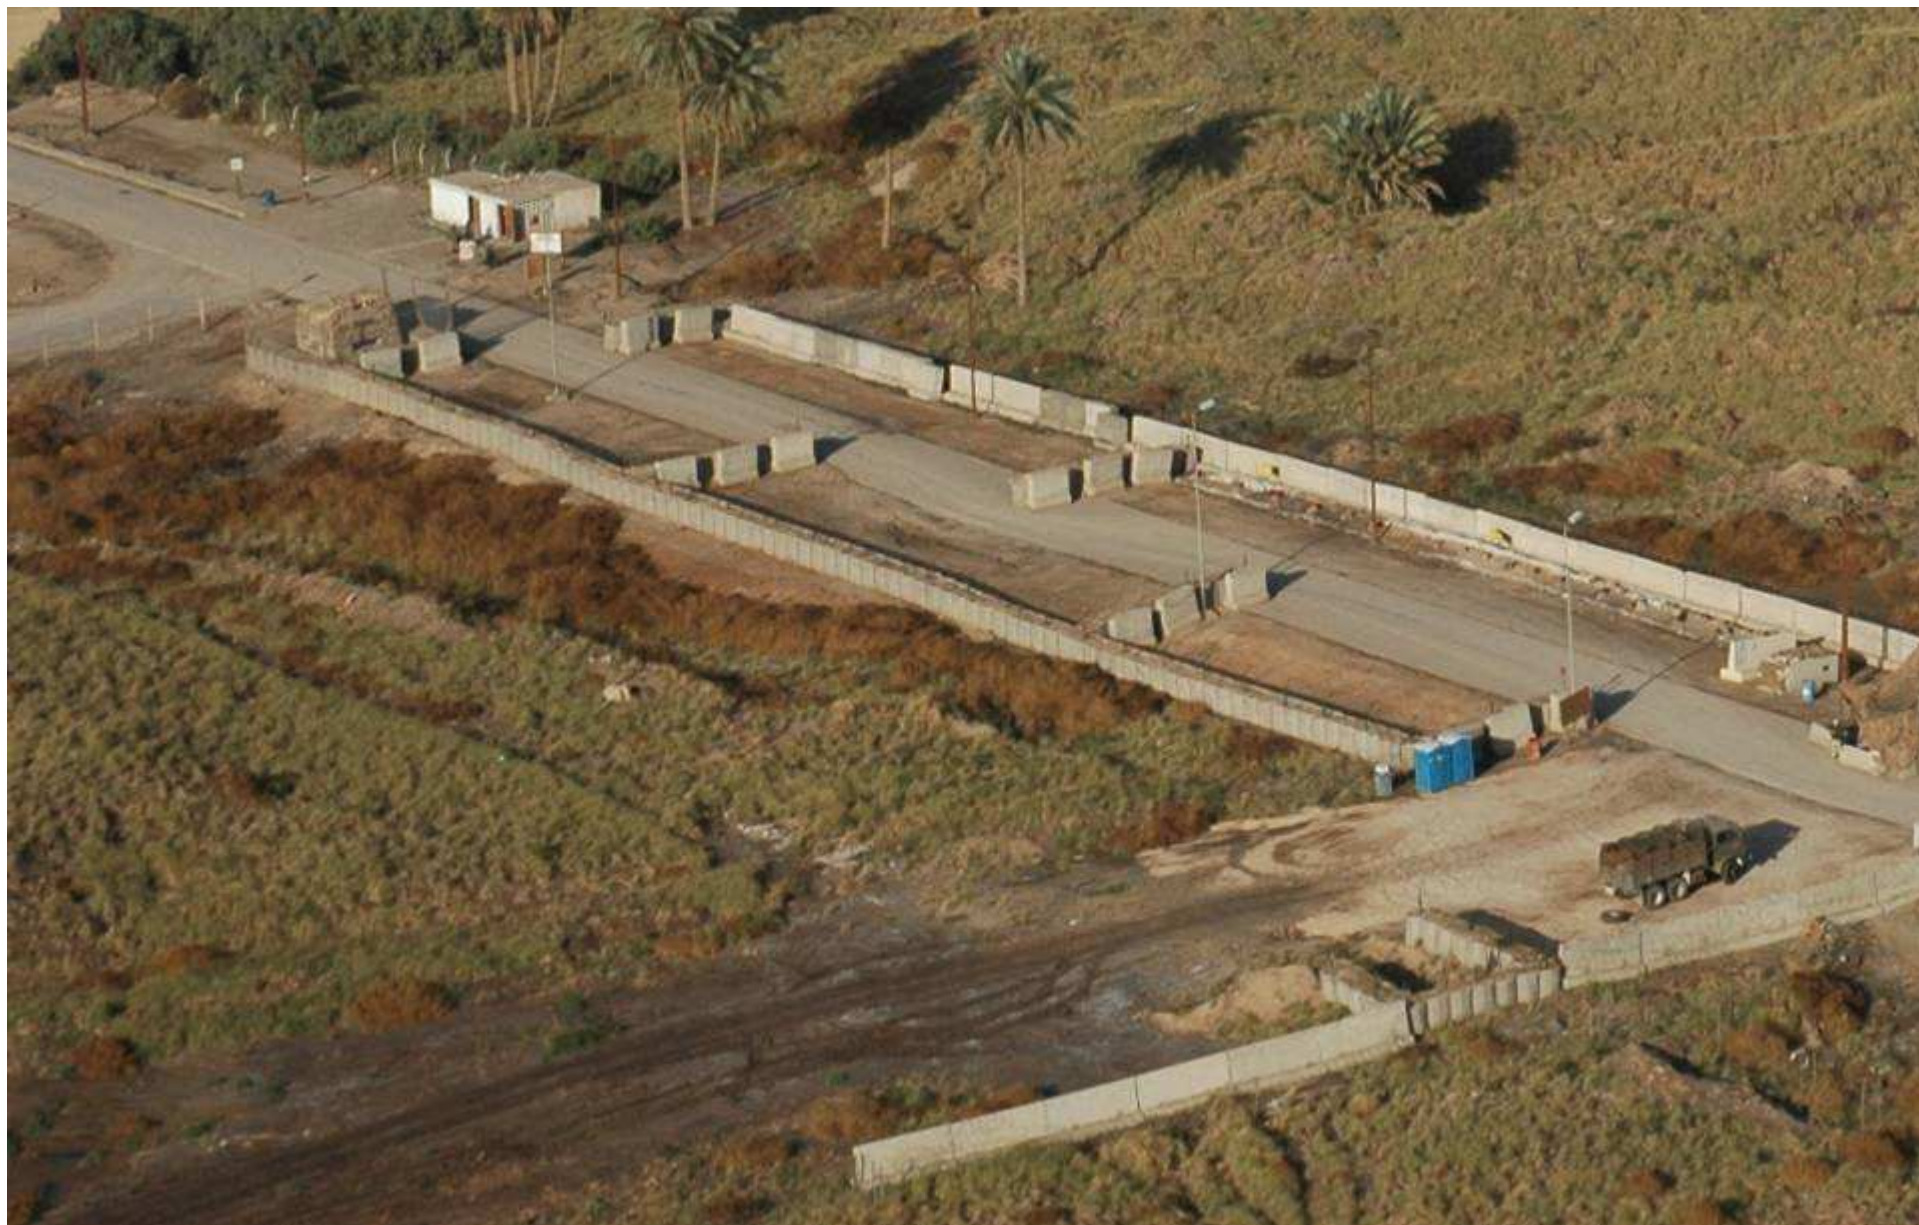
9th cut at upper left, Polish photo 27, detail (photo © Ministry of Culture and National Heritage, Republic of Poland)

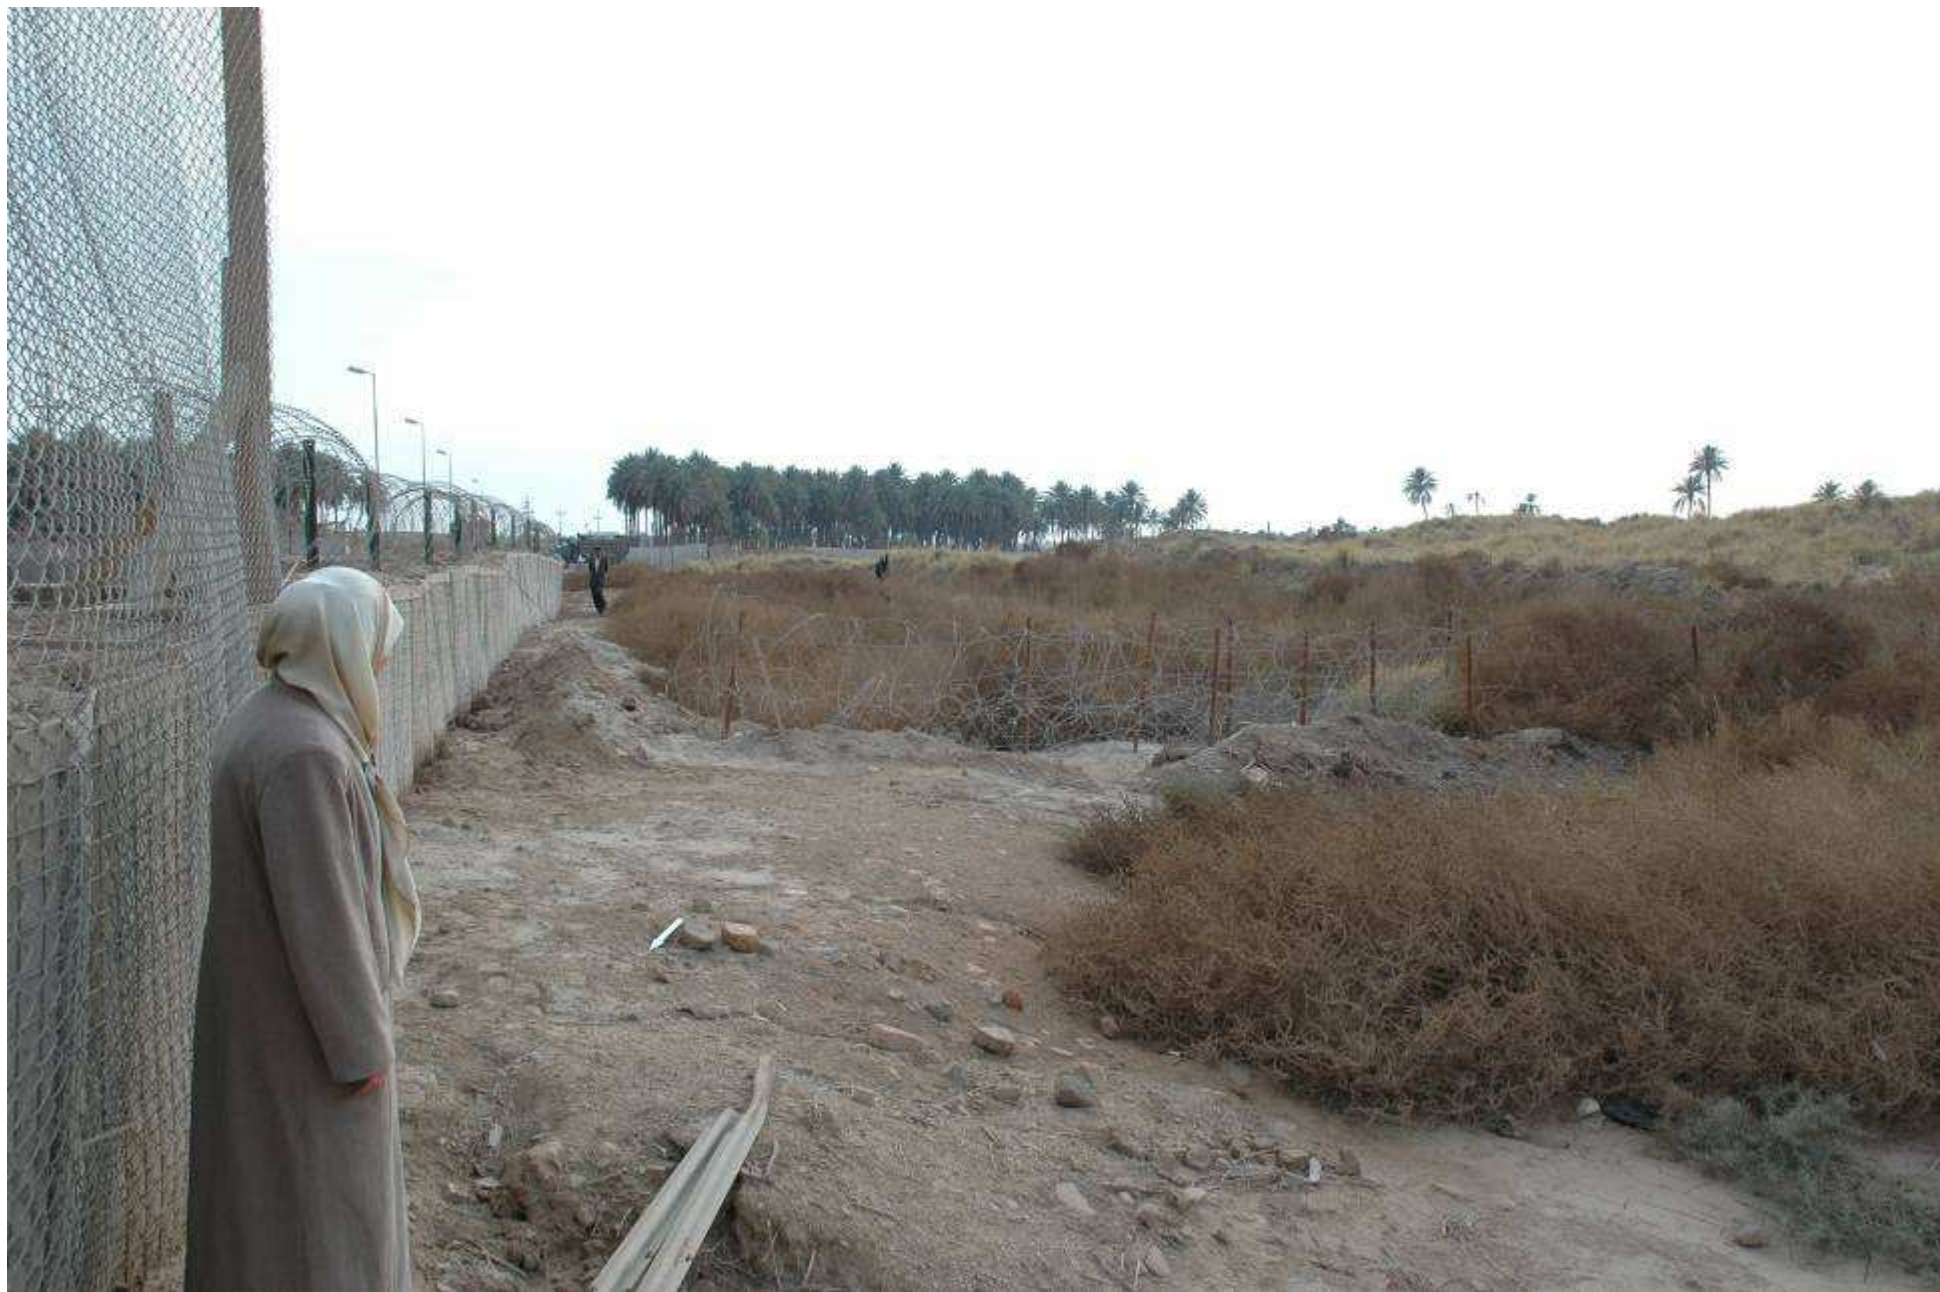
9th cut, Iraqi final report fig. 47

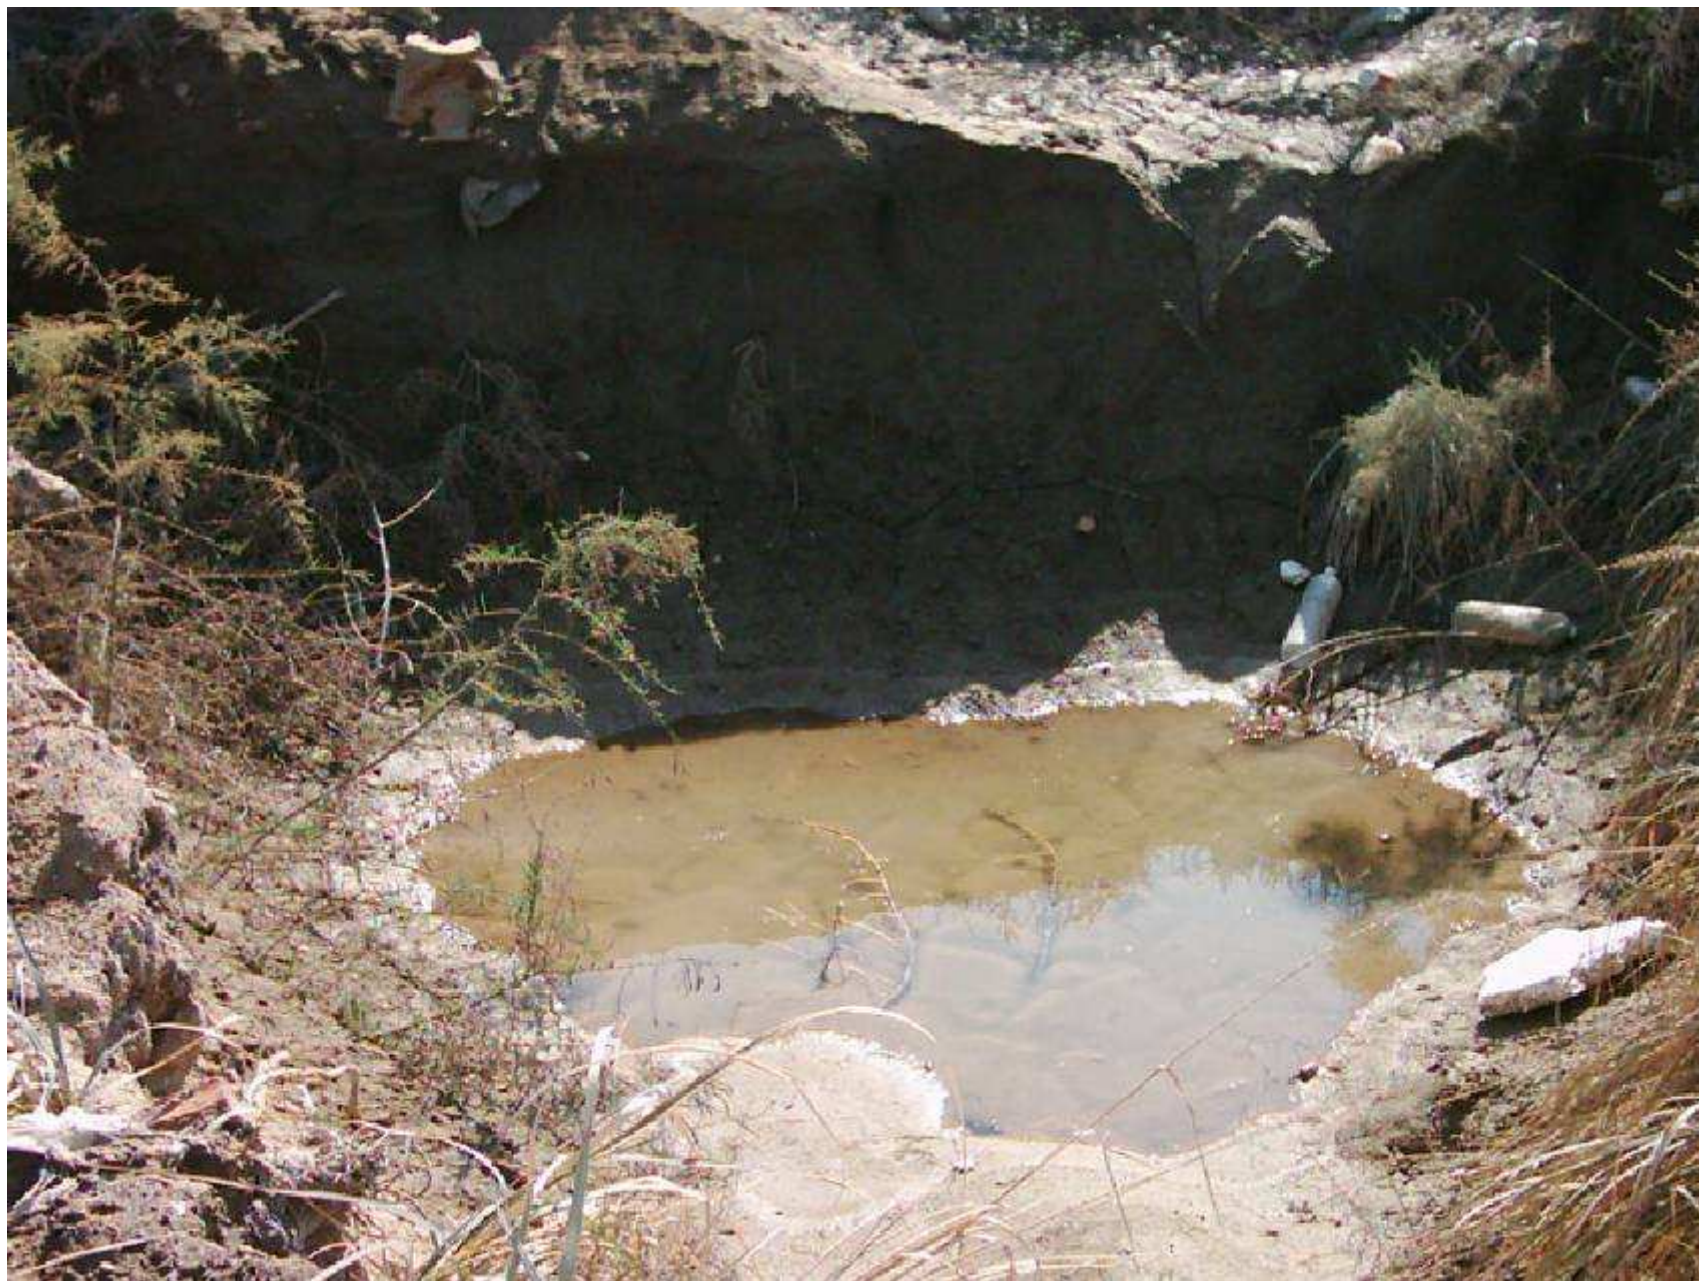
Pit 10, Iraqi final report fig. 37
