# **Report on Damage to the Site of Babylon, Iraq**

**John Malcolm Russell, Ph.D.**

**Cultural Heritage Center  
Bureau of Educational and Cultural Affairs  
Department of State**

**April 2010**

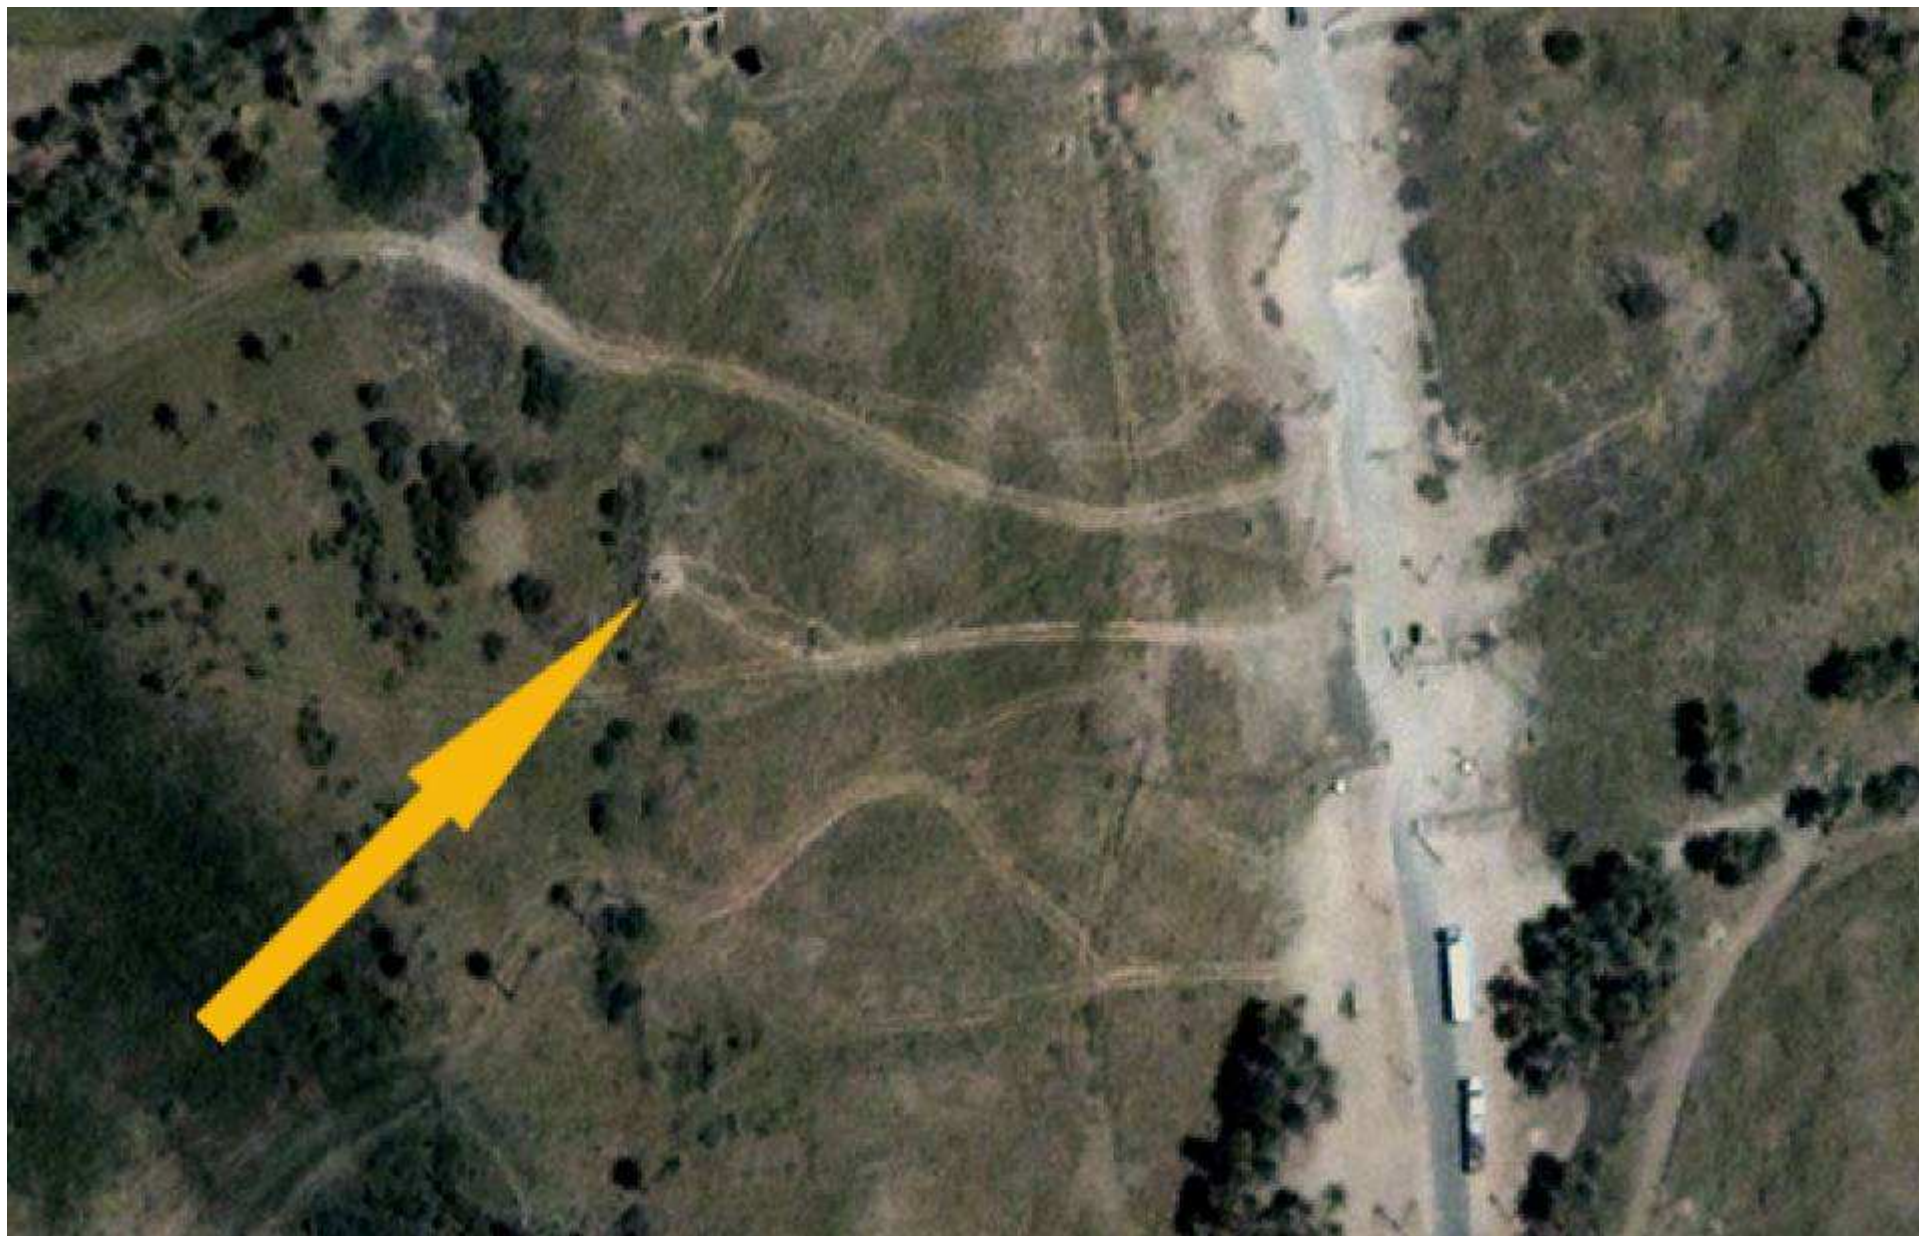
Observation tower 6, first version, 31 August 2003, Russell composite

**Observation tower 6:** The first watch tower was replaced between August 2003 and June 2004. During this same period, a large parking lot was carved out to the east of the tower (8th cut).

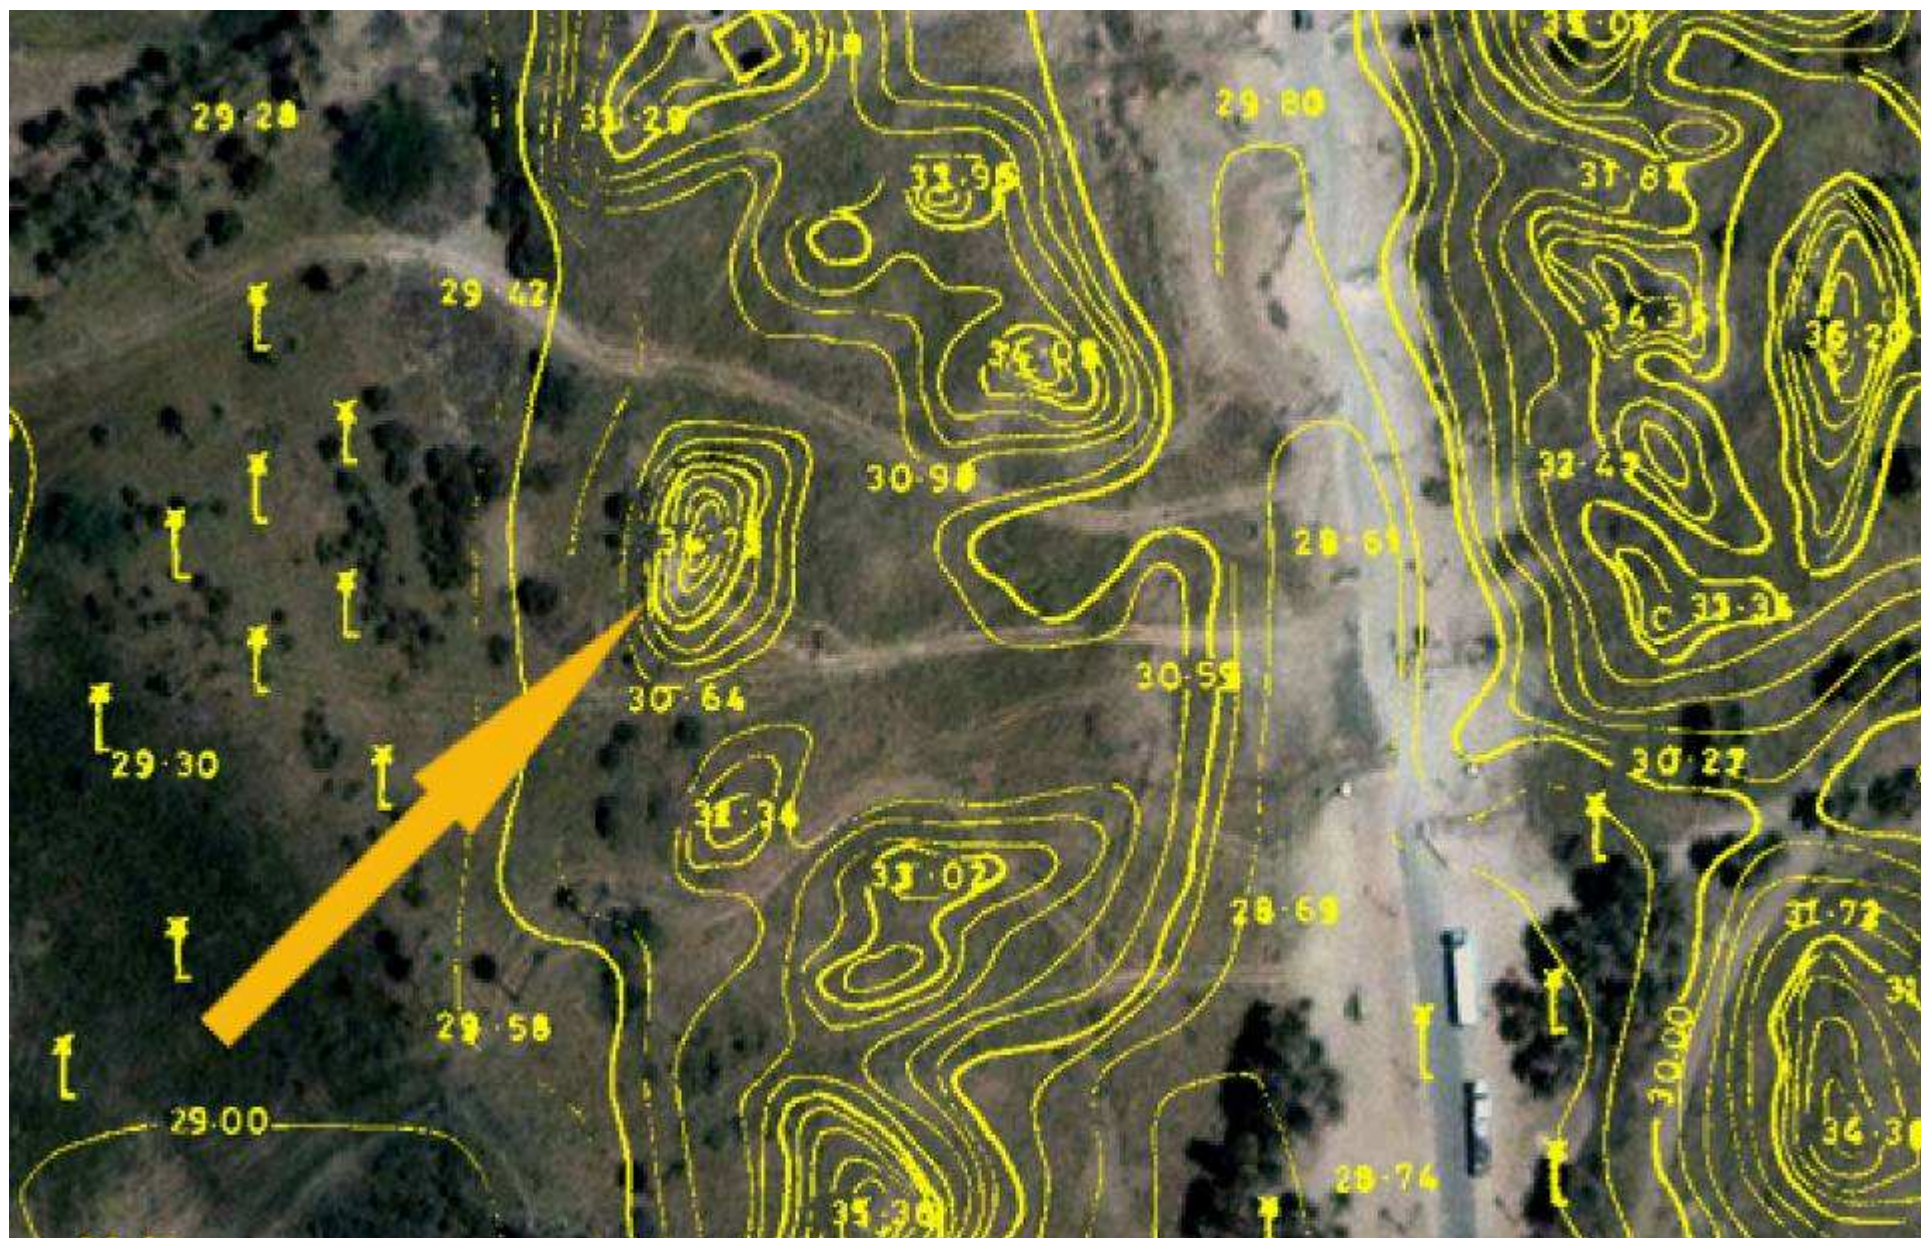
Topography of site of observation tower 6, 31 August 2003, Russell composite

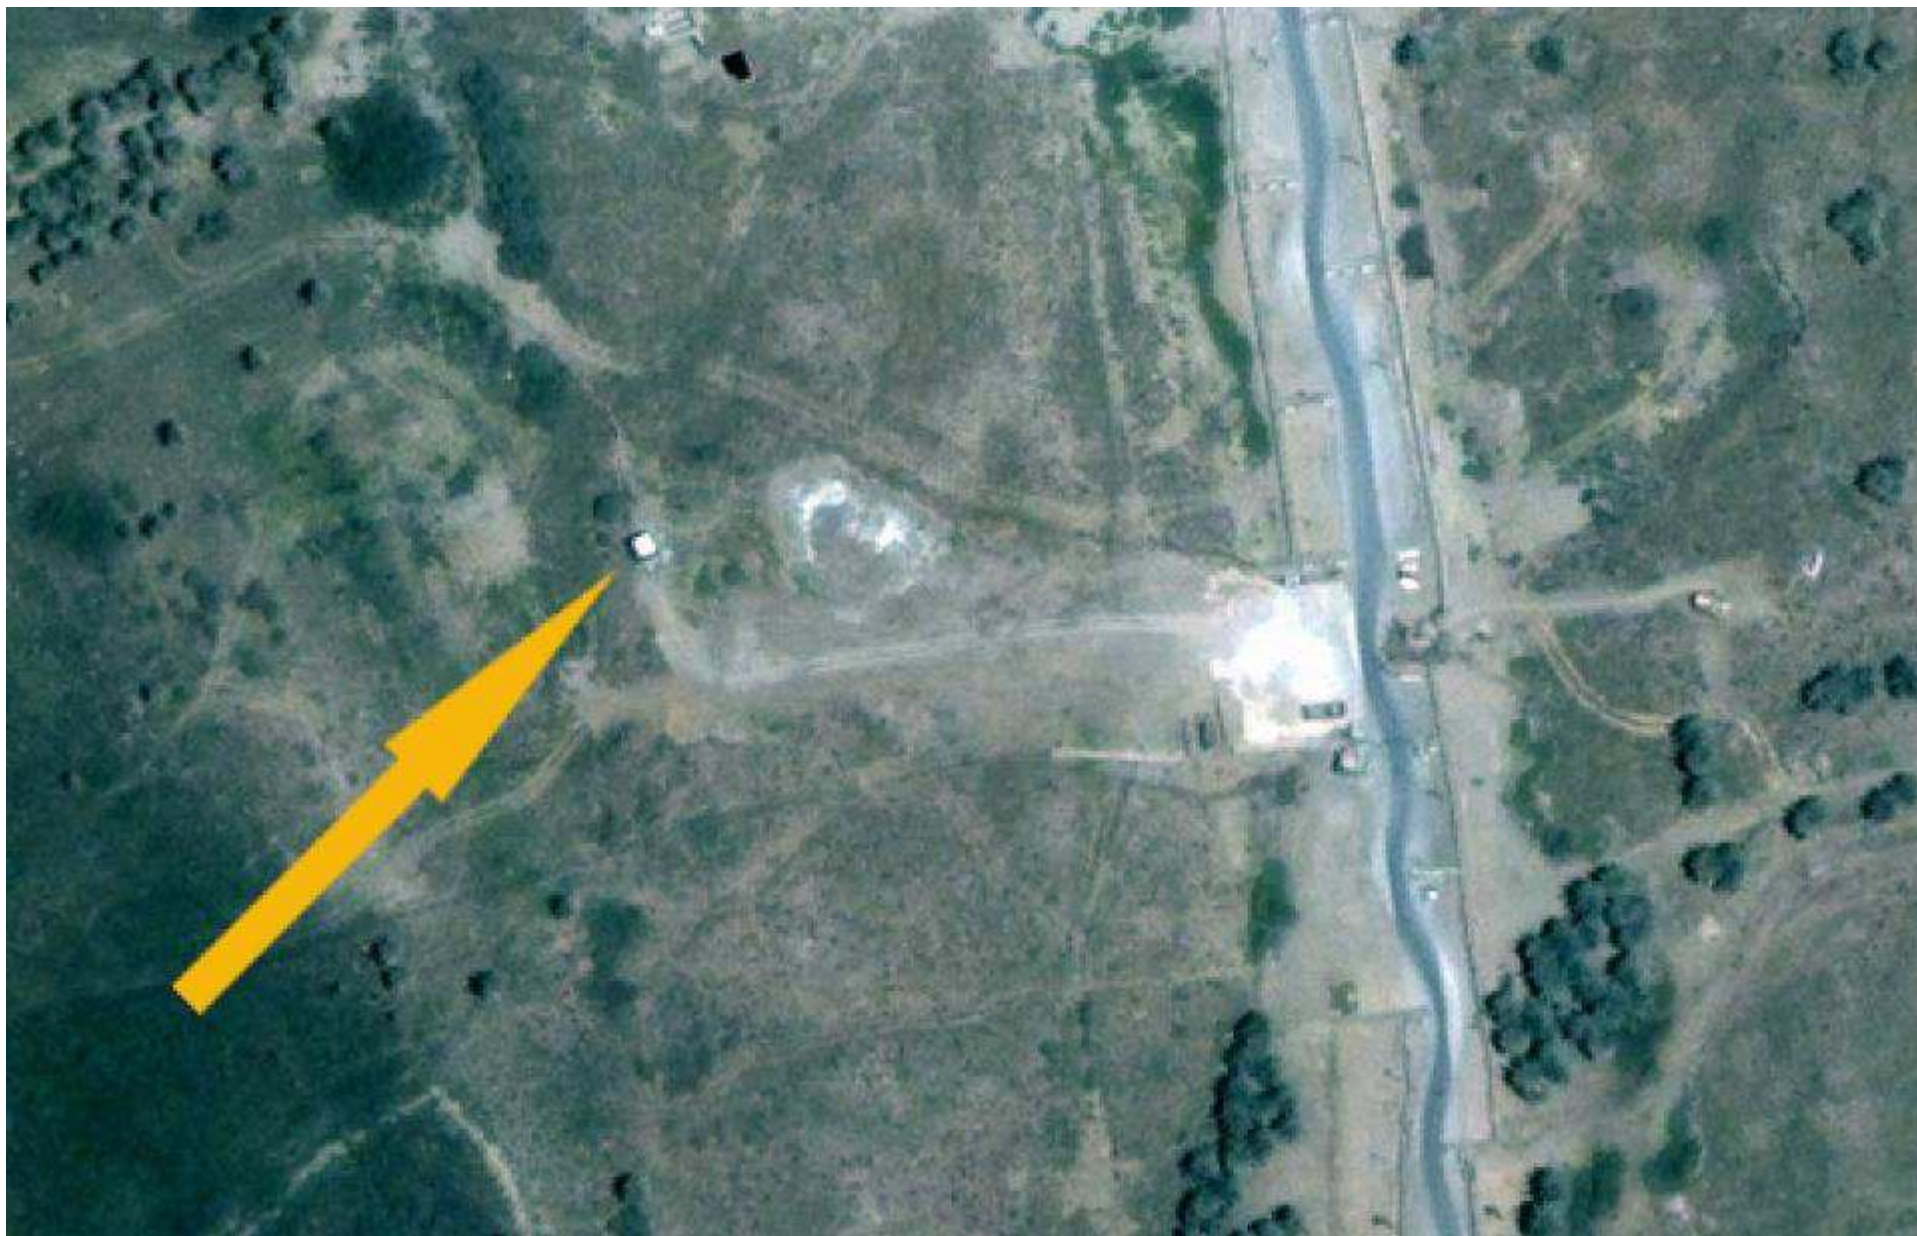
Observation tower 8 (arrow), final version, with 8th cut visible just to the east, 4 June 2004, Russell composite

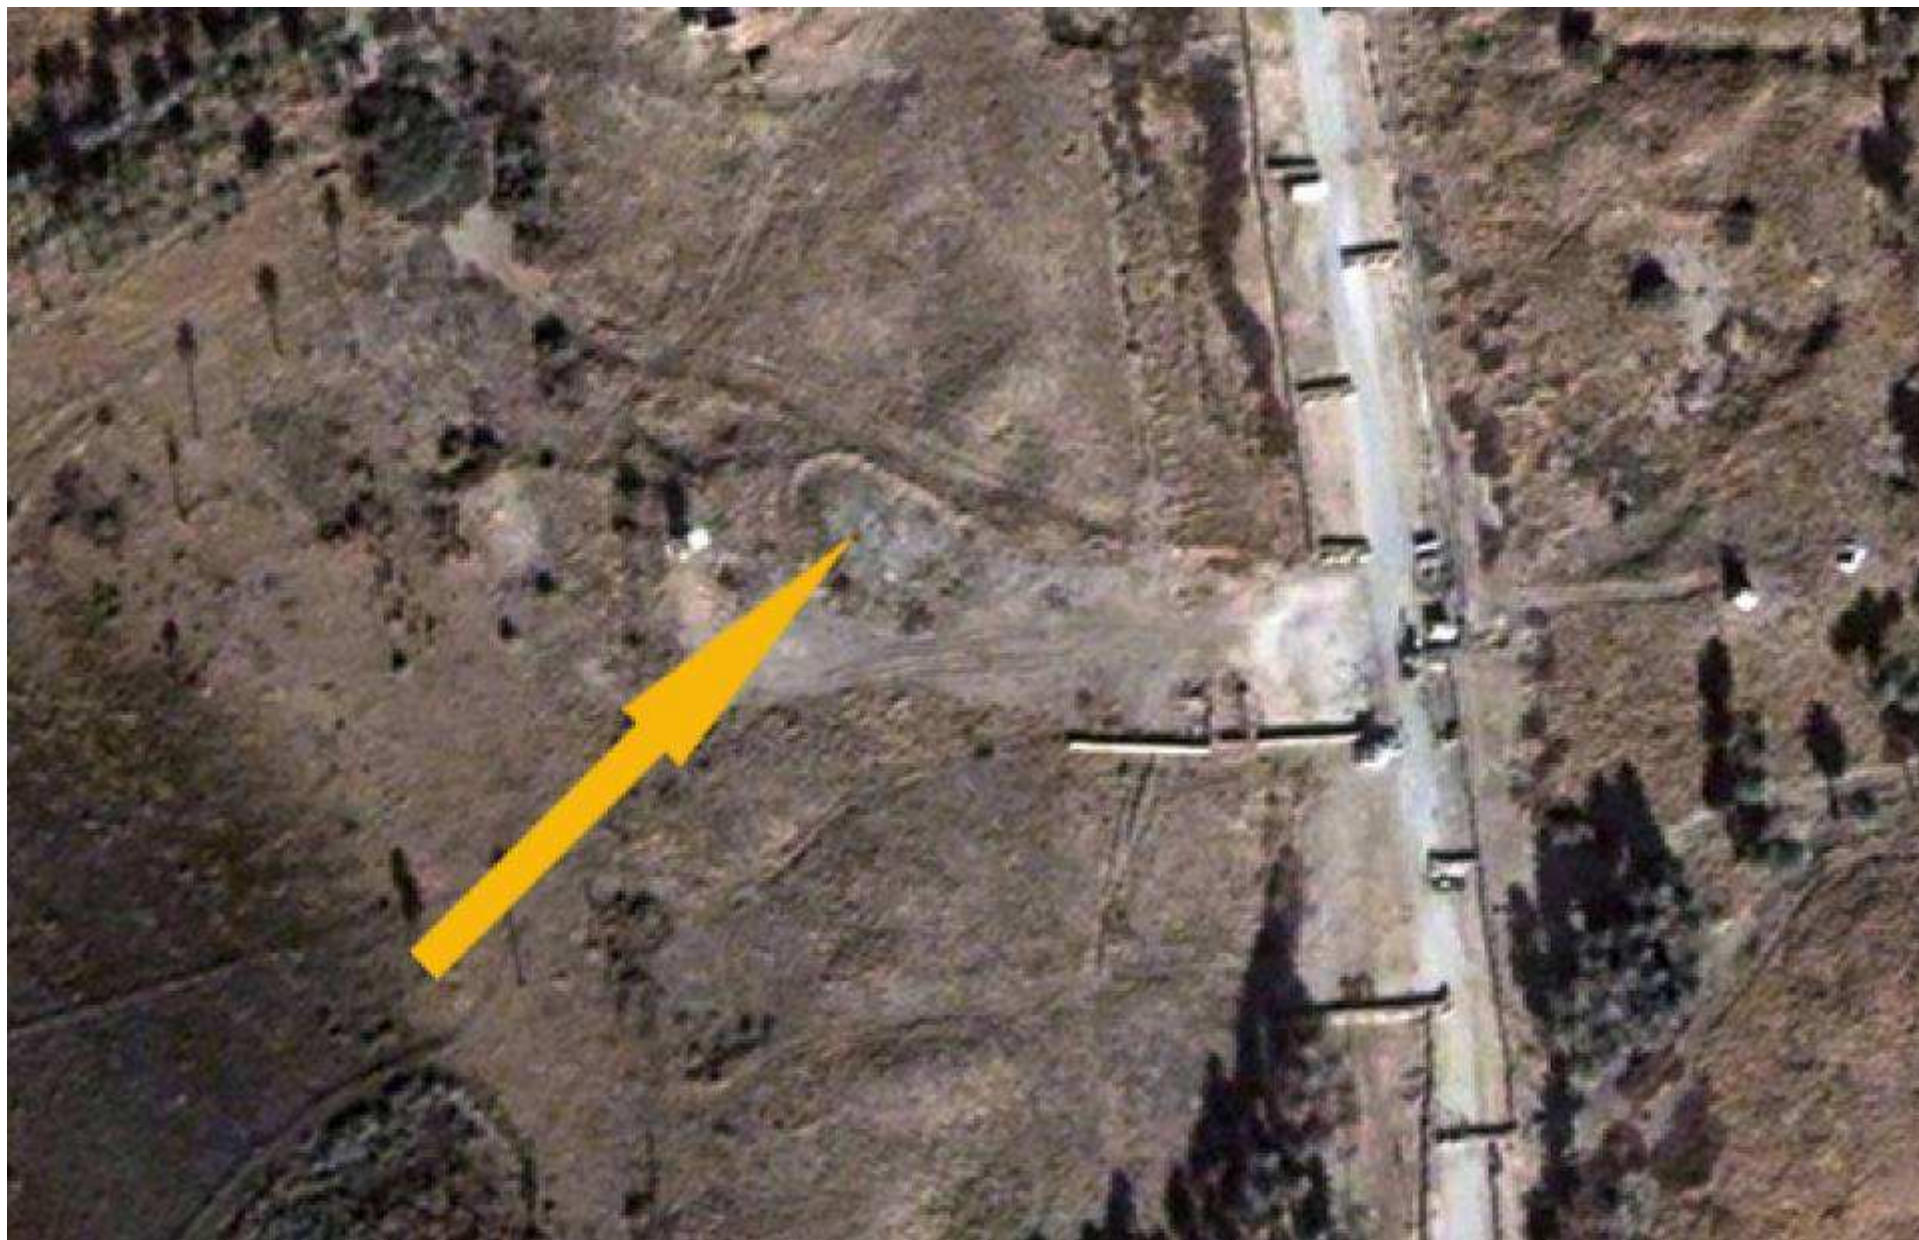
8th cut, clearly visible after abandonment of camp, 26 November 2005, Russell composite

Iraqi final report	Curtis report	Polish report
8. Eighth cut: It is south of the brick kiln. This cut covers a large area estimated at 600 m. The dirt removed from the cut contains fragments of baked bricks and diverse pottery fragments (Photo 46).	To the west of the Reno Gate there is a trench c.30m x 10m, up to 2m deep, that is said to have been dug to fill conix containers (HESCO bags).	2) The tower no. 6 (on the below picture its approximate location has been indicated with letter “x” and digit 6). The earth that has been piled up to elevate one of the tells was gained as a result of grading of the area directly adjacent to the tower no 6 (surface of the area is 1200 square meters). There are many fragments of ceramic and brick on the slopes of the hill.

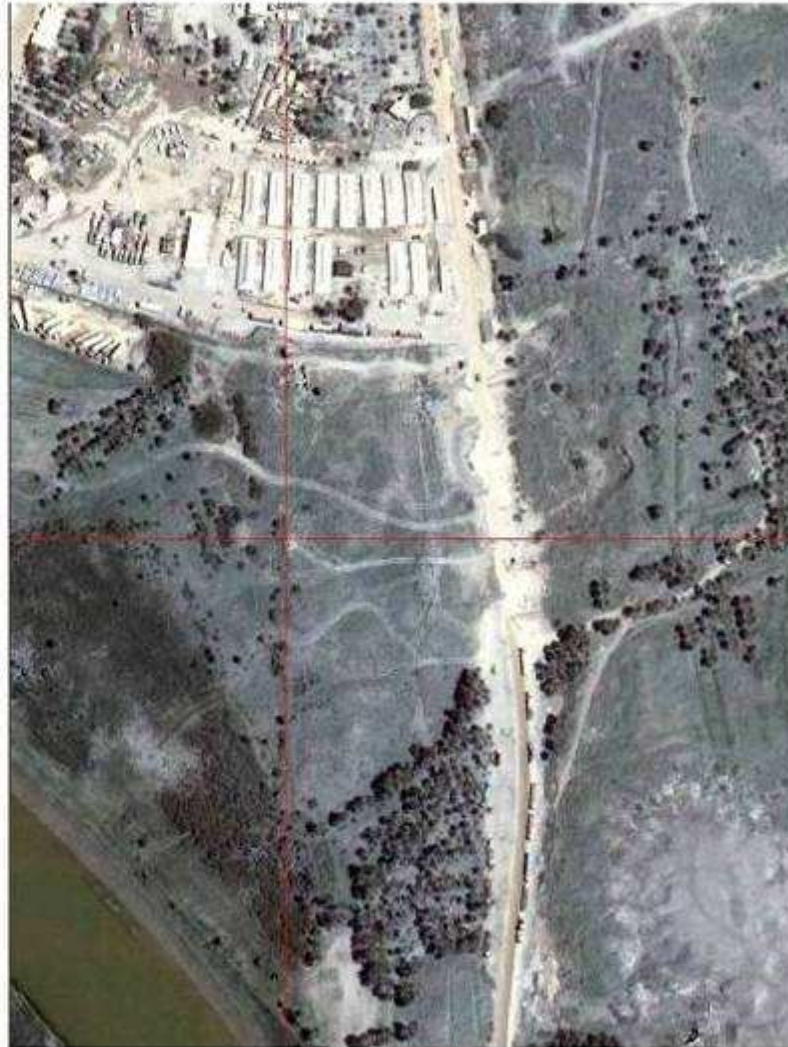
31 August 2003

**Stone report:** A second eminence was used for the same purpose to the east of the ziggurat (Fig. 37). Like the other, it was a fairly minor structure in August 2003, ...

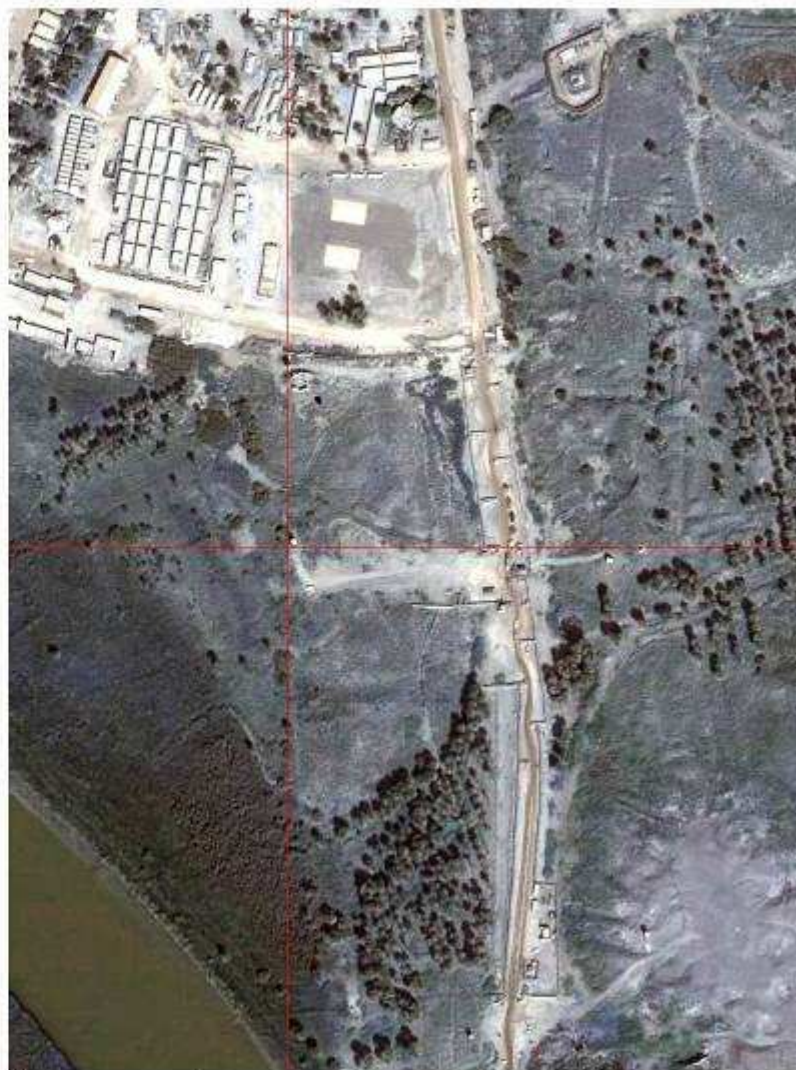
**8 October 2004**

**Stone report:** ...but gained in size and in its disruption to the mound by October 2004 (Fig 38).

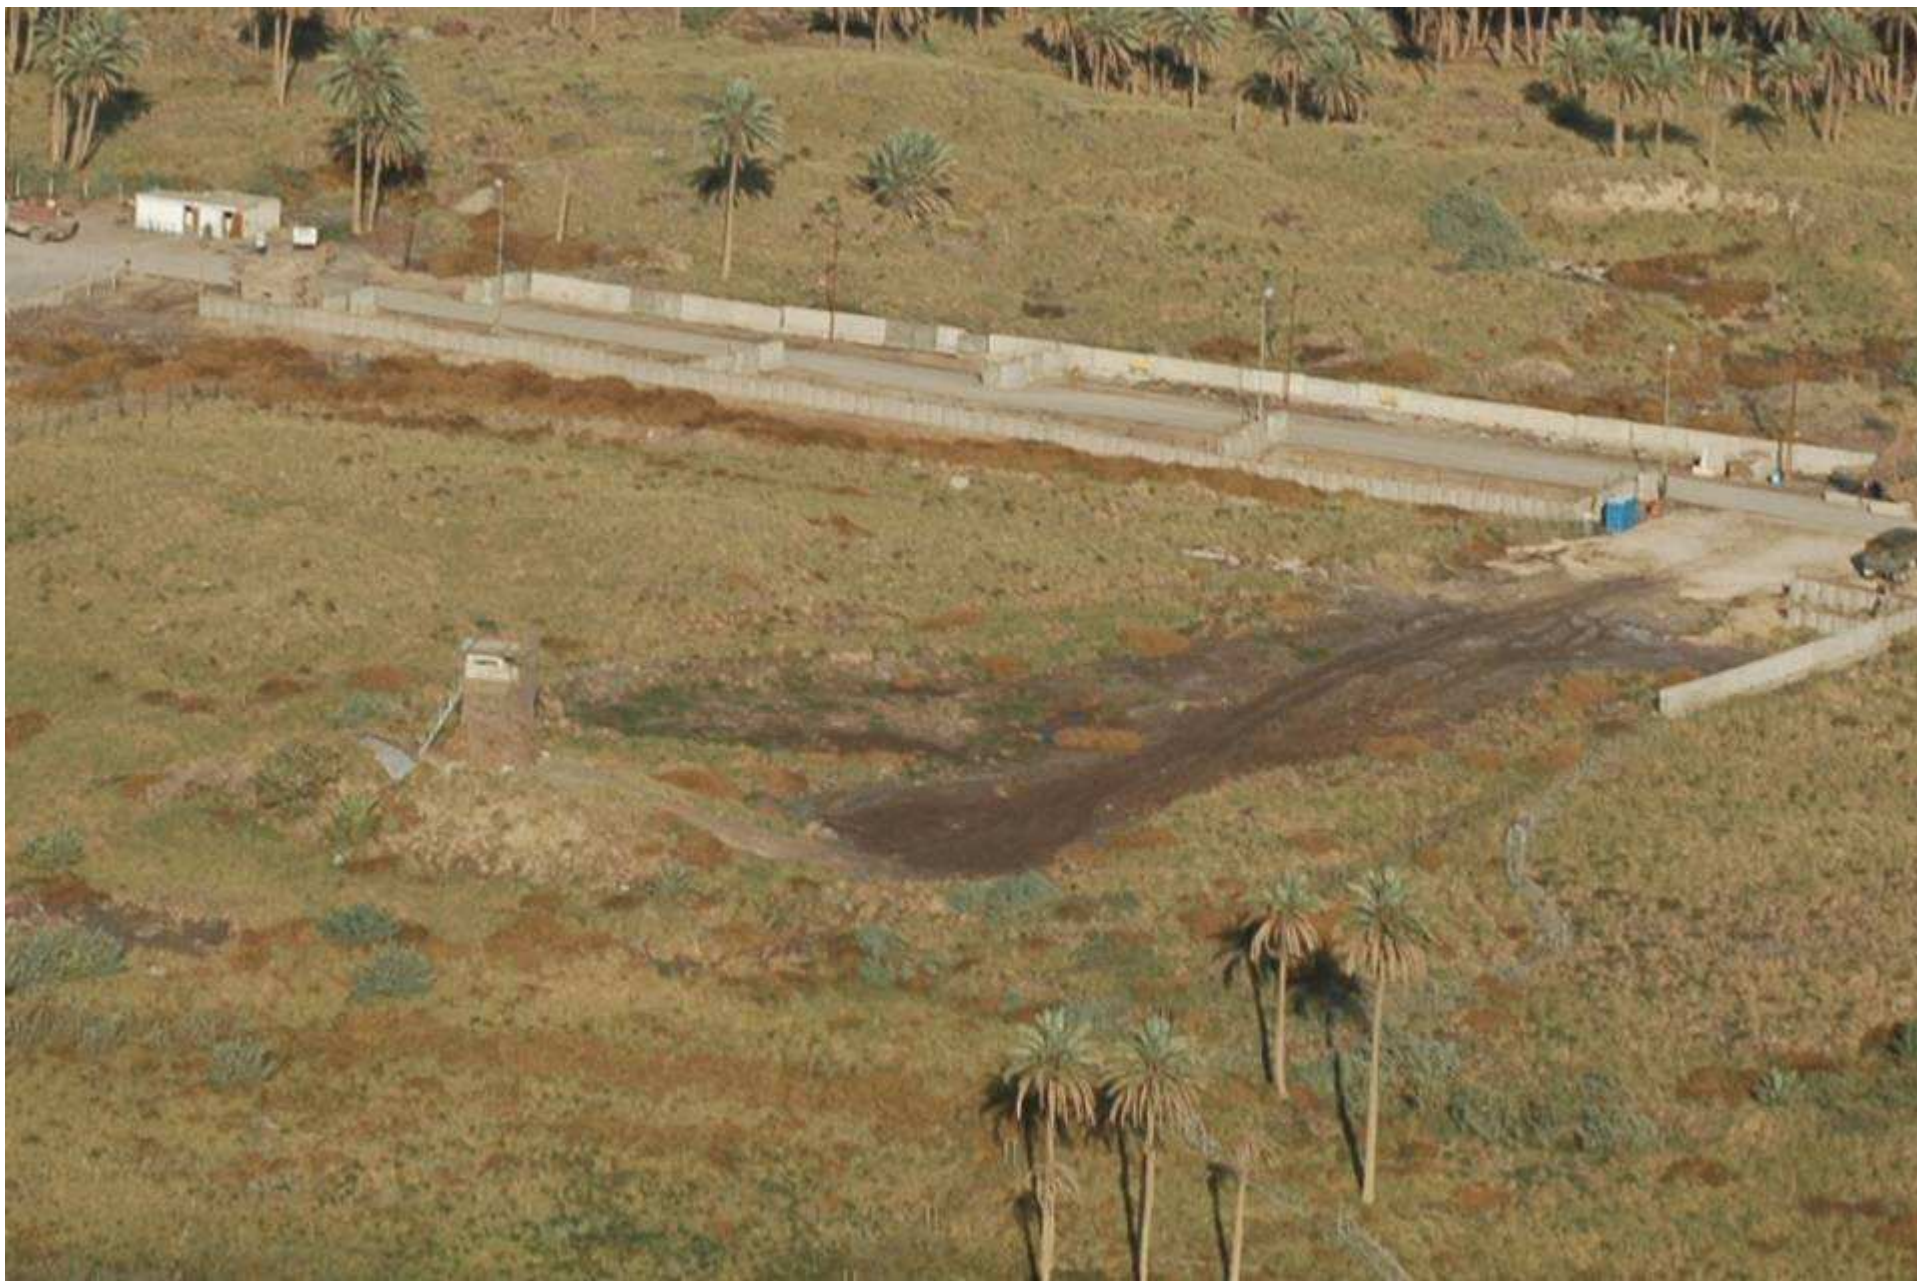
Observation tower 8, with 8th cut just to the right of it, Polish photo 26, detail (photo © Ministry of Culture and National Heritage, Republic of Poland)

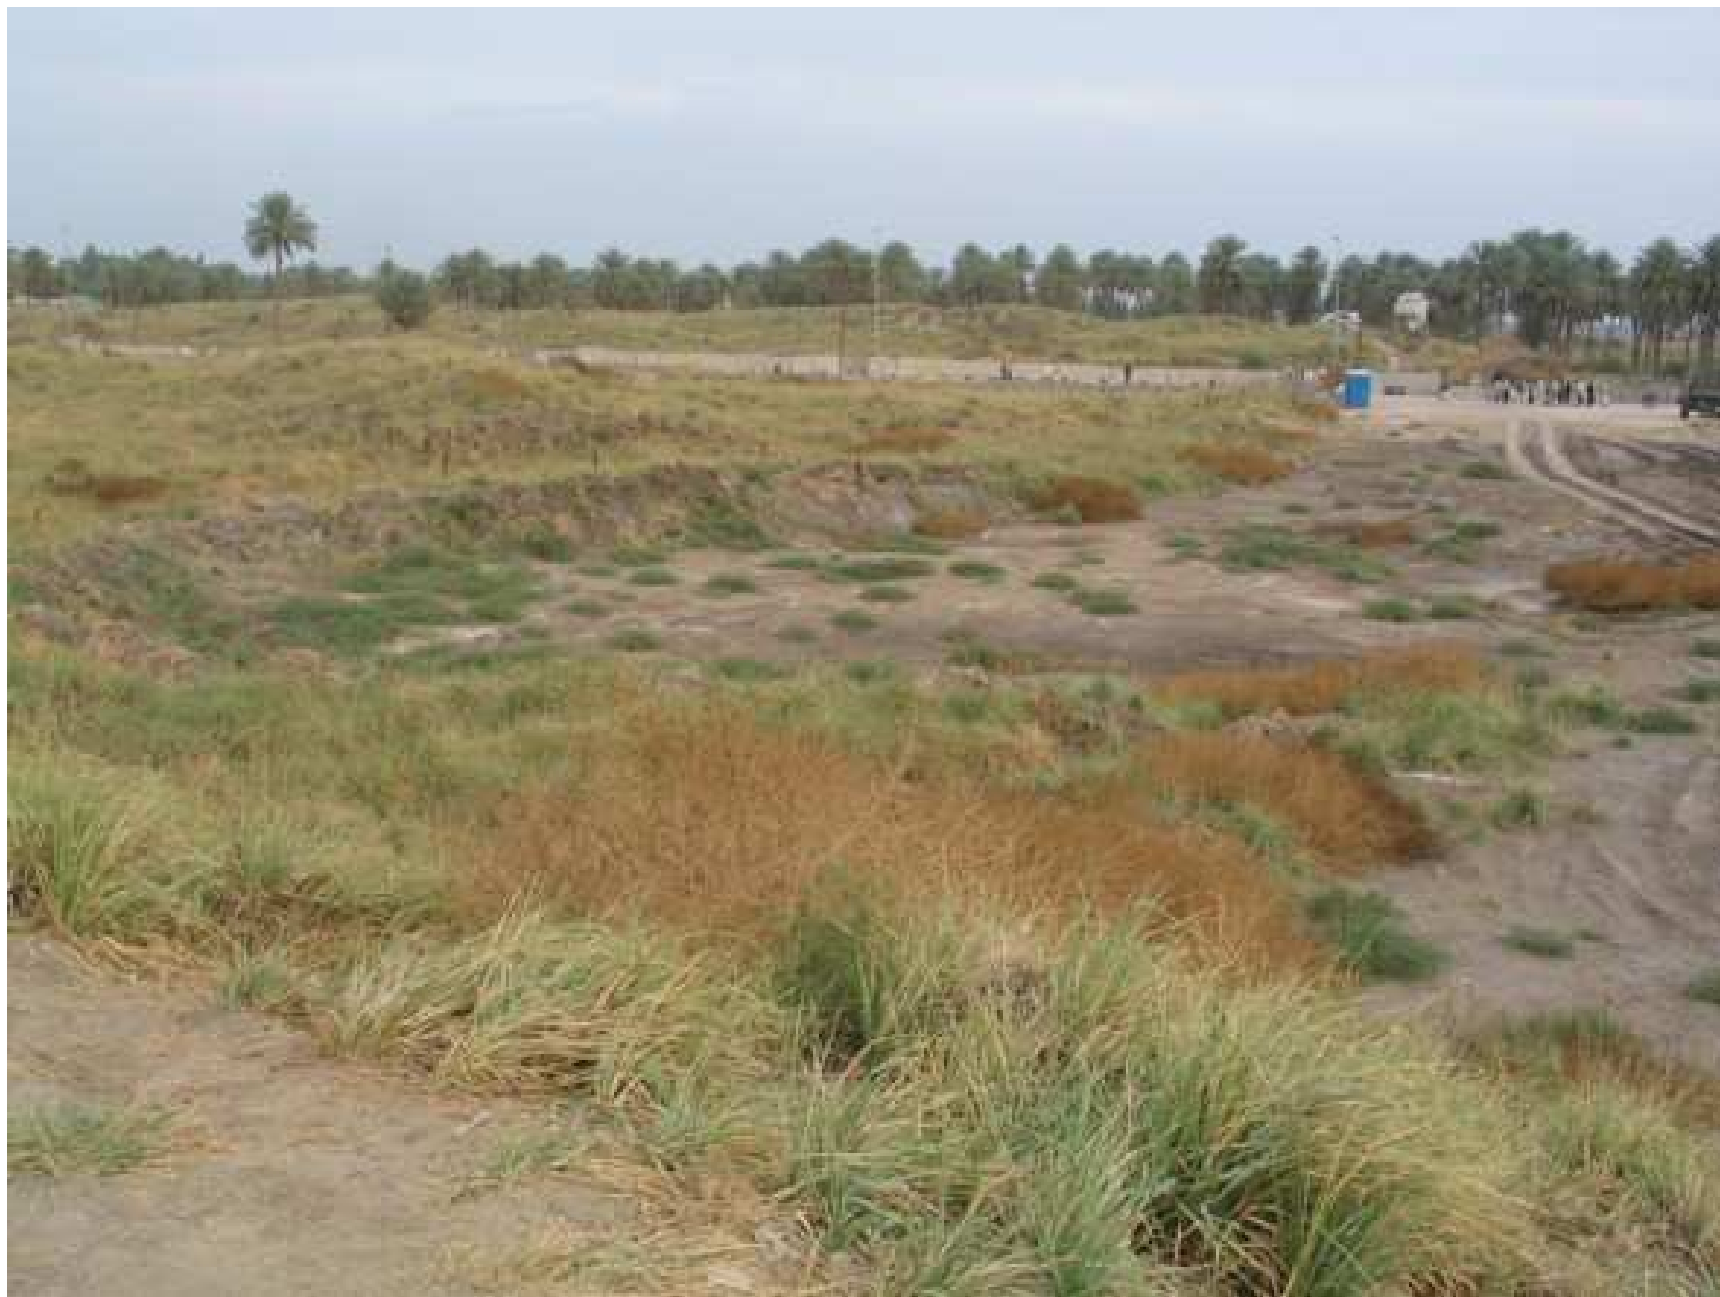
8th cut, view toward east from tower, Polish report p. 43 (photo © Ministry of Culture and National Heritage, Republic of Poland)

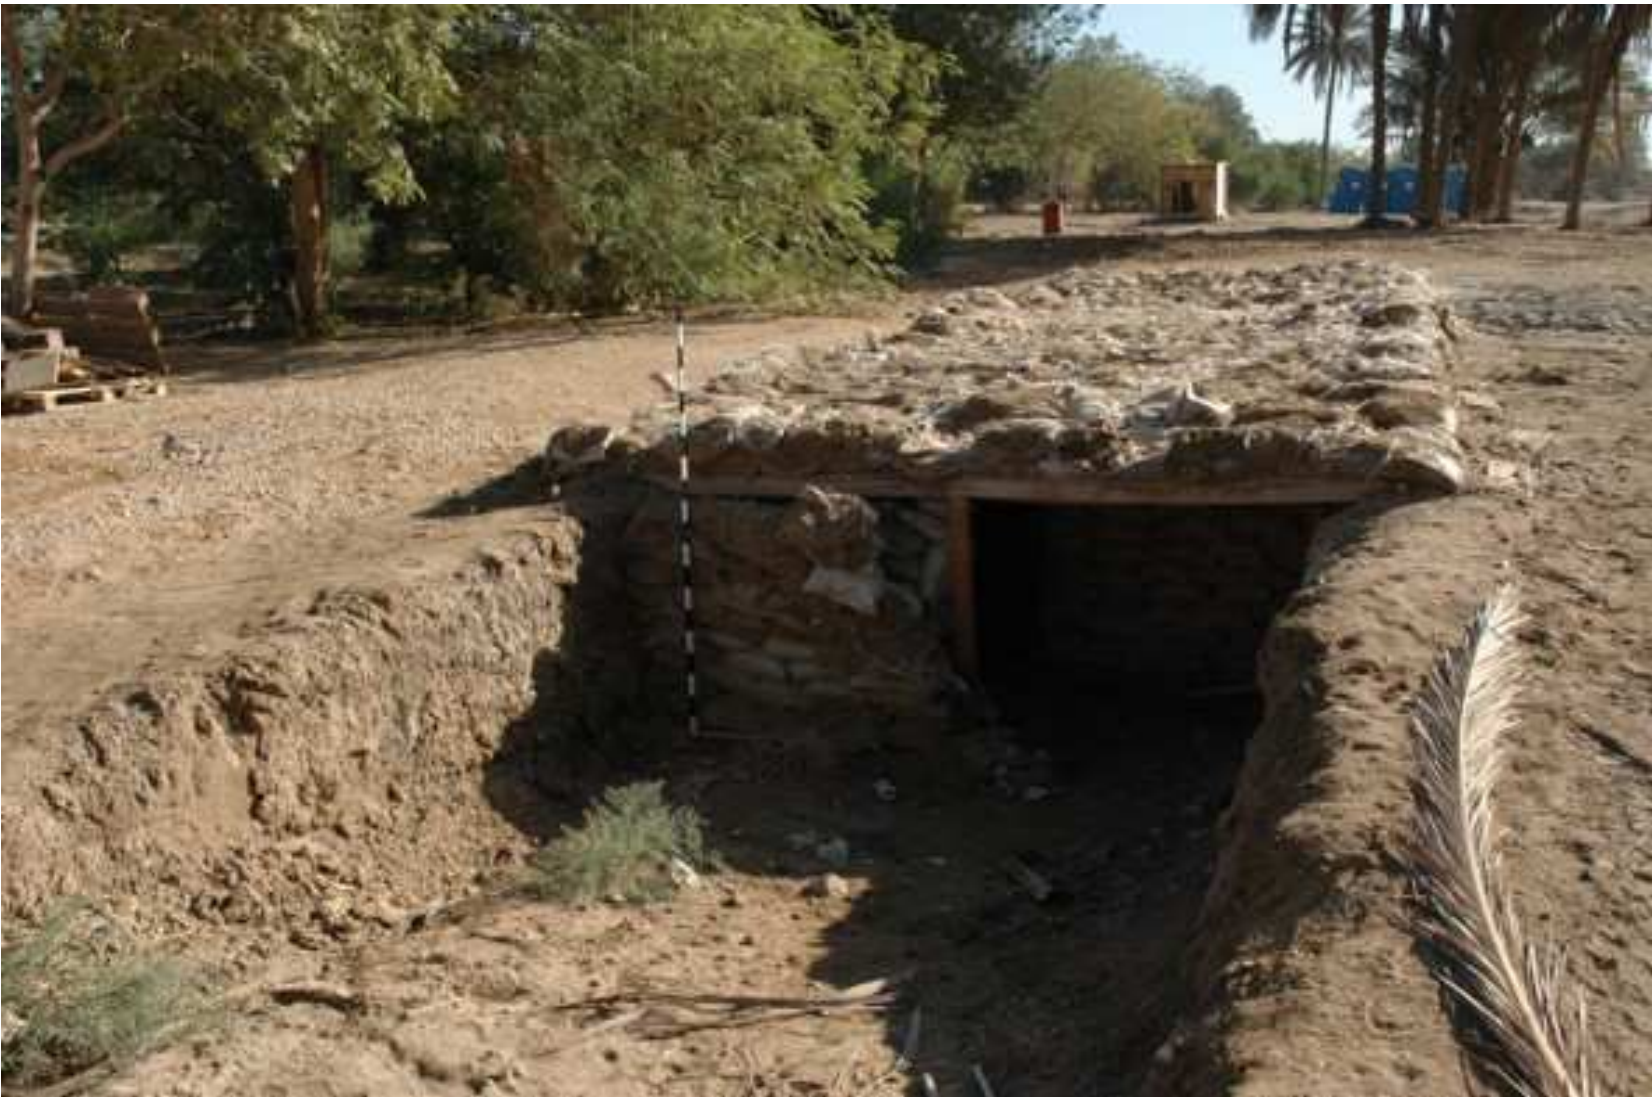
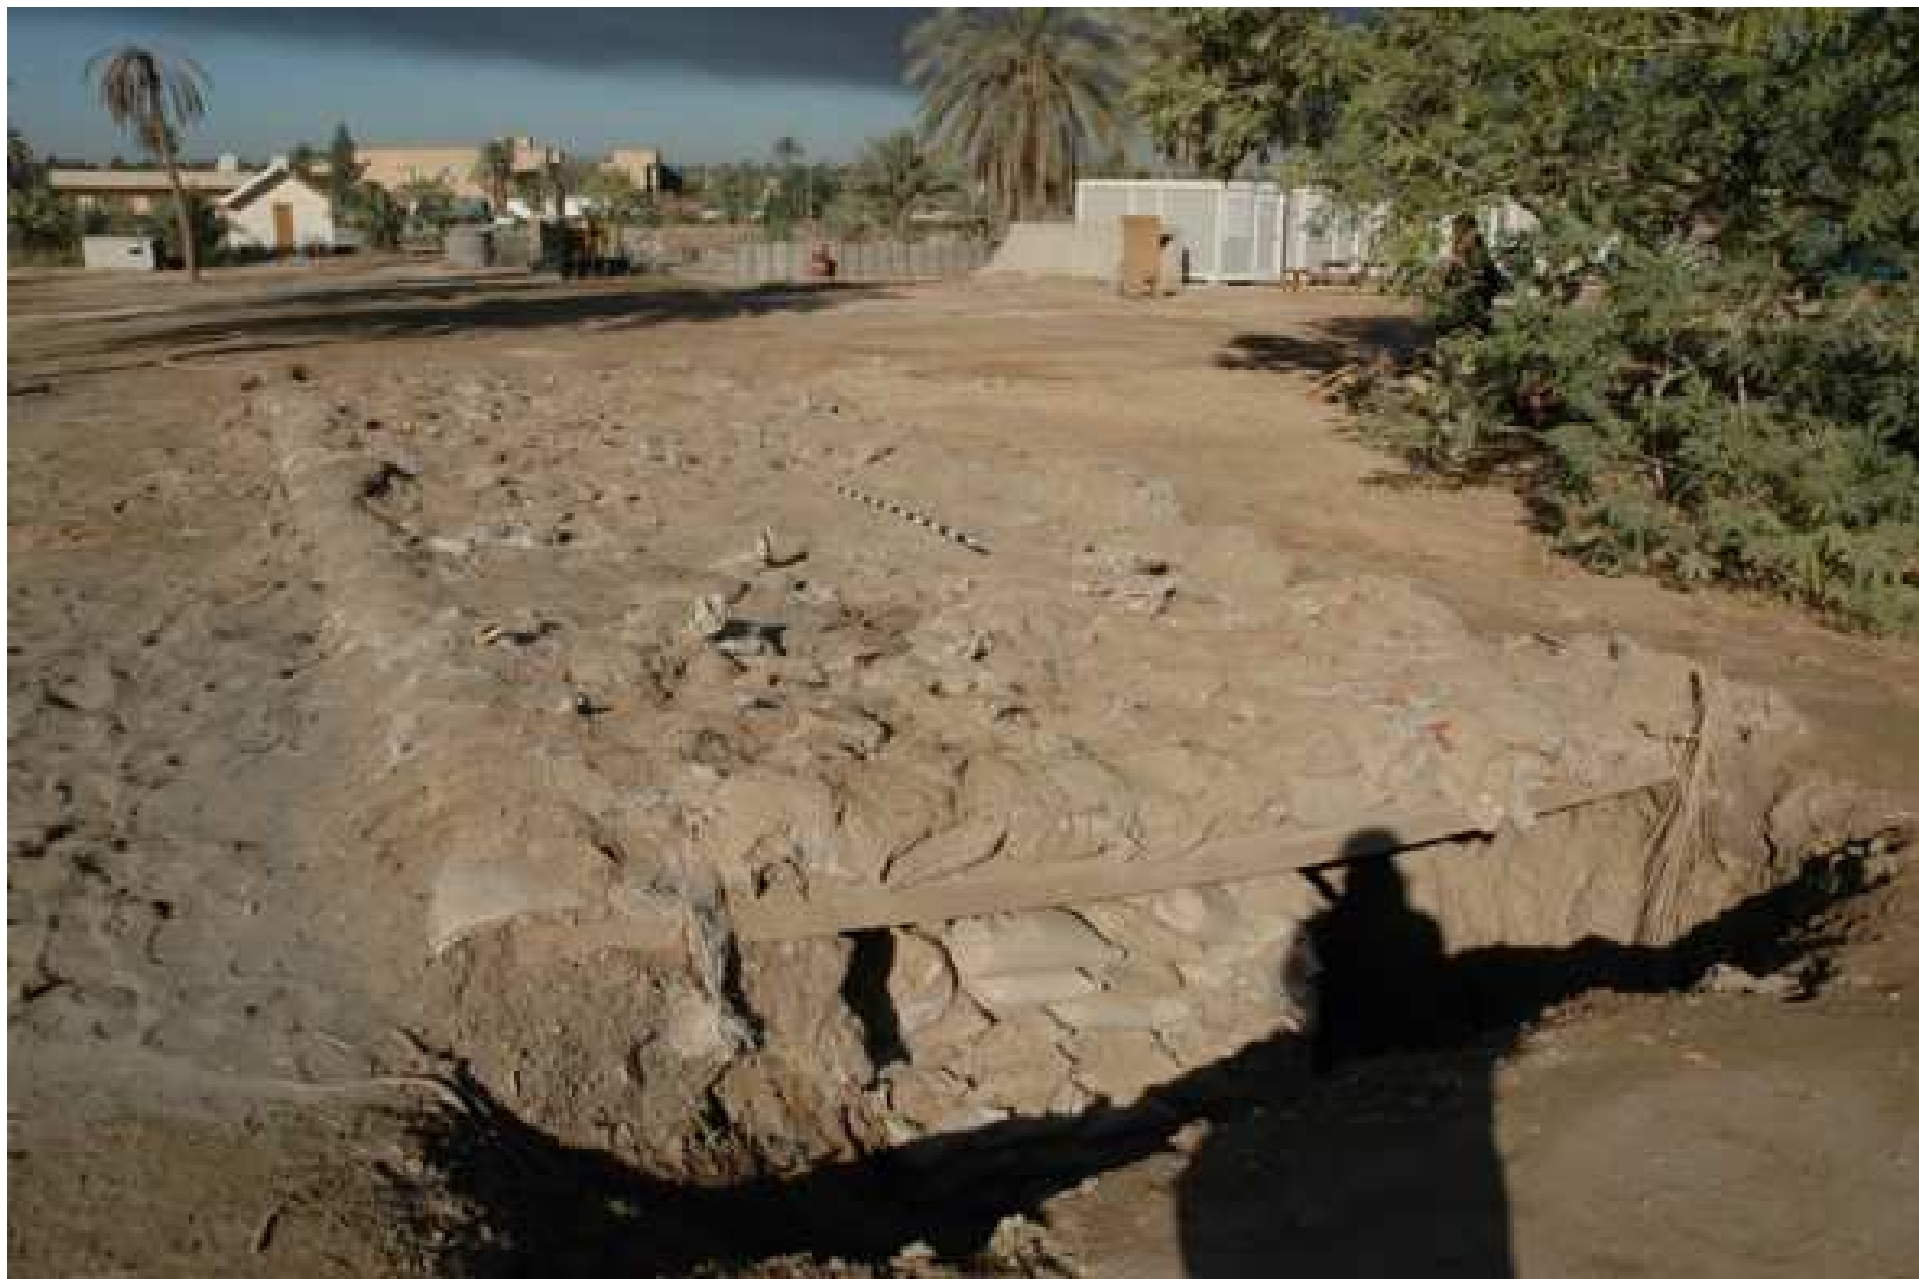
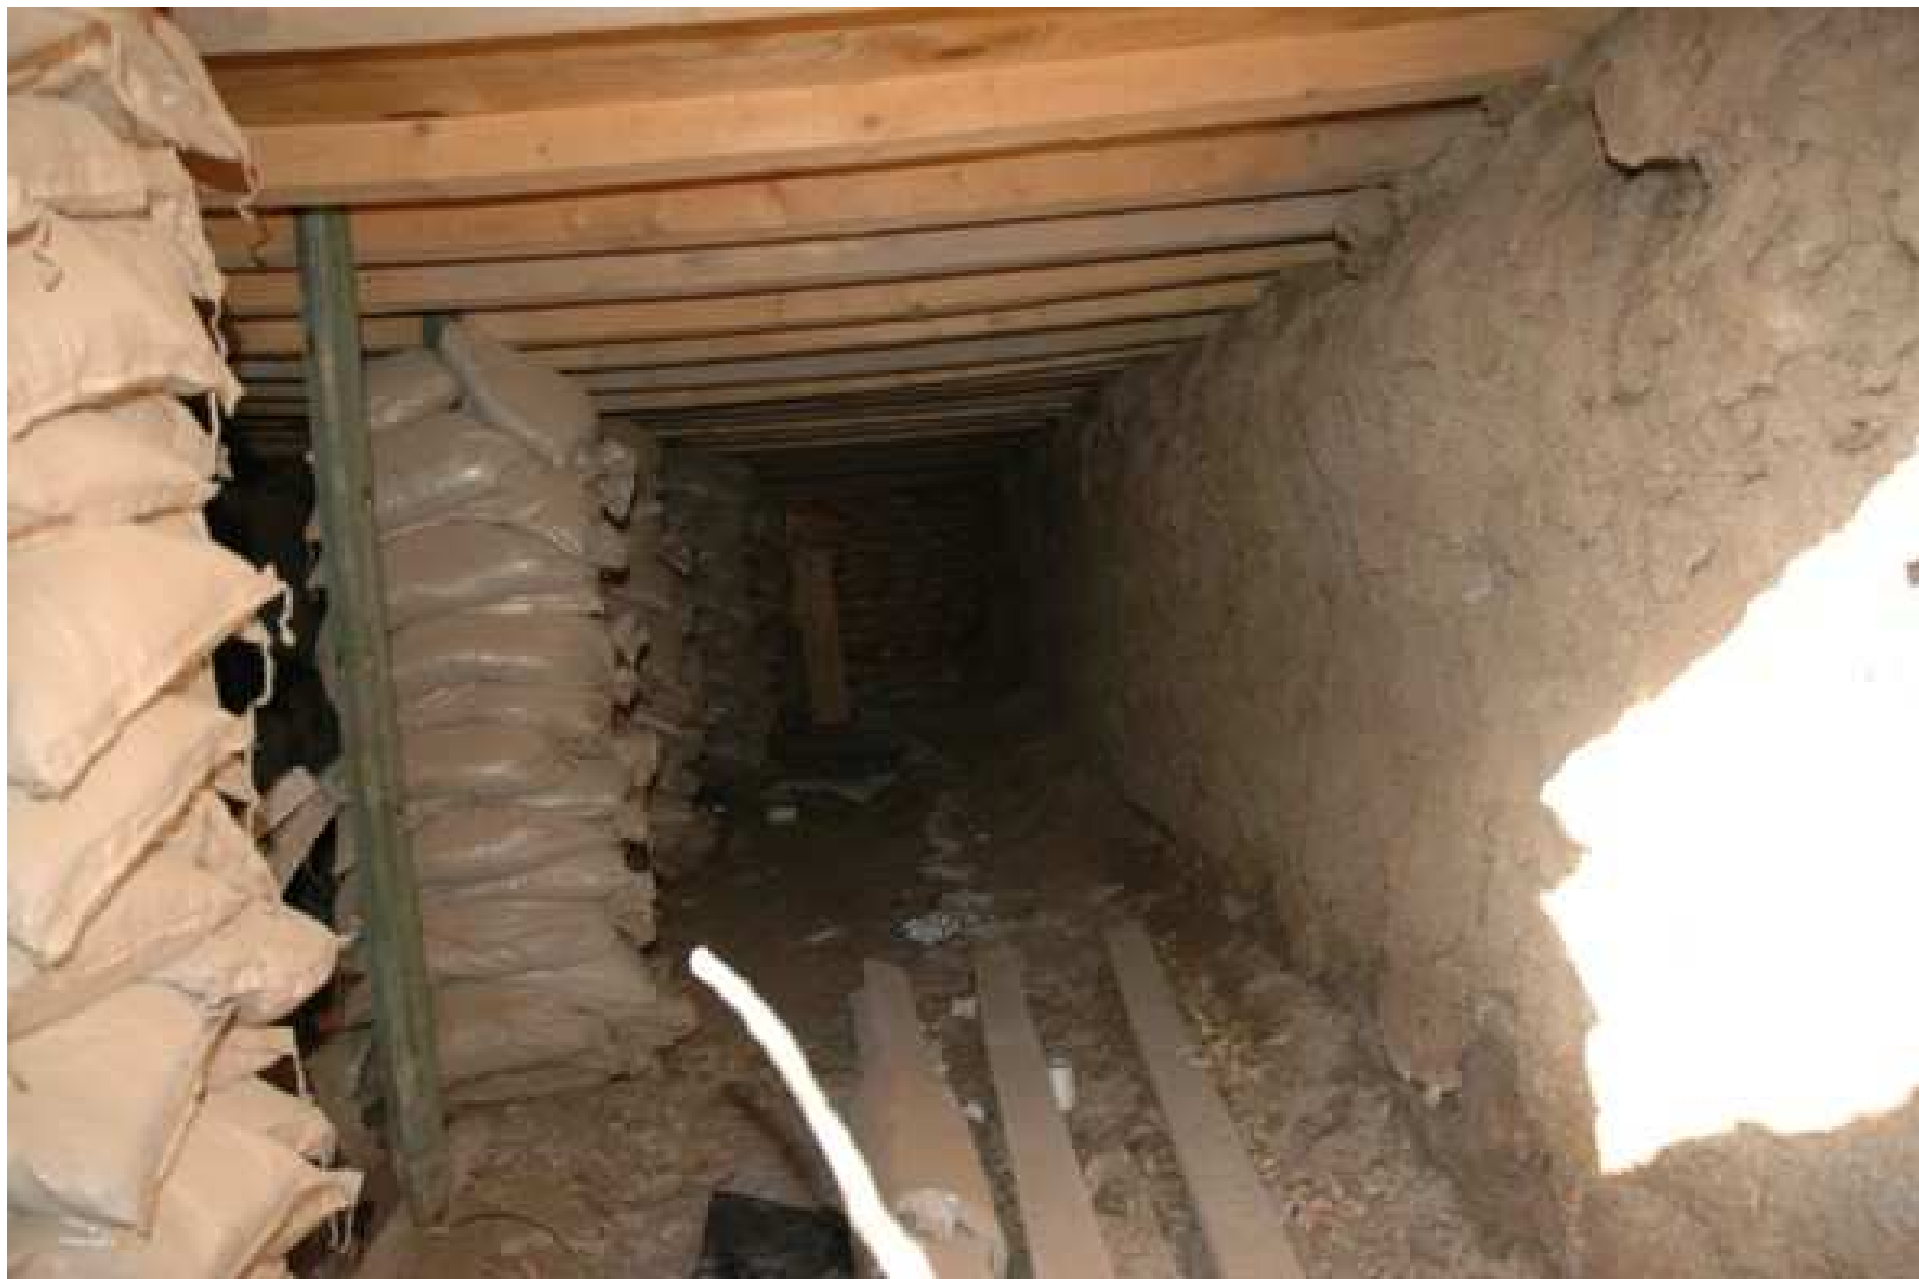
<b>Russell</b>	<b>Polish report</b>	<b>Stone report</b>
This bunker is not visible in the satellite images.	In the place marked on the picture by letter “C” is shelter.	The camouflaged shelter is not visible in any of the imagery. I should note, however, that the photographs of the area around the shelter and indeed the shelter walls show no signs of artifacts or other archaeological debris.

Shelter, Polish report p. 17 (photo © Ministry of Culture and National Heritage, Republic of Poland)

Shelter, Polish report p. 18 (photo © Ministry of Culture and National Heritage, Republic of Poland)
