# **Report on Damage to the Site of Babylon, Iraq**

**John Malcolm Russell, Ph.D.**

**Cultural Heritage Center  
Bureau of Educational and Cultural Affairs  
Department of State**

**April 2010**

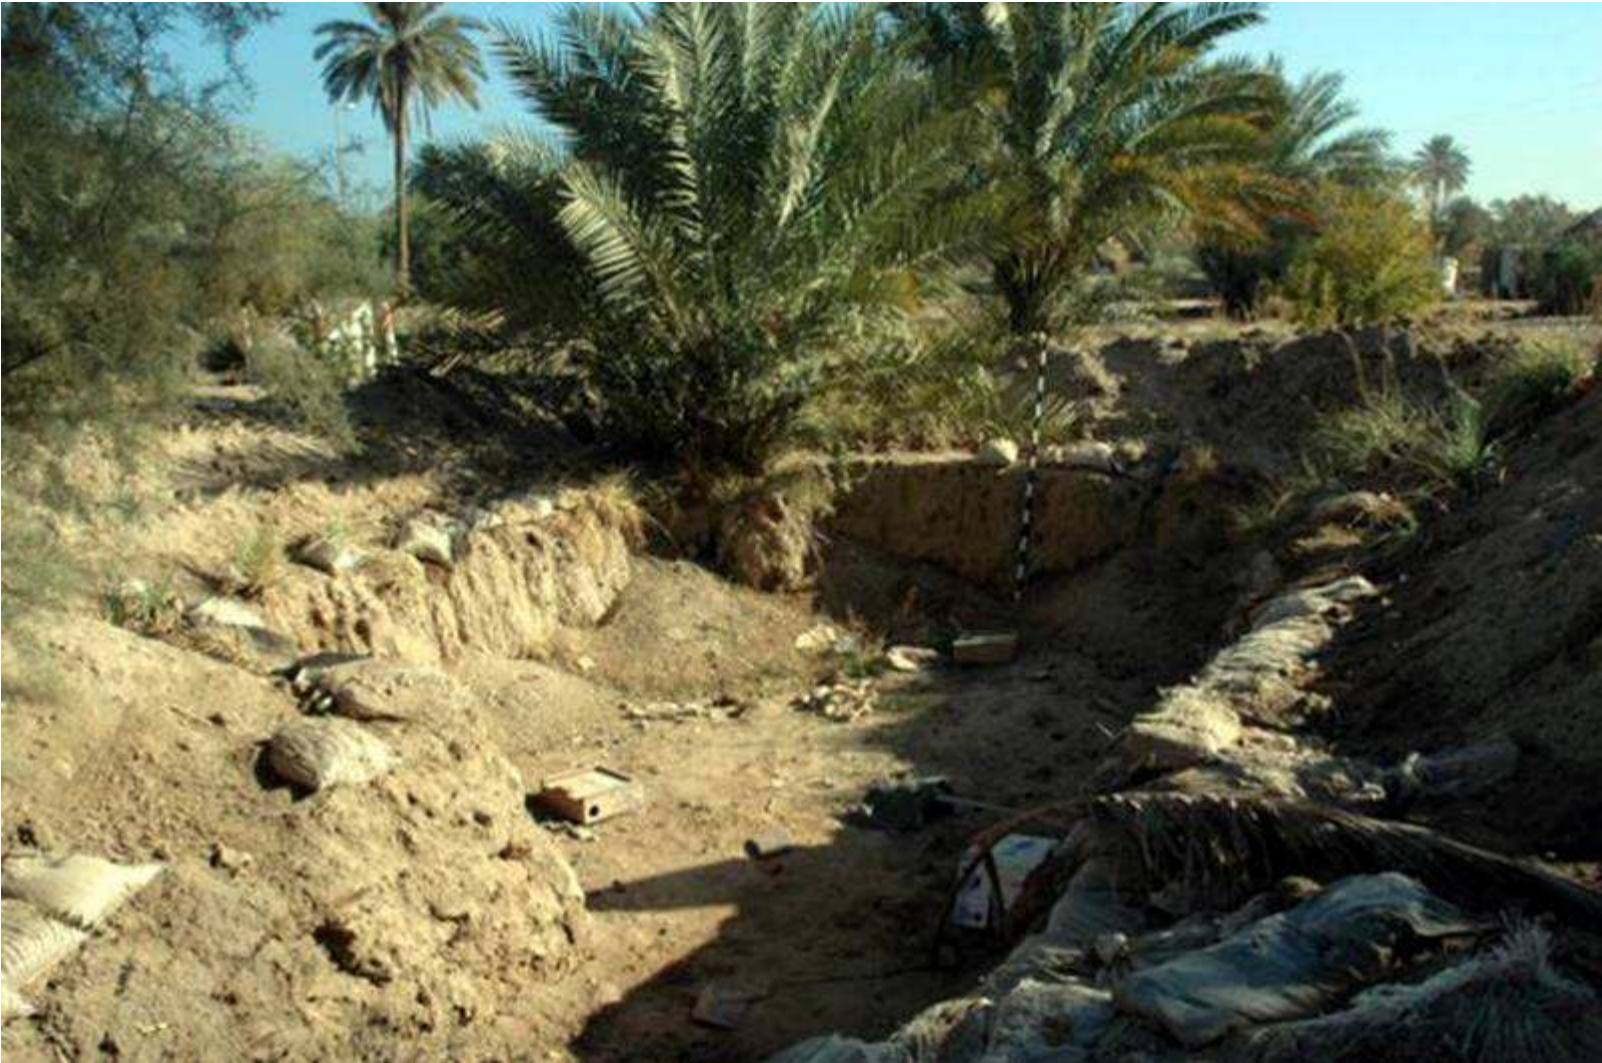
**Open pit (abandoned bunker):** Because of shadows and trees, it is not clear where this pit is, or when it was dug. Tentatively identified in satellite image.

Polish report	Stone report
On the area of the City Tent #2, in the place marked on the picture as letter “D” is a pit.	The open pit noted in the Polish report is not visible in the August 03 imagery. It is probably present in the July 04 imagery, but is more clearly seen in the August and October 04 imagery.

Pit, Polish report p. 18 (photo © Ministry of Culture and National Heritage, Republic of Poland)

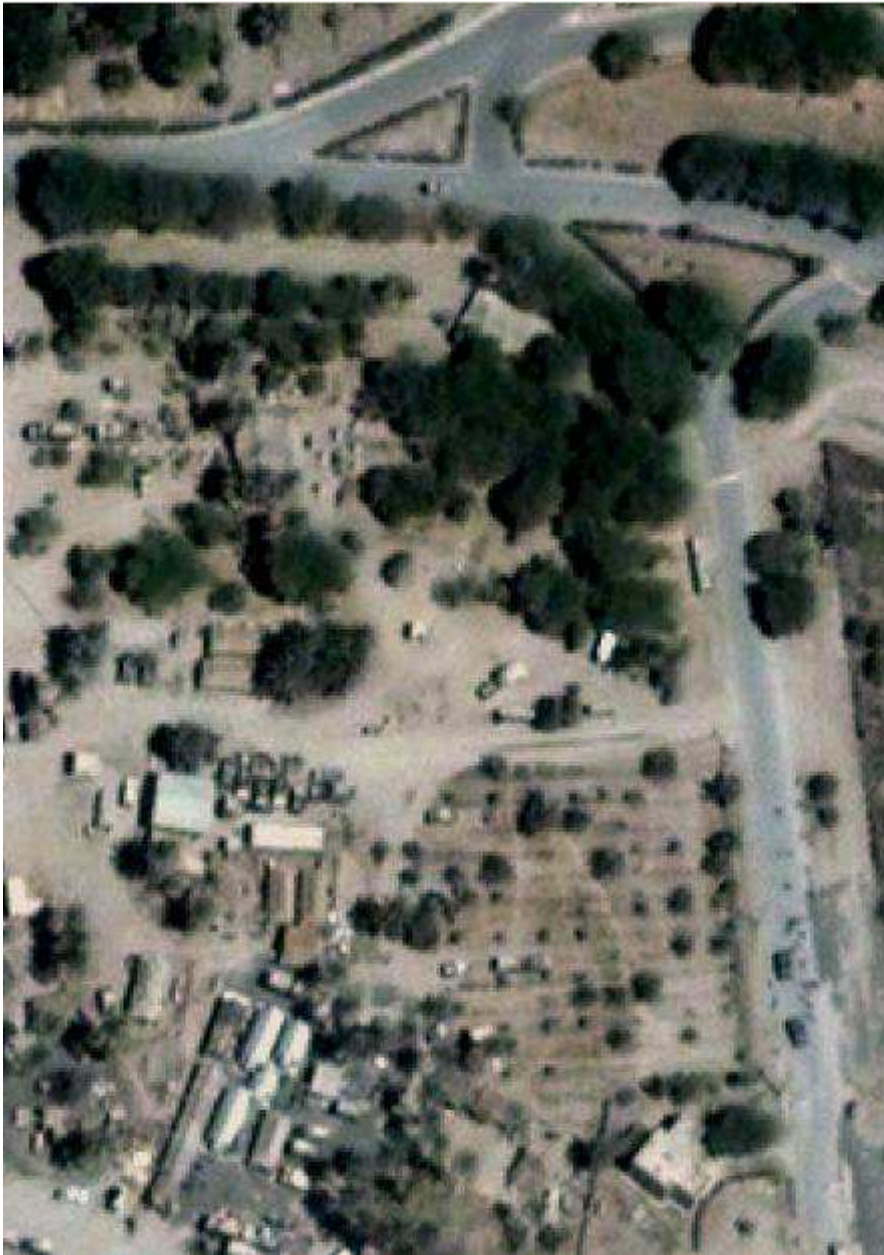
Area of pit, 31 August 2003, Russell composite

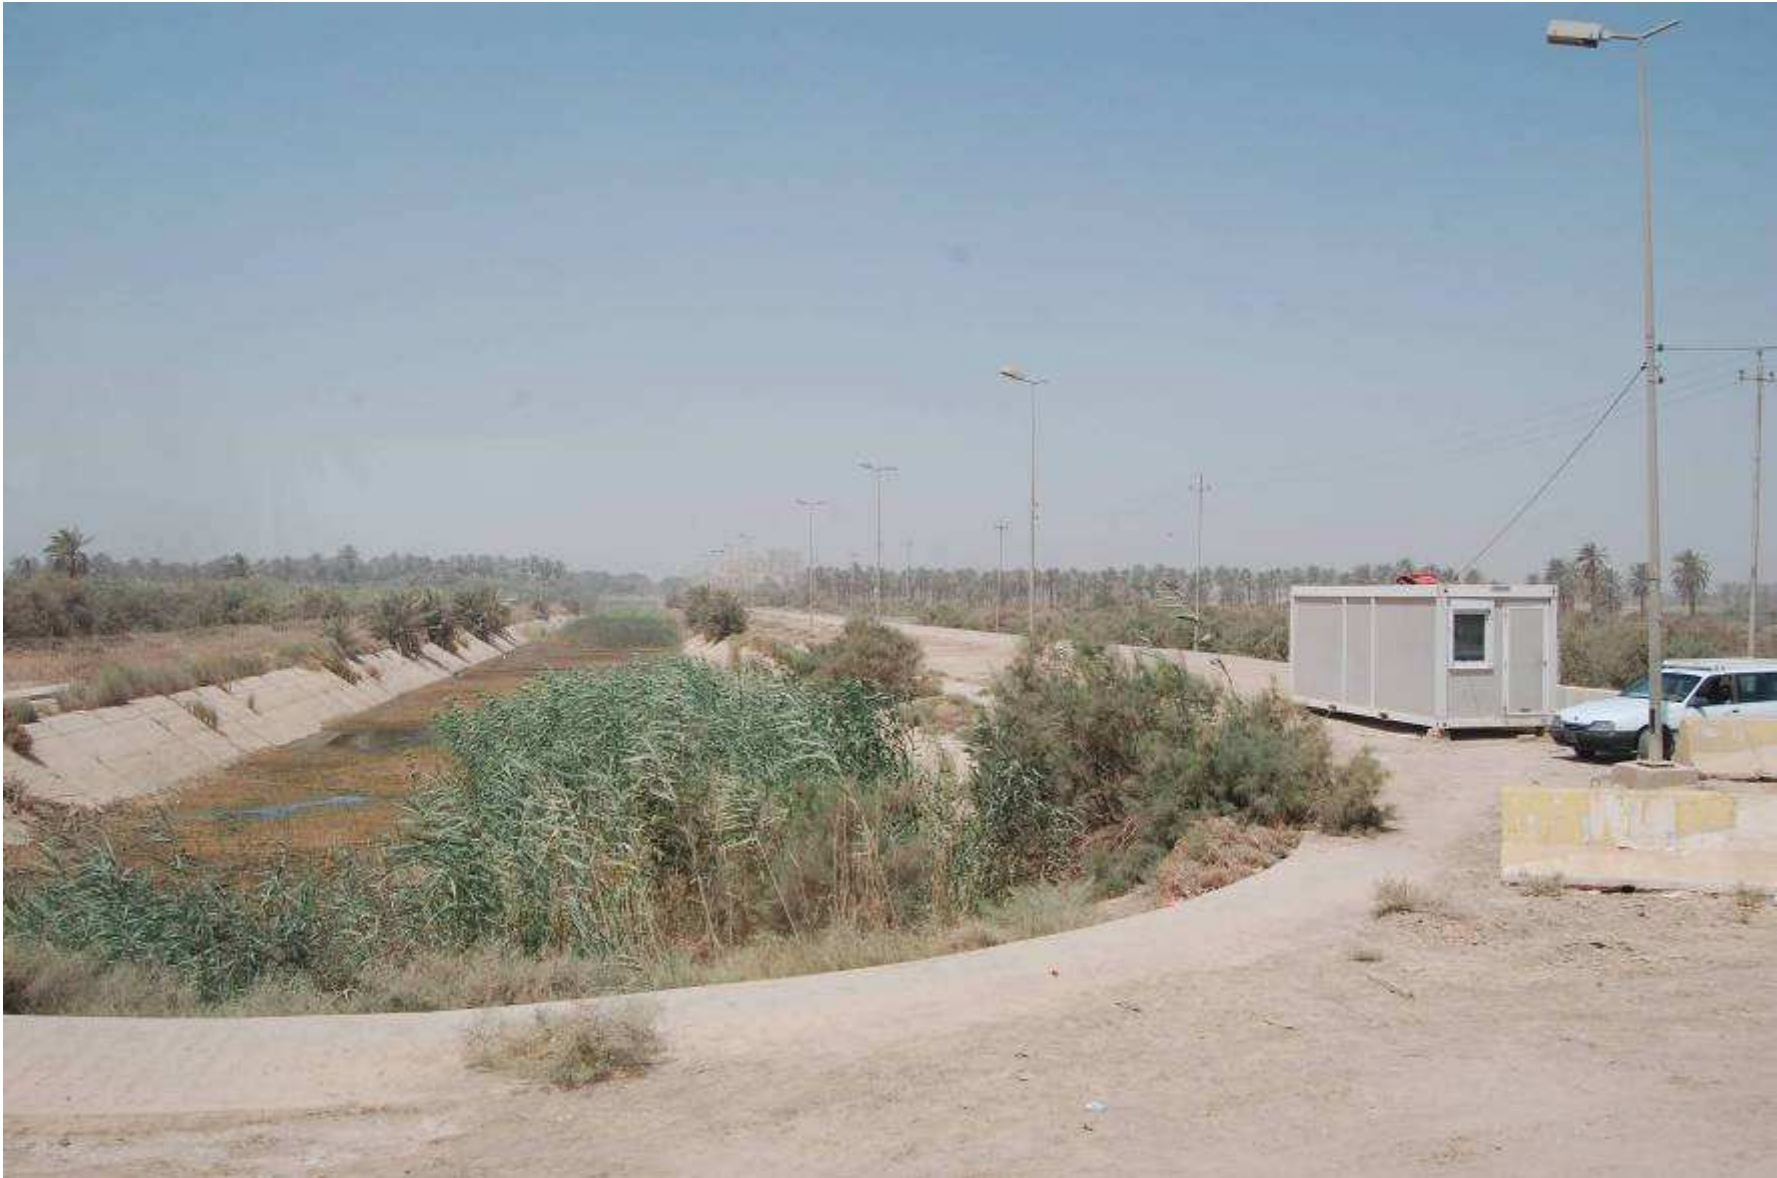
Al-Hawliyah moat or canal: In June 2009, Saddam's canal that surrounds three sides of the ancient Inner City was choked with vegetation and much of it had dried up (Russell photo 37, © John Russell).

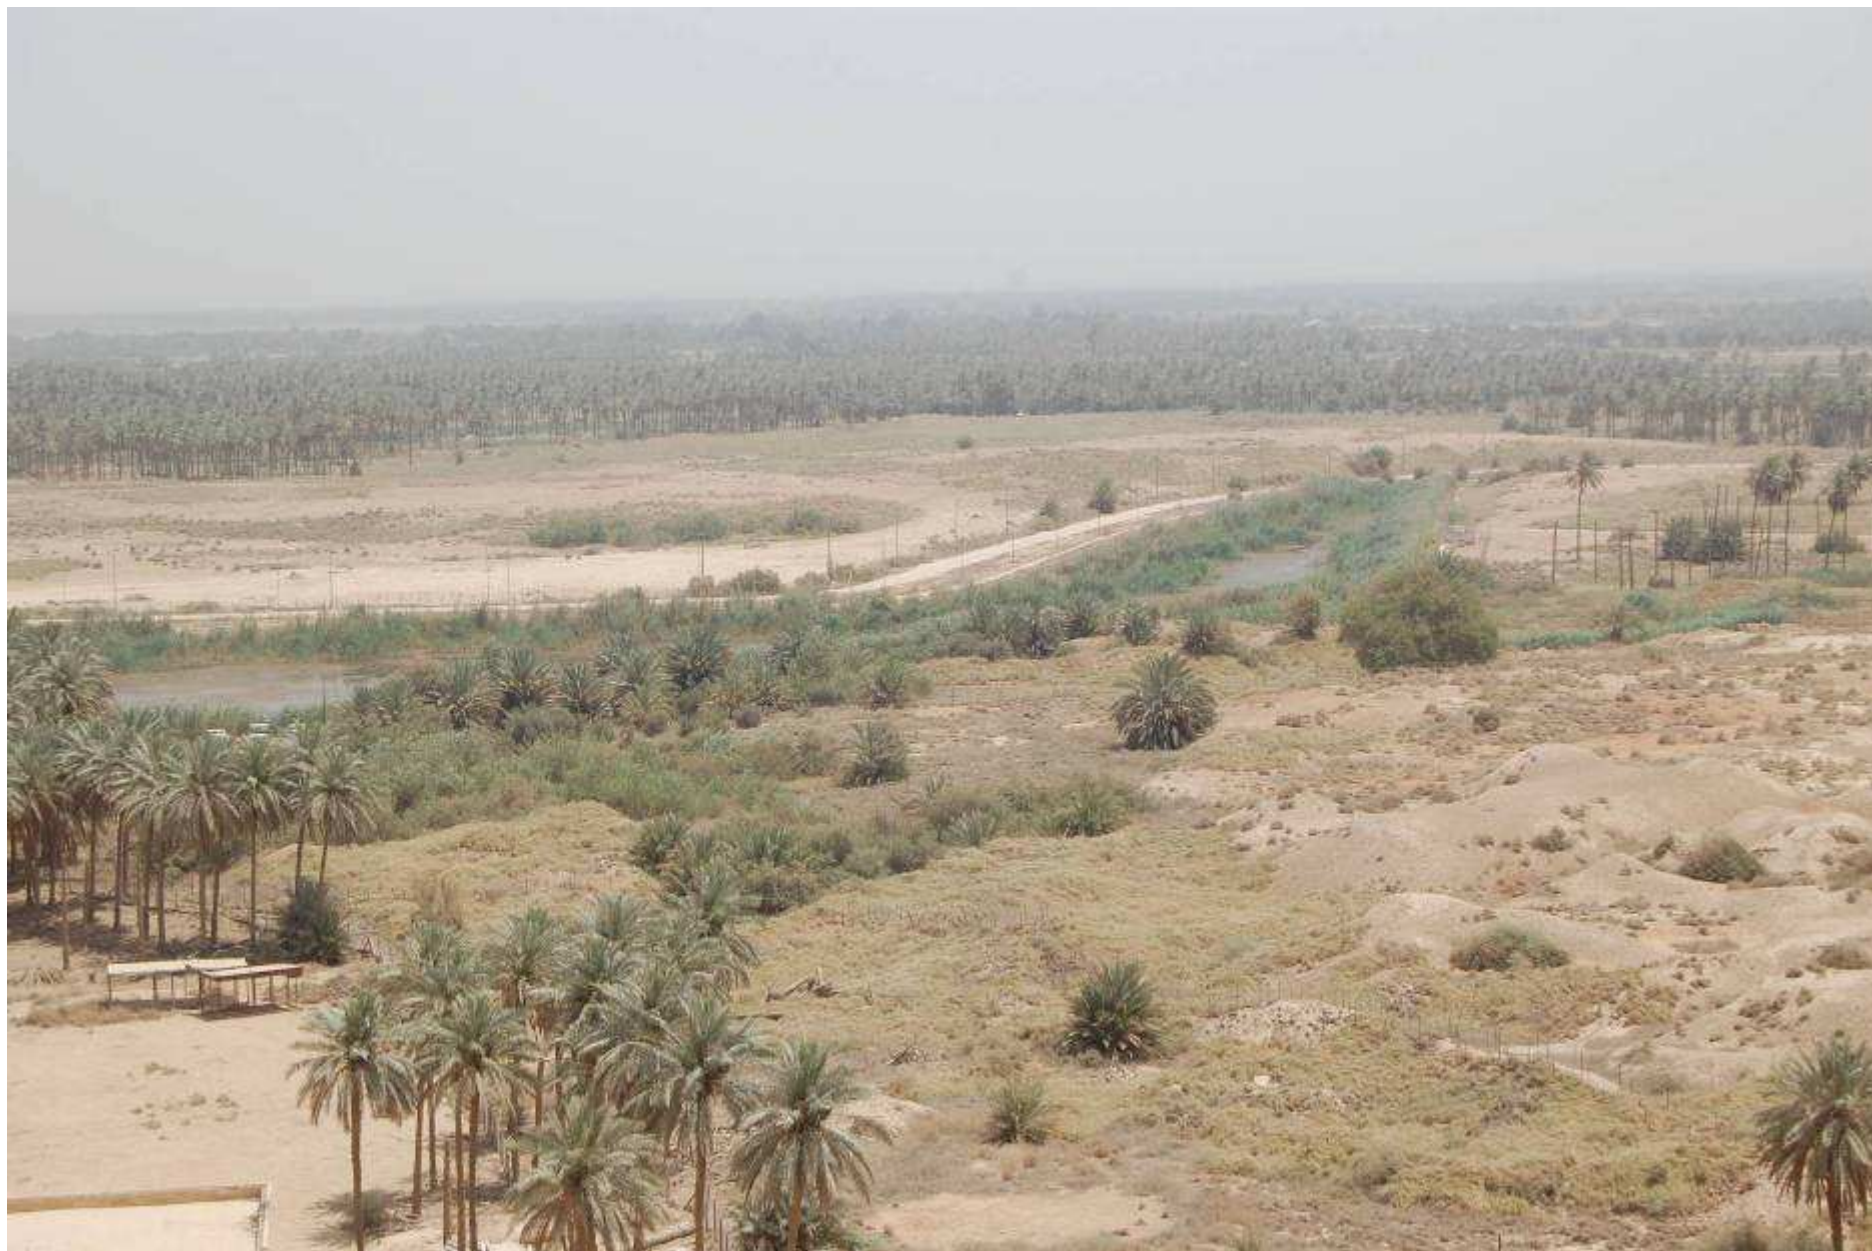
Lake Saddam (northern lake): In June 2009, this lake (shown above at left) still contained water (Russell photo 74, © John Russell)

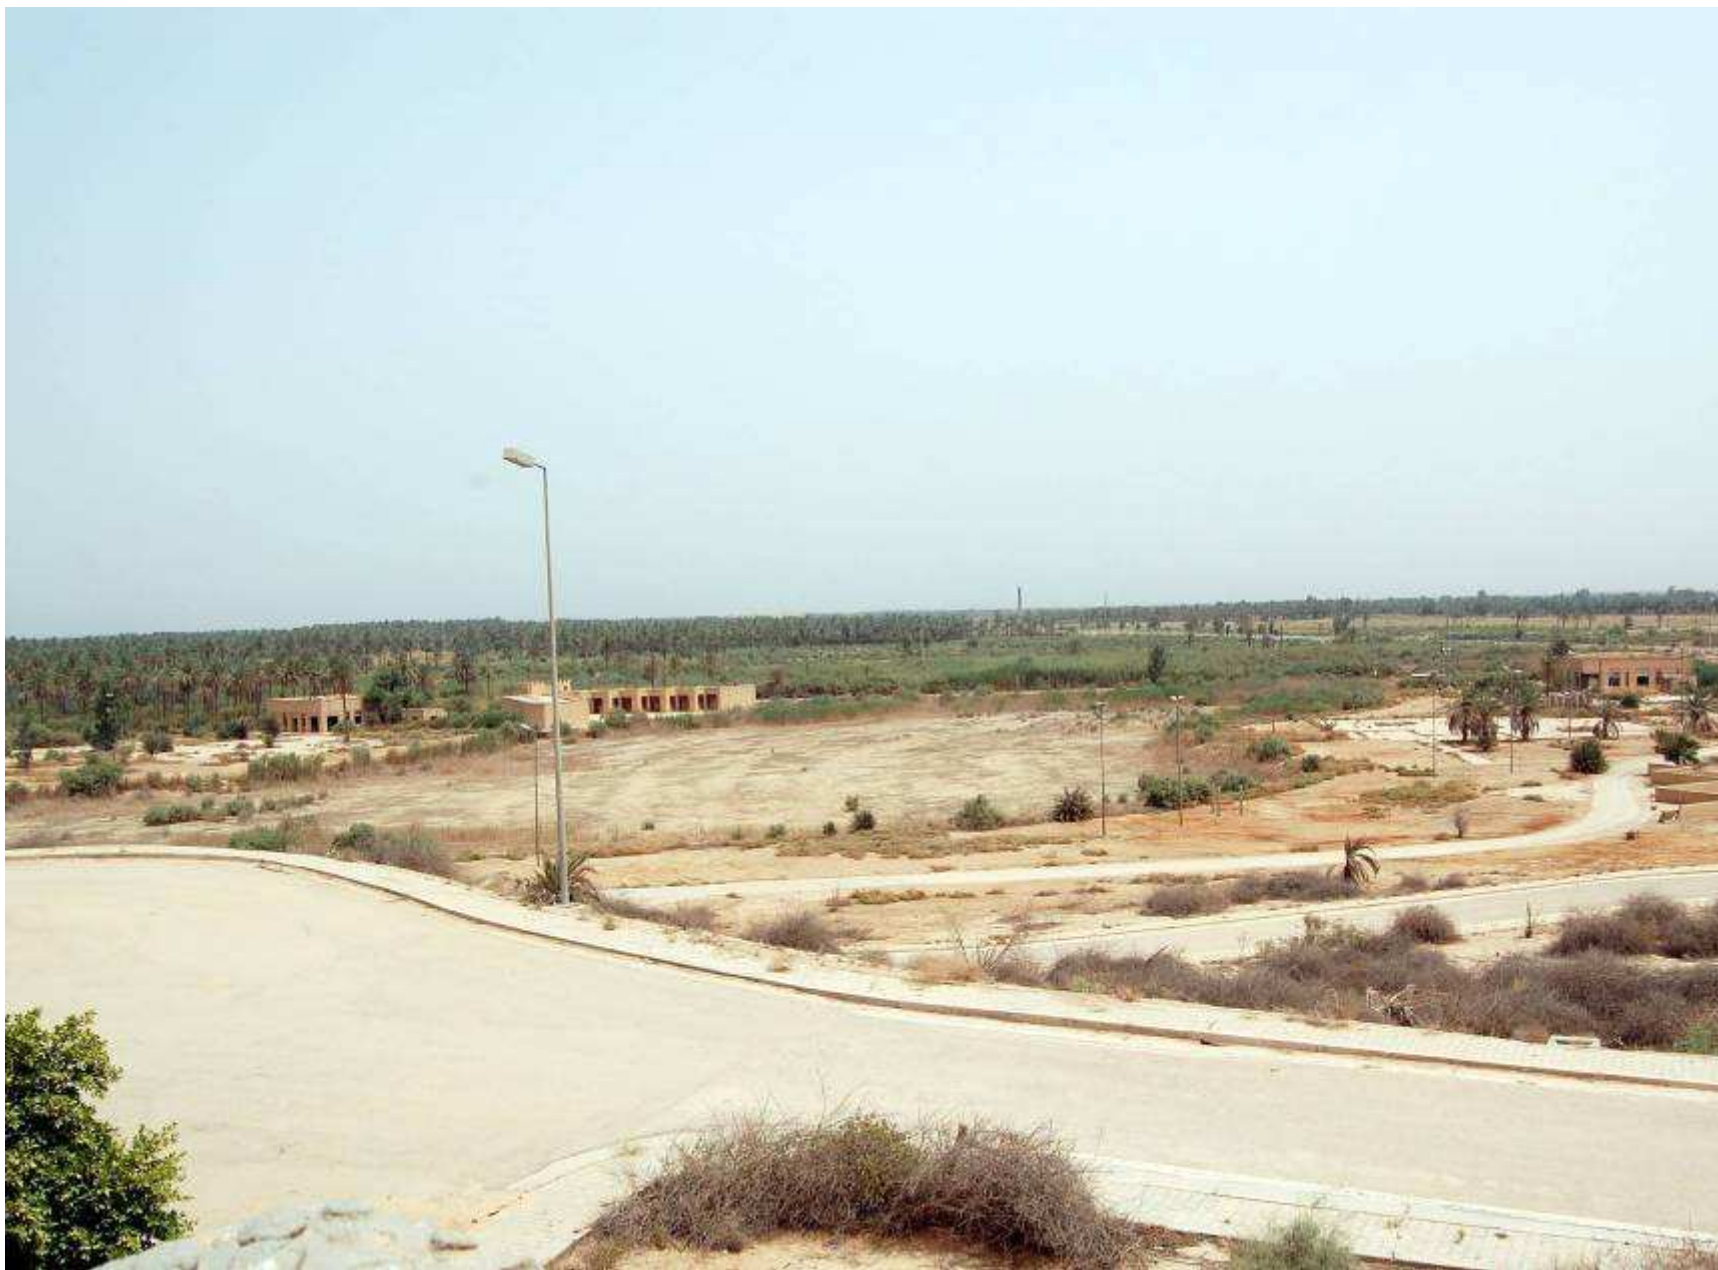
Lake north of the theatre: In July 2008, this lake was completely dry (Russell photo 166, © John Russell)

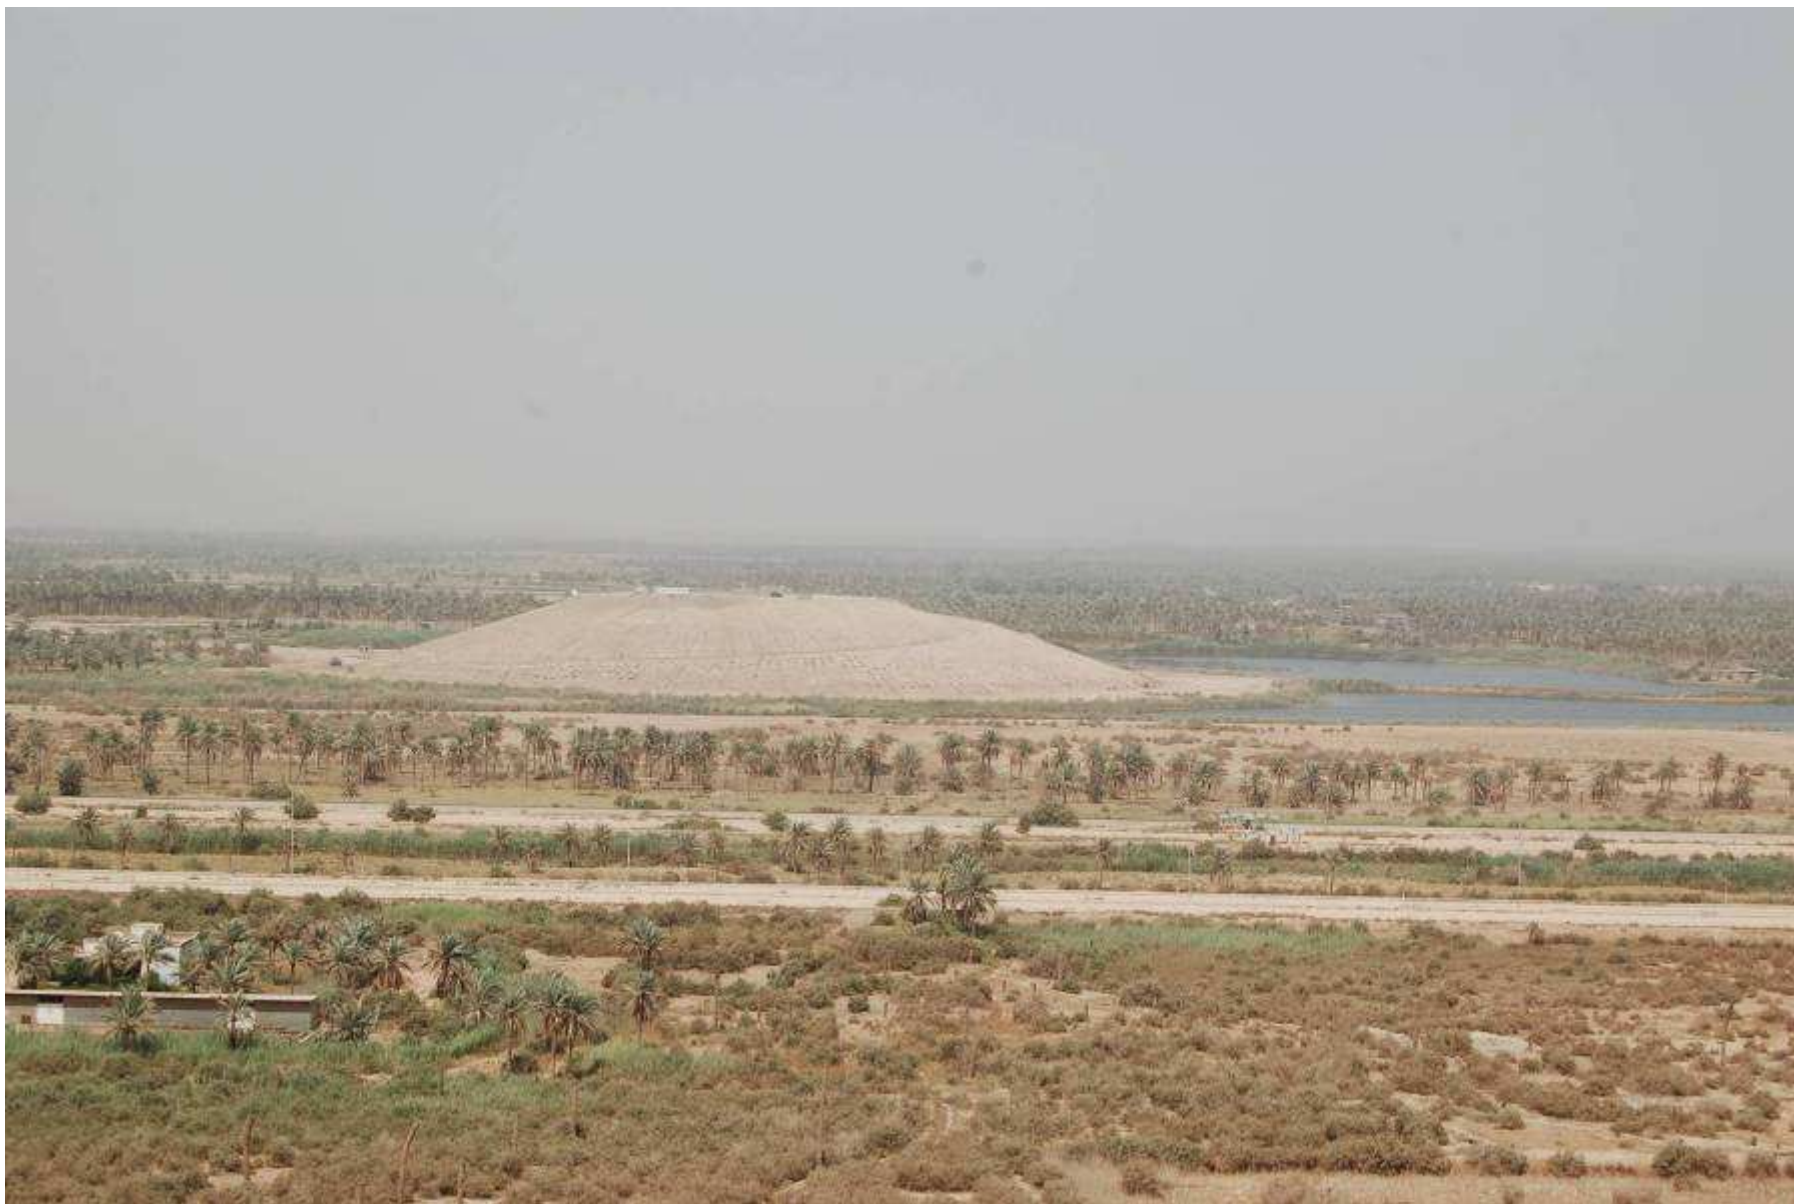
Mt. Nissan and Lake Nissan (eastern mound and lake): In June 2009, the mound was occupied by a few vehicles and temporary structures, and was perhaps being used as an observation post. The lake appeared to be full of water (Russell photo 5, © John Russell).

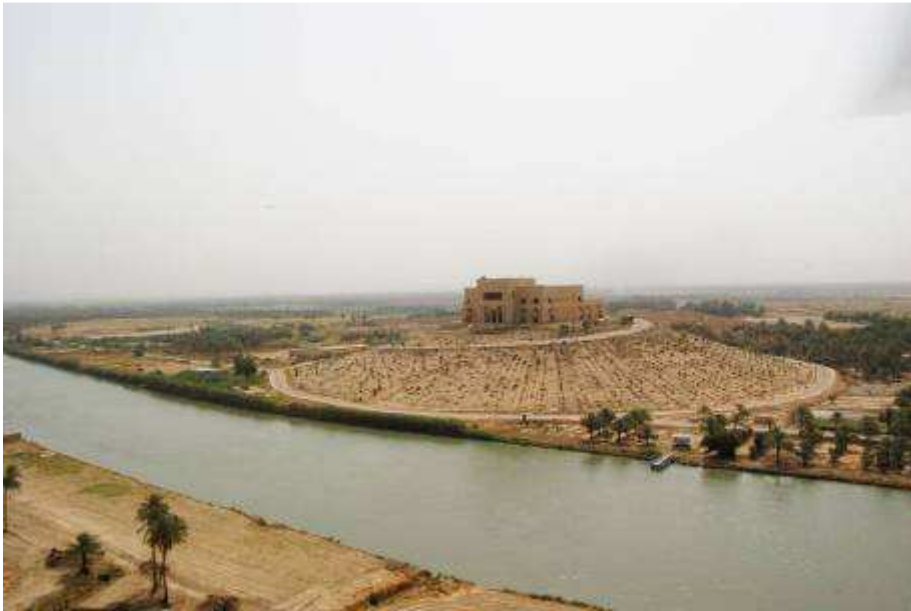
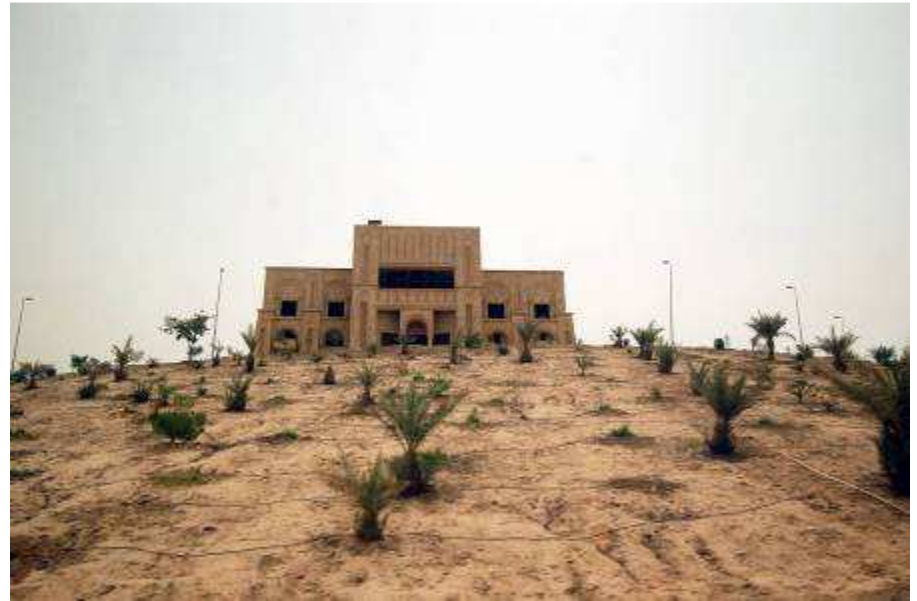
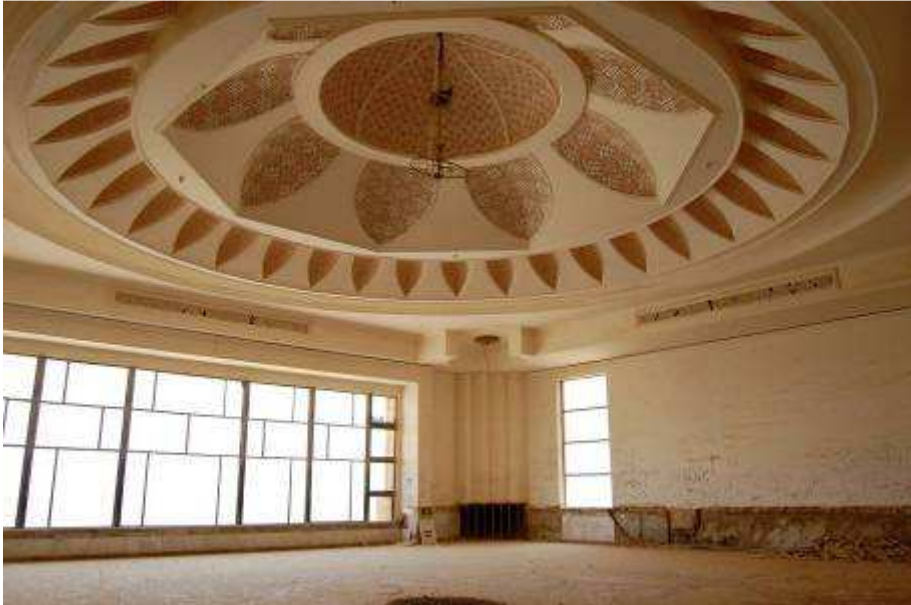
Mt. Tammuz and Lake Tammuz (southern mound and lake): In July 2008 and June 2009, the mound was occupied by a few vehicles and temporary structures, and was perhaps being used as an observation post. The lake appeared full of water.

17 July 08 (Russell photo 120, © John Russell)

17 July 08 (Russell photo 262, © John Russell)

22 June 09 (Russell photo 68, © John Russell)

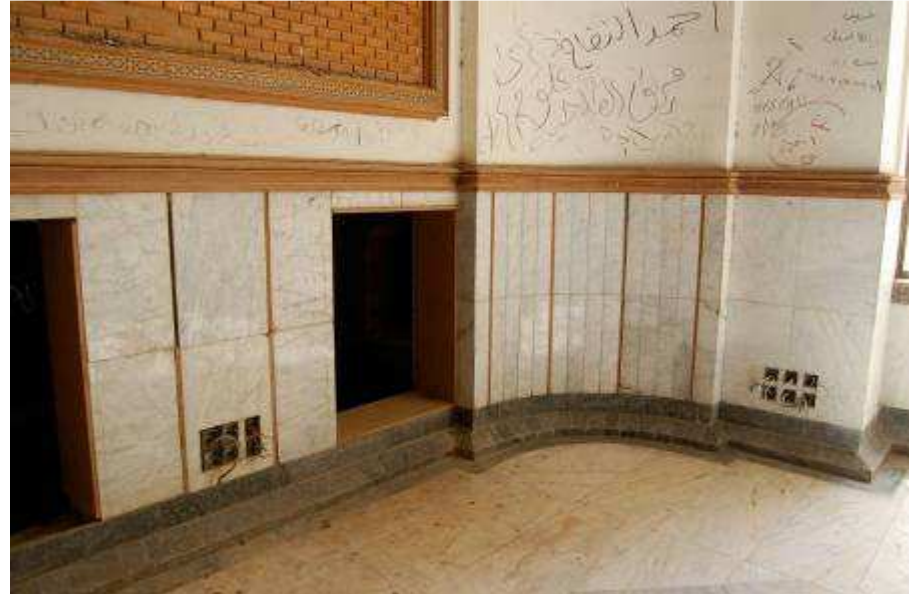
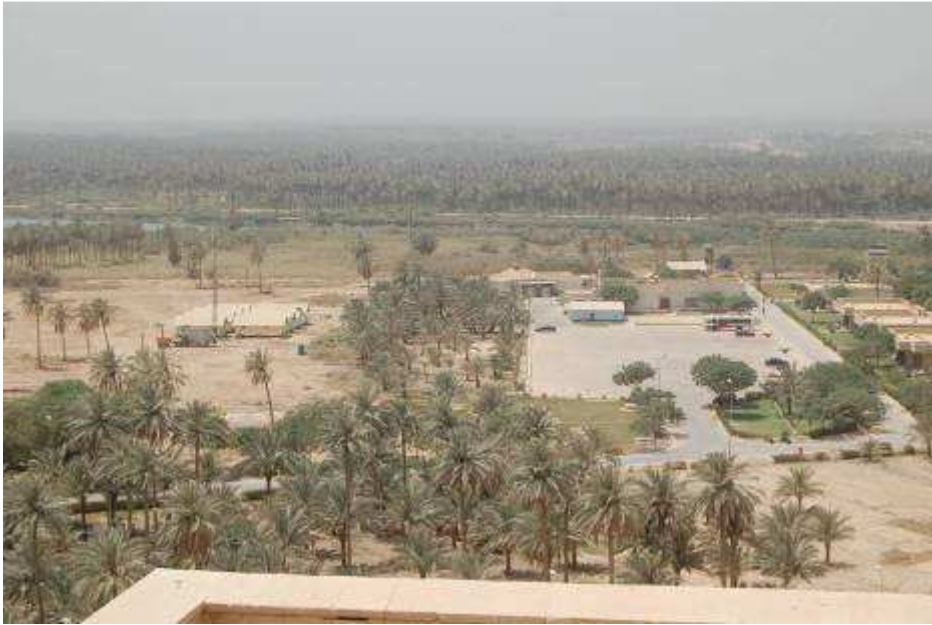
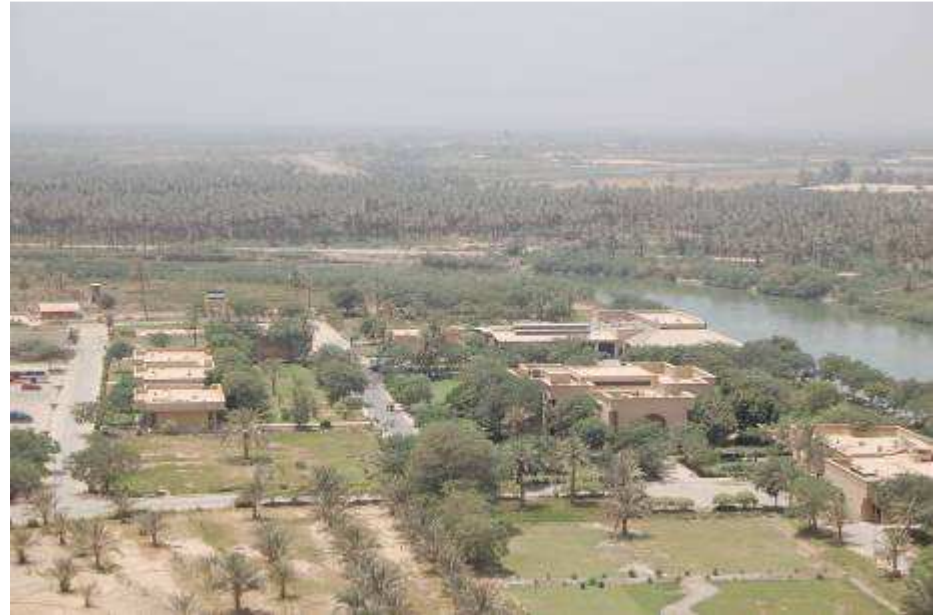
Mt. Saddam (modern palace mound): By June 2009, the palace interior had been seriously damaged by looters and vandals, and had been stripped of its wiring, plumbing, and physical plant.

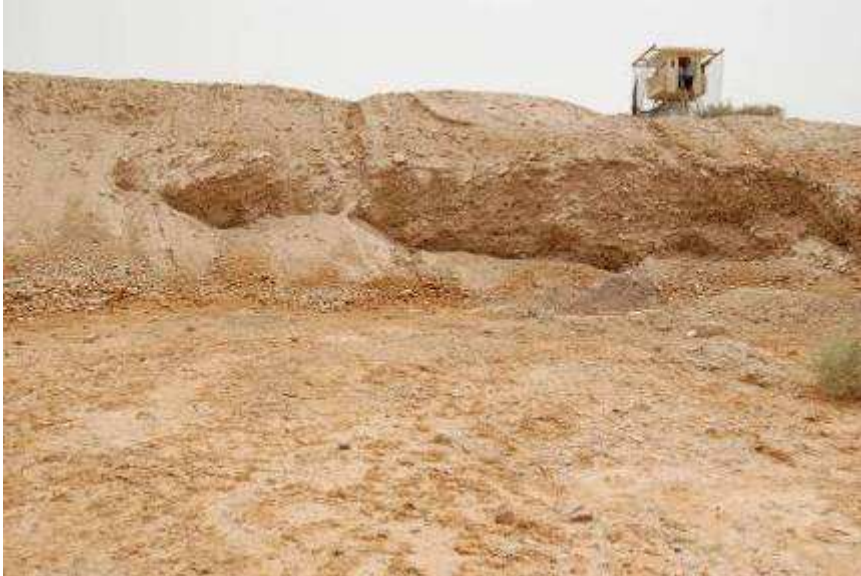
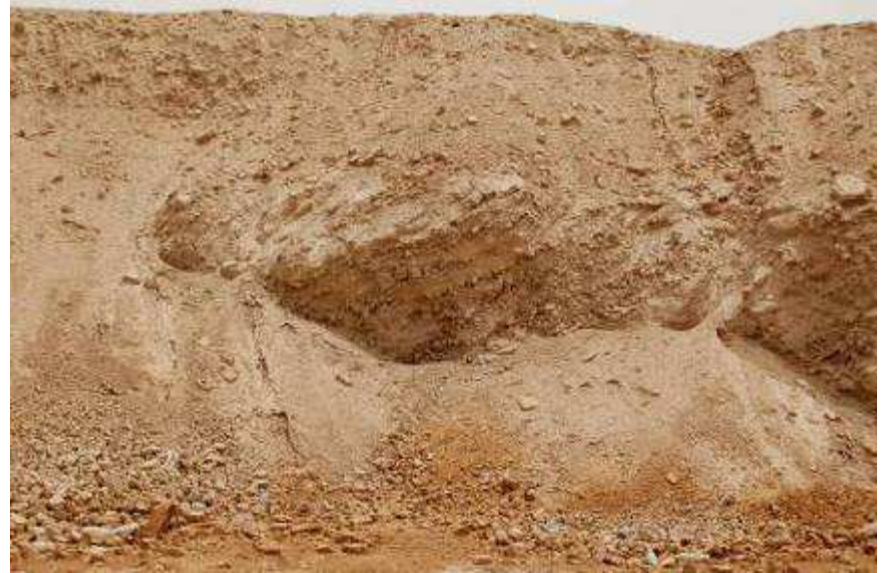
Cut 2, 17 July 2008 (Russell photo 243, © John Russell)

Cut 2, 17 July 2008 (Russell photo 244, © John Russell)

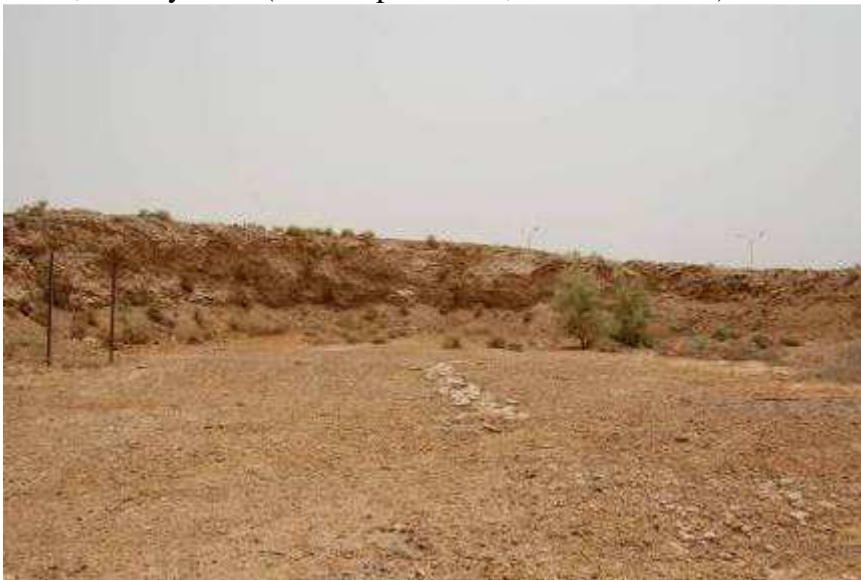
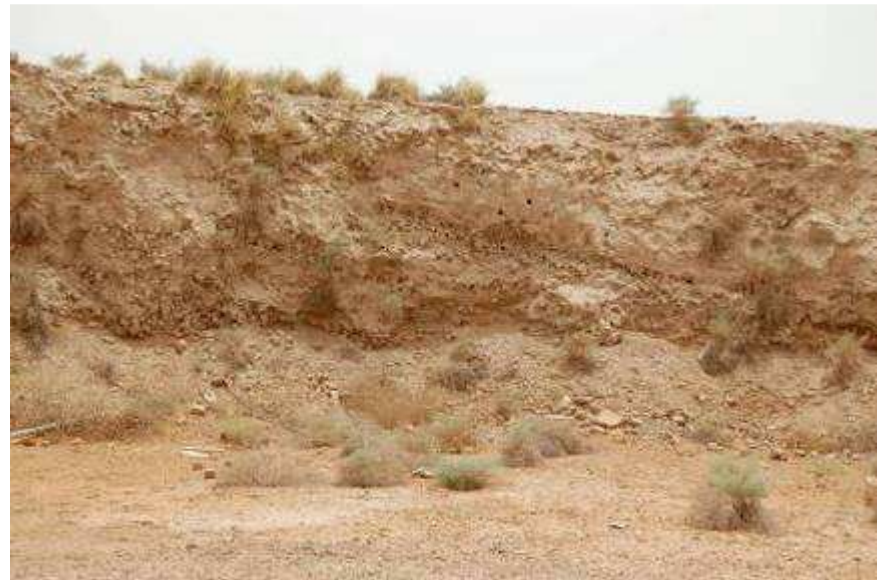
Cut 3, 17 July 2008 (Russell photo 234, © John Russell)

Cut 3, 17 July 2008 (Russell photo 237, © John Russell)

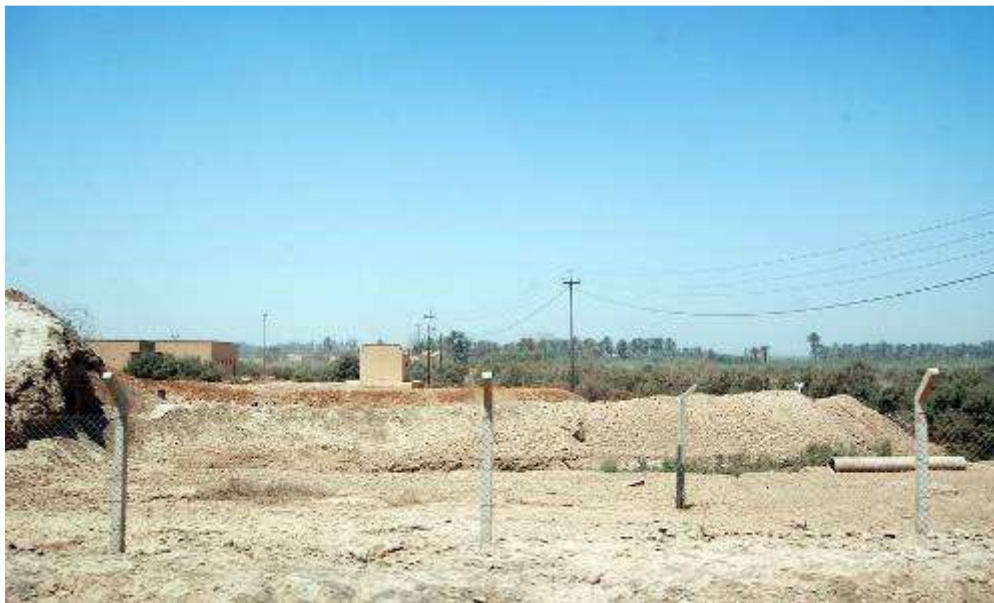
Cuts into the Homera mound: The artifact-rich earth removed from the Homera mounds probably accounts for most of the earth used in berms and HESCO containers prior to September 2003.

outer berm and trench, 23 June 2009 (Russell photo 41, © John Russell)

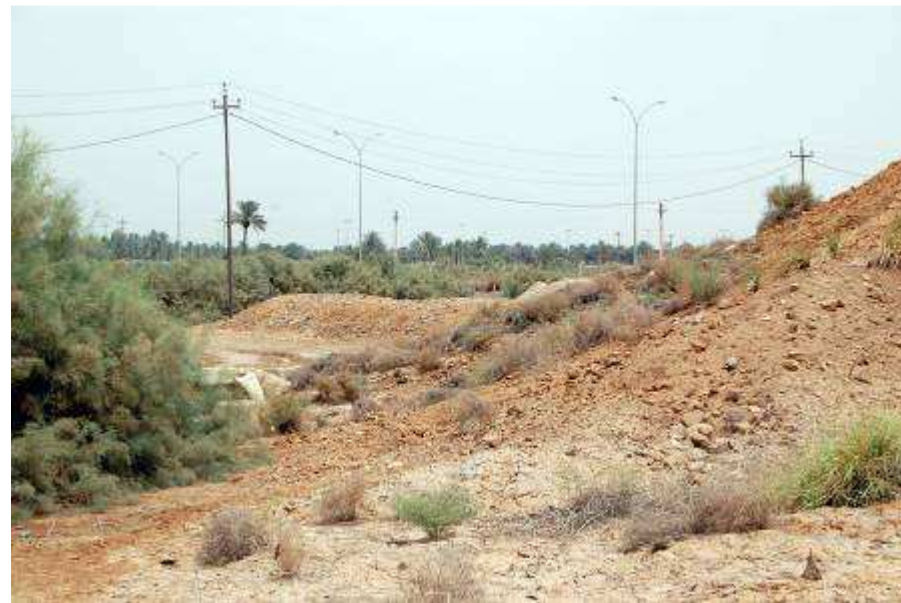
middle berm, 17 July 2008 (Russell photo 248, © John Russell)

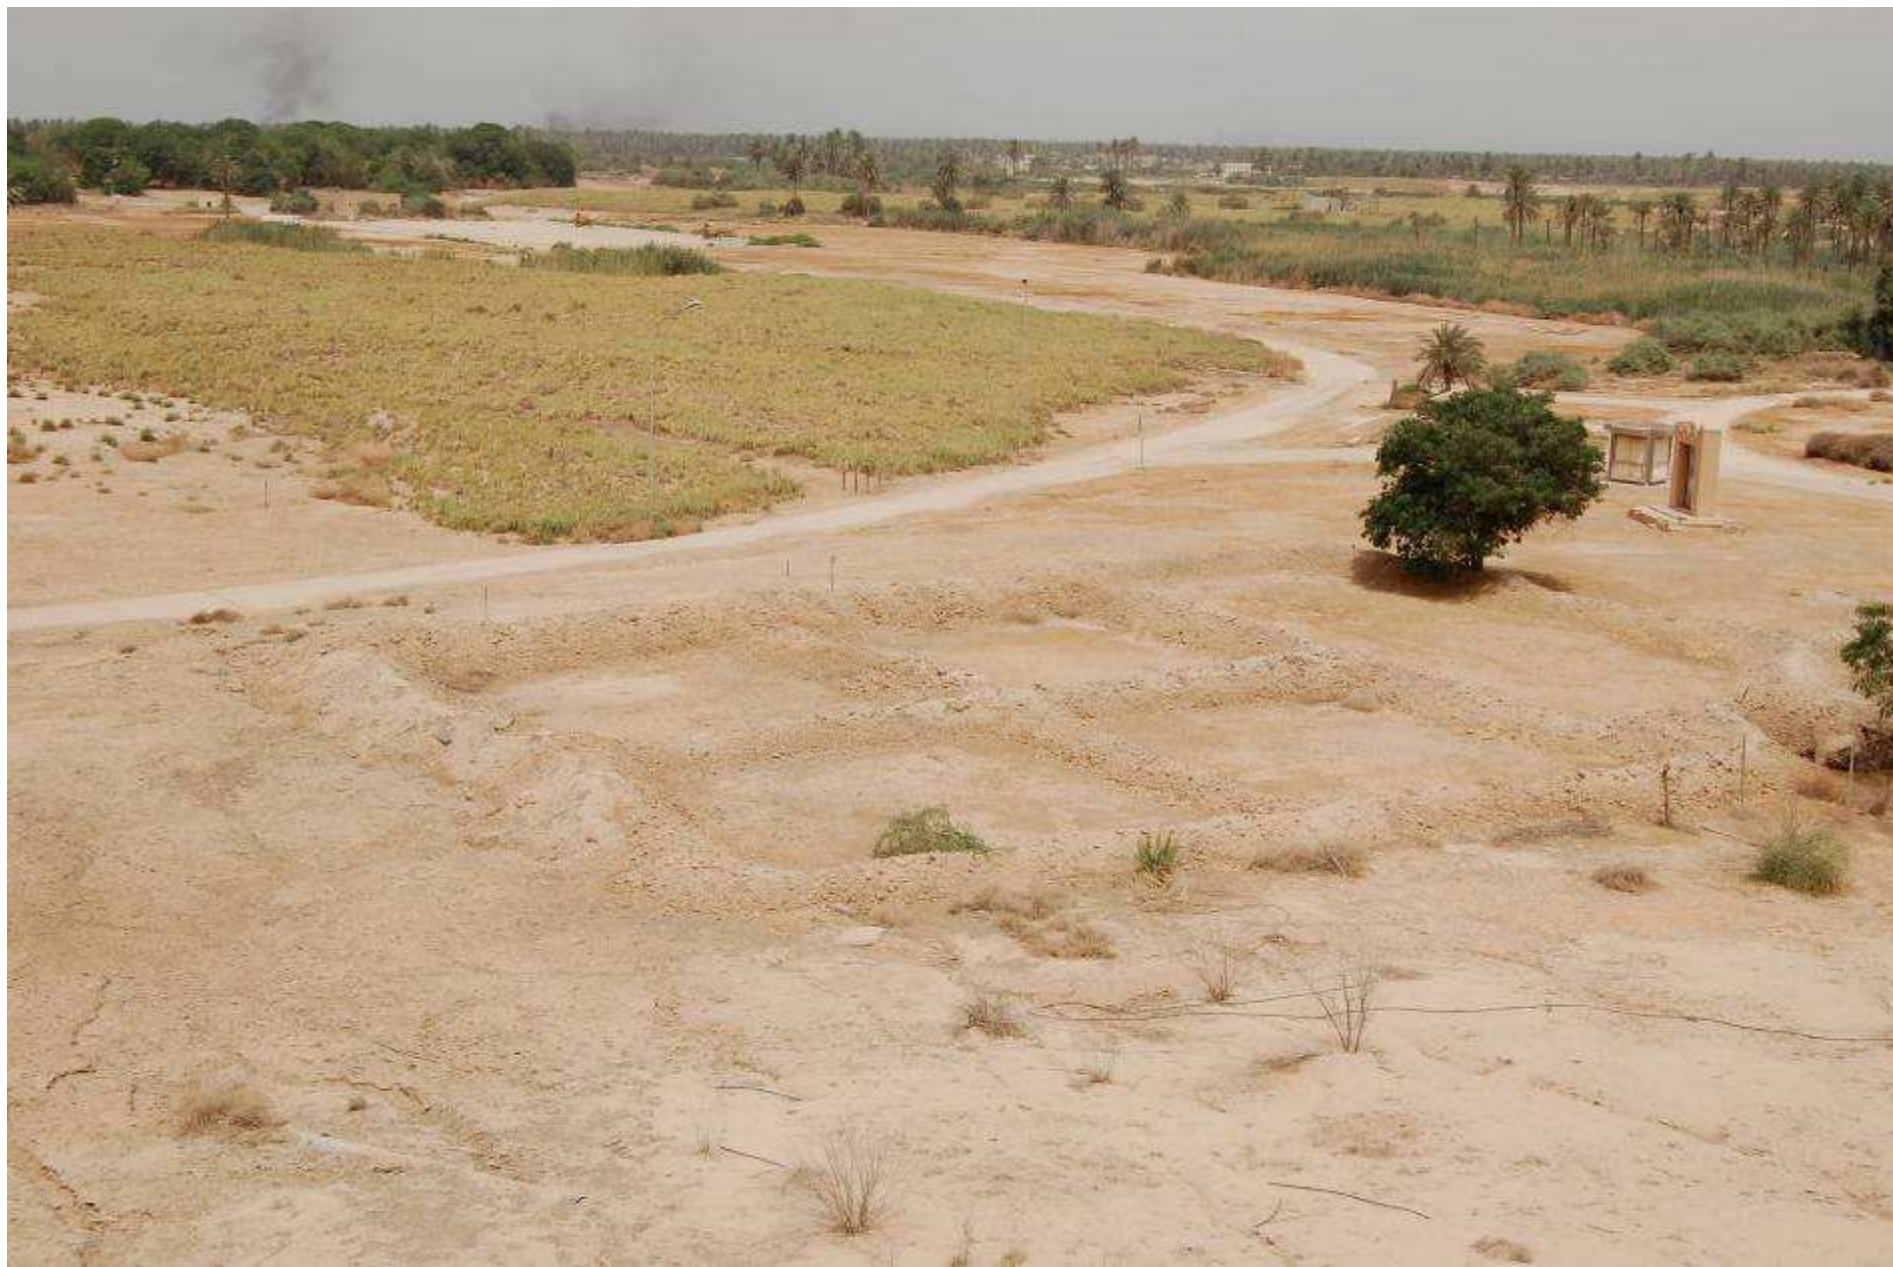
Fuel depot: The protective berms are still in place, 17 July 2008 (Russell photo 163, © John Russell)

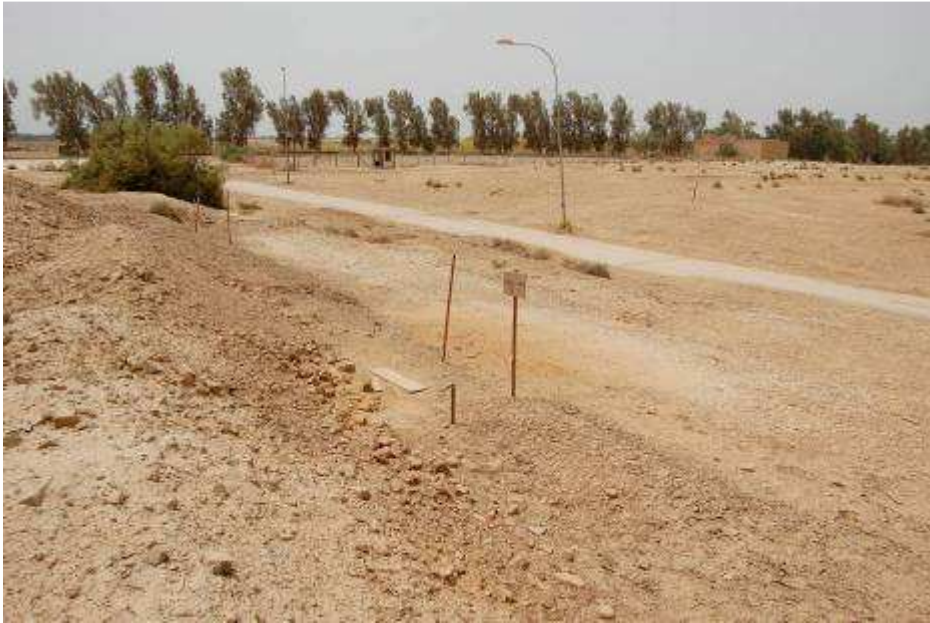
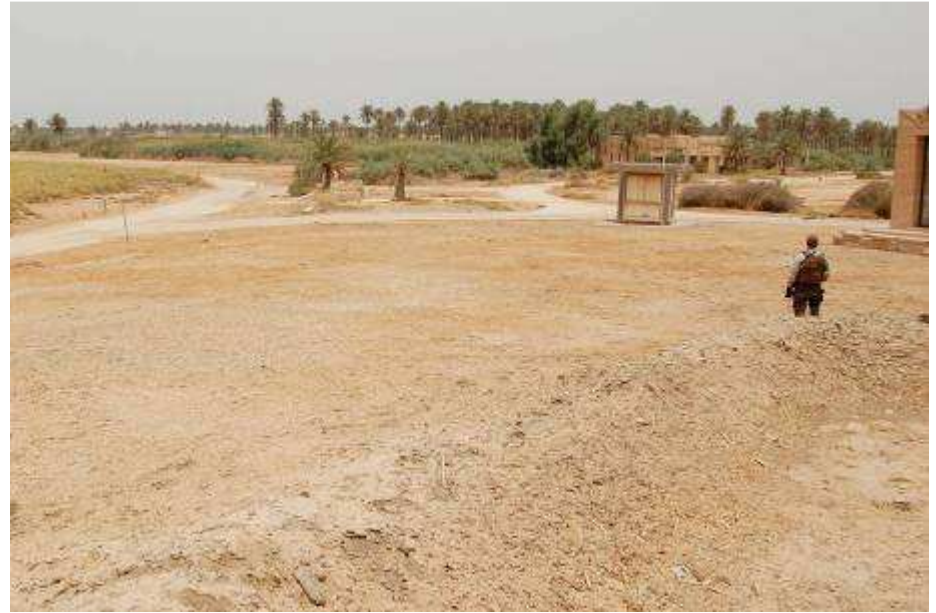
fuel spill, 17 July 2008 (Russell photo 221, © John Russell)

fuel spill, 17 July 2008 (Russell photo 222, © John Russell)

Fuel spills beside fuel depot: Areas contaminated by fuel spills seem to be fading out on the surface. It is not possible without digging to determine the depth of the fuel penetration or its impact on the archaeological remains it contacts.

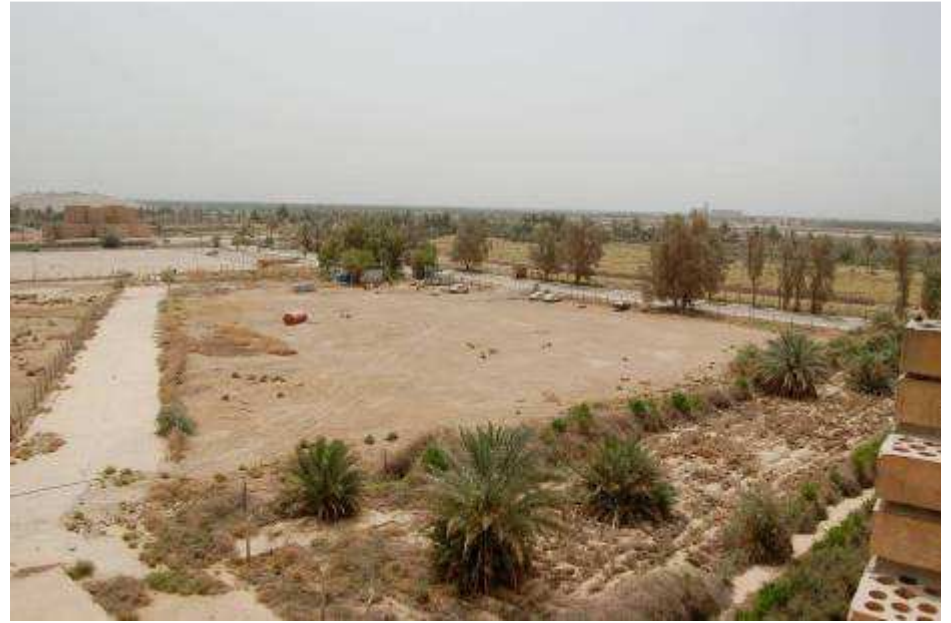
17 July 2008 (Russell photo 175, © John Russell)

Parking lots west of the Marduk Gate, are largely empty.
