# **Report on Damage to the Site of Babylon, Iraq**

**John Malcolm Russell, Ph.D.**

**Cultural Heritage Center  
Bureau of Educational and Cultural Affairs  
Department of State**

**April 2010**

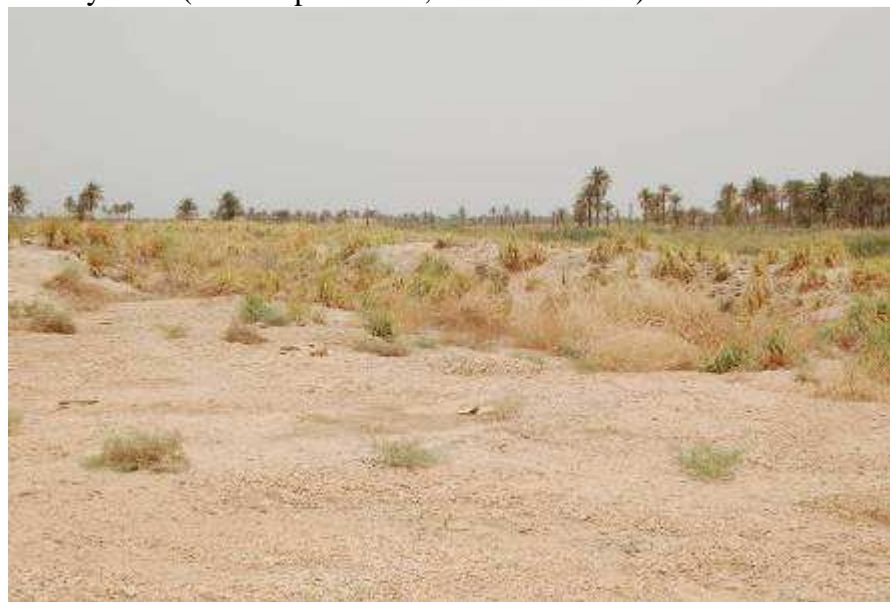
detail of cut 14, 17 July 2008 (Russell photo 225, © John Russell)

The KBR utility area around the Babylonian House is empty. Cut 14 is still visible.

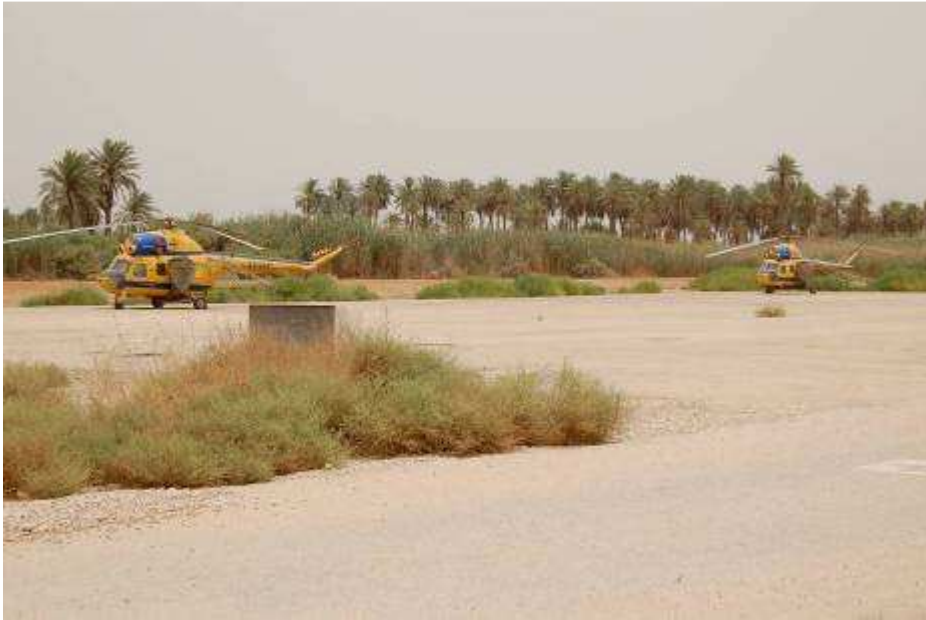
Landing zone 1, 17 July 2008 (Russell photo 260, © John Russell)

Landing zone #1 was empty except for two helicopters. The adjacent parking area still shows apparent staining from surface oiling.

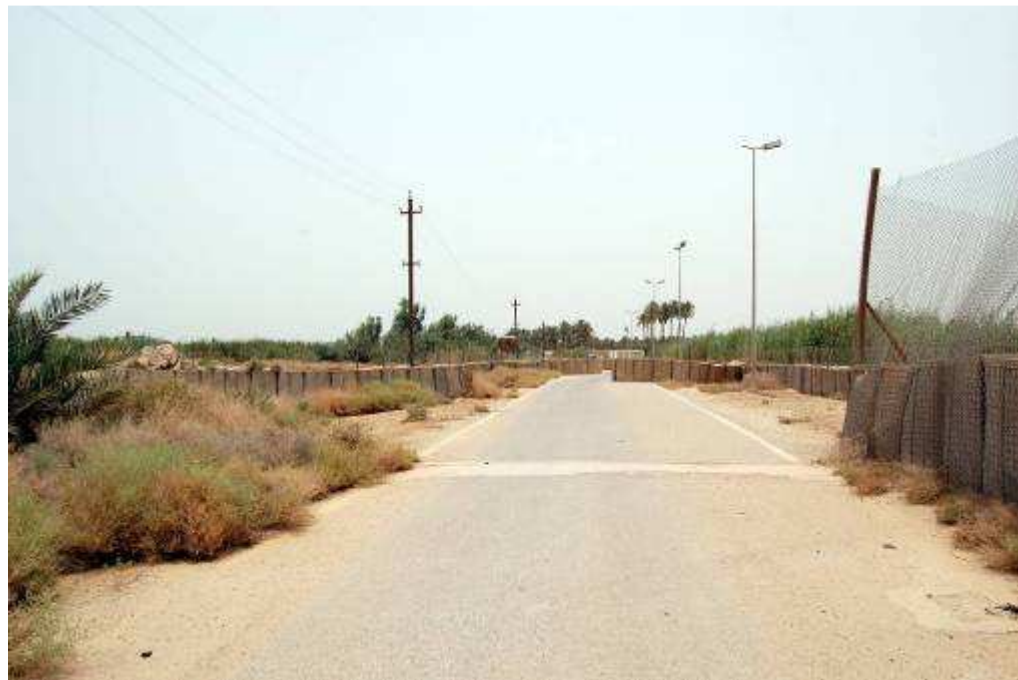
Lots 3-7, 22 June 2009 (Russell photo 119)

Lots 3-7: Although the berm between Lots 5 and 6 is filled with chunks of baked bricks, which suggests that this fill originates from the Homera mound, the surface of the lot itself had no sherds, consistent with identification of this area as a former river bed (photos © John Russell).

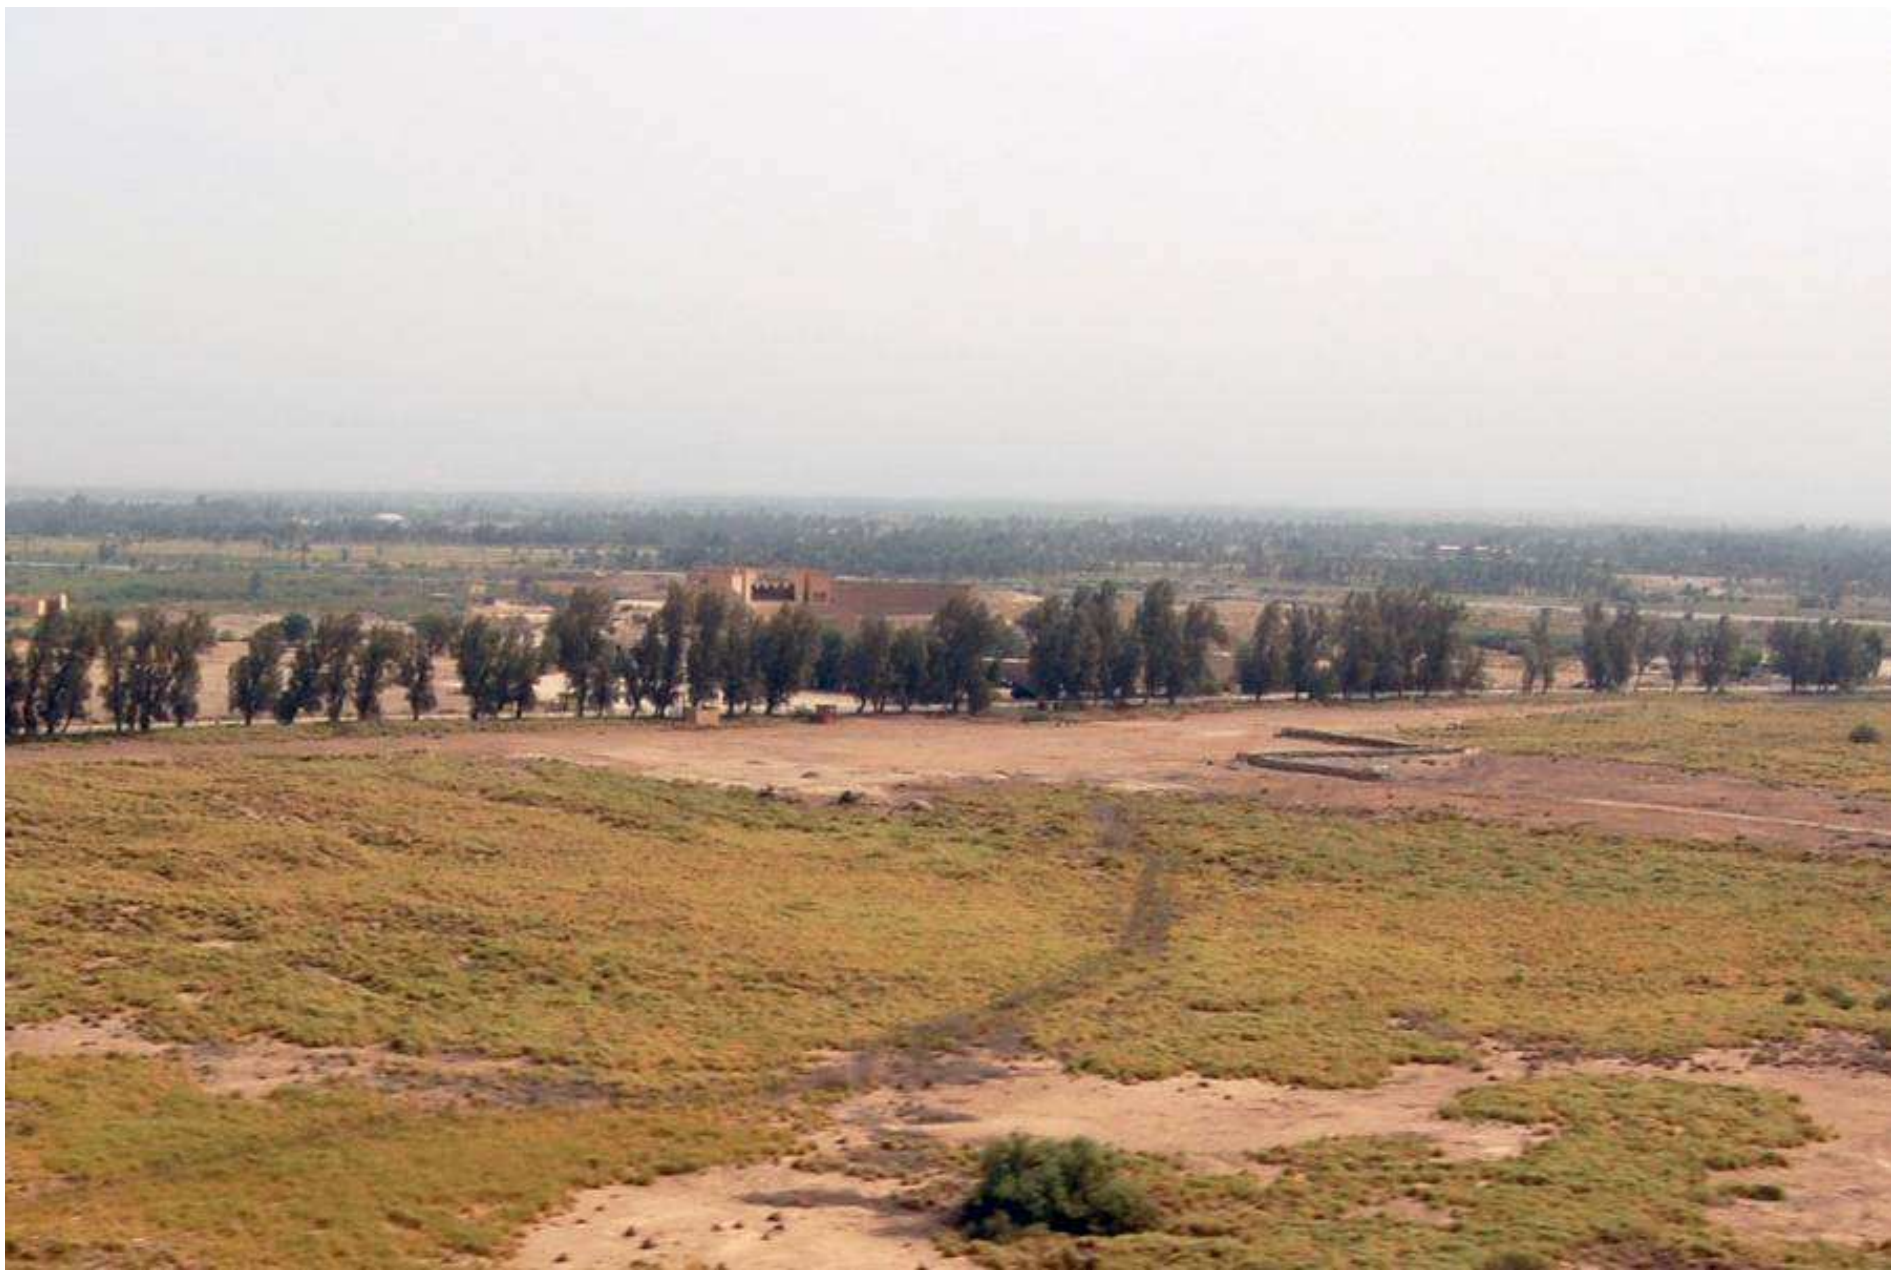
Parking area/Landing zone 3, 17 July 2008: HESCO barriers are deteriorating. Bulldozing at the east end of the area appears superficial and not to have cut into archaeological deposits (Russell photo 139, © John Russell)

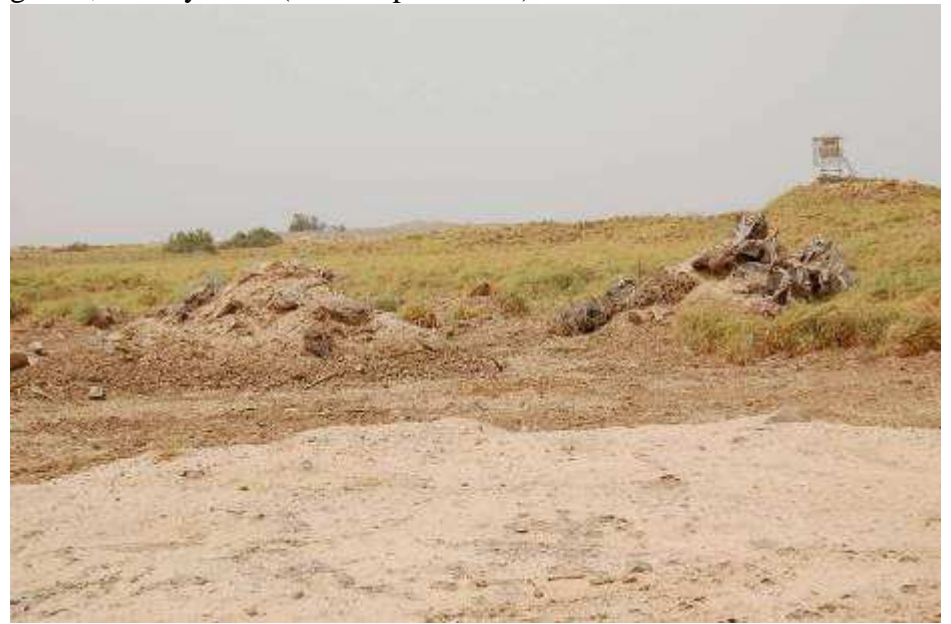
Trench to the west of the Marduk Gate, along Marduk Street: HESCO containers still mark the course of this trench, 17 July 2008 (Russell photo 180, © John Russell)

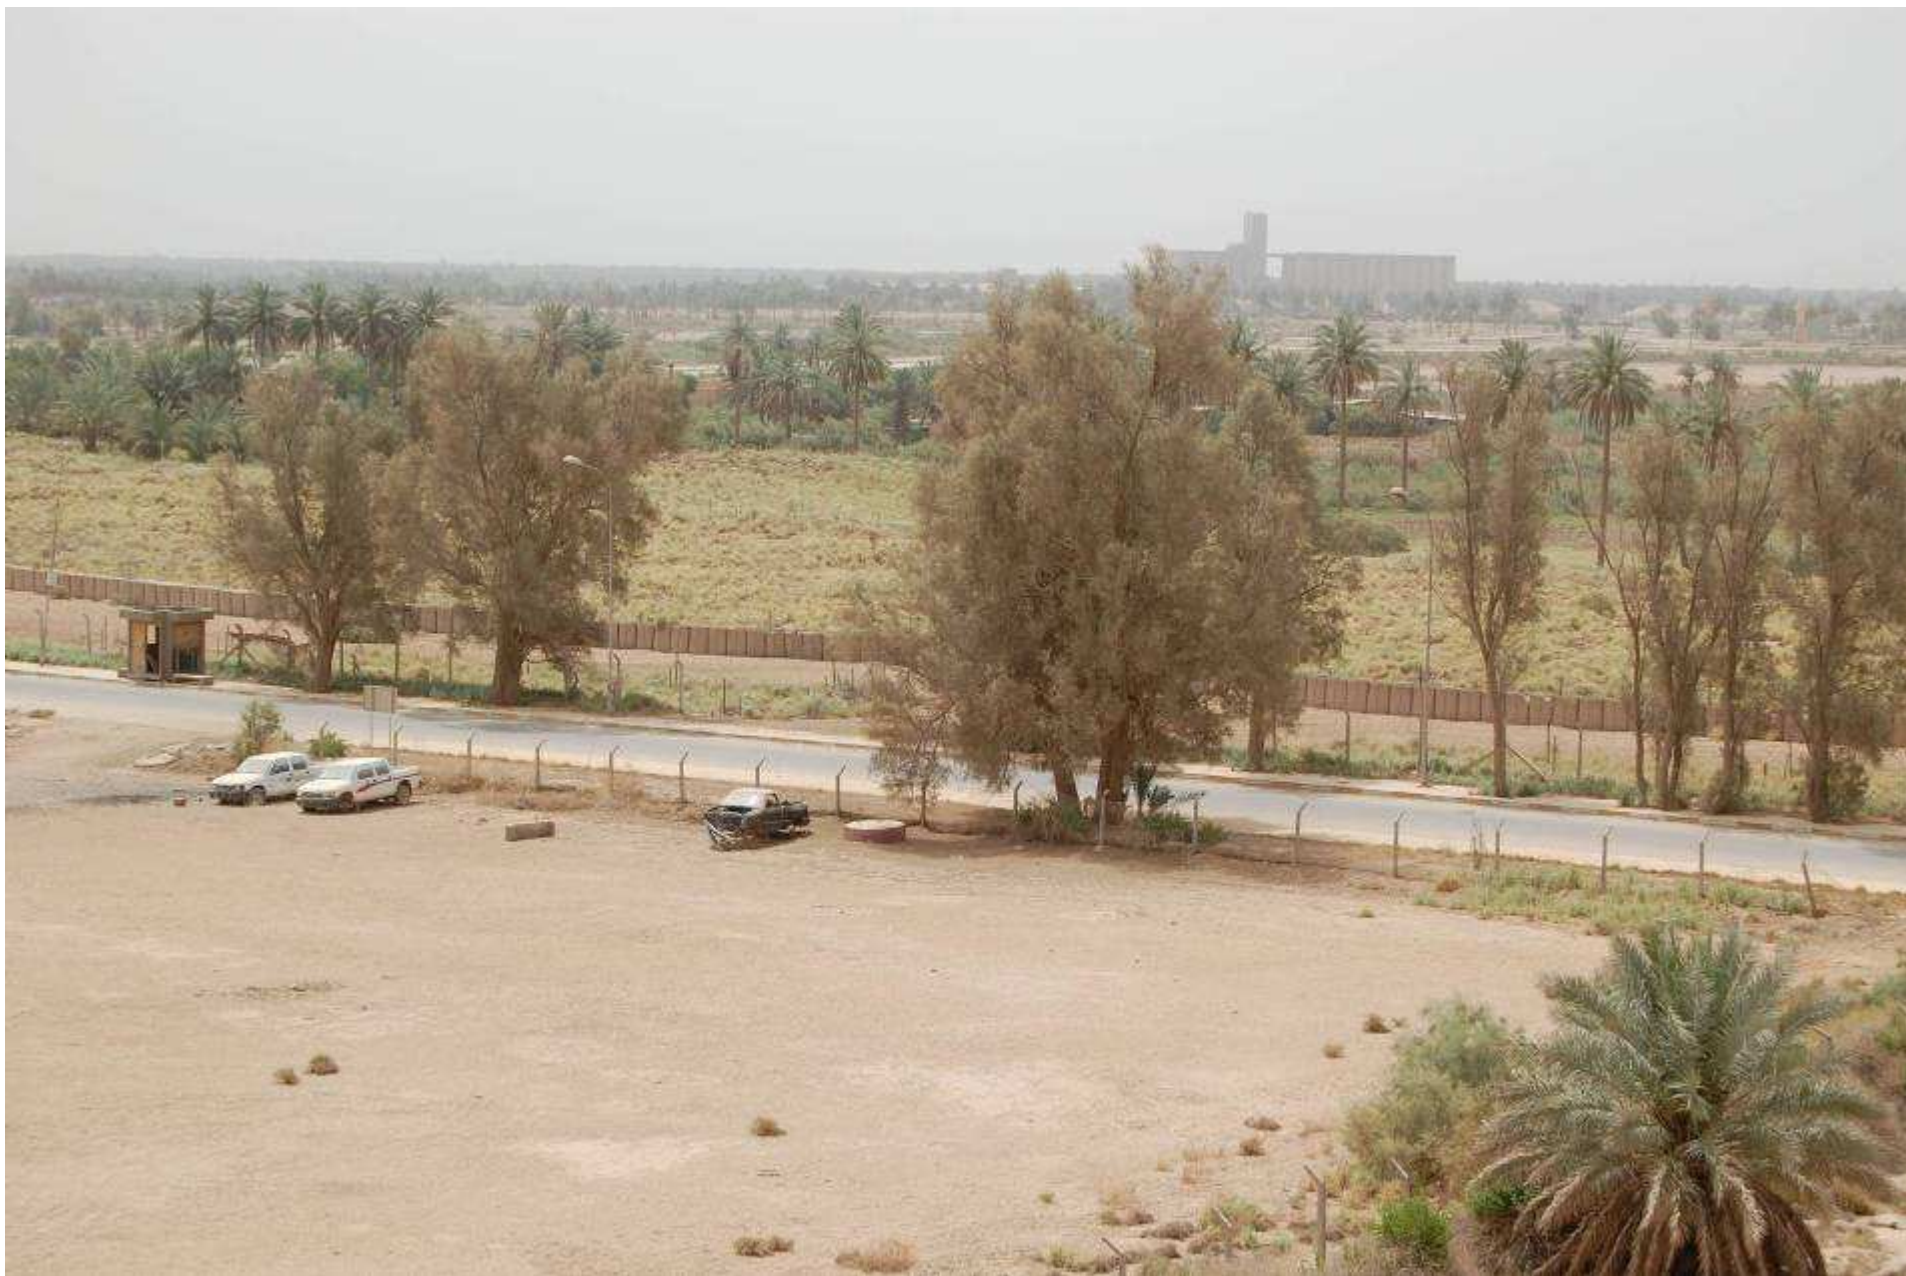
Tent City #1, overview, ditch, 17 July 2008 (Russell photo 132, © John Russell)

Tent city #1 and the adjacent parking area still show surface alterations from the military camp.

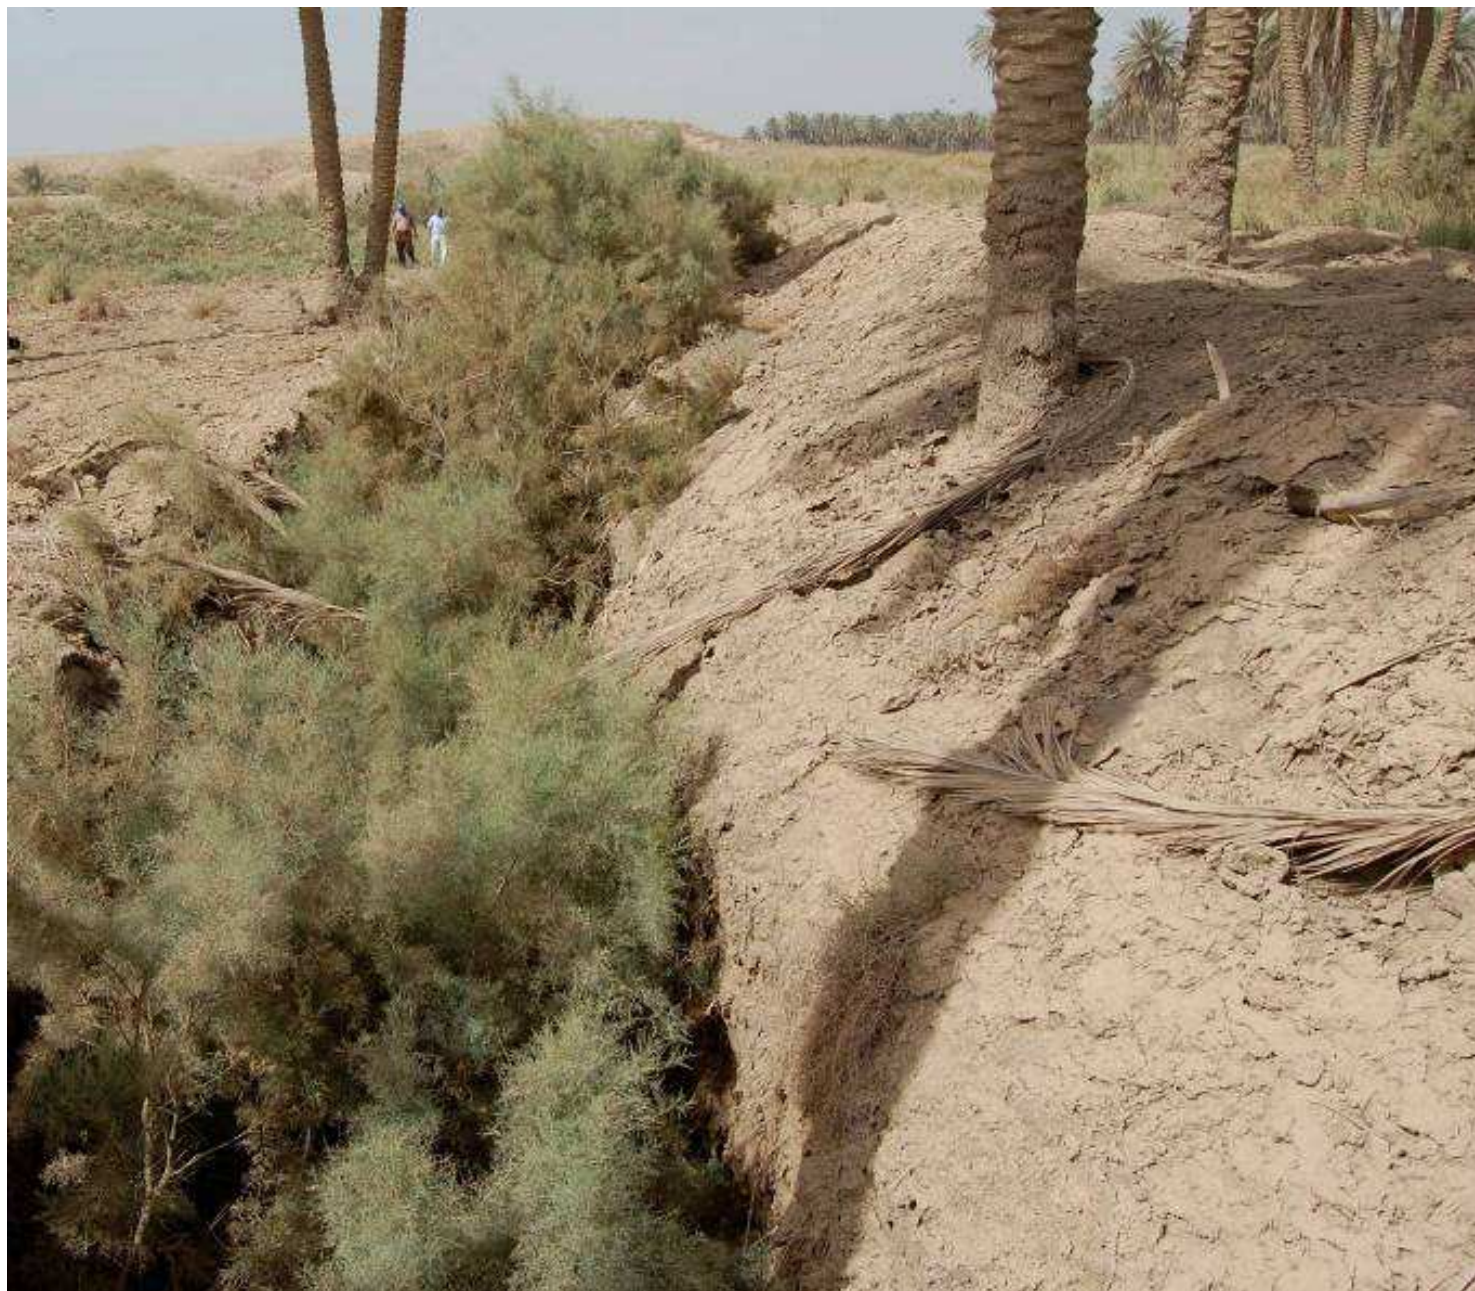
Trenches south of the camp, now overgrown with vegetation, 22 June 2009 (Russell photo 17, © John Russell)

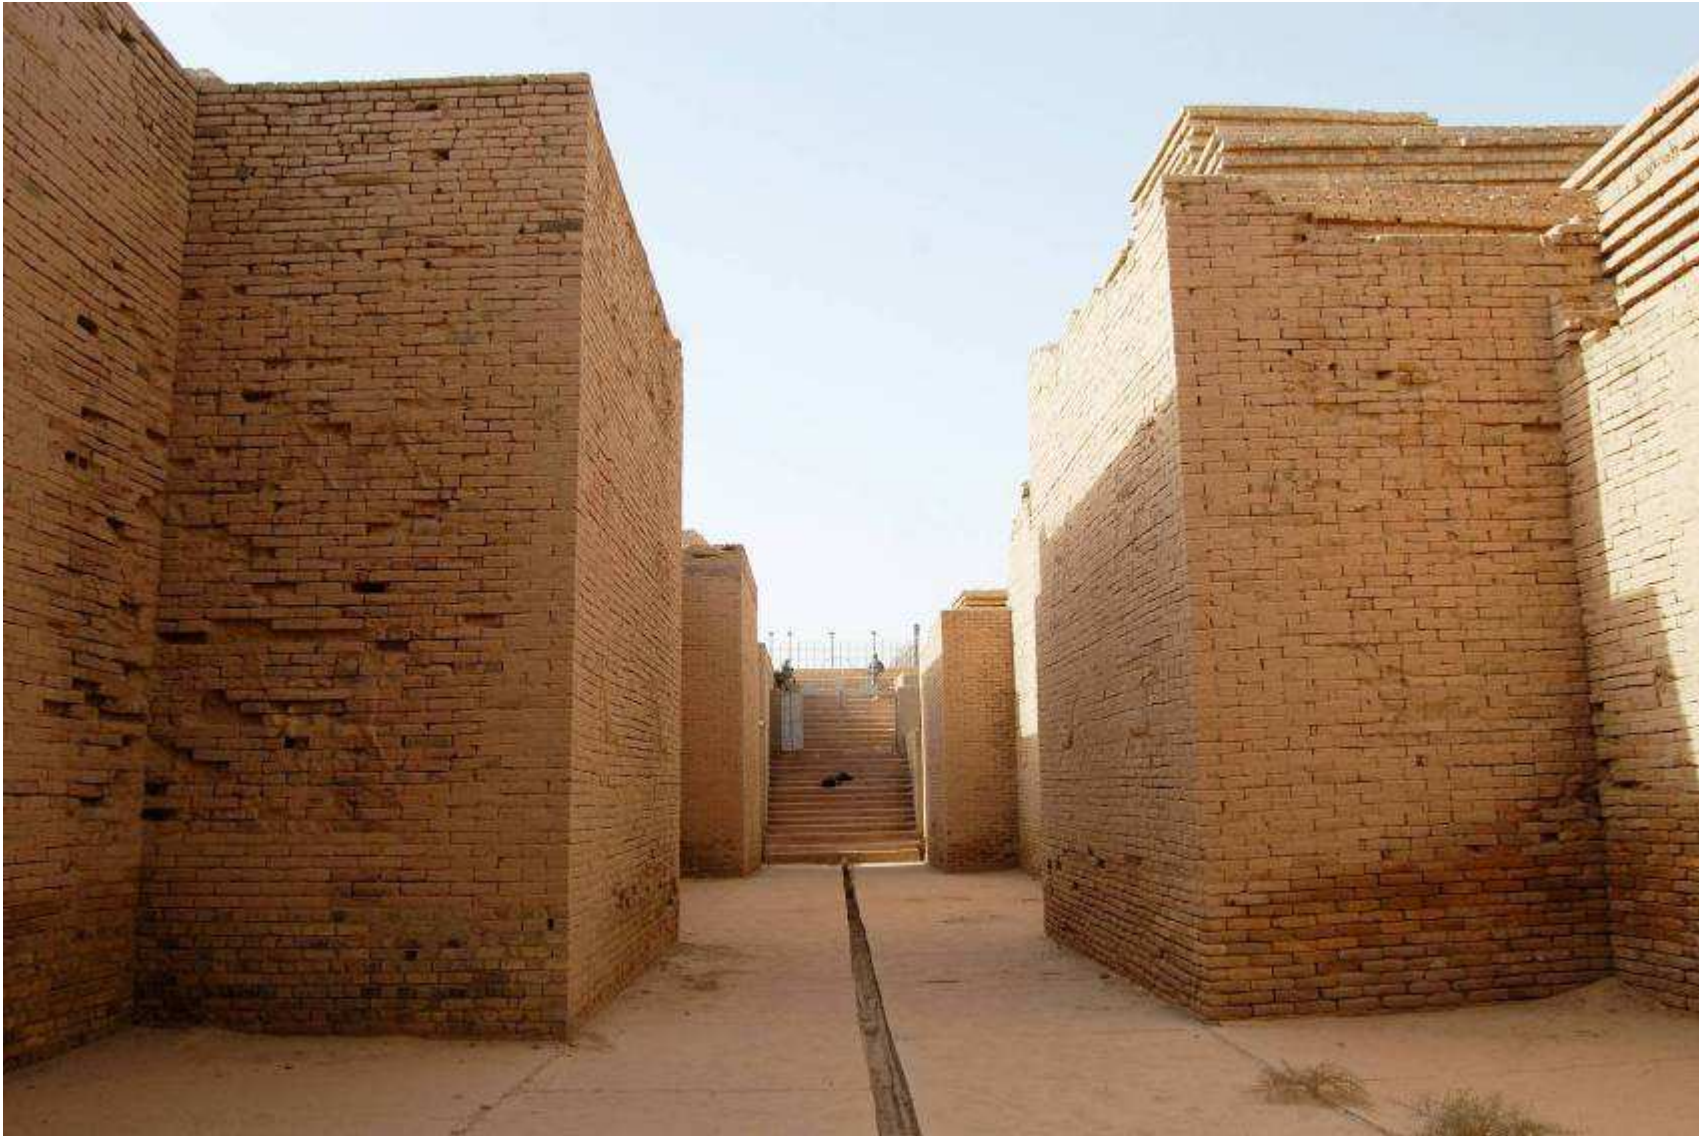
The Ishtar Gate has suffered serious damage from salt and moisture infiltration, with many crumbling bricks and a number of molded figures damaged, apparently during the period of the Coalition occupation (Russell photo 230, 21 June 09, © John Russell).

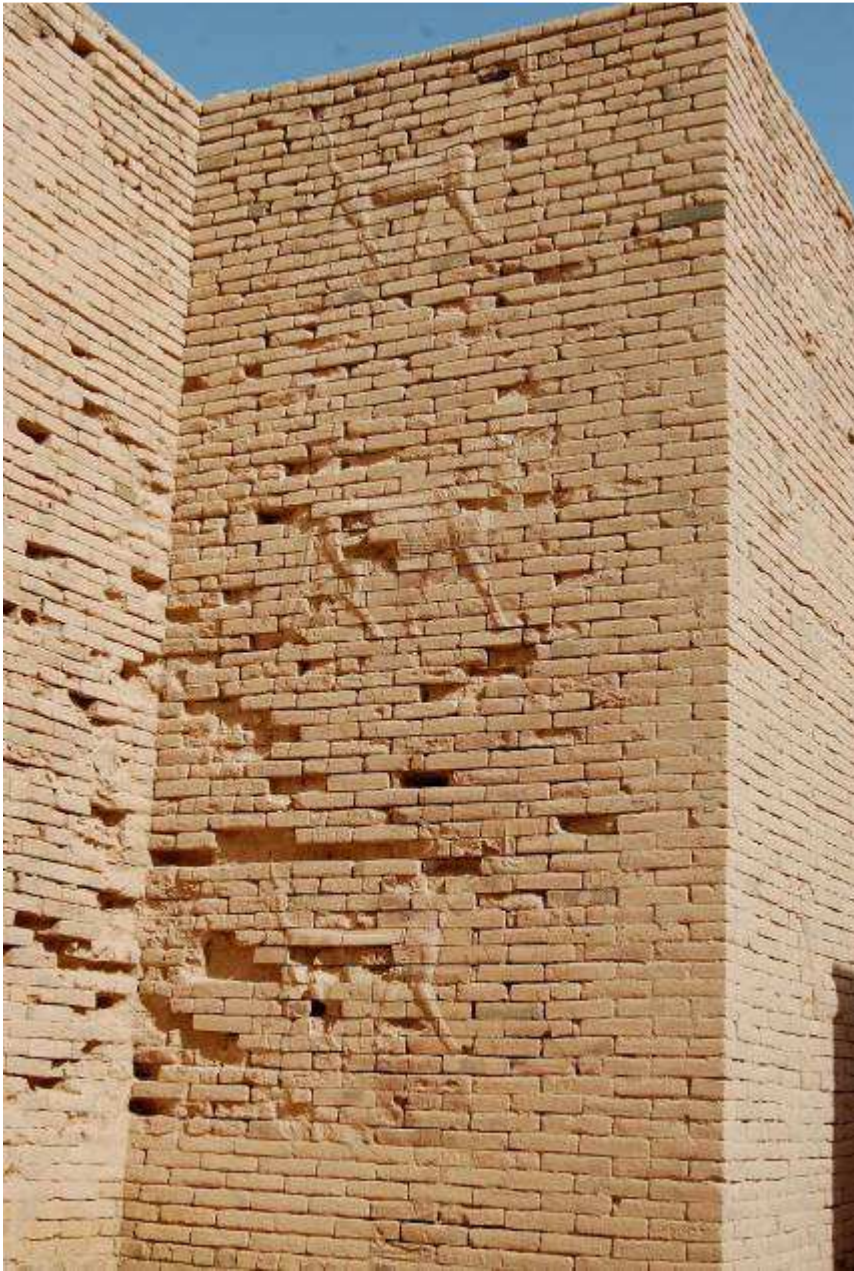
Missing bricks and damaged figures, 24 June 09 (Russell photo 94)  
Photos © John Russell

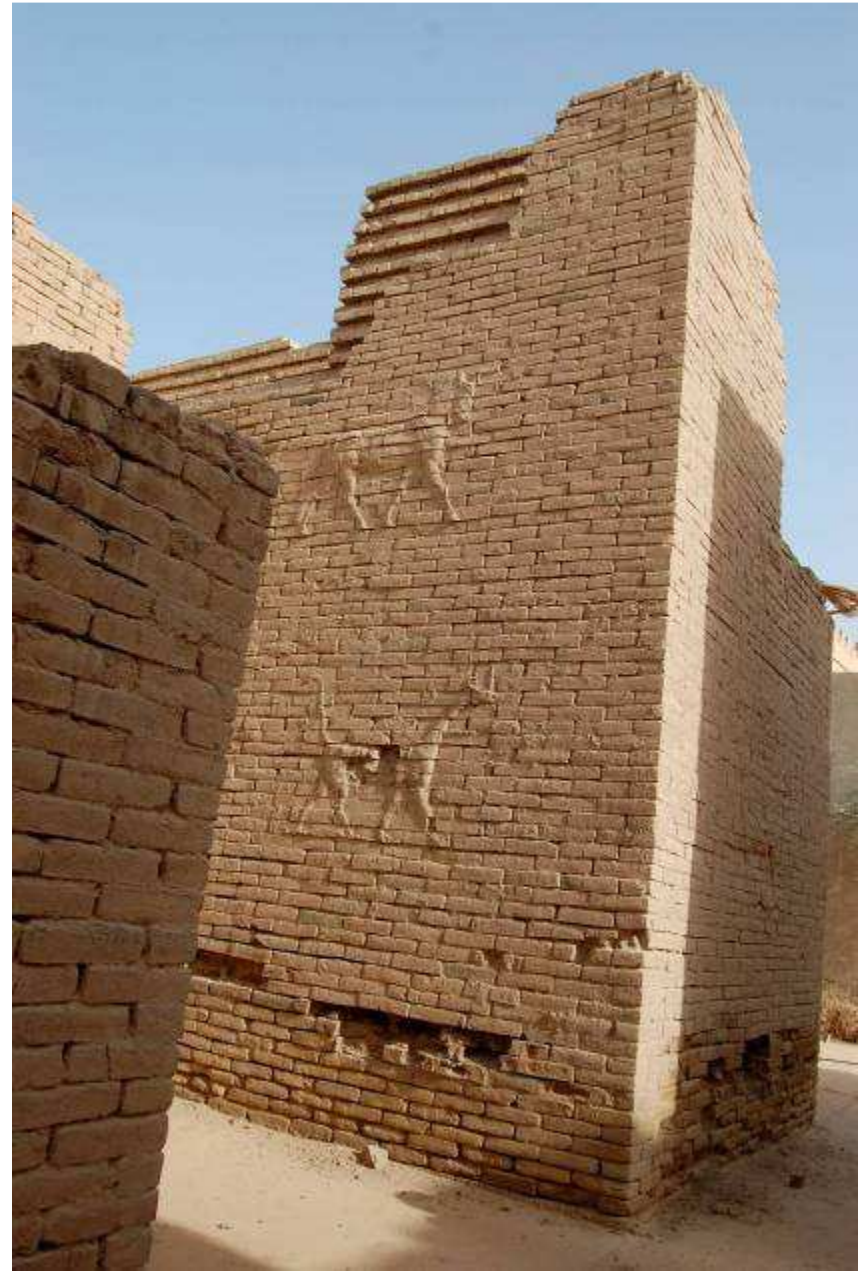
Damage from rising damp, 21 June 09 (Russell photo 229)

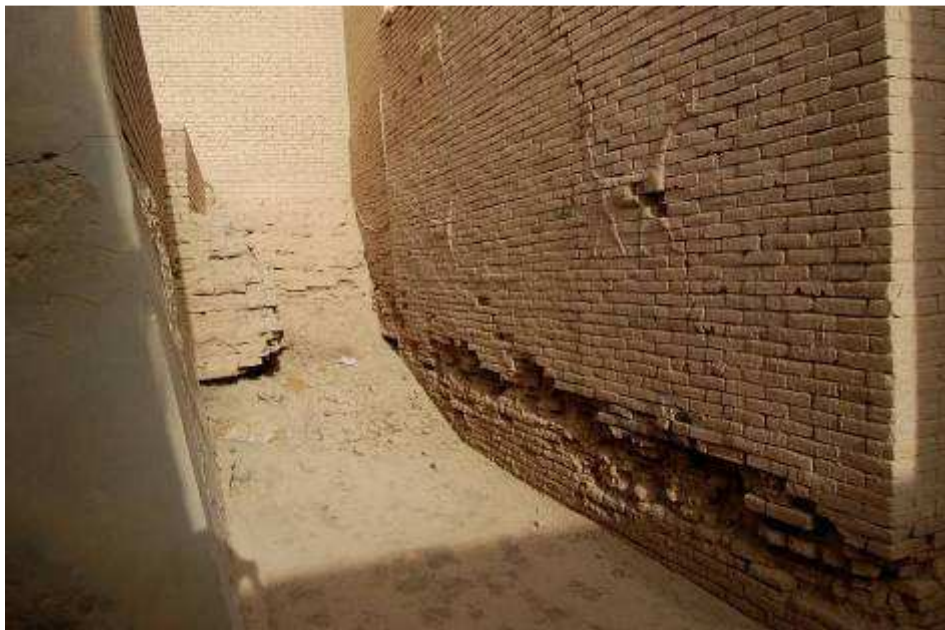
21 June 09 (Russell photo 185, © John Russell)

The lower wall in the SW corner has been seriously undermined by rising damp (left), possibly resulting in the structural crack in the upper part (right).

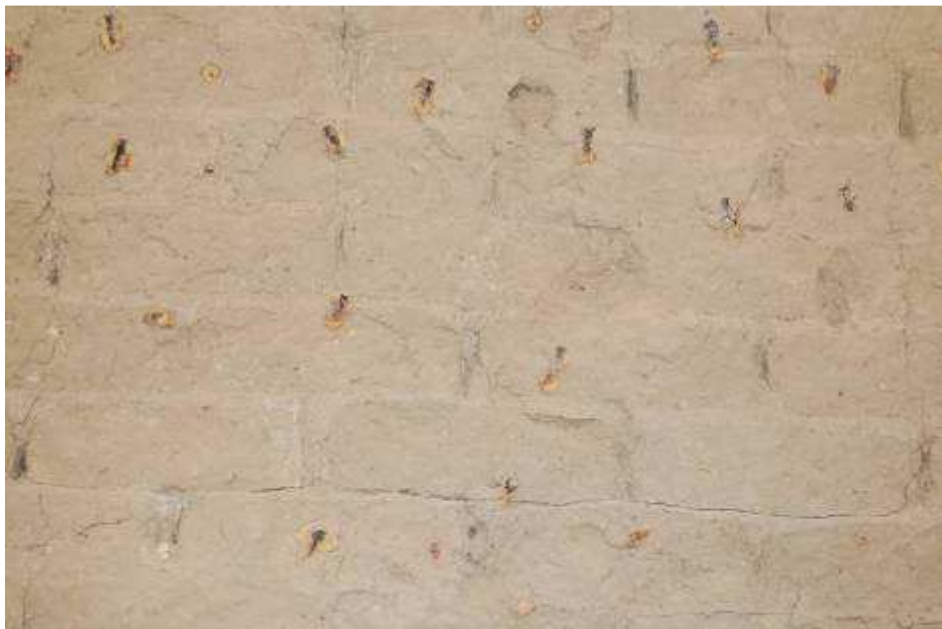
21 June 09 (Russell photo 103, © John Russell)

The plaster was applied by driving large iron nails into the original mudbrick wall, hanging wire mesh on the nails, and then placing a coat of gypsum plaster as much as 10 cm thick on top of that.

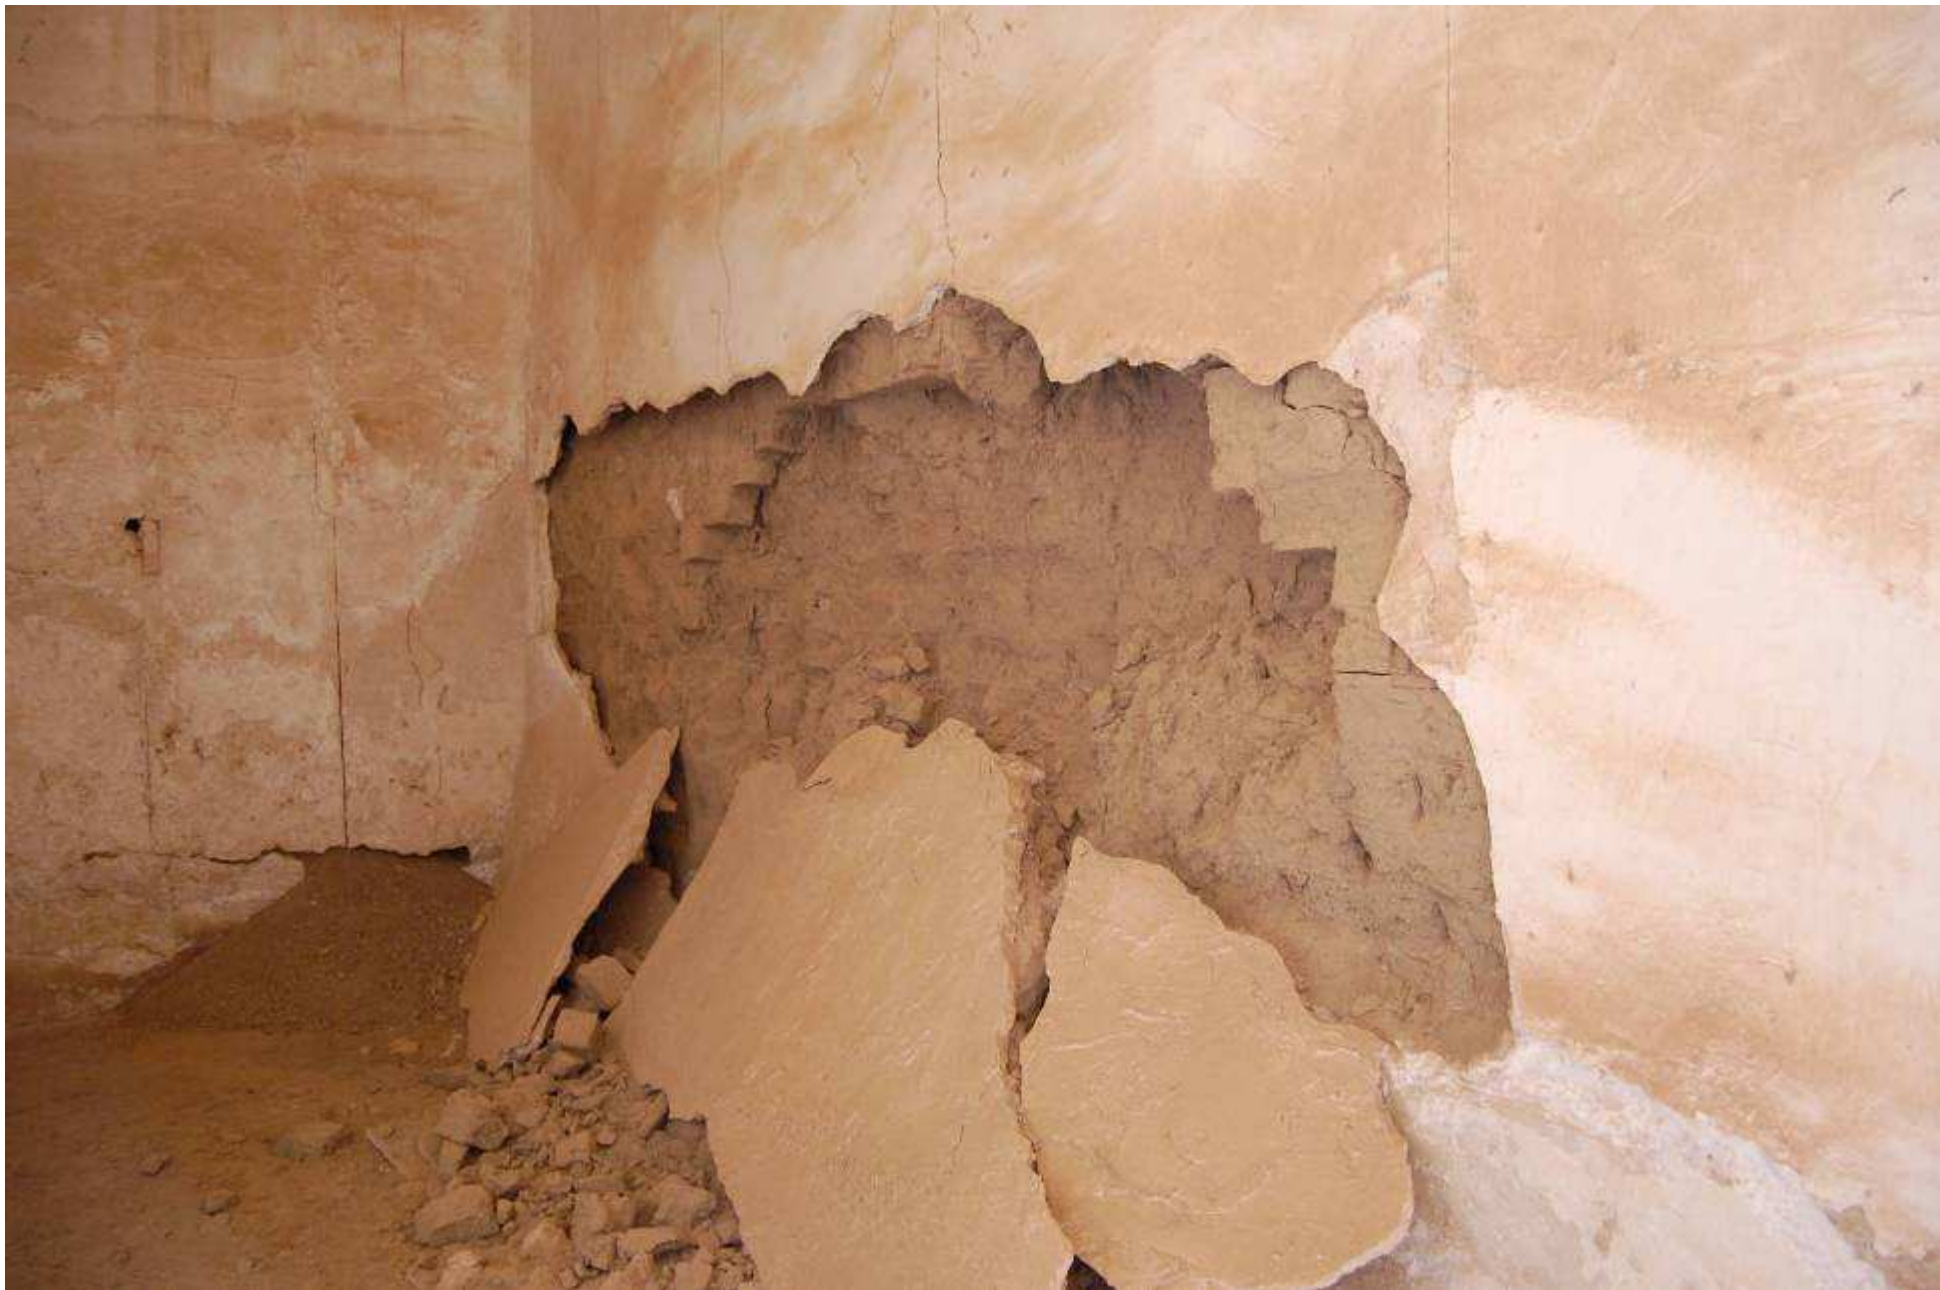
The plaster did not bond with the mud bricks, and is so heavy that in several places it caused large areas of the original brick to shear off and collapse, leaving walls large cavities in their surface (Russell photo 99, 21 June 09, © John Russell)

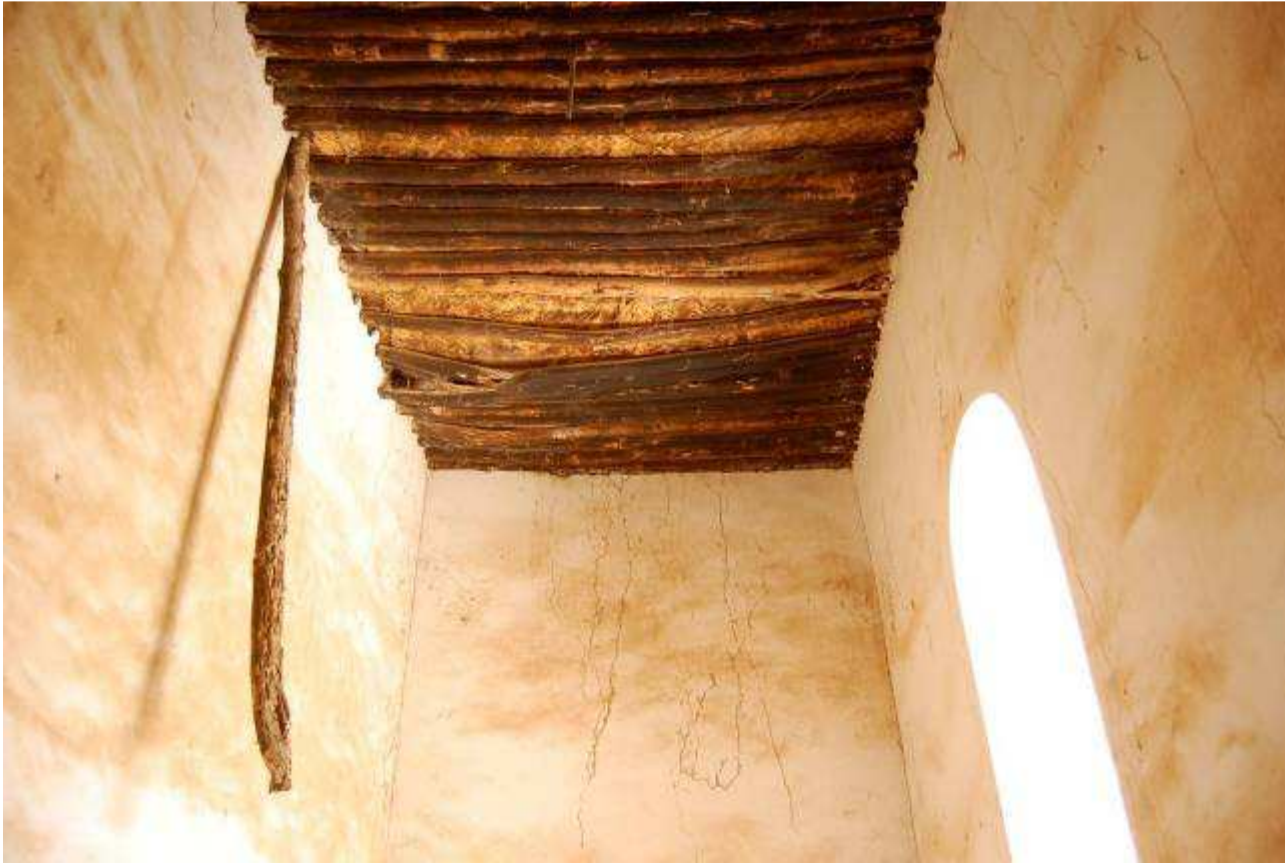
21 June 09 (Russell photo 78, © John Russell)

The roof beams are riddled by termites so that some of them have broken and many others are badly compromised.

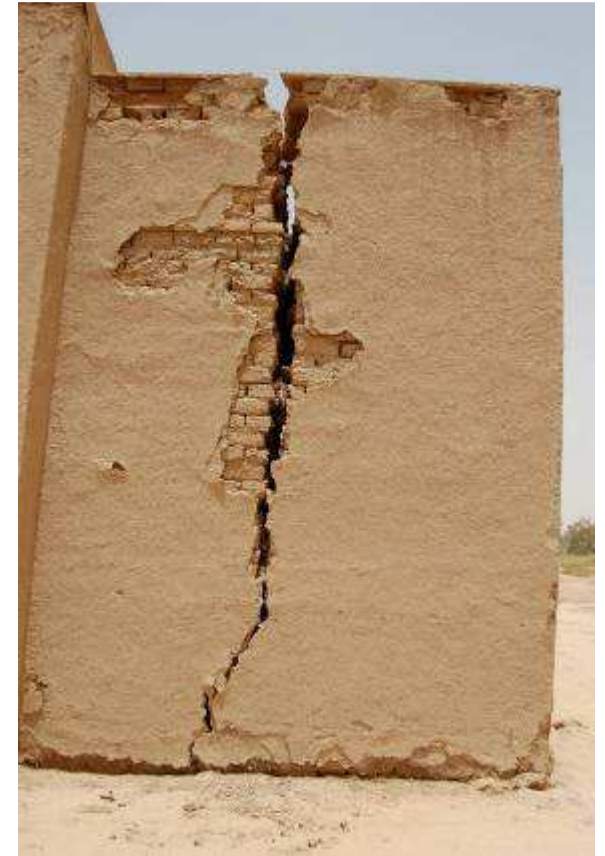
Ishtar Temple, outer wall, 20 June 09 (Russell photo 127)

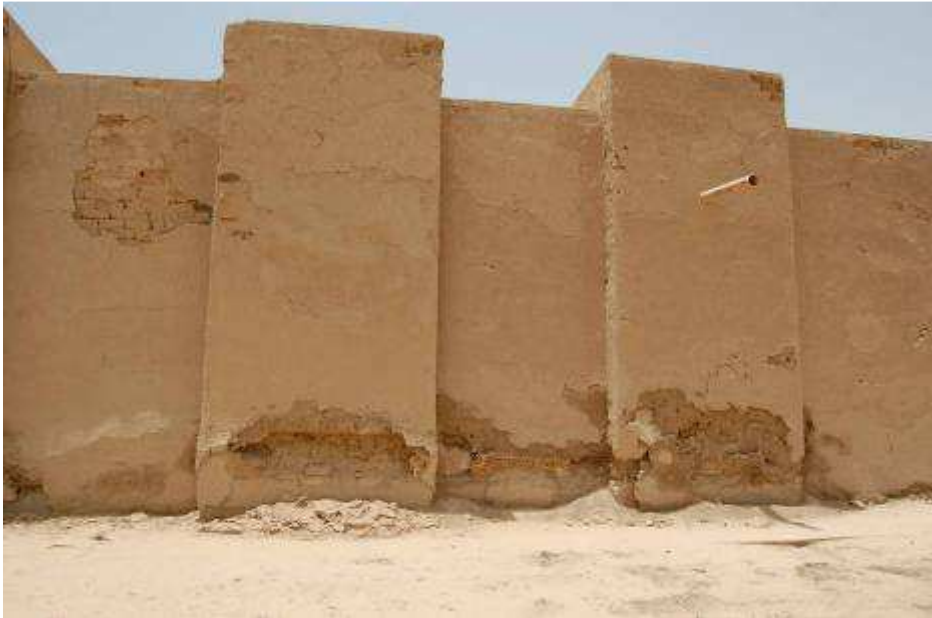
Ishtar Temple, outer wall, detail, 20 June 09 (Russell photo 129)

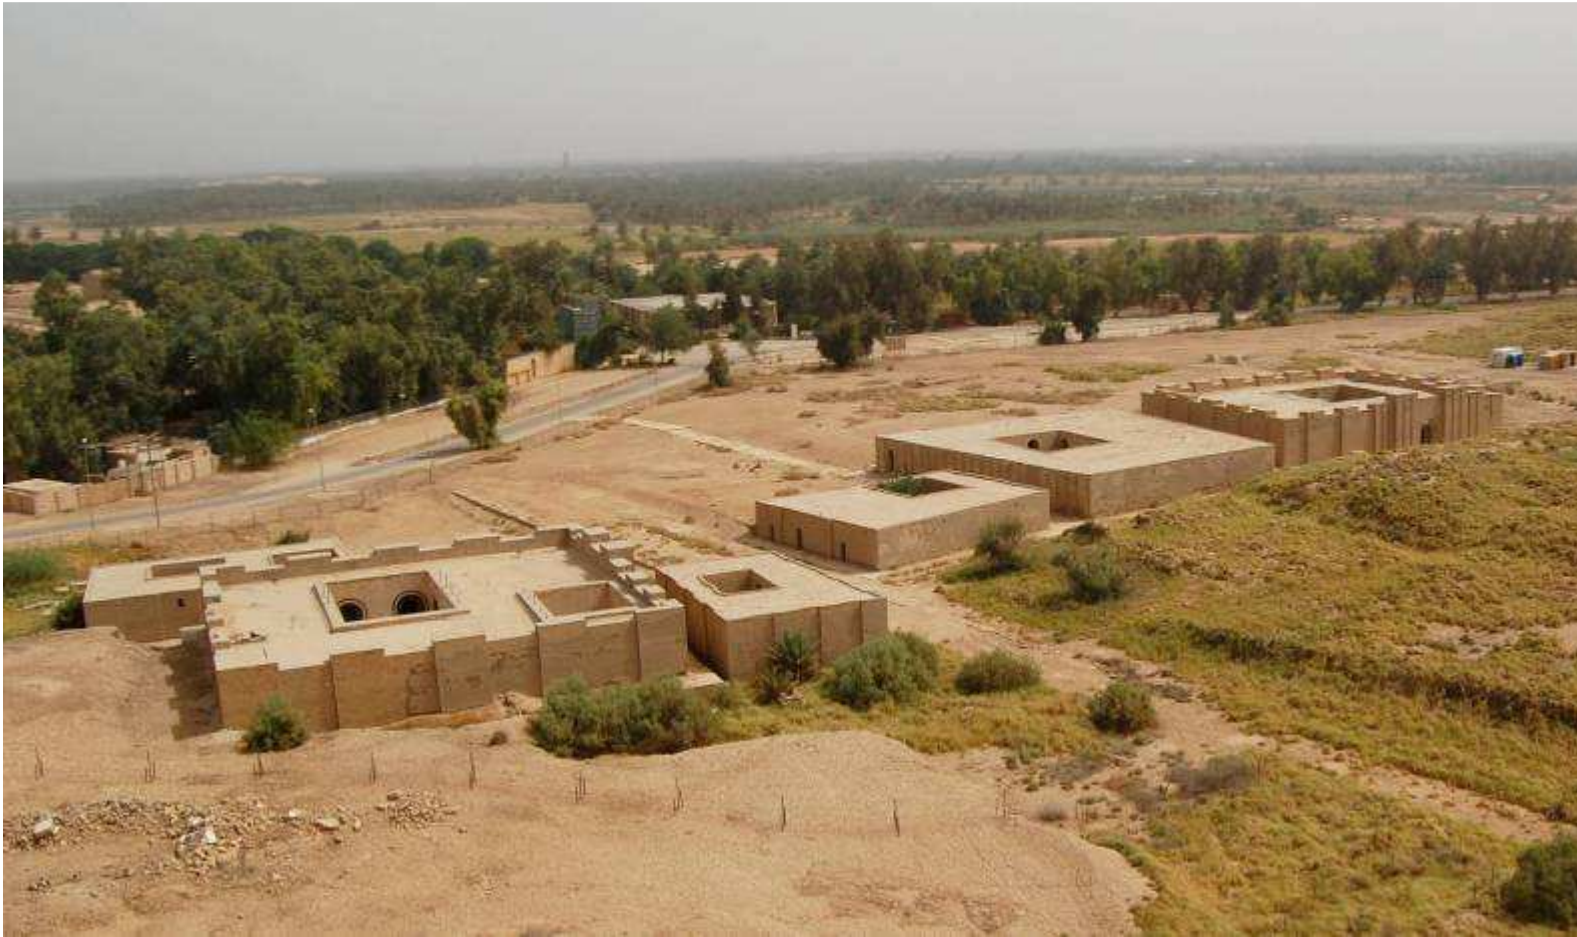
Left to right: Restored Babylonian house, Nabu sha-Hare Temple, three restored Babylonian houses, Ishtar Temple, 17 July 2008 (Russell photo 135)

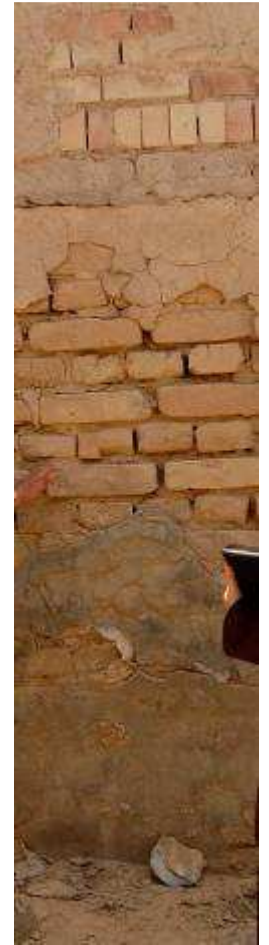
We looked briefly at the two restored Babylonian houses, adjacent to the Ishtar Temple. Both had been reconstructed from the ground up with a variety of modern fired bricks, and it was not possible to see if there was any original brick in the foundations.

Modern brickwork of restored Babylonian house, 23 June 09 (Russell photo 112)

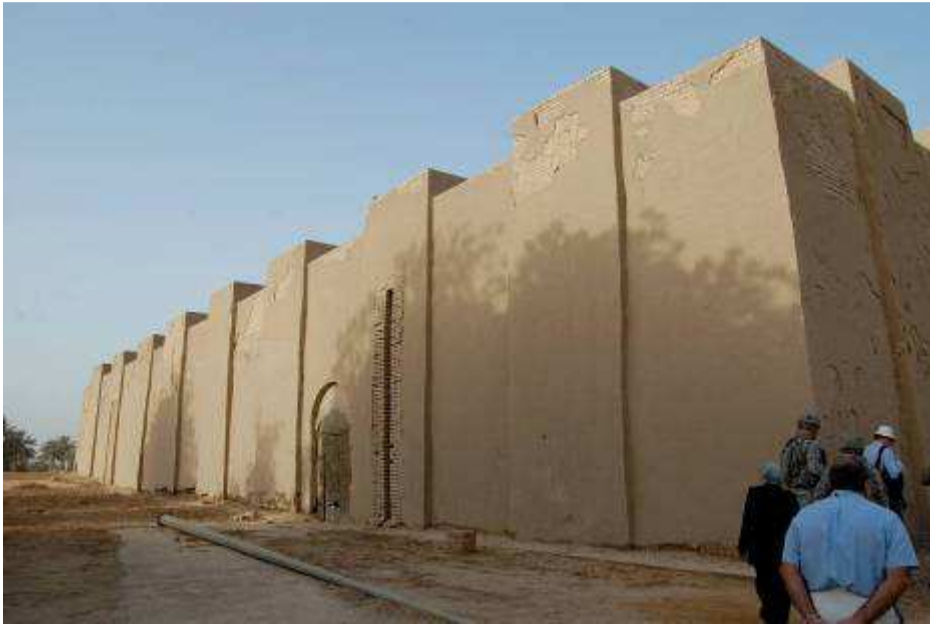
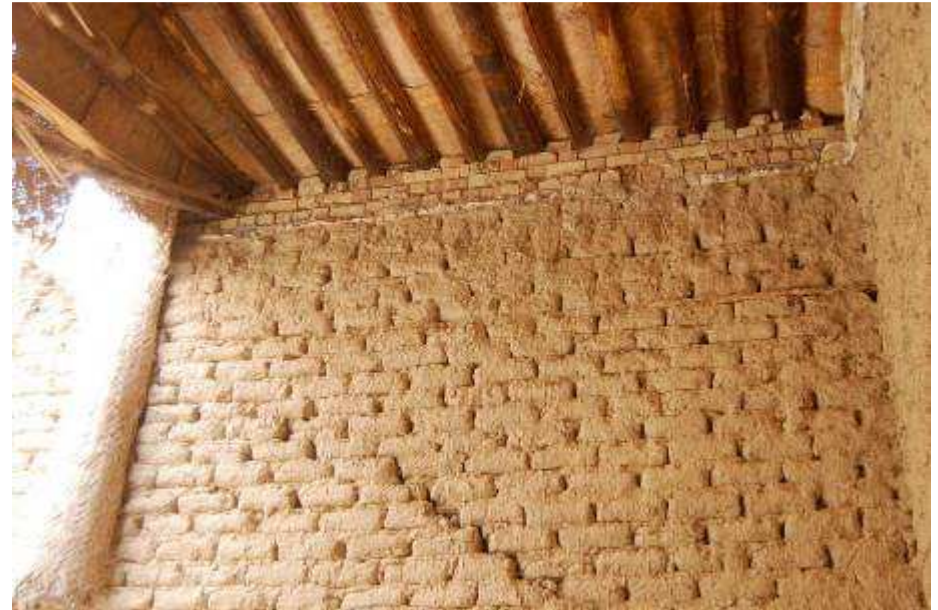
## Ninmah Temple

The Ninmah Temple is largely a modern restoration, apparently originally carried out in the 1960's. It displays a mixture of different restoration techniques with various modern materials, used at different times in the maintenance of the restored building. There appeared to be at least one substantial section of original wall, but it is difficult to distinguish if there is more because of all the restoration.

The roof was done in the same technique as the other reconstructions, and again the timbers are riddled with termite holes, so that all the large spans have collapsed, leaving at least 6 large holes in the roof.
