# **Report on Damage to the Site of Babylon, Iraq**

**John Malcolm Russell, Ph.D.**

**Cultural Heritage Center  
Bureau of Educational and Cultural Affairs  
Department of State**

**April 2010**

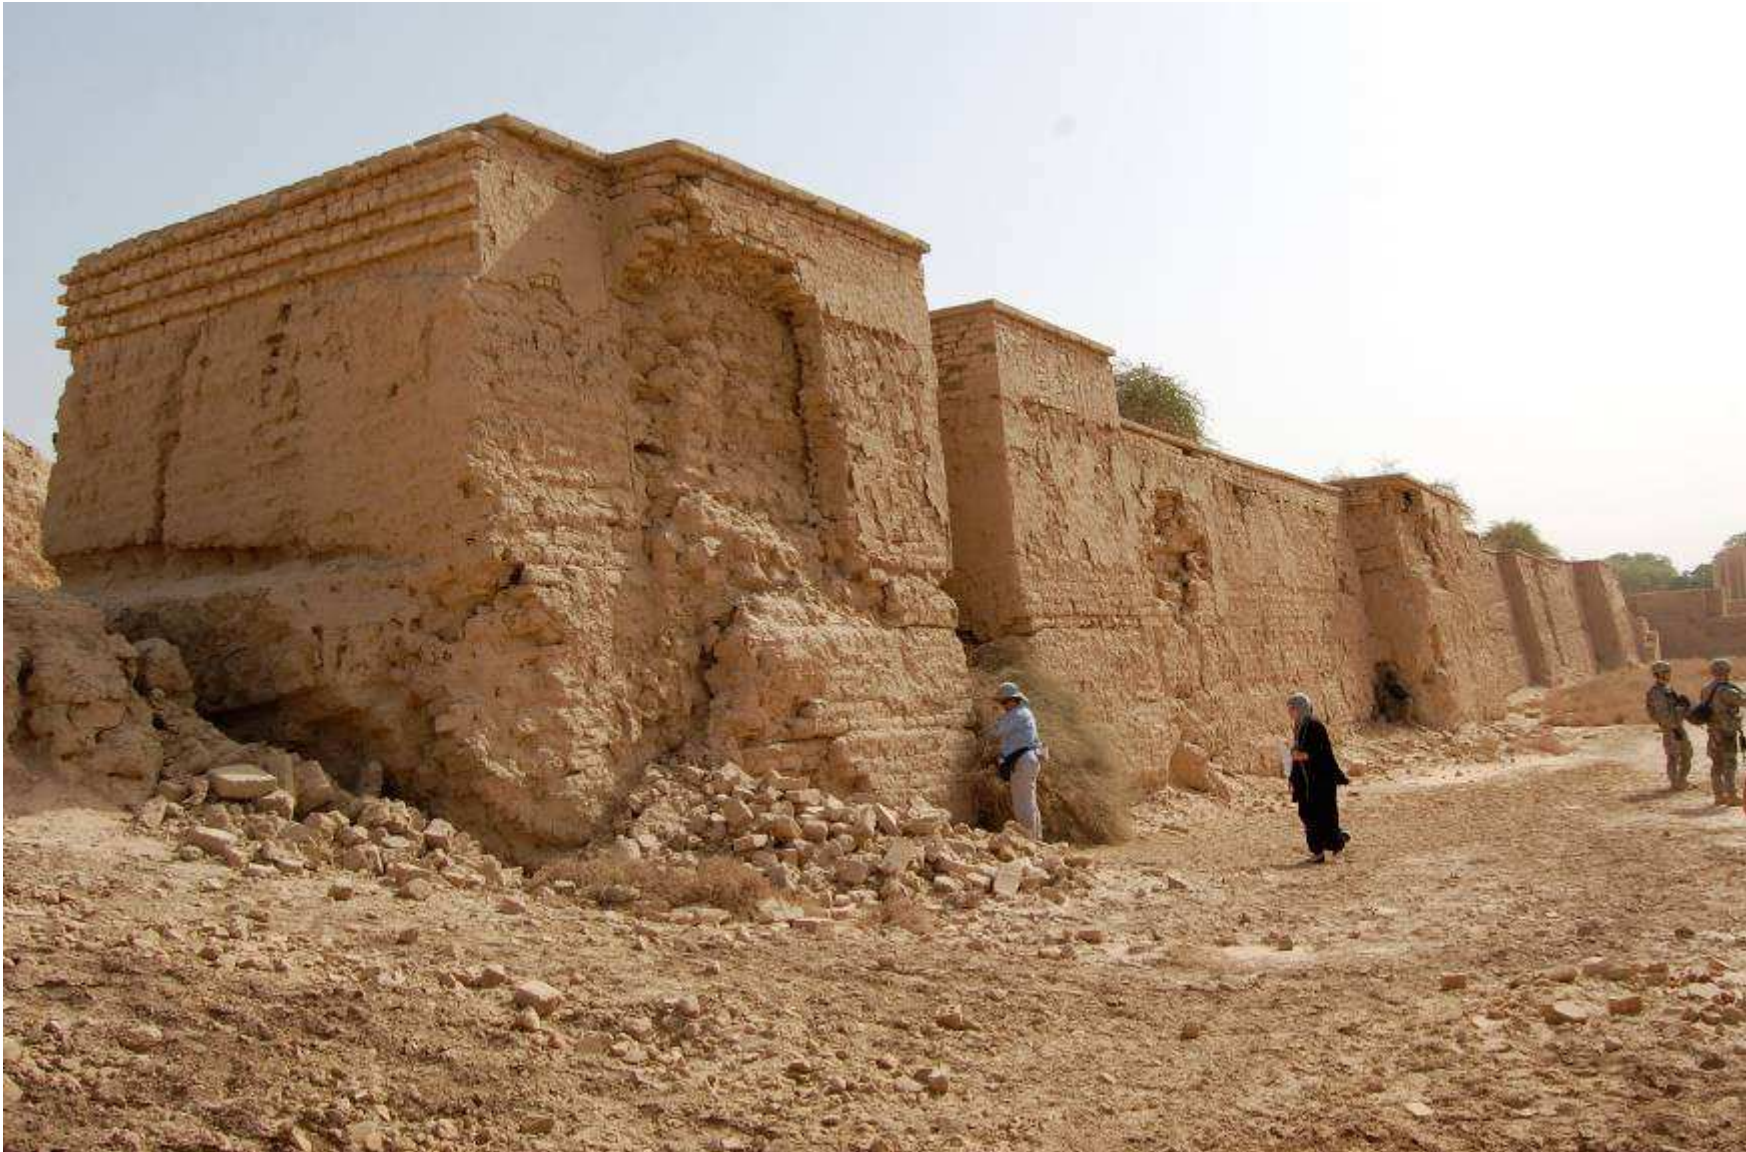
This is a double wall, with the Iraqi pre-2003 firing pits on top of the outer part. The facade of the inner part where it faces the Southern Palace (above) is well-preserved, but deteriorating, with sections of the original mud brick facade becoming detached and collapsing, as well as areas that are being damaged by vegetation, 21 June 2009 (Russell photo 247, © John Russell)

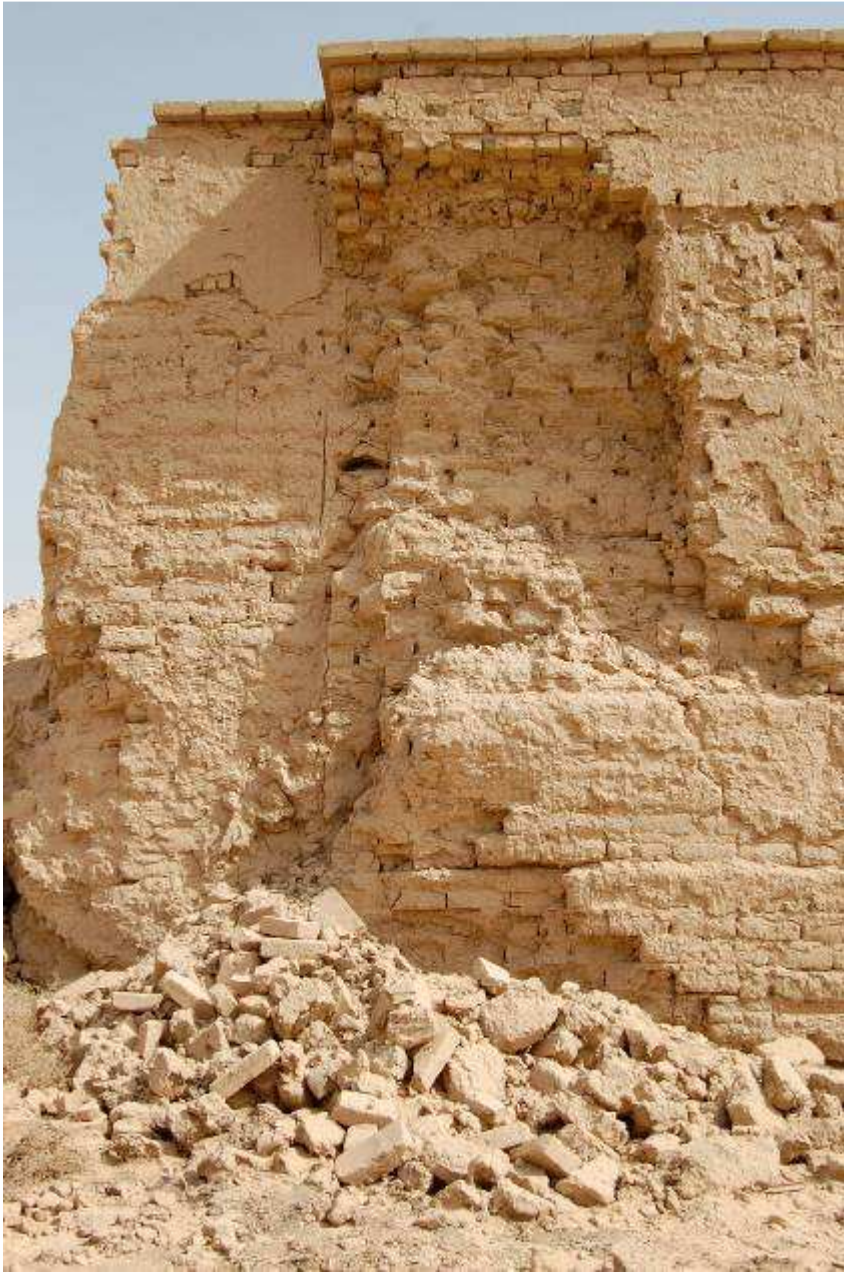
Inner wall, 21 June 2009 (Russell photo 251, © John Russell)

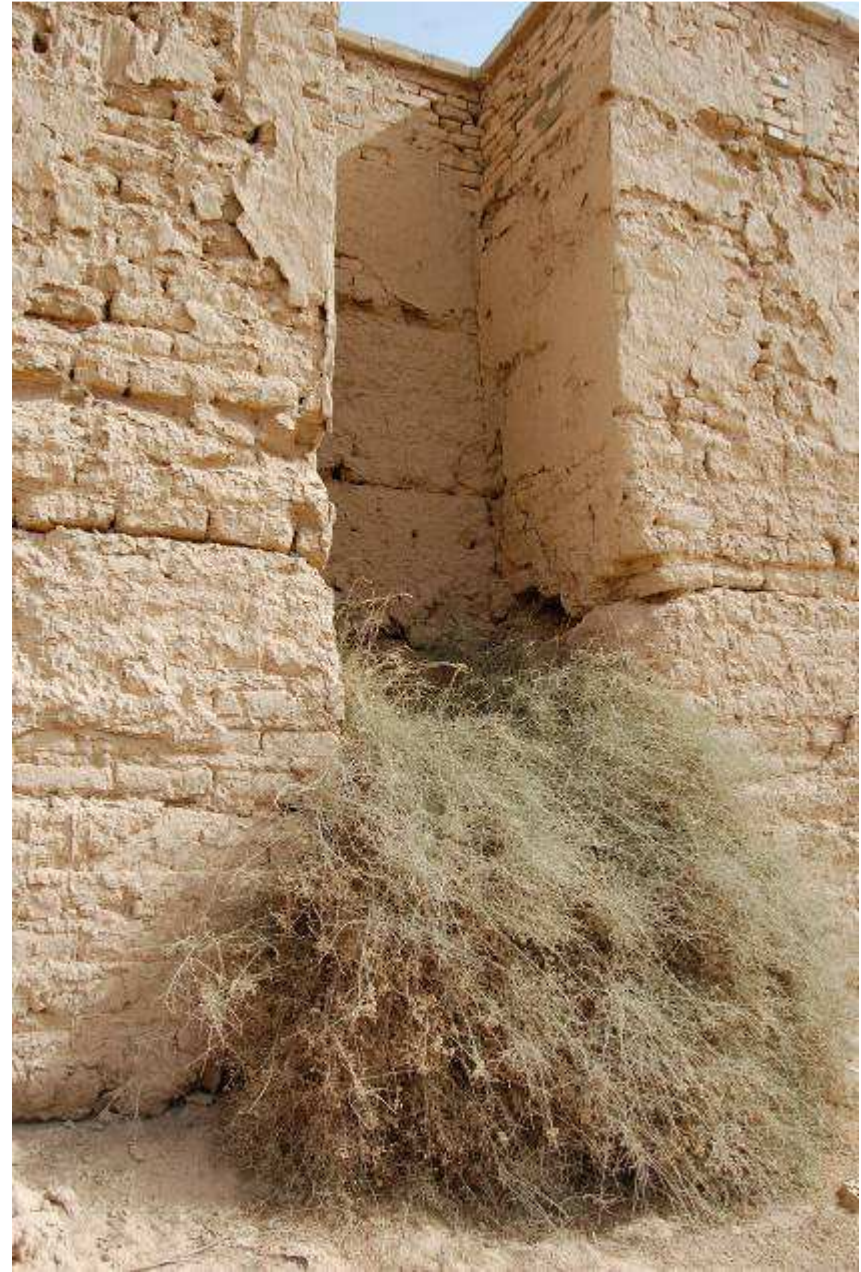
Inner wall, 21 June 2009 (Russell photo 249, © John Russell)

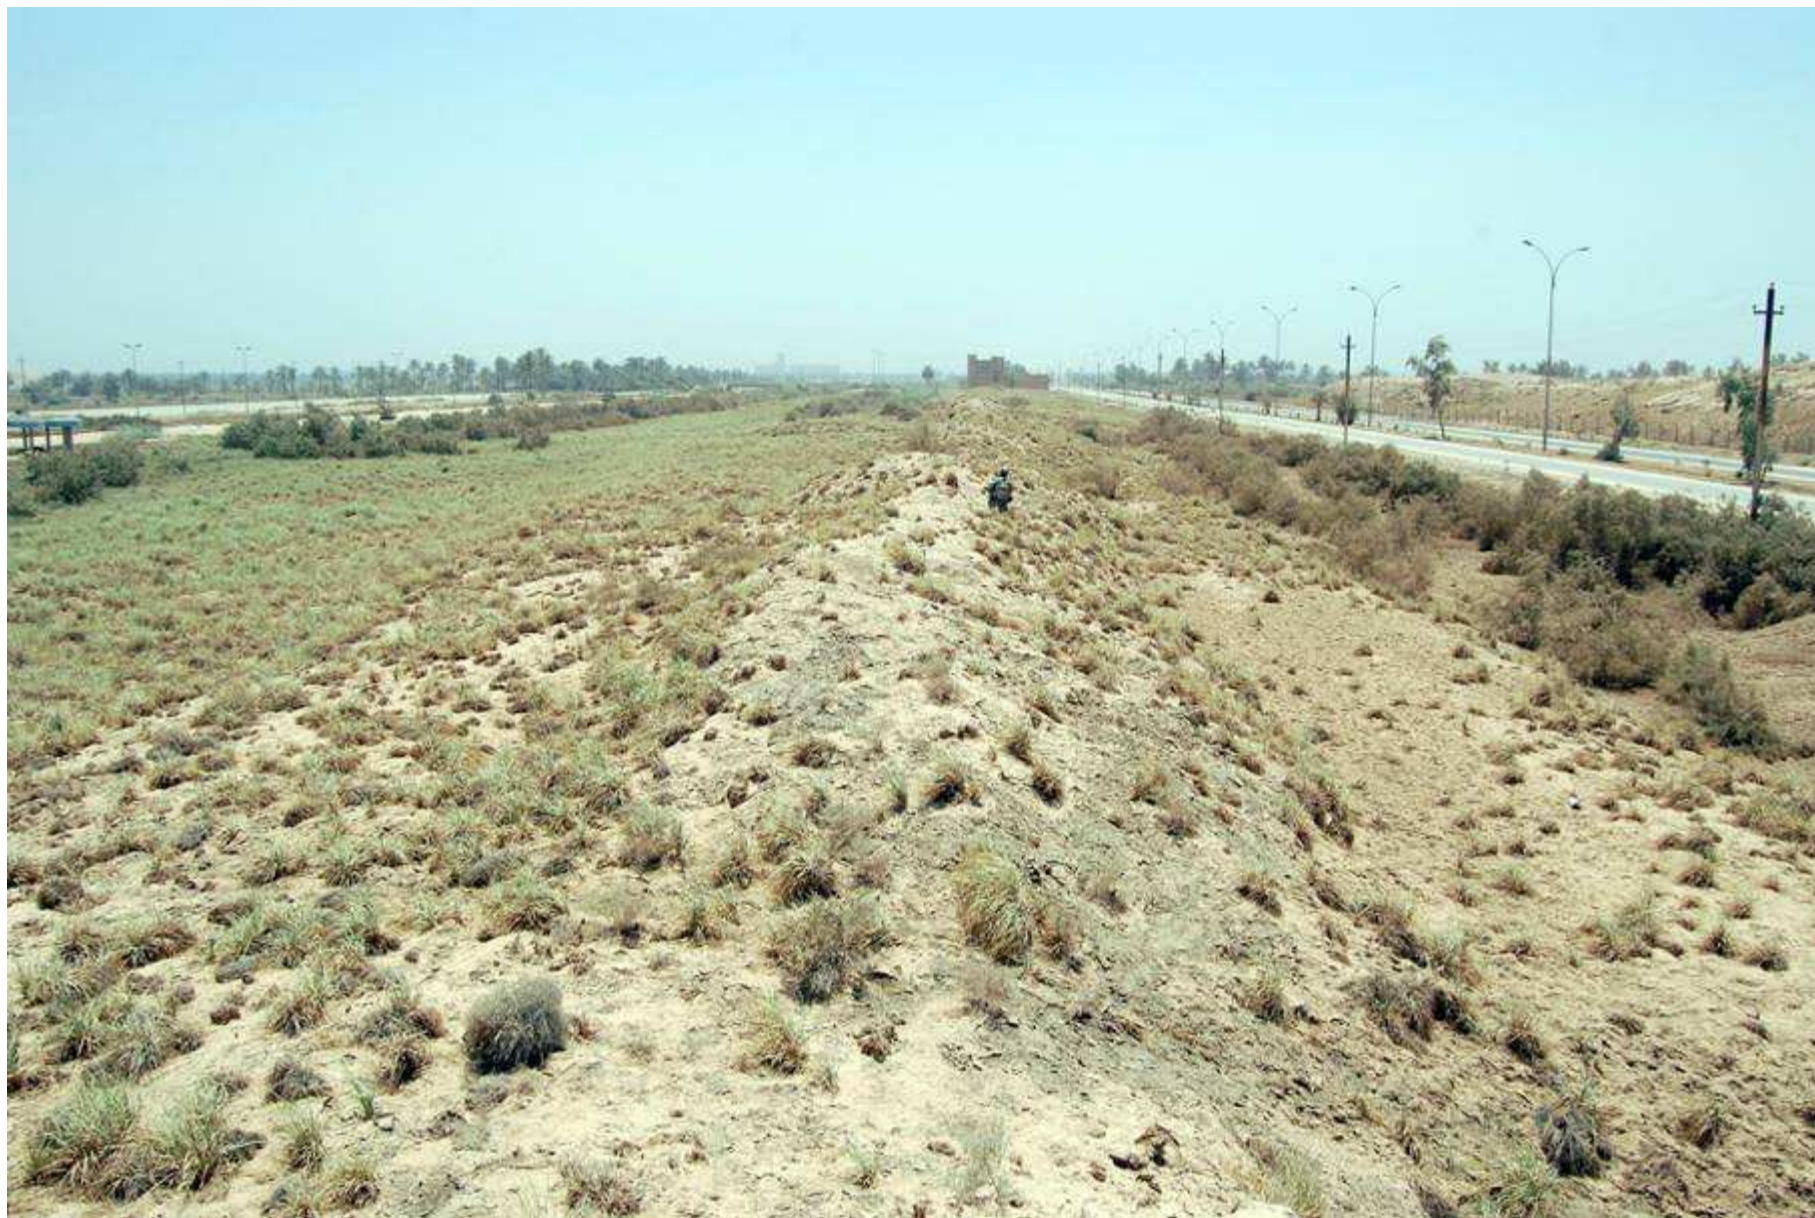
View of original remains of the eastern side of the inner city wall, looking south, 21 June 2009 (Russell photo 266, © John Russell).

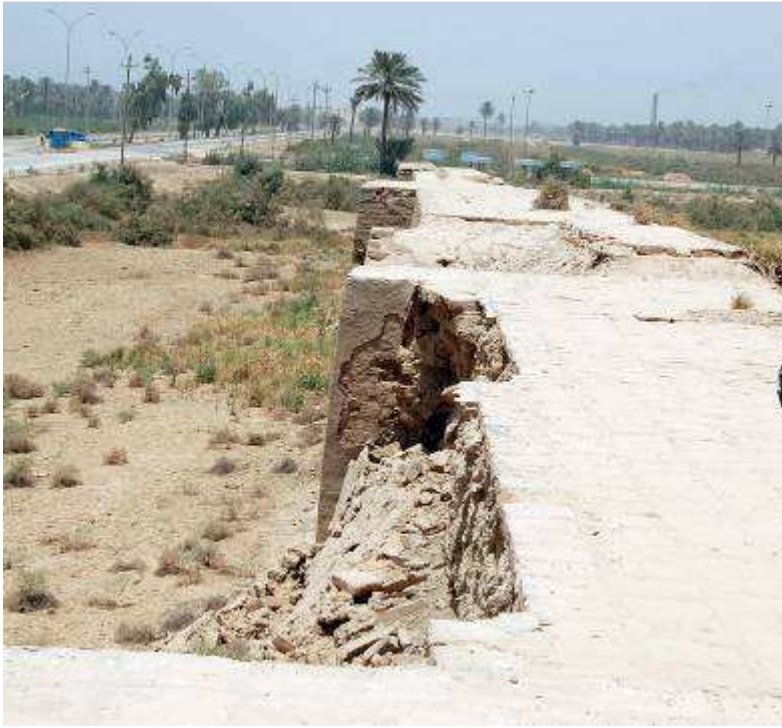
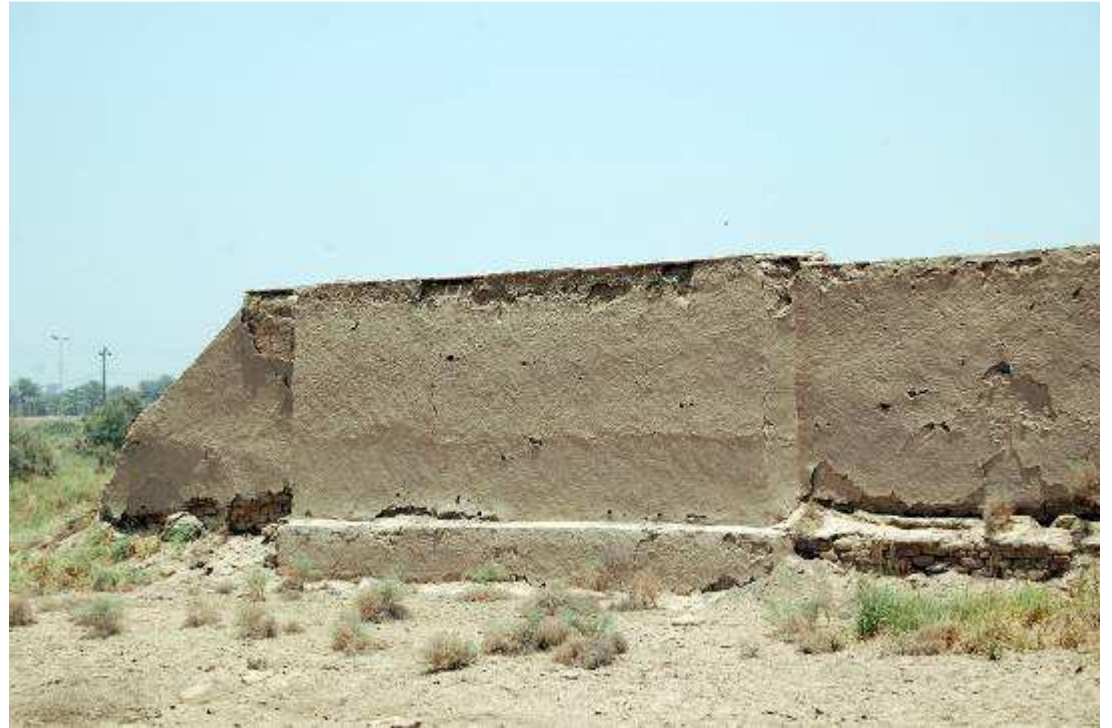
**Inner City Wall, north end of eastern wall**

The northern end of the eastern stretch of the inner city wall had been capped with a heavy layer of modern mud brick and concrete, and large chunks of the facade had collapsed, 21 June 2009.

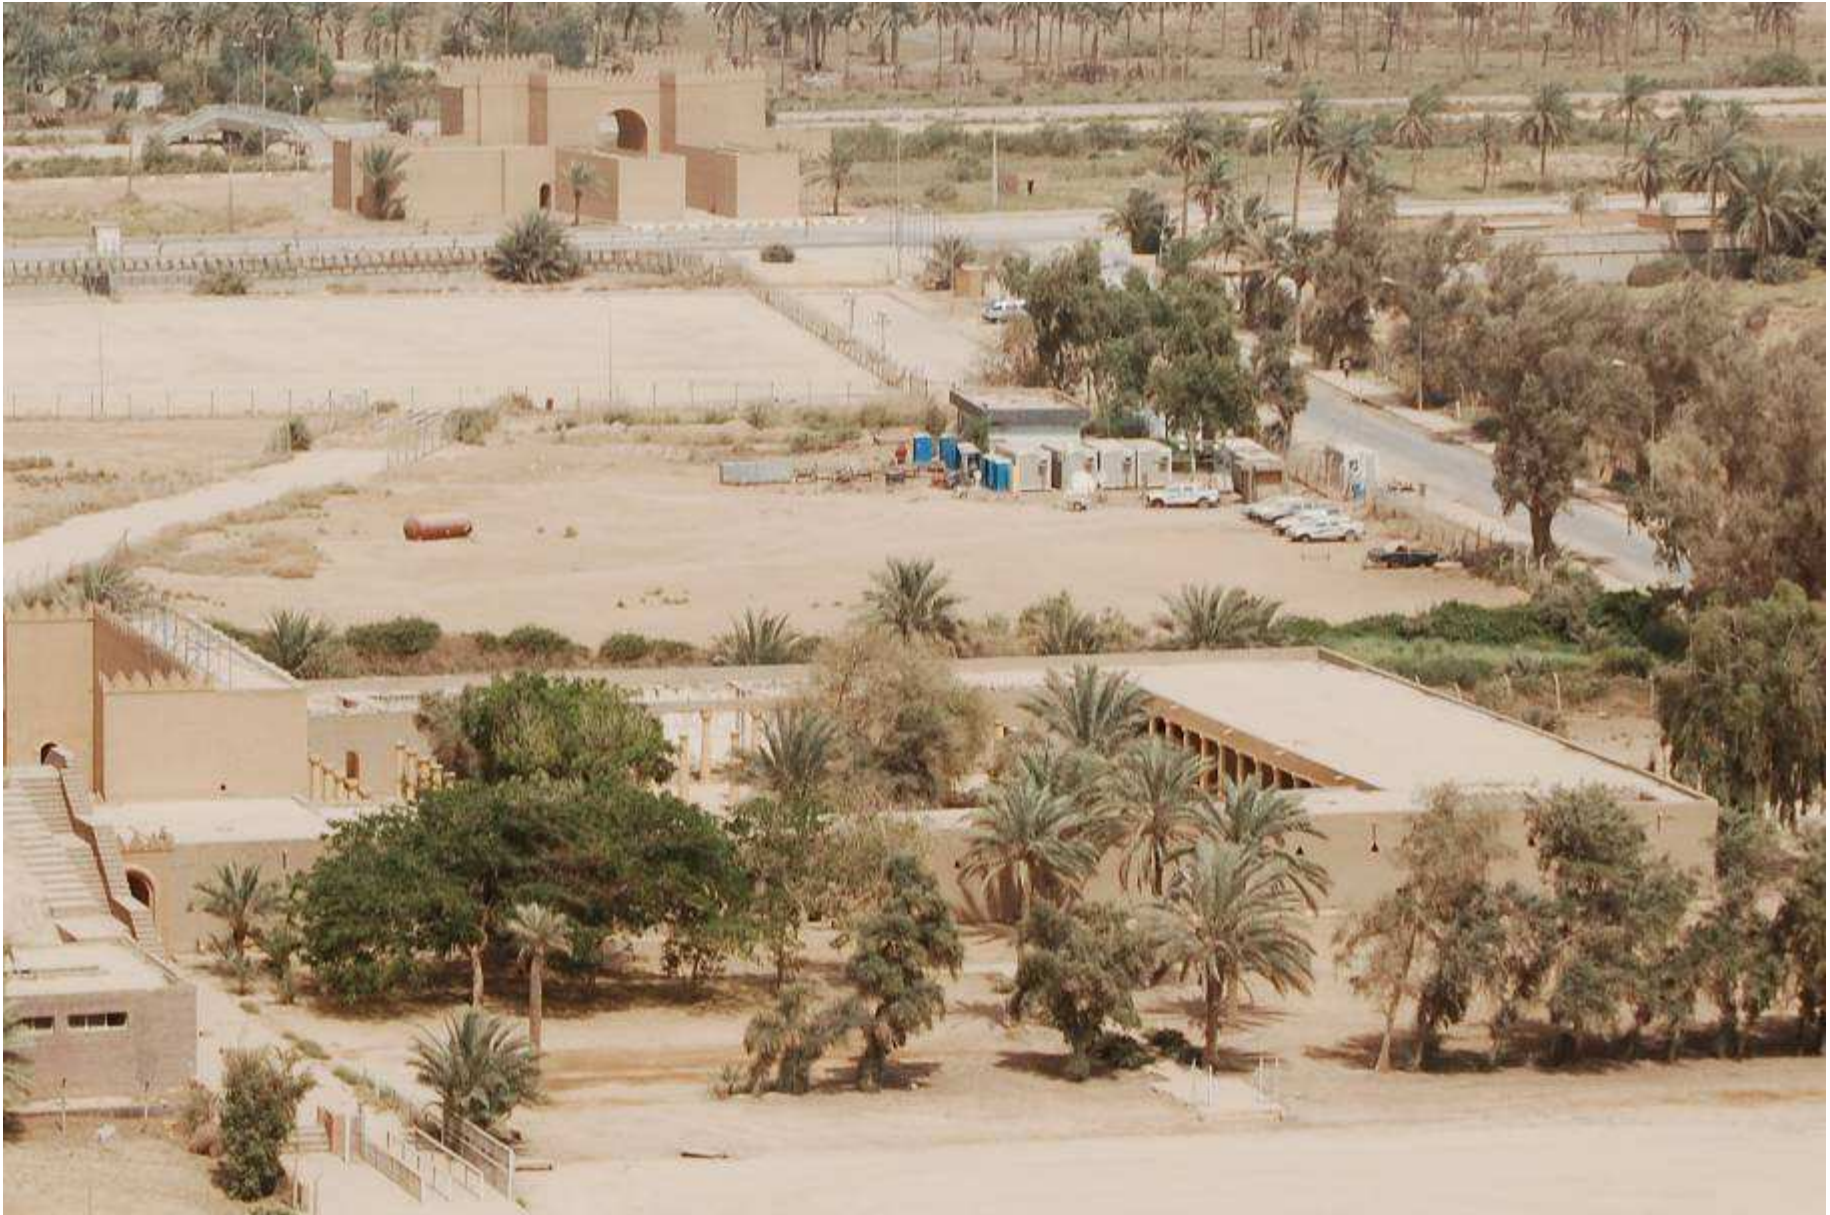
Greek Theater: The roof of the reconstructed courtyard of the Greek theater has been missing since 2003, 25 June 09 (Russell photo 7, © John Russell)

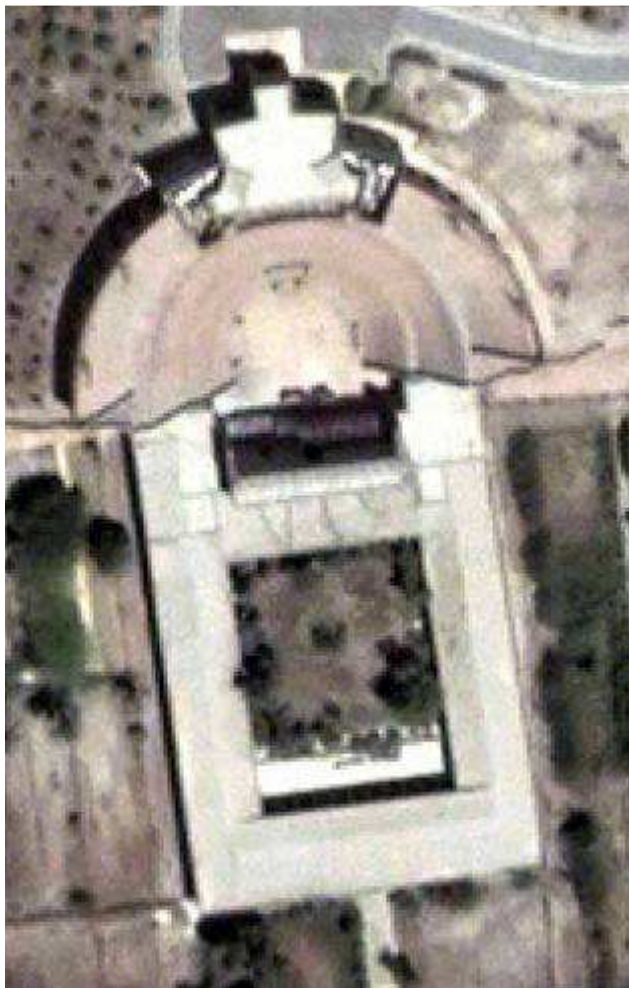
5 July 2002

Comparison showing area of roof of Greek theater that has been missing since 2003, Russell composite.

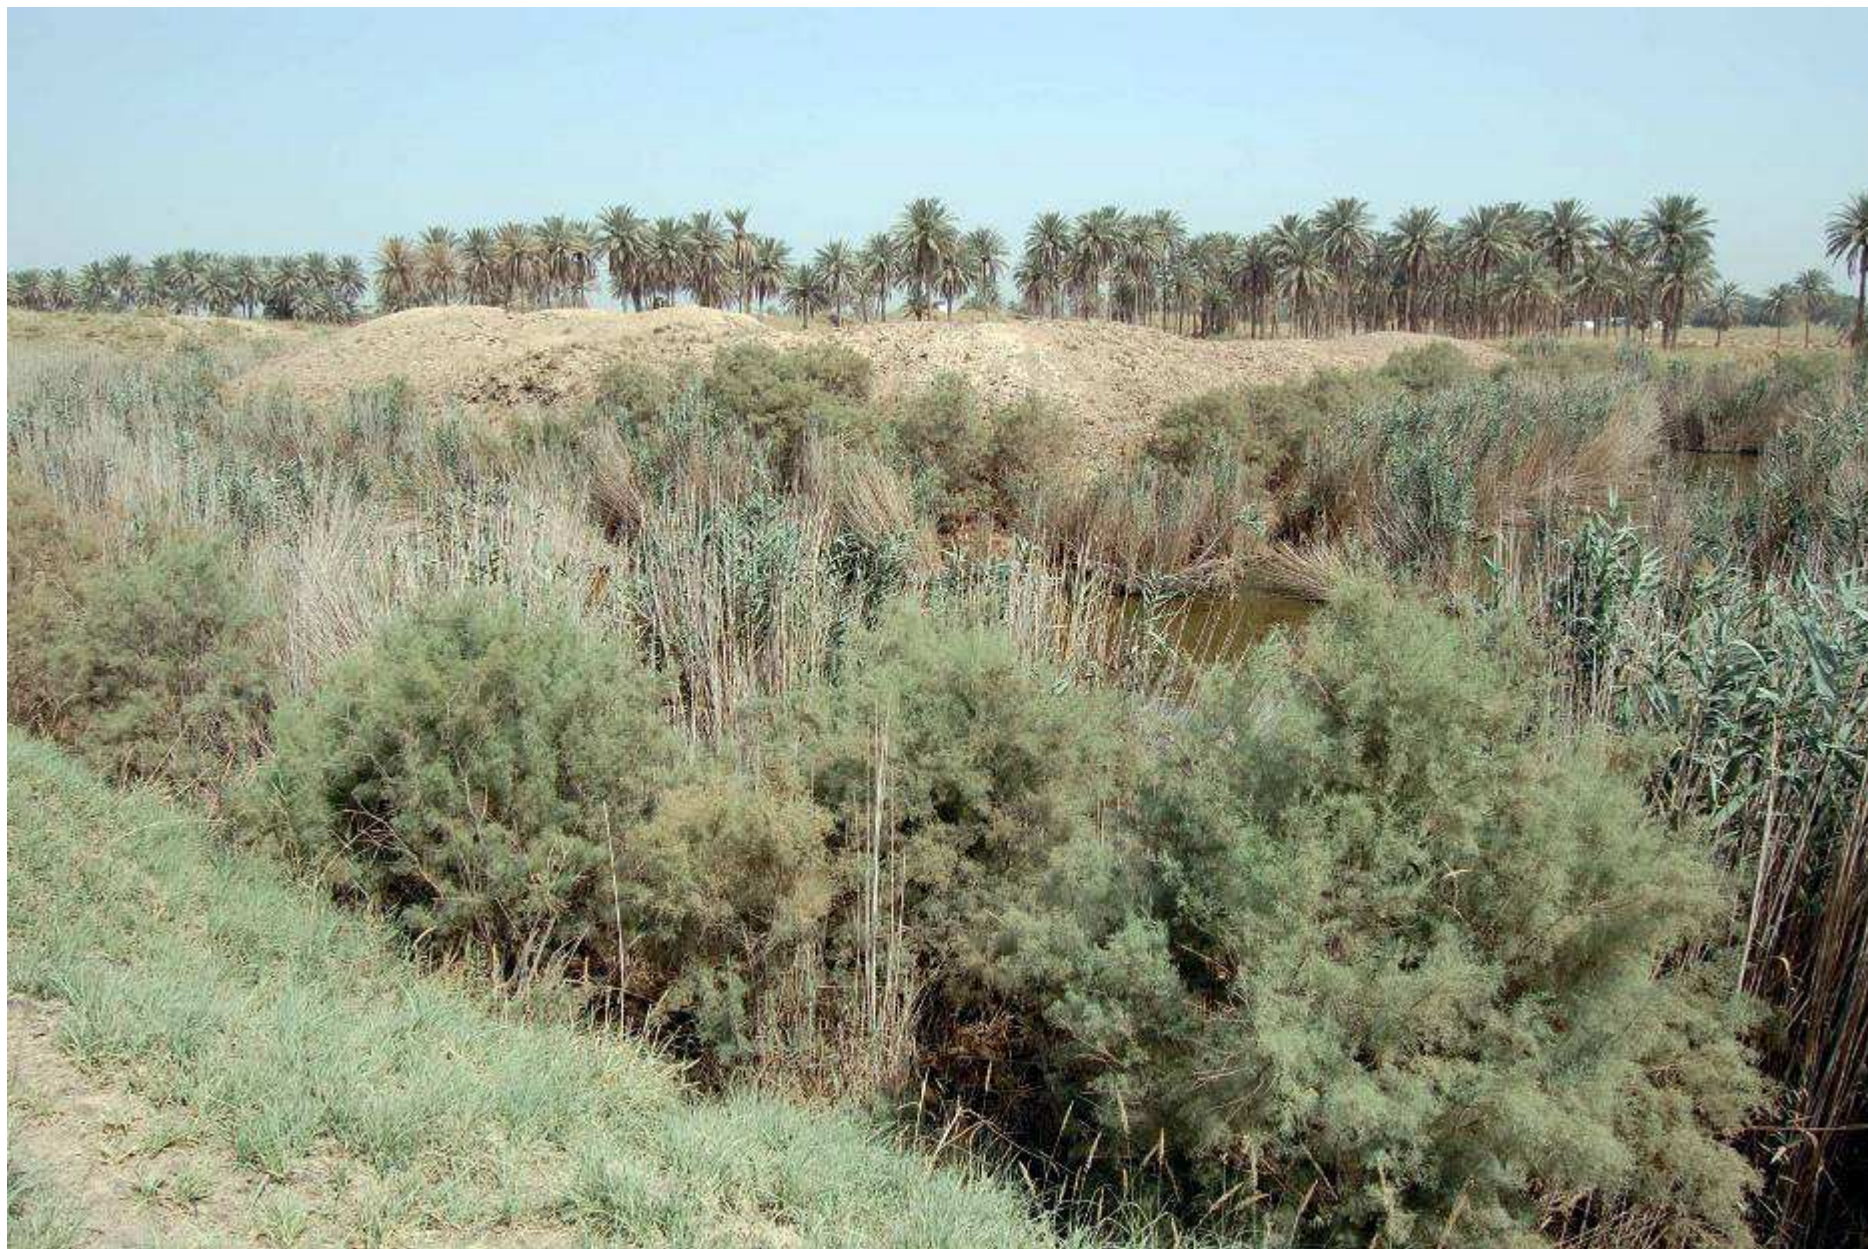
The earth core of the ziggurra is surrounded by a water-filled ditch, 22 June 2009 (Russell photo 27, © John Russell)

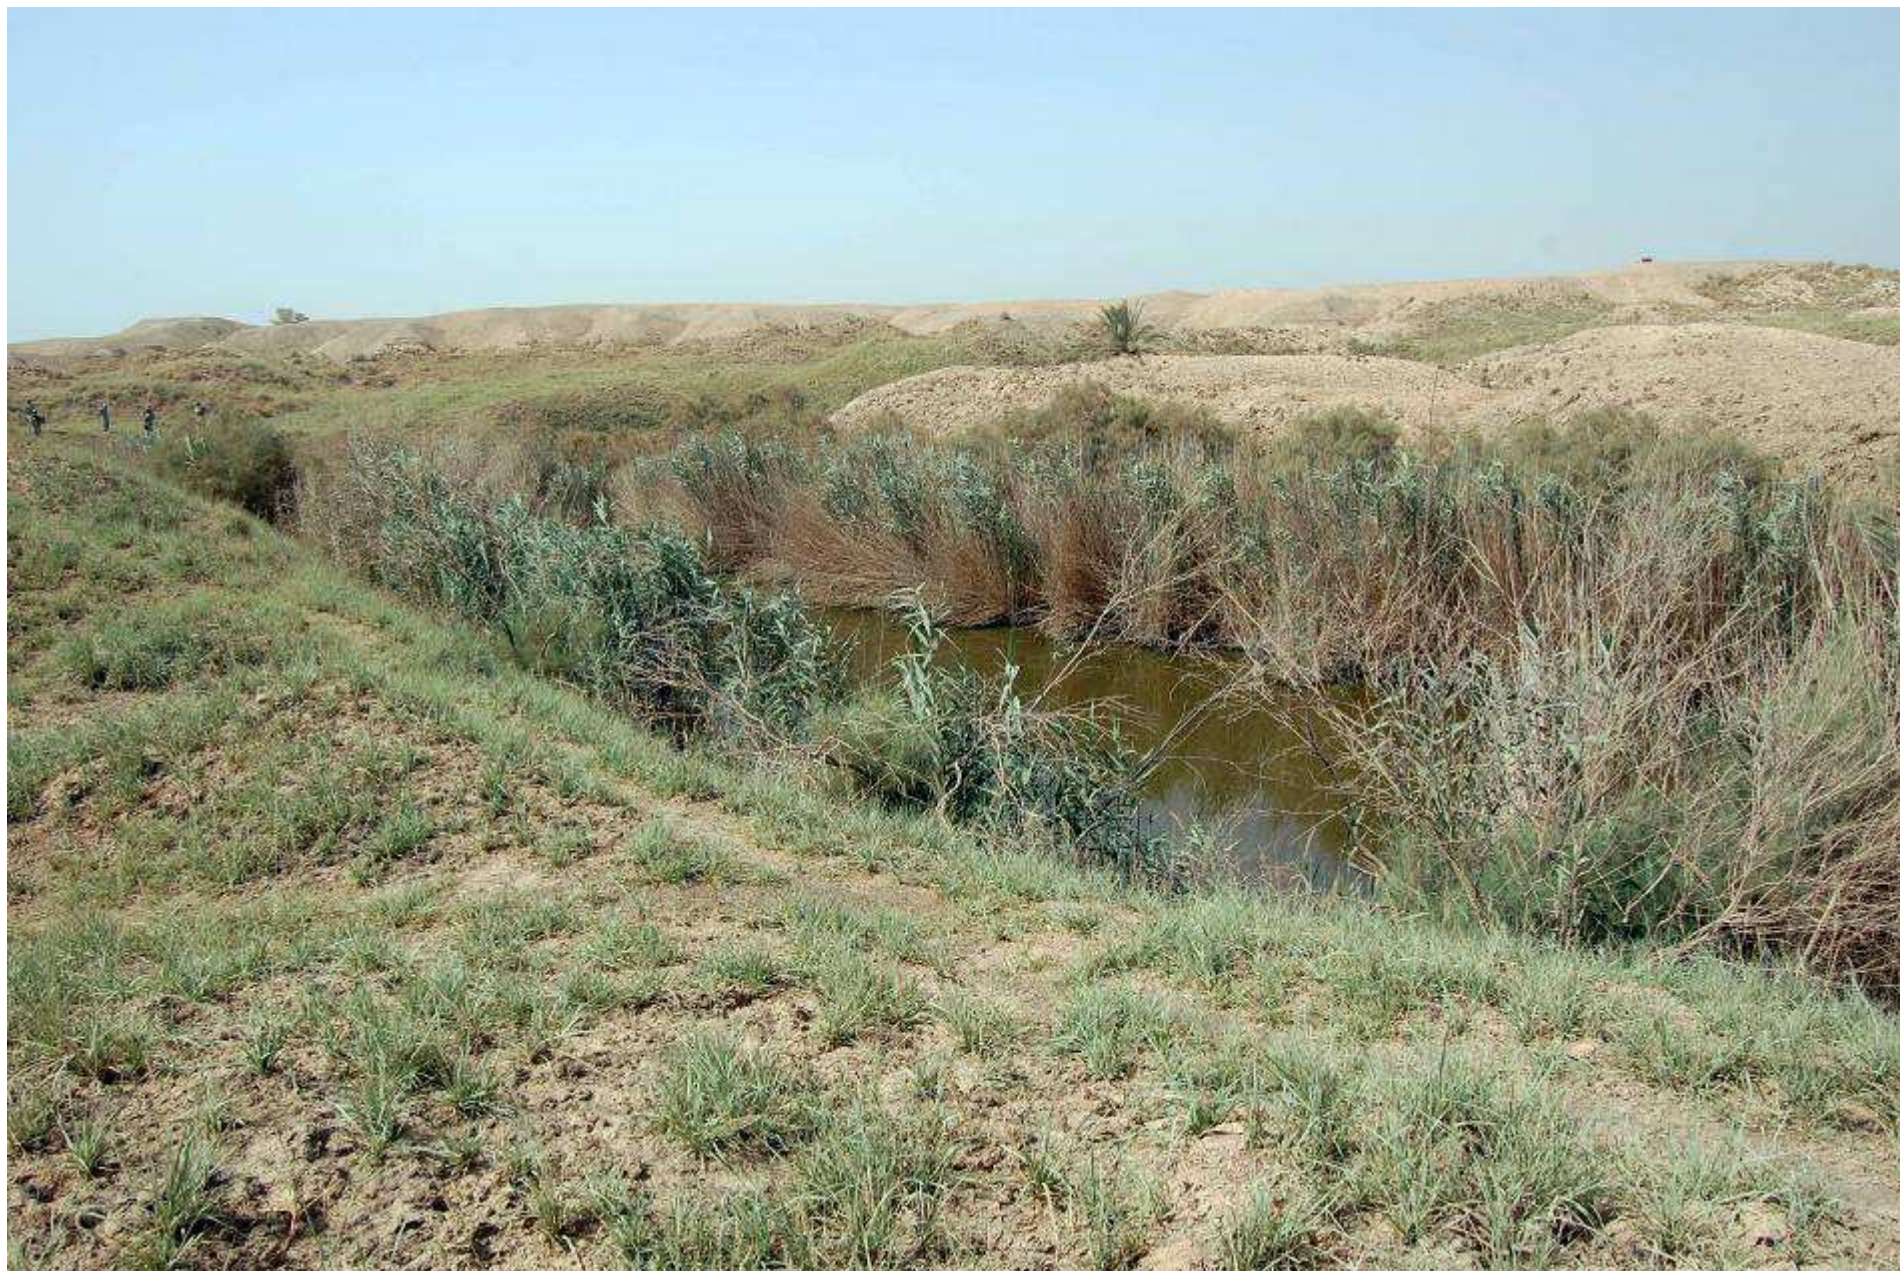
View of water-filled trench surrounding ziggurat core, 22 June 2009 (Russell photo 24, © John Russell)

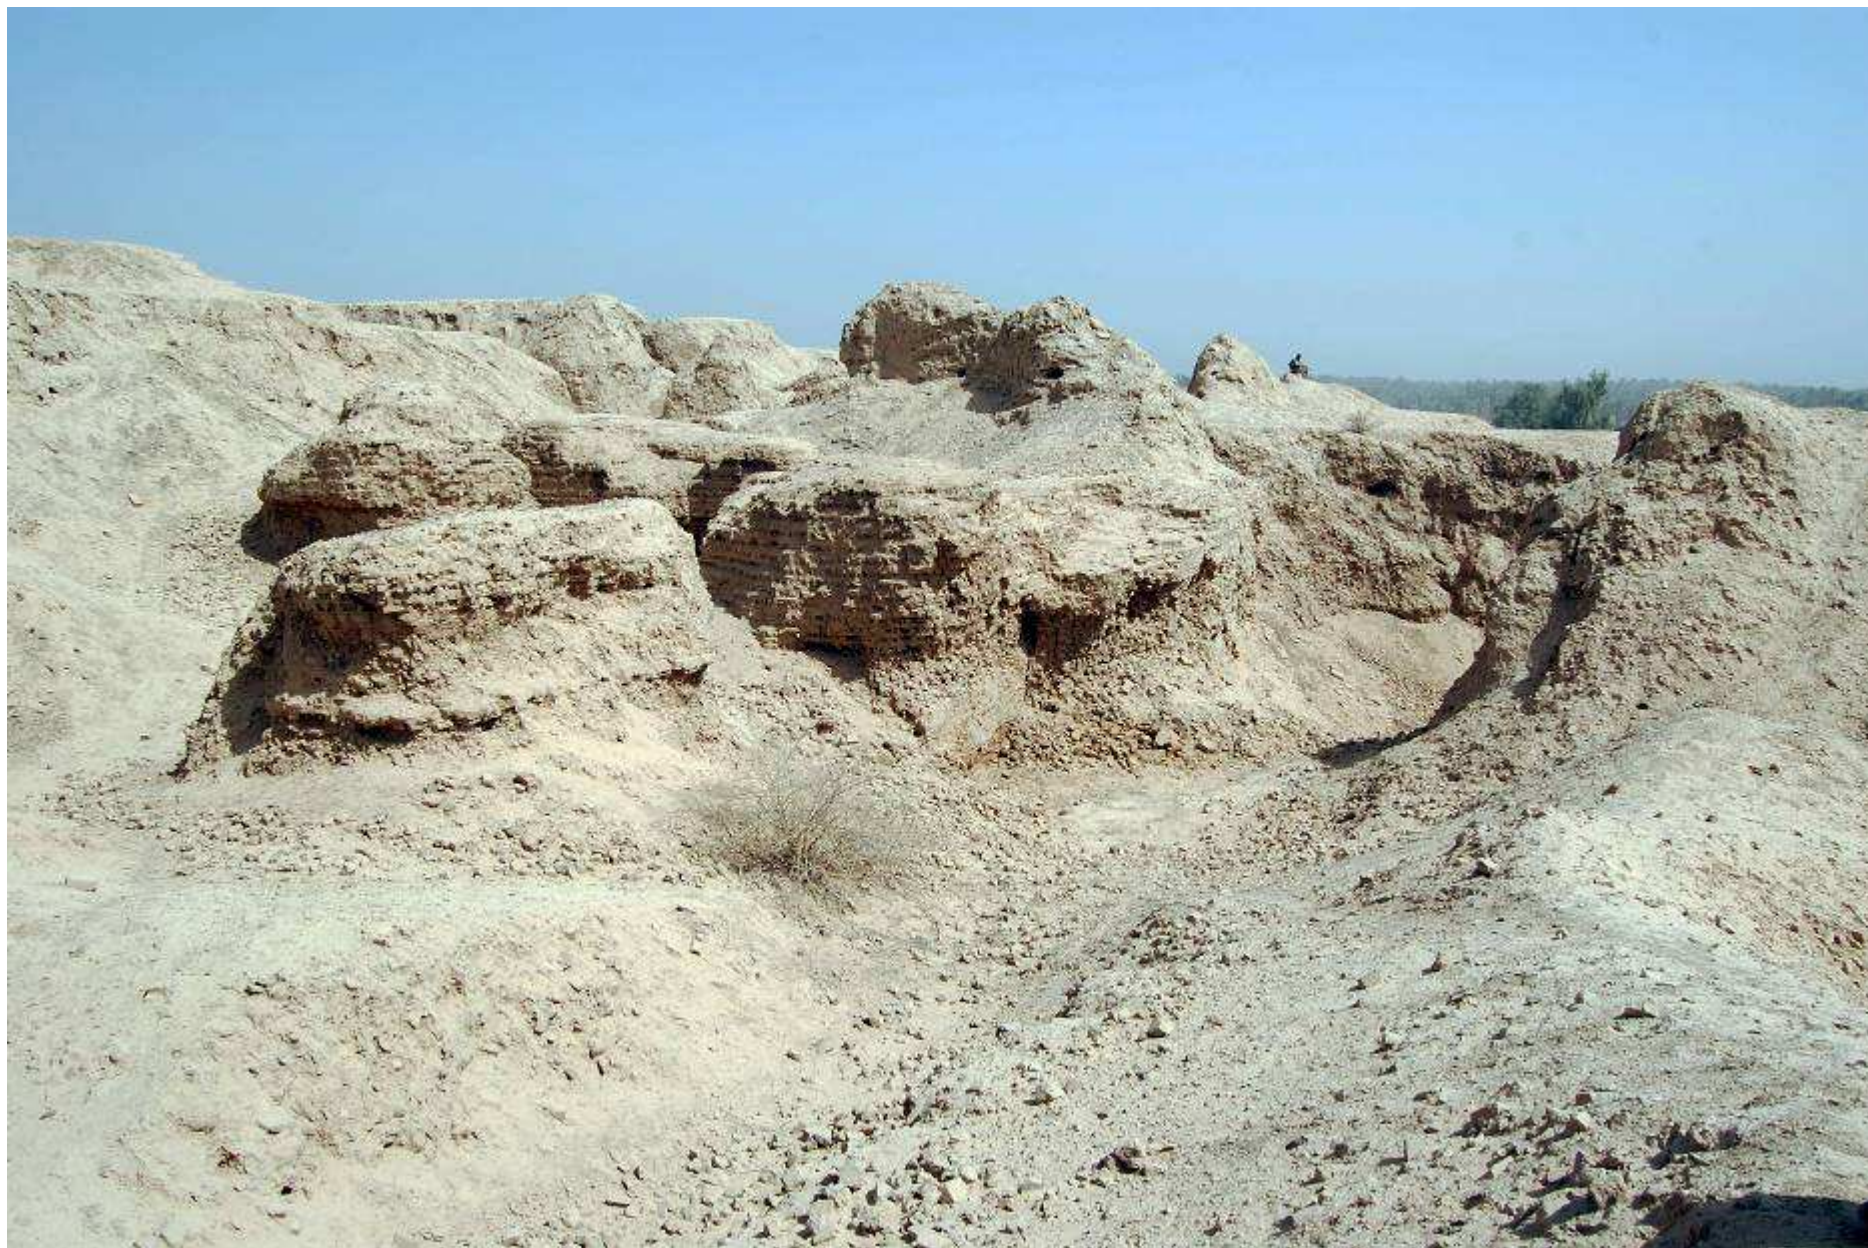
Surface of Babil mound, showing eroded Parthian(?) mud brick architecture, 23 June 2009 (Russell photo 27, © John Russell)
